#### Press-house and cellar

# Misseuri Historie Architectural Inventory for Division of Parks and Historic Preservation Department of Natural Resources

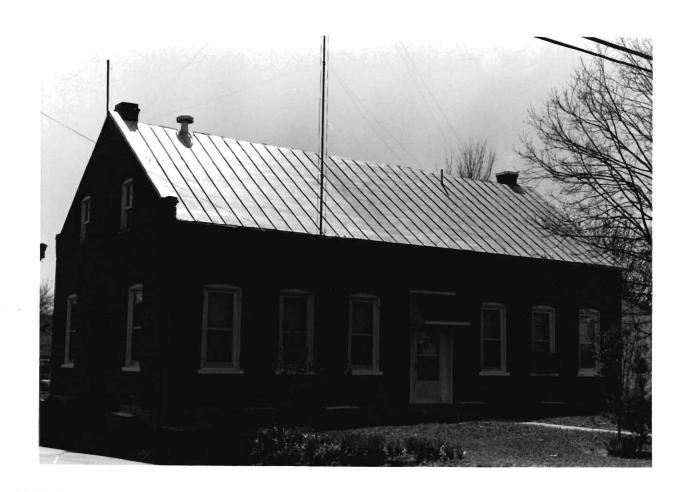
John Fleisch wine cellar plan

The storage cellar has a single course of brick vault arch with approximately four inches of dirt on top of the arch. There are three arches in the north long wall intersecting with the main arch. These segmental shaped brick arches rise to below grade vents. Below the level of the arch the vents actually begin at floor level raking slightly back at an increasing angle inthe masonry of the stone wall. In the stone endwall there are raking vents at the ends of the arch which clear the end of the arch and are slightly below grade level, with exterior stone lined well shafts.
