MISSOURI DEPARTMENT OF NATURAL RESOURCES
STATE HISTORIC PRESERVATION OFFICE, P.O. Box 176, Jefferson City, MO 65102
ARCHITECTURAL/HISTORIC INVENTORY FORM

1. Survey number: JP-AS-006-184		2. Survey Name: East Town (Original Joplin) Historic Survey Phase 1	
3. County: JASPER		4. Address 1401	Street (name): E. Hill Street
5. City: Joplin	Vicinity <input type="checkbox"/>	7. Township/Range/Section: T: R: S:	
8. Historic name (if known):		9. Present/other name (if known):	
10. Ownership: <input checked="" type="checkbox"/> Private <input type="checkbox"/> Public		11a. Historic use (if known): Domestic/Single Dwelling	11b. Current use: Domestic/Single Dwelling

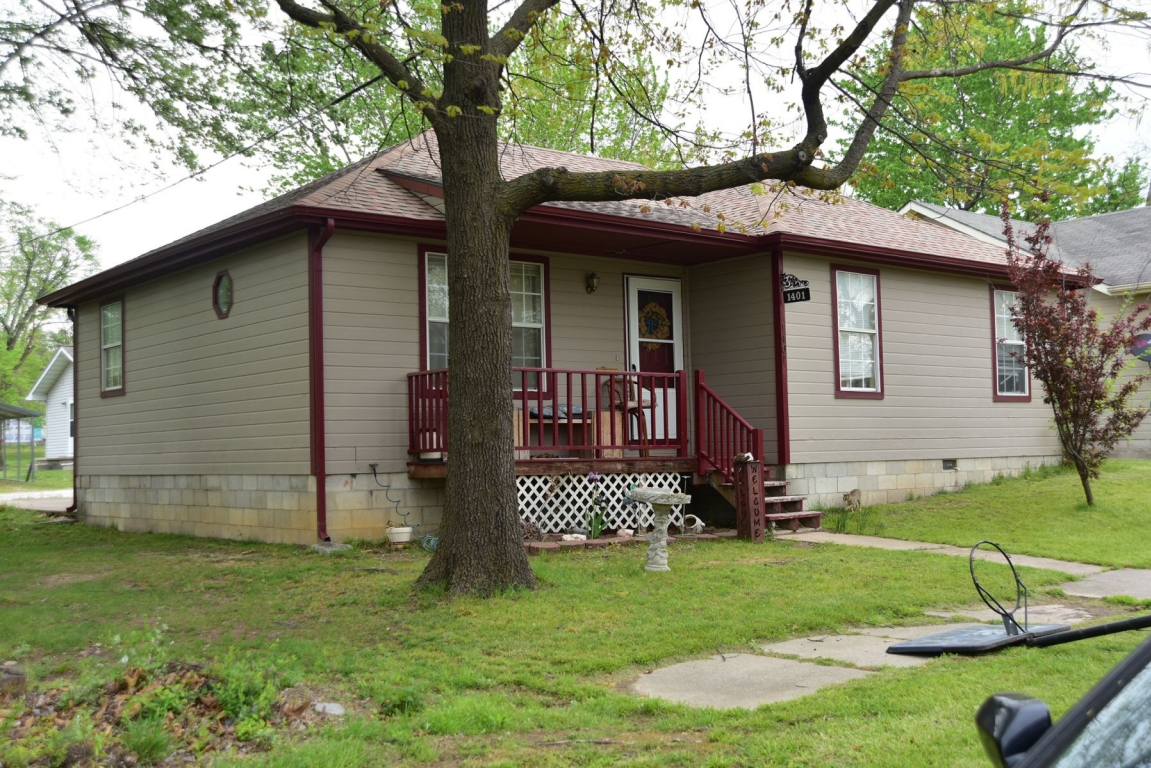
This Minimal Traditional dwelling faces south and has an L-shaped footprint. It has a concrete masonry unit foundation and wood cladding. The hipped roof with cross-gables has asphalt shingles. The dwelling is four bays wide and two asymmetrical bays deep. The west two bays are recessed, creating a partial-width open porch. The porch elements are non-historic. A Non-historic wood door occupies the second-from-west bay while six-over-six vinyl windows occupy the remaining bays.

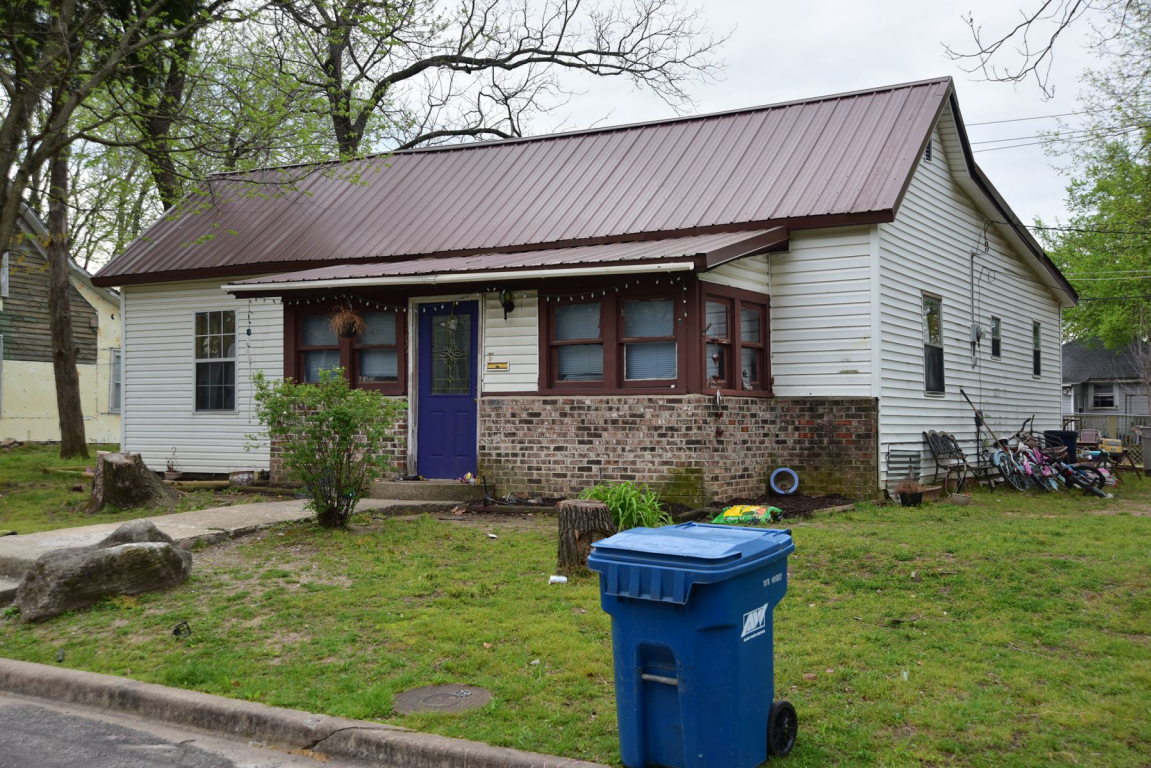
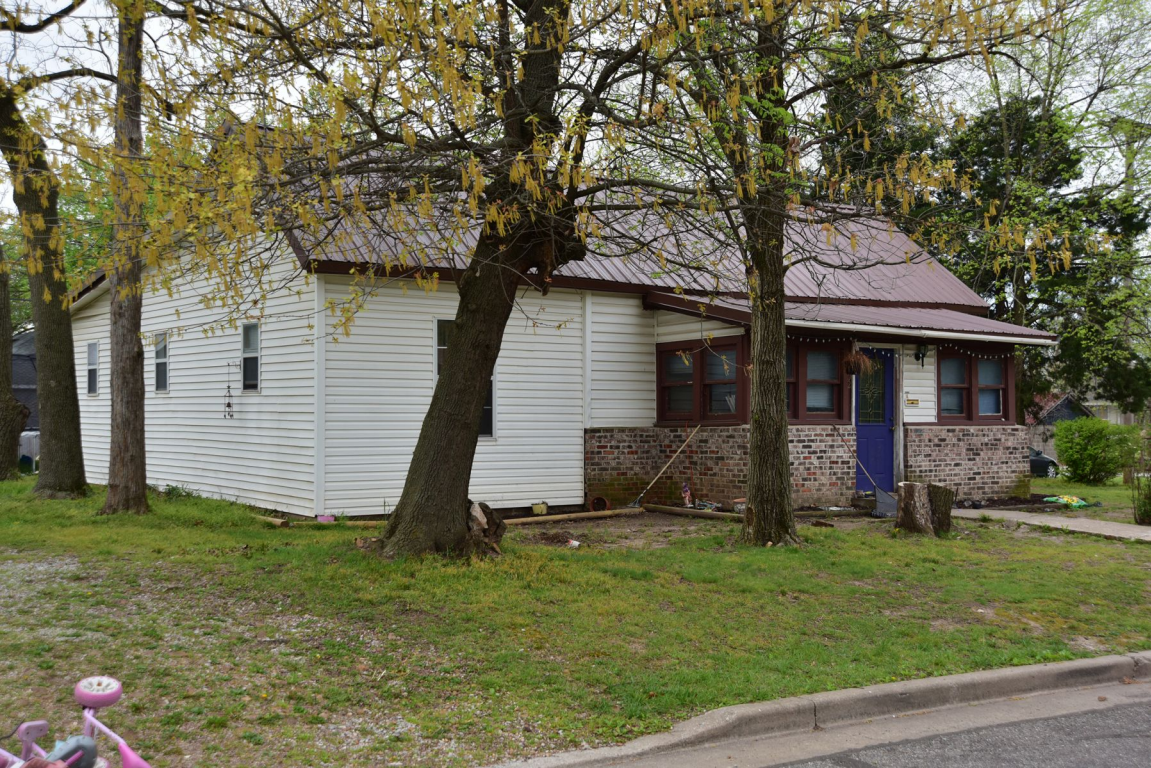
This National Folk House dwelling faces north and has a square footprint. It has a concrete foundation and corrugated metal roof. Brick veneer clads the lower third of the enclosed porch at the primary elevation. The remainder of the dwelling has vinyl siding. The dwelling is four asymmetrical bays wide and three bays deep. A three-quarter width enclosed porch with a shed roof contains the three west bays. The porch enclosure is an alteration. One-over-one wood windows occupy the first and third bays of the dwelling while a six-over-six vinyl window occupies the fourth bay. A non-historic wood door with glazing defines the second bay.

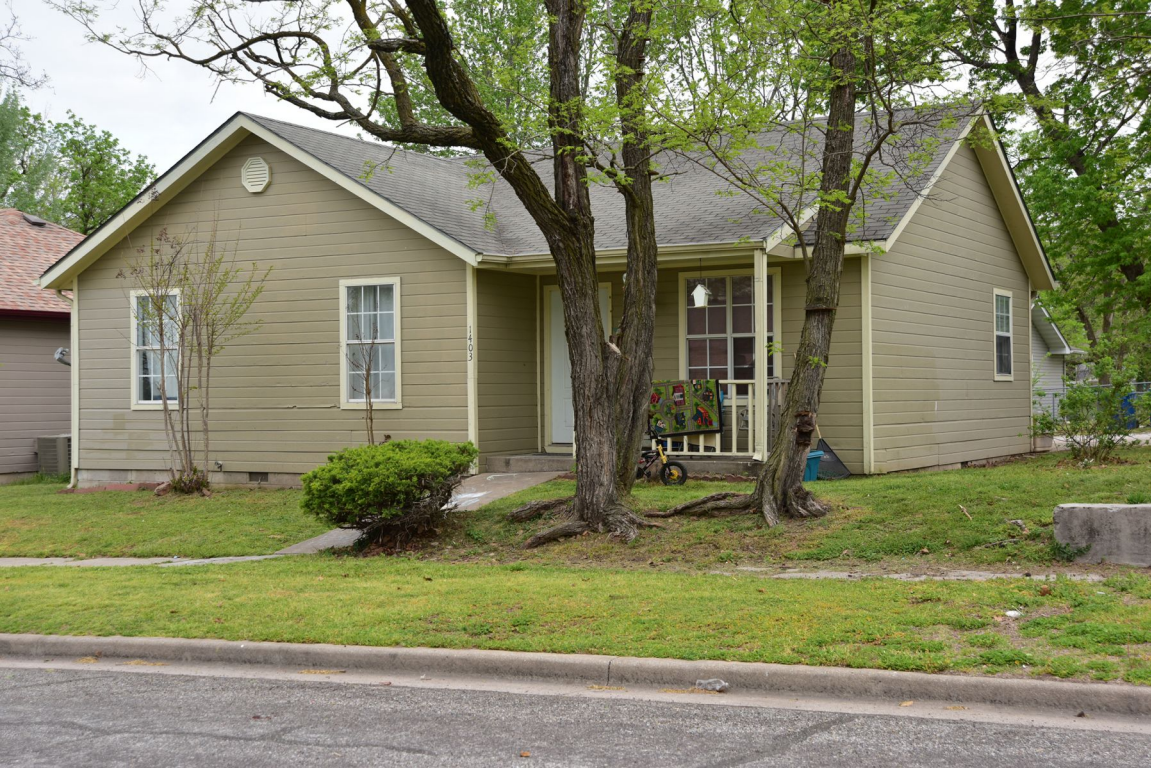
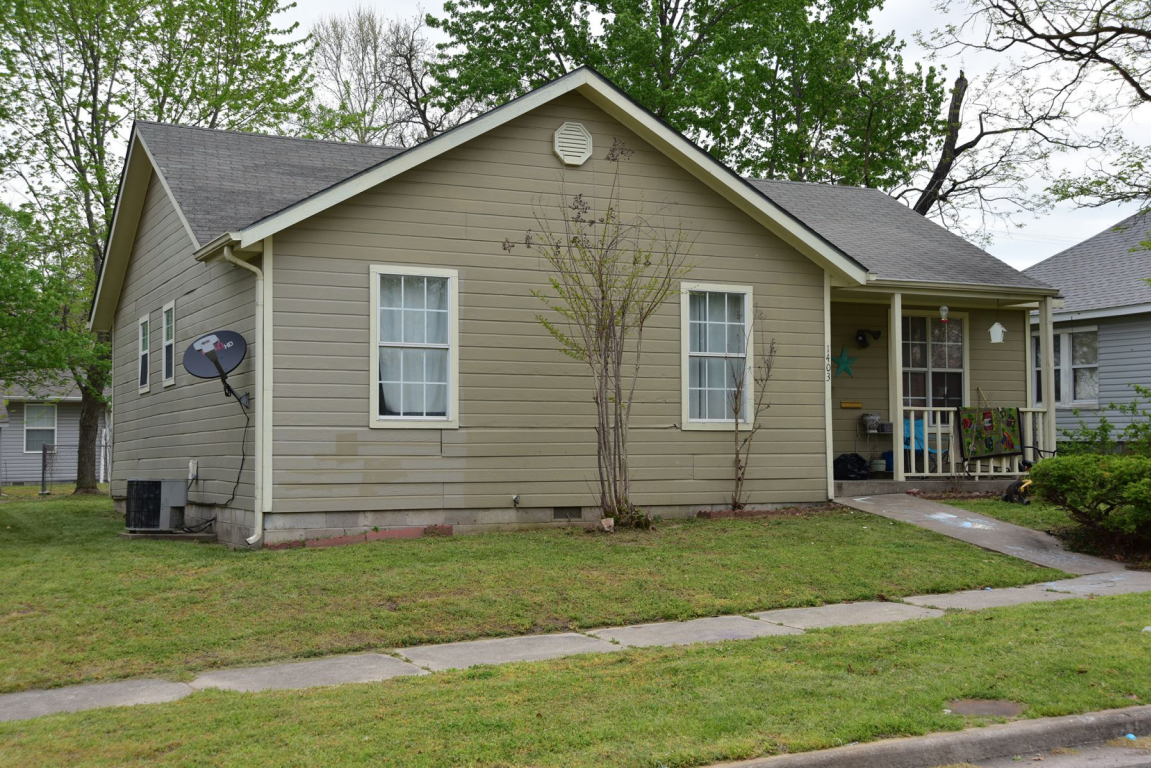
This Minimal Traditional dwelling faces south and has an L-shaped footprint. It has a concrete masonry unit foundation and wood cladding. The intersecting gable roof has asphalt shingles. The dwelling is four bays wide and two asymmetrical bays deep. The east two bays recede, creating a partial-width open porch. The porch has a shed roof, concrete foundation, and matchstick balustrade. A wood door with glazing occupies the second-from-east bay while six-over-six vinyl windows occupy the remaining bays.

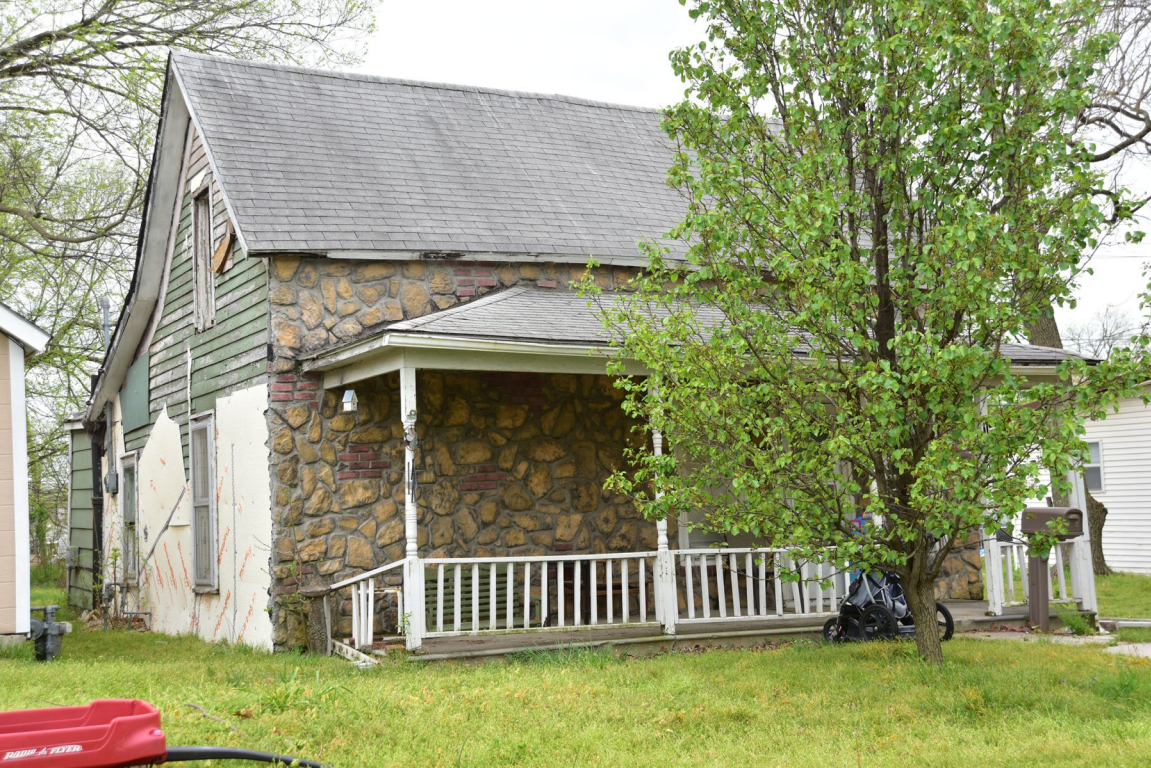
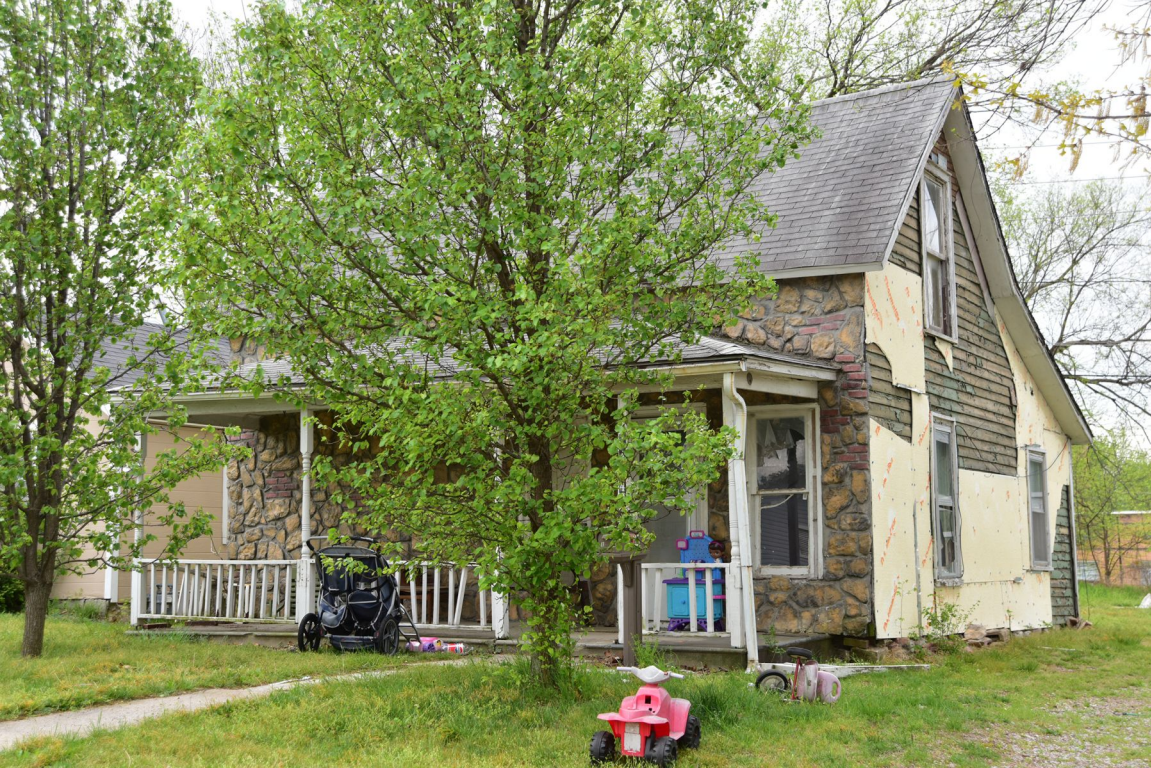
This National Folk House dwelling faces north and has a rectangular footprint. It has a stone foundation and asphalt shingle roof. Stone and brick veneer clads the primary elevation while wood clapboards clad the secondary elevations. The dwelling is three asymmetrical bays wide and two bays deep. A historic wood door occupies the center bay while historic one-over-one wood windows fill the remaining bays. A non-historic porch with a hipped roof, turned wood support posts, and concrete foundation spans the primary elevation. An enclosed porch projects from the south elevation.

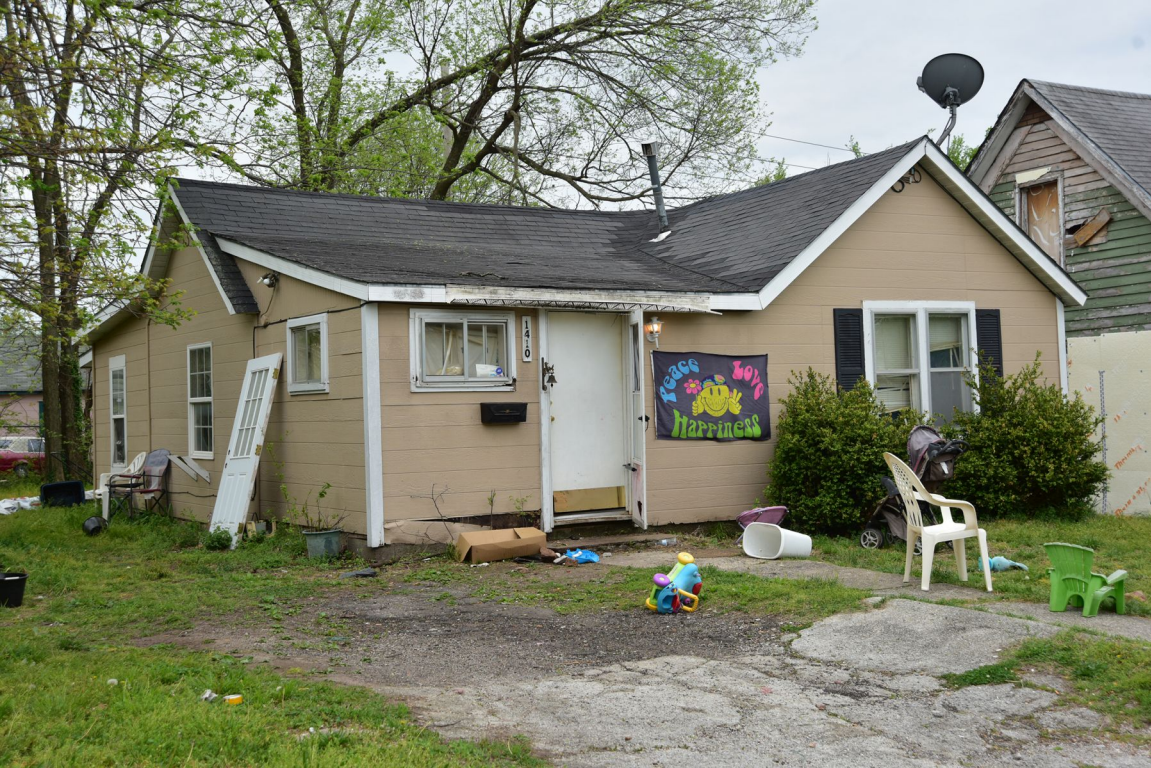
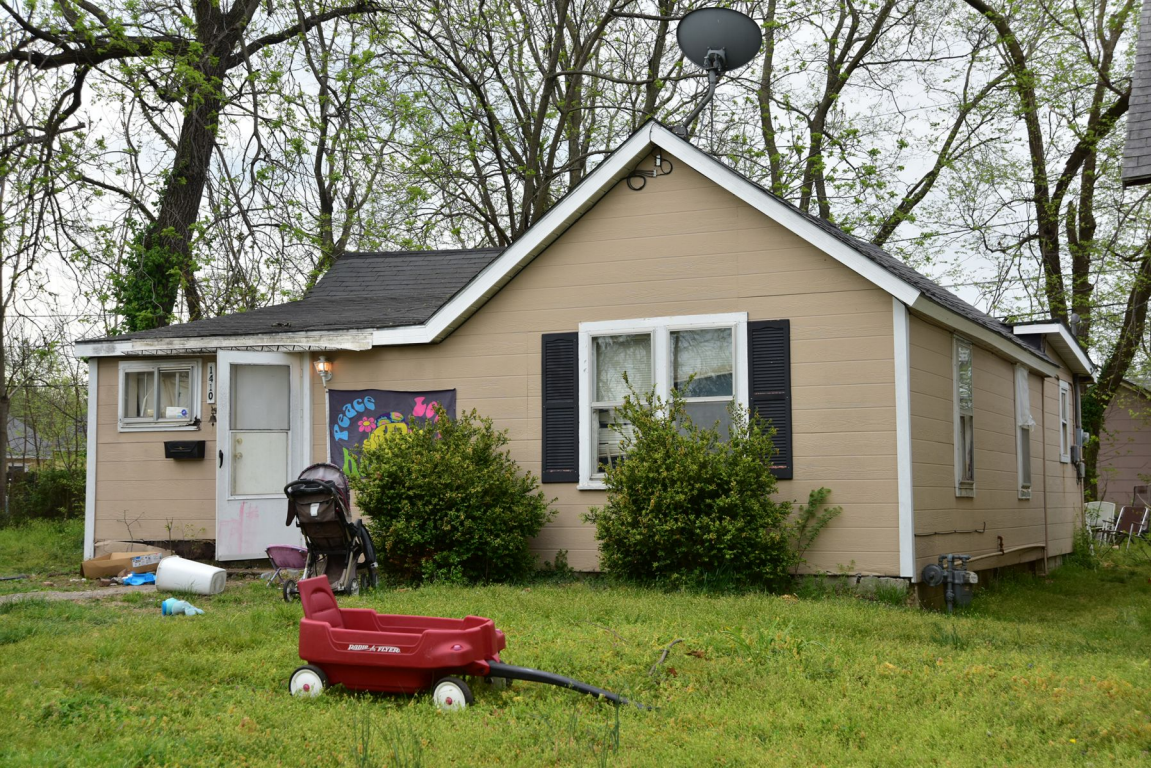
This Gabled-ElI dwelling faces north and has a rectangular footprint. It has a concrete foundation and non-historic wood cladding. The roof has asphalt shingles. The dwelling is three bays wide and three bays deep. An enclosed porch with a shed roof contains the east two bays. The enclosure is an alteration. A non-historic wood door occupies the center bay while a one-by-one metal window occupies the west bay. A pair of one-over-one metal windows with false shutters occupies the west bay. An enclosed shed-roof porch projects from the south elevation.

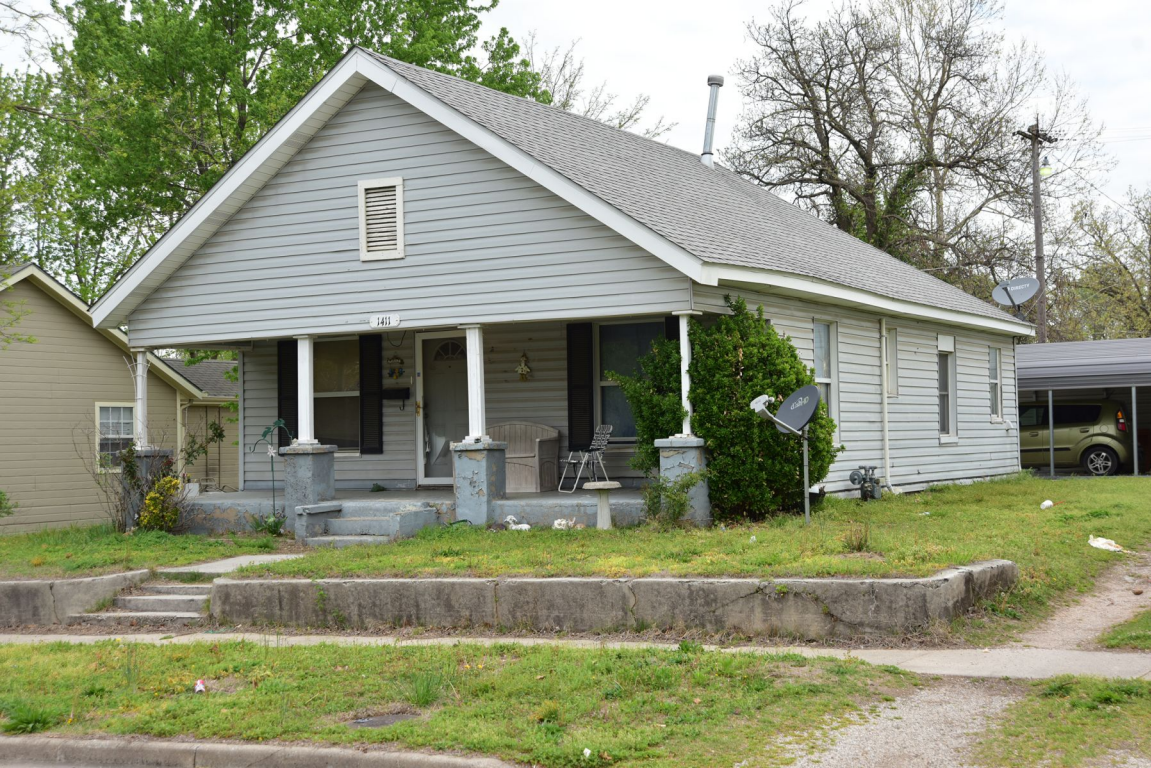
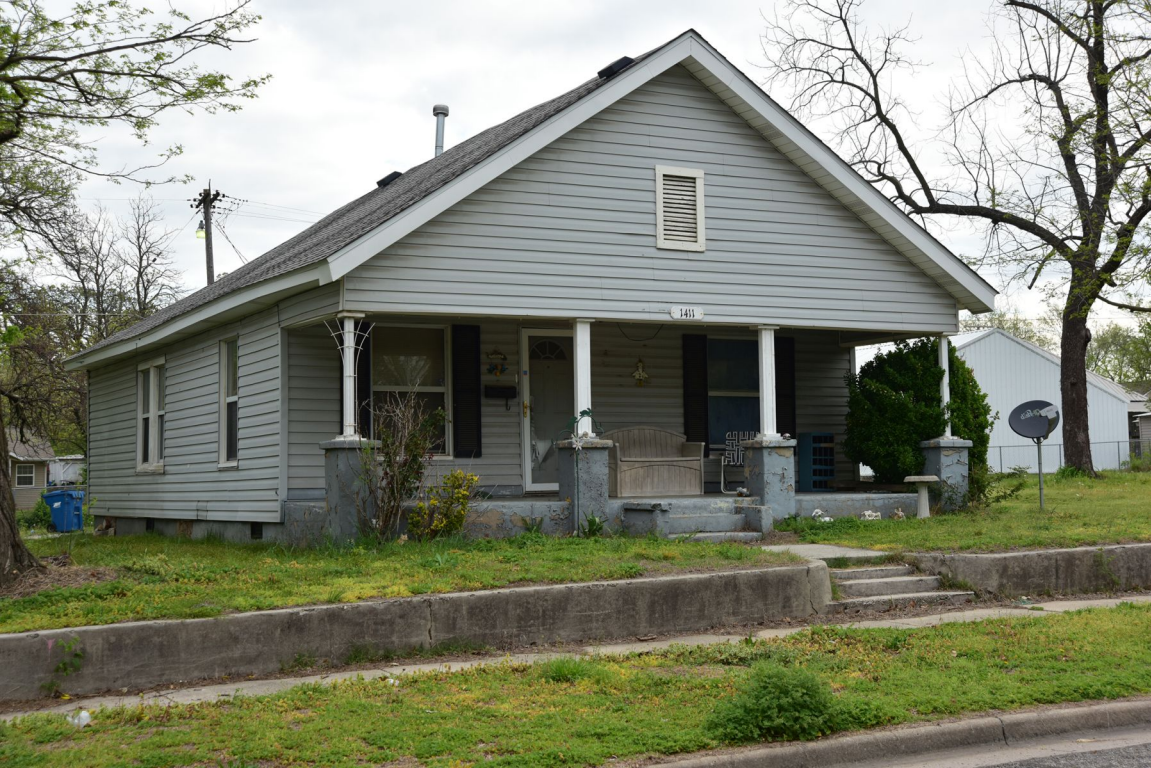
This bungalow dwelling faces south and has an irregular footprint. It has vinyl cladding and an asphalt shingle roof. The foundation is not visible. The dwelling is three bays wide and four bays deep. An open porch with a concrete foundation spans the primary elevation. Squared wood columns on concrete piers support the porch roof. A non-historic fiberglass door occupies the center bay of the primary foundation while one-over-one vinyl windows with false shutters occupy the adjacent bays.

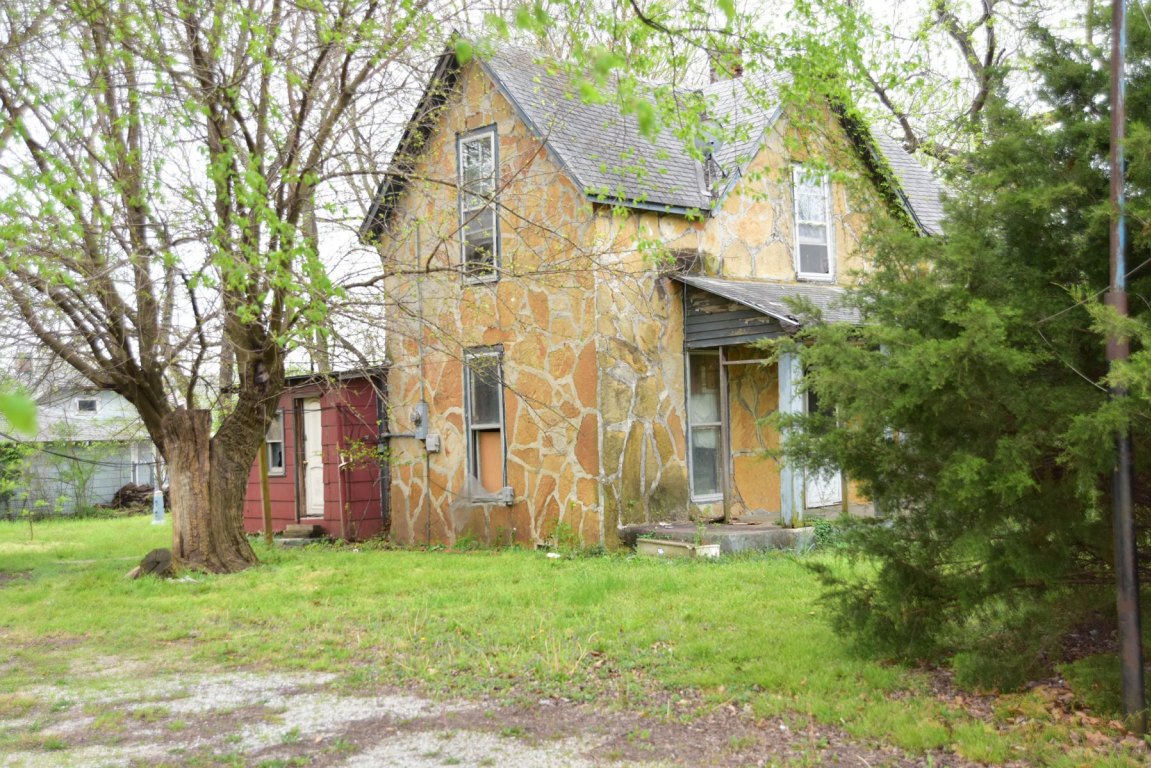
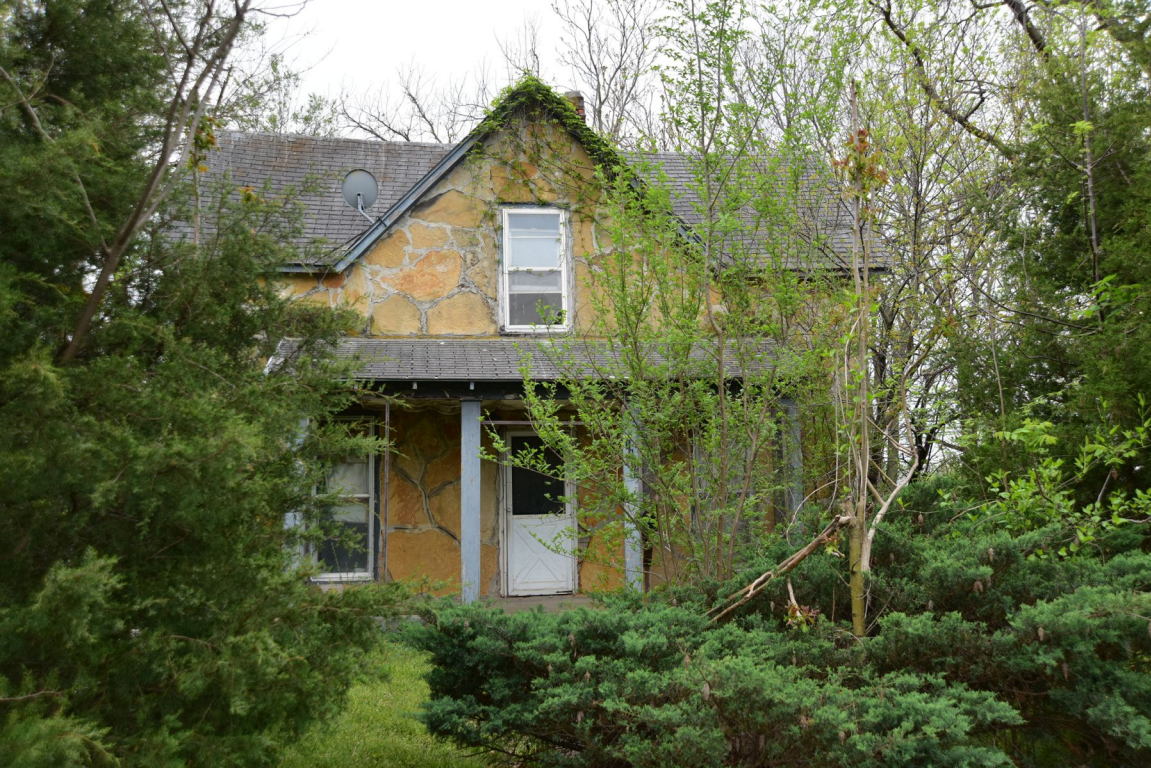
This two-story Gothic Revival dwelling faces north and has a rectangular footprint. It has a field stone foundation and split-slab field stone cladding. The roof has asphalt shingles and a brick chimney pierces the ridge. The dwelling is three bays wide and one bay deep. An open, three-quarter width historic porch shelters the primary elevation bays. A non-historic wood door occupies the center bay while narrow historic one-over-one wood windows occupy the remaining bays. A historic one-over-one wood window occupies the center gable.

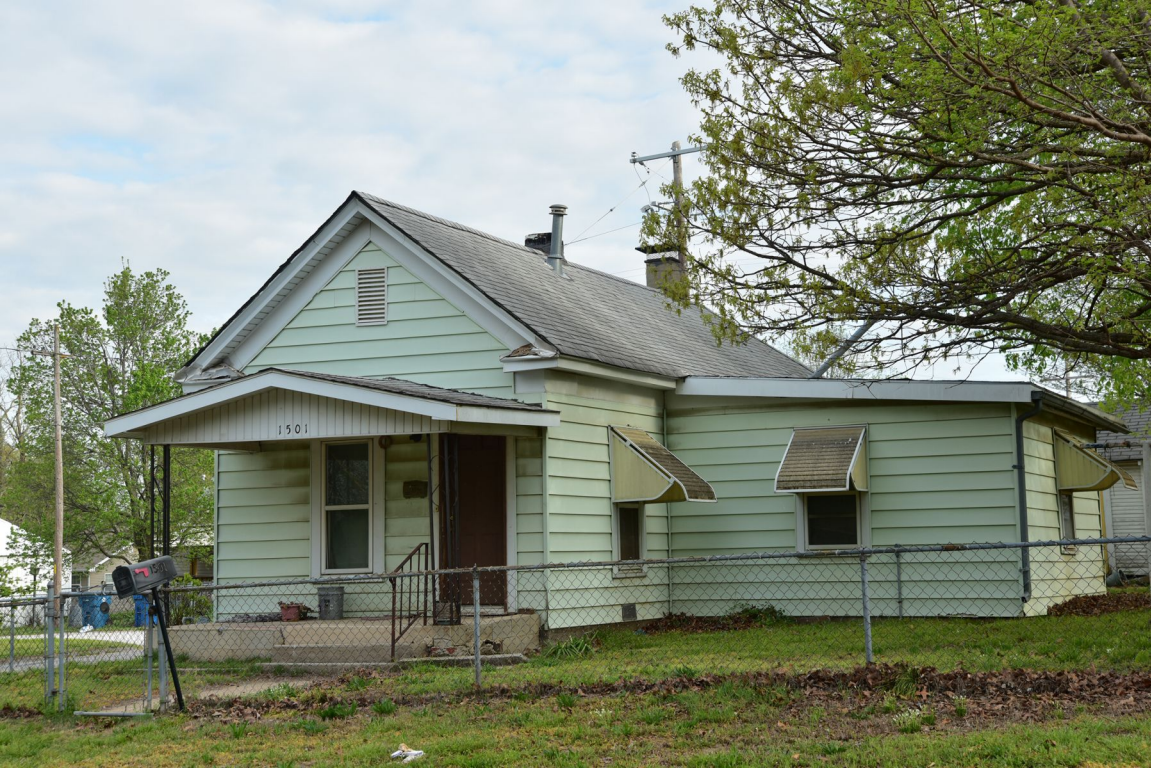
This Shotgun dwelling faces south and has an irregular footprint. It has a concrete foundation, vinyl cladding, and asphalt shingle roof. A shed-roof addition projects from the east elevation. A non-historic porch with front-gable roof and metal support posts shelters the primary elevation bays. A non-historic wood door occupies the east bay while a one-over-one vinyl window occupies the west bay. Windows at secondary elevations have non-historic awnings. The east addition is not present on the 1950 Sanborn Map, but is present in the 1961 aerial photograph.

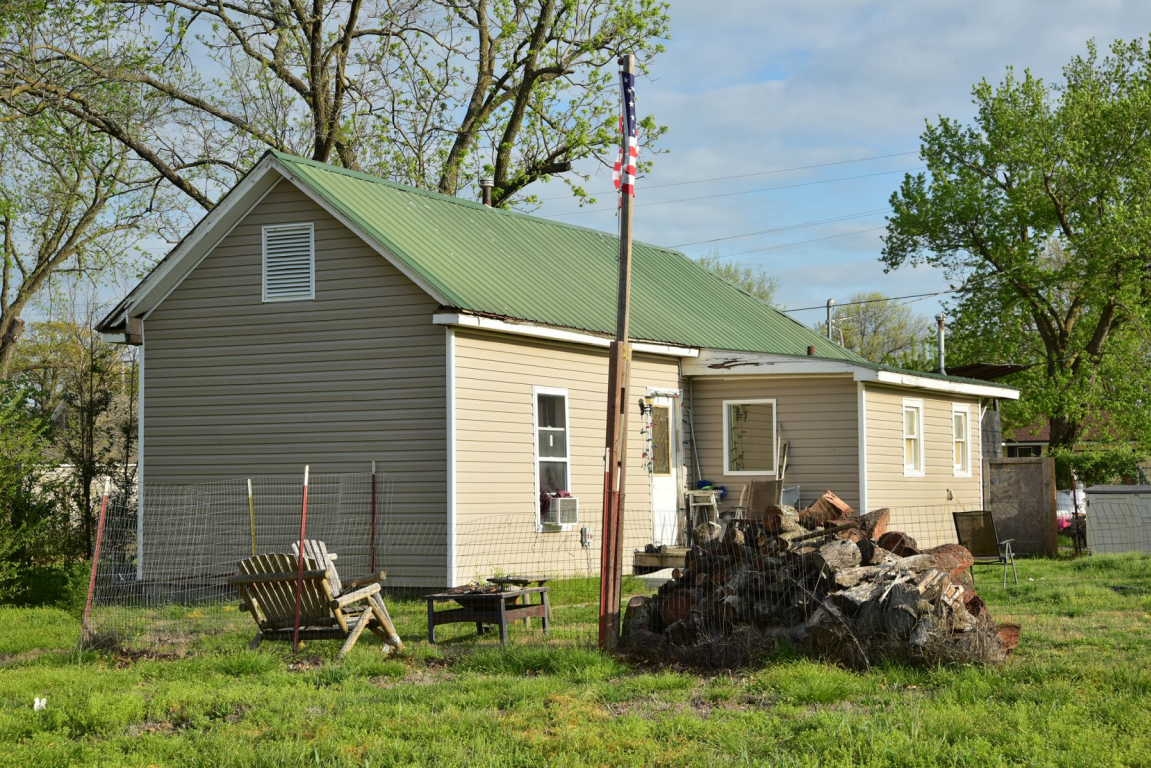
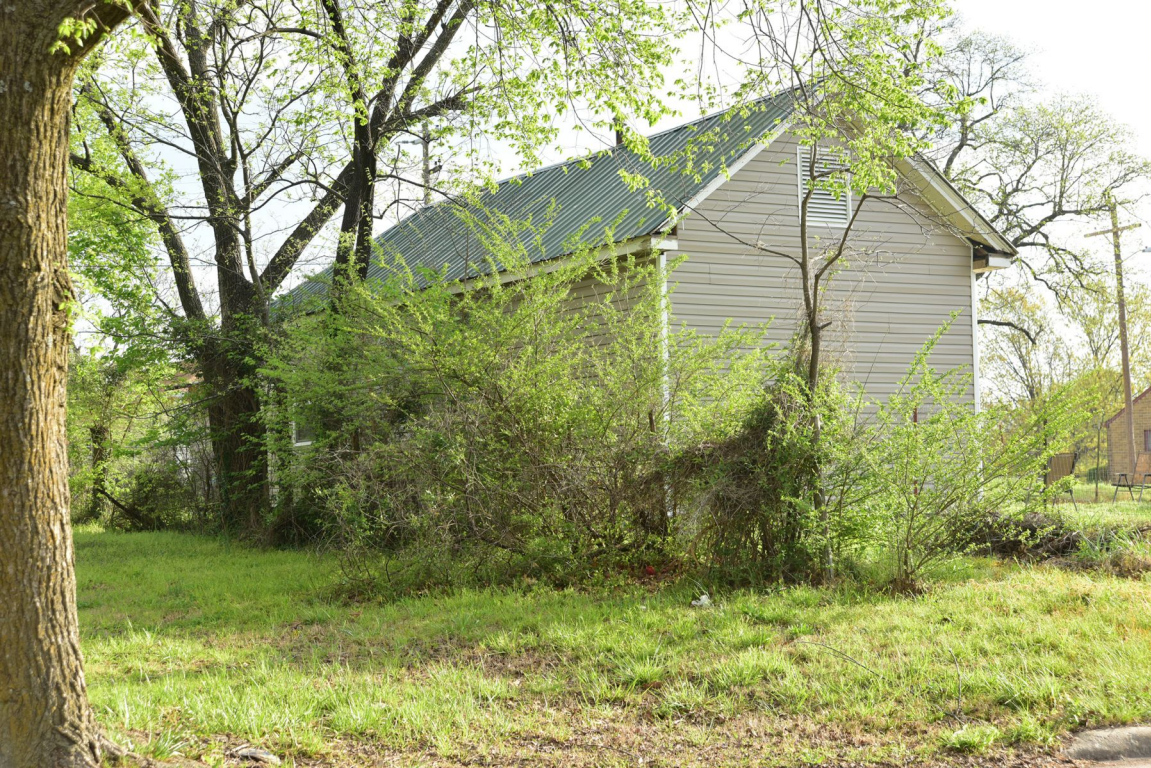
This resource has poor integrity. Non-historic alterations, including the application of non-historic siding that covers the entire south façade obscuring the historic entrance and any indication that there was once a porch there, as well as the replacement of windows and roof compromise the ability of this resource to convey its historic function and date of construction. This resource would be non-contributing to the East Joplin Residential Historic District, significant for its associations with the early residential development of Joplin, specifically the African American community. Areas of significance are Community Planning & Development, and Ethnic History/Black.

This dwelling faces south and has an L-shaped footprint. An enclosed porch contains the north two bays of the east elevation. The dwelling has a concrete foundation, vinyl cladding, and a seamed metal gabled roof. It is four bays wide. A non-historic wood door with glazing occupies the second bay while one-over-one vinyl windows occupy the remaining bays. The 2013 Google Street View shows that the northeast porch was already enclosed with historic wood siding and the south elevation had a single door and a window, both of which have been infilled. The south porch had been removed prior to 2007.

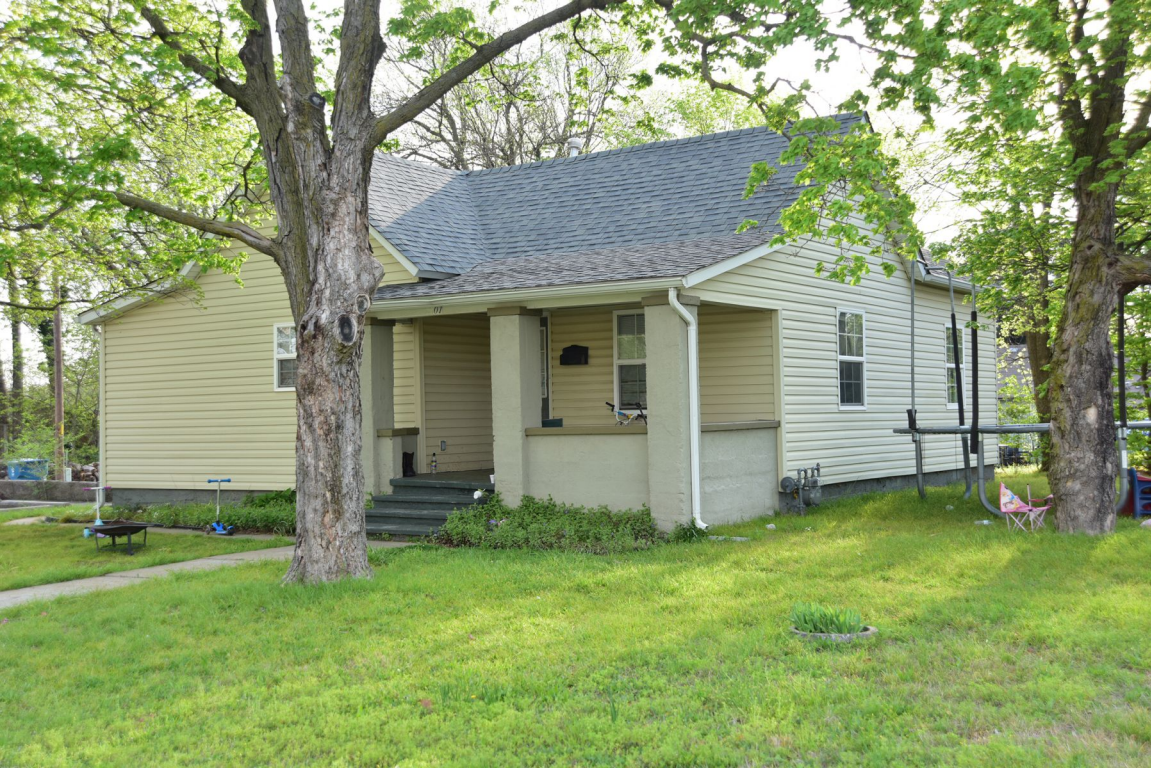
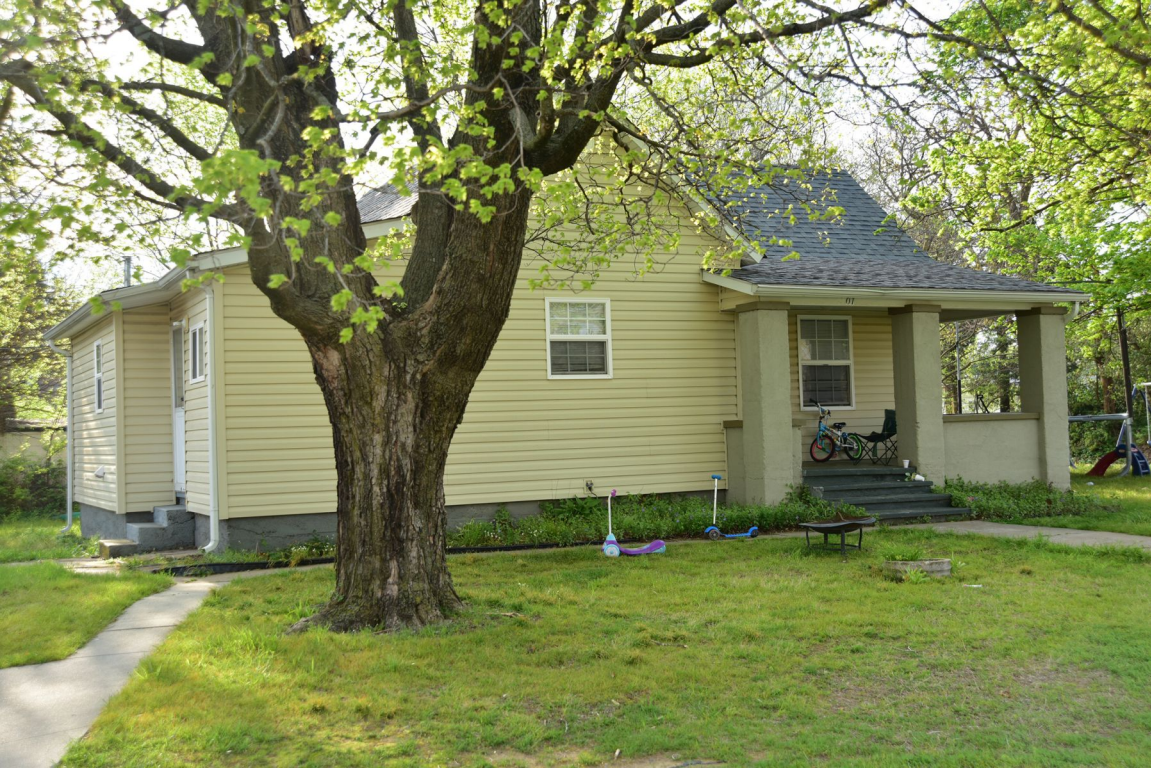
This Gabled-ElI dwelling faces south and has an L-shaped footprint. It has a parged foundation and vinyl cladding. The roof has asphalt shingles. The dwelling is three bays wide and two bays deep. The east two bays recede, creating a partial-width open porch. The porch has a shed roof and concrete foundation. The masonry walls and piers are parged. A non-historic wood door with non-light glazing occupies the center bay at the primary elevation while a six-over-six vinyl window occupies the west bay and a six-over-six wood window occupies the east bay.

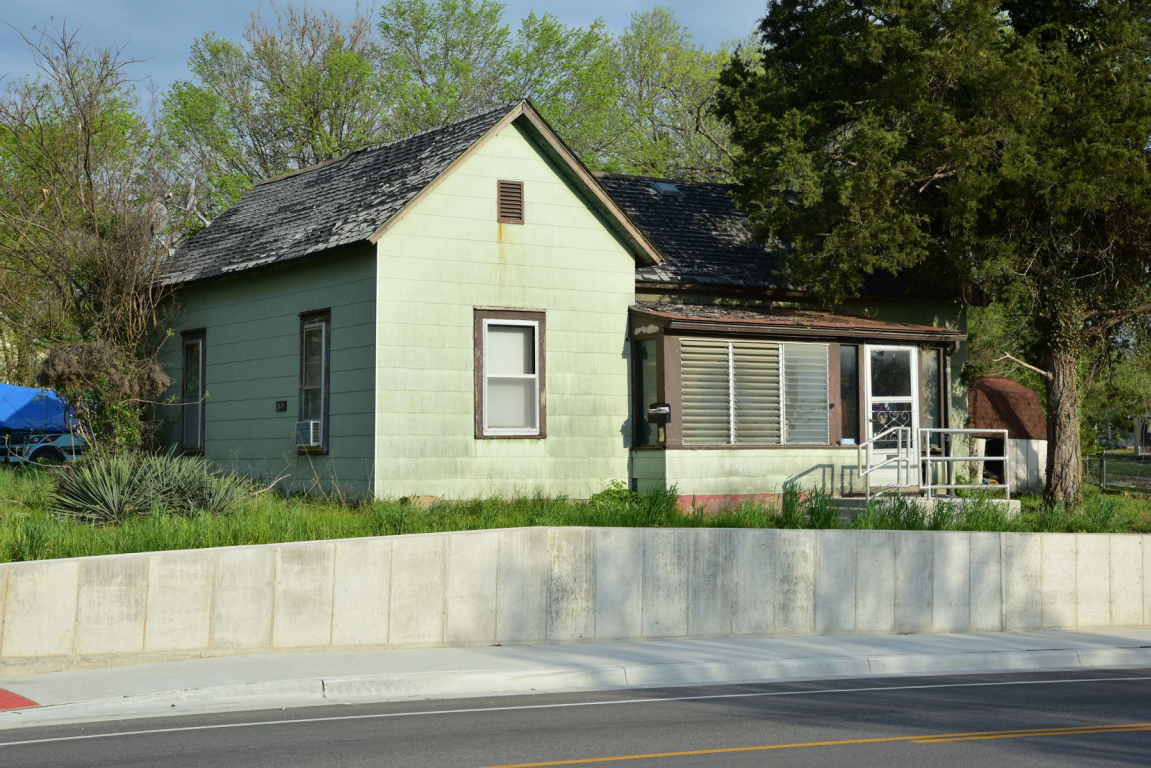
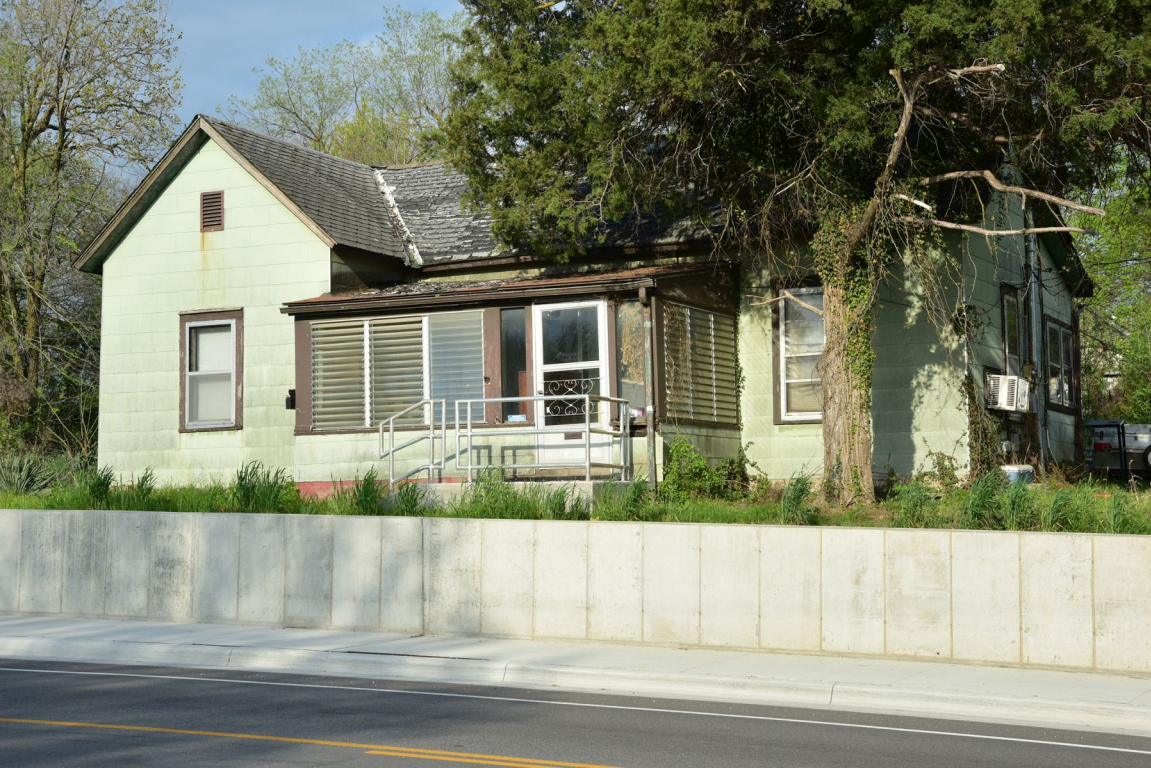
This Gabled-ElI dwelling faces east and has a T-shaped footprint. It has a concrete foundation, asbestos shingle cladding, and asphalt shingle roof. The dwelling is three bays wide and two bays deep. A historic enclosed shed-roof porch with jalousie windows defines the center bay. One-over-one metal windows with flat board trim define the remaining bays. The primary entrance door is not visible.

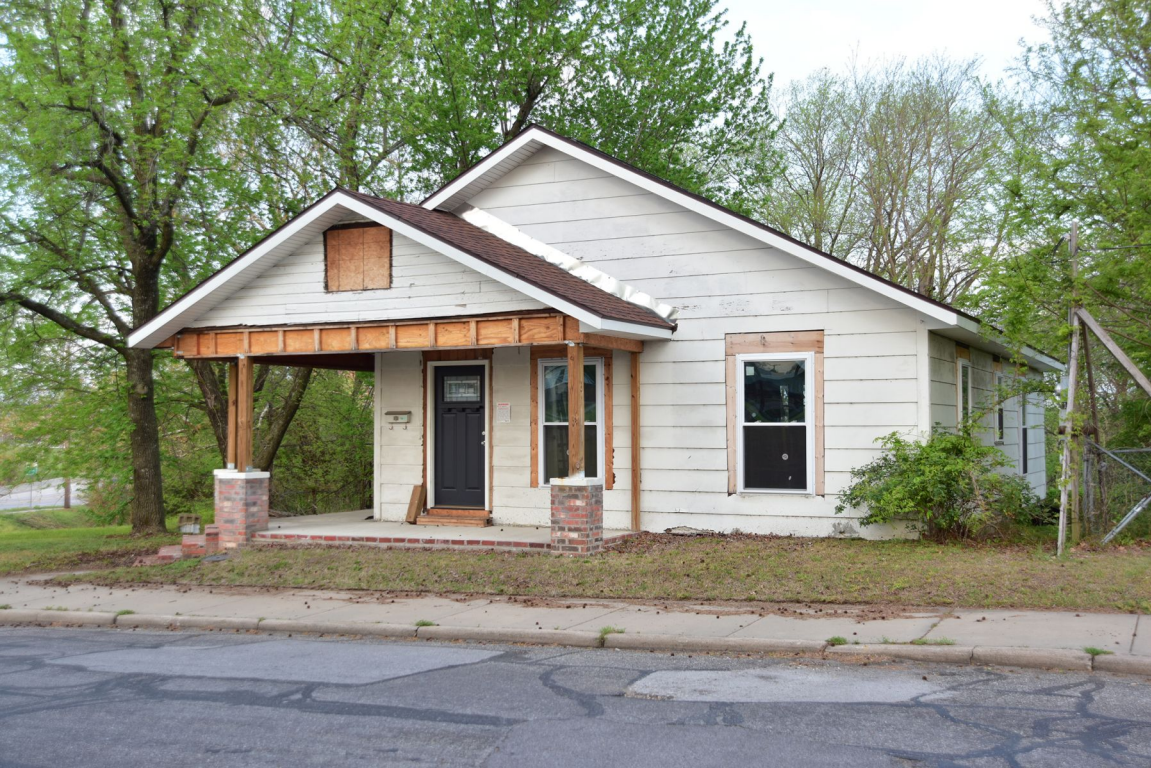
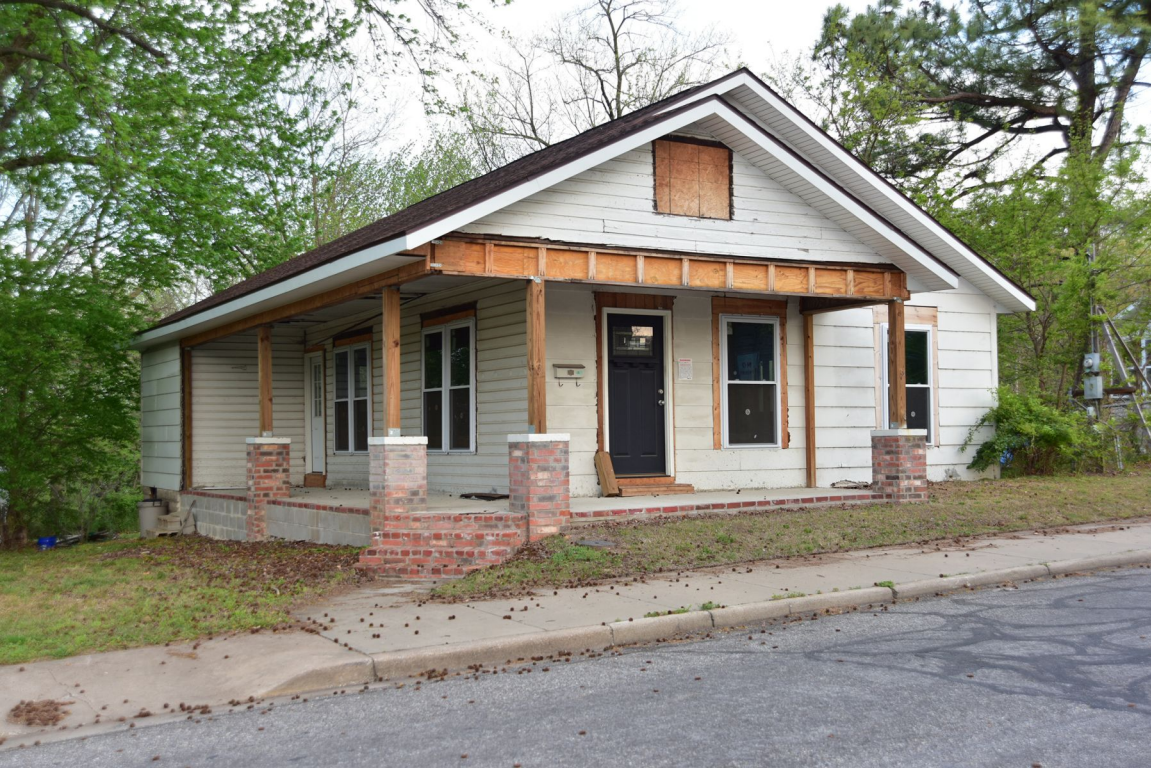
This Open Gable dwelling faces east and has a rectangular footprint. It has a concrete foundation and pressboard cladding. The front-gable roof has asphalt shingles. The dwelling is three bays wide and three bays deep. A front-gable roof shelters the south two bays of the primary elevation. The porch wraps around the south elevation has a concrete foundation and brick piers. Brick steps are located at the southeast corner. Non-historic wood posts support the roof. A non-historic wood door with glazing occupies the south bay while one-over-one vinyl windows fill the remaining bays. The new windows are smaller than the original openings and thus have wood infill. It is unknown what the new siding material will be.
