MISSOURI DEPARTMENT OF NATURAL RESOURCES
STATE HISTORIC PRESERVATION OFFICE, P.O. Box 176, Jefferson City, MO 65102
ARCHITECTURAL/HISTORIC INVENTORY FORM

1. Survey number: JP-AS-006-184		2. Survey Name: East Town (Original Joplin) Historic Survey Phase 1	
3. County: JASPER		4. Address 1401	Street (name): E. Hill Street
5. City: Joplin	Vicinity <input type="checkbox"/>	7. Township/Range/Section: T: R: S:	
8. Historic name (if known):		9. Present/other name (if known):	
10. Ownership: <input checked="" type="checkbox"/> Private <input type="checkbox"/> Public		11a. Historic use (if known): Domestic/Single Dwelling	11b. Current use: Domestic/Single Dwelling

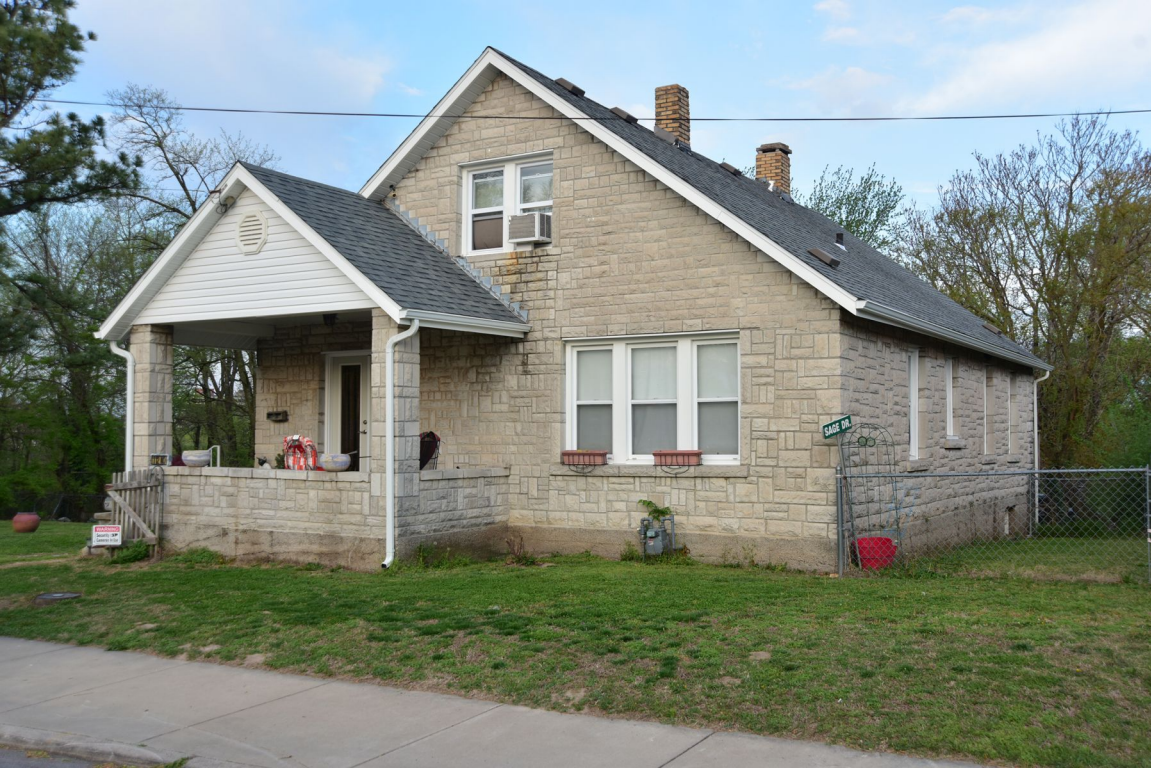
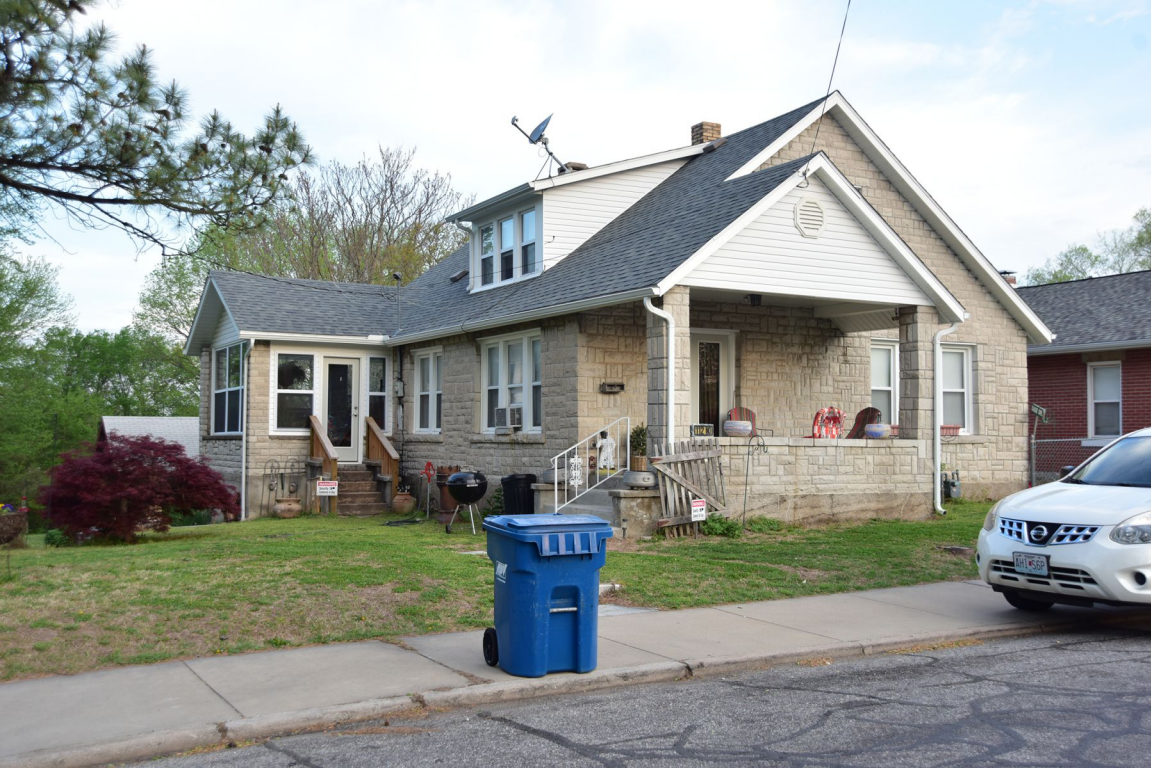
This bungalow dwelling faces east and has a L-shaped footprint. It has a concrete foundation and cut stone cladding. The front-gable roof features asphalt shingles and two straddle-ridge brick chimneys. A shed roof dormer is located on the south slope. An enclosed porch with a gabled roof projects from the south elevation. The dwelling is two bays wide and four bays deep. A front-gable porch with concrete foundation shelters the south primary elevation bay. The porch features cut stone walls and piers. A non-historic door occupies the south bay while a set of three one-over-one vinyl windows occupies the north bay. The dwelling windows have stone sills.

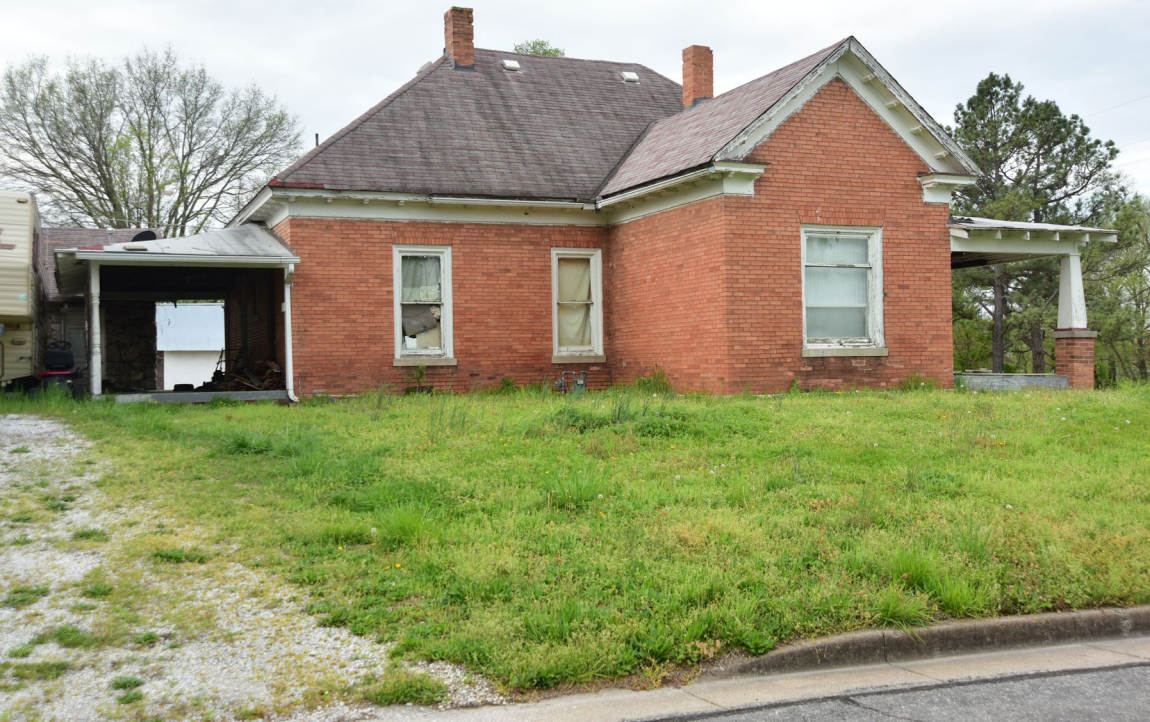
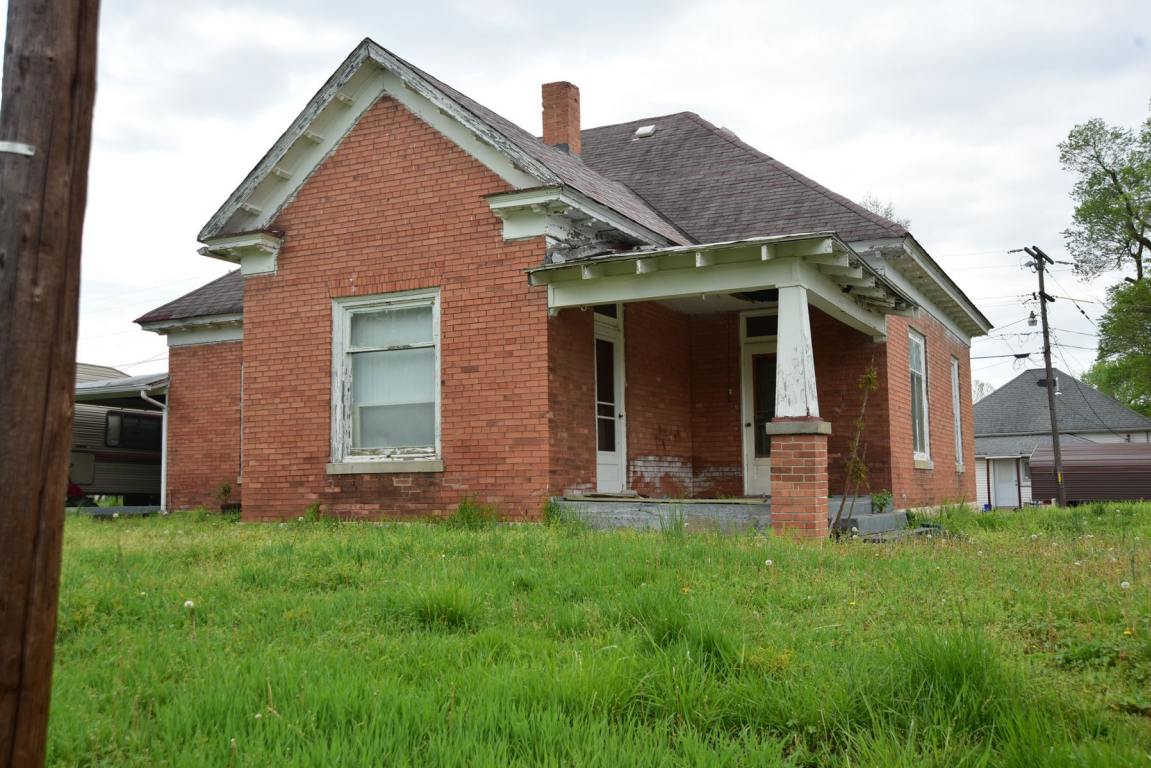
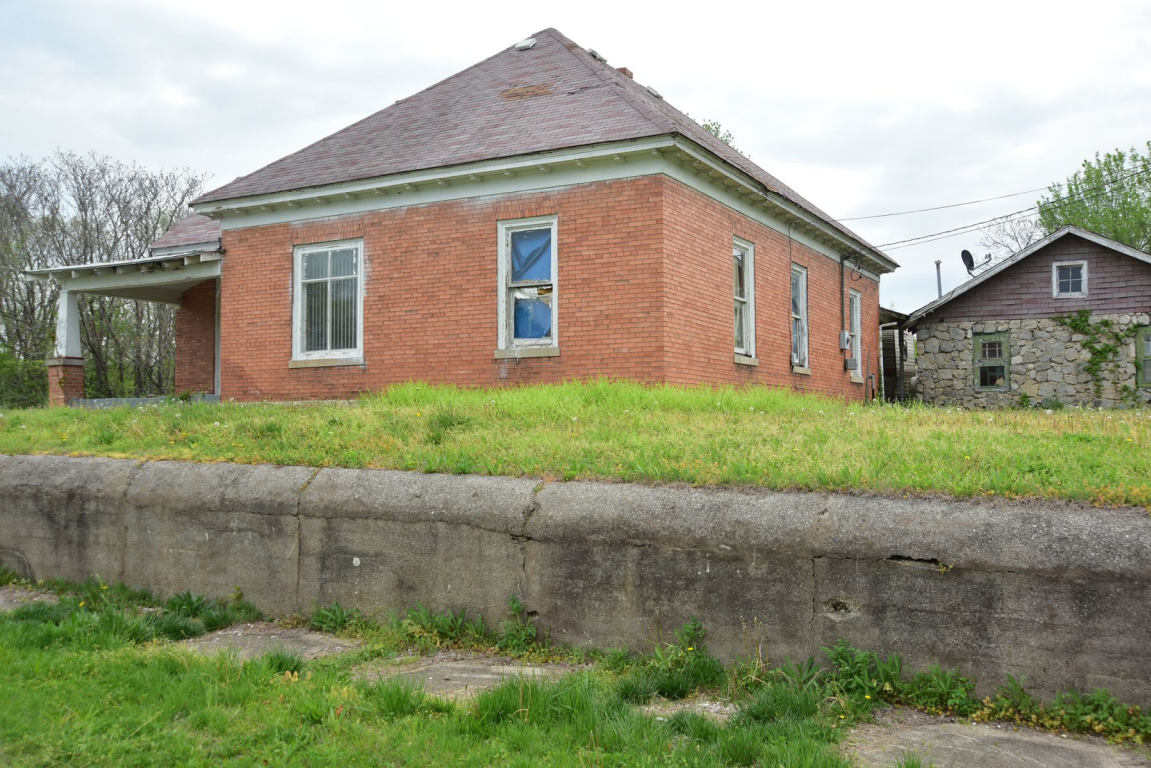
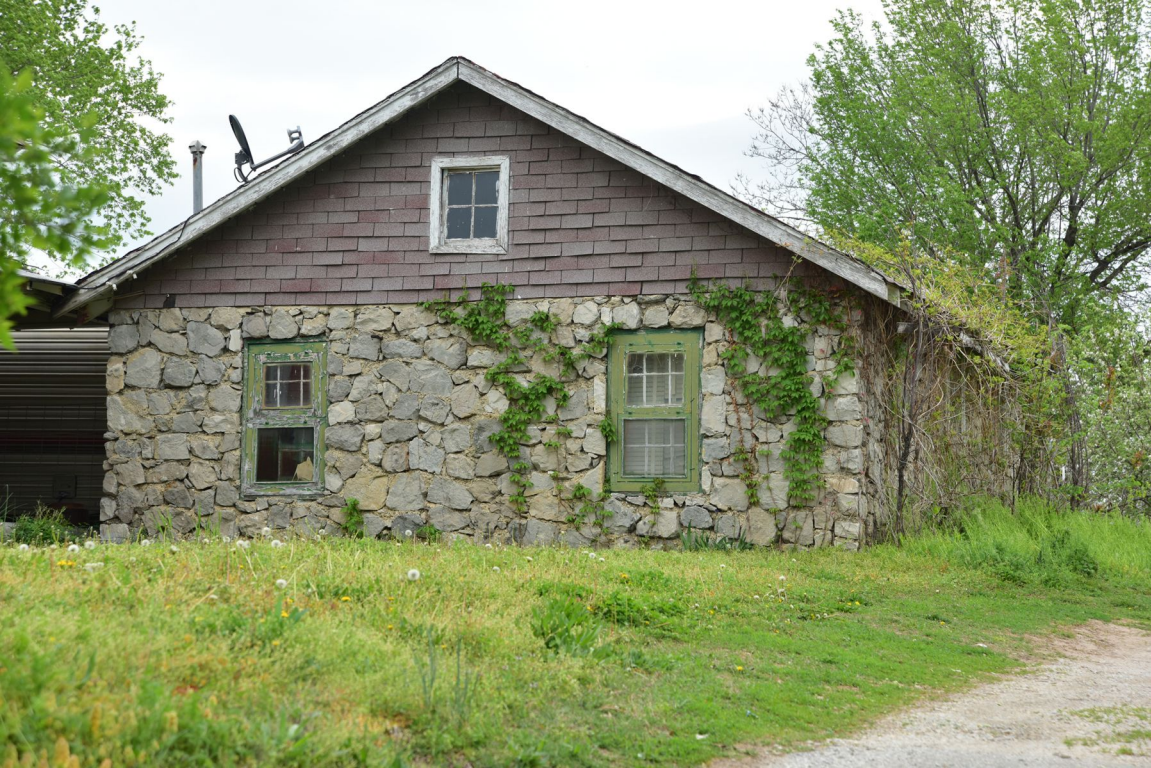
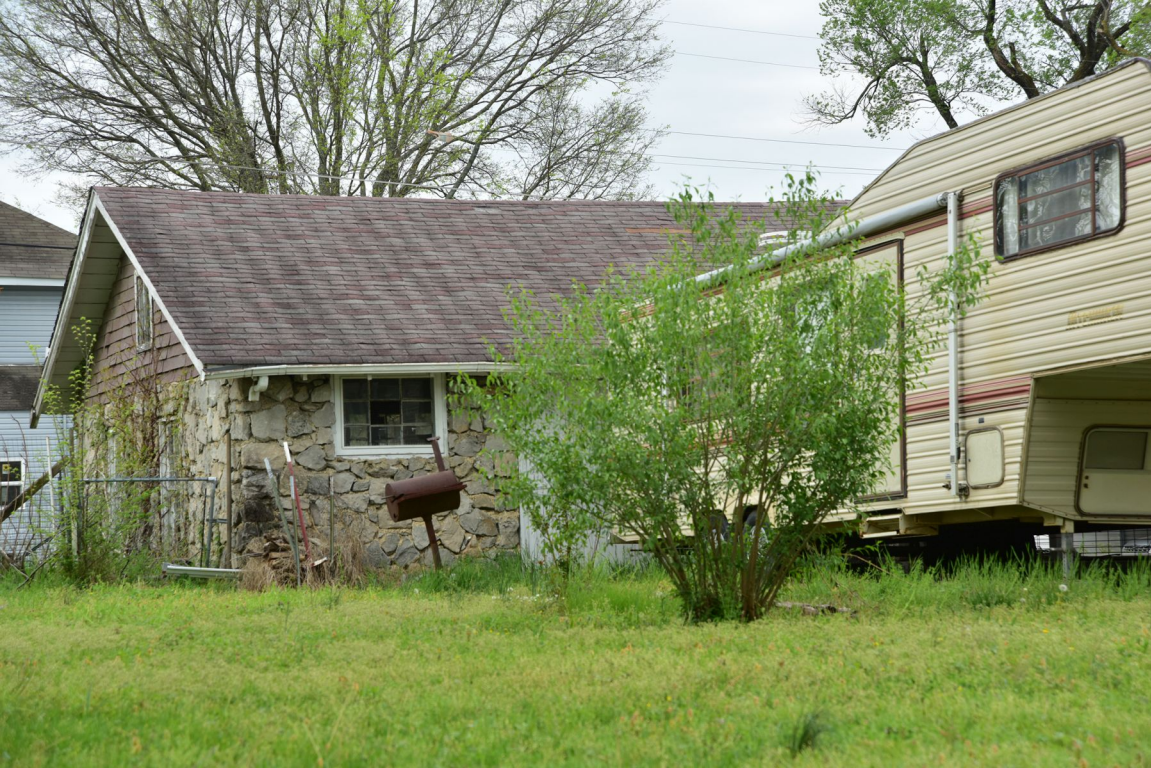
This dwelling faces west and has an irregular footprint. An outbuilding is connected to the dwelling at the southeast corner. The dwelling has a stone foundation and brick cladding. The hipped roof with cross-gable has asphalt shingles. Brackets and cornice returns characterize the roof. The dwelling is three bays wide and three bays deep. The north primary elevation bay recedes, creating a partial-width open porch. The historic porch features a concrete foundation and a shallow hipped roof with exposed rafter tails. Tapered wood columns on brick piers support the roof. A historic wood door with a transom occupies the north bay while a matching door with transom is located on the south wall of the porch. A historic two-over-two wood window occupies the center bay while a historic one-over one wood window fills the south bay. Matching windows are present at the secondary elevations. All windows have stone sills.

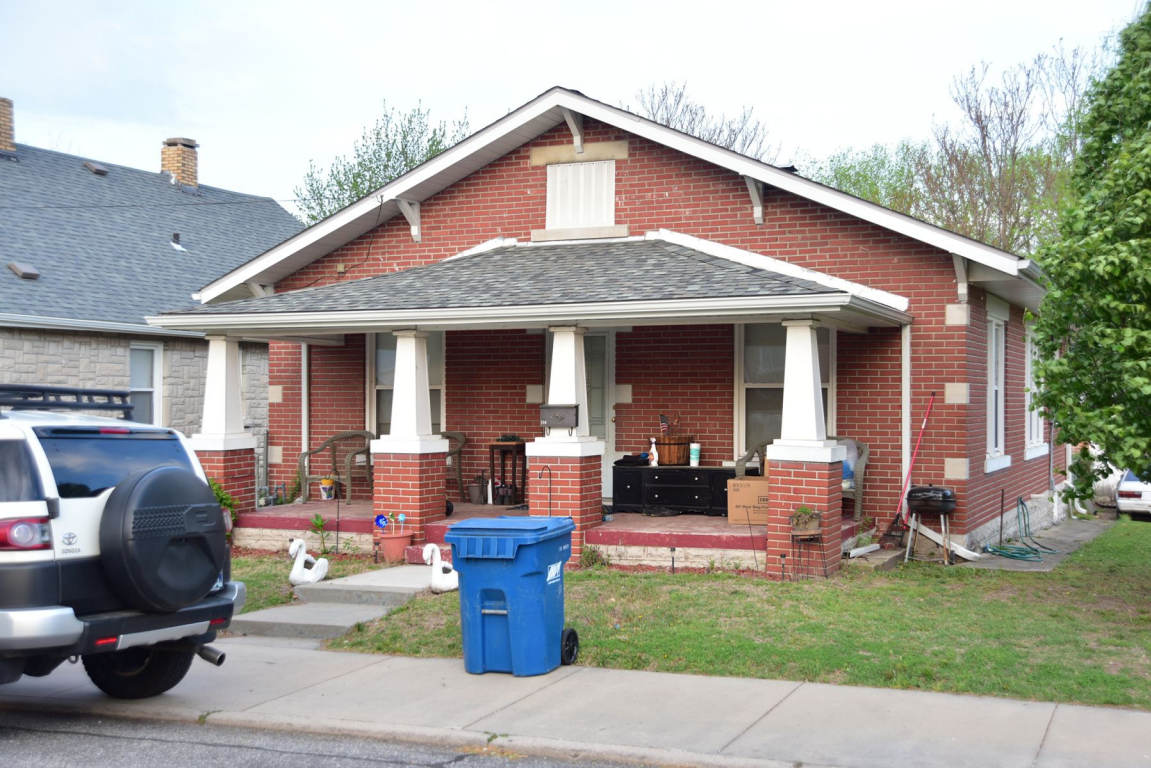
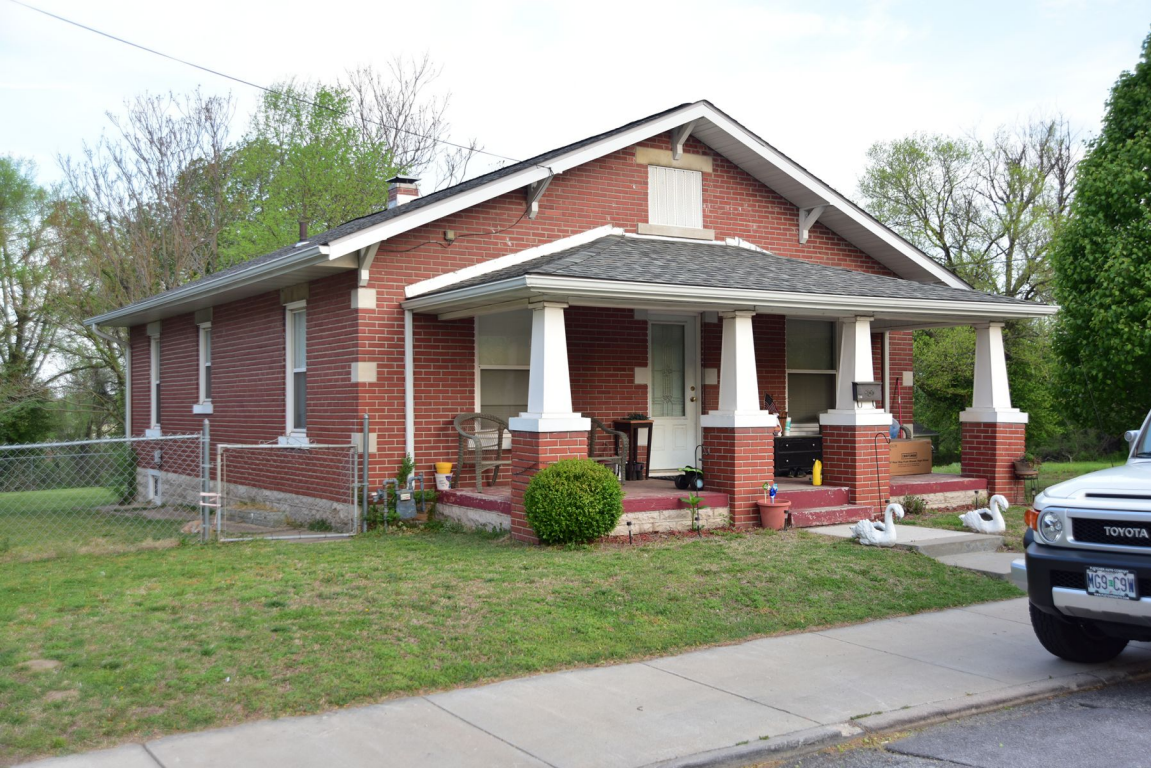
This bungalow dwelling faces east and has a rectangular footprint. It has a concrete block foundation and brick cladding with stone quoins. The front-gable roof features brackets at the gable end and asphalt shingles. A square window opening with a stone sill and lintel occupies the gable peak. The dwelling is three bays wide three bays deep. An open, three-quarter width porch shelters the primary elevation bays. It has a concrete block foundation and shallow hipped roof. Tapered wood columns on brick piers support the roof. A non-historic wood door with glazing occupies the center bay while one-over-one vinyl windows fill the remaining bays. The windows have stone sills. One-over-one vinyl windows with stone sills and lintels are present at the secondary elevations.

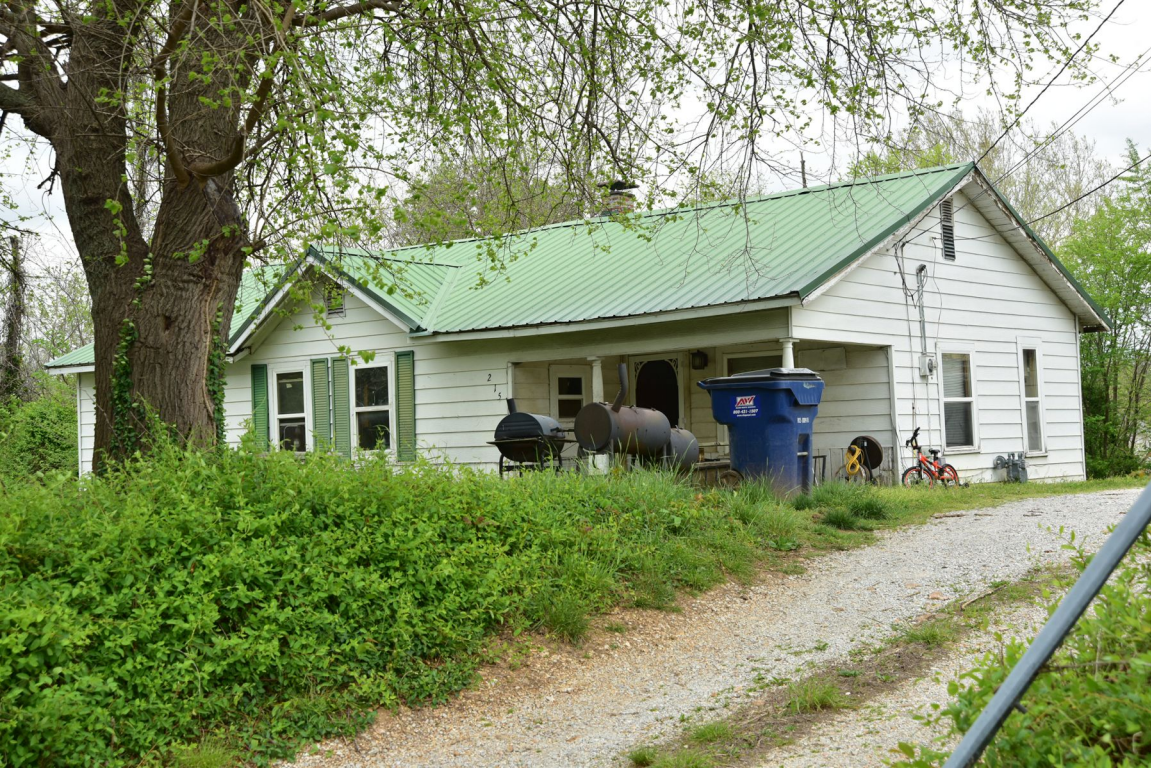
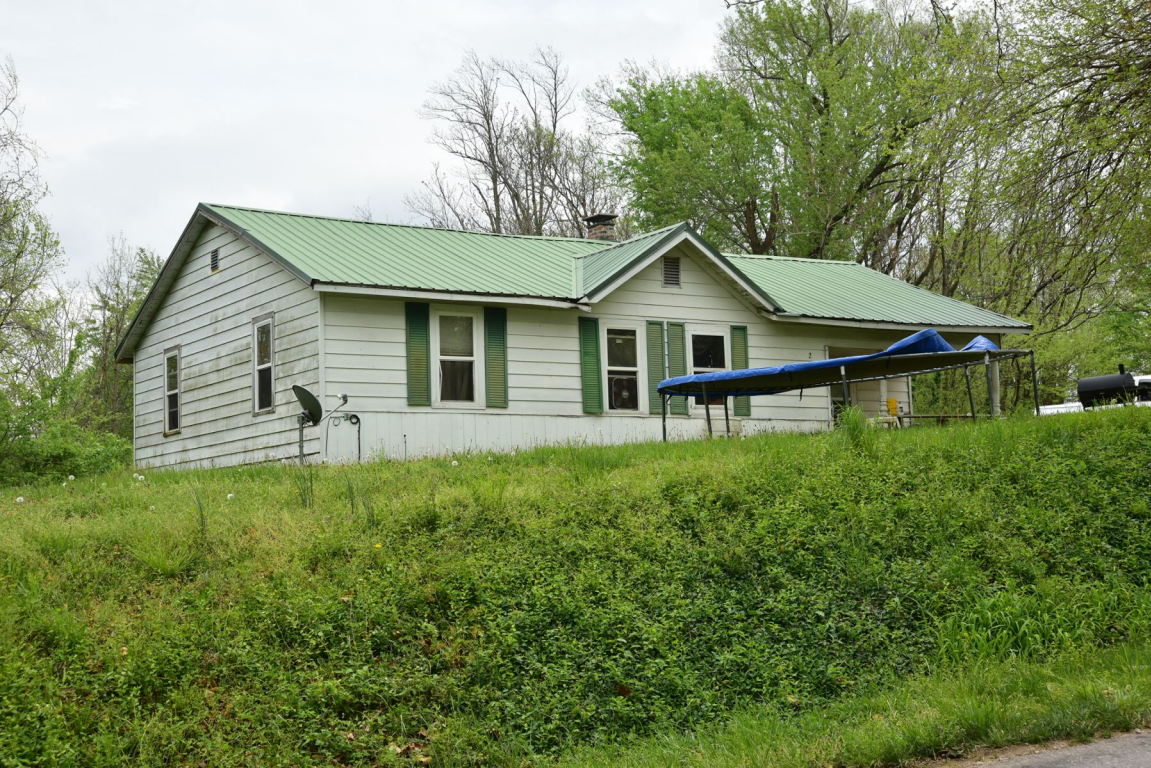
This Ranch dwelling faces west and has a rectangular footprint. It has metal cladding and a seamed metal roof with a center gable. The foundation is not visible. The dwelling is four bays wide and two bays deep. One-over-one wood windows with false shutters occupy the north two bays. A wood door forms the third bay and a one-over-one wood window occupies the south bay. The south two bays recede, creating a partial-width open porch. Wood columns support the porch roof.

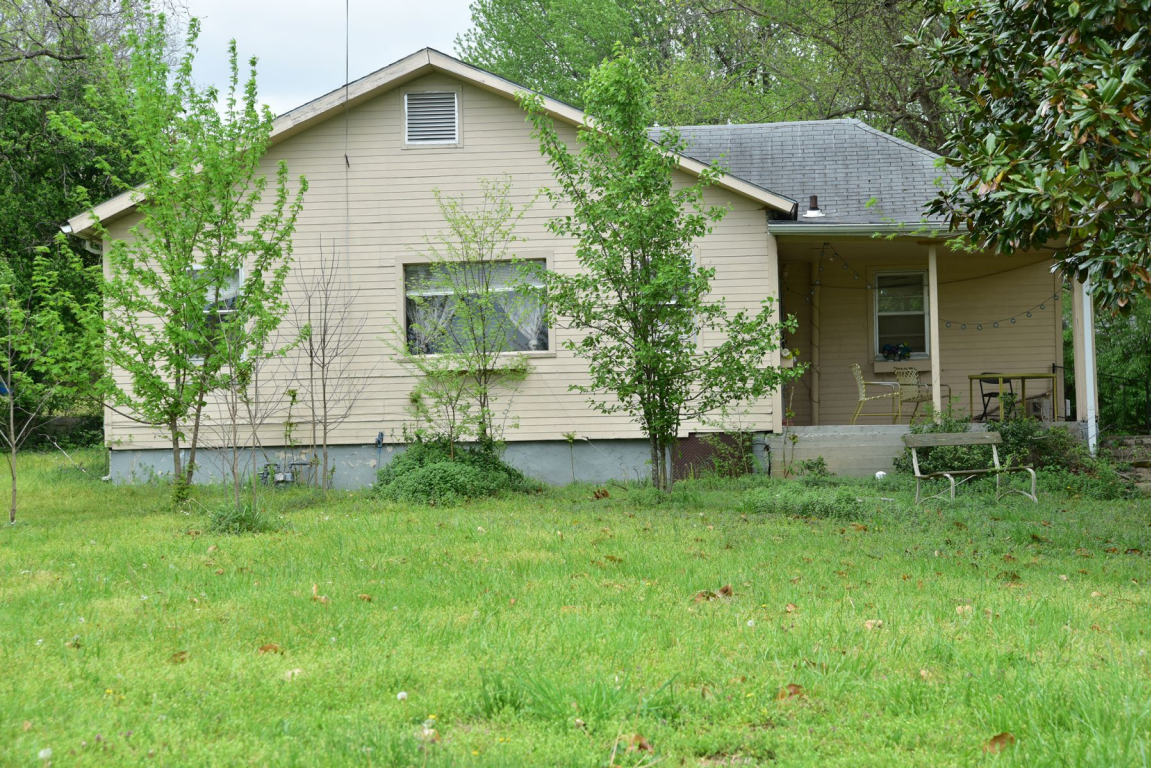
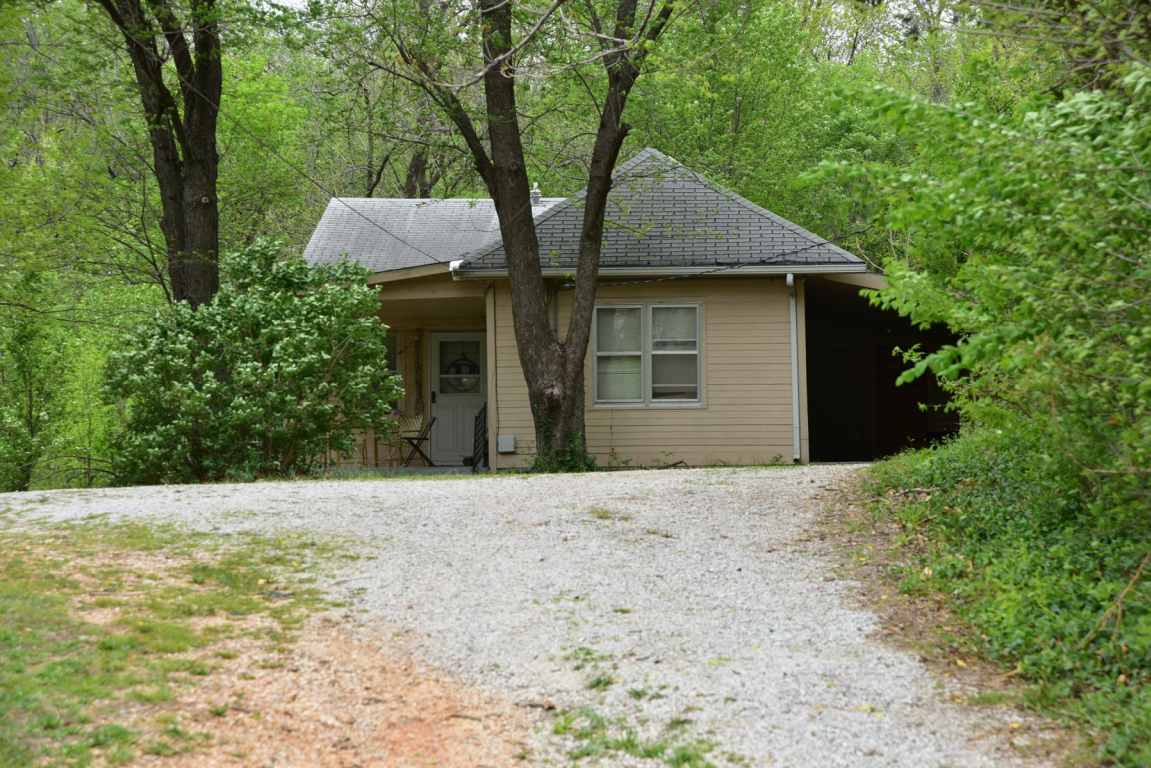
This dwelling faces south and has a square footprint. It has wood clapboard cladding and an asphalt shingle roof. The foundation is not visible. The dwelling is three bays wide. The west two bays recede, creating a partial-width open porch with a shed roof. Non-historic wood posts support the porch roof. One-over-one metal windows occupy the first and third bays. The primary entrance occupies the center bay; however, the door is not visible. A shed-roof carport projects from the east elevation.

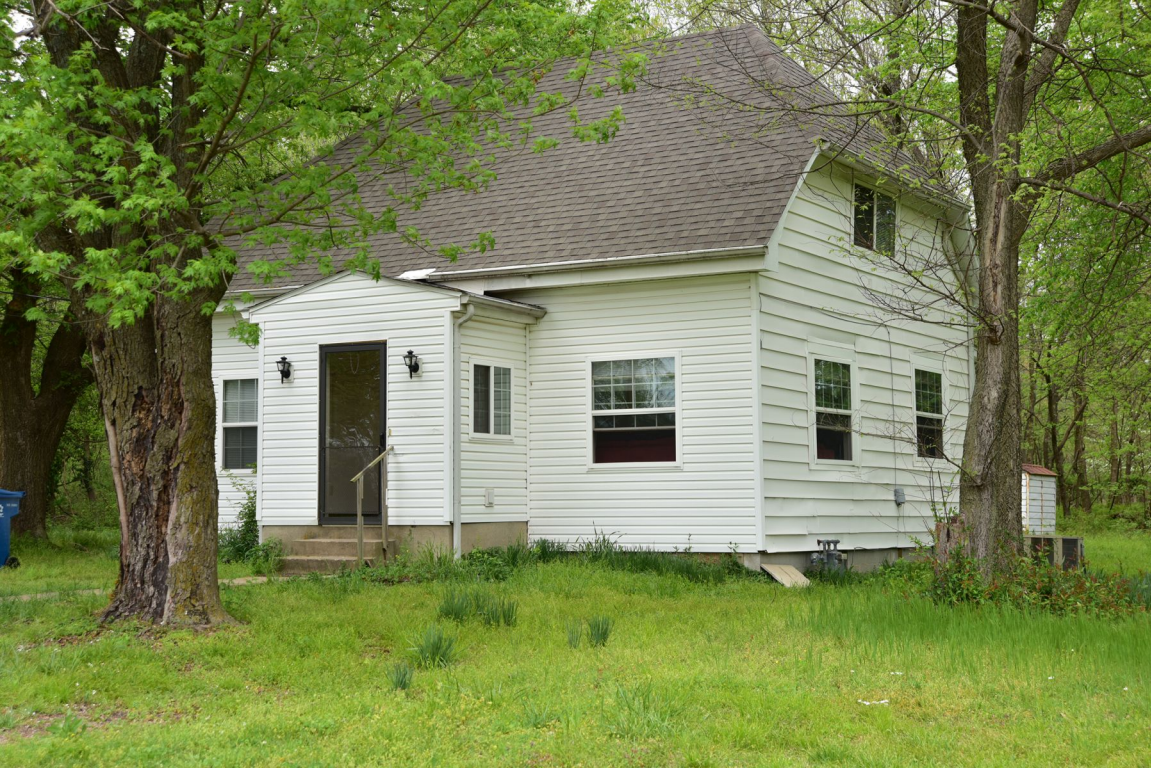
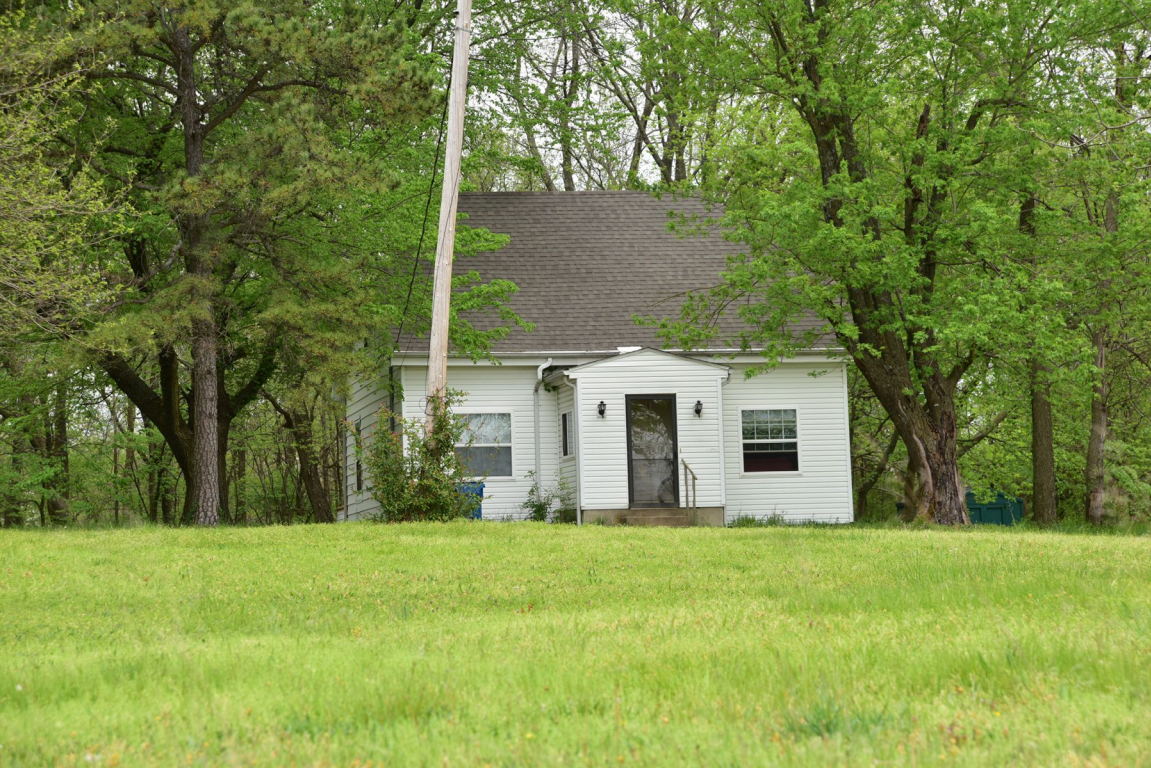
This dwelling faces west and has a rectangular footprint. It has a concrete foundation and hipped-gable roof with asphalt shingles. The primary elevation is vinyl-clad while the secondary elevations have metal siding. The dwelling is three bays wide and two bays deep. A non-historic enclosed stoop with a front-gable roof, concrete foundation, and vinyl cladding obscures the center bay of the primary elevation. It features a non-historic metal door with glazing and obscures the non-historic wood primary entrance door. Eight-over-eight vinyl windows occupy the north and south bays of the primary elevation. Eight-over-eight vinyl windows occupy the first-story bays of the secondary elevations while one-by-one windows are present in the gable ends.

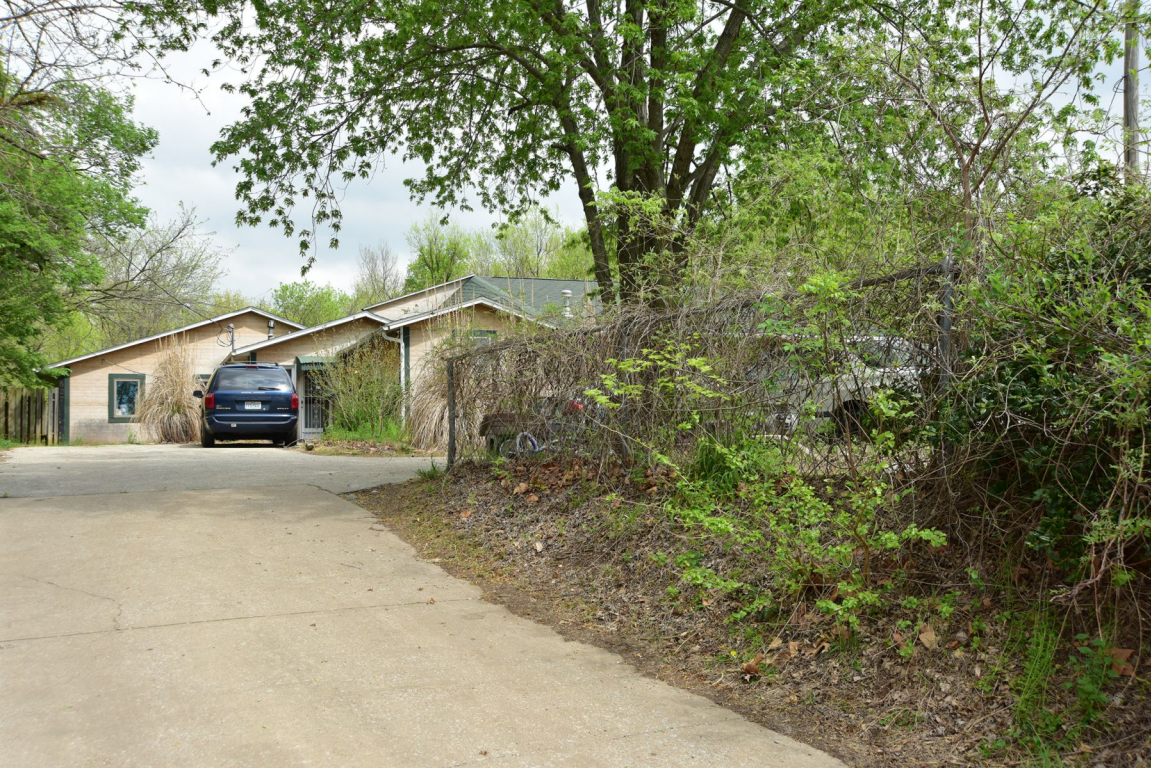
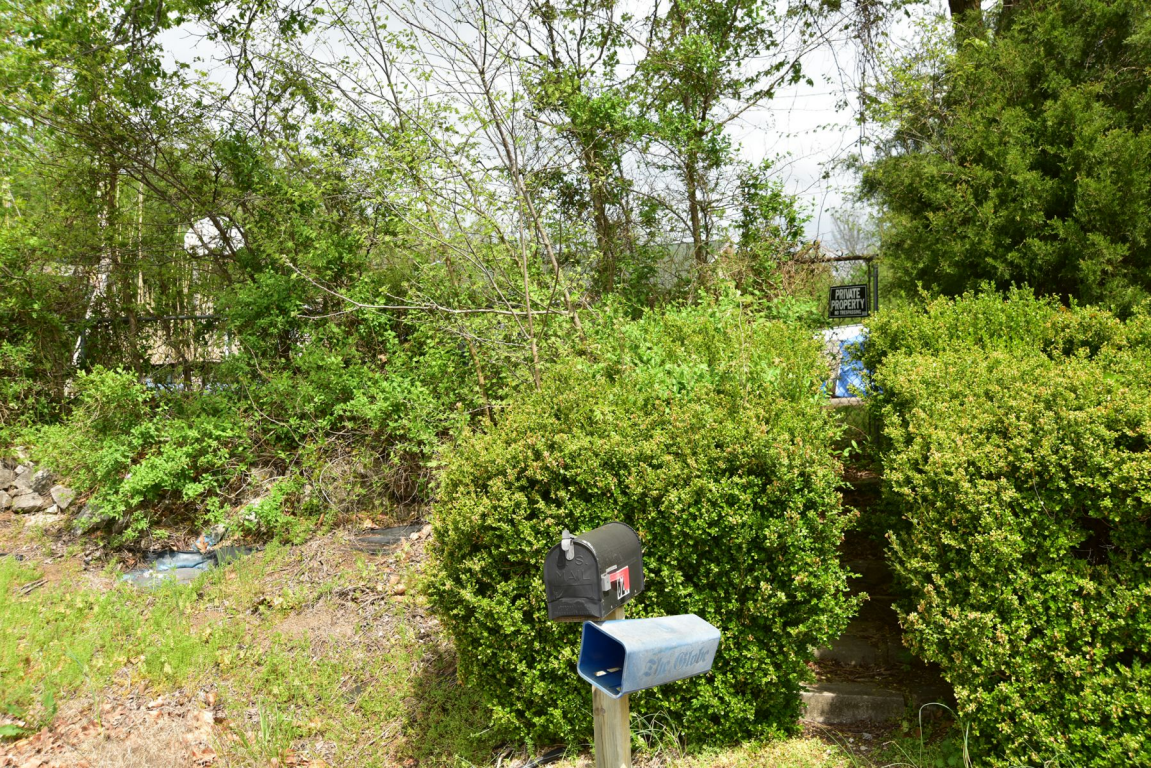
This dwelling faces west and has an irregular footprint. It is heavily obscured by fencing and brush, making it difficult to photograph from the public right-of-way. The complex roof has asphalt shingles and the foundation is not visible. It has stone veneer panel cladding.

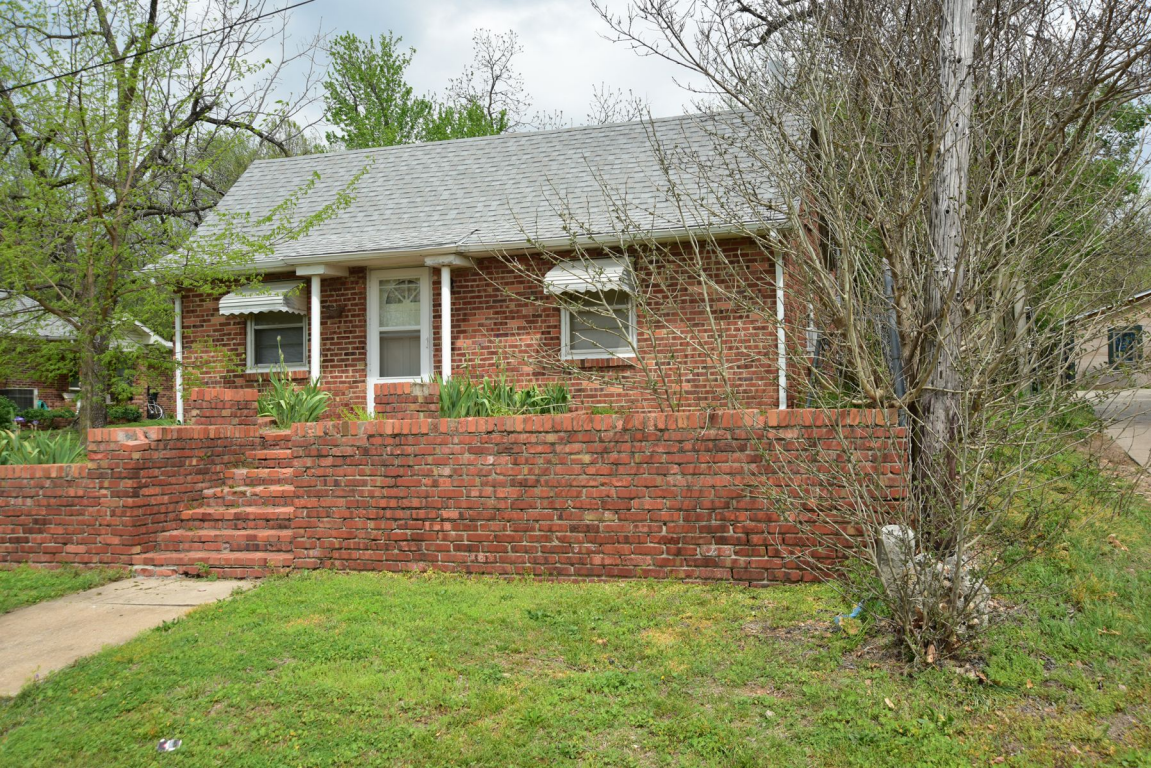
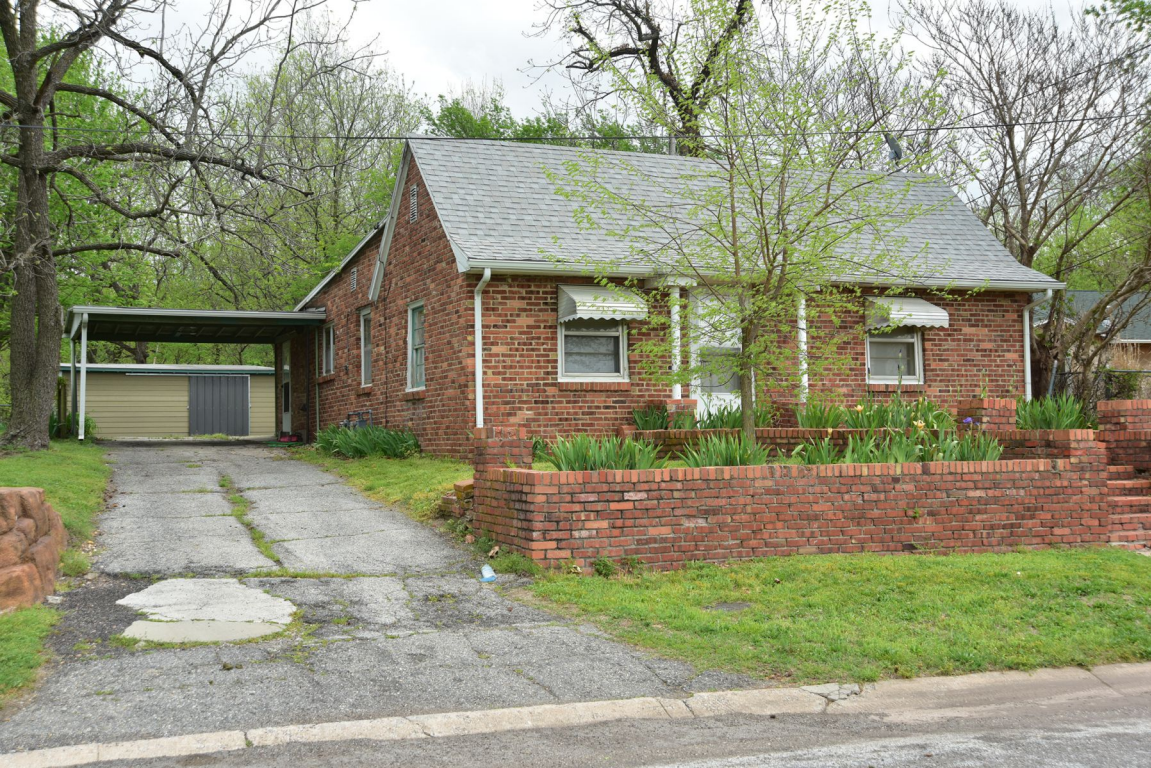
This dwelling faces west and has an L-shaped footprint. It has brick cladding and an asphalt shingle roof. The foundation is not visible. The dwelling is three bays wide and four bays deep. A non-historic fiberglass door occupies the center bay of the primary elevation while historic two-over-two wood windows with header brick sills occupy the remaining bays. A frame carport projects from the north elevation and shelters a secondary entrance.

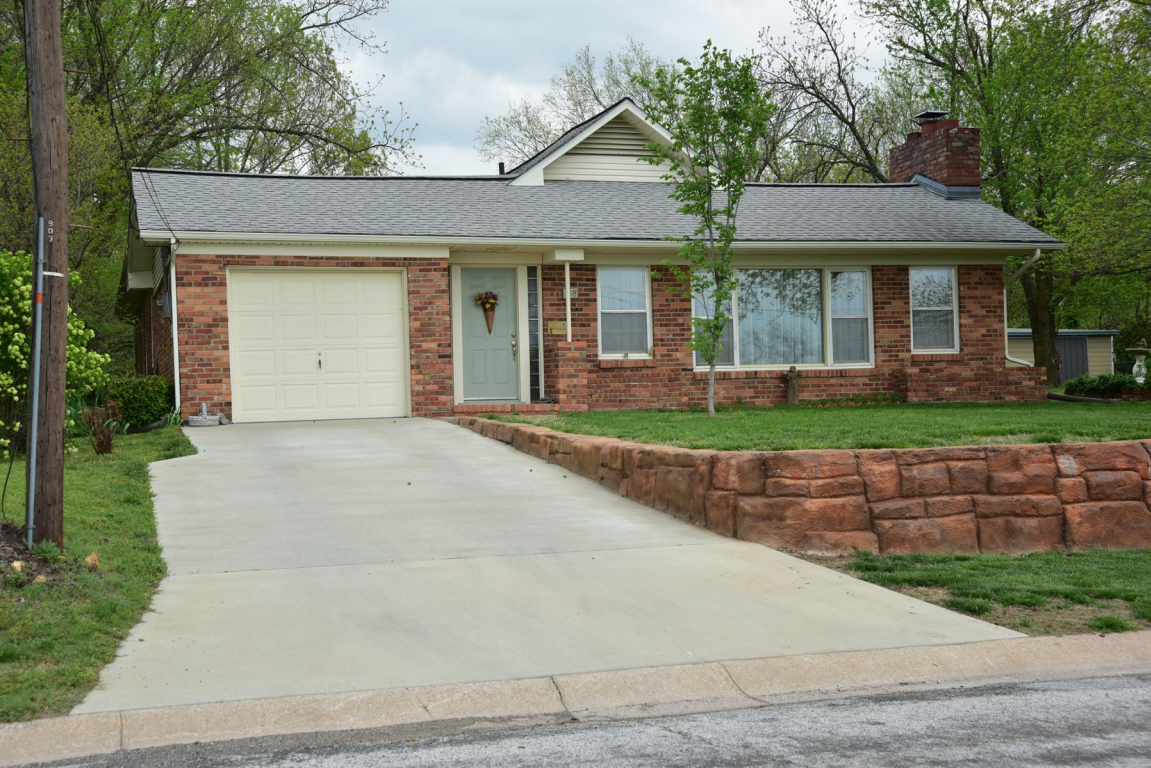
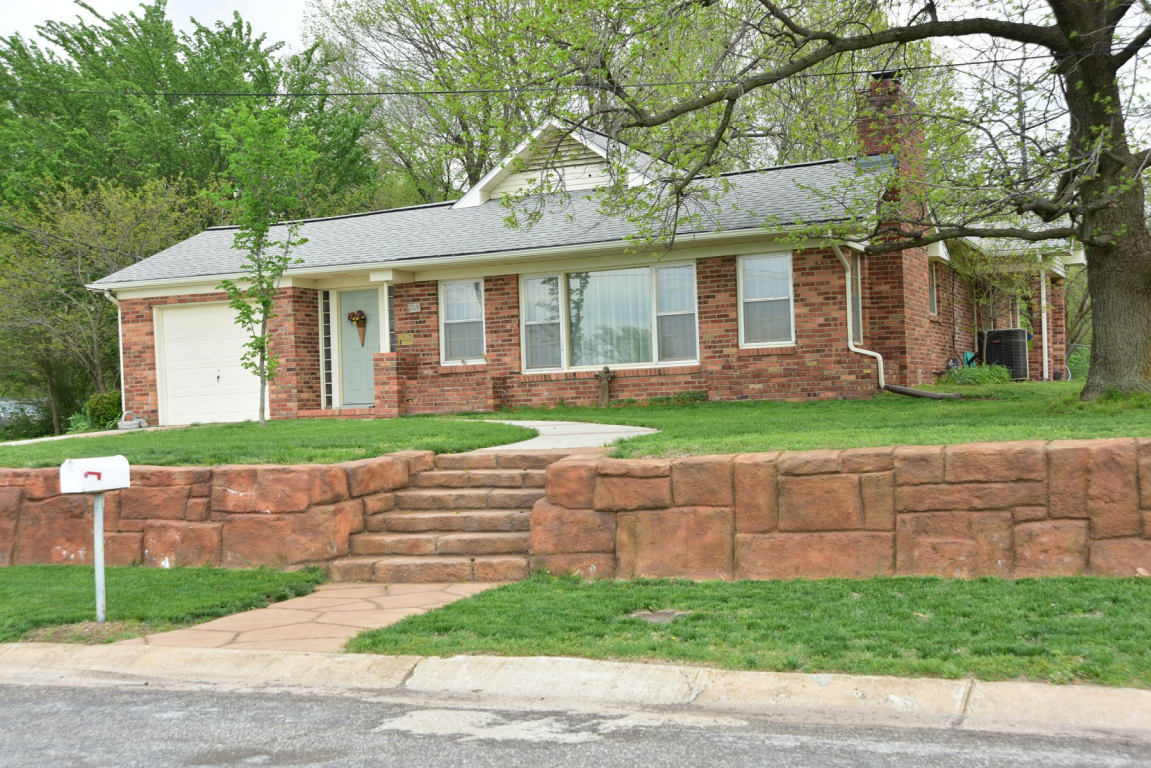
This dwelling faces west and has a rectangular footprint. It has brick cladding and an asphalt shingle roof. The foundation is not visible. The dwelling is five bays wide. A non-historic overhead garage door occupies the north bay while a wood door with sidelights fills the adjacent bay. The second bay is slightly recessed, creating a recessed stoop. Two-over-two wood windows occupy the third and fifth bays while a tripartite picture window fills the fourth bay. The picture window features a single-light wood window flanked by two-over-two wood windows. A front-gable porch with brick support pillars projects from the south elevation. An exterior brick chimney is located at the southwest corner of the dwelling.

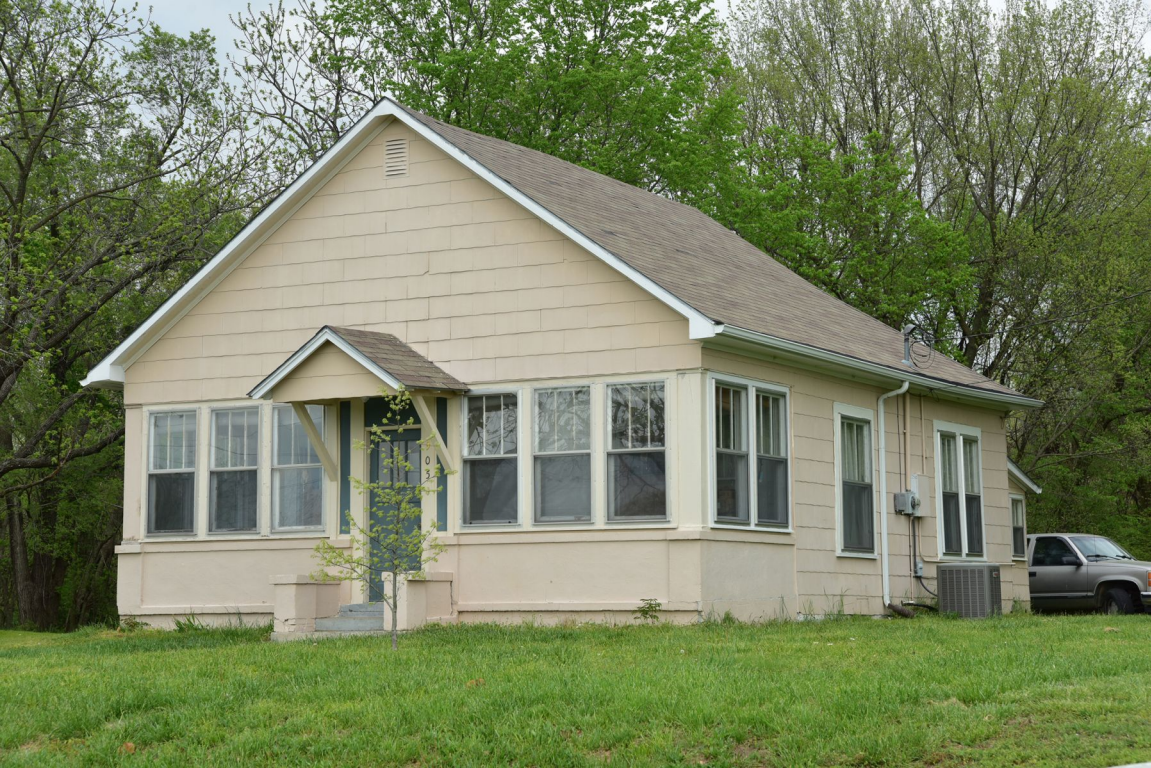
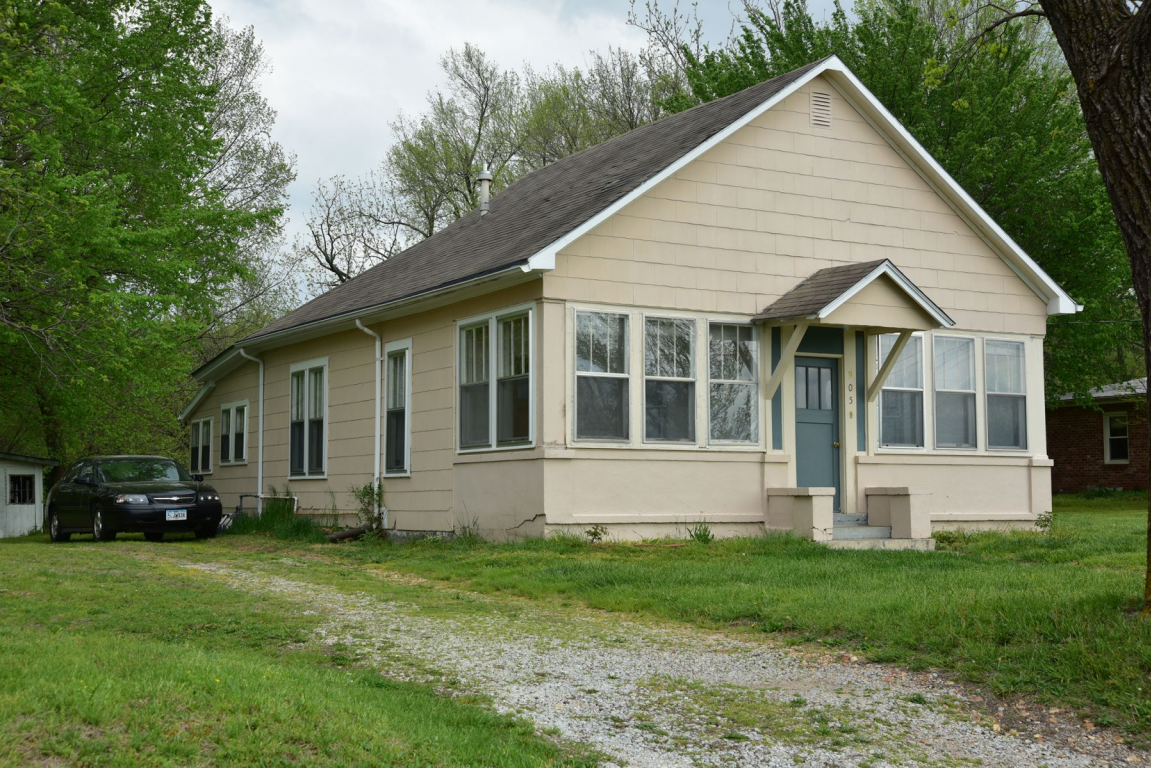
This bungaloid dwelling faces west and has a rectangular footprint. It has a concrete foundation and asbestos shingle cladding. The front-gable roof has asphalt shingles. The dwelling is three bays wide and five bays deep. An enclosed porch spans the primary elevation. A historic wood door with three-light glazing occupies the center bay of the primary elevation. Sets of three historic three-over-one wood windows occupies the north and south bays. The entrance features a concrete stoop with a front gable roof. The stoop roof features exposed rafter tails and knee brackets.
