MISSOURI DEPARTMENT OF NATURAL RESOURCES
STATE HISTORIC PRESERVATION OFFICE, P.O. Box 176, Jefferson City, MO 65102
ARCHITECTURAL/HISTORIC INVENTORY FORM

1. Survey number: JP-AS-006-184		2. Survey Name: East Town (Original Joplin) Historic Survey Phase 1	
3. County: JASPER		4. Address 1401	Street (name): E. Hill Street
5. City: Joplin	Vicinity <input type="checkbox"/>	7. Township/Range/Section: T: R: S:	
8. Historic name (if known):		9. Present/other name (if known):	
10. Ownership: <input checked="" type="checkbox"/> Private <input type="checkbox"/> Public		11a. Historic use (if known): Domestic/Single Dwelling	11b. Current use: Domestic/Single Dwelling

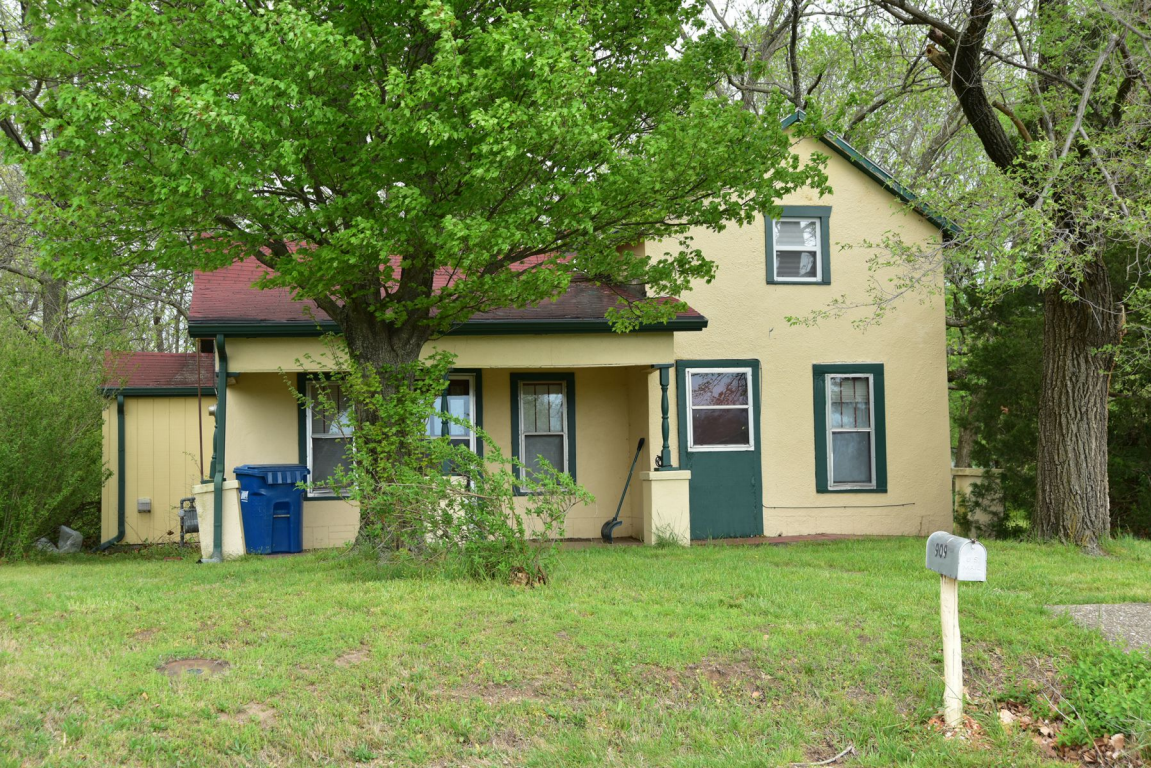
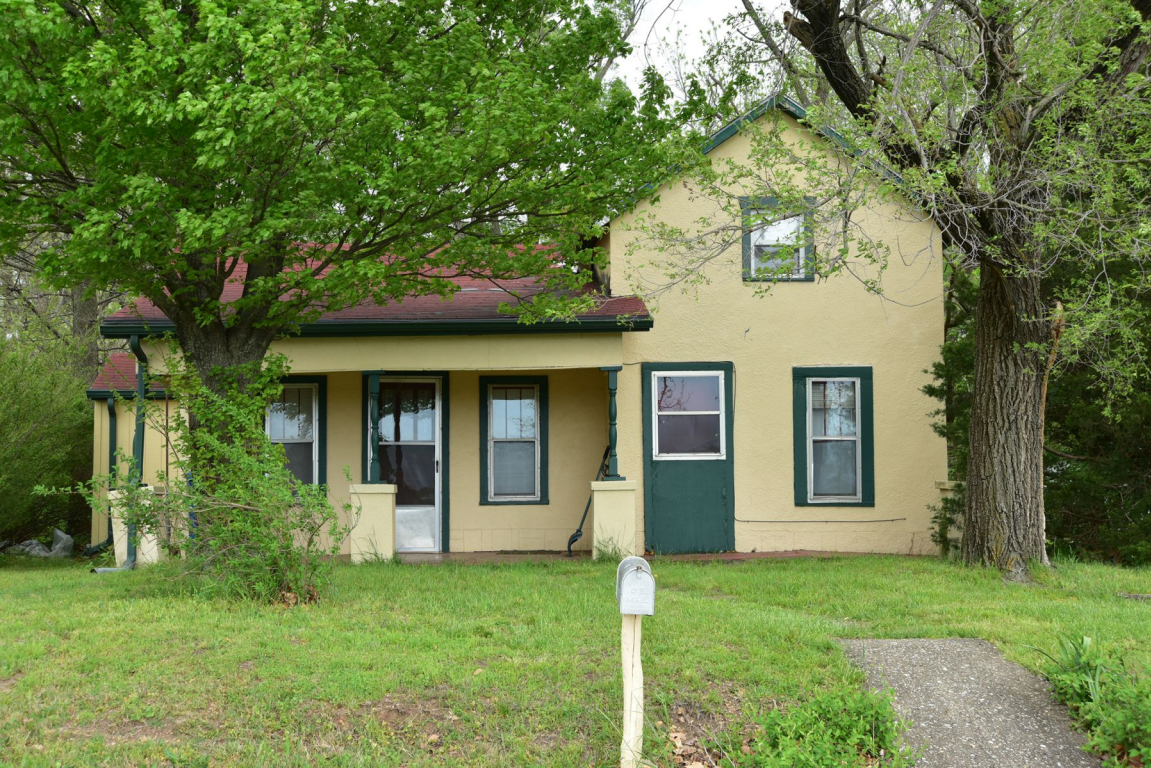
This Gabled-Ell dwelling faces west and has an L-shaped footprint. It has stucco cladding and an asphalt shingle roof. The foundation is not visible. The dwelling is five bays wide. Historic three-over-one wood windows occupy the first, third, and fifth bays while a historic wood door with three-light glazing occupies the second bay. A one-over-one aluminum window and wood infill occupies a former entrance opening in the fourth bay and a one-over-one vinyl window is located in the gable peak. The north three bays are recessed, creating an open, partial-width porch. The porch has a shed roof and concrete foundation. Non-historic turned wood posts on parged piers support the roof.

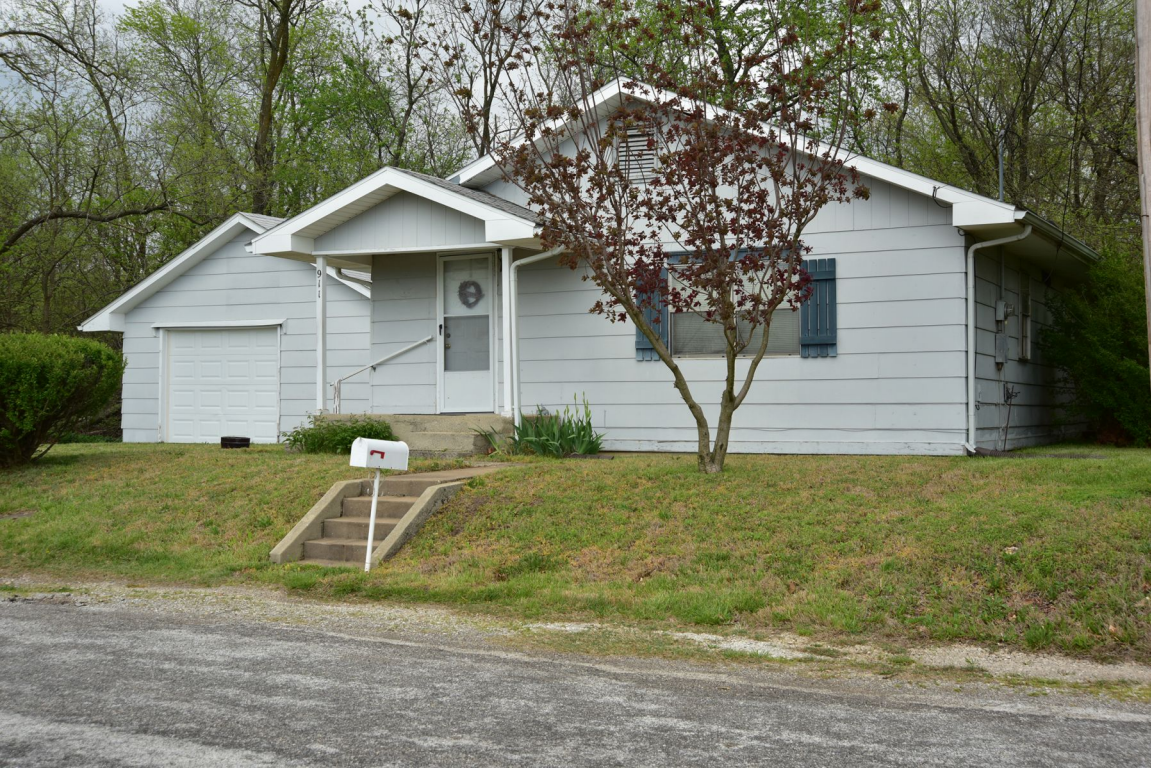
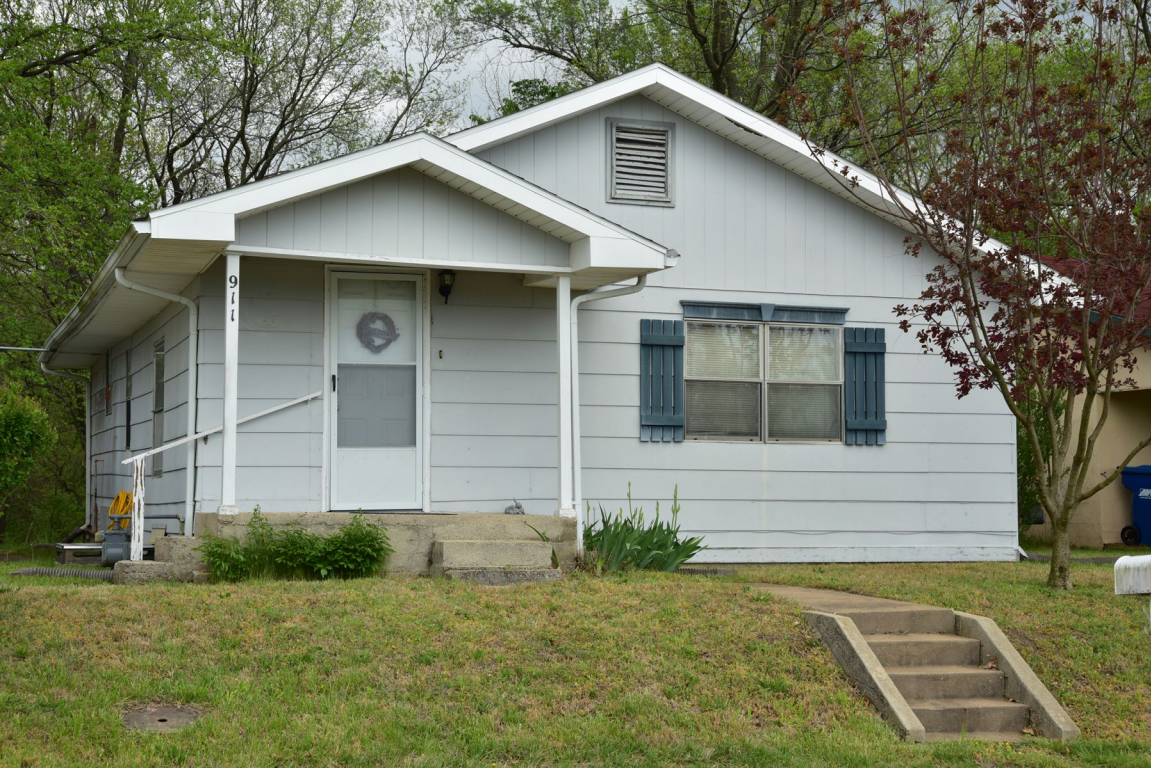
This bungalow dwelling faces west and has a rectangular footprint. It has asbestos shingle cladding, concrete foundation, and a front-gable roof with asphalt shingles. The dwelling is two bays wide and three bays deep. A non-historic wood door occupies the north bay of the primary elevation while a pair of one-over-one wood windows occupies the south bay. The windows feature non-historic false shutters and a non-historic wood lintel with keystone detail. A front-gable porch shelters the entrance. It has a concrete foundation and non-historic wood support posts.

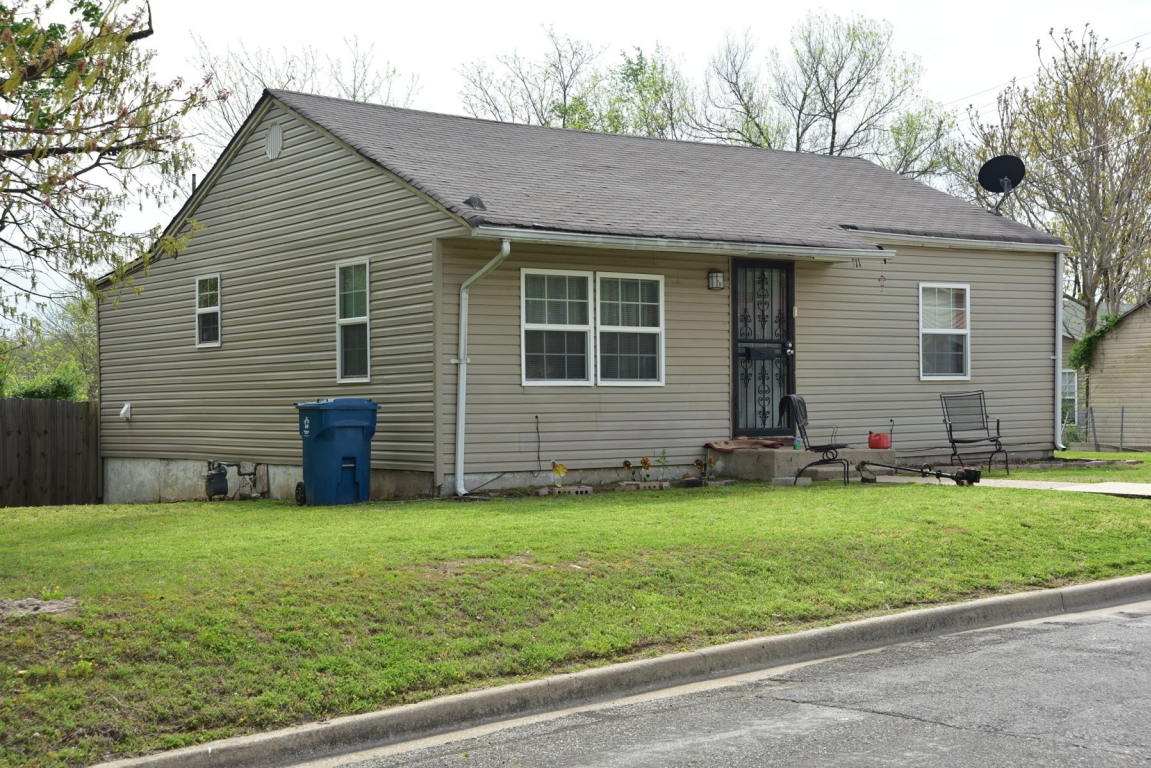
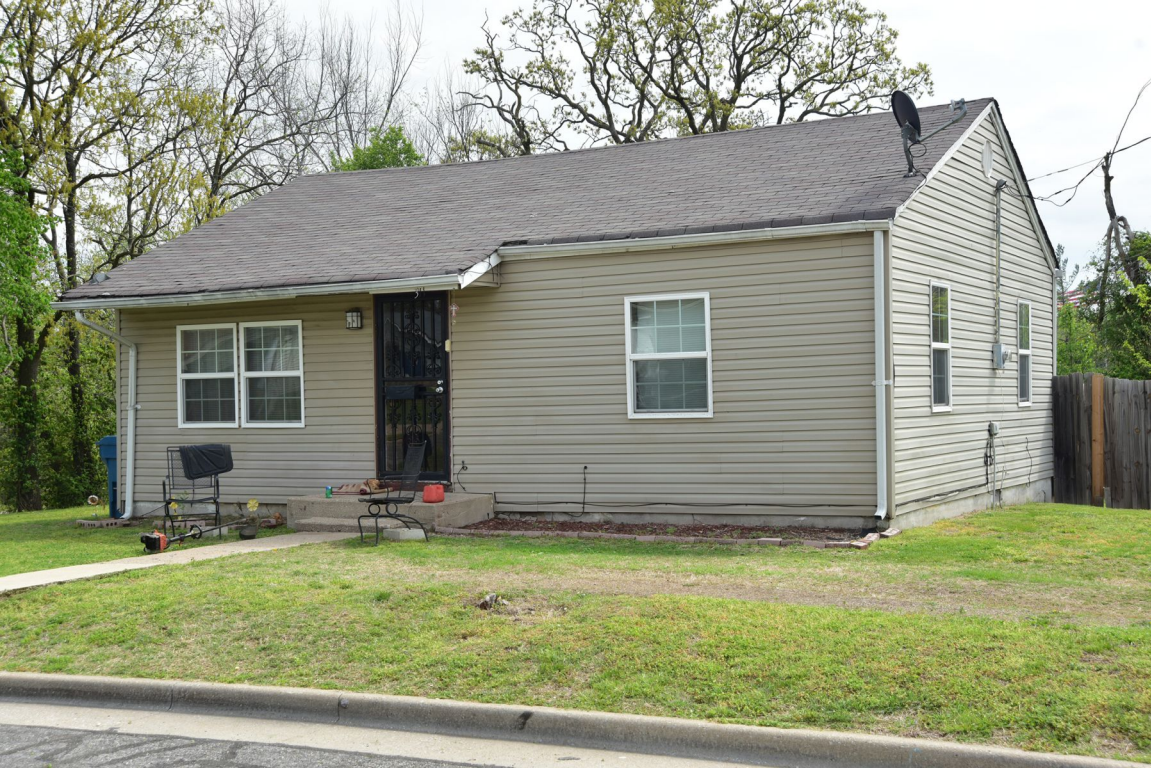
This dwelling faces west and has an L-shaped footprint. It has a parged stone foundation and vinyl cladding. The side-gable roof has asphalt shingles. The dwelling is three bays wide and two bays deep. Singles and pairs of six-over-six vinyl windows occupy the north and south bays of the primary elevation while a non-historic wood door occupies the center bay. The roof slightly overhangs and shelters the north two bays and a concrete stoop.

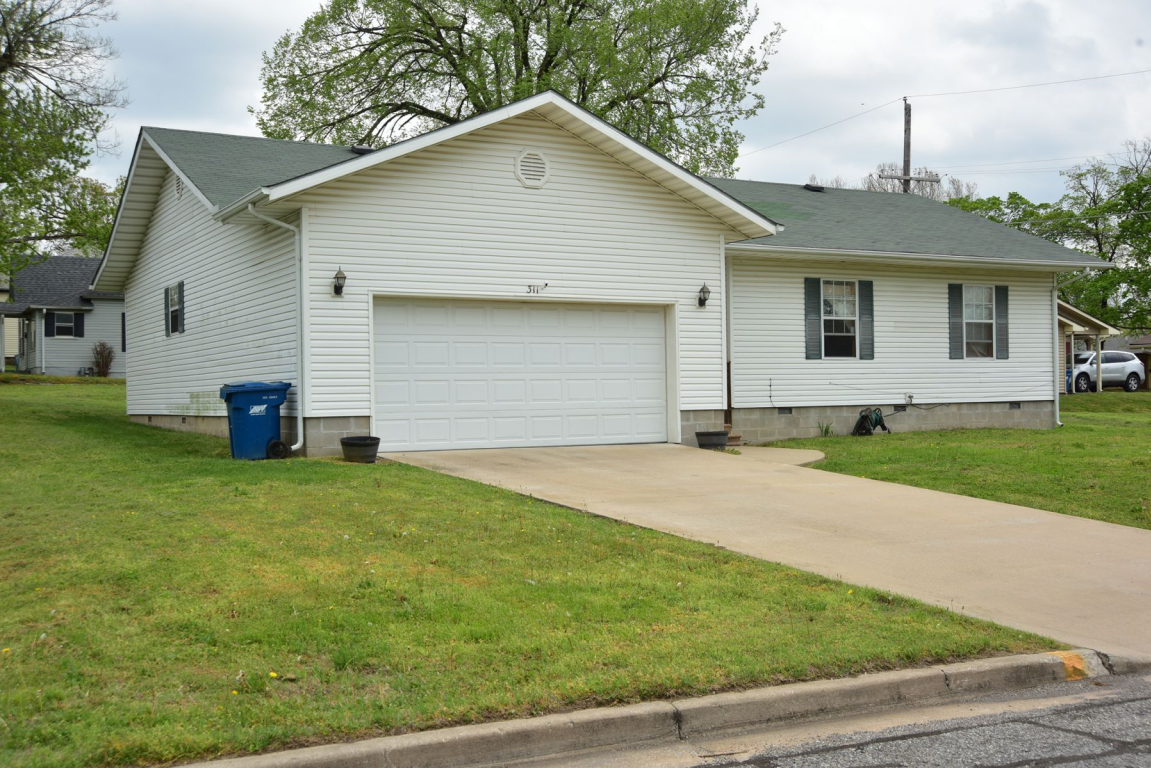
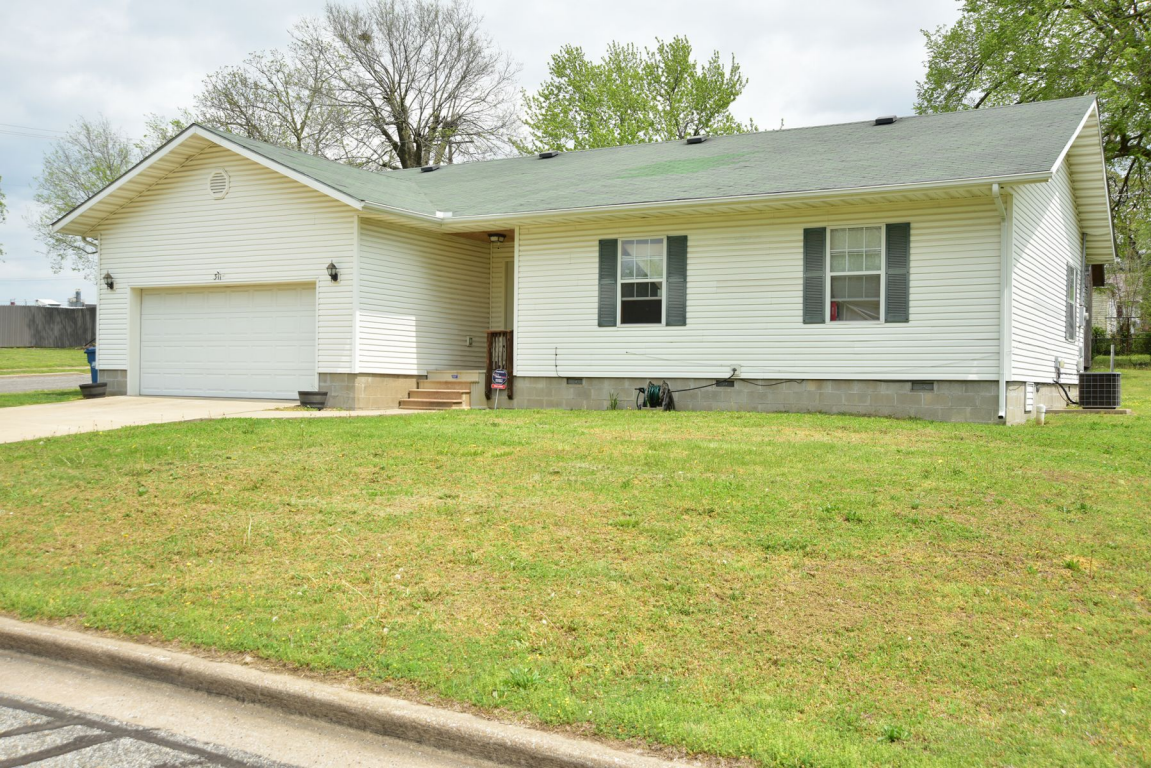
This Ranch dwelling faces west and has an L-shaped footprint. It has a concrete masonry unit foundation, vinyl cladding, and a side-gable roof with asphalt shingles. A cross-gable is located at the north end of the dwelling and houses an attached garage. The dwelling is four bays wide and one bay deep. The garage forms the first bay while six-over-six vinyl windows with false shutters occupy the third and fourth bays. The second bay is recessed and contains the primary entrance.

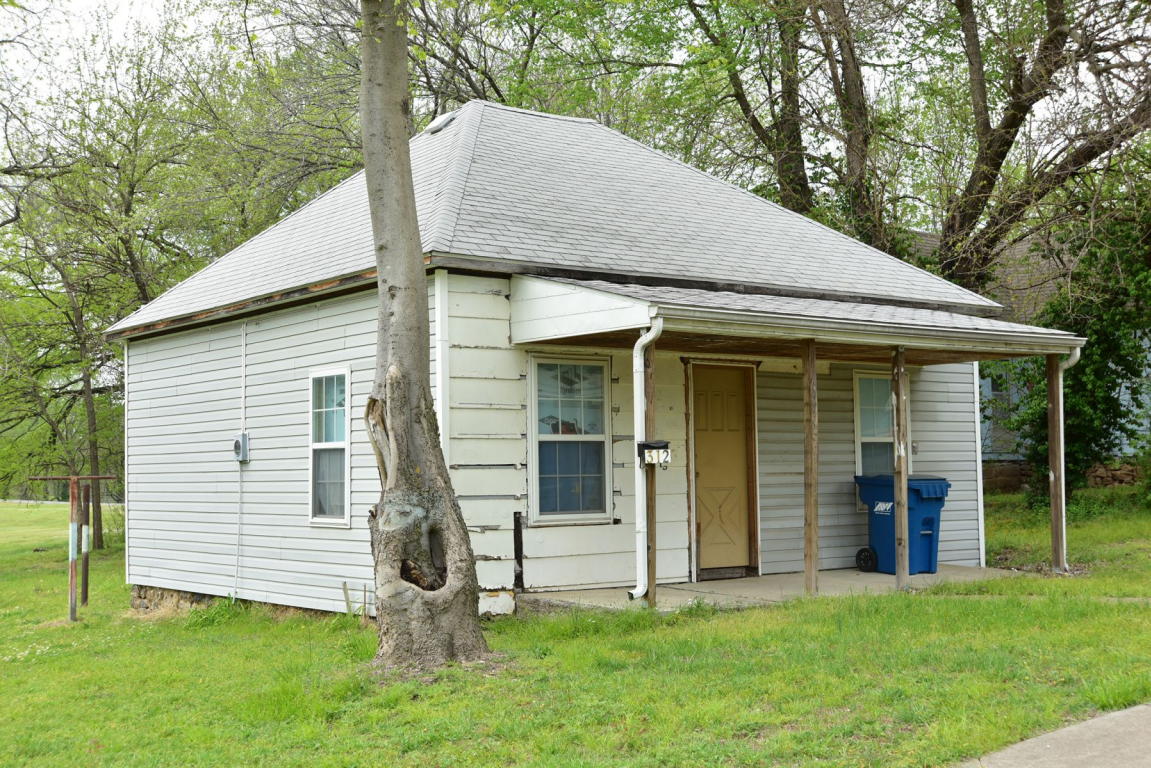
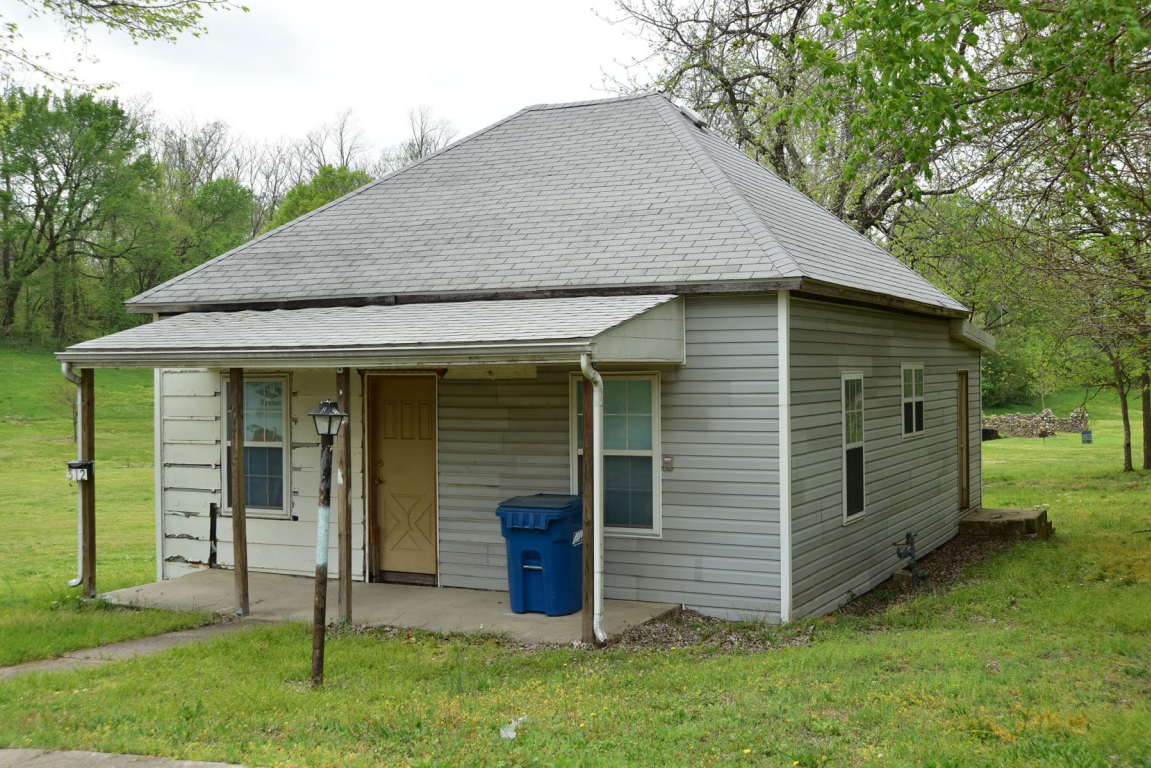
This Pyramid Square Folk House faces east and has a T-shaped footprint. It has a stone foundation, asphalt shingle roof, and pressboard and vinyl cladding. The dwelling is three bays wide and three bays deep. A non-historic wood door occupies the center bay of the primary elevation while six-over-six vinyl windows occupy the remaining bays. A non-historic, three-quarter width open porch shelters the bays. It has a shed roof supported by wood posts and a concrete slab foundation.

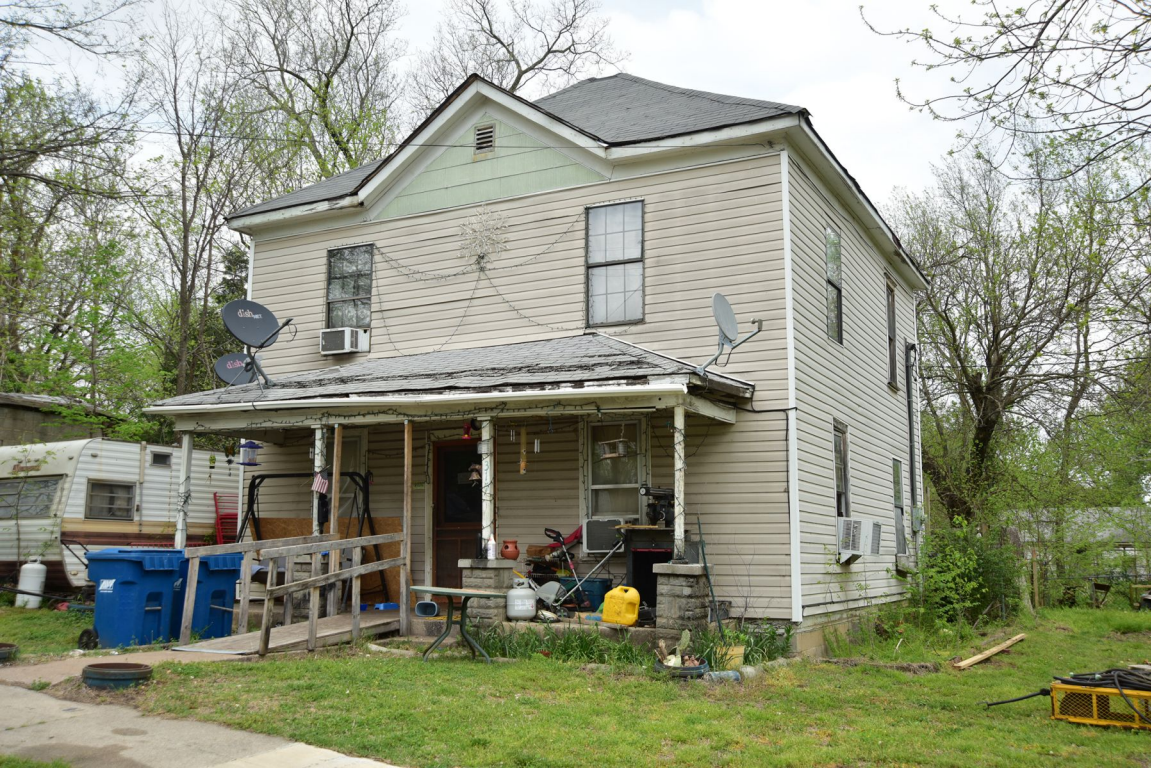
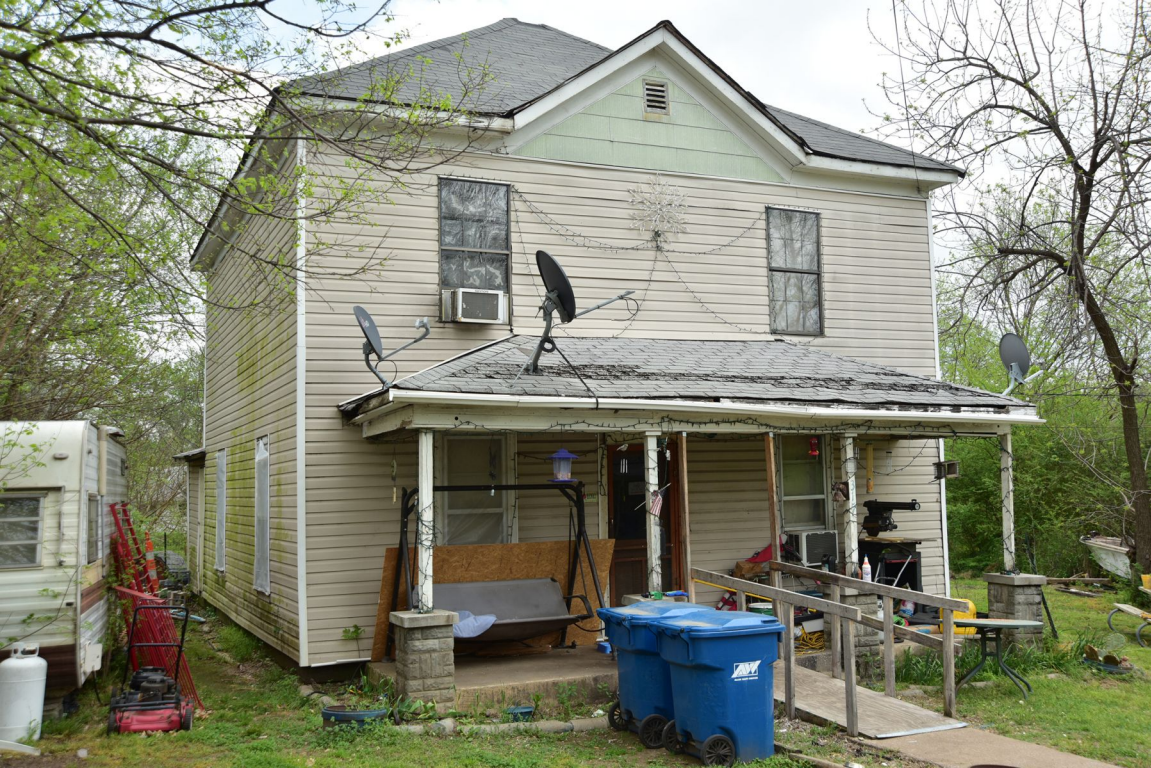
This two-story dwelling faces west and has a rectangular footprint. The dwelling has a concrete masonry unit foundation, vinyl cladding, and a hipped roof with asphalt shingles and a center gable at the primary elevation. The dwelling is three bays wide and three bays deep. A one-story hipped roof addition projects from the rear elevation and forms the third bay. One-over-one vinyl windows occupy the north and south first-story bays of the primary elevation and an entrance forms the center bay. The door was not visible at the time of survey. Six-over-six windows occupy both second-story bays at the primary elevation. A three-quarter width open porch shelters the primary elevation bays. It has a concrete foundation and hipped roof with asphalt shingles. Squared wood posts on concrete block piers support the porch roof.

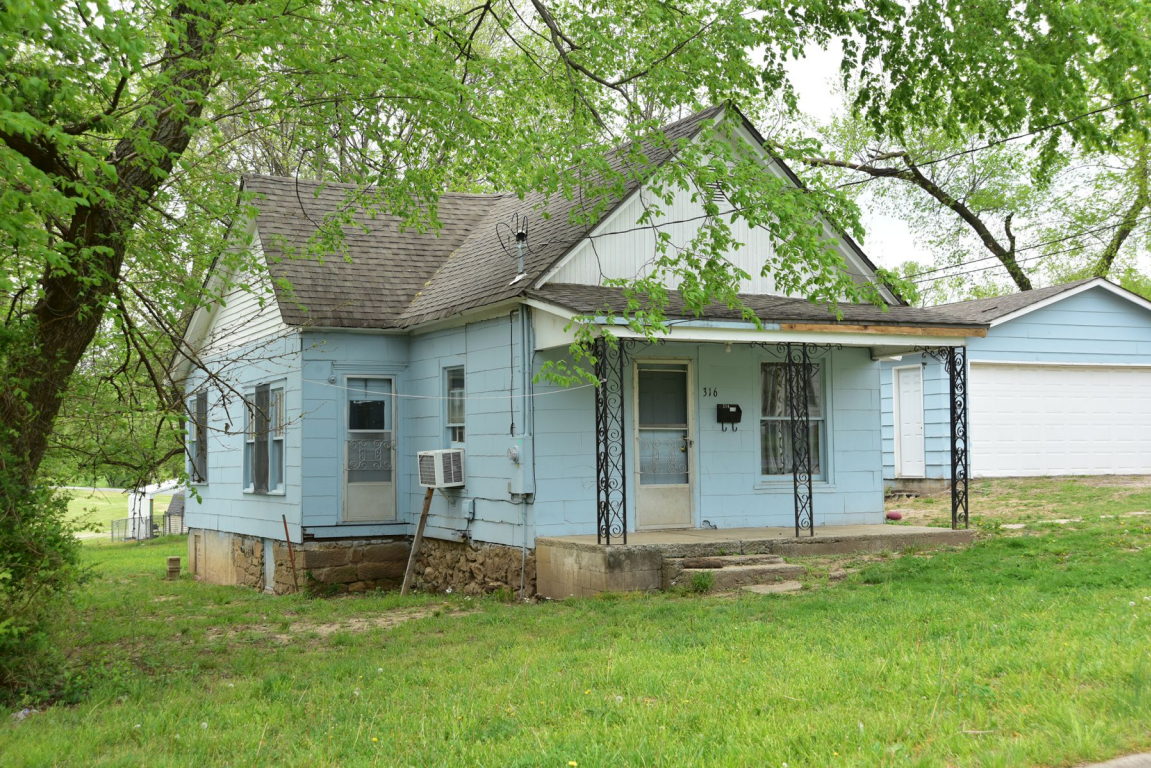
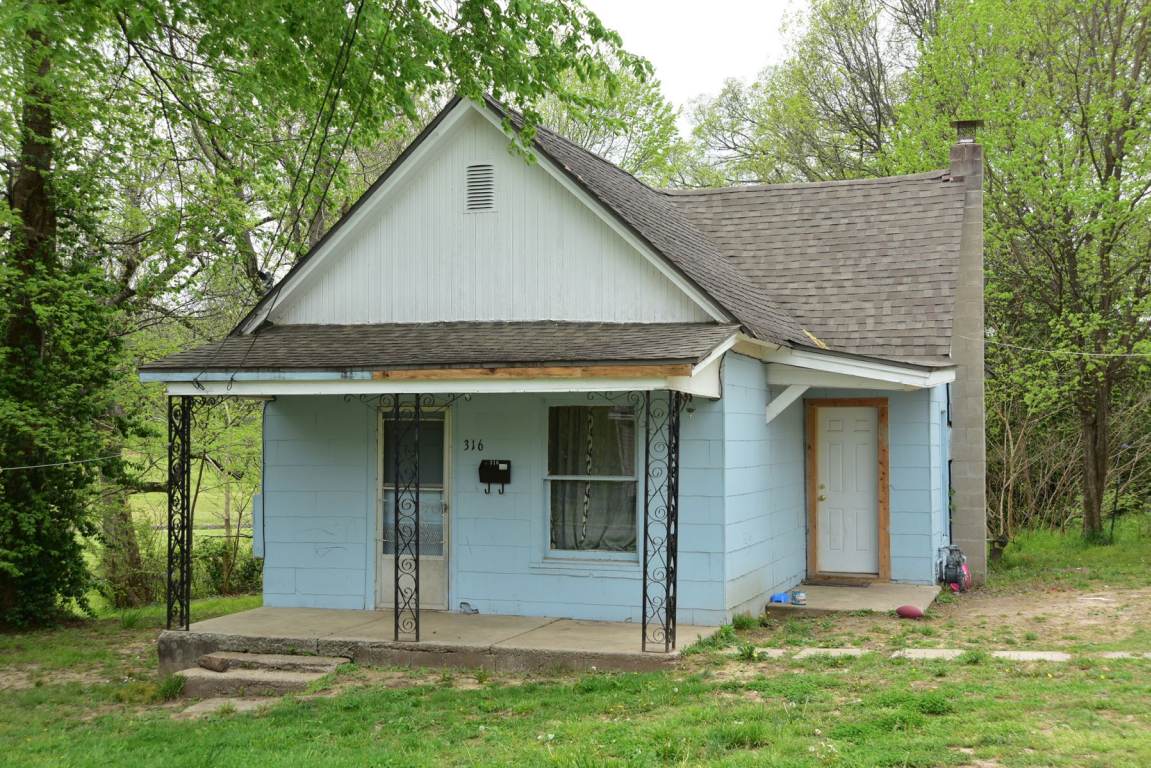
This National Folk House dwelling faces east and has a rectangular footprint. It has a stone foundation and cross-gabled roof with asphalt shingles and wood cladding in the gable peaks. The dwelling has asbestos shingle cladding. It is two bays wide and three asymmetrical bays deep. A non-historic wood door occupies the south bay of the primary elevation while a historic one-over-one wood window occupies the north bay. A shed-roof porch with a concrete foundation and non-historic decorative metal support posts spans the width of the primary elevation. Secondary entrances are located at the west elevations of the cross-gabled projections. The south secondary entrance contains a historic wood door with historic trim while the north secondary entrance contains a non-historic wood door with non-historic flat trim. A concrete masonry unit exterior chimney is located at the north elevation.

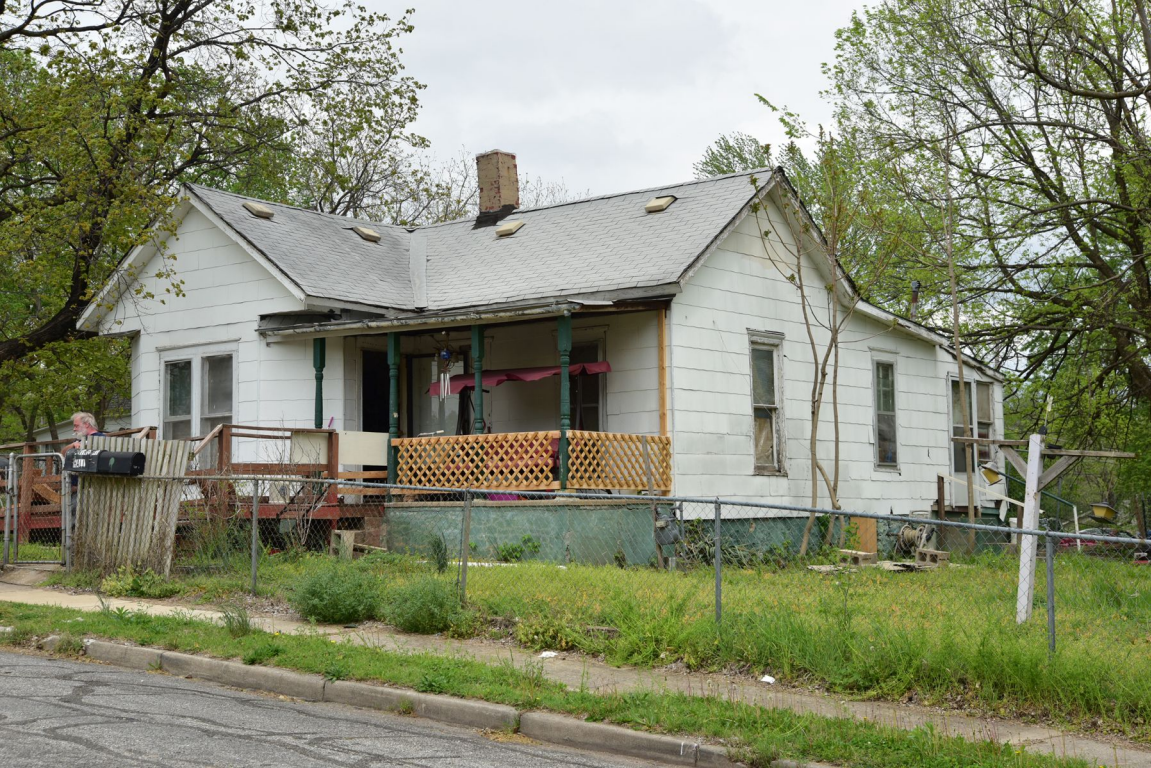
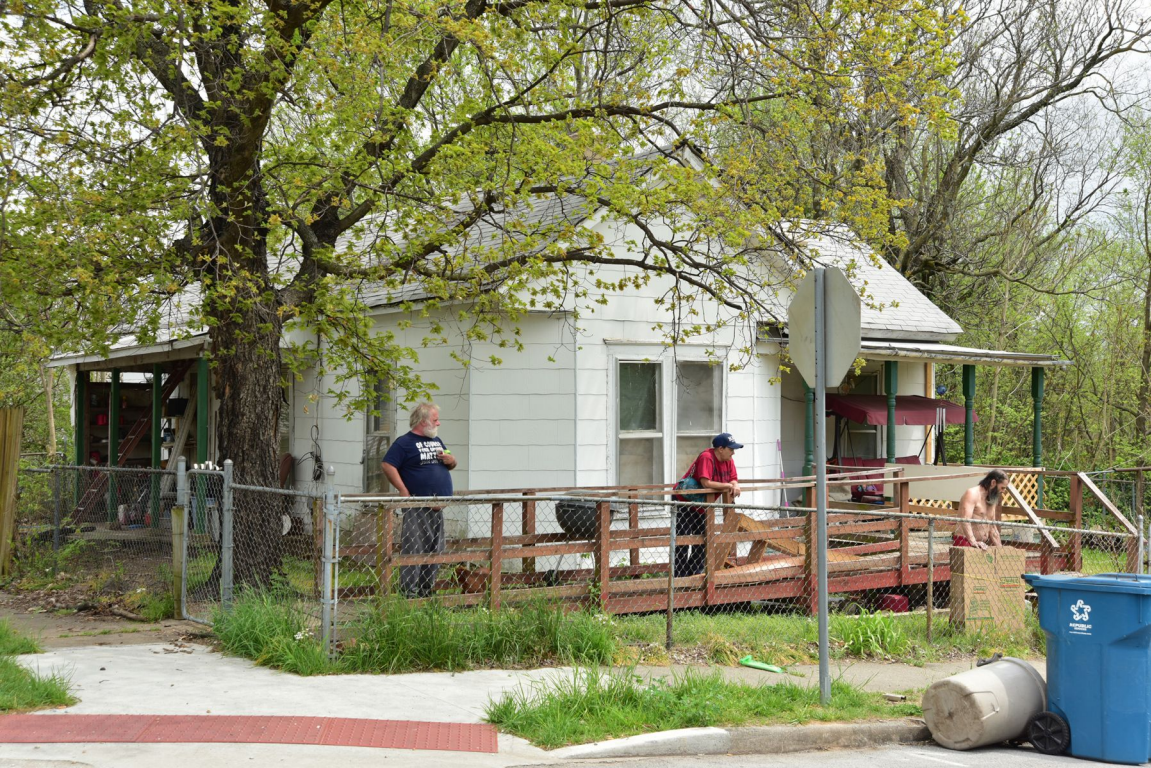
This Gabled-Ell dwelling faces west and has a square footprint. It has stone foundation, asphalt roof, and asbestos shingle cladding. A brick straddle-ridge chimney pierces the roof. The dwelling is three bays wide and three bays deep. An enclosed shed-roof porch forms the fourth bay. A pair of historic one-over-one wood windows occupies the north bay of the primary elevation while single historic one-over-one wood windows occupy the remaining bays. The south two bays recede, creating a partial-width open porch. The porch has a shed roof, parged foundation, and turned wood support posts. An entrance is located in the north wall of the projecting ell at the west elevation. The dwelling's windows feature historic wood trim and modest crown molding.

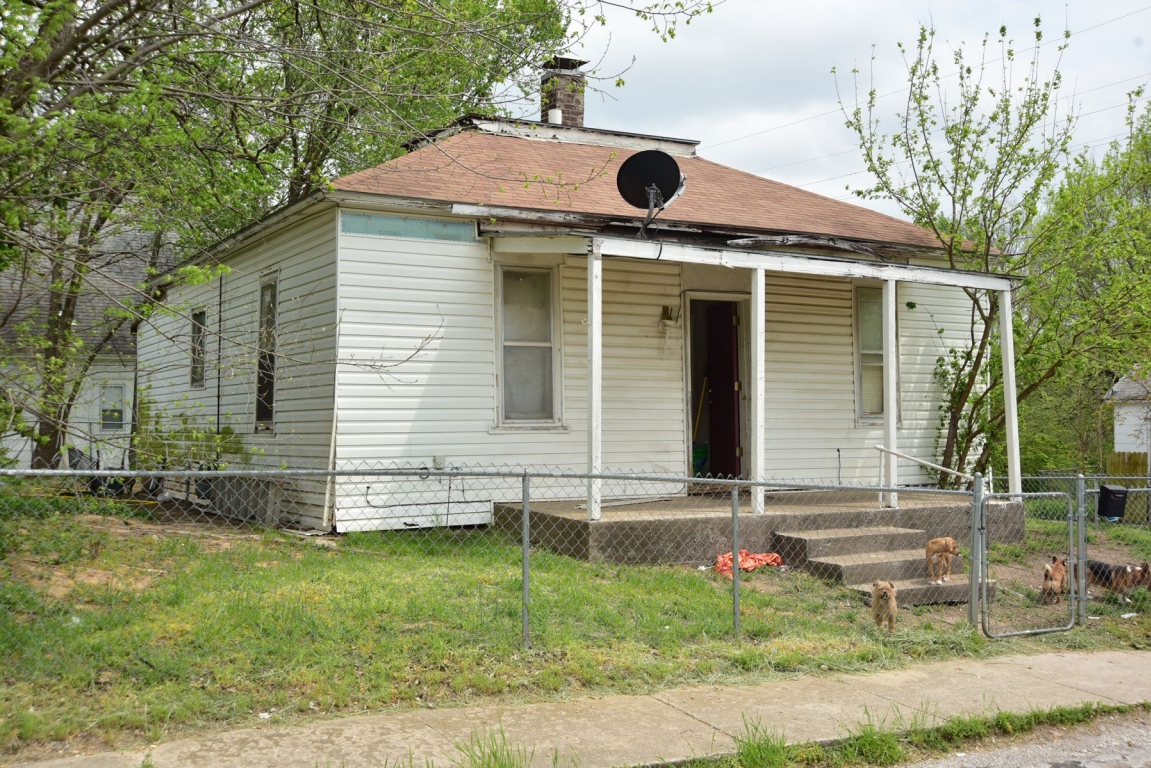
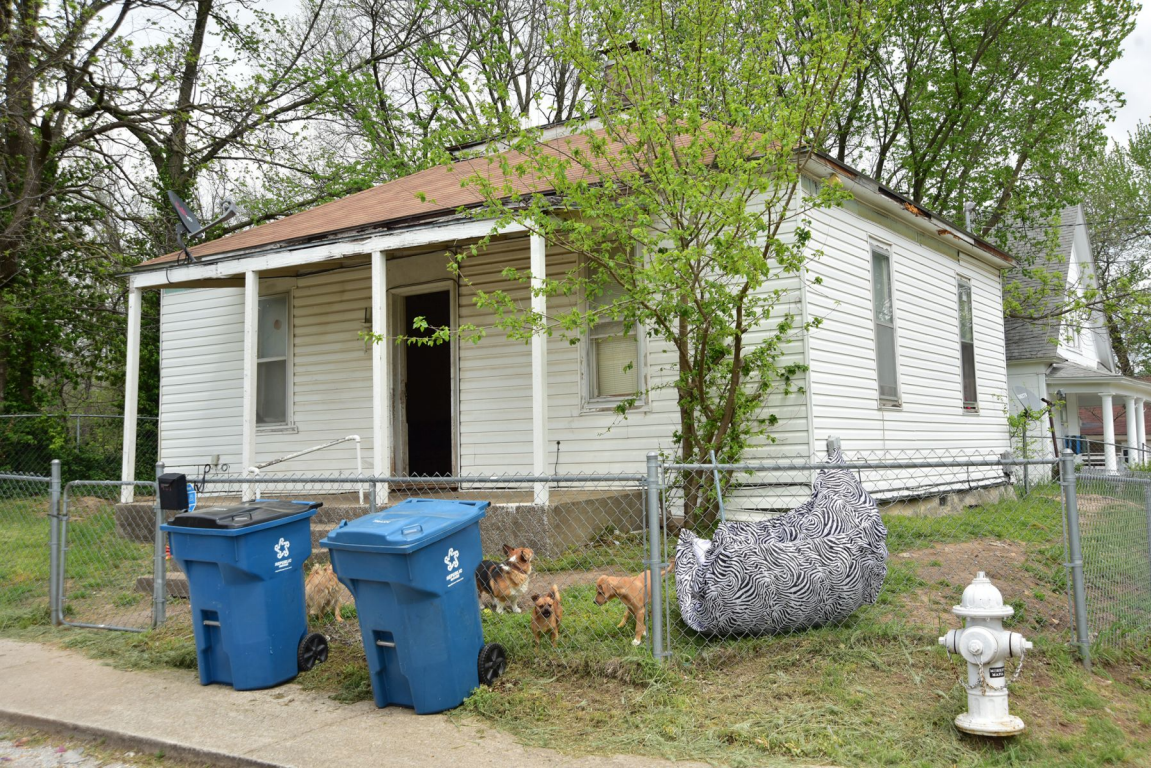
This Pyramid Square Folk House faces west and has a square footprint. It has a parged foundation, asphalt shingle roof, and vinyl cladding. It is three bays wide and two bays deep. A brick chimney pierces the chimney peak. A wood door occupies the center bay of the primary elevation while narrow one-over-one wood windows fill the remaining bays. An open, three-quarter width porch shelters the bays. It has a shed roof, concrete foundation, and squared wood support posts.

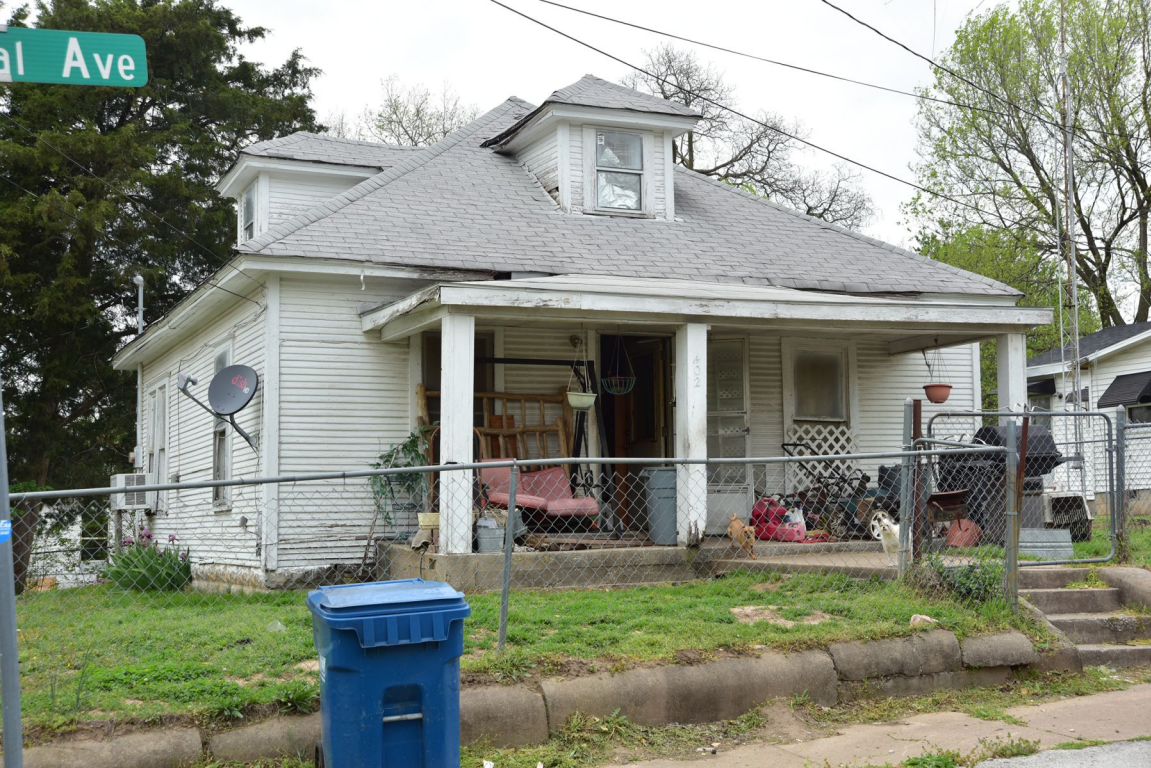
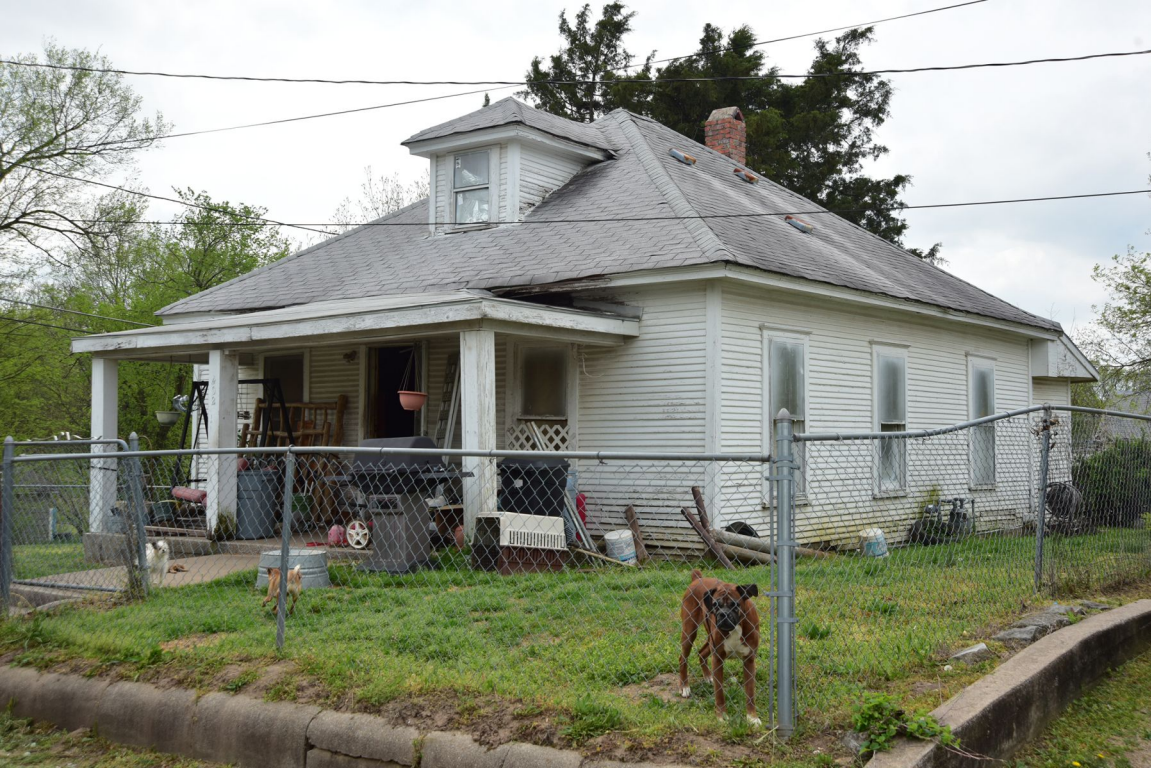
This bungalow dwelling faces east and has a rectangular footprint. It has a concrete block foundation, wood clapboard cladding, and an asphalt shingle roof. Hipped roof dormers are located on the south and east slopes while a short brick chimney pierces the west slope. The dwelling is three bays wide and four bays deep. An enclosed shed-roof porch forms the fourth bay. Historic one-over-one wood windows occupy the north and south bays of the primary elevation while a wood door with glazing occupies the center bay. An open, three-quarter width porch shelters the bays. It has a shallow hipped roof, concrete foundation, and wood support posts. The dormers and secondary elevations possess historic one-over-one wood windows and the secondary elevation windows have modest crown molding.

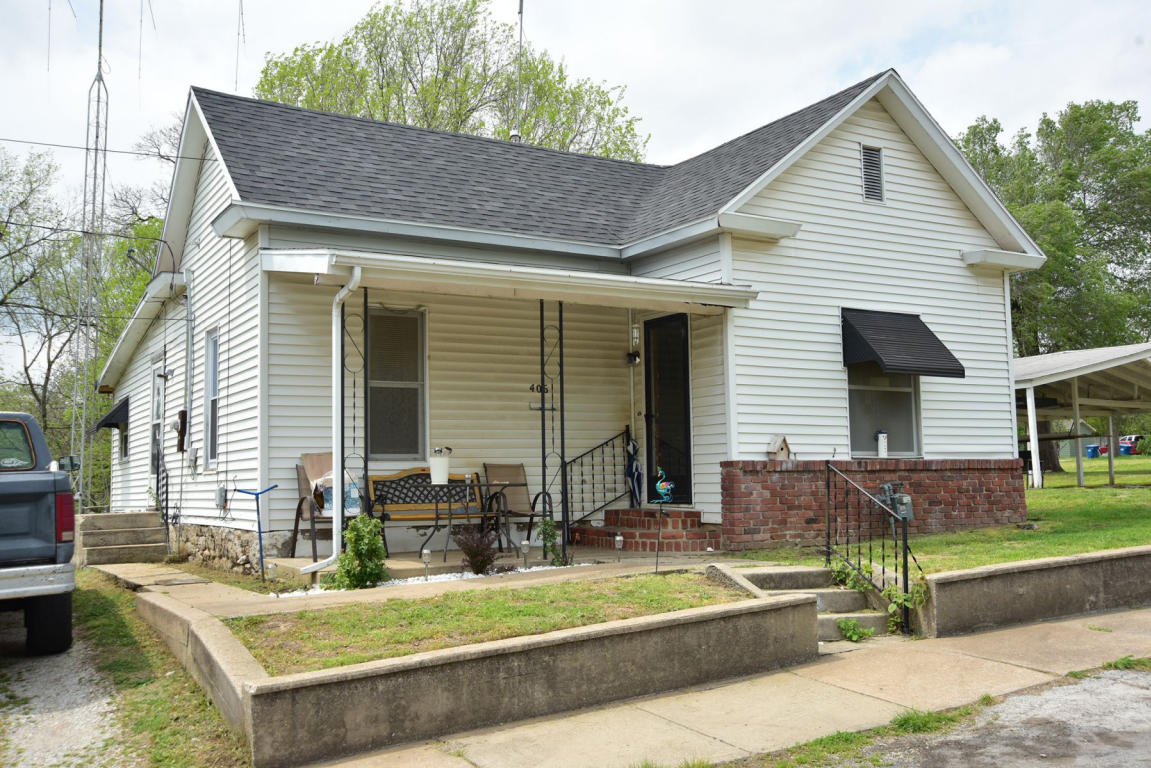
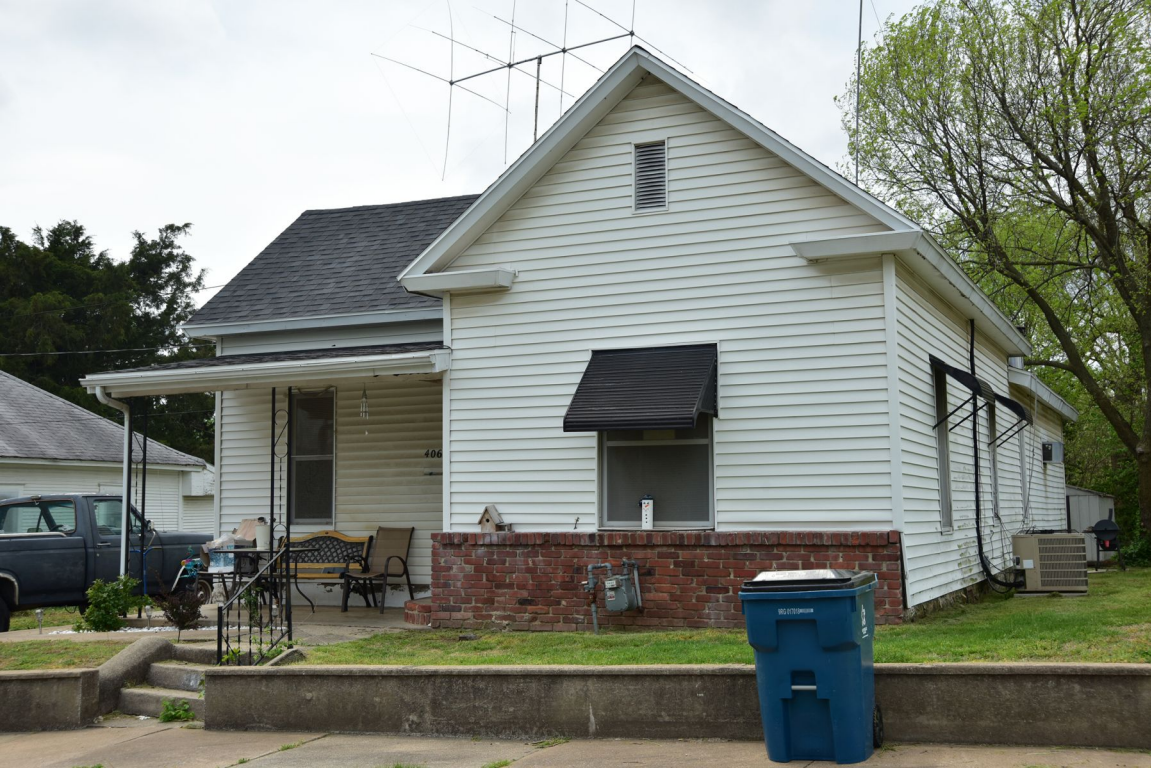
This Gabled-Ell dwelling faces east and has a rectangular footprint. It has a stone foundation and complex asphalt shingle roof. Brick veneer clads the lower quarter of the primary elevation gabled-ell while vinyl clads the remainder of the dwelling. The dwelling is two asymmetrical bays wide and four bays deep. An enclosed shed-roof porch forms the fourth bay. One-over-one wood windows occupy the primary elevation bays. The primary entrance features a non-historic wood door and curved brick steps and is located in the south wall of the gabled-ell. A non-historic shed-roof porch shelters the entrance and south bay. It has a concrete slab foundation and decorative metal support posts. A secondary entrance with a concrete stoop is located at south elevation.
