MISSOURI DEPARTMENT OF NATURAL RESOURCES
STATE HISTORIC PRESERVATION OFFICE, P.O. Box 176, Jefferson City, MO 65102
ARCHITECTURAL/HISTORIC INVENTORY FORM

1. Survey number: JP-AS-006-184		2. Survey Name: East Town (Original Joplin) Historic Survey Phase 1	
3. County: JASPER		4. Address 1401	Street (name): E. Hill Street
5. City: Joplin	Vicinity <input type="checkbox"/>	7. Township/Range/Section: T: R: S:	
8. Historic name (if known):		9. Present/other name (if known):	
10. Ownership: <input checked="" type="checkbox"/> Private <input type="checkbox"/> Public		11a. Historic use (if known): Domestic/Single Dwelling	11b. Current use: Domestic/Single Dwelling

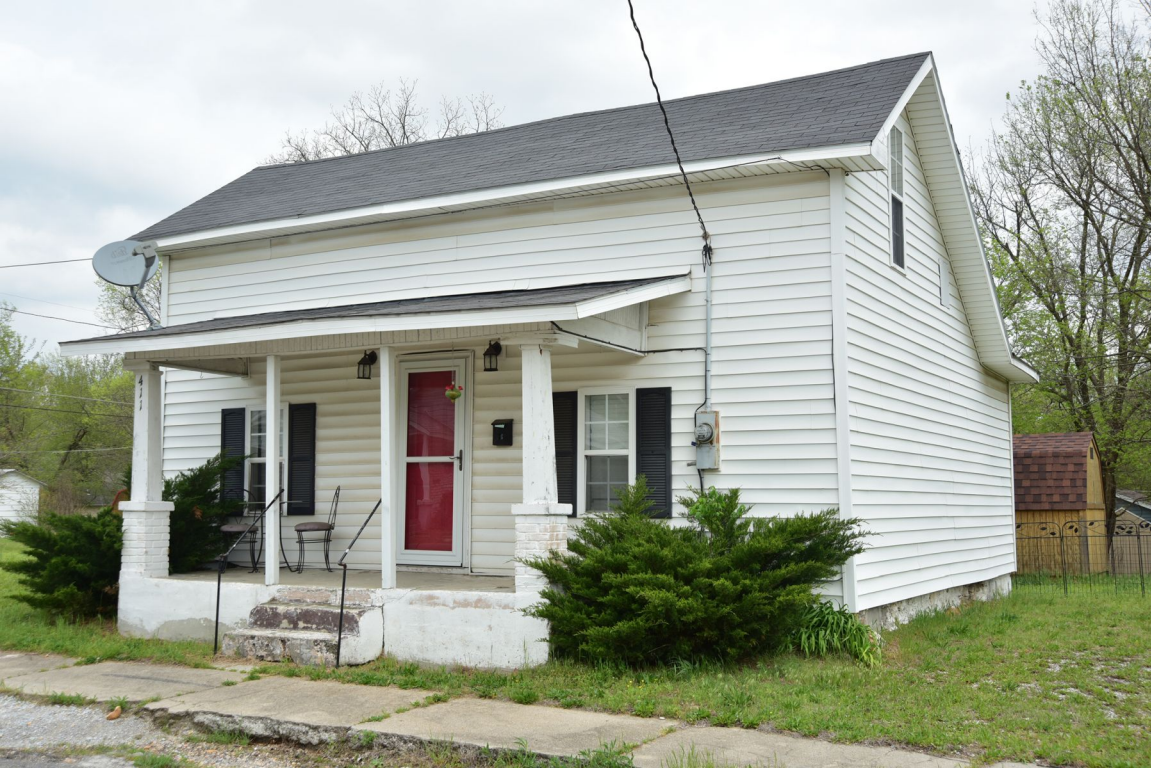
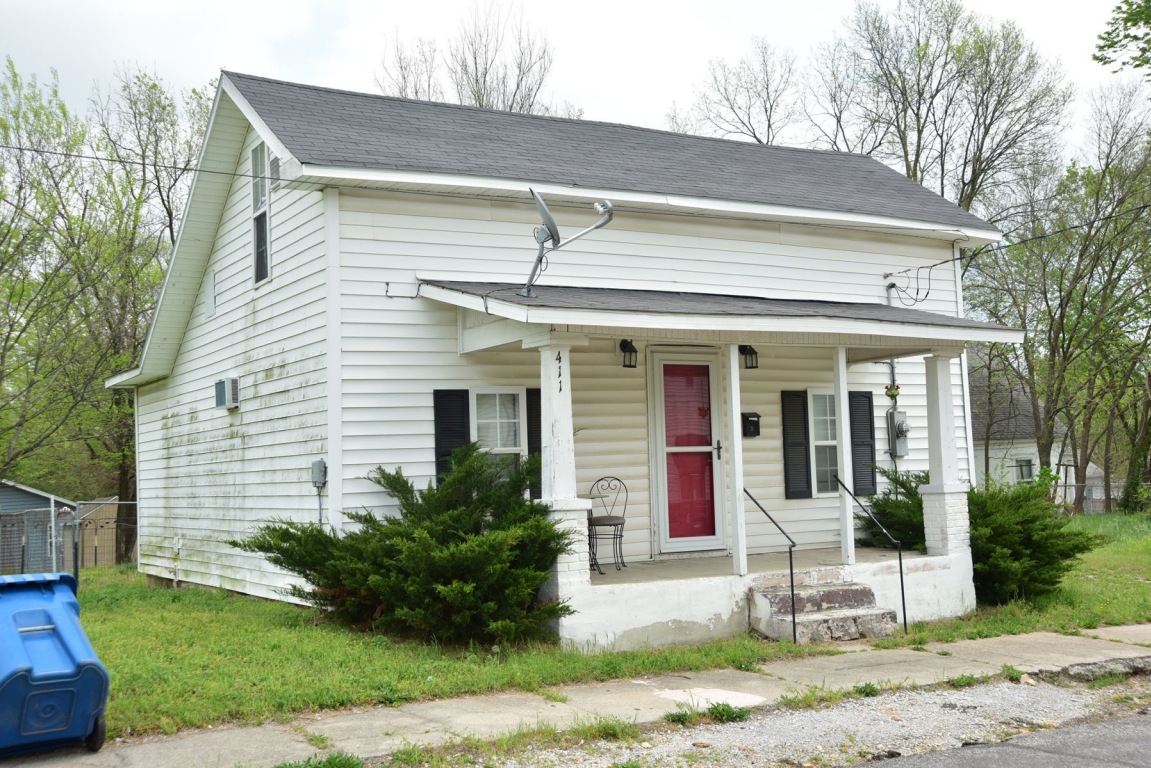
This dwelling faces west and has a rectangular footprint. It has a stone foundation, metal cladding, and asphalt shingle roof. It is three bays wide. A non-historic wood door occupies the center bay while four-over-four vinyl windows occupy the remaining bays. Four-over-four vinyl windows are located in the gable peaks and are the only windows at the north and south elevations. An open, three-quarter width porch shelters the primary elevation bays. It has a shed roof and concrete foundation. Wood columns on brick piers support the porch roof.

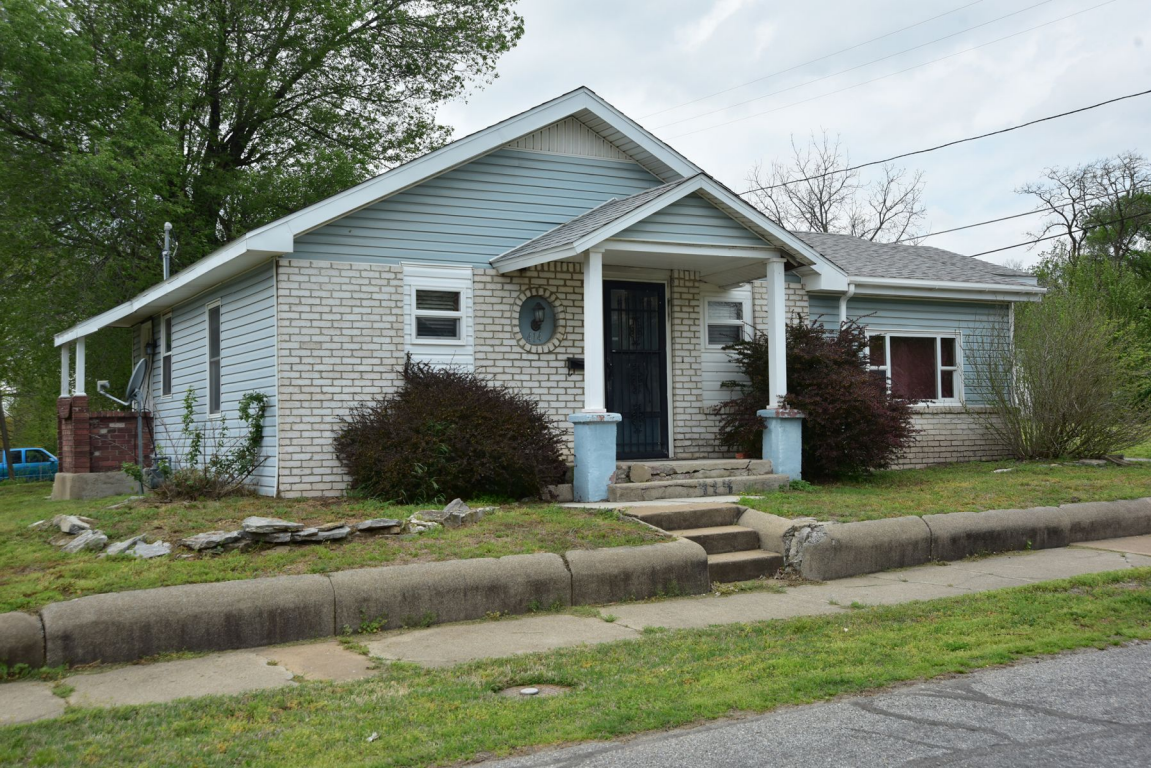
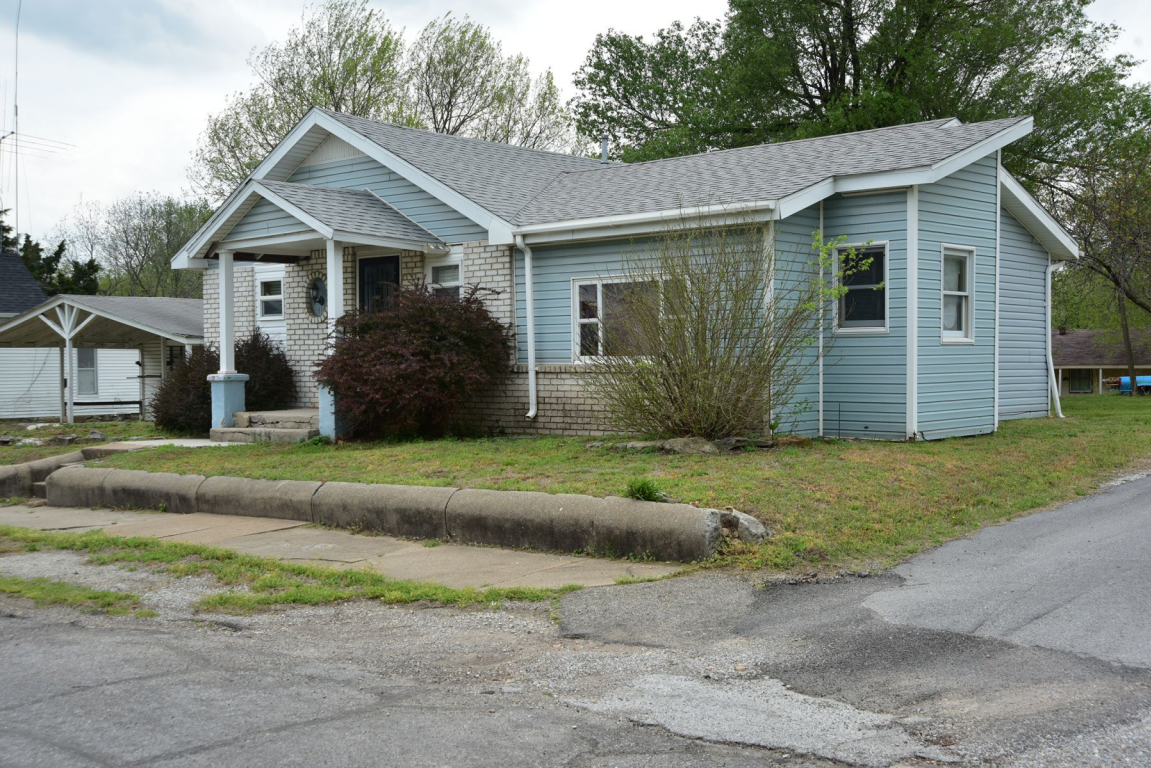
This Minimal Traditional dwelling faces east and has an irregular footprint. It has a concrete foundation and asphalt shingle roof. The primary elevation has a combination of brick and vinyl cladding. The secondary elevations have vinyl cladding. The dwelling is four bays wide and three bays deep. One-over-one vinyl windows occupy the first and third bays while a vinyl tripartite picture fills the fourth bay. A wood panel door defines the second bay. A front-gable porch shelters the entrance. It has a concrete foundation and steps. Squared wood columns on concrete piers support the porch roof. A secondary entrance is located at the south elevation. A shed-roof porch with brick walls shelters this entrance. The roof above the south wing has been raised above its original height.

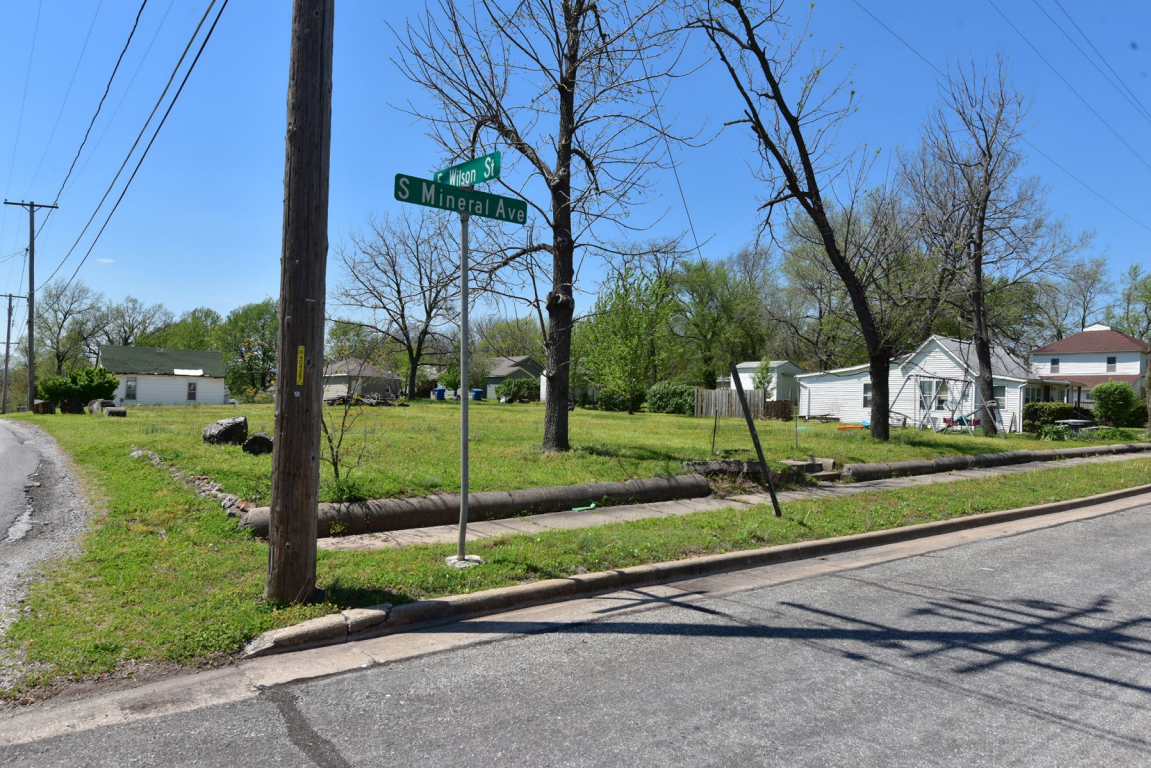
This grassy lot is vacant. A low, stone retaining wall with steps lines the east edge of the lot.

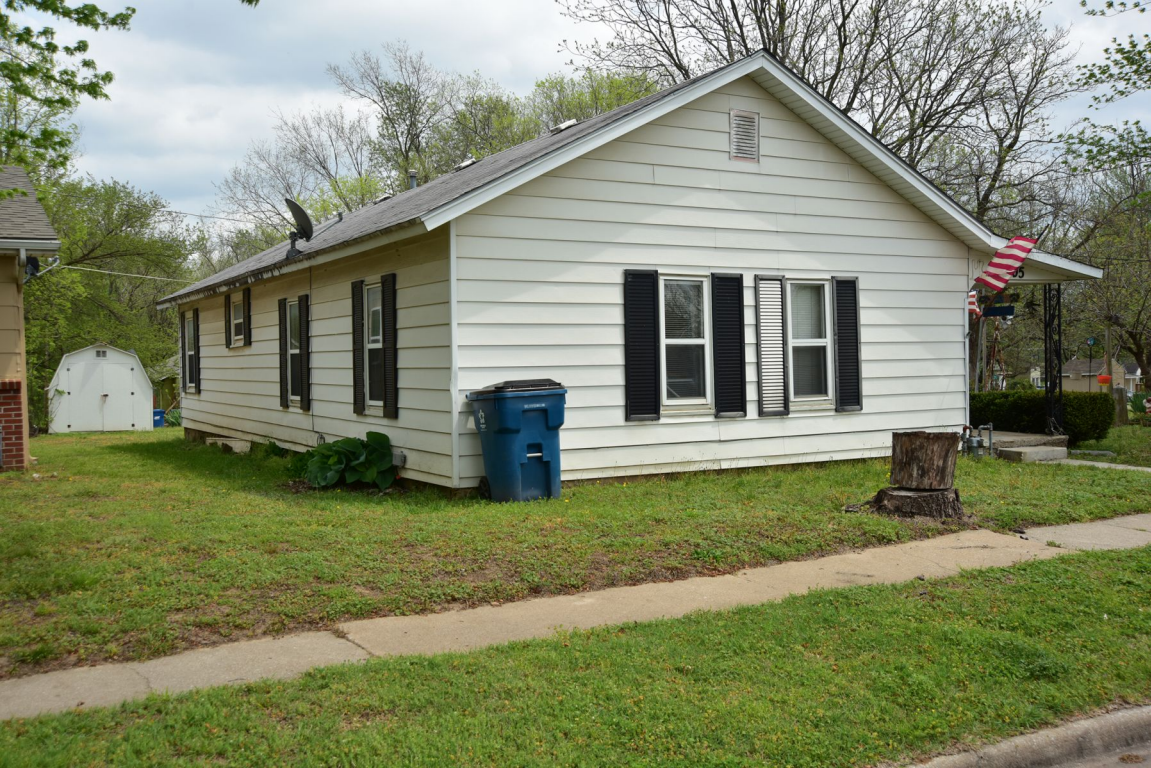
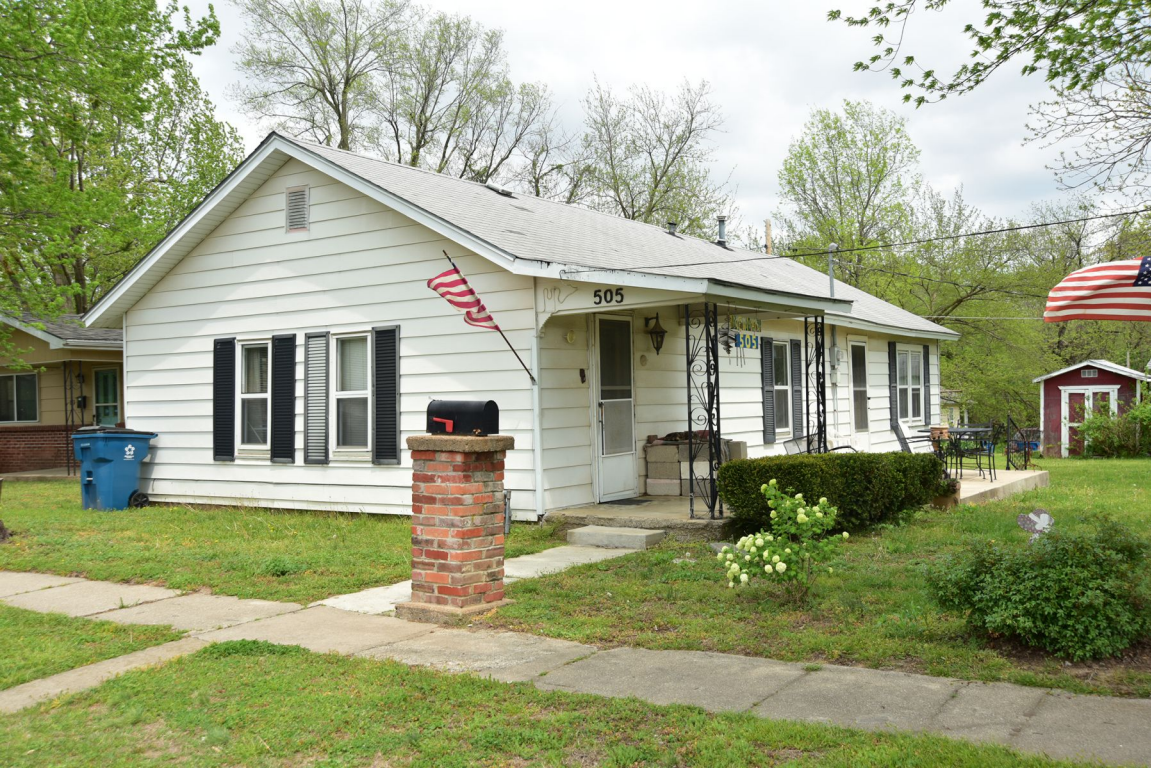
This Ranch dwelling faces south and has a rectangular footprint. It has a concrete foundation and metal siding. The front-gable roof has asphalt shingles. The dwelling is four bays wide and one bay deep. A non-historic wood door occupies the first bay. Single one-over-one window vinyl windows occupy the second and third bay while a pair of one-over-one vinyl windows defines the fourth bay. A shed-roof porch shelters the entrance and features a concrete foundation and non-historic decorative metal support posts. A non-historic concrete slab porch spans the rest of the primary elevation.

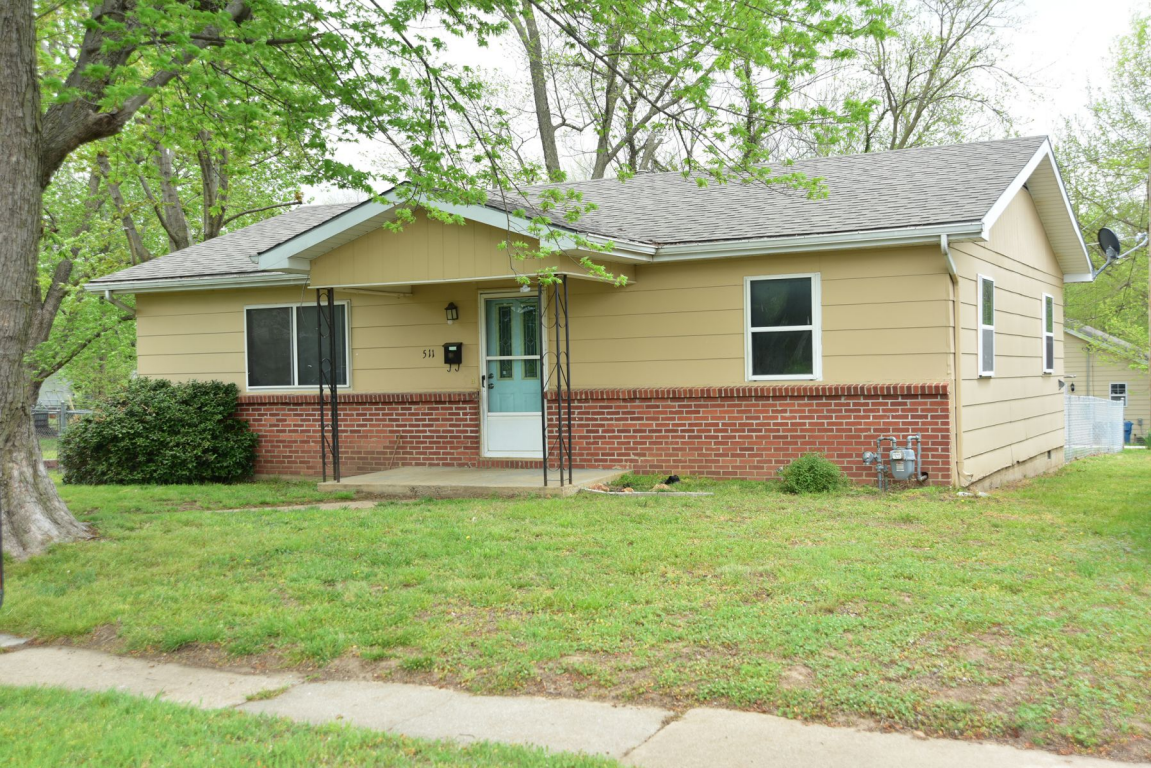
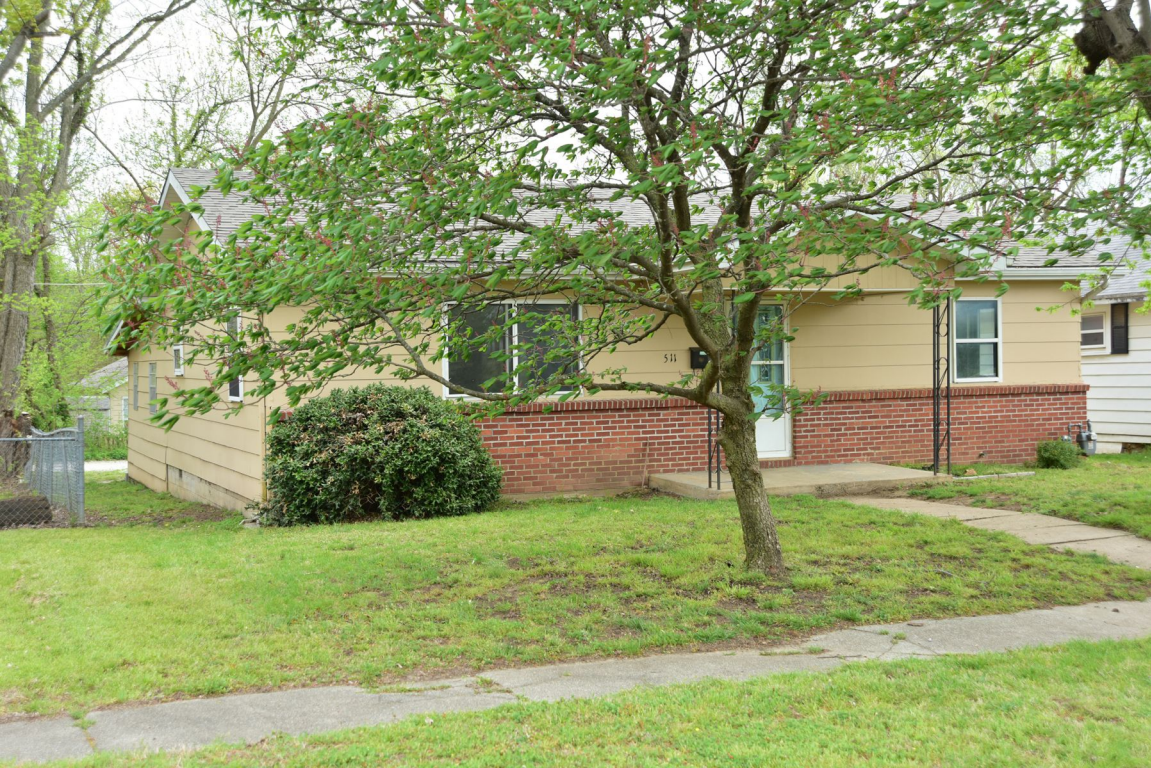
This Ranch dwelling faces west and has an L-shaped footprint. It has a concrete masonry unit foundation and an asphalt shingle roof. Brick veneer clads the lower third of the primary elevation and the remaining of the cladding is pressboard. The dwelling is three bays wide and four bays deep. A non-historic wood door with glazing occupies the center bay while a one-over-one vinyl windows occupies the south bay. The north bay contains a one-by-one wood window. A non-historic porch with a concrete foundation, front-gable roof, and decorative metal support posts shelters the entrance bay.

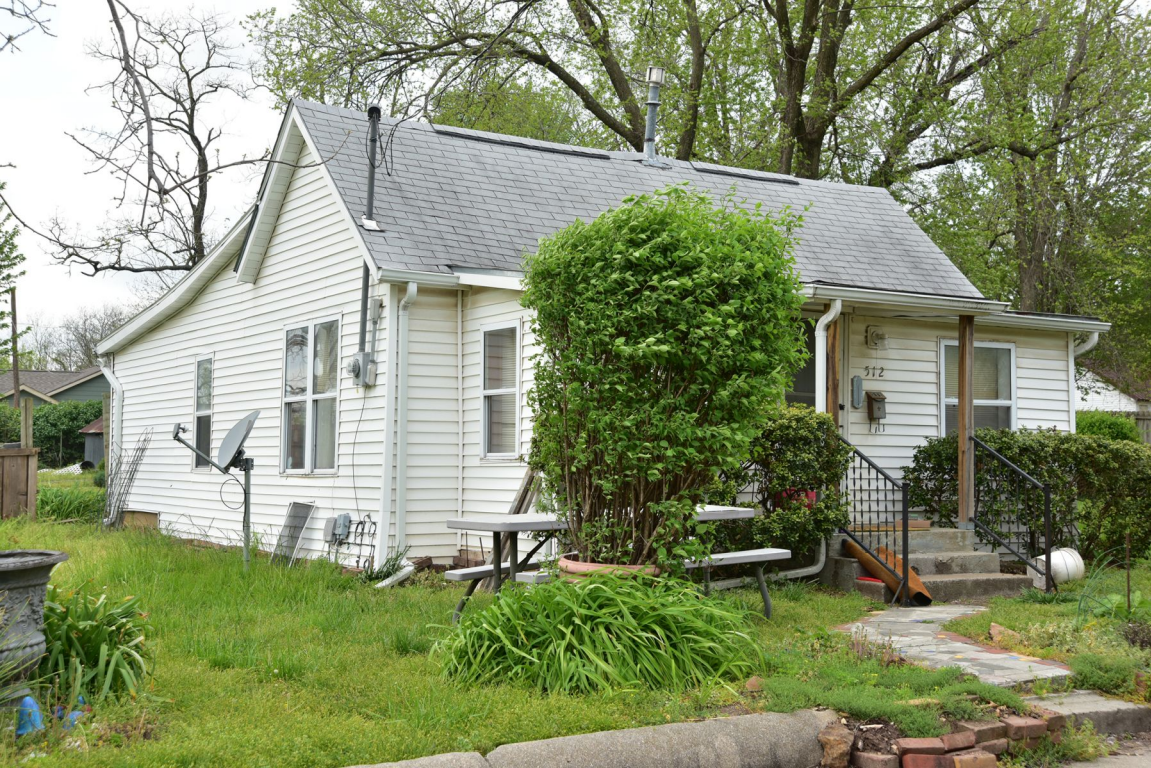
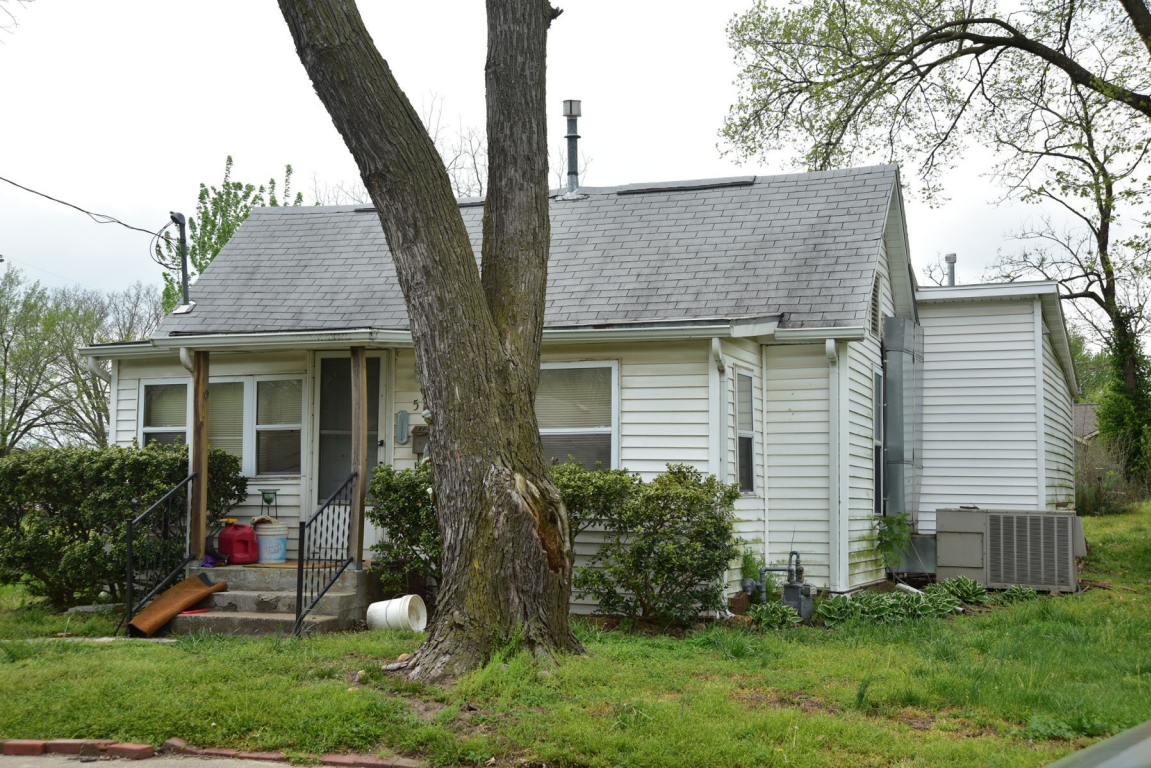
This National Folk House dwelling faces east and has a rectangular footprint. It has an asphalt roof and metal cladding. The foundation is not visible. The dwelling is three bays wide and three bays deep. An enclosed shed-roof porch at the west elevation forms the third bay. An enclosed shed-roof porch contains the primary elevation bays. The porch enclosure is an alteration. A non-historic wood door occupies the center bay while a one-over-one vinyl window occupies the north bay. A vinyl tripartite picture window defines the south bay. A non-historic flat-roof porch with a concrete foundation, wood support posts, and a metal railing shelters the entrance

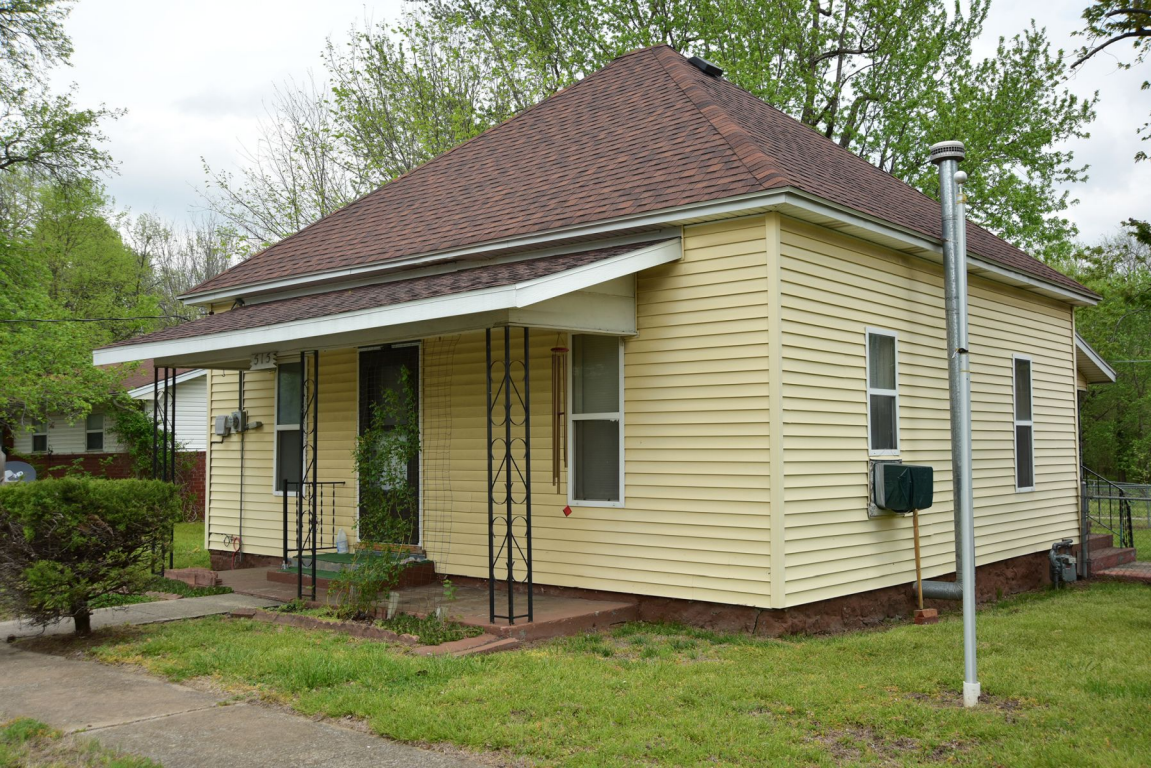
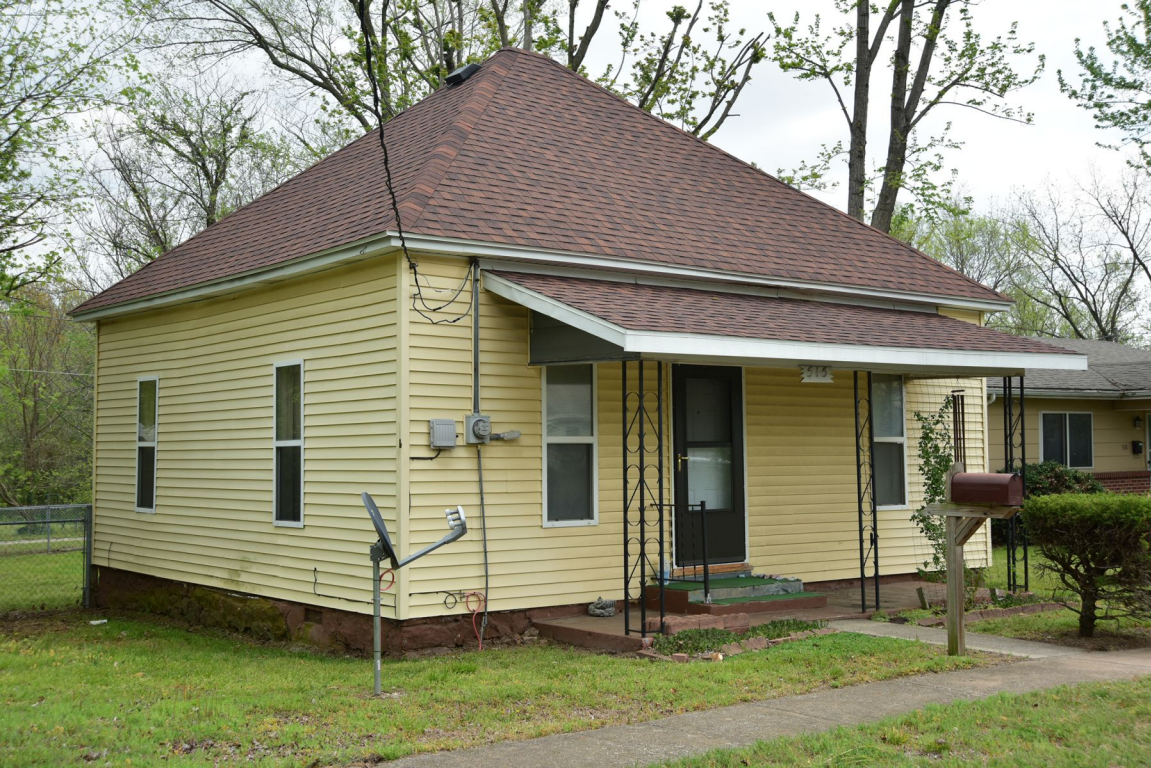
This Pyramid Square Folk House faces west and has a rectangular footprint. The foundation is parged and the pyramidal hipped roof features asphalt shingles and narrow eaves. The dwelling has vinyl cladding. It is three bays wide and two bays deep. A non-historic wood door occupies the center bay while one-over-one wood windows define the remaining bays. A shed-roof porch with a concrete foundation and decorative metal support posts shelters the primary elevation bays.

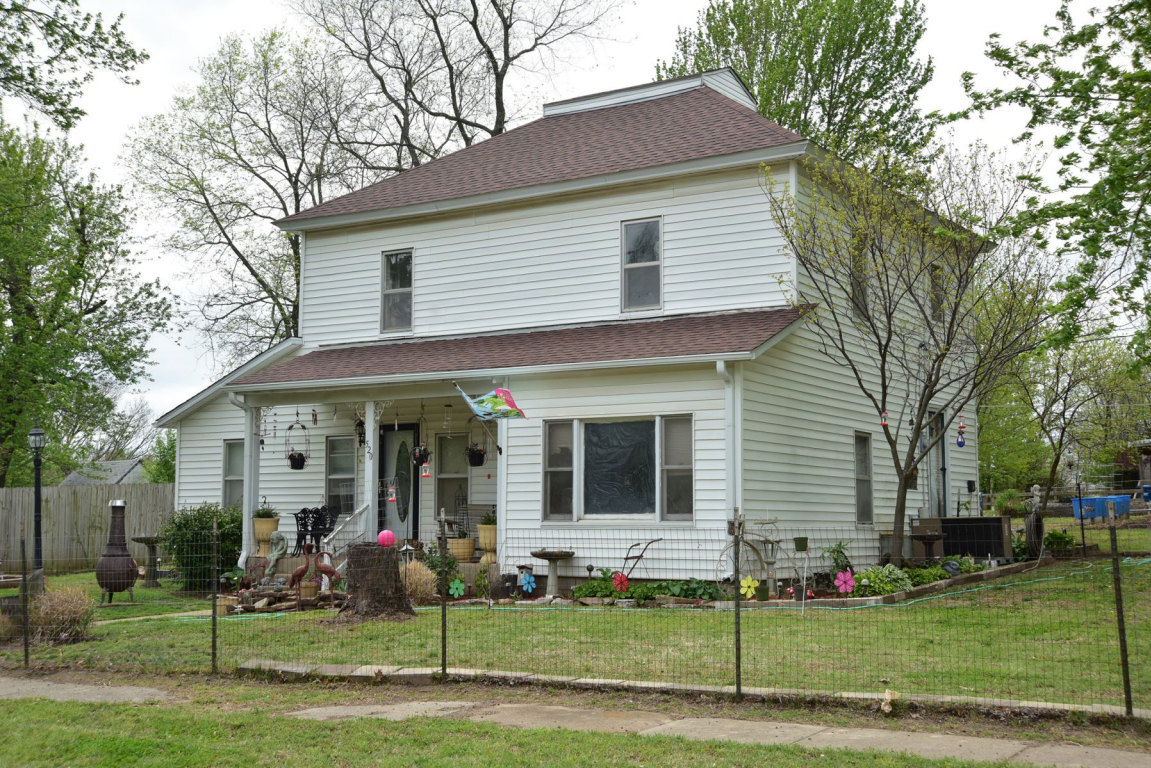
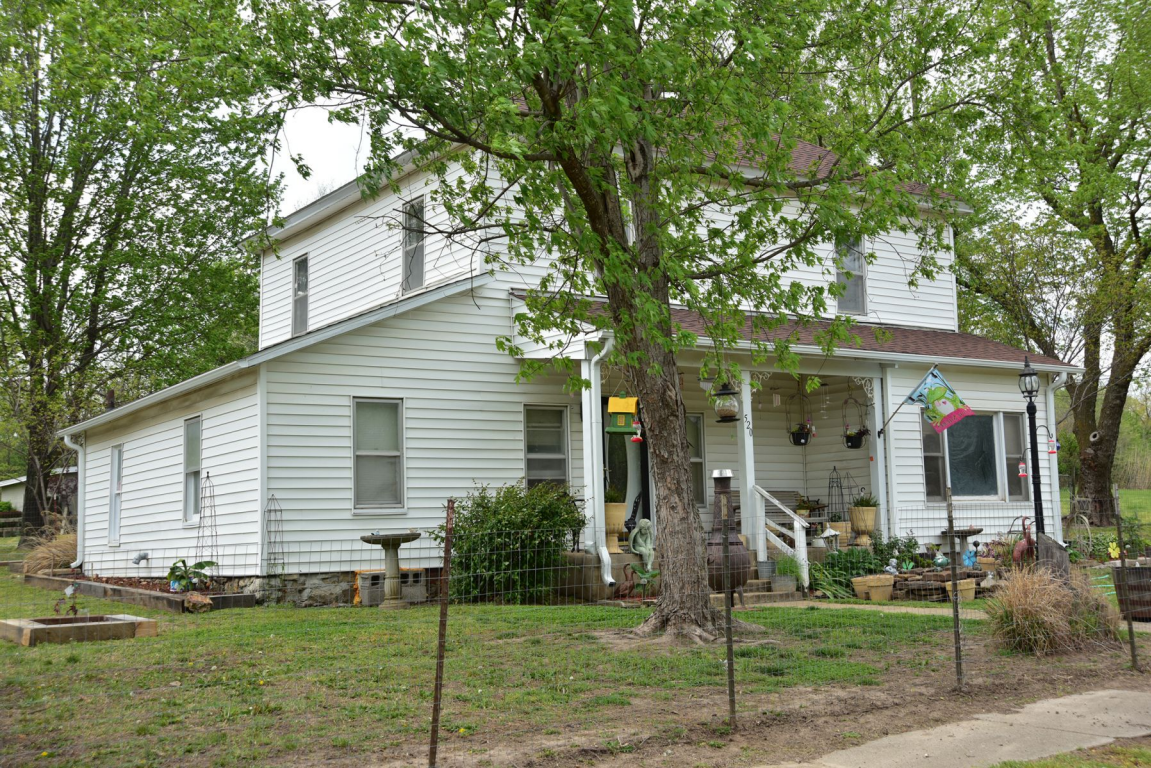
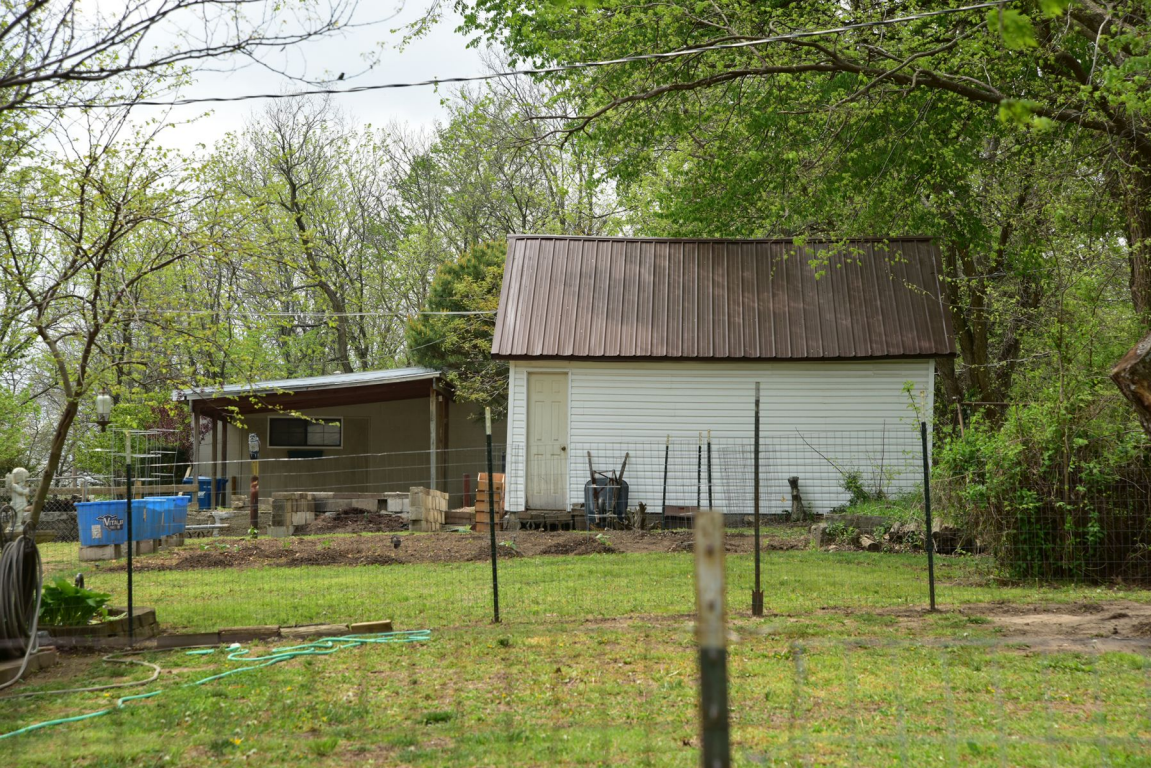
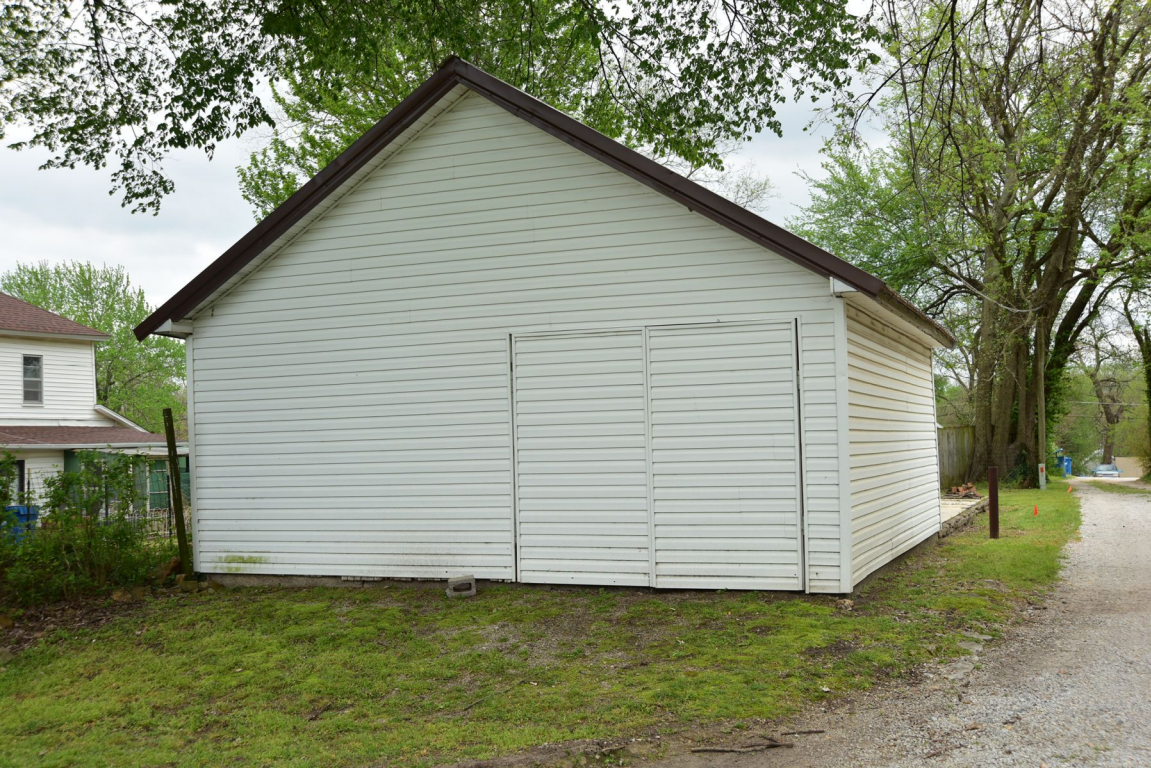
This two-story American Foursquare dwelling faces west and has a square footprint. It has a stone foundation and vinyl cladding. The hipped roof with gablet has asphalt shingles. A one-story shed-roof addition projects from the south elevation. The dwelling is five asymmetrical bays wide at the first story and two asymmetrical bays wide at the second story. It is two bays deep. A non-historic wood door with glazing occupies the center bay while one-over-one wood windows occupy the first, second, and fourth bays. A wood tripartite picture window defines the fifth bay, which projects from the elevation. A shed-roof porch with a concrete foundation and squared wood support posts shelters the second-fourth bays. One-over-one wood windows occupy the second-story bays.

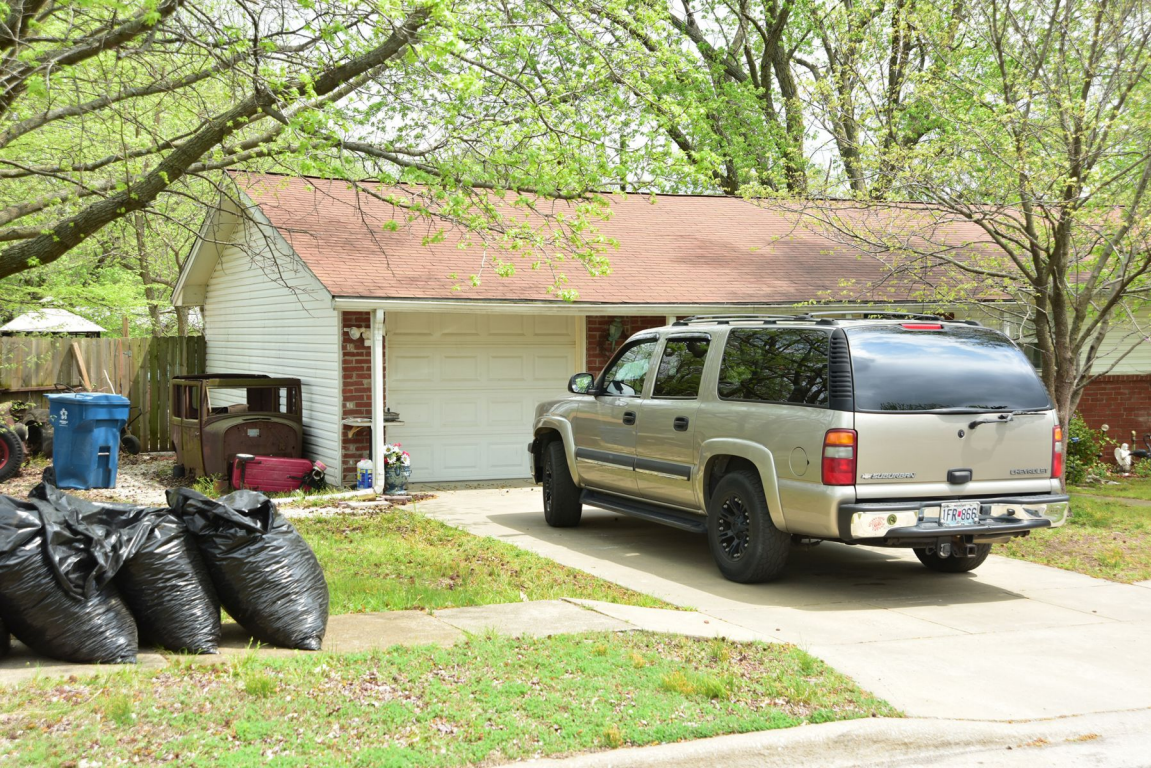
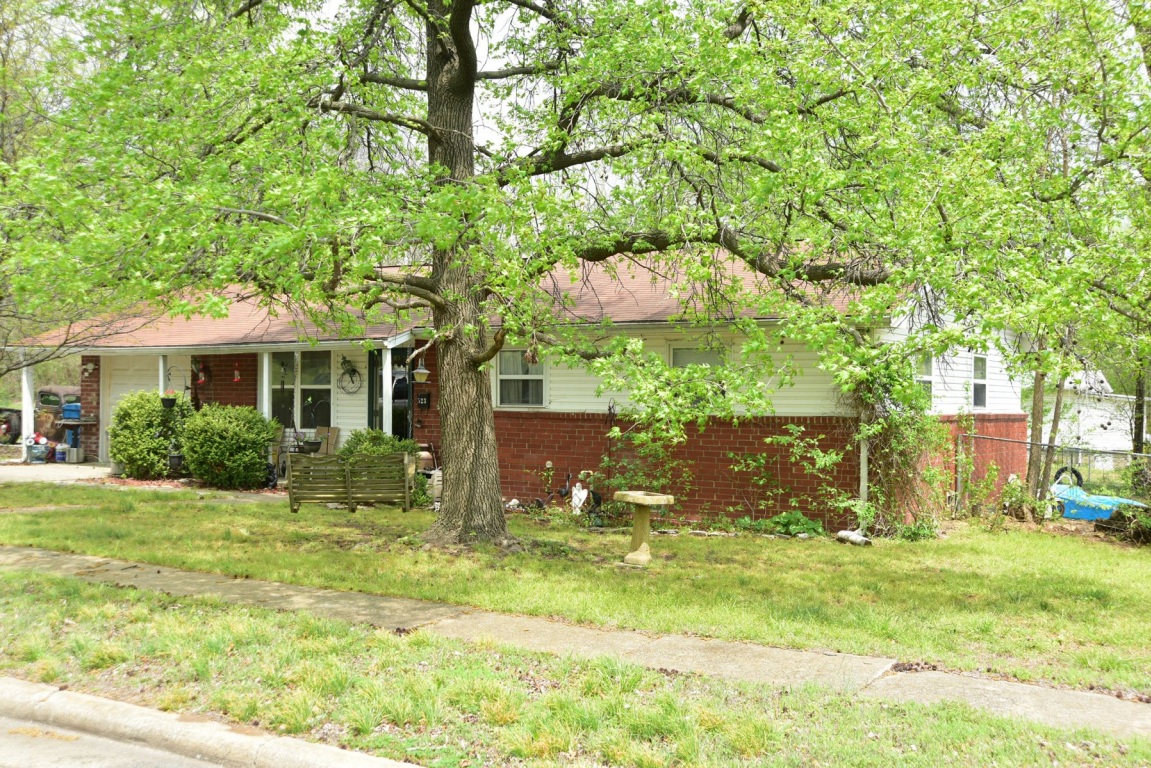
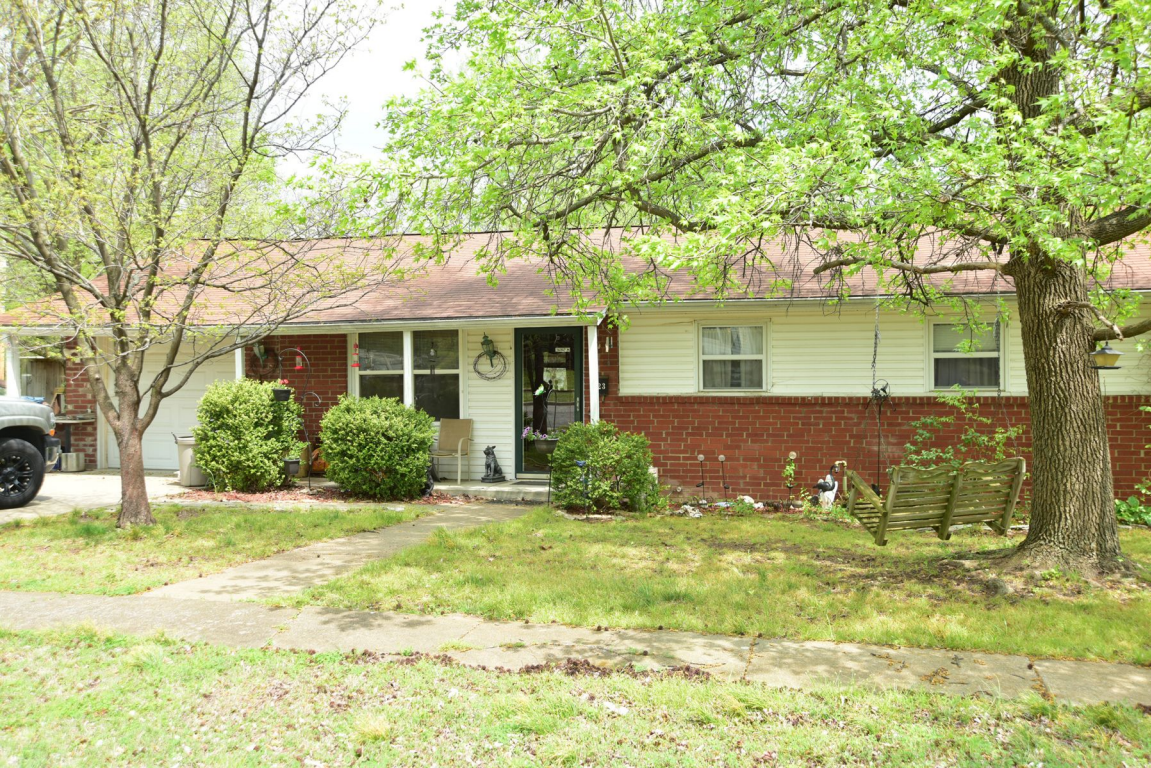
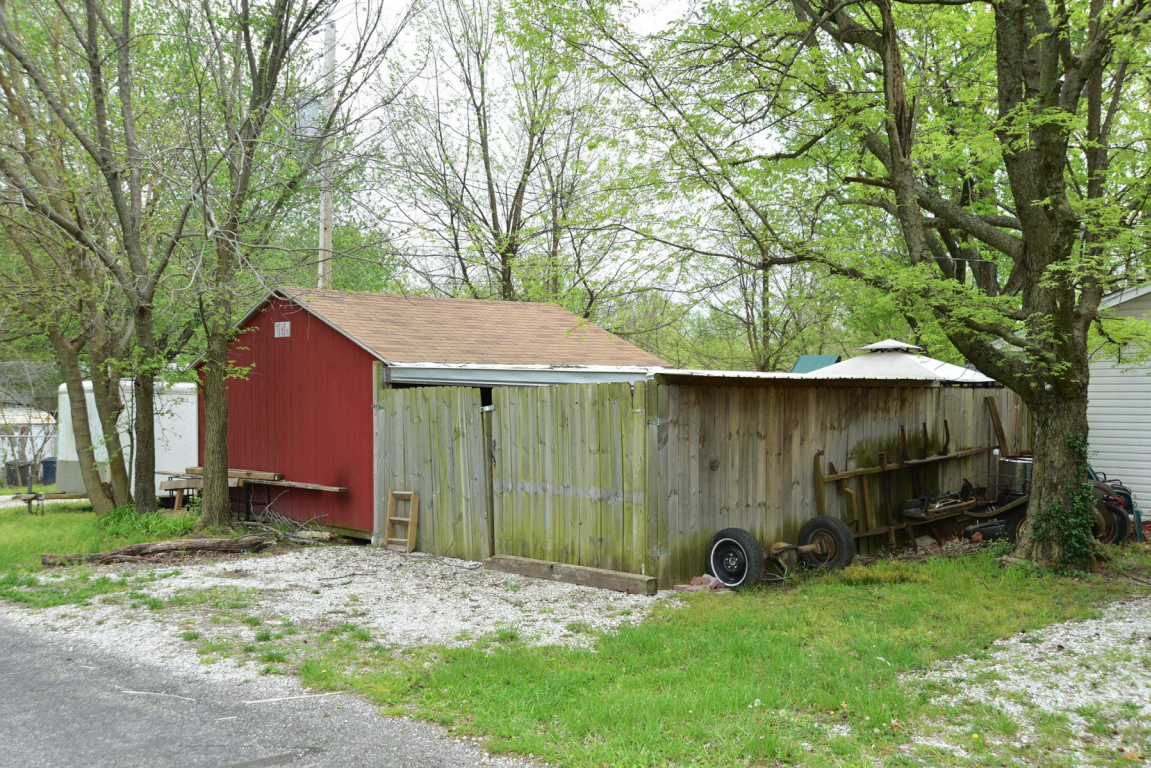
This Ranch dwelling faces west and has a rectangular footprint. It has a concrete foundation and asphalt roof. Brick veneer clads the lower third of the dwelling and the north half of the primary elevation. The dwelling is five bays wide and two bays deep. An overhead garage door occupies the north bay while an entrance with a metal storm door occupies the center bay. One-over-one vinyl windows occupy the remaining bays. A shed-roof porch shelters the north three bays.
