MISSOURI DEPARTMENT OF NATURAL RESOURCES
STATE HISTORIC PRESERVATION OFFICE, P.O. Box 176, Jefferson City, MO 65102
ARCHITECTURAL/HISTORIC INVENTORY FORM

1. Survey number: JP-AS-006-184		2. Survey Name: East Town (Original Joplin) Historic Survey Phase 1	
3. County: JASPER		4. Address 1401	Street (name): E. Hill Street
5. City: Joplin	Vicinity <input type="checkbox"/>	7. Township/Range/Section: T: R: S:	
8. Historic name (if known):		9. Present/other name (if known):	
10. Ownership: <input checked="" type="checkbox"/> Private <input type="checkbox"/> Public		11a. Historic use (if known): Domestic/Single Dwelling	11b. Current use: Domestic/Single Dwelling

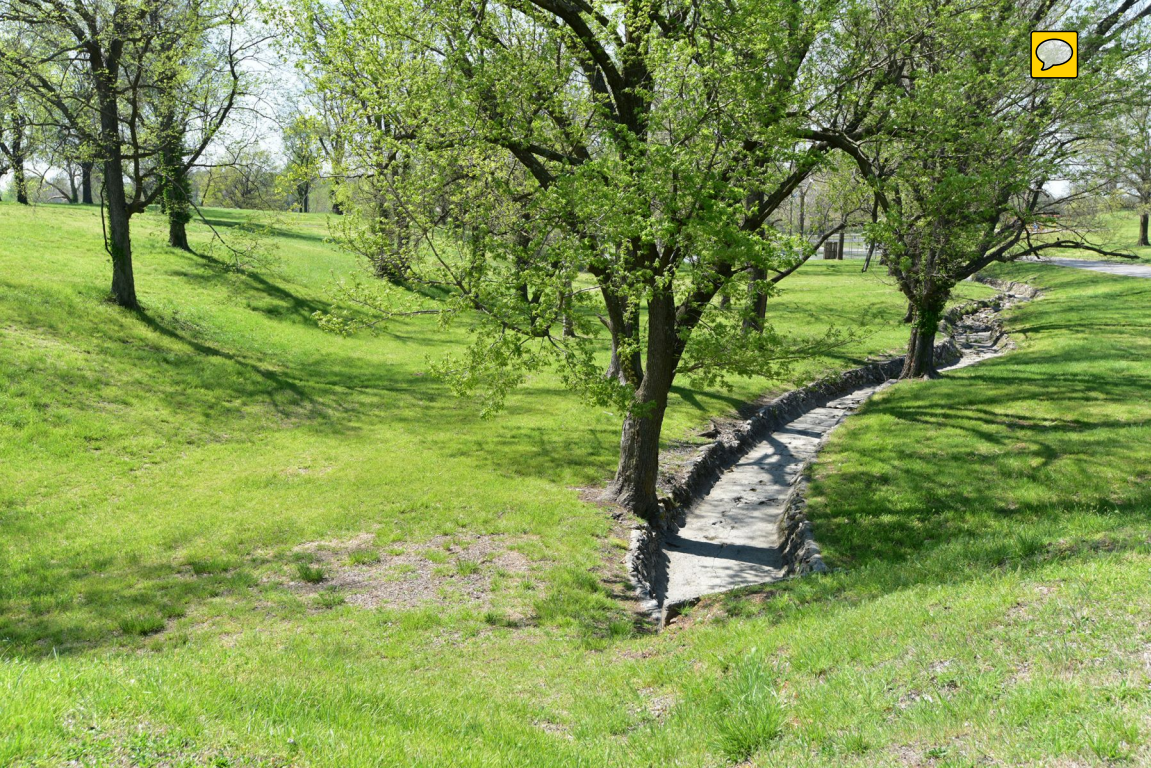
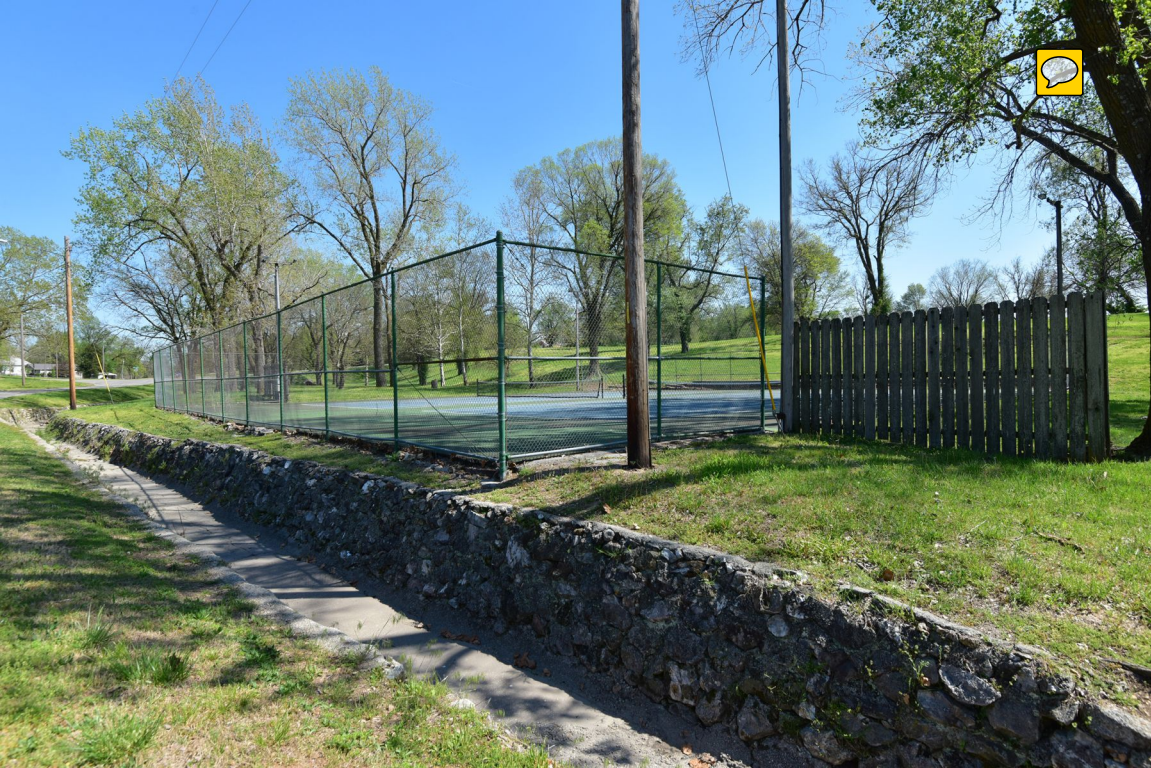
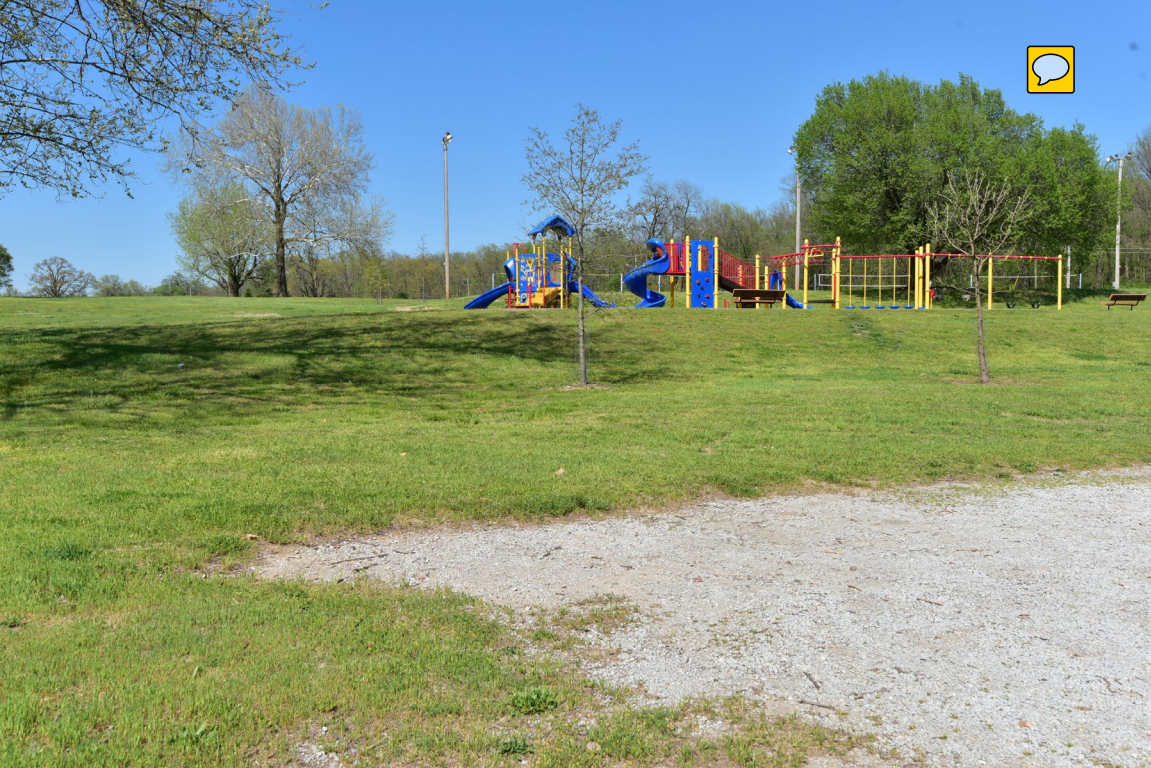
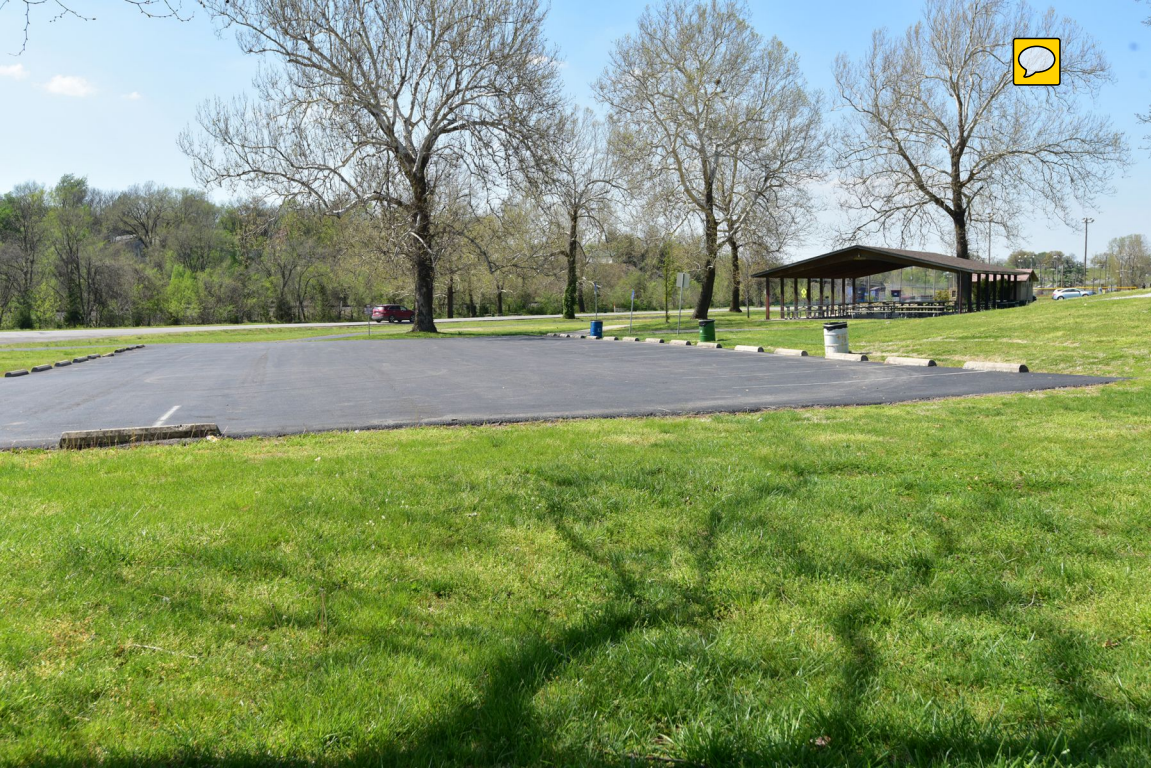
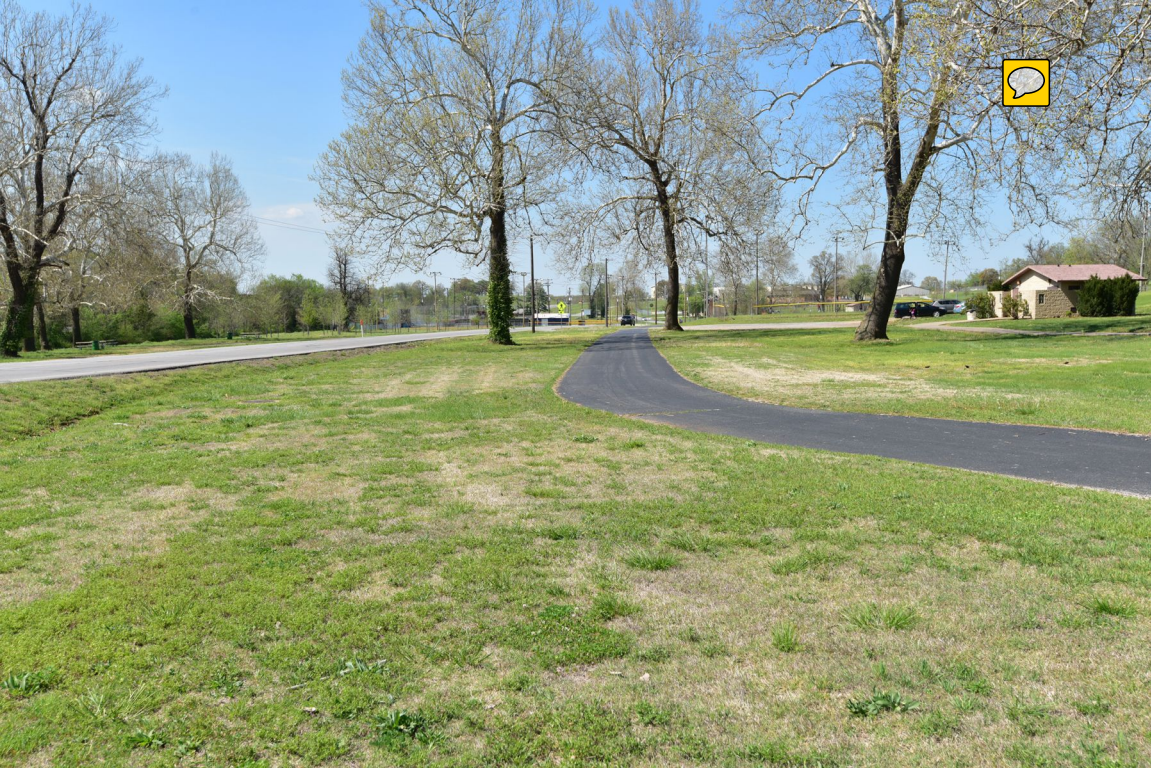
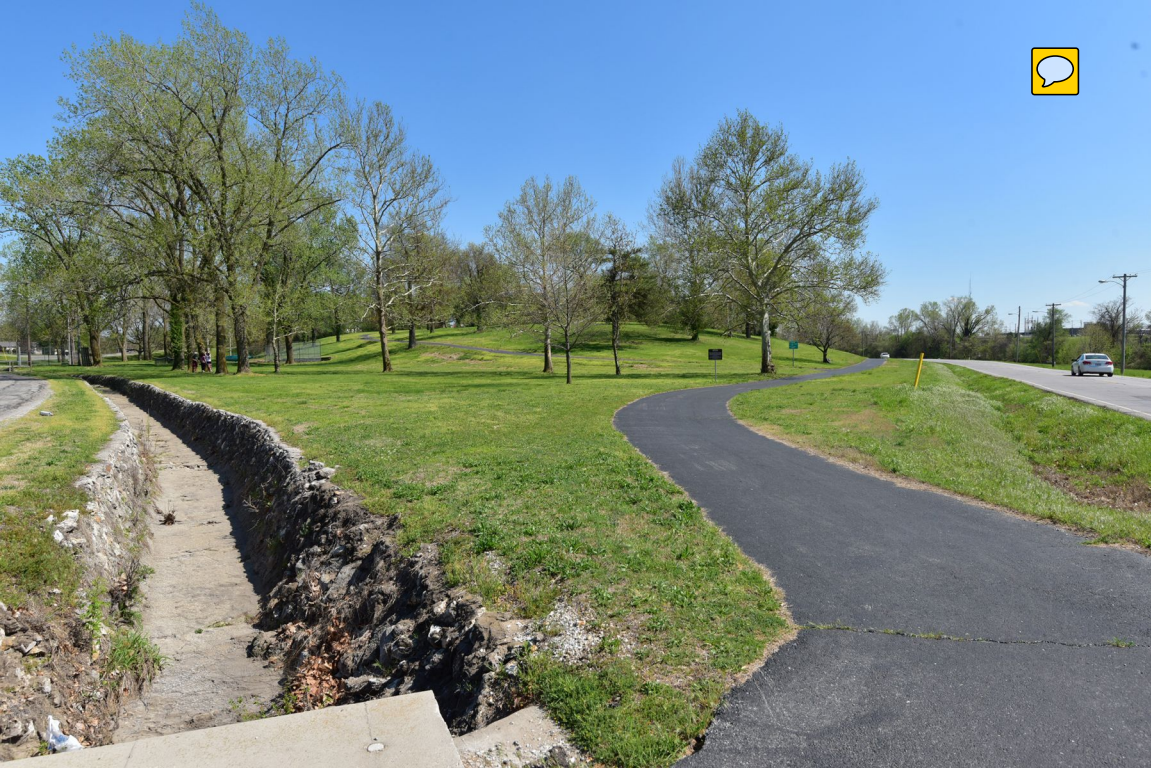
Landreth Park is a public park roughly bounded by East Hill Street to the south, North Landreth Avenue at the east and north. Joplin Creek and the Kansas City Southern Railroad tracks form the west boundary. The park is characterized by grassy open areas with mature trees, recreation fields, and walking trails. A northwest-southeast concrete storm culvert with stone retaining walls roughly bisects the park. The historic baseball fields are extant on the west side the park. The swimming pool, bath house, and bandstand have been demolished on the east side of the park (between 1961 and 1996), but the historic rustic stone bridge is extant. Non-historic structures and buildings are consistent with the historic use of the park, specifically restrooms, picnic shelters, and an amphitheater (constructed around 2005).

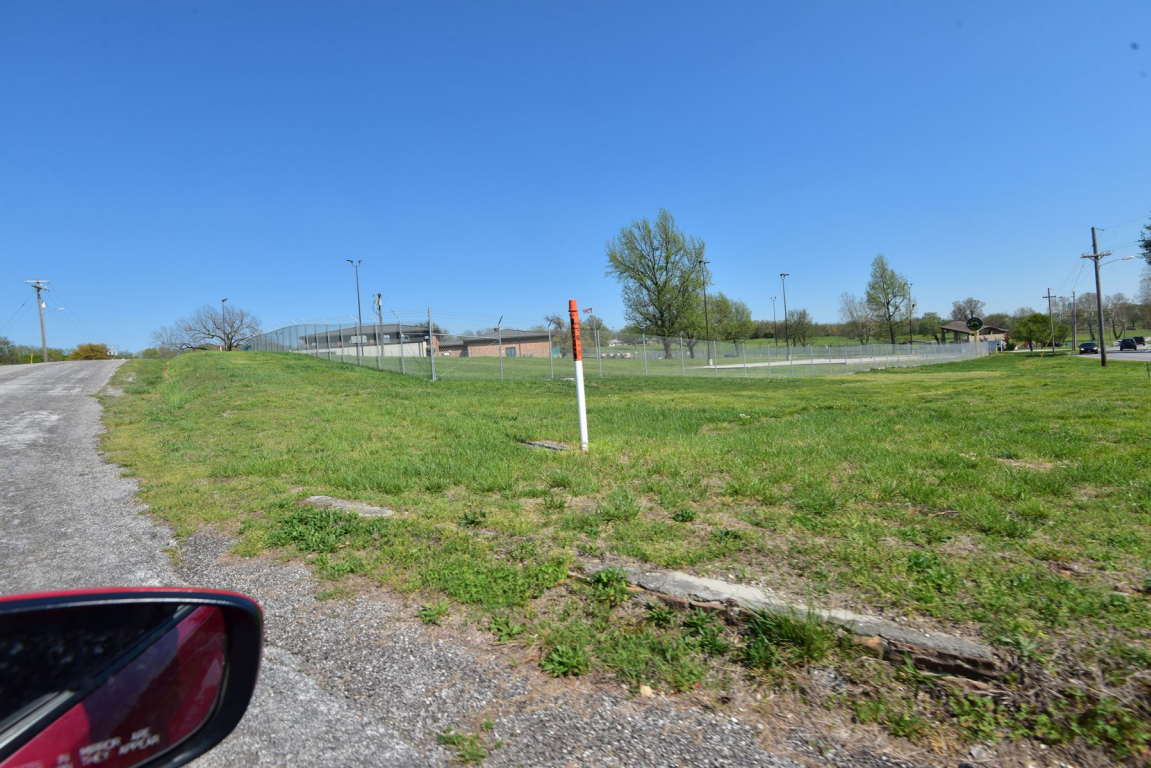
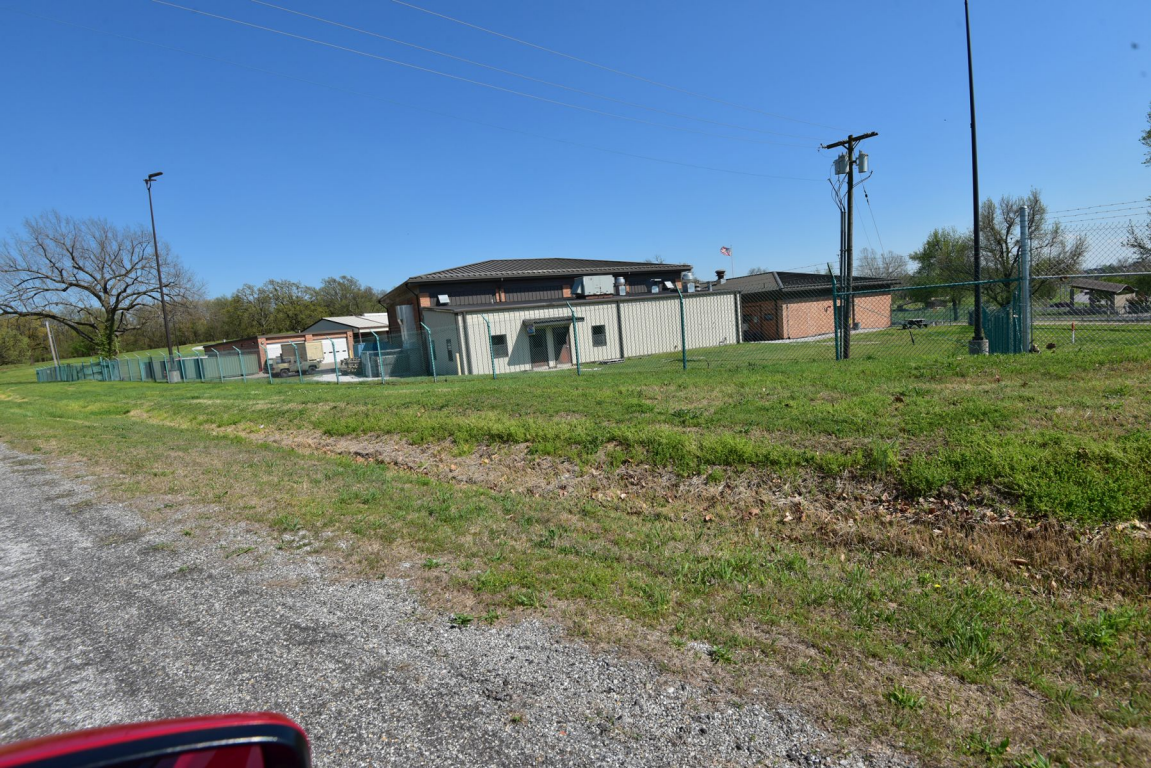
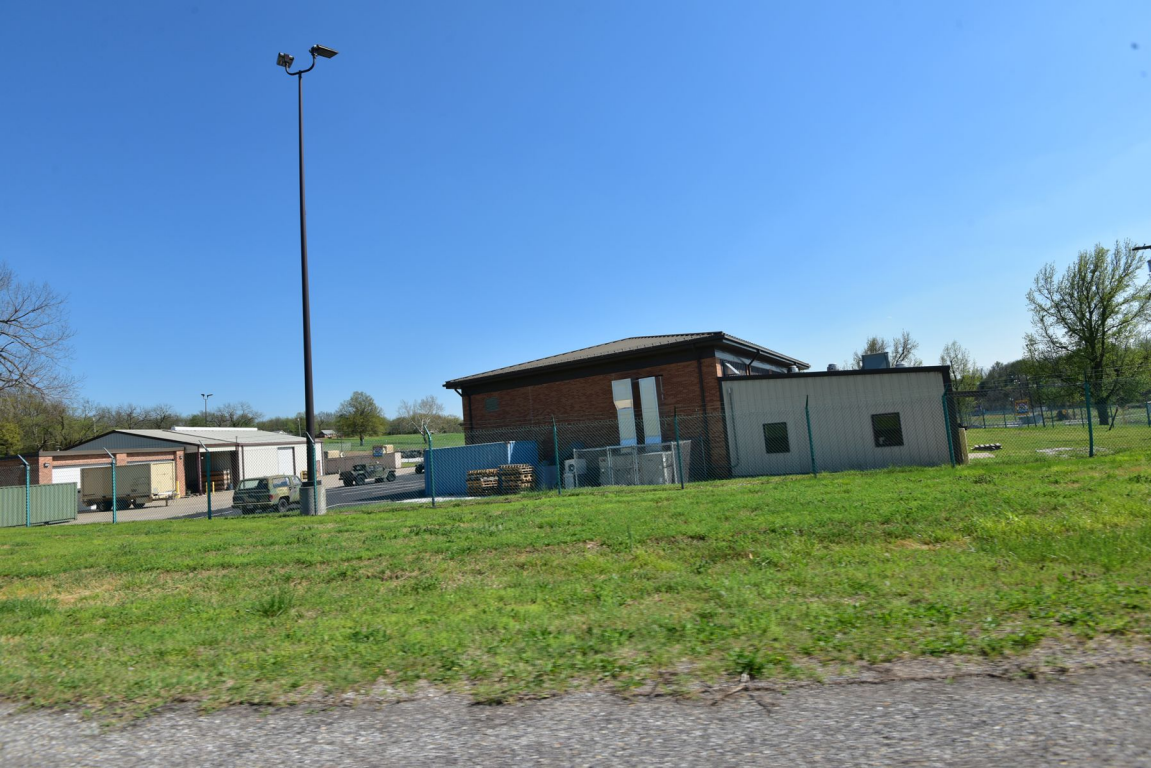
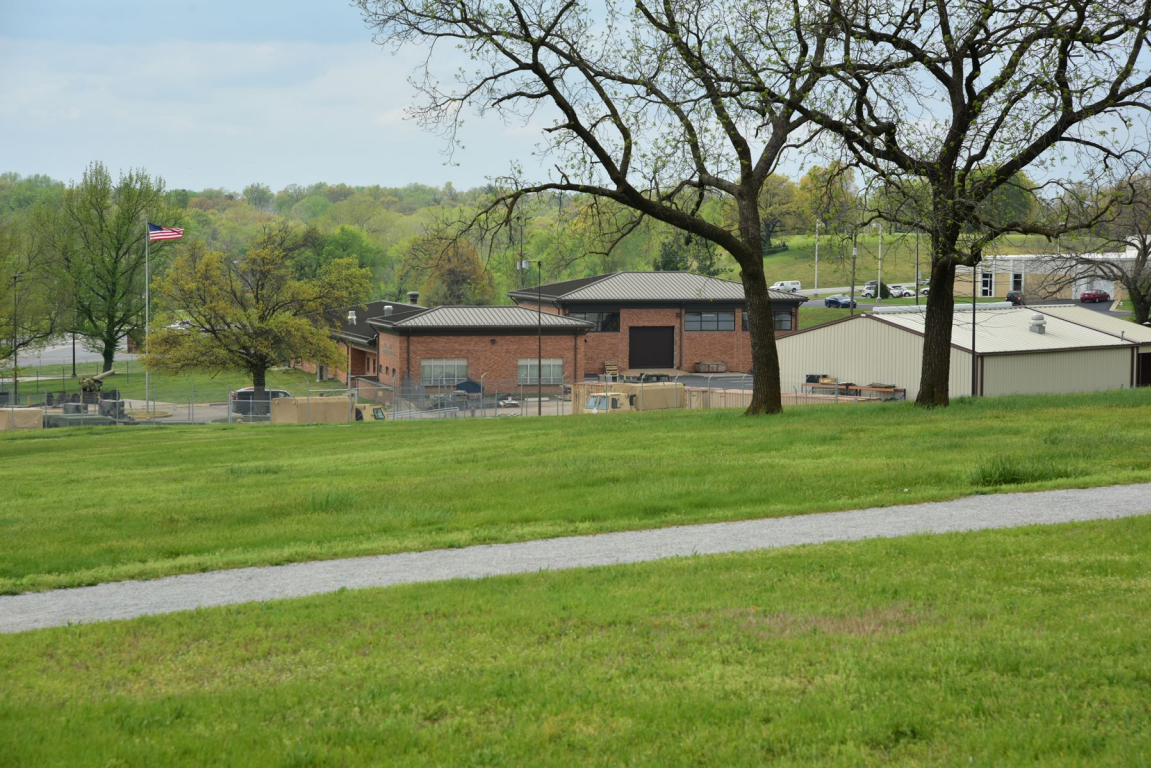
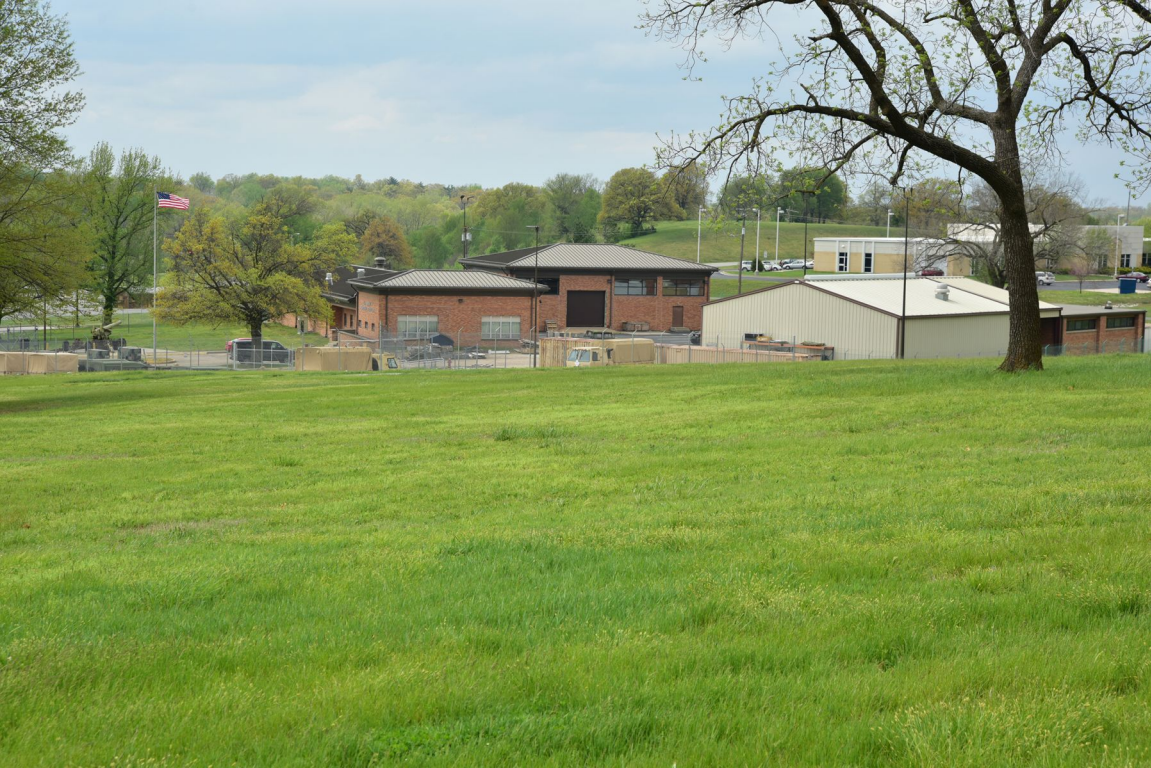
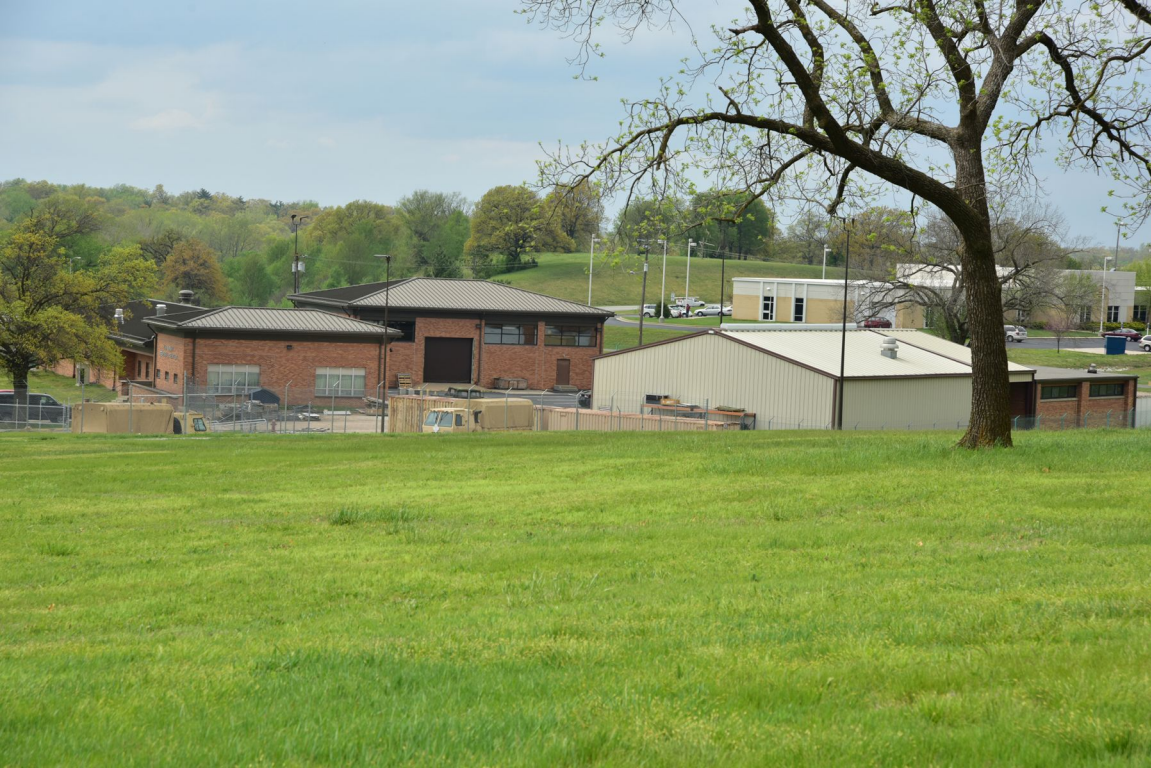
The Army Reserve Center faces southwest and has an irregular footprint comprised of two main blocks connected by a short wing. It has a deep set-back and is heavily fenced. It has a concrete foundation and brick cladding. The south block has a metal side-gable roof with an intersecting hipped-roof block at the east end. The hipped block rises slightly above the side-gable block. The south block is approximately sixteen bays. The fourth through seventh-from-east primary elevation bays recede, creating a partial-width porch. An entrance occupies the fourth-from-east bay. Two-over-two windows occupy the remaining porch bays. Small, rectangular windows occupy the remaining primary elevation bays. The south block is two bays. Six-light fixed sash windows occupy the bays. The north block has a metal hipped-roof and rises above the south block. The north block is four bays. A vehicular bay with a metal door occupies the second bay while six light metal clerestory windows define the remaining bays. An entrance is located below the last (north) window bay. A metal shed-roof addition projects from the NW elevation. The addition is four asymmetrical bays. Metal doors with glazing occupy the center two bays while single one-over-one metal windows occupy the end bays. A shed roof shelters the entrances.

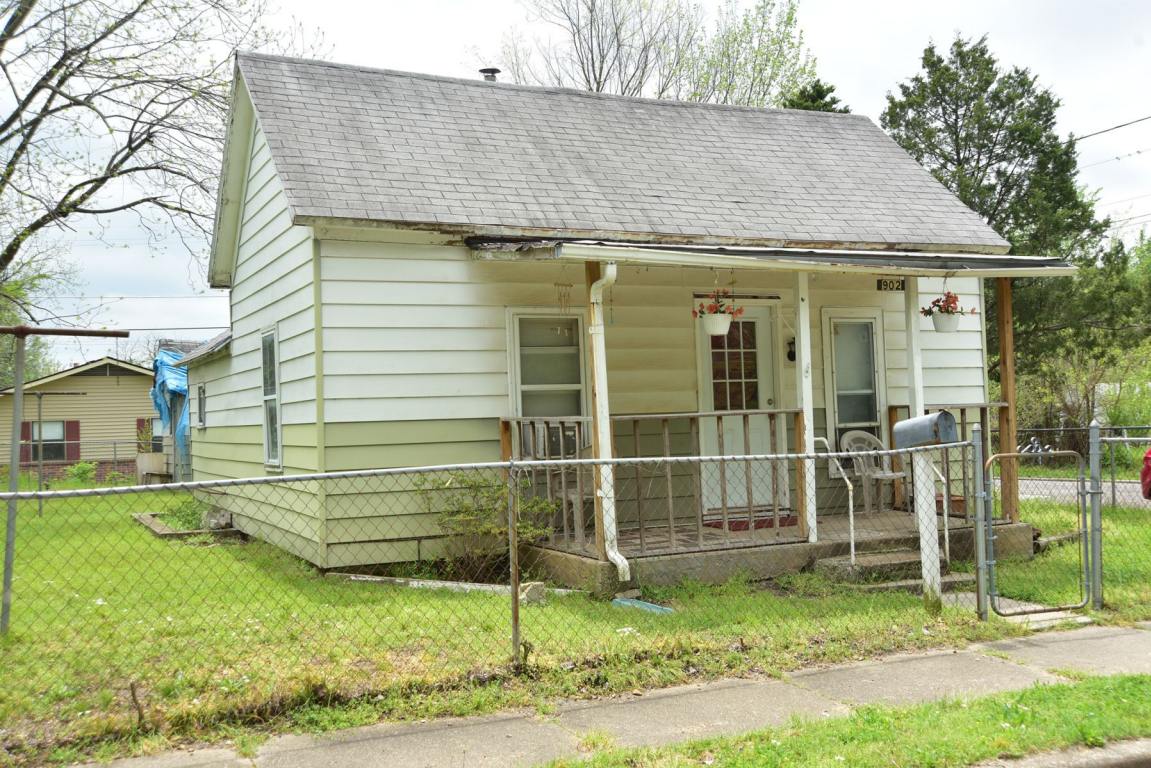
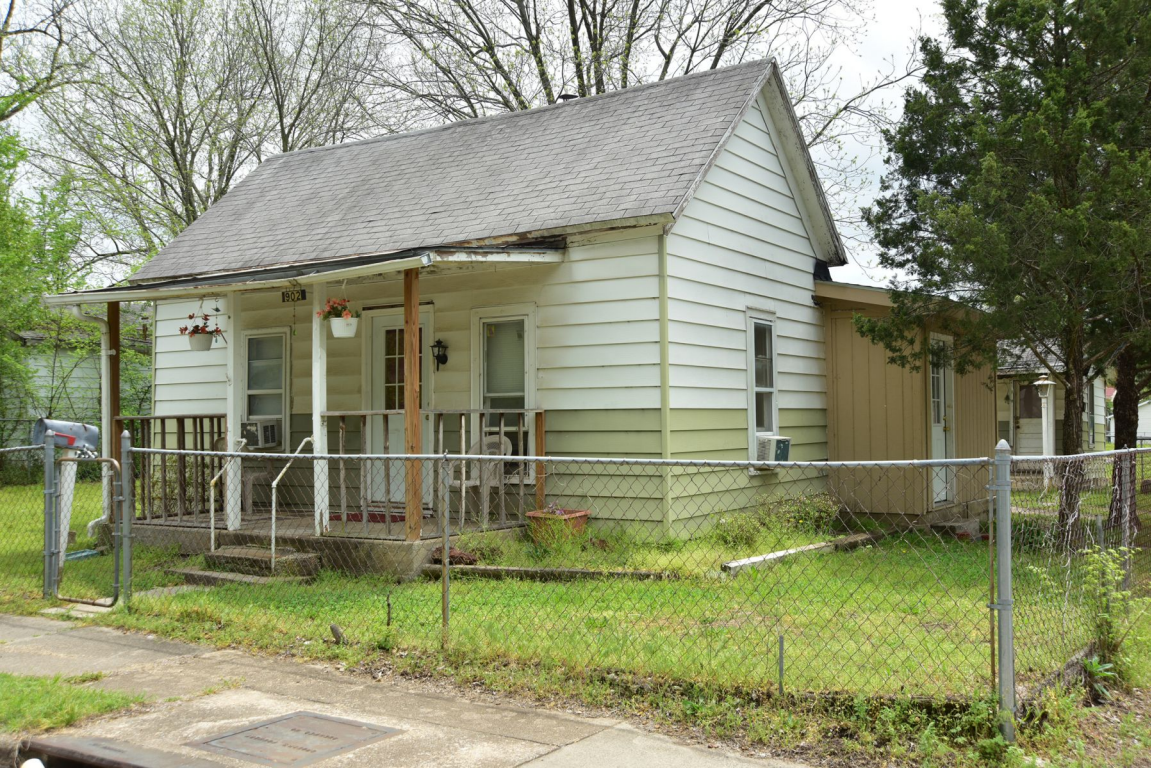
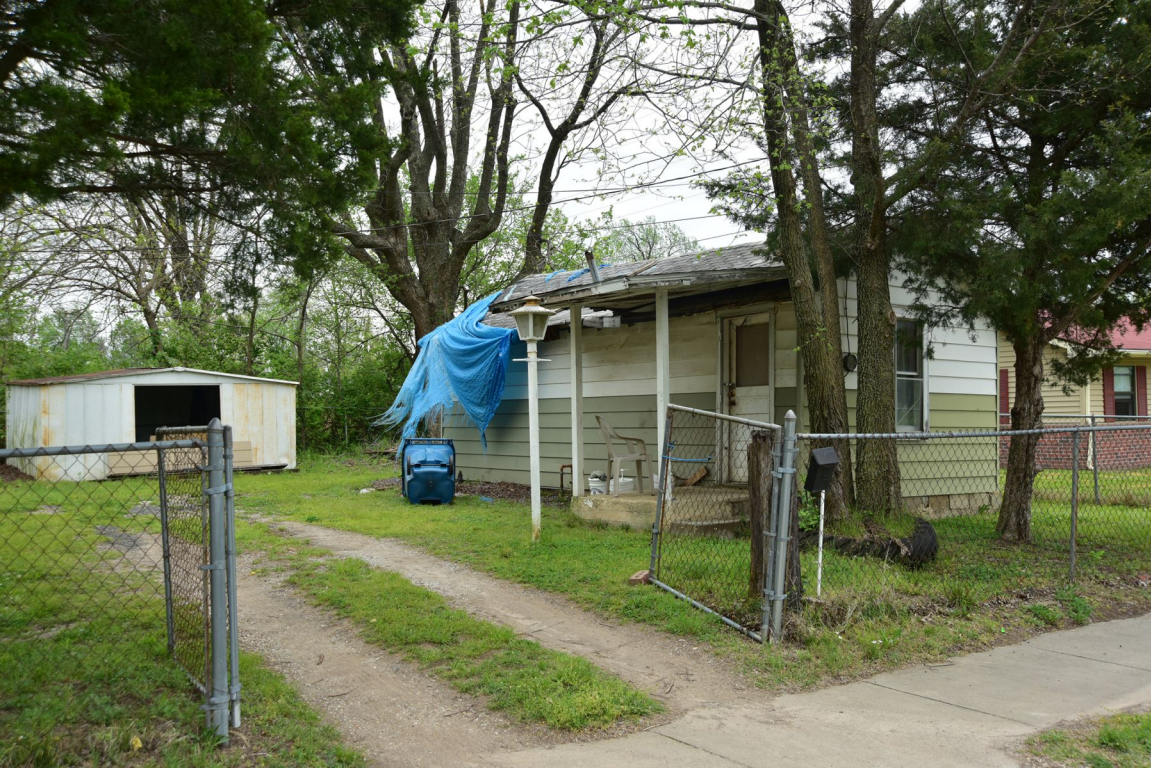
This resource has poor integrity. Non-historic alterations to the siding, replacement of doors, and replacene compromise the ability of this resource to convey its historic function and date of construction. It is not eligible.

This National Folk House dwelling faces north and has a rectangular footprint. It has a concrete foundation, asphalt shingle roof, and metal cladding. The dwelling is three bays wide and two bays deep. Enclosed shed-roof porches at the east and west elevations form the contain the rear bays. The porch enclosure is an alteration. A non-historic three-quarter width porch shelters the primary elevation bays. A non-historic wood door with nine-light glazing occupies the center bay while one-over-one wood windows occupy the remaining bays.

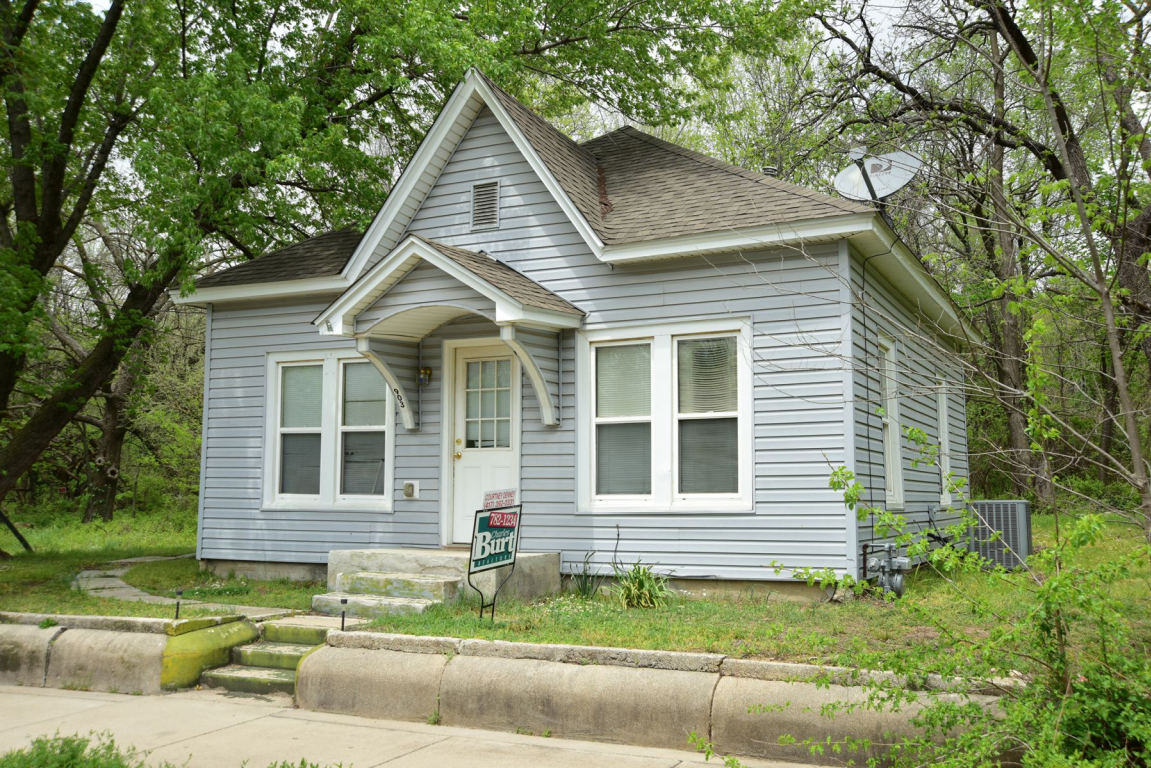
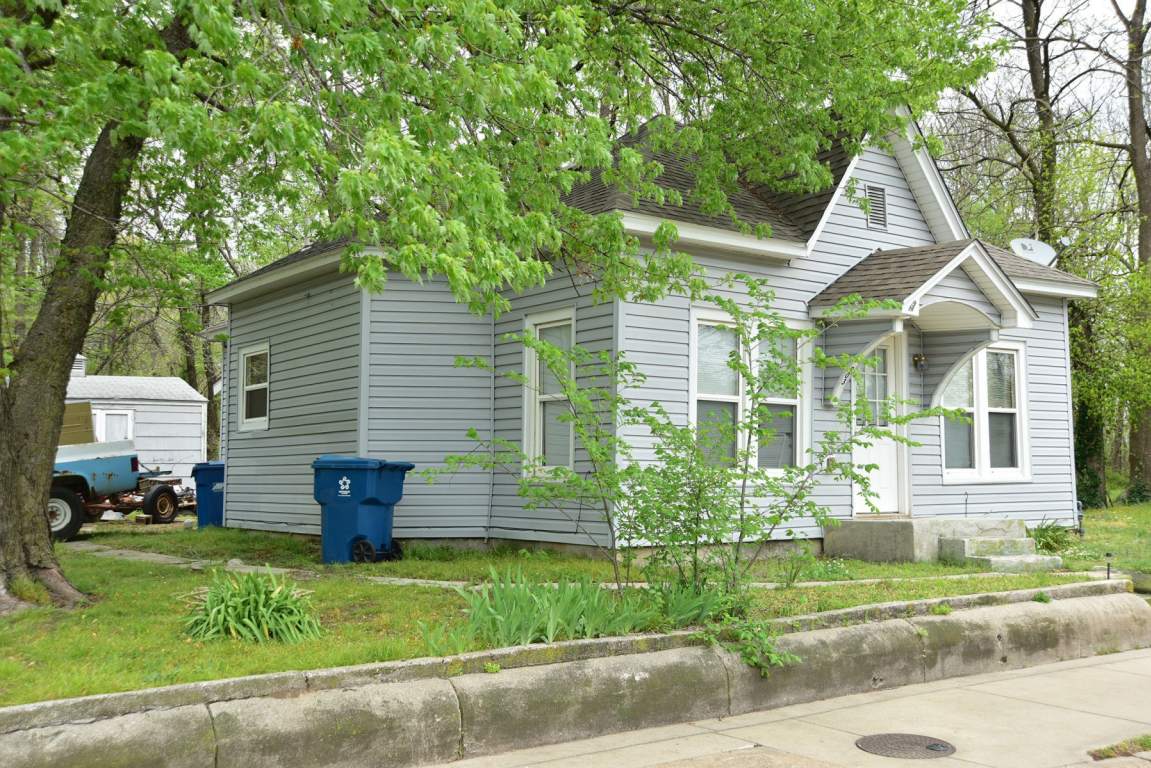
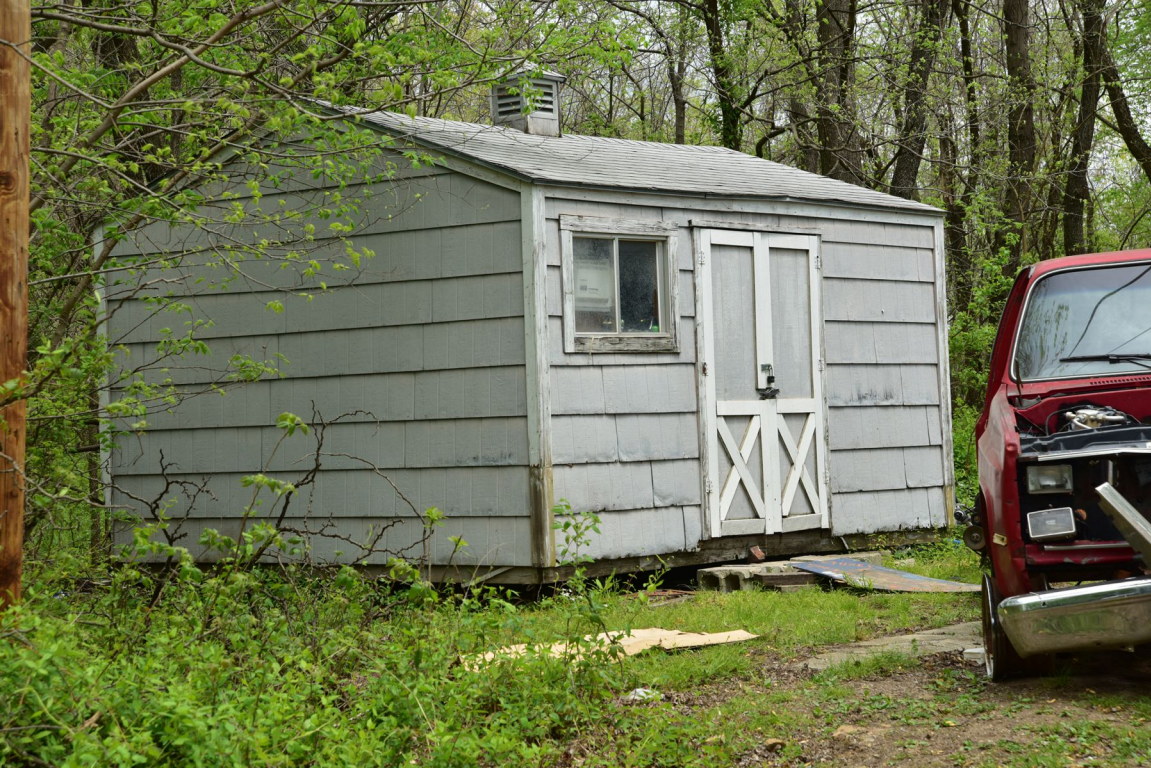
This Pyramid Square dwelling faces south and has a rectangular footprint. It has concrete foundation and vinyl cladding. The hipped roof with cross gables has asphalt shingles. The dwelling is three bays wide and three asymmetrical bays deep. A non-historic wood door with nine-light glazing occupies the center bay of the primary elevation while paired one-over-one vinyl windows occupy the remaining bays. A front-gable roof with vinyl-wrapped knee brackets shelters the concrete stoop.

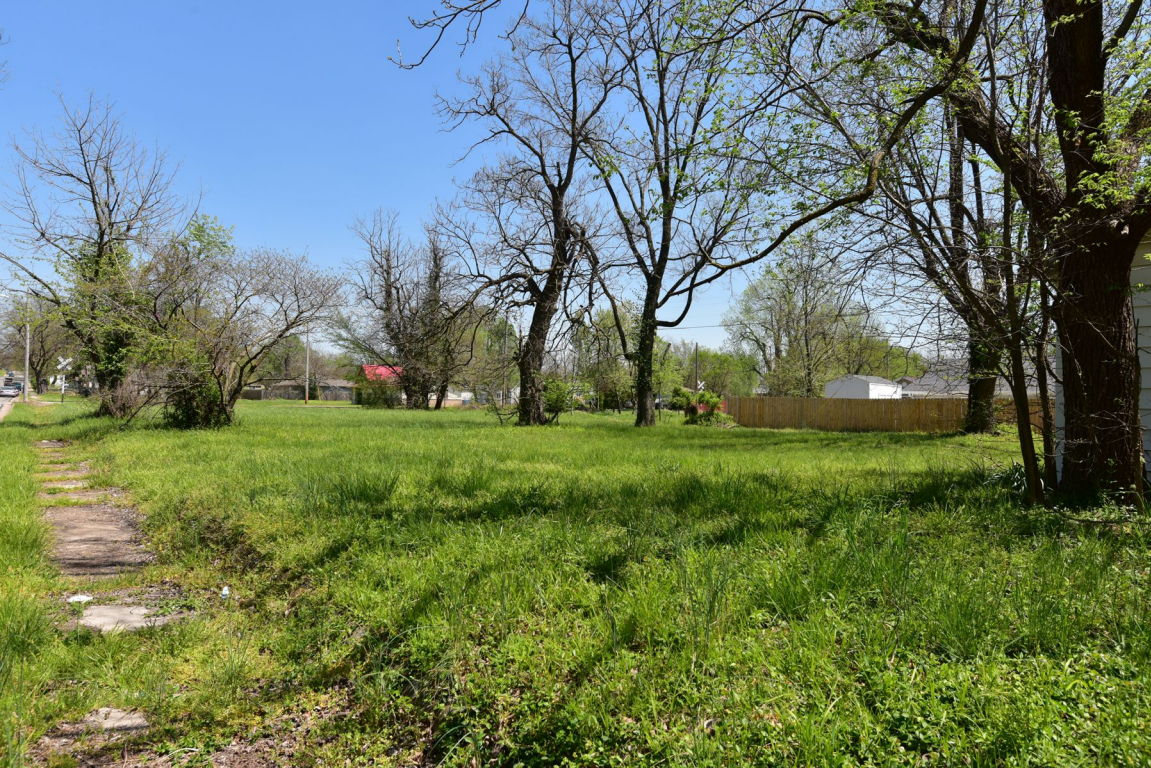
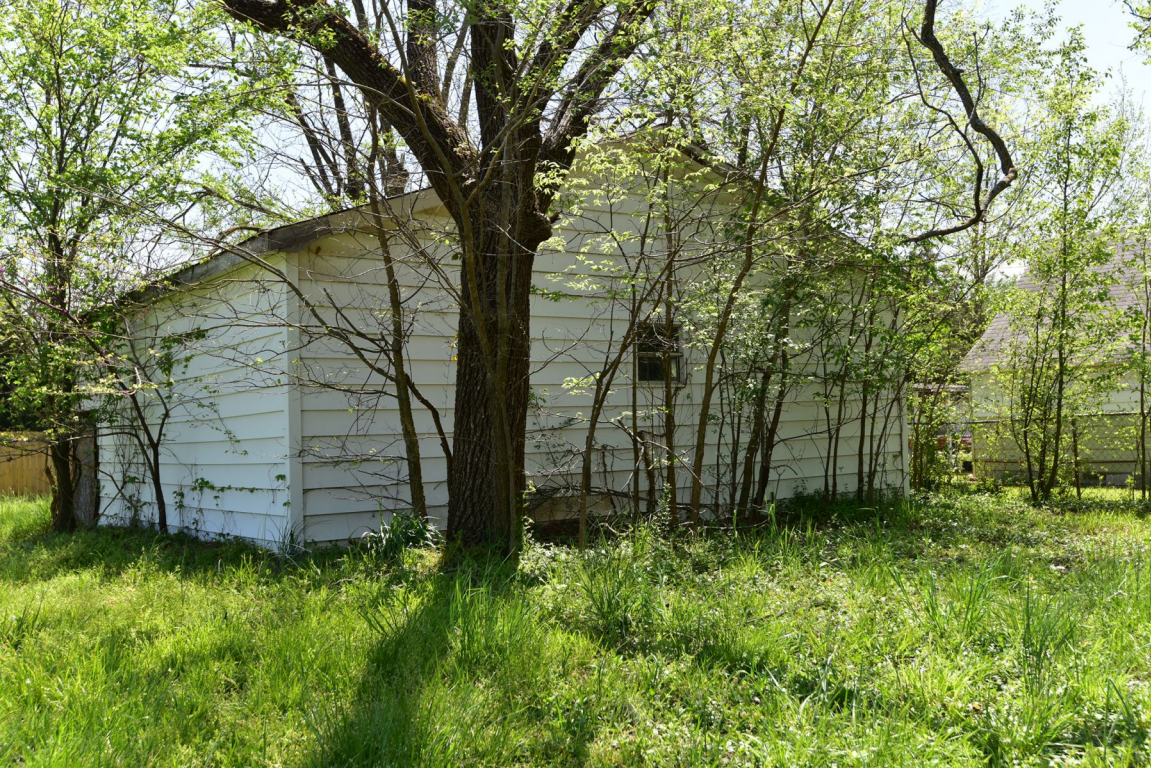
The primary resource of this lot has been demolished. A side-gable outbuilding is located in the northwest corner of the lot. It has pressboard cladding and the foundation is not visible. It has poor integrity and is not eligible for listing.

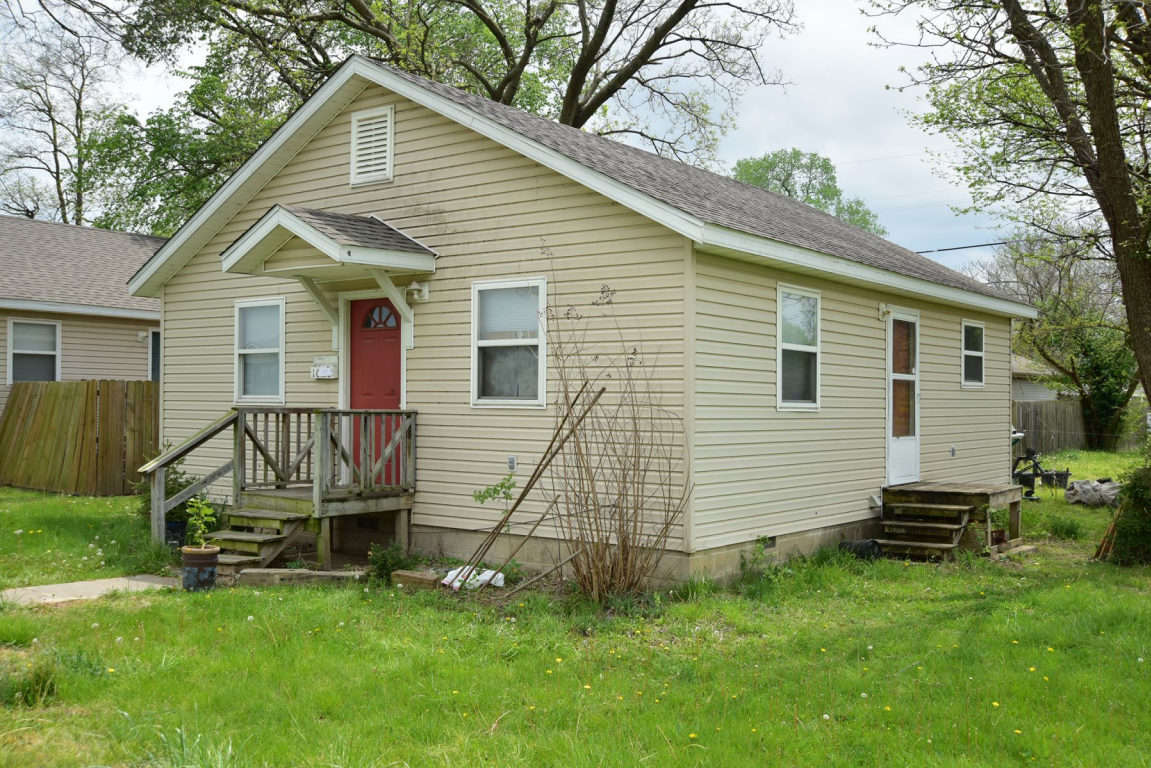
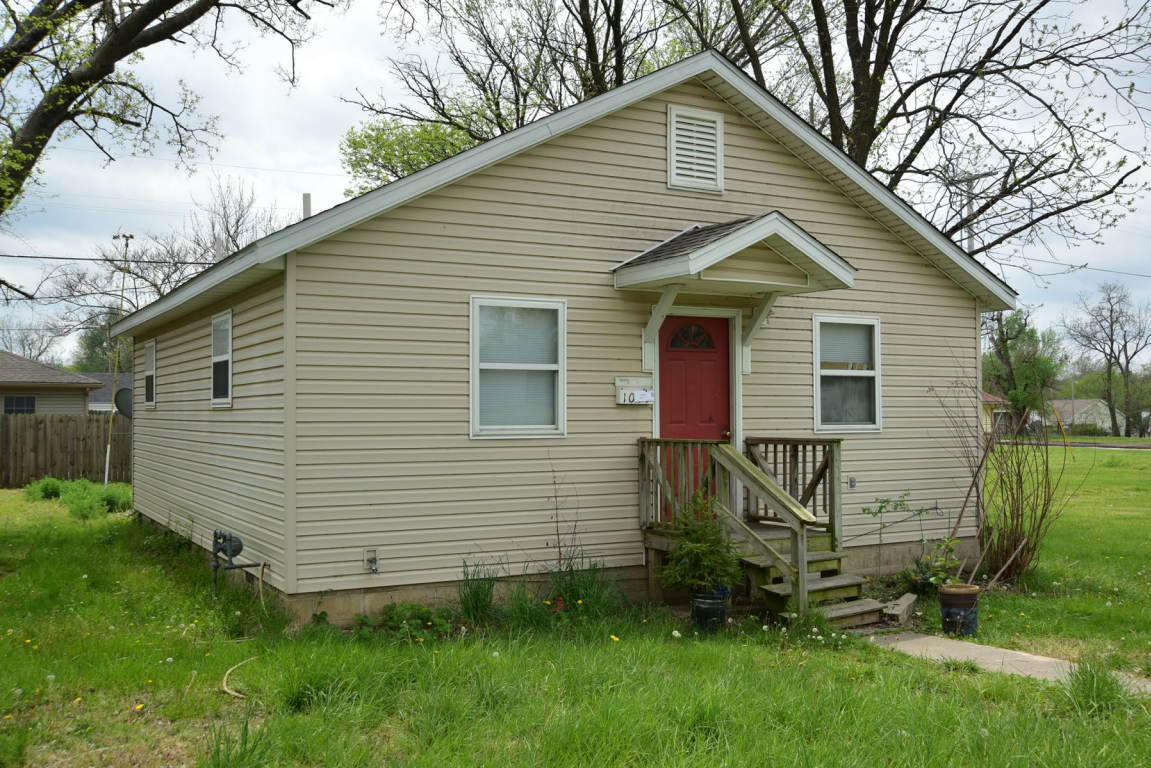
This Open Gable dwelling faces north and has a rectangular footprint. It has a concrete masonry unit foundation and vinyl cladding. The front-gable roof has asphalt shingles. The dwelling is three bays wide and three bays deep. A non-historic fiberglass door occupies the center bay of the primary elevation while one-over-one vinyl windows occupy the remaining bays. A non-historic front-gable roof with vinyl knee brackets shelters the entrance and non-historic wood stoop. A secondary entrance occupies the center bay of the west elevation. This dwelling is a twin to the adjacent dwelling, 1020 E. North Street.

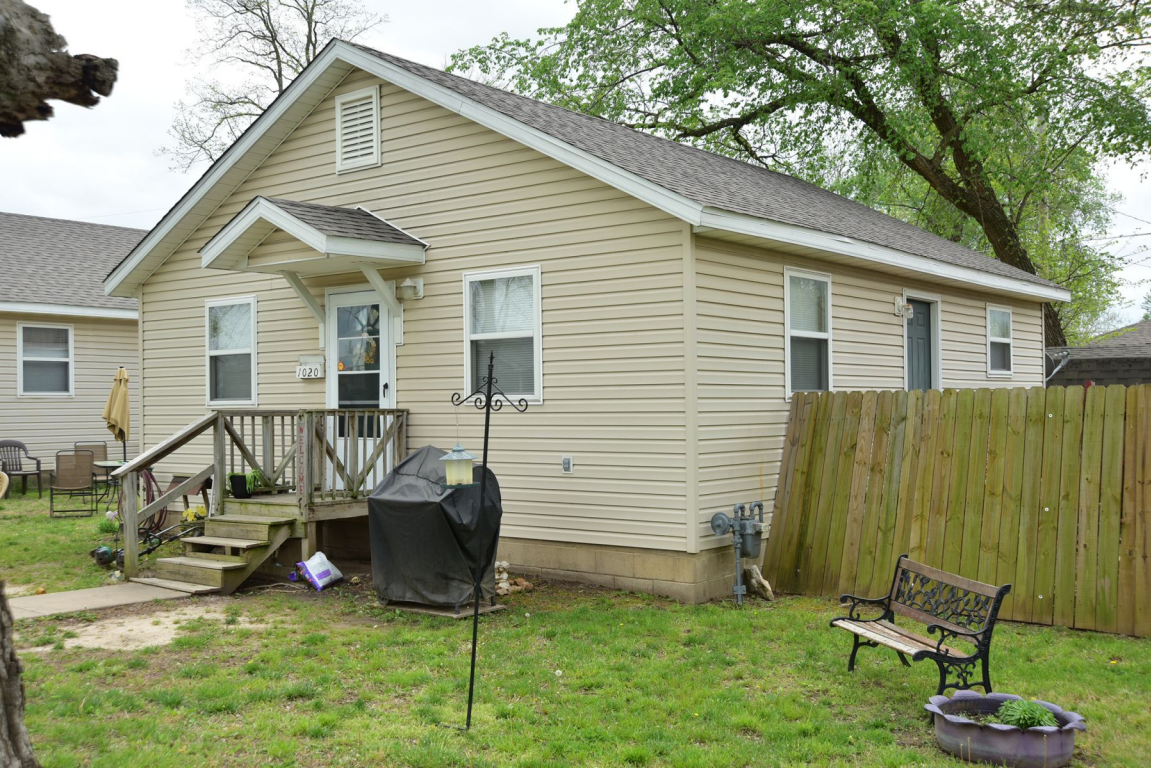
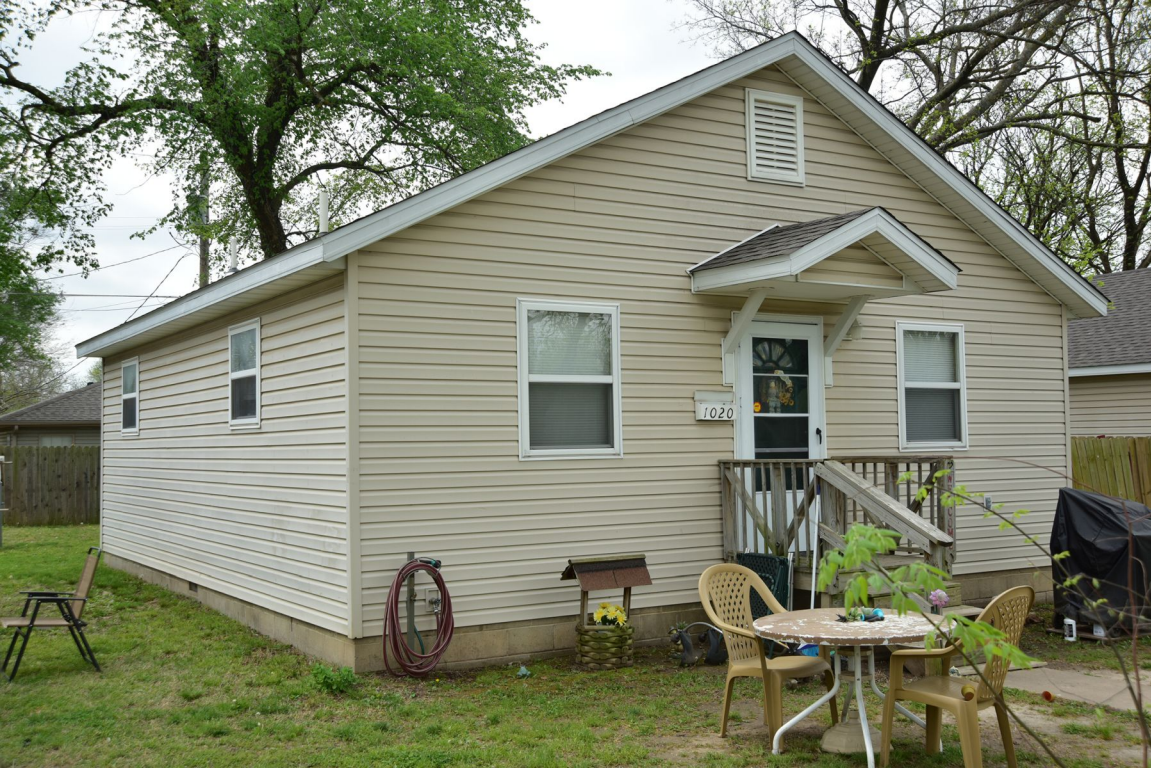
This Open Gable dwelling faces north and has a rectangular footprint. It has a concrete masonry unit foundation and vinyl cladding. The front-gable roof has asphalt shingles. The dwelling is three bays wide and three bays deep. A non-historic fiberglass door occupies the center bay of the primary elevation while one-over-one vinyl windows occupy the remaining bays. A non-historic front-gable roof with vinyl knee brackets shelters the entrance and non-historic wood stoop. A secondary entrance occupies the center bay of the west elevation. This dwelling is a twin to the adjacent dwellings, 1014 and 1022 E. North Street.
