MISSOURI DEPARTMENT OF NATURAL RESOURCES
STATE HISTORIC PRESERVATION OFFICE, P.O. Box 176, Jefferson City, MO 65102
ARCHITECTURAL/HISTORIC INVENTORY FORM

1. Survey number: JP-AS-006-184		2. Survey Name: East Town (Original Joplin) Historic Survey Phase 1	
3. County: JASPER		4. Address 1401	Street (name): E. Hill Street
5. City: Joplin	Vicinity <input type="checkbox"/>	7. Township/Range/Section: T: R: S:	
8. Historic name (if known):		9. Present/other name (if known):	
10. Ownership: <input checked="" type="checkbox"/> Private <input type="checkbox"/> Public		11a. Historic use (if known): Domestic/Single Dwelling	11b. Current use: Domestic/Single Dwelling

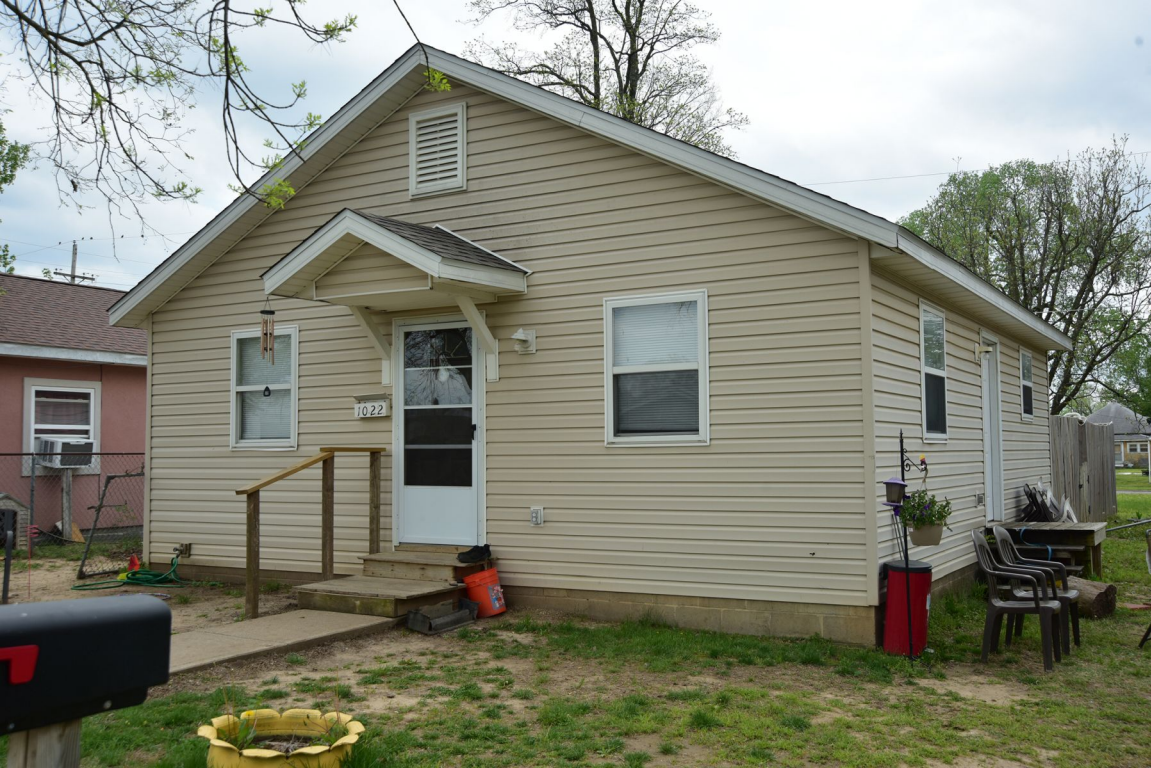
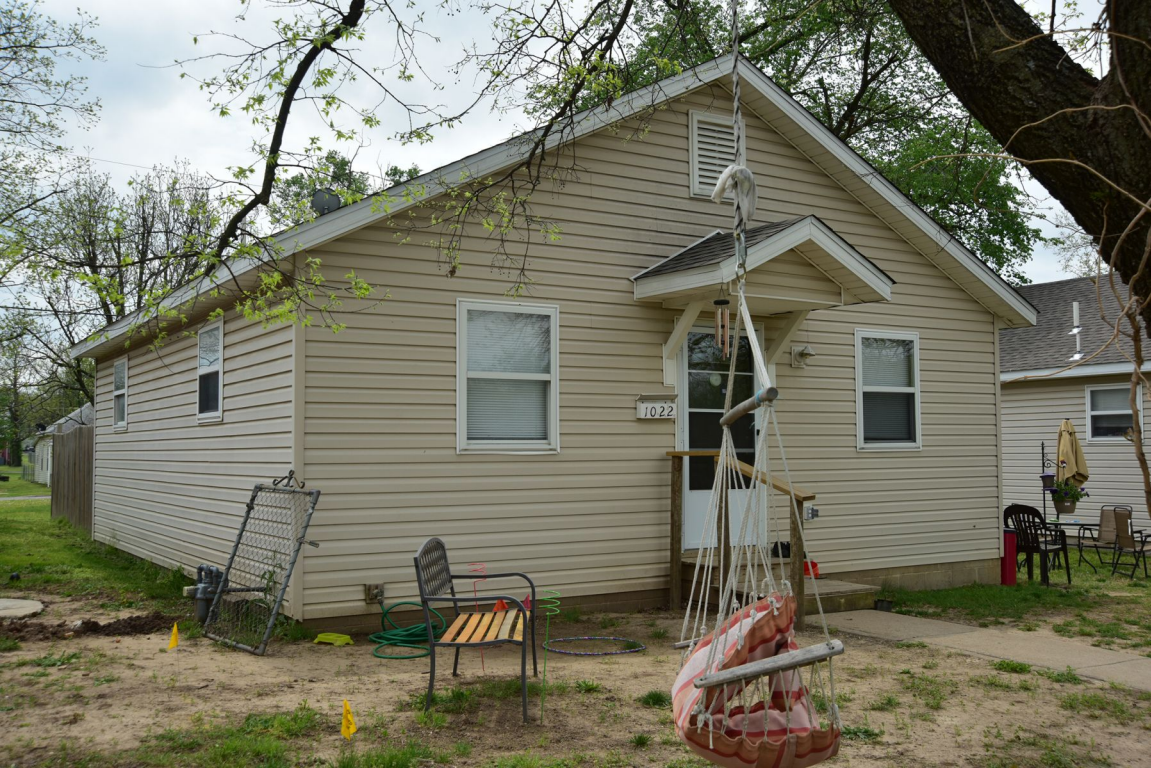
1022

This Open Gable dwelling faces north and has a rectangular footprint. It has a concrete masonry unit foundation and vinyl cladding. The front-gable roof has asphalt shingles. The dwelling is three bays wide and three bays deep. A non-historic fiberglass door occupies the center bay of the primary elevation while one-over-one vinyl windows occupy the remaining bays. A non-historic front-gable roof with vinyl knee brackets shelters the entrance and non-historic wood stoop. A secondary entrance occupies the center bay of the west elevation. This dwelling is a twin to the adjacent dwelling, 1020 E. North Street.

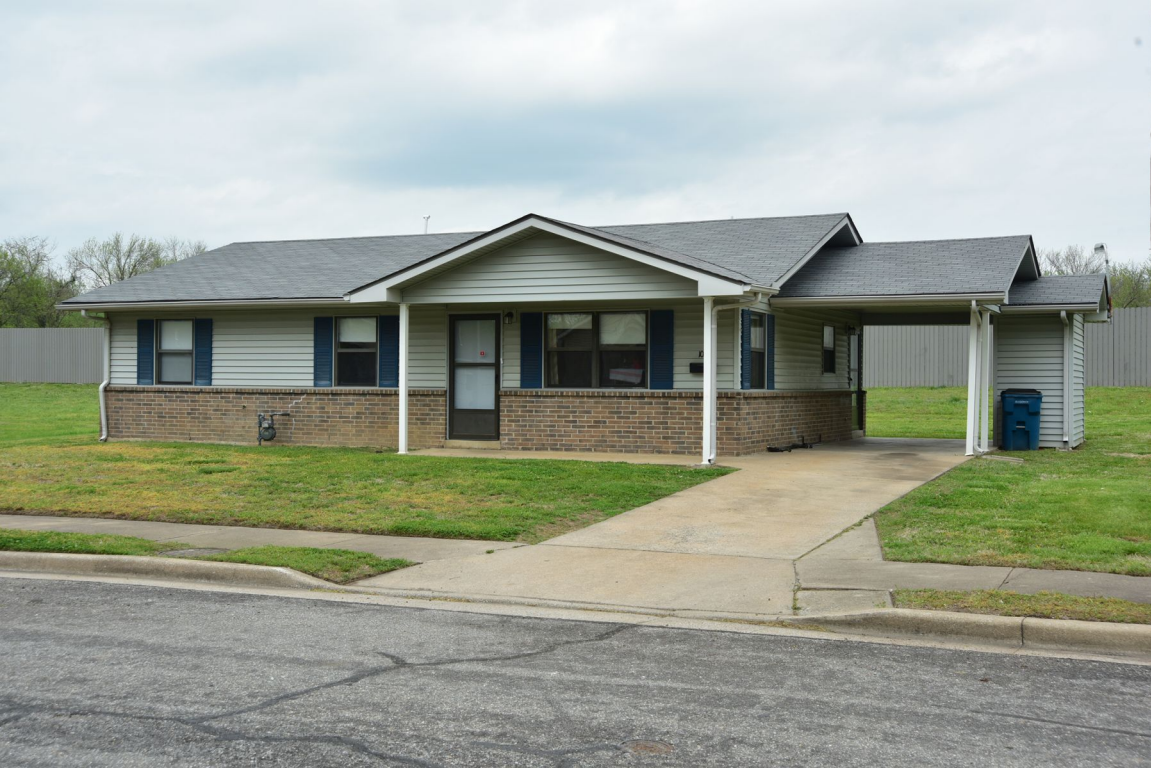
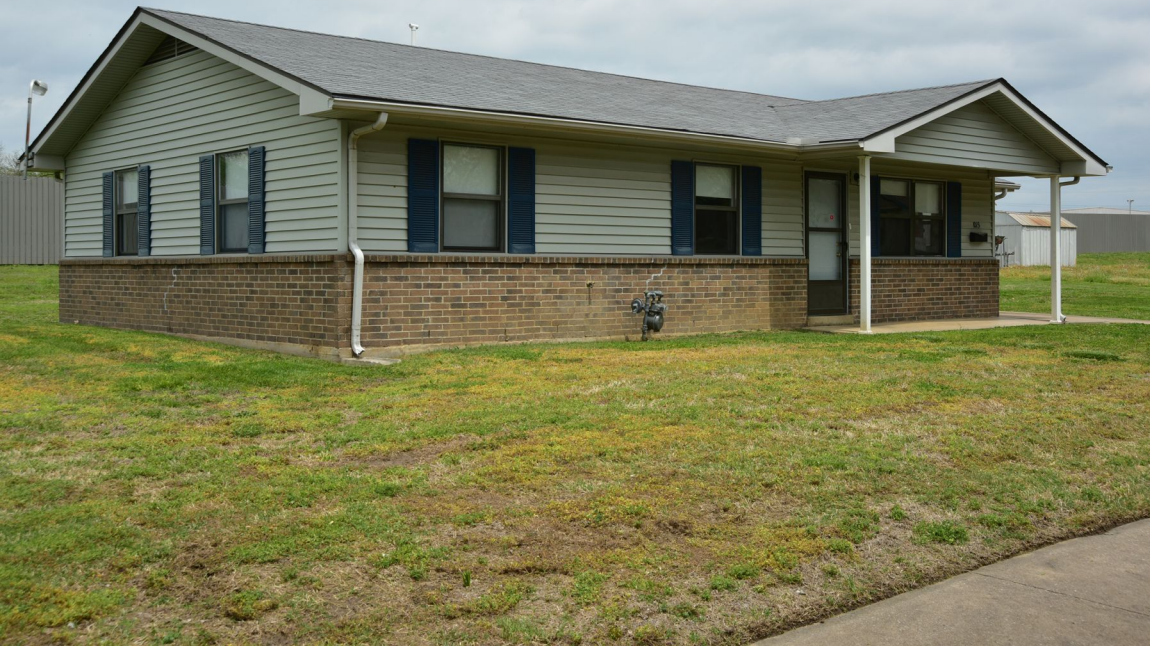
This Ranch dwelling faces south and has a rectangular footprint. It has a concrete foundation and side-gable roof with asphalt shingles. Brick veneer clads the lower third of the dwelling while the remainder is vinyl clad. The dwelling is four bays wide and three bays deep. A front-gable porch shelters the two east bays of the primary elevation. A wood door with metal storm door fills the second-from-east bay. One-over-one metal windows with false shutters define the remaining bays. A side-gable carport projects from the east elevation and shelters a secondary entrance. An enclosed storage area with gable roof is located at the east end of the carport.

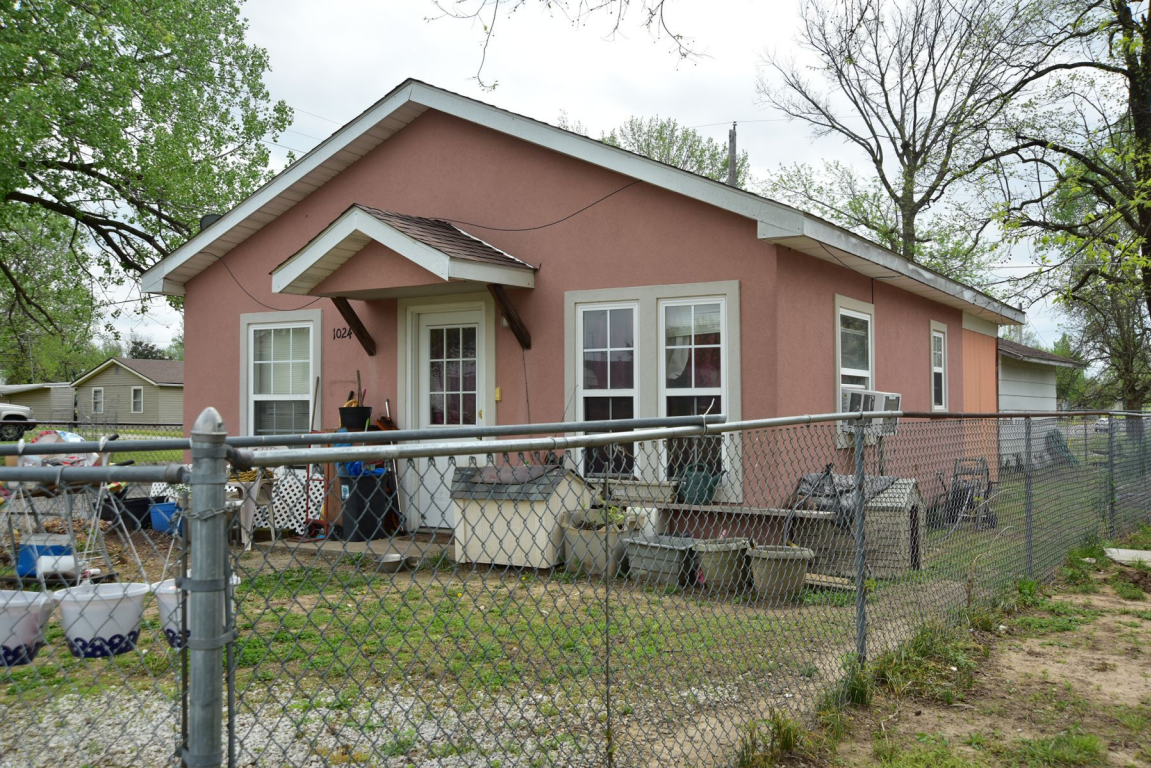
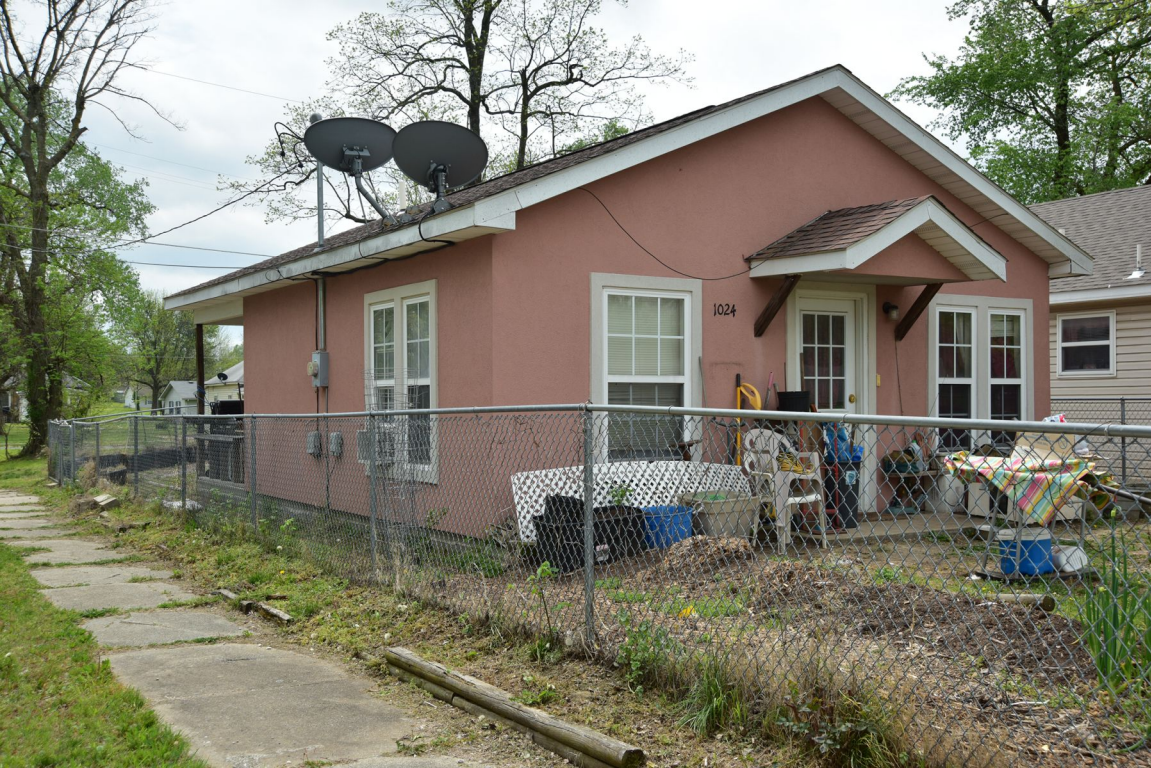
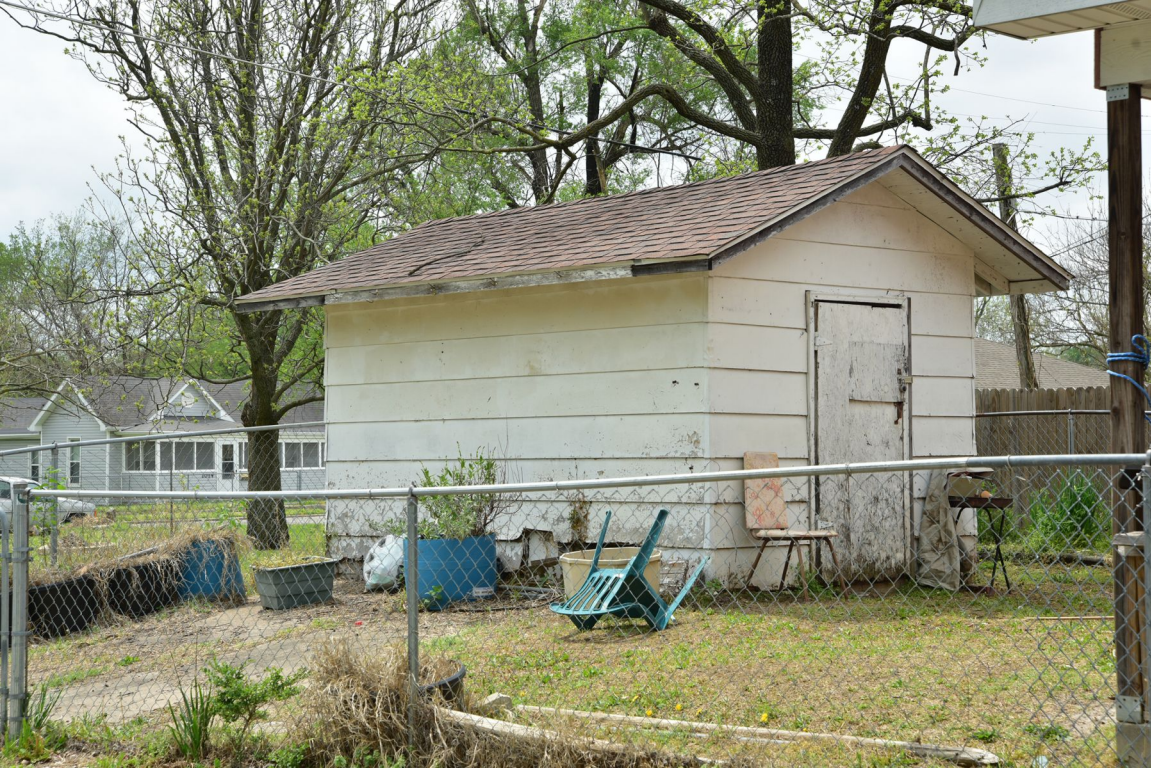
This Open Gable dwelling faces north and has a rectangular footprint. It has a concrete masonry unit foundation and stucco cladding. The front-gable roof has asphalt shingles. The dwelling is three bays wide and three bays deep. A non-historic wood door with nine-light glazing occupies the center bay of the primary elevation while six-over-six vinyl windows occupy the remaining bays. A non-historic front-gable roof with knee brackets shelters the entrance and concrete stoop.

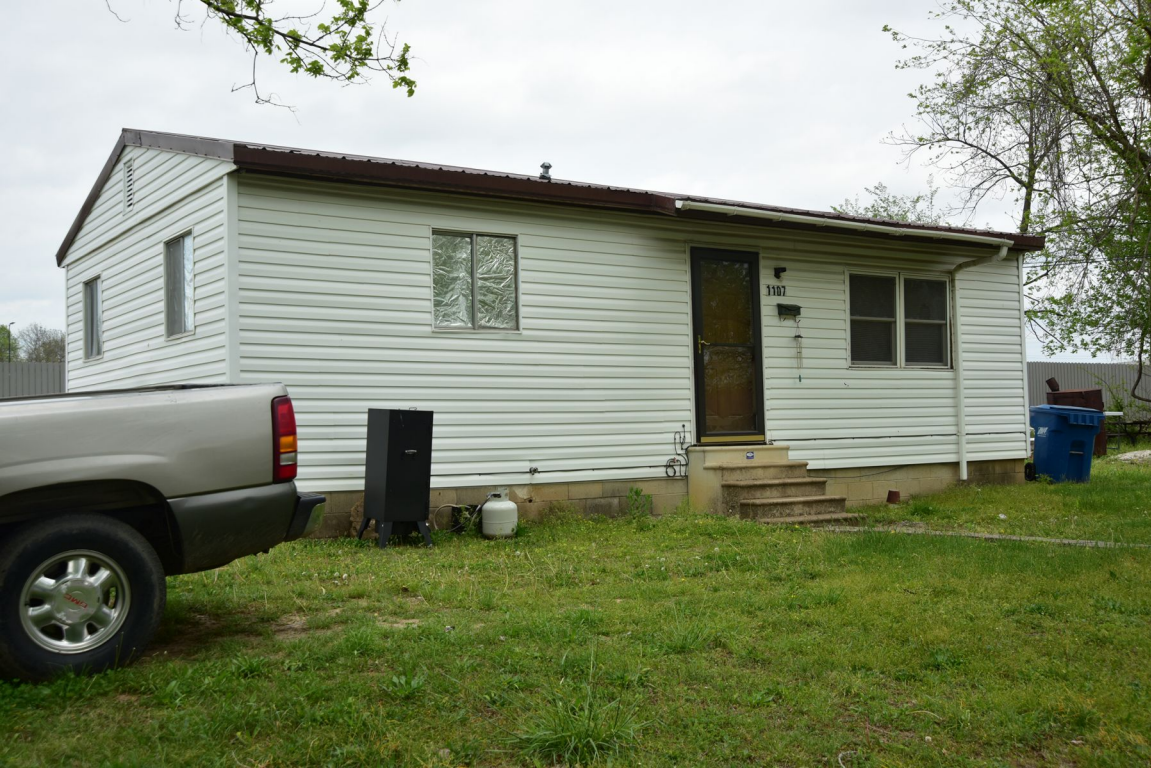
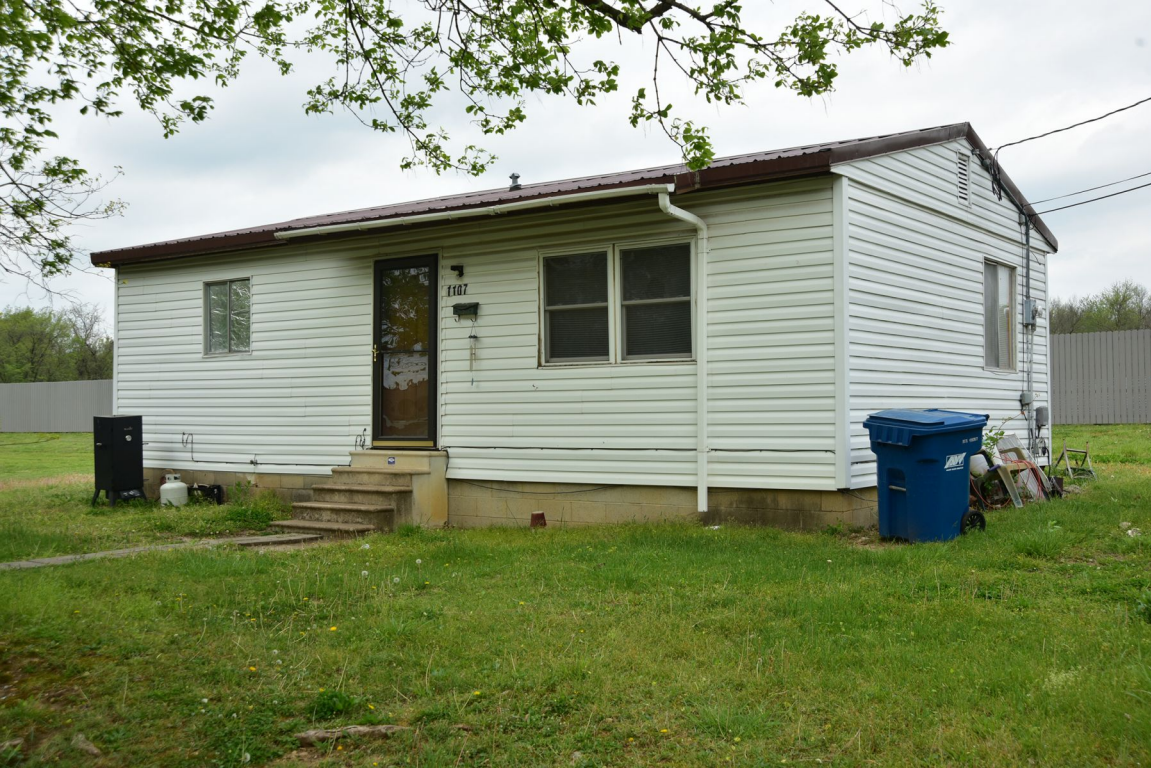
This Minimal Traditional dwelling faces south and has a rectangular footprint. It has a concrete masonry unit foundation, vinyl cladding, and corrugated metal side-gable roof. It is three bays wide and two bays deep. A one-by-one metal window occupies the first bay while a pair of one-over-one vinyl windows occupies the east bay. A wood door occupies the center bay.

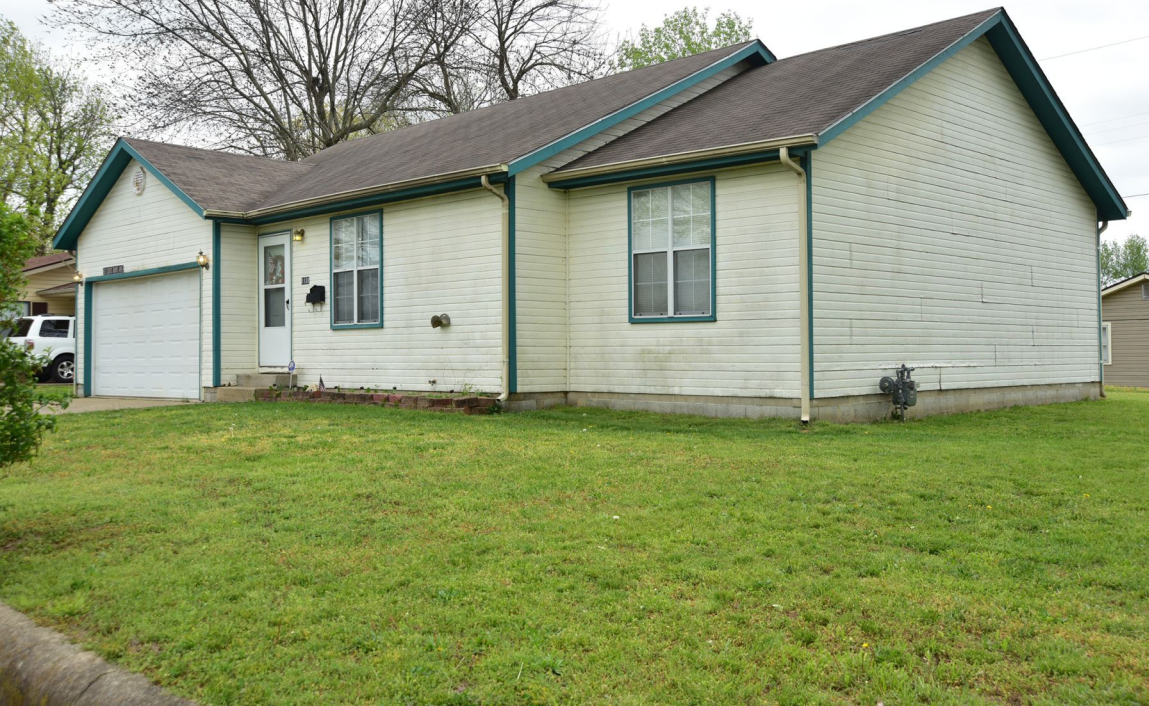
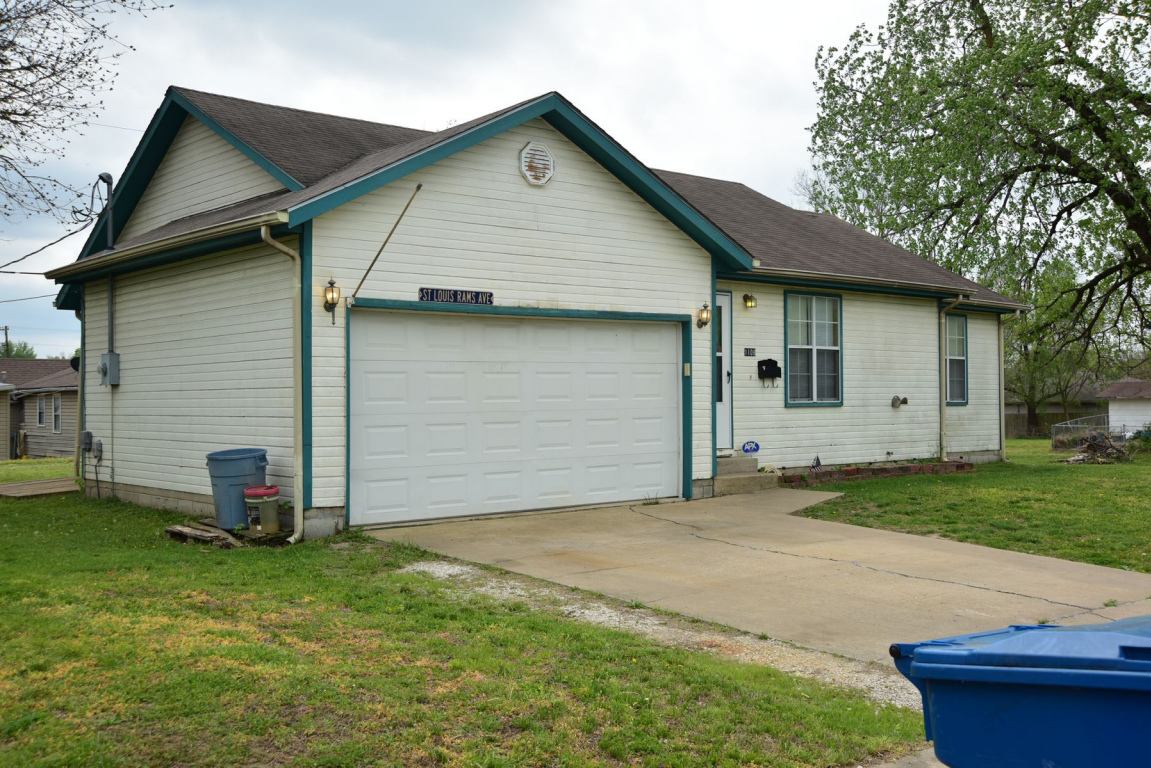
This Ranch dwelling faces north and has a rectangular footprint. It has a concrete masonry unit foundation, vinyl cladding, and side-gable roof with asphalt shingles. The dwelling is four bays wide. A two-car garage with an overhead door defines the east bay. Paired six-over-six vinyl windows occupy the two west bays while a wood door fills the remaining bay.

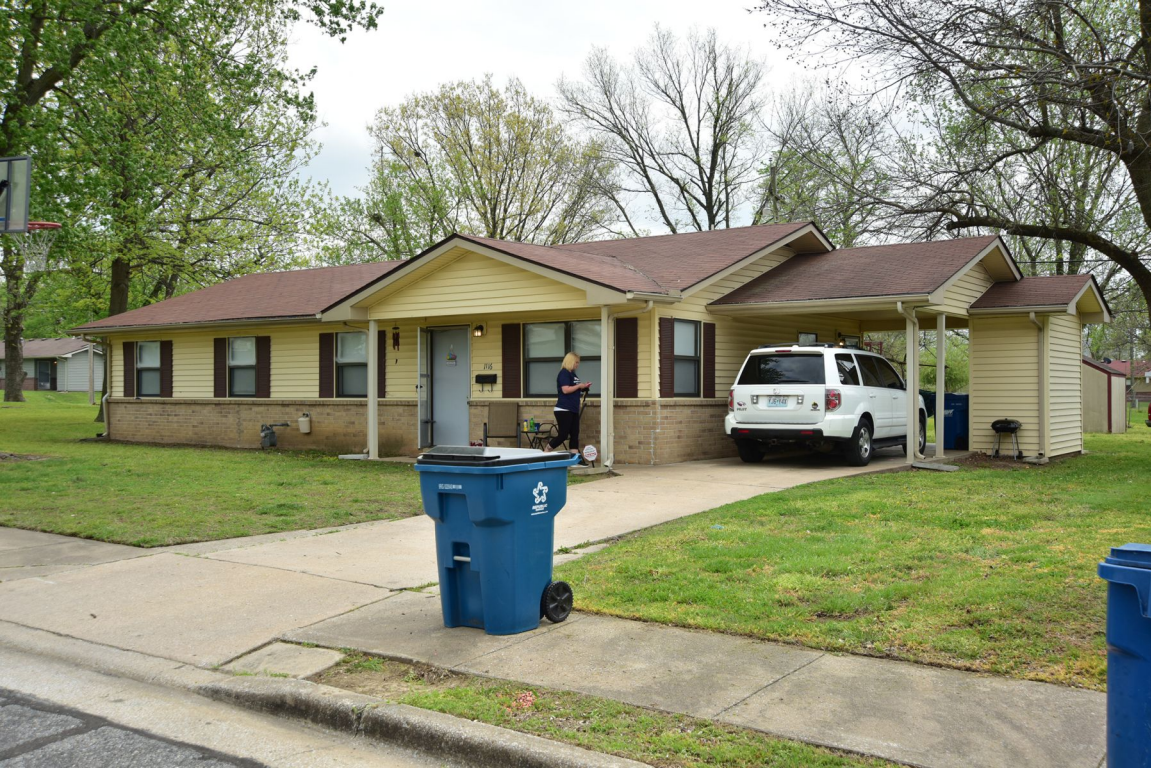
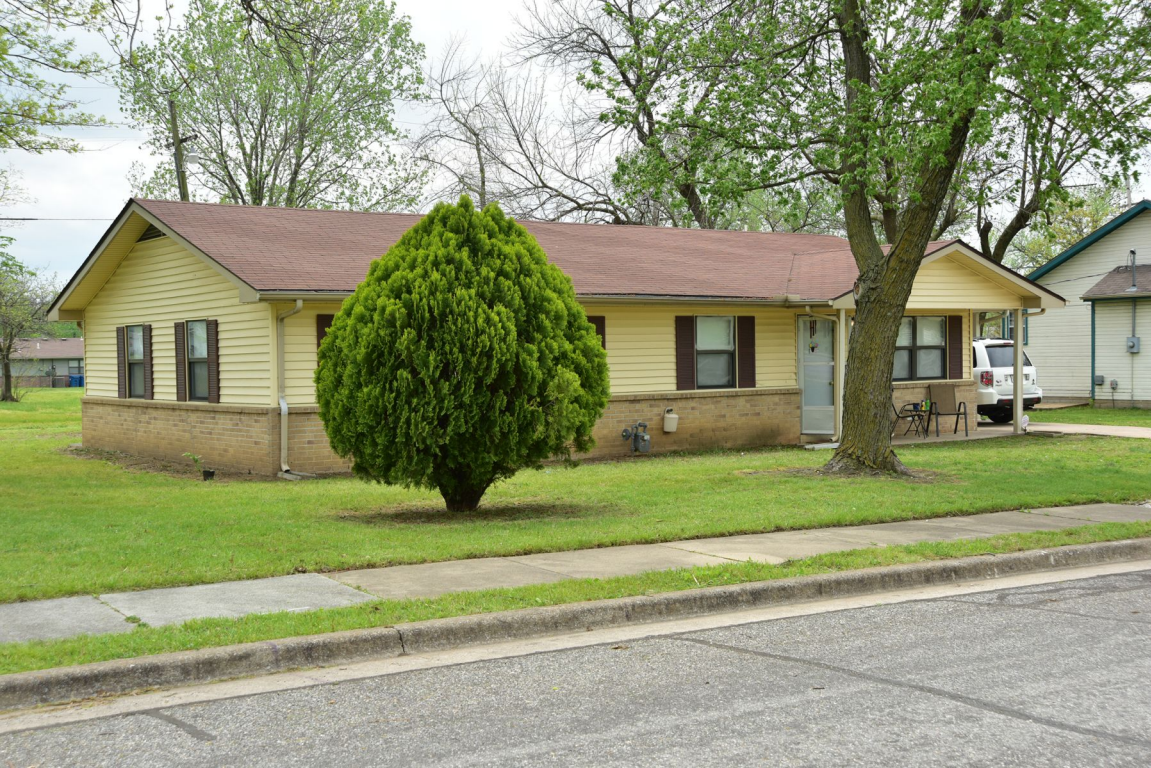
This Ranch dwelling faces north and has a rectangular footprint. It has a concrete foundation and side-gable roof with asphalt shingles. Brick veneer clads the lower third of the dwelling while the remainder is vinyl clad. The dwelling is five bays wide and three bays deep. A front-gable porch shelters the two west bays of the primary elevation. A wood door with metal storm door fills the second-from-west bay. One-over-one metal windows with false shutters define the remaining bays. A side-gable carport projects from the west elevation and shelters a secondary entrance. An enclosed storage area with gable roof is located at the west end of the carport.

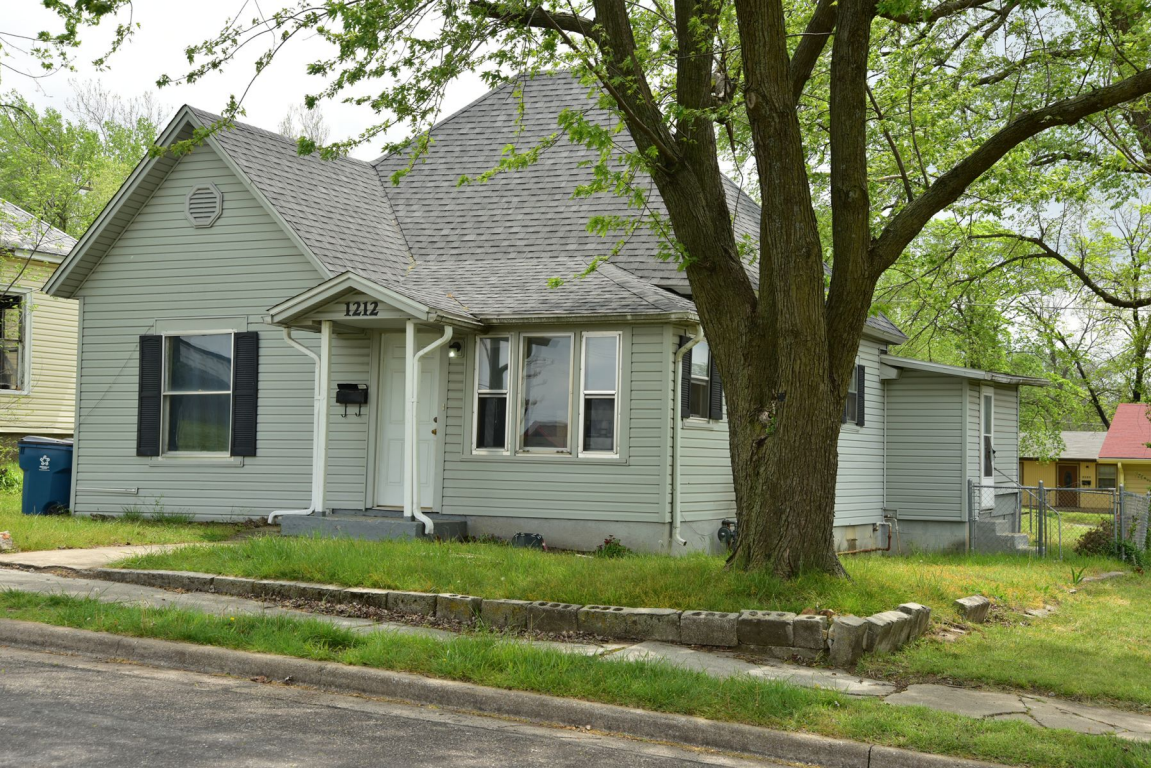
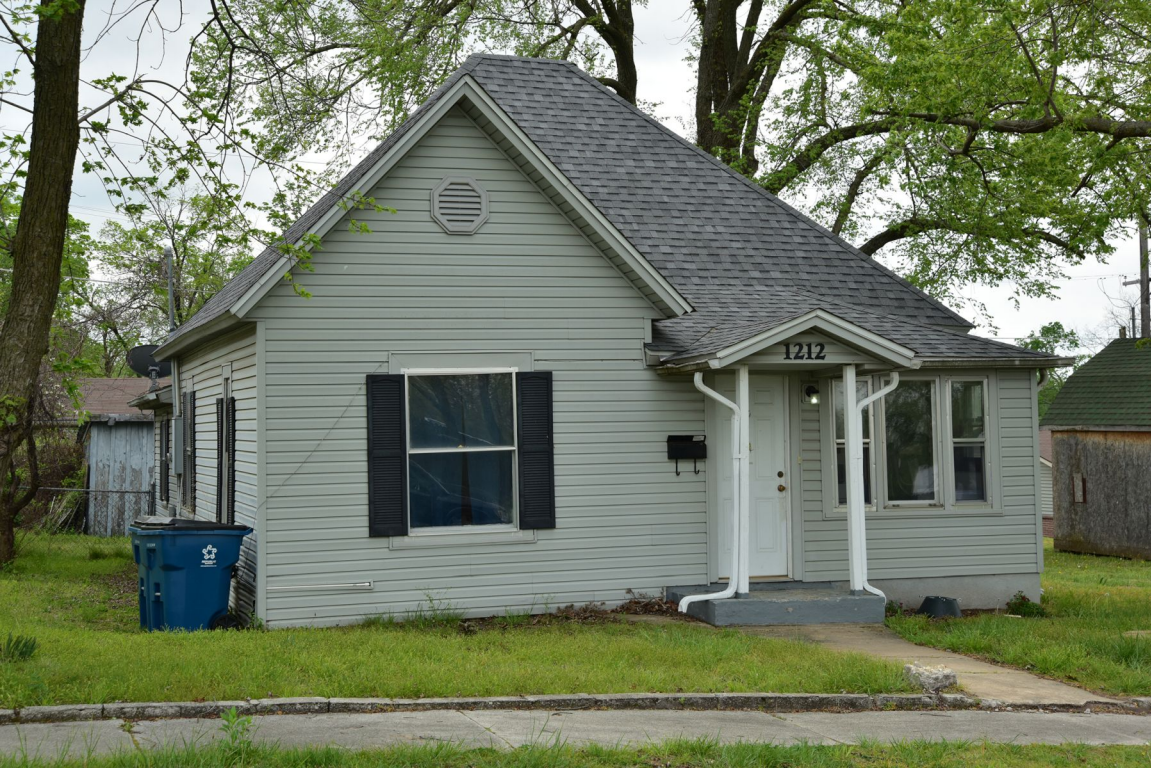
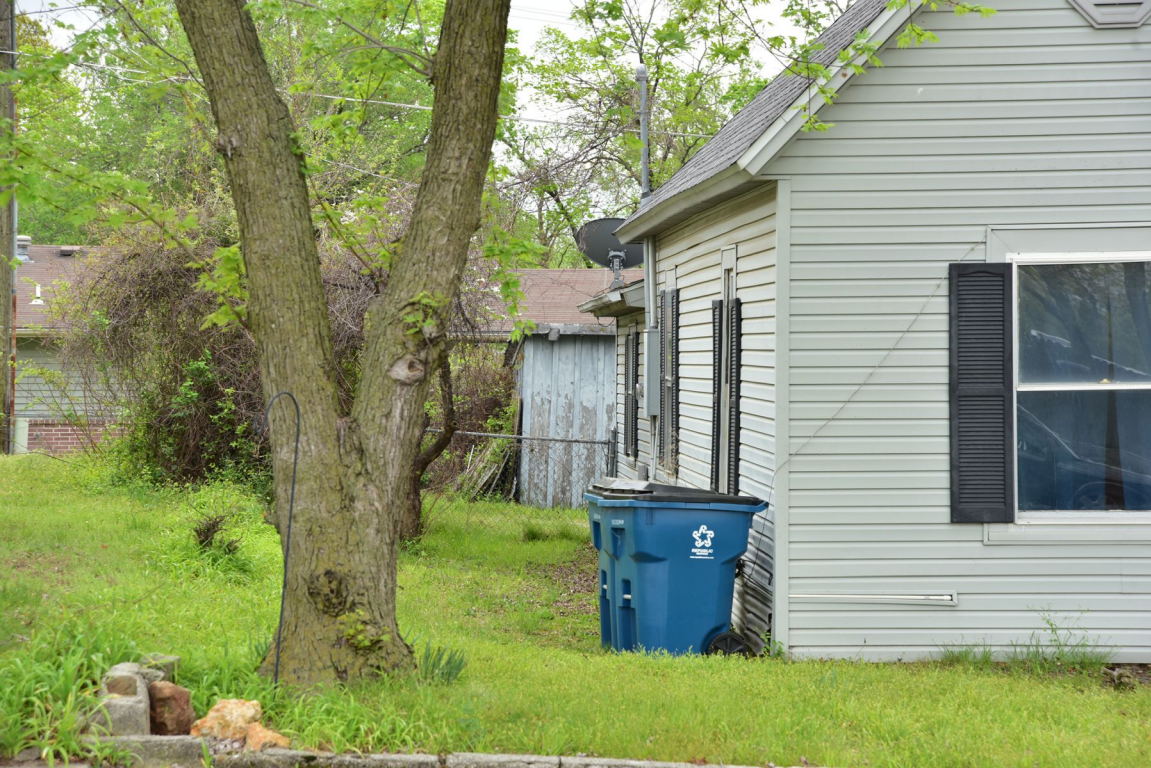
1212

This Pyramid Square Folk House dwelling faces north and has a rectangular footprint. A shed-roof enclosed porch projects from the southwest corner and an enclosed porch forms the west half of the primary elevation. The porch enclosure is an alteration. The dwelling has a parged foundation and vinyl cladding. The pyramidal hipped roof features cross-gables and asphalt shingles. The dwelling is three bays wide and three bays deep. A one-over-one wood window occupies the east bay while a wood tripartite picture window occupies the west bay. A non-historic wood door fills the center bay and is sheltered by a non-historic gabled porch with a concrete foundation.

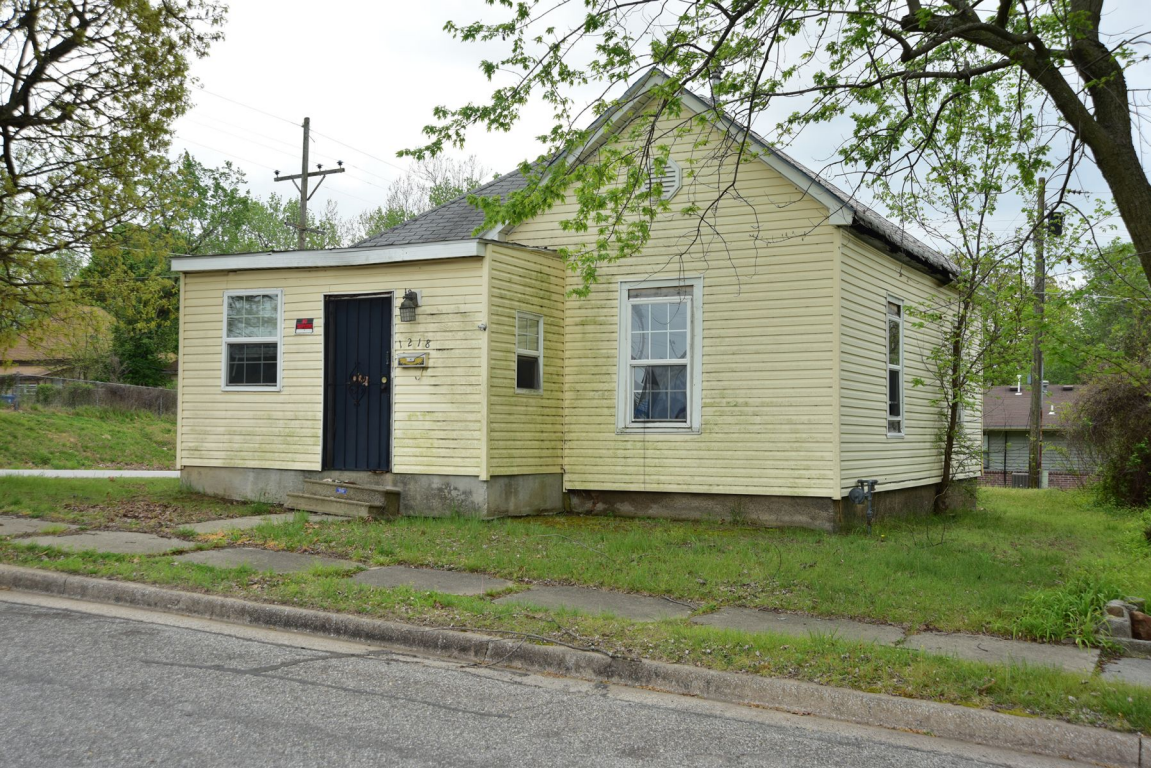
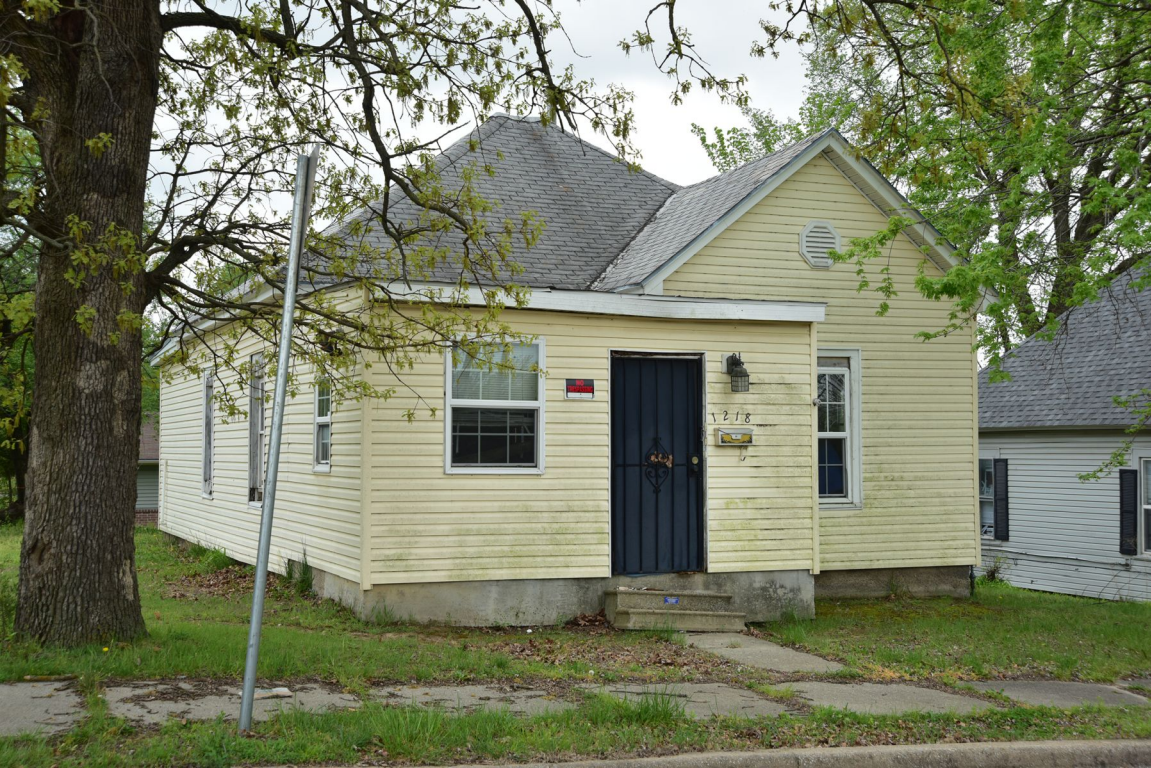
This Pyramid Square Folk House dwelling faces north and has a rectangular footprint. A shed-roof enclosed porch projects from the south elevation and an enclosed porch forms the east half of the primary elevation. The porch enclosure is an alteration. The dwelling has a parged foundation and vinyl cladding. The hipped roof features cross-gables and asphalt shingles. The dwelling is three bays wide and three bays deep. Six-over-six vinyl windows occupy the east and west bays. A non-historic wood door with a metal grille fills the center bay.

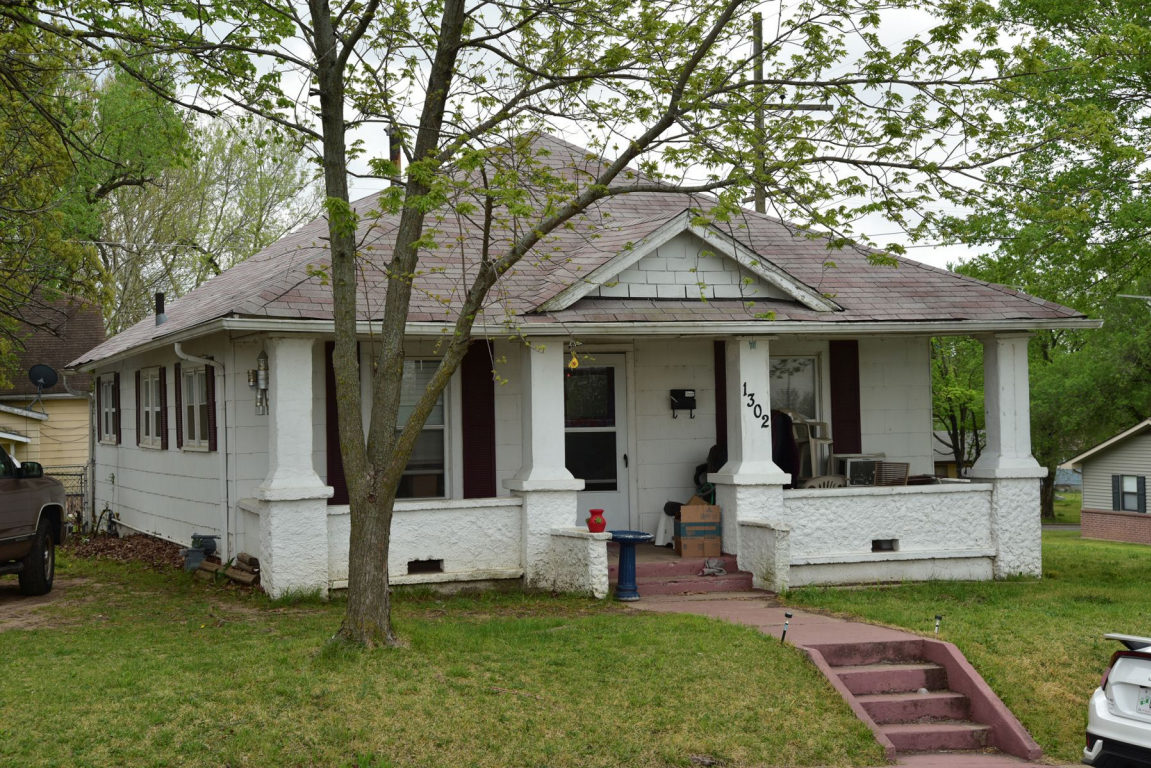
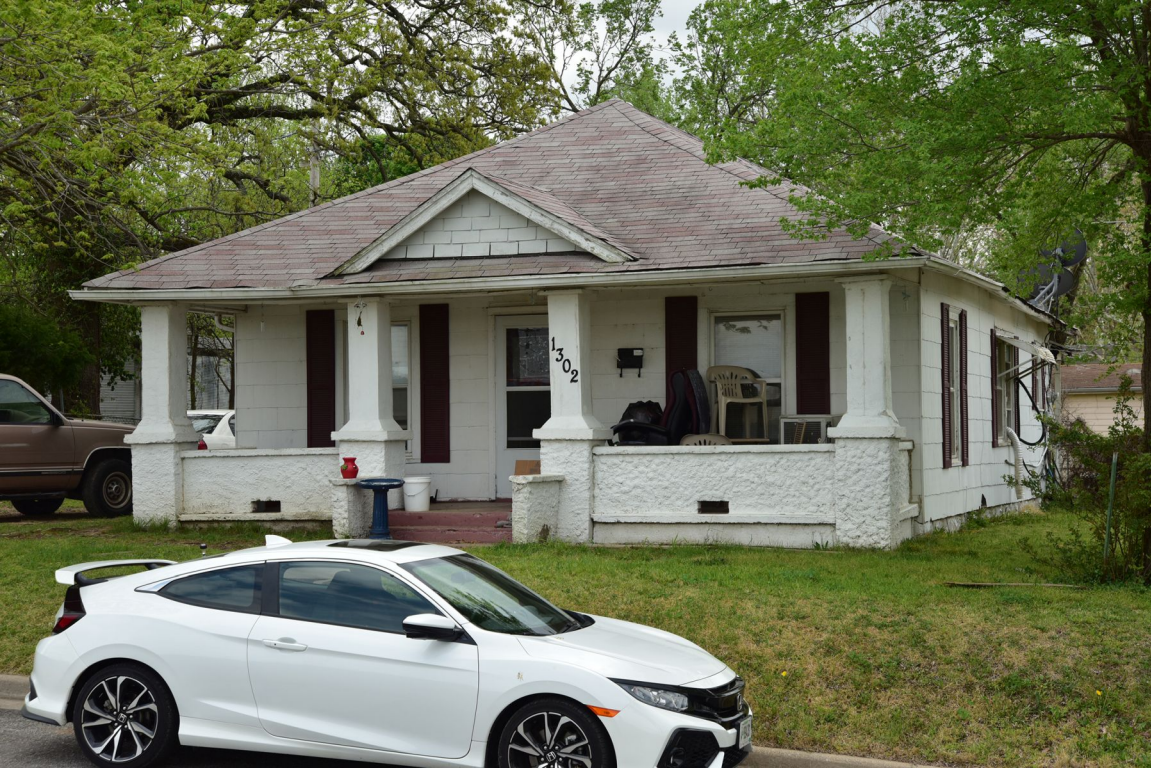
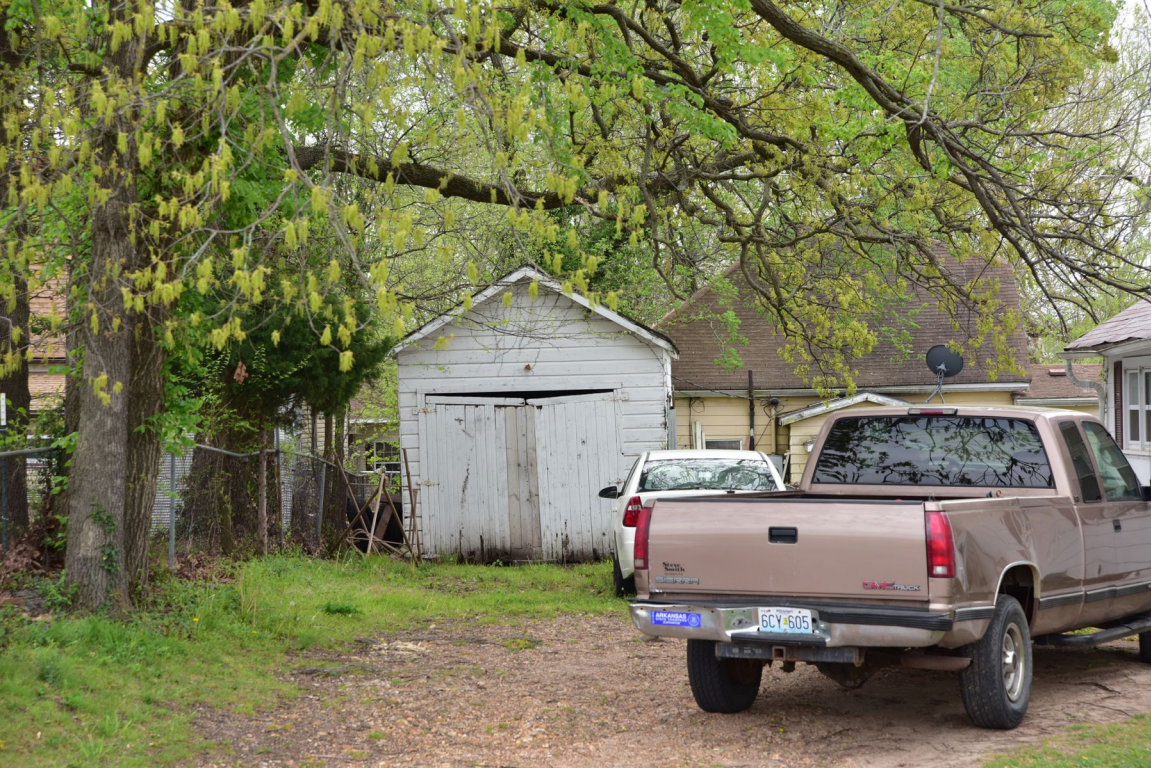
This bungalow dwelling faces north and has a rectangular footprint. It has asbestos shingle cladding and a hipped asphalt roof. The dwelling is three bays wide and three bays deep. An open porch with parged masonry walls, piers, and columns spans the primary elevation. One-over-one vinyl windows occupy the east and west bays while the primary entrance defines the center bay. The door is not visible.

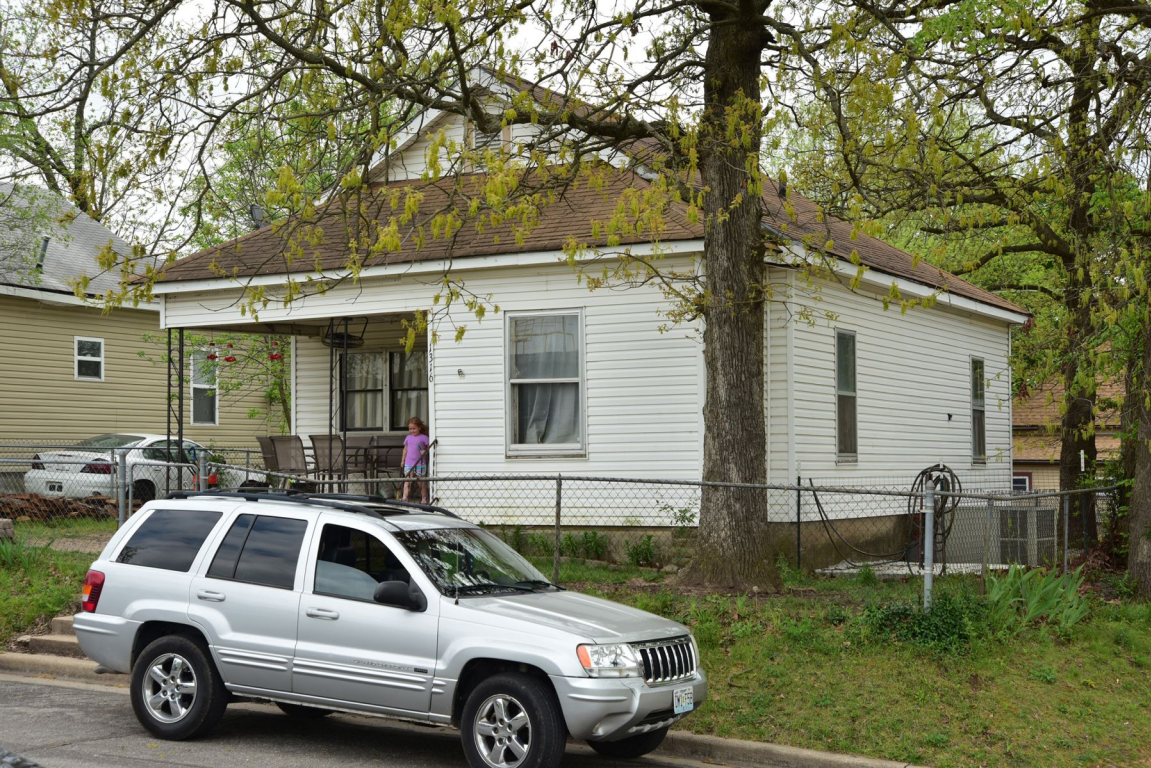
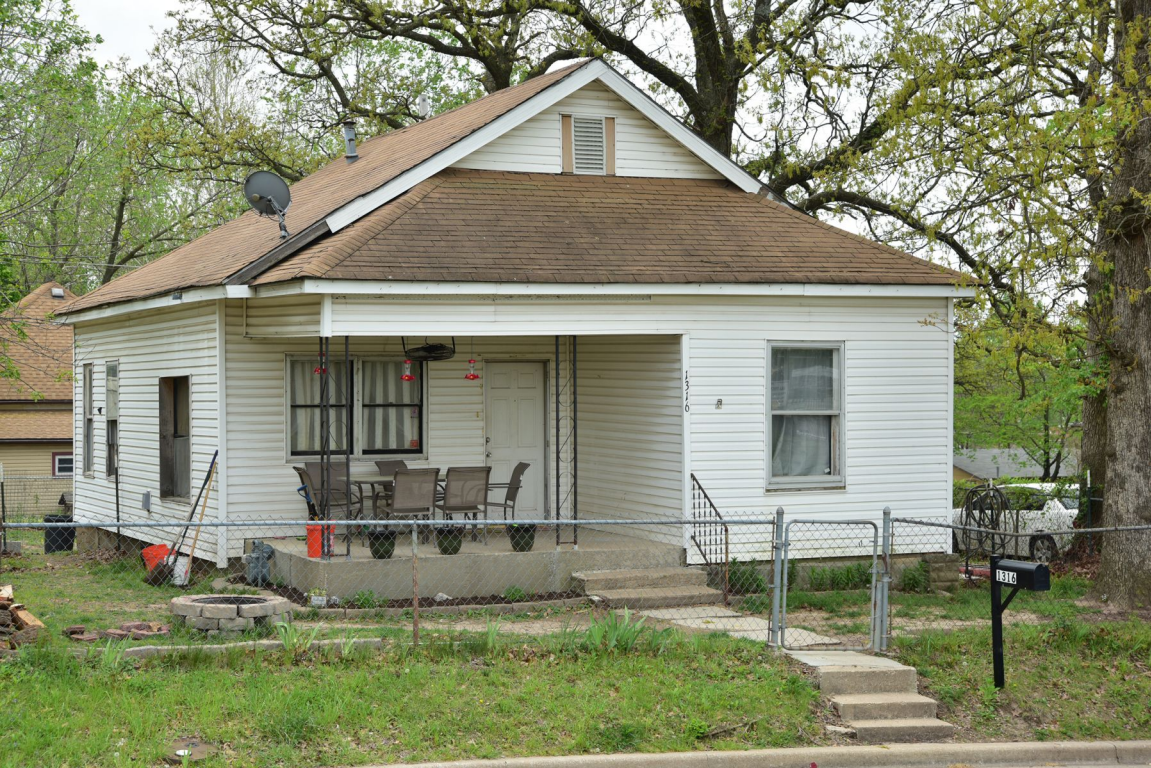
This bungalow dwelling faces north and has a rectangular footprint. It has a parged foundation and vinyl cladding. The front-gable roof is asphalt. The dwelling is three bays wide and three bays deep. A hipped-roof porch spans the primary elevation. The west half is enclosed while the open east half has decorative metal support posts. A pair of one-over-one metal windows occupies the east bay while a single one-over-one metal window occupies the west bay. The center bay contains a non-historic wood door.
