MISSOURI DEPARTMENT OF NATURAL RESOURCES
STATE HISTORIC PRESERVATION OFFICE, P.O. Box 176, Jefferson City, MO 65102
ARCHITECTURAL/HISTORIC INVENTORY FORM

1. Survey number: JP-AS-006-184		2. Survey Name: East Town (Original Joplin) Historic Survey Phase 1	
3. County: JASPER		4. Address 1401	Street (name): E. Hill Street
5. City: Joplin	Vicinity <input type="checkbox"/>	7. Township/Range/Section: T: R: S:	
8. Historic name (if known):		9. Present/other name (if known):	
10. Ownership: <input checked="" type="checkbox"/> Private <input type="checkbox"/> Public		11a. Historic use (if known): Domestic/Single Dwelling	11b. Current use: Domestic/Single Dwelling

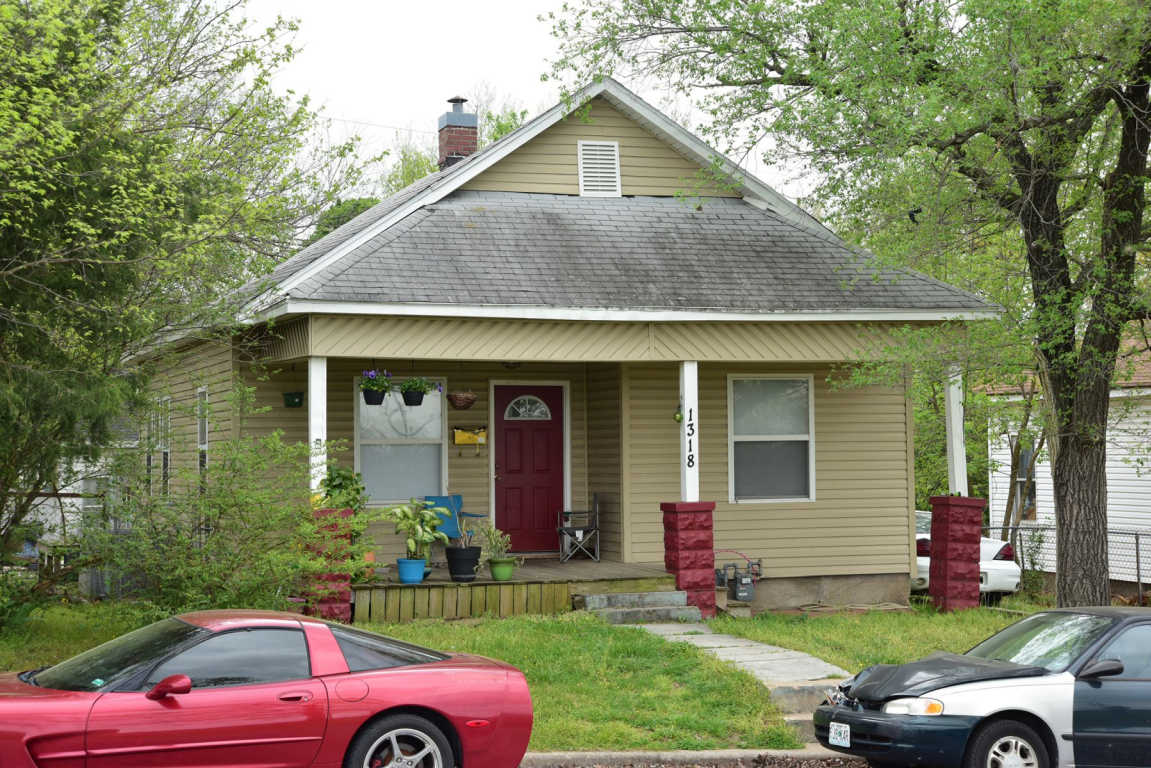
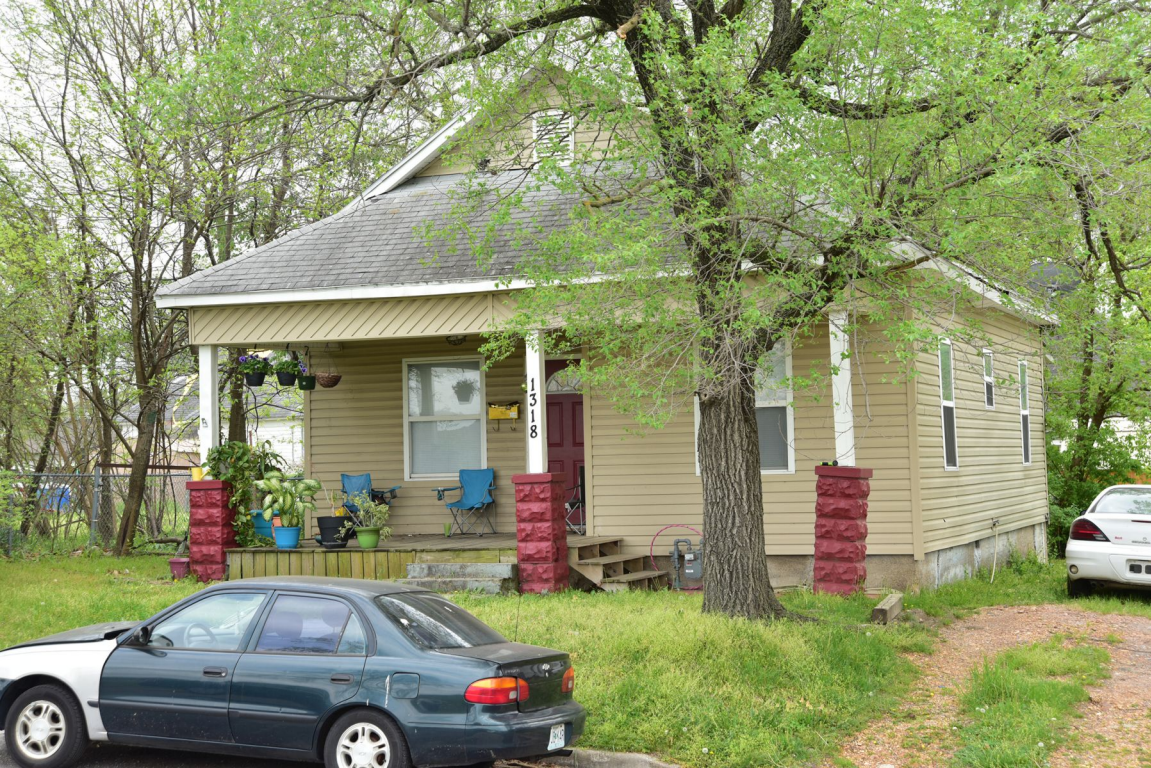
This bungalow dwelling faces north and has a rectangular footprint. It has a parged foundation and vinyl cladding. The front-gable roof is asphalt. The dwelling is three bays wide and three bays deep. A hipped-roof porch spans the primary elevation. Squared wood posts on concrete block piers support the porch roof. One-over-one vinyl windows occupies the east and west bays while a non-historic fiberglass door occupies the center bay. A short brick chimney pierces the roof ridge.

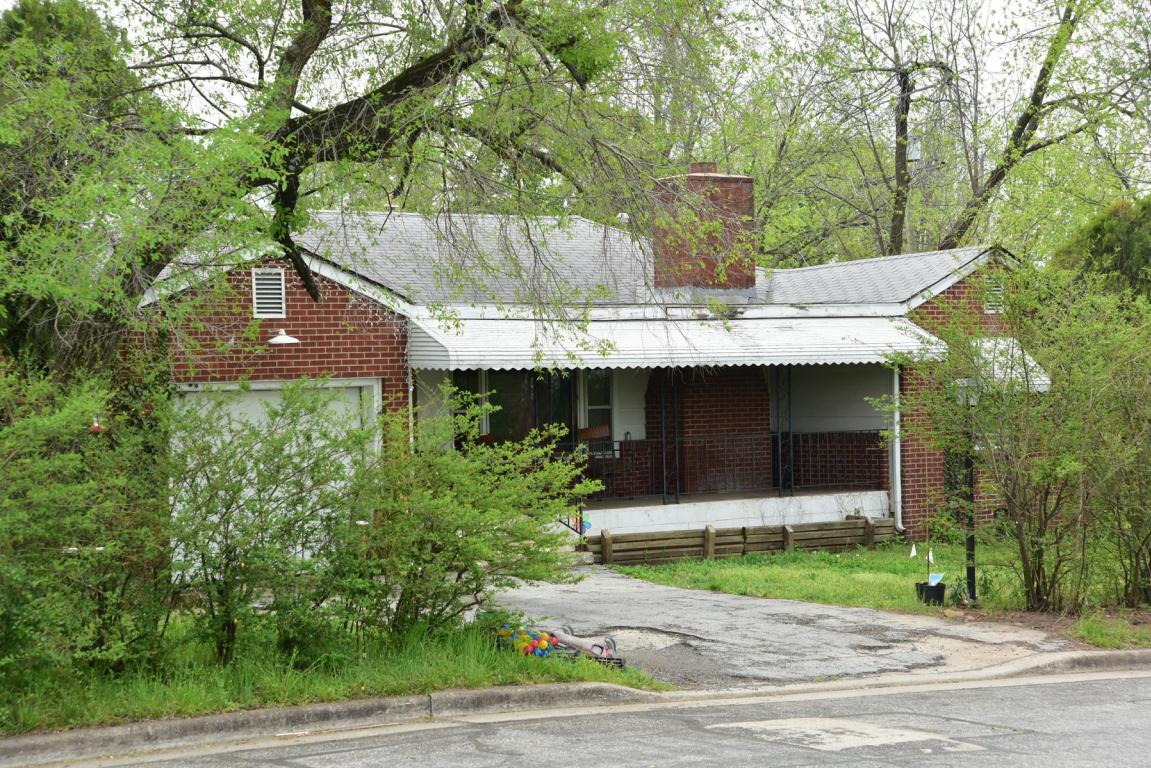
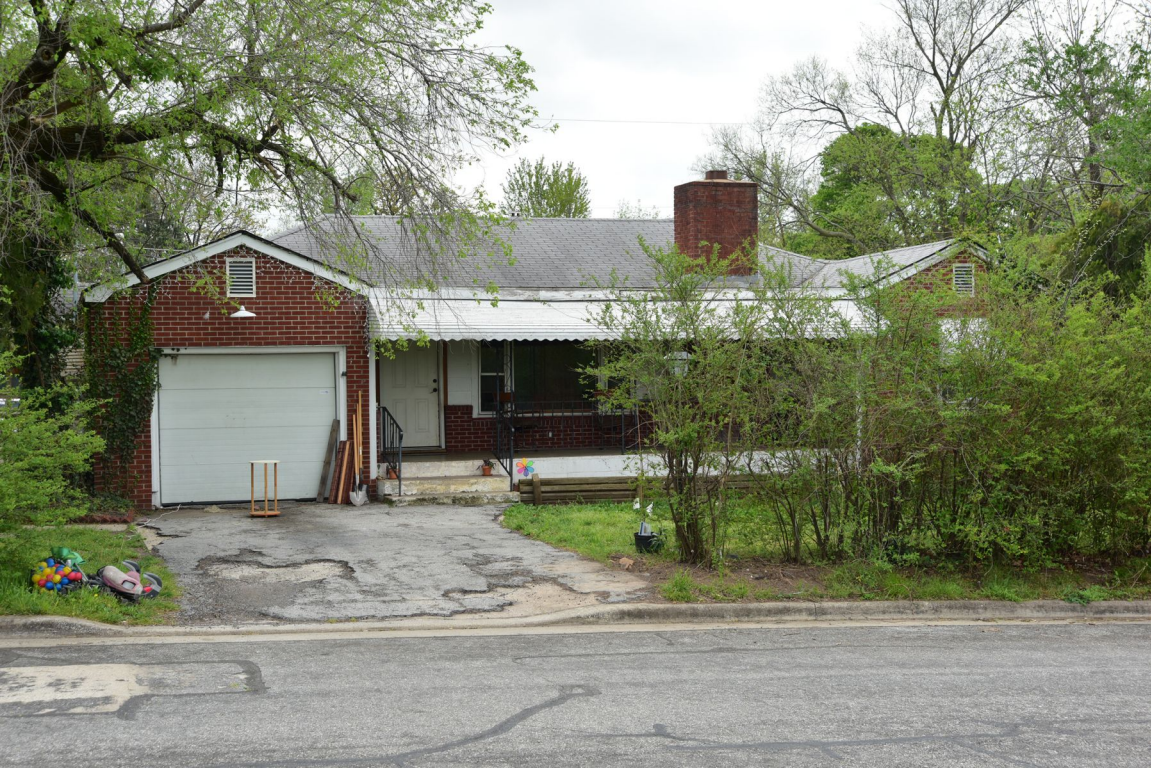
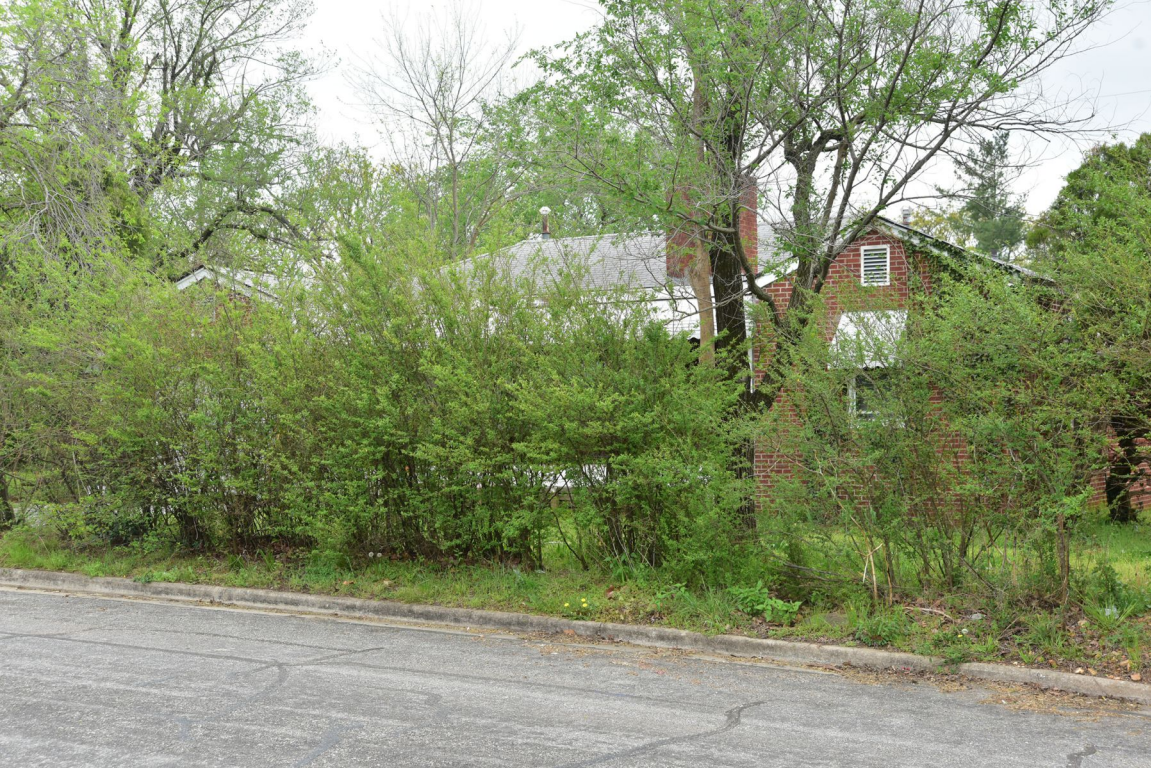
This Ranch dwelling faces north and has a rectangular footprint. It has brick cladding and an asphalt roof. The foundation is not visible. The dwelling is five bays wide. The center three bays recede, creating an open porch. The porch has a metal awning, concrete masonry unit foundation, and decorative metal support posts. A single-car overhead garage door occupies the first bay and a non-historic wood pedestrian door occupies the second bay. A wood tripartite picture window occupies the third bay while a one-over-one window with a metal awning occupies the last bay. A distinctive broad brick chimney defines the fourth bay and pierces the roofline.

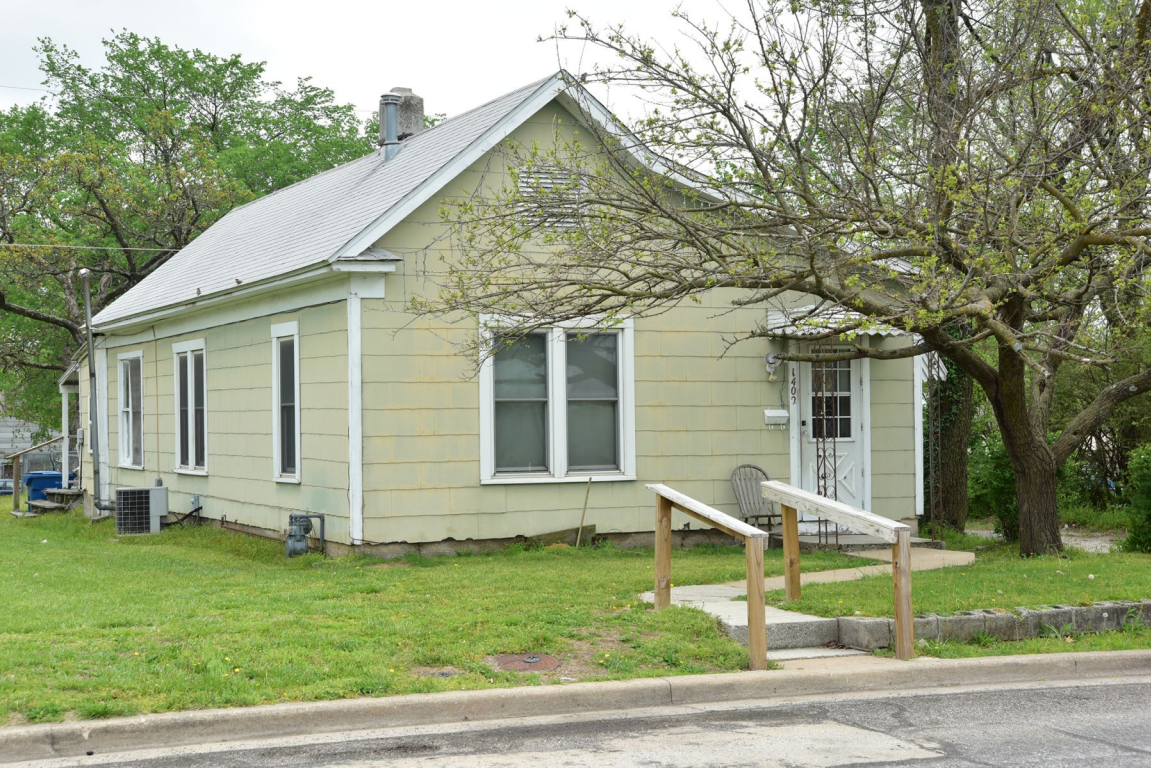
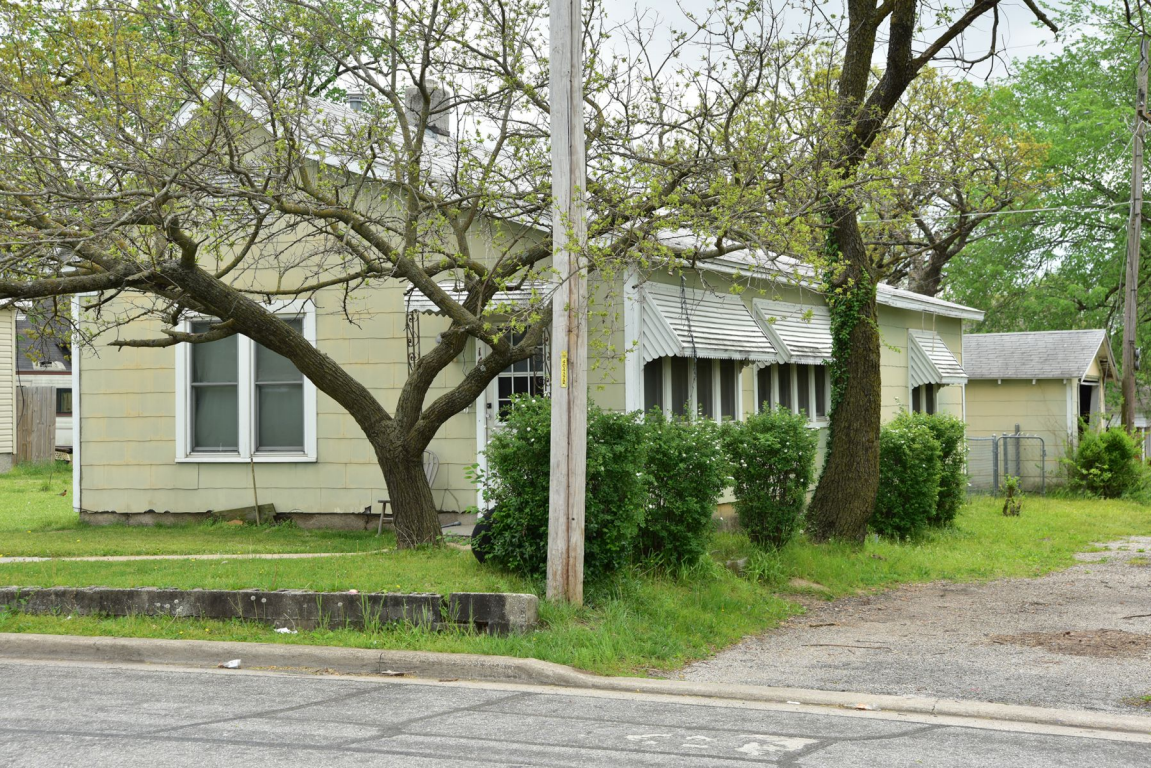
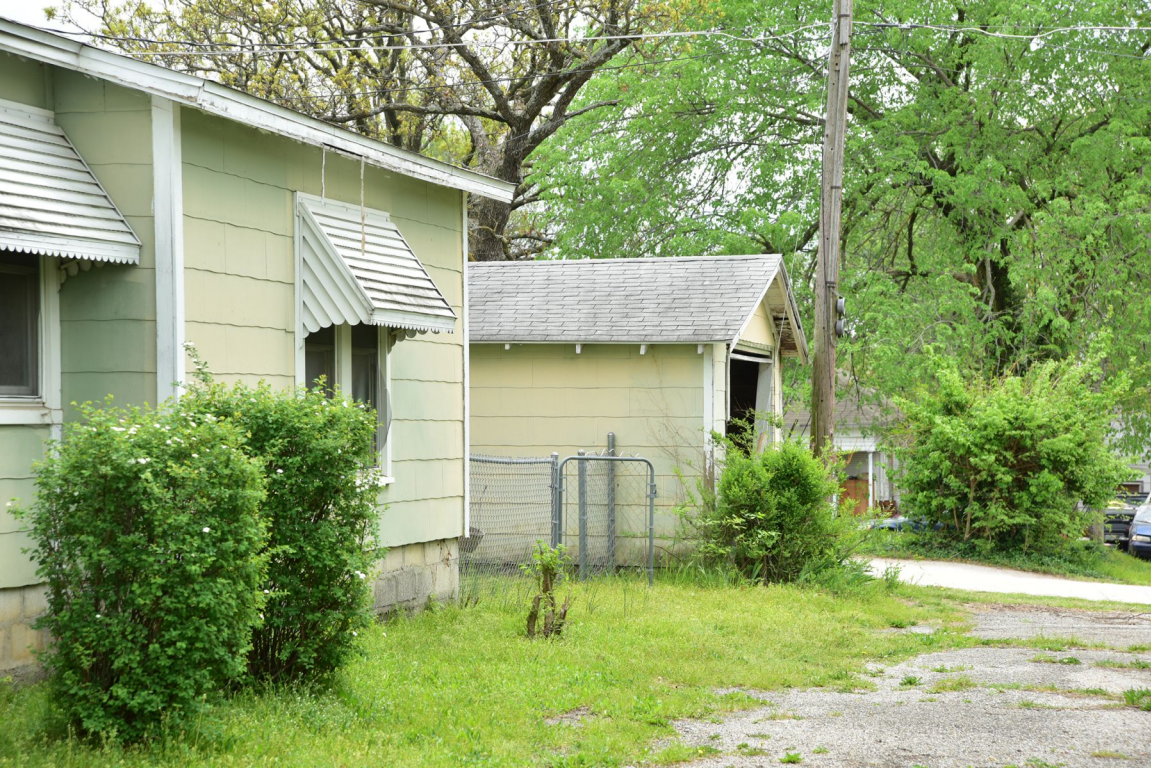
This resource has good integrity. The asbestos siding is not original, but it is likely a historic alteration, as is the enclosure of the front porch. The replacement windows are a non-historic alteration. This resource would be contributing to the East Joplin Residential Historic District, significant for its associations with the early residential development of Joplin, specifically the African American community. Areas of significance are Community Planning & Development, and Ethnic History/Black.

This one-story dwelling faces south and has a rectangular footprint. It has a concrete foundation asbestos shingle cladding, and an asphalt front-gable roof. The roof features a centered, parged straddle-ridge chimney. The dwelling is two bays wide and three bays deep. A shed-roof enclosed porch forms the primary elevation and a shed-roof addition spans the north portion of the west elevation. A pair of one-over-one vinyl windows occupies the east bay of the primary elevation while a non-historic wood door with glazing occupies the west bay. A metal awning with decorative metal support posts shelters the entrance.

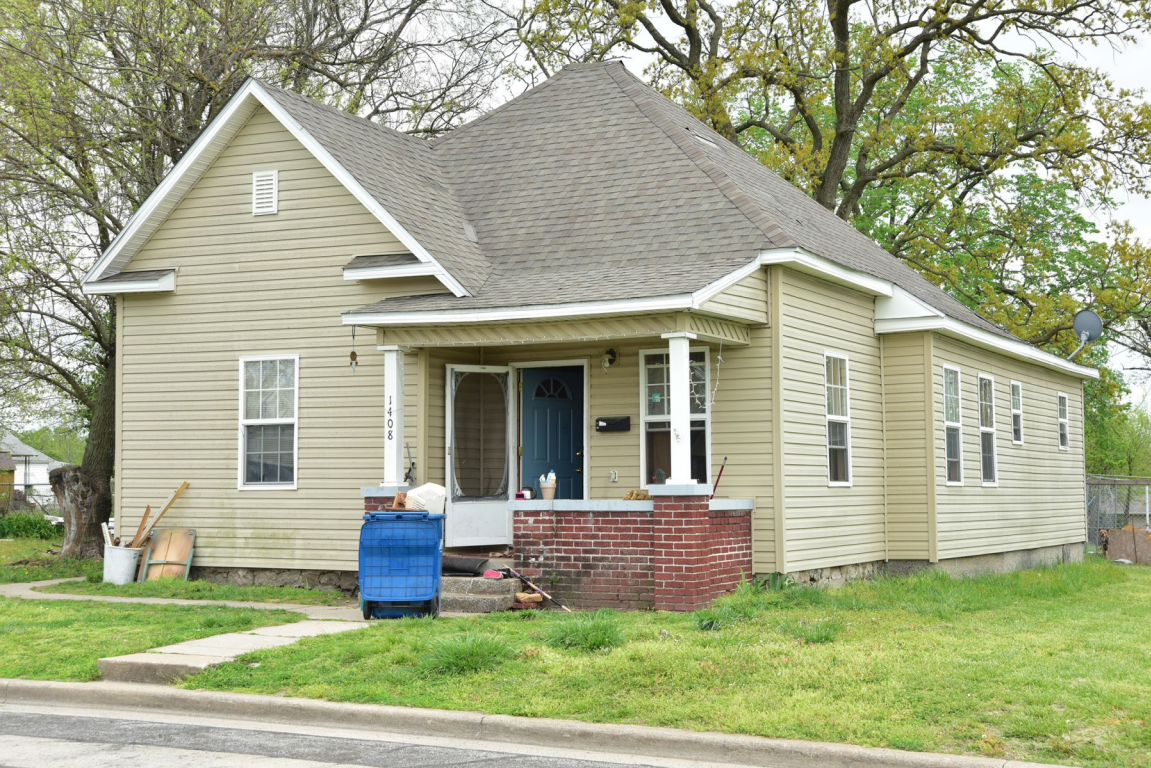
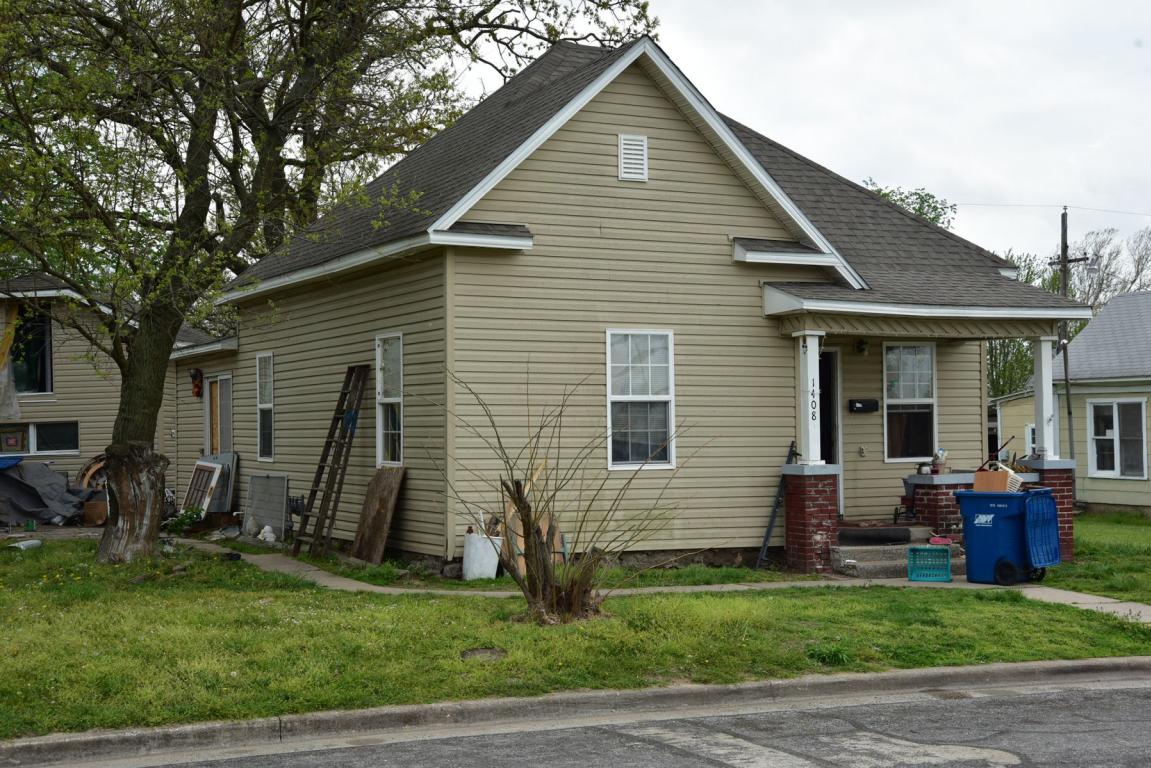
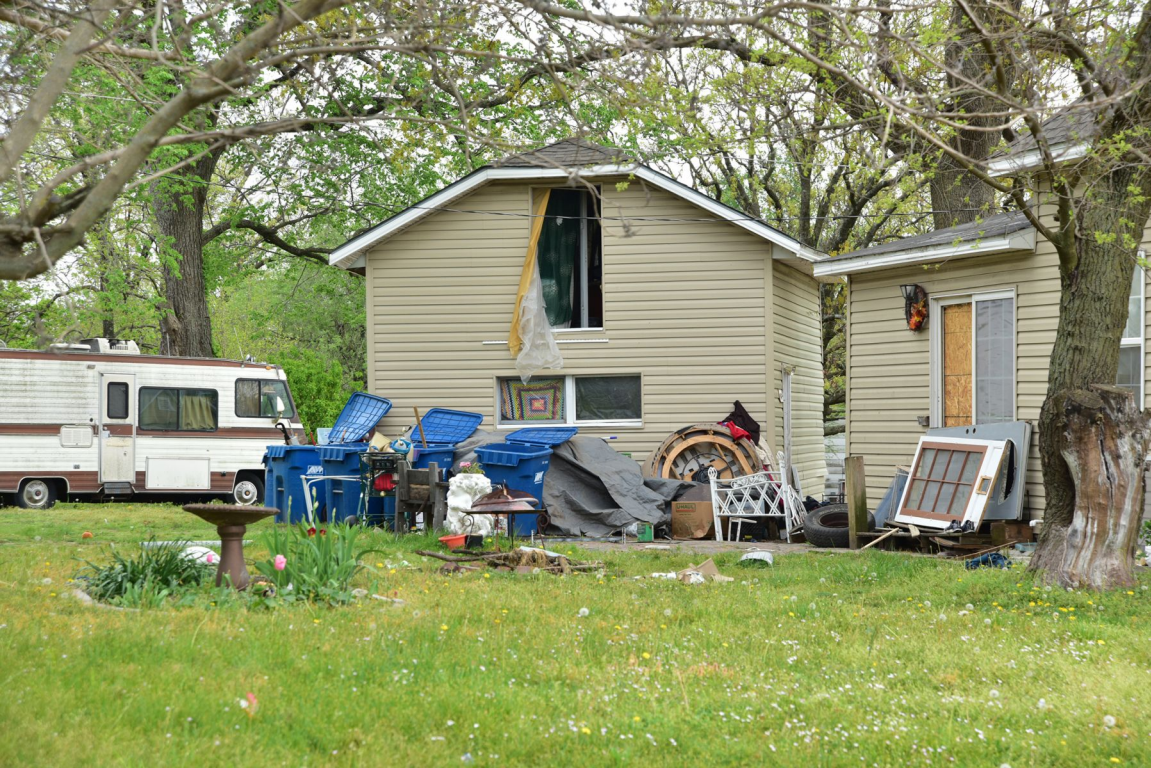
This Pyramid Square Folk House dwelling faces north and has a rectangular footprint. It has a stone foundation and vinyl cladding. The pyramidal hipped roof features a cross-gable at the primary elevation. The dwelling is three bays wide and five asymmetrical bays deep. Six-over-six vinyl windows occupy the east and west bays while a non-historic fiberglass door occupies the center bay. A partial-width open porch shelters the west two bays. It has a shed roof, concrete foundation, and brick walls. Wood columns support the roof.

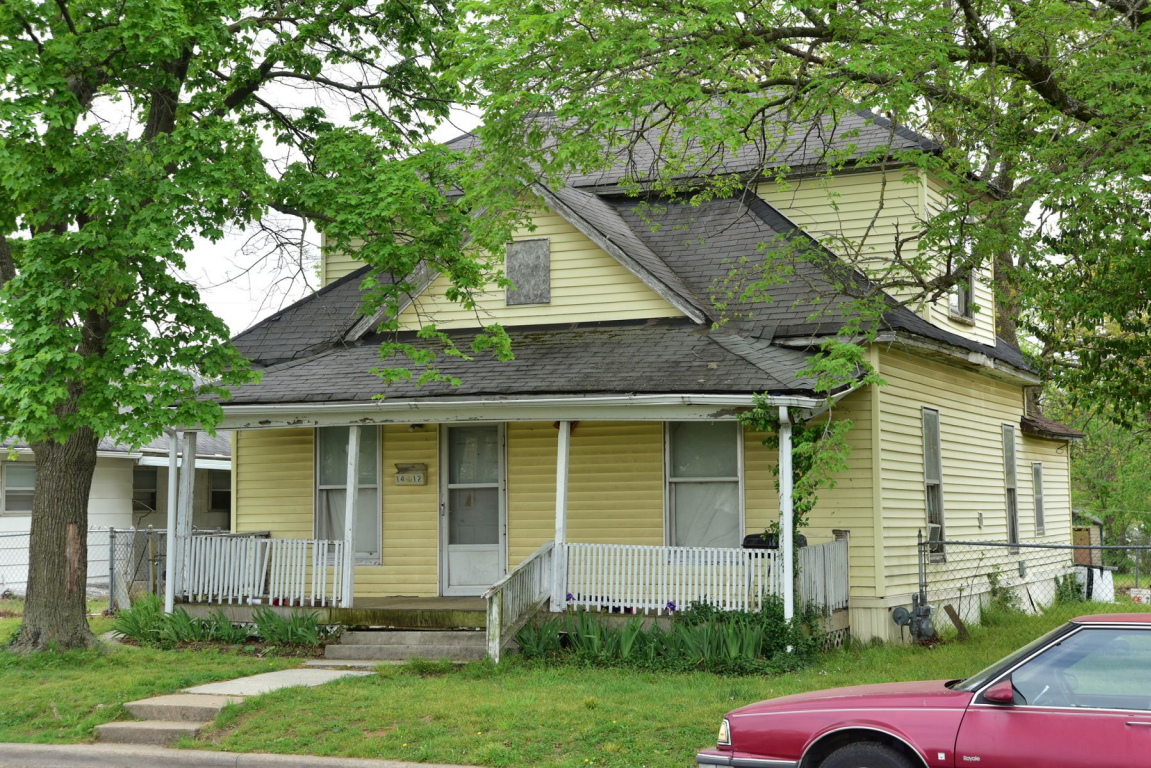
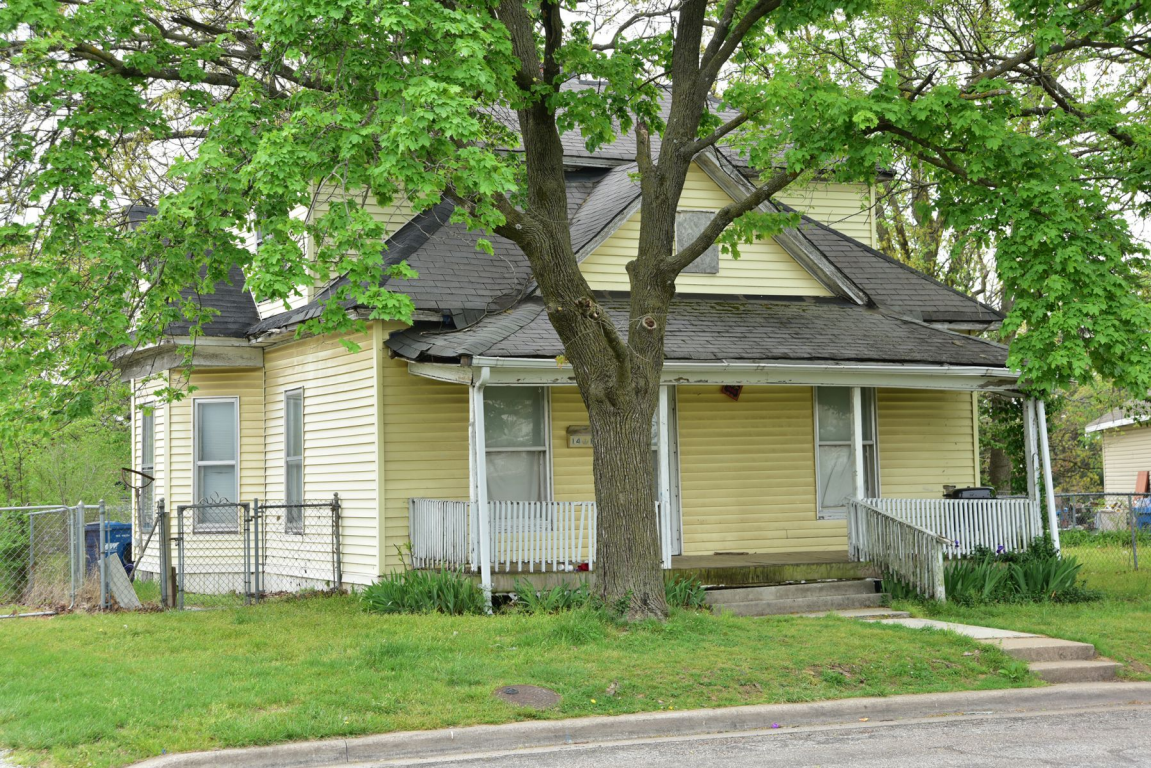
This dwelling faces north and has a rectangular footprint. It has a masonry foundation and vinyl cladding. The complex roof has asphalt shingles and wood fascia boards. Hipped dormers are located on the east and west roof slopes while a gablet is present on the primary slope. The dwelling is three bays wide and three bays deep. A non-historic open, full-width porch shelters the primary elevation bays. It has a hipped roof, wood support posts, and a matchstick balustrade. A non-historic wood door occupies the center bay while one-over-one wood windows occupy the remaining bays. A bay window projects from the east elevation and has a gabled roof.

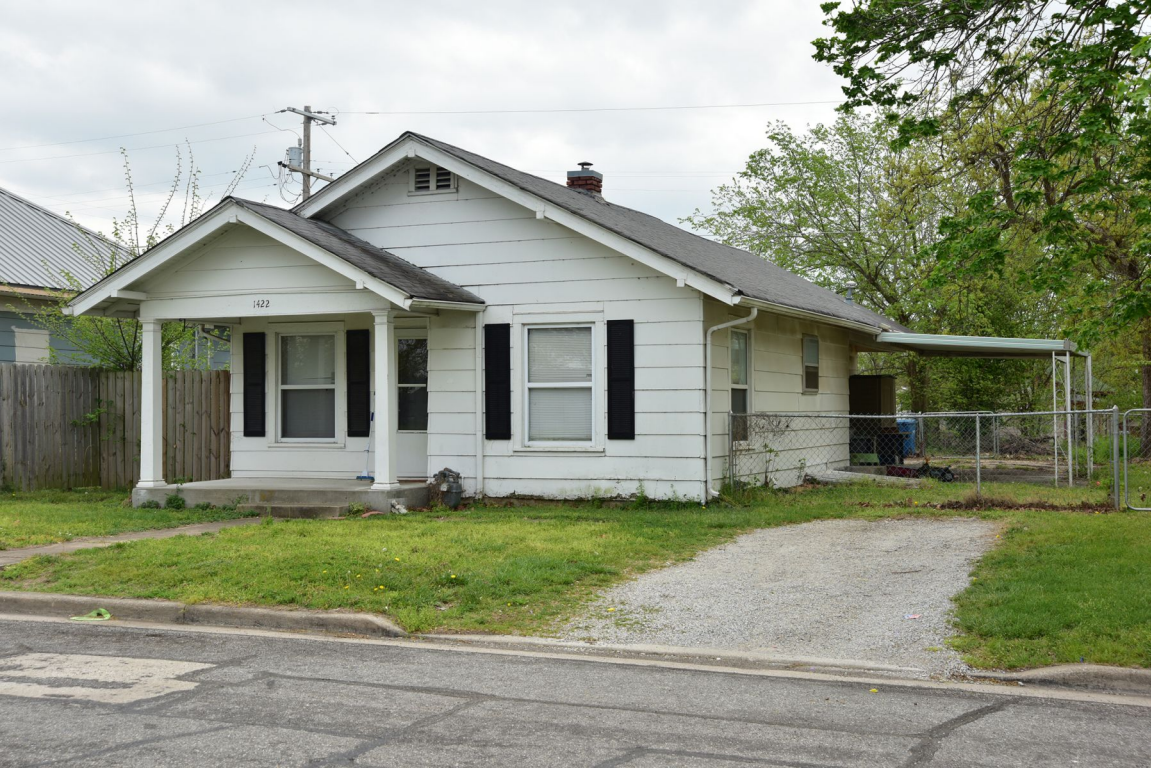
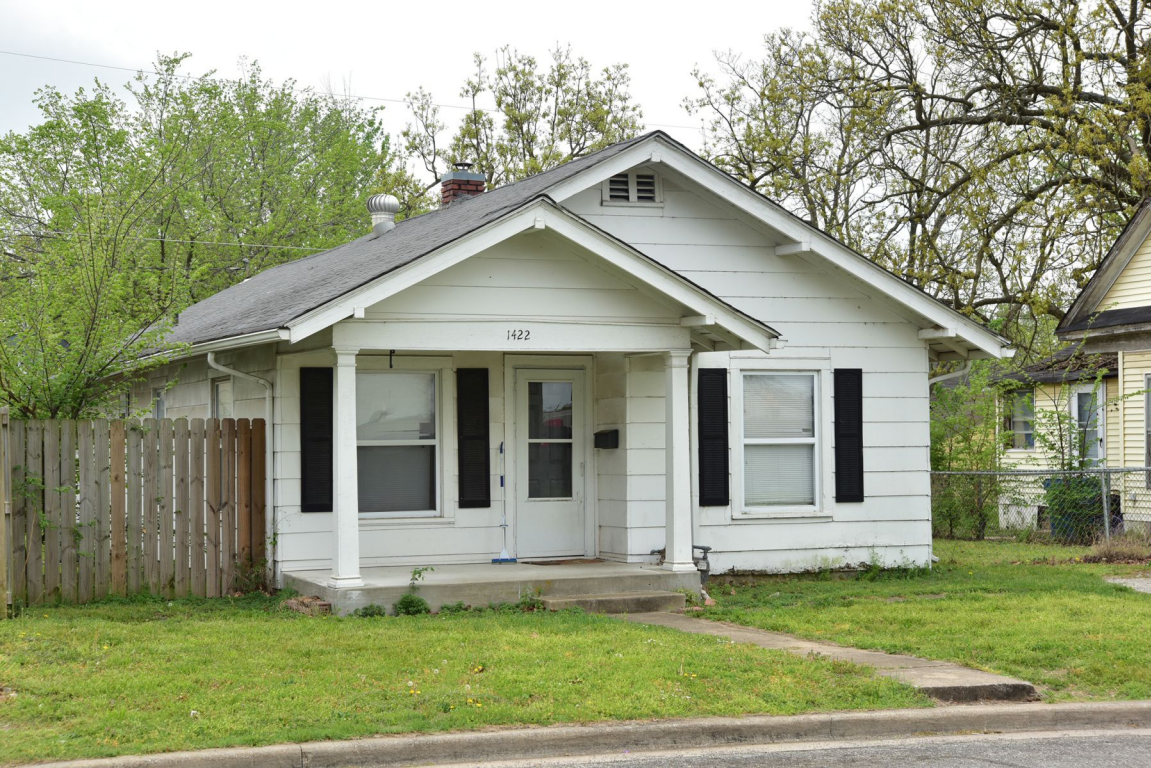
1422

This bungalow dwelling faces north and has an L-shaped footprint. It has a concrete foundation and pressboard siding. The front-gable roof features asphalt and wood brackets. A short brick chimney pierces the ridge. The dwelling is three bays wide and three bays deep. The east two bays of the primary elevation slightly recede, creating a partial-width open porch. The porch has a concrete foundation and squared wood columns support the front-gable roof. One-over-one vinyl windows with flat board trim and false shutters occupy the east and west bays while a non-historic wood door occupies the center bay. A modern carport projects from the west elevation while a wood privacy fence obscures the east elevation.

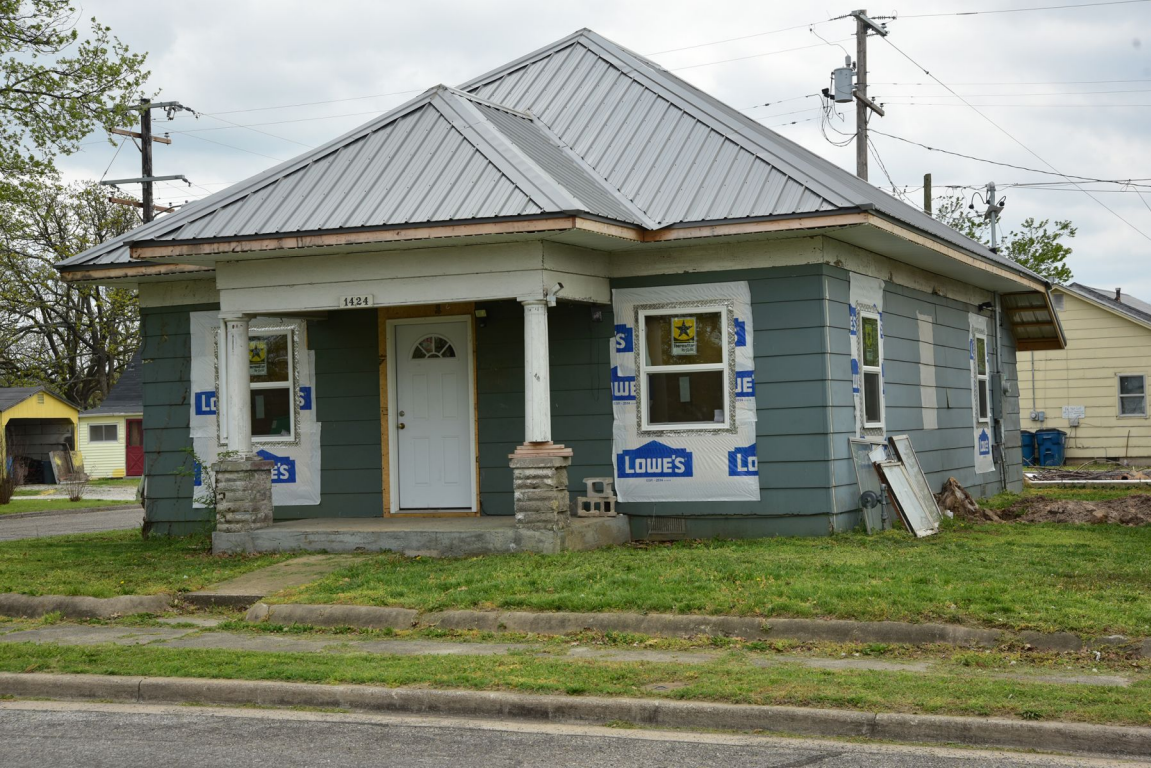
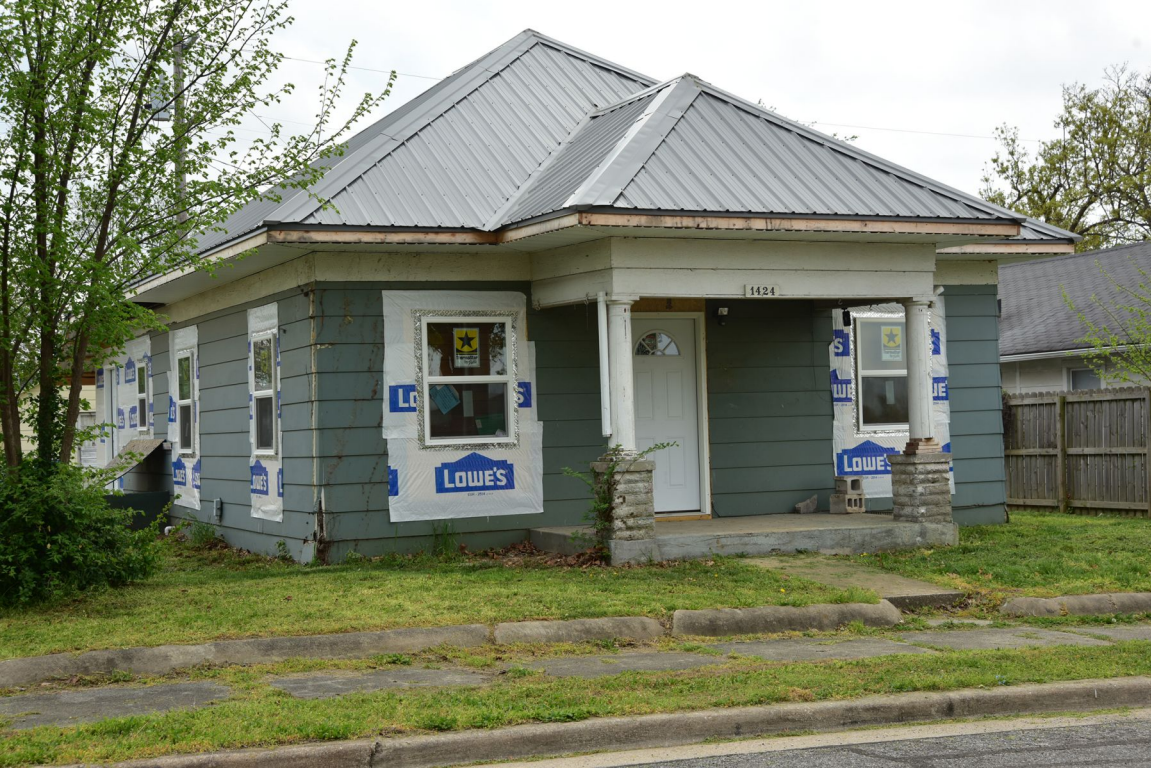
1424

This Pyramid Square Folk House dwelling faces north and has a rectangular footprint. The dwelling is three bays wide and four asymmetrical bays deep. It has a parged foundation, standing seam metal roof, and pressboard siding. A hipped-roof porch projects from the front slope of the dwelling's hipped roof and shelters the entrance. The porch has a concrete foundation and wood columns on concrete block piers support the roof. One-over-one vinyl windows occupy the east and west bays while a non-historic fiberglass door occupies the center bay. The windows are smaller than the historic openings, requiring infill around them. A modern carport projects from the west elevation while a wood privacy fence obscures the east elevation.
