MISSOURI DEPARTMENT OF NATURAL RESOURCES
STATE HISTORIC PRESERVATION OFFICE, P.O. Box 176, Jefferson City, MO 65102
ARCHITECTURAL/HISTORIC INVENTORY FORM

1. Survey number: JA-AS-087-025		2. Survey Name: McGee Street Historic Resources Survey 2017	
3. County: JACKSON		4. Address (Street No.): 215	Street (name): E. 18th Street
5. City: Kansas City	Vicinity <input type="checkbox"/>	6. Lat / Long: 39.091481 -94.580440	7. Township/Range/Section: T: R: S:
8. Historic name (if known): Interstate Securities Building		9. Present/other name (if known):	
10. Ownership: <input checked="" type="checkbox"/> Private <input type="checkbox"/> Public		11a. Historic use (if known): Commercial	11b. Current use: Commercial

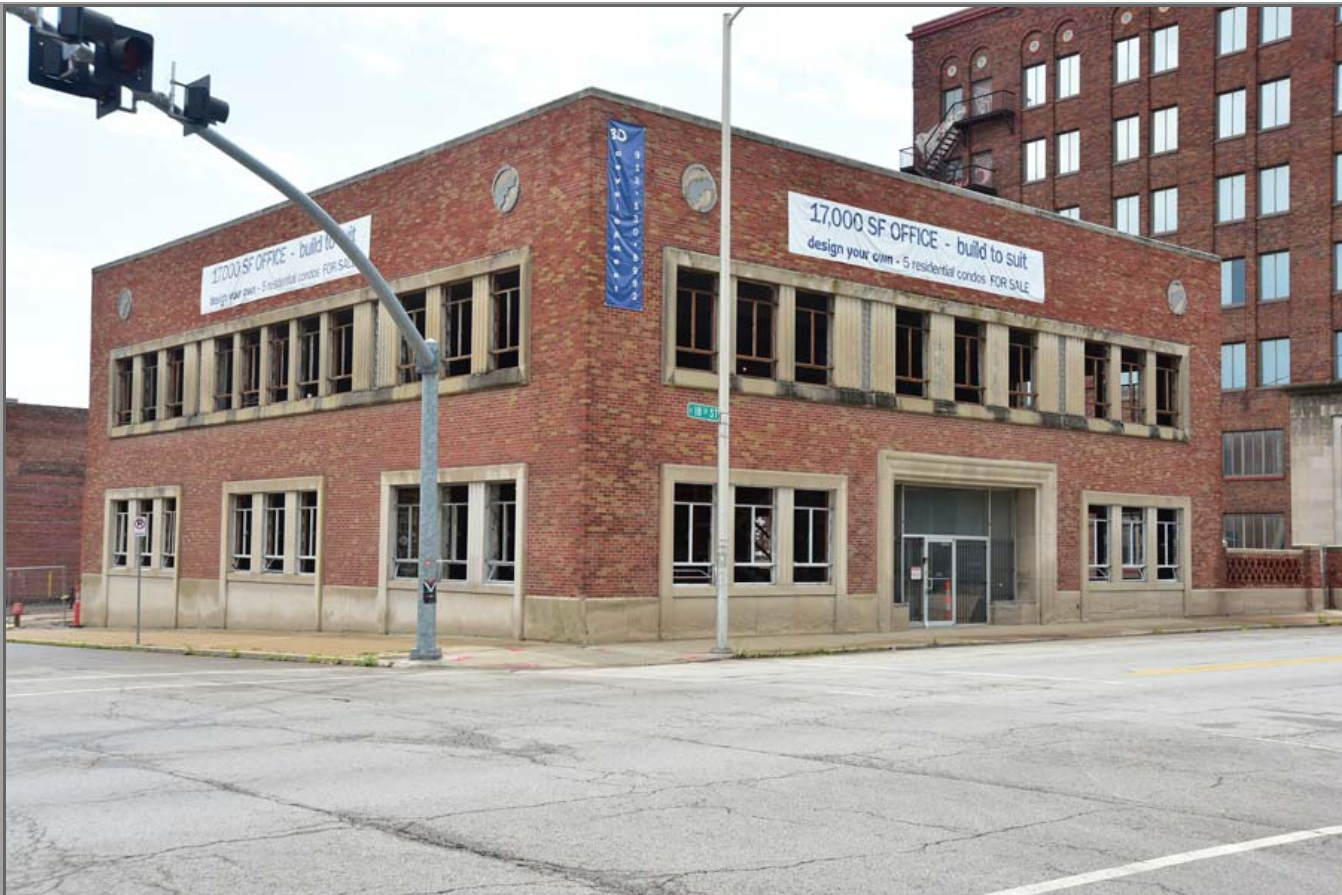
Photographer Brad Finch, f-stop Photography	Date: June 29, 20	Description: east and north elevations, view SW
--	----------------------	--

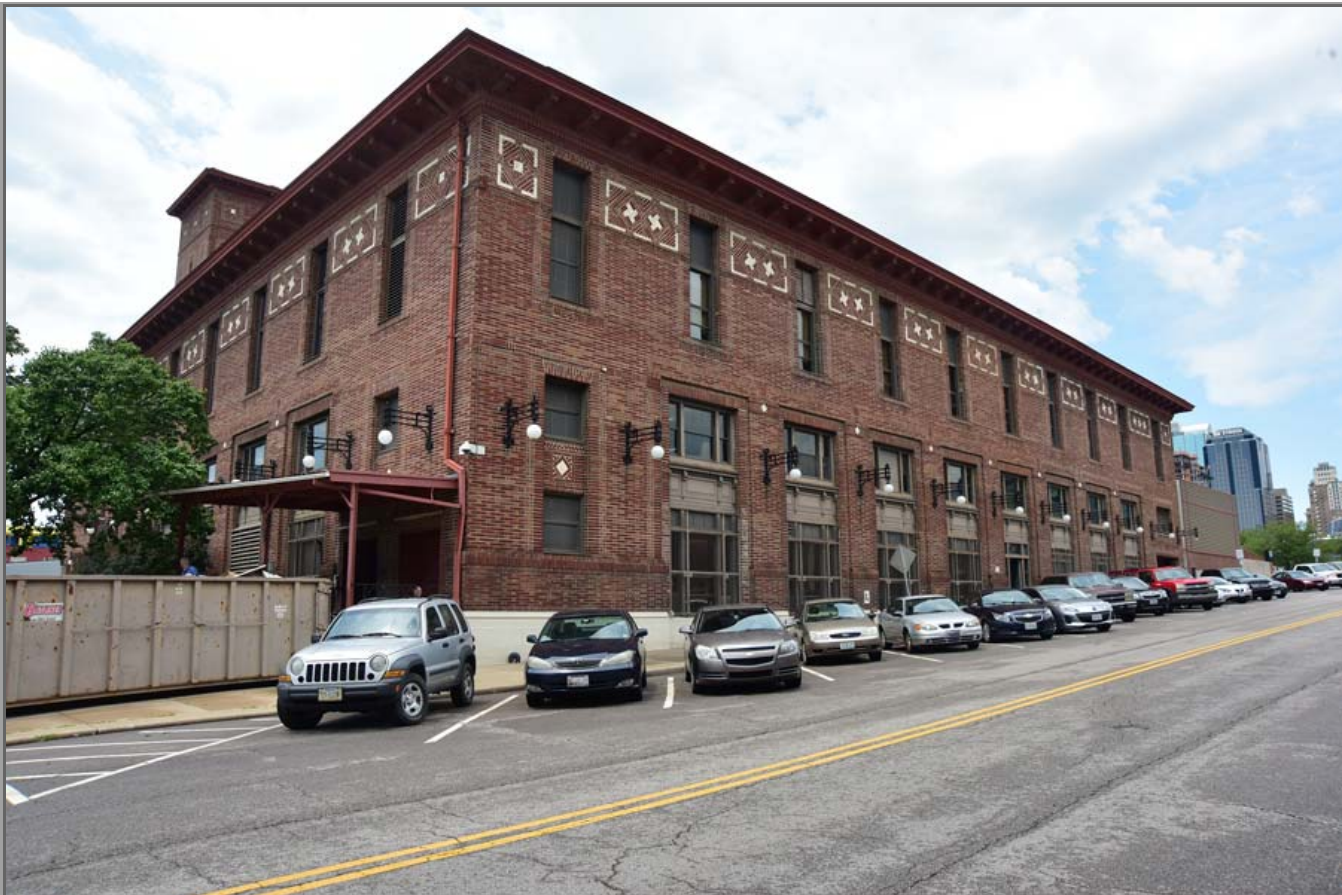
Photographer Brad Finch, f-stop Photography	Date: June 29, 20	Description: south and east elevations, view NW
--	----------------------	--

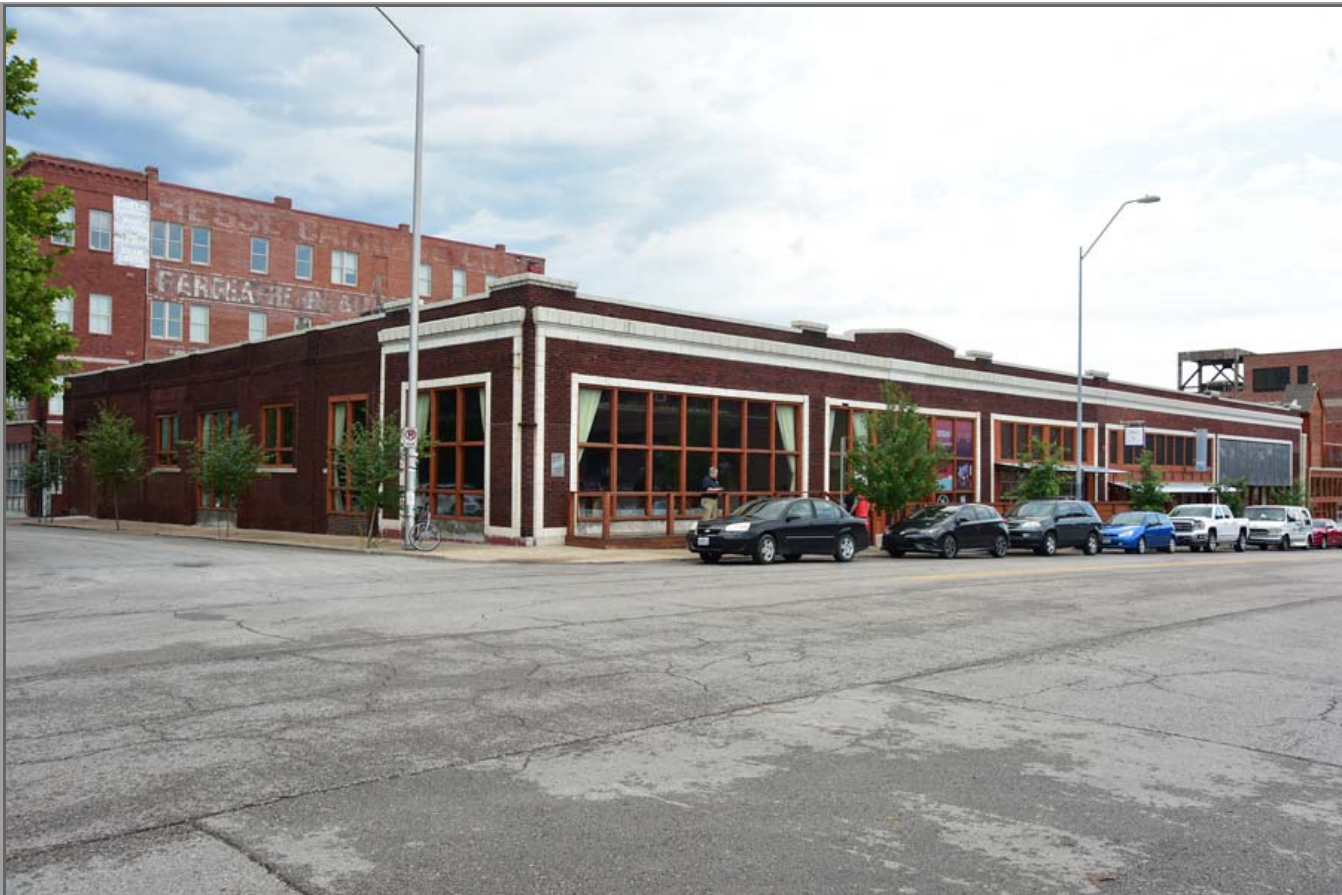
Photographer Brad Finch, f-stop Photography	Date: June 29, 20	Description: north and west elevations, view SE
--	----------------------	--

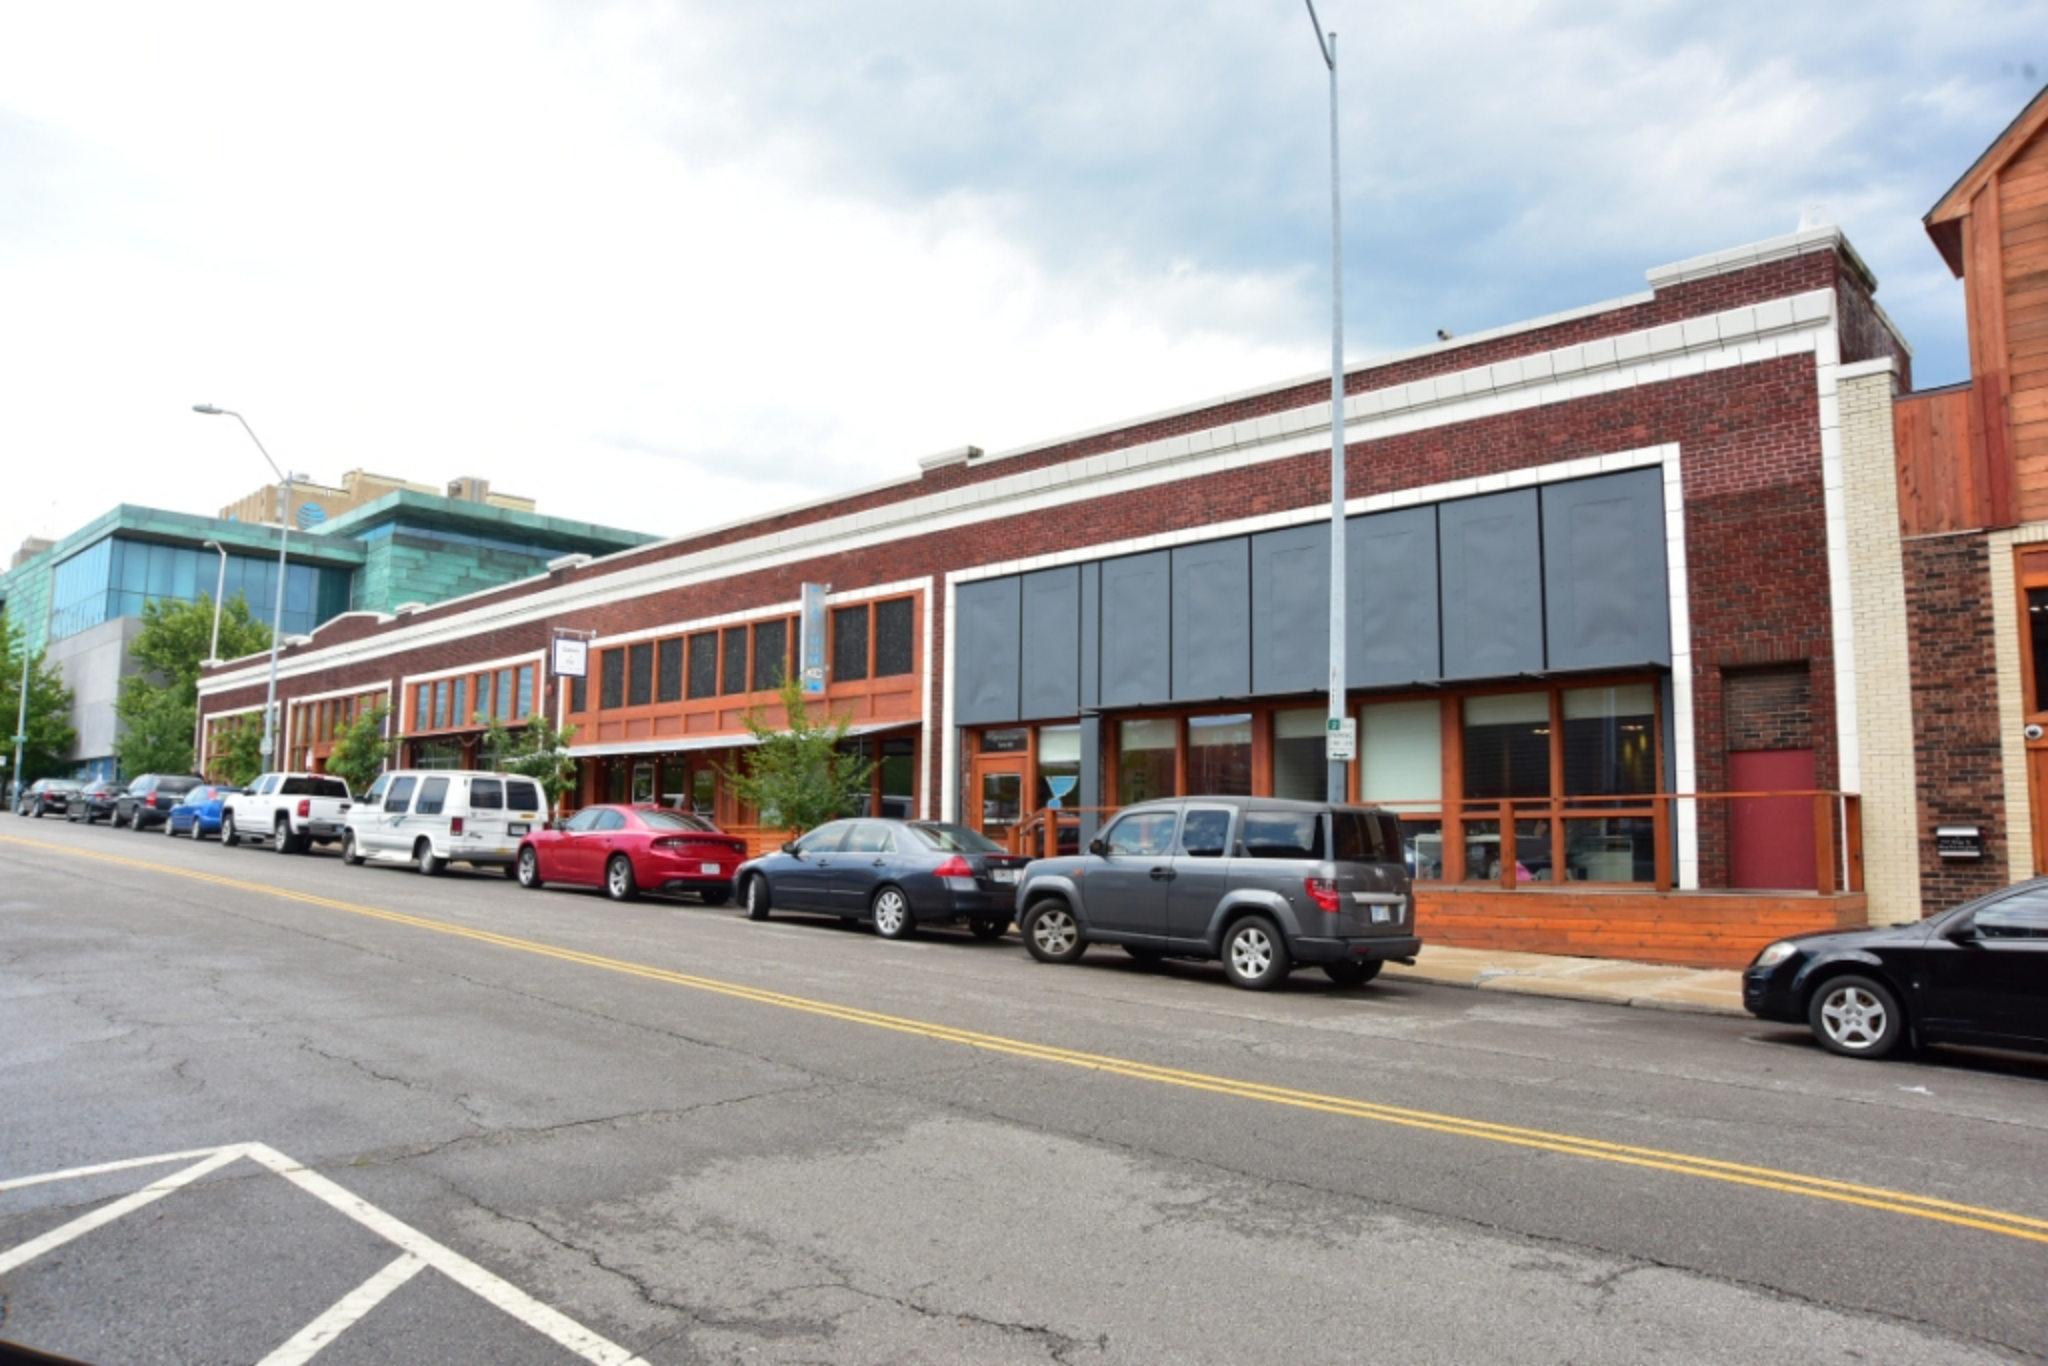
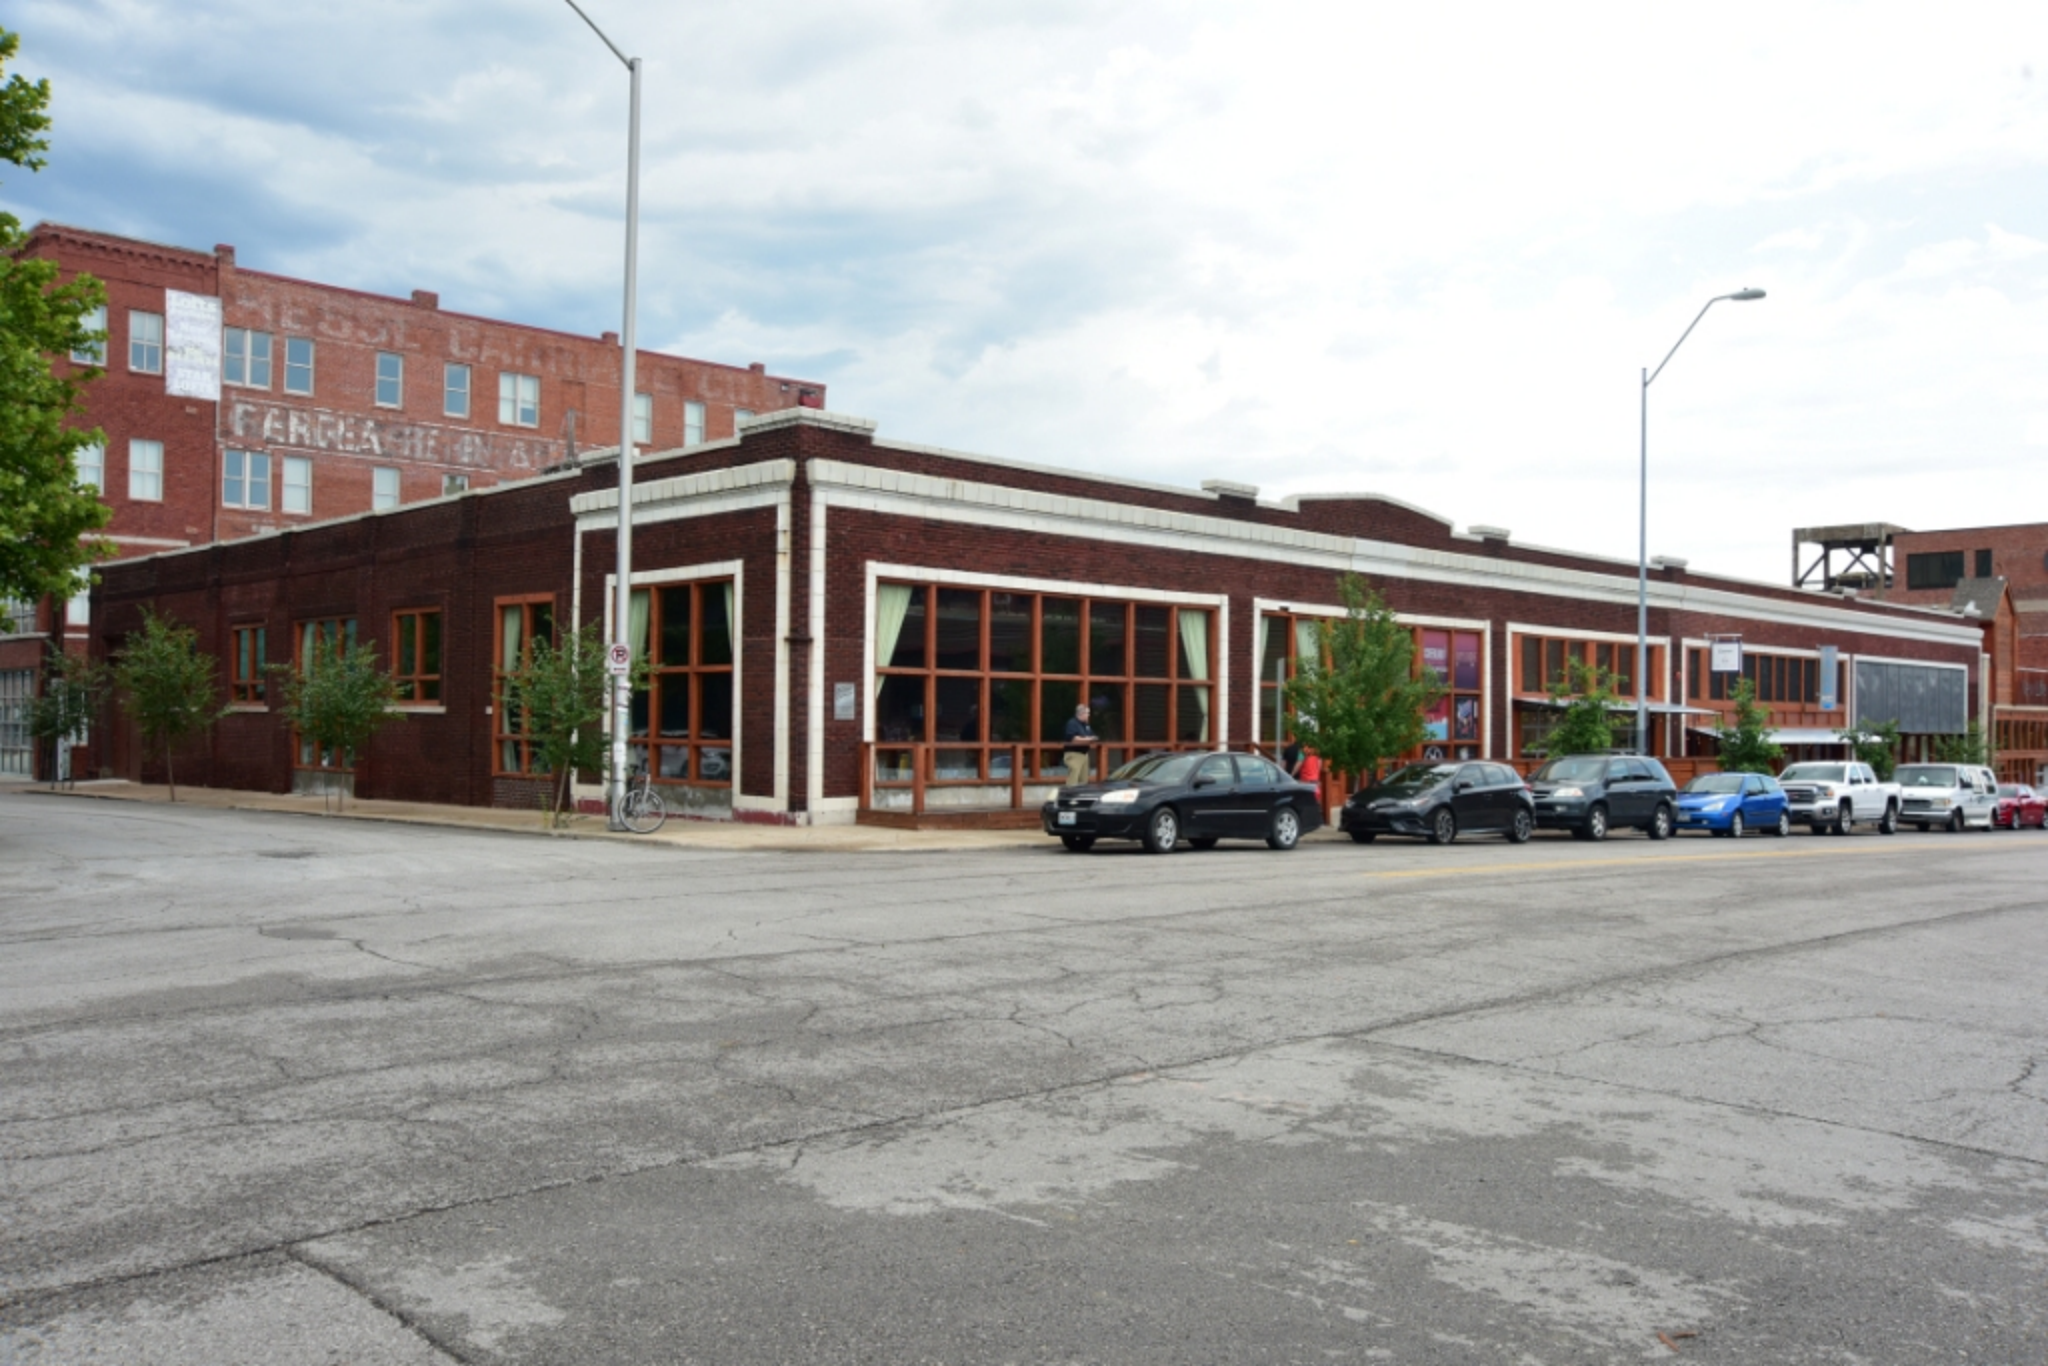
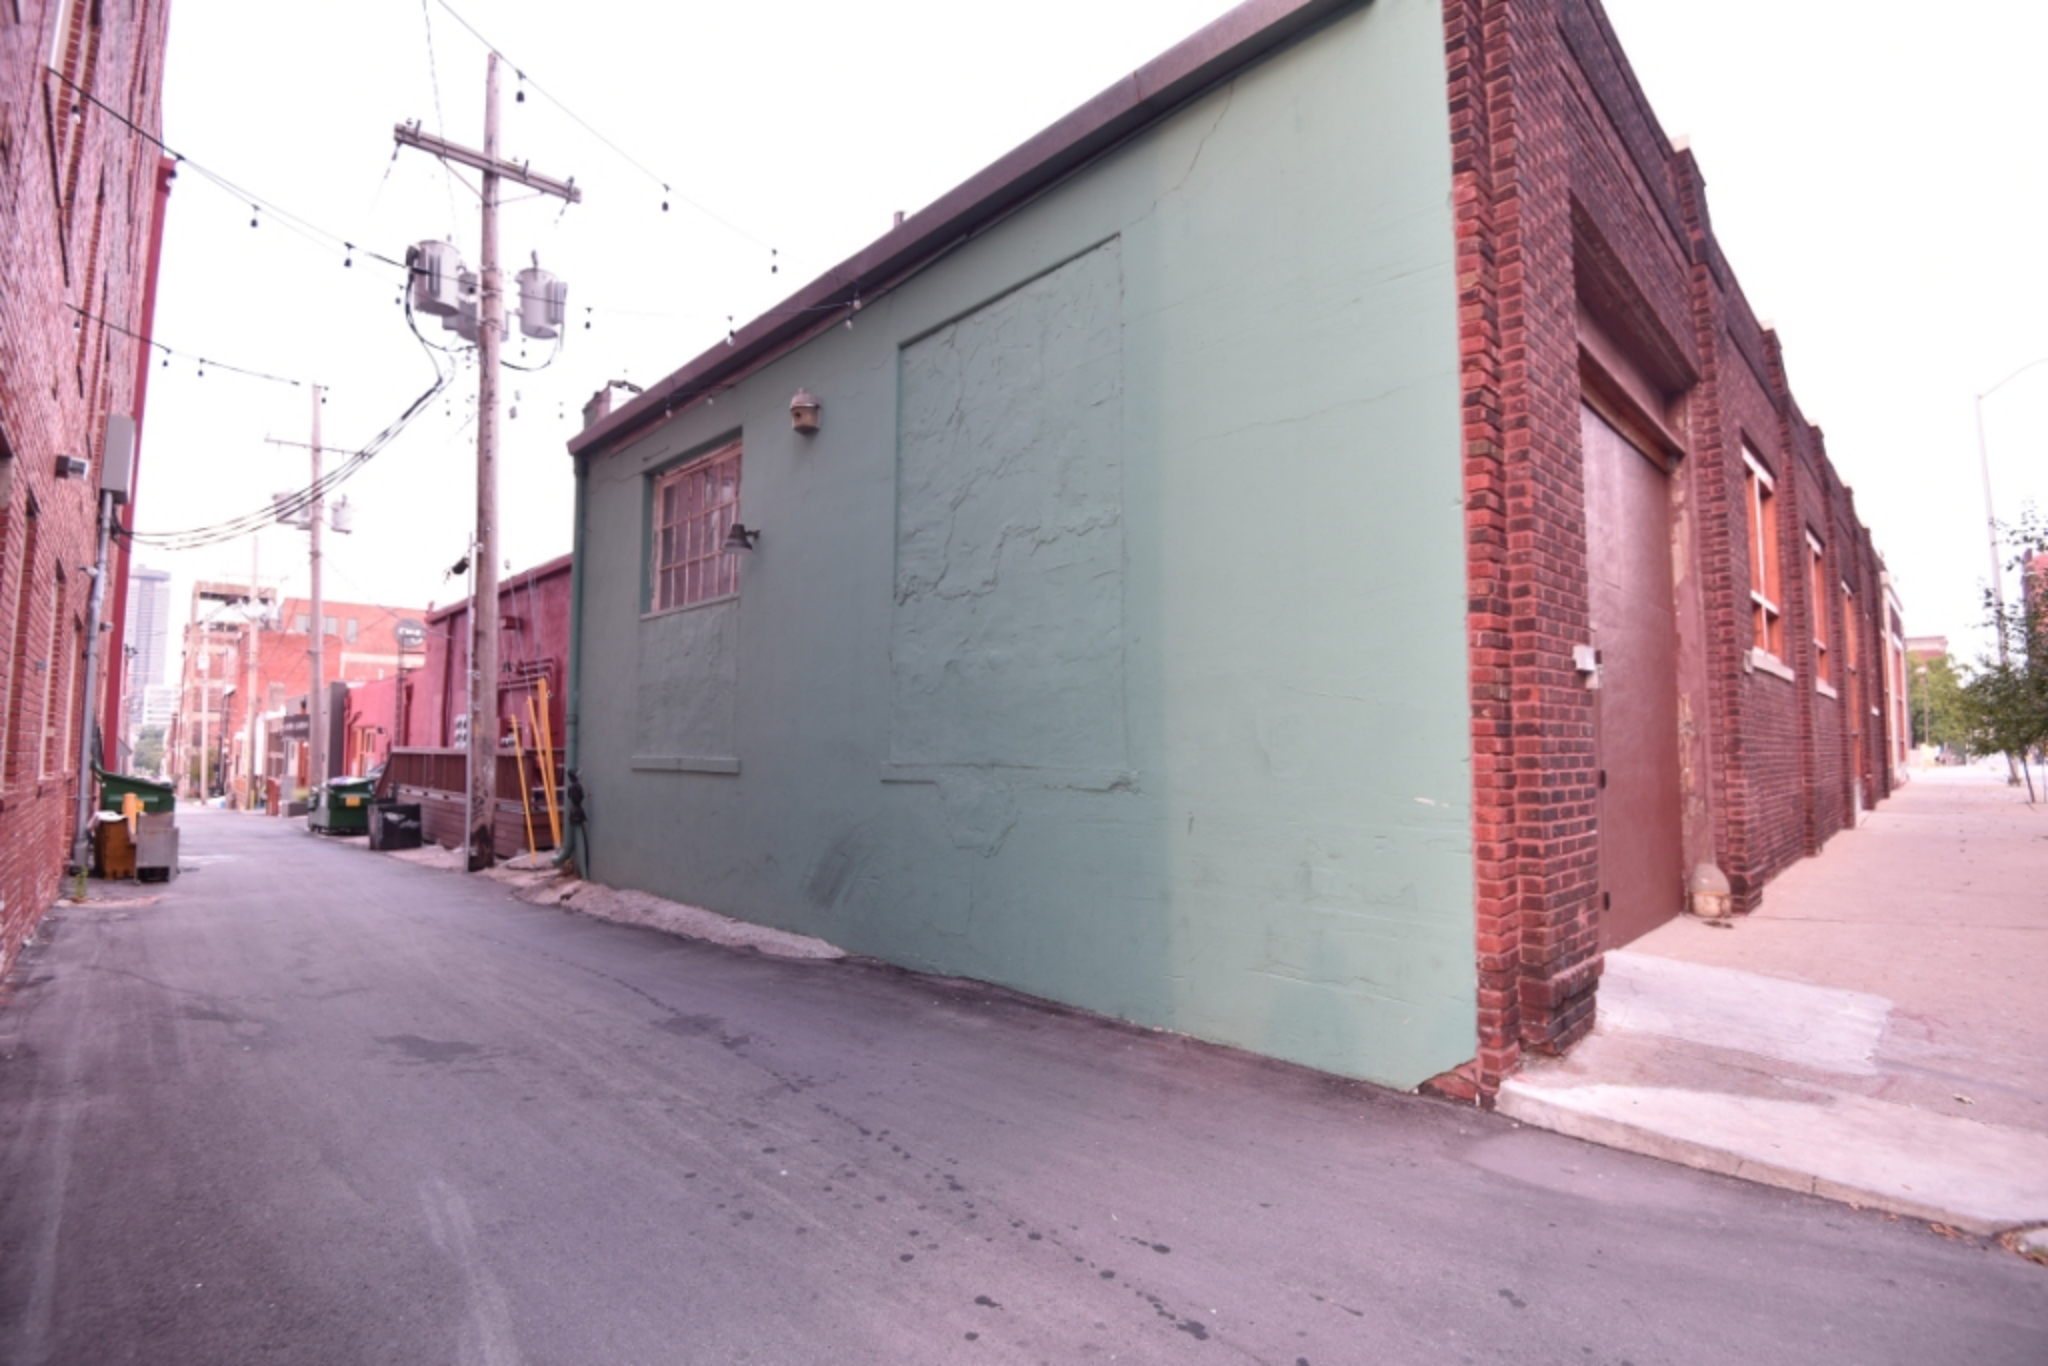
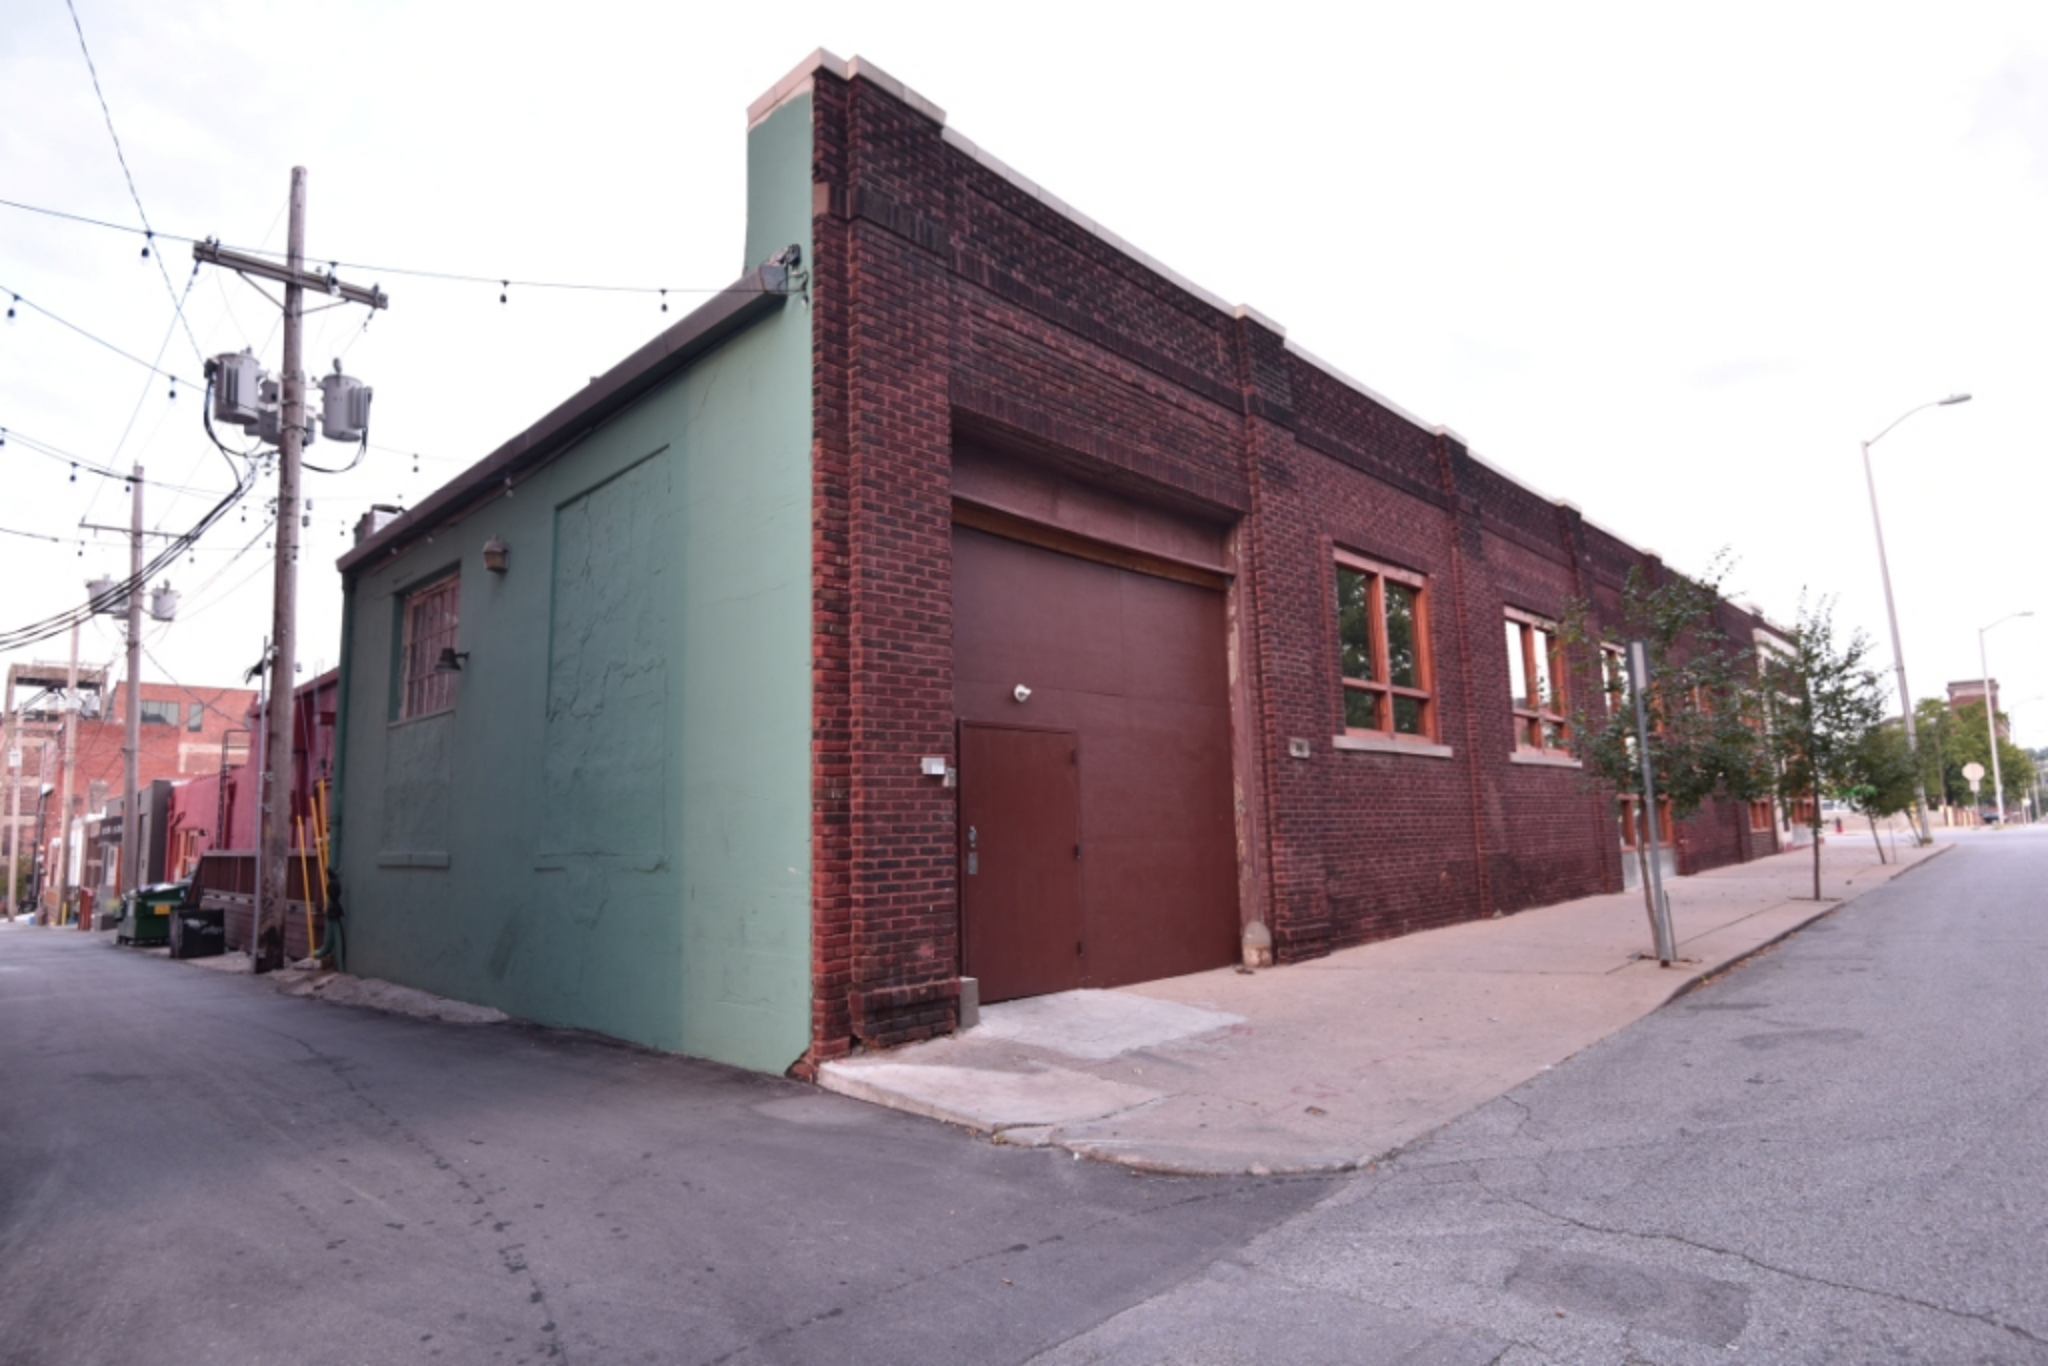
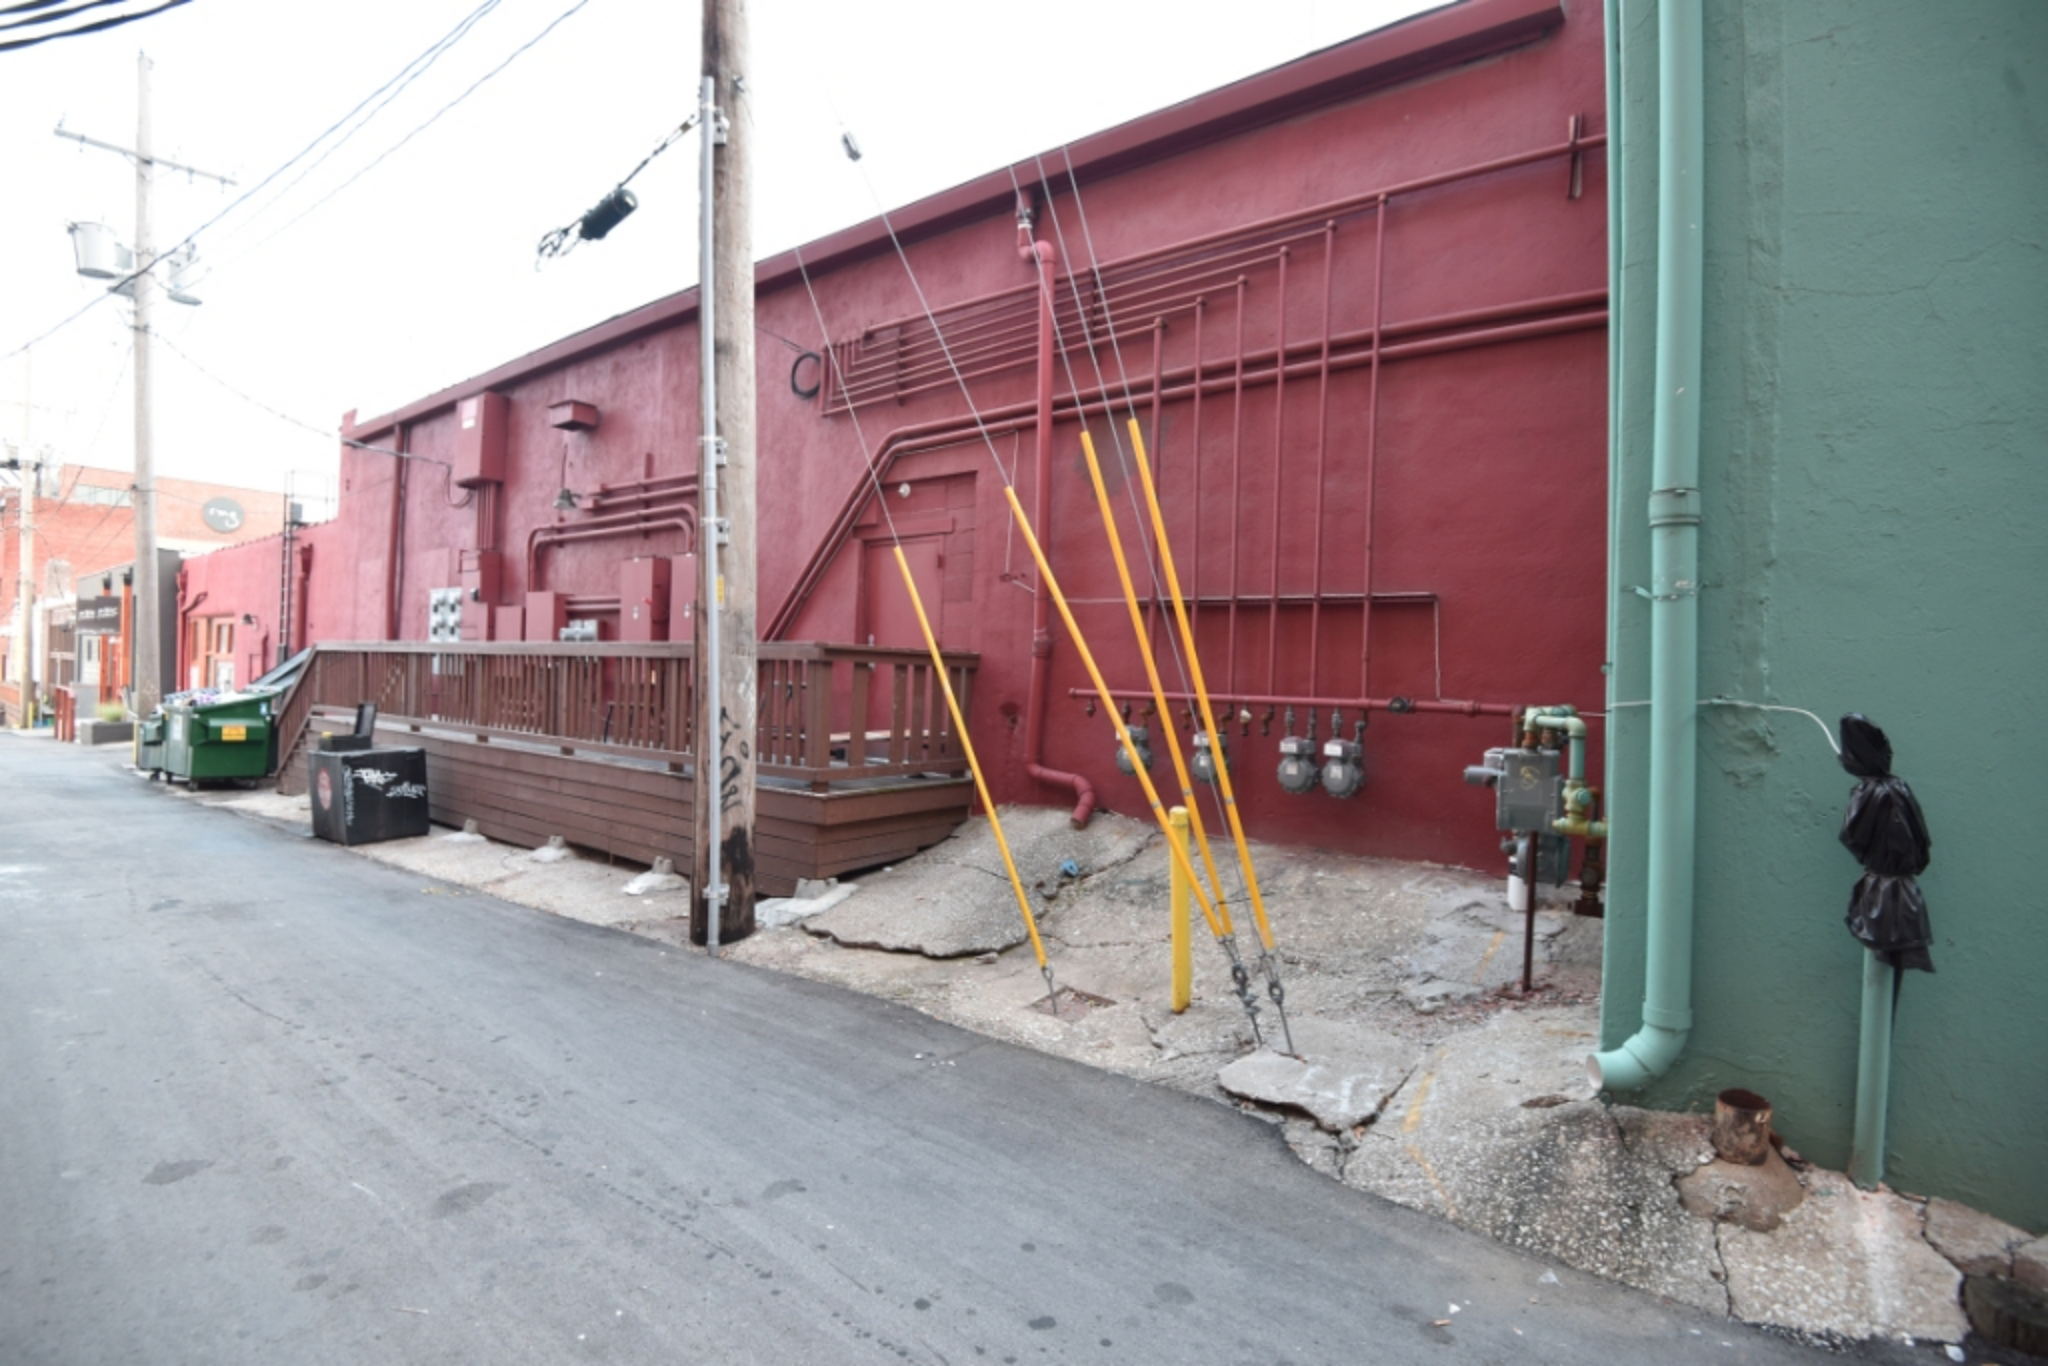
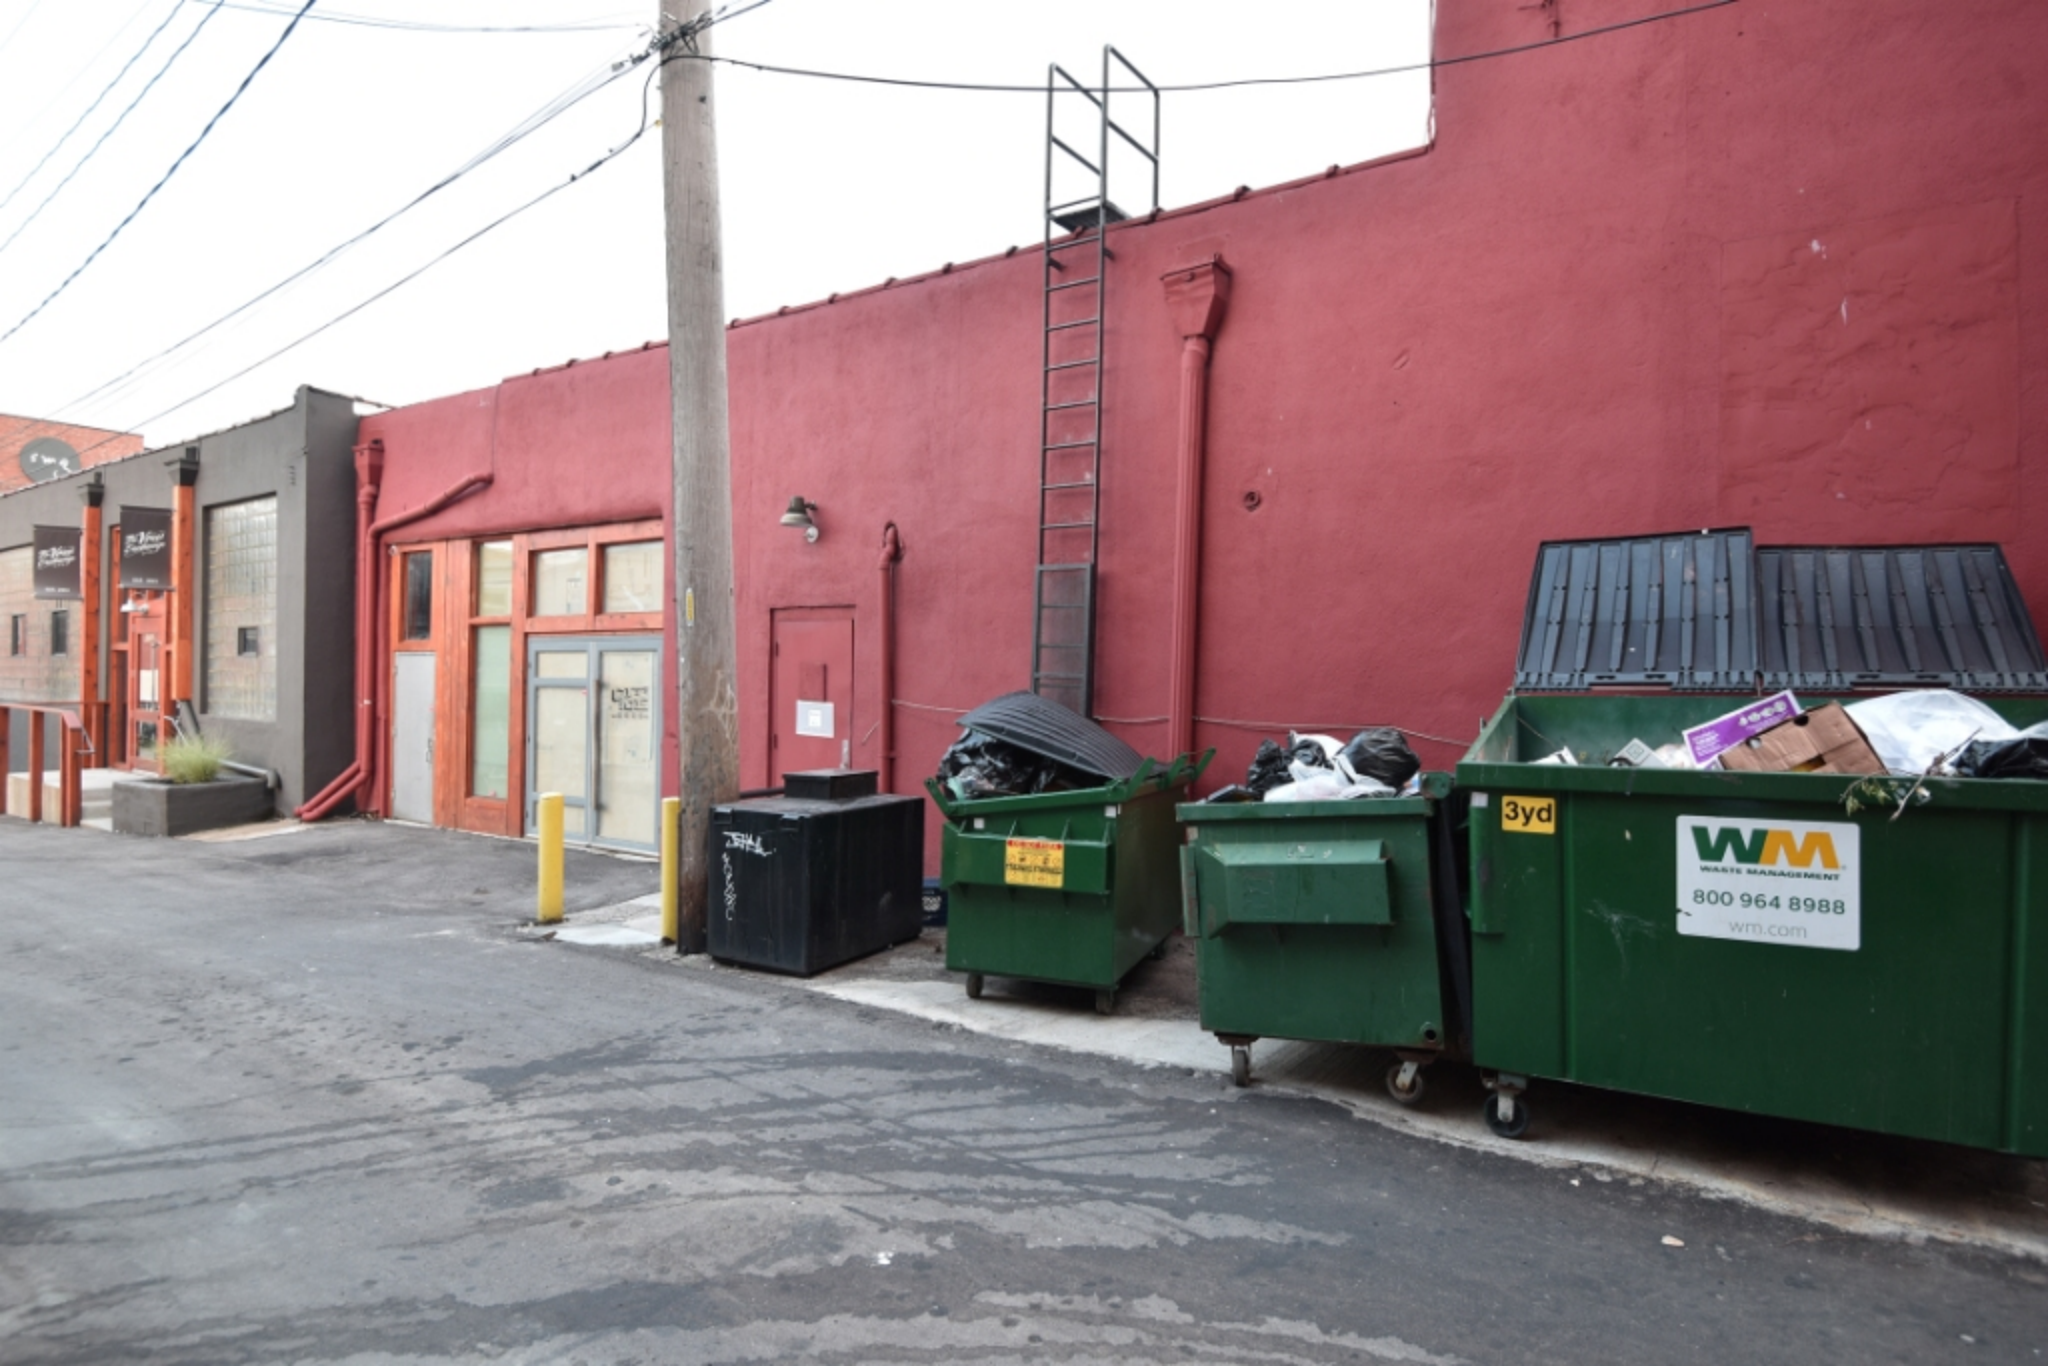
This one-story brick building has a rectangular plan and a flat roof with a parapet. The building occupies a corner lot and fronts McGee Street. Five bays organize the front (west) elevation. Raised columns with terra cotta coping define each bay at the roofline. A peaked parapet rises over the second bay. A glazed white terra cotta stringcourse spans the west elevation and the first bay of the north elevation under the roofline. Glazed white terra cotta bands surround five storefront openings on the west and the first bay of the north elevation. Non-historic wood storefronts fill the historic openings. While the storefront materials are not historic, they retain the historic proportions of transoms, display windows, and entrances. Brick pilasters define seven bays on the north elevation. Non-historic windows fill historic openings on the north elevation. Brick soldier course and concrete sills line window openings. A pair of metal slab doors will the northeast bay.

Rear elevations are parged with parapets. Two metal slab doors provide pedestrian access on the north portion. A metal slab door and a double metal door with glazing pierce the middle section rear elevation. Fixed light and transoms surround the non-historic door construction that fills a large opening that was possibly a vehicle entry. Large glass block glazing with centered fixed windows flank a wood entry door with glazing, sidelights, and transoms on the southern portion of the rear elevation. The entry is raised with concrete stairs accessing it.

1701 McGee Street has good integrity and is recommended as a contributing resource to a potential historic district. The building is associated with automobile-related commercial buildings concentrated in an "Automobile Row" along McGee Street. The building retains the large display window openings and vehicular entrances that convey its significance as an early automobile-related commercial building.

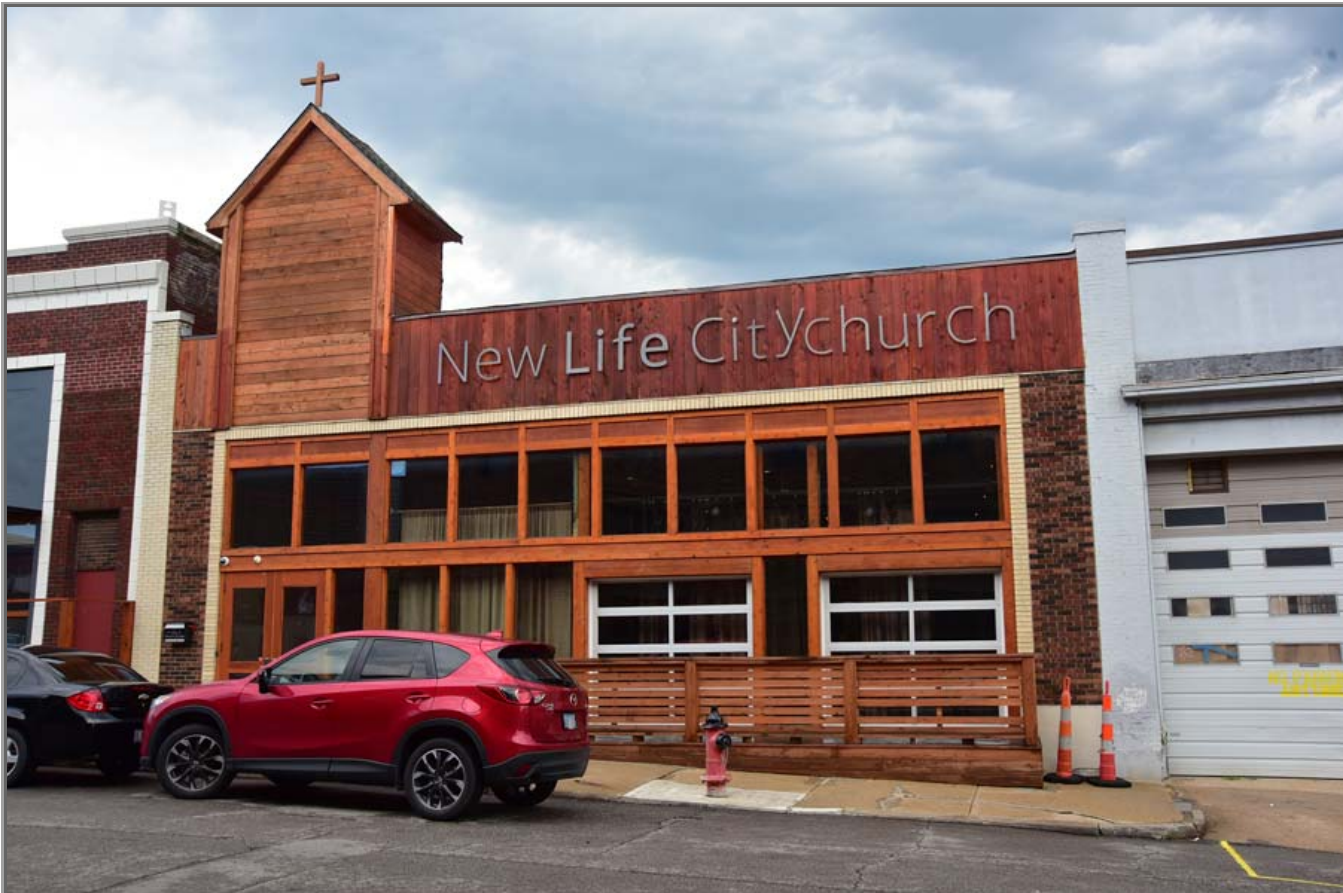
Photographer Brad Finch, f-stop Photography	Date: June 29, 2017	Description: west elevation, view E
--	------------------------	--

The building at 1717 McGee has poor integrity. Alterations to the parapet and storefront compromise its ability to convey its significance as an early twentieth century automobile-related commercial building. The addition of a raised element above the parapet alters the form and disrupts the streetwall created by commercial buildings of similar scale. The resource is recommended as non-contributing to the potential historic district.
