MISSOURI DEPARTMENT OF NATURAL RESOURCES
STATE HISTORIC PRESERVATION OFFICE, P.O. Box 176, Jefferson City, MO 65102
ARCHITECTURAL/HISTORIC INVENTORY FORM

1. Survey number: JA-AS-087-025		2. Survey Name: McGee Street Historic Resources Survey 2017	
3. County: JACKSON		4. Address (Street No.): 215	Street (name): E. 18th Street
5. City: Kansas City	Vicinity <input type="checkbox"/>	6. Lat / Long: 39.091481 -94.580440	7. Township/Range/Section: T: R: S:
8. Historic name (if known): Interstate Securities Building		9. Present/other name (if known):	
10. Ownership: <input checked="" type="checkbox"/> Private <input type="checkbox"/> Public		11a. Historic use (if known): Commercial	11b. Current use: Commercial

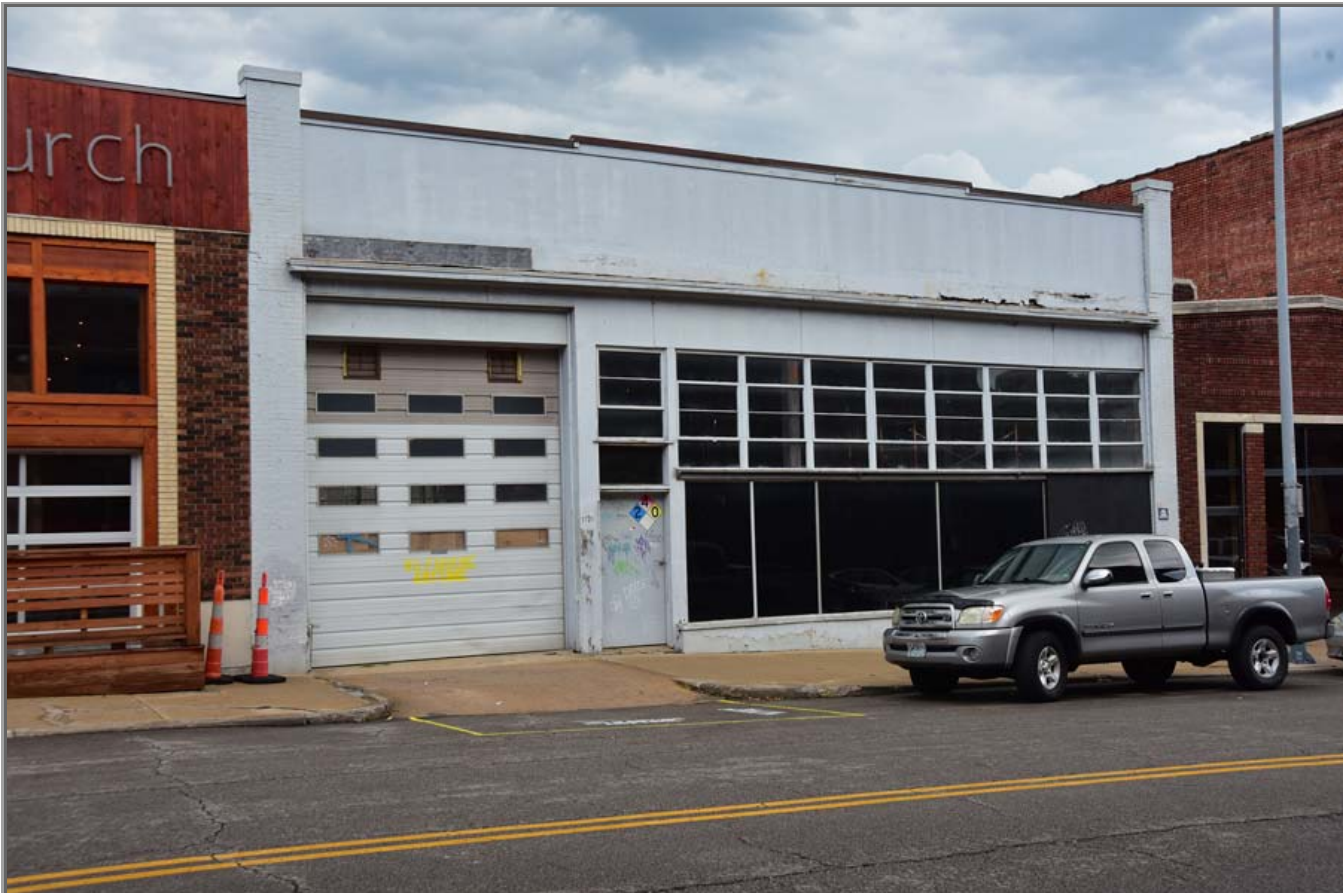
Photographer Brad Finch, f-stop Photography	Date: June 29, 20	Description: west elevation, view SE
--	----------------------	---

1721 McGee Street has good integrity and is recommended as a contributing resource to a potential historic district. The building is associated with automobile-related commercial buildings concentrated in an "Automobile Row" along McGee Street. The building retains the configuration of the vehicular entrance and storefront display windows that convey integrity and communicate its significance as an early automobile-related commercial building.

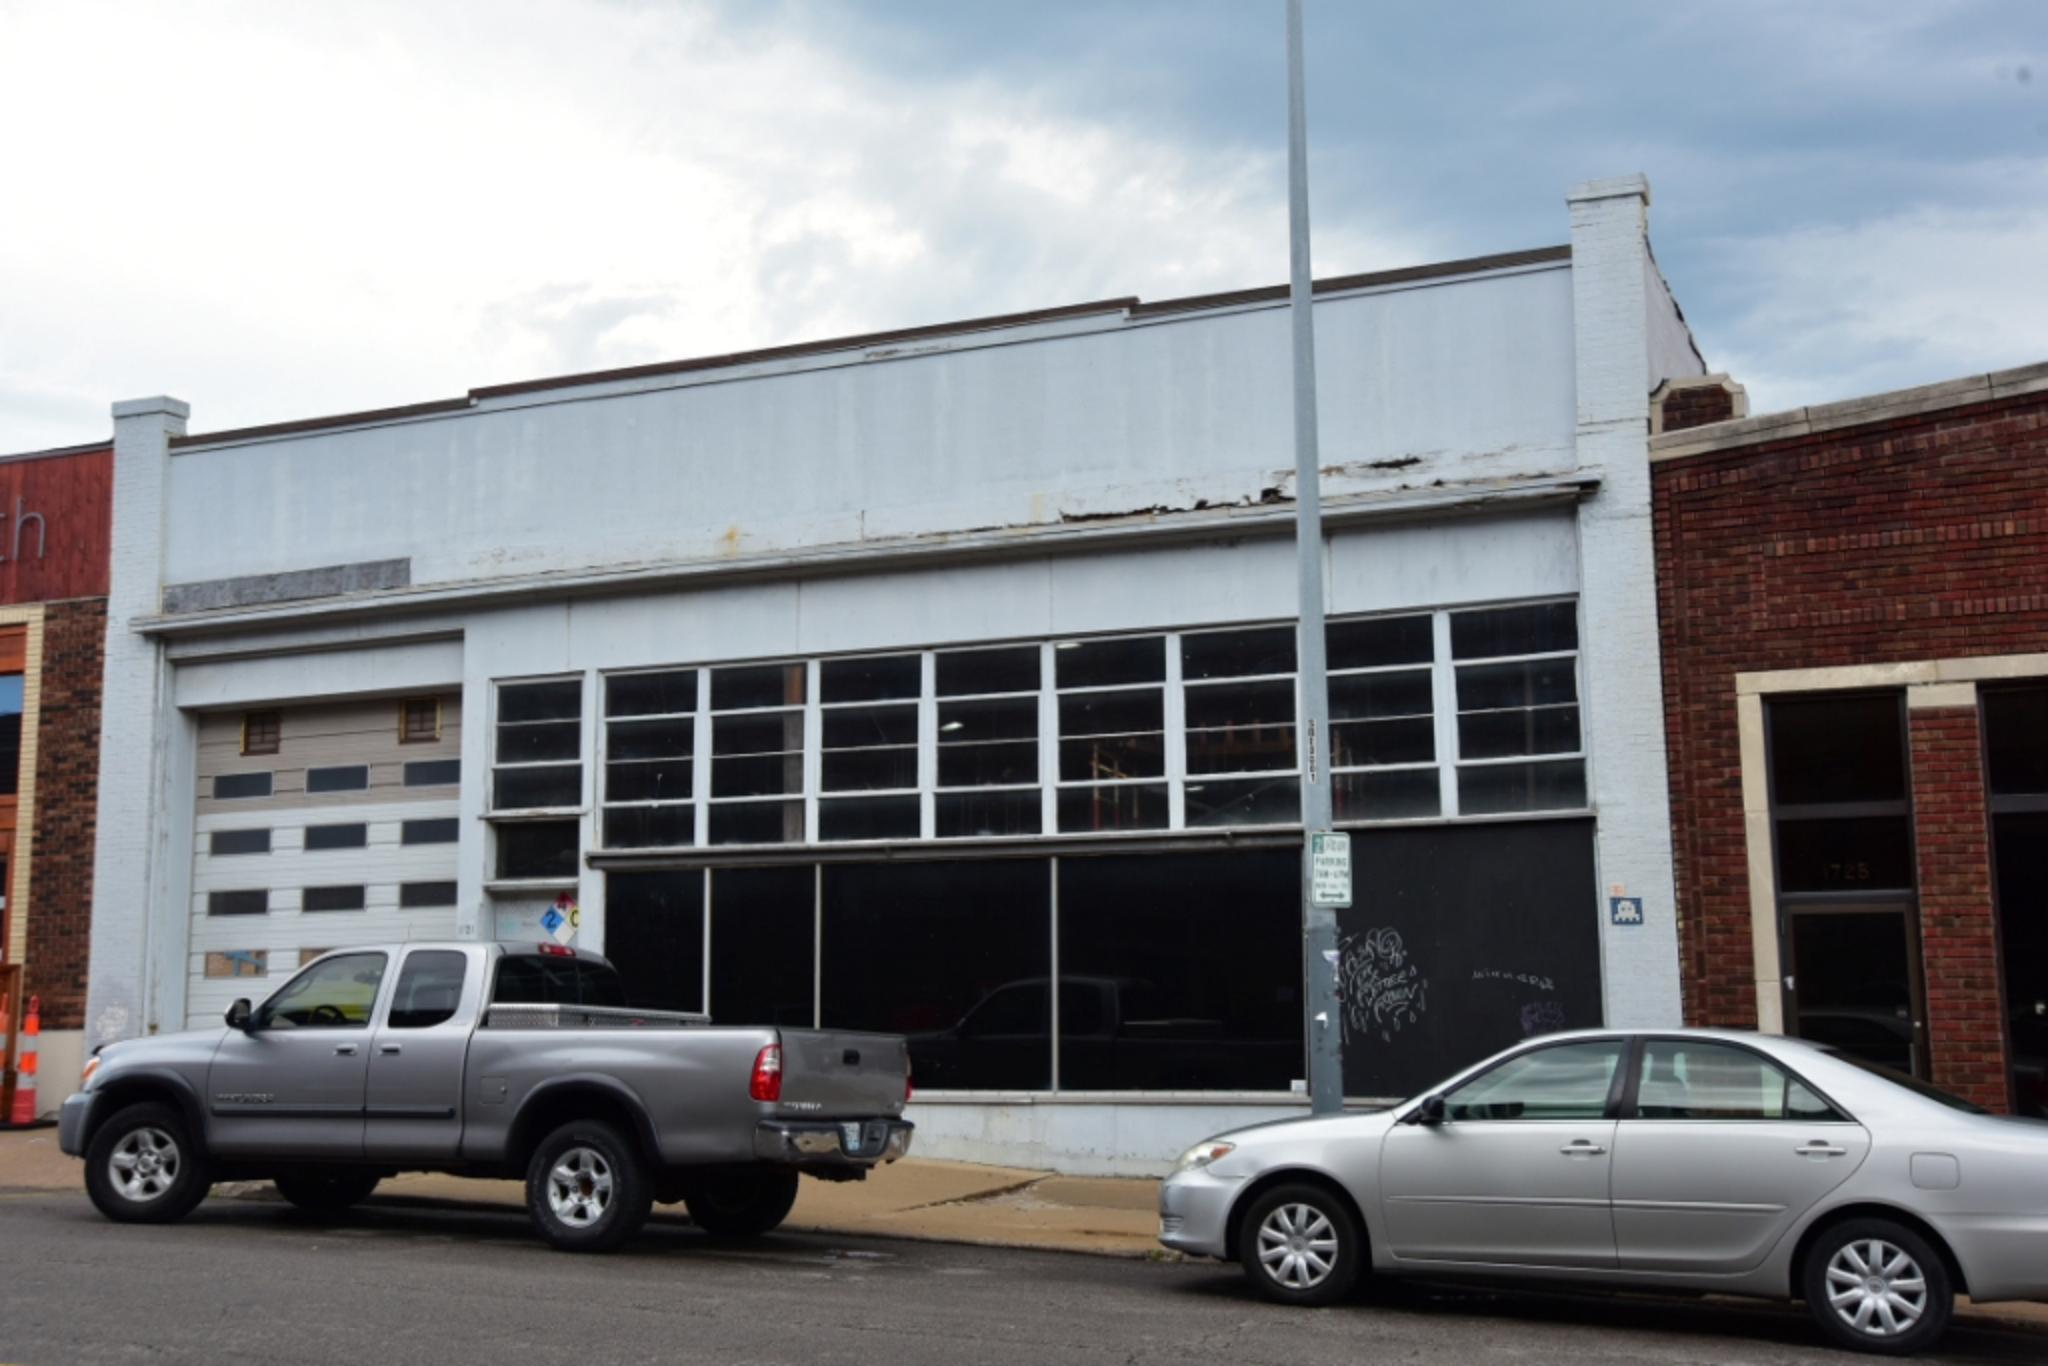
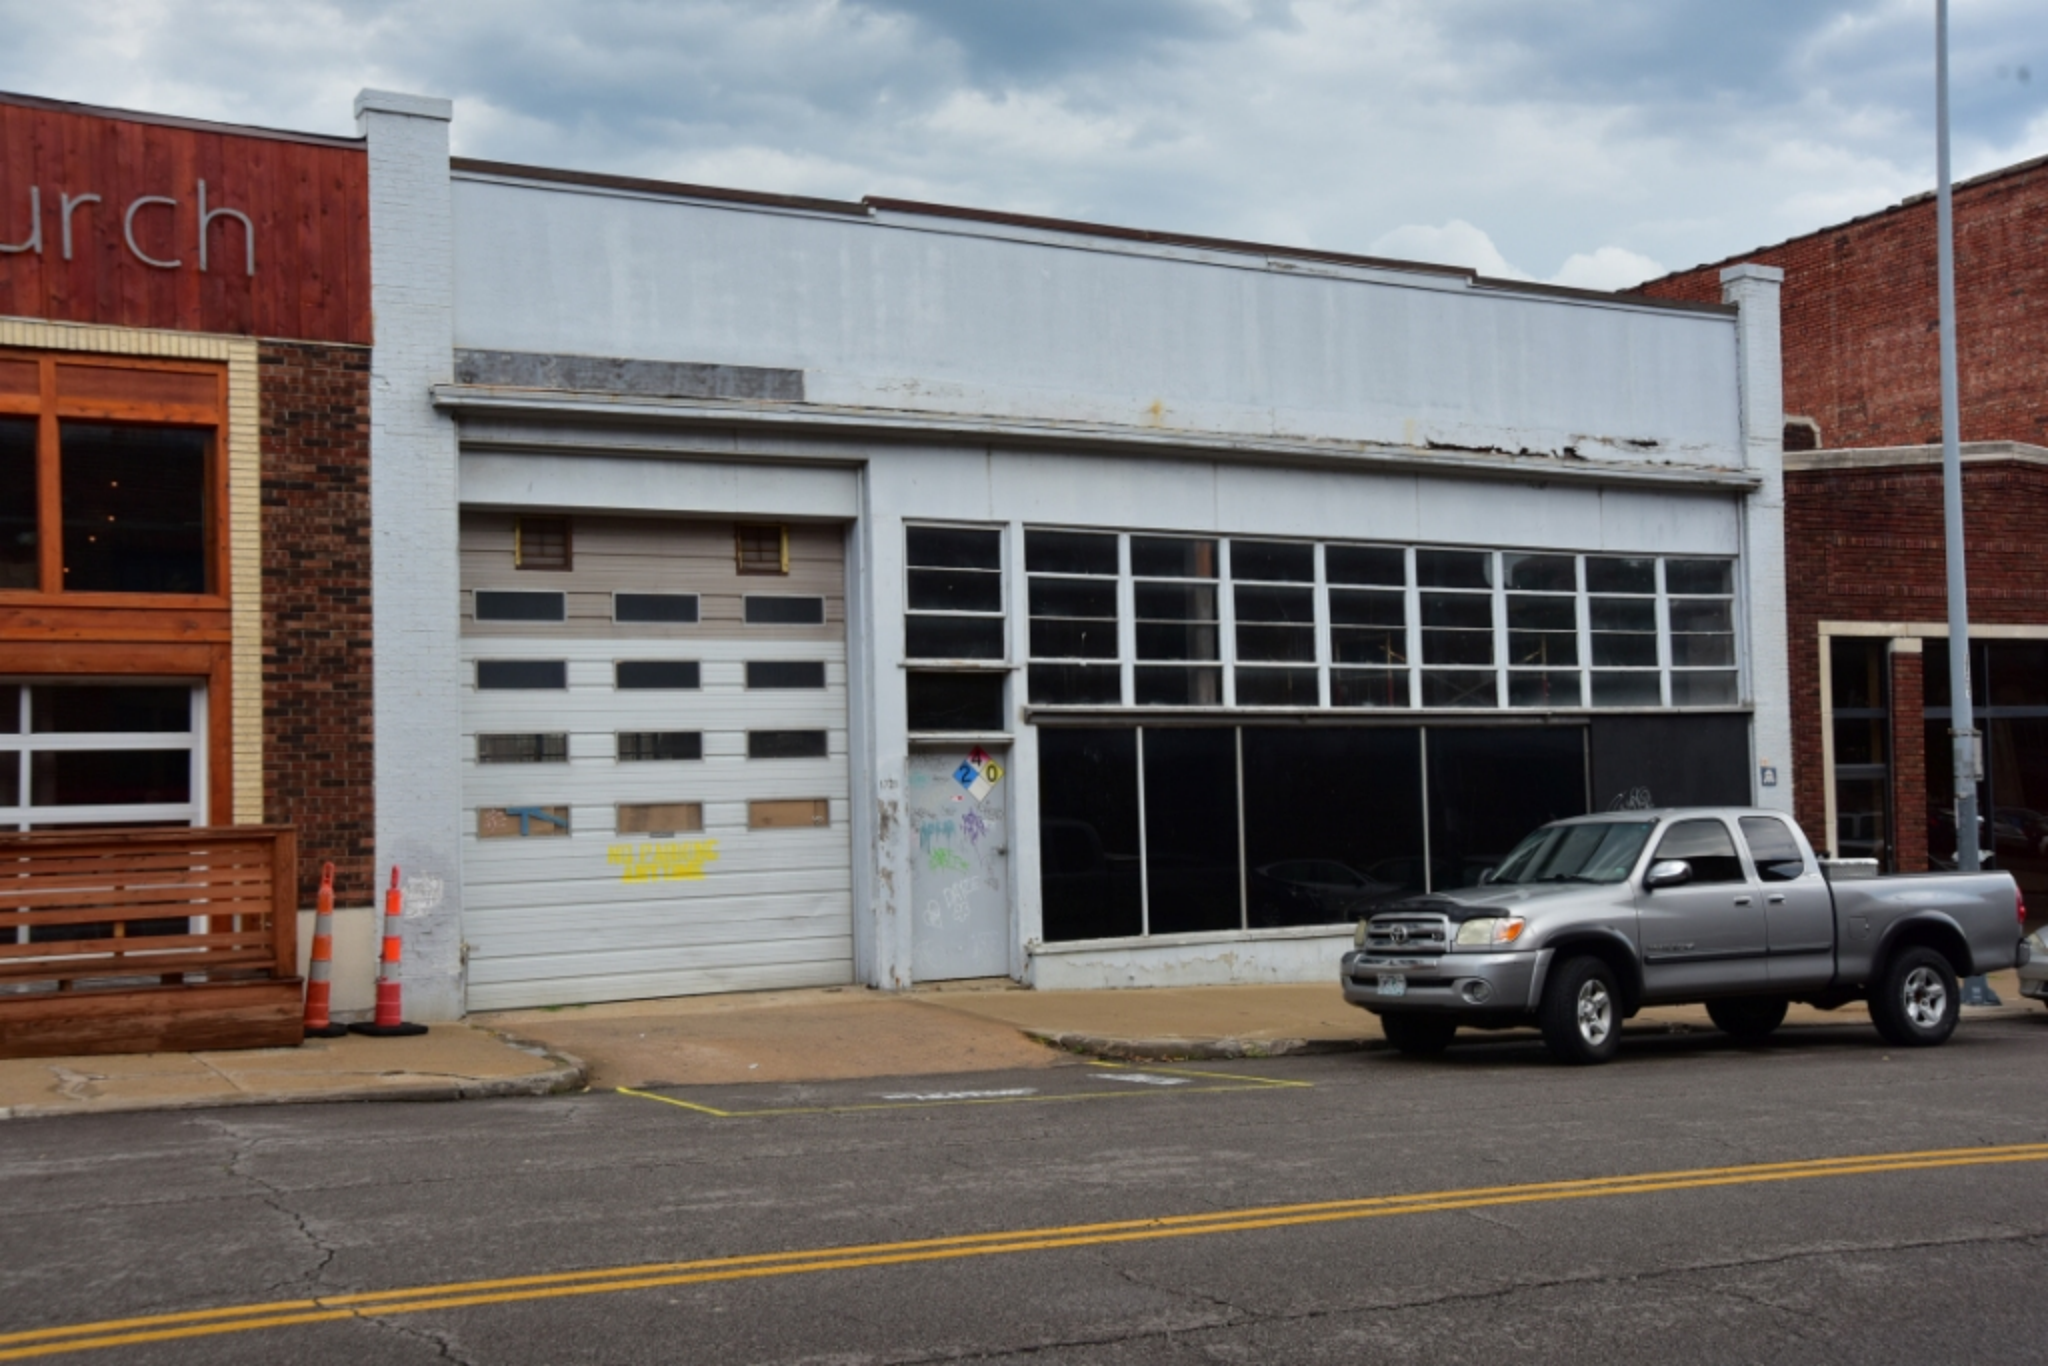
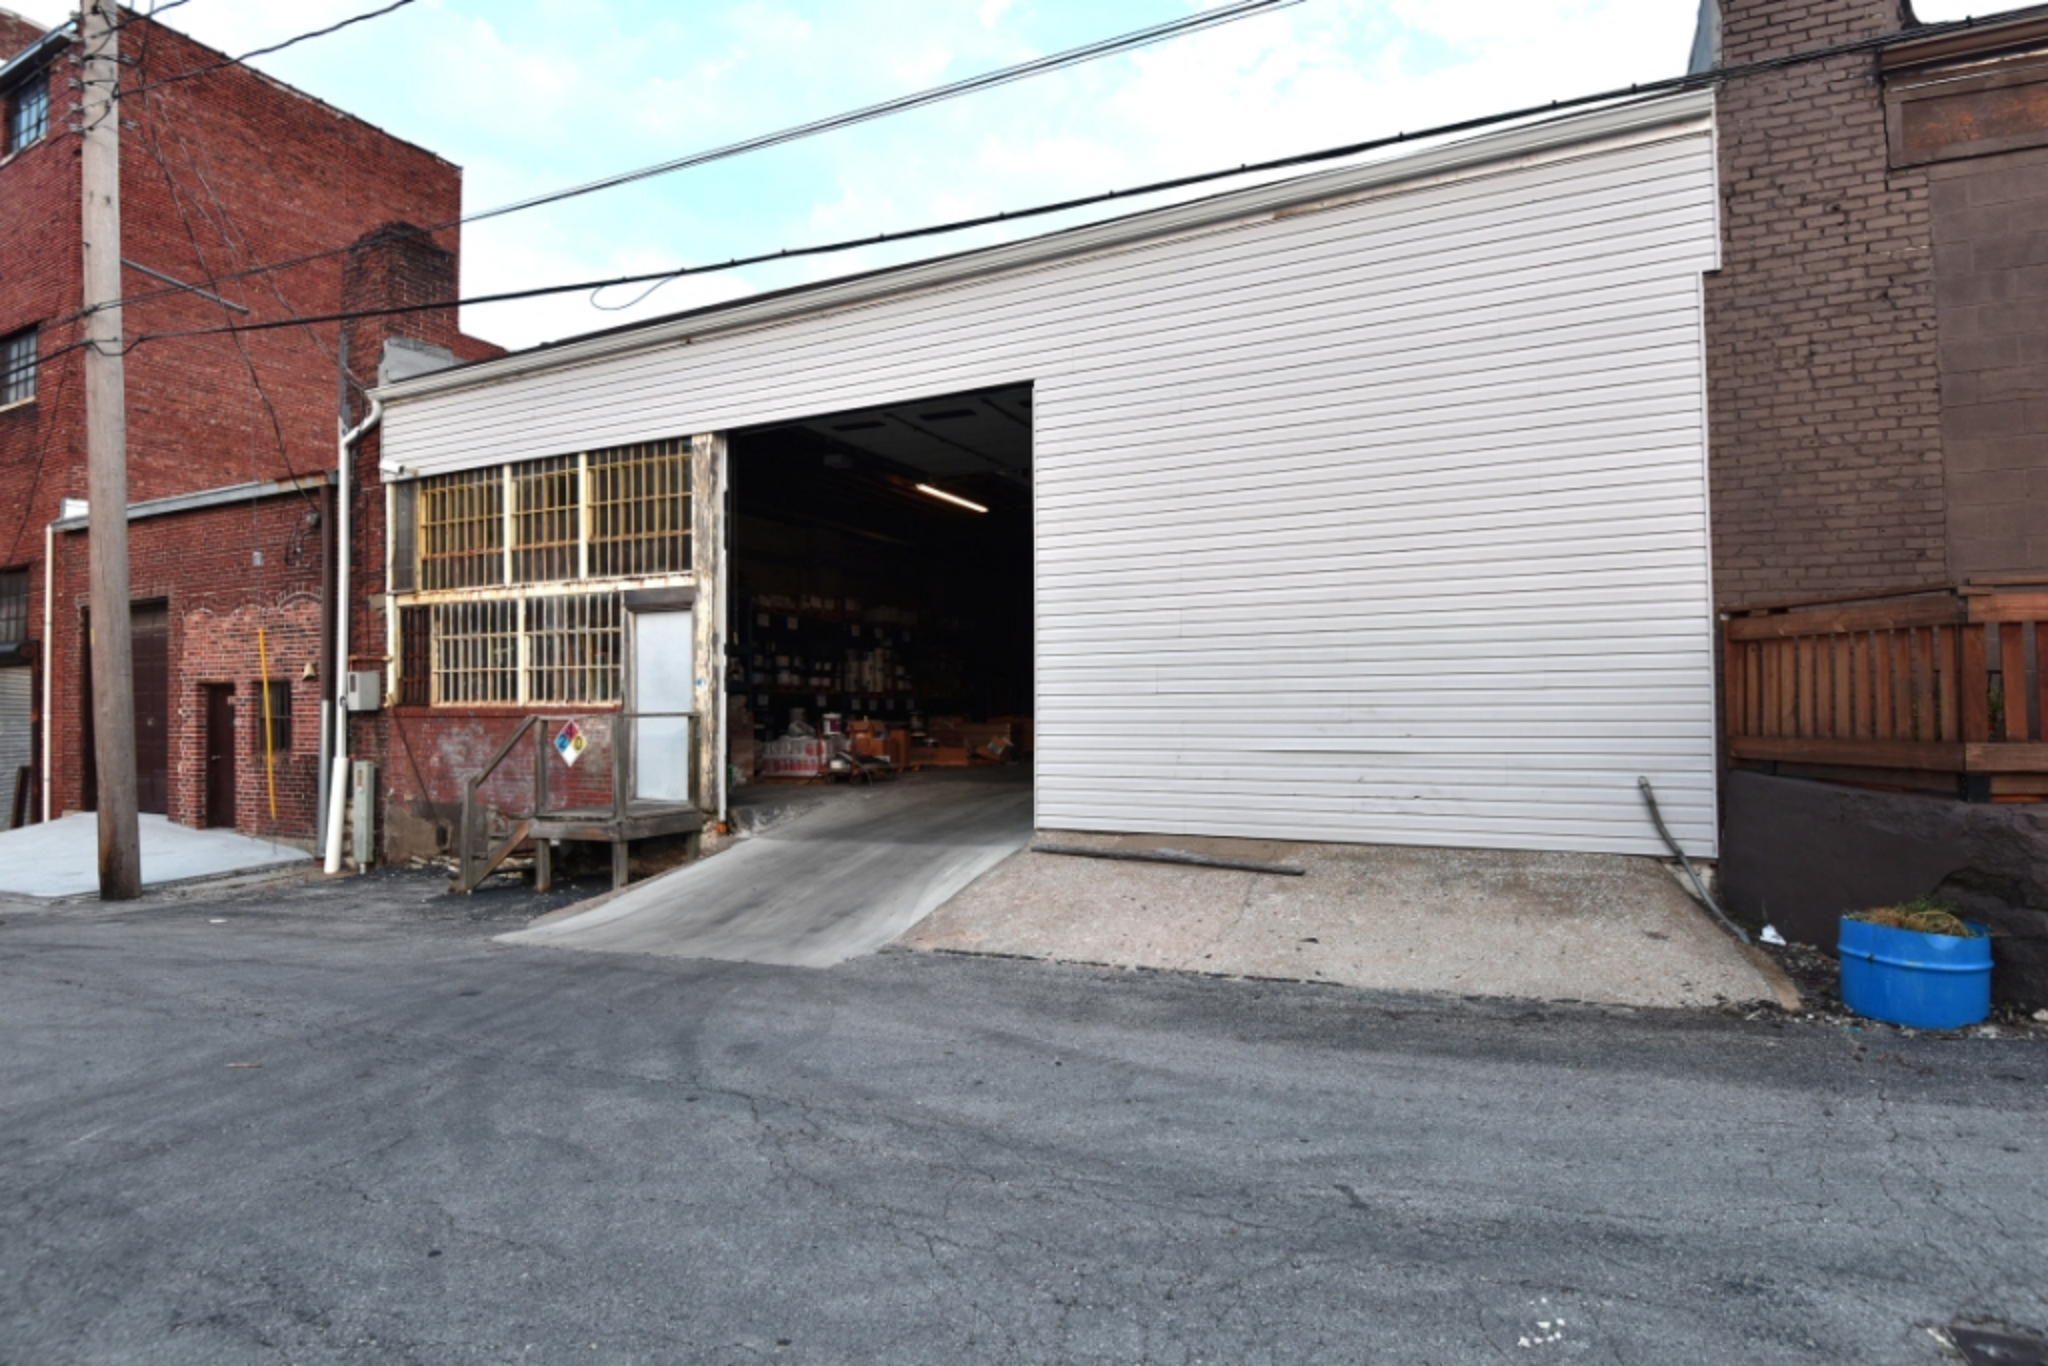
This one-story brick building has a rectangular plan and a flat roof with a parapet. Plywood covers the storefront frame and at the parapet. Historic painted brick pilasters are visible on each end of the façade. A metal overhead rolling door with glazing fills the north bay. A band of rectangular metal windows with operable middle sash top fixed aluminum storefront windows and a non-historic metal slab door in the south bay. A slightly raised parapet has metal coping. A metal ledge cornice spans the west elevation.

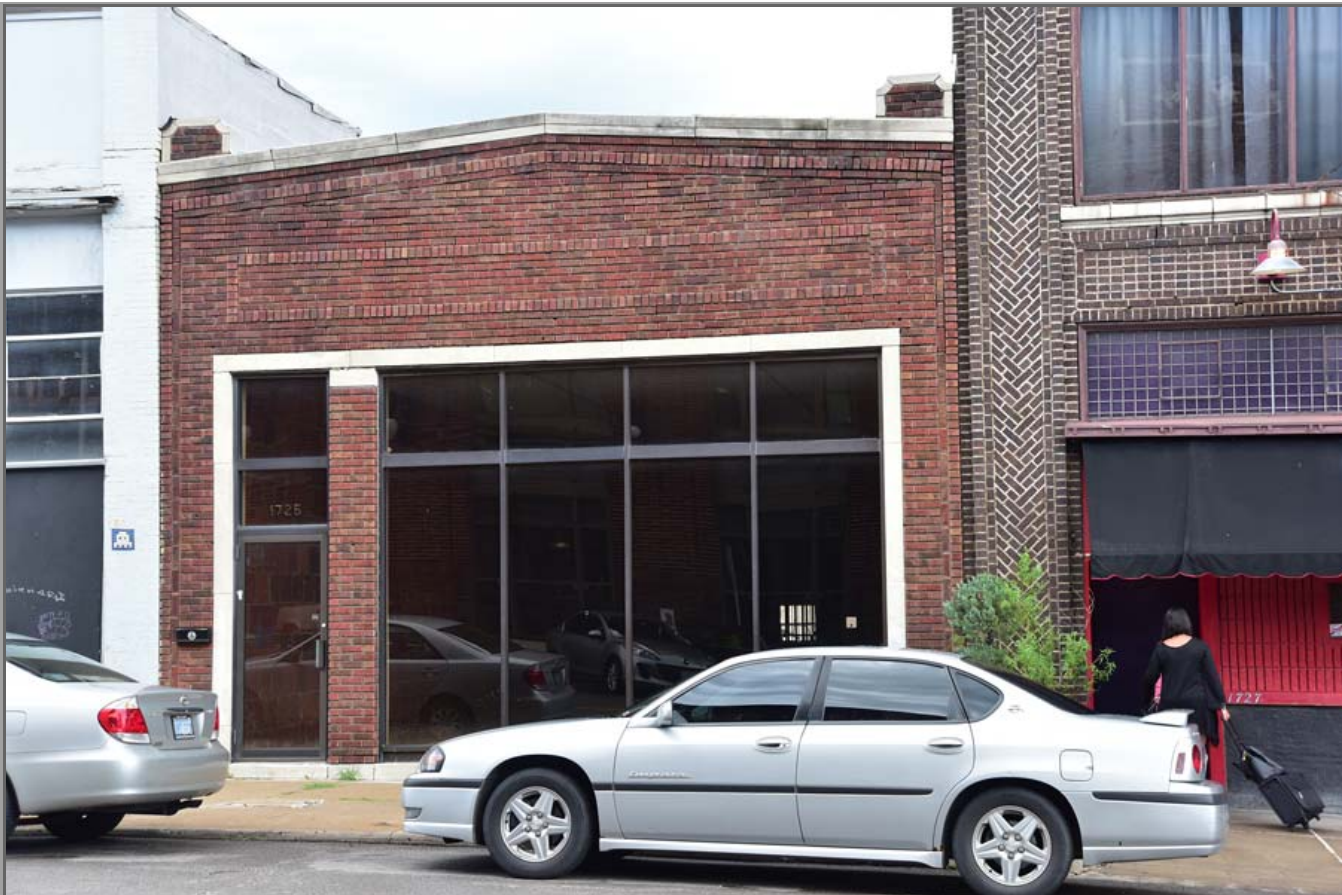
Photographer Brad Finch, f-stop Photography	Date: June 29, 20	Description: west elevation, view NE
--	----------------------	---

1725 McGee Street has good integrity and is recommended as a contributing resource to a potential historic district. The building is associated with automobile-related commercial buildings concentrated in an "Automobile Row" along McGee Street. The building retains the configuration of openings and simple parapet ornament that convey integrity and communicate its significance as an early automobile-related commercial building.

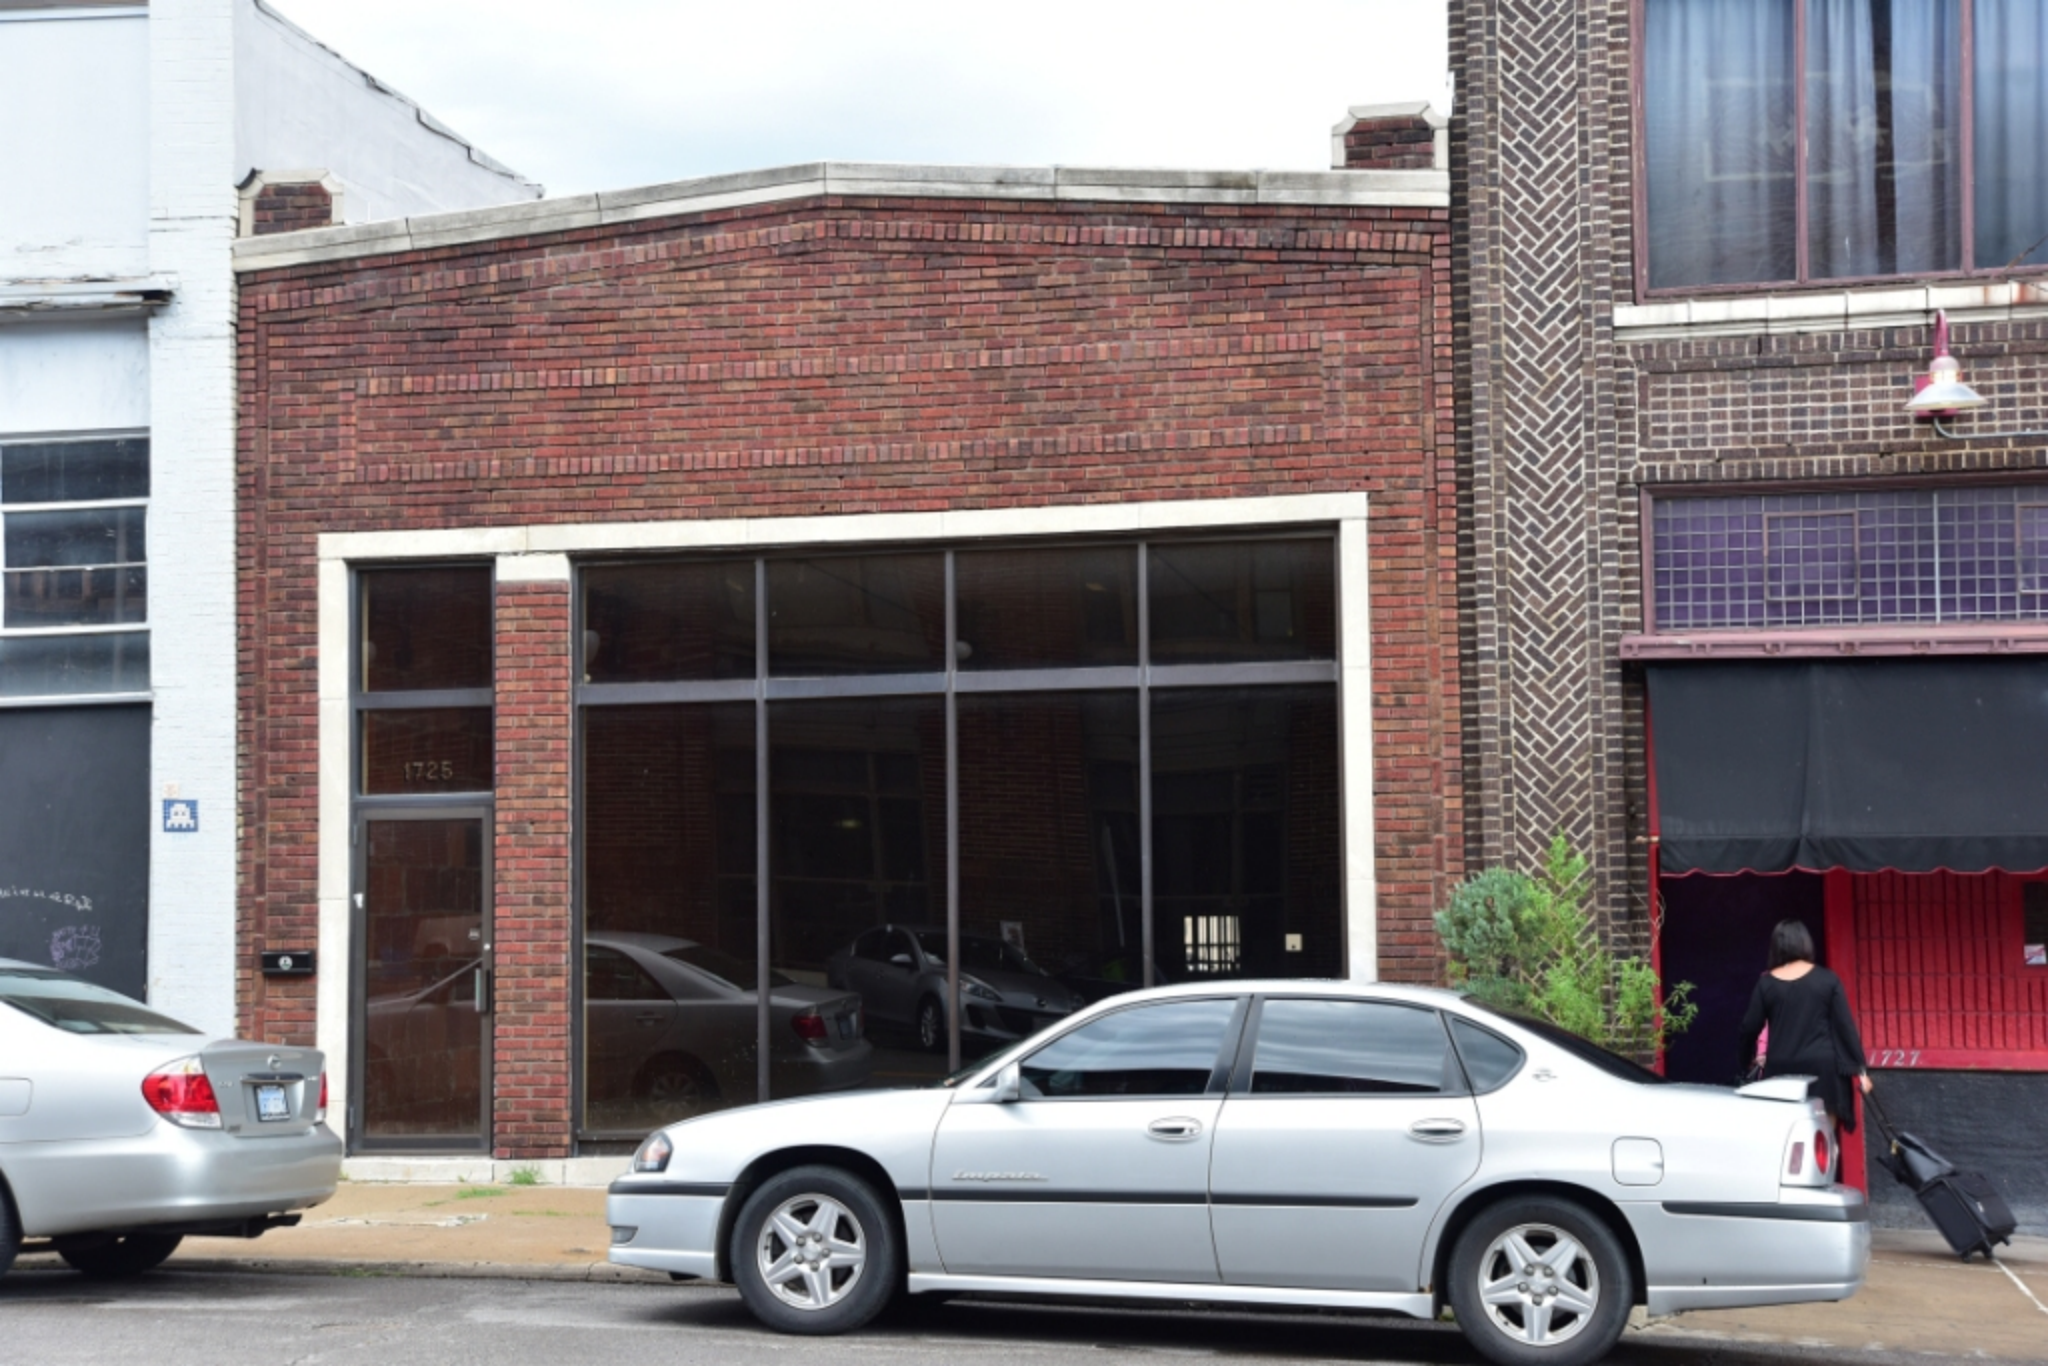
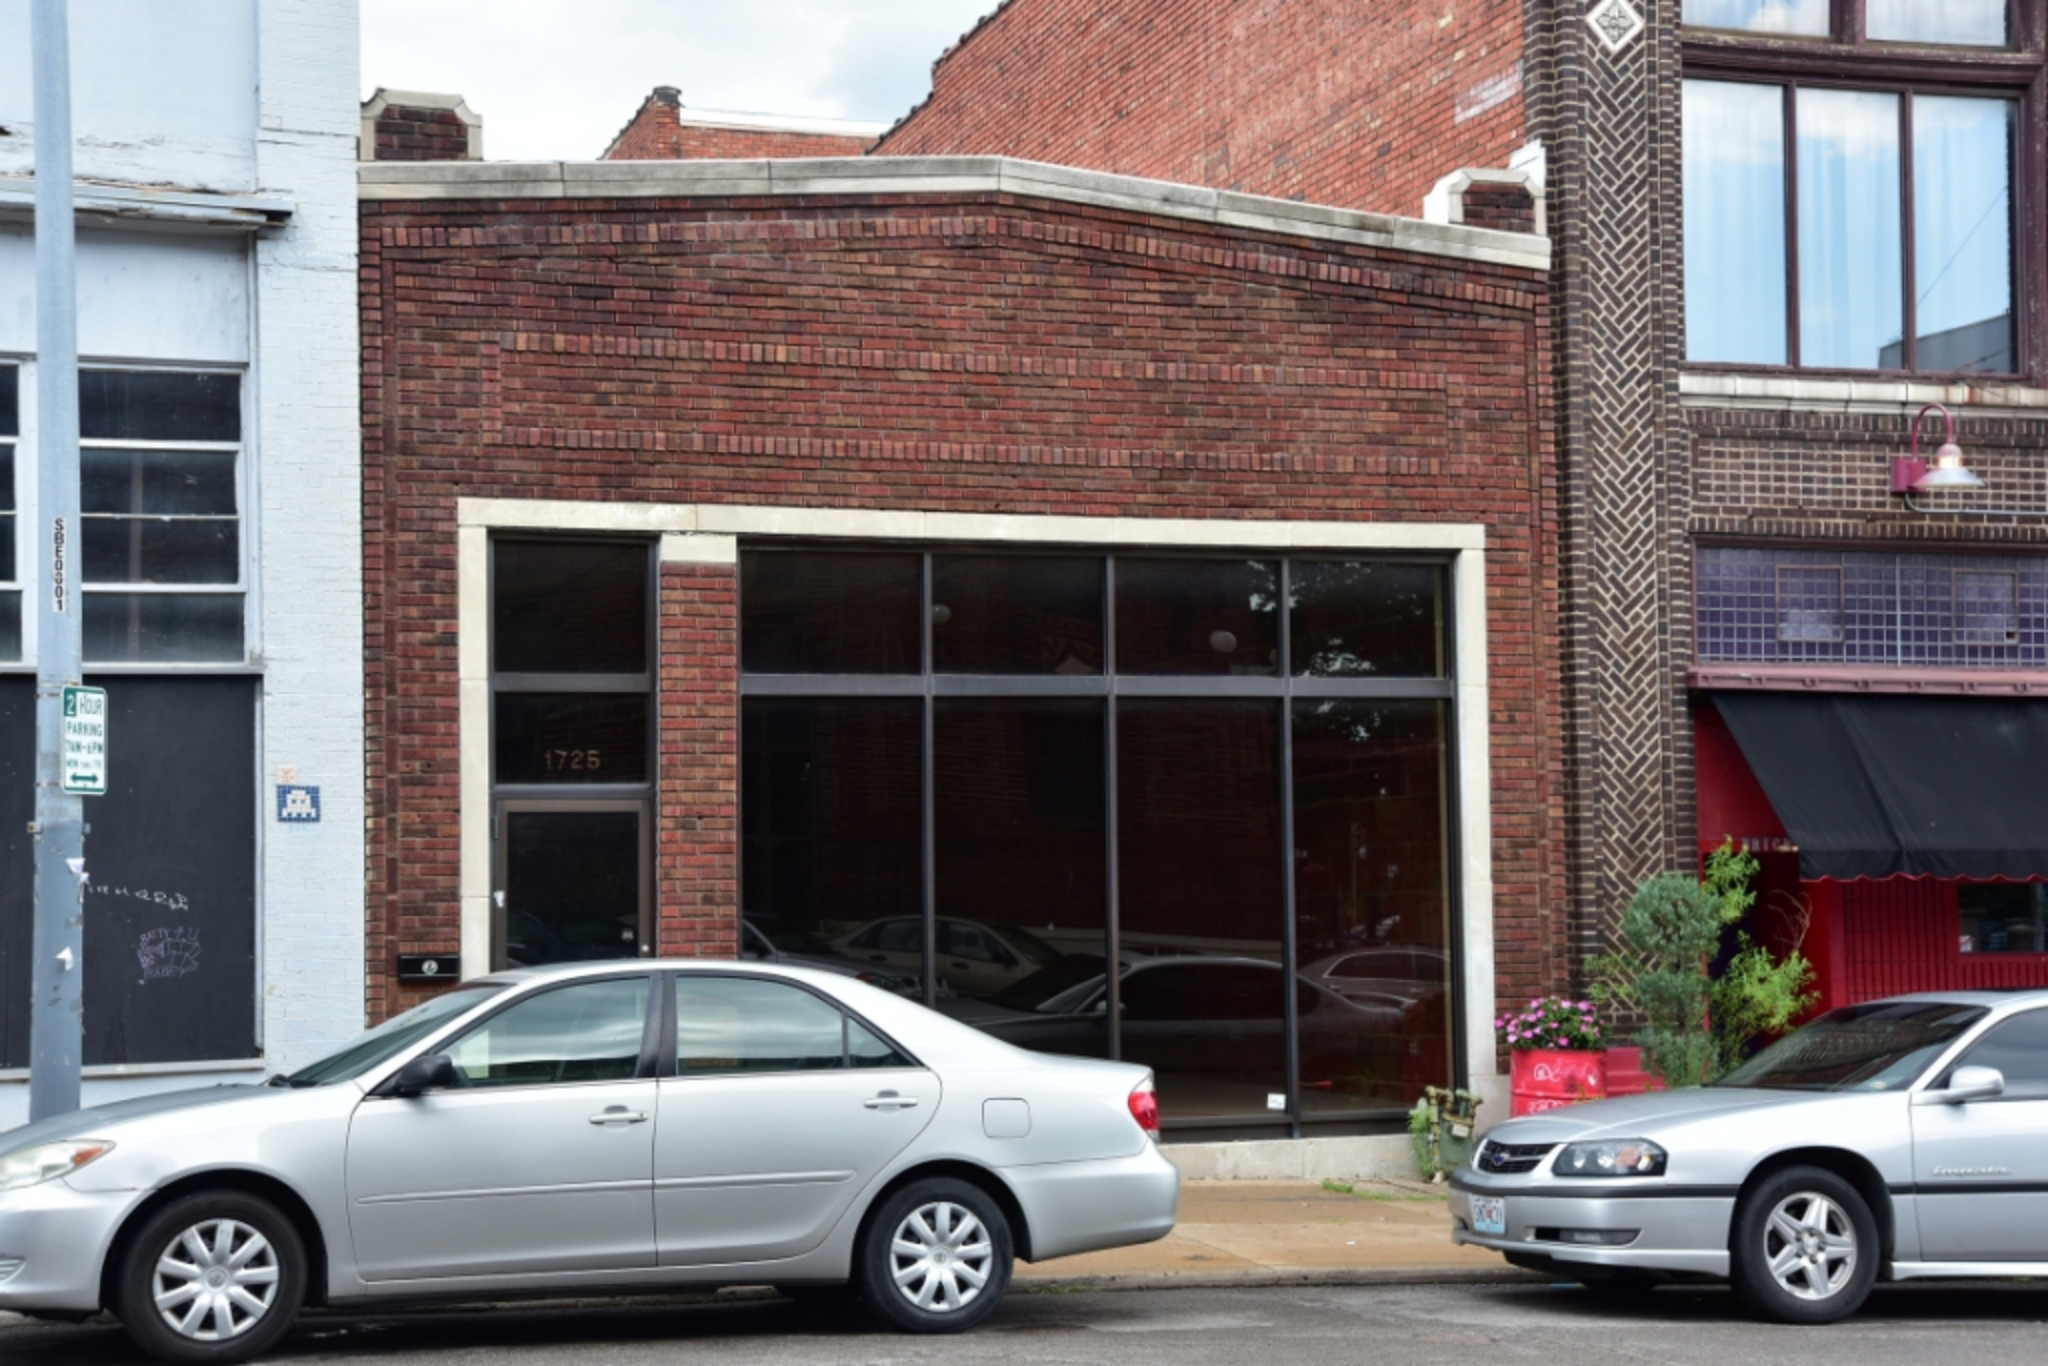
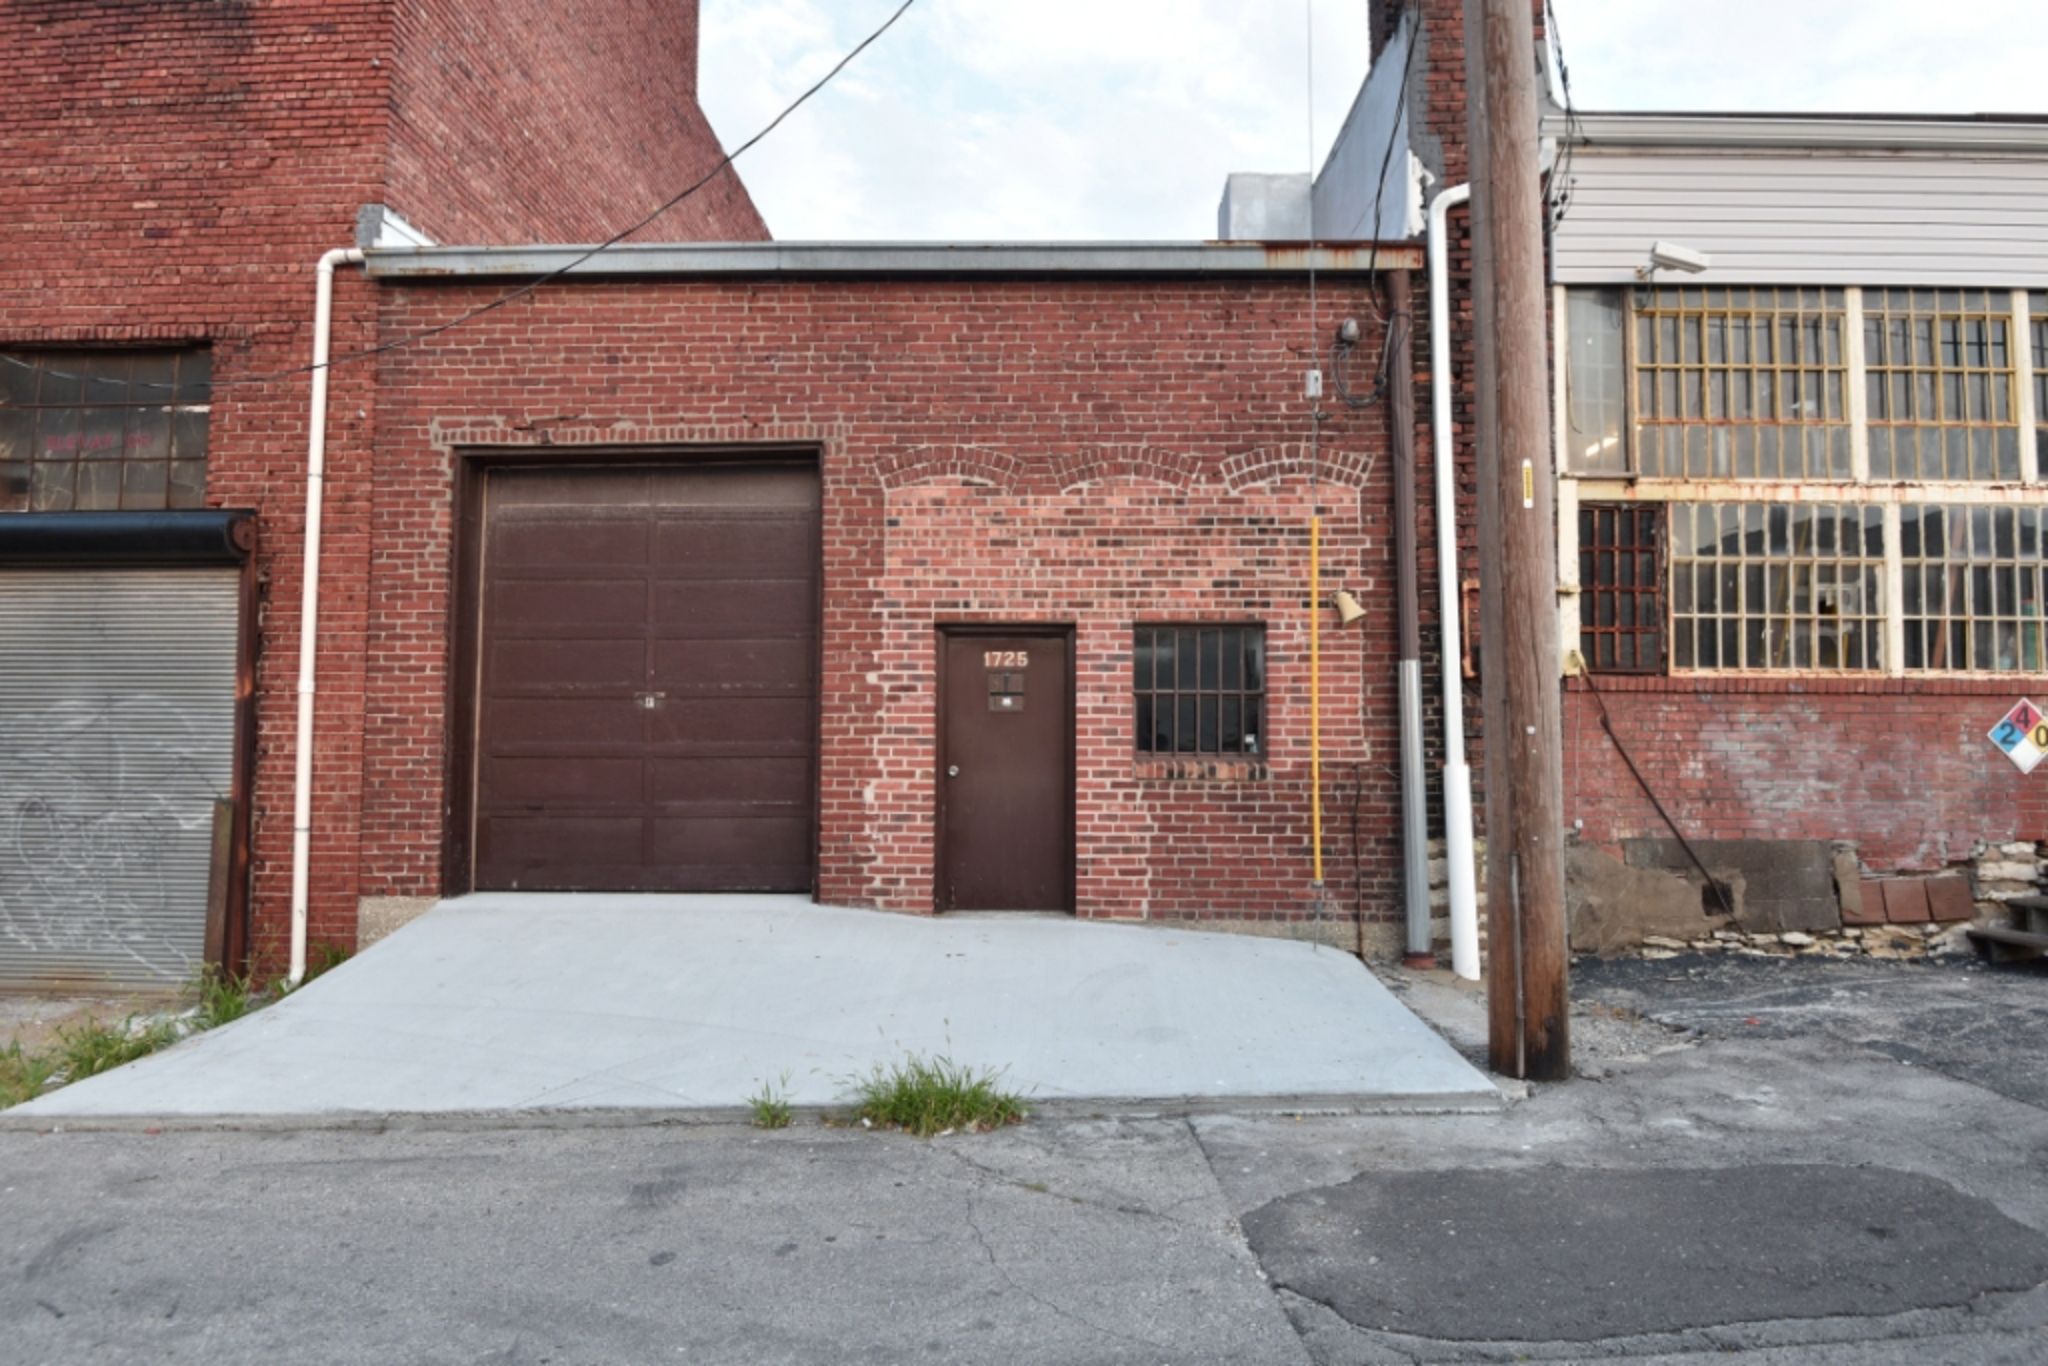
This one-story brick building has a rectangular plan and a flat roof with a shallow peaked parapet. A single cut stone band frames the two bays that organize the west elevation. A storefront with non-historic metal frame, tall fixed-windows and a transom. A brick column separates the bays. A metal door with glazing and glass transom fills the north bay. Soldier row brick coursing creates a rectangular panel above both bays and outlining the elevation. Cut stone coping lines the parapet and two raised columns on either side. A wood panel overhead rolling door covers a rear vehicle entrance. A metal slab door and a window with metal security bars on the rear fill a rear bay that retains three rowlock course arches that likely topped historic window openings.

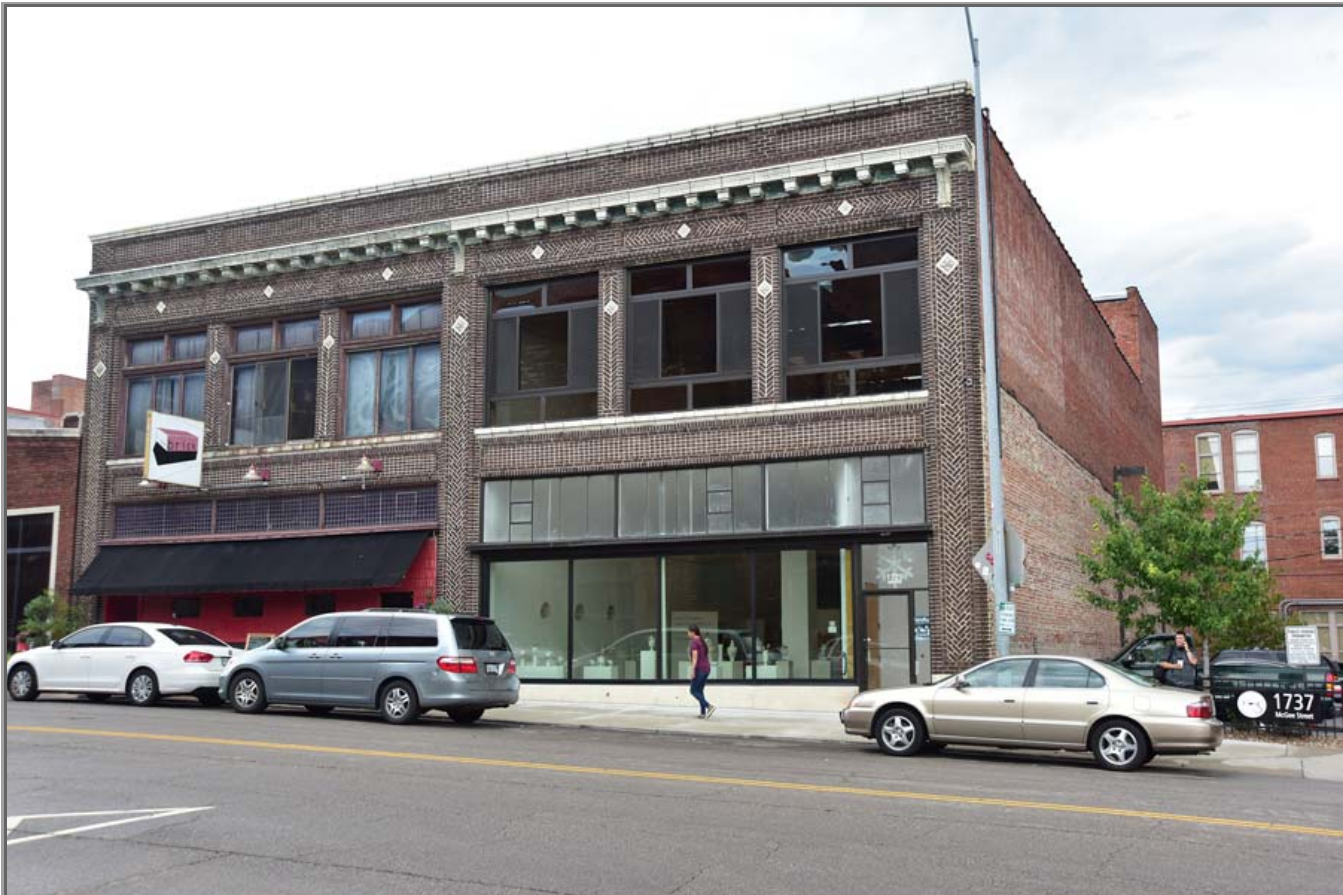
Photographer Brad Finch, f-stop Photography	Date: June 29, 20	Description: west and south elevations, view NE
--	----------------------	--

1727-1729 McGee Street is recommended as a contributing resource to a potential historic district. The building is associated with automobile-related commercial buildings concentrated in an "Automobile Row" along McGee Street. The building has good integrity and communicates its significance as an early automobile-related commercial building. The rear vehicular entrances attached to large freight elevators are a custom feature associated with its design specifically for automobile-related commerce.

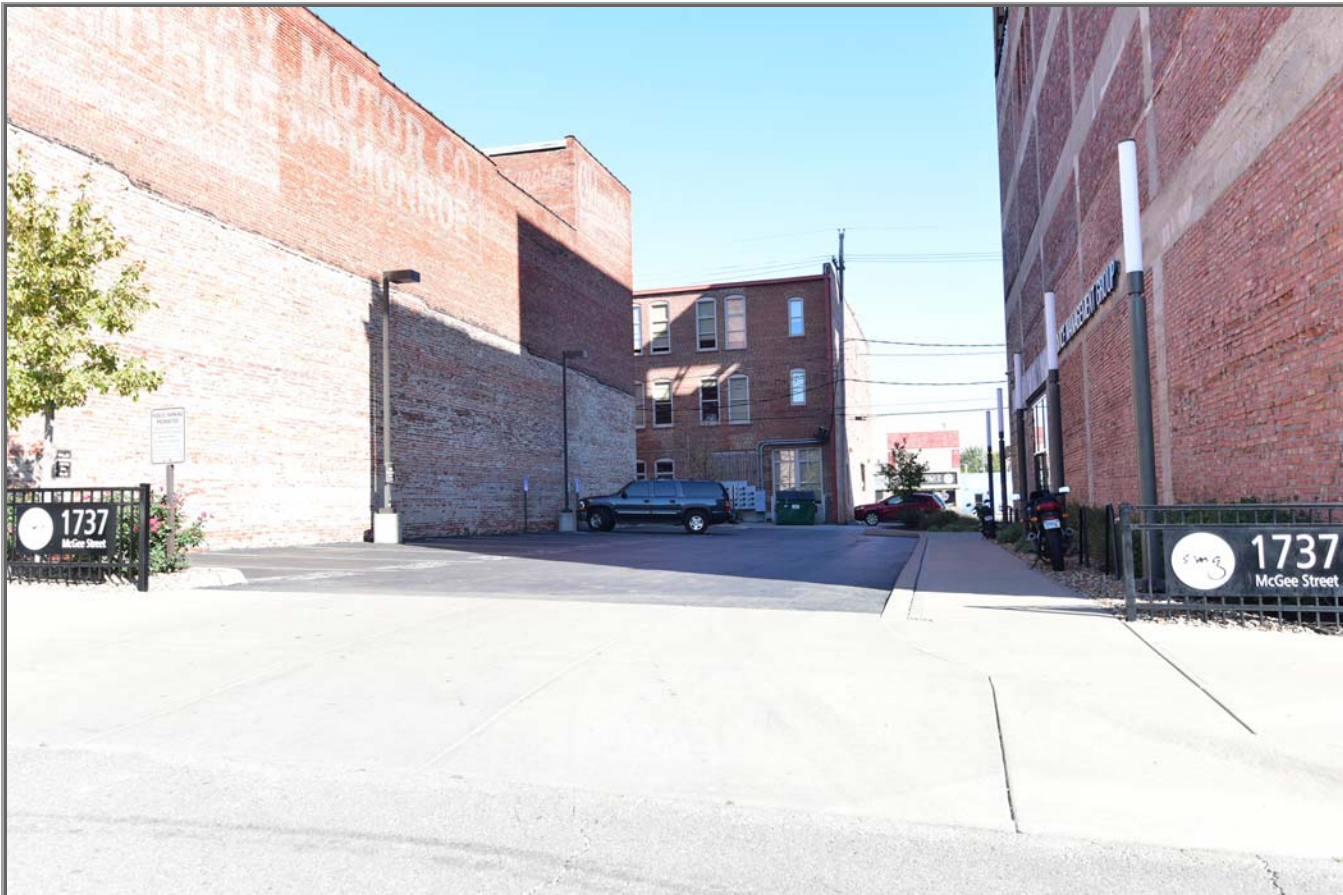
This surface parking lot replaced a one-story commercail building circa 1990. The previous buidling was recorded in the 1982 survey.
