MISSOURI DEPARTMENT OF NATURAL RESOURCES
STATE HISTORIC PRESERVATION OFFICE, P.O. Box 176, Jefferson City, MO 65102
ARCHITECTURAL/HISTORIC INVENTORY FORM

1. Survey number: JA-AS-087-025		2. Survey Name: McGee Street Historic Resources Survey 2017	
3. County: JACKSON		4. Address (Street No.): 215	Street (name): E. 18th Street
5. City: Kansas City	Vicinity <input type="checkbox"/>	6. Lat / Long: 39.091481 -94.580440	7. Township/Range/Section: T: R: S:
8. Historic name (if known): Interstate Securities Building		9. Present/other name (if known):	
10. Ownership: <input checked="" type="checkbox"/> Private <input type="checkbox"/> Public		11a. Historic use (if known): Commercial	11b. Current use: Commercial

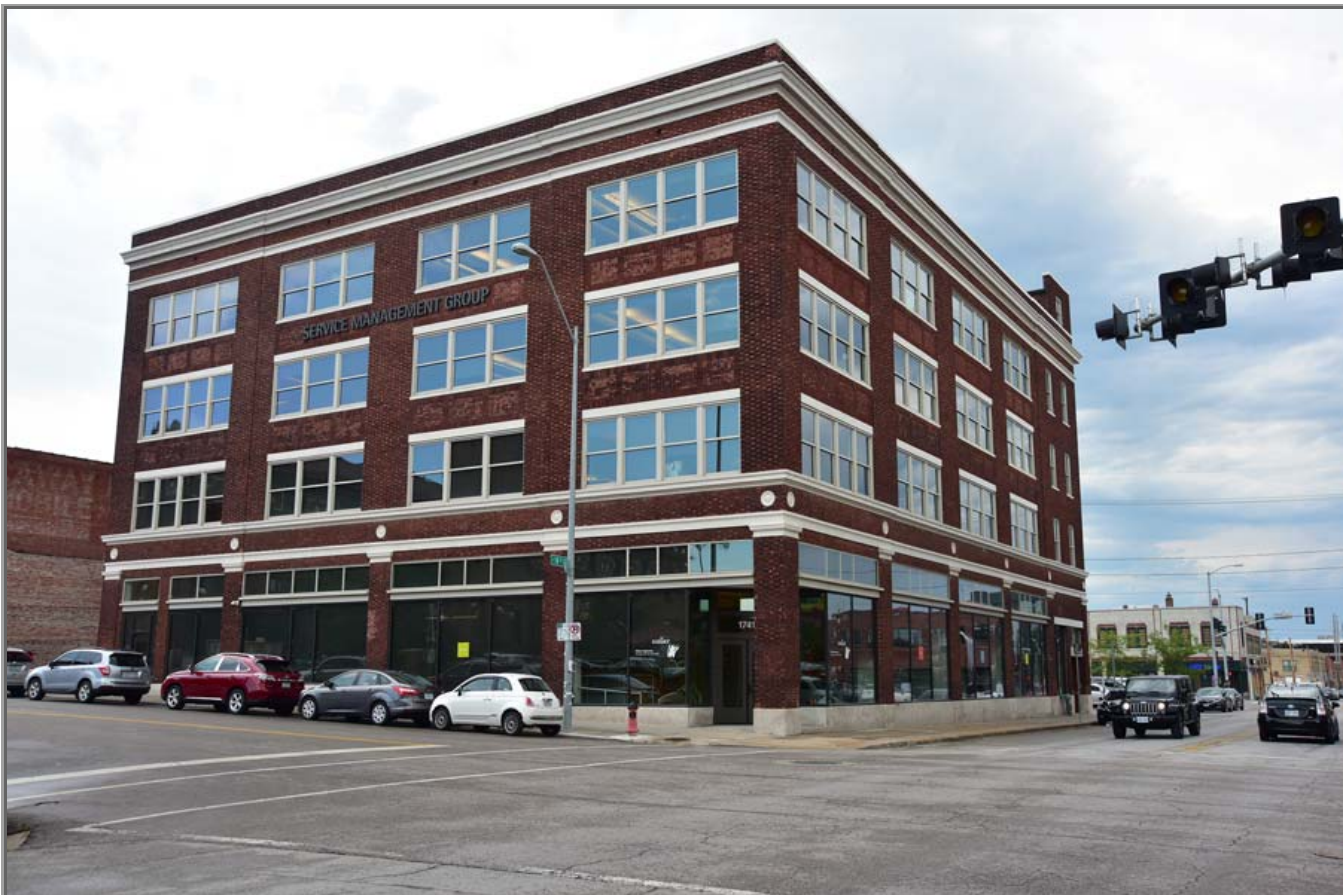
Photographer Brad Finch, f-stop Photography	Date: June 29, 20	Description: west and south elevations, view NE
--	----------------------	--

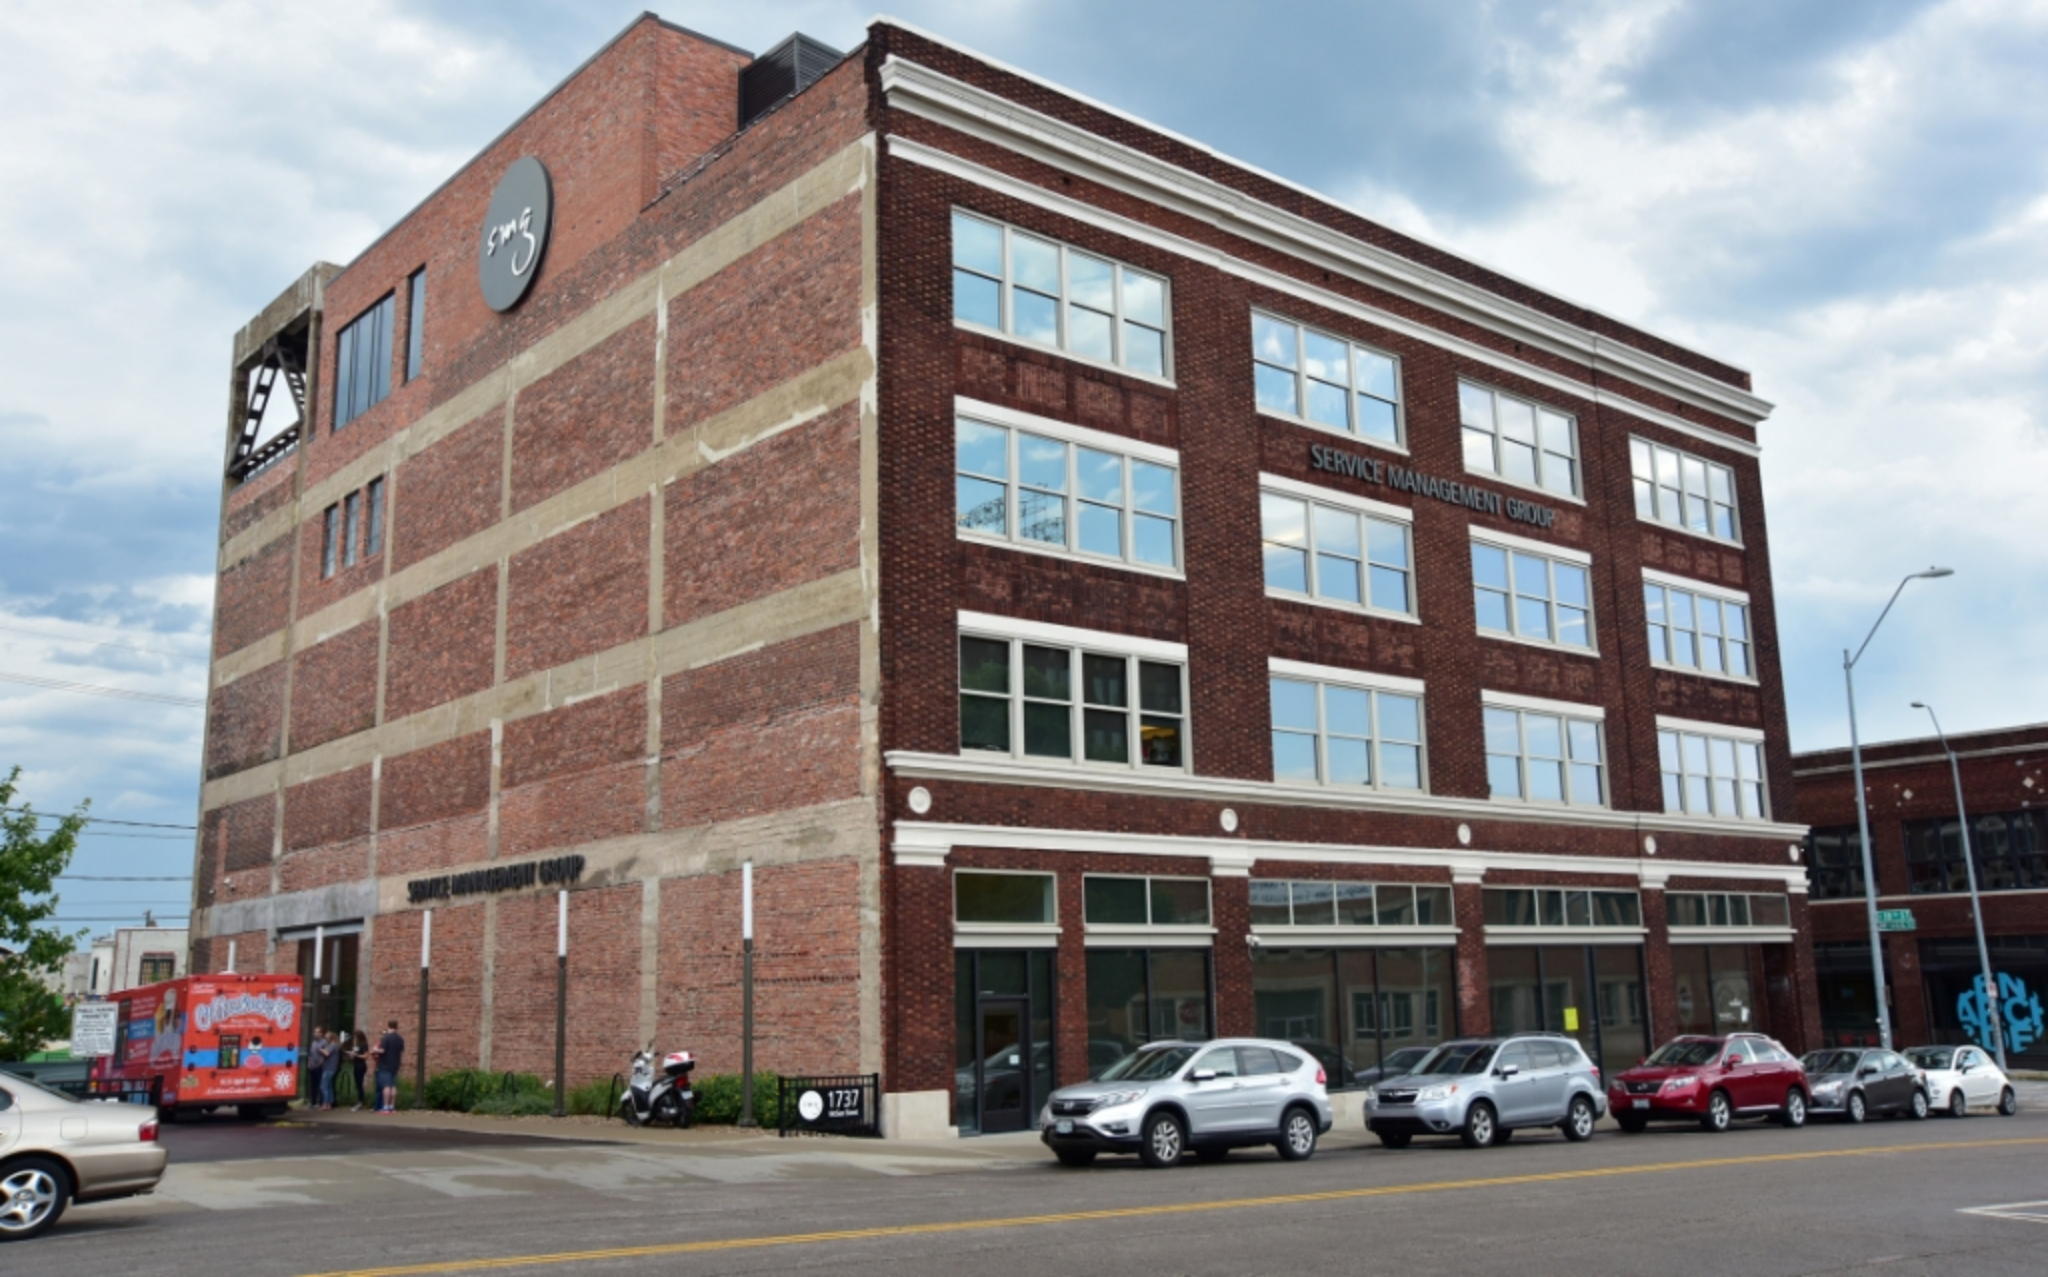
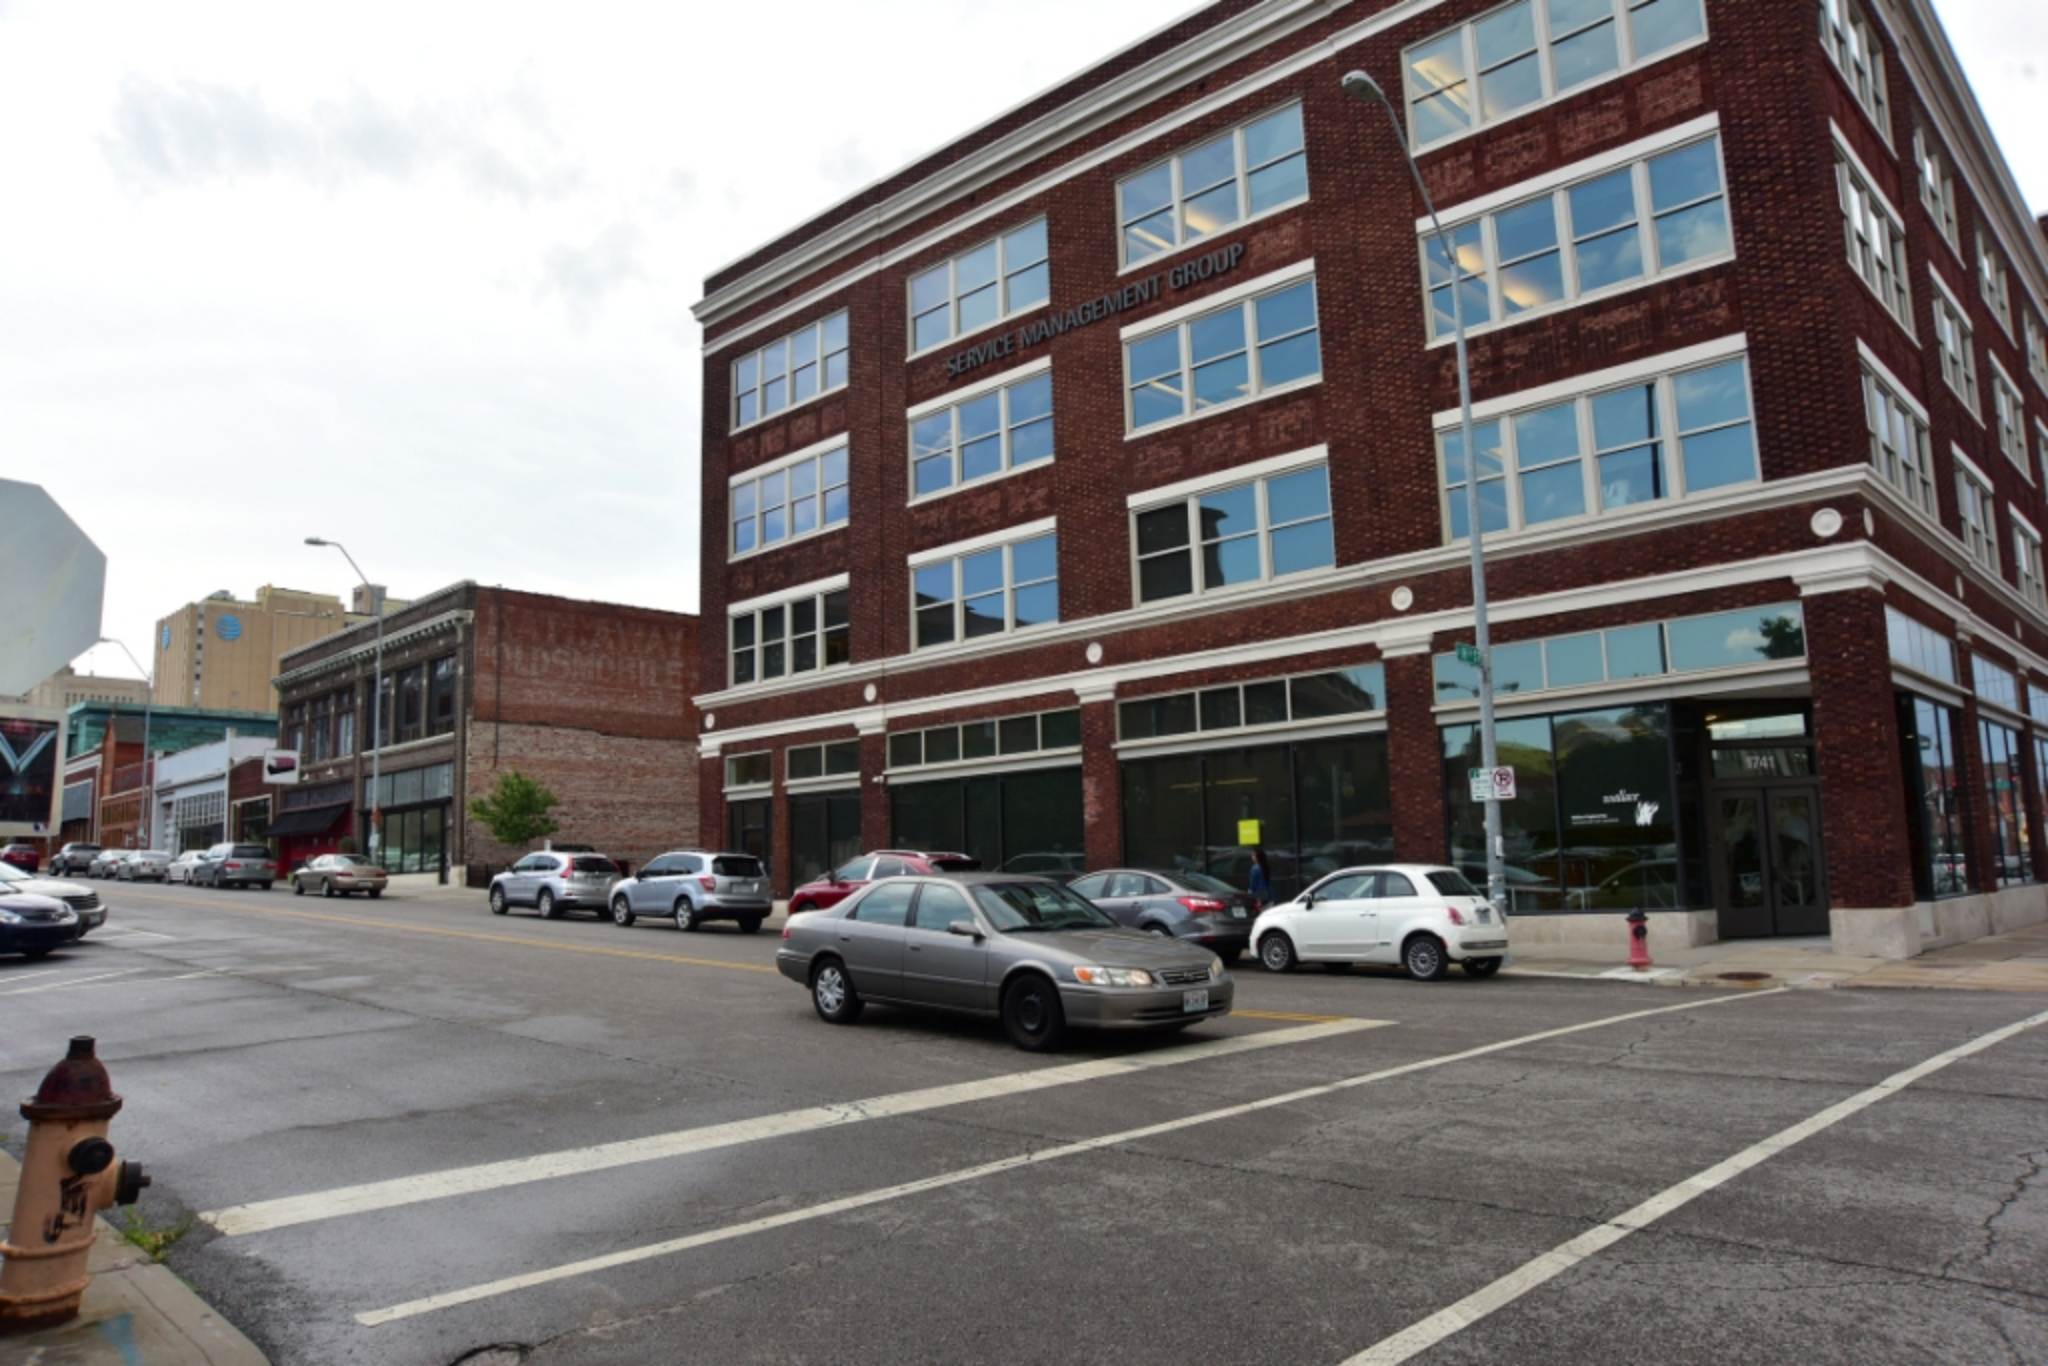
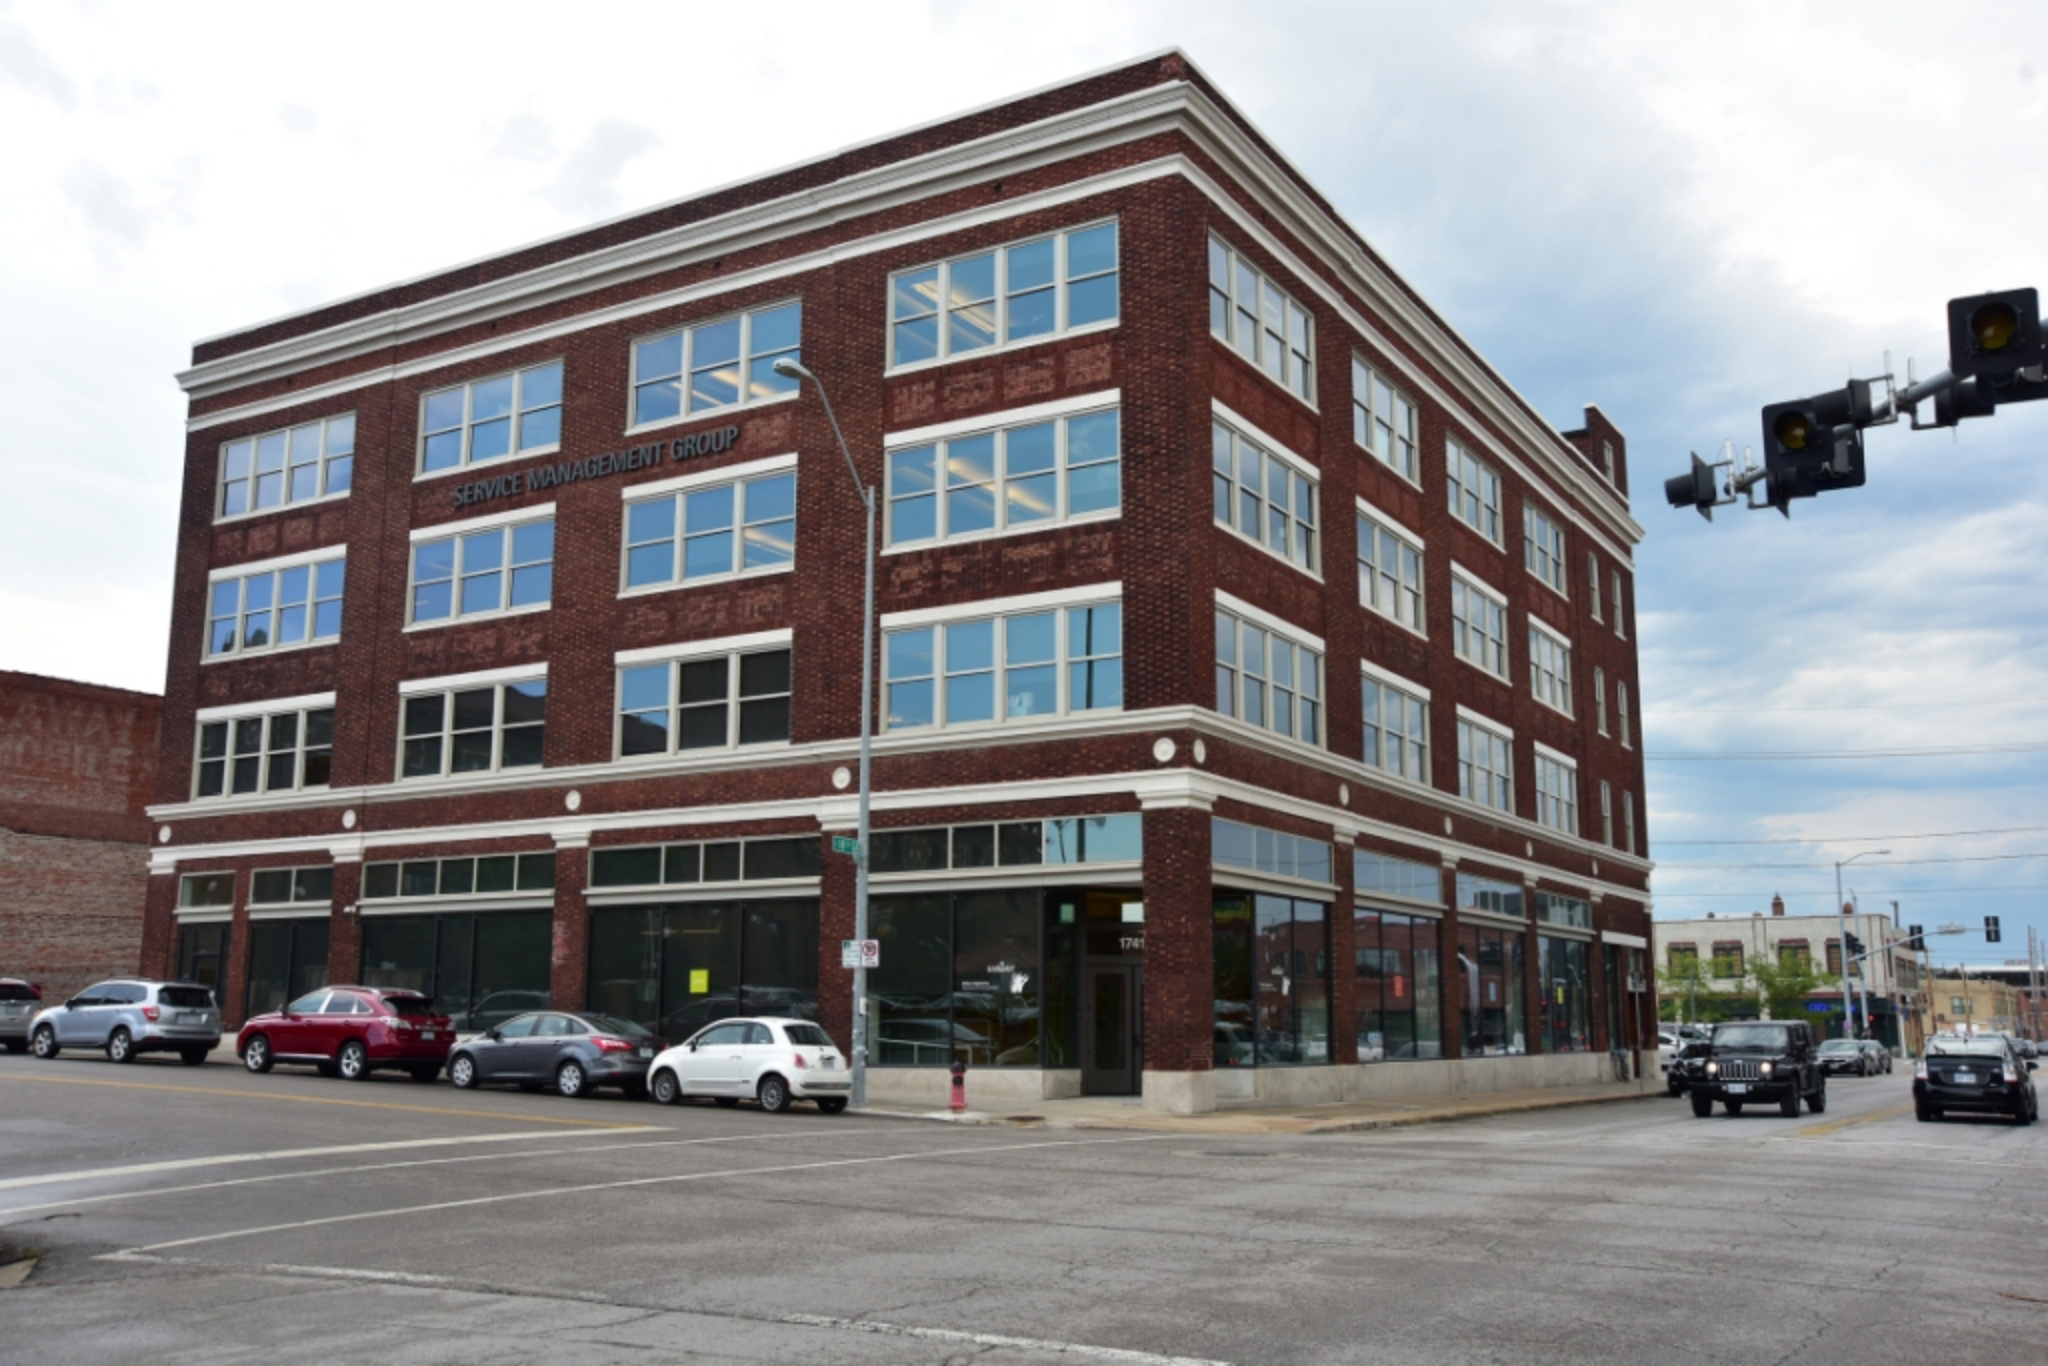
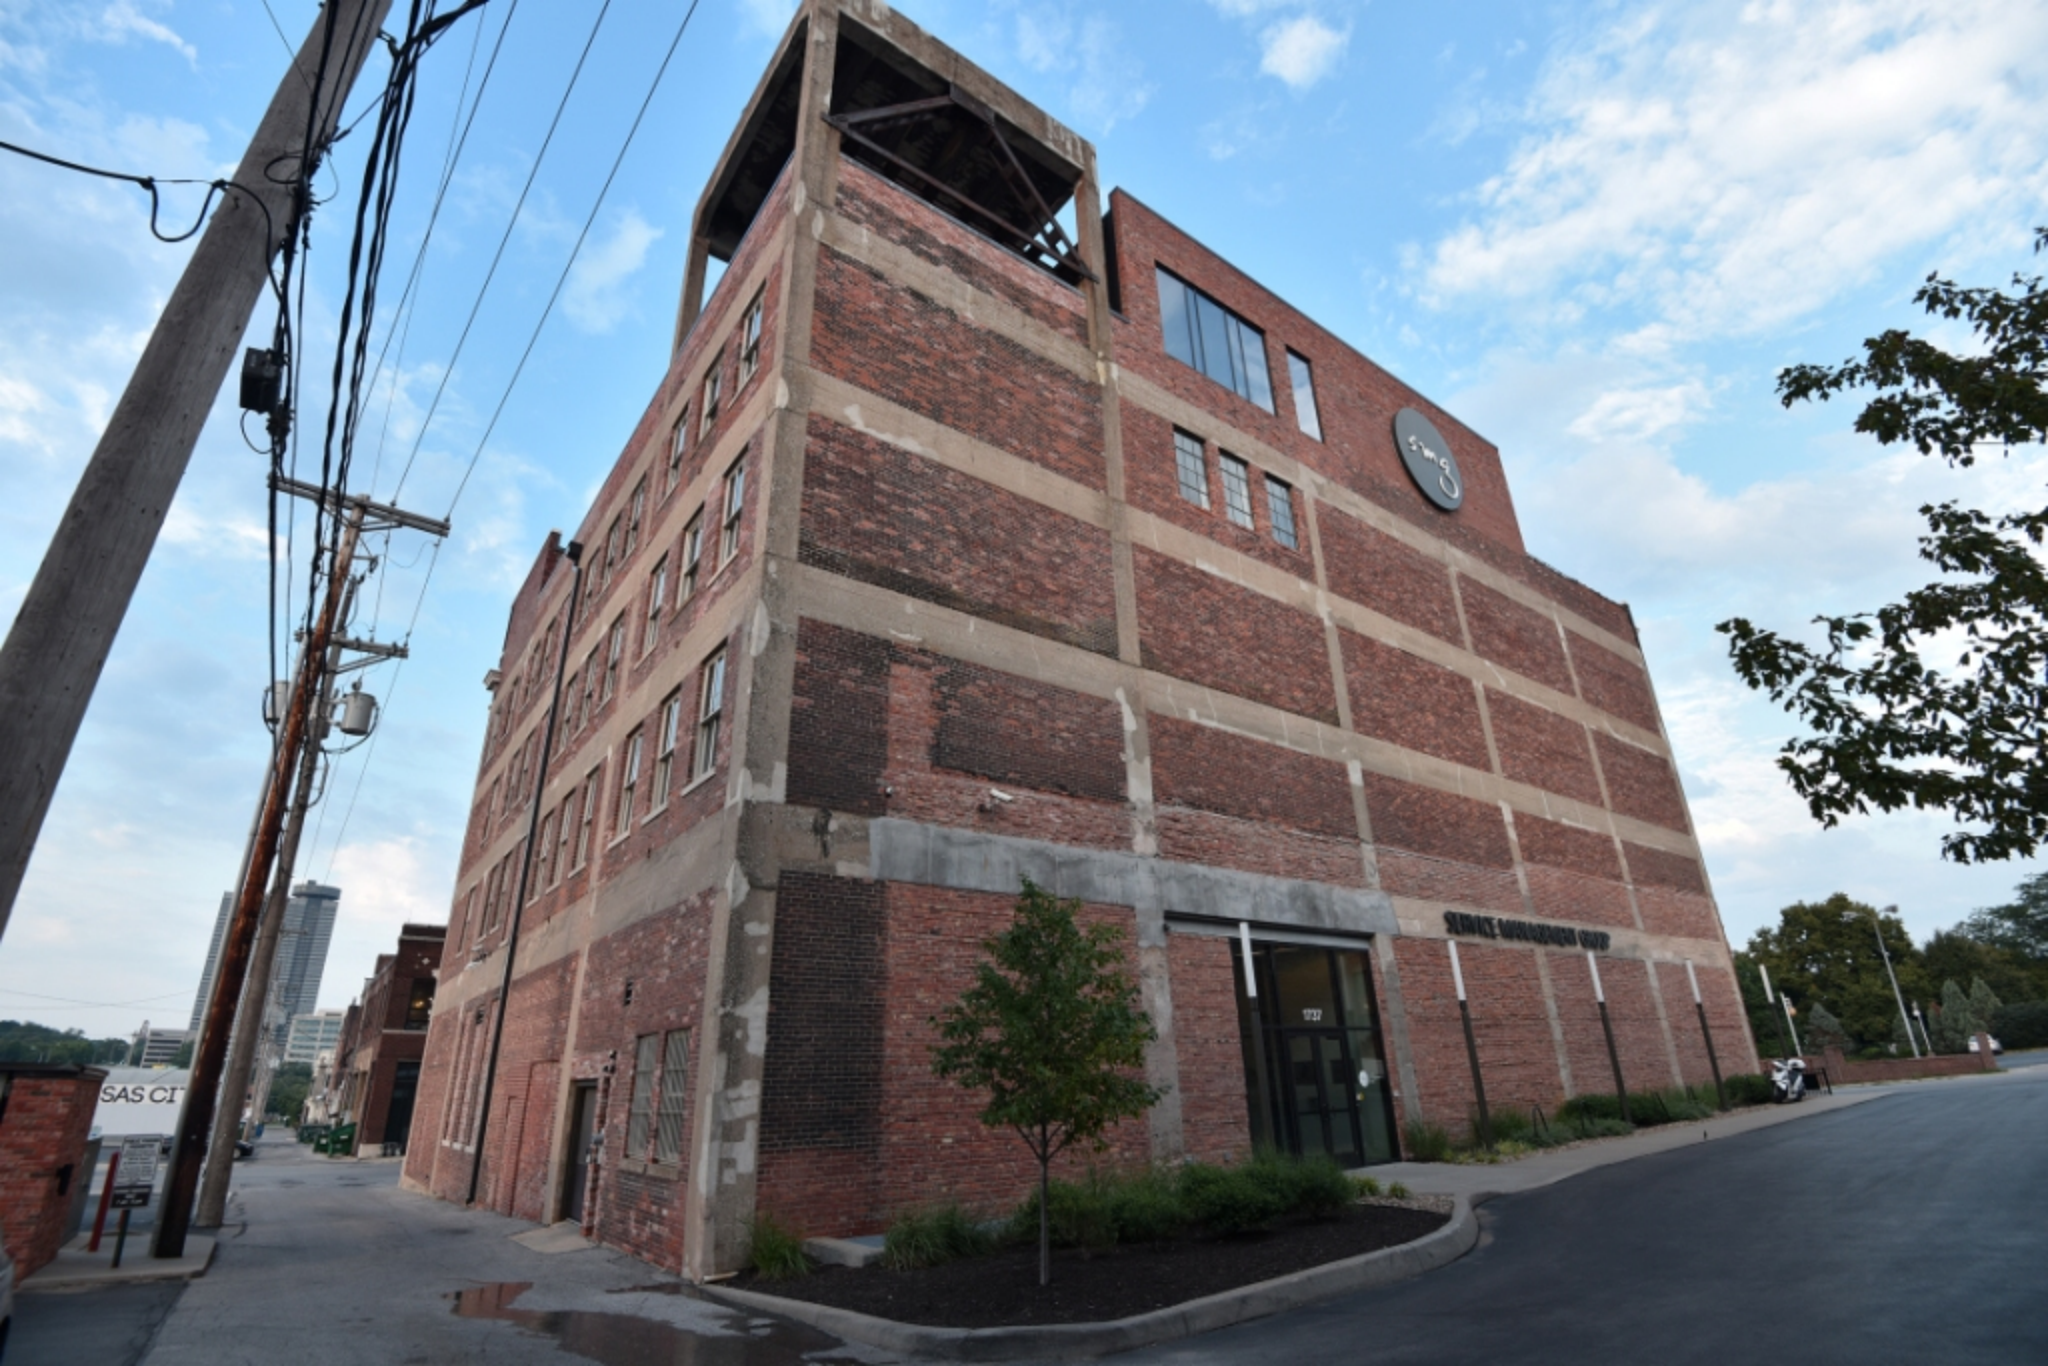
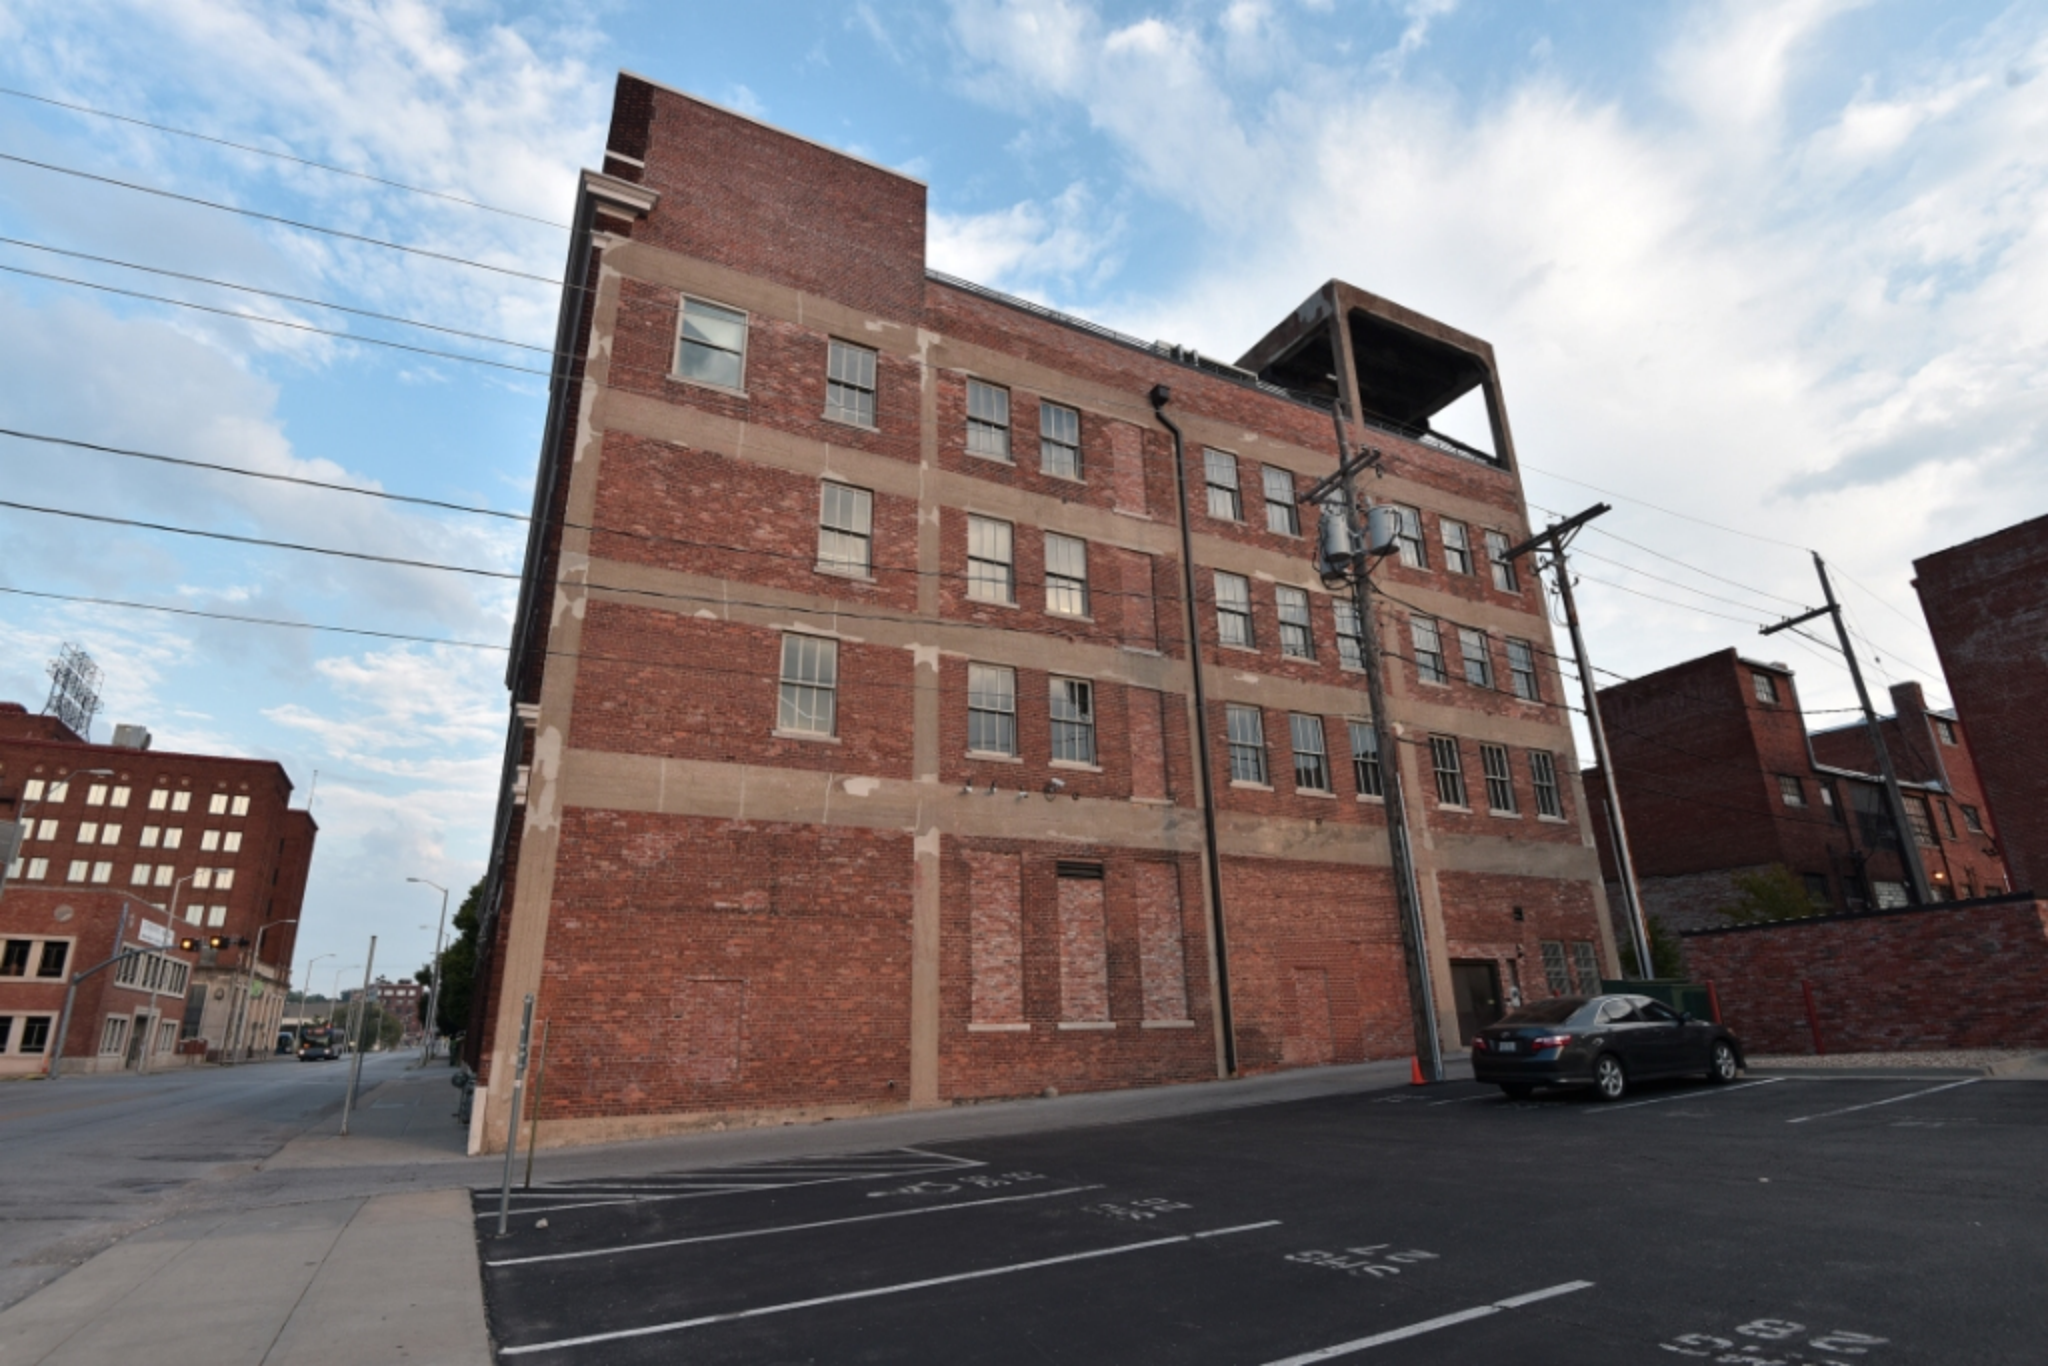
The four-story concrete frame and structural clay tile building at the northeast corner of E. 19th Street and McGee Street has a concrete foundation and a flat roof with a parapet. Brick, set in a decorative pattern of header brick, clads the exterior with cut stone and terra cotta detailing. Four bays organize the west façade fronting McGee Street. Five bays organize the south elevation fronting E. 19th Street. The first story has a recessed canted corner entry while brick pilasters define the bays. Each bay has an aluminum storefront with a banded transom. The bays on the second, third and fourth stories have banded one-over-one windows in sets of three and four. Banded cut stone tops first and fourth story windows and forms a continuous sill for second story windows. Decorative stone medallions ornament the spandrel area between the first and second stories while stretcher and soldier brick bands frame stacked header brick panels in the spandrel areas between the upper three stories. A cut stone cornice surrounds the parapet. The concrete structure is expressed on the north and east secondary elevations and common brick clads the exterior. A brick parapet conceals a concrete elevator penthouse on the southeast corner and a concrete and steel water tower platform rises on the northeast corner. Metal doors with glazing pierce the north elevation. Double metal slab doors and two windows pierce the north bay on the east rear elevation. Cut stone sills indicate infilled window openings on the rear elevation. Three-over-three wood windows pierce upper stories.

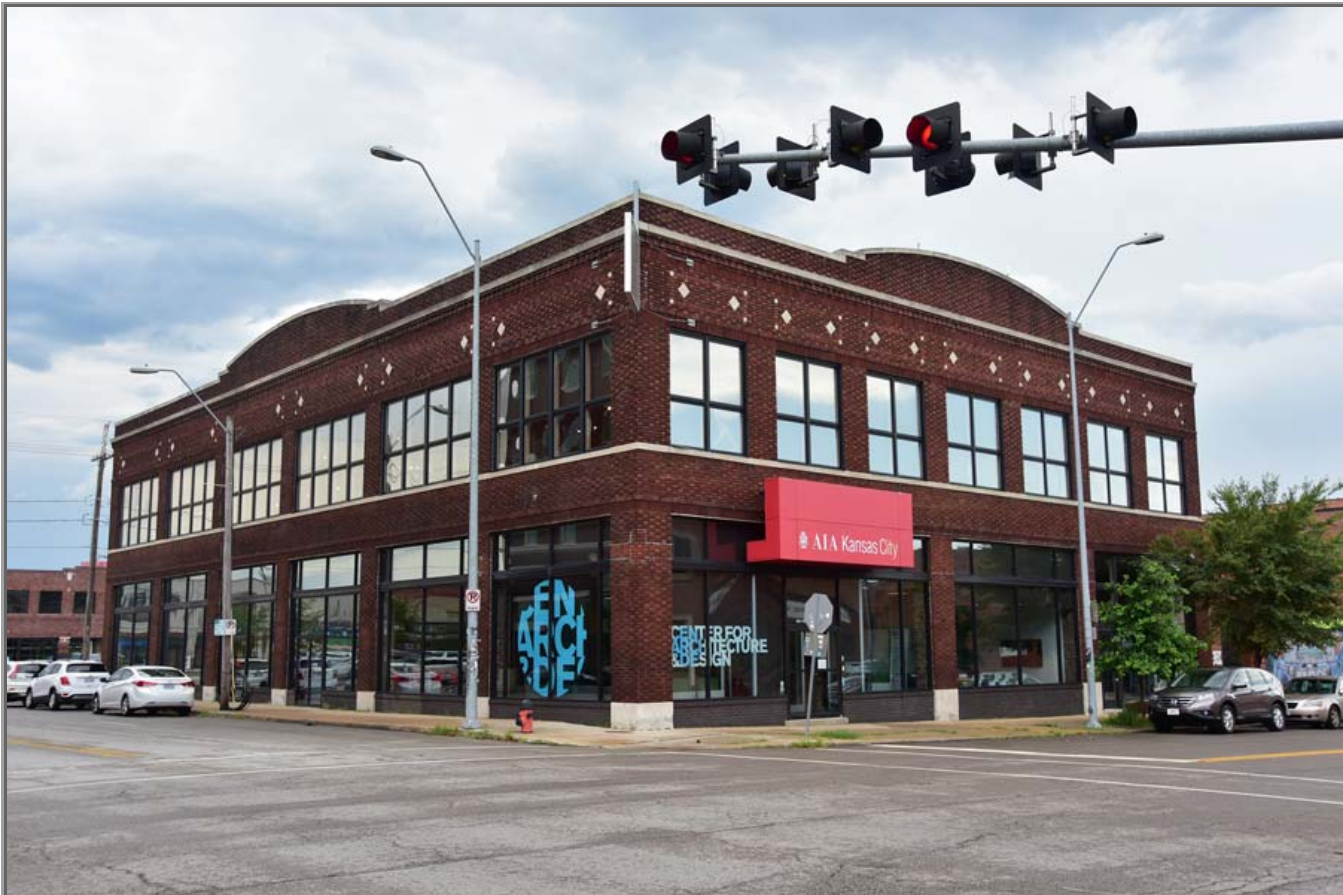
Photographer Brad Finch, f-stop Photography	Date: June 29, 20	Description: north and west elevations, view SE
--	----------------------	--

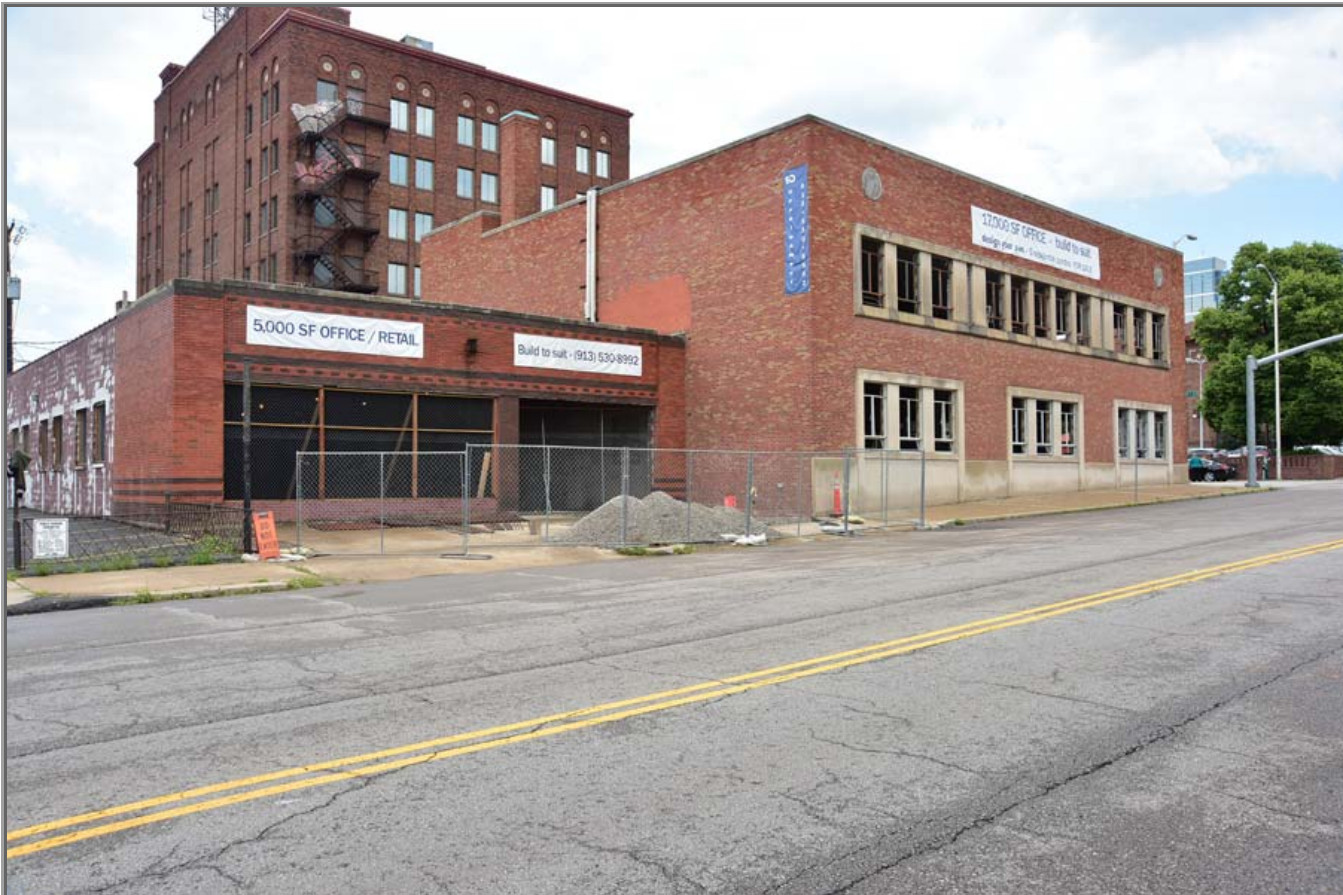
Photographer Brad Finch, f-stop Photography	Date: June 29, 20	Description: east and south elevations, view NW
--	----------------------	--
