MISSOURI DEPARTMENT OF NATURAL RESOURCES
STATE HISTORIC PRESERVATION OFFICE, P.O. Box 176, Jefferson City, MO 65102
ARCHITECTURAL/HISTORIC INVENTORY FORM

1. Survey number: JA-AS-087-025		2. Survey Name: McGee Street Historic Resources Survey 2017	
3. County: JACKSON		4. Address (Street No.): 215	Street (name): E. 18th Street
5. City: Kansas City	Vicinity <input type="checkbox"/>	6. Lat / Long: 39.091481 -94.580440	7. Township/Range/Section: T: R: S:
8. Historic name (if known): Interstate Securities Building		9. Present/other name (if known):	
10. Ownership: <input checked="" type="checkbox"/> Private <input type="checkbox"/> Public		11a. Historic use (if known): Commercial	11b. Current use: Commercial

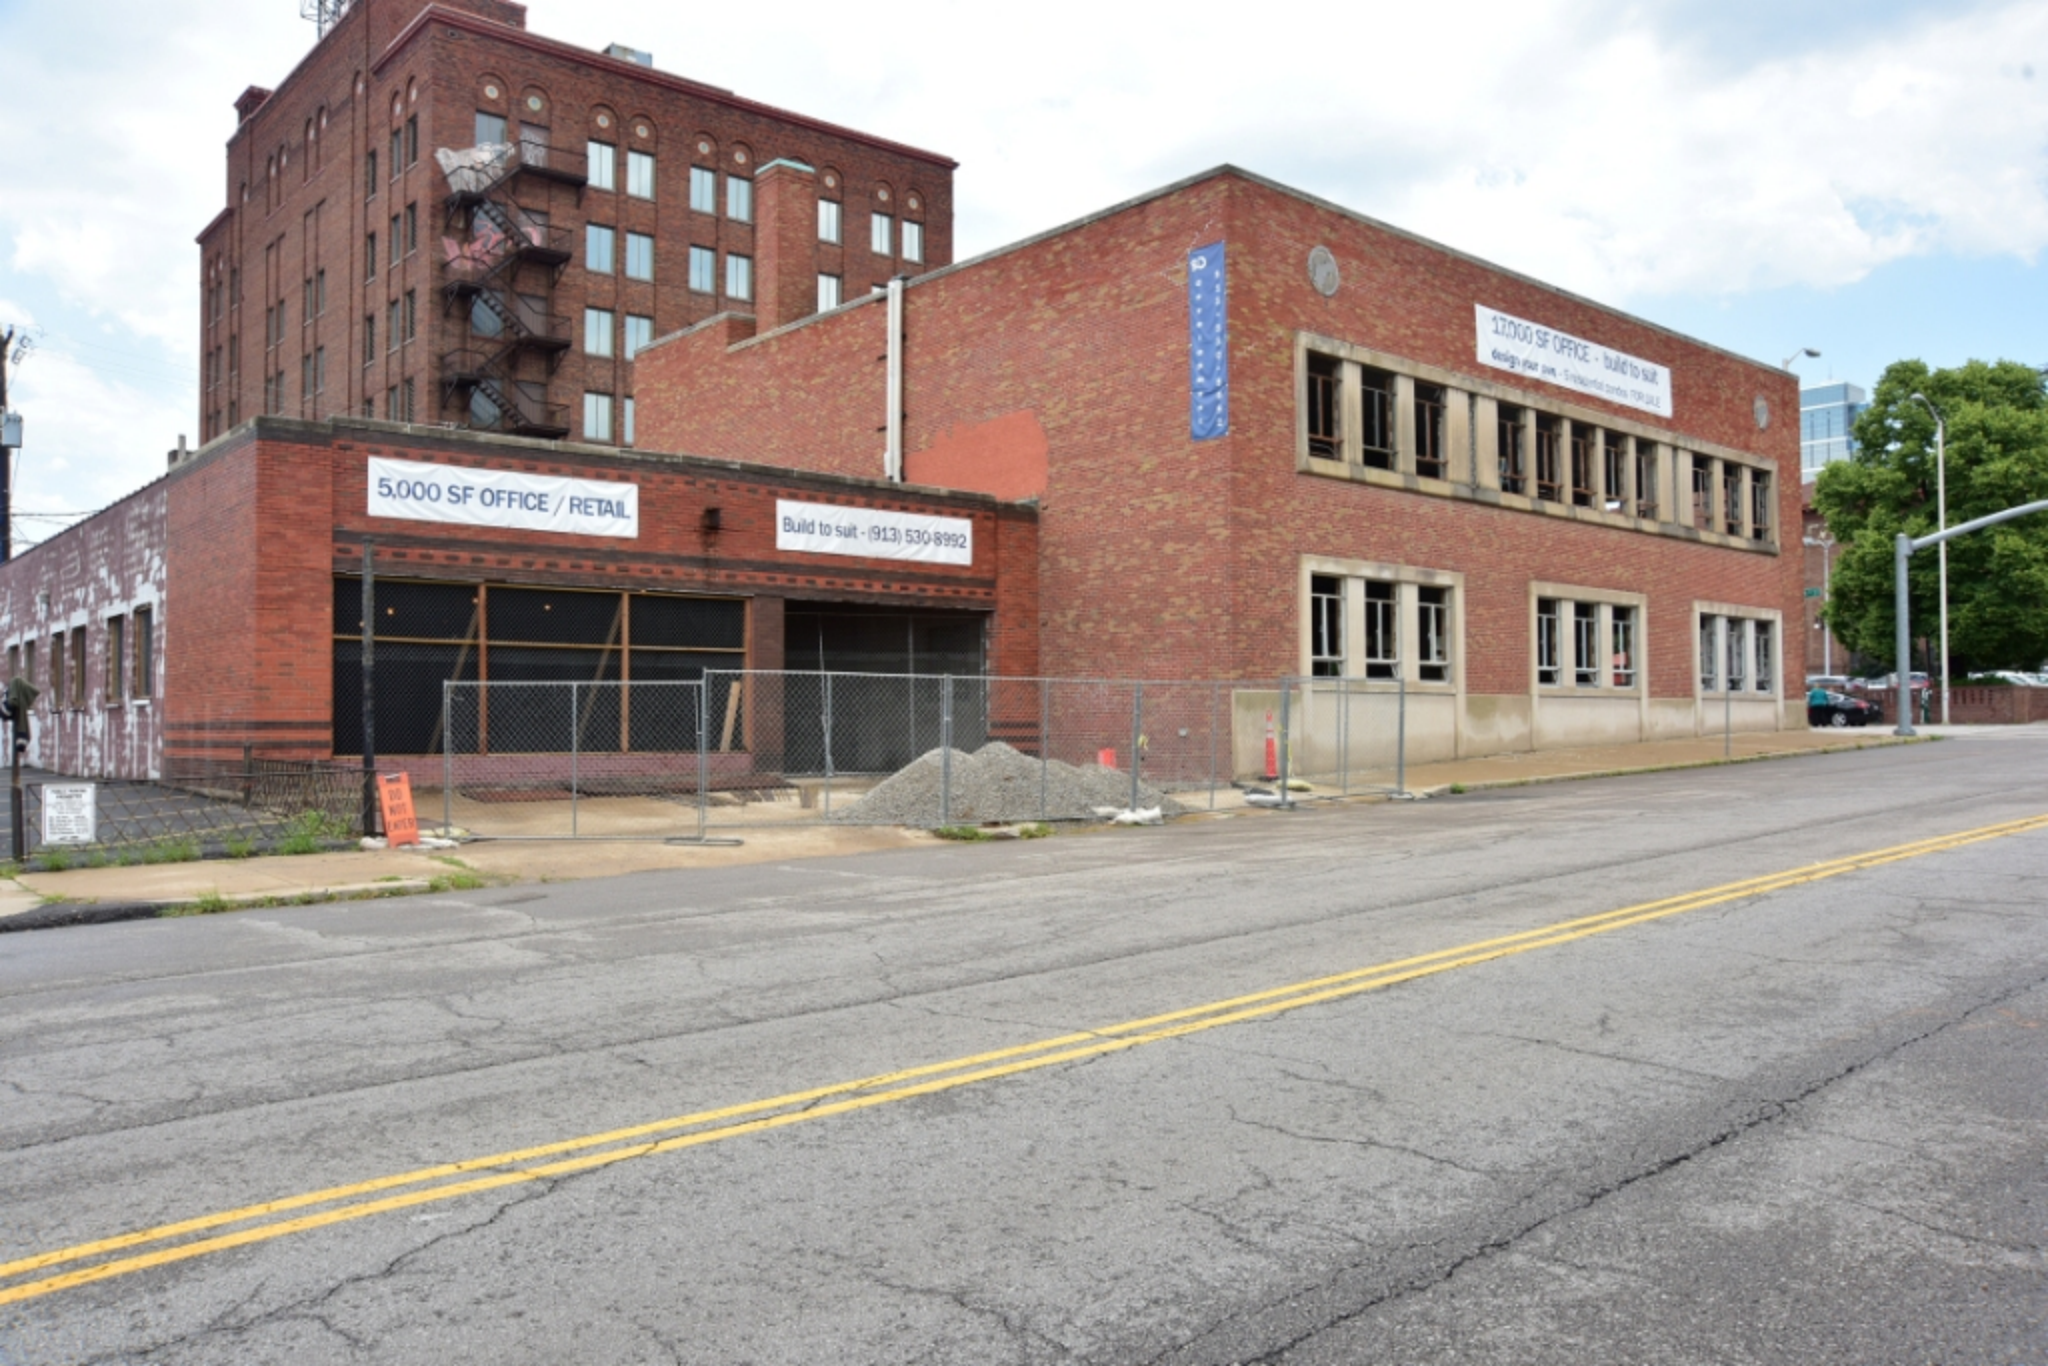
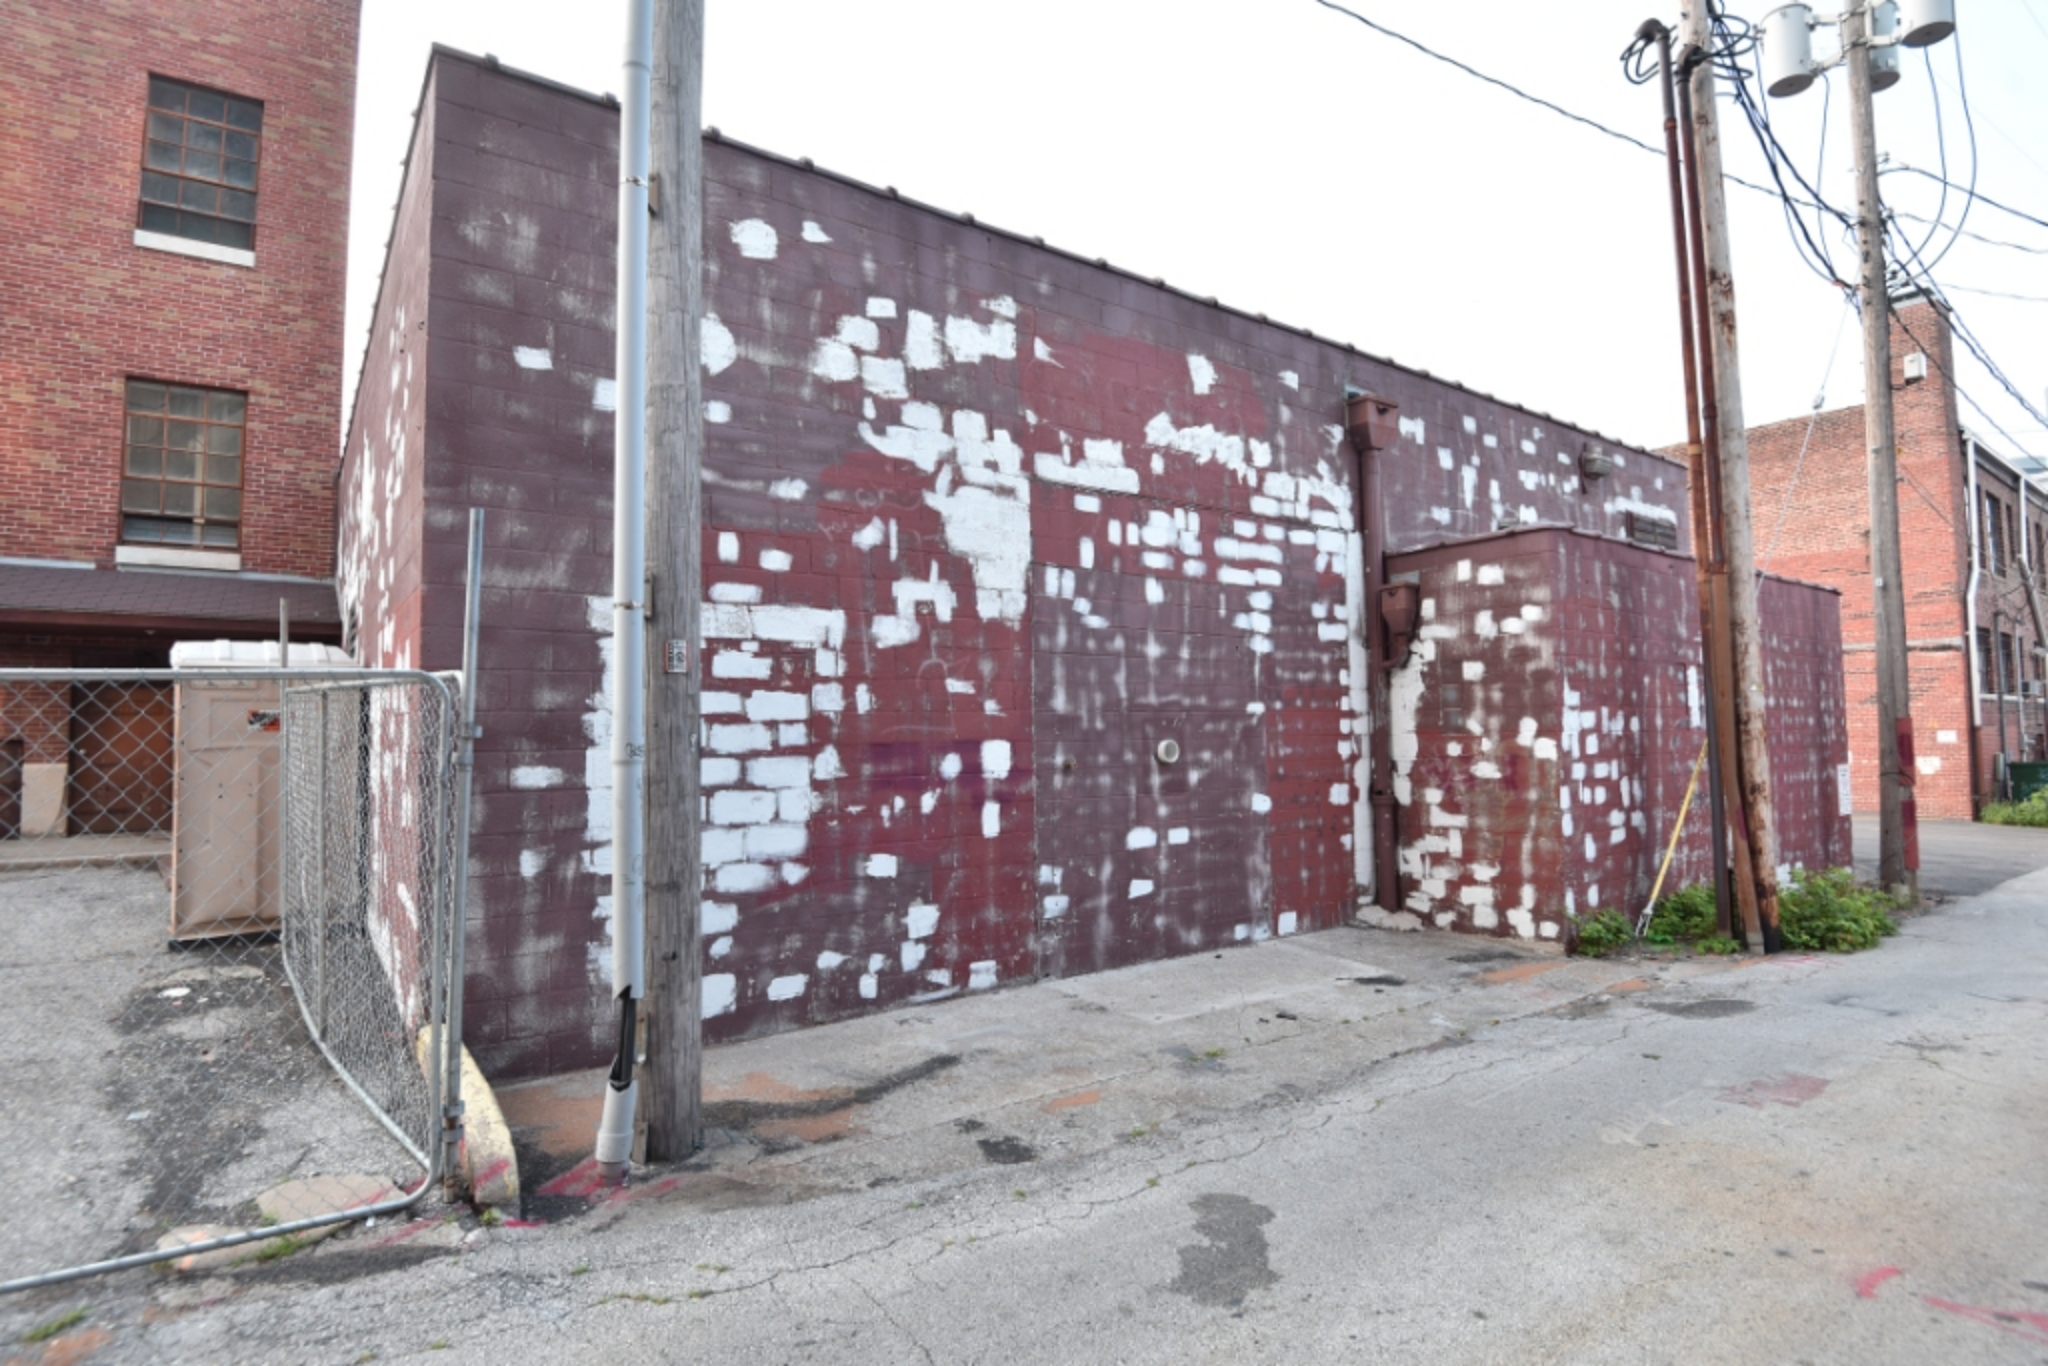
This one-story, rectangular plan building has a flat roof with a parapet. The building abuts 215 East 18th Street on the north, but does not share walls or interior openings. Its placement is slightly recessed and the storefront east elevation is setback. Brick clads the east front elevation and wraps around the side to the south elevation. Masonry unit clads the south and west elevations. Two bays organize the east elevation. A vehicle entry opening with no door fills the north bay. A storefront opening with no glazing fills the south bay. Doors and windows are currently missing. Contrasting brick courses create horizontal banding at the base, above openings and at the parapet under coping. A small addition extends from the rear and a historic vehicle opening appears infilled with masonry unit.

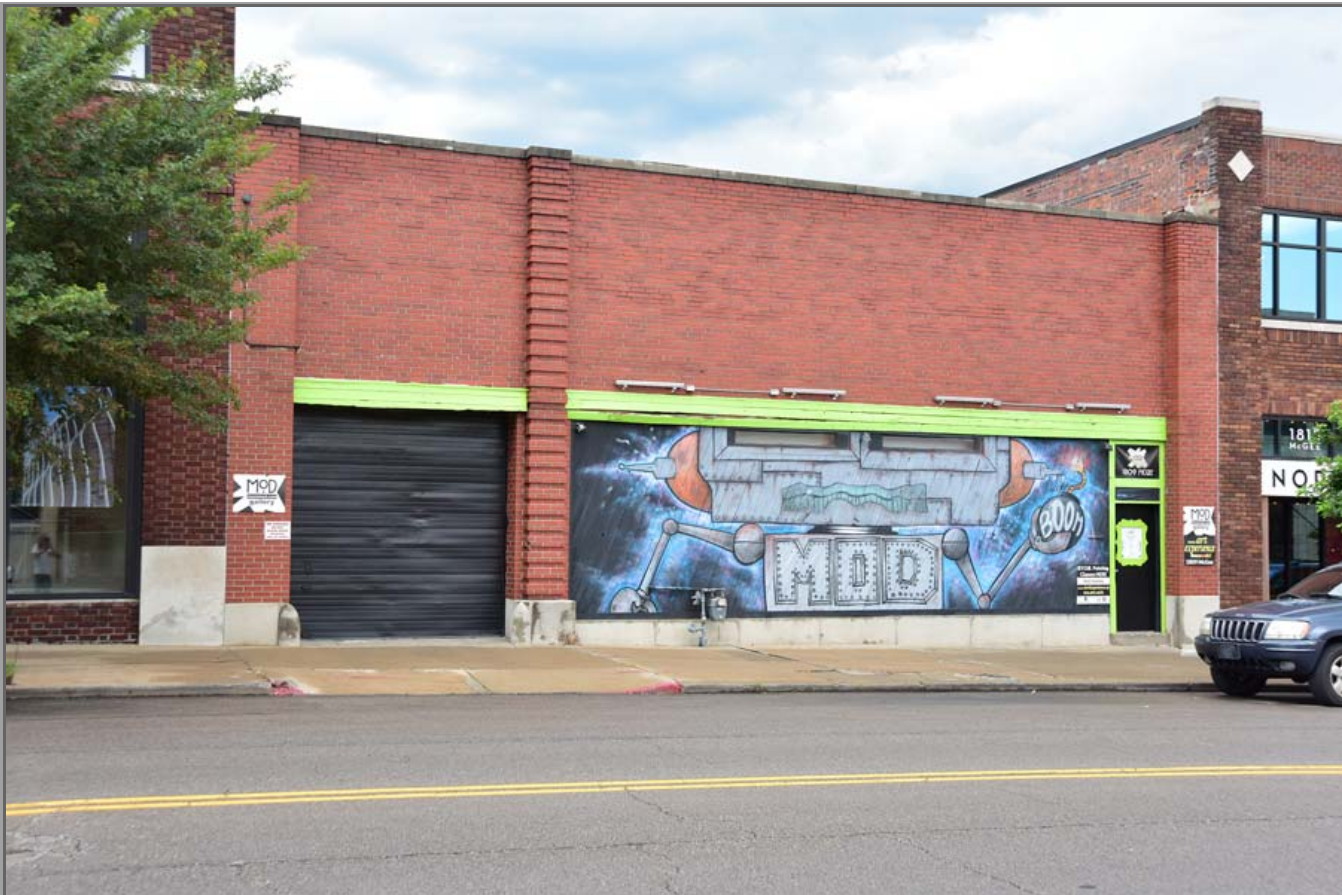
Photographer Brad Finch, f-stop Photography	Date: June 29, 20	Description: west elevation, view SE
--	----------------------	---

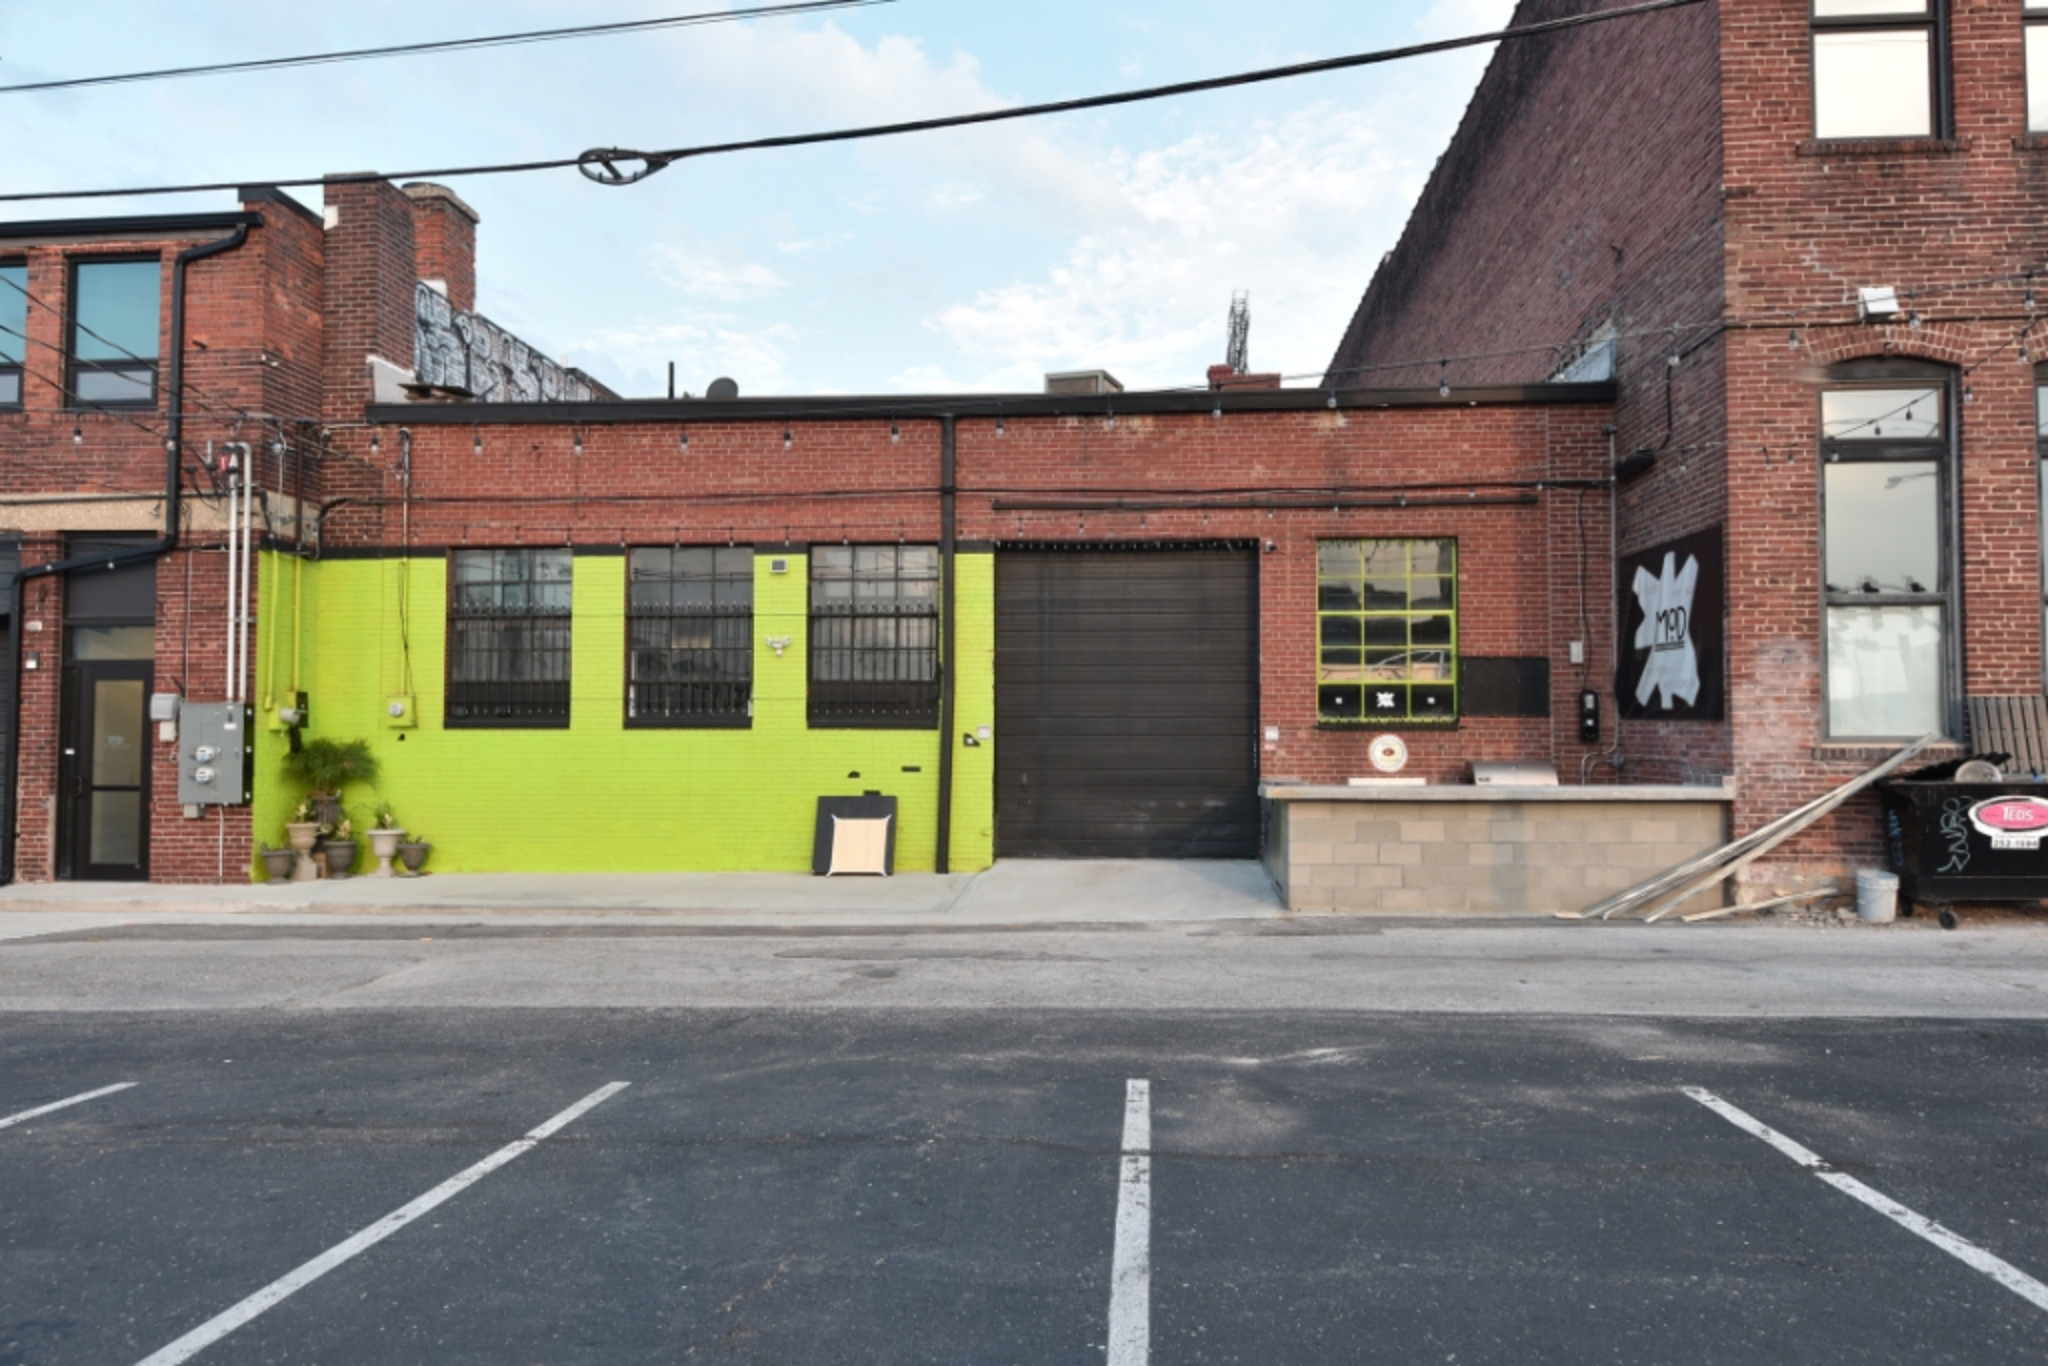
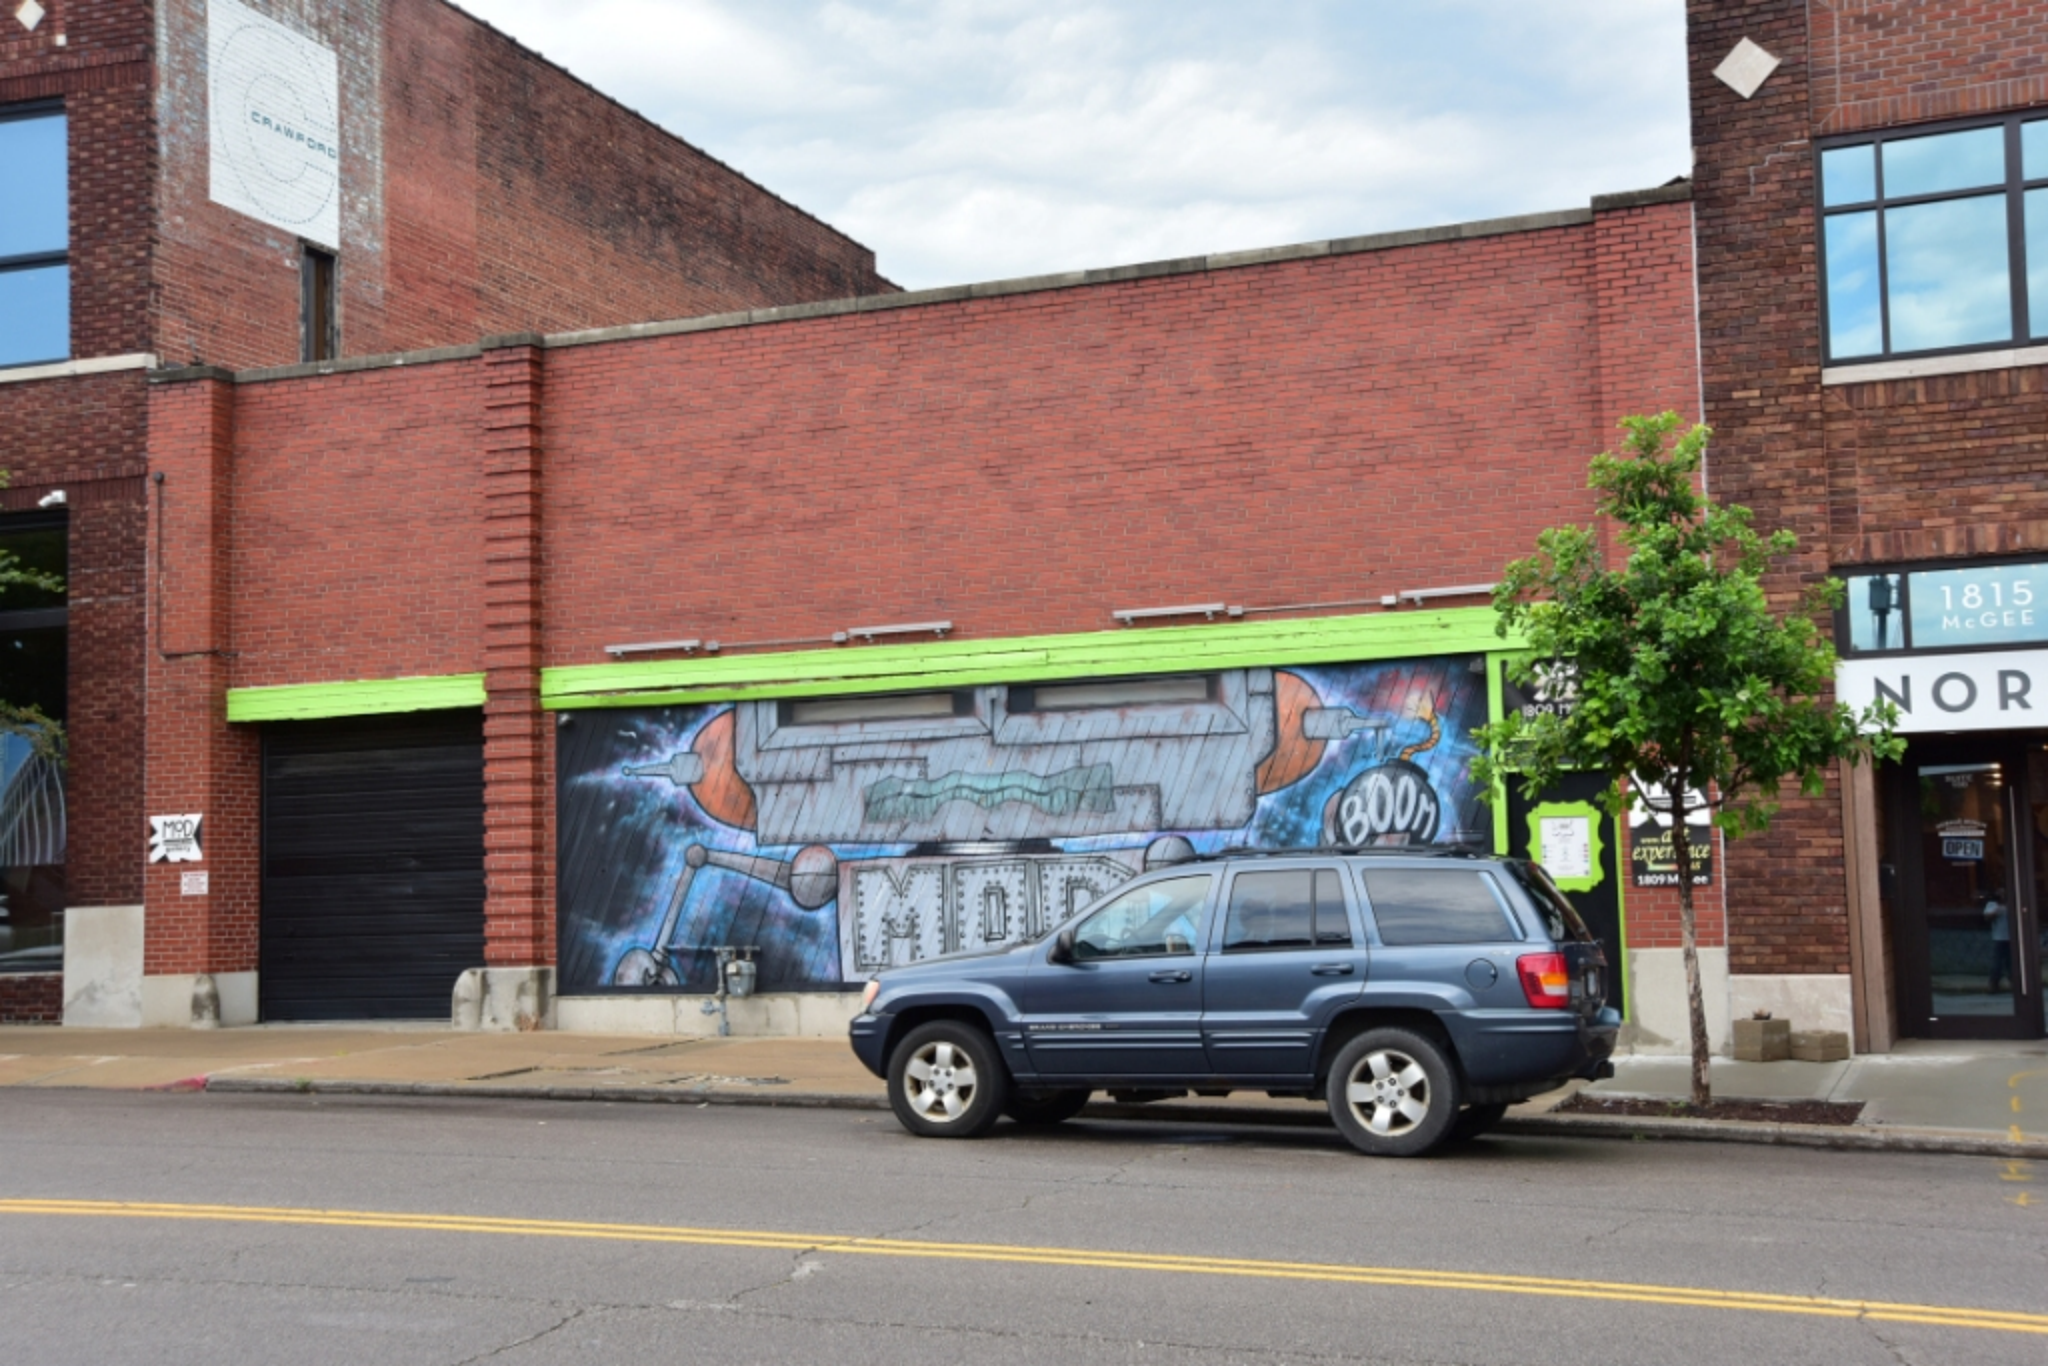
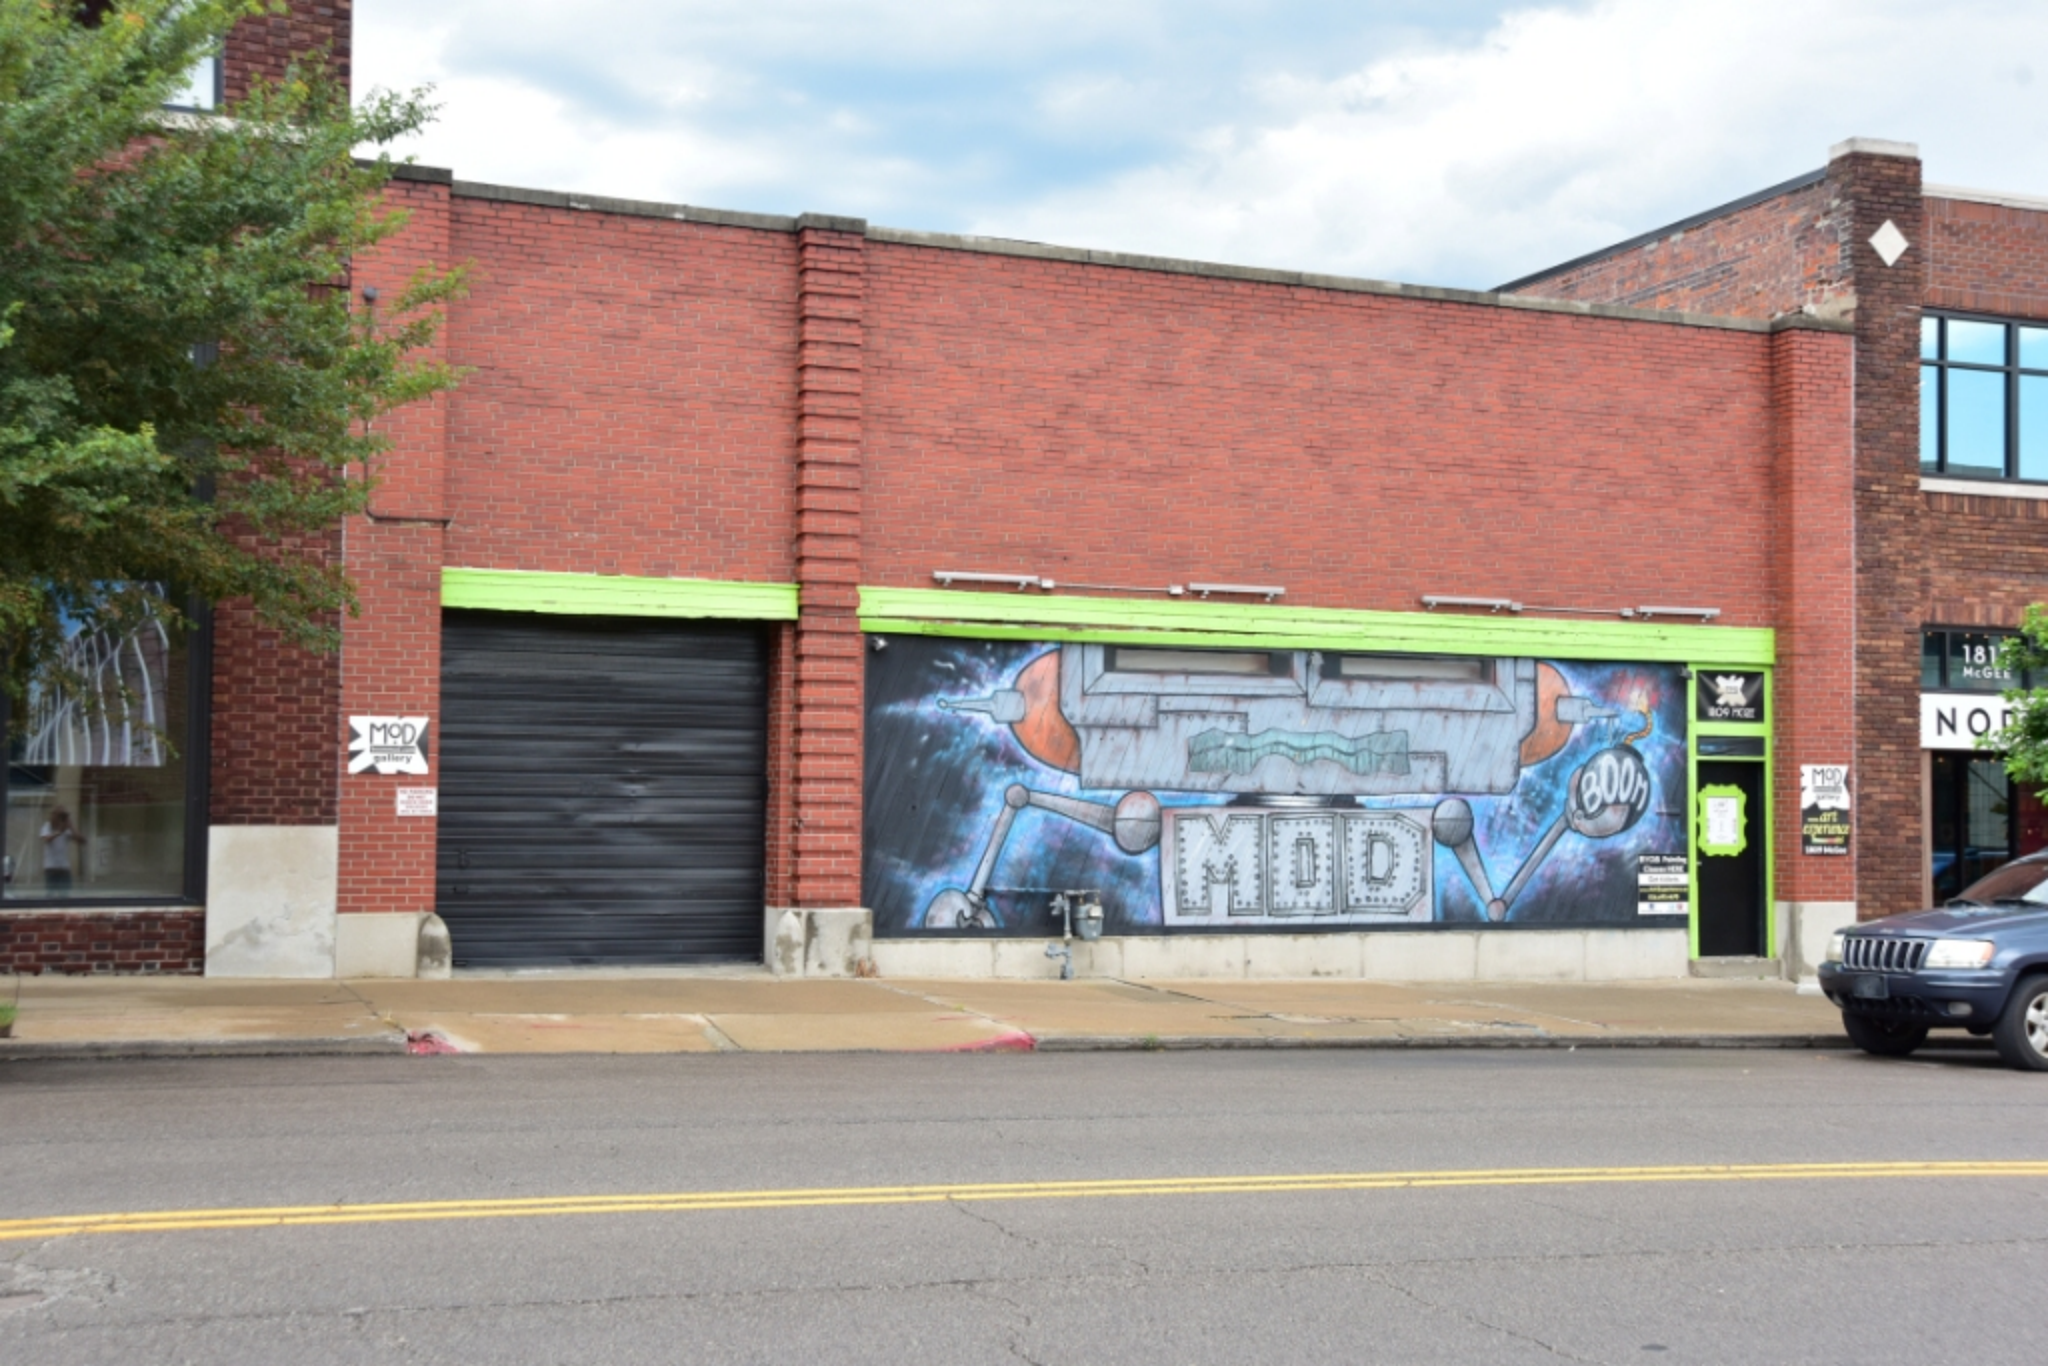
This one-story brick building has a rectangular plan and a flat roof. Two bays organize the west elevation. A metal overhead rolling garage door fills the north bay. Diagonal wood infill, two narrow fixed windows, and a metal door with glazing and a glass transom fill the south bay. A full-height banded vertical brick pier separates the two bays and brick piers project from each end of the building. Stone coping lines the parapet. The building was altered in 1915 when the rear elevation was moved in fifteen feet to accommodate gasoline tanks adjacent to the alley (#58315). The façade was altered in 1947 (#22097). Storefront glazing was extant in 1982. Multi-light metal windows and a metal overhead rolling garage door pierce the rear, east elevation.

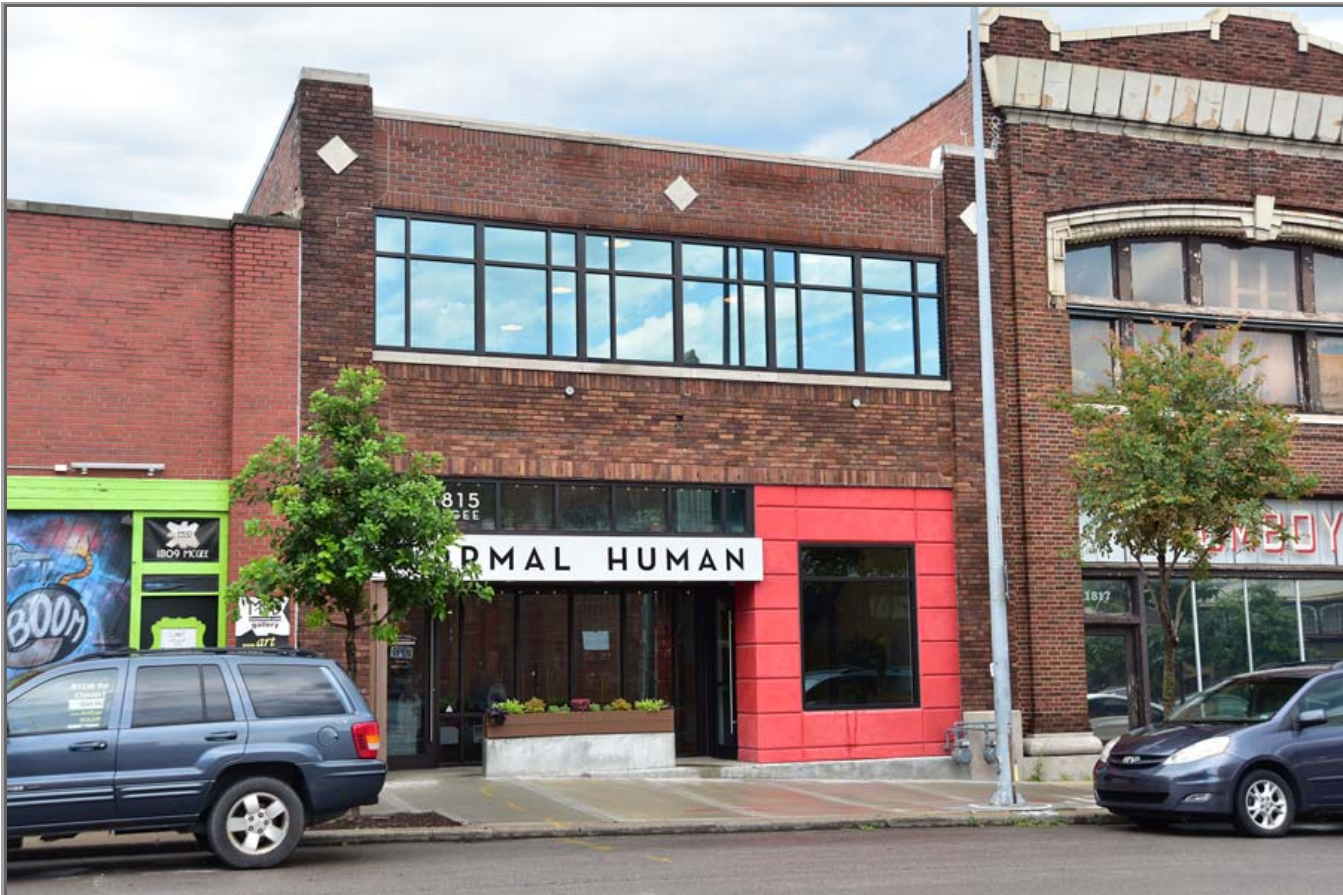
Photographer Brad Finch, f-stop Photography	Date: June 29, 20	Description: east elevation, view SE
--	----------------------	---

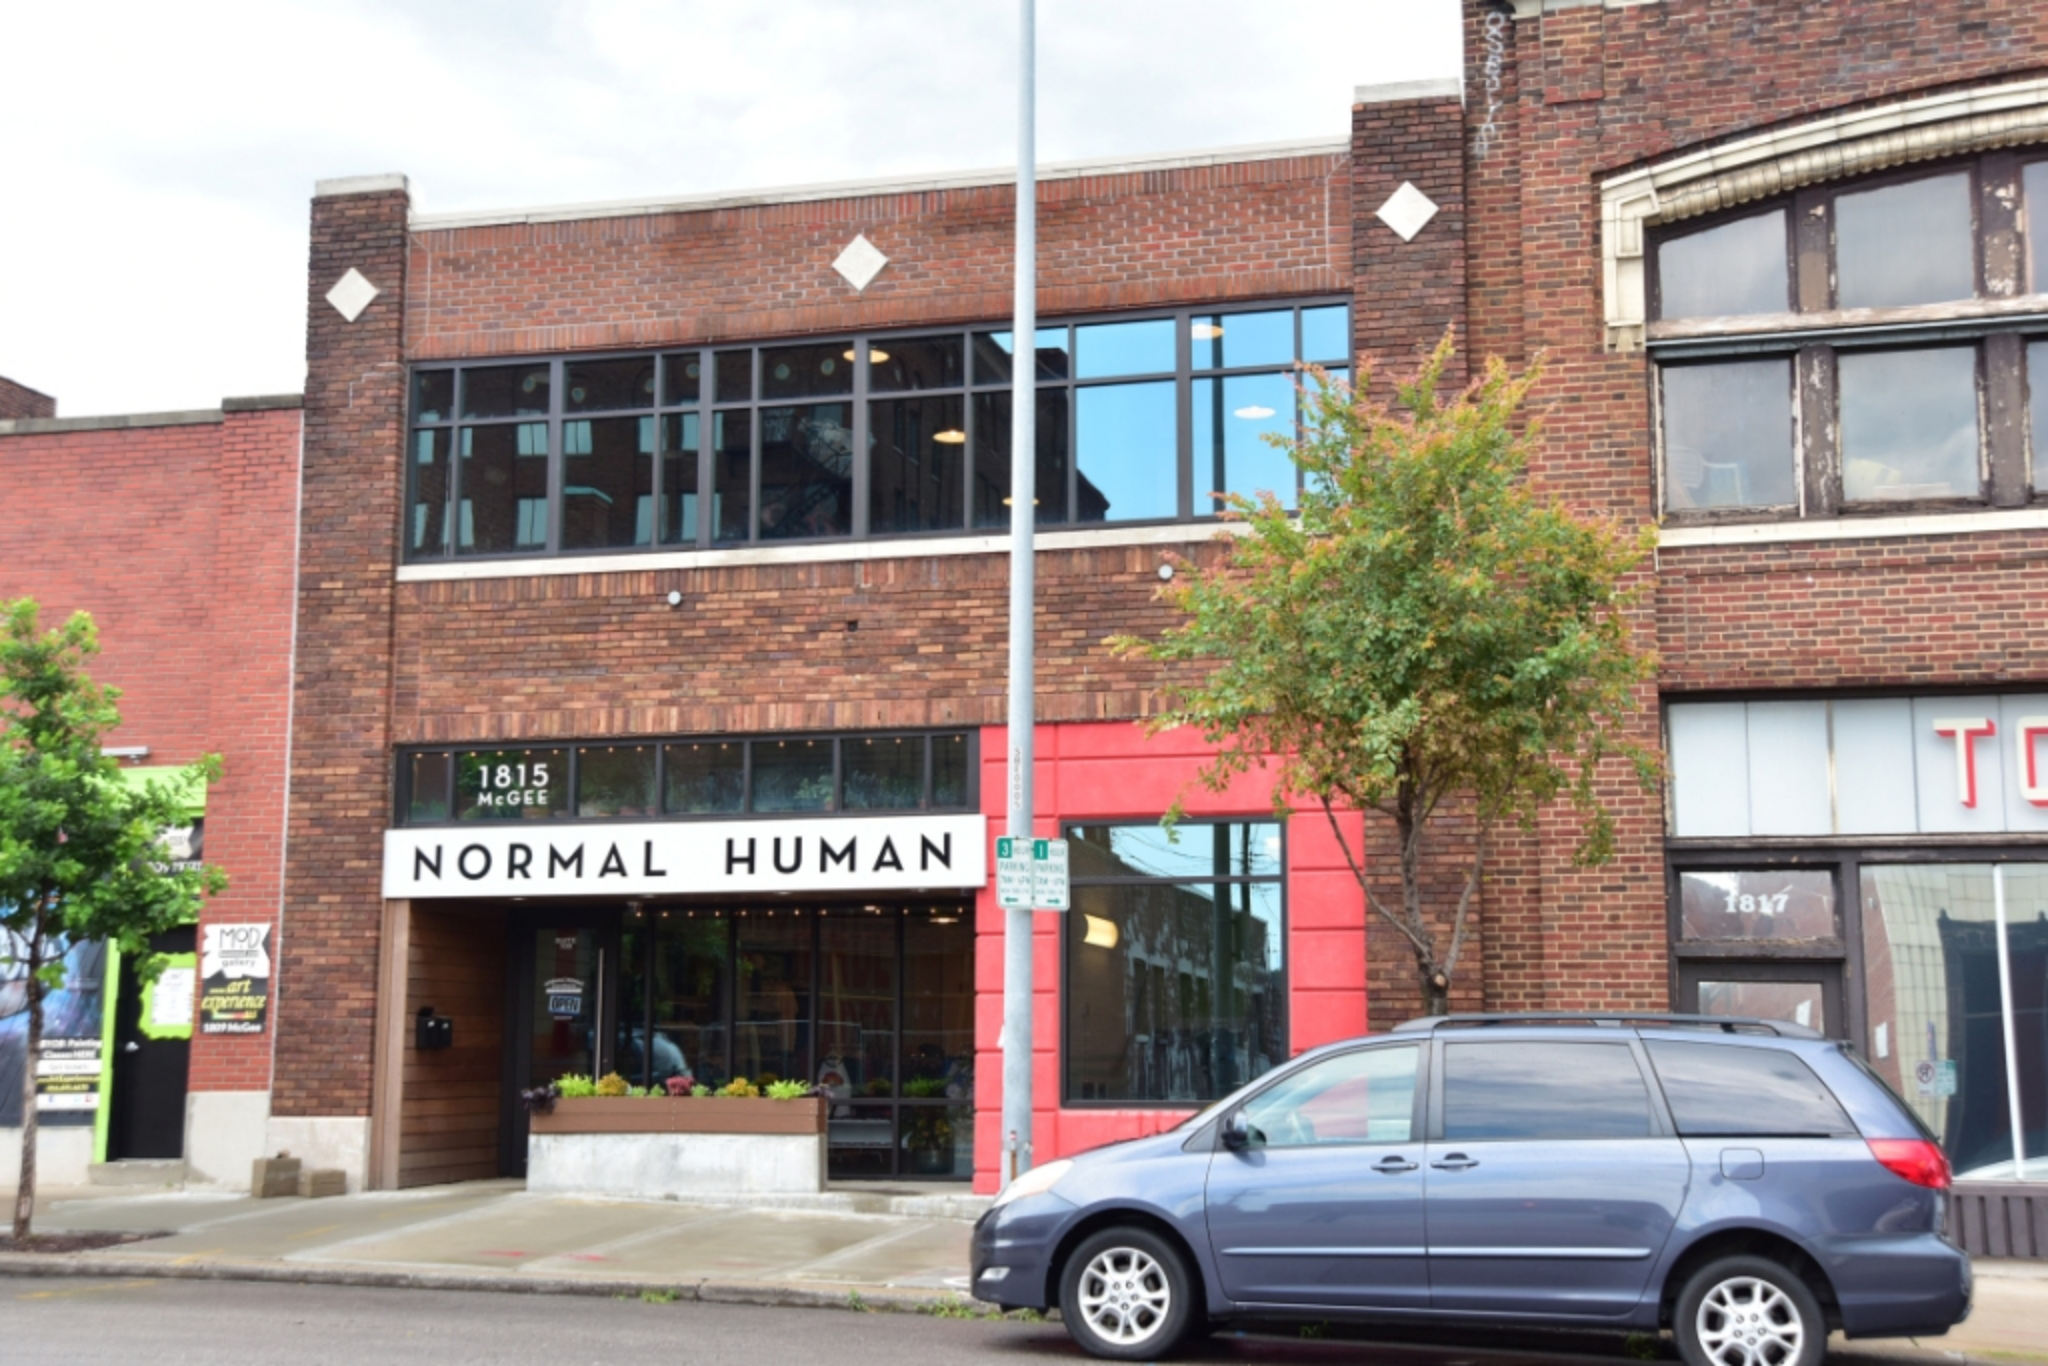
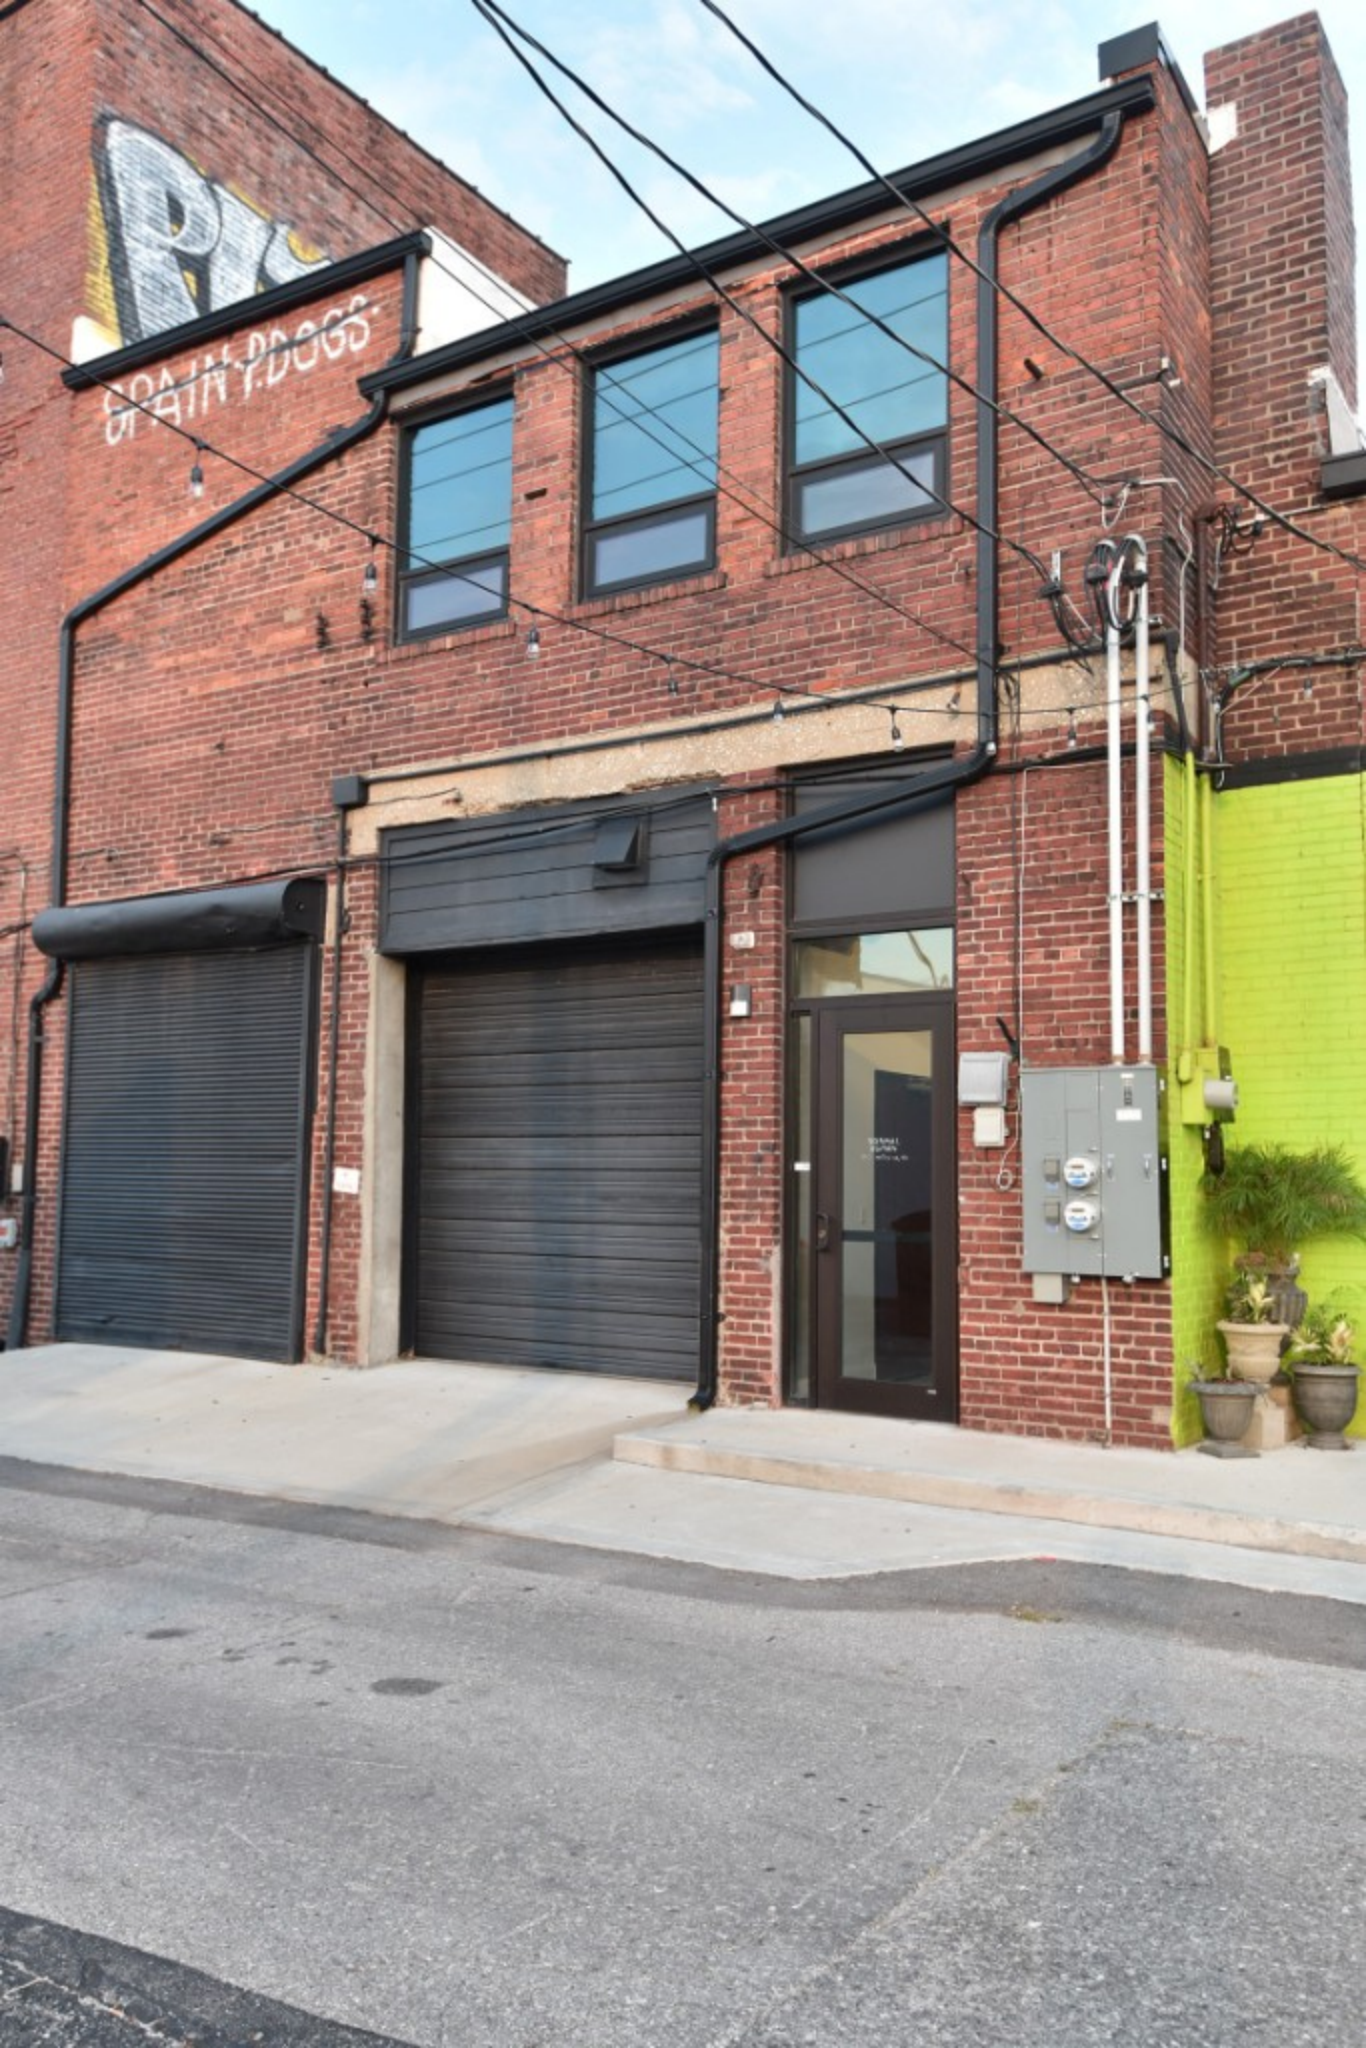
This two-story brick building has a rectangular plan and a flat roof. Full-height brick corner piers rise above a parapet. Stone coping stops the roofline. Two bays organize the first story. The north bay has a glass transom with metal muntins tops a recessed non-historic aluminum storefront with glazing and a glazed aluminum door. The south bay has scored concrete surrounding a fixed window with a horizontal aluminum muntin. Sailor course brick bands create geometric ornament above first and second story windows. Diamond-shaped stone inlays are geometrically spaced above second story windows. The storefront was altered circa 2012. Two overhead rolling doors cover vehicle entries and a metal door with glazing and a transom pierce the rear elevation. The south bay parapet is raised and historic Sanborn maps show an elevator at this location above the vehicle entry. Three non-historic one-over-one aluminum windows pierce the second story.
