MISSOURI DEPARTMENT OF NATURAL RESOURCES
STATE HISTORIC PRESERVATION OFFICE, P.O. Box 176, Jefferson City, MO 65102
ARCHITECTURAL/HISTORIC INVENTORY FORM

1. Survey number: JA-AS-087-025		2. Survey Name: McGee Street Historic Resources Survey 2017	
3. County: JACKSON		4. Address (Street No.): 215	Street (name): E. 18th Street
5. City: Kansas City	Vicinity <input type="checkbox"/>	6. Lat / Long: 39.091481 -94.580440	7. Township/Range/Section: T: R: S:
8. Historic name (if known): Interstate Securities Building		9. Present/other name (if known):	
10. Ownership: <input checked="" type="checkbox"/> Private <input type="checkbox"/> Public		11a. Historic use (if known): Commercial	11b. Current use: Commercial

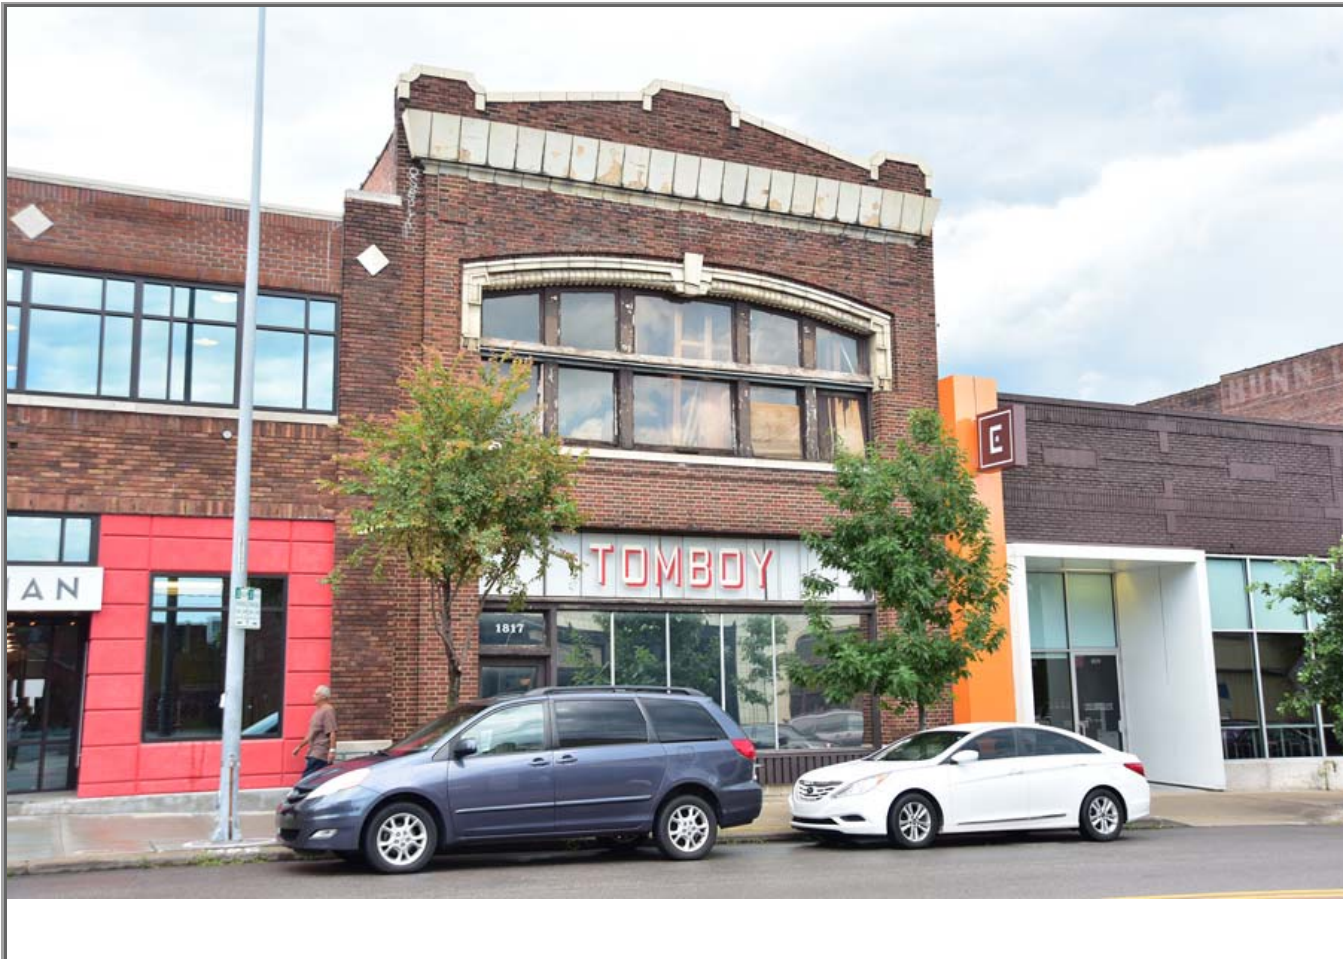
Photographer Brad Finch, f-stop Photography	Date: June 29, 20	Description: west elevation, view SE
--	----------------------	---

This two-story brick building has a rectangular plan and a flat roof. The front façade has one wide bay at each story. A transom tops storefront glazing and a wood door with glazing on the first story. The wood frame is historic while the glazing has been replaced. At the second story, a single, long arched window with wood mullions fills the bay. The opening has a terra cotta lugsill and terra cotta arch with an exaggerated keystone. Terra cotta coping lines a shaped parapet above a tall but simple terra cotta cornice.

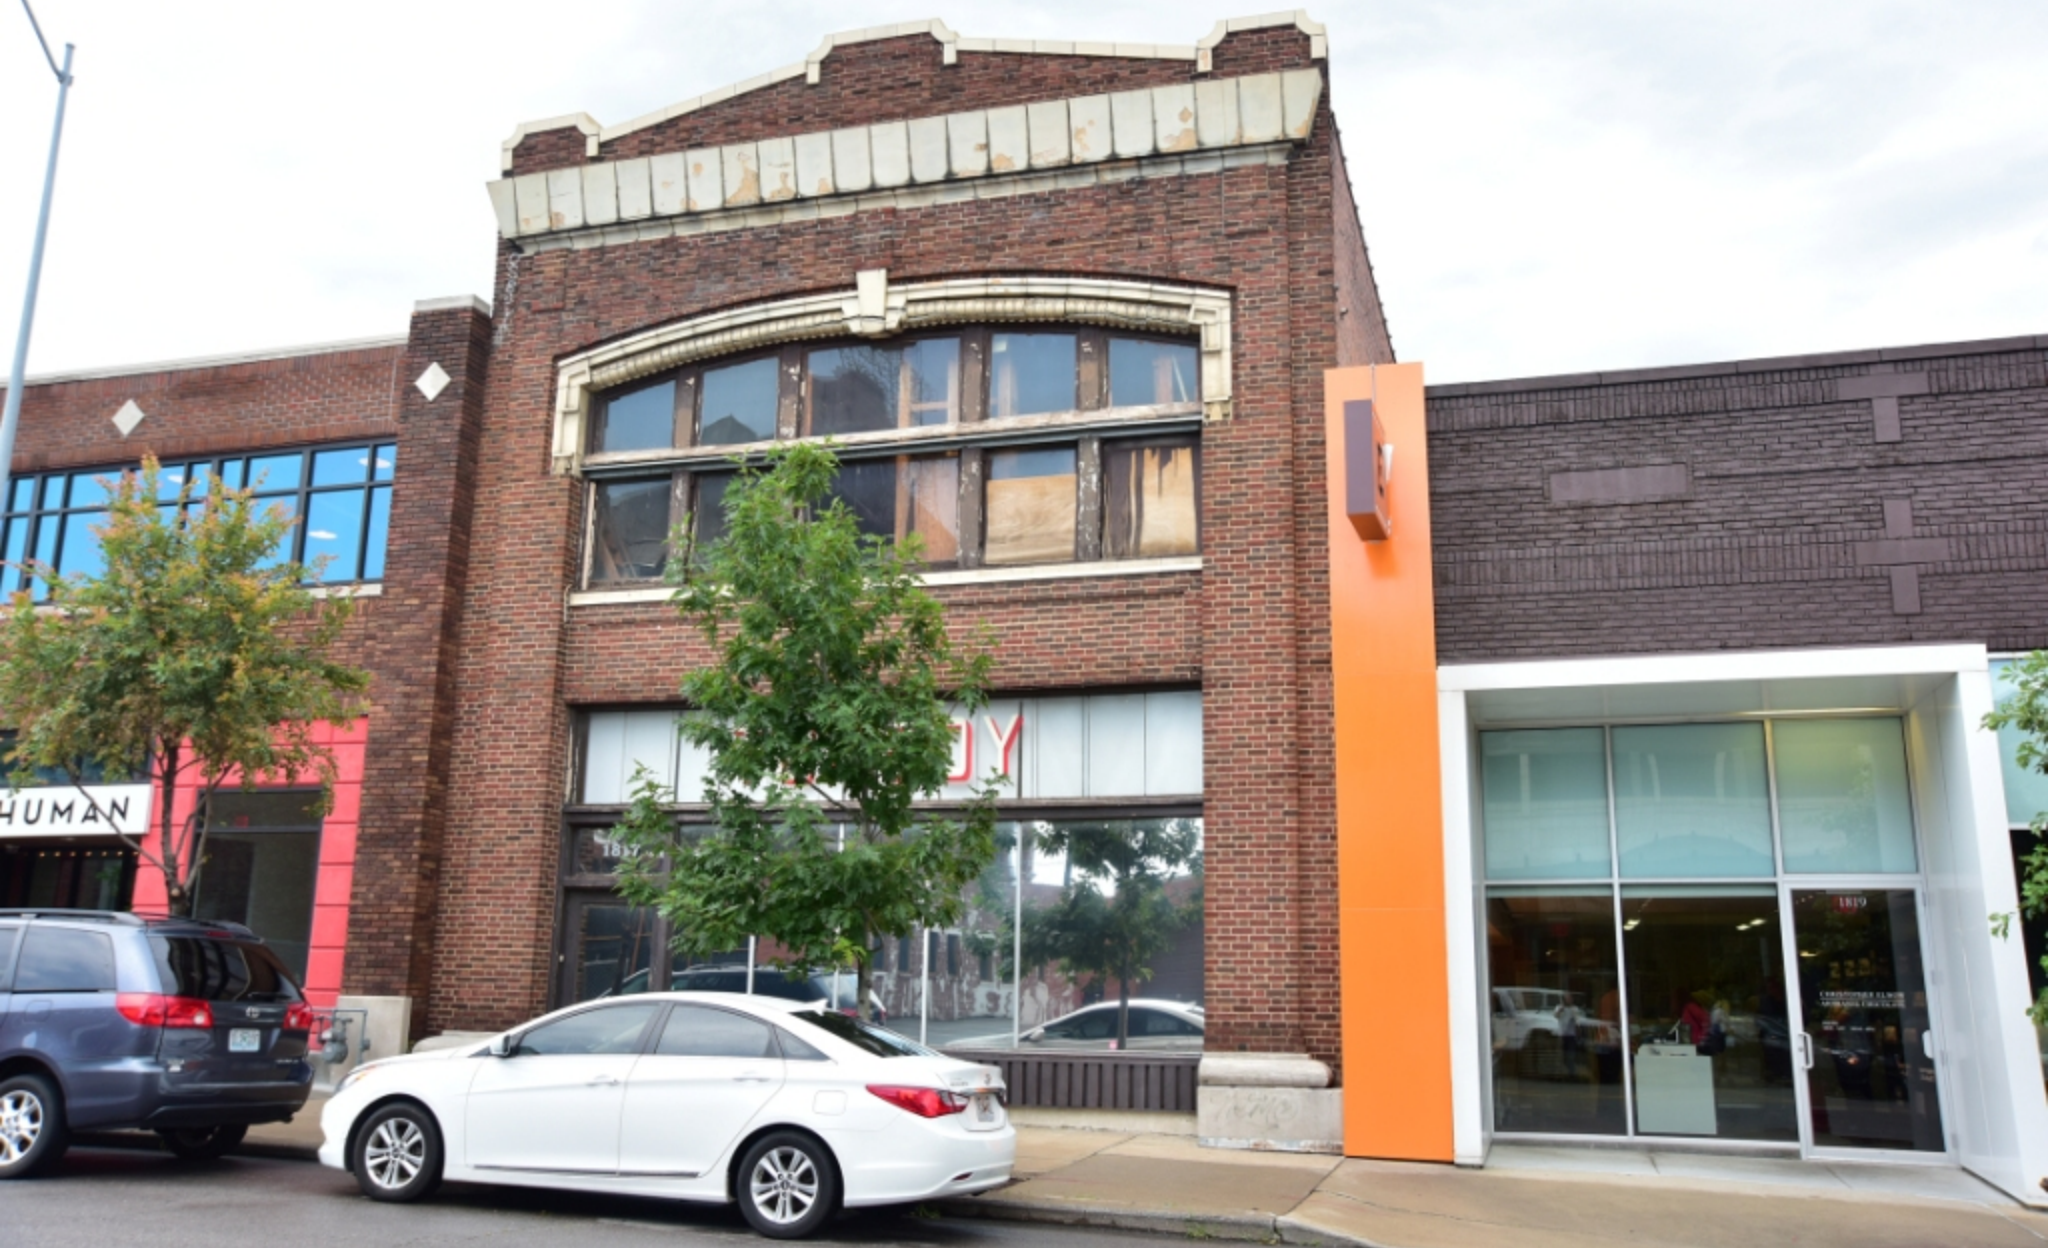
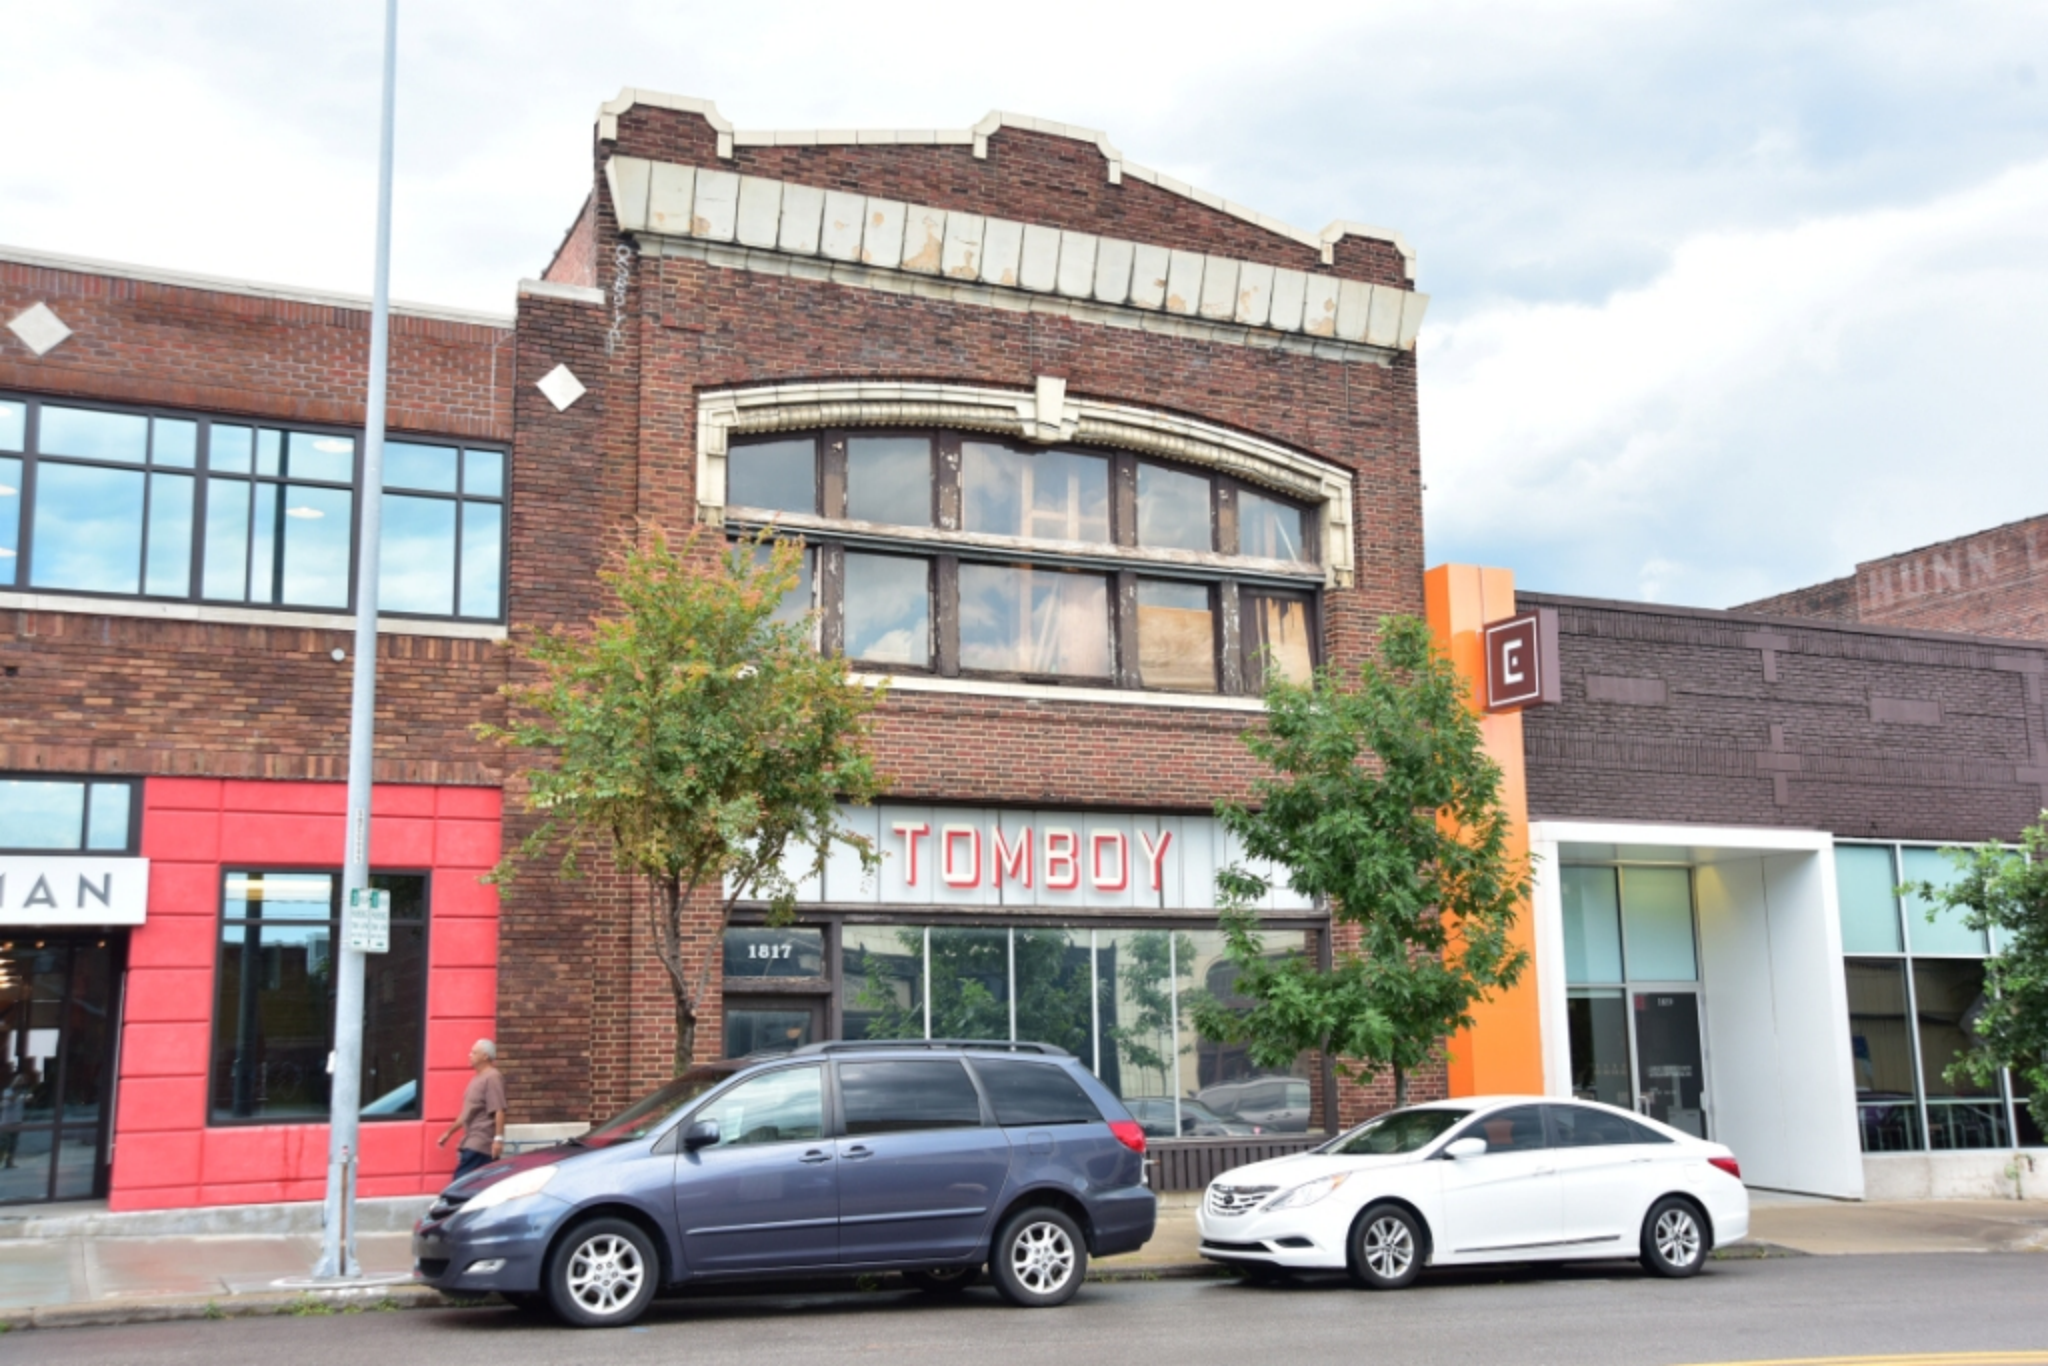
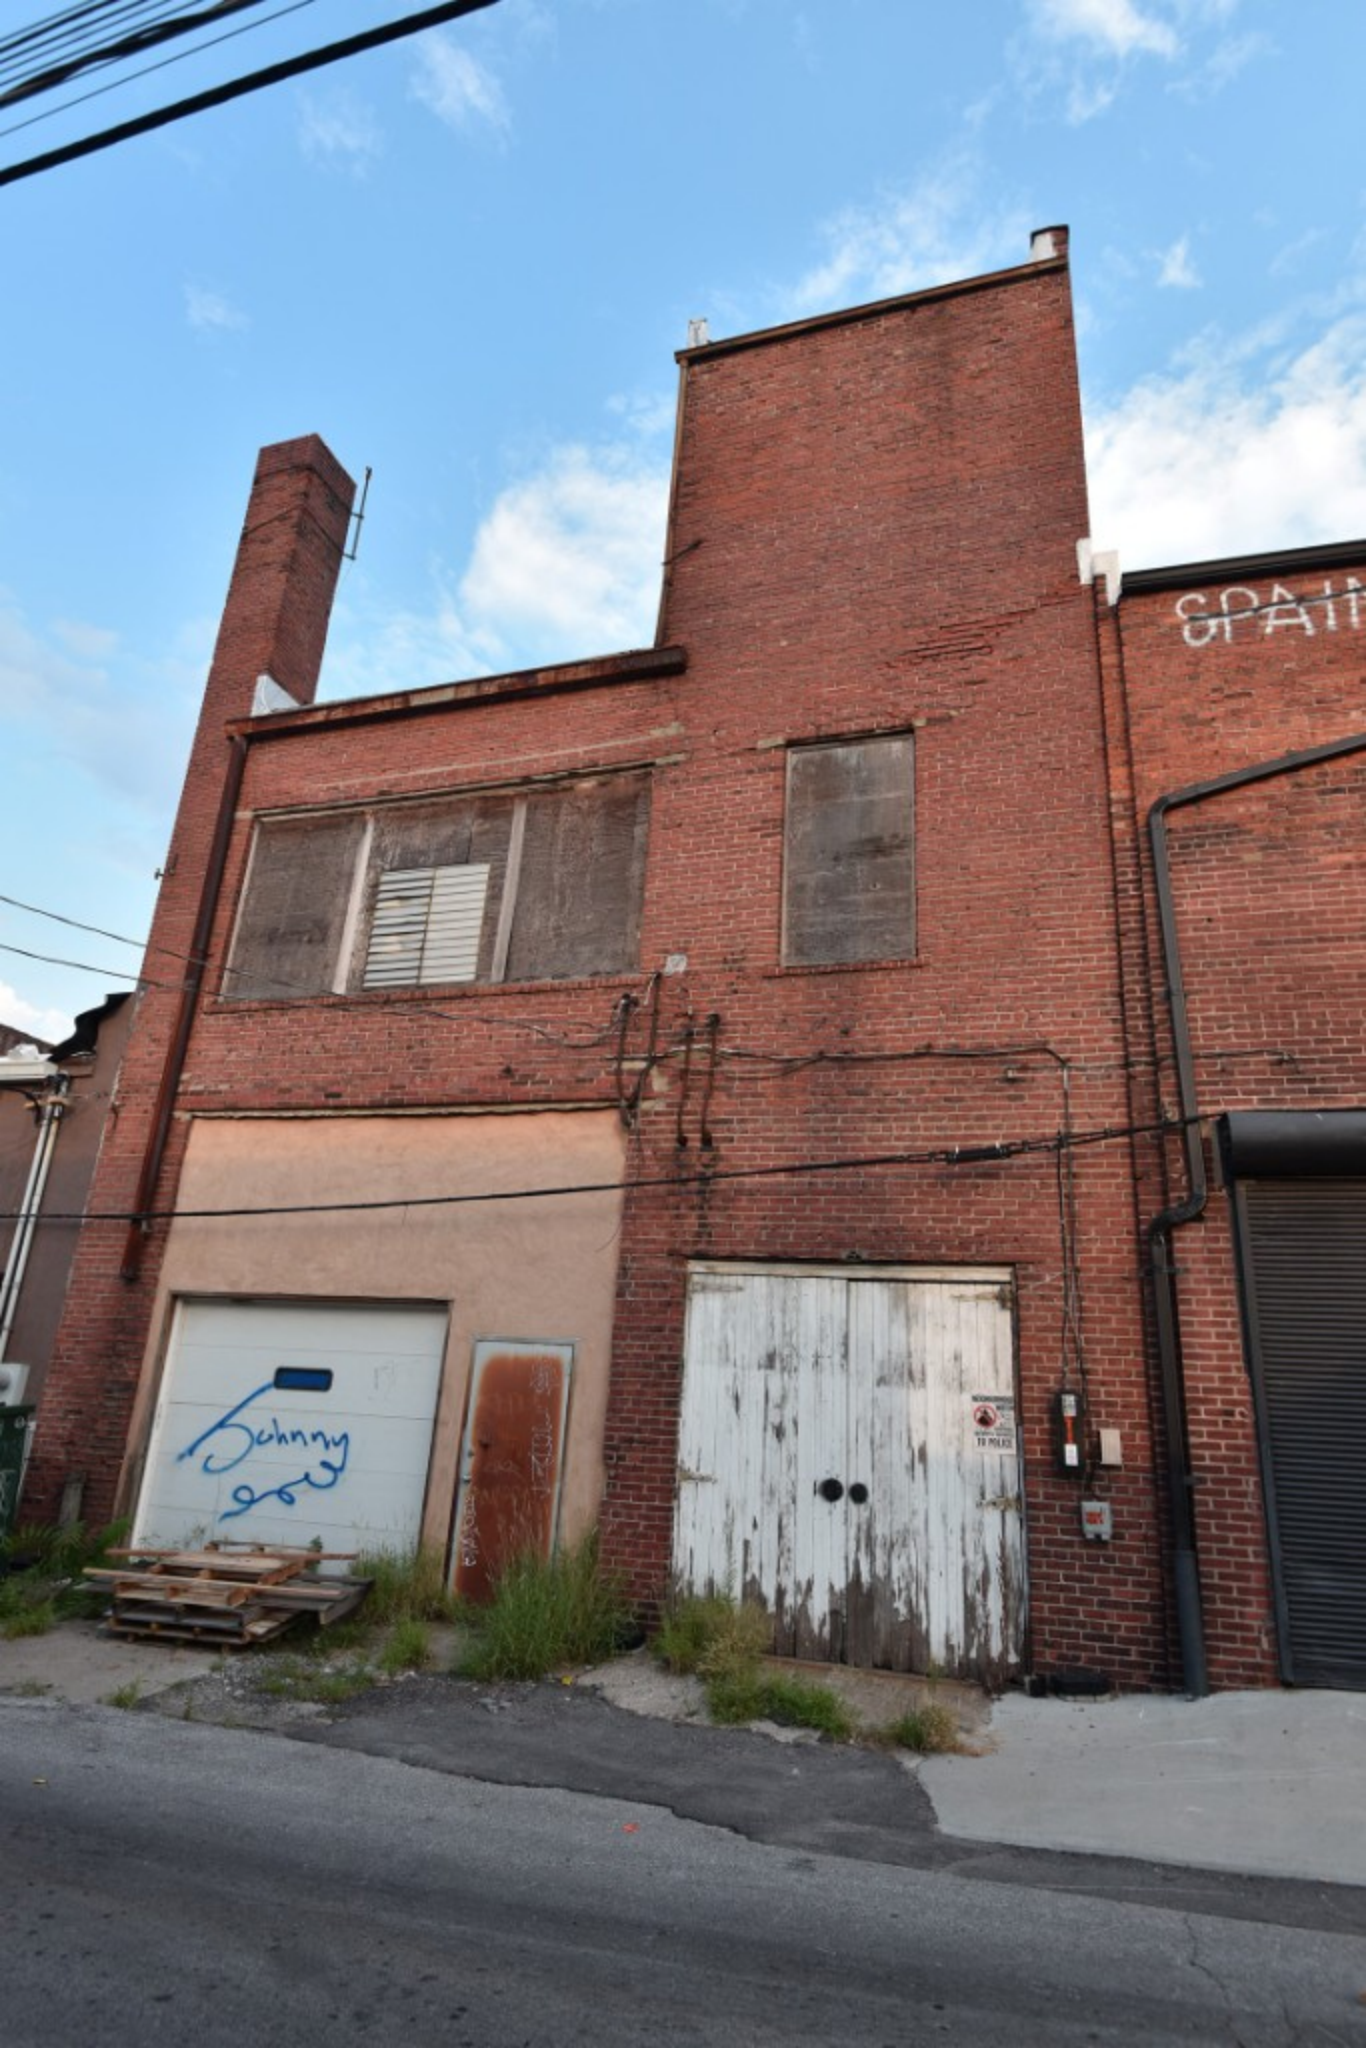
Two bays organize the rear elevation. Paired wood hinged doors access a vehicle entry under a raised elevator shaft on the north bay. A non-historic metal panel overhead rolling door and a metal slab door surrounded by stucco infill fill the south bay. A banded set of three windows and a single window are covered in plywood on the second story. A brick chimney rises at the southeast corner.

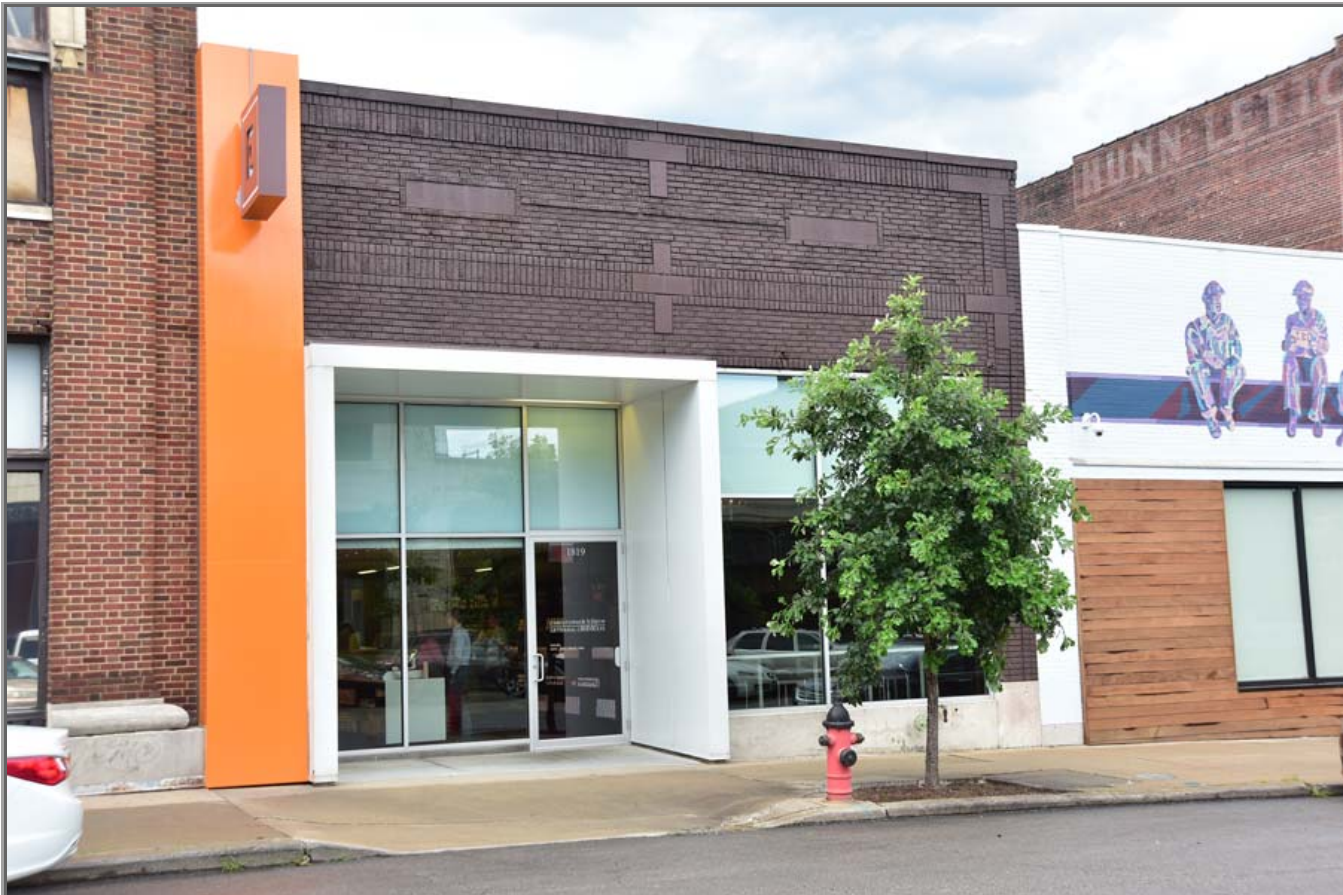
Photographer Brad Finch, f-stop Photography	Date: June 29, 20	Description: west elevation, view SE
--	----------------------	---

1819 McGee Street has good integrity and is recommended as a contributing resource to a potential historic district. The building is associated with automobile-related commercial buildings concentrated in "Automobile Row." The building communicates its significance as an early automobile-related commercial building. The large recessed opening in the north bay historically contained a vehicular entrance and although the storefront system has been replaced, the east bay historically contained the display window. The alterations to this façade do not compromise the ability of the building to convey its historic auto-related function and the era of construction.

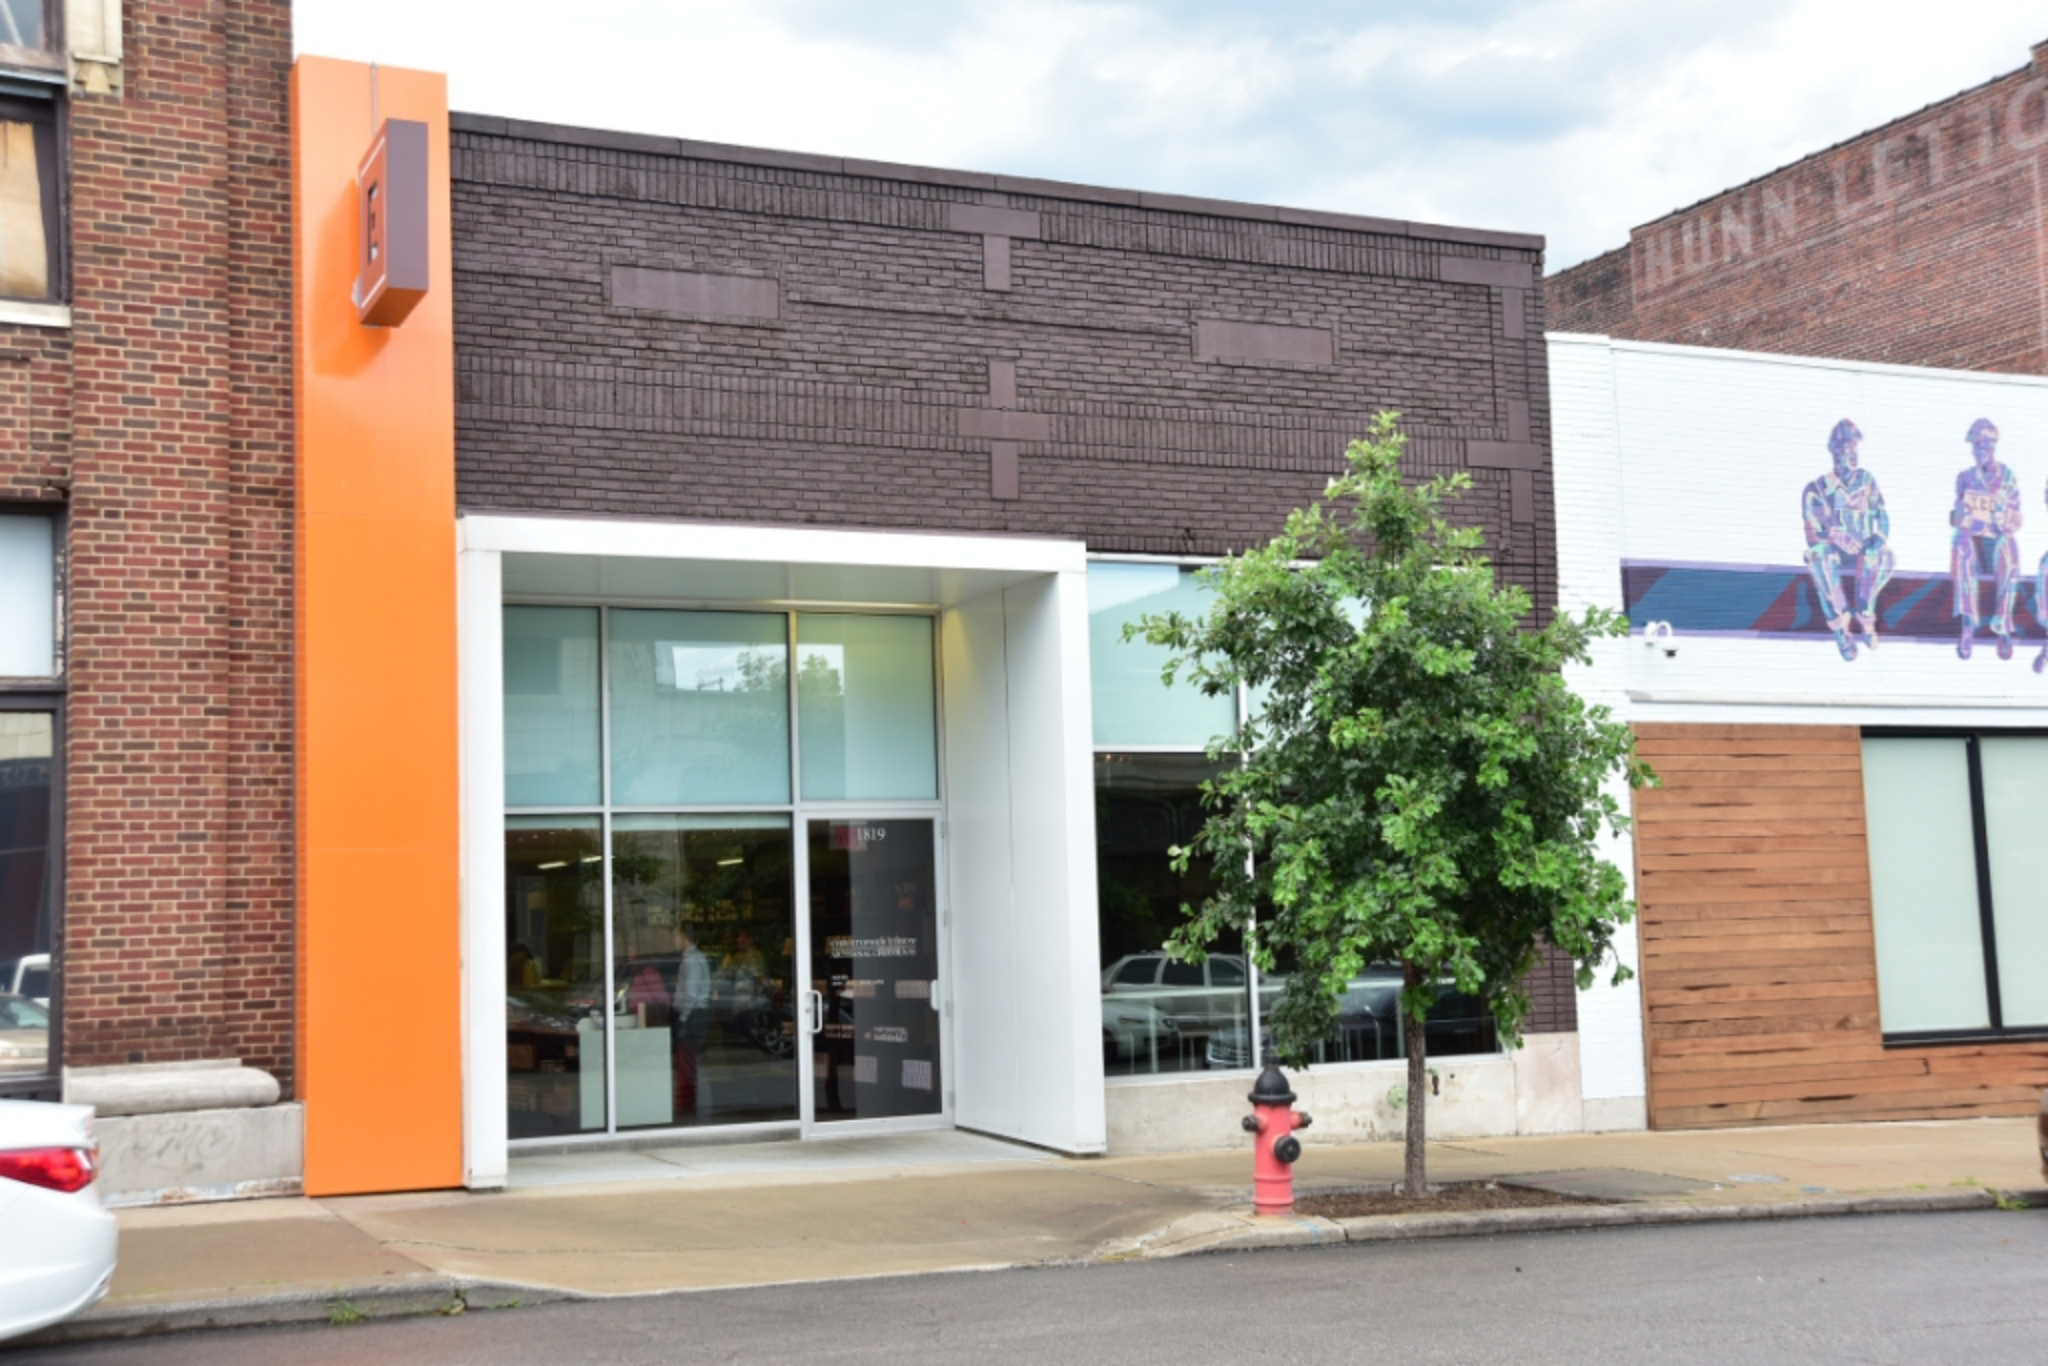
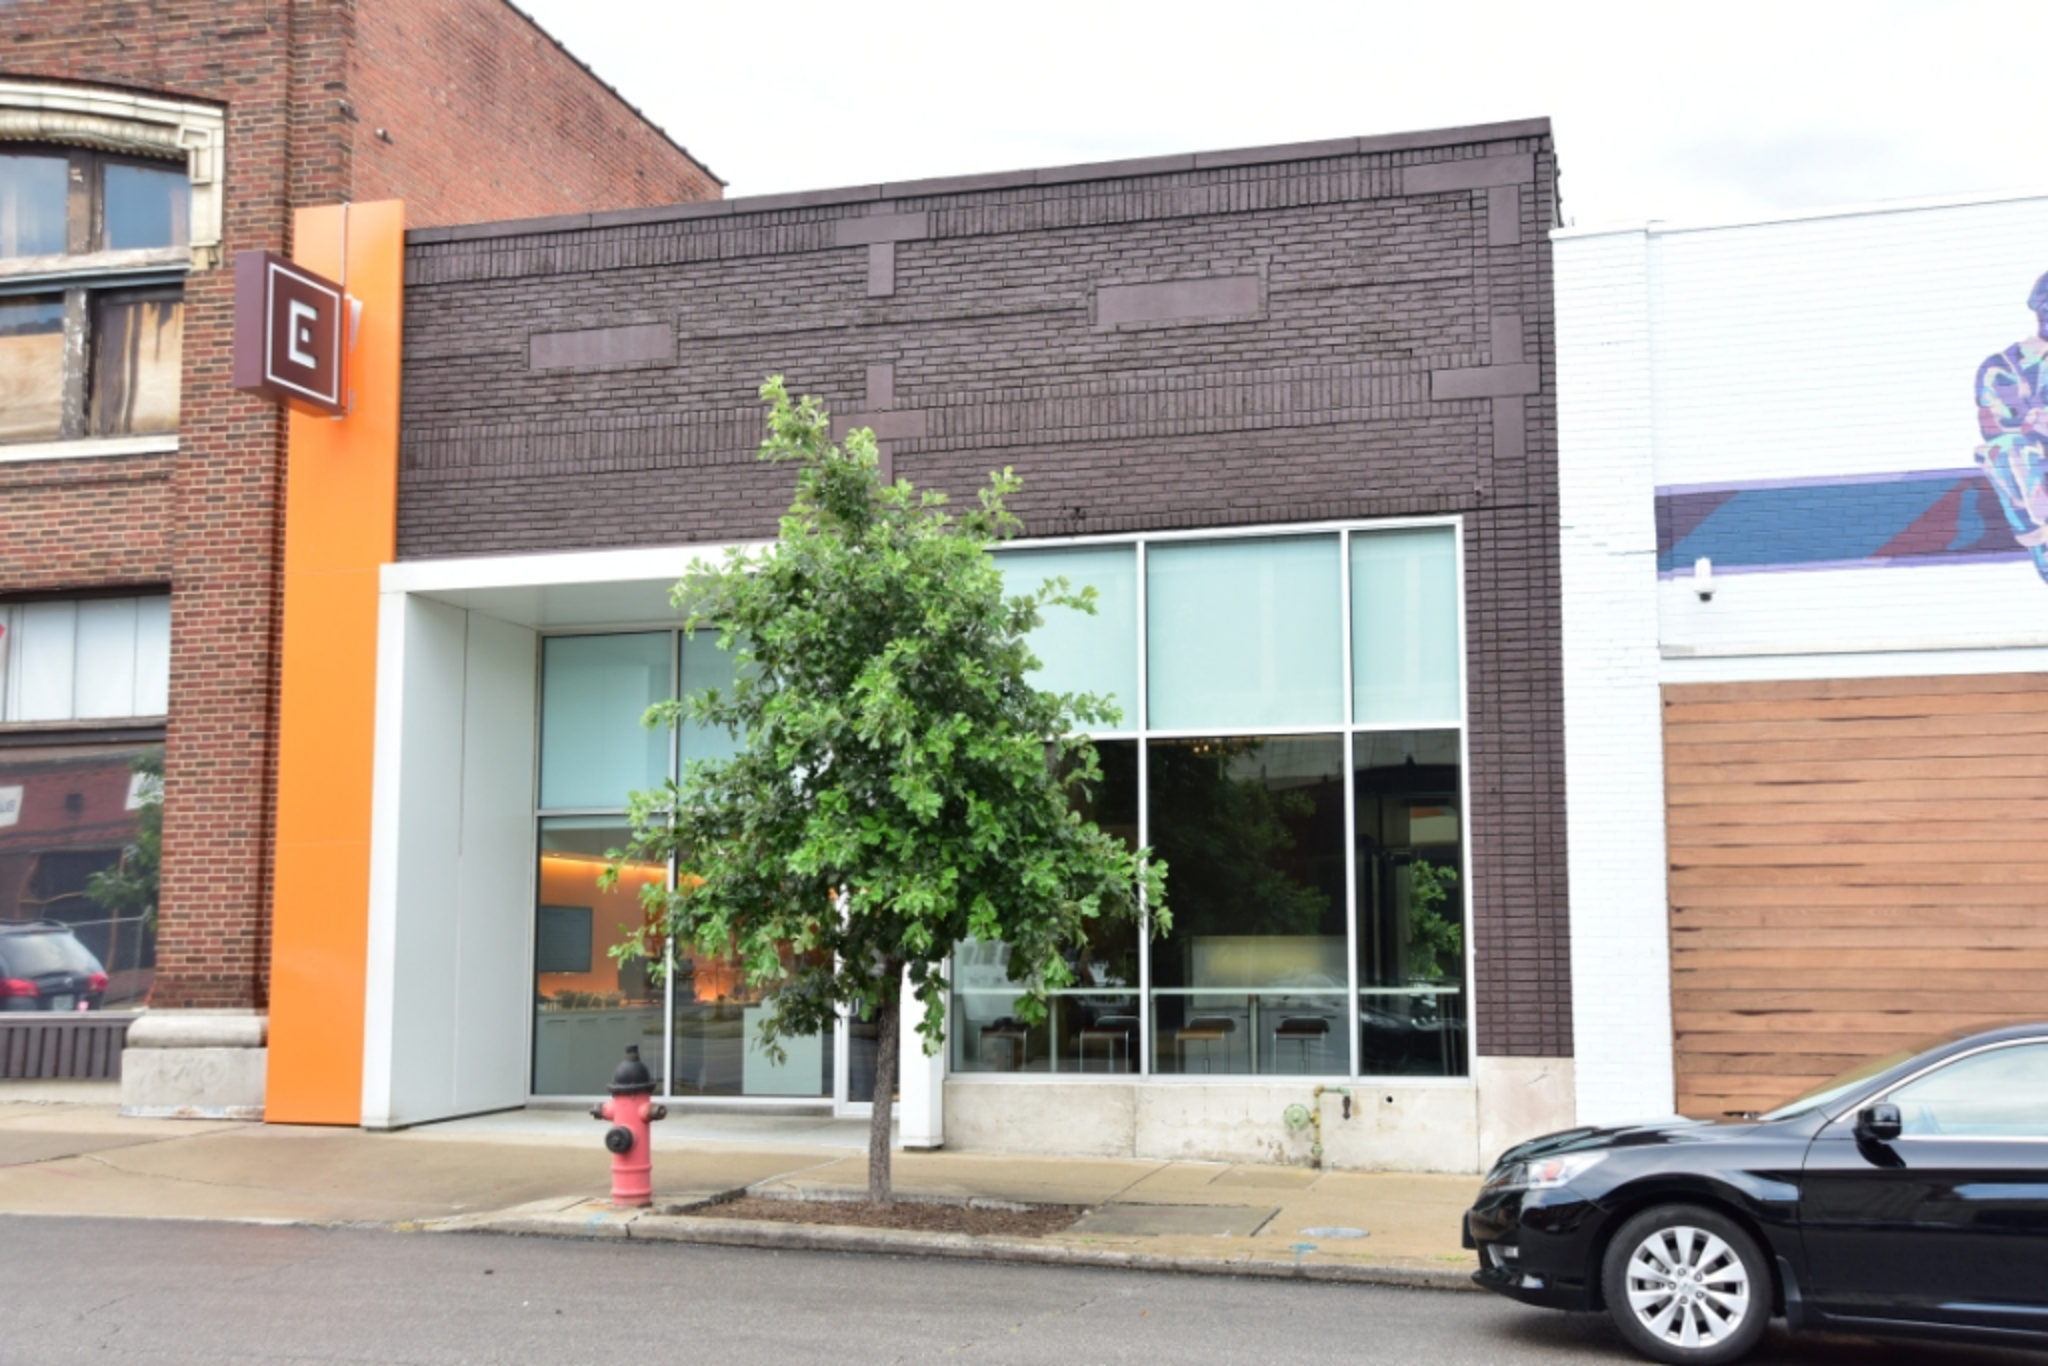
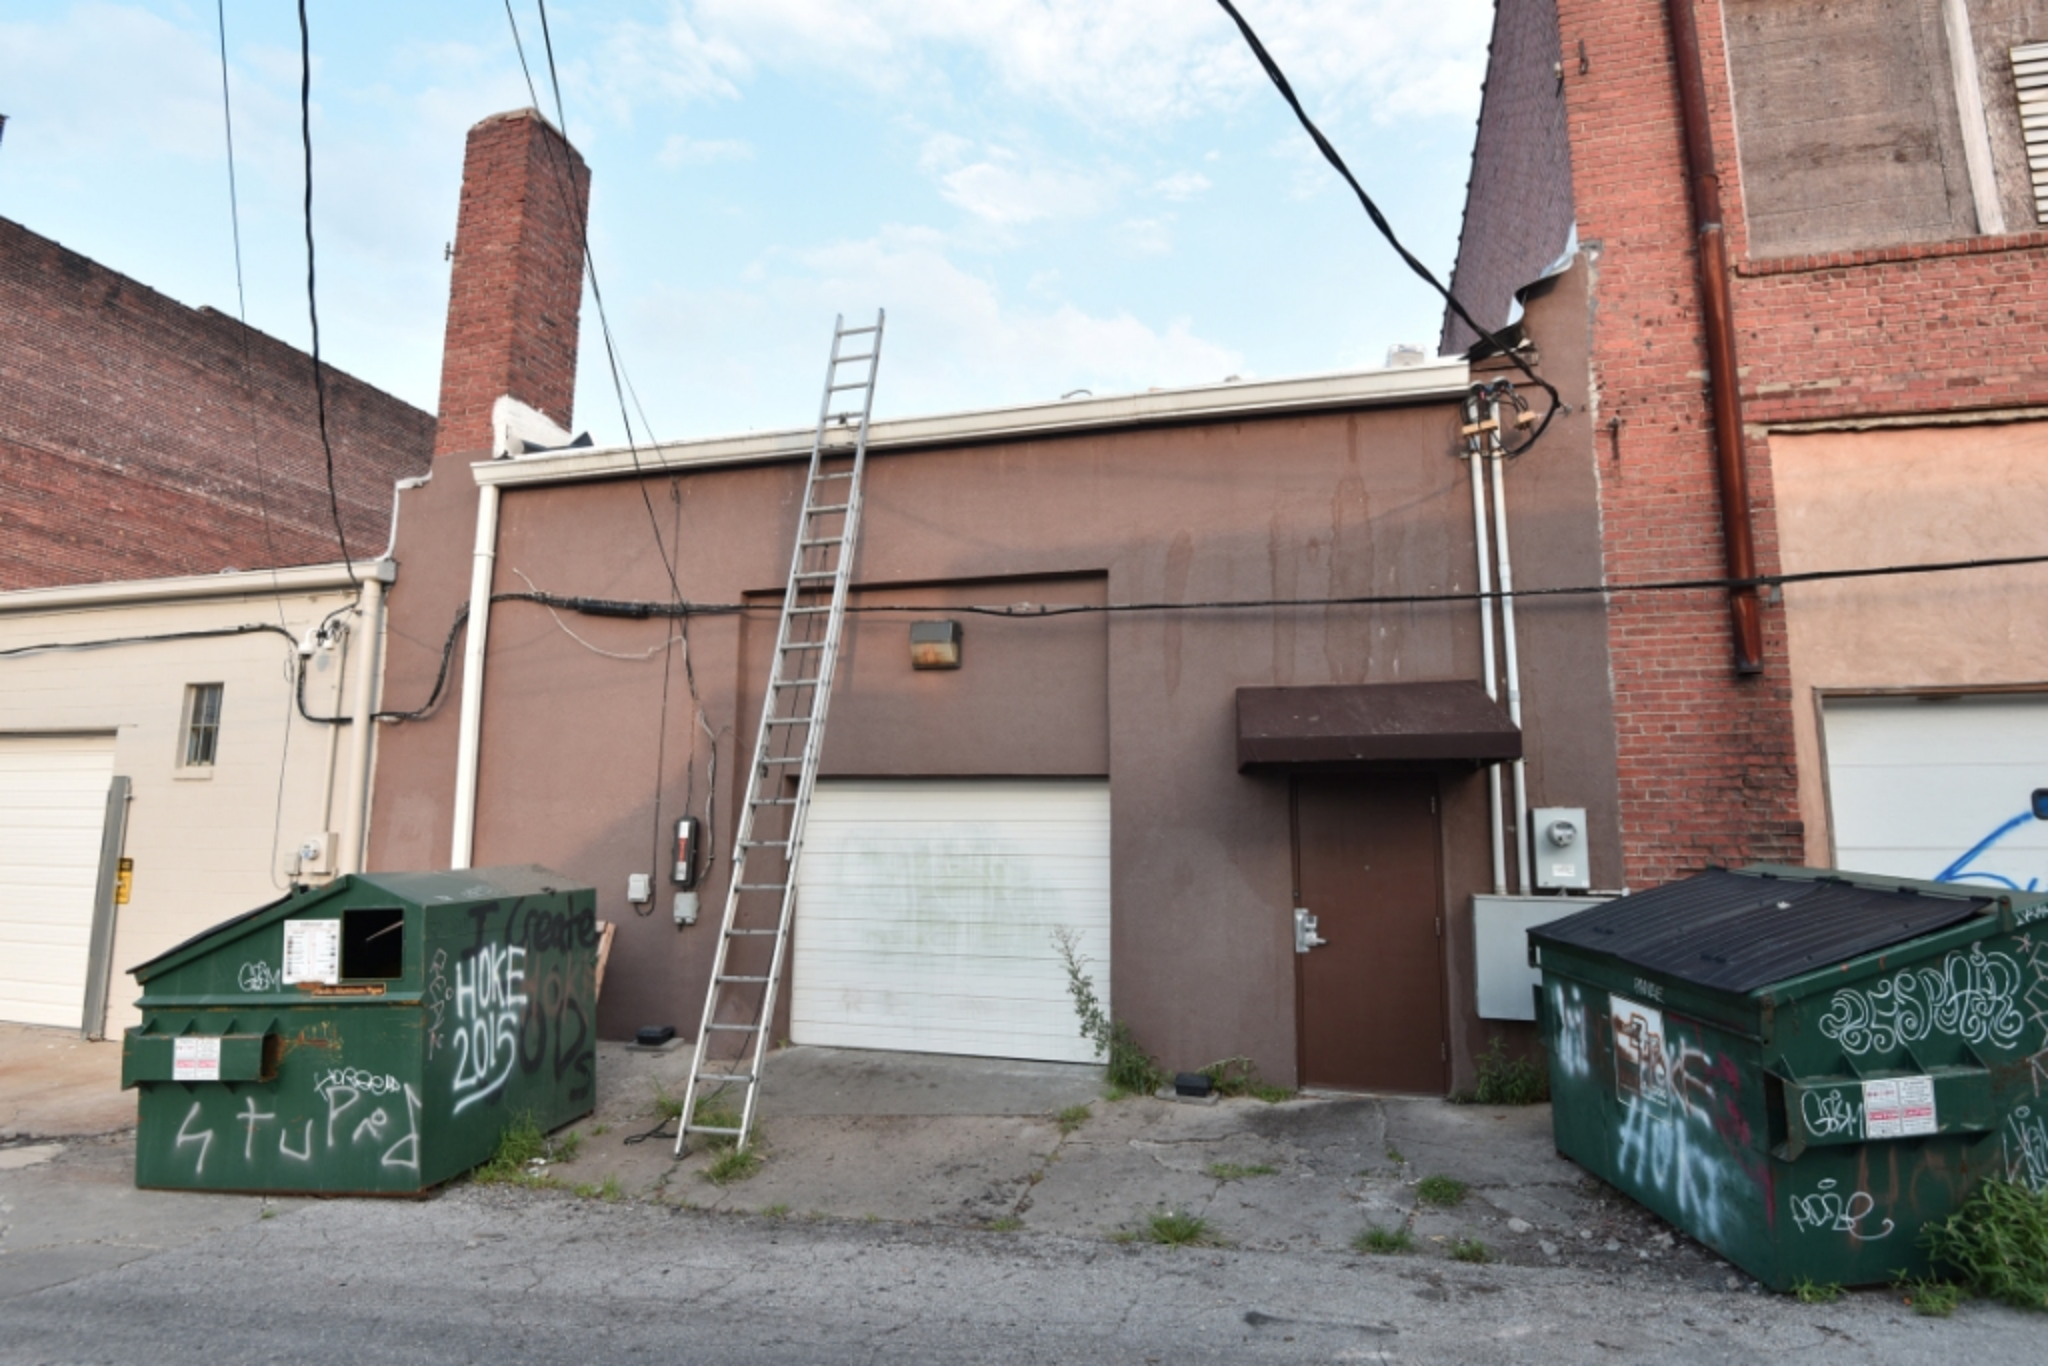
This one-story brick building has a rectangular plan and a flat roof. Two bays organize the west elevation. The north bay is a recessed storefront with a transom and a metal door with glazing that maintains the dimensions of the historic garage door opening. The south bay is a storefront with a transom above the historic stone kneewall that maintains the historic storefront opening. Brick courses and inlaid geometric stone ornament the brick parapet. Stone coping tops the parapet.
Stucco clads the rear, east elevation. A metal overhead rolling garage door fills a recessed vehicle entry in the south bay. A metal slab door pierces the north bay. A brick chimney rises in the southeast corner.

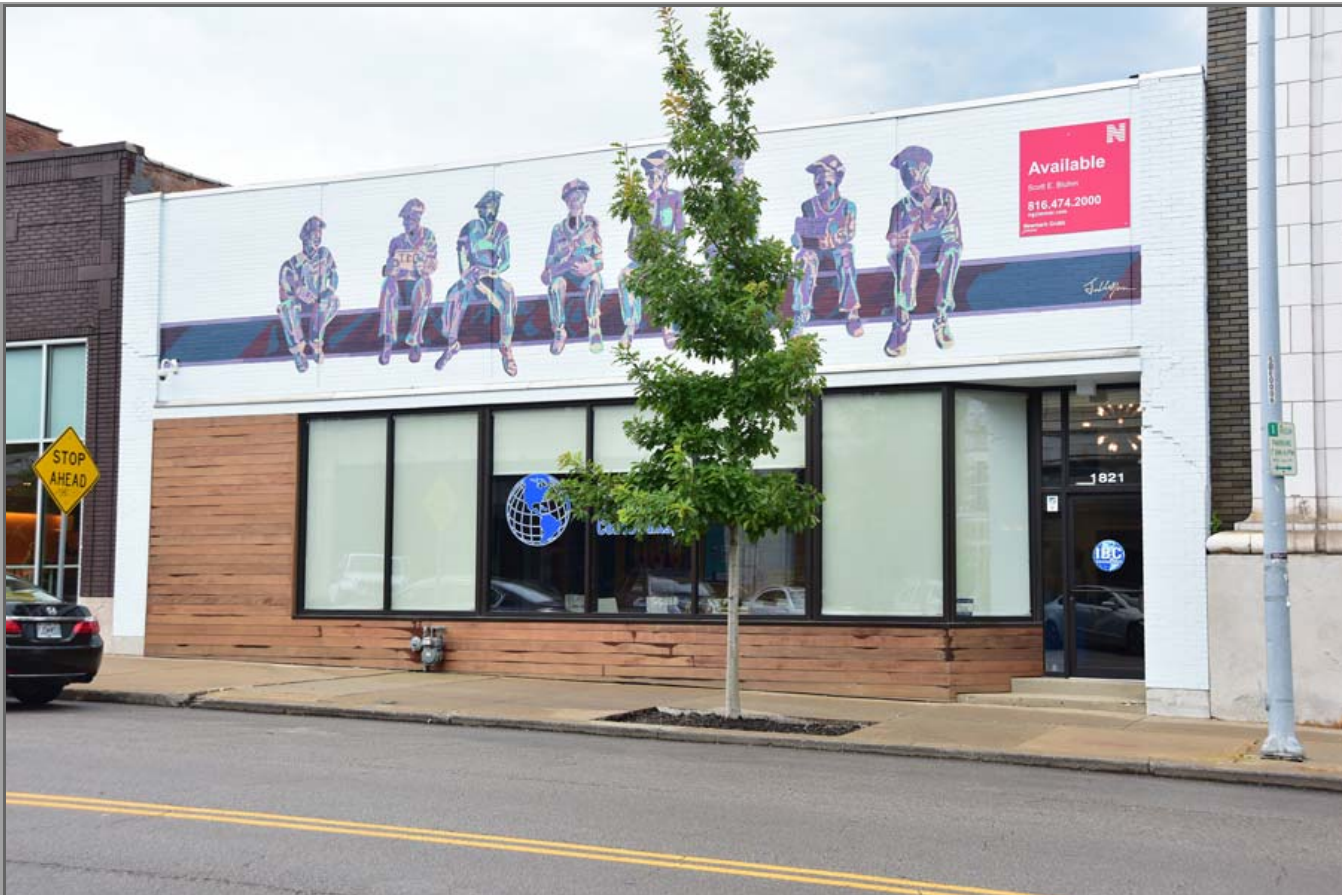
Photographer Brad Finch, f-stop Photography	Date: June 29, 20	Description: west elevation, view NE
--	----------------------	---

This one-story brick building has a rectangular plan and a flat roof. The storefront is a circa 2012 update that maintains the arrangement of an earlier 1961 alteration to the storefront. The solid brick parapet has vertical contrasting course brick dividing it into five sections. Full-height brick columns rise on the north and south end of the front elevation. The wide storefront opening fills the area between the columns. Wood planks clad the north end of the opening and the bulkhead below the band of aluminum storefront windows. A recessed entry with an aluminum door with glazing and a transom fills the south end of the storefront. Building permit number 67143A documents alterations to the building front in 1961.

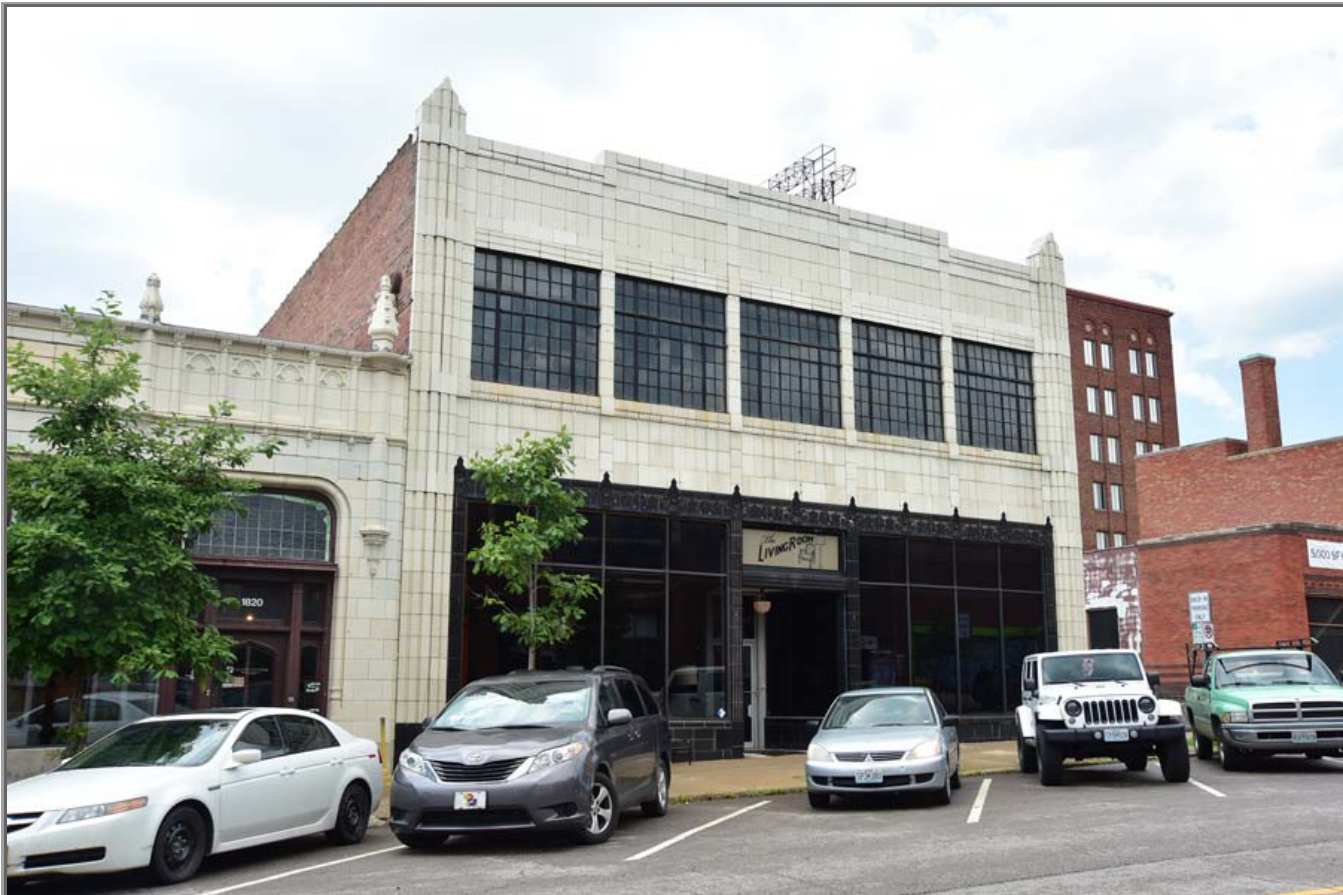
Photographer Brad Finch, f-stop Photography	Date: June 29, 20	Description: east and south elevations, view NW
--	----------------------	--

This two-story building has a rectangular plan and a flat roof with a parapet. Terra cotta clads the exterior front elevation. Fluted, pointed pilaster rise on both ends of a stepped parapet. Black terra cotta surrounds storefront windows with a centered, recessed entry with a transom. A transom tops a metal entry door with glazing. Brick clads the side and rear elevations. A brick chimney rises on the northwest corner and an elevator penthouse is setback from the southwest corner of the west elevation. Three bays organize the west (rear) elevation. A vehicle entry with a wood panel door enters the elevator shaft in the south bay. A metal slab pedestrian door with glazing fills the second bay. Brick infilled vehicle openings fill the north bays on the first story. Multi-light metal windows with stone sills pierce the second and third stories.
