MISSOURI DEPARTMENT OF NATURAL RESOURCES
STATE HISTORIC PRESERVATION OFFICE, P.O. Box 176, Jefferson City, MO 65102
ARCHITECTURAL/HISTORIC INVENTORY FORM

1. Survey number: JA-AS-087-025		2. Survey Name: McGee Street Historic Resources Survey 2017	
3. County: JACKSON		4. Address (Street No.): 215	Street (name): E. 18th Street
5. City: Kansas City	Vicinity <input type="checkbox"/>	6. Lat / Long: 39.091481 -94.580440	7. Township/Range/Section: T: R: S:
8. Historic name (if known): Interstate Securities Building		9. Present/other name (if known):	
10. Ownership: <input checked="" type="checkbox"/> Private <input type="checkbox"/> Public		11a. Historic use (if known): Commercial	11b. Current use: Commercial

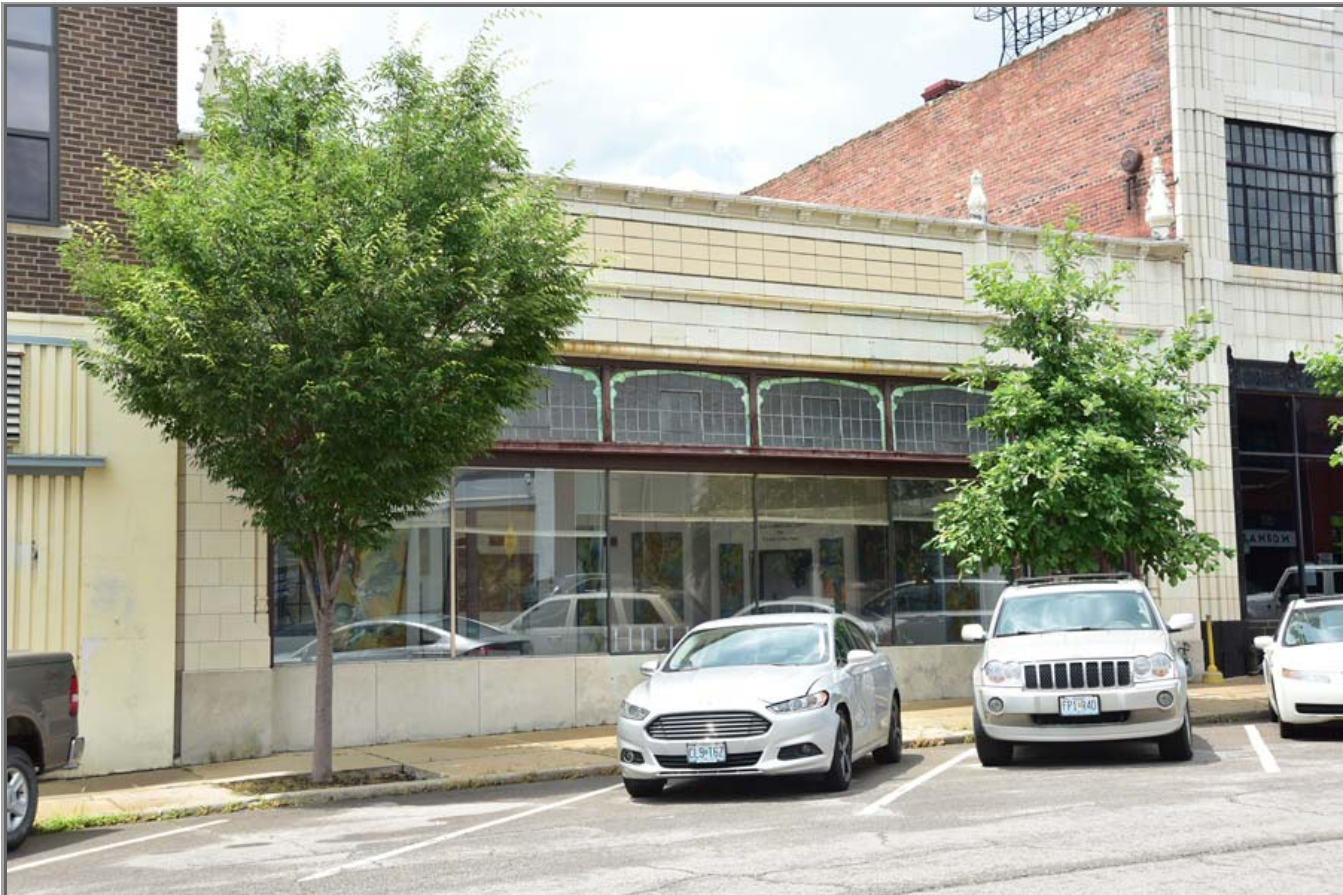
Photographer Brad Finch, f-stop Photography	Date: June 29, 20	Description: east elevation, view NW
--	----------------------	---

This one-story building has a rectangular plan and a flat roof. White terra cotta clads the exterior. Finials rise above the parapet. Decorative segmented arches ornament the parapet. Six bays organize a framed storefront. Multi-light transoms with stained glass top storefront windows and an entry in the north bay. A transom and sidelights surround a wood entry door with glazing in the north bay. The building abuts two story buildings on the north and the south. Brick clads the west (rear) elevation. Three, nine-over-six metal windows covered with metal security bars flank a metal overhead rolling door and a metal slab pedestrian door on either side.

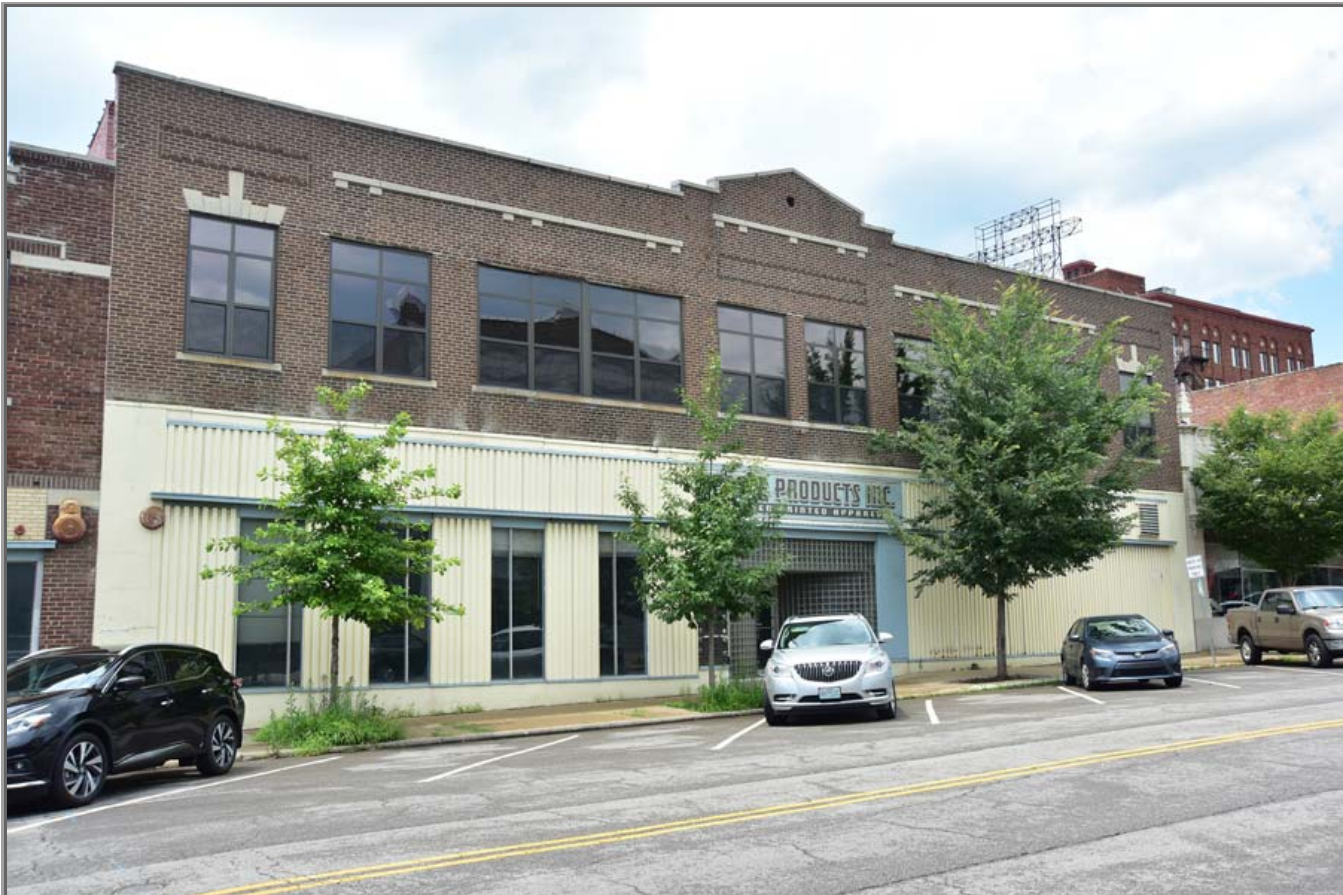
Photographer Brad Finch, f-stop Photography	Date: June 29, 20	Description: east elevation, view NW
--	----------------------	---

This two-story brick building has a rectangular plan and a flat roof with a peaked parapet. The first story storefront and a horizontal transom that historically topped the storefront are currently clad in corrugated metal. Vertical storefront windows are visible in the south bay. Glass block surrounds a recessed entry with a metal door with glazing. Paired and banded one-over-one metal windows with smaller top lights pierce the second story. All second story windows have stone lugsills. Lentils with elongated keystones fill outer bays. Stone banding and contrasting brick courses ornament the parapet. Stone coping caps the parapet. The storefront cladding and the glass block was part of a 1950 renovation (#28027A). Brick clads the side and rear elevations. Five bays organize the west (rear) elevation. A stepped parapet corresponds to the bays. Two arched window openings with stone sills have concrete masonry unit infill on the first story in the north bay. Concrete masonry unit infills a vehicle opening in the second bay. Two metal overhead rolling doors fill vehicle openings in the third bay. The 1951 Sanborn map shows an elevator shaft in this bay. An arched window opening with a stone sill is infilled with brick in the fourth bay. Two arched windows with stone sills are infilled with brick in the fifth bay. A metal frame fixed glass window with metal security bars pierces the infill. Paired one-over-one vinyl windows with transoms fill seven second-story arched window openings on the second story. A smaller arched window opening is infilled with concrete masonry unit on the second story in the elevator shaft.

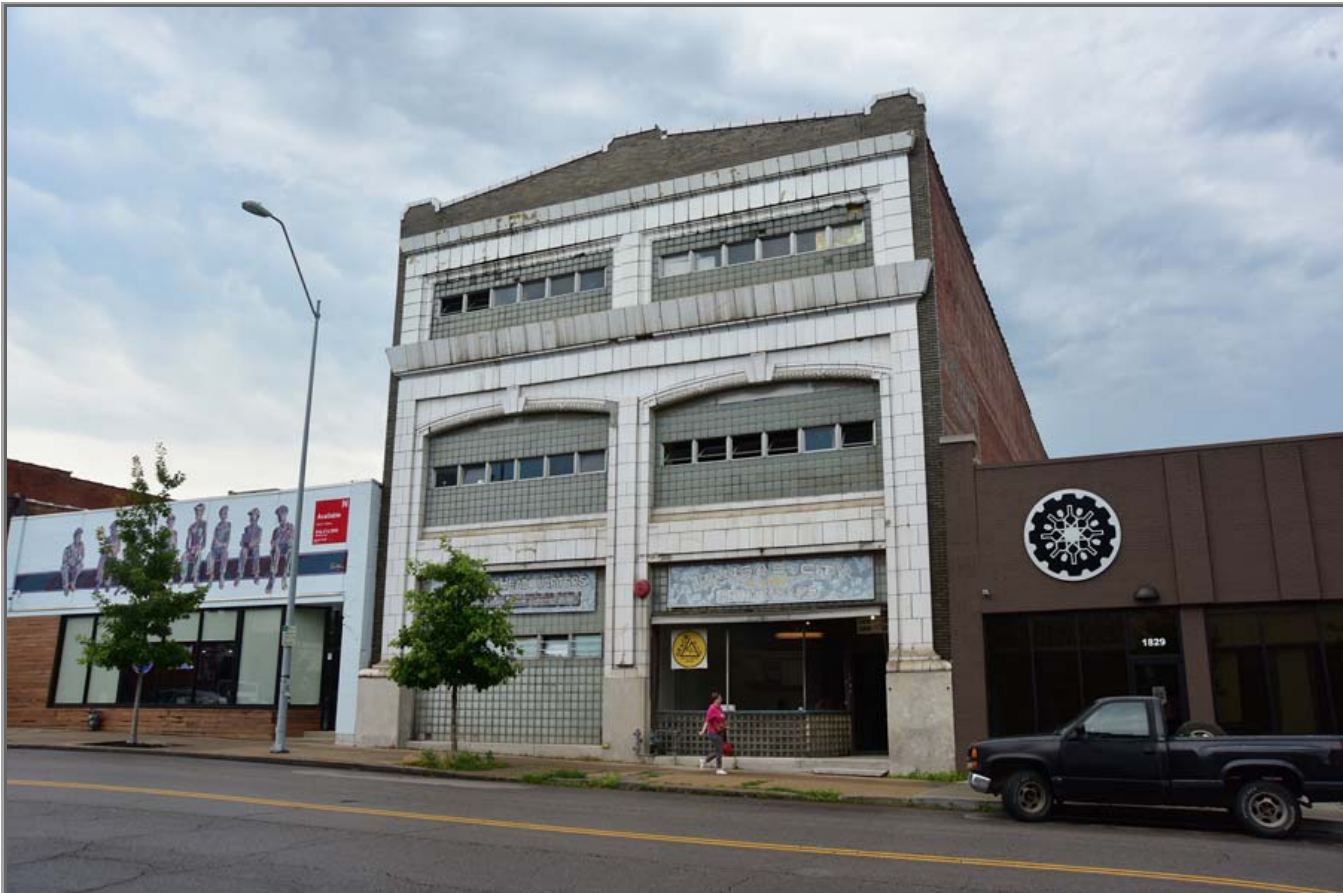
Photographer Brad Finch, f-stop Photography	Date: June 29, 20	Description: west elevation, view NE
--	----------------------	---

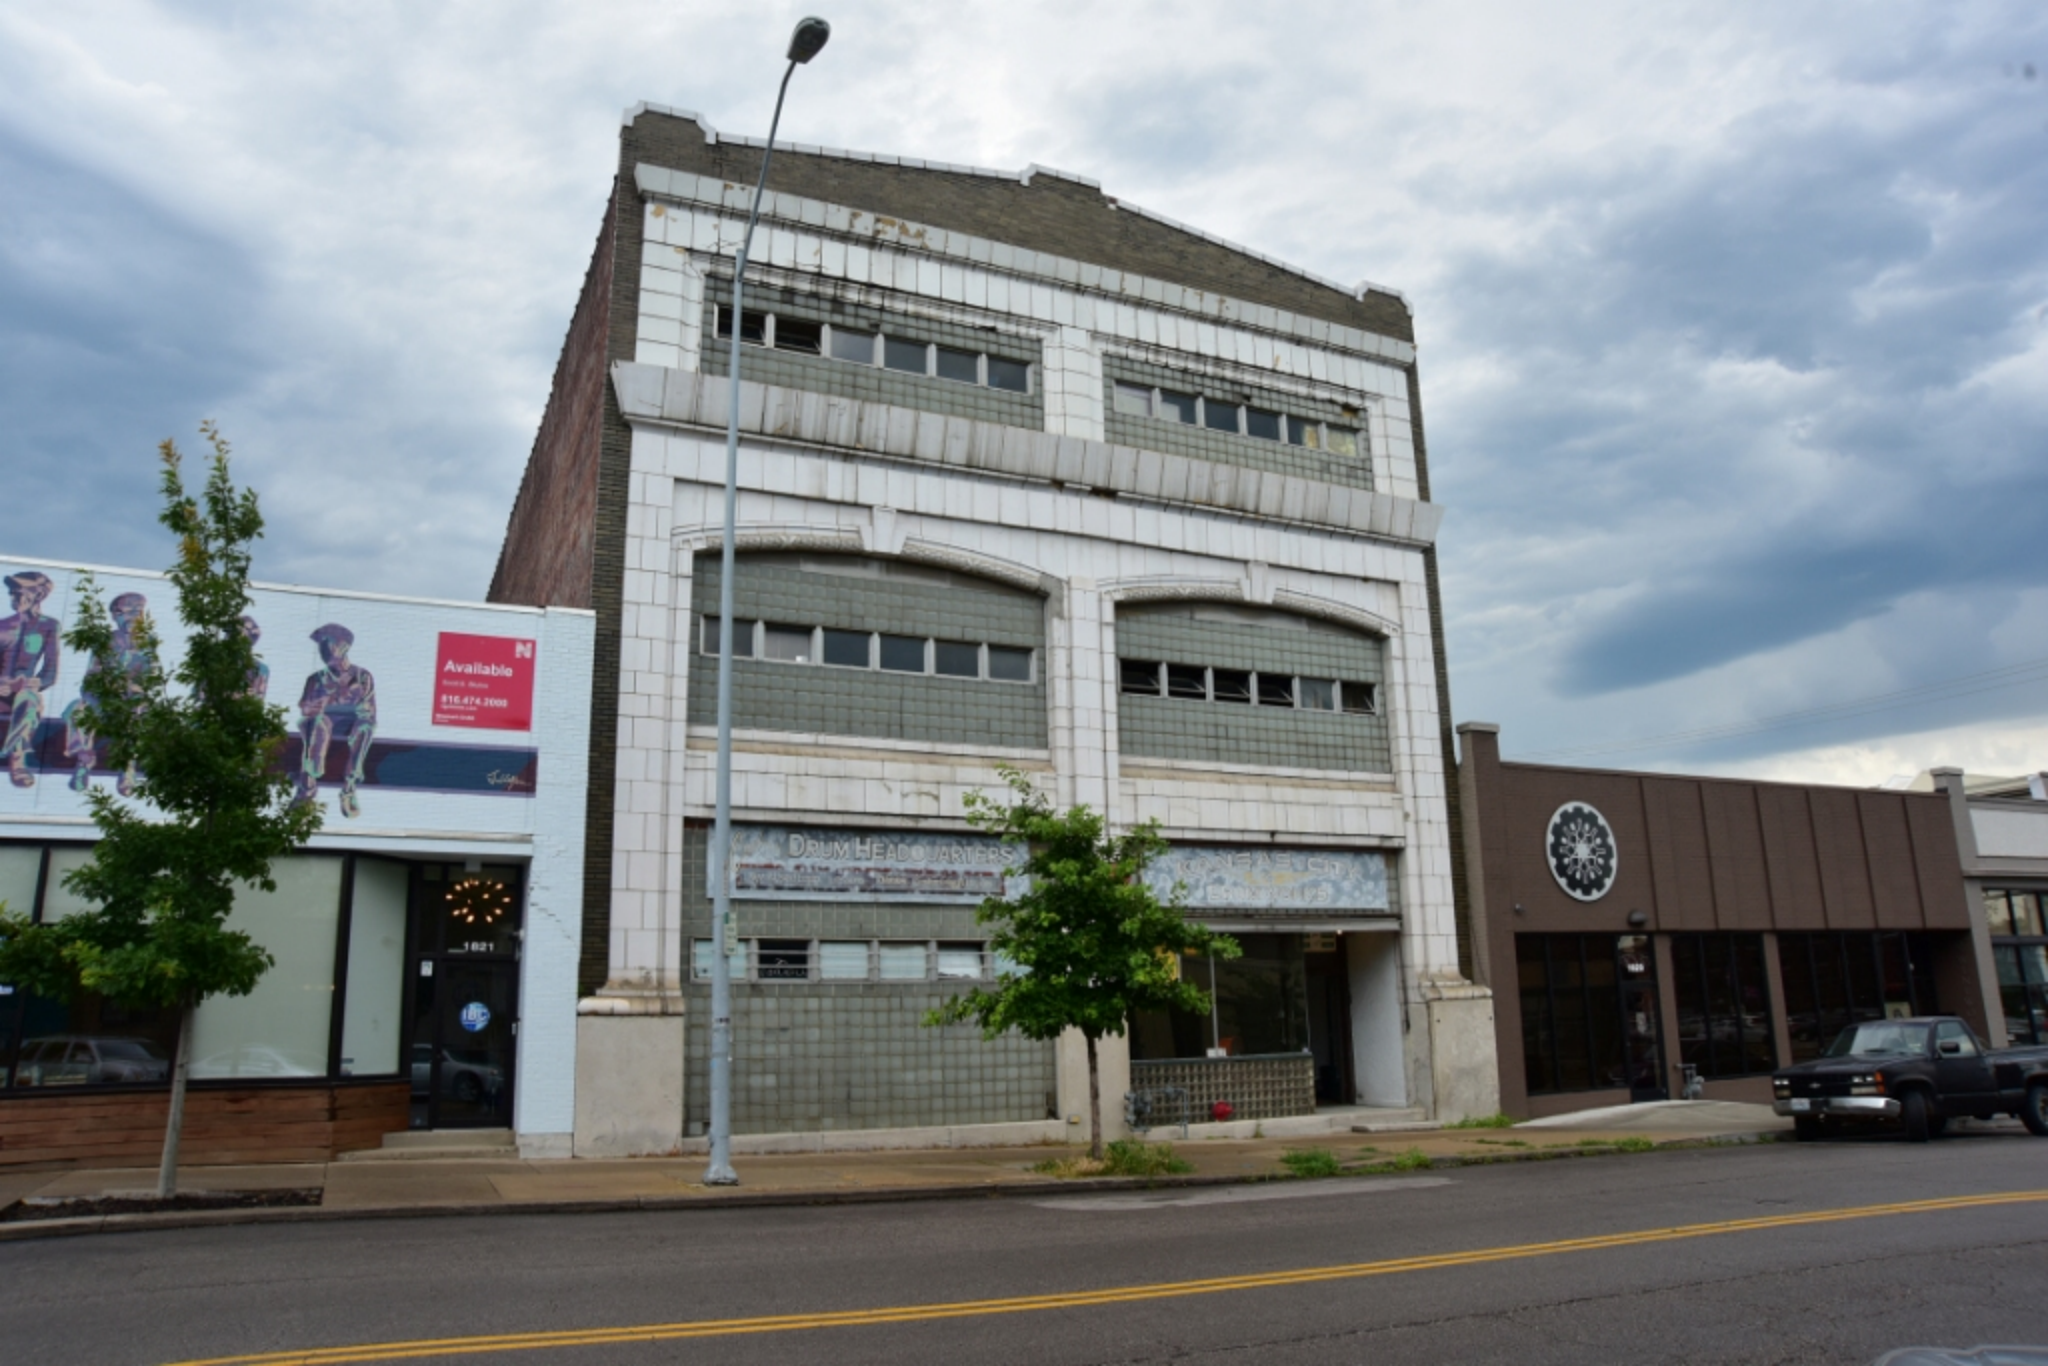
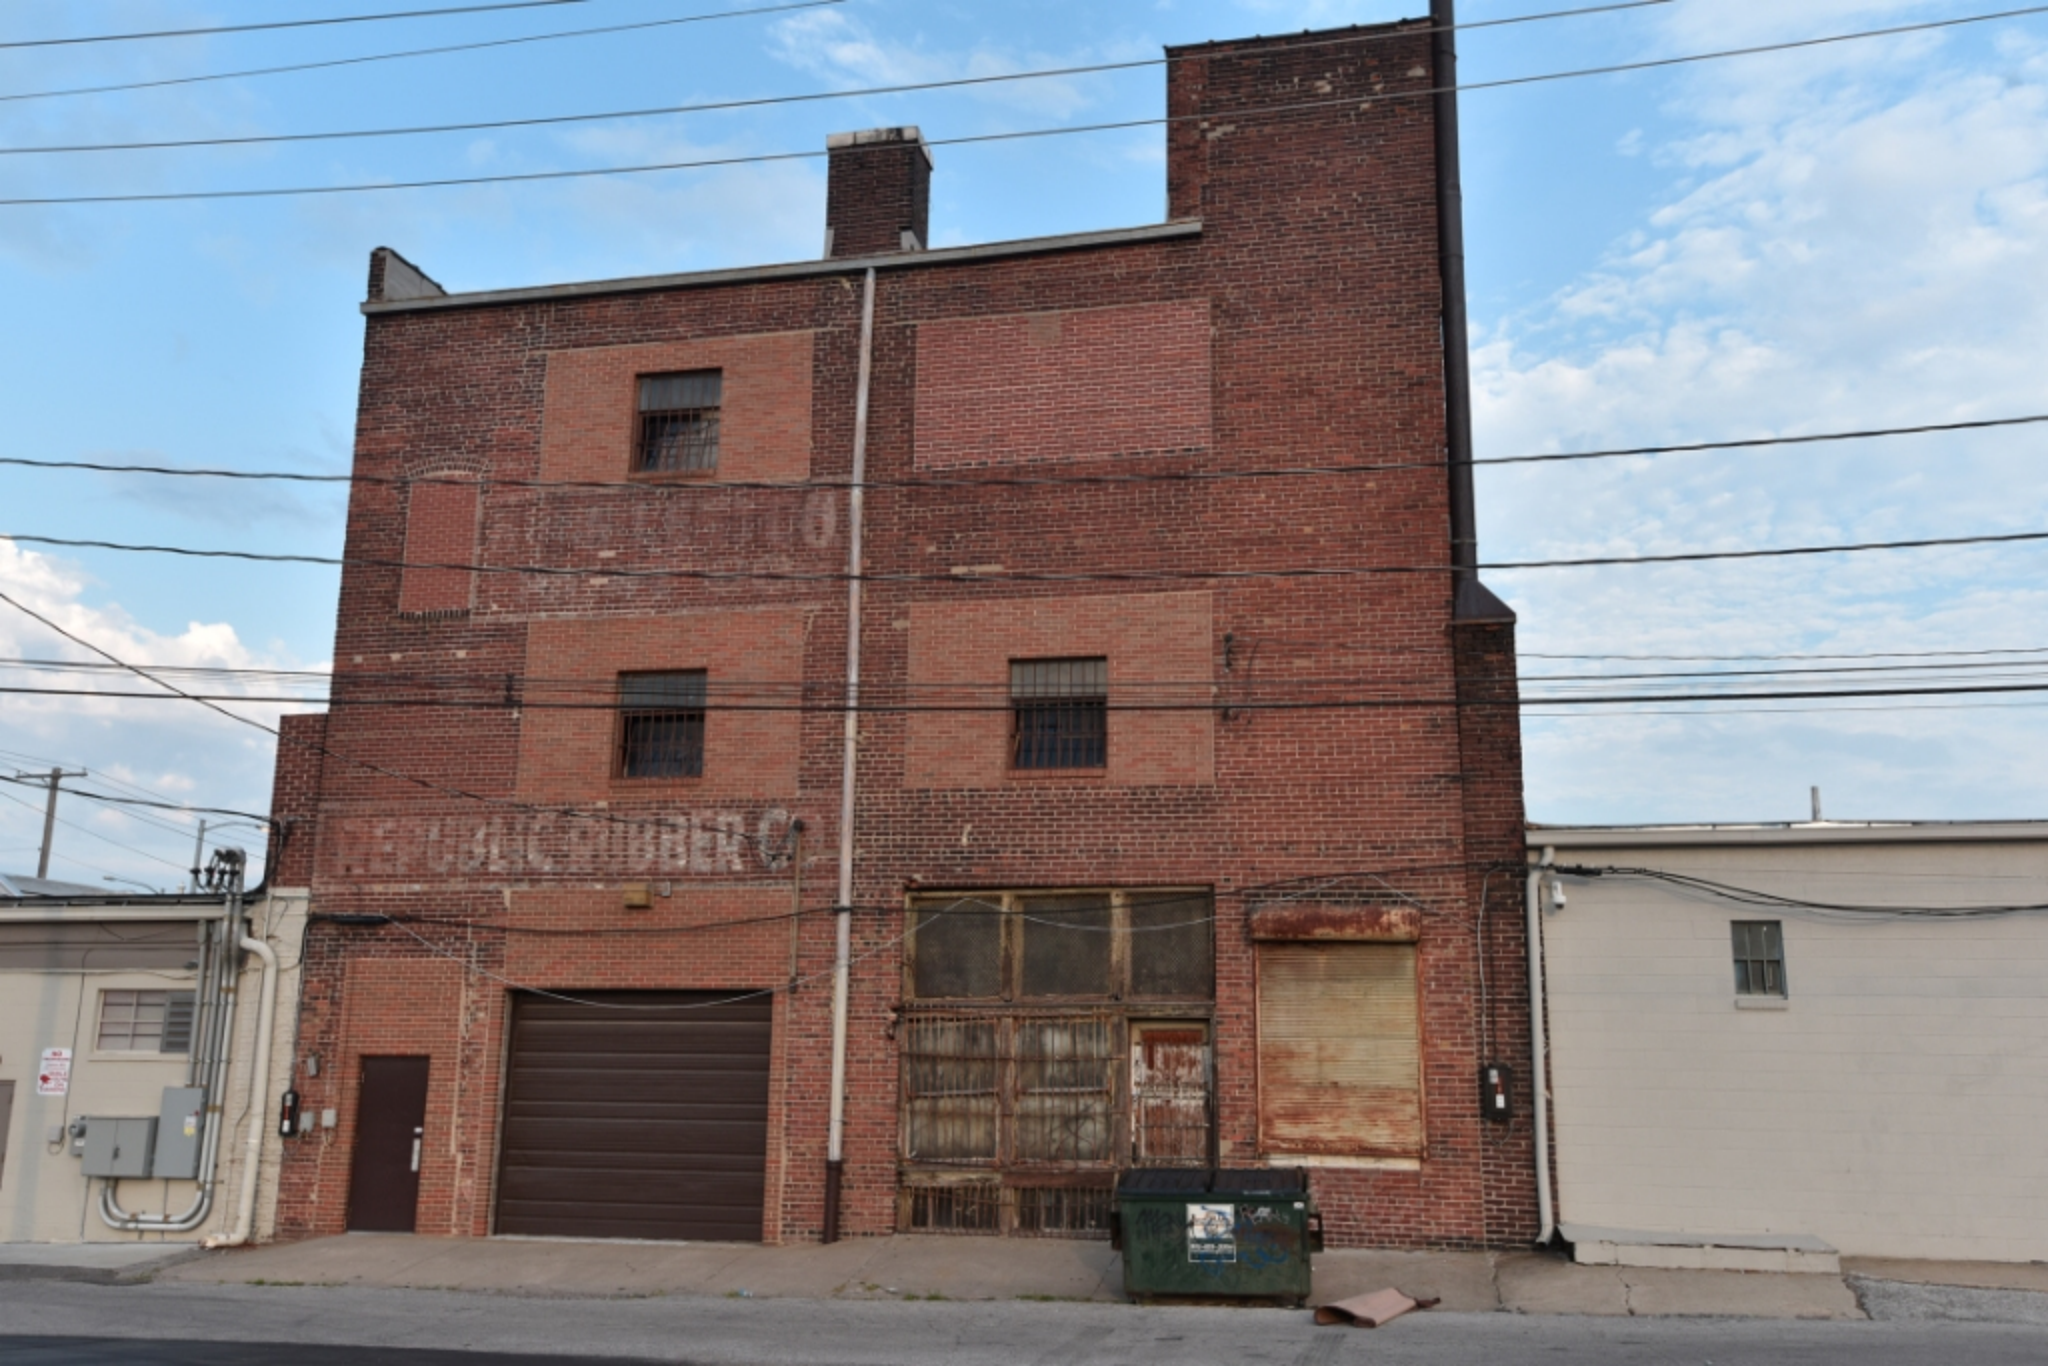
Storefront glazing above glass block, a recessed entry with a wood door with glazing and a glass block transom fill the south bay on the first story. Glass block with metal hopper windows fill the arch in the second story of the south bay. Glass block with banded metal hopper windows fill the first and second story of the north bay. A terra cotta cornice spans the elevation above the second story. Terra cotta framing organizes two bays on the third story. Glass block surrounds banded metal hopper windows in both bays. A terra cotta cornice spans the two bays underneath a raised parapet with terra cotta coping. A 1953 remodel removed windows and replaced them with glass block (#36157).

Two bays organize the rear elevation. An elevator shaft rises at the northeast corner. An overhead rolling metal door on a raised dock accesses the elevator shaft. A door with a transom and two windows with wood mullions tops basement-level windows with vertical wood mullions in the north bay. A metal multi-light window with metal security bars surrounded by brick infill pierces the second story on the north bay. Brick infills a window opening on the third floor. A brick chimney rises between the bays. A metal overhead rolling door fills a vehicle opening in the south bay. A metal slab door surrounded by brick infill pierces the south bay. Metal multi-light windows with metal security bars surrounded by brick infill pierce the second and third stories in the south bay.

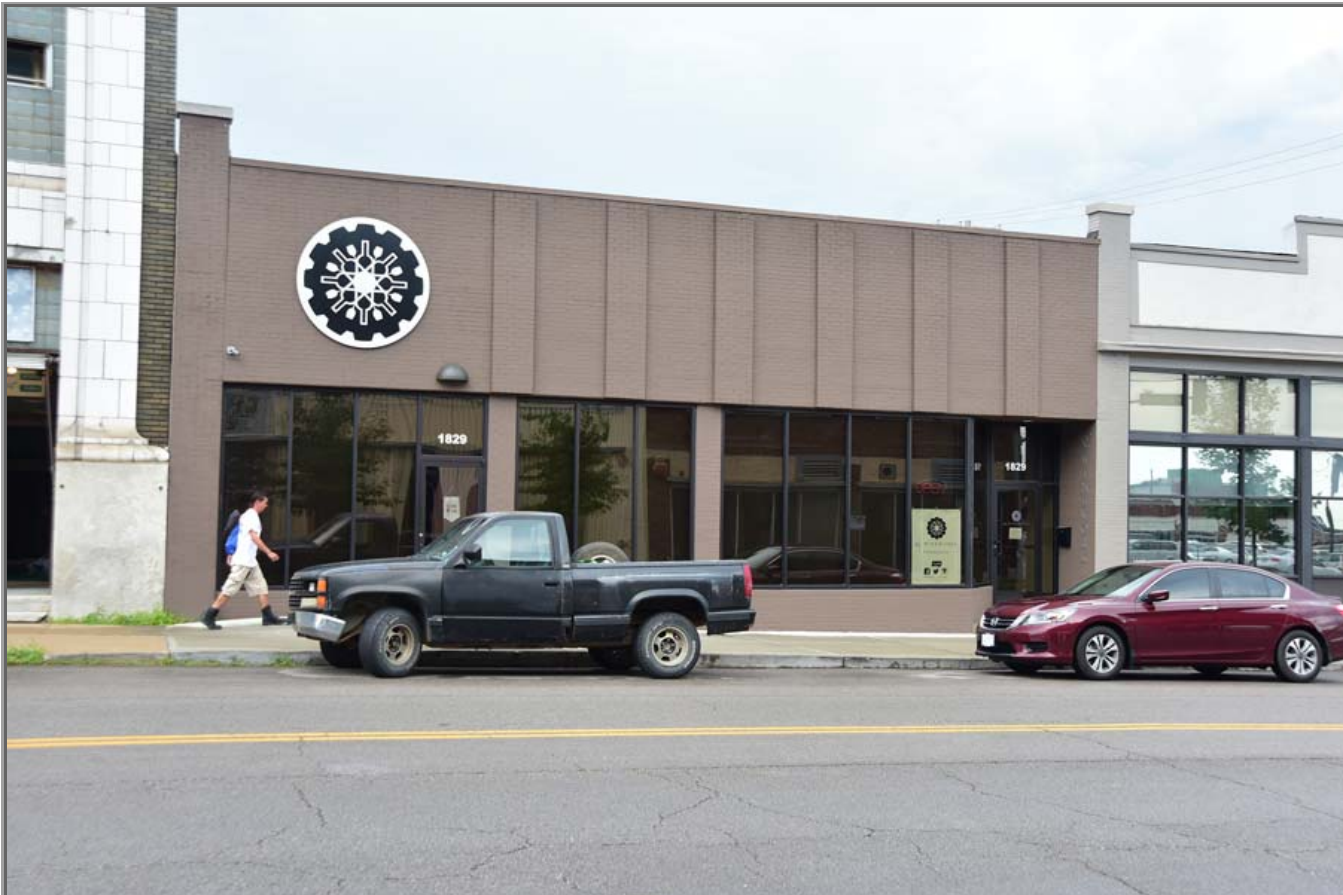
Photographer Brad Finch, f-stop Photography	Date: June 29, 20	Description: west elevation, view SE
--	----------------------	---
