MISSOURI DEPARTMENT OF NATURAL RESOURCES
STATE HISTORIC PRESERVATION OFFICE, P.O. Box 176, Jefferson City, MO 65102
ARCHITECTURAL/HISTORIC INVENTORY FORM

1. Survey number: JA-AS-087-025		2. Survey Name: McGee Street Historic Resources Survey 2017	
3. County: JACKSON		4. Address (Street No.): 215	Street (name): E. 18th Street
5. City: Kansas City	Vicinity <input type="checkbox"/>	6. Lat / Long: 39.091481 -94.580440	7. Township/Range/Section: T: R: S:
8. Historic name (if known): Interstate Securities Building		9. Present/other name (if known):	
10. Ownership: <input checked="" type="checkbox"/> Private <input type="checkbox"/> Public		11a. Historic use (if known): Commercial	11b. Current use: Commercial

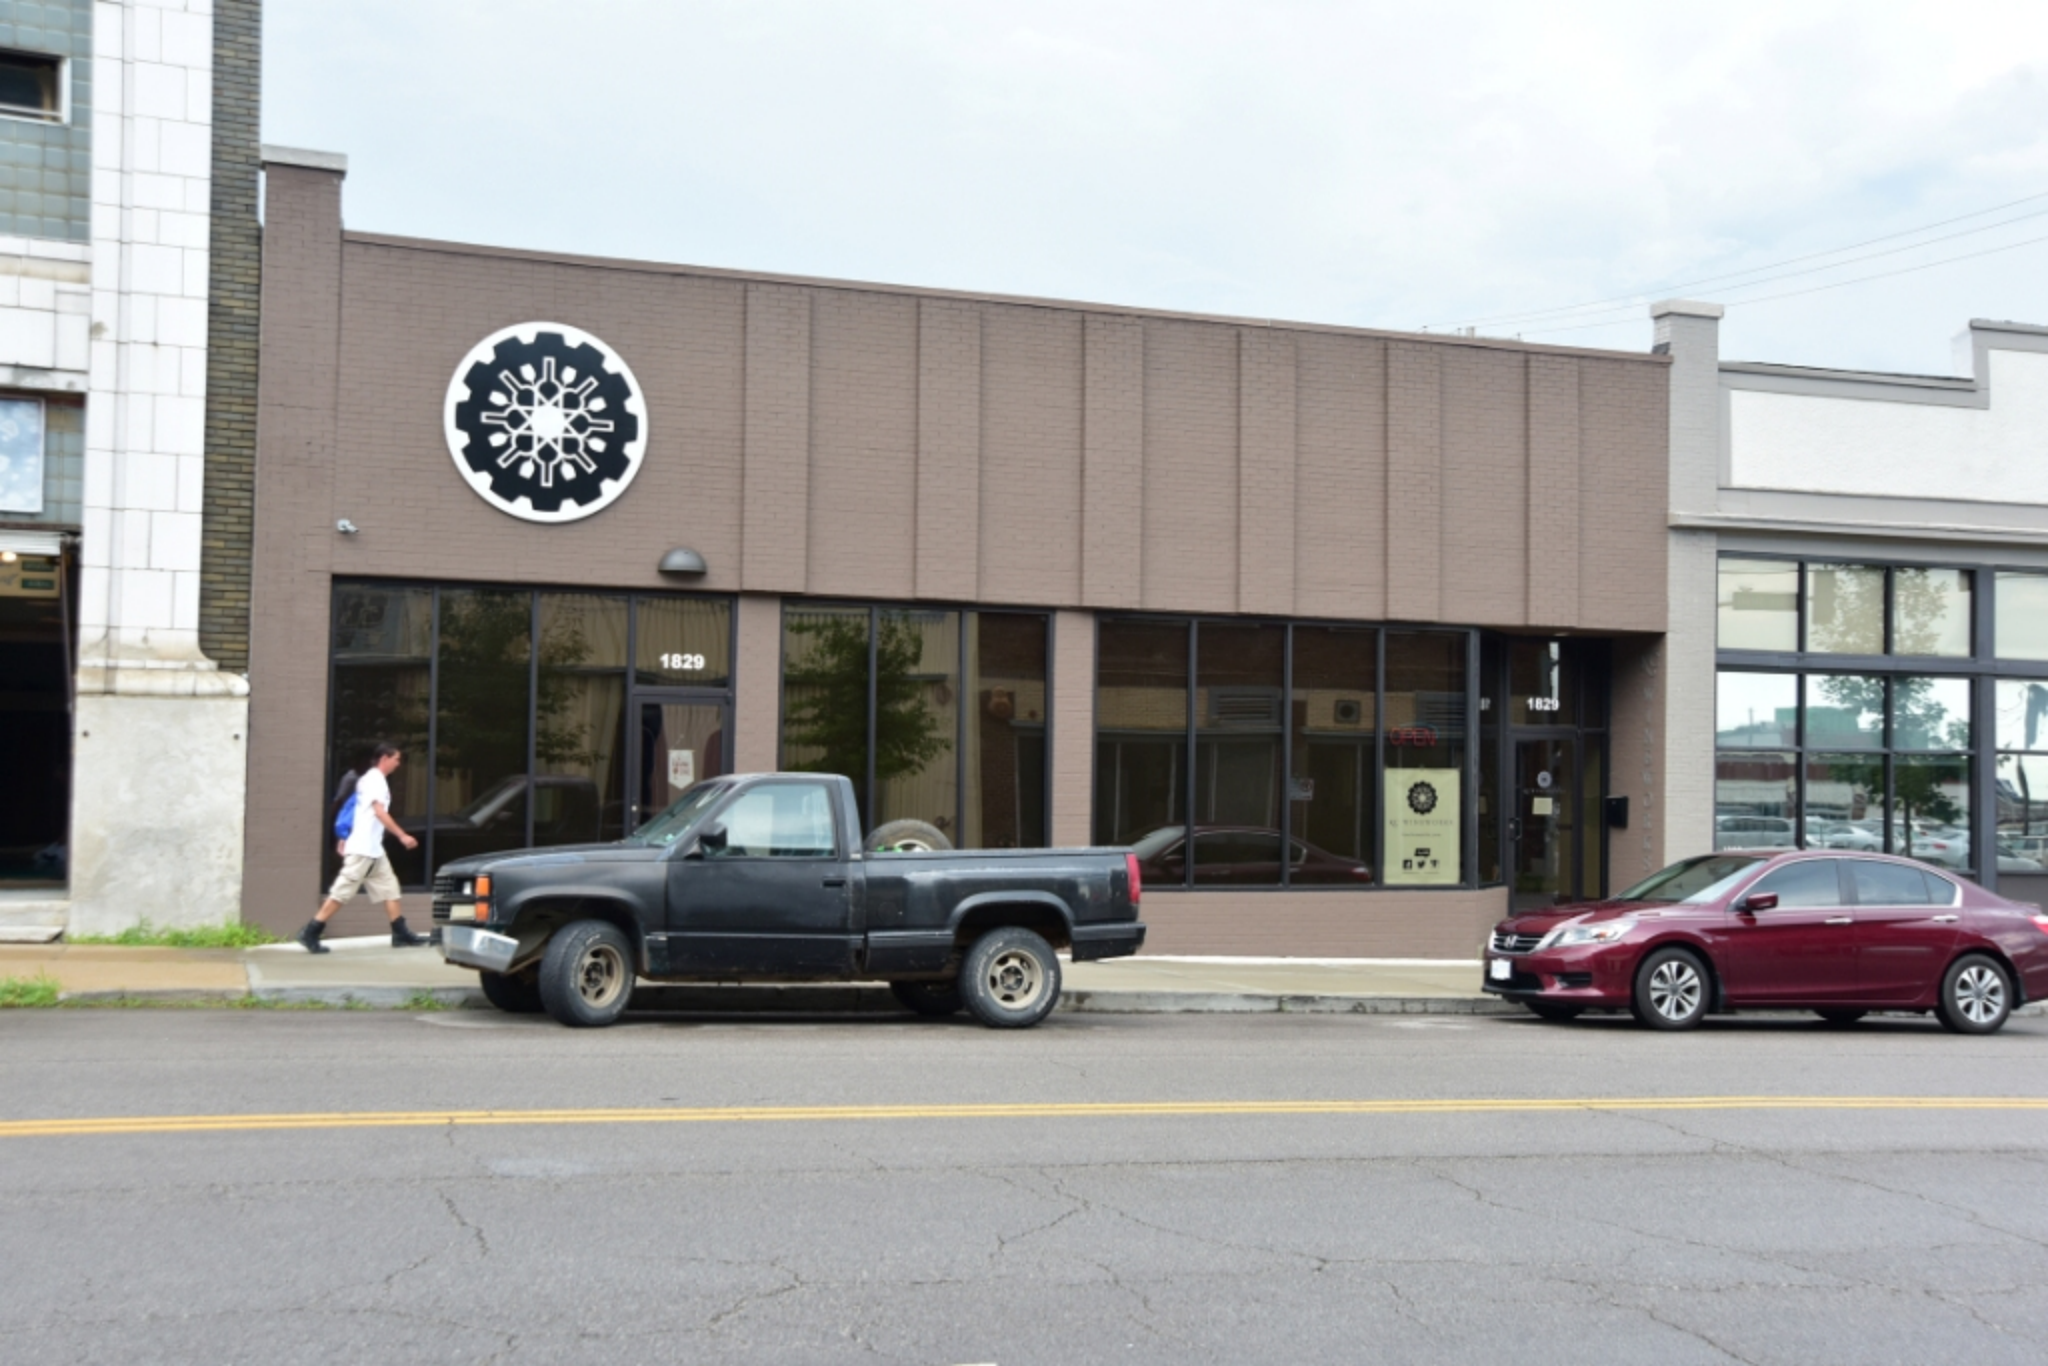
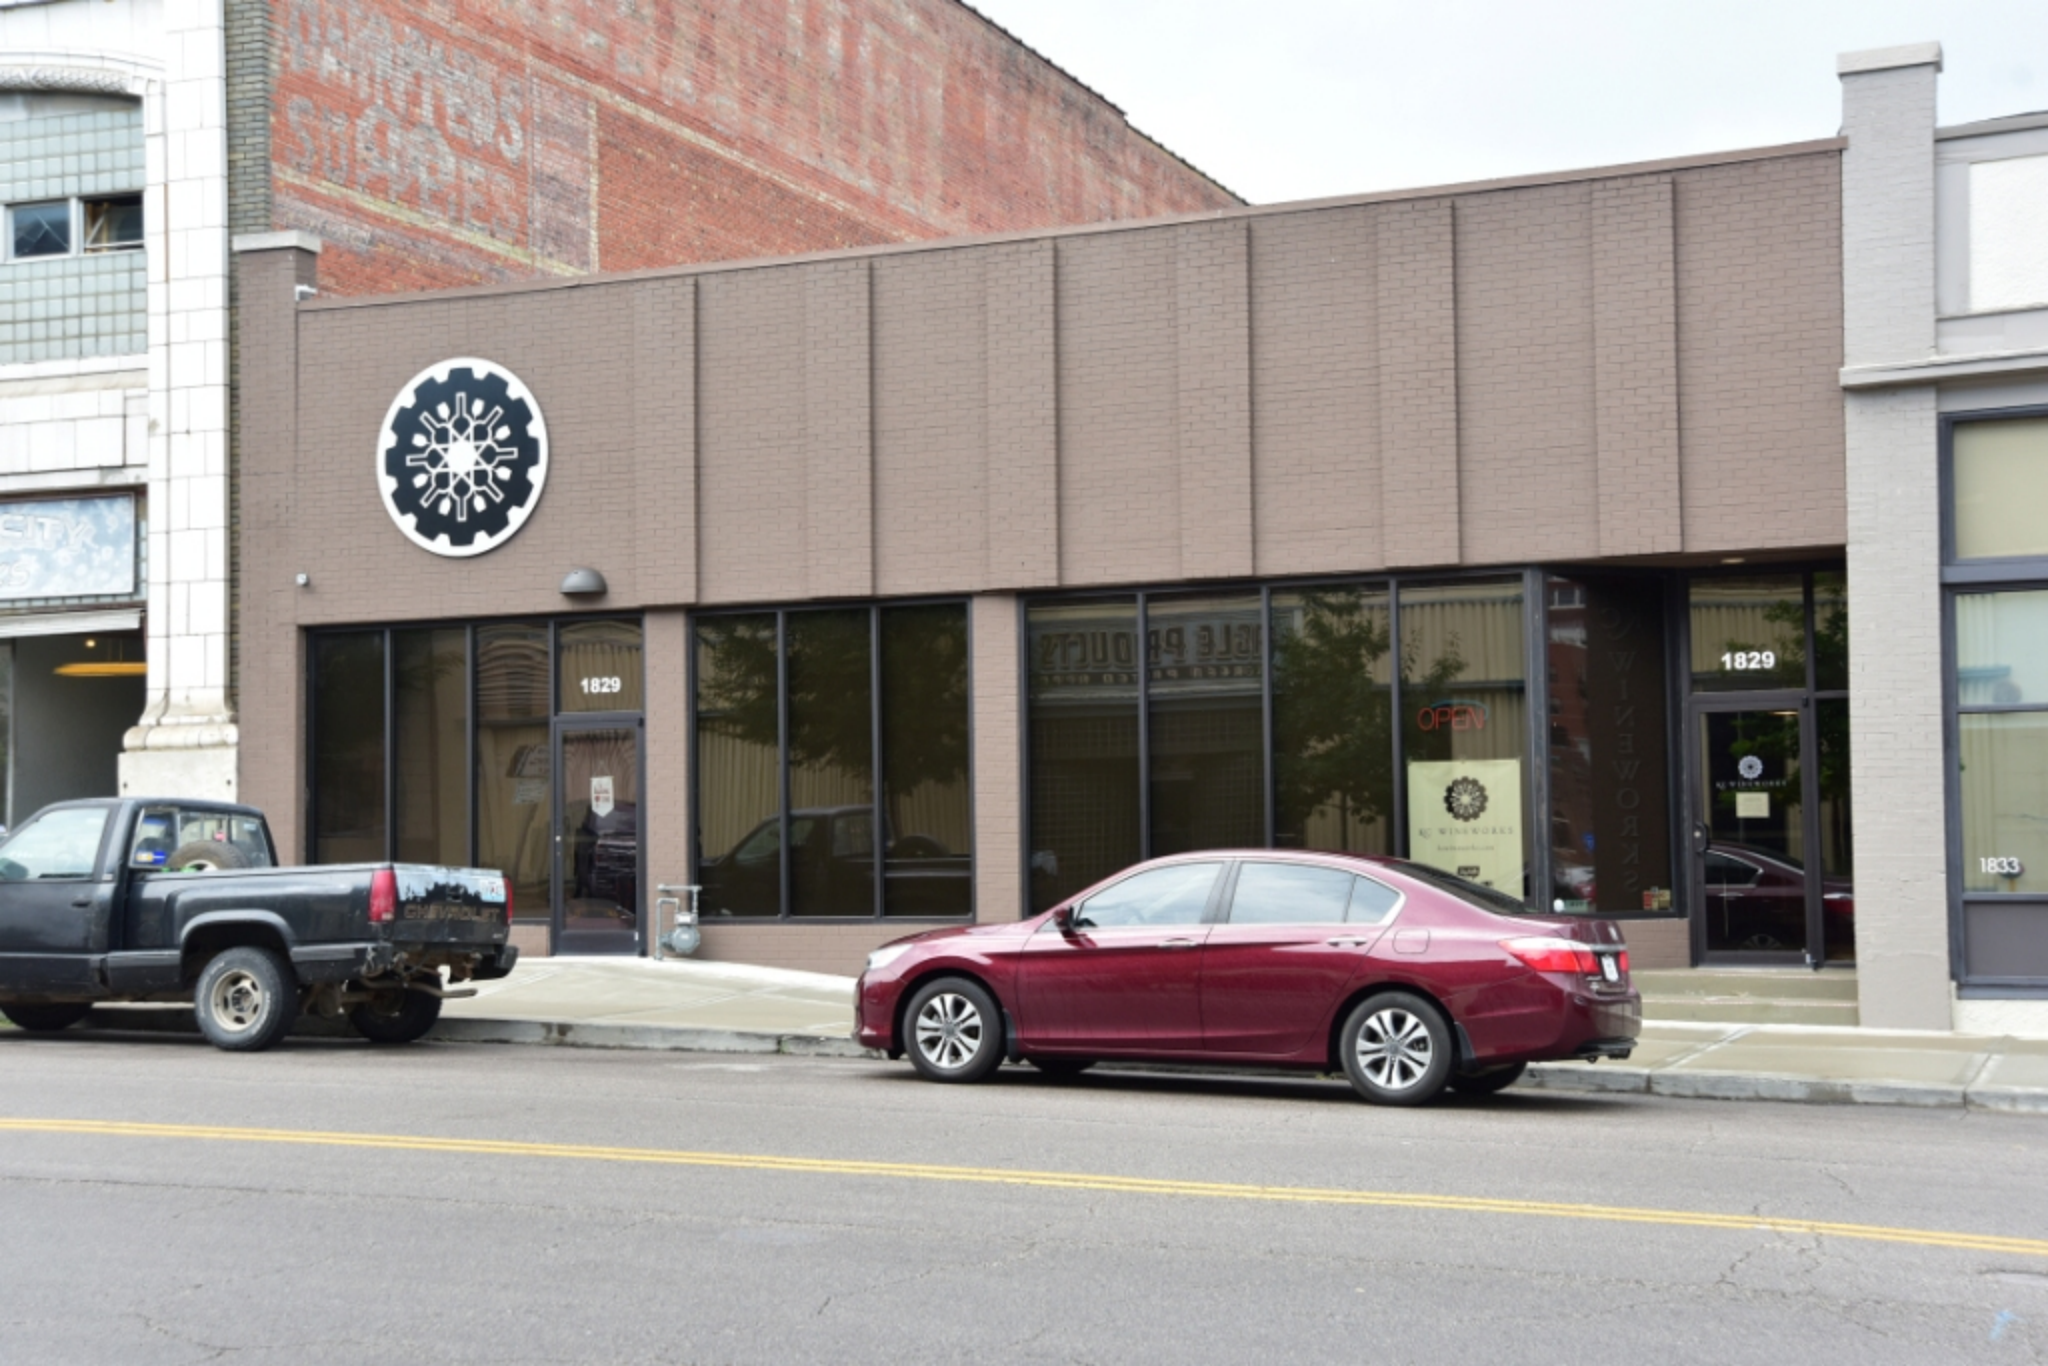
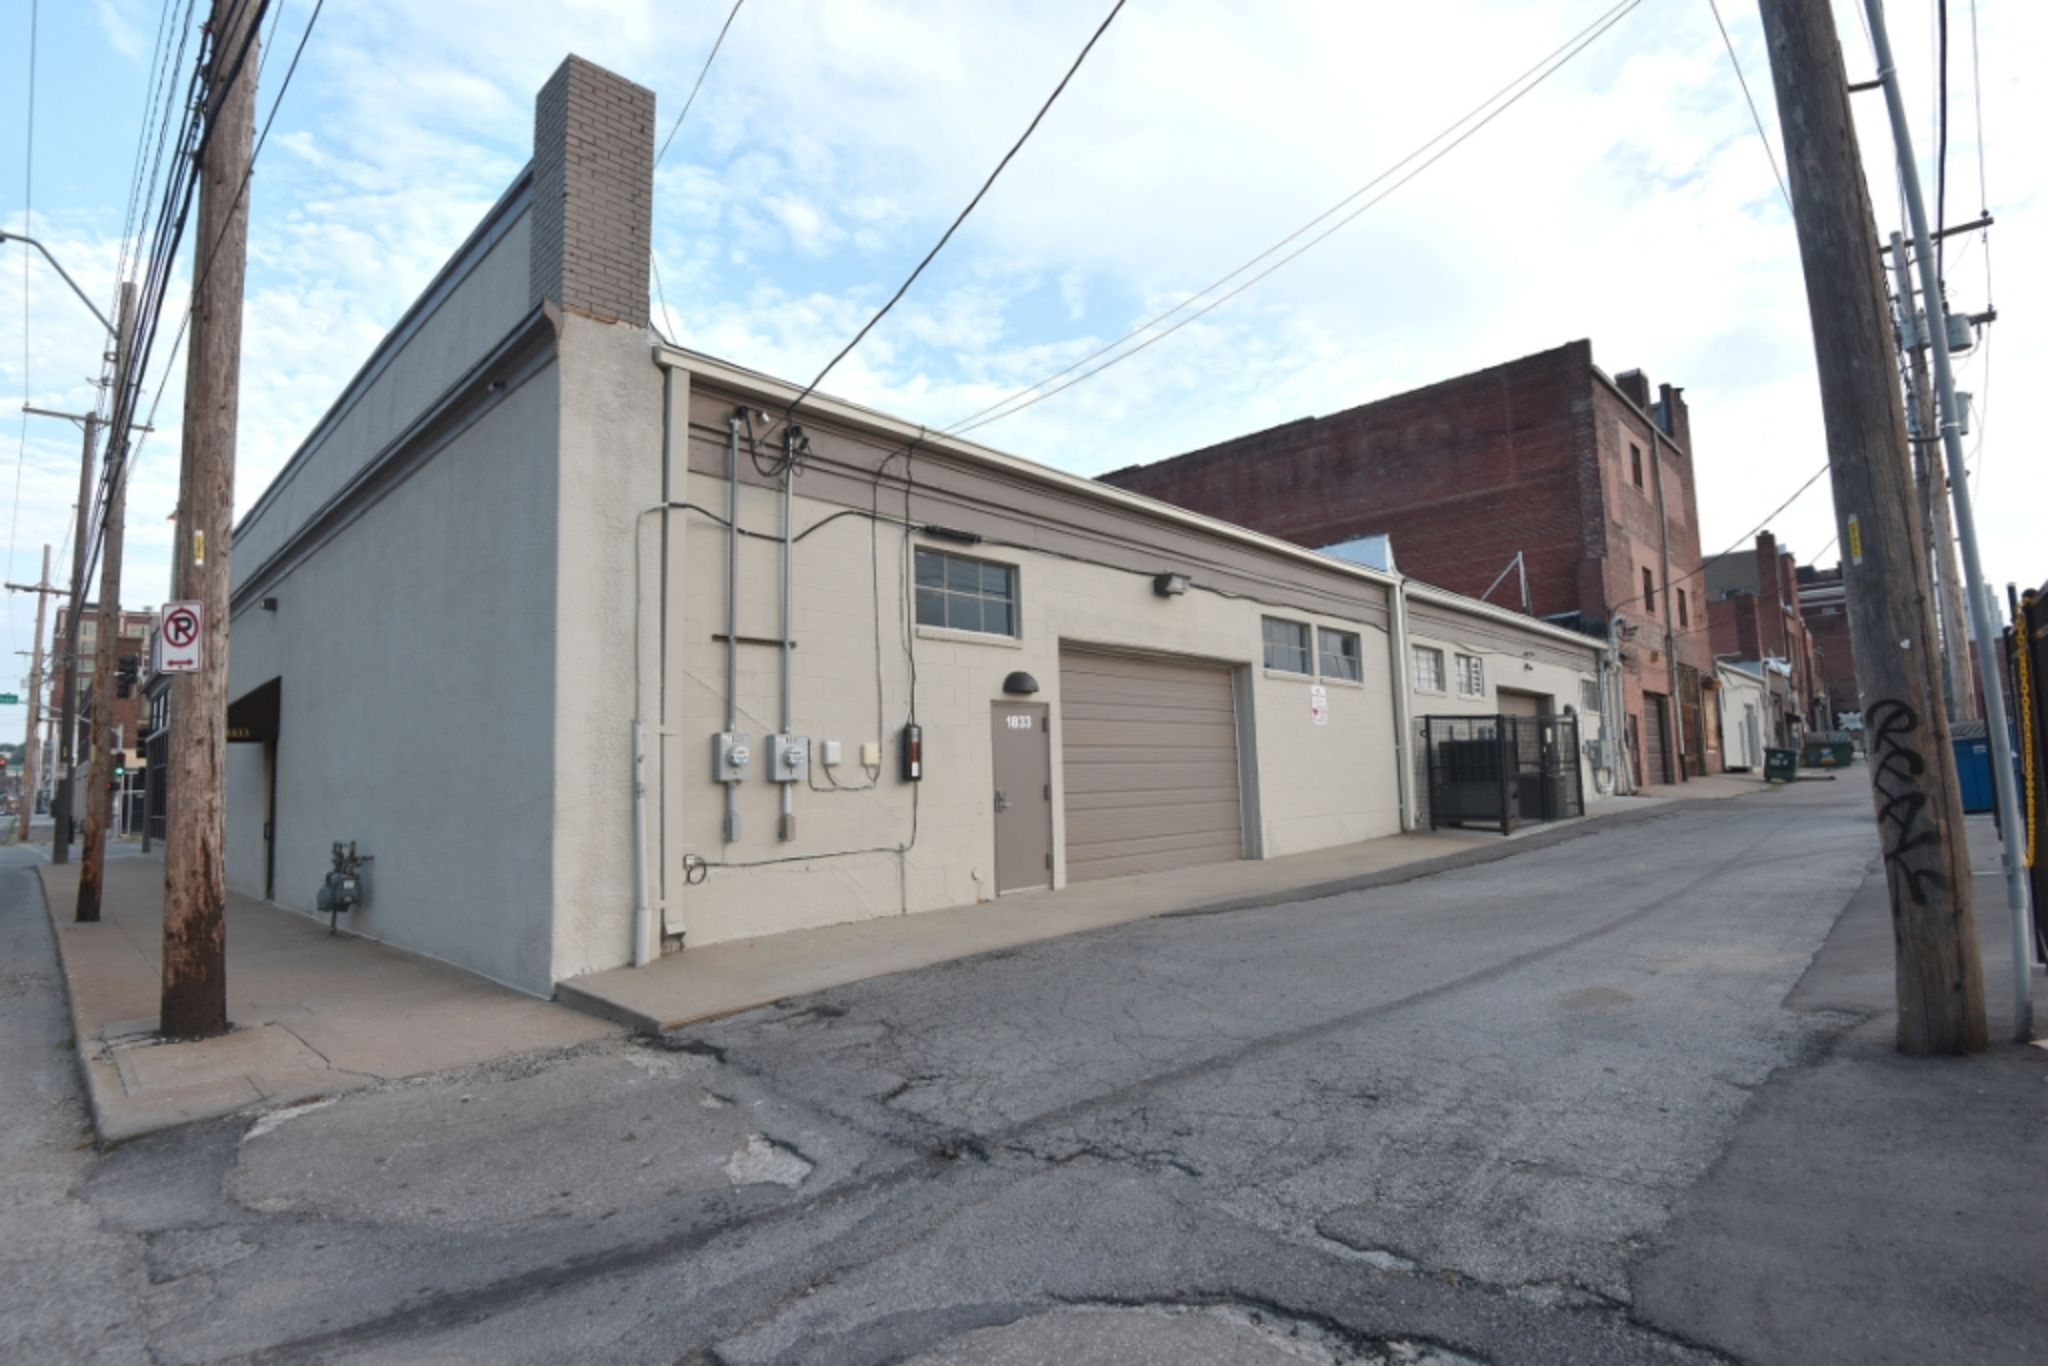
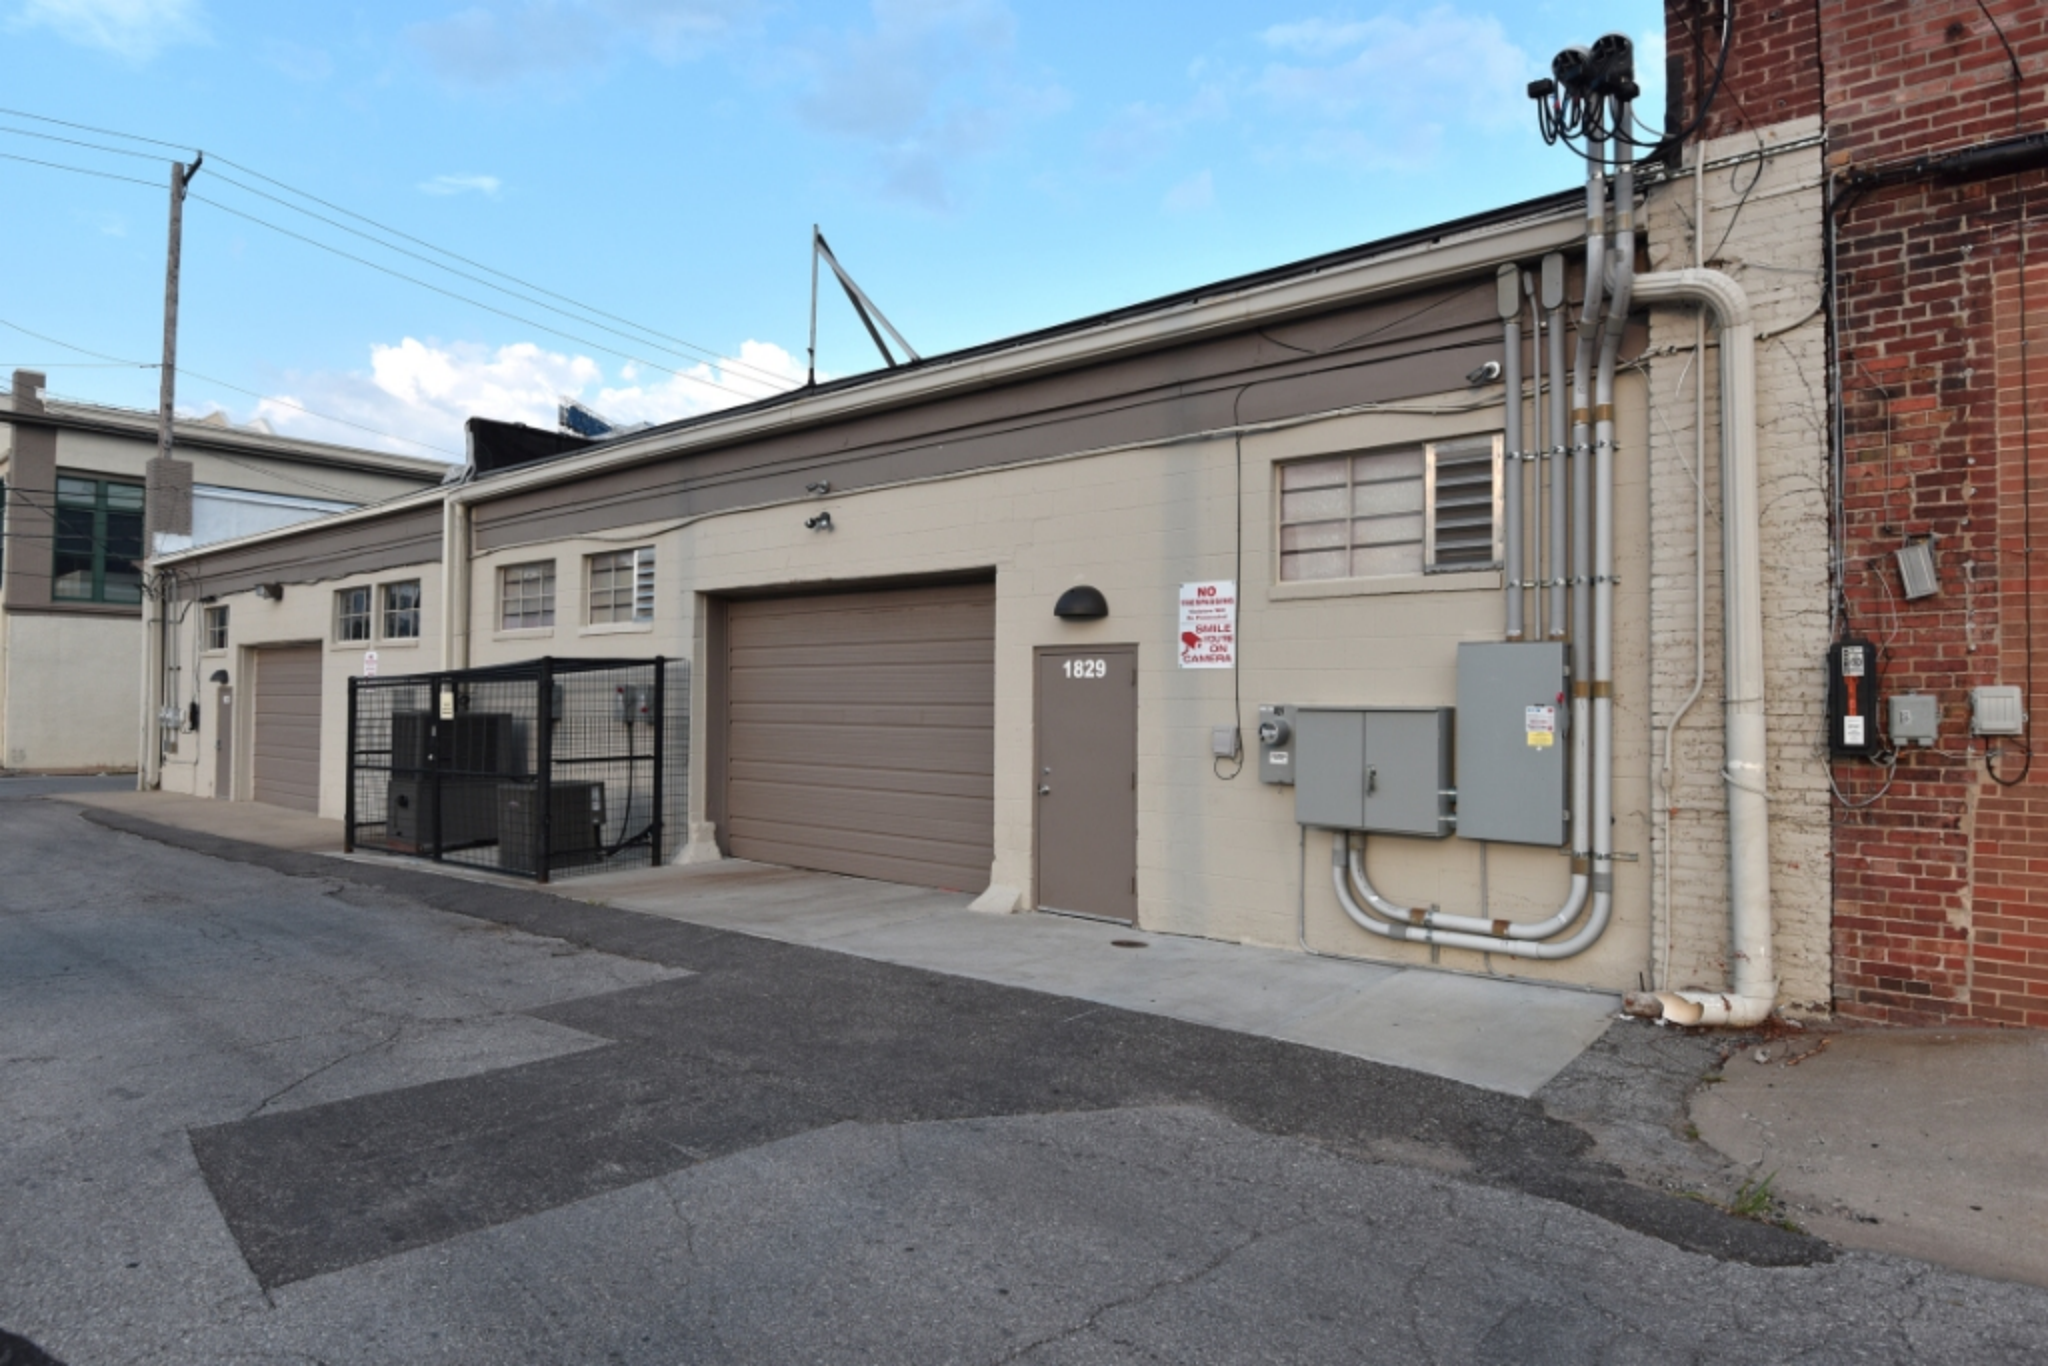
1829 McGee Street is a one-story brick building with a rectangular plan and a flat roof. The building represents the north portion of a larger building (1833 McGee directly to the south), but each storefront has a separate owner and the two addresses are on individual parcels. Brick piers separate three bays on the storefront. The north bay has storefront glazing and a metal door with glazing and a transom light. The middle bay has storefront glazing and the south bay contains glazing and a recessed entry with a metal door with glazing and a transom. The brick parapet between columns on either end with coping has engaged pilasters in a pattern that communicates the historic garage door opening in the north bay. The current storefront and flat parapet are a 1965 alteration (#17323). The historic parapet was stepped and matched the parapet on the building immediately to the south. Masonry block clads the rear elevation and was added in 1963 to replace a non load-bearing wall (#4590). A metal overhead rolling door fills a vehicle entry and a metal slab door provides pedestrian access. Three multi-light metal windows pierce the north bay.

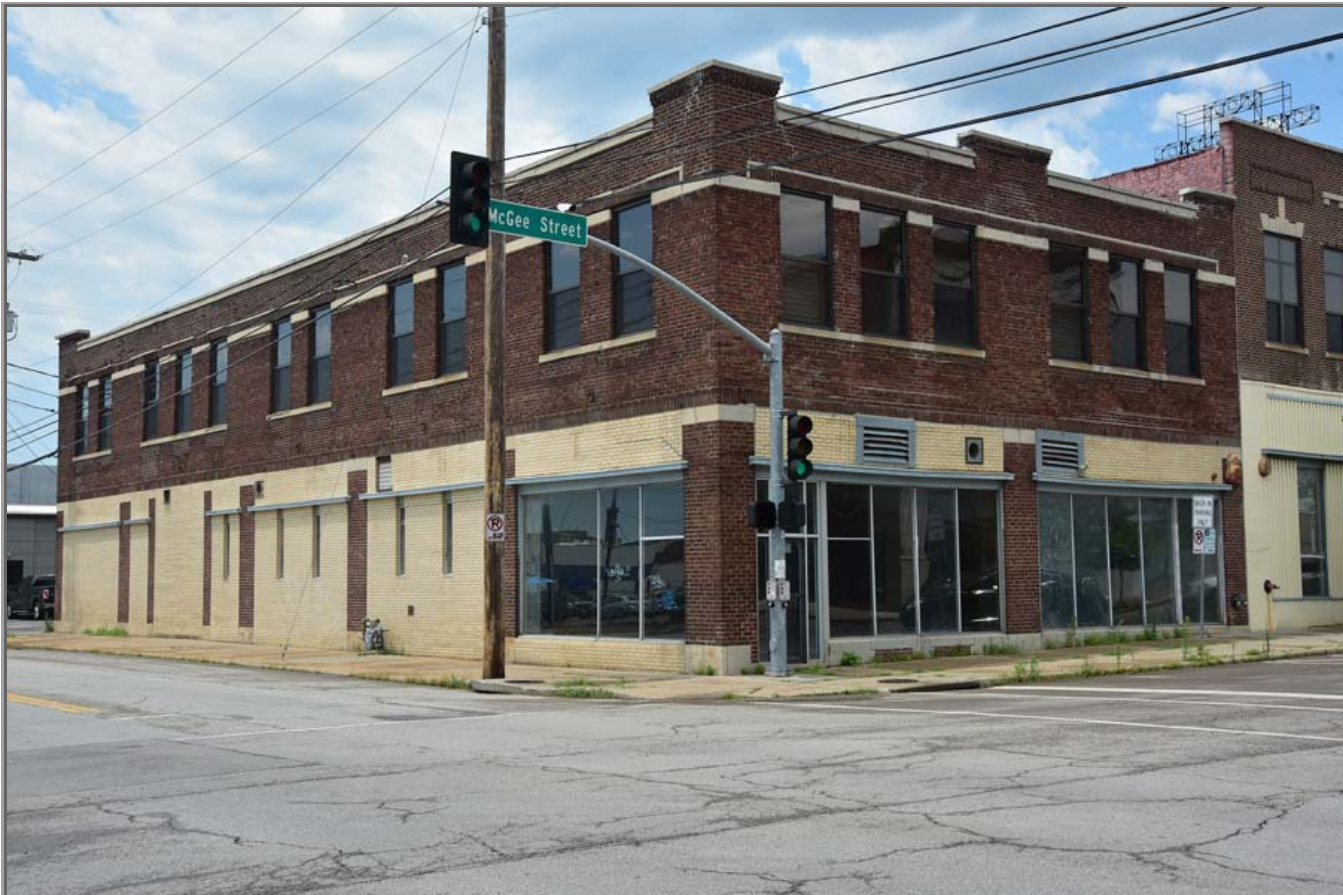
Photographer Brad Finch, f-stop Photography	Date: June 29, 20	Description: south and east elevations, view NW
--	----------------------	--

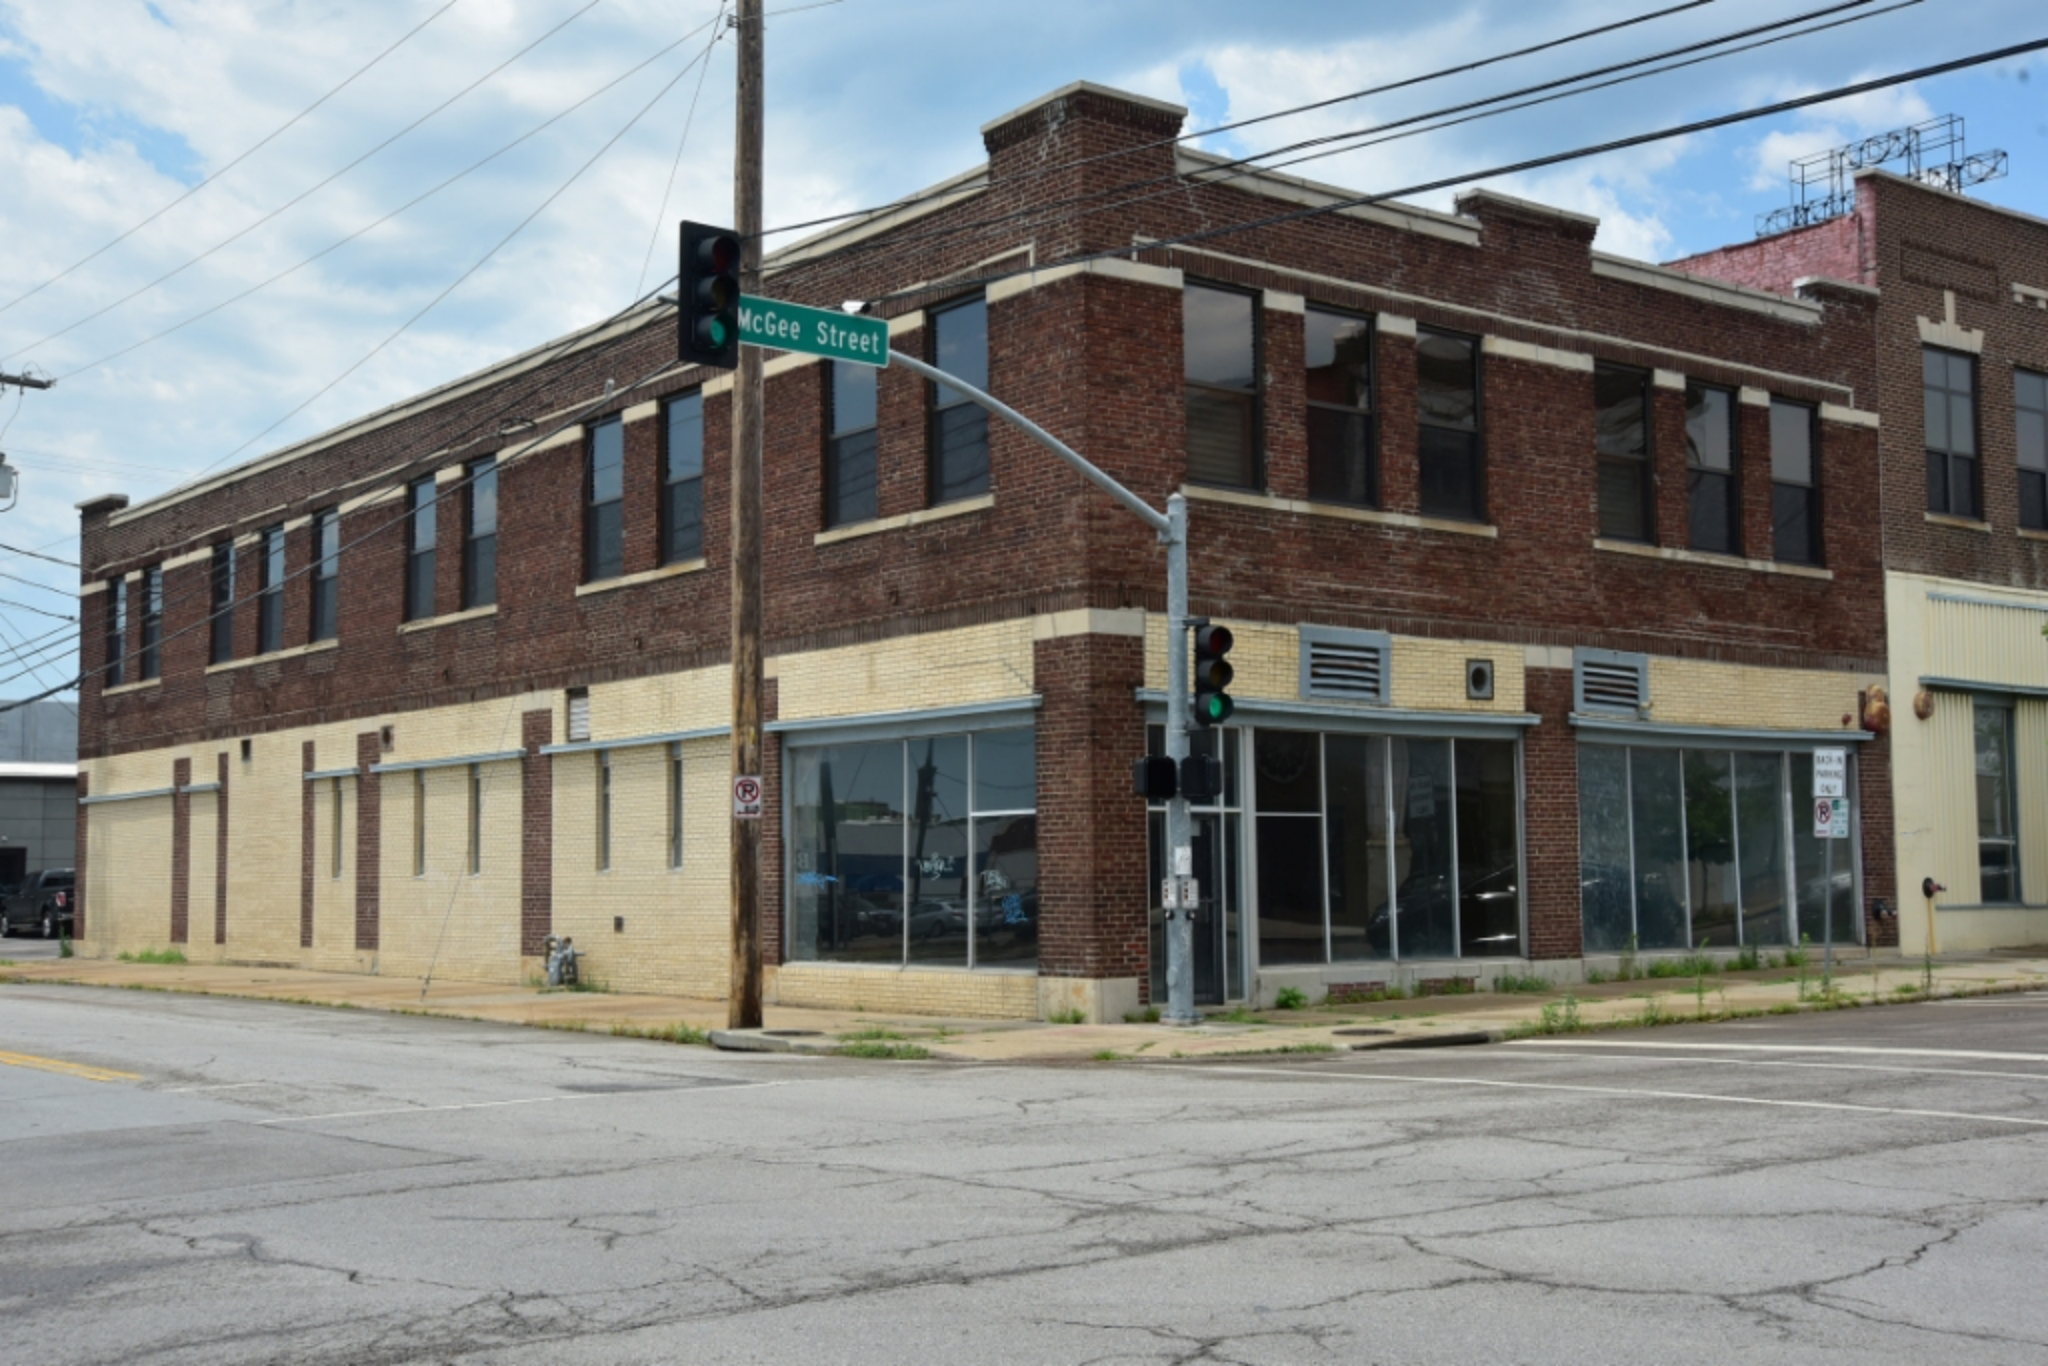
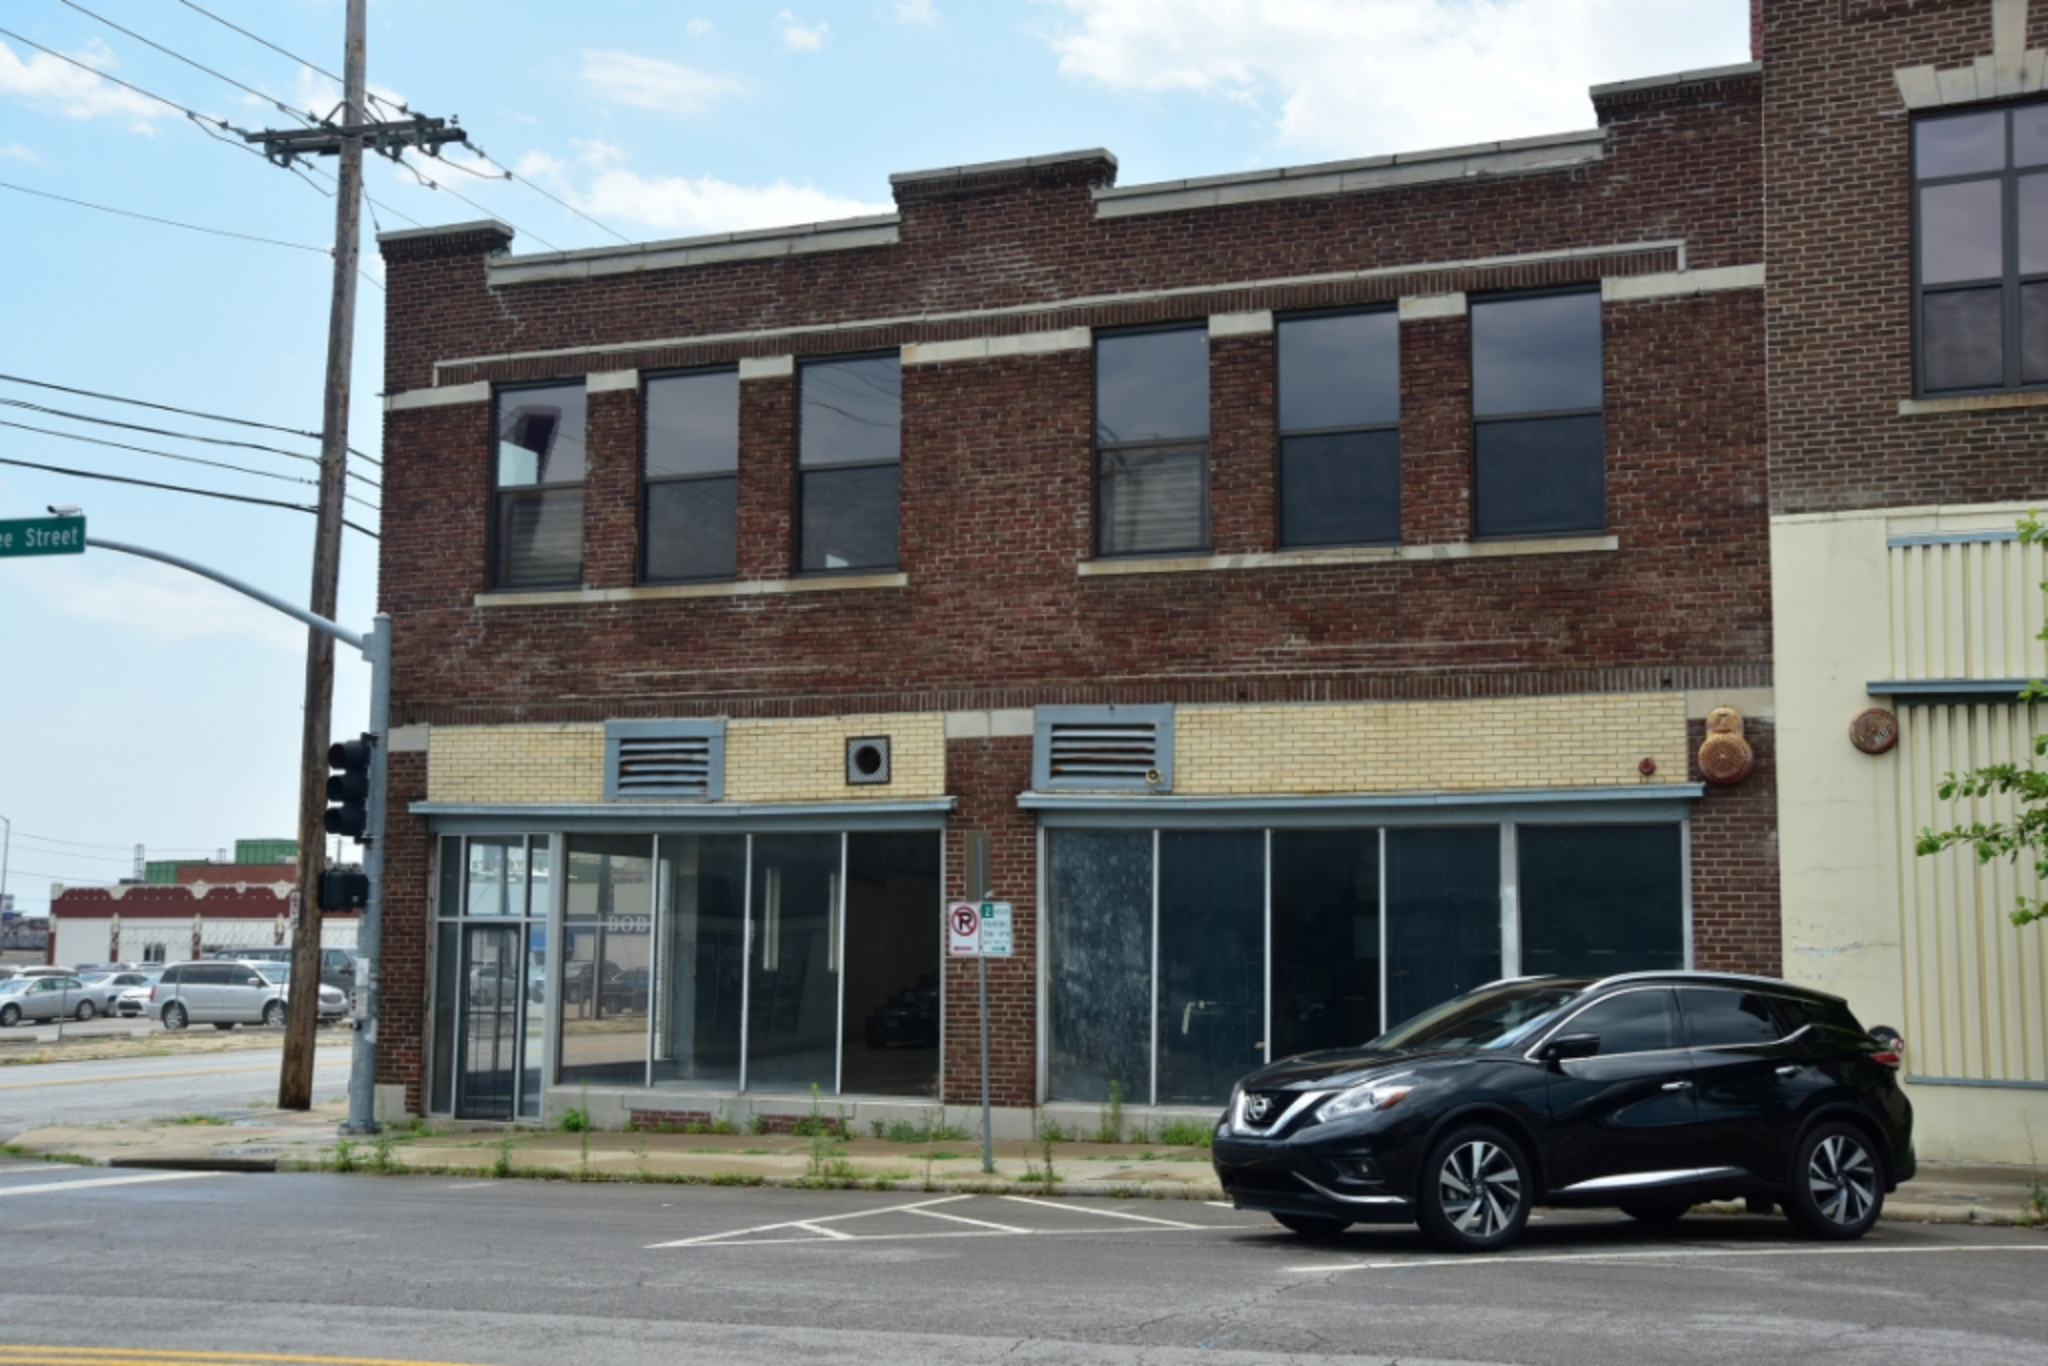
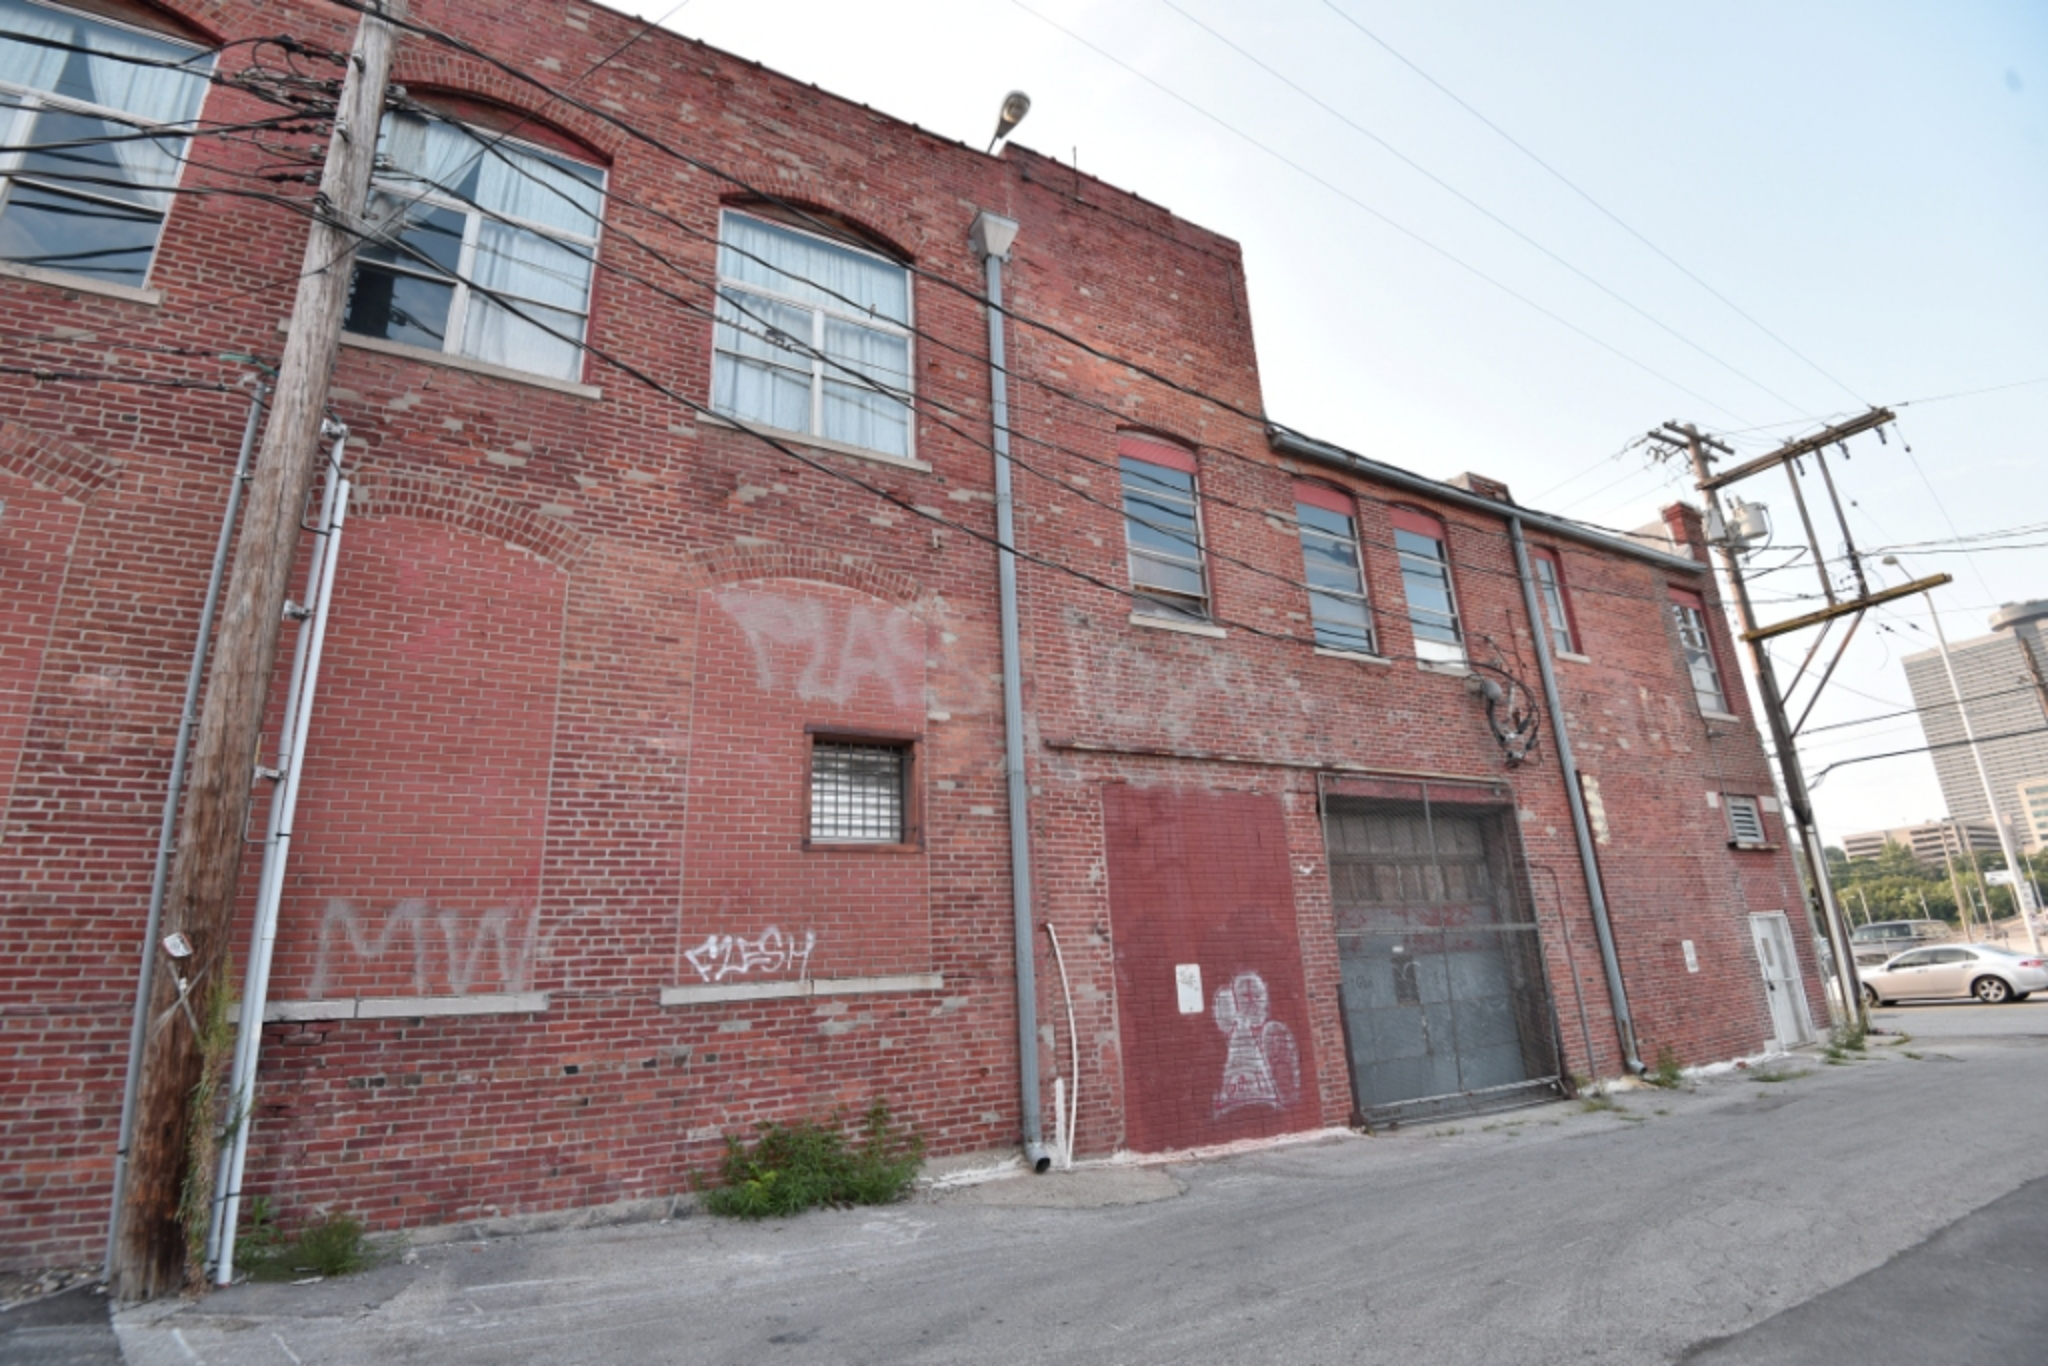
This two-story, rectangular brick building occupies the northwest corner of East 19th Street and McGee Street. Two bays organize the main, east elevation fronting McGee Street. Brick piers separate two storefronts. A metal entry door with glazing, transom, and sidelights is in the southern portion of the south bay. Contrasting buff brick spandrels top each storefront under a soldier course of red brick. Three one-over-one metal windows fill each bay on the second story. Stone banding creates continuous lugsills. Cut stone tops brick piers separating each window. Stone coping caps a parapet which is elevated at ends and in the center.

Five bays organize the south elevation. Storefront glazing fills the east bay on the first floor. Buff brick with vertical fixed light windows and red brick piers fill two bays. An offset fixed vertical rectangular window between red brick piers and a buff brick bay are the western bays. One-over-one metal windows with continuous stone lugsills pierce the second story south elevation. Stone coping caps the parapet which is elevated at the building corner. Three bays organize the rear elevation. A vehicle entry is infilled with brick in the north bay and accessed an elevator shaft that rises above the parapet. A wood panel overhead rolling door with glazing fills the center bay on the first story. A metal slab door with glazing pierces the south bay. Five aluminum windows with an awning sash and stone sills fill arched window openings on the second story.

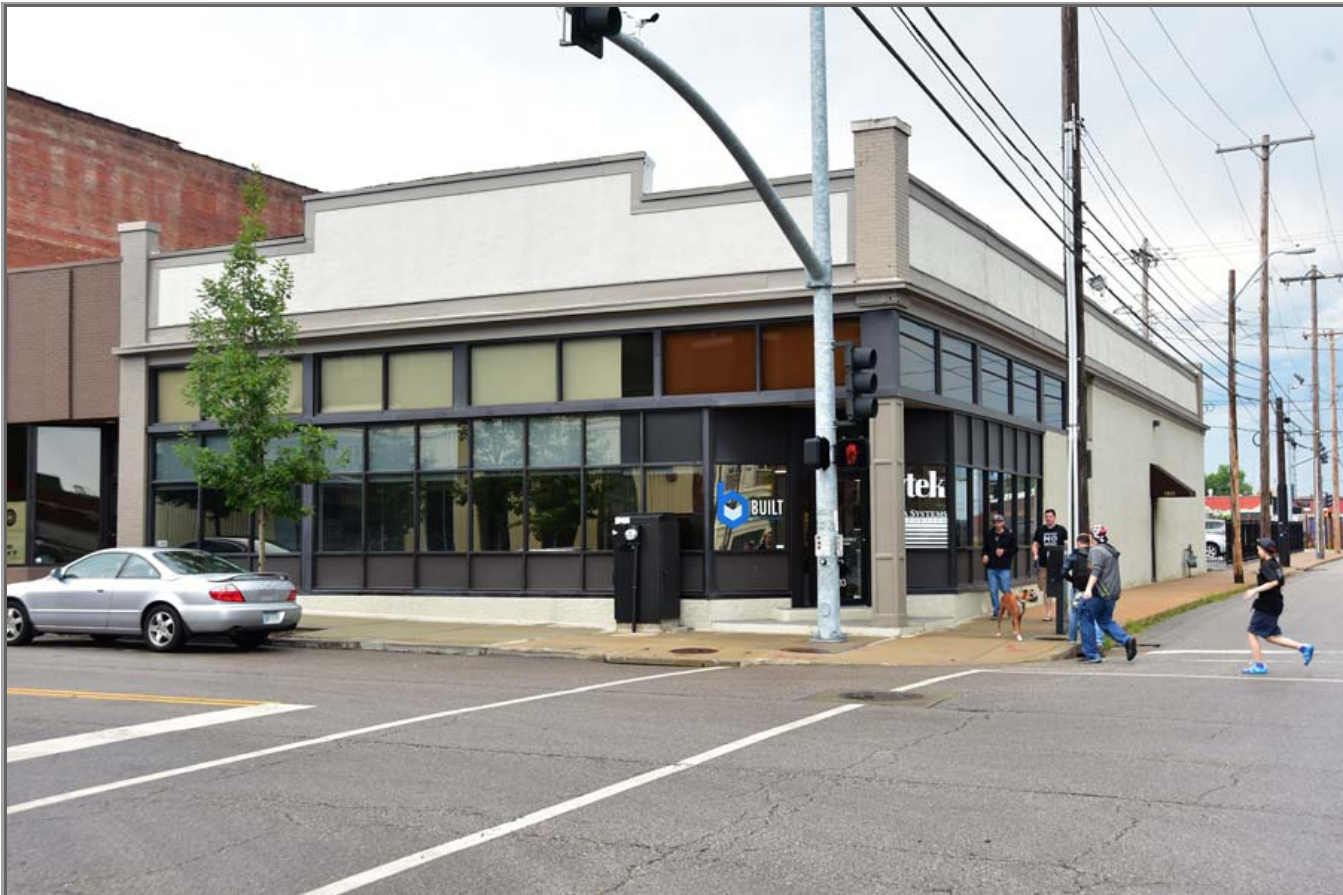
Photographer Brad Finch, f-stop Photography	Date: June 29, 20	Description: west and south elevations, view NE
--	----------------------	--
