MISSOURI DEPARTMENT OF NATURAL RESOURCES
STATE HISTORIC PRESERVATION OFFICE, P.O. Box 176, Jefferson City, MO 65102
ARCHITECTURAL/HISTORIC INVENTORY FORM

1. Survey number: JA-AS-087-025		2. Survey Name: McGee Street Historic Resources Survey 2017	
3. County: JACKSON		4. Address (Street No.): 215	Street (name): E. 18th Street
5. City: Kansas City	Vicinity <input type="checkbox"/>	6. Lat / Long: 39.091481 -94.580440	7. Township/Range/Section: T: R: S:
8. Historic name (if known): Interstate Securities Building		9. Present/other name (if known):	
10. Ownership: <input checked="" type="checkbox"/> Private <input type="checkbox"/> Public		11a. Historic use (if known): Commercial	11b. Current use: Commercial

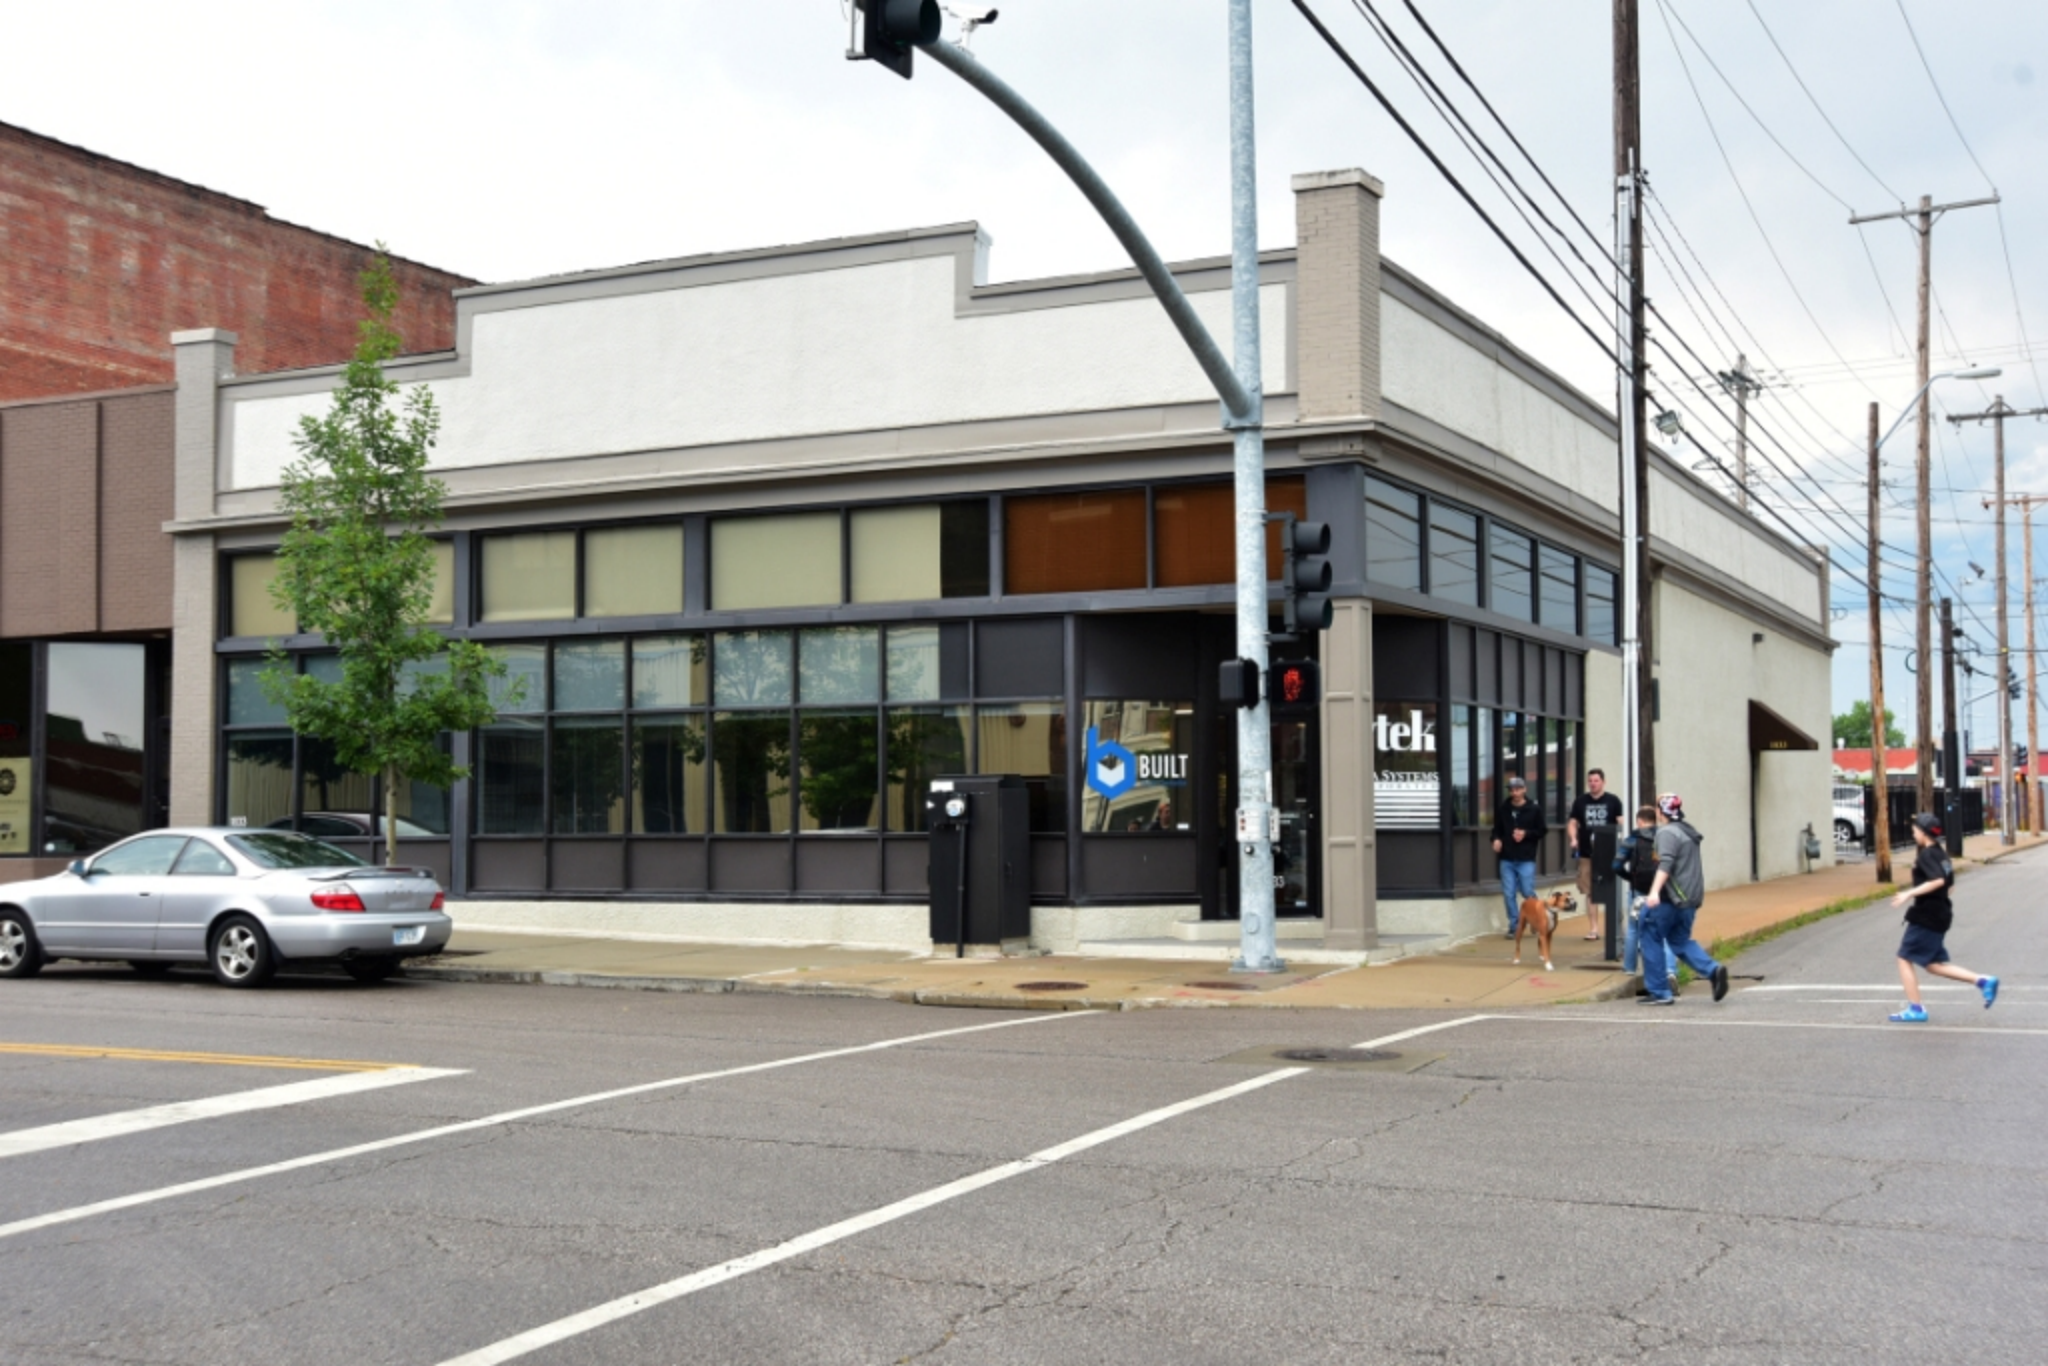
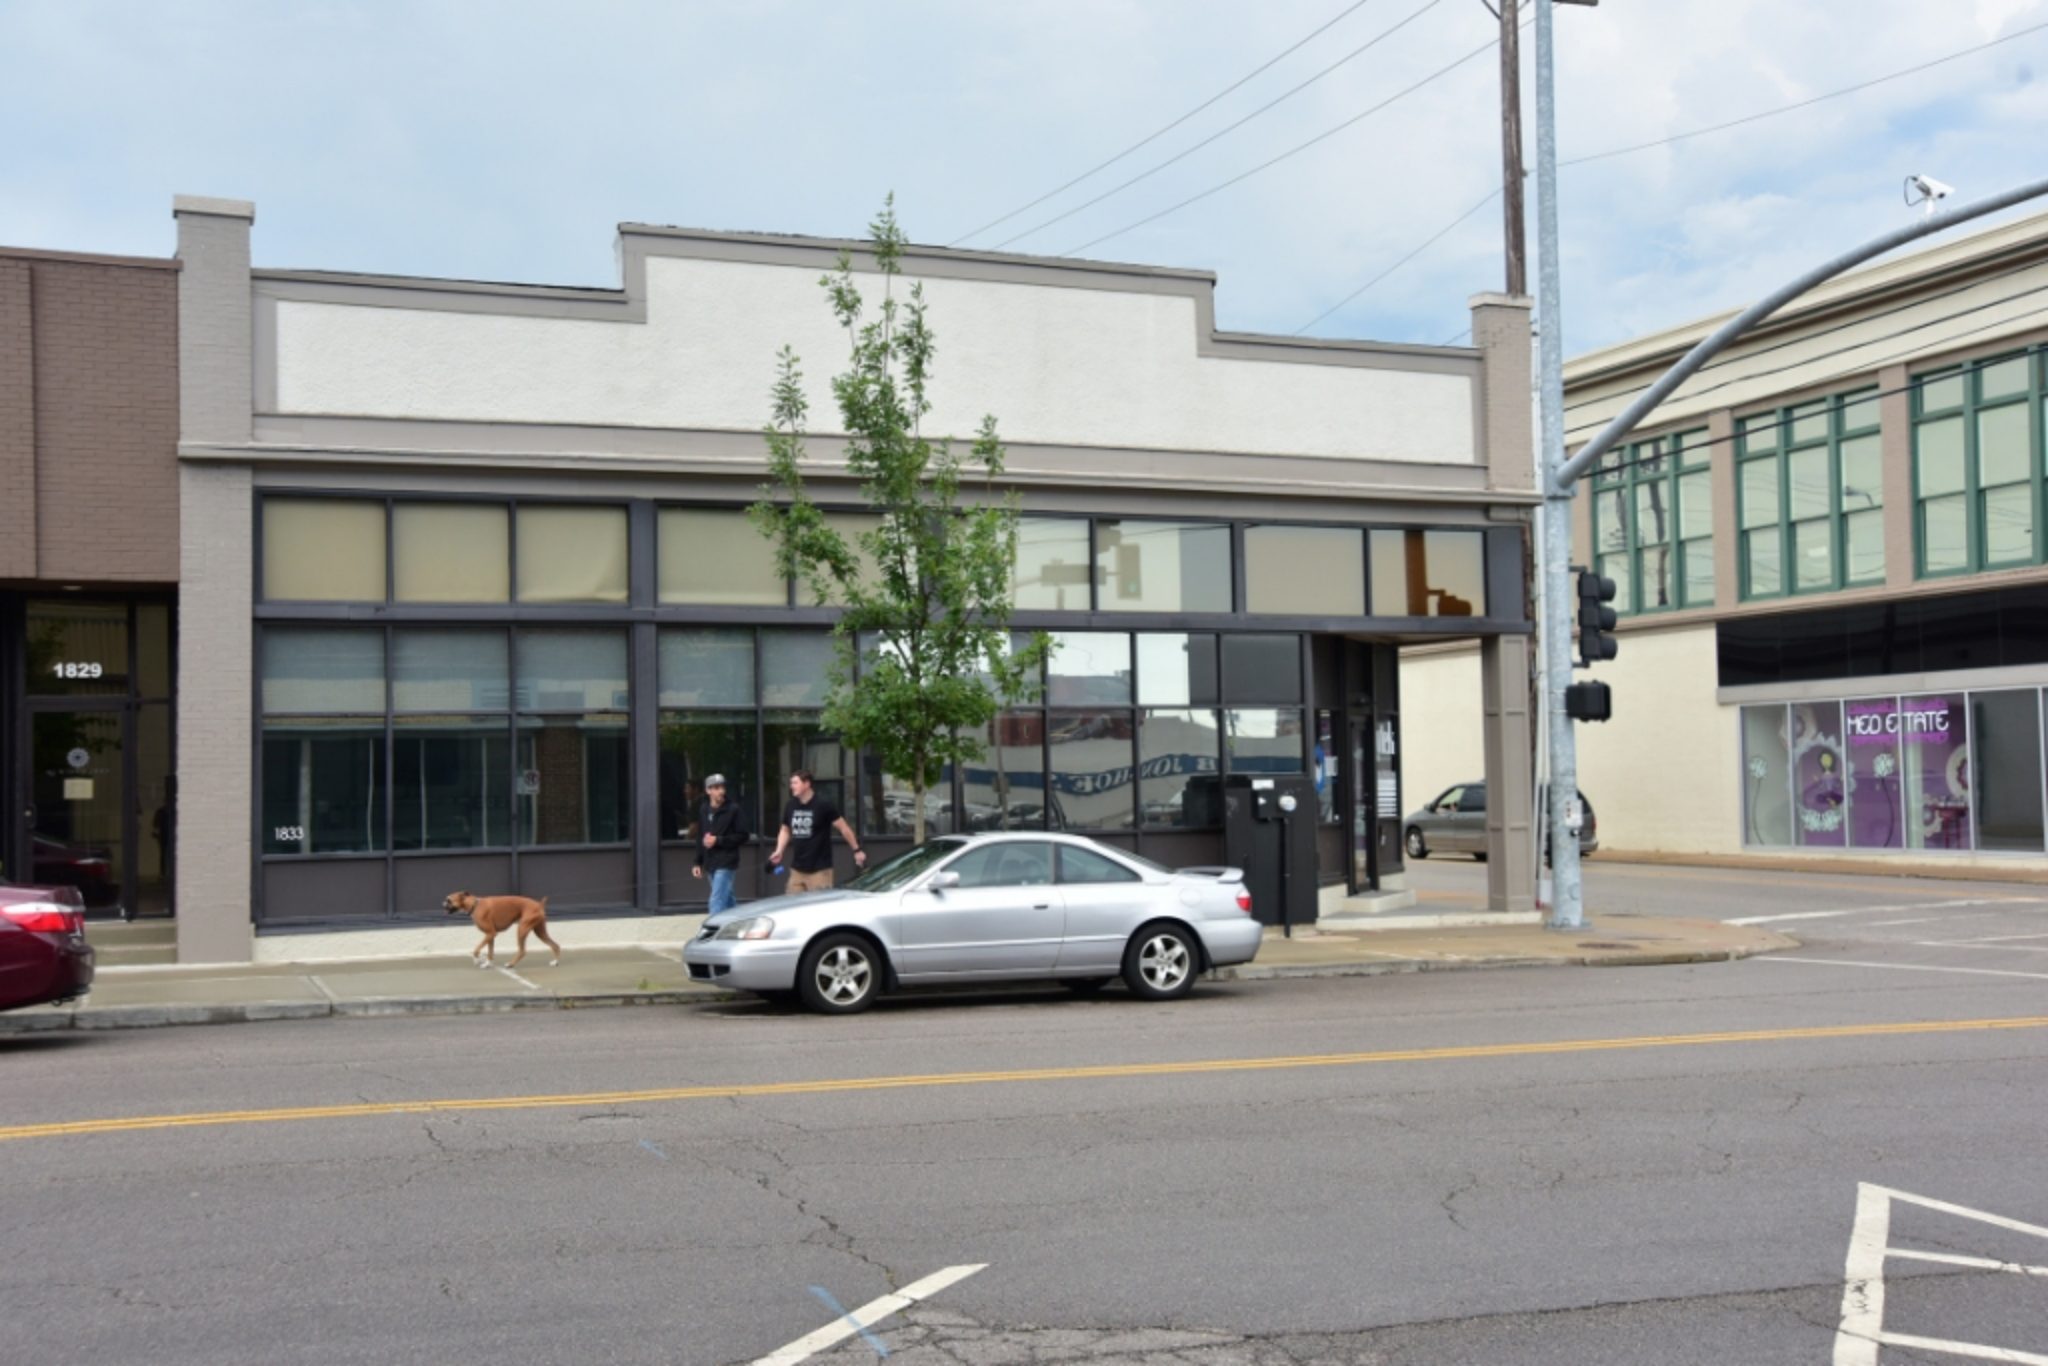
Masonry block clads the rear elevation and was added in 1963 to replace a non load-bearing wall (#4590). A metal overhead rolling door fills a vehicle entry and a metal slab door provides pedestrian access. Three multi-light metal windows pierce the south bay.

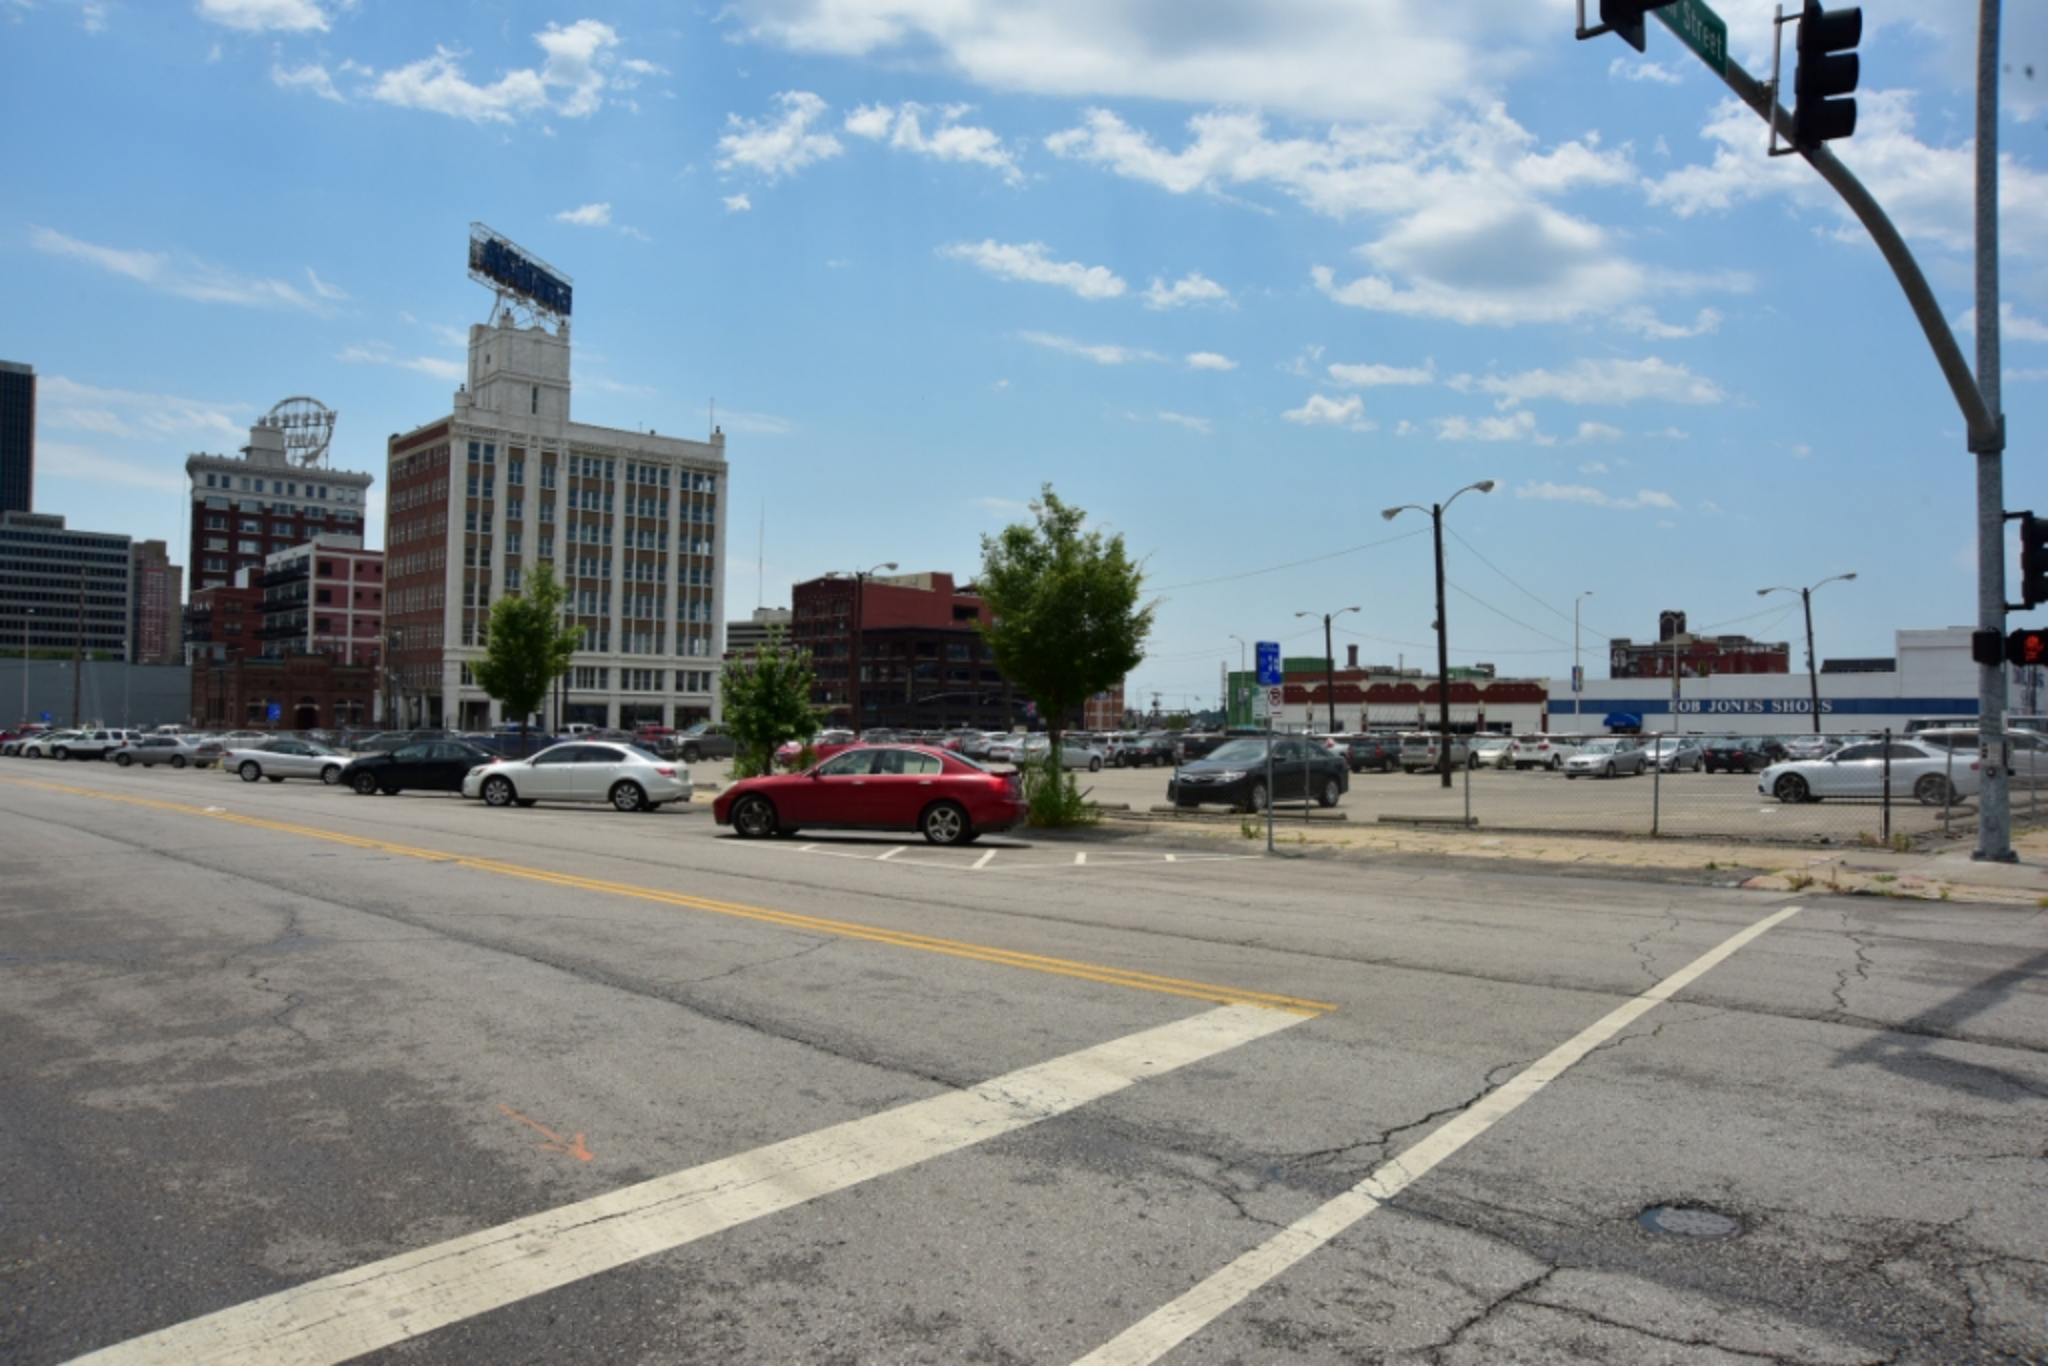
1900 McGee Street is an asphalt-paved surface parking lot that occupies an entire block between East 19th Street and East 20th Street. The surface lot was constructed circa 1978.

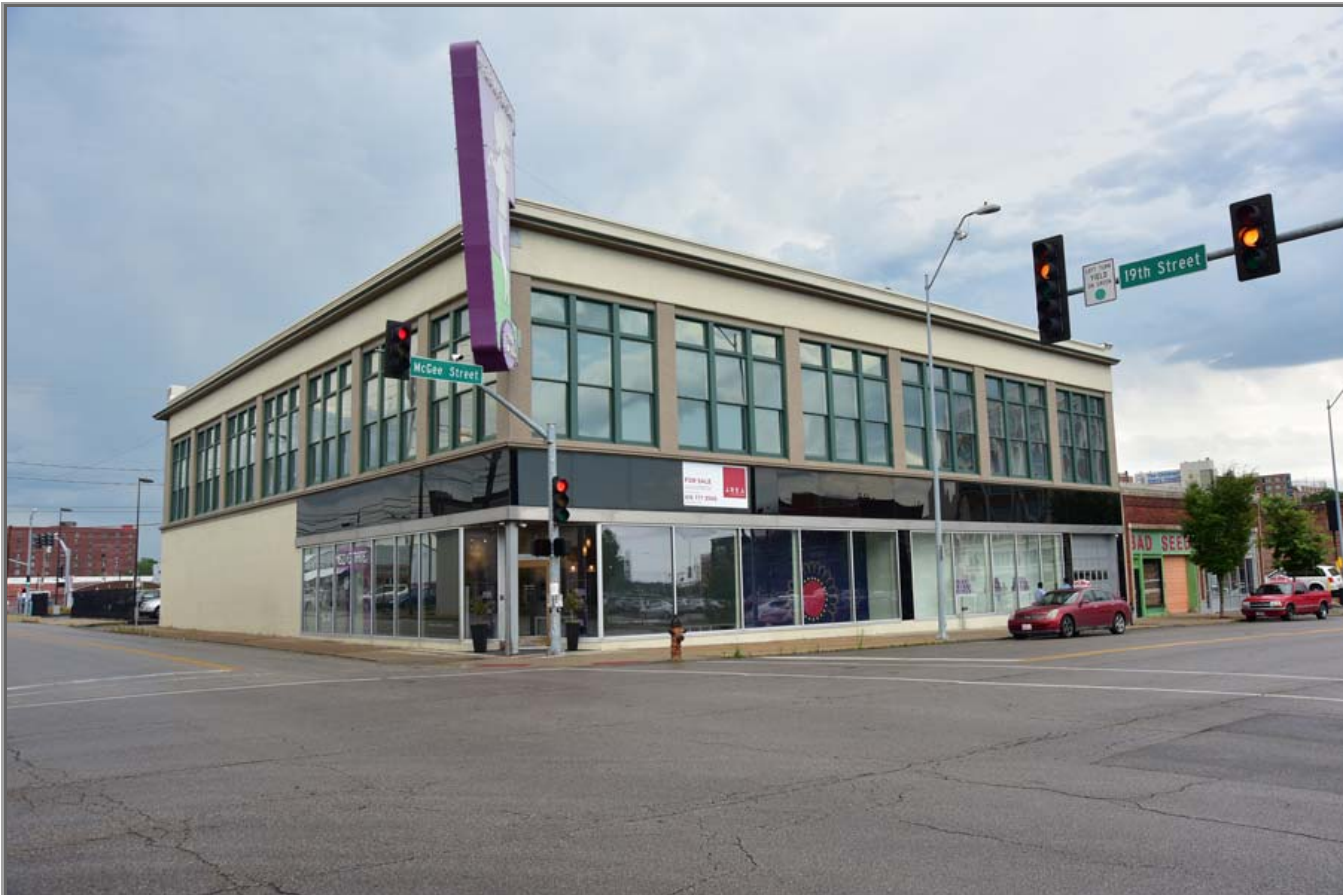
Photographer Brad Finch, f-stop Photography	Date: June 29, 20	Description: north and west elevations, view SE
--	----------------------	--

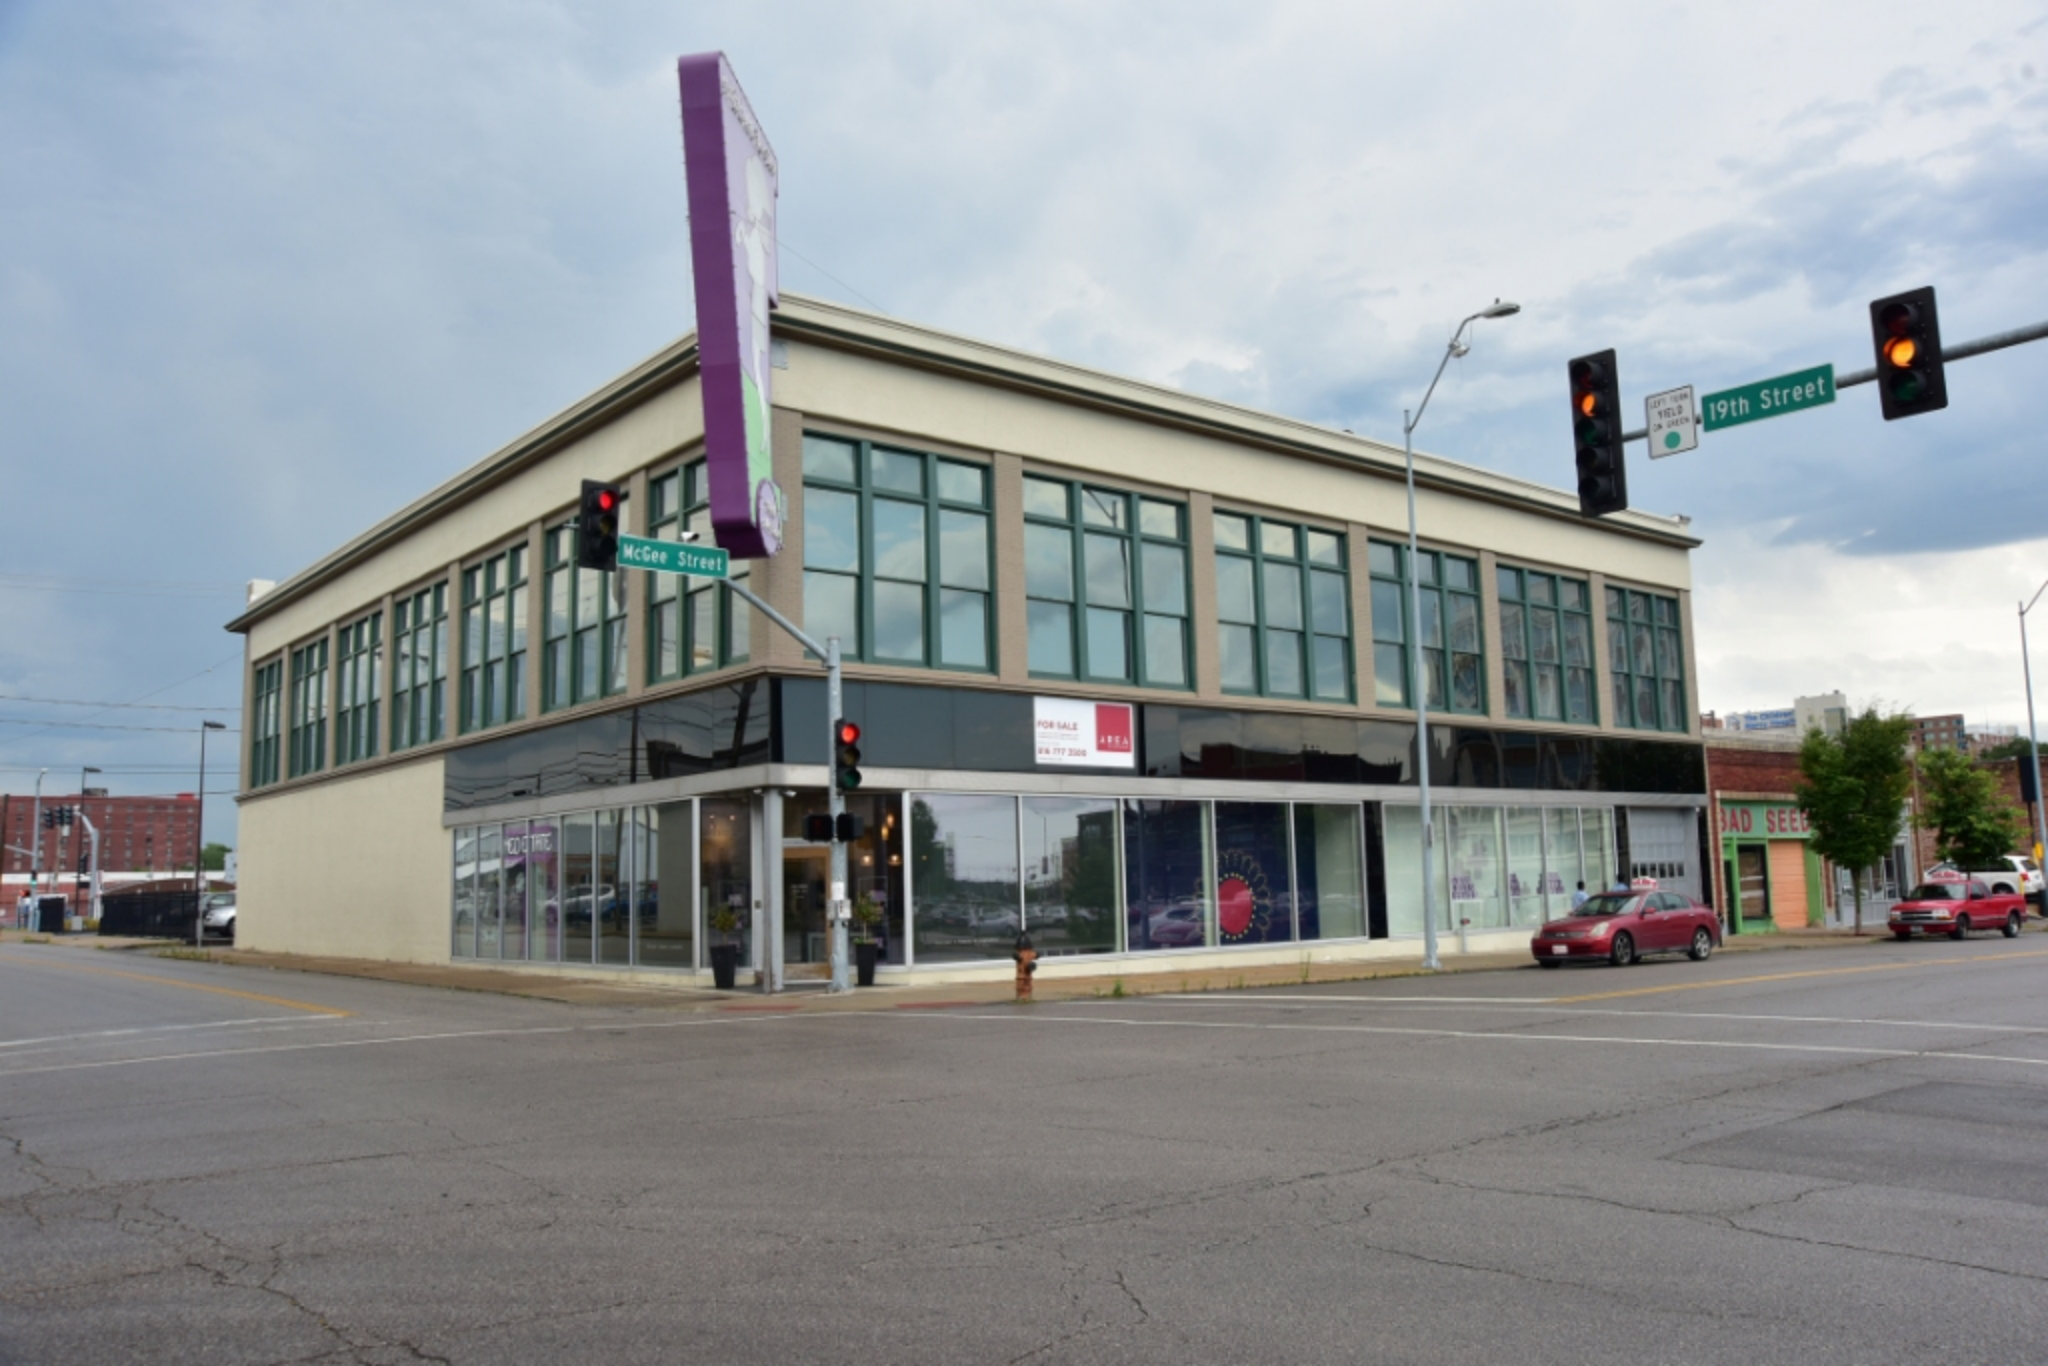
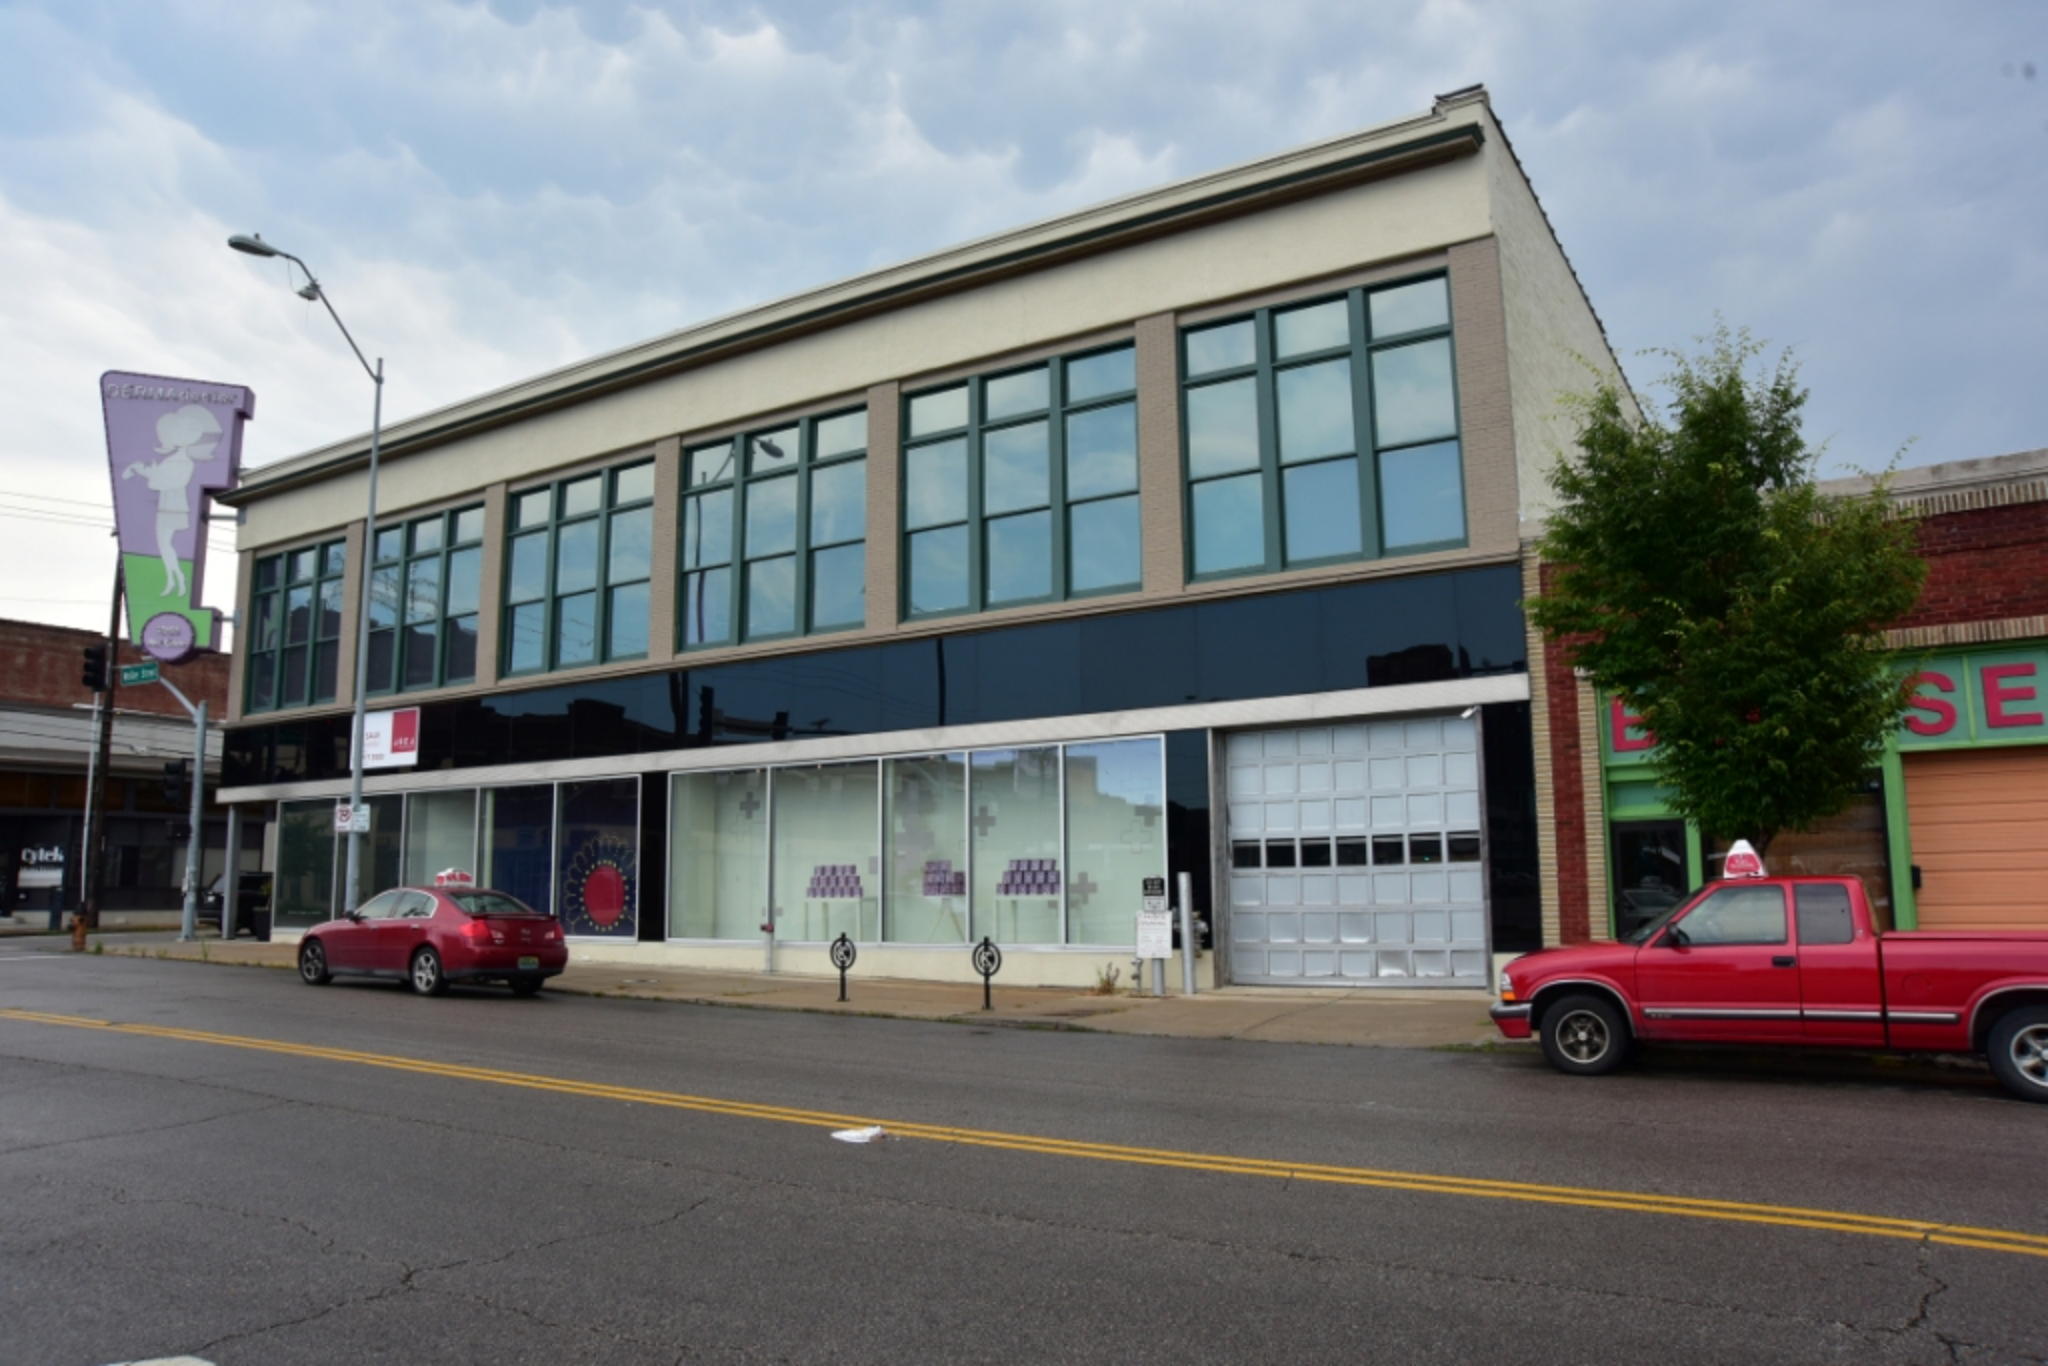
Stucco clads the rear east elevation. A centered elevator penthouses rises above a vehicle entry with a metal overhead rolling door. A second overheard rolling metal door fills a vehicle entry in the south bay. Banded sets of three and paired sets of twelve-over-twelve wood windows and a metal slab door with glazing pierce the east elevation on the first story. Banded sets of three and paired sets of twelve-over-twelve wood windows pierce the second story. Brick chimney flues rise on the northeast and the southeast corners.

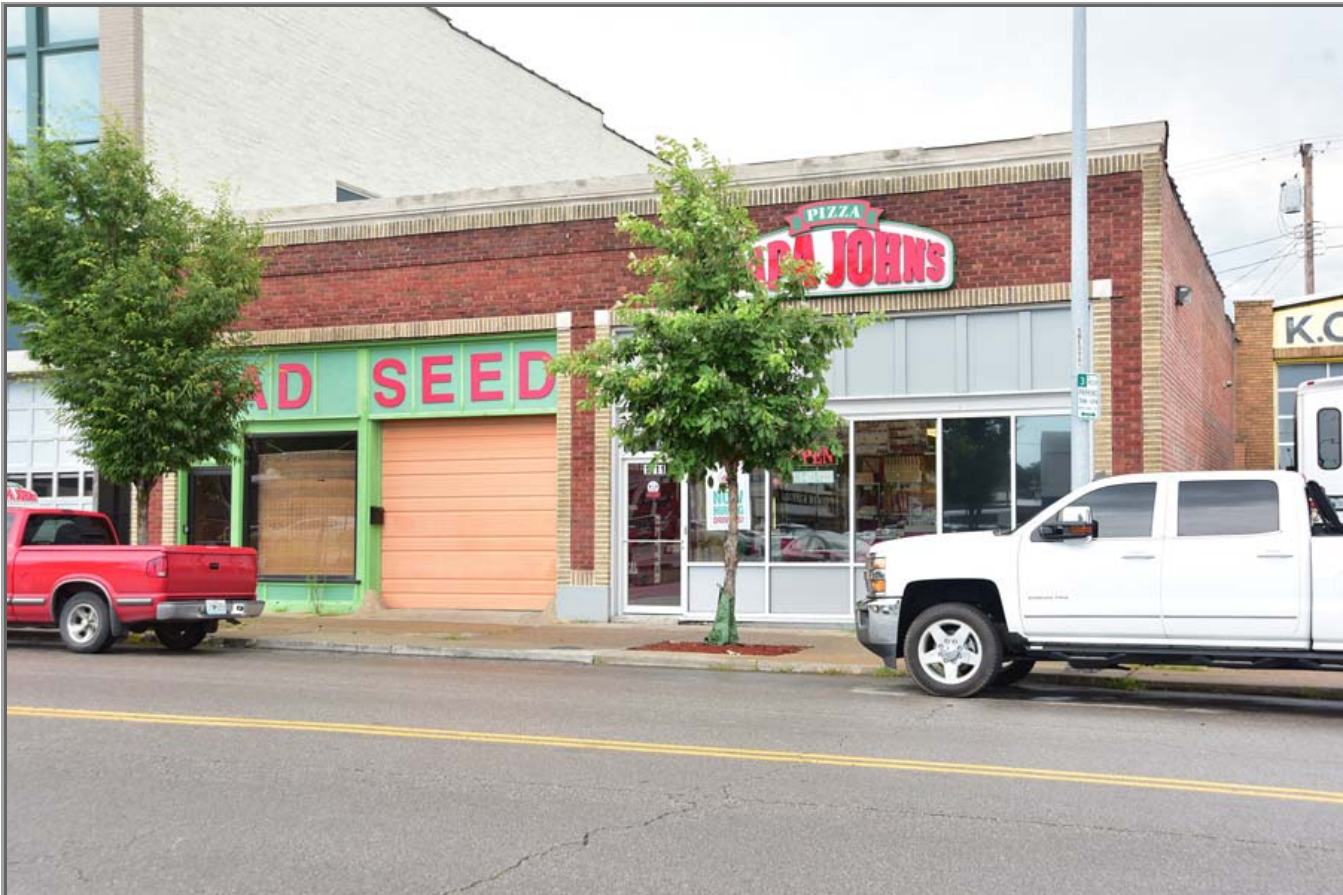
Photographer Brad Finch, f-stop Photography	Date: June 29, 20	Description: west and south elevations, view NE
--	----------------------	--

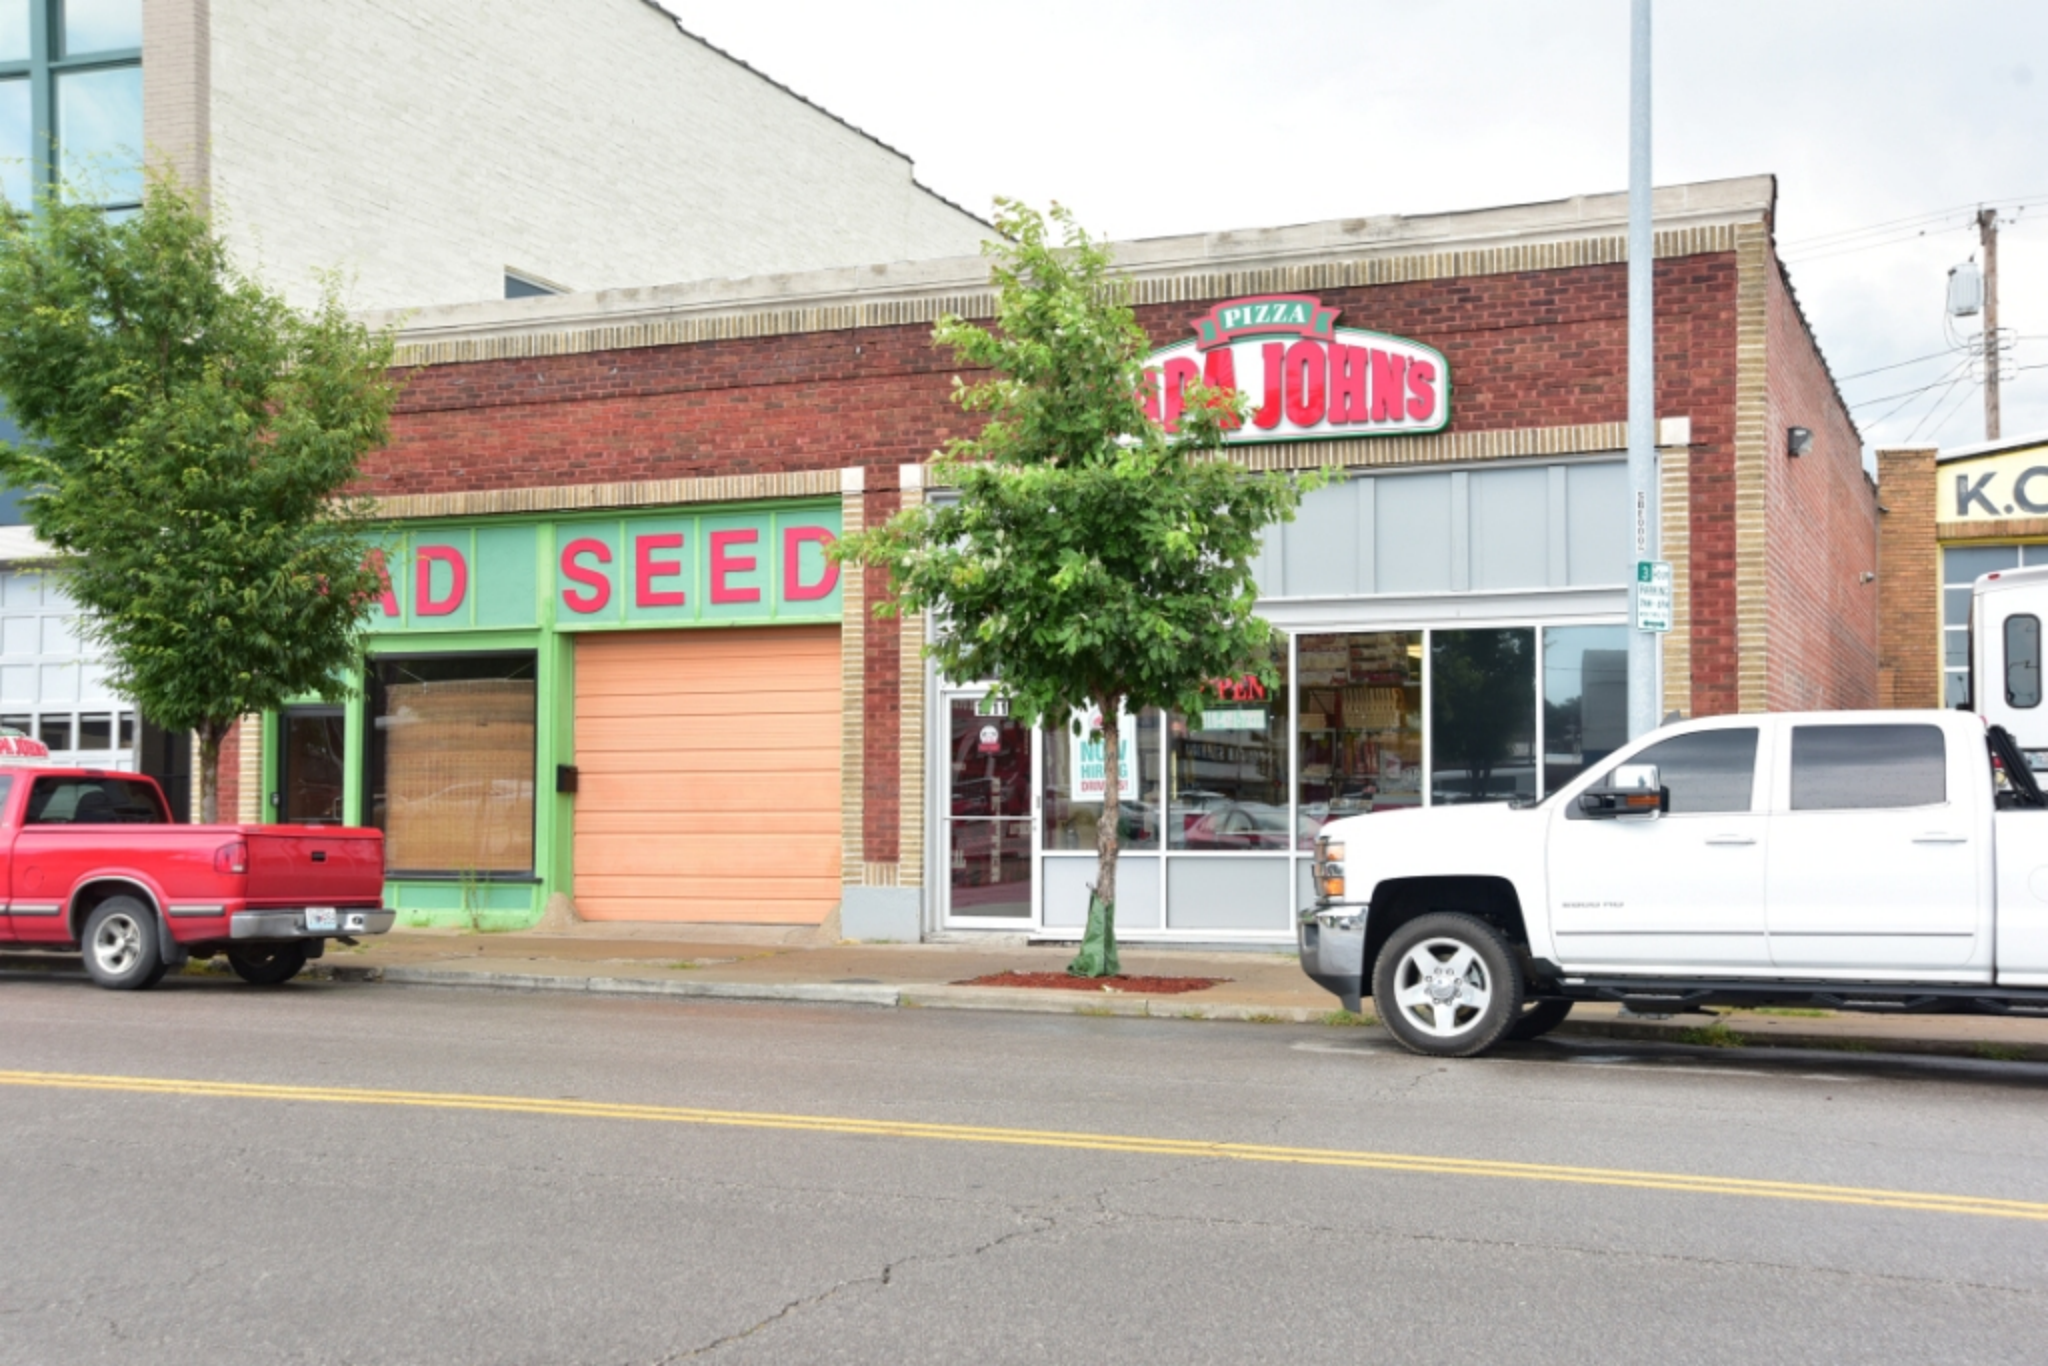
A brick column divides and organizes two bays on the east, rear elevation. A metal overhead rolling door fills a vehicle entry with plywood infill in the north bay. A metal door with glazing and a transom pierces the north bay. Glass block and wood infill two arched historic window openings in the north bay. A metal overhead rolling door and a metal slab pedestrian door with a metal infilled transom fill the south bay.

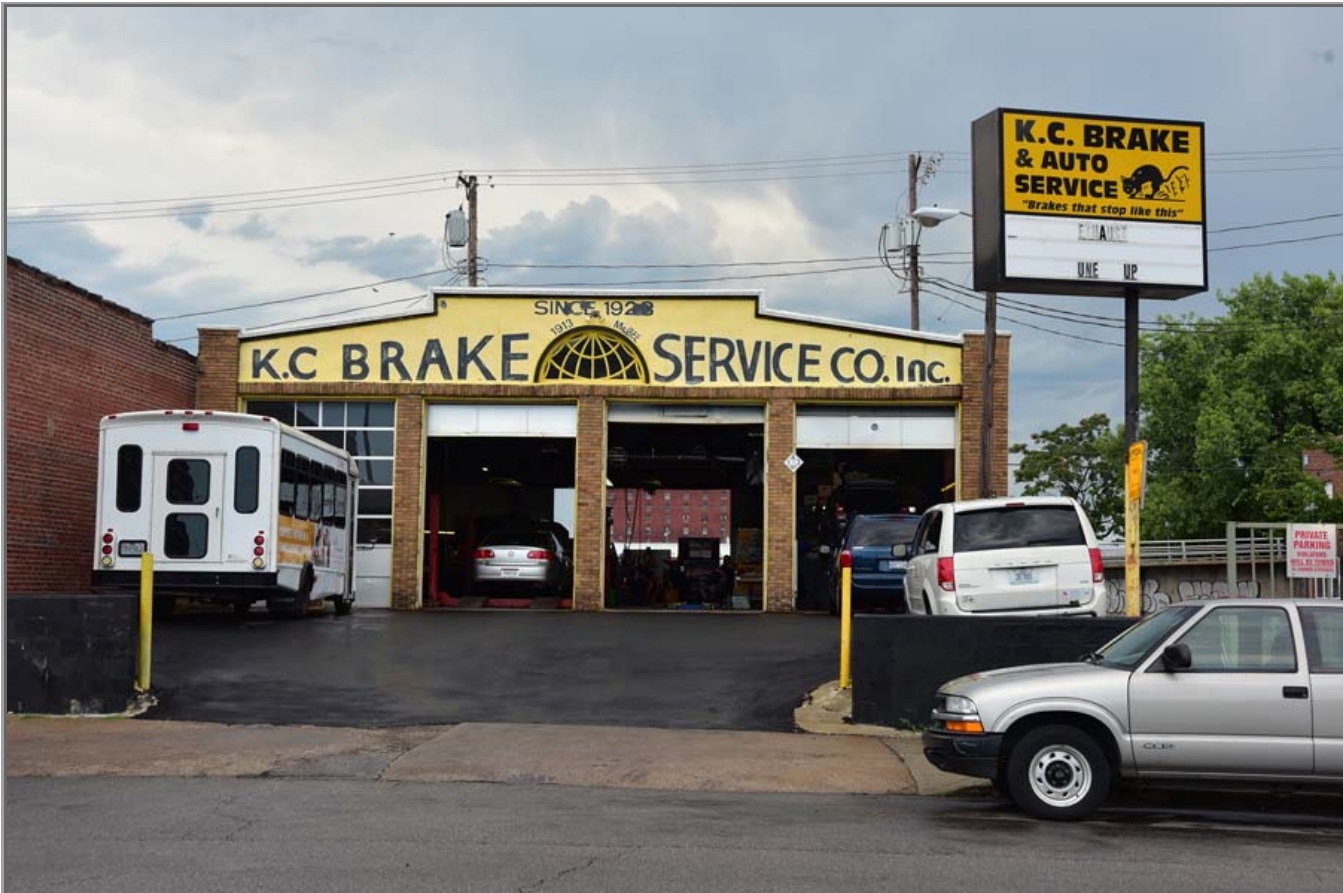
Photographer Brad Finch, f-stop Photography	Date: June 29, 20	Description: west elevation, view E
--	----------------------	--

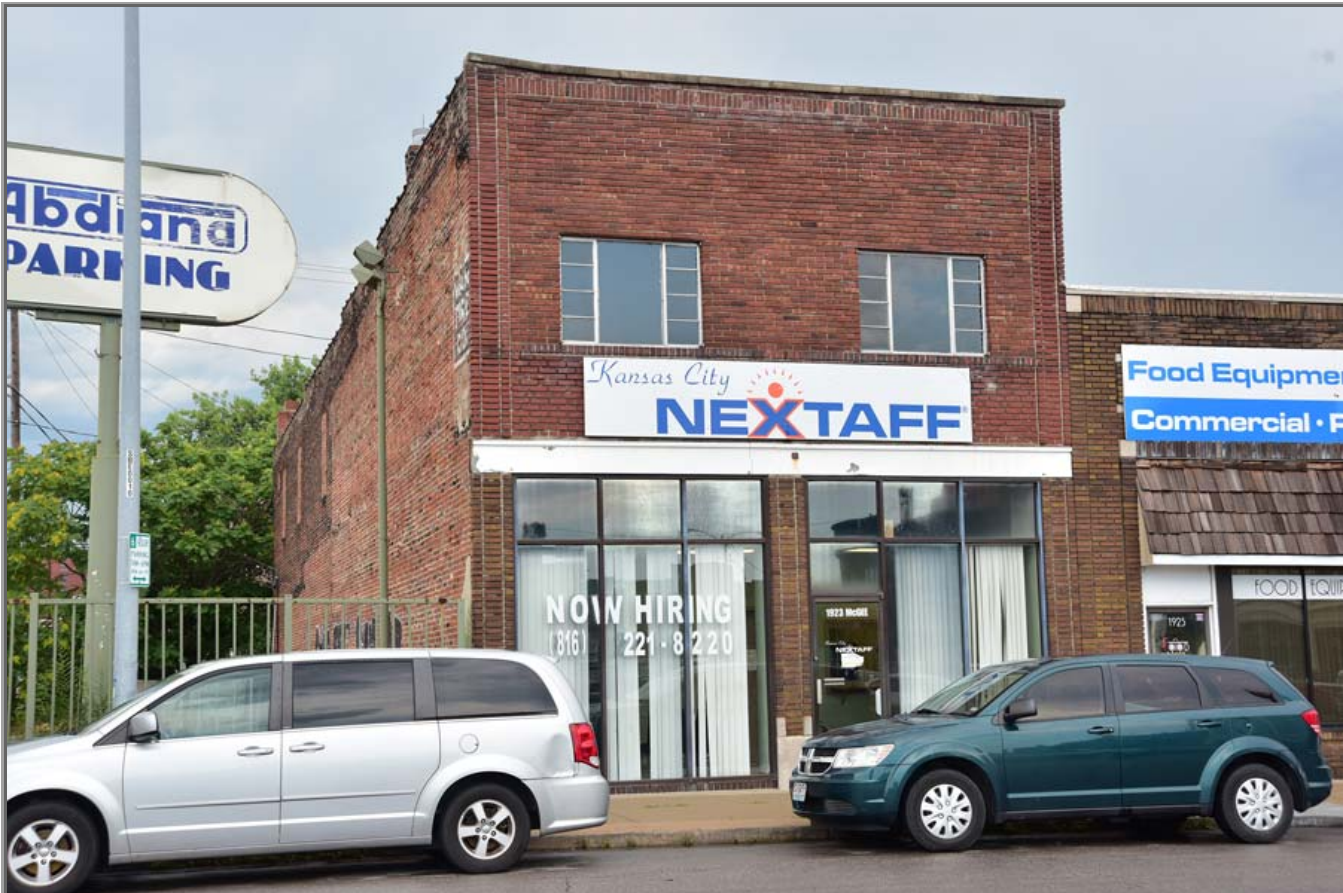
PHOTOGRAPH

Photographer Brad Finch, f-stop Photography	Date: June 29, 20	Description: north and west elevations, view E
--	----------------------	---

1921 McGee Street has good integrity and is recommended as a contributing resource to a potential historic district. The building is associated with automobile-related commercial buildings concentrated in "Automobile Row." Alterations to the second story fenestration do not compromise the building's ability to convey its significance. The historic configuration of a storefronts, entry, and transoms is intact. The building retains integrity and communicates its significance as an early automobile-related commercial building.
