MISSOURI DEPARTMENT OF NATURAL RESOURCES
STATE HISTORIC PRESERVATION OFFICE, P.O. Box 176, Jefferson City, MO 65102
ARCHITECTURAL/HISTORIC INVENTORY FORM

1. Survey number: JA-AS-087-025		2. Survey Name: McGee Street Historic Resources Survey 2017	
3. County: JACKSON		4. Address (Street No.): 215	Street (name): E. 18th Street
5. City: Kansas City	Vicinity <input type="checkbox"/>	6. Lat / Long: 39.091481 -94.580440	7. Township/Range/Section: T: R: S:
8. Historic name (if known): Interstate Securities Building		9. Present/other name (if known):	
10. Ownership: <input checked="" type="checkbox"/> Private <input type="checkbox"/> Public		11a. Historic use (if known): Commercial	11b. Current use: Commercial

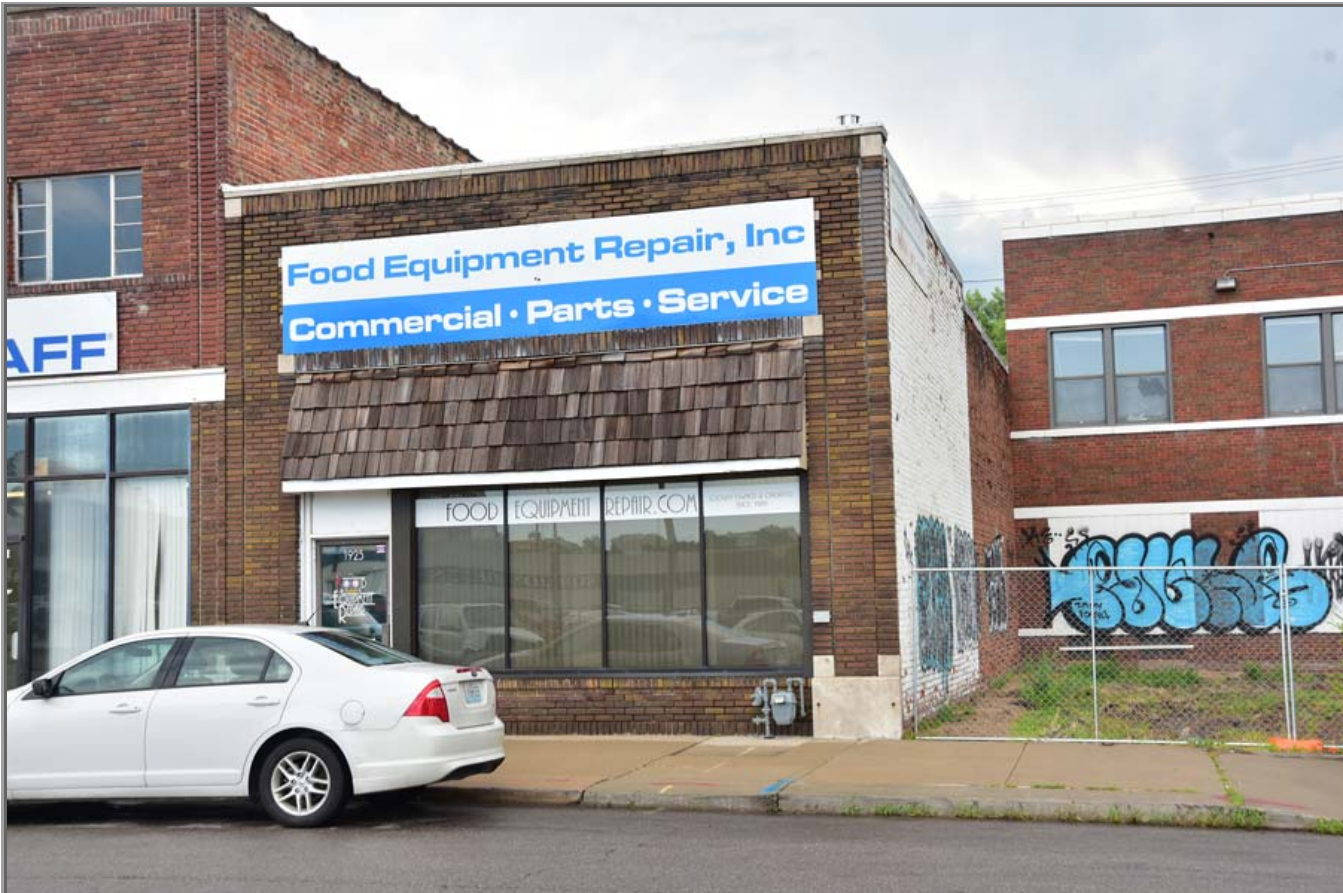
PHOTOGRAPH

Photographer Brad Finch, f-stop Photography	Date: June 29, 20	Description: west and south elevations, view NE
--	----------------------	--

1925 McGee Street has fair integrity and is recommended as a contributing resource to a potential historic district. The building is associated with automobile-related commercial buildings concentrated in "Automobile Row." The building's form, materials, storefront configuration and rear vehicle entry are intact. The building retains integrity and communicates its significance as an early automobile-related commercial building.

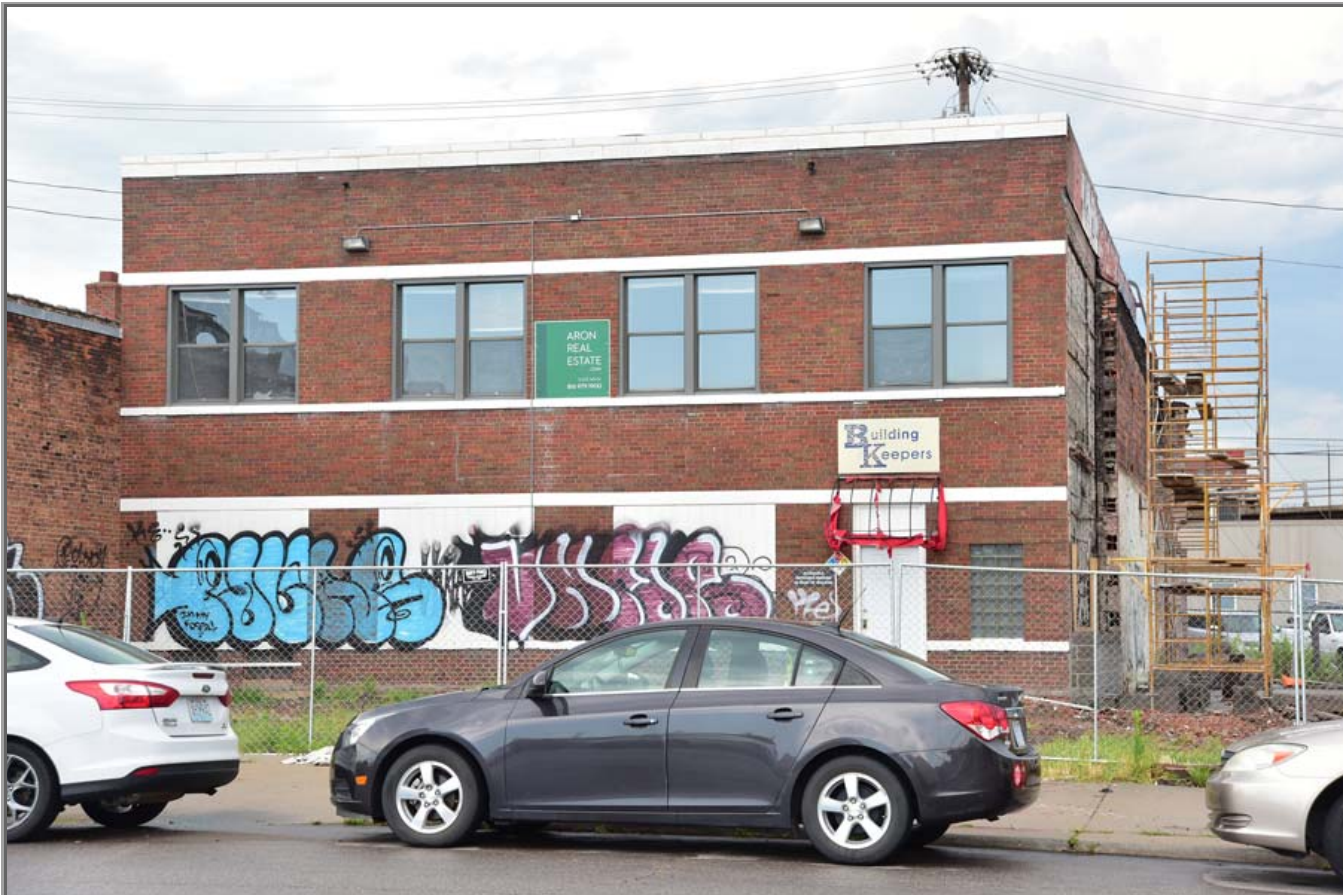
PHOTOGRAPH

Photographer Brad Finch, f-stop Photography	Date: June 29, 20	Description: west and south elevations, view NE
--	----------------------	--

1927 McGee Street has fair integrity and is recommended as a contributing resource to a potential historic district. The building is associated with automobile-related commercial buildings concentrated in "Automobile Row." The replacement of windows with glass block did not compromise the ability of the building to convey its historic auto-related function and the era of construction. The terra cotta detailing that organizes the front façade is intact and the storefront configuration and rear vehicle entry communicate its significance as an early automobile-related commercial building. 1927-A McGee Street is an addition to a building that is no longer extant. The loss of the majority of the associated building compromises this resource's integrity and it no longer conveys its significance as an automobile-related resource. It is recommended as contributing to a potential historic district.

1927 McGee Street is a two-story brick building with a rectangular plan and a flat roof. The building is a 1948 addition to a larger 1918 commercial building that is no longer extant. The building is set-back from McGee Street and historically had surface parking in front of its west elevation. Four bays organize the first story of the west elevation. Window openings are currently covered with wood. A non-historic entry door with an infill transom and a glass block window with concrete banding sill fills the south bay. Continuous concrete banding creates a sill and tops four sets of metal one-over-one paired windows on the second story under a brick parapet with terra cotta coping. Three bays organize the east elevation. Exposed concrete structure frames a vehicle entry opening with plywood infill. Two multi-light metal windows flank the vehicle opening. A wood slab door accessed by a metal fire escape and a three-light metal window pierce the south elevation on the second story. Three metal multi-light windows pierce the second story above the vehicle opening. Two metal multi-light windows pierce the north bay on the second story.
