This was a survey project begun by Missouri's State Historic Preservation Office staff. Due to staff changes and time constraints it was not completed. However, the photographs are of a high quality and there is still a wealth of useful information provided. Thus we are posting the draft survey and report online for research purposes.

MISSOURI DEPARTMENT OF NATURAL RESOURCES
STATE HISTORIC PRESERVATION OFFICE, P.O. Box 176, Jefferson City, MO 65102
ARCHITECTURAL/HISTORIC INVENTORY FORM

1. Survey No. CIAS002-001		2. Survey name: Plattsburg Reconnaissance Survey	
3. County: Clinton		4. Address (Street No.) 202	Street (name) N. 2nd
5. City: Plattsburg	Vicinity: <input type="checkbox"/>	6. UTM: 15/375589/4380573	7. Township/Range/Section: T: 55 N R: 33 W S: 24
8. Historic name (if known): Unknown		9. Present/other name (if known): Whisker's Antiques	
10. Ownership: <input checked="" type="checkbox"/> Private <input type="checkbox"/> Public		11a. Historic use (if known): Commerce/Trade: Specialty Store	11b. Current use: Commerce/ Specialty Store

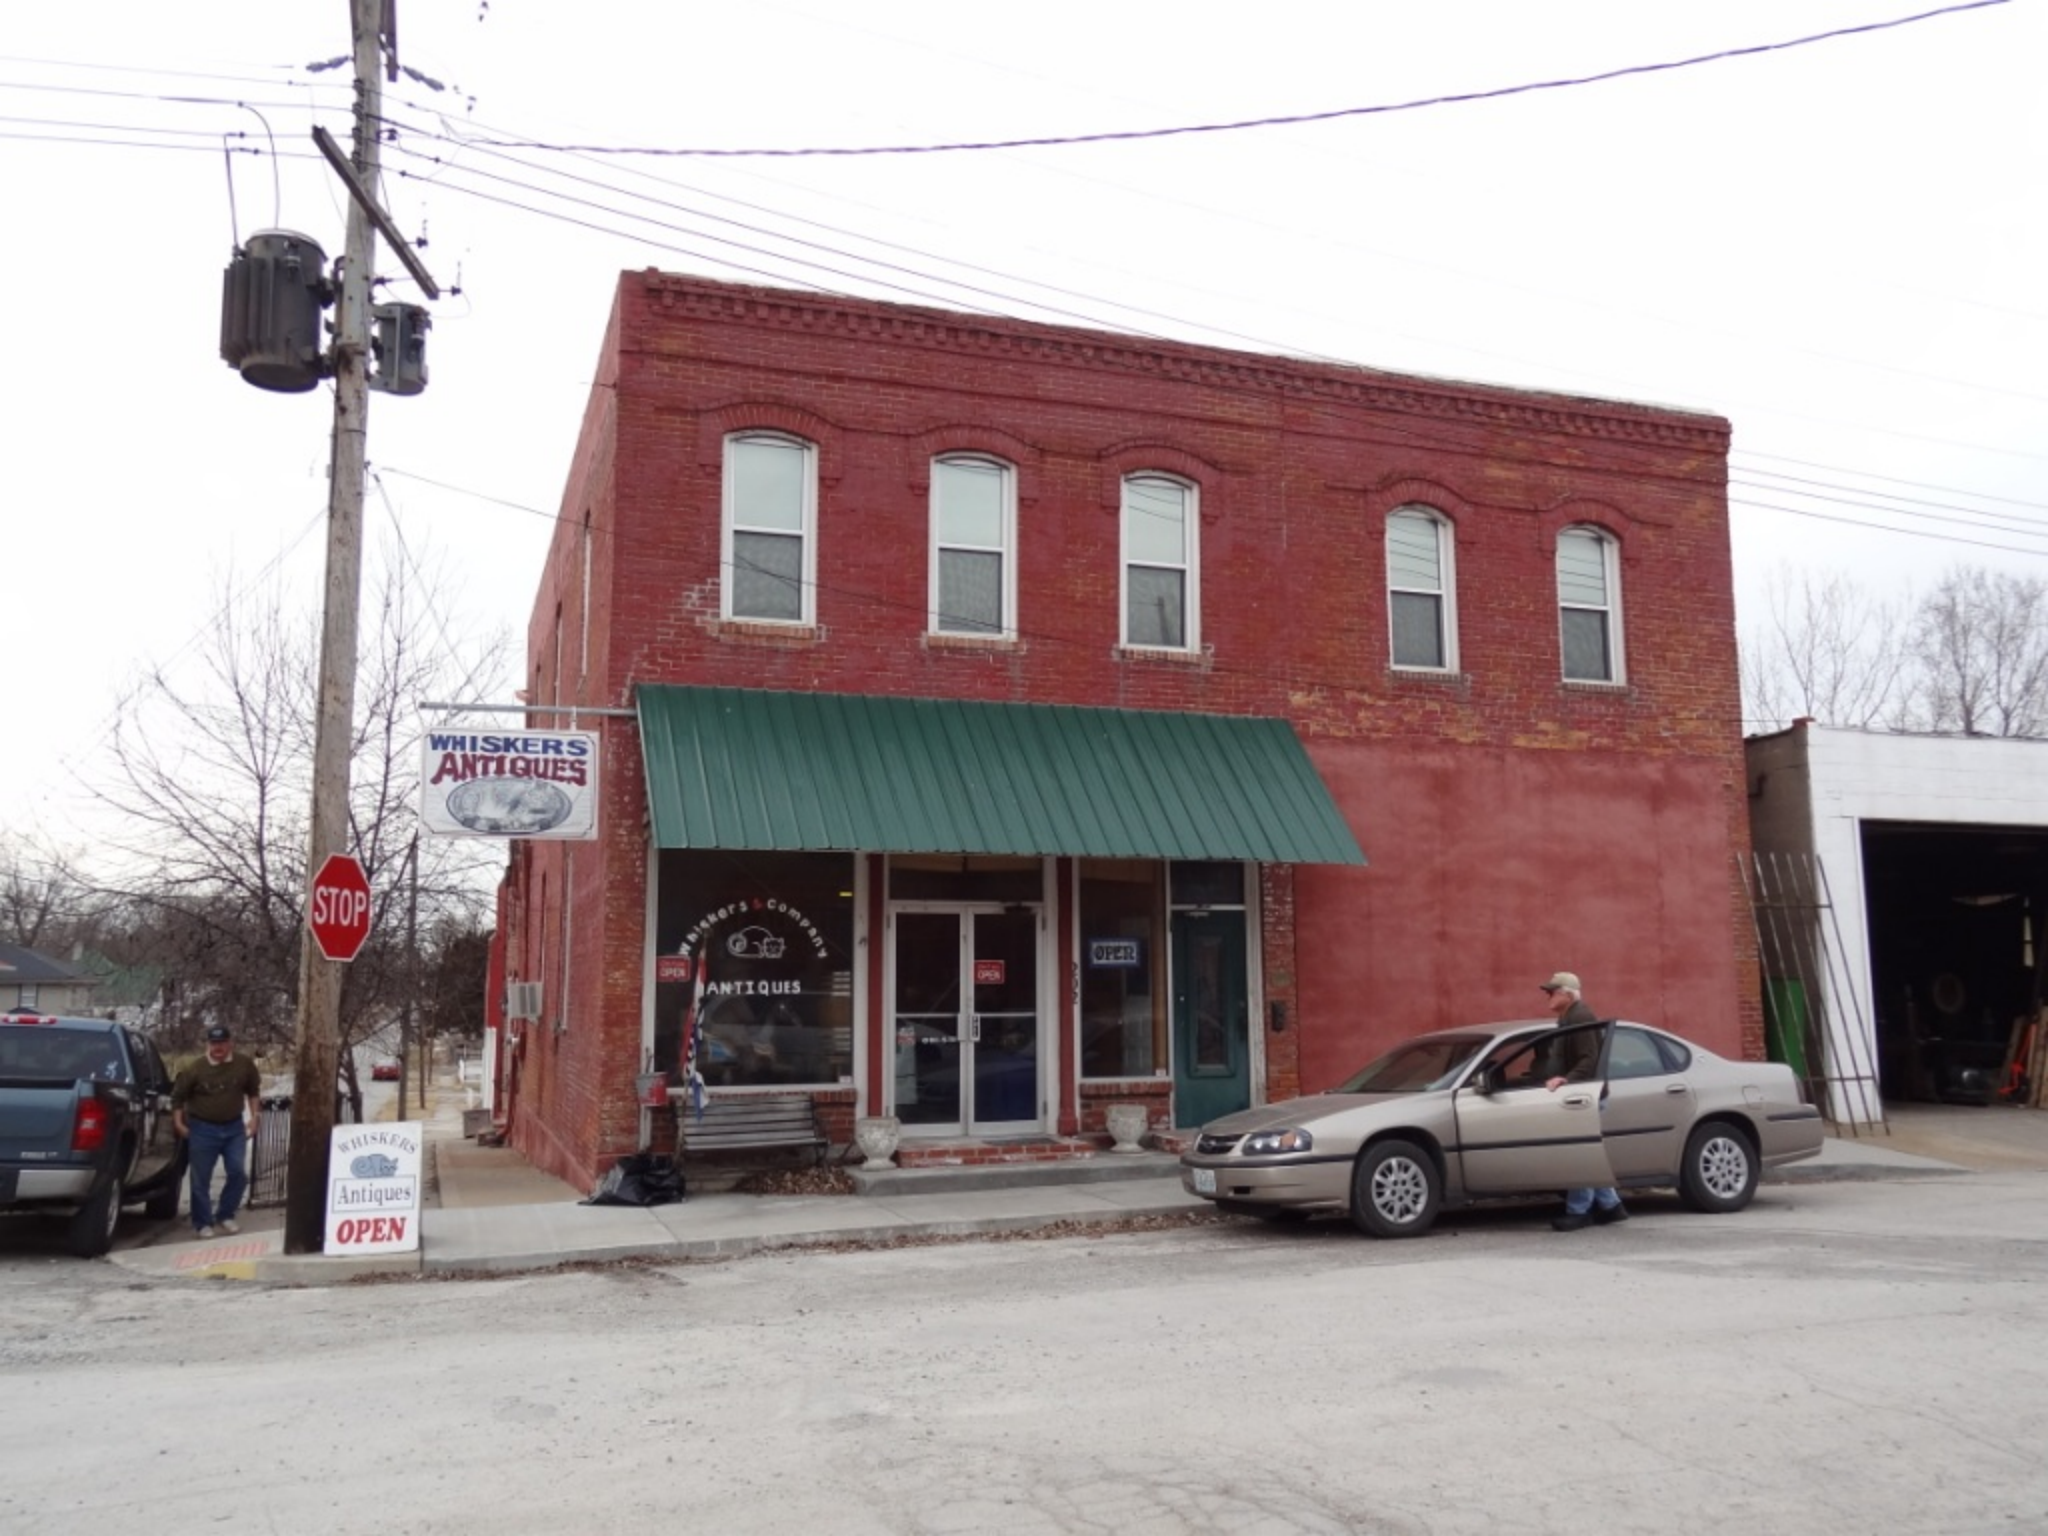
Insert photograph of primary structure on property.

23. Category of property: <input checked="" type="checkbox"/> building(s) <input type="checkbox"/> site <input type="checkbox"/> structure <input type="checkbox"/> object	30. Roof material: Unknown	37. Windows: <input type="checkbox"/> historic <input checked="" type="checkbox"/> replacement Pane arrangement: Fixed single pane

26. Plan shape: Rectangular	33. Exterior wall cladding: Brick	
27. No. of stories: 2	34. Foundation material: Concrete	
28. No. of bays (1 st floor): 5	35. Basement type: Unknown	40. No. of outbuildings (describe in box 40 cont.):

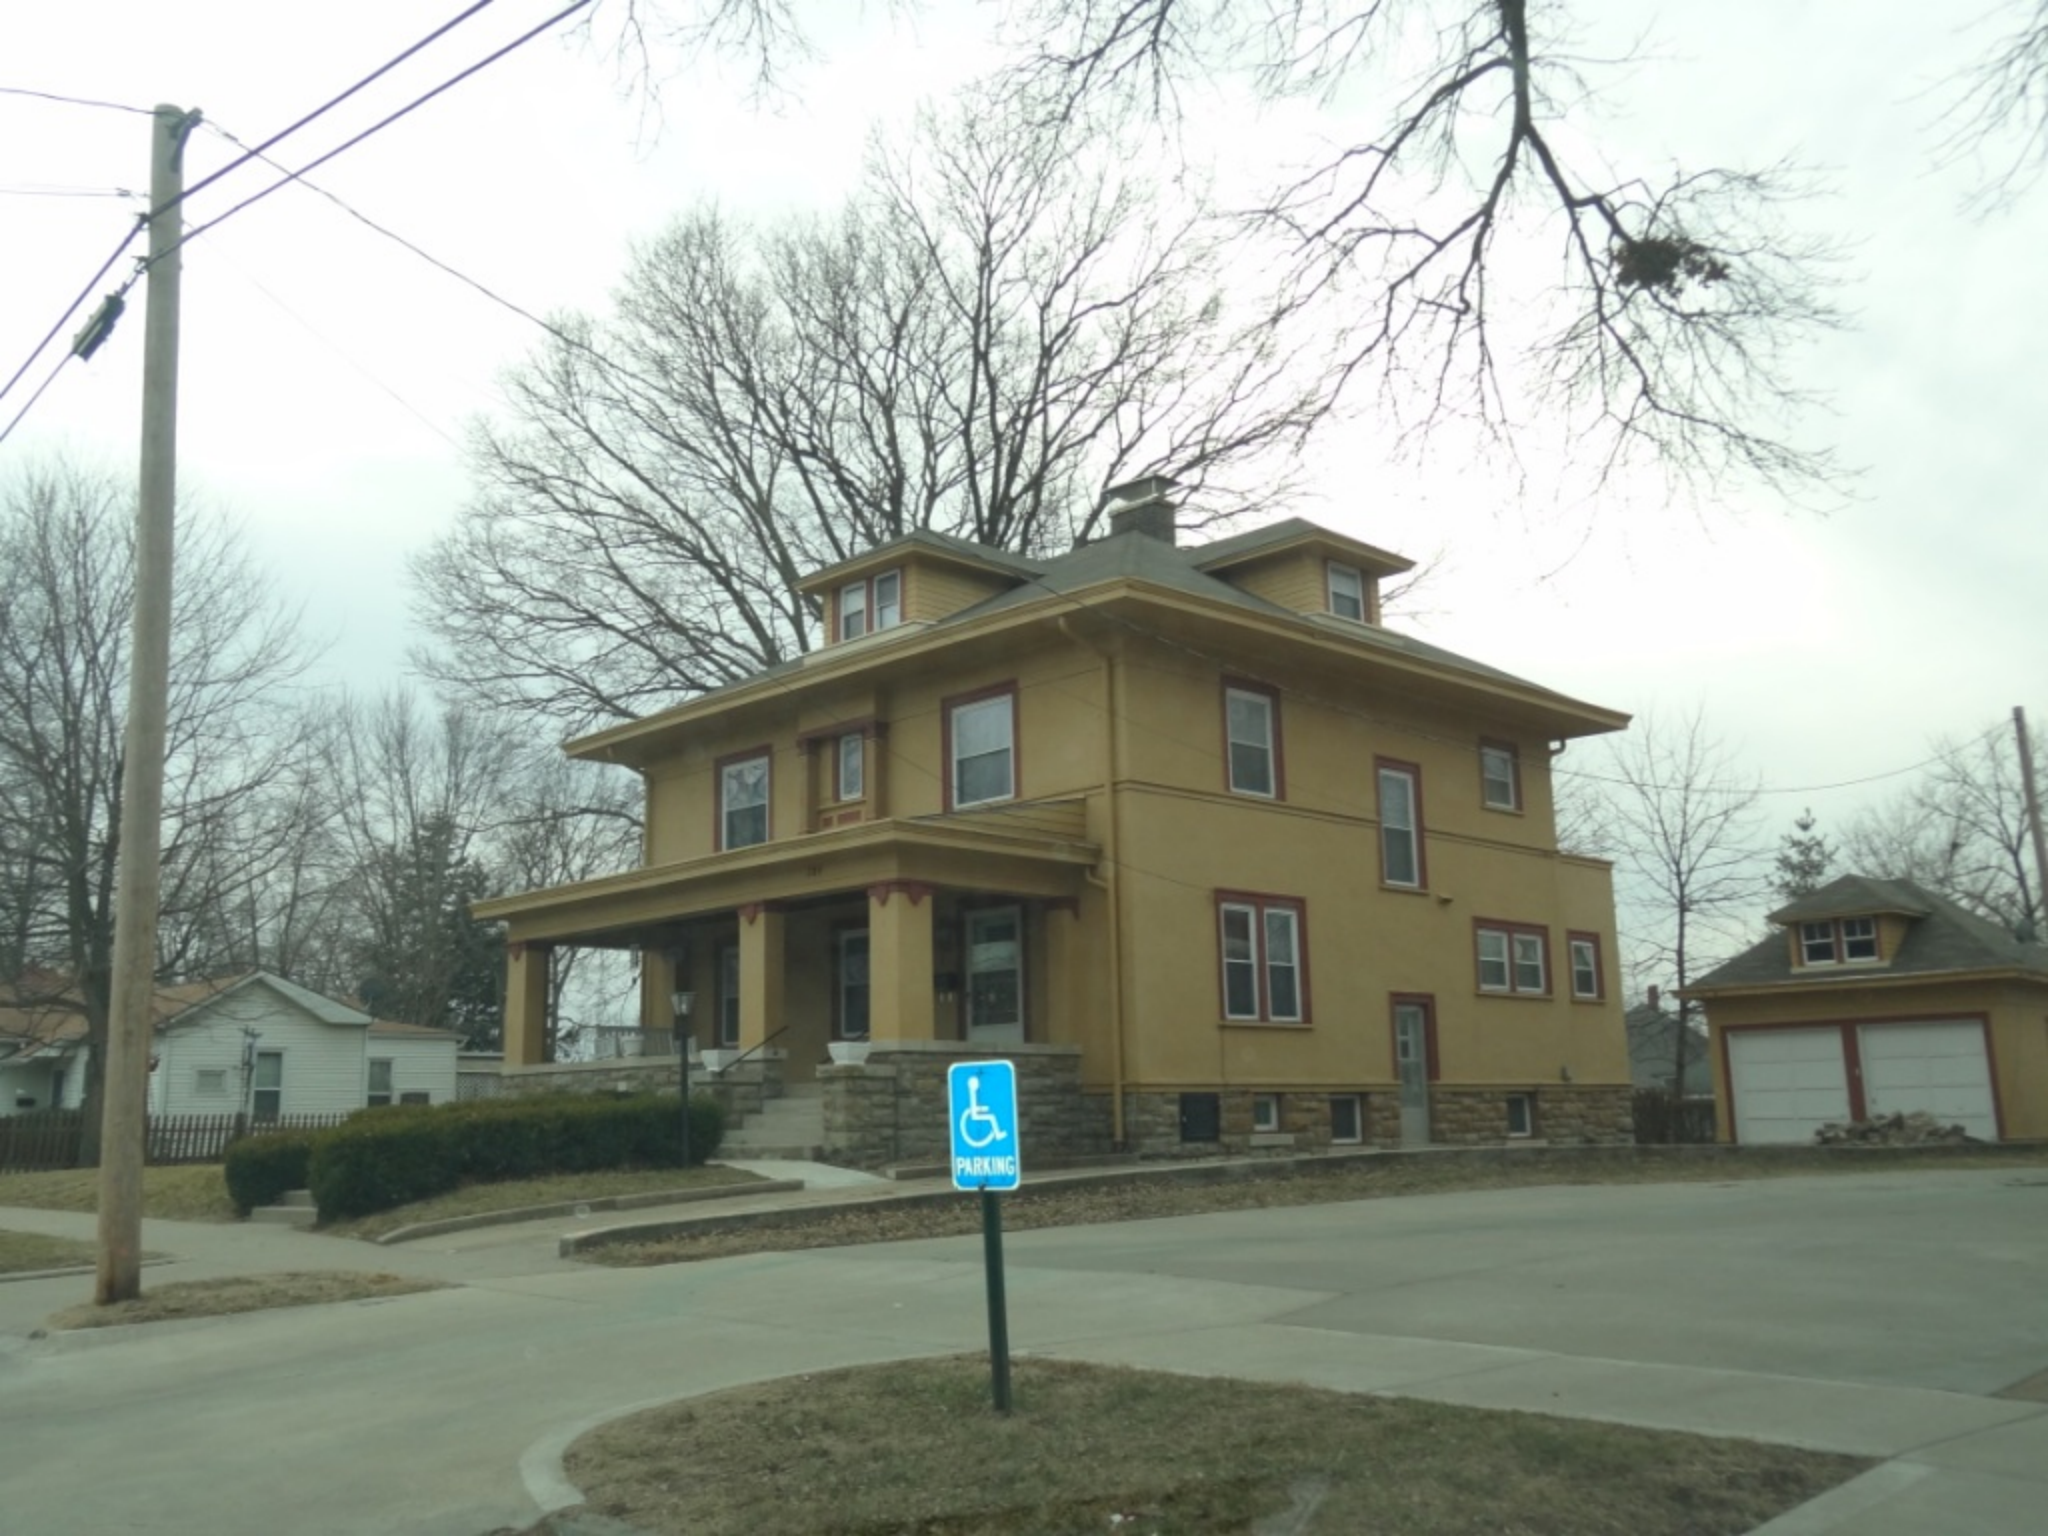
Insert photograph of primary structure on property.

This large American Foursquare house has Prairie style-influenced detailing, indicated by the wide eaves, broad porch with very low-pitch shed roof and broad entablature, and the horizontal decorative detailing separating the first floor from the second story windows. The house has a slightly raised basement and stone foundation. It is topped by a hipped roof with hipped roof dormers on three (possibly four) sides. The walls are stuccoed. The entrance on the three bay façade is offset to the north with two 1/1 windows to the south. The second floor has a slightly projecting window surround flanked by thick engaged columns. To either side are large 1/1 windows. All windows in the building appear to be replacement vinyl sash.

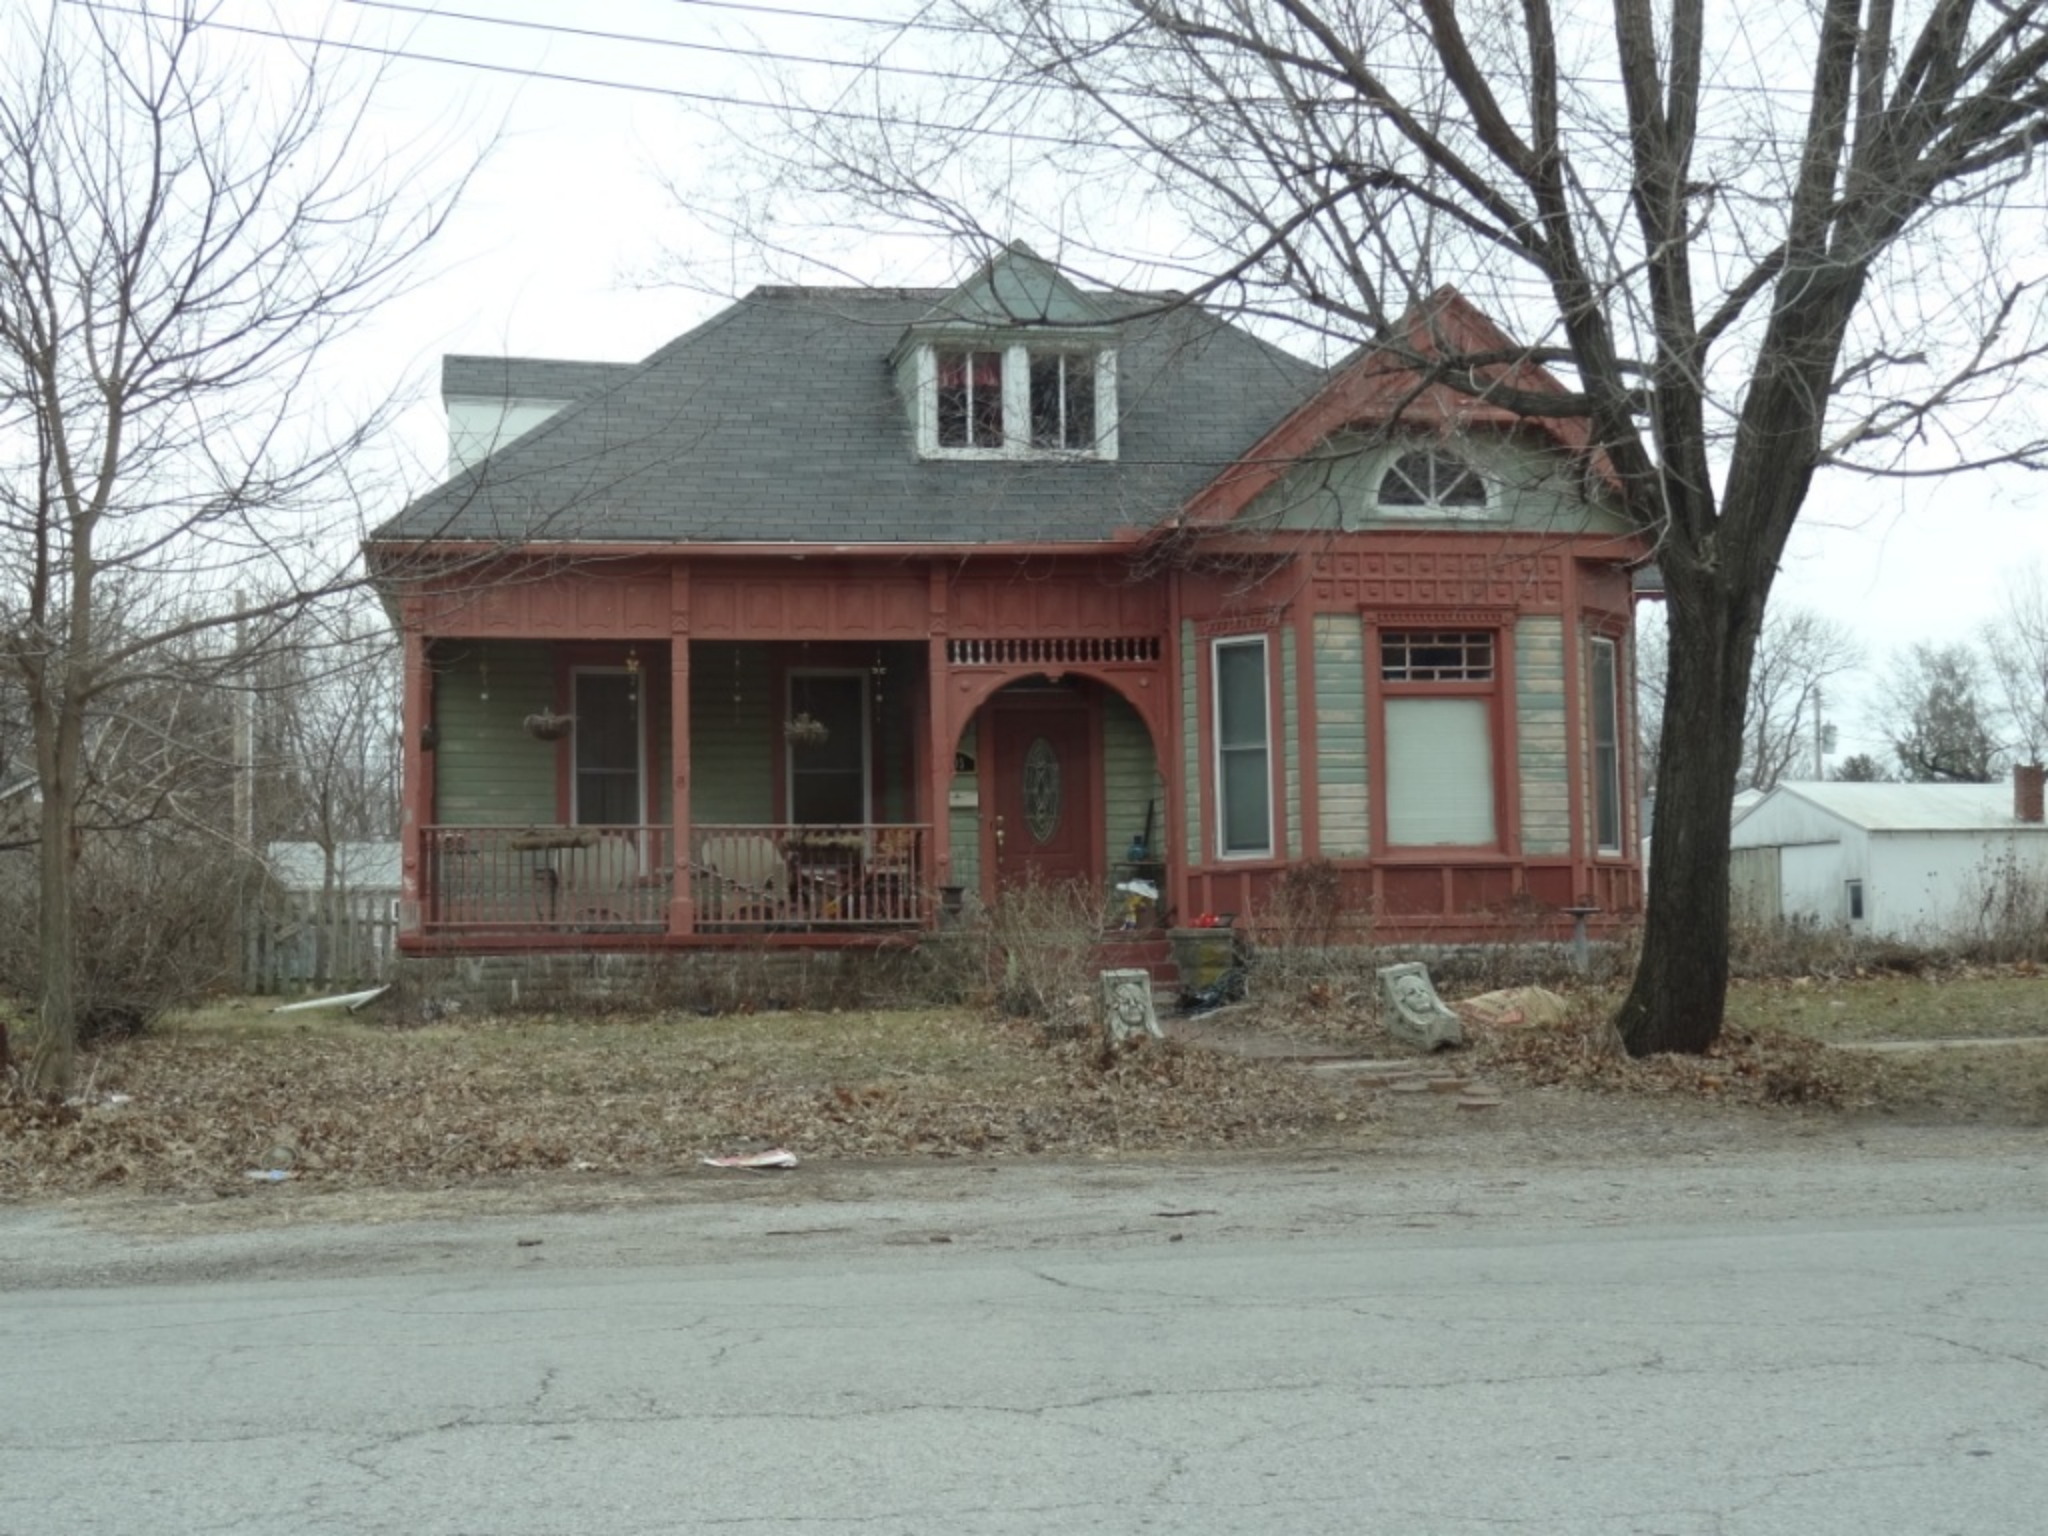
Insert photograph of primary structure on property.

This frame house sits on a foundation of what appears to be rusticated concrete blocks. The roof is hipped with a centered gabled dormer with paired (fixed?) windows. A projecting cross gable with canted corners is at the south corner of the façade. The front wall of the projection has a Queen Anne style multi-light transom and fixed lower pane. Above this window is a panel consisting of framed squares with small central squared modillions. The windows in the canted walls (possibly replacements) are 1/1 sash and are topped by decorative dentiled hoods. The gable end has a half-round fan light window and decorative paneled and carved verge board.

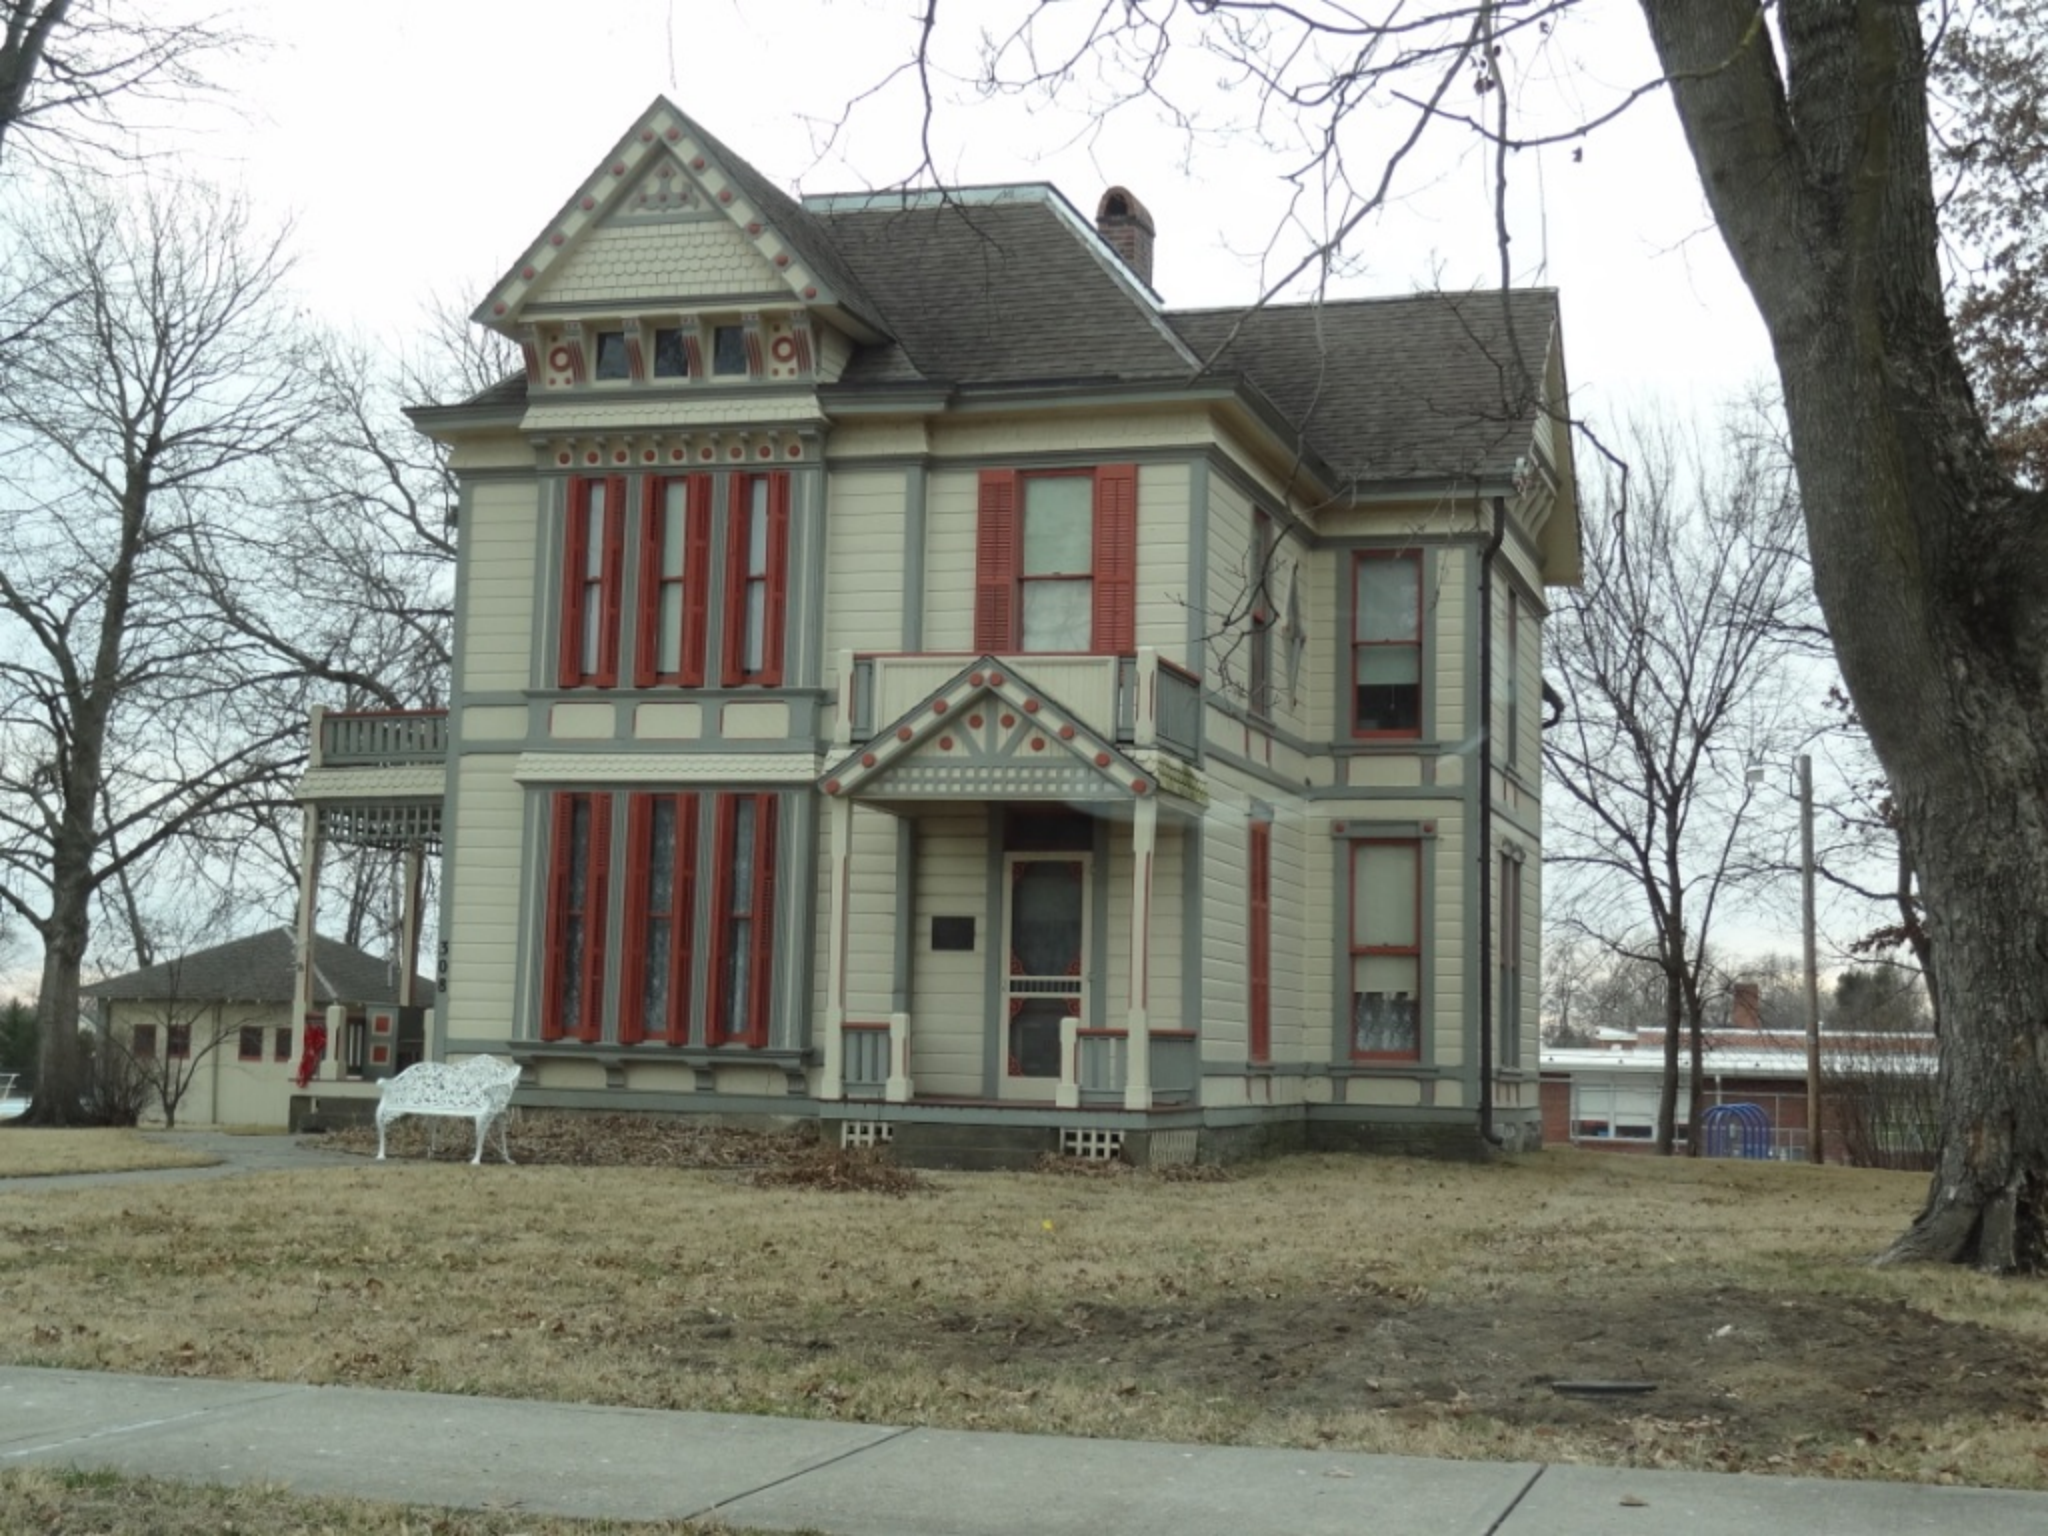
Insert photograph of primary structure on property.

This 2 ½ story frame house has a hipped roof and stone foundation. The main entrance is under a one-bay flat roof porch with decorative gable fronting a small second story balcony. The Gable has Stick style framing with decorative modillions. The porch roof/balcony is supported by simple wood posts with canted corners. To the south is a slightly projecting bay with three tall narrow windows on the first and second floors. Between the window is a simple paneled detail, a detail that extends across the façade and sides of the house. Above the windows is a decorative cornice. Topping the projection is a large dormer with brackets supporting the slightly projecting gable roof. Between the brackets are three fixed pane windows. The gable end has imbricated shingles with an applied decorative feature in the peak. The verge boards are also decorative with evenly spaced modillions. A secondary front entrance is located on the south, recessed, corner of the house. The entrance also has a porch with flat roof and second story balcony. The balcony has a "skirt" of imbricated shingles and simple balustrade.

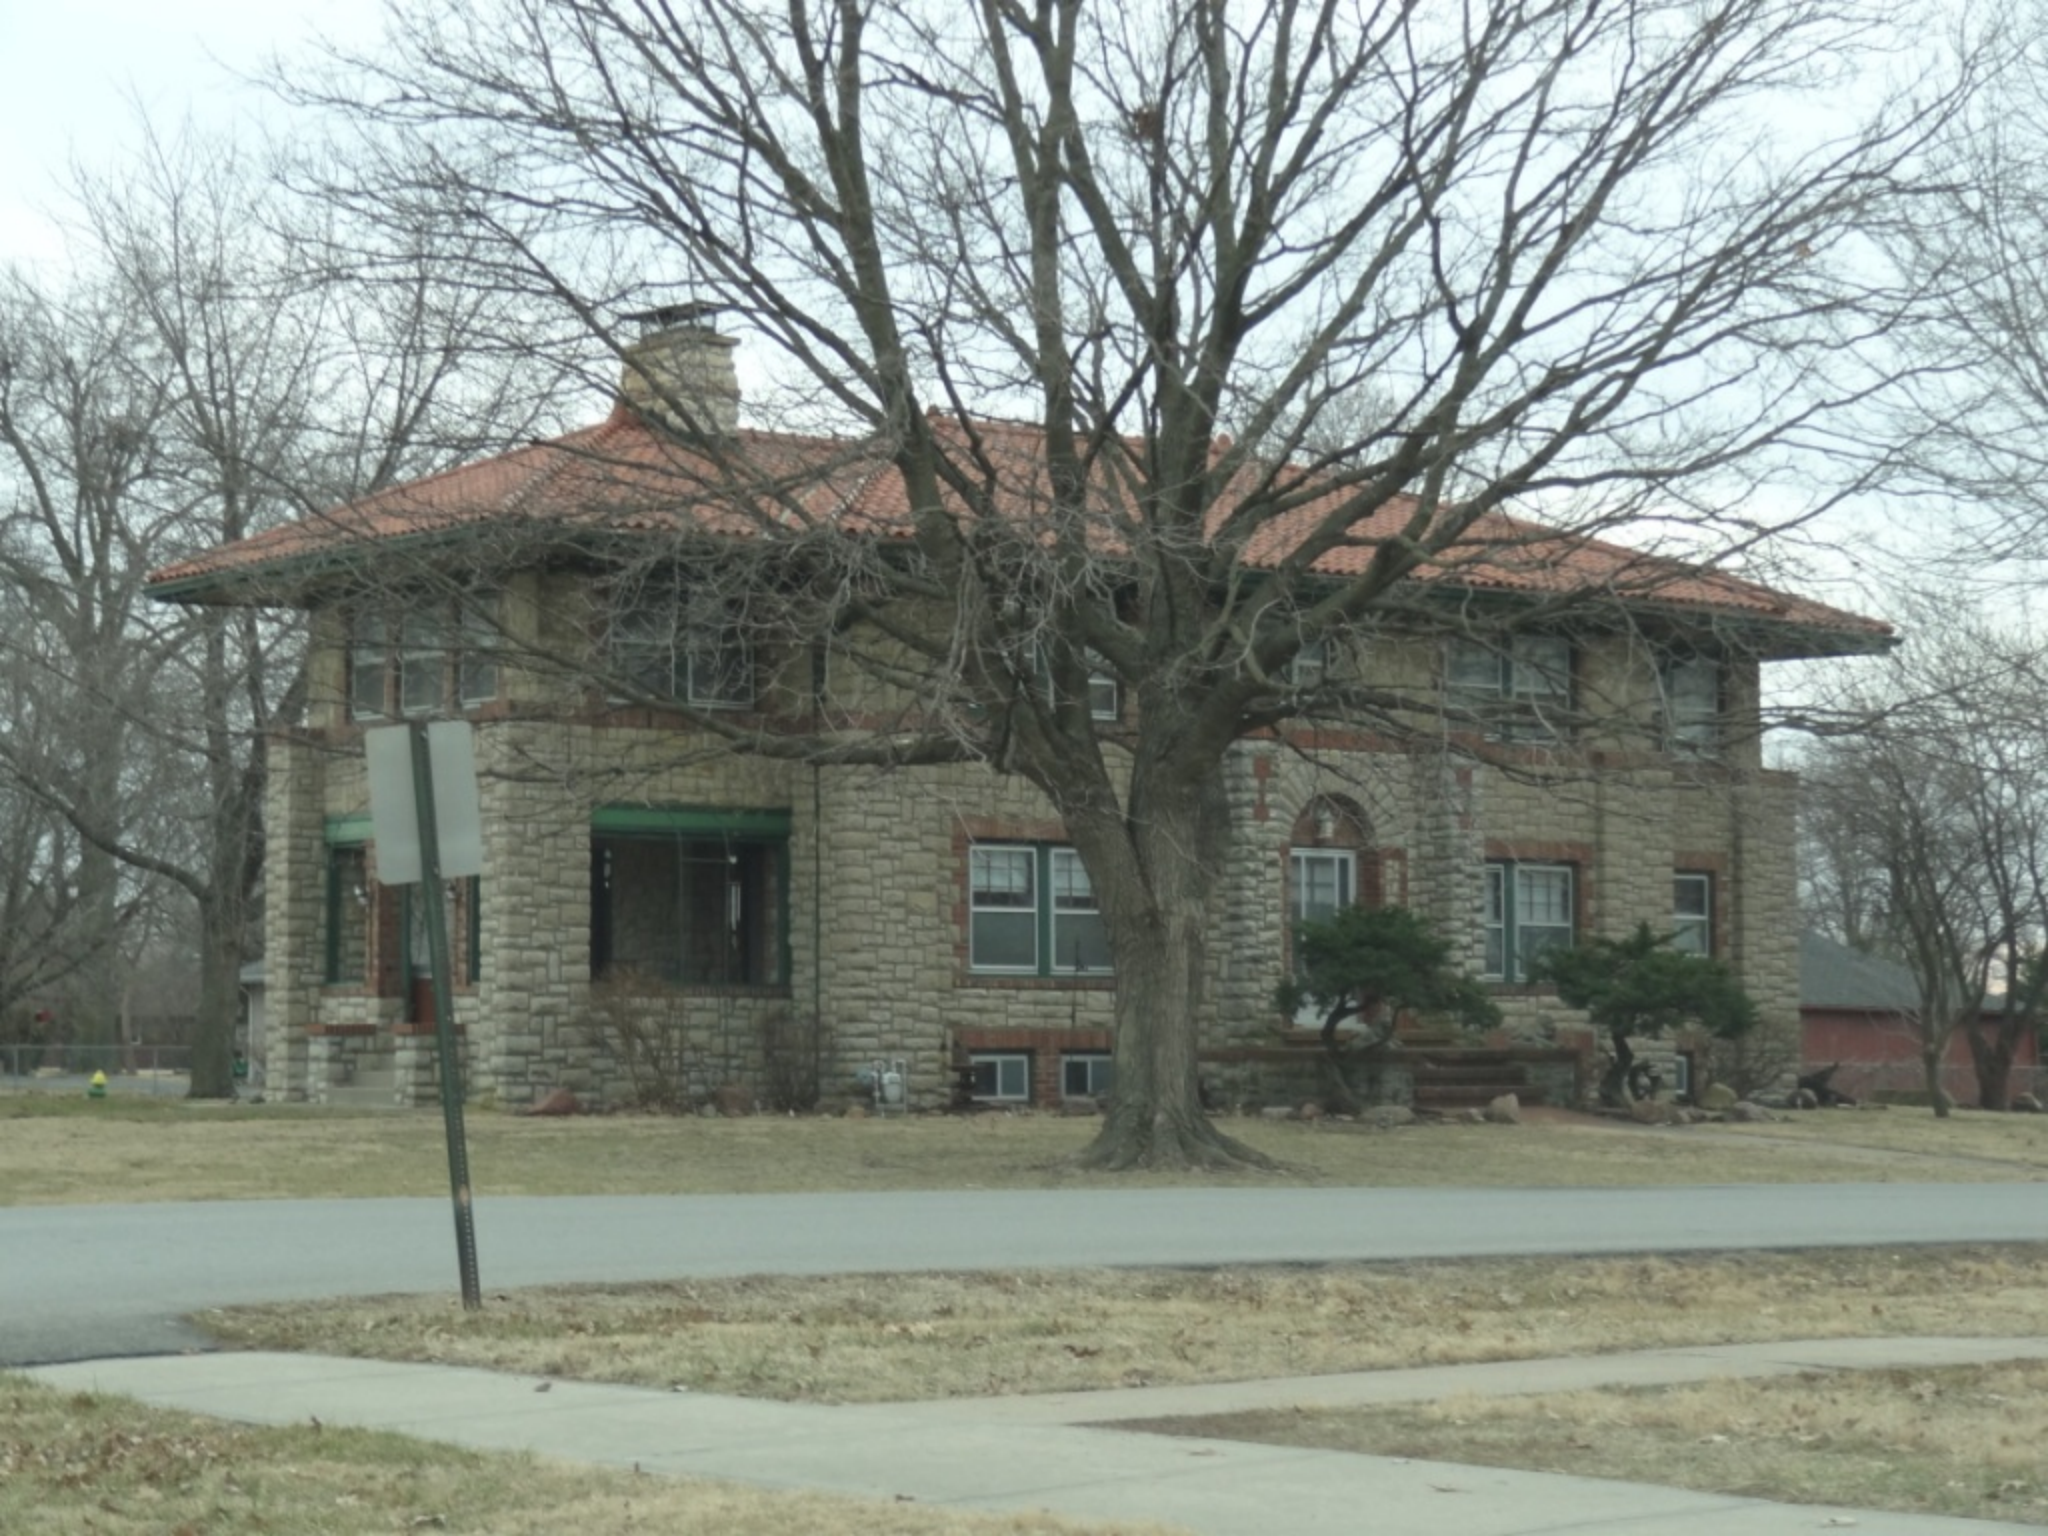
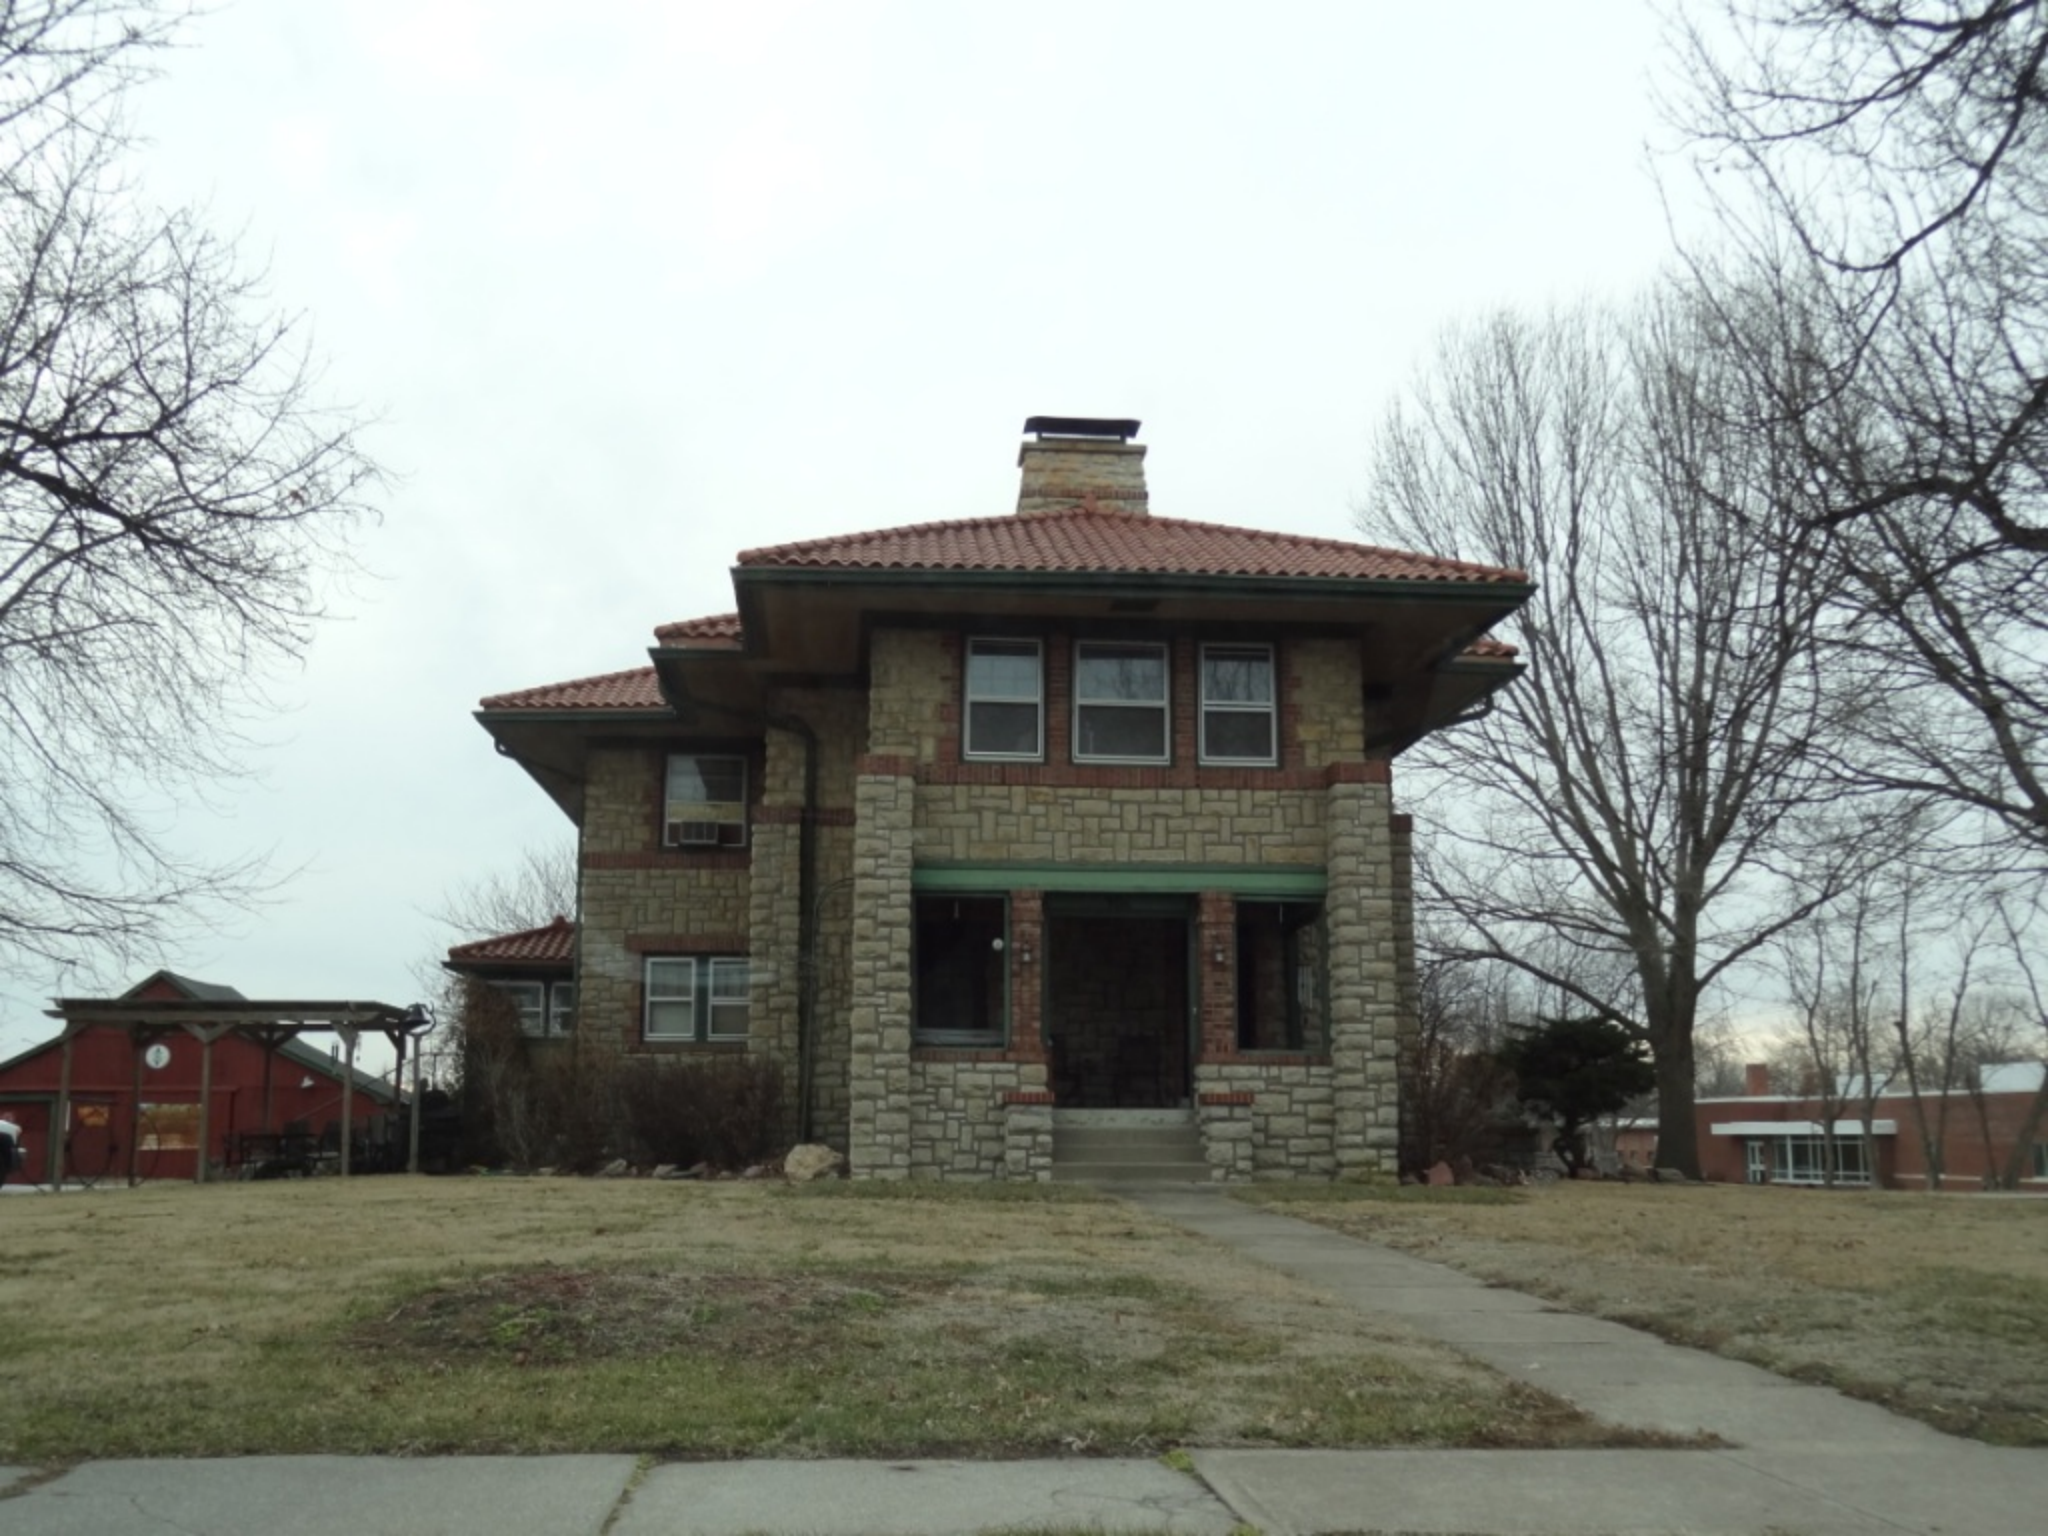
2

The house sits on a large lot and, despite the Birch St. address, faces onto Frost Street. At the southwest corner of the lot is a small Midwestern Three Portal type barn (see photo 2). The barn has a broad front facing gable roof, is of frame construction, and is clad in vertical wood (?) siding. There may be additional outbuildings on site that were not noted during windshield survey.
