This was a survey project begun by Missouri's State Historic Preservation Office staff. Due to staff changes and time constraints it was not completed. However, the photographs are of a high quality and there is still a wealth of useful information provided. Thus we are posting the draft survey and report online for research purposes.

MISSOURI DEPARTMENT OF NATURAL RESOURCES
STATE HISTORIC PRESERVATION OFFICE, P.O. Box 176, Jefferson City, MO 65102
ARCHITECTURAL/HISTORIC INVENTORY FORM

1. Survey No. CIAS002-001		2. Survey name: Plattsburg Reconnaissance Survey	
3. County: Clinton		4. Address (Street No.) 202	Street (name) N. 2nd
5. City: Plattsburg	Vicinity: <input type="checkbox"/>	6. UTM: 15/375589/4380573	7. Township/Range/Section: T: 55 N R: 33 W S: 24
8. Historic name (if known): Unknown		9. Present/other name (if known): Whisker's Antiques	
10. Ownership: <input checked="" type="checkbox"/> Private <input type="checkbox"/> Public		11a. Historic use (if known): Commerce/Trade: Specialty Store	11b. Current use: Commerce/ Specialty Store

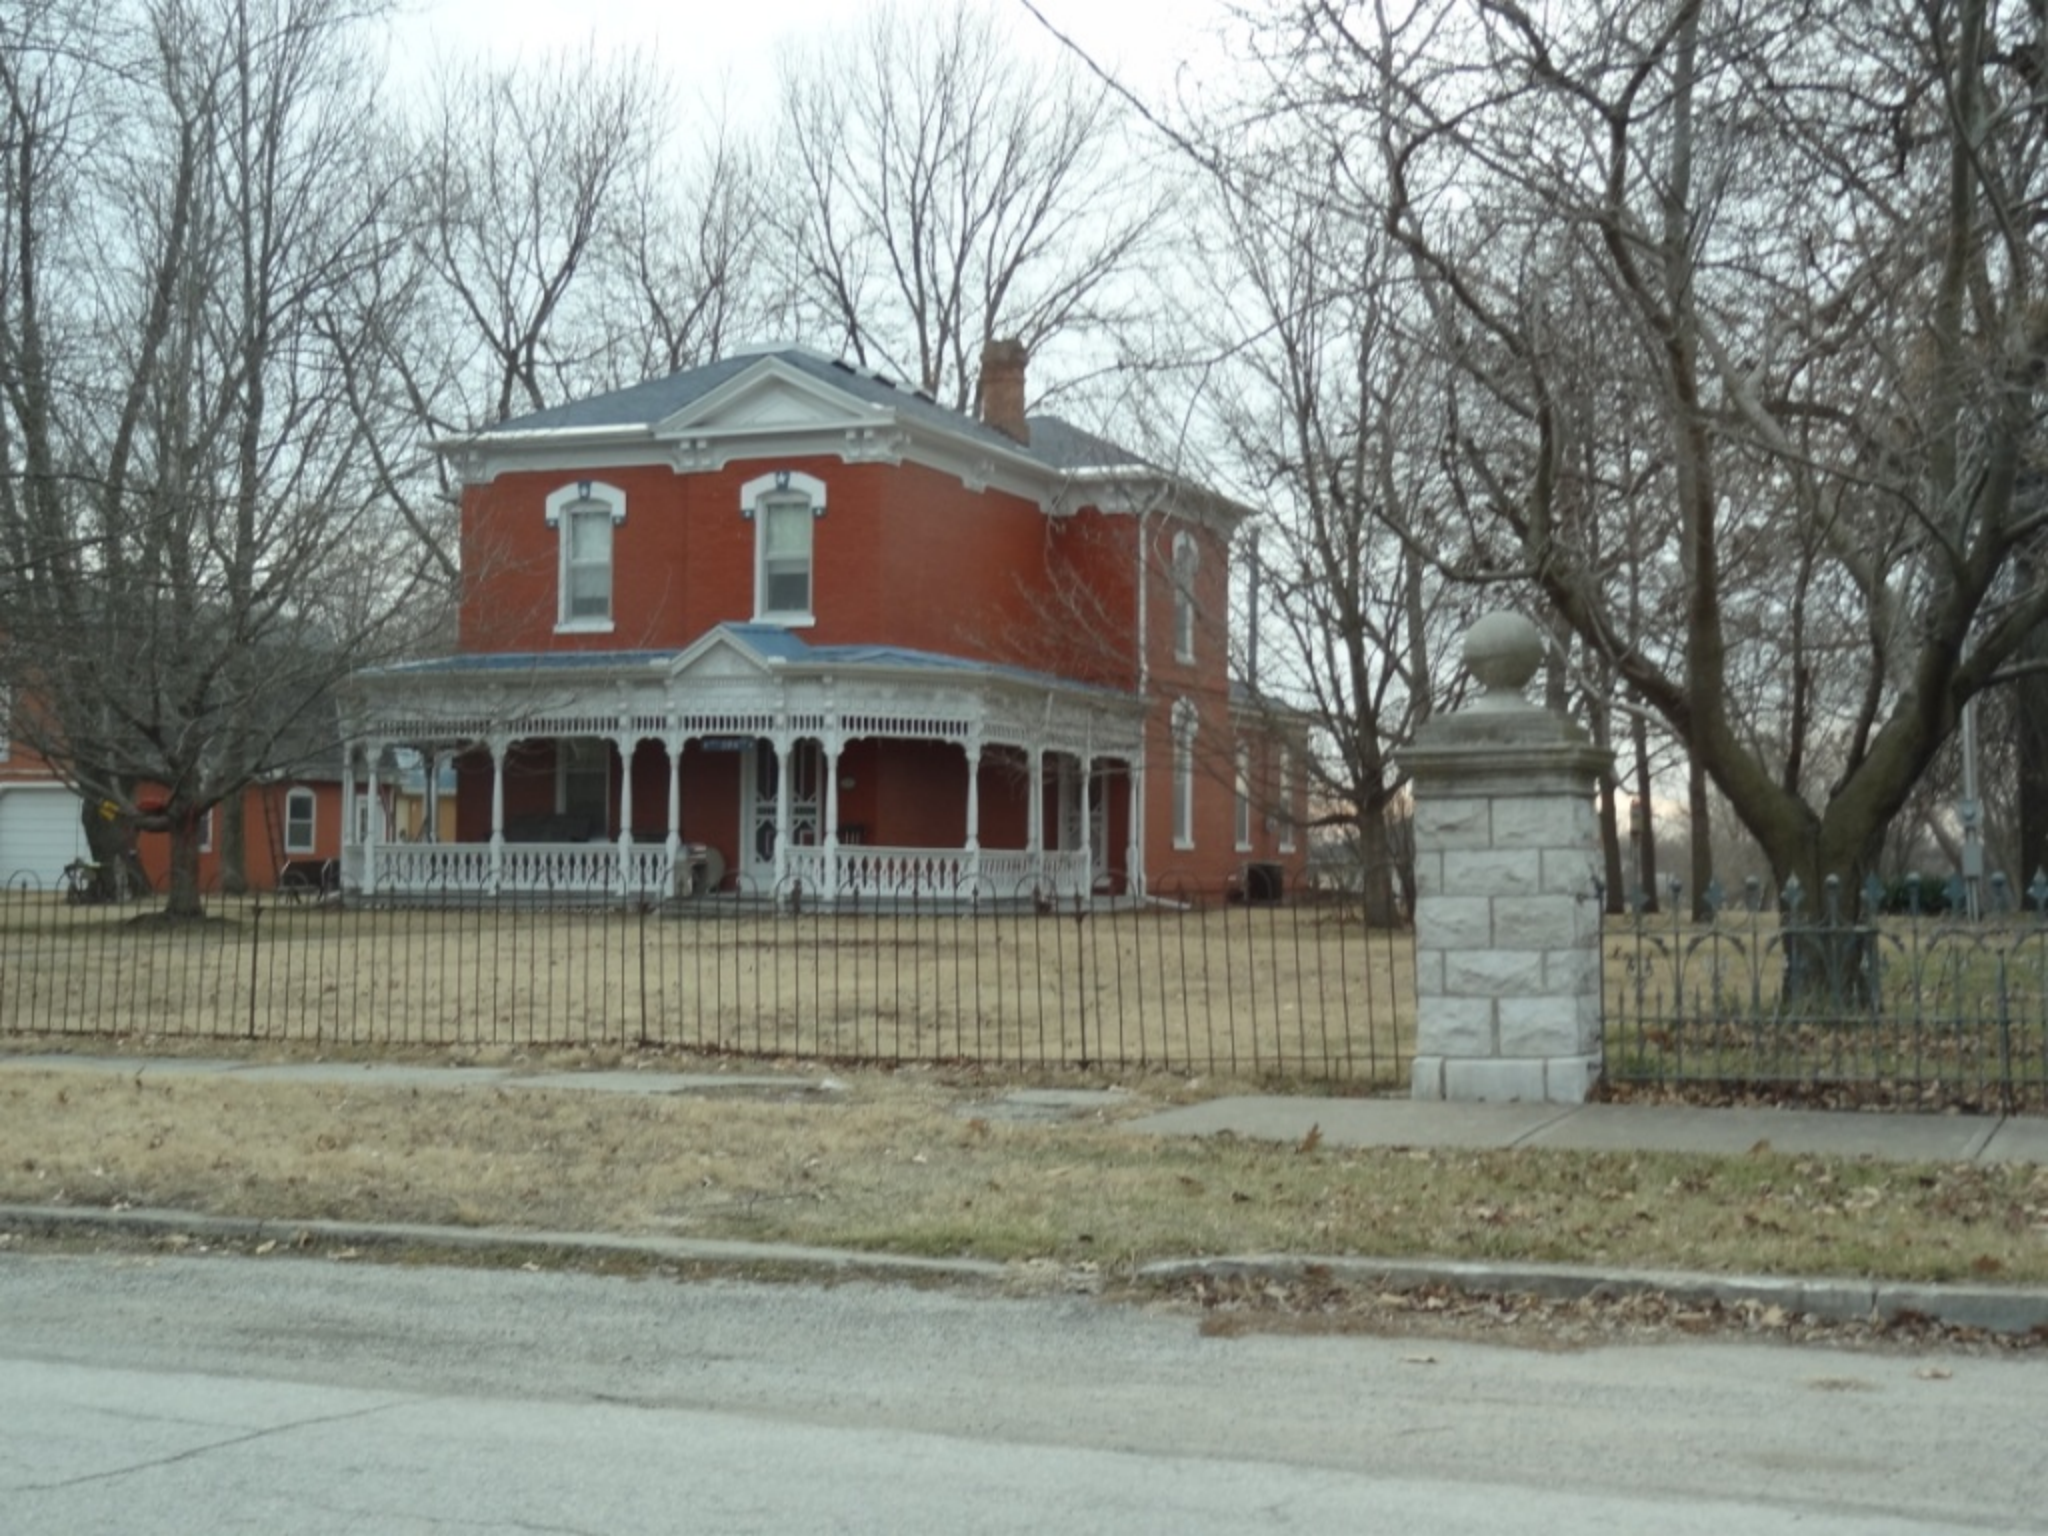
Insert photograph of primary structure on property.

According to the "Walking Tour of Historical Homes," "Built 1838, the oldest home on the tour. The house's exterior was once a rosy brick. The bricks were all hand-made. The walls are 12 inches thick. The porch was added in the 1870's to make it a Victorian. The back was put on in later years. During the Civil War the house served as a doctor's quarters. The doctor serviced both sides so they wouldn't burn his house down."

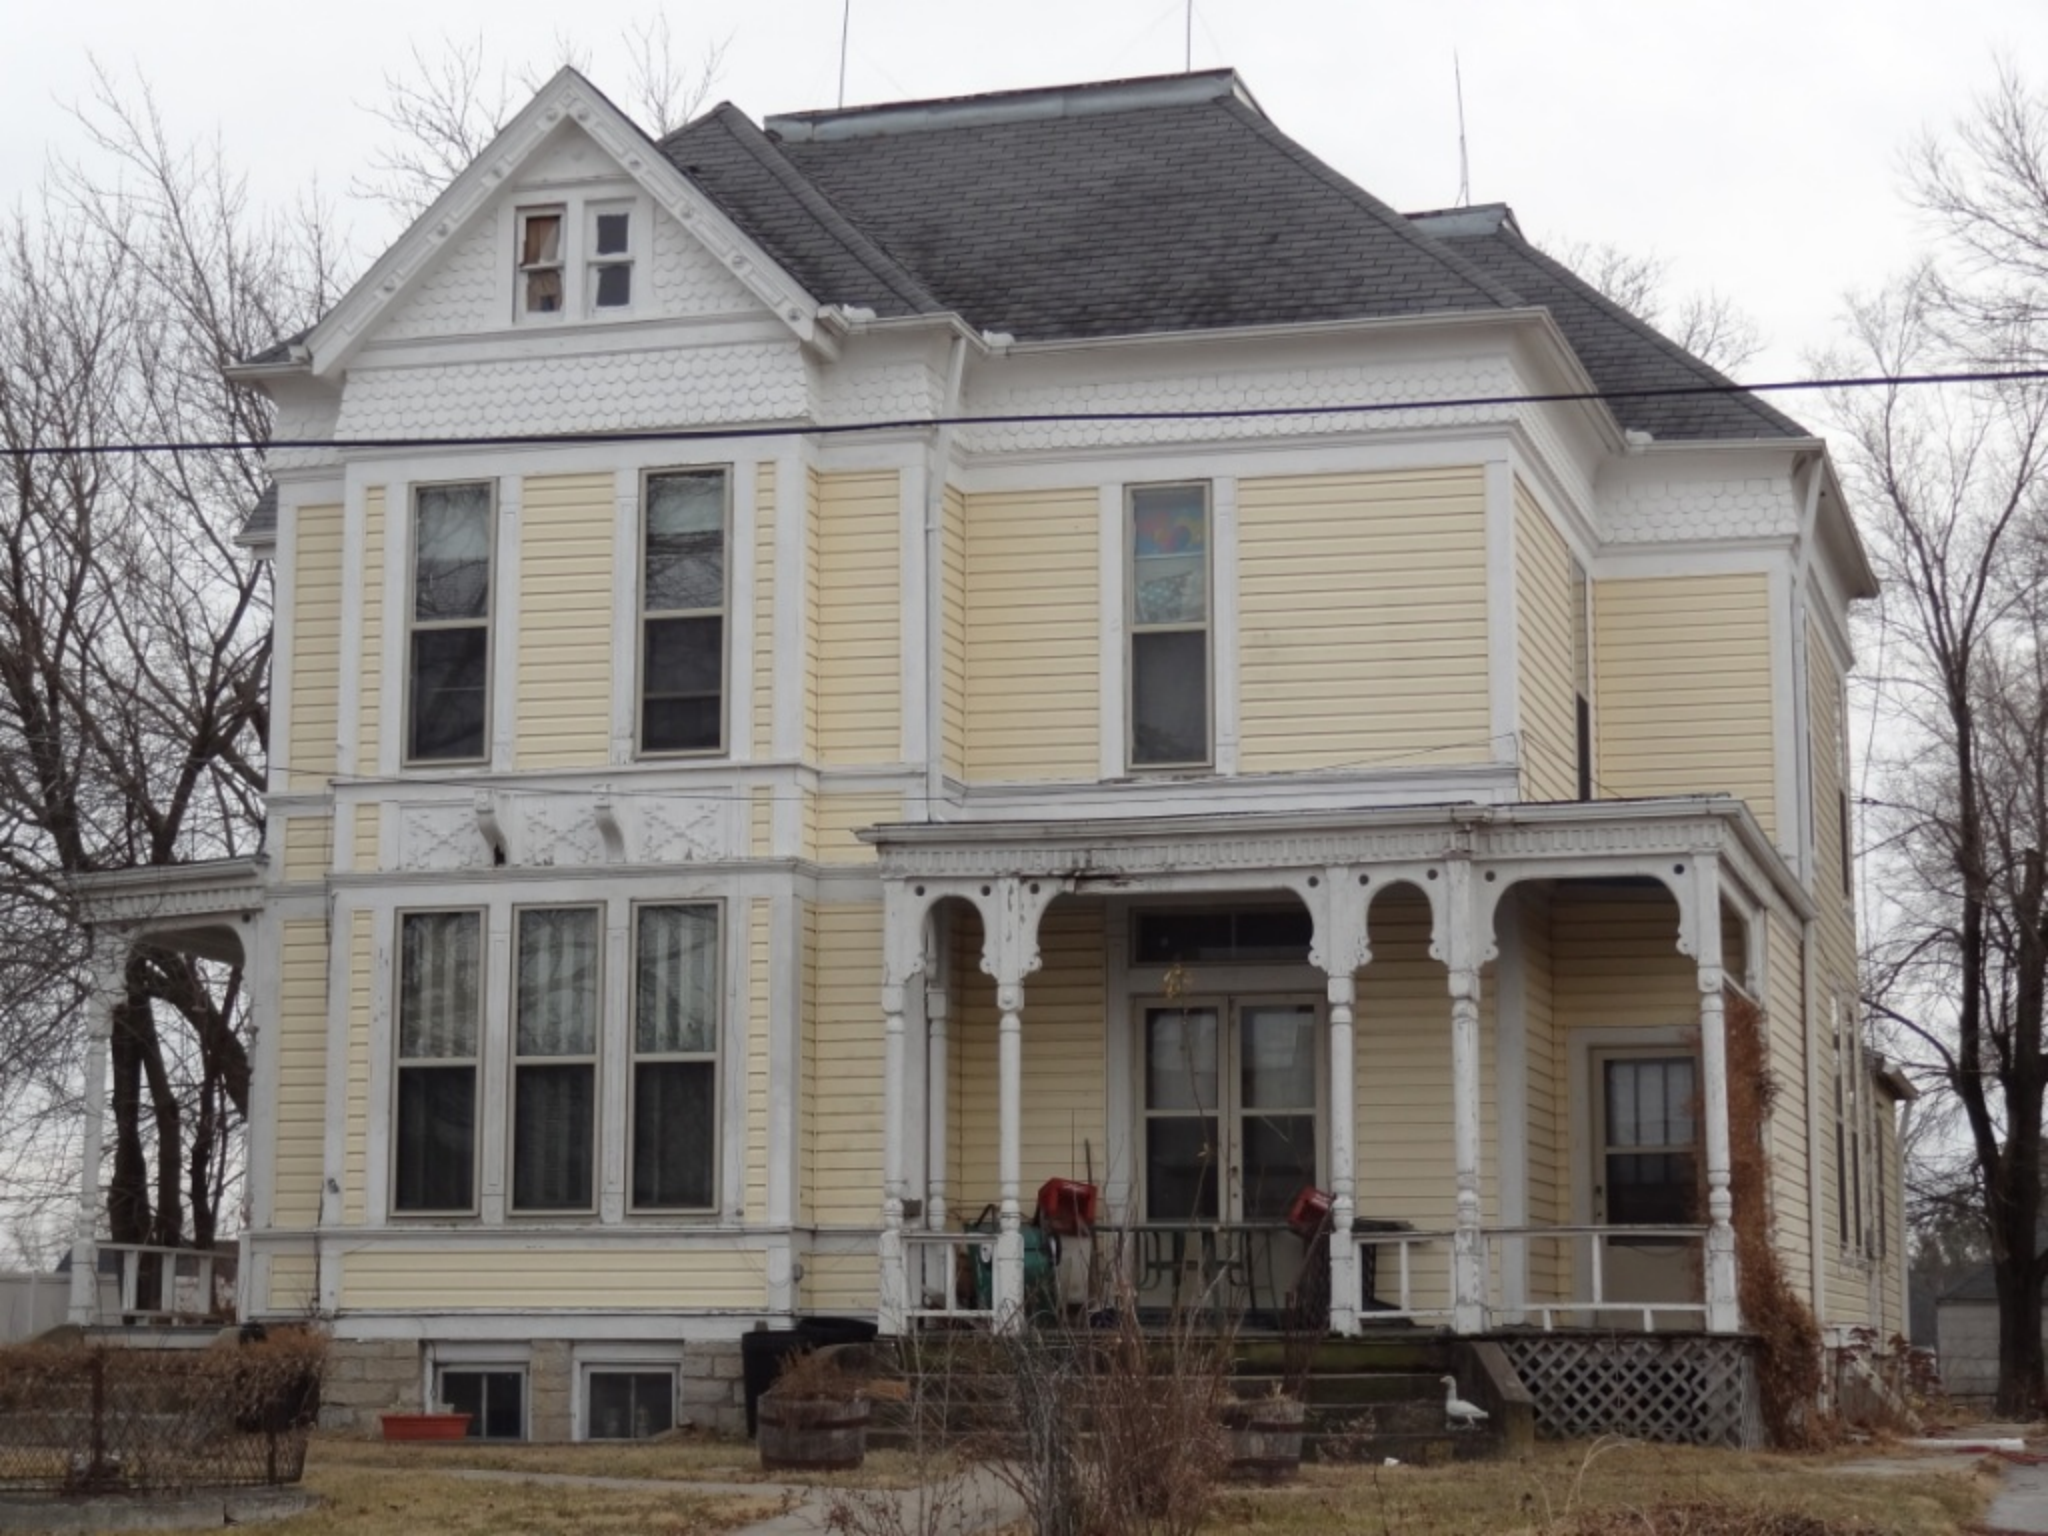
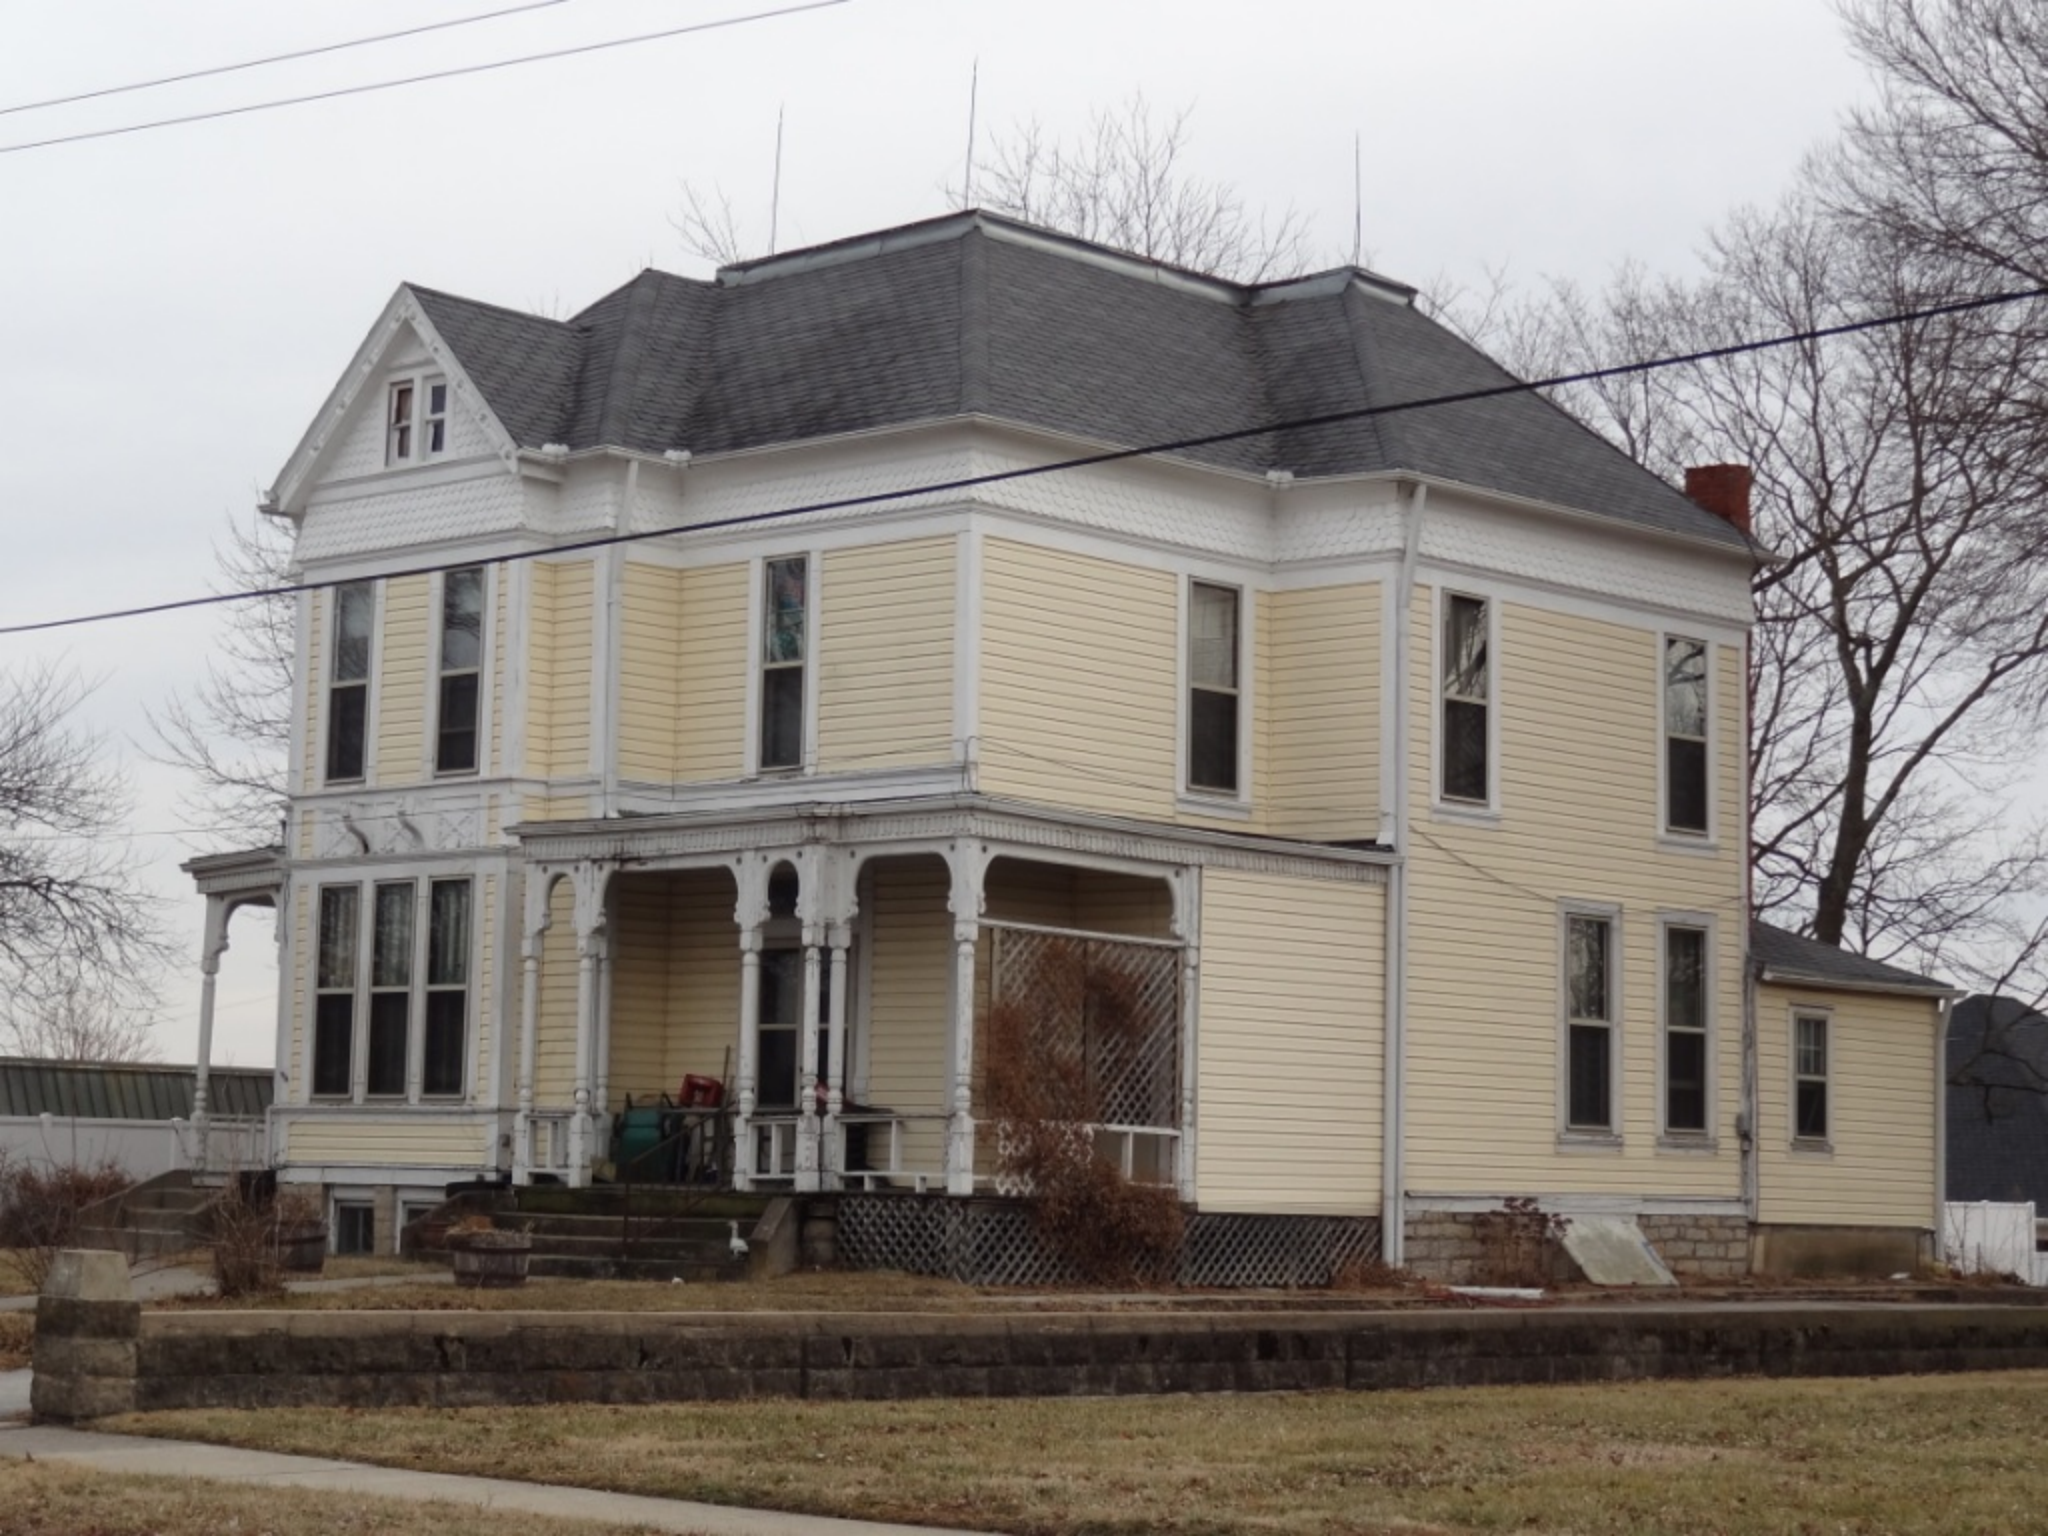
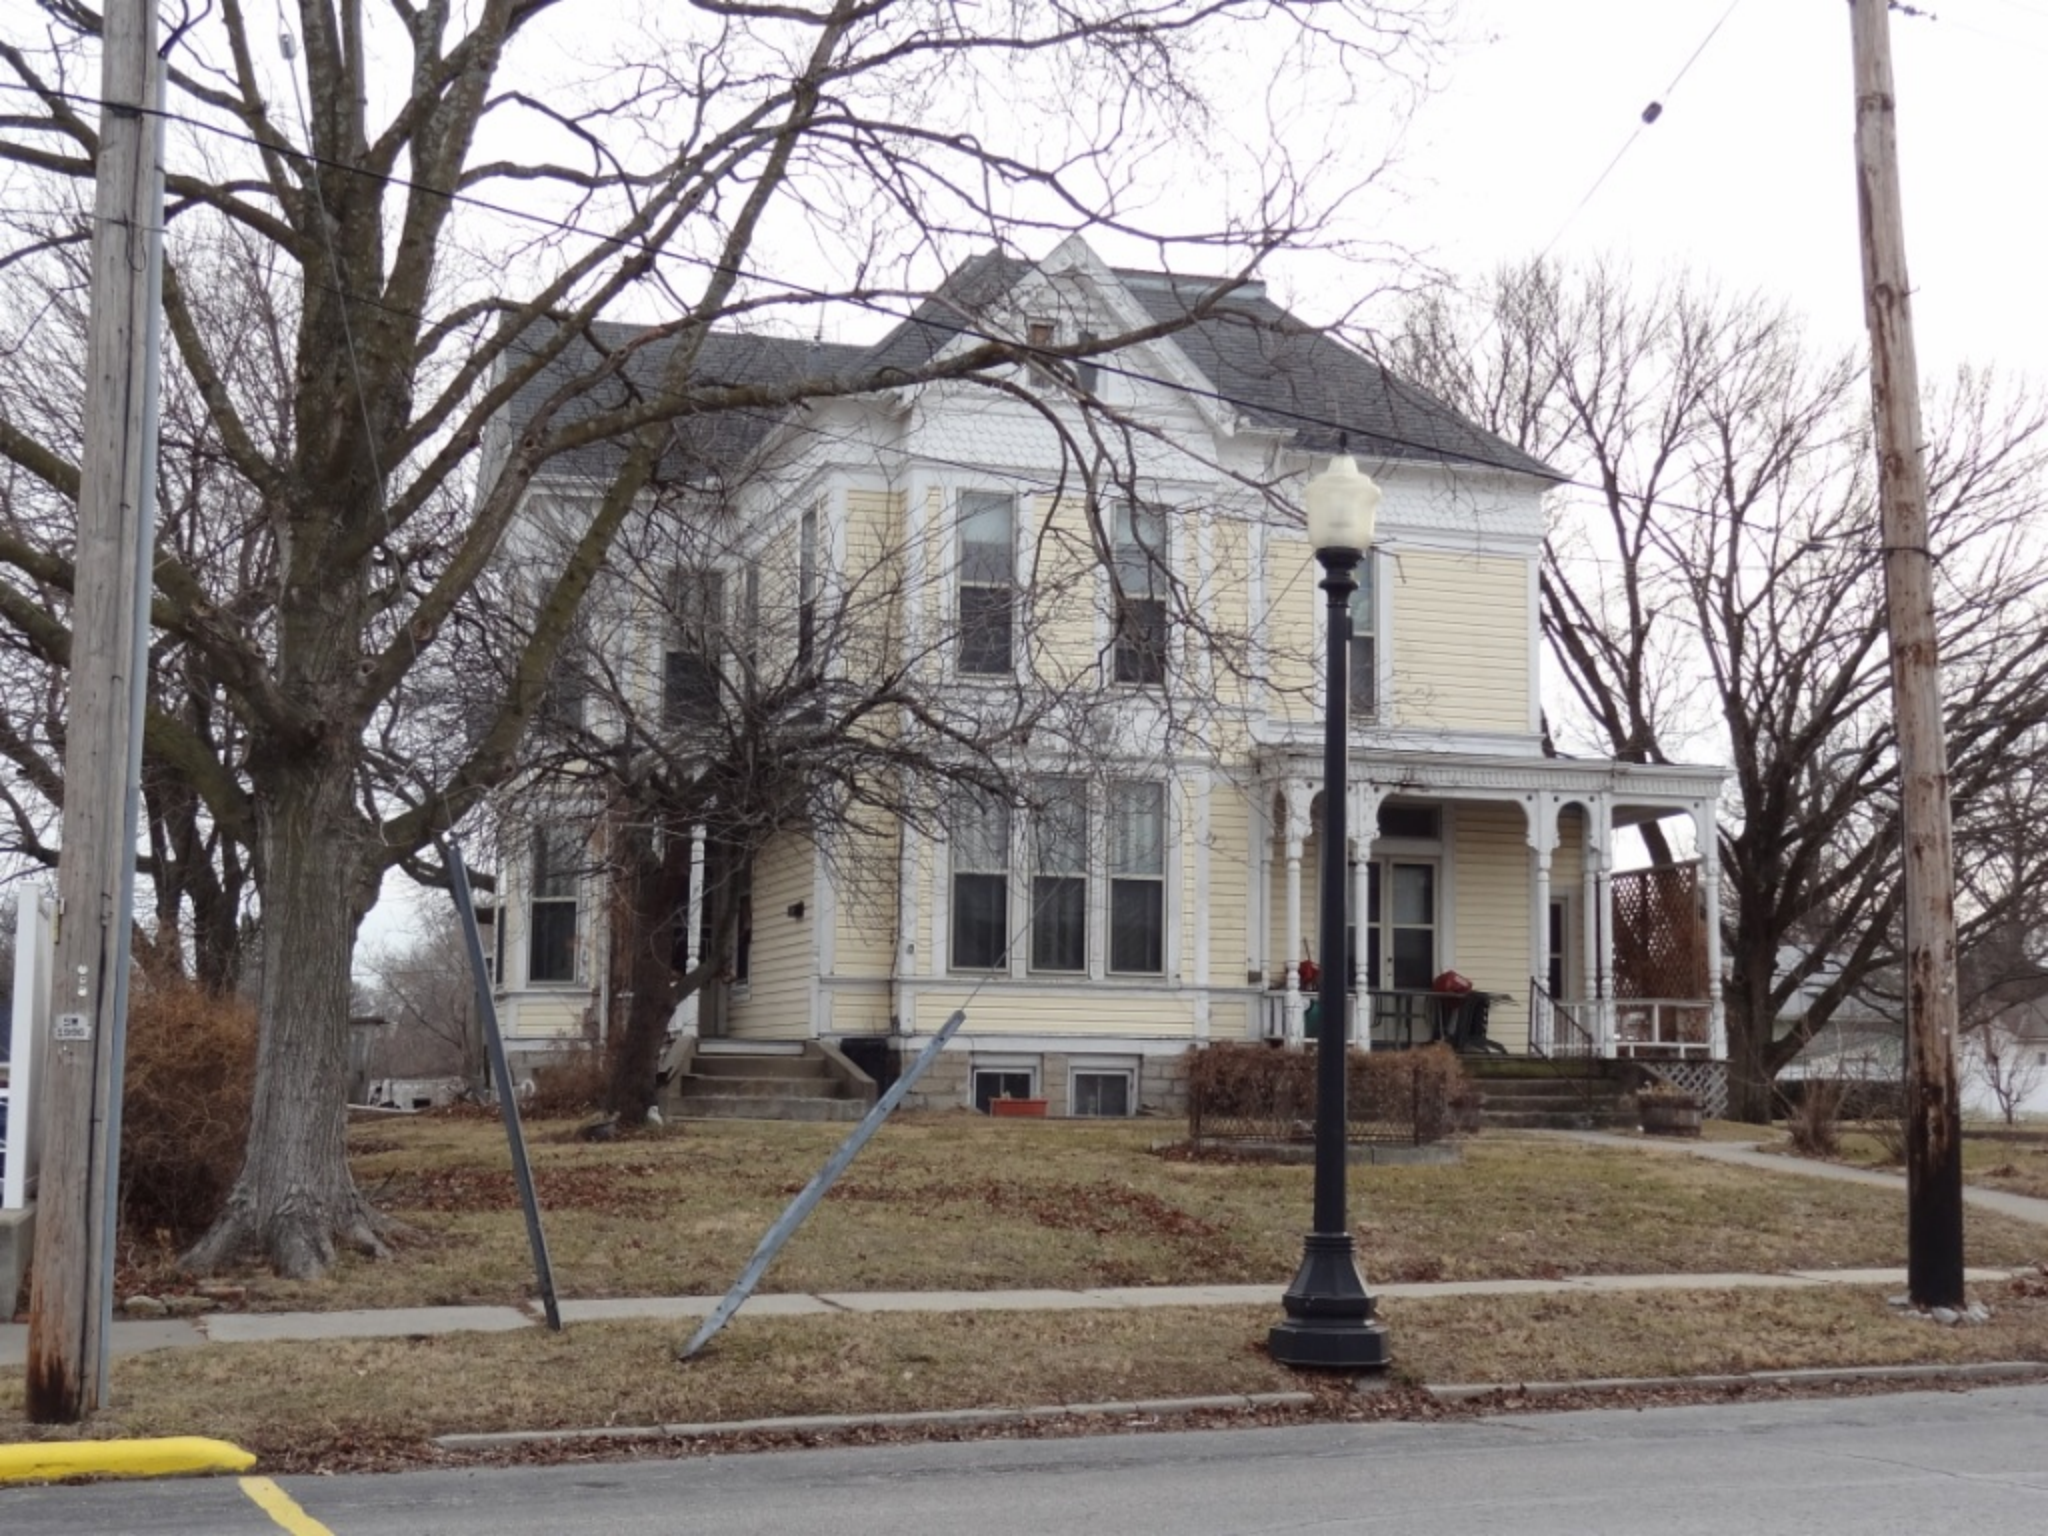
2

Late Victorian house with massing of a Queen Ann, but more sedately detailed. The projecting cross gable is topped by a gabled dormer with imbricated shingles. Between the first and second floors of the cross gable is a decorative wood panel. The porch has turned posts and brackets, indicative of Italianate stylistic influences. Though clad in vinyl, the application was sensitive, leaving most of the decorative details (window surrounds, decorative shingled gable dormer and cornice line, etc.) intact. The 1984 survey photograph shows asbestos siding. The current vinyl siding either replaced or covers the older (non-original) cladding. Historic metal cresting around the roof has also been removed since the 1984 survey.

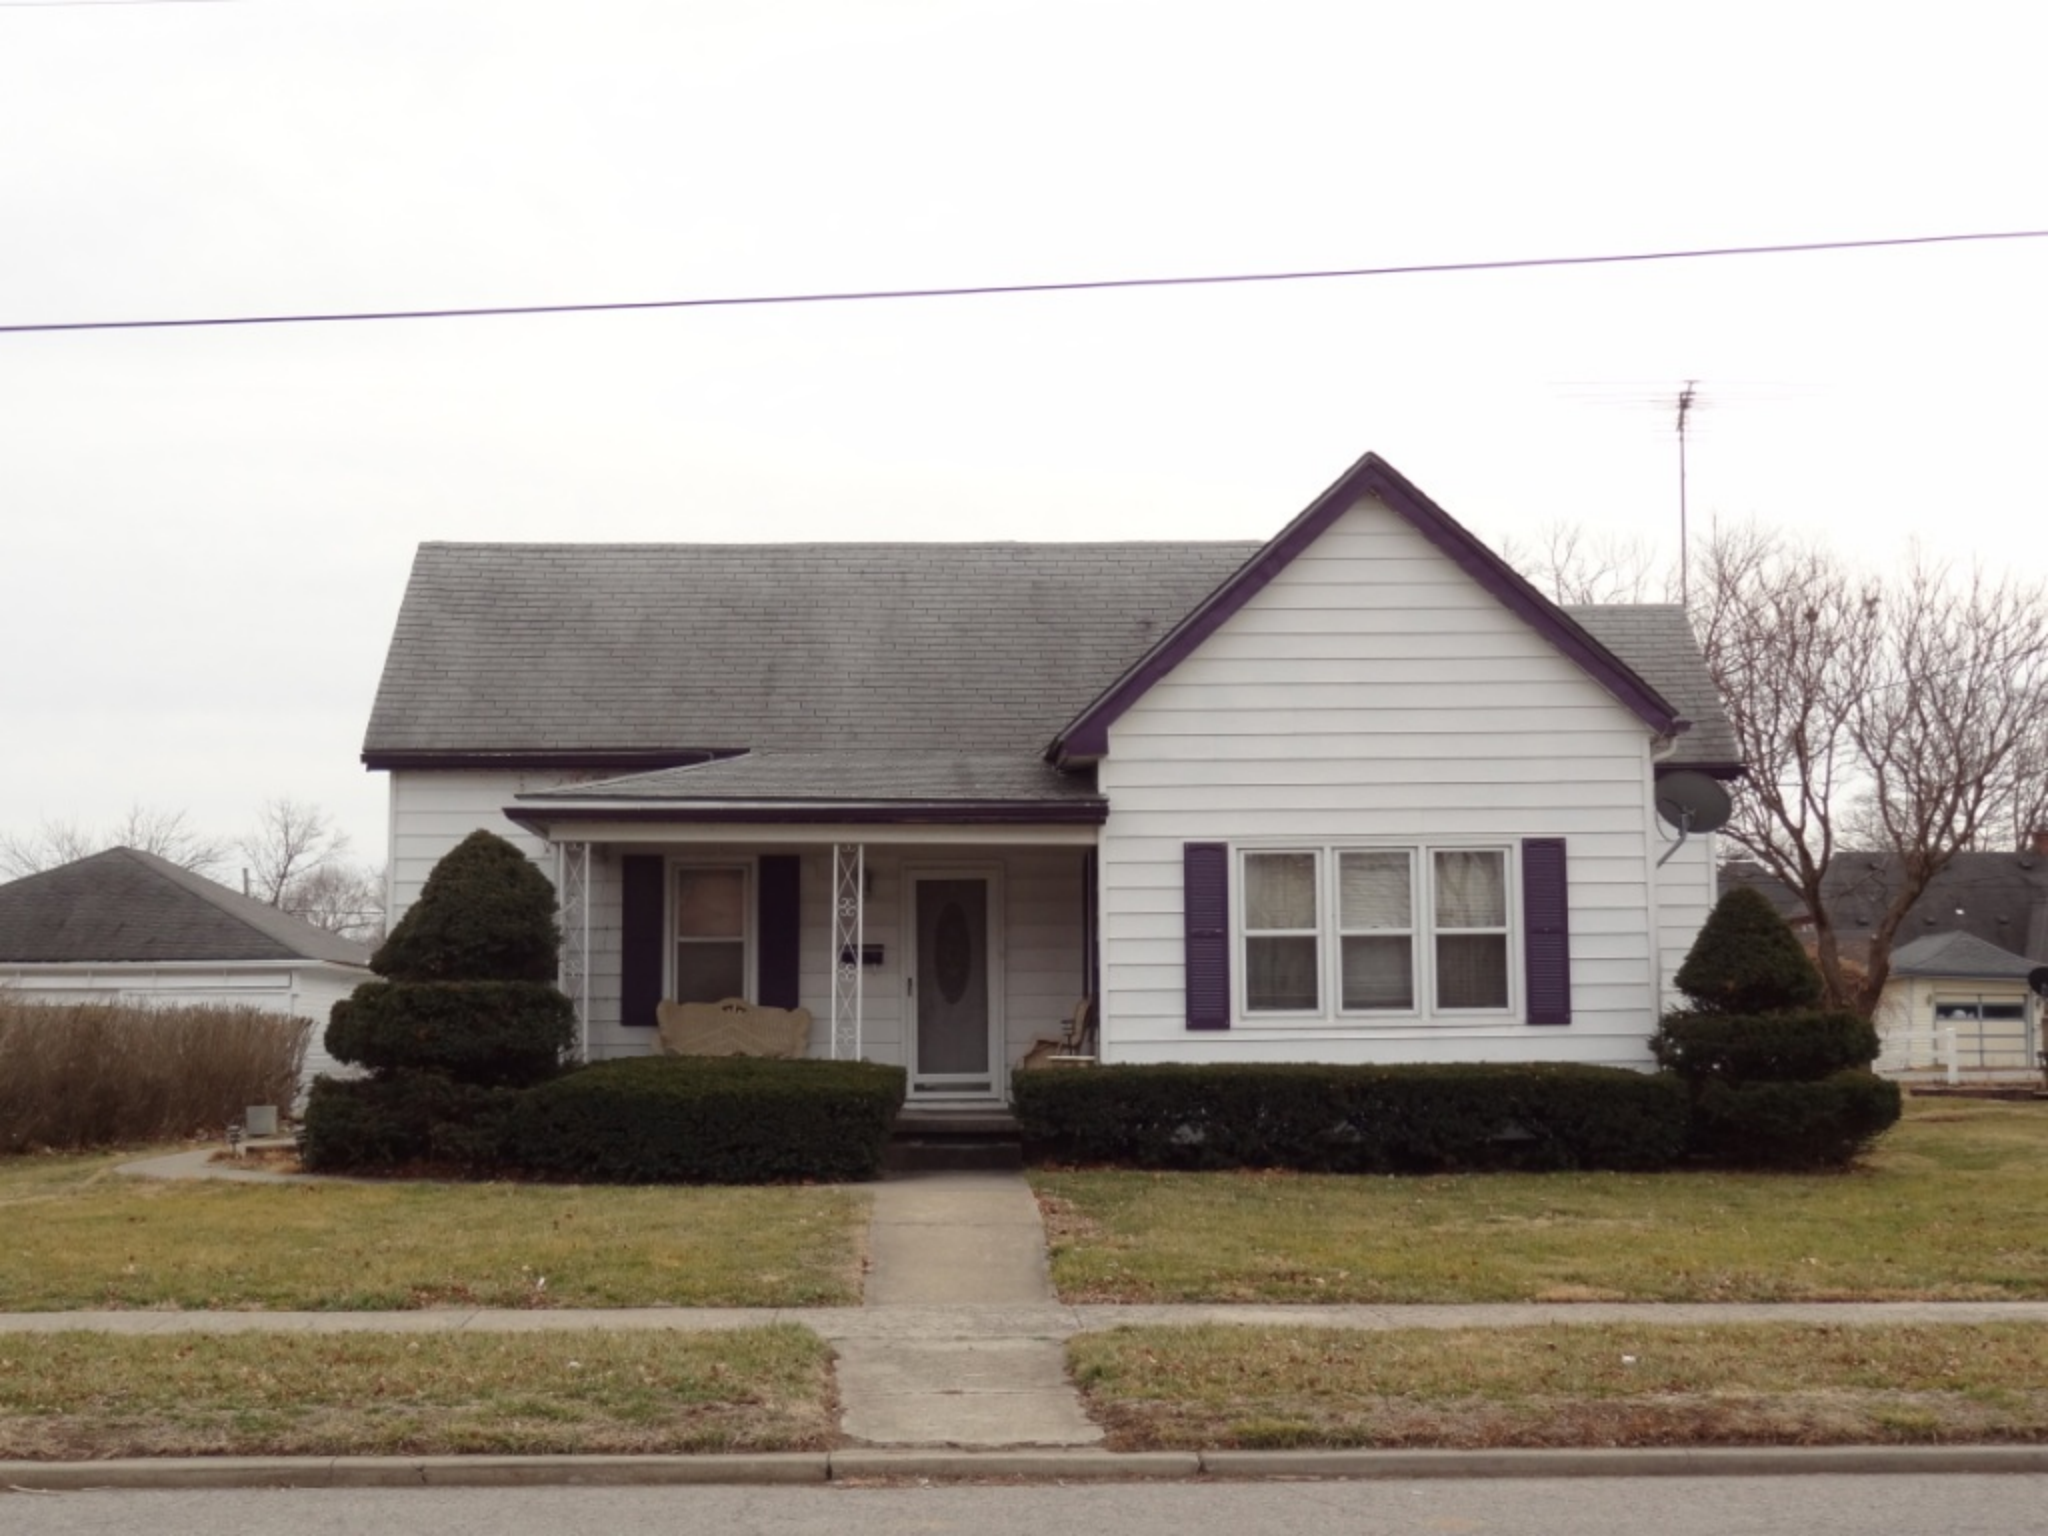
Insert photograph of primary structure on property.

This one story gable & wing house is of frame construction. The foundation material was not noted due to large foundation plantings. The projecting gable includes a span of three grouped 1/1 windows (replacements). The hipped roof porch shelters the roughly centered entrance and extends from the projecting gable across the façade to the east. It is supported by replacement cast metal posts. In the 1950s or 1960s, the building was altered with new porch posts (cast metal) and aluminum (possibly steel) siding. More recent alterations include the replacement of all window. The grouping of three 1/1 vinyl (?) sash windows in the projecting gable may have replaced a c. 1955 picture window. No garages or other outbuildings were noted during the windshield survey.

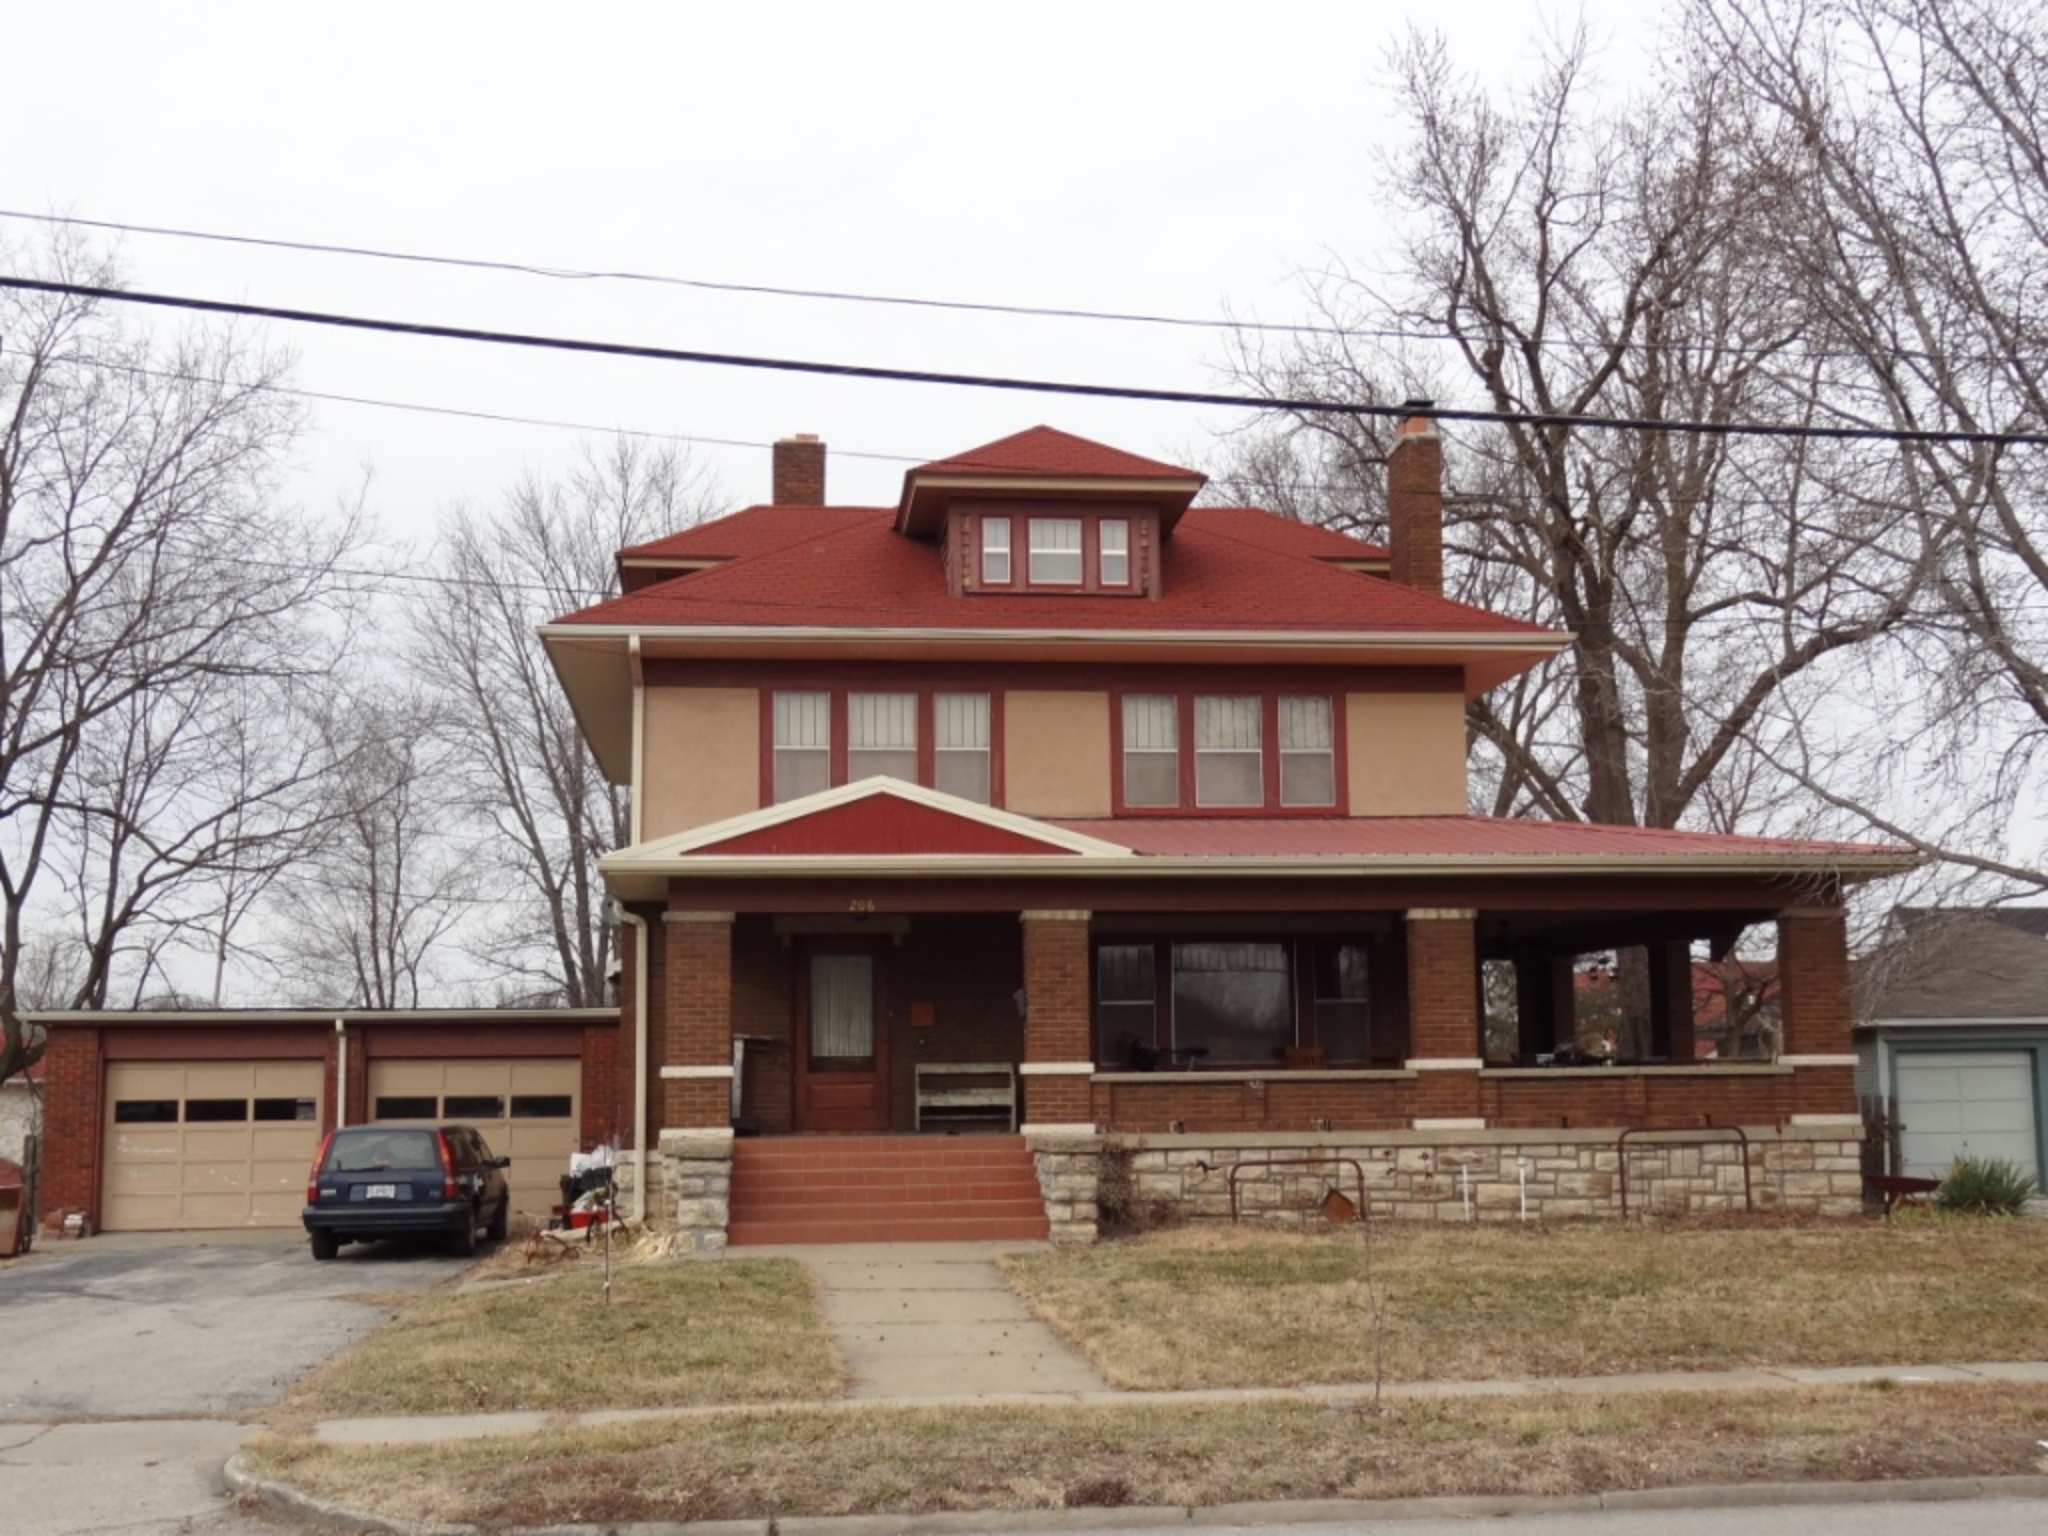
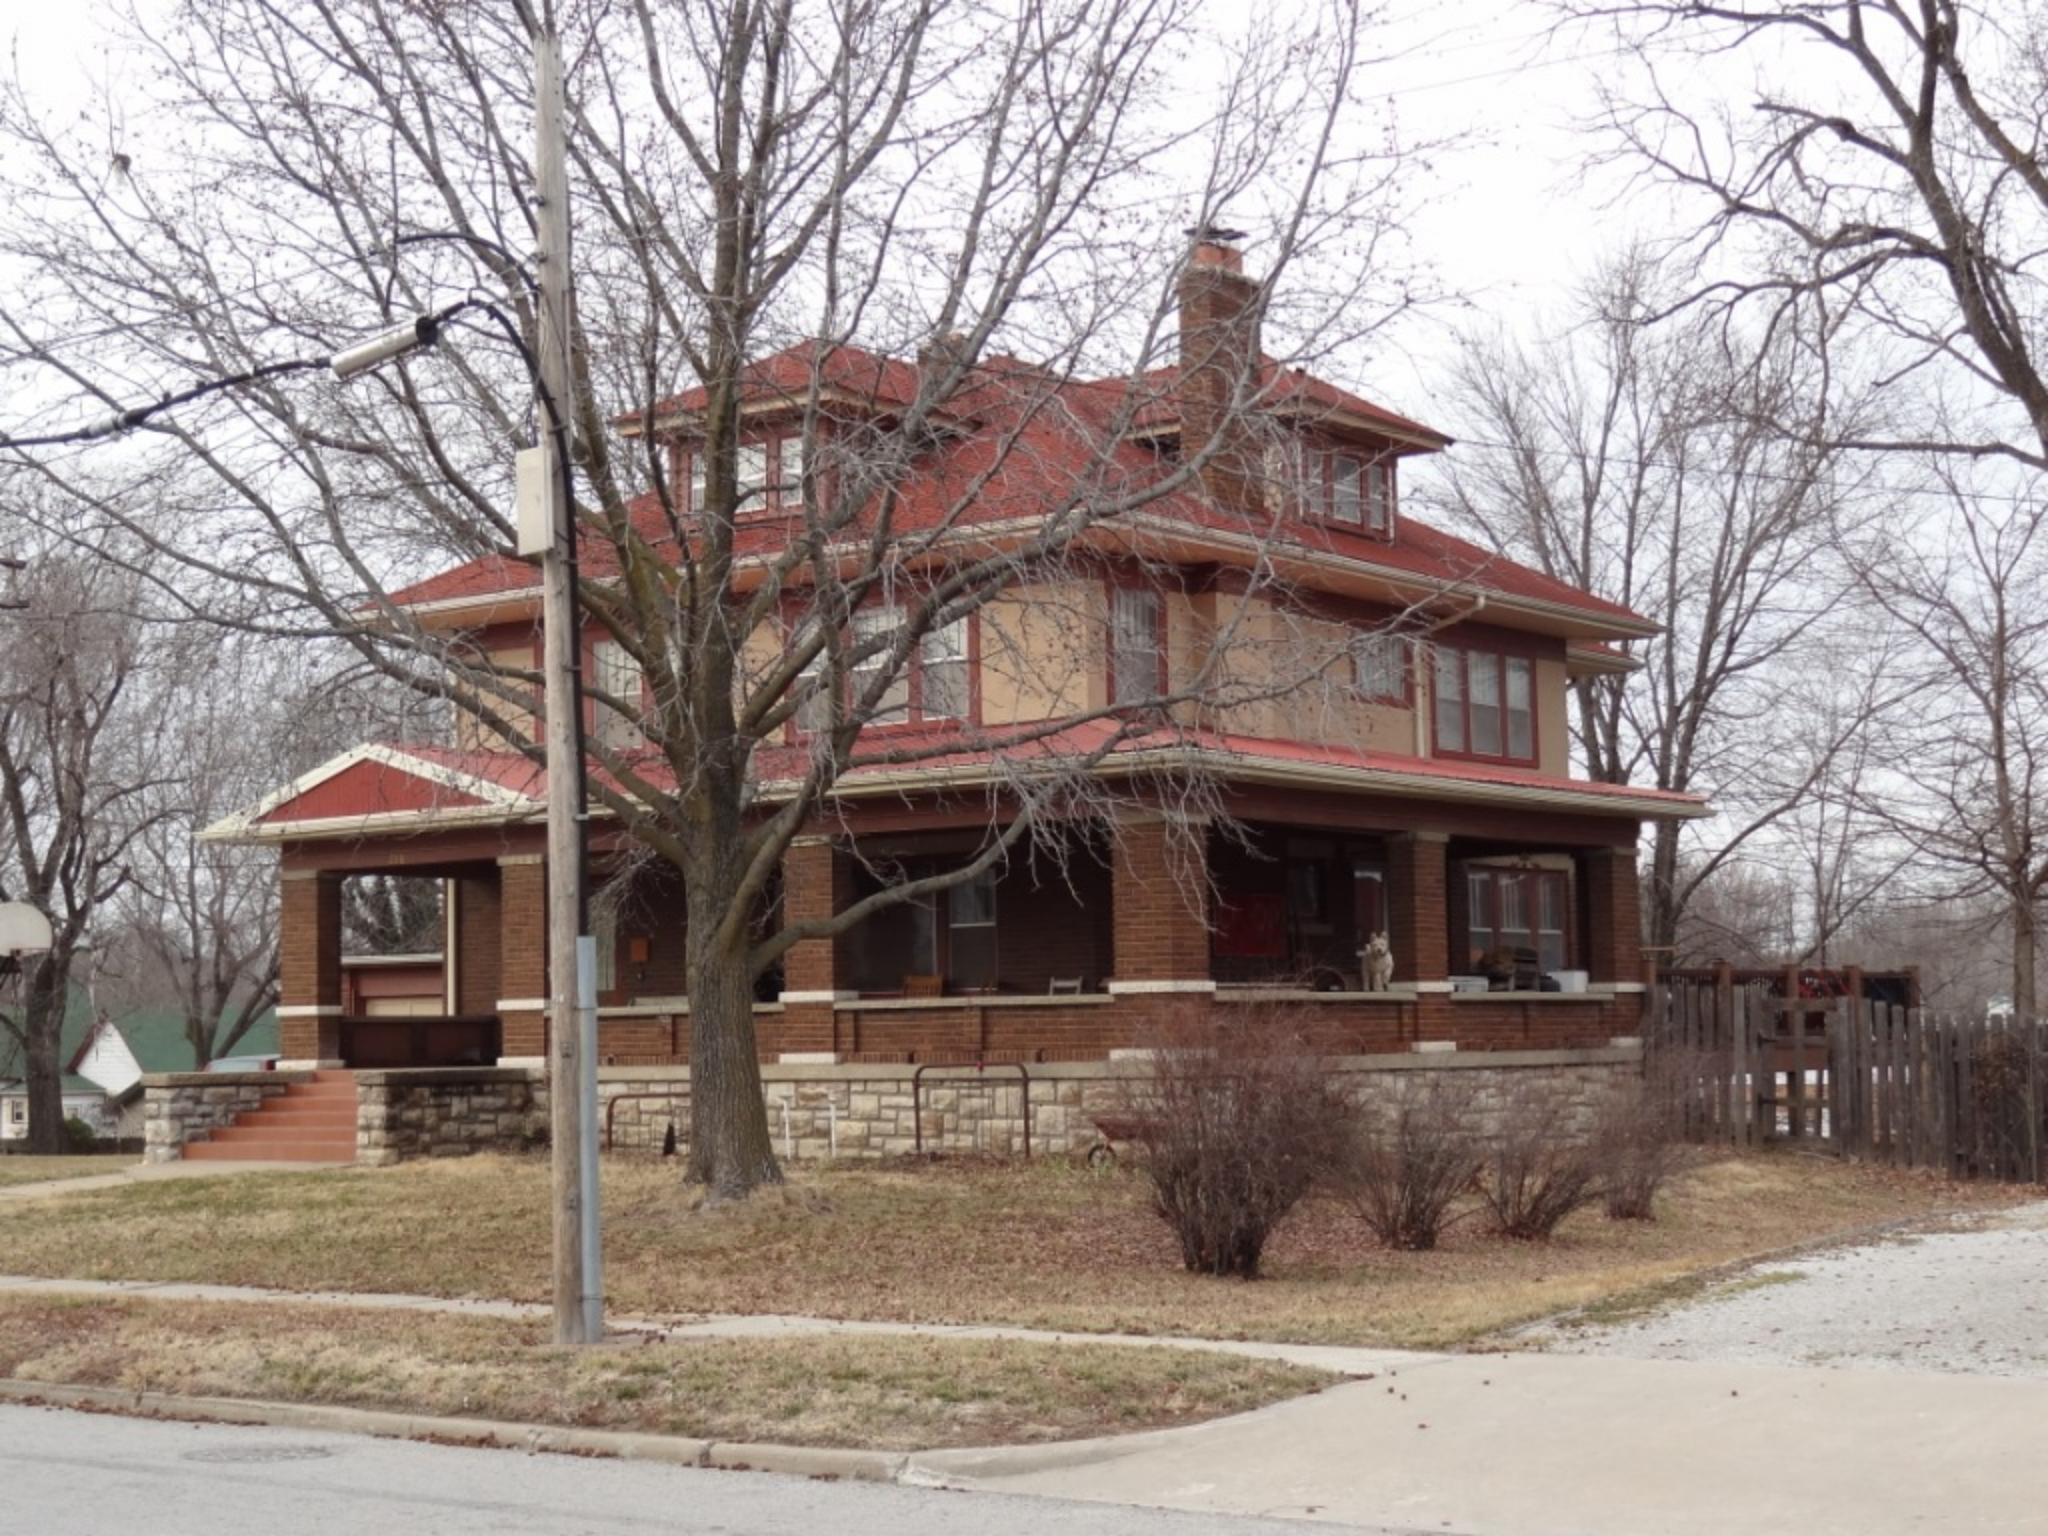
This 2 ½ story foursquare is clad in stucco and has a massive wraparound porch with stone foundation, square brick columns and a low brick knee wall. An offset gable and stair mark the entrance to the porch. The second story has two evenly spaced groups of three wood frame windows. The central window is slightly wider with 5/1 sash. Flanking windows are 4/1. The hipped roof has wide eaves and hipped roof dormers on at least three sides. A 2 car brick garage was attached to the northwest corner sometime after the 1949 Sanborn map was printed.
