## **Instructions for Using This Digital Survey**

Survey Report	Survey Date
Pleasant Hill Survey	August 2003

!preparer !HistOriC Preservation Services, LLC

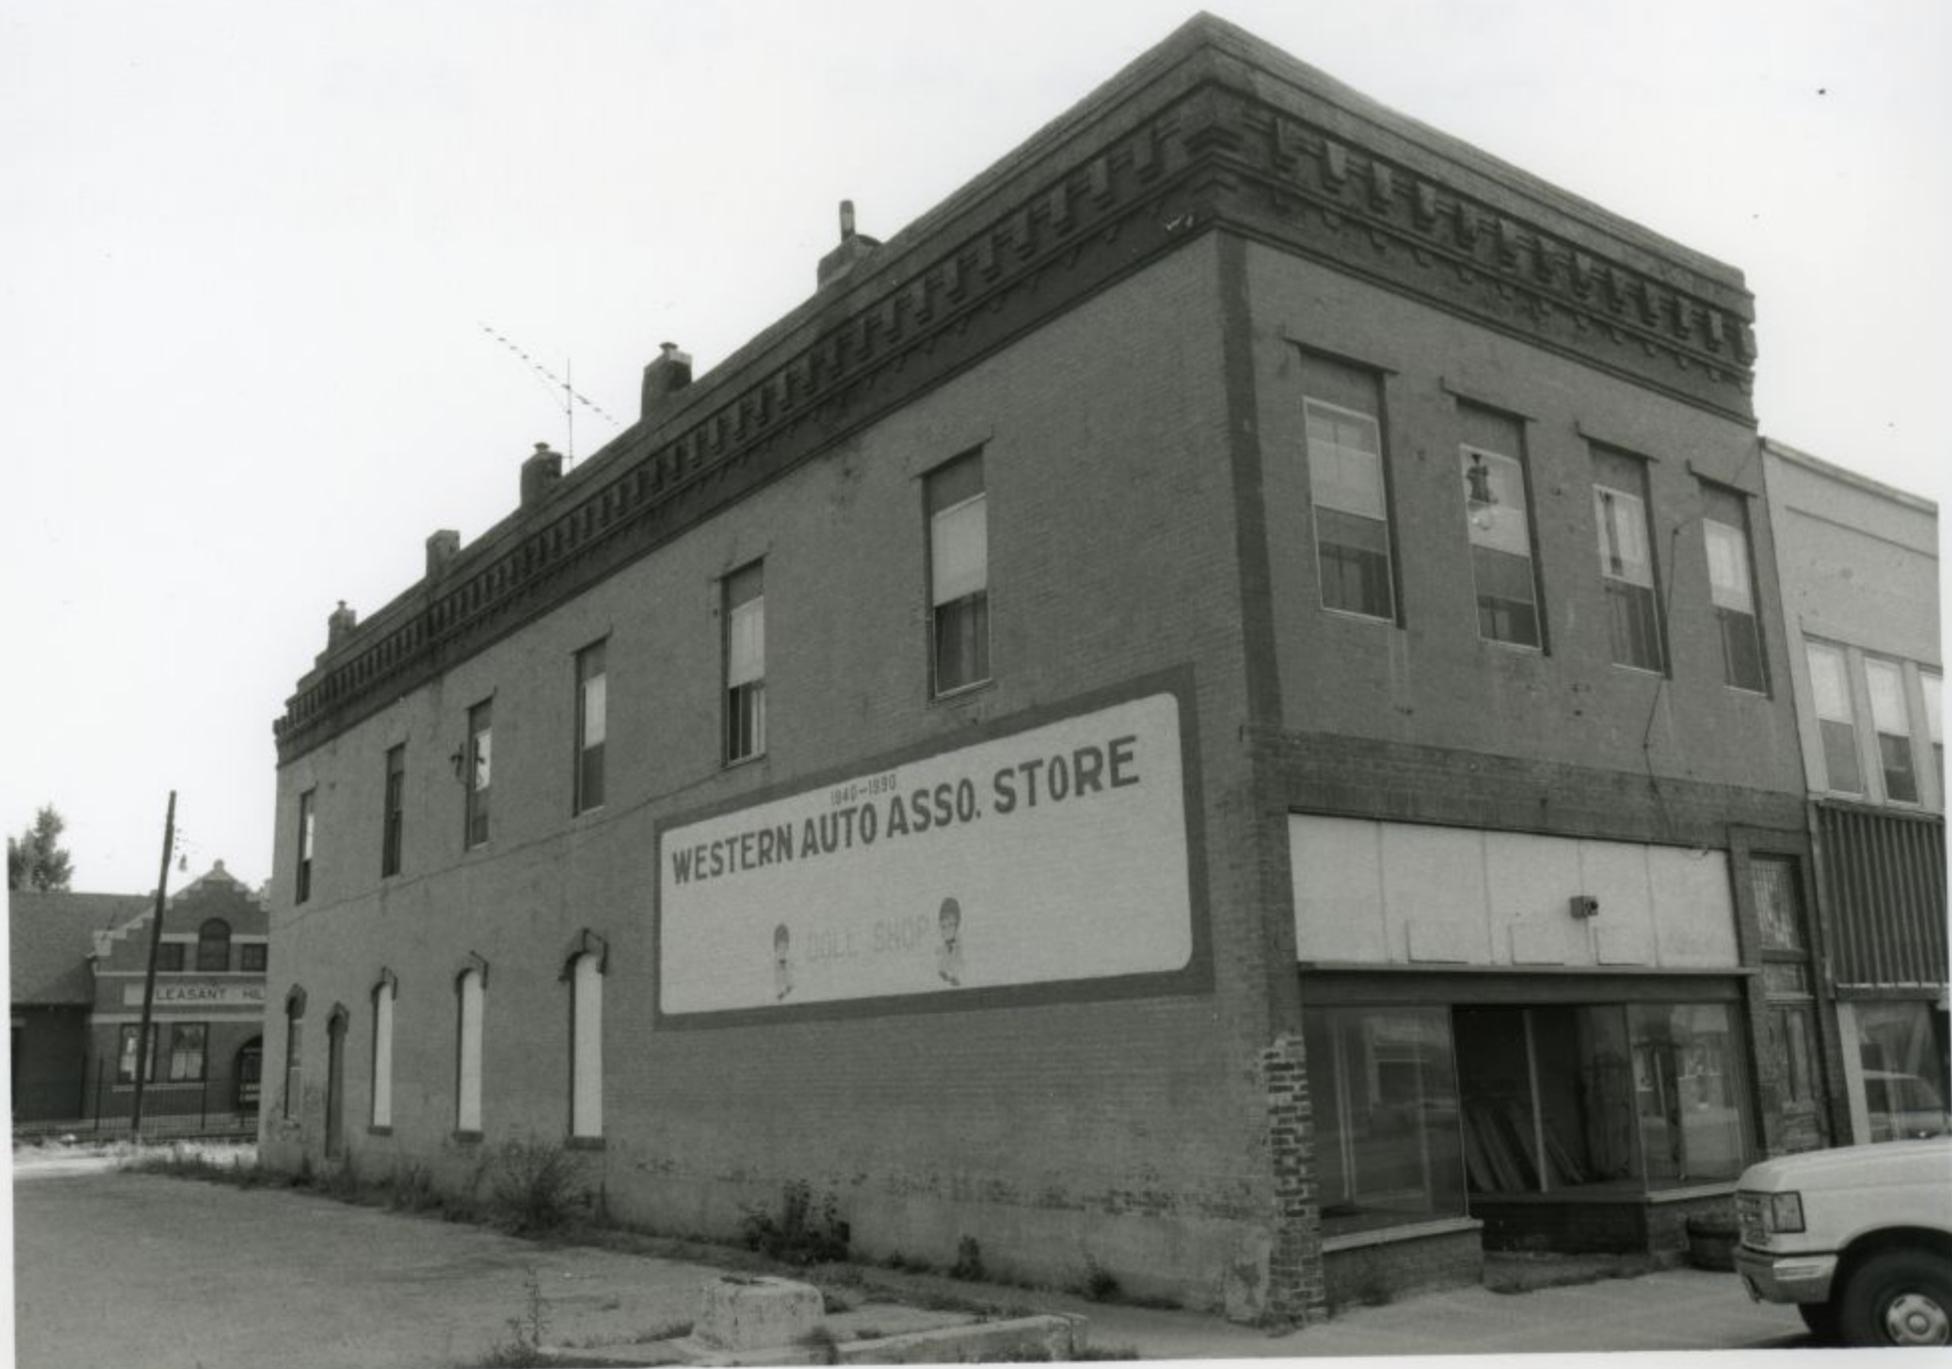
This brick two-part commercial block has a rectangular footprint. The front elevation is four bays wide and the side (northwest) elevation is six bays deep. Second-story fenestration defines the bays and includes single two-over-two light, double-hung wood windows with cast stone lintels. The front elevation features a wood- and steel-framed plate glass storefront window system. The storefront configuration consists of a recessed entrance flanked by display windows that rest on brick bulkheads. Plywood covers the storefront transom window. Adjacent to the storefront, the entrance to the second floor occupies the south end bay. Additional character-defining features include the corbelled brick "brackets" at the cornice; the original segmental arch window openings with decorative limestone hoods and sills that are intact on the first story of the northwest elevation; the bead board ceiling over the storefront entrance, and the historic panel wood door with a leaded glass transom window at the entrance to the second floor. Although the storefront is not original, it is a historic alteration that has gained significance in its own right. The plywood that covers several window openings does not effect the overall ability of this building to convey its historic associations.

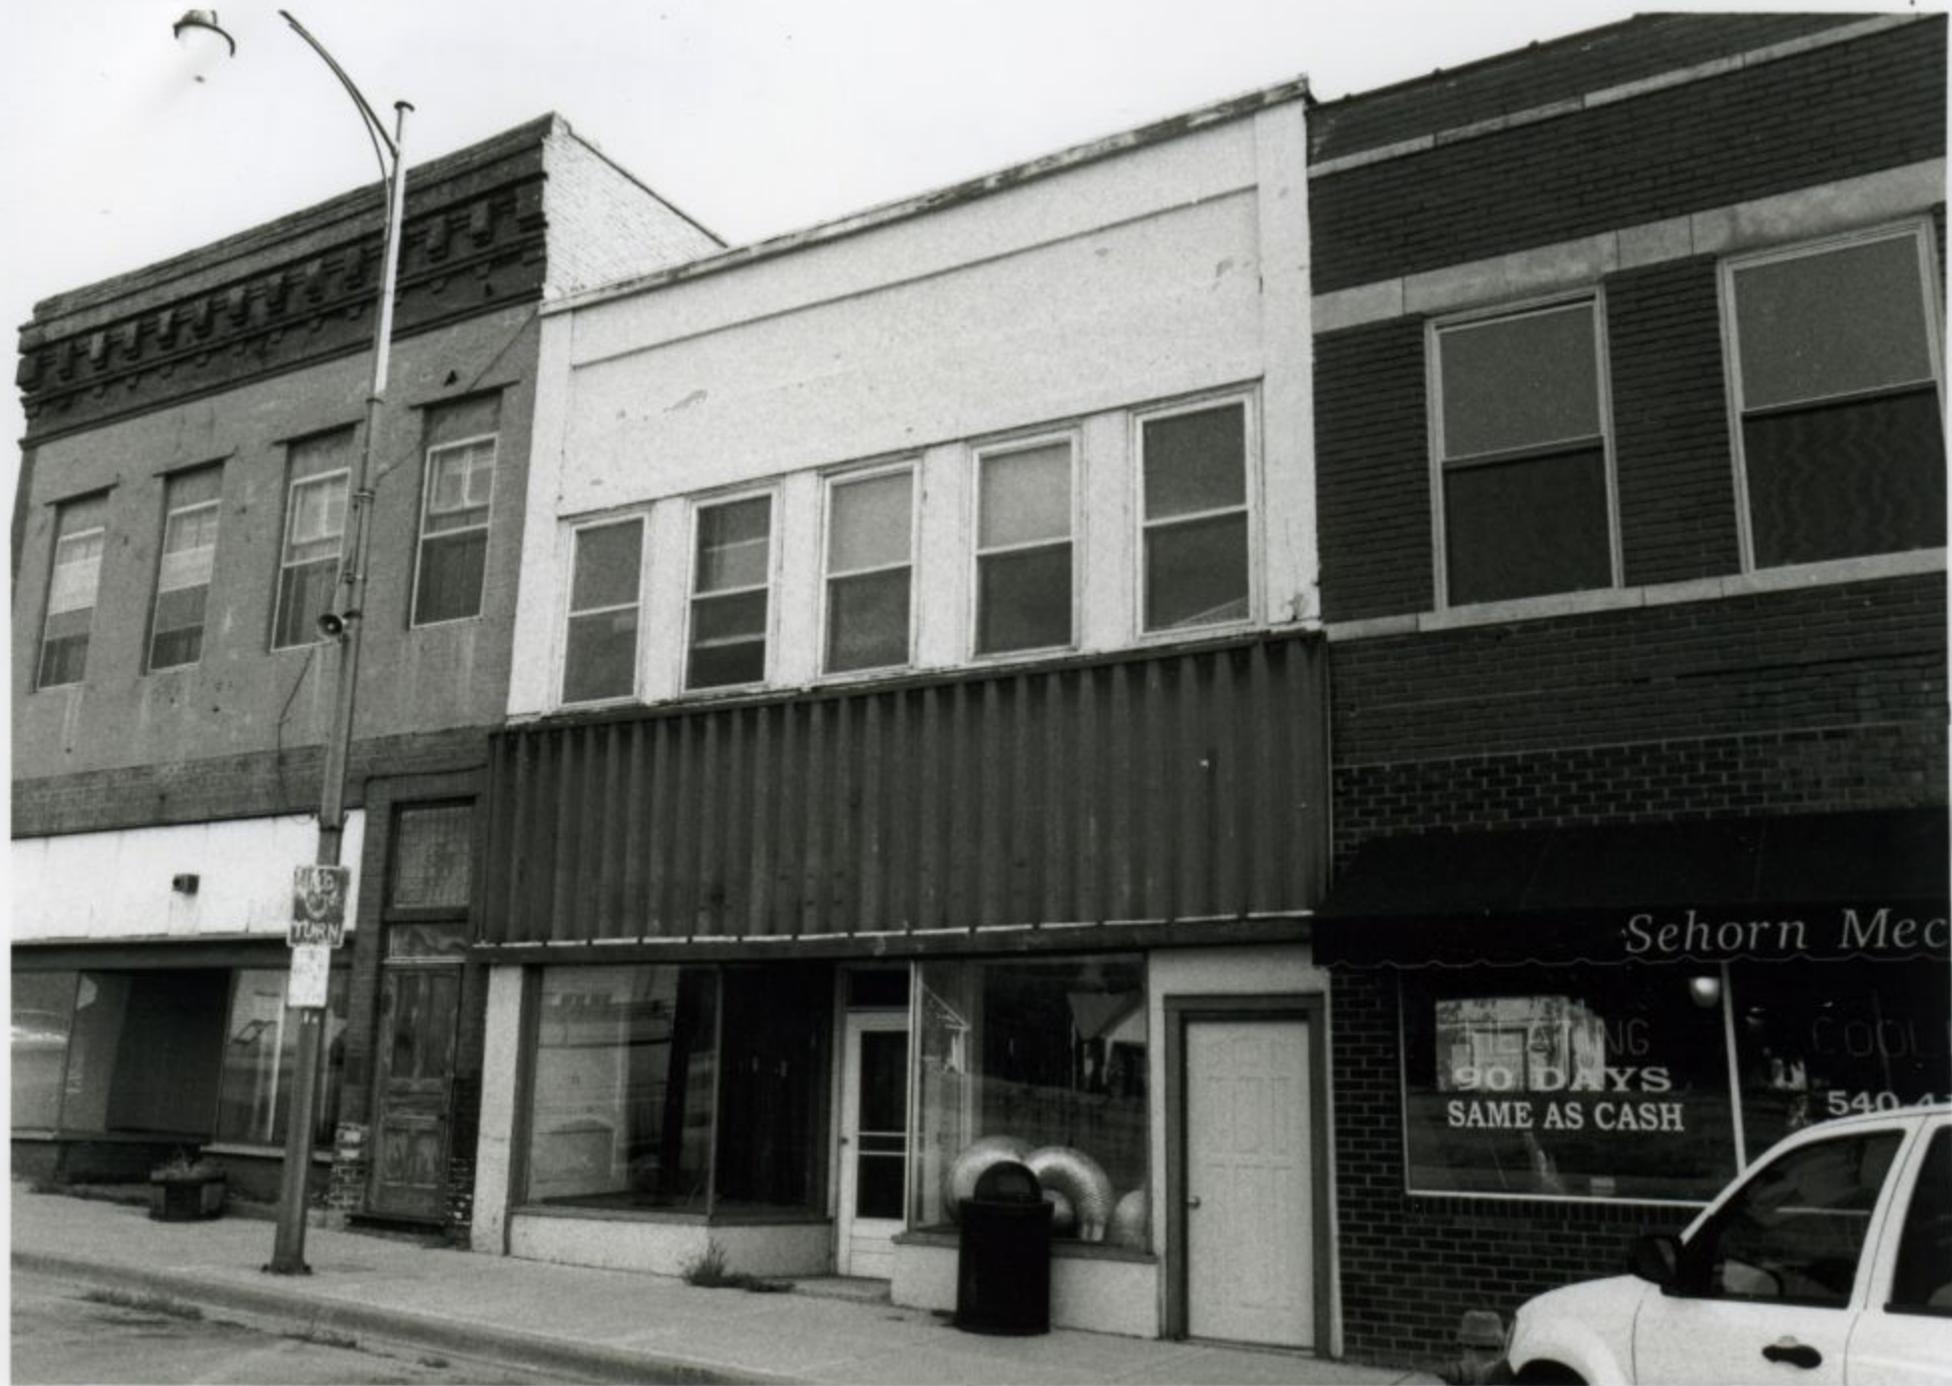
This brick two-part commercial block has a rectangular footprint. Historic stucco covers the front facade wall. Second-story fenestration defines the five bays and includes single one-over-one light, double-hung wood windows. The first-story storefront features a wood- and steel-framed plate glass window system that rests on stucco-covered brick bulkheads. The display windows flank the storefront's recessed entrance. Adjacent to the storefront, the entrance to the second floor occupies the south end bay. Corrugated metal covers the storefront's transom window. Additional character-defining features include a recessed rectangular panel across the full width of the cornice, a mosaic tile entrance floor, and a historic paneled wood door and screen doors. Although corrugated metal covers the storefront transom window opening, this building retains its architectural integrity and clearly conveys its historic associations.
