Architectural/Historic Inventory Form

1. Survey No. SEC 15-036 290		2. Survey Name: Villie	
3. County: St. Louis [Independent City]		4. Address: 4452 KENNERLY AV	
5. City/State: St. Louis, MO		6. UTM: / /	
7. Township/Range/Section: T: R: S:		Not Applicable	
8. Historic Name (if known):		9. Present Name (if known):	
10. Ownership: Domestic		11. Present Use: Domestic	
12. Historic Use (if known): Sub-use: Single Dwelling		13. Present Use: Sub-use:

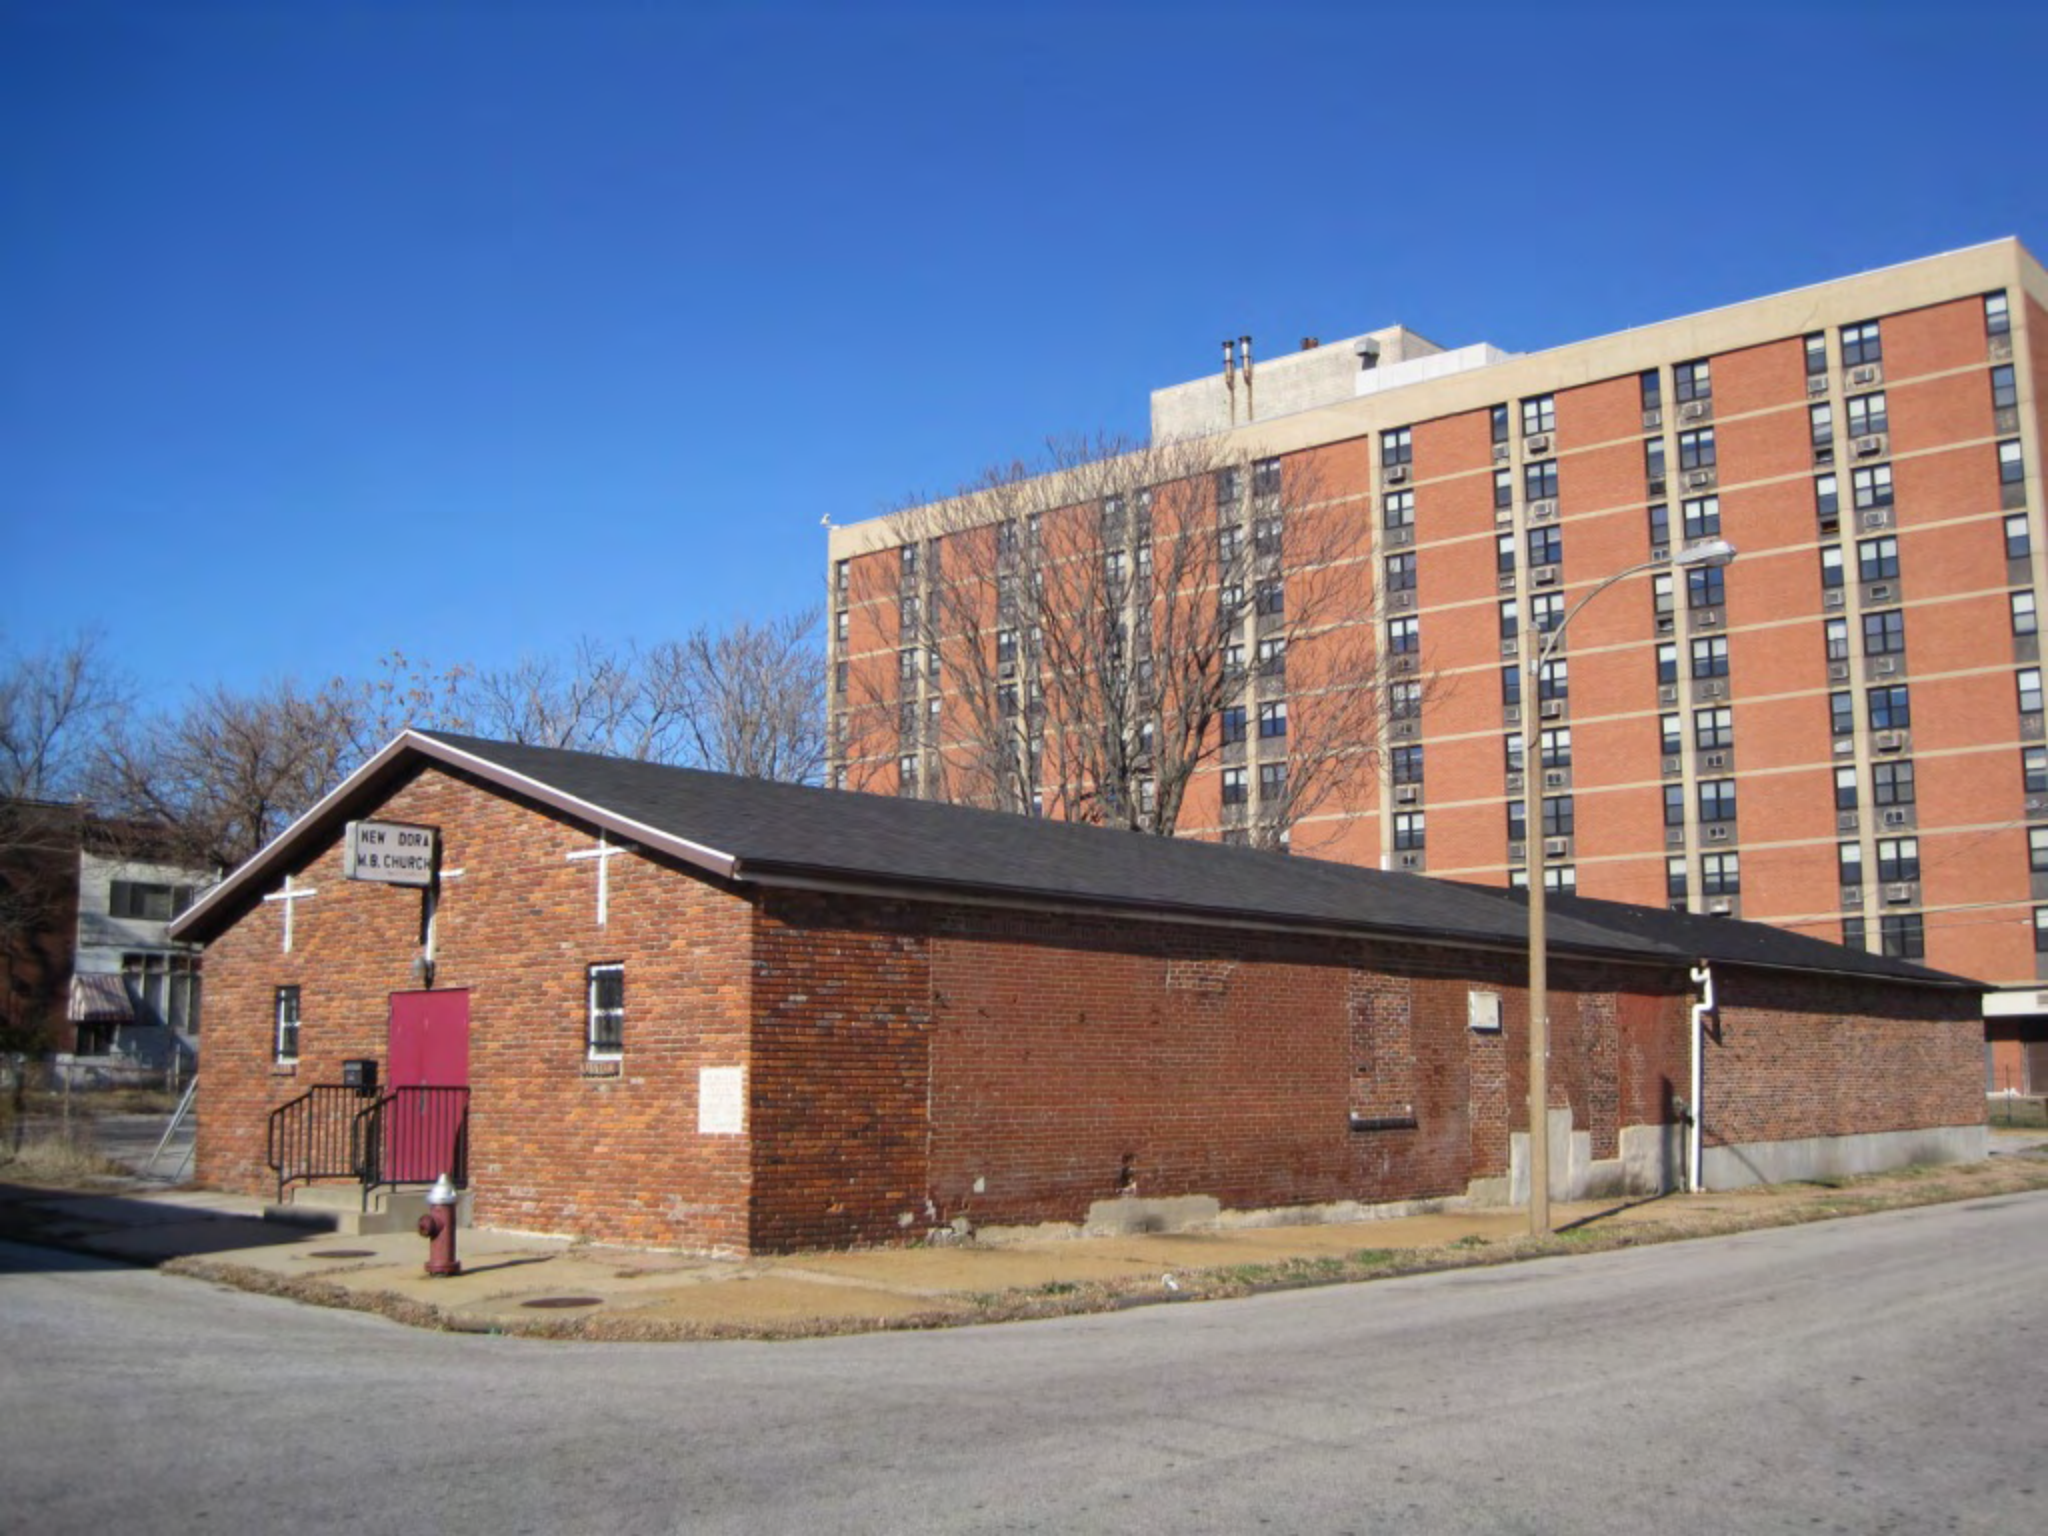
Red brick gabled church built in at least three phases, with evident vertical masonry seams and difference in brick tones. The main section appears to be part of a two-story store that appears on the 1909 and 1951 Sanborn maps. The cornerstone states that the building was "rebuilt" starting on July 11, 1976. (No building permit records found.) Front elevation has concrete steps to entrance with double steel doors. Two small window openings are high on the wall to each side, and a corner stone is at right. Three concrete crosses are embedded in the wall above the openings, and a blade sign extends at center.

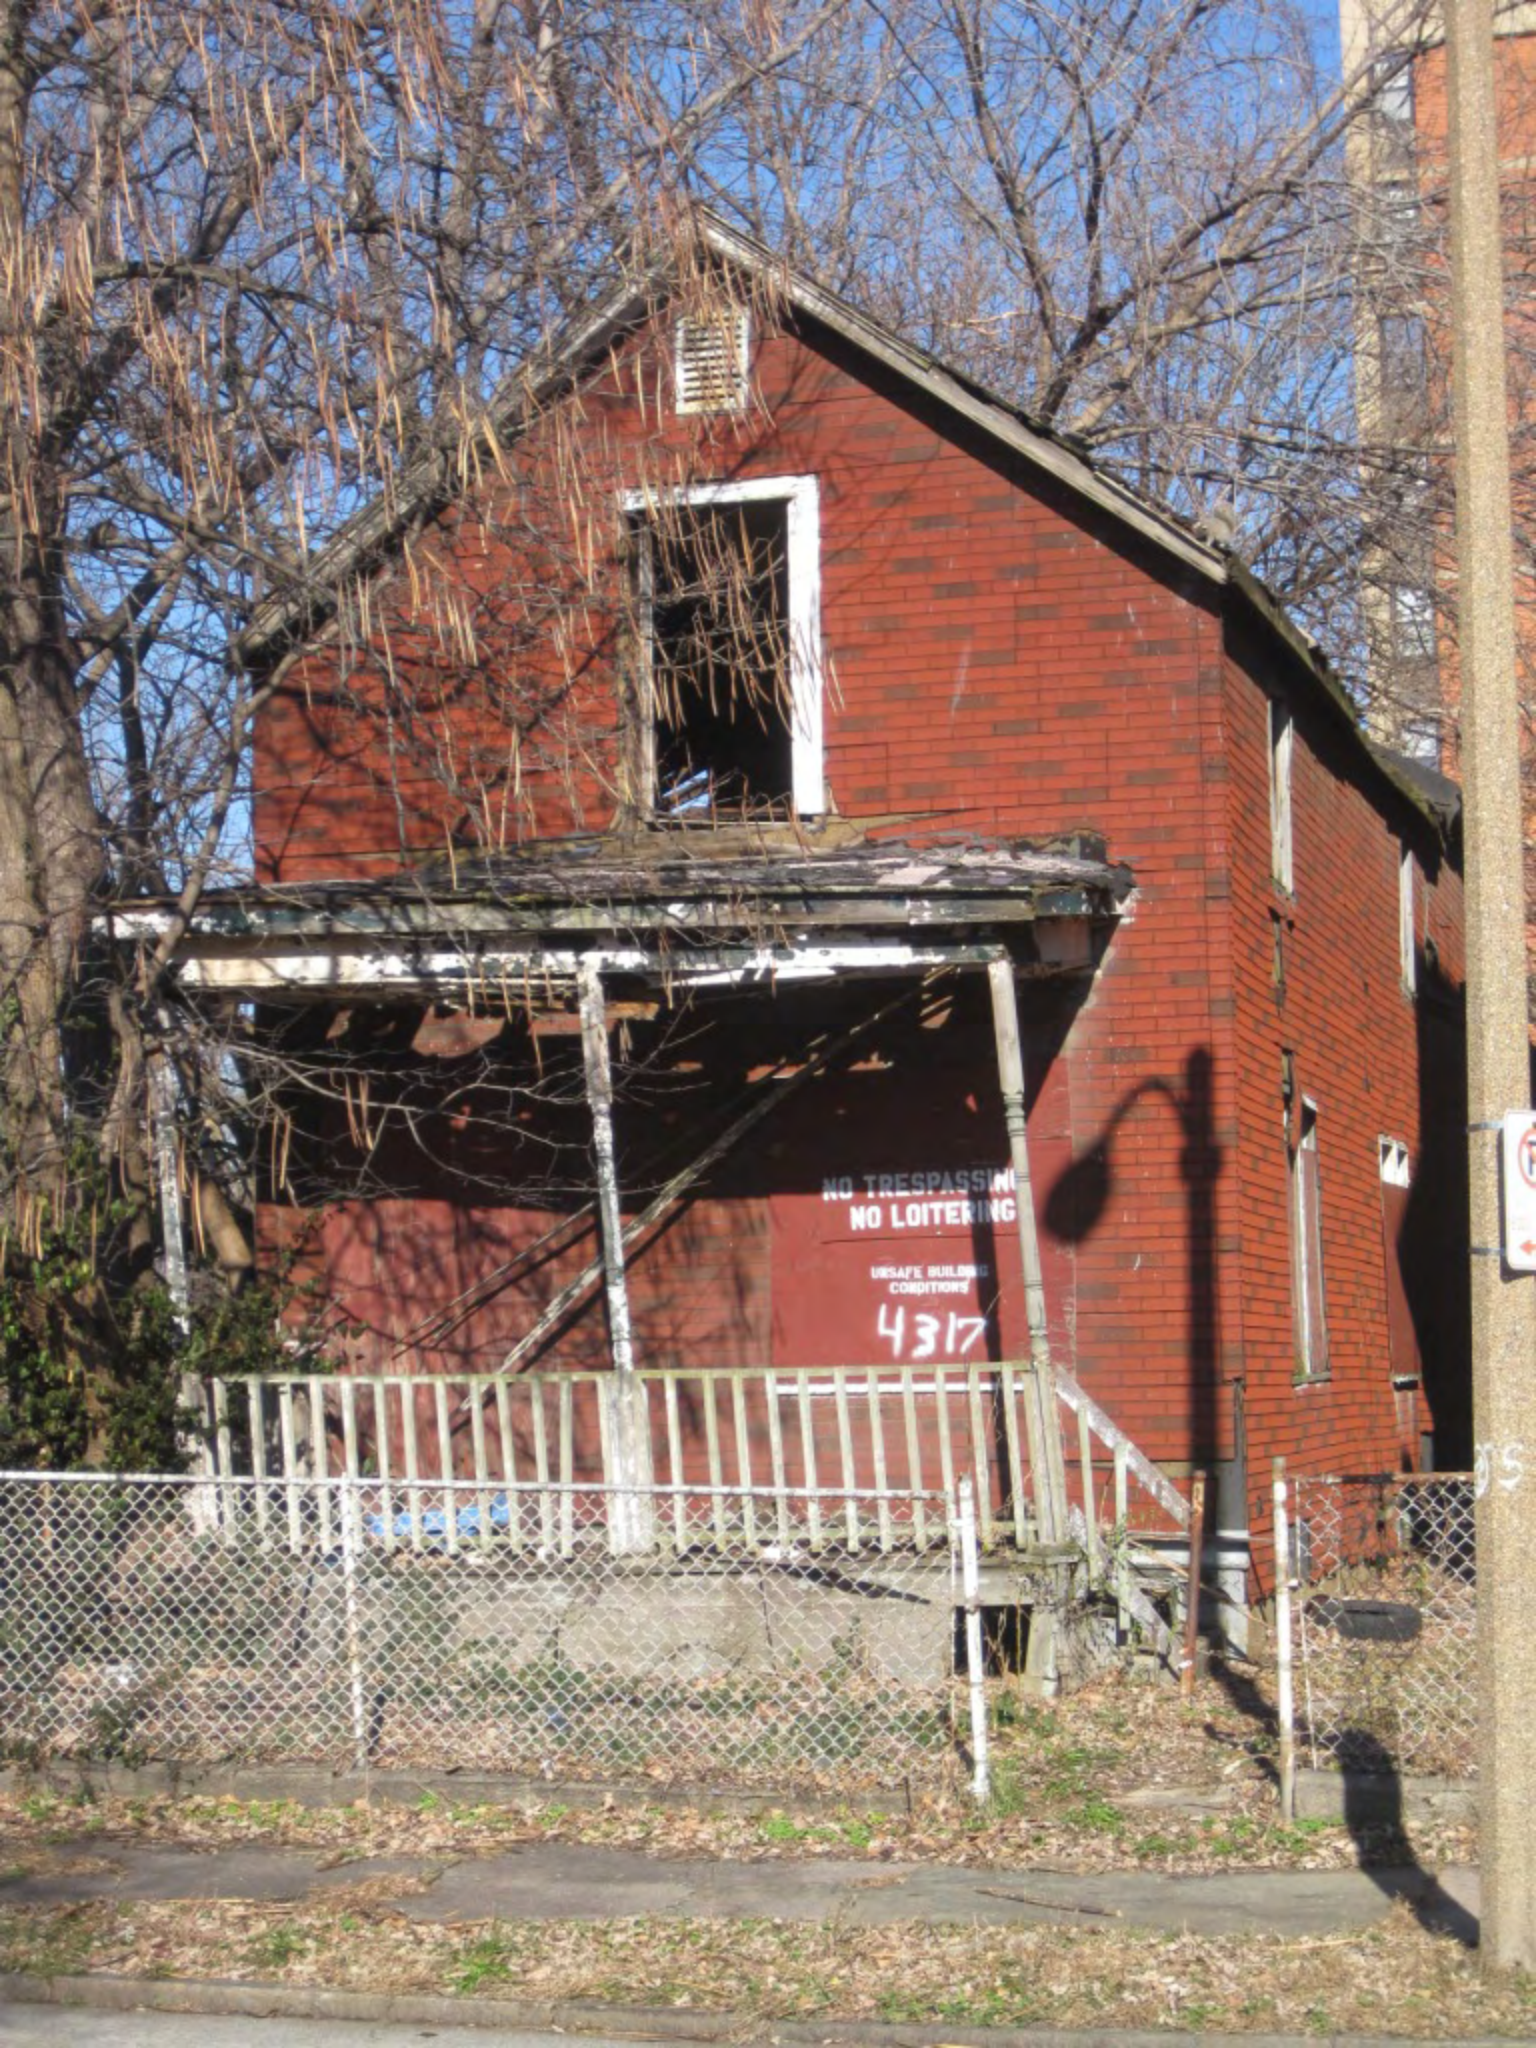
Deteriorated building clad in asphalt siding. Shed-roofed porch retains turned wooden columns. First floor openings boarded, second floor opening open without a window. Wooden vergeboards.

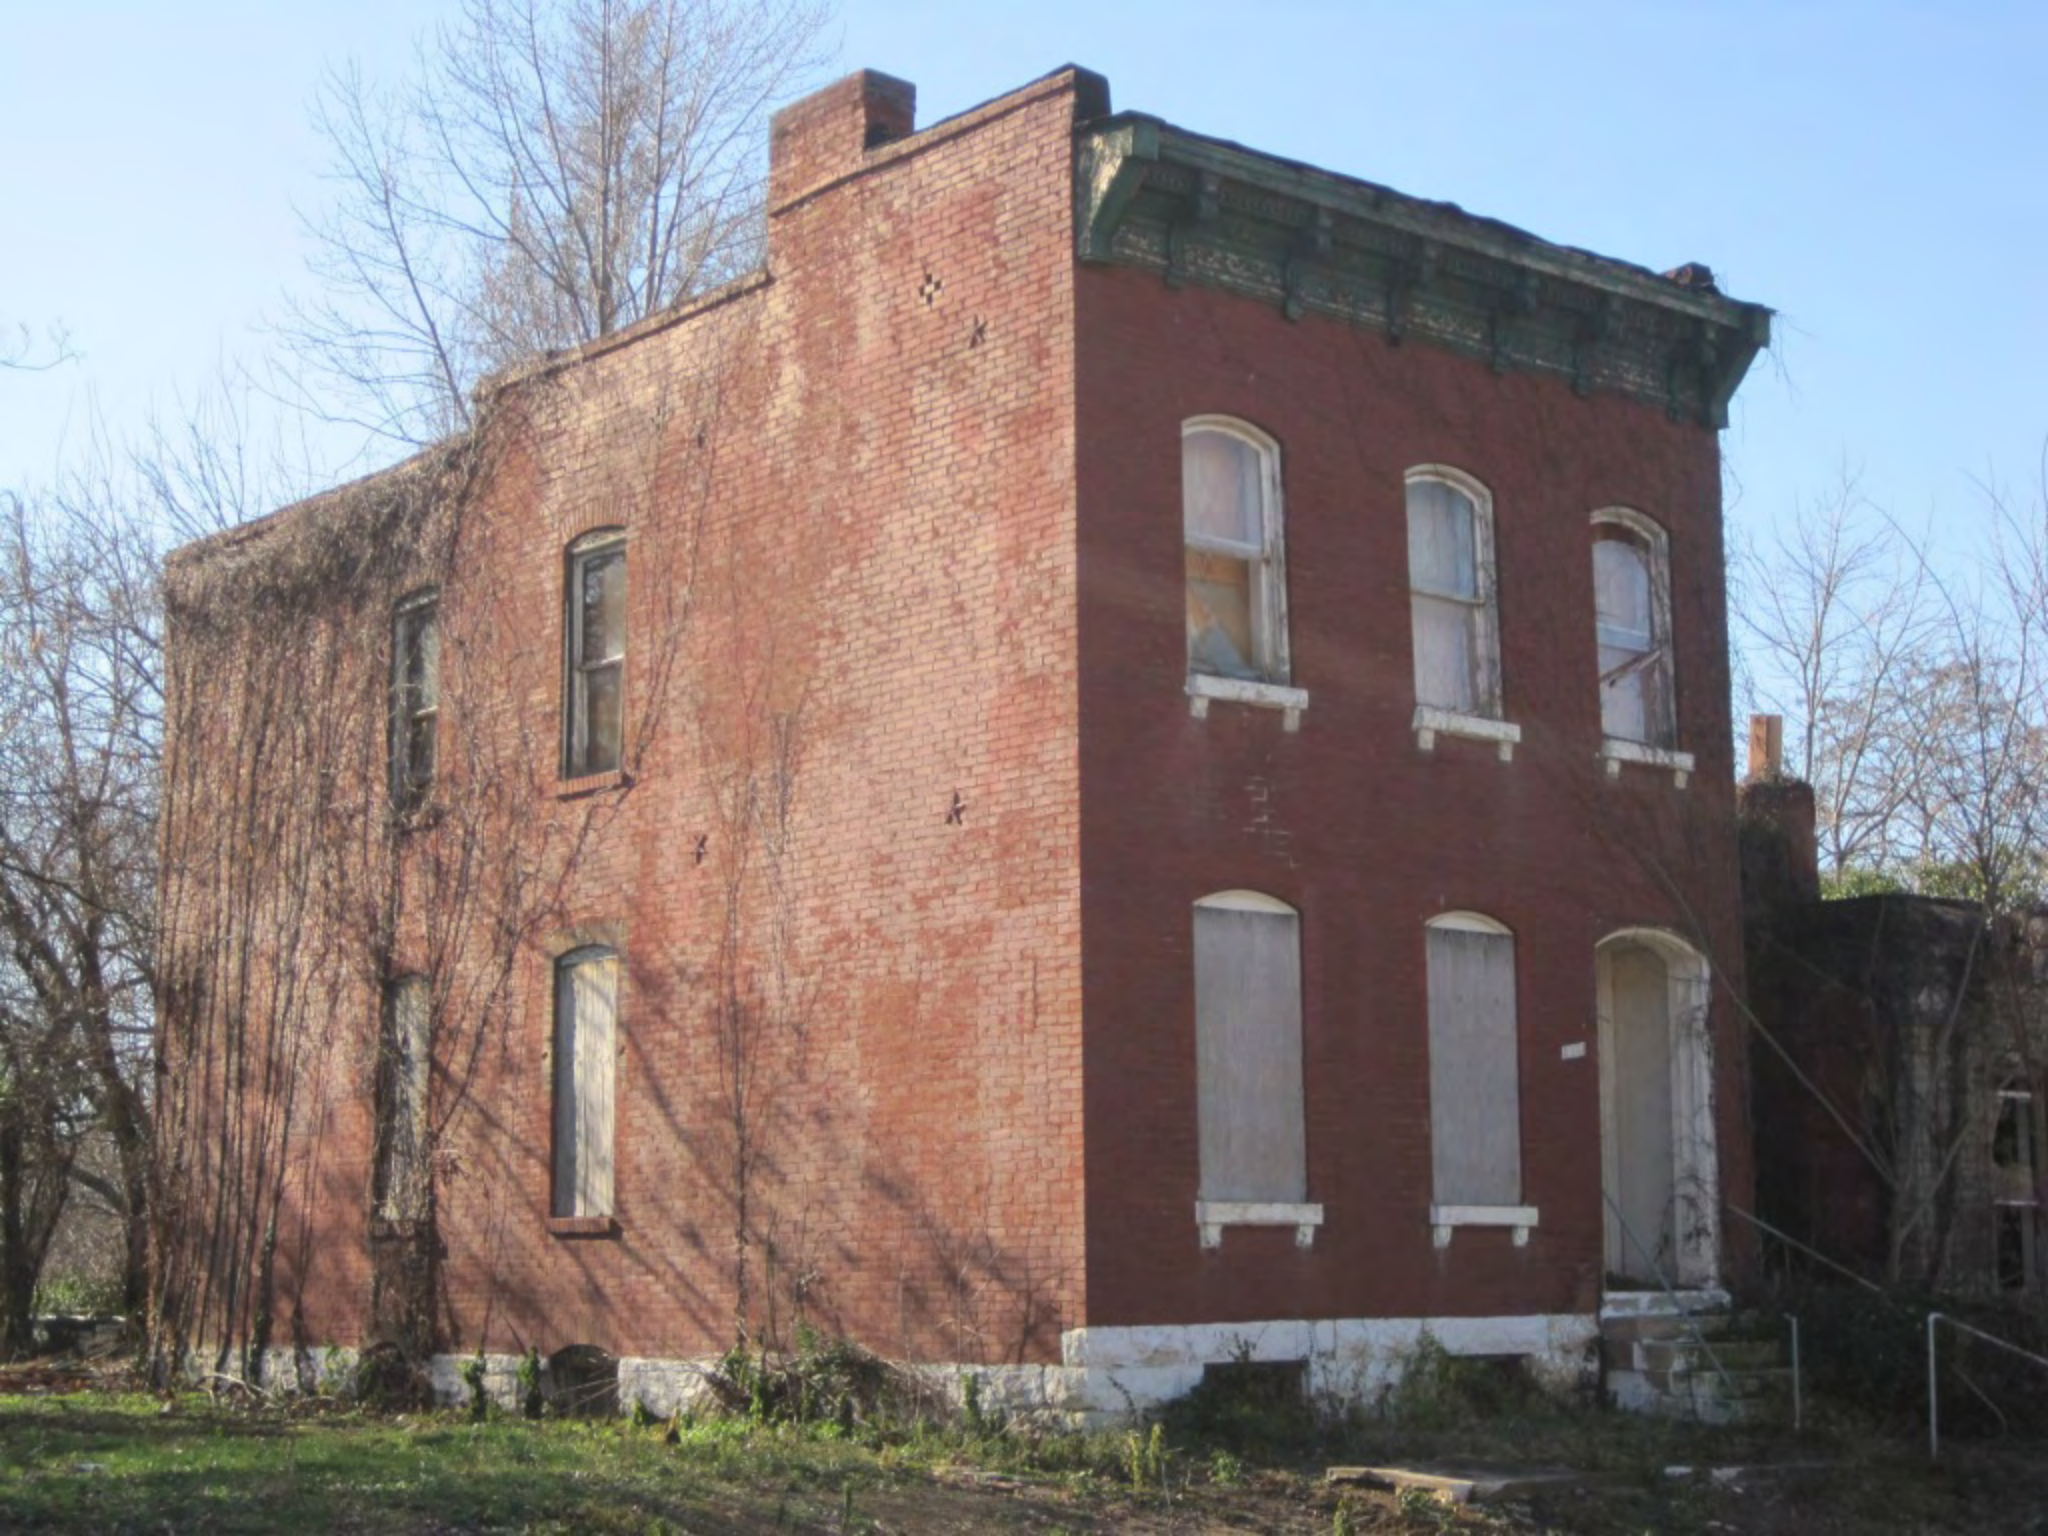
Rusticated stone foundation and stone steps are painted. Red brick walls. Recessed entrance boarded but retains wooden casements and beadboard. Window openings have segmental arches and stone sills with consoles. First floor openings boarded, second floor openings have wooden one-over-one arch-top windows. Wooden cornice with brackets, ornamented fascia and crown molding.

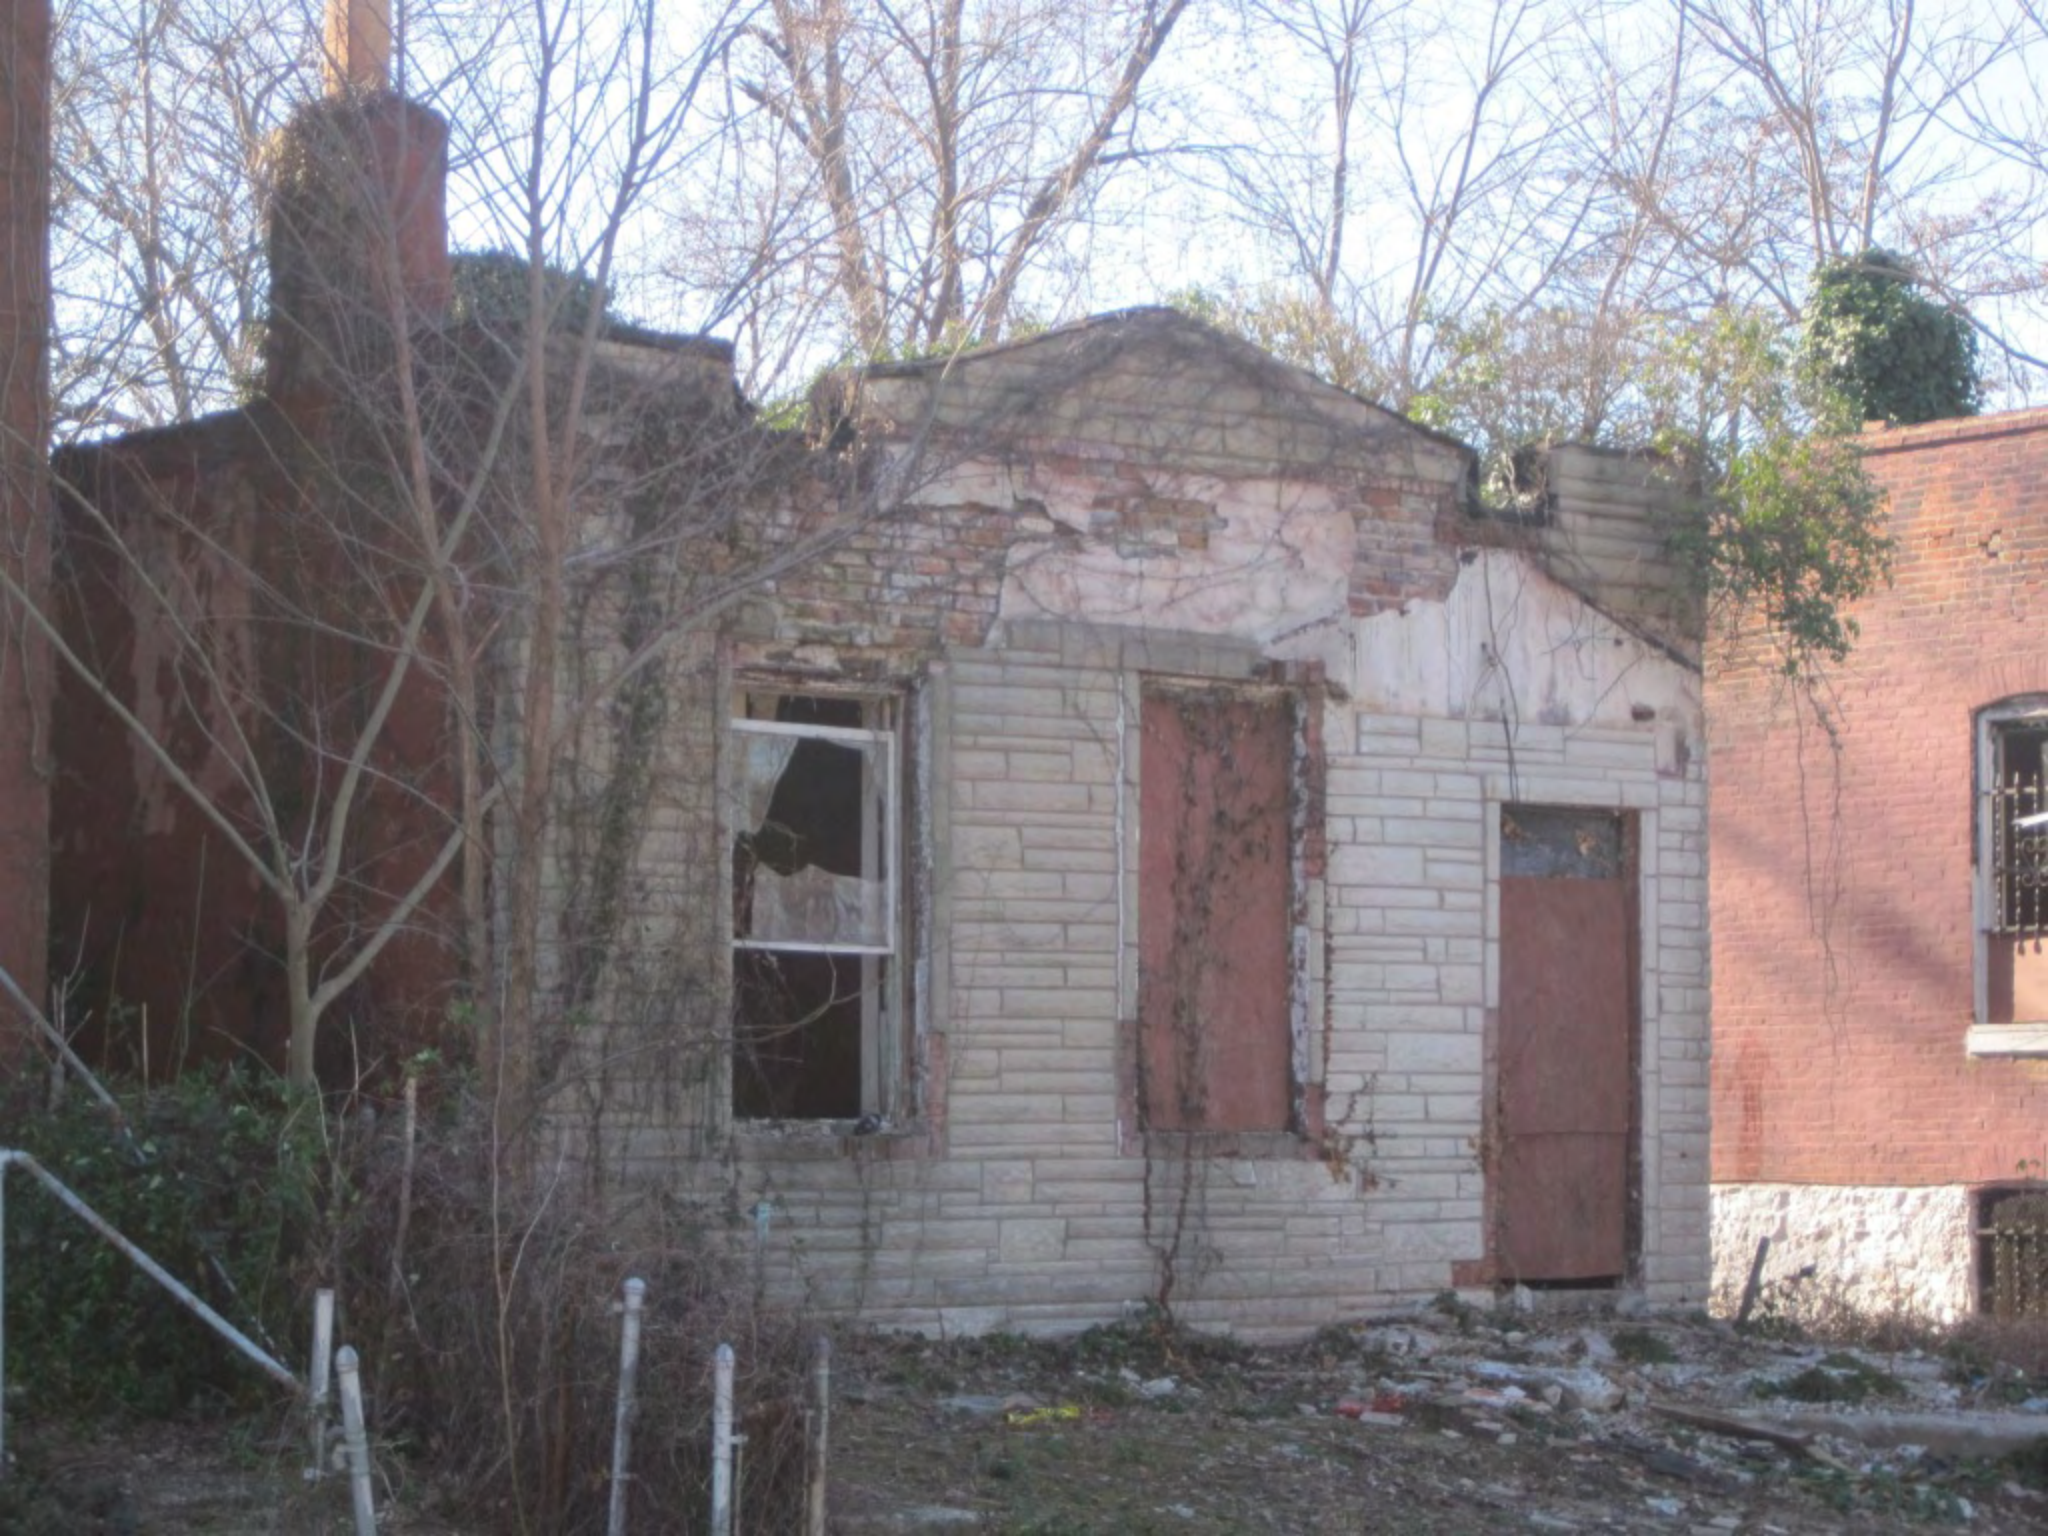
Front elevation is clad in simulated stone masonry. Parapet has center pediment and end blocks. Openings boarded except left window openings, which is missing its window.

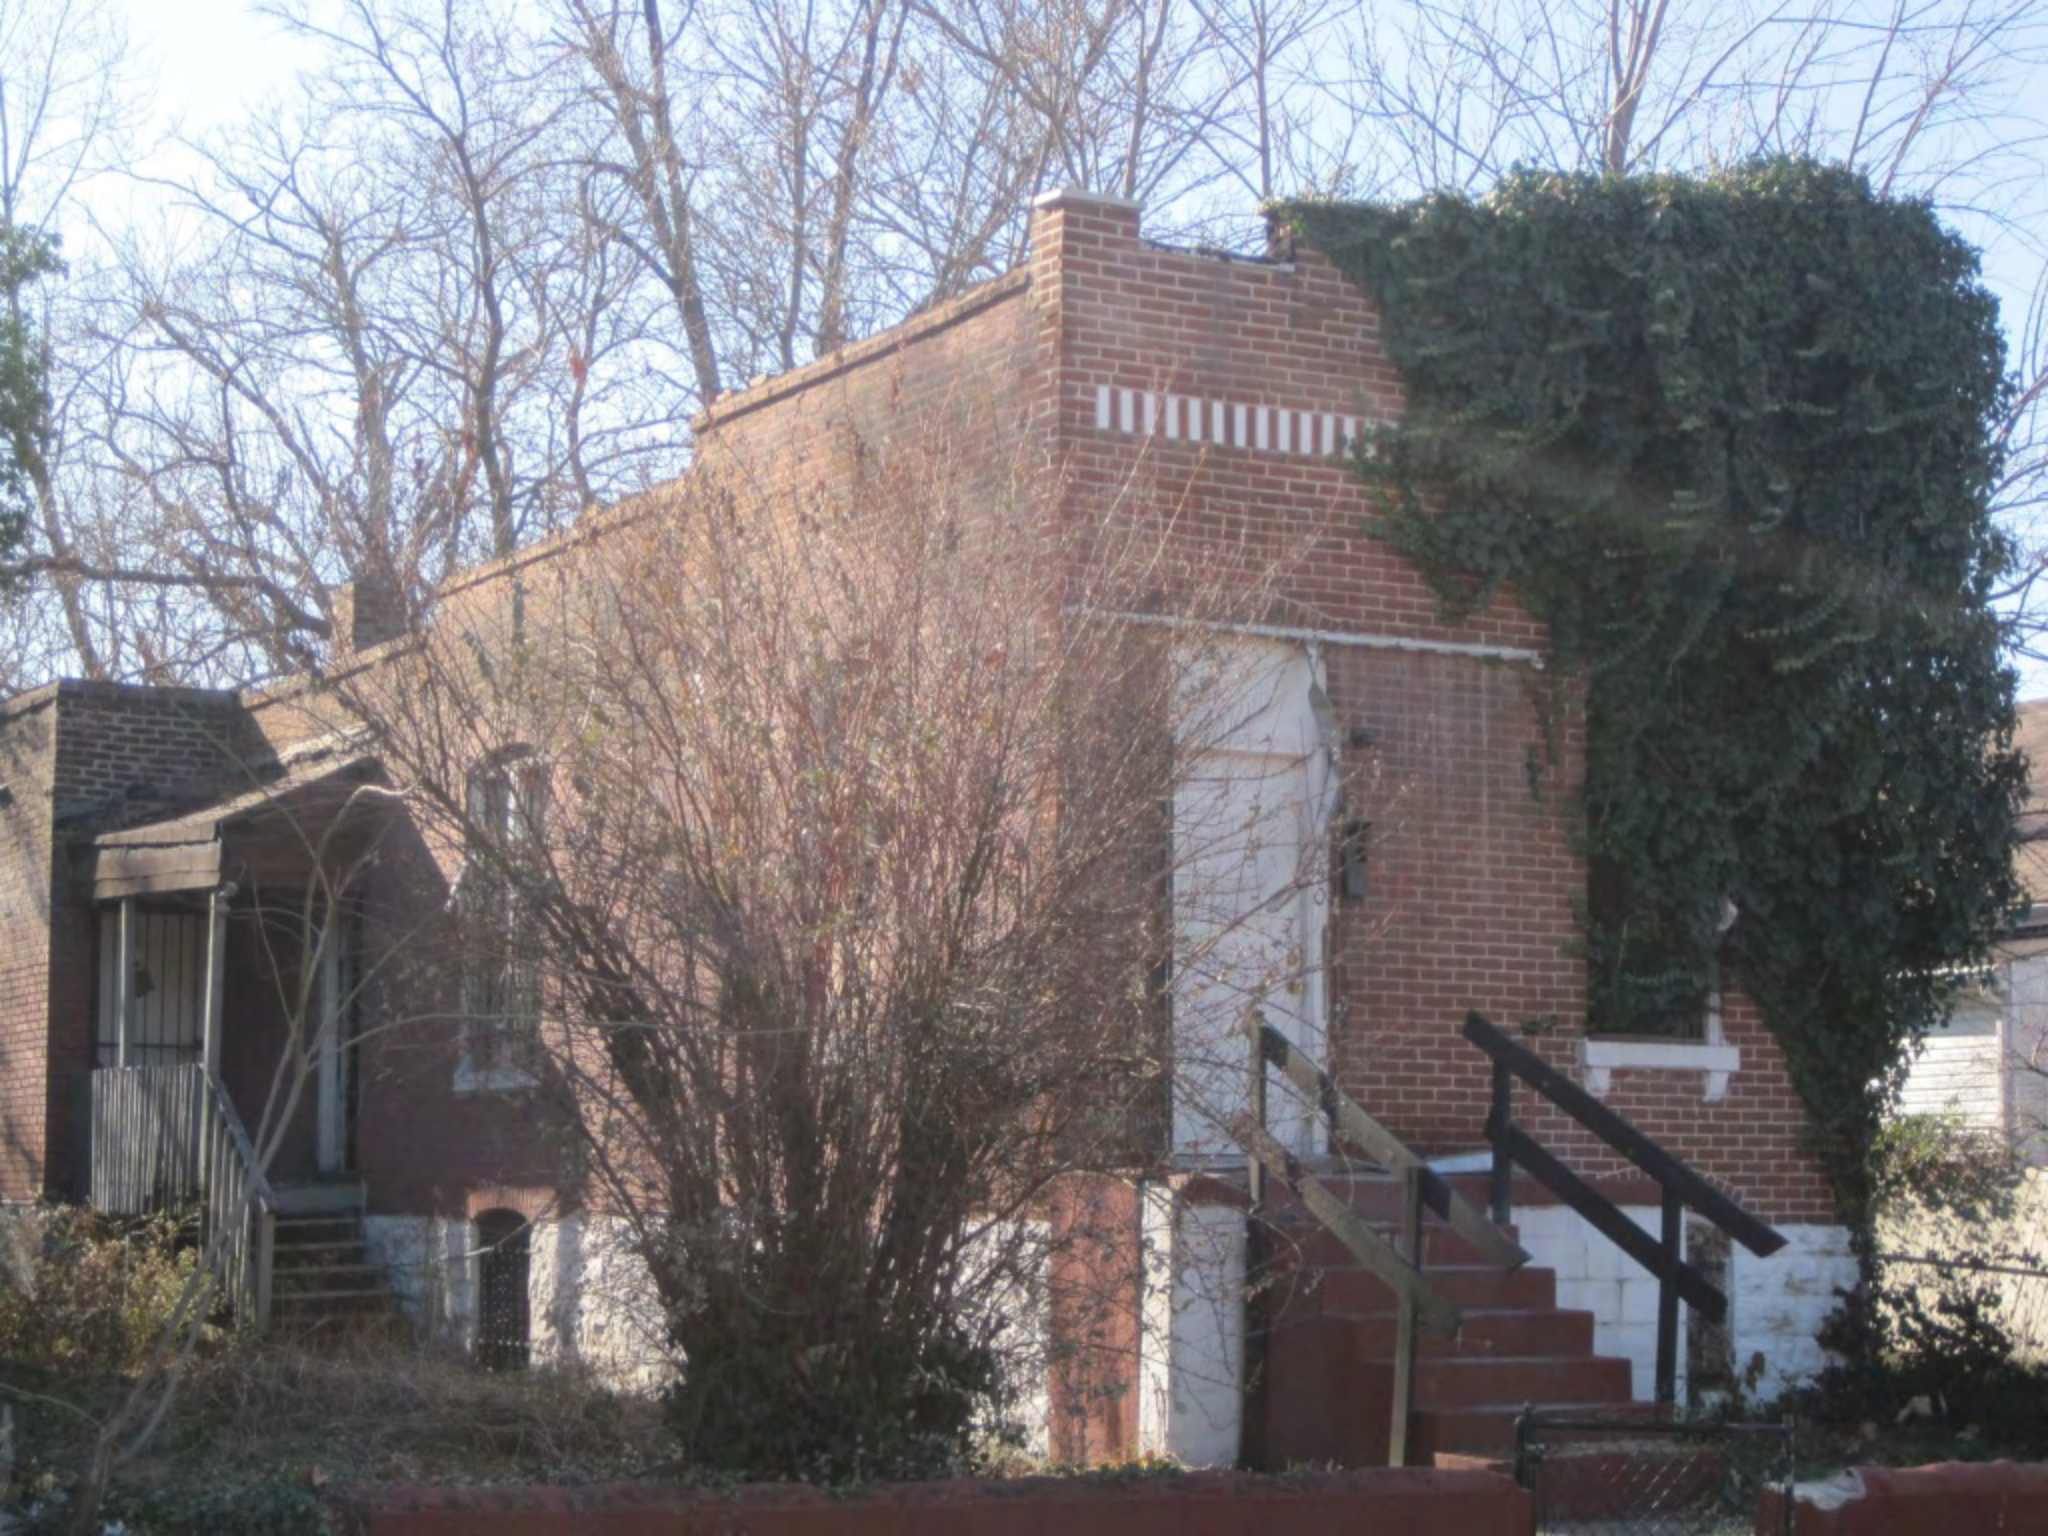
Rusticated painted stone foundation. Red brick. Concrete stoop with wooden railings. Entrance with segmental arch has replacement door. Window has stone sill and consoles as well as segmental arch; window missing. Parapet has soldier course of alternating red and bakery bricks. Parapet has center step and end blocks. Wooden shed-roof porch at rear leads to two secondary entrances.

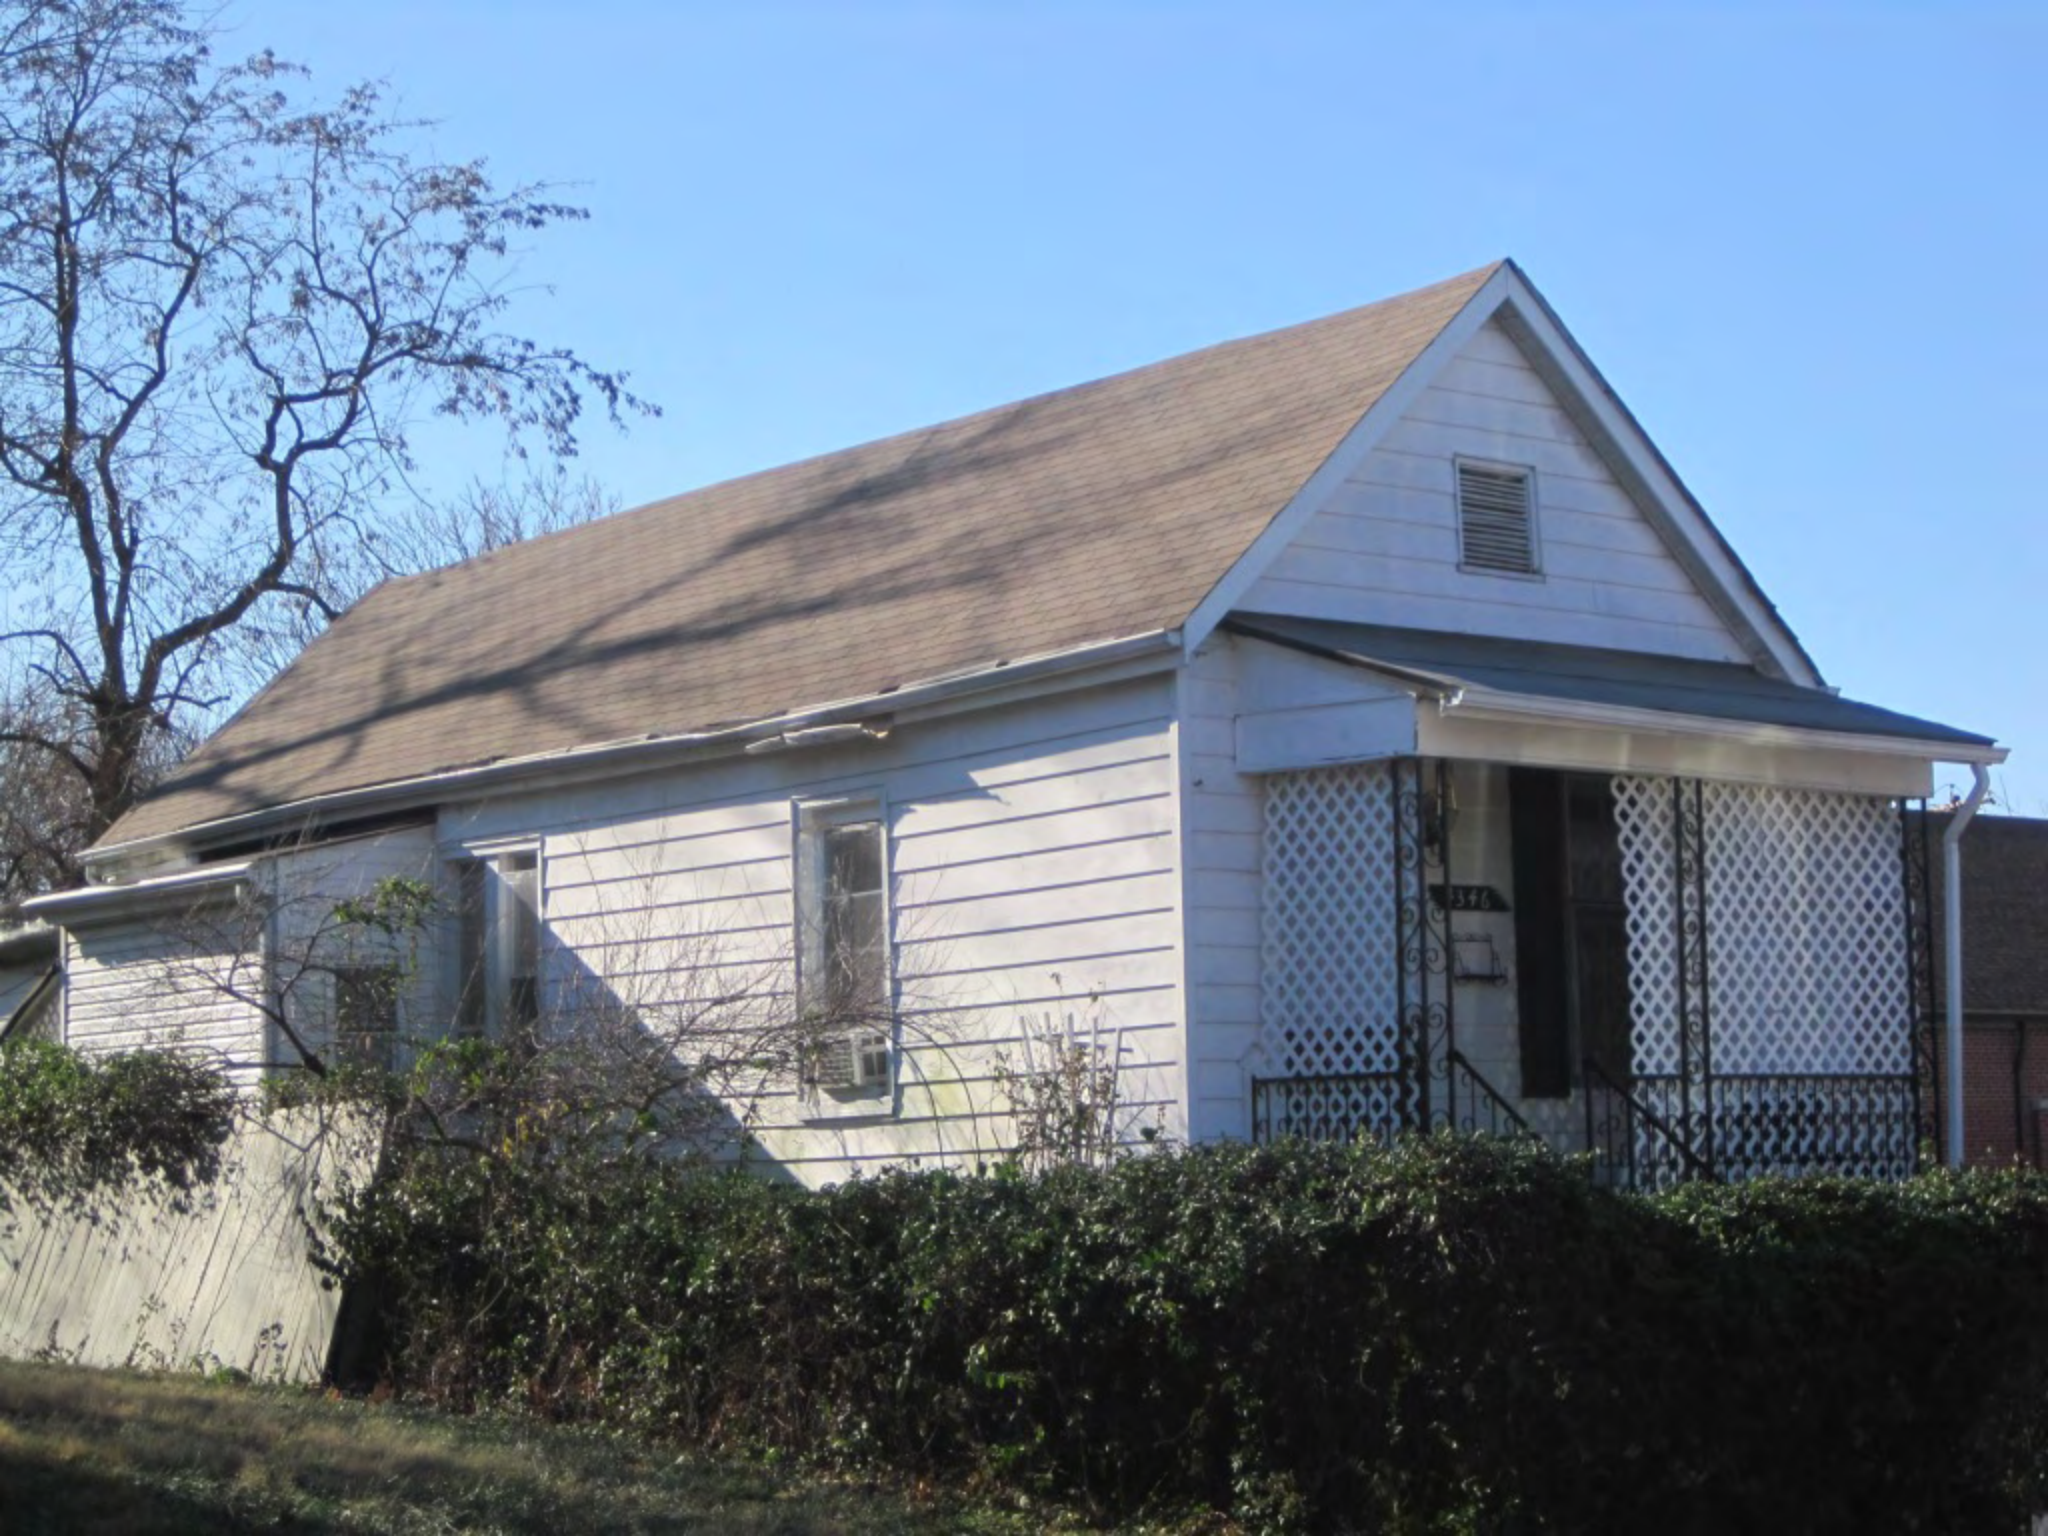
Concrete porch with shed roof and metal columns; wooden lattice hung on porch. Entrance with replacement door and window opening with wooden one-over-one window. Opening at gable end contains metal louvered-vent.

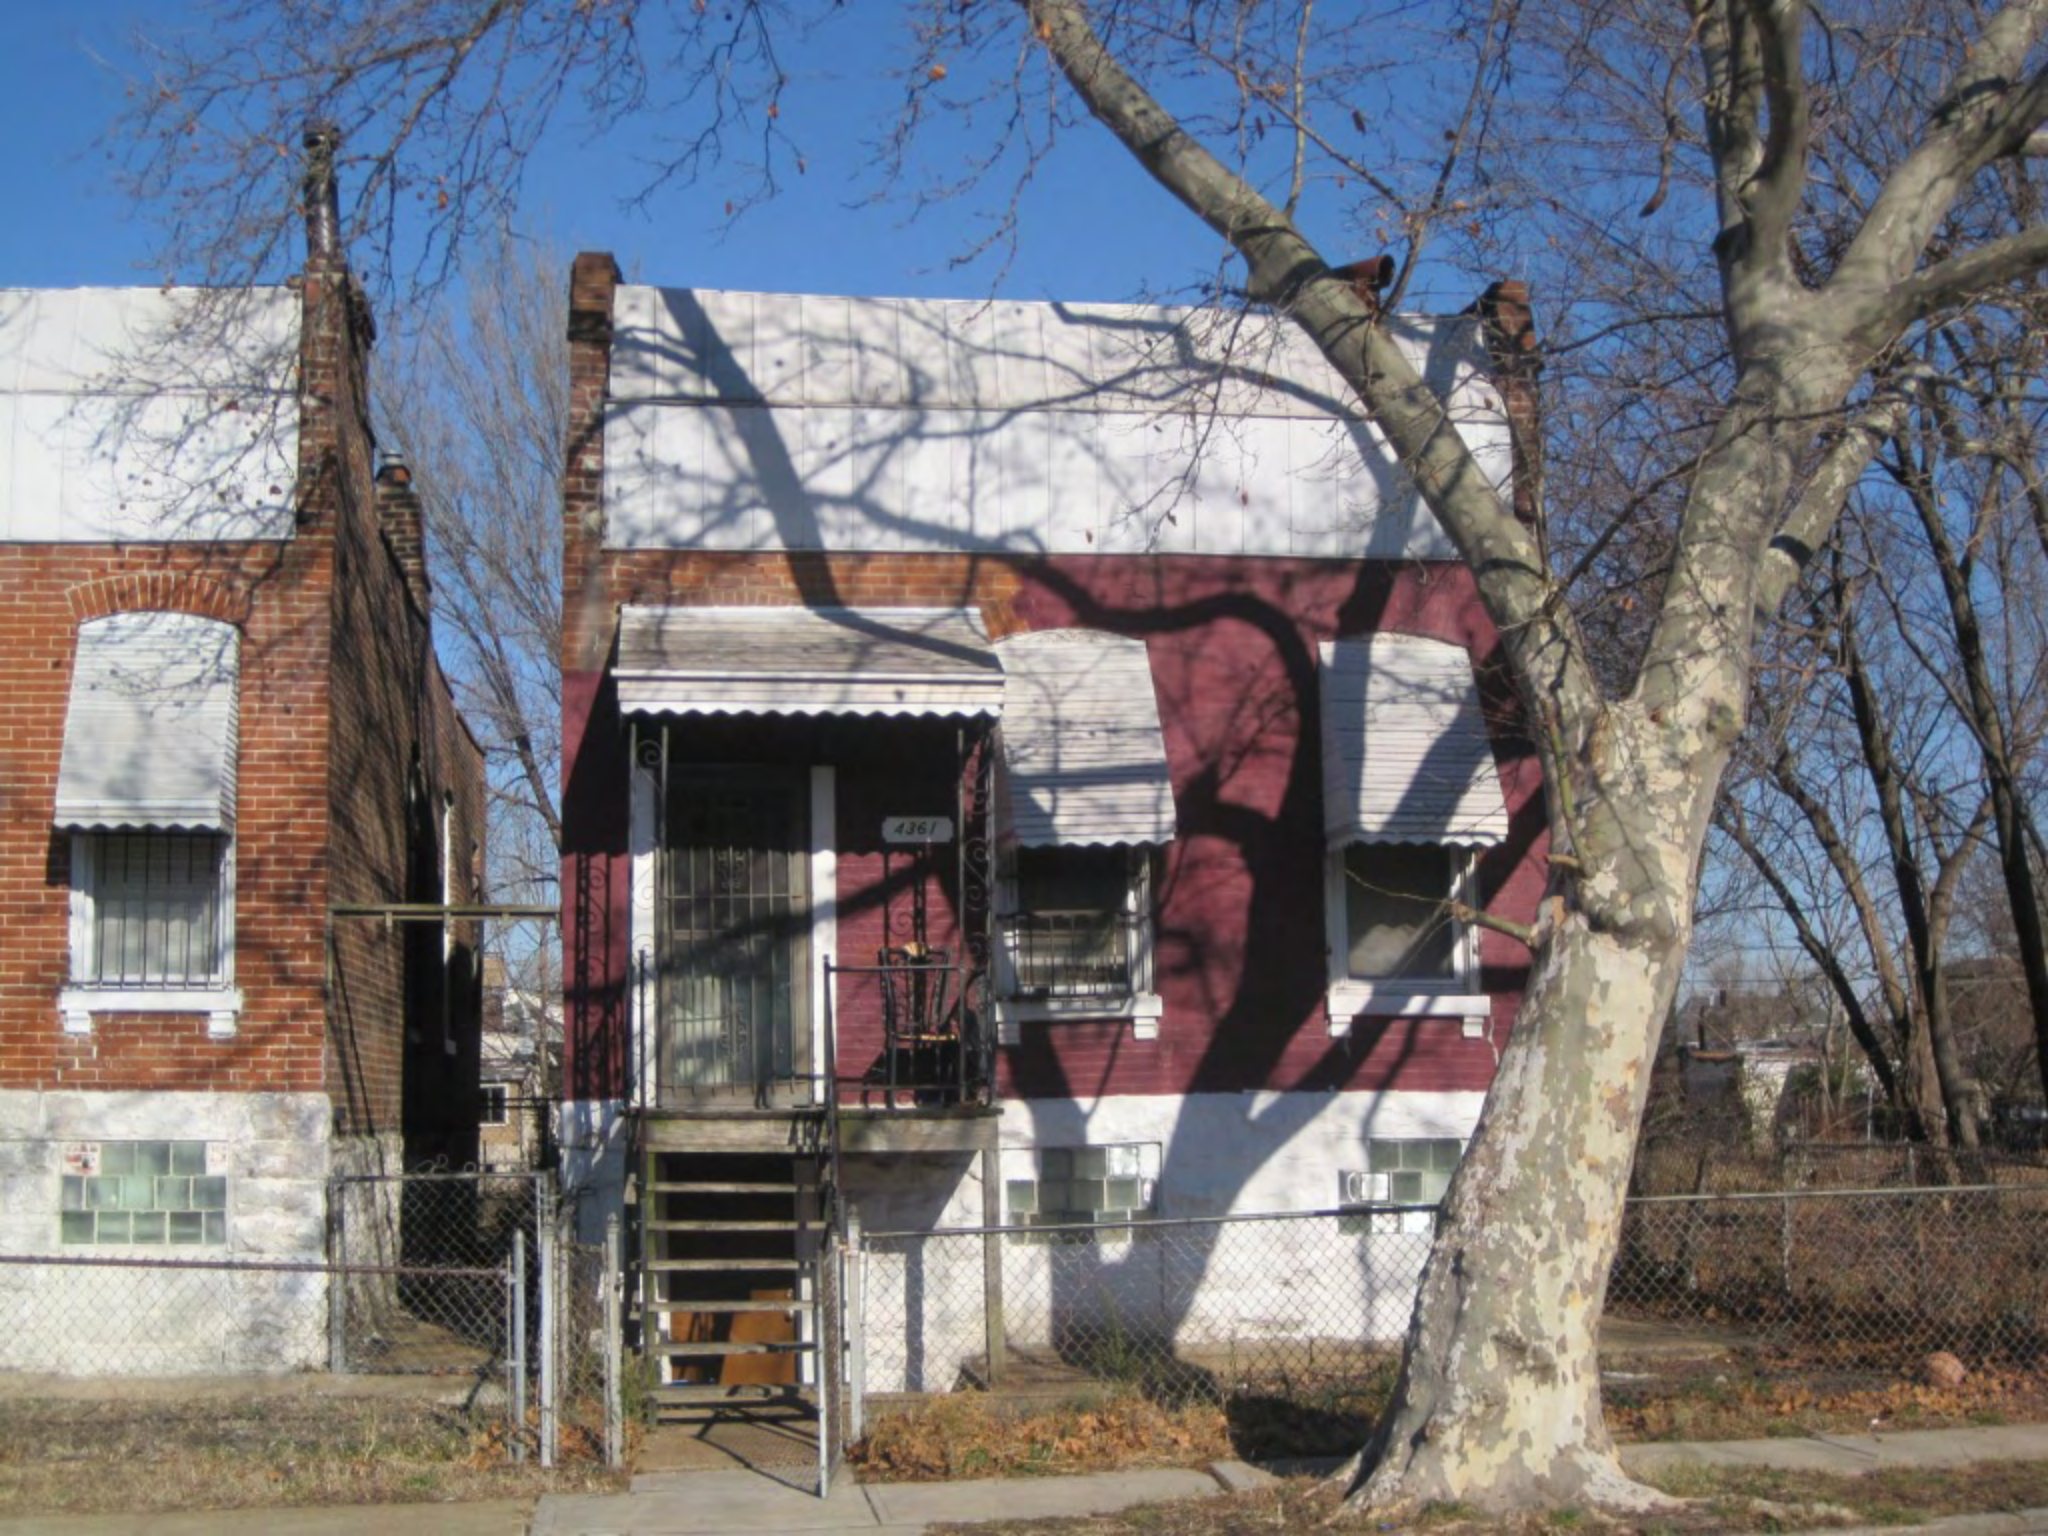
Painted rusticated limestone foundation and partially painted brick front elevation. Wooden porch with metal columns and awning. Entrance has replacement door. Basement has entrance under porch. Basement windows filled with glass block. First floor window openings have stone sills with consoles, segmental arches, wooden one-over-one windows and metal awnings. Brick parapets rise to each side of a false mansard clad in metal siding.
