Architectural/Historic Inventory Form

1. Survey No. SEC 15-036 290		2. Survey Name: Villie	
3. County: St. Louis [Independent City]		4. Address: 4452 KENNERLY AV	
5. City/State: St. Louis, MO		6. UTM: / /	
7. Township/Range/Section: T: R: S:		Not Applicable	
8. Historic Name (if known):		9. Present Name (if known):	
10. Ownership: Domestic		11. Present Use: Domestic	
12. Historic Use (if known): Sub-use: Single Dwelling		13. Present Use: Sub-use:

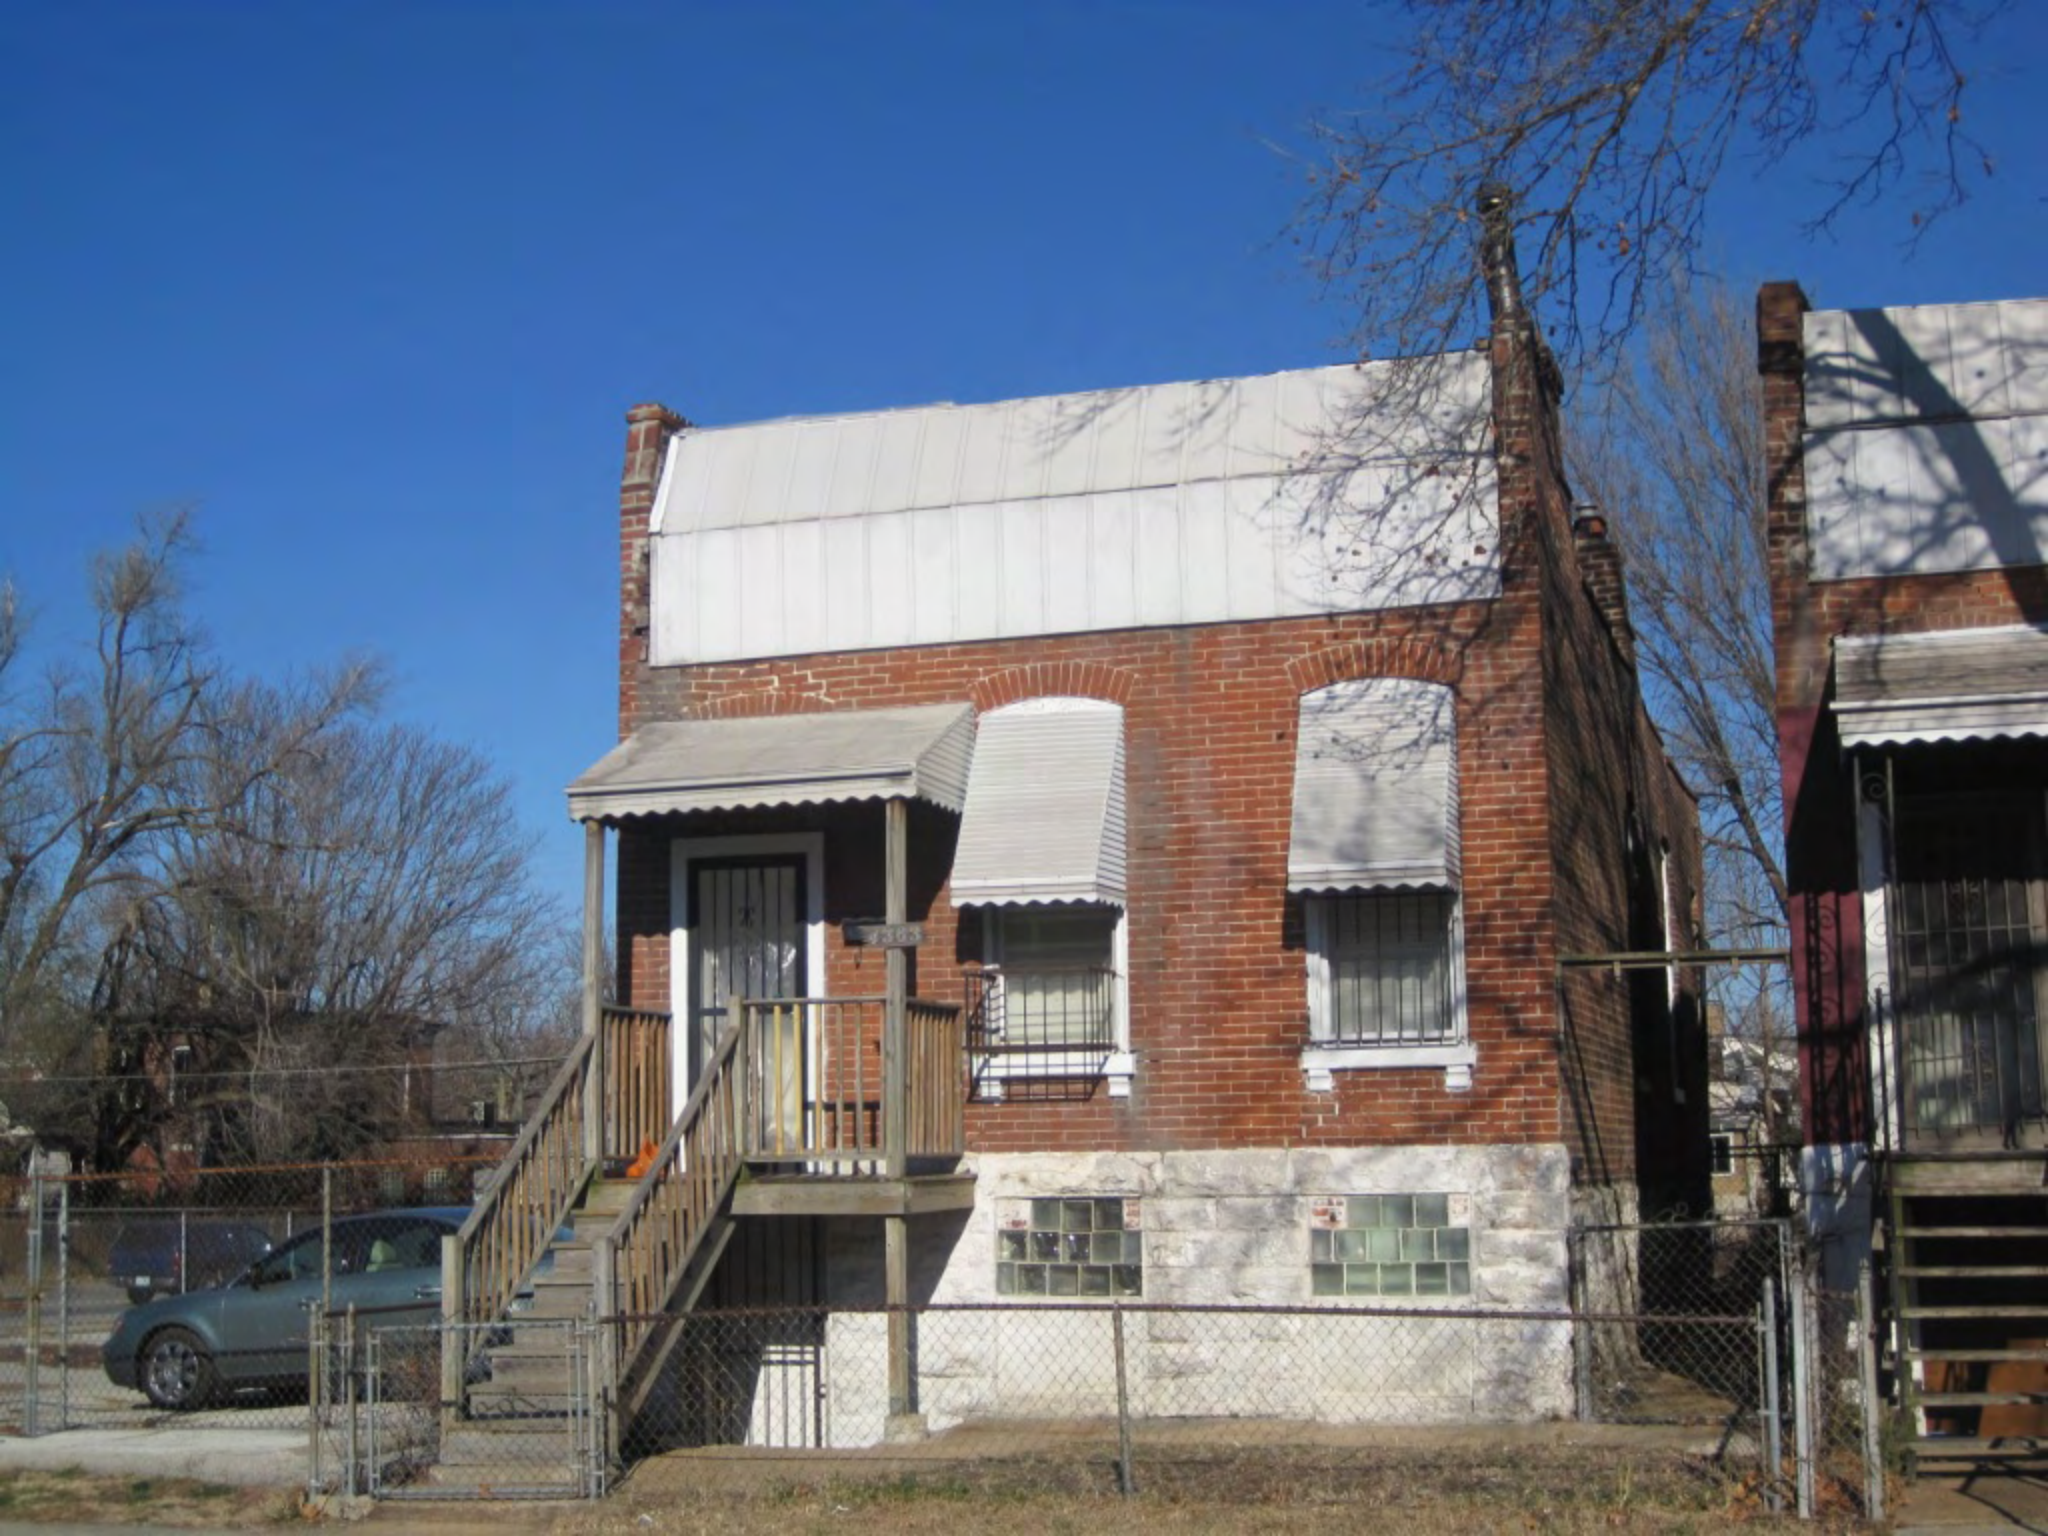
Painted rusticated limestone foundation and red brick front elevation. Wooden porch with metal columns and awning. Entrance has replacement door. Basement has entrance under porch. Basement windows filled with glass block. First floor window openings have stone sills with consoles, segmental arches, wooden one-over-one windows and metal awnings. Brick parapets rise to each side of a false mansard clad in metal siding.

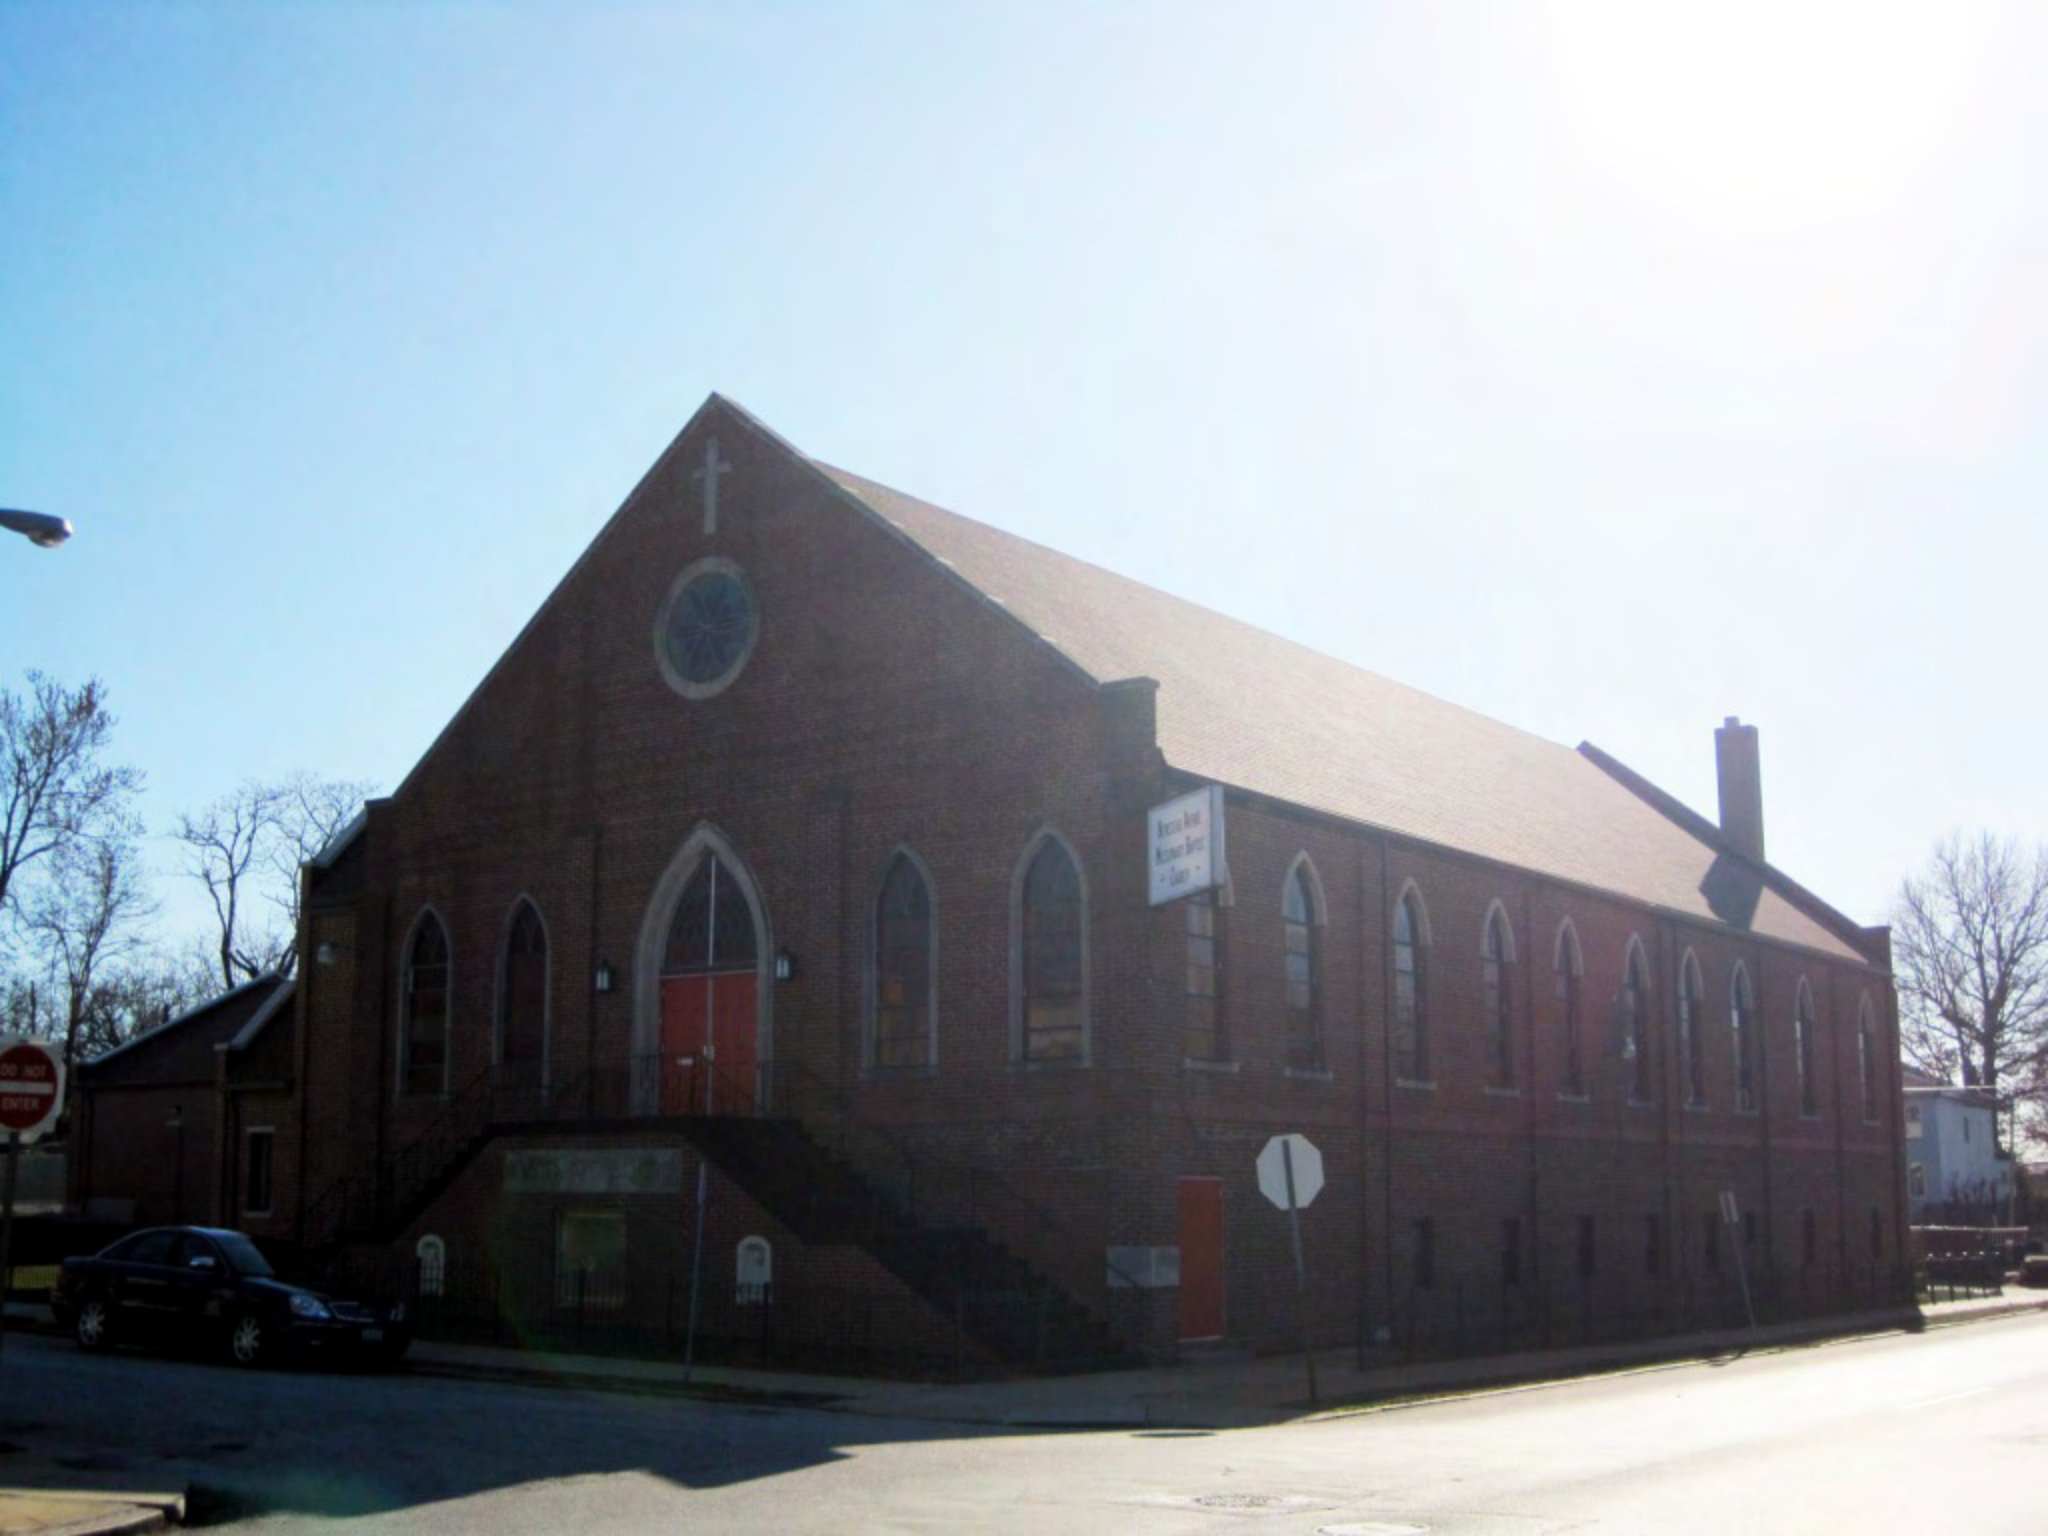
Large red brick church has shallow buttress piers between paired window openings. Window openings have stone sills and headers forming lancet arches; windows are stained glass set in metal segments. A brick wall faces the stairs and stoop leading to the entrance, raised almost a full story off of the sidewalk. The entrance is fully surrounded in limestone forming a lancet arch; double metal doors are under a stained glass transom within. A limestone-surrounded stained glass rosette window is above, and a small stone cross is embedded at the top center of the gable end. There is a large, recent brick addition to the east of the church building.

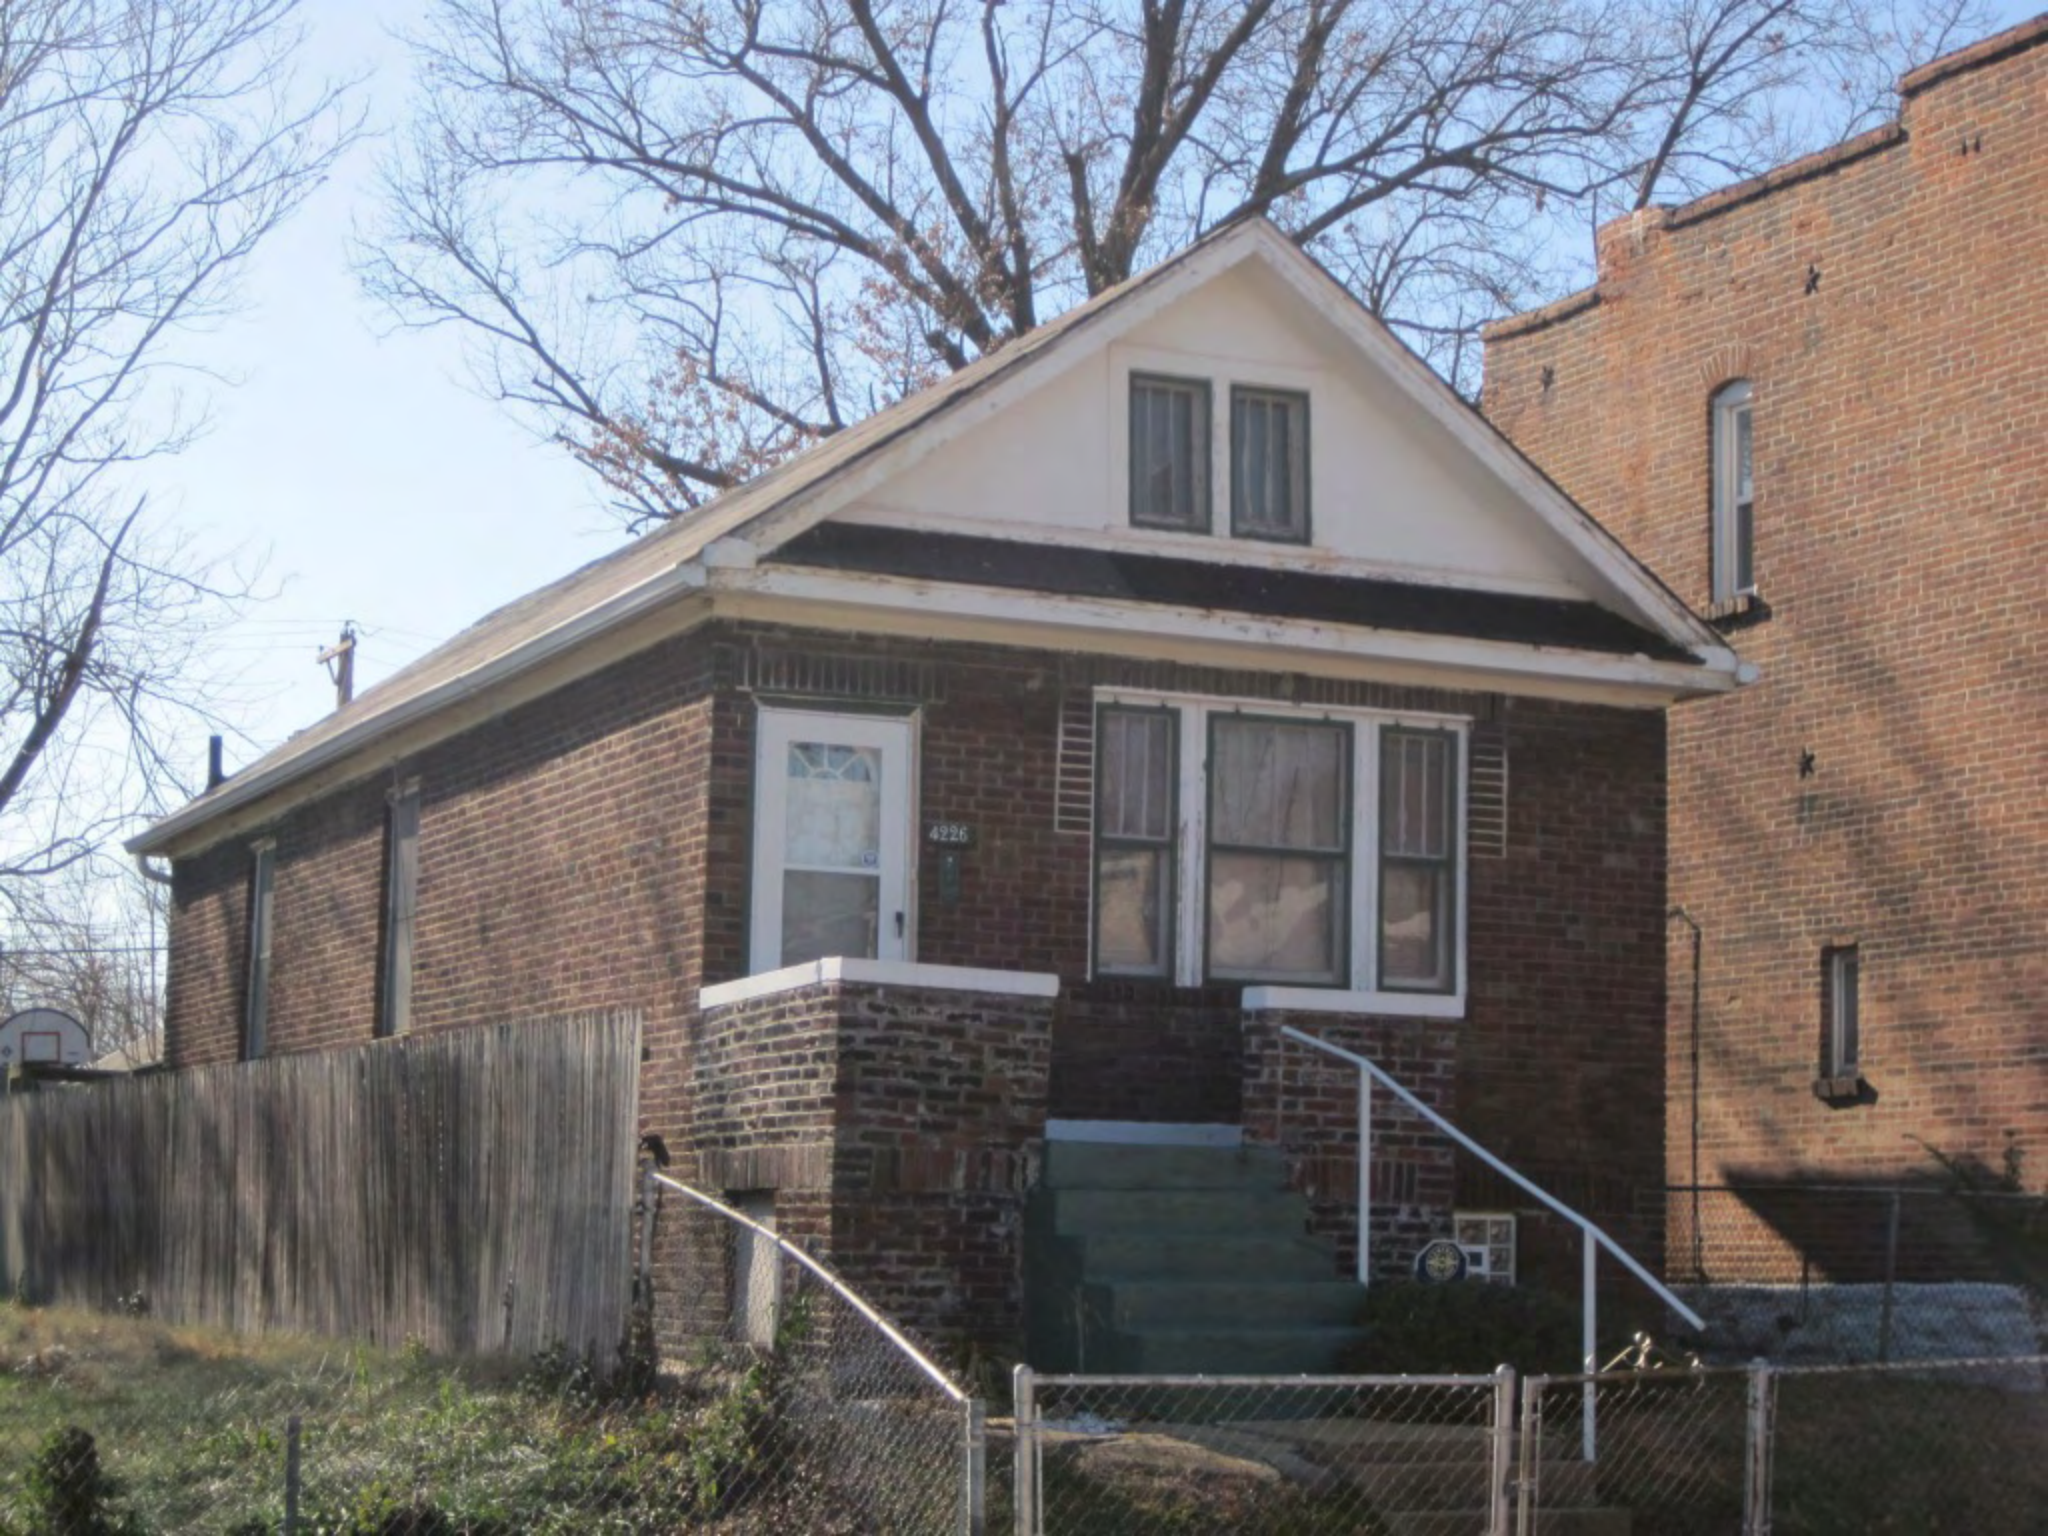
Machine-raked brown brick. Concrete steps to stoop, which has brick walls and stone coping. A soldier course runs across the walls at stoop level. Entrance has soldier course header and contains replacement door. Opening at right has brick rowlock sill, triple window (wooden, one-over-one) and soldier label course. Projecting gable end has shallow shed roof at base and wooden siding on gable end. Wood vergeboards. Paired wooden single-pane windows in gable end.

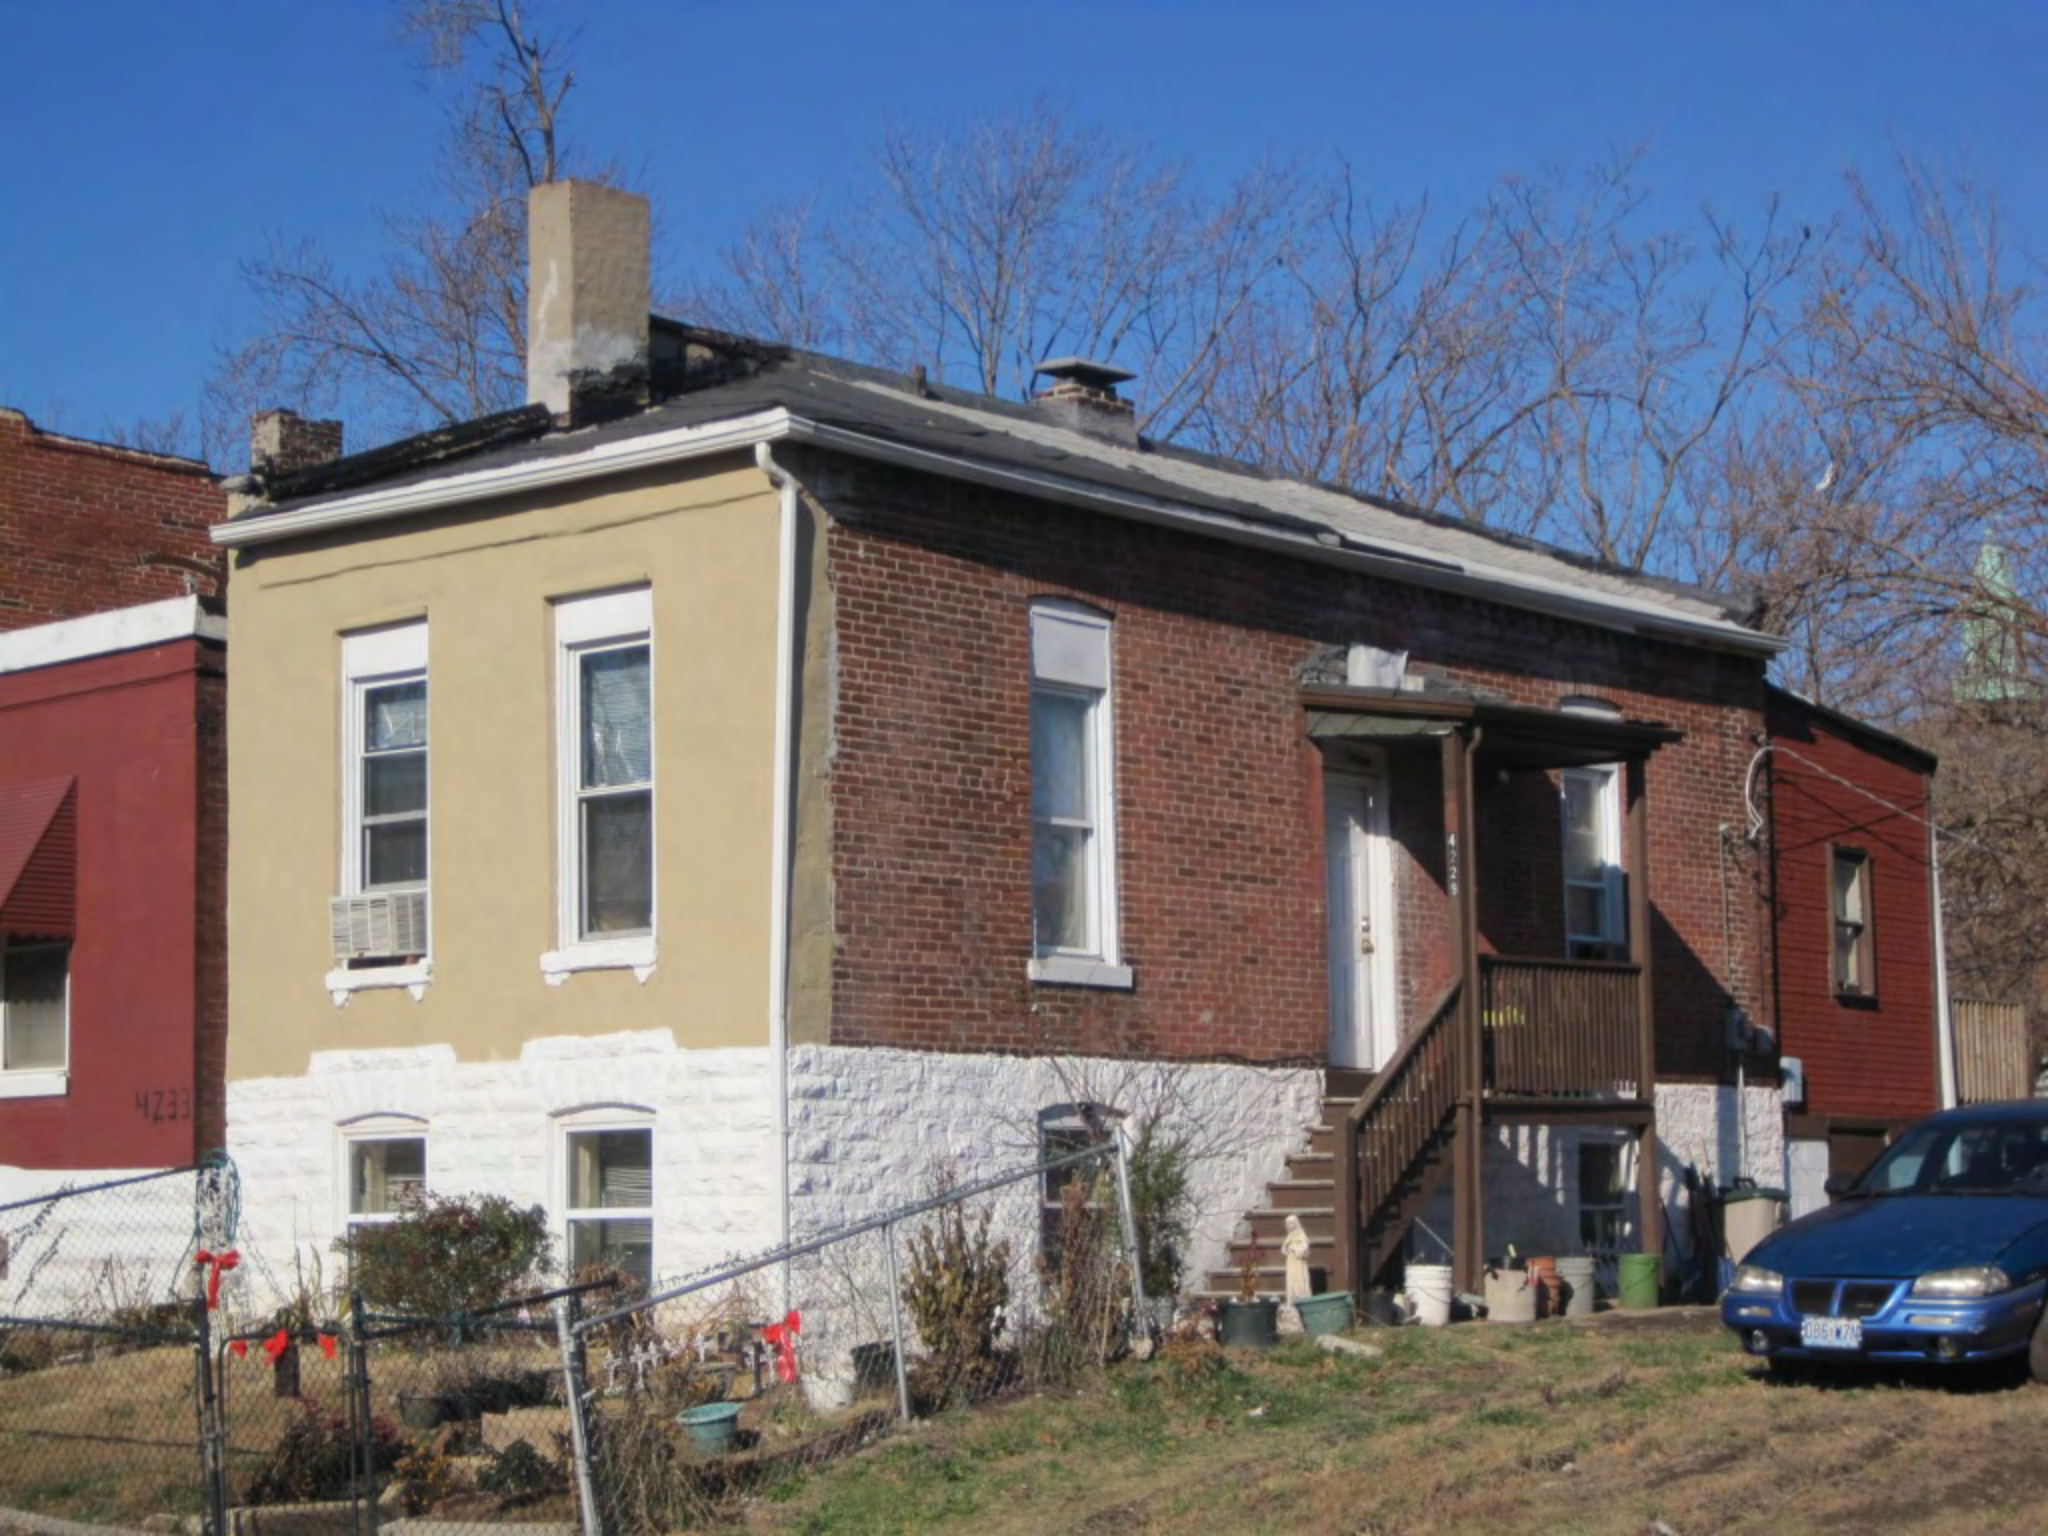
Painted front elevation and foundation. Front elevation parged, while side walls are red brick. Rusticated stone foundation, high basement. Entrance on side elevation off of wooden porch with shed roof. Basement openings have segmental arches and stone sills. Window openings on front elevation have flat arches and stone sills with consoles. Replacement windows with wooden infill headers. There is a shed-roofed addition clad in asphalt roll siding at rear.

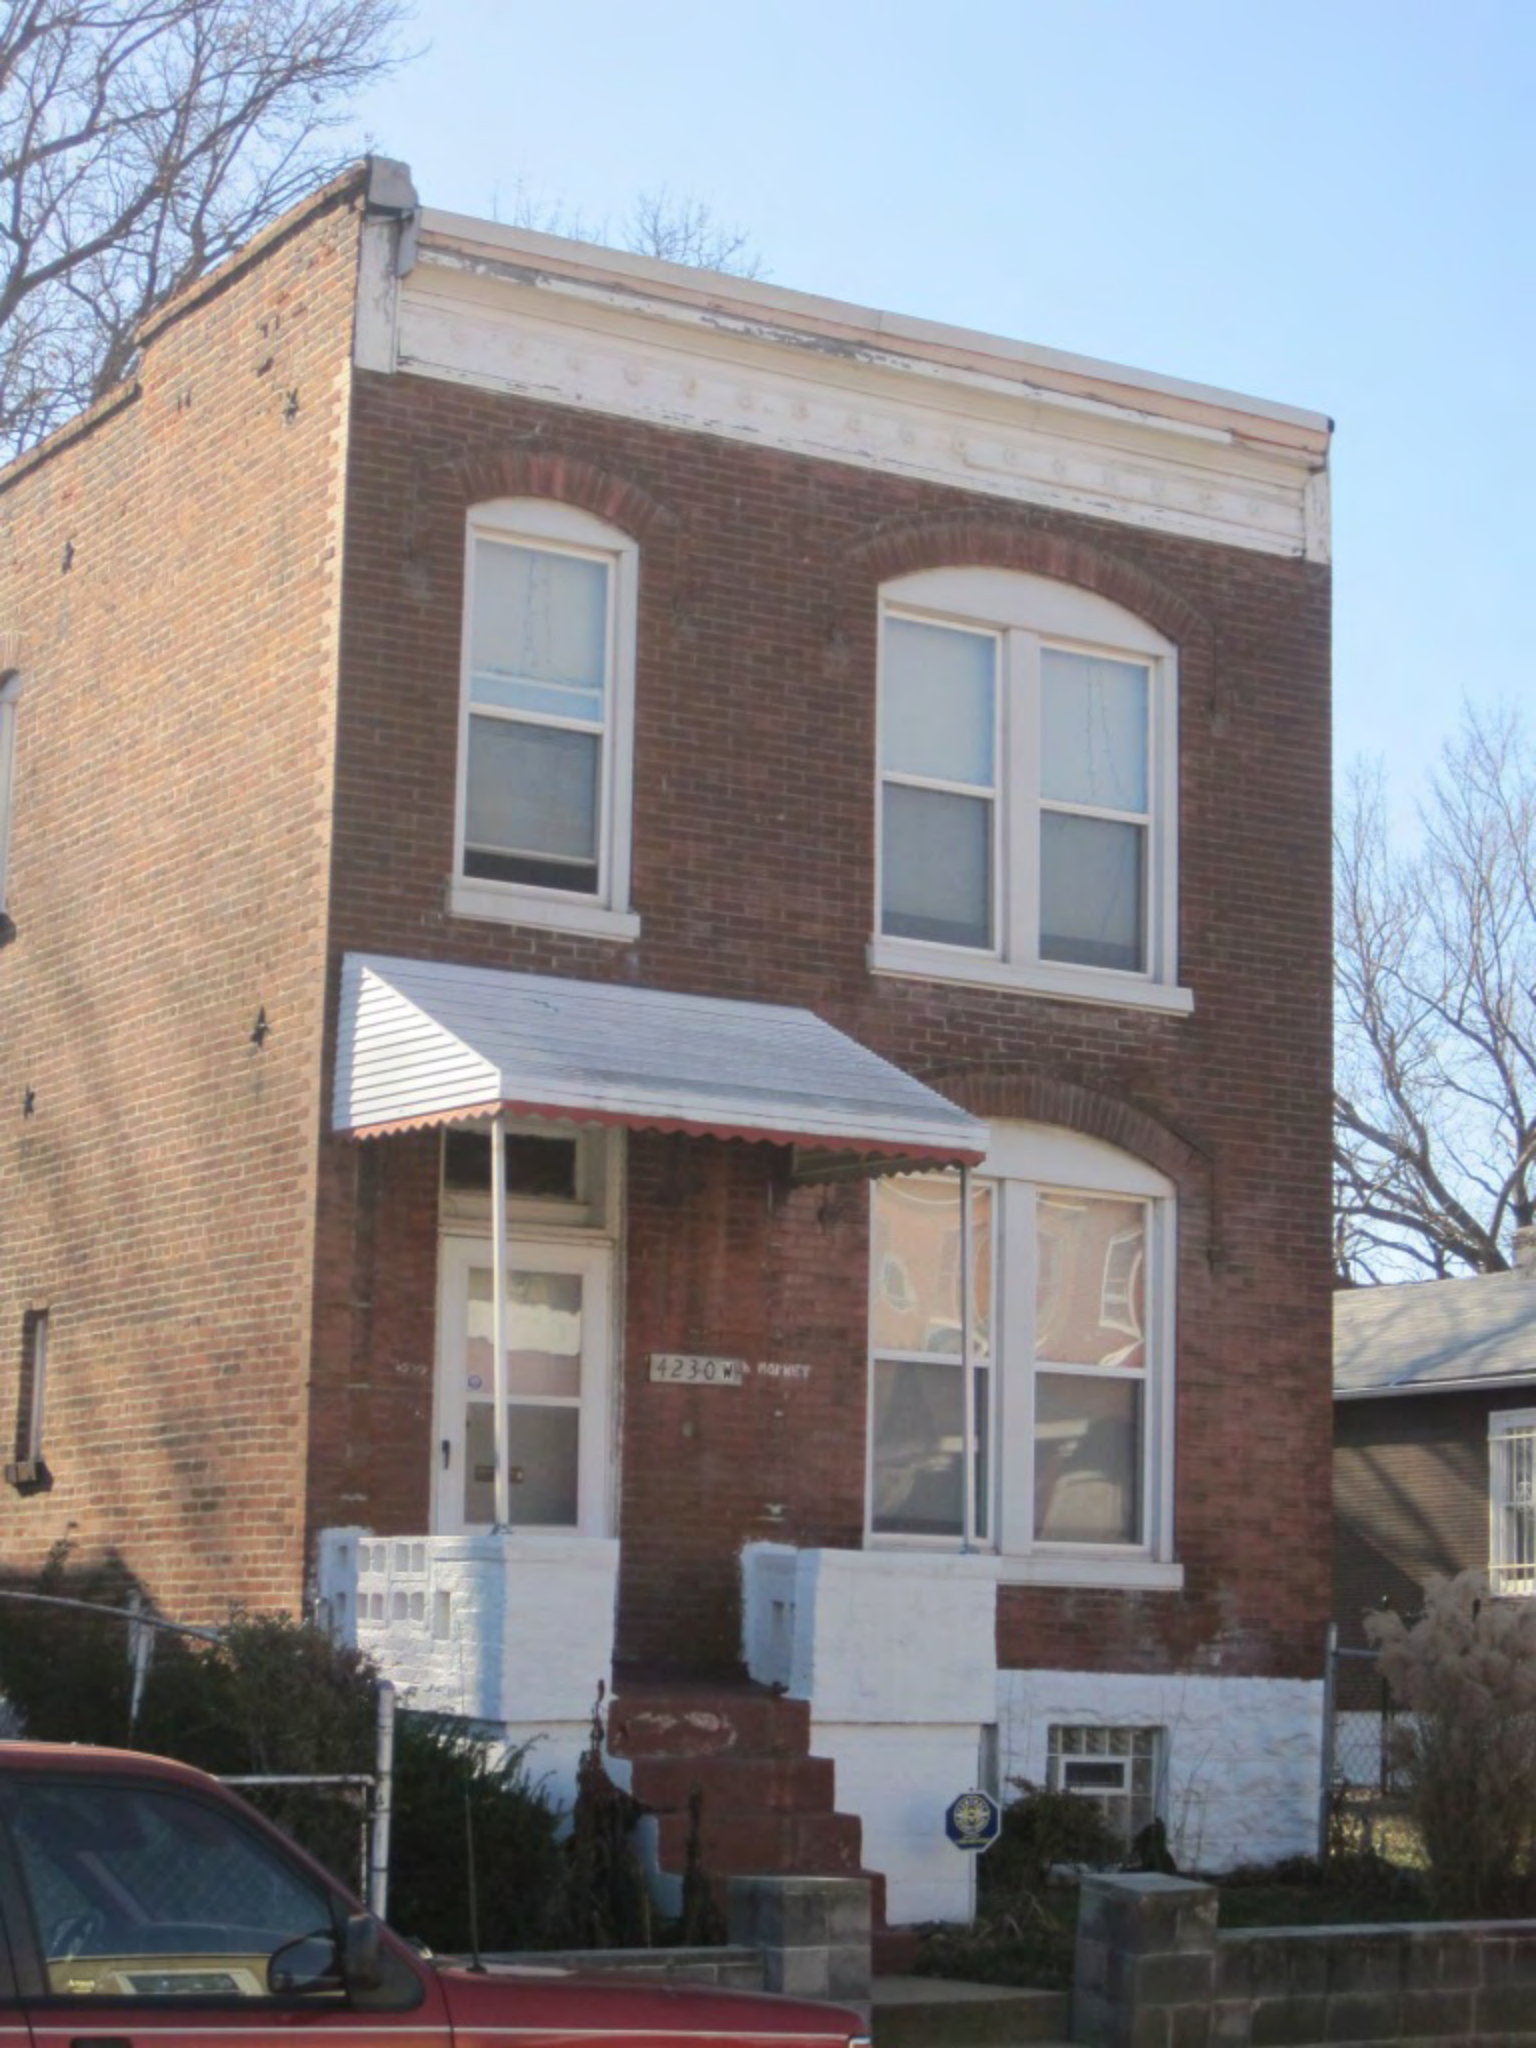
Painted, rusticated stone foundation. Red brick walls. Concrete block porch and knee walls, with metal columns and awning. Openings have soldier label courses with projecting tracing courses. Sills are wrapped in metal. Entrance has replacement door and wrapped transom window. Windows are replacements. Wooden cornice at top has ornamental fascia and projecting crown.

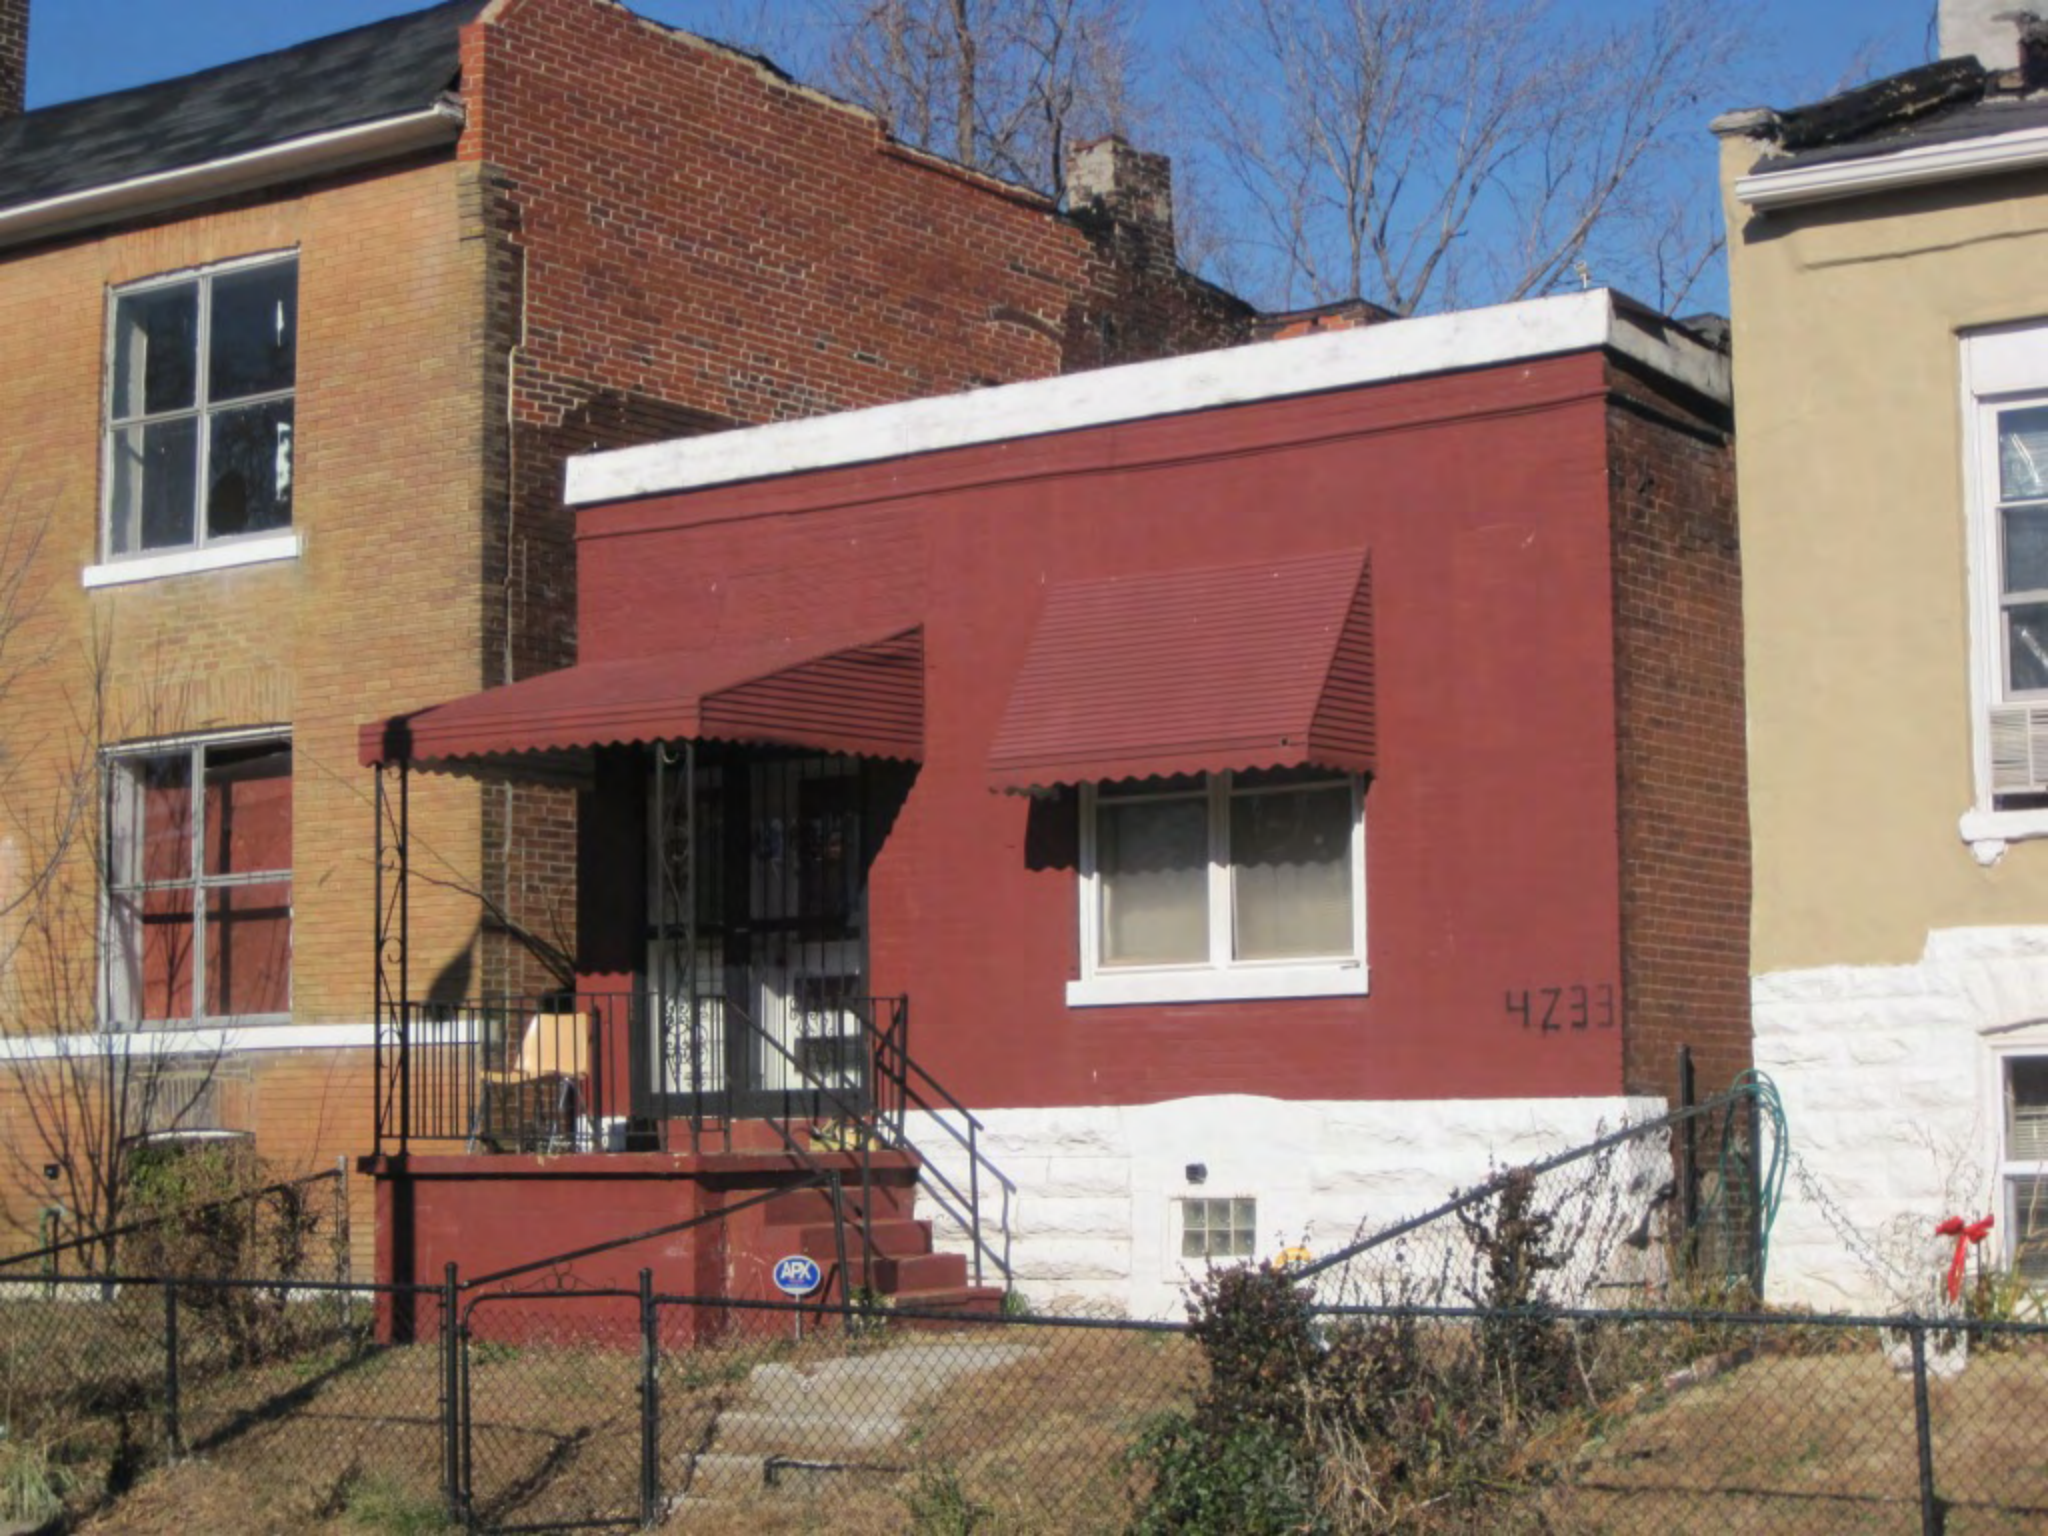
Painted front elevation; red brick side walls. Rusticated stone foundation. Concrete block stoop with metal rails and columns supporting an awning. Entrance has segmental arch and wooden door, sidelight window and transom window. Window opening has wrapped sill, segmental arch, paired one-over-one windows and metal awning. Basement opening partly filled around glass block and vent. Tracing course runs across front elevation and wraps sides. Parapet above wrapped with metal.

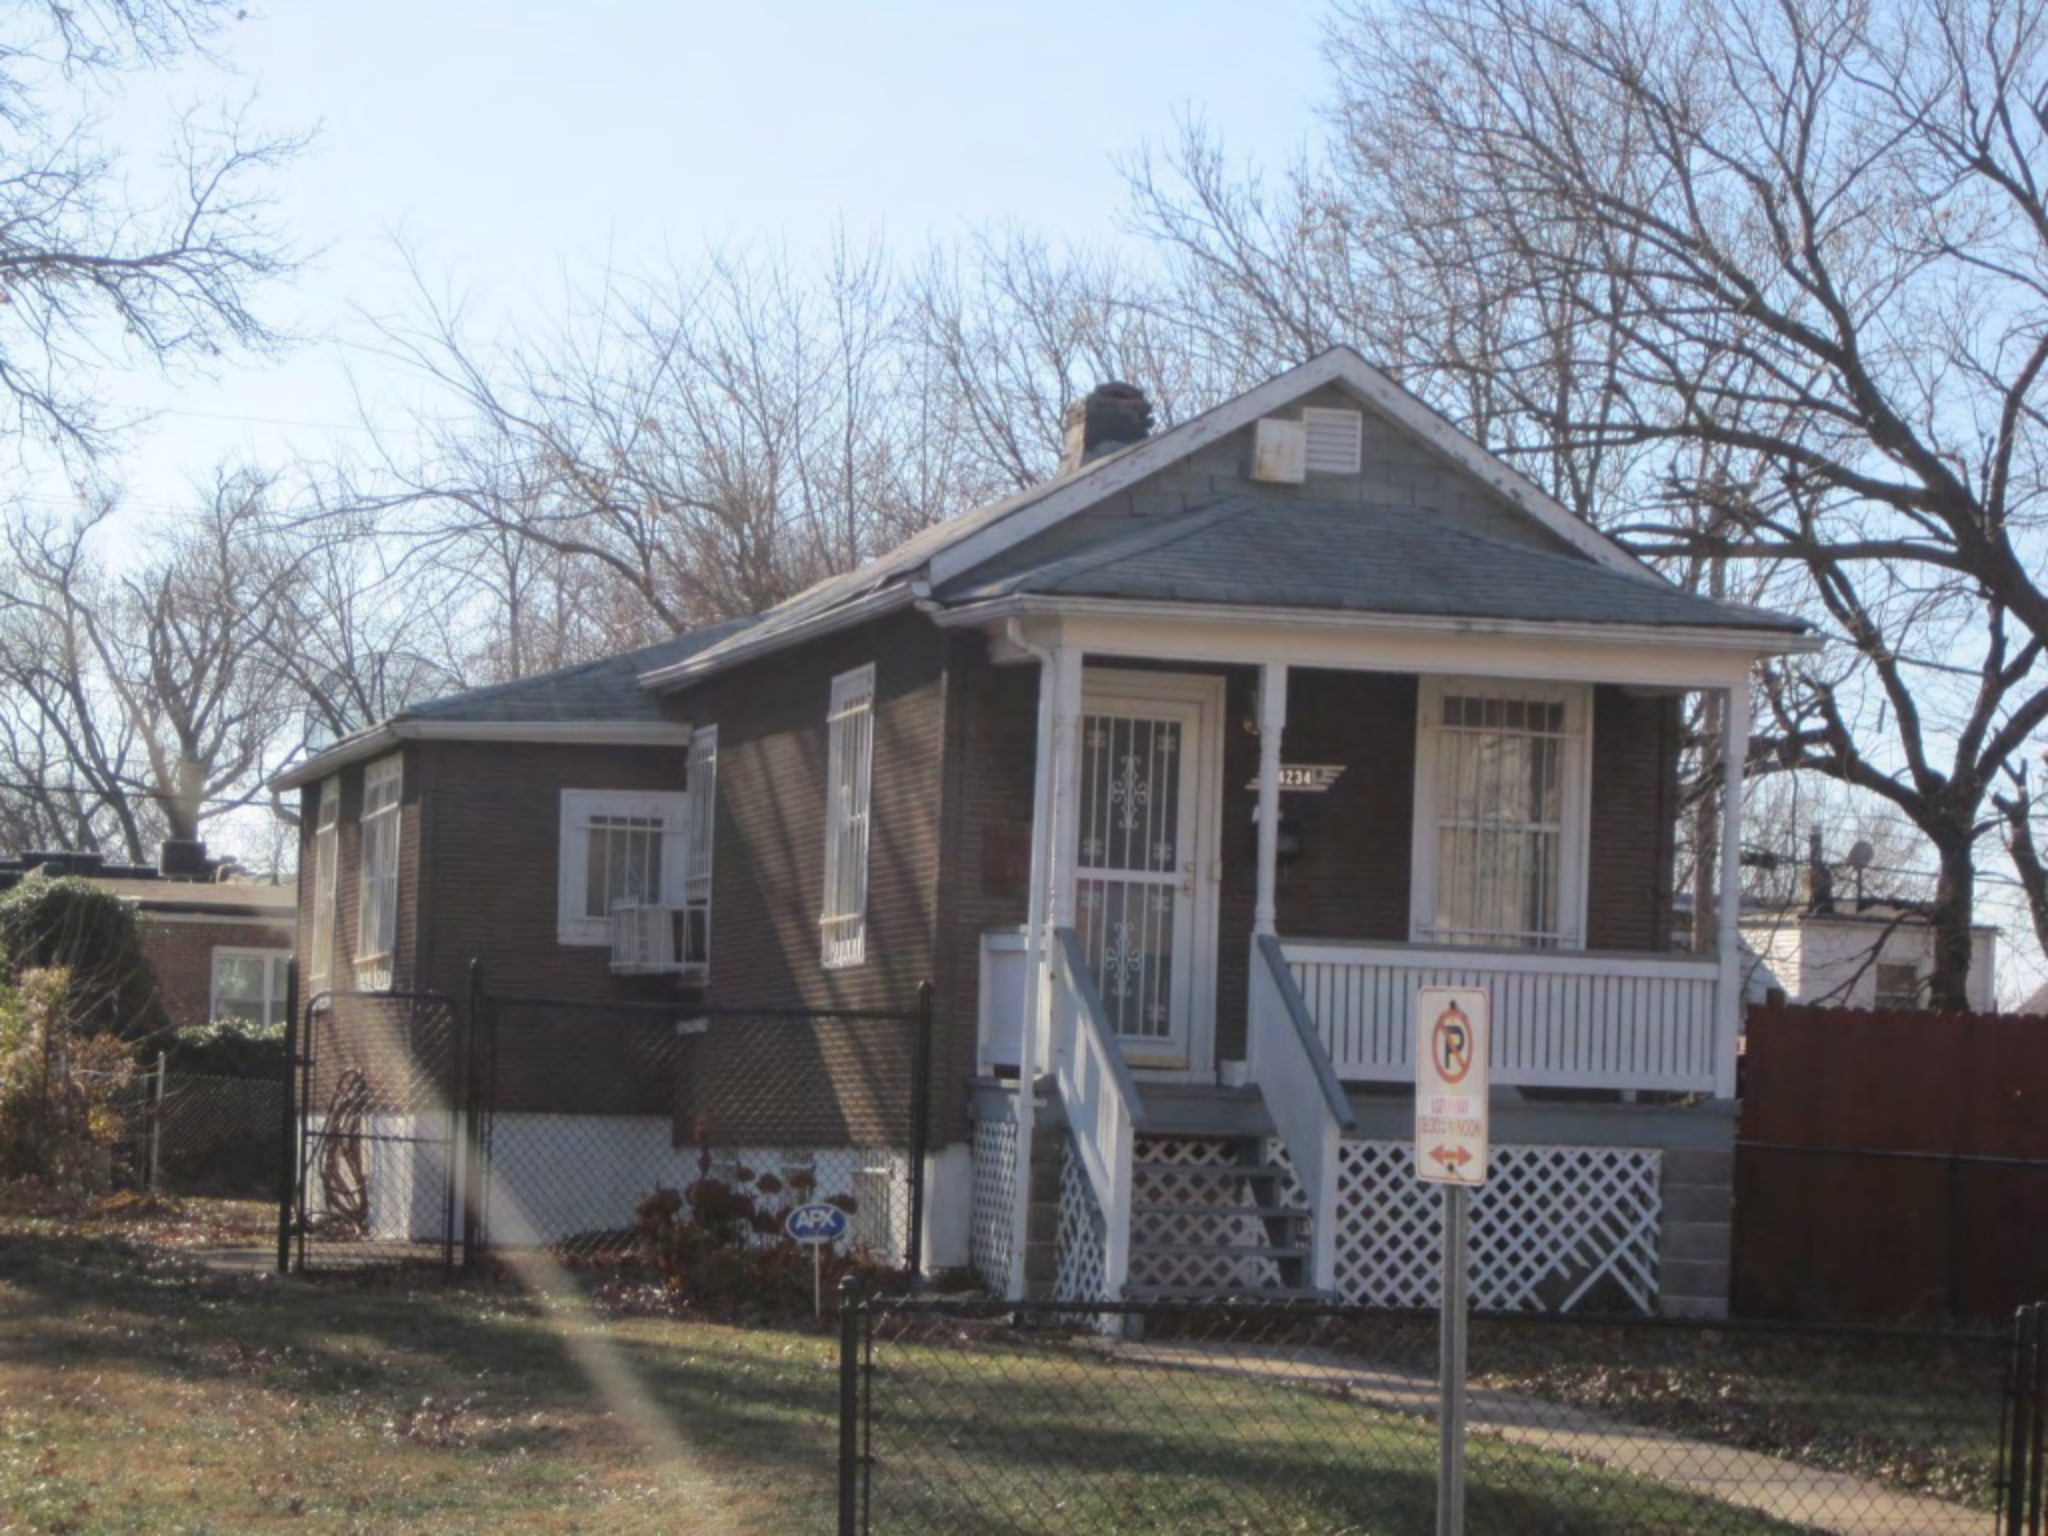
At this front gabled house, the full-width porch has wooden steps, lattice skirt, and hipped roof. Entrance has replacement door and security door. Window opening covered in metals bars but has wooden one-over-one window. Asphalt siding. Addition at east side with hipped roof.
