Architectural/Historic Inventory Form

1. Survey No. SEC 15-036 290		2. Survey Name: Villie	
3. County: St. Louis [Independent City]		4. Address: 4452 KENNERLY AV	
5. City/State: St. Louis, MO		6. UTM: / /	
7. Township/Range/Section: T: R: S:		Not Applicable	
8. Historic Name (if known):		9. Present Name (if known):	
10. Ownership: Domestic		11. Present Use: Domestic	
12. Historic Use (if known): Sub-use: Single Dwelling		13. Present Use: Sub-use:

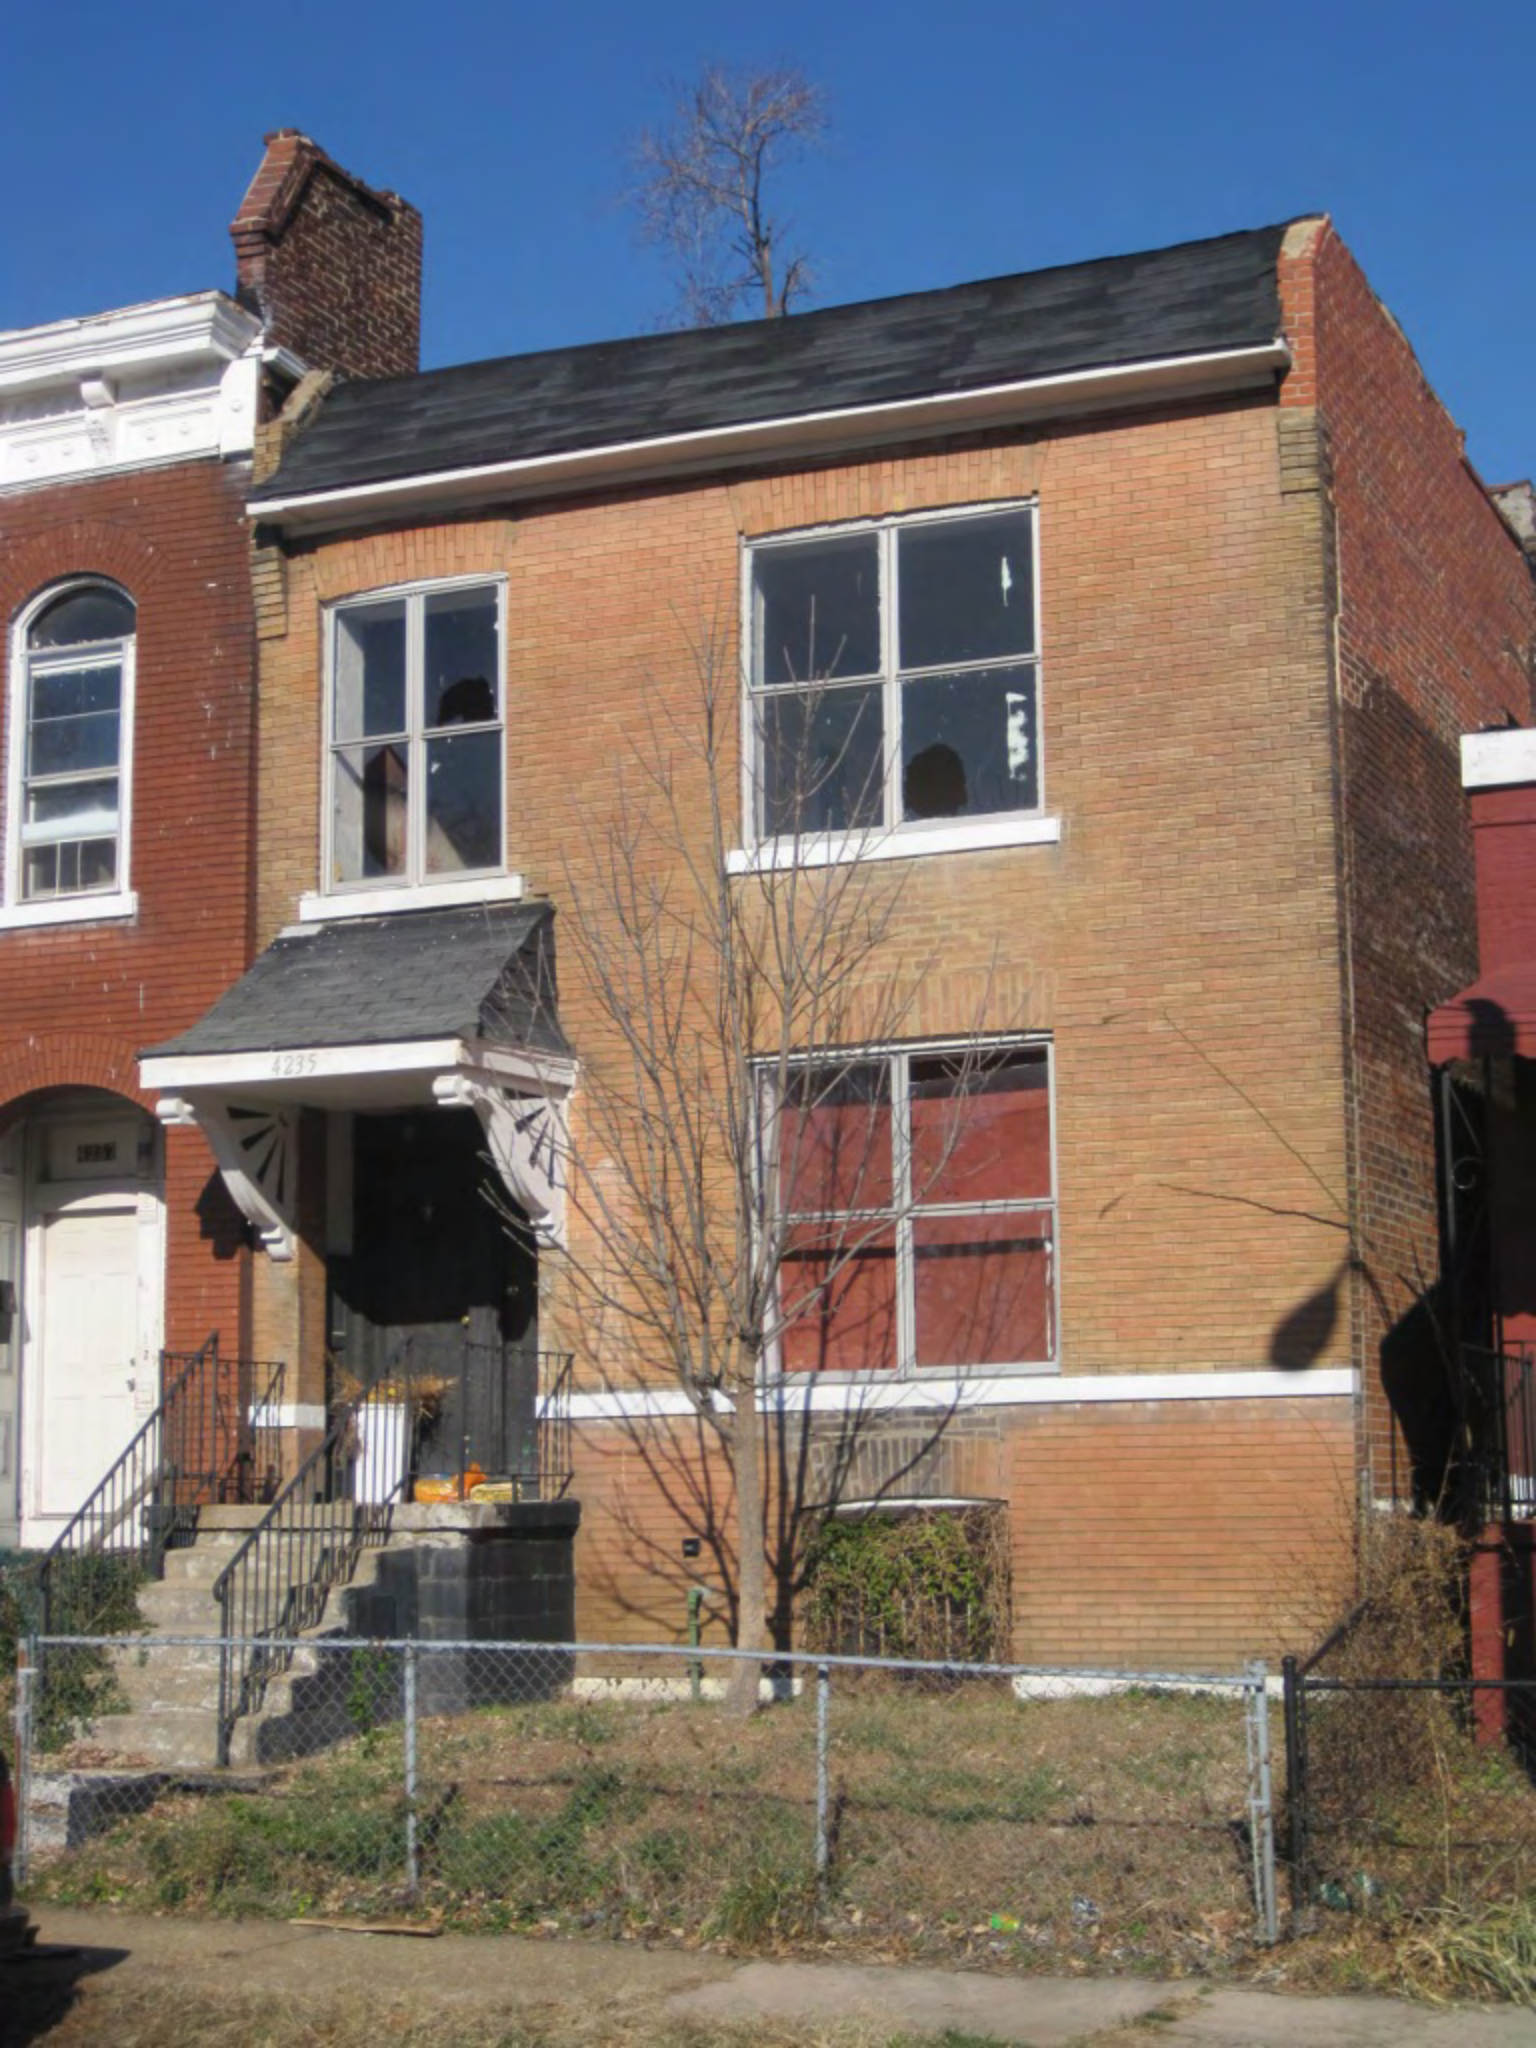
Buff brick front wall, red brick side walls. Concrete block stoop with shed-roofed wooden hood supported by ornate curved wooden openwork brackets. Recessed entrance with two replacement doors. Stone sill course at first floor window opening level, and stone sills on second floor. Openings have vertical brick headers. Windows are replacements. False mansard above clad in asphalt shingles.

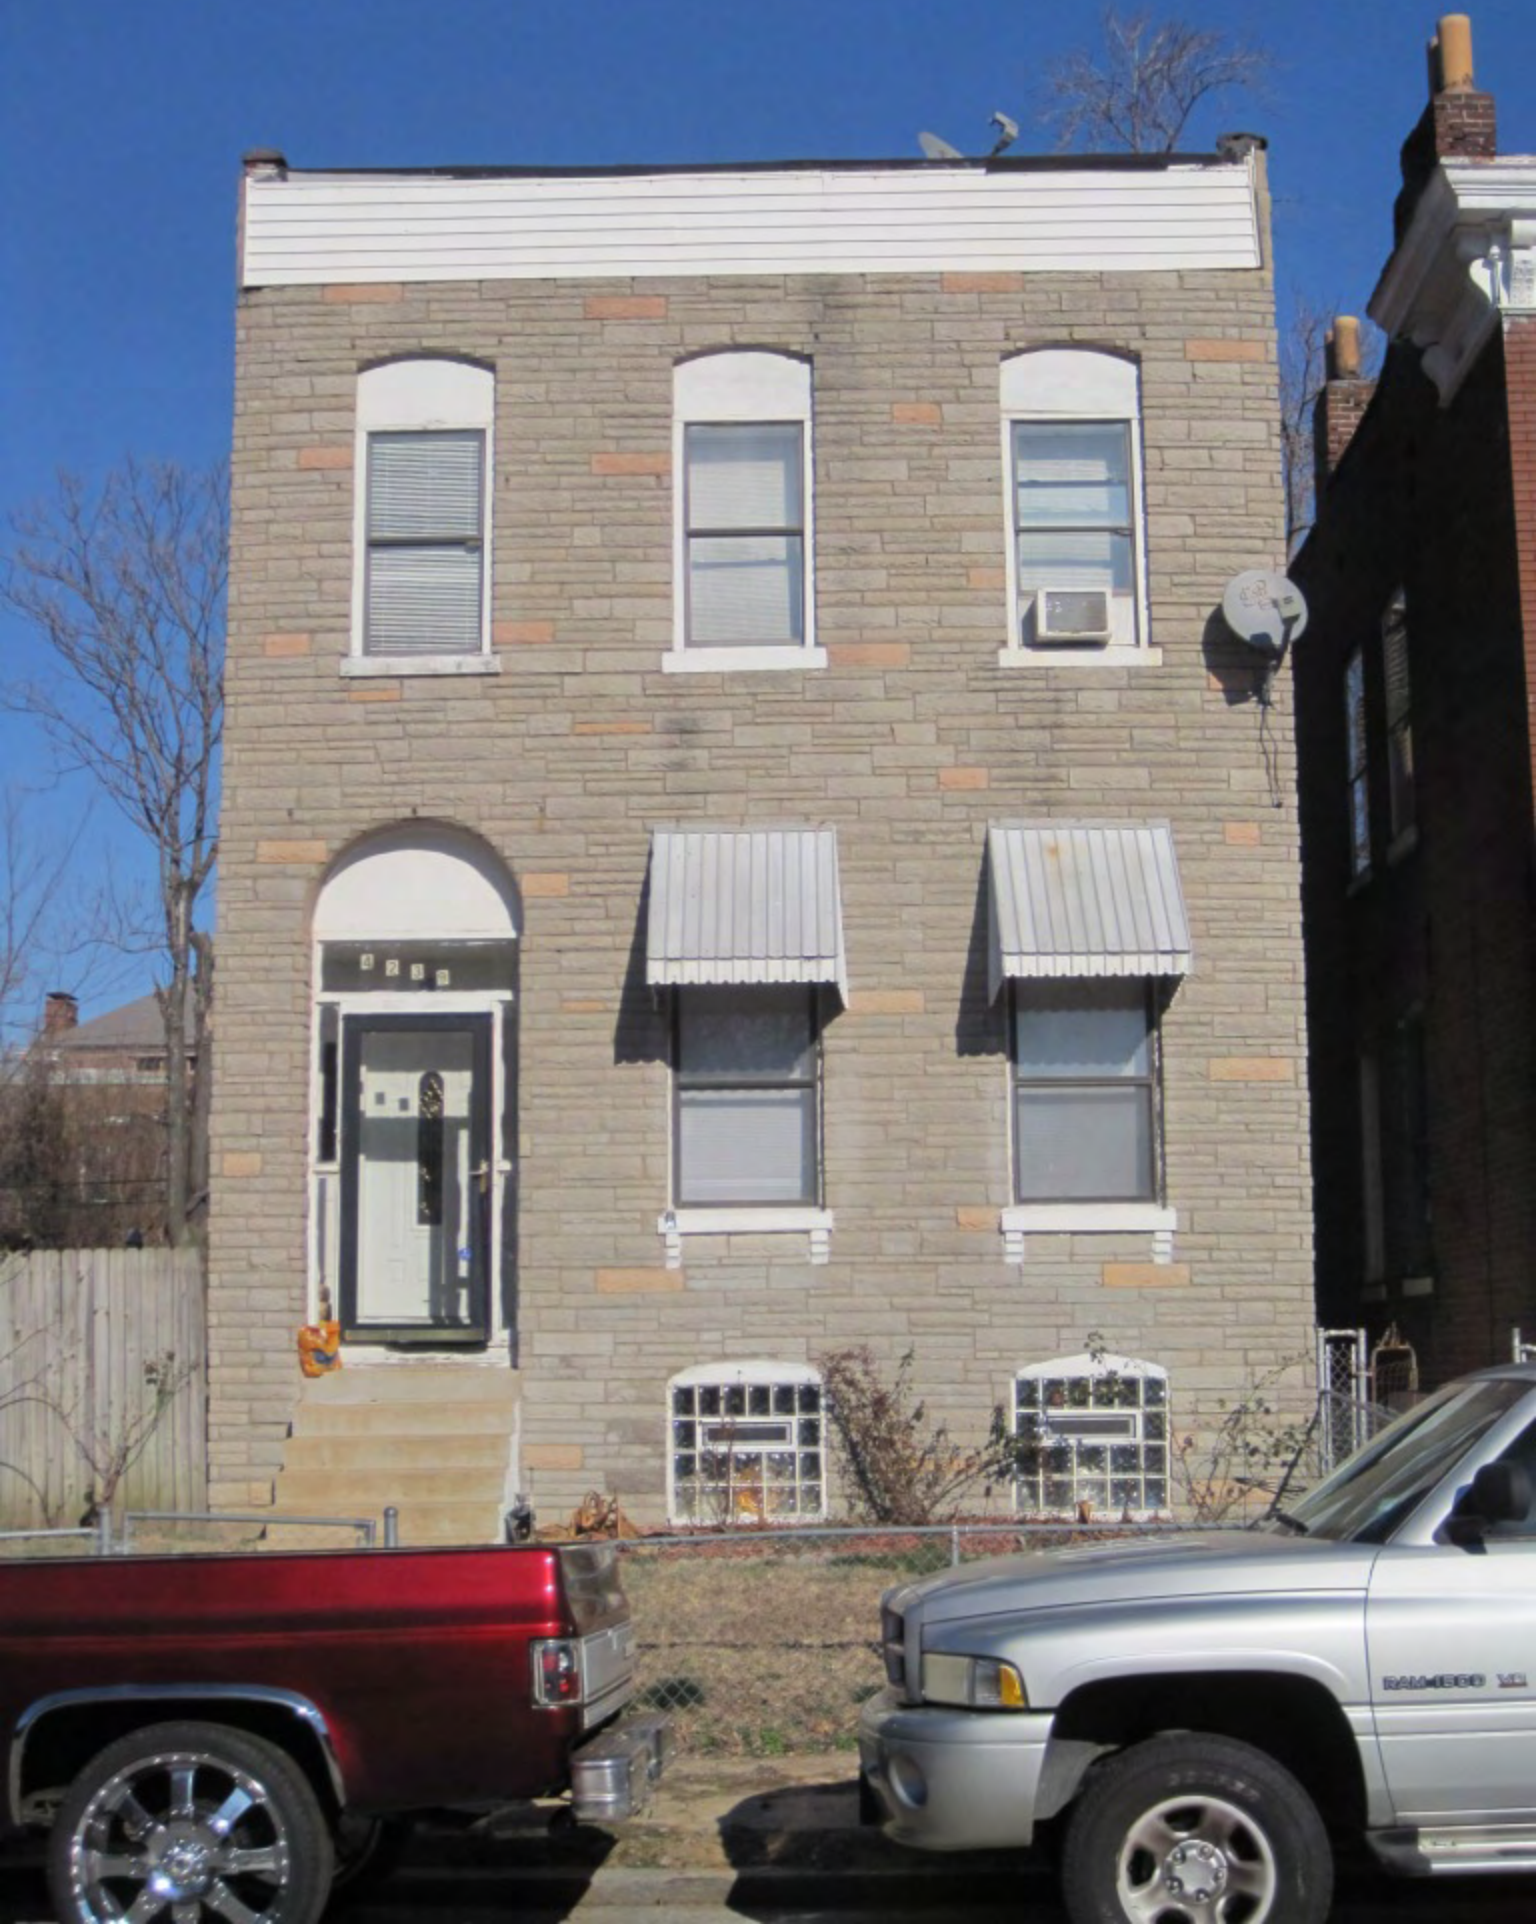
Painted stone foundation with projecting top course. Red brick wall above. Basement window openings boarded with wooden muntin between. Openings have stone sills and segmental vertical headers. Entrance has wooden casement and metal replacement doors. Openings have wooden one-over-one windows with transoms; double windows in left bay have center decorated muntins. Wooden cornice at top has ornamental fascia, bracket and crown molding; cornice wraps left side. Brick parapet wall rises high on right side.

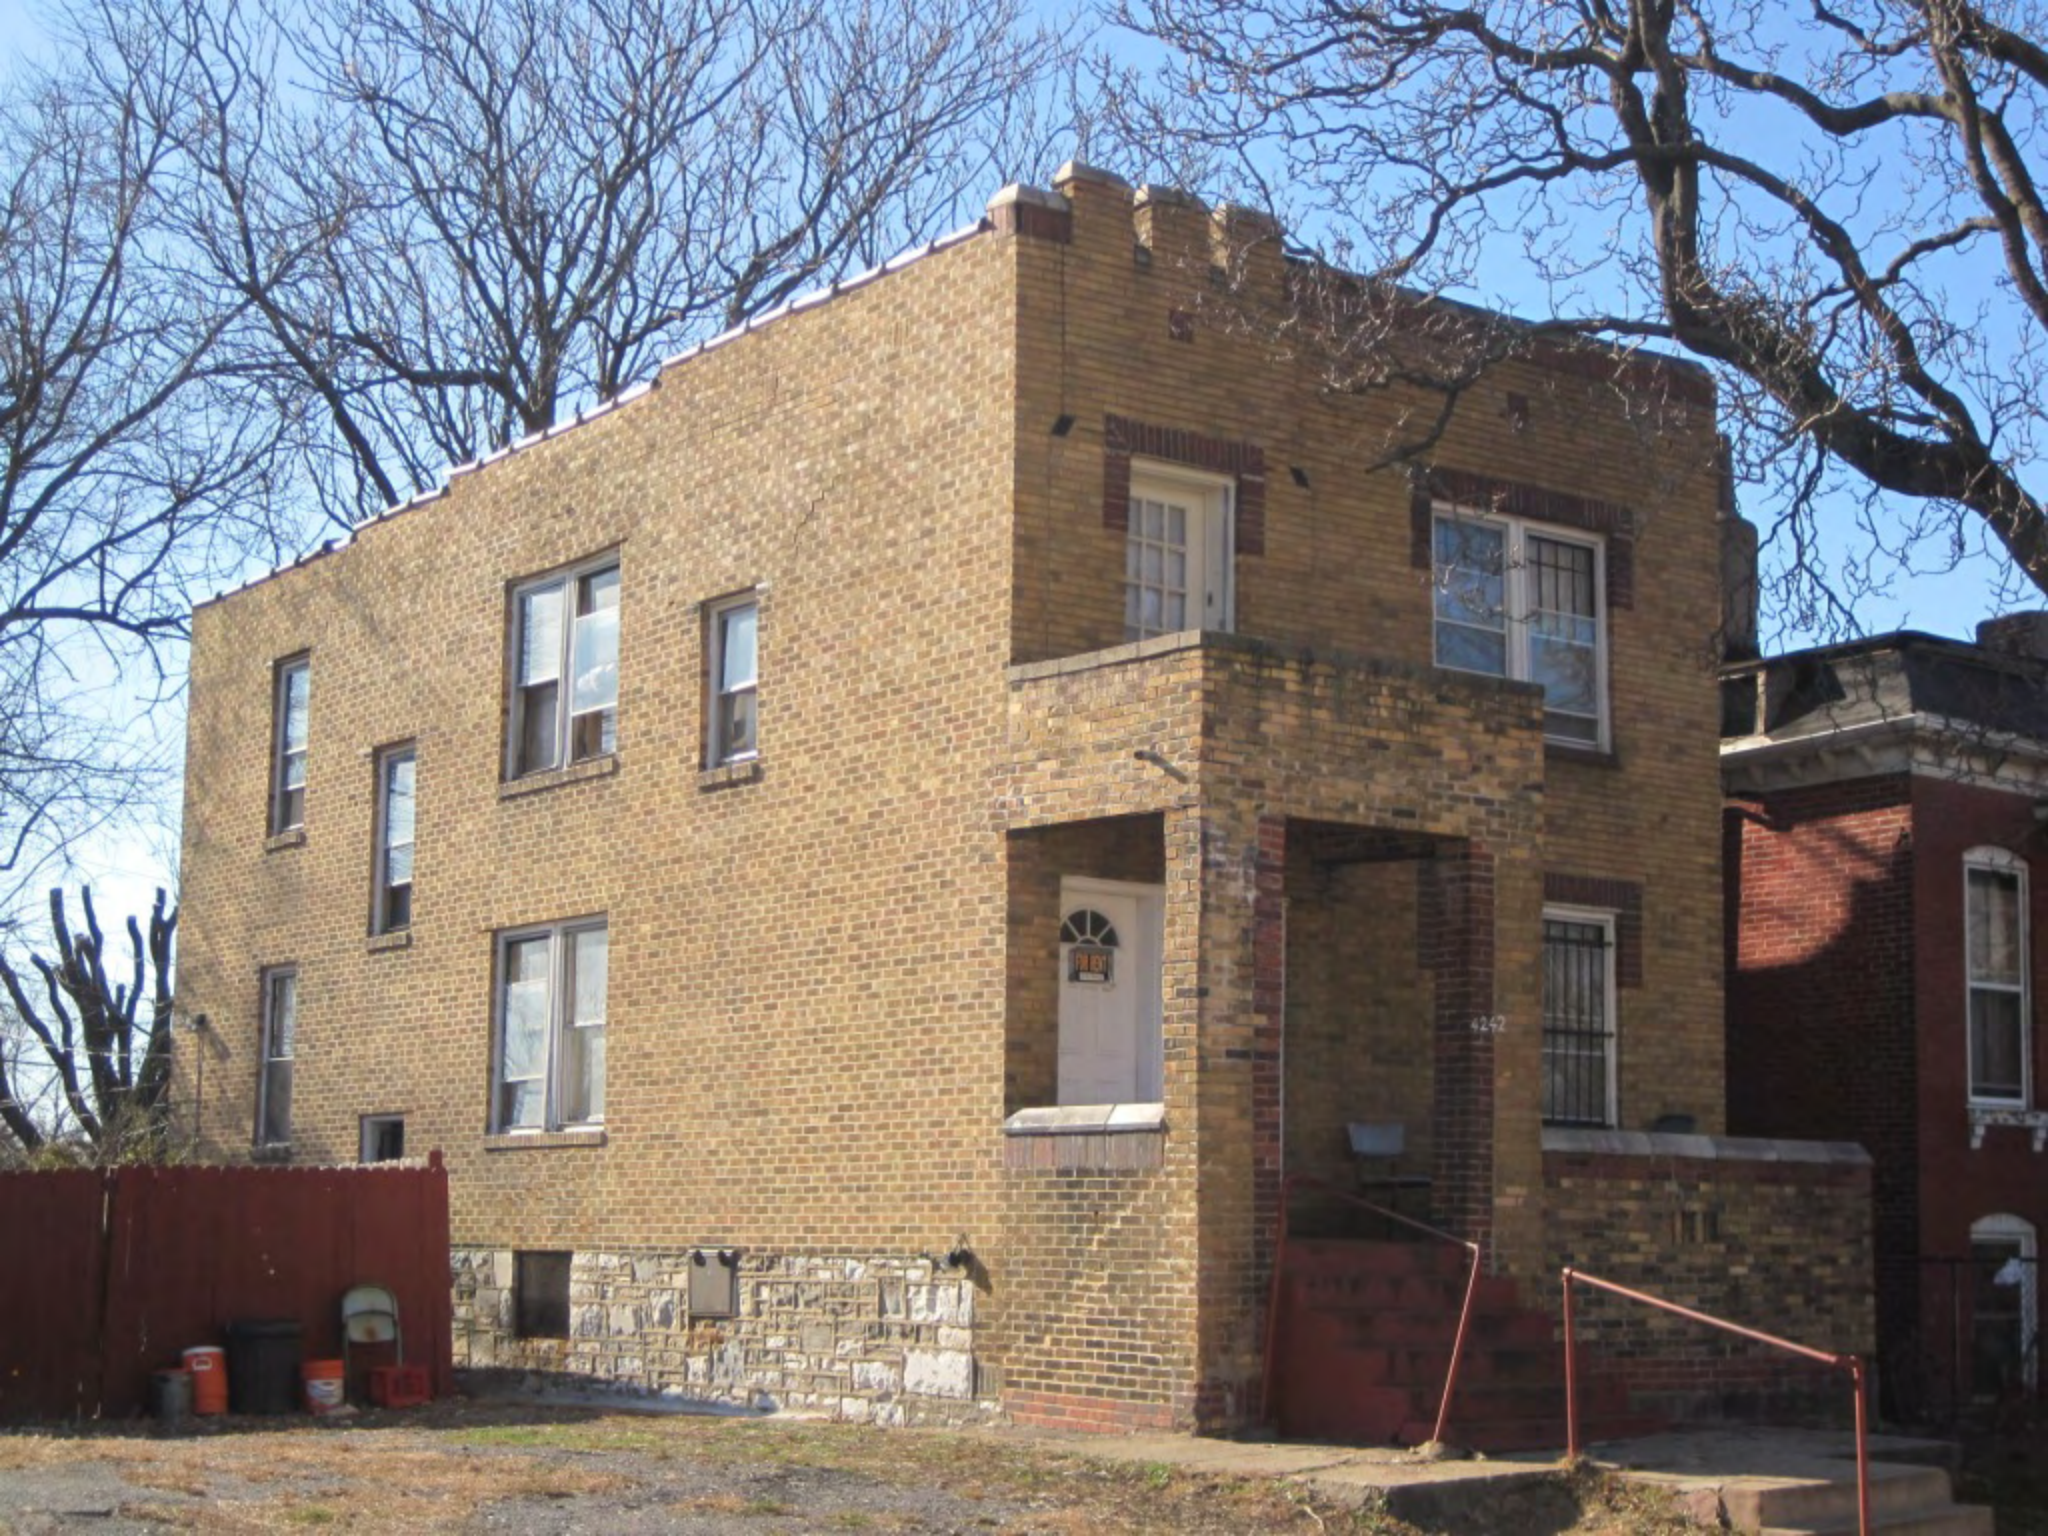
Buff brick with red brick at base and around front opening on porch. Porch is full with high side walls and beveled stone caps. Brick piers rise on each side of concrete steps to form balcony with knee wall and flat stone cap. Double entrance with replacement doors. Other openings have brown brick soldier label courses. Door at balcony replaced. Paired four-over-one wooden windows in right bay openings, which have brown brick rowlock sills. Crenellation over entrance bay; brock brick soldier course at walltop with beveled stone coping.

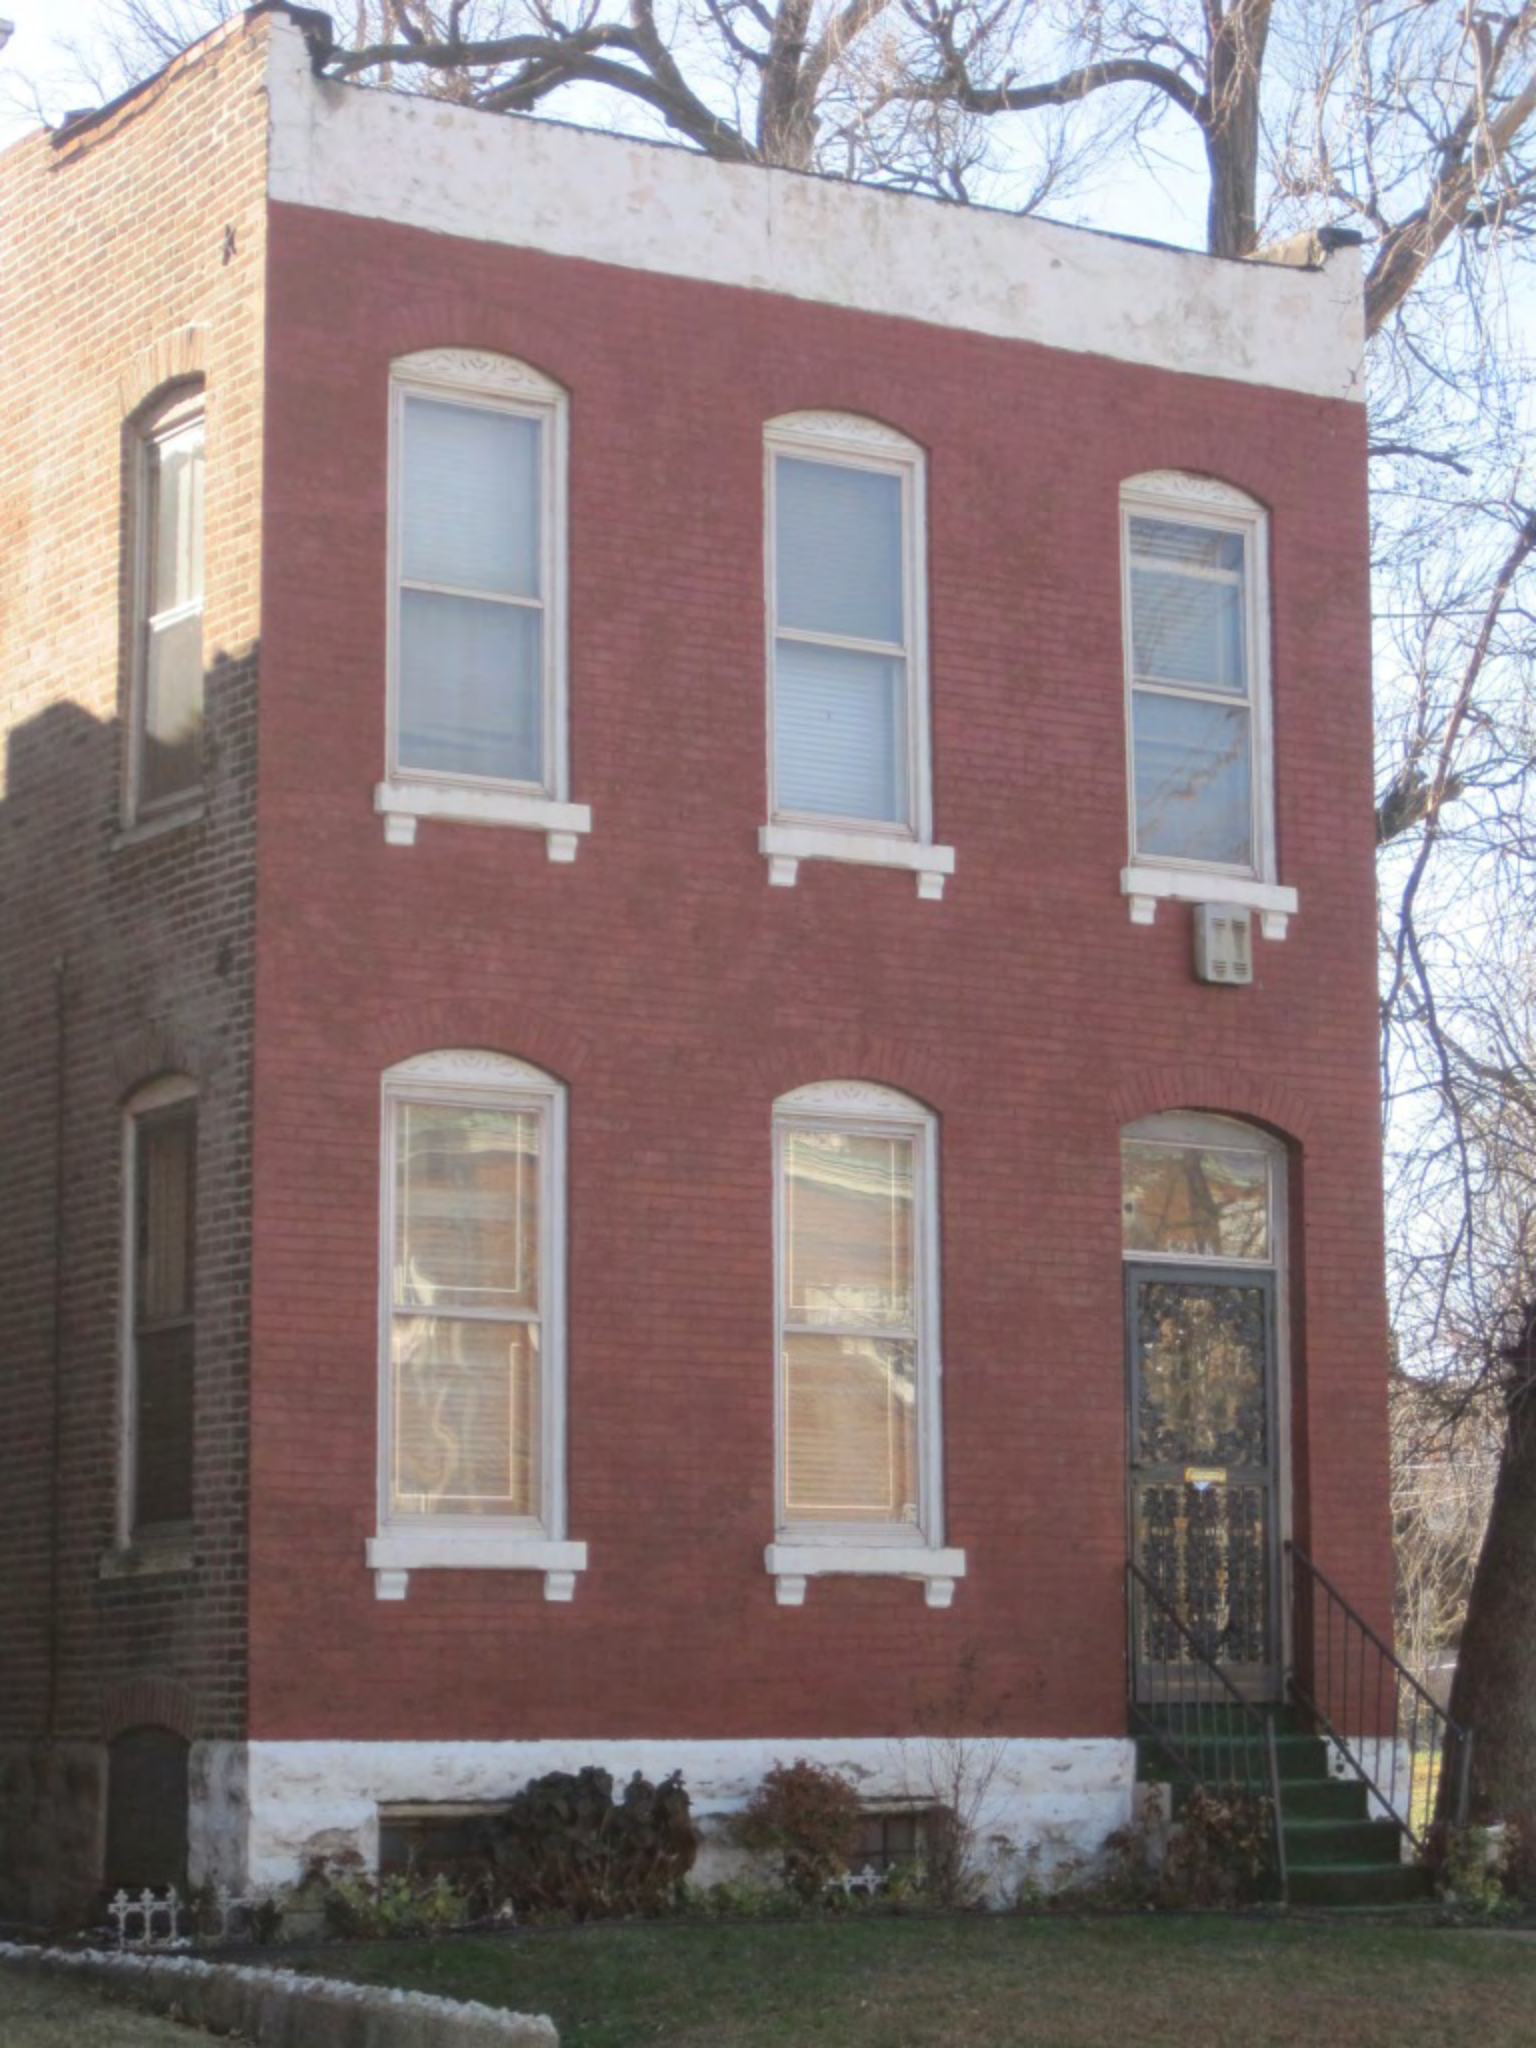
Brown brick. Stone retaining wall along alley in ashlar bond joins foundation wall. Concrete stoop with wooden columns supporting low gabled roof. Entrances have wooden multi-light doors. Window openings on each side of entrance bay have white terra cotta surrounds. Decorative terra cotta pieces laid in wall over entrance and in parapet. Terra cotta coping on front parapet.

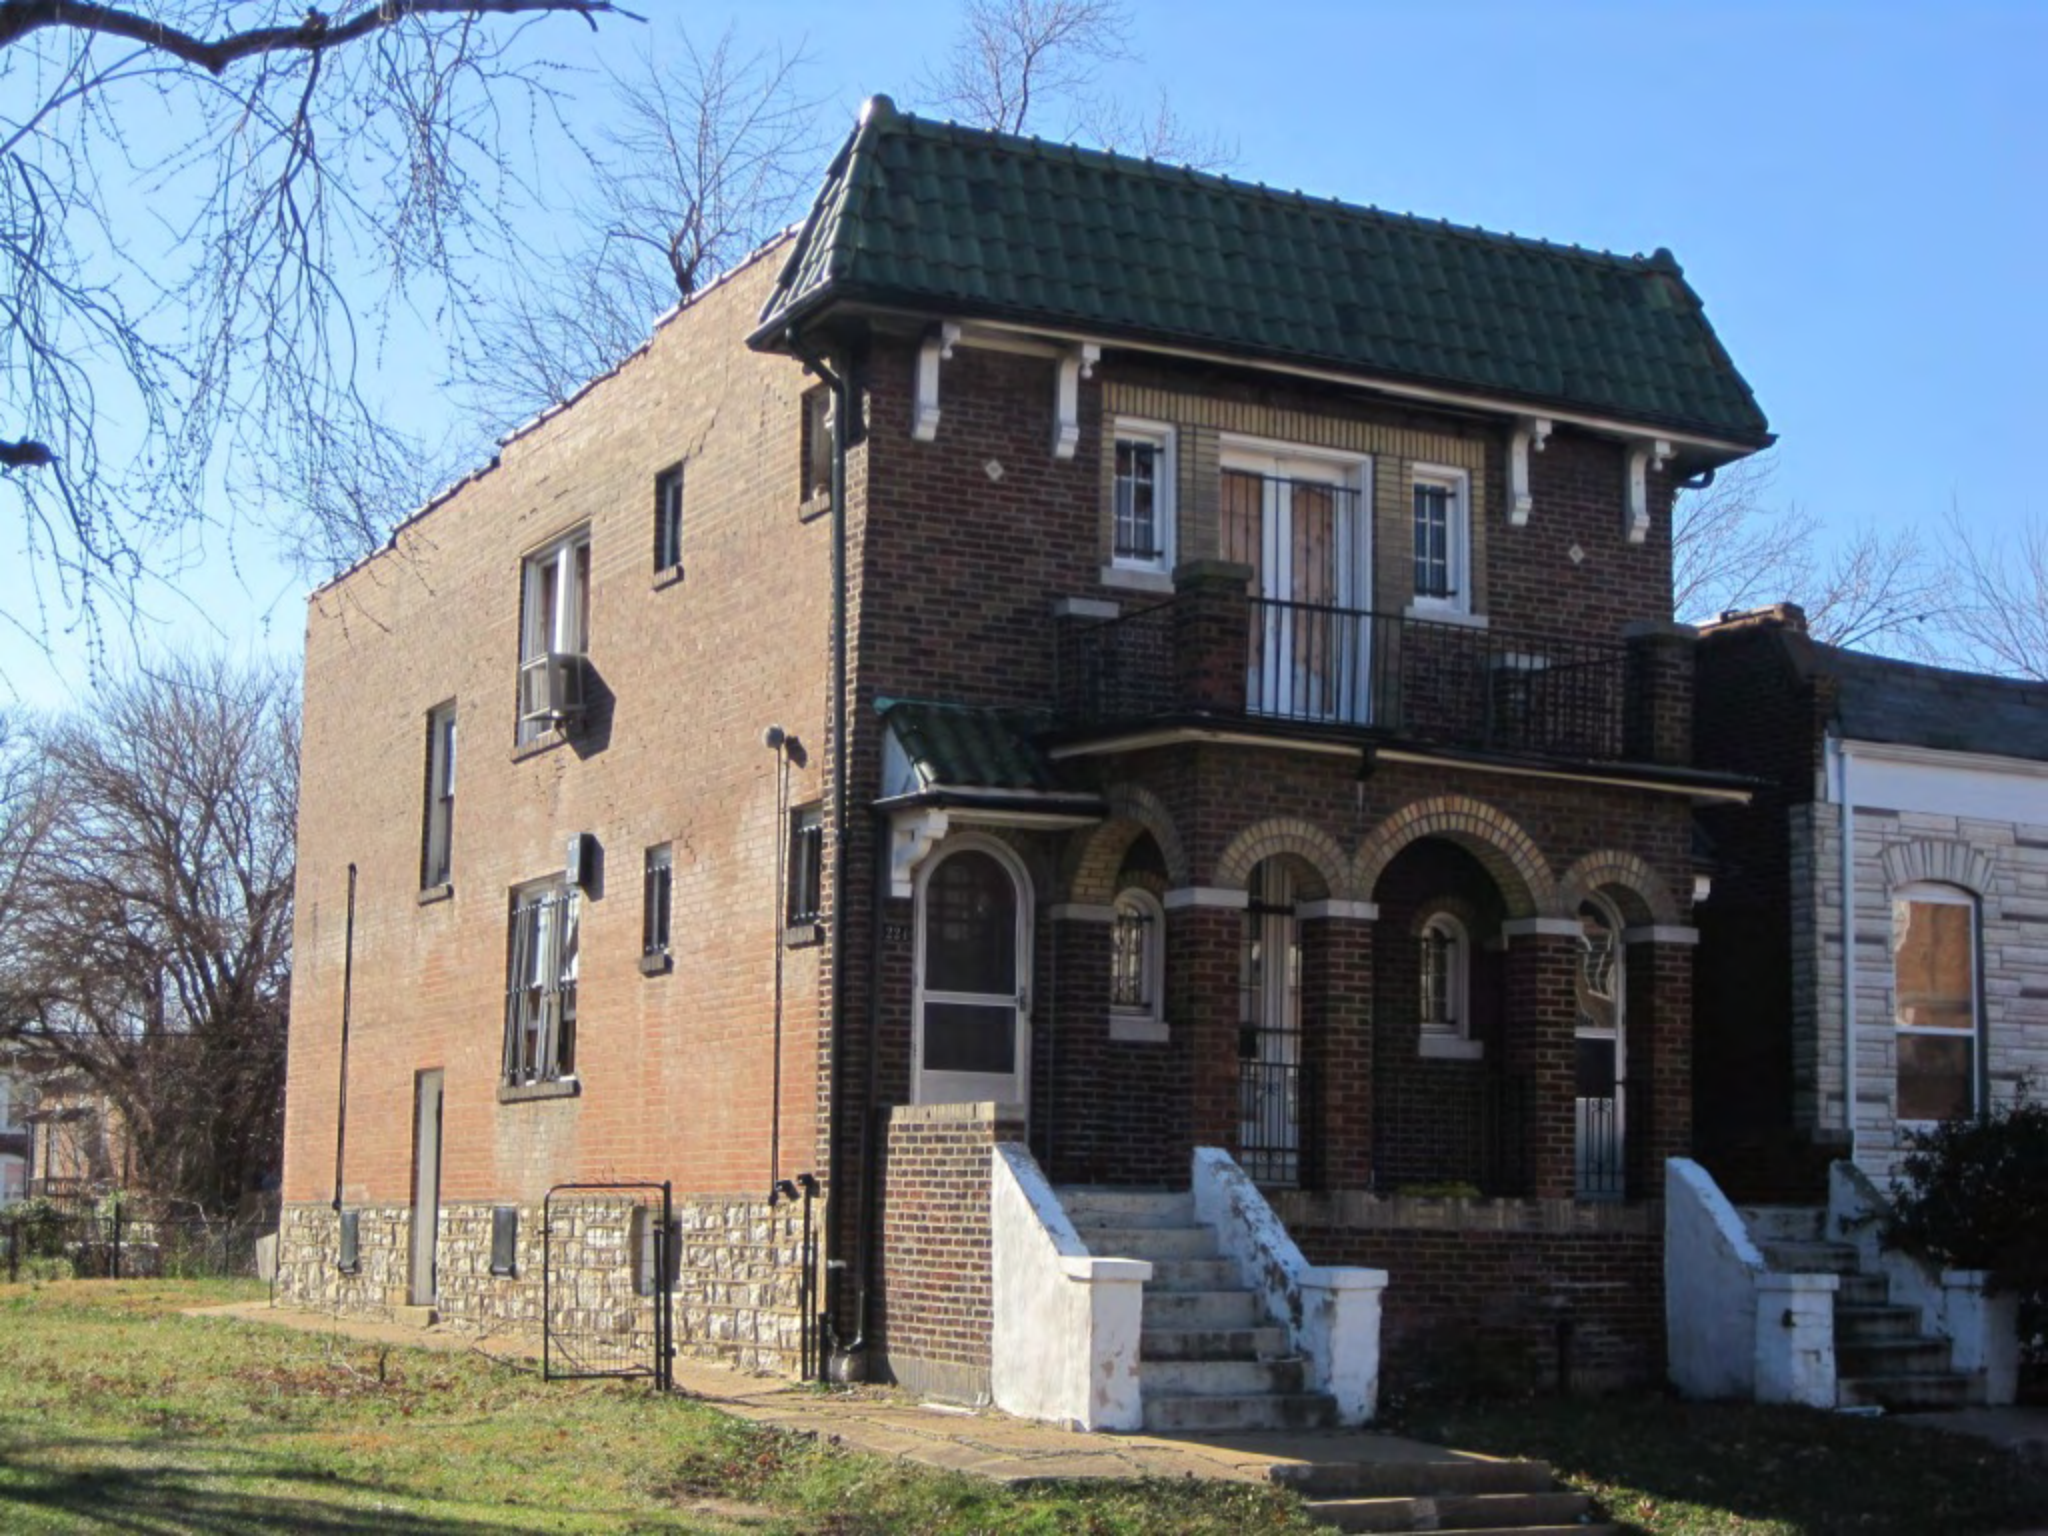
The front elevation is painted while the other three elevations are red brick. The entrance is in the right bay. The window openings have stone sills with consoles and segmental arches. The windows are wooden one-over-one windows. Stone steps to entrance. Entrance has wooden surround and metal security door with wooden replacement door and wooden transom window behind. The cornice is missing and the area where it was is parged.

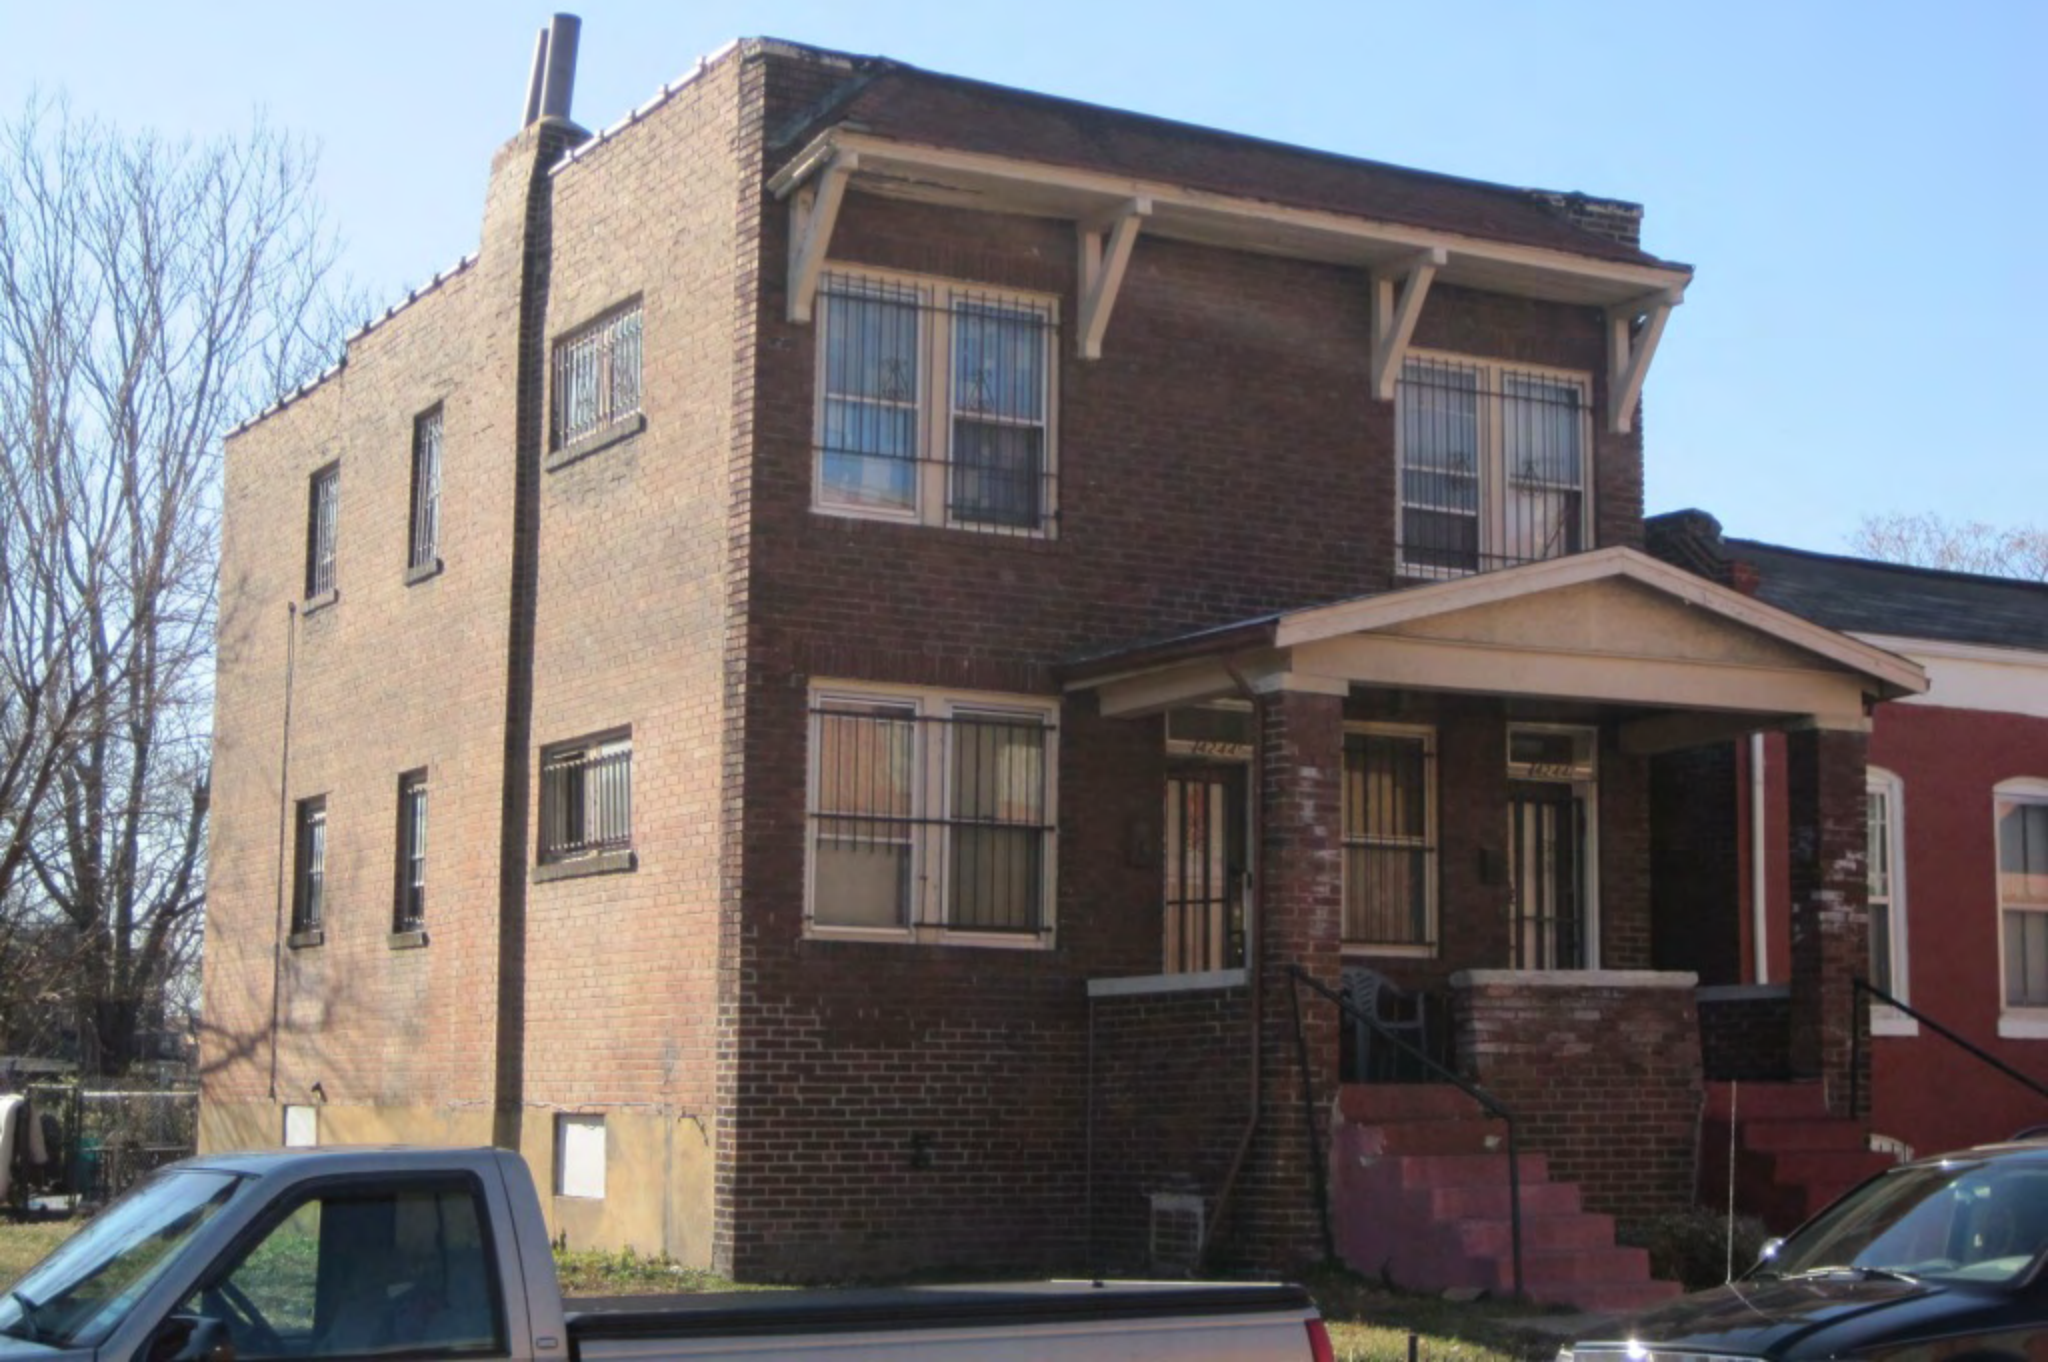
Red brick front elevation. Painted stone foundation. Entrance in slightly projecting right bay. Window openings have brackets stone sills and carved patternwork in wooden eyebrows. Paired one-over-one windows in left bay openings, single one-over-one window over jack-arch recessed entrance in right bay. Cornice missing and area is sided in vinyl.

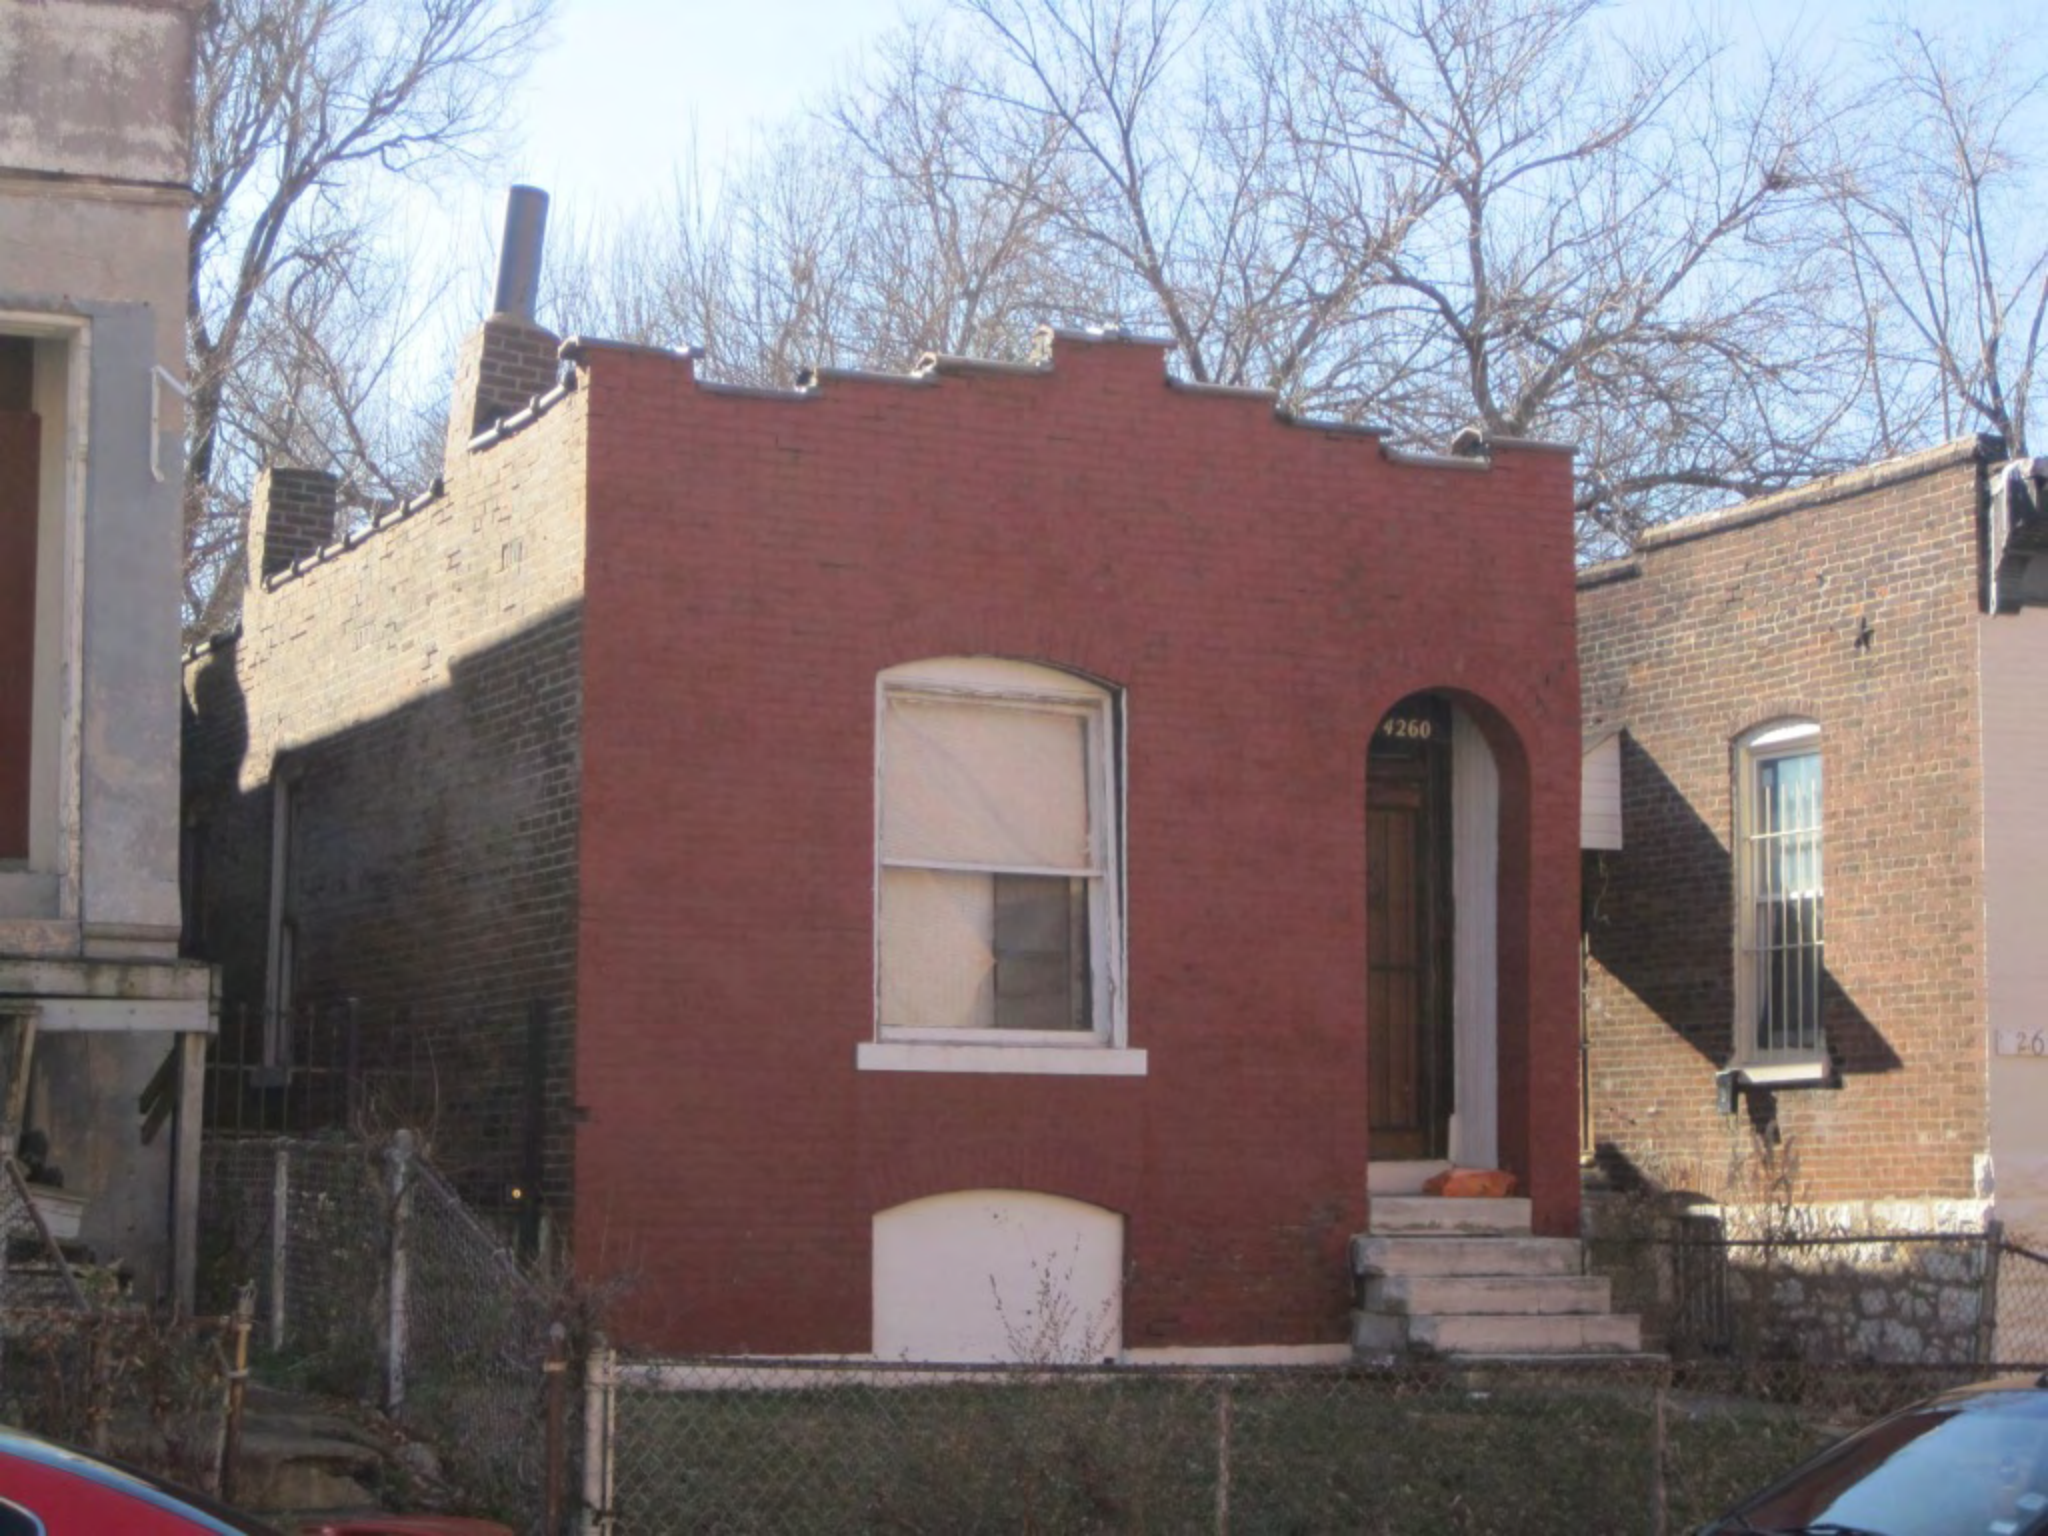
Raised basement with full window openings and entrances at basement and first floors. All openings boarded. Stone sills with consoles at first floor windows. Carved patternwork in flat earmolds over first floor openings. Cornice missing.
