Architectural/Historic Inventory Form

1. Survey No. SEC 15-036 290		2. Survey Name: Villie	
3. County: St. Louis [Independent City]		4. Address: 4452 KENNERLY AV	
5. City/State: St. Louis, MO		6. UTM: / /	
7. Township/Range/Section: T: R: S:		Not Applicable	
8. Historic Name (if known):		9. Present Name (if known):	
10. Ownership: Domestic		11. Present Use: Domestic	
12. Historic Use (if known): Sub-use: Single Dwelling		13. Present Use: Sub-use:

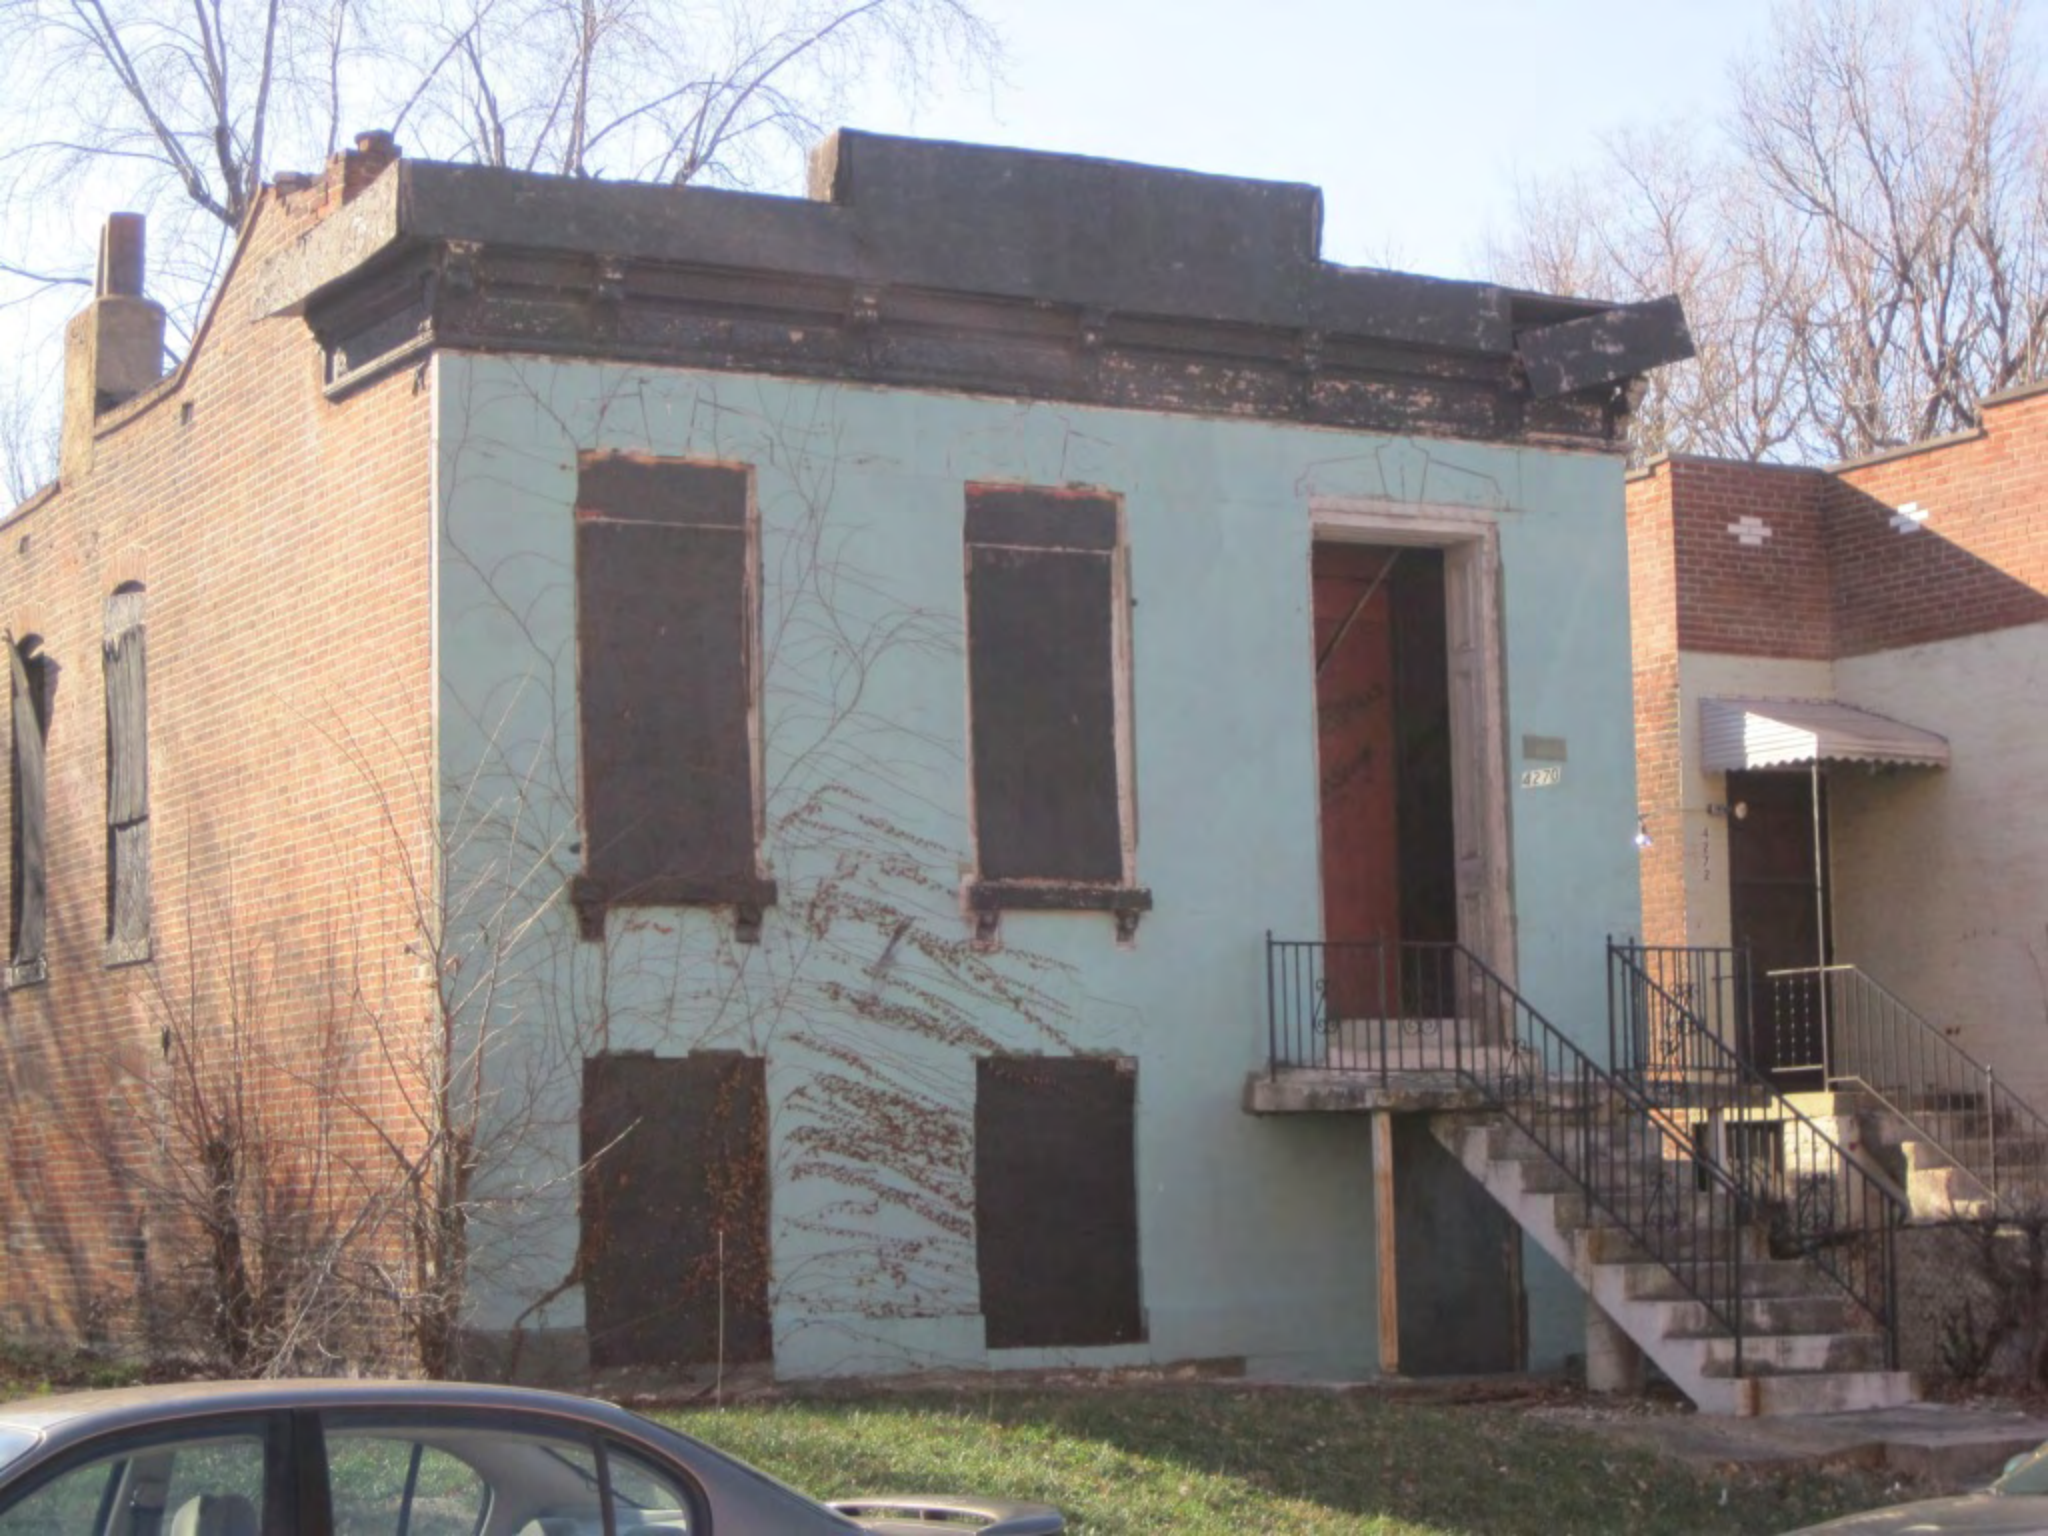
Painted brick front elevation with rusticated stone foundation. Bracketed wooden cornice above two centered window bays. The openings on the first floor have segmental arches and iron sills with under-sized replacement windows. The basement openings have jack arches and replacement windows. The entrance is at the side on the east elevation between full-sized two window openings.

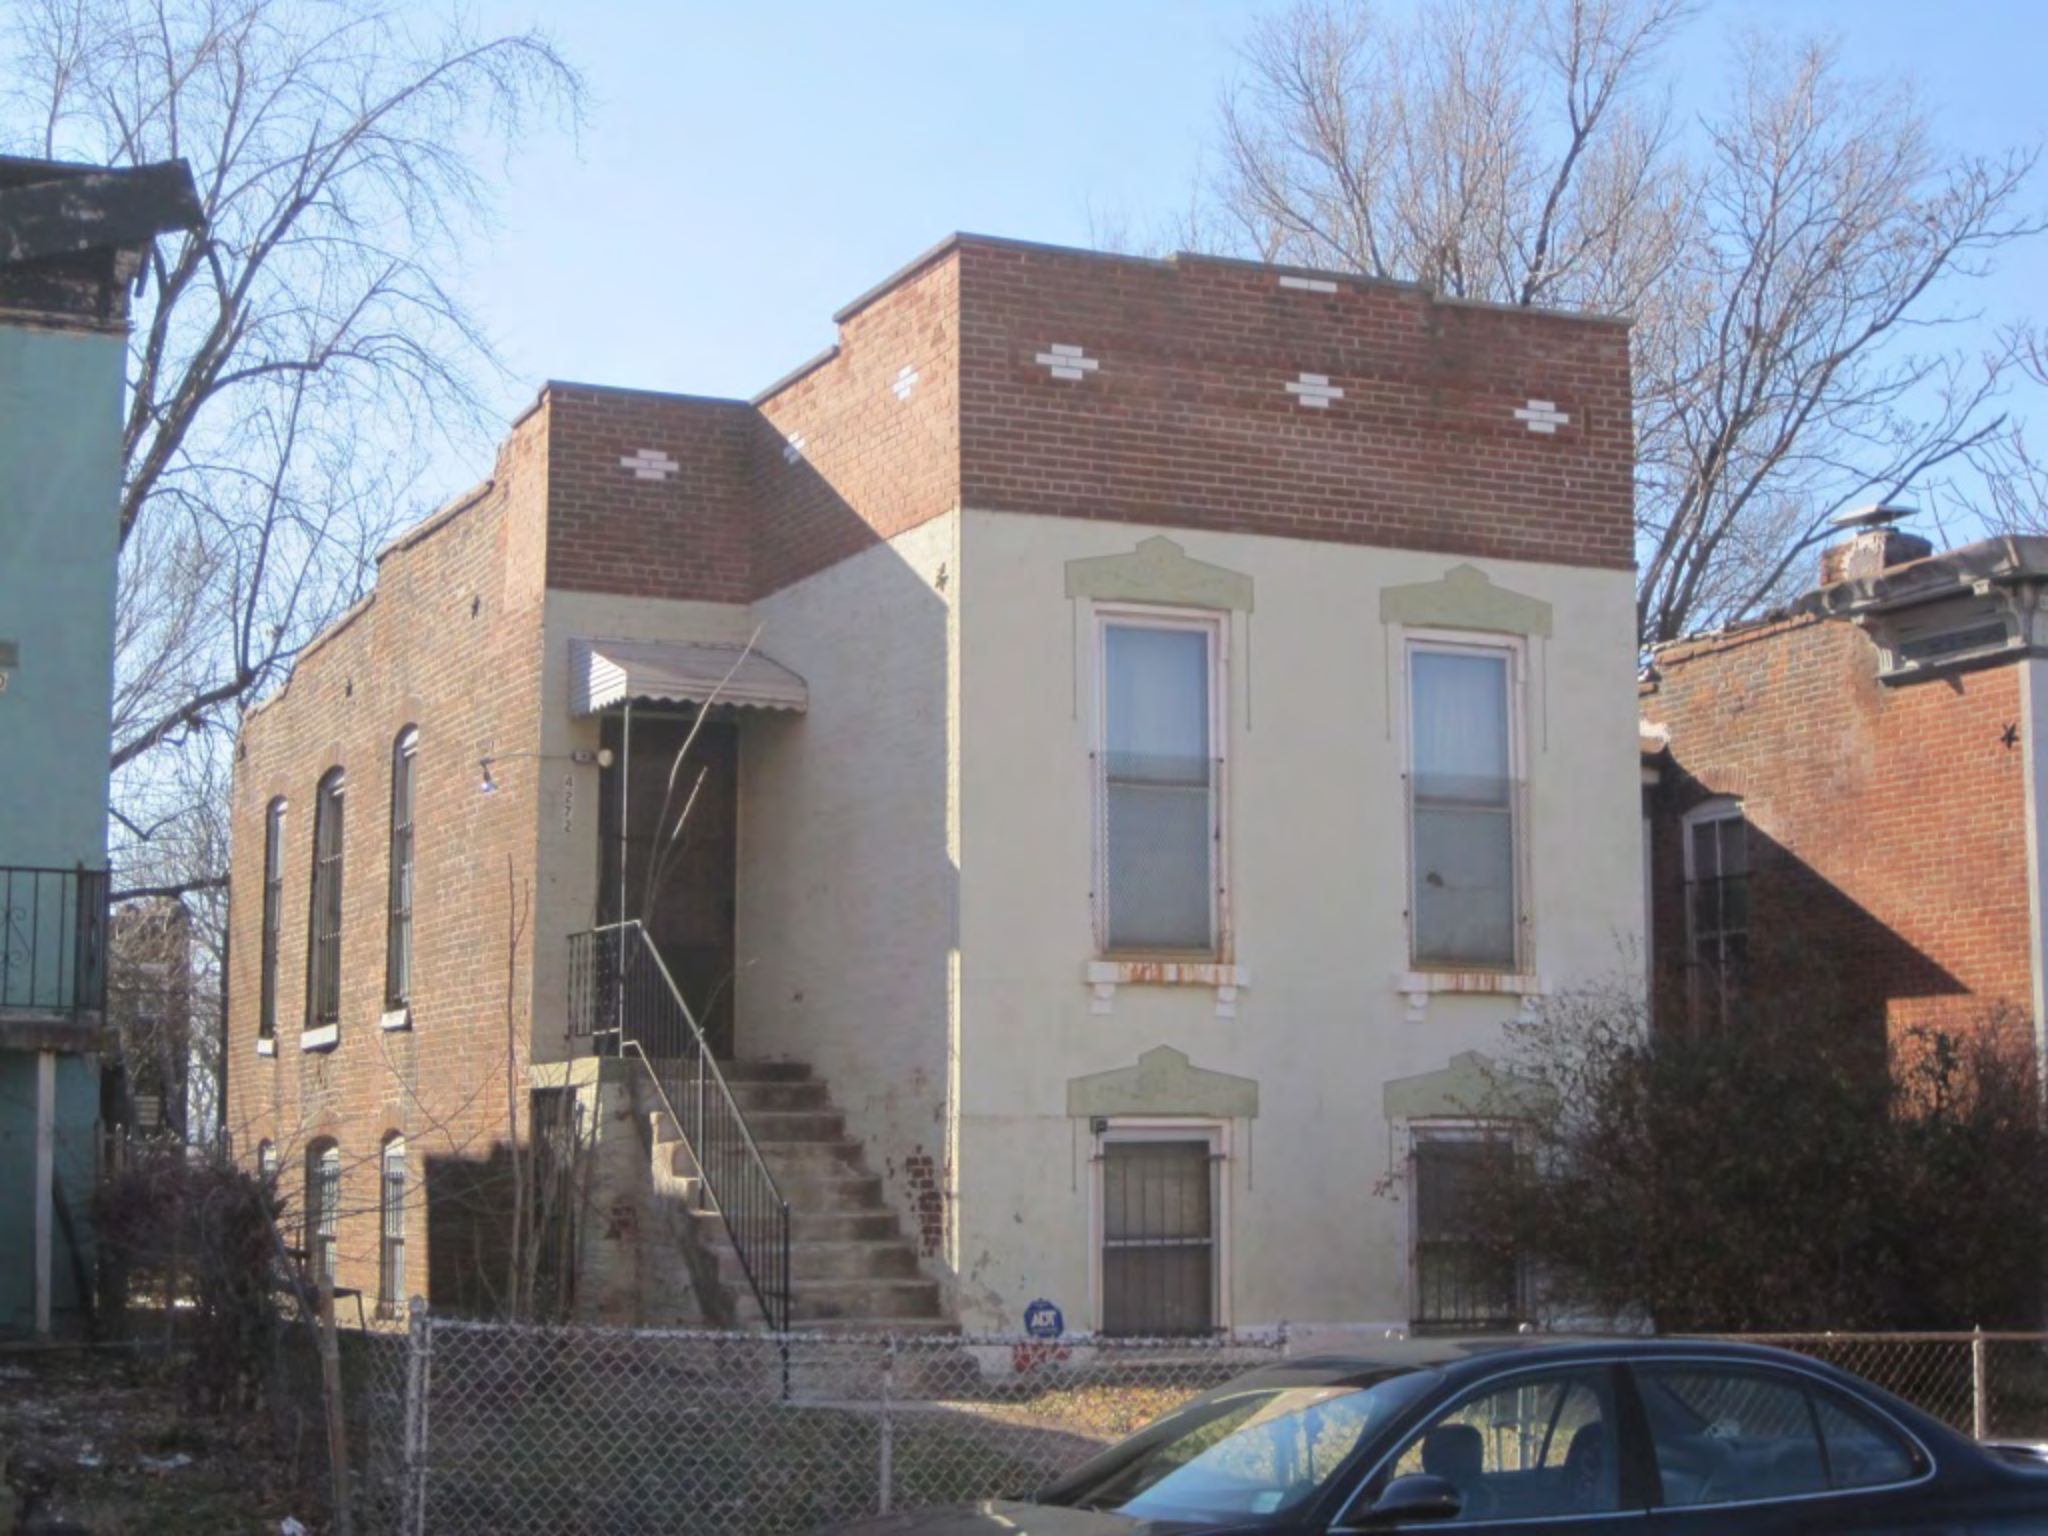
Painted front elevation. Sides red brick, with broken parapet sections that rise toward front perhaps as part of a removed false mansard. Wooden brackets support cornice that has been altered with plywood cladding. Stone front elevation, high basement, full openings on each level. Openings have flat carved earmolds that rise to form keystones. Bracketed stone sills on window openings. Recessed entrance has original wooden casement. All openings boarded. Concrete steps and porch with metal railing.

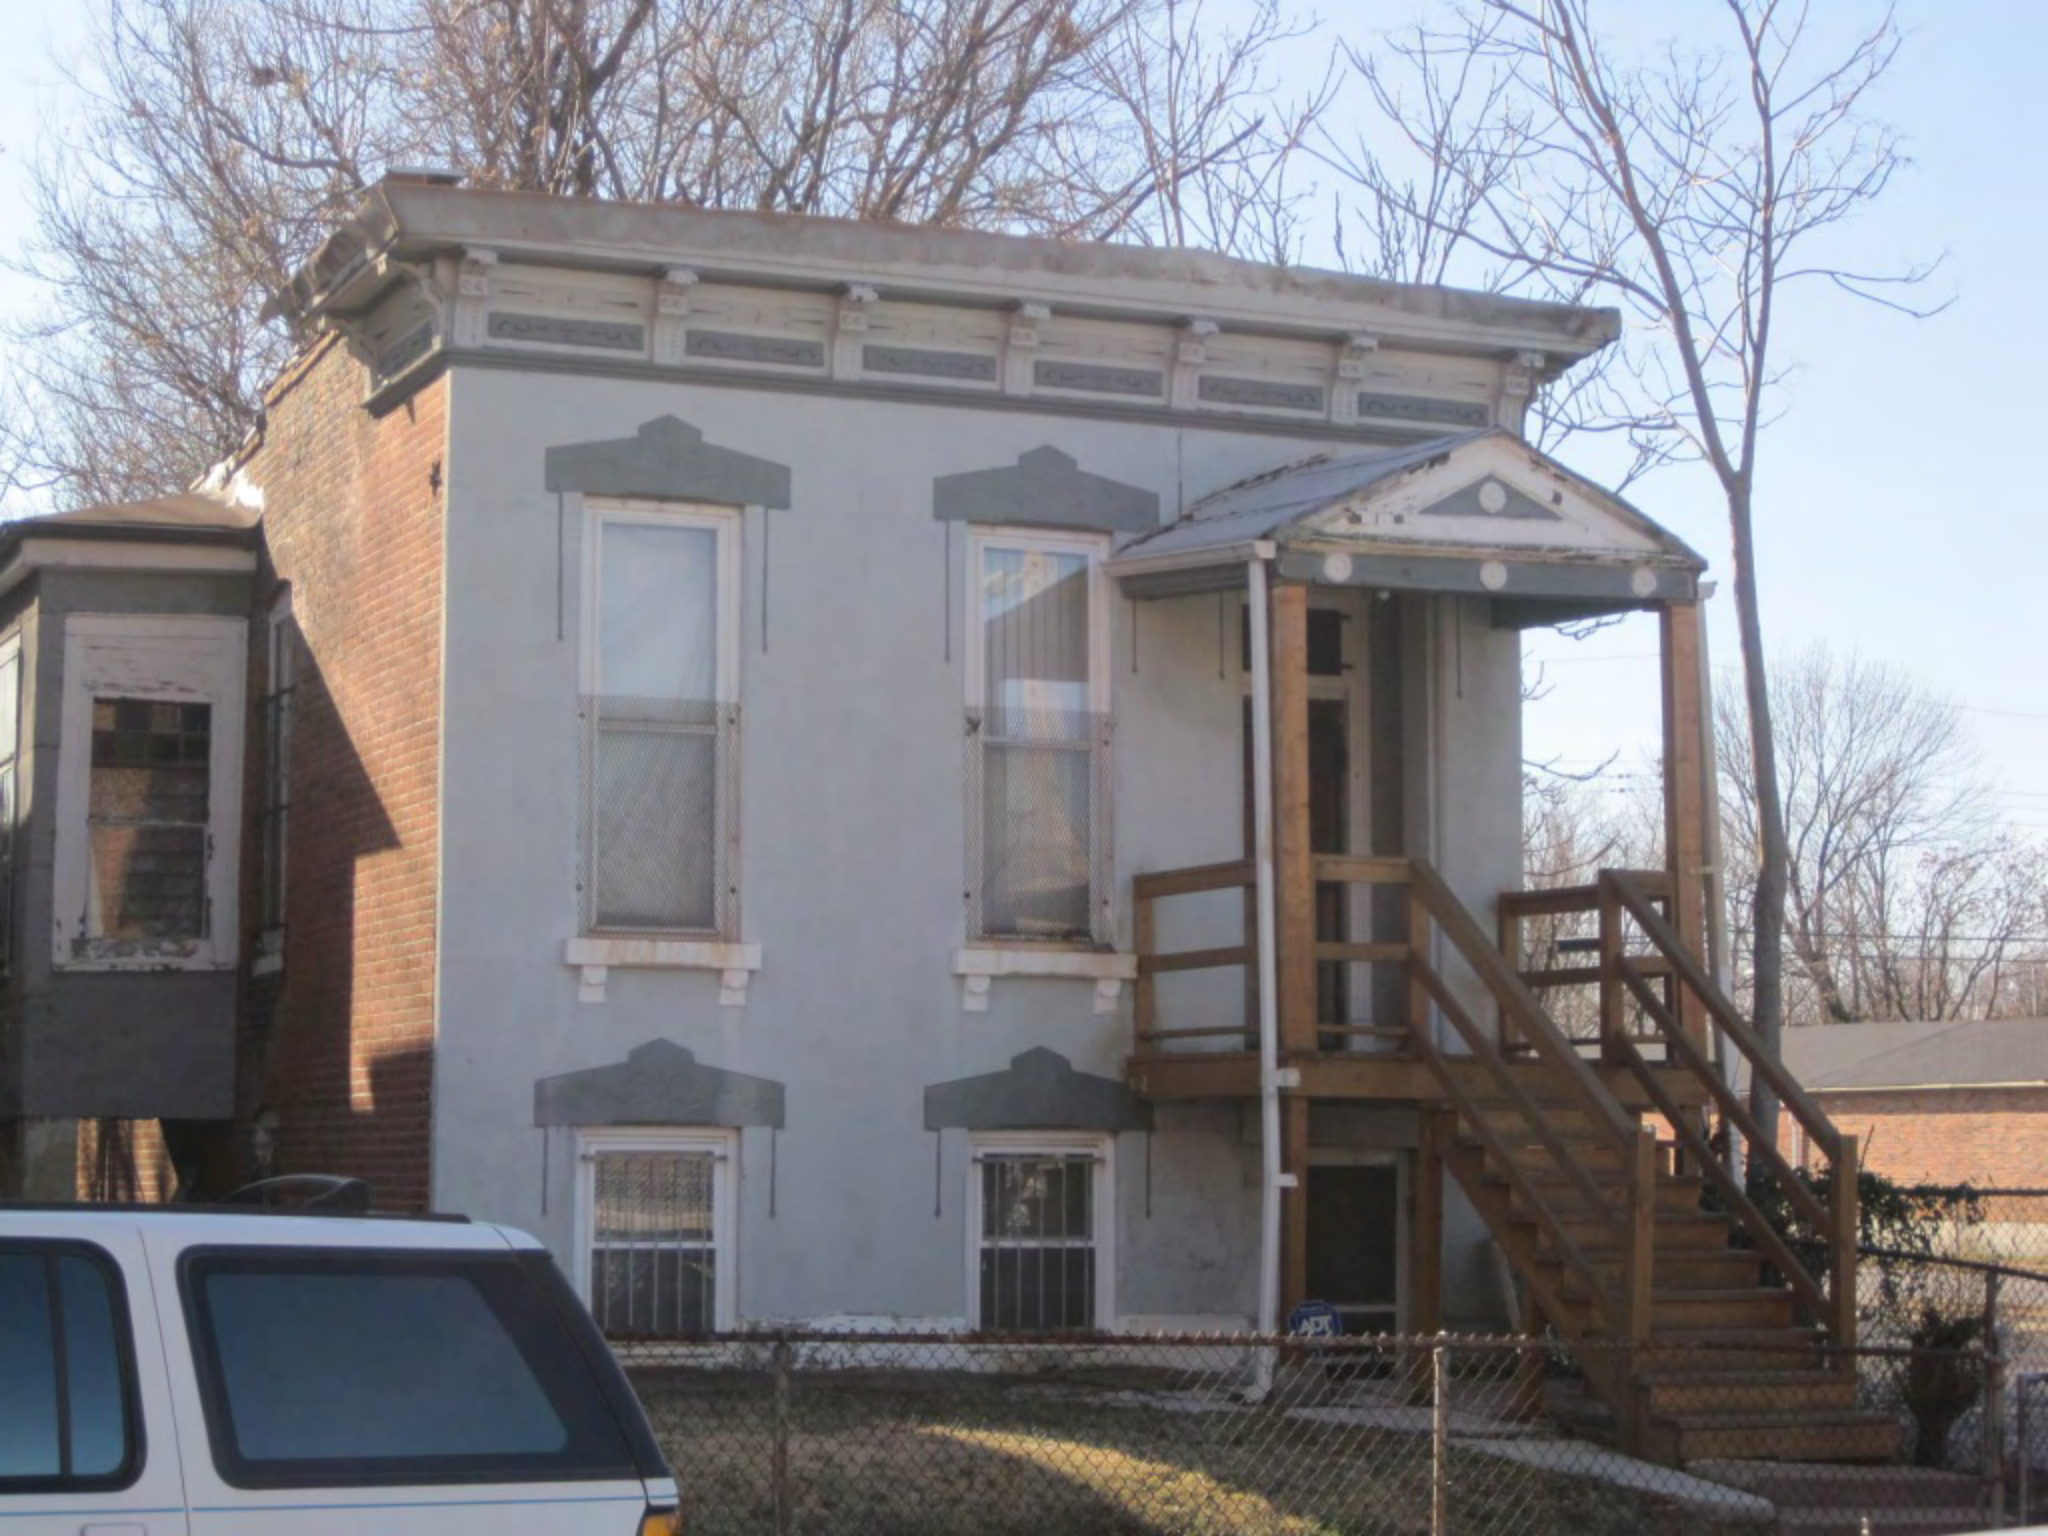
High basement. Entrance bay recessed at left. Concrete steps and stoop with metal awning over entrance. Window bays clad in stone with carved, shaped lintels. Stone walls with brackets. Parapet relayed in brown brick with bakery brick accents and stone coping. Replacement windows and door.

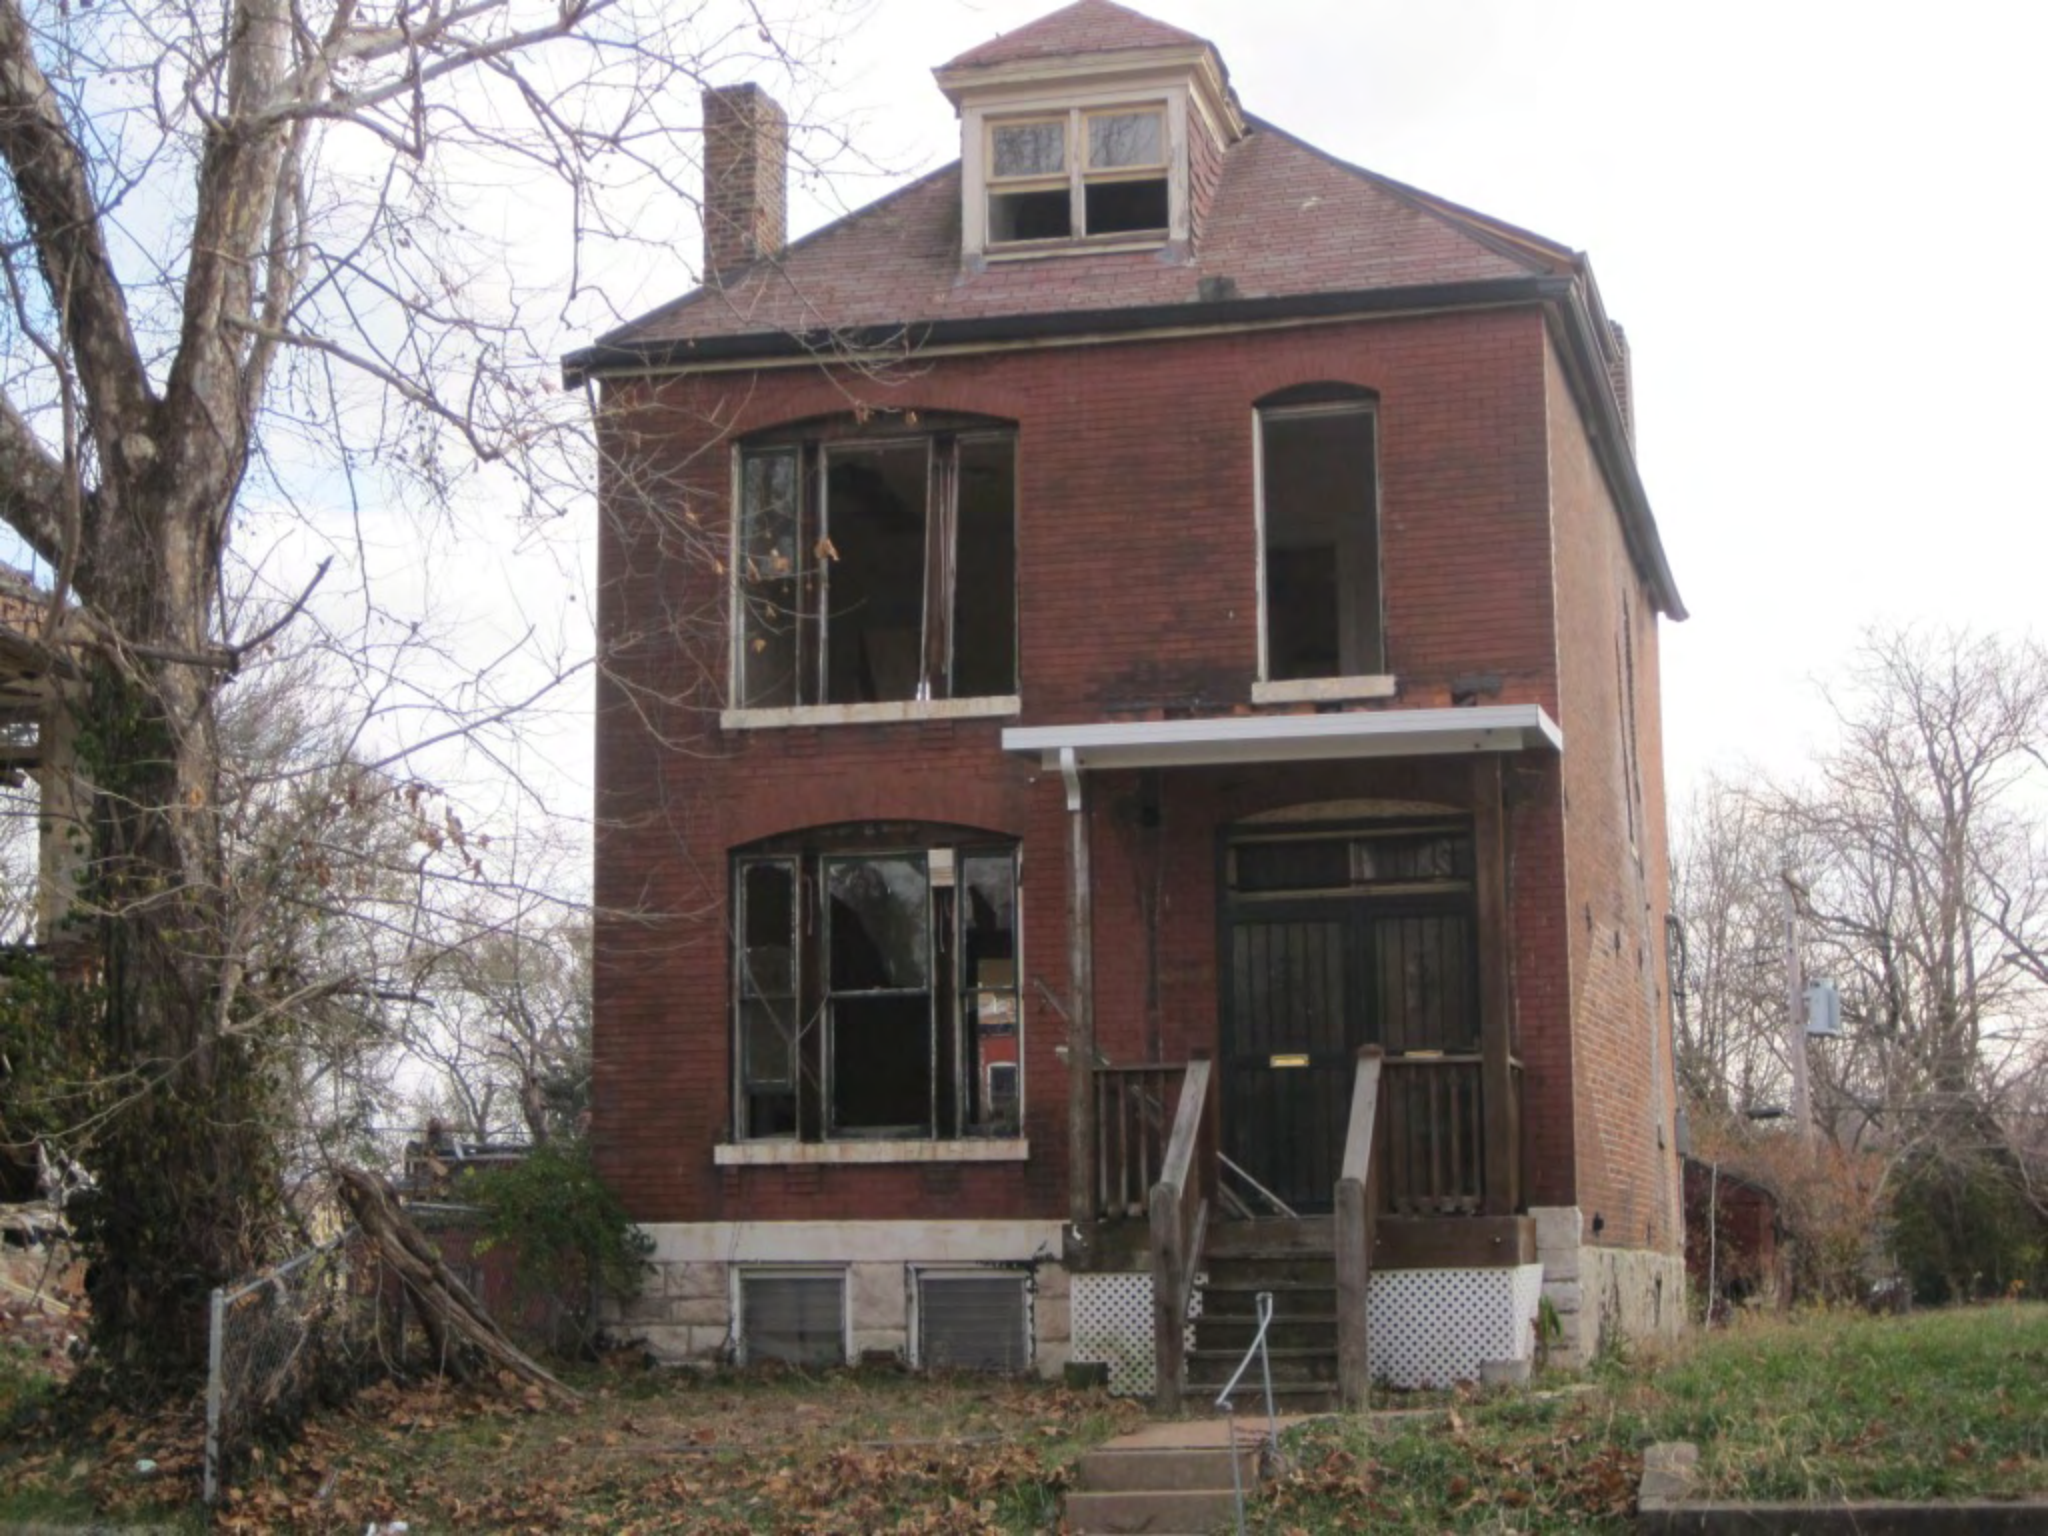
Building completely collapsed other than the façade and front ten feet or so of side walls. Front elevation has rusticated limestone foundation under red brick wall. Recessed entrance (still boarded) with stone steps at left. First floor window openings (boarded) with some brick infill; second floor openings (missing casements and sash) have stone sills with consoles and soldier course headers on segmental arches. Parapet rebuilt with different red brick and buff brick band courses; terra cotta coping.

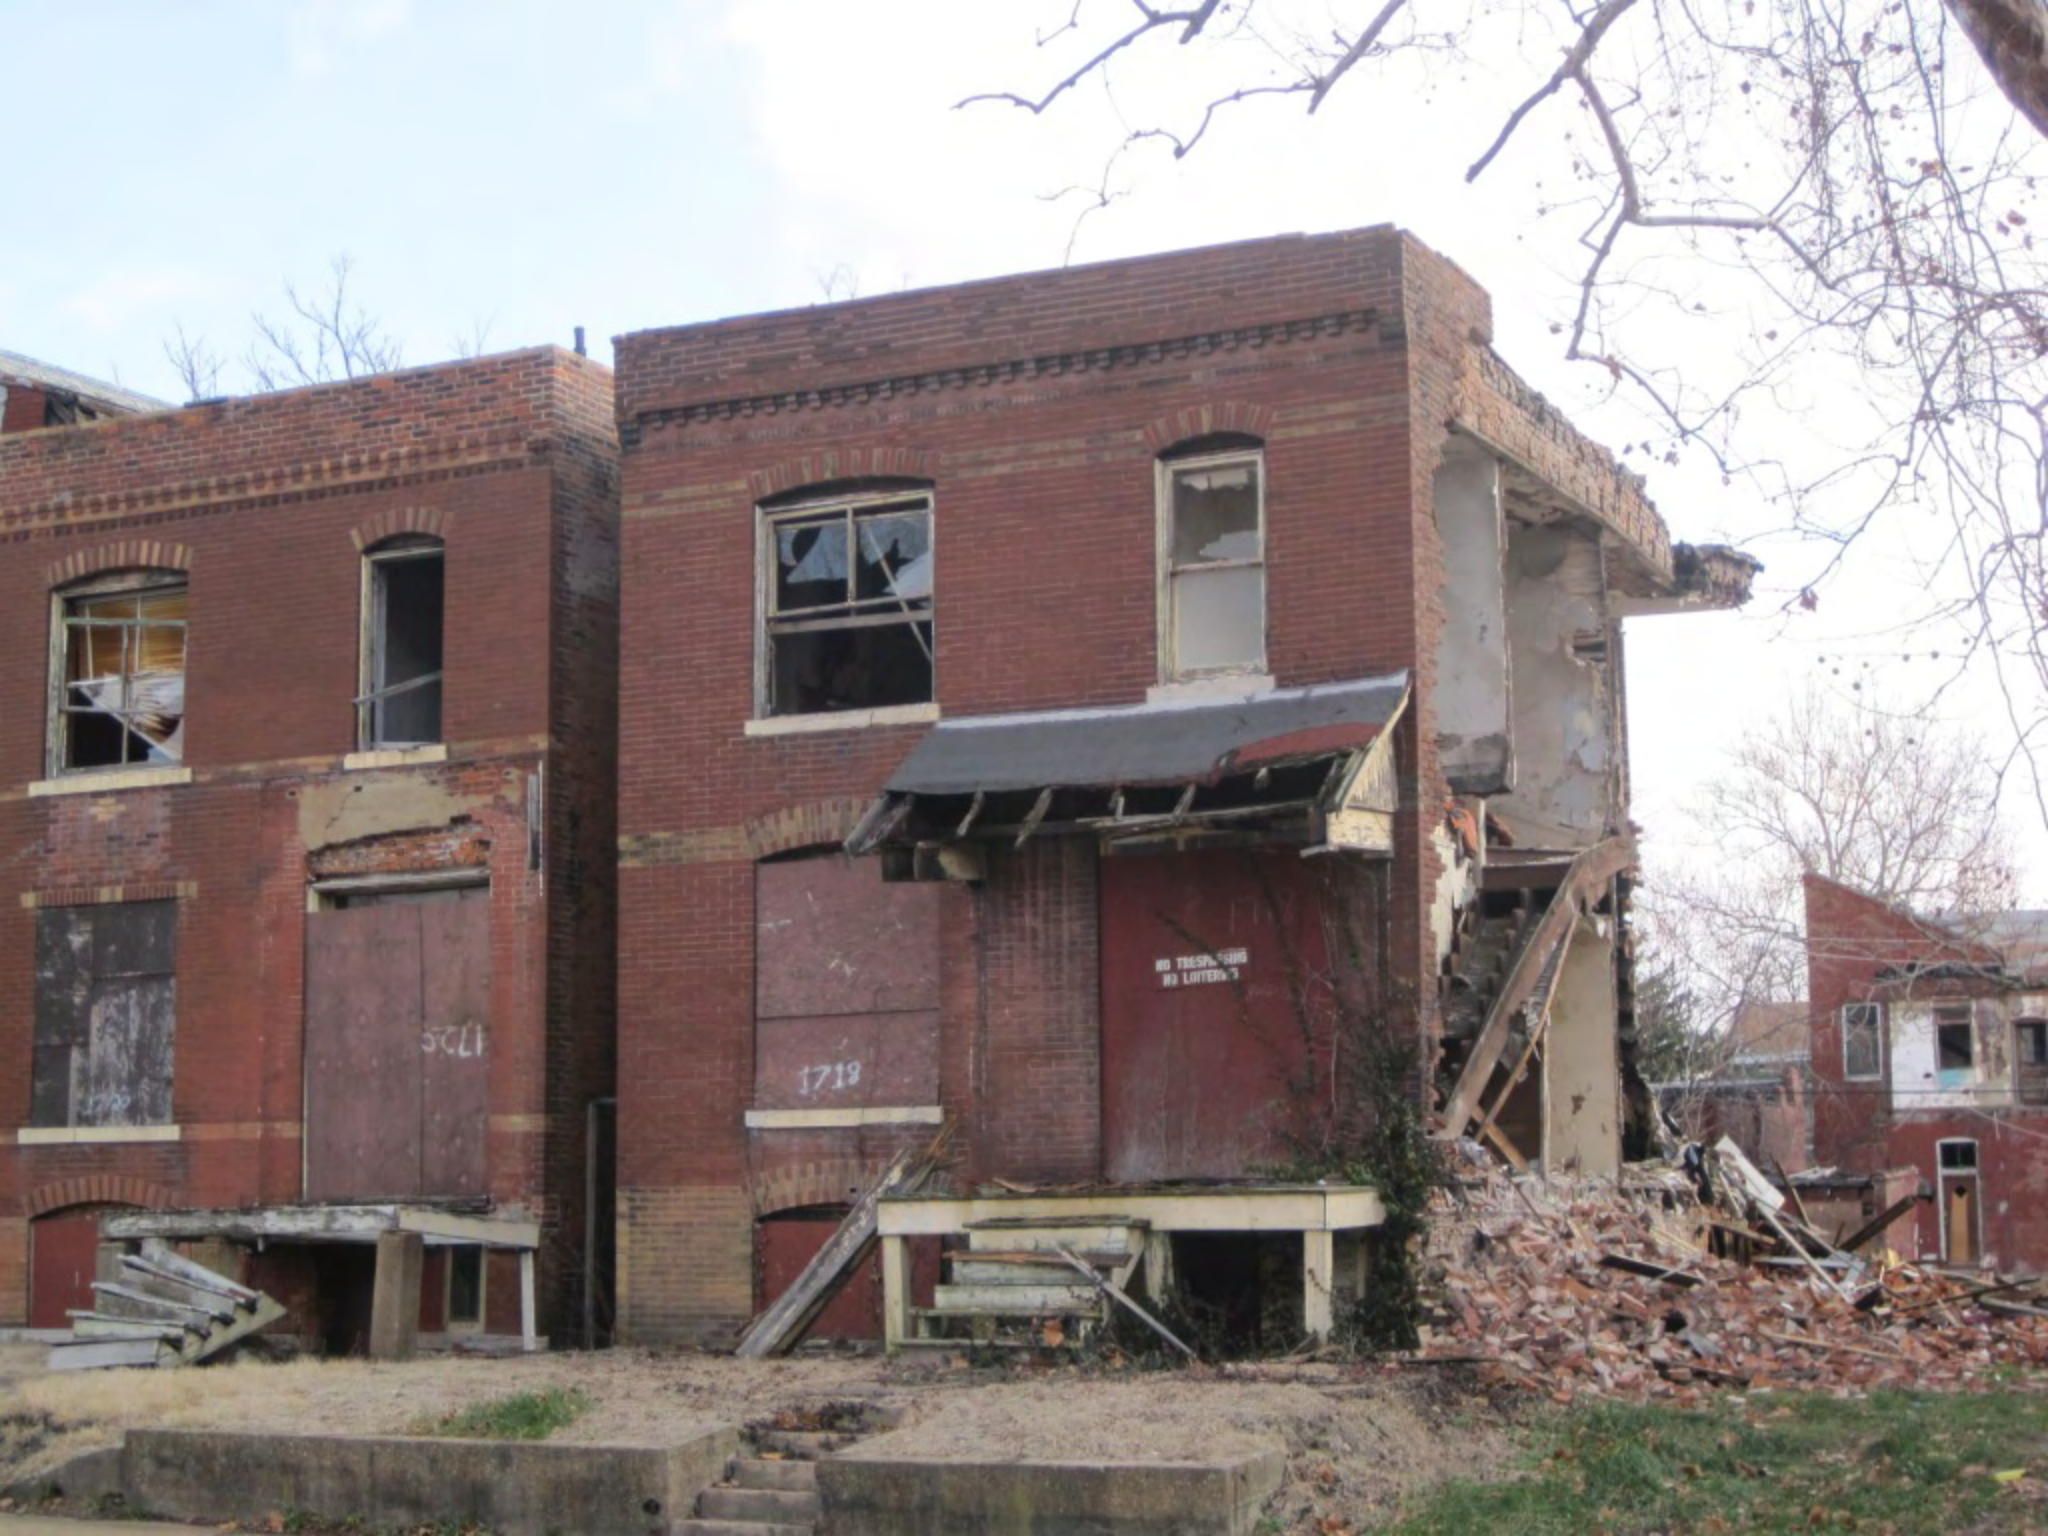
Rusticated limestone foundation with smooth top course; red brick walls. Wooden steps and porch with columns supporting flat roof. Entrance has two wooden doors and transom windows in casement. Window openings have stone sills and segmental arches with soldier headers. Windows in left bay are triple windows; wooden one-over-one windows remain in first floor opening while second floor opening is missing sash. Other opening missing sash. Metal gutter pan under roof, which is clad in asphalt shingles and has hipped dormer with openings containing wooden one-over-one windows.

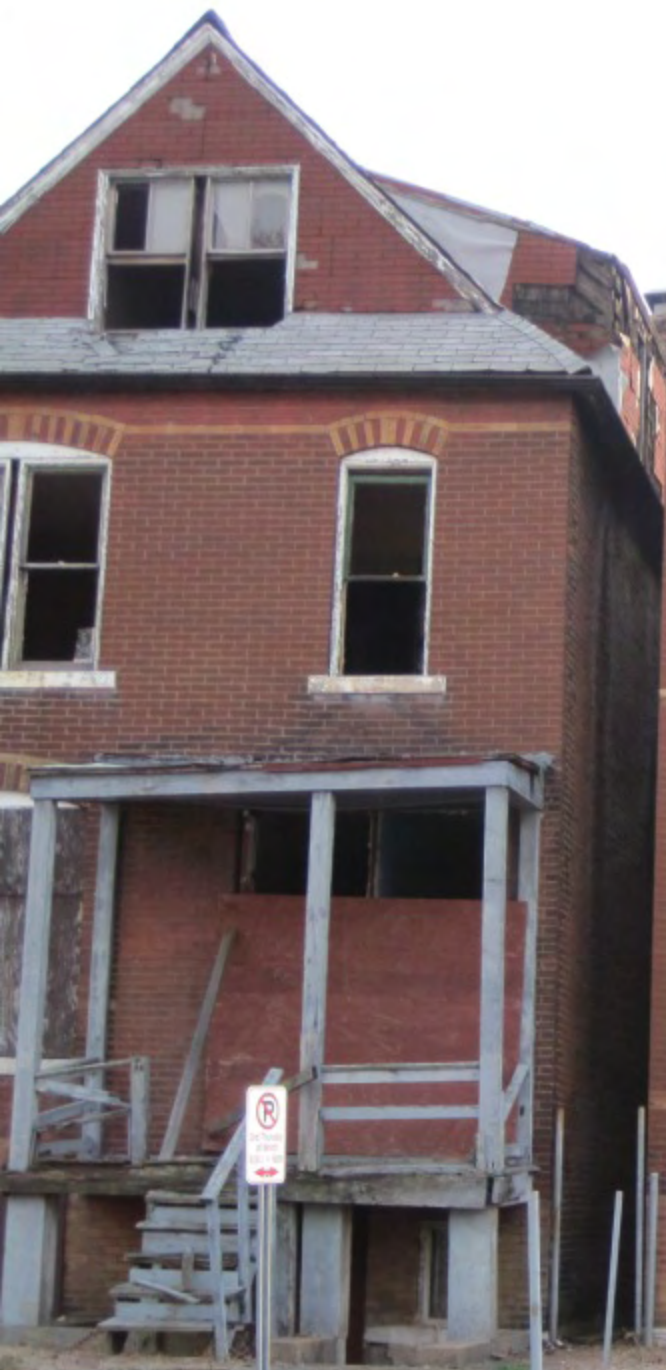
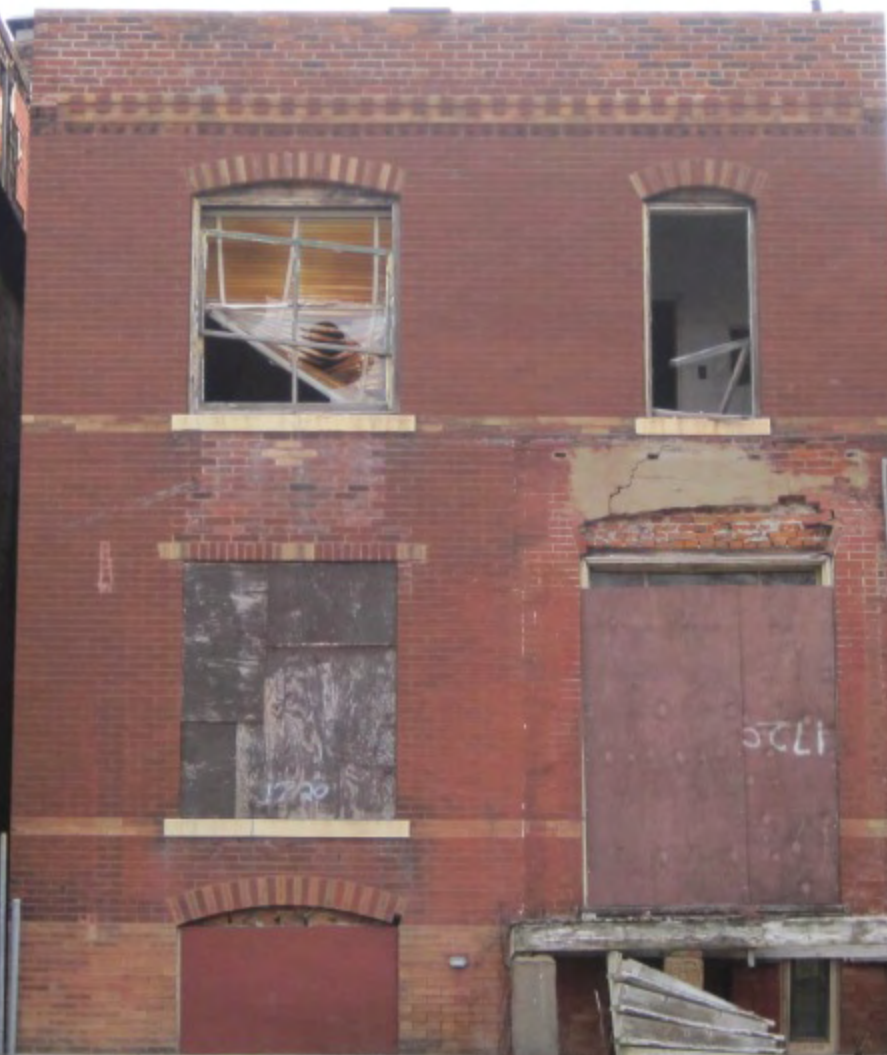
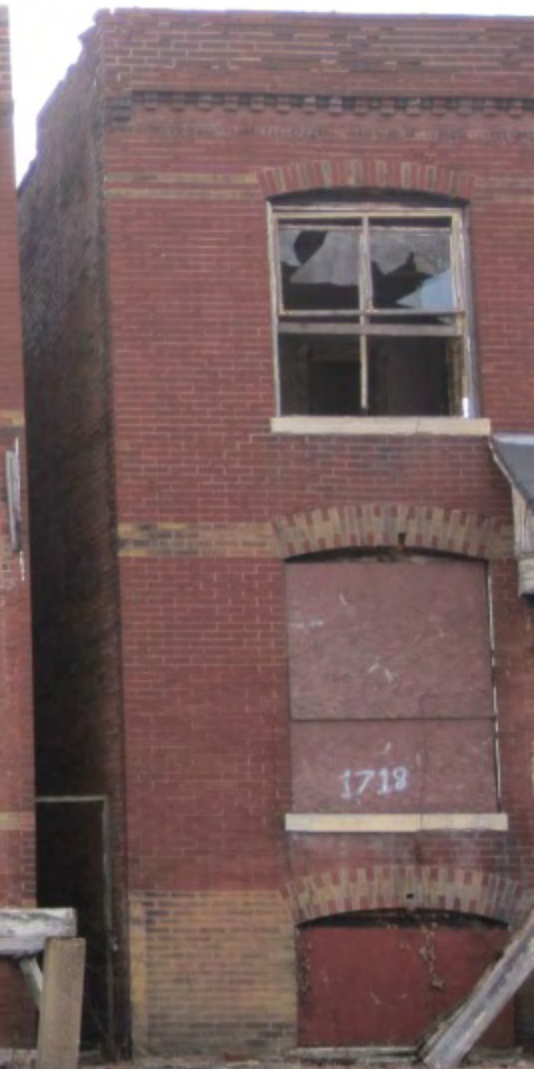
East and south walls missing. Ochre brick water table and red brick body. Wooden porch with shed-roof hood. Entrance boarded. Window openings have stone sills and polychromatic brick headers (vertical on first floor and soldier course on the second). Ochre brick courses run on each floor at header level. Basement and first floor window openings boarded. Second floor openings have wooden two-over-two window at left and one-over-one window at right. Ornamental brick course under architrave at top.

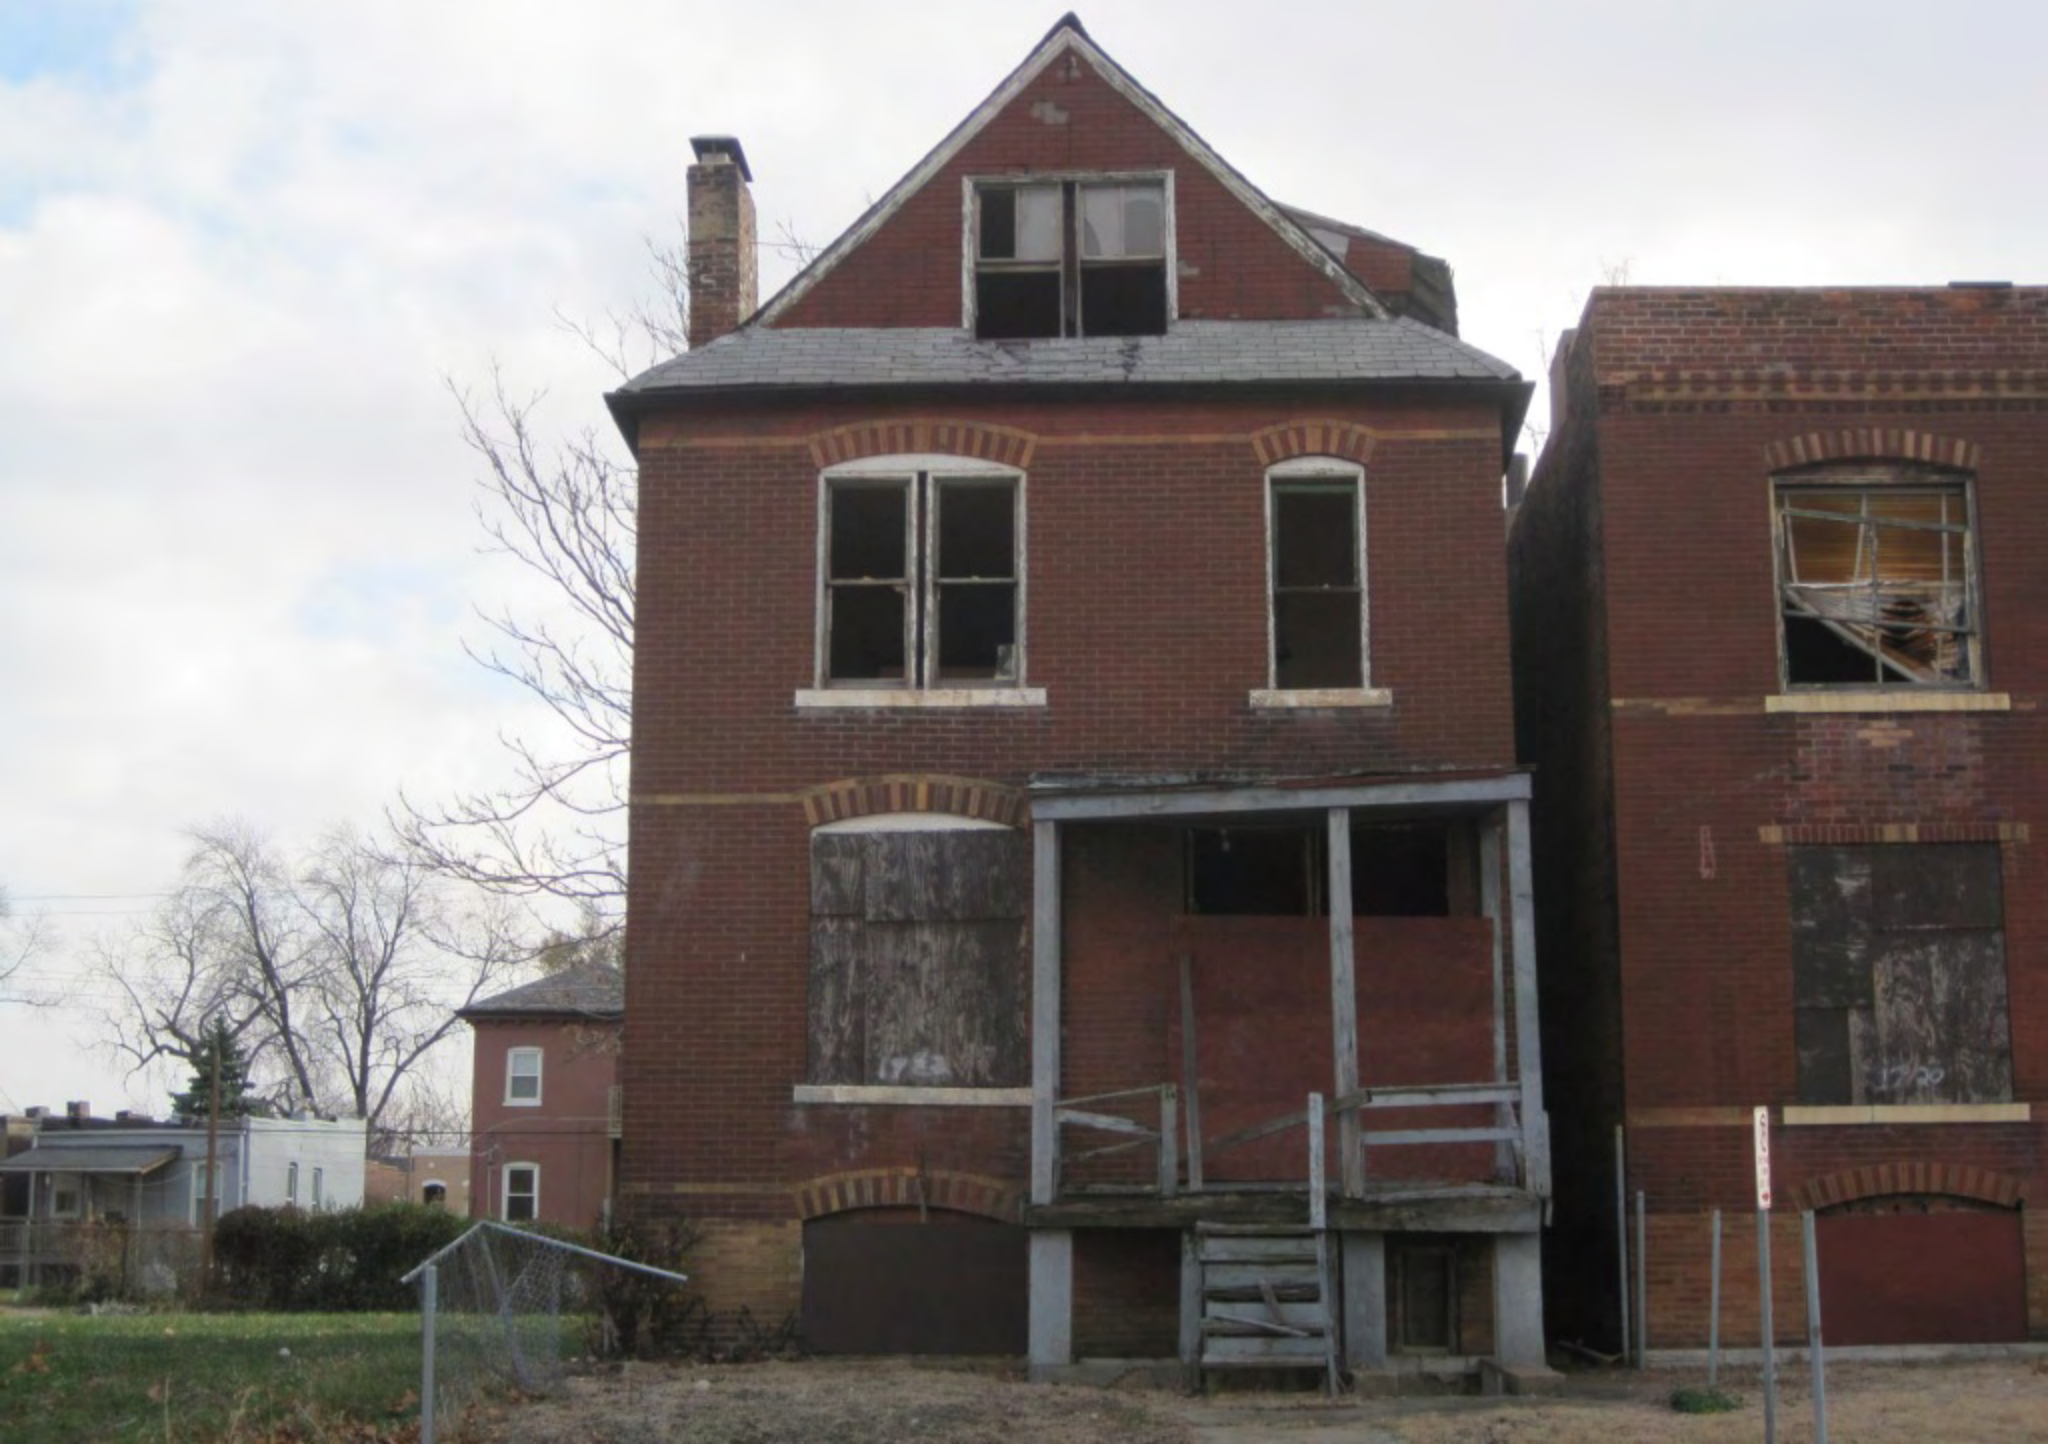
Ochre brick water table on red brick wall. Wooden stoop in shambles. Entrance with jack arch is boarded but wooden transom window evident under board. Doubled ochre courses run at sill levels. Openings have limestone sills. Basement opening (boarded) has segmental arch header with soldier course of alternating red and ochre bricks. First floor opening (boarded) rebuilt with jack arch with rowlock header. Second floor openings have segmental arches with soldier course headers of alternating brick colors. Left opening has damaged wooden two-over-two window inside; right opening is missing its sash. A band course of polychromatic patternwork is at the base of an architrave at top of elevation.
