Architectural/Historic Inventory Form

1. Survey No. SEC 15-036 290		2. Survey Name: Villie	
3. County: St. Louis [Independent City]		4. Address: 4452 KENNERLY AV	
5. City/State: St. Louis, MO		6. UTM: / /	
7. Township/Range/Section: T: R: S:		Not Applicable	
8. Historic Name (if known):		9. Present Name (if known):	
10. Ownership: Domestic		11. Present Use: Domestic	
12. Historic Use (if known): Sub-use: Single Dwelling		13. Present Use: Sub-use:

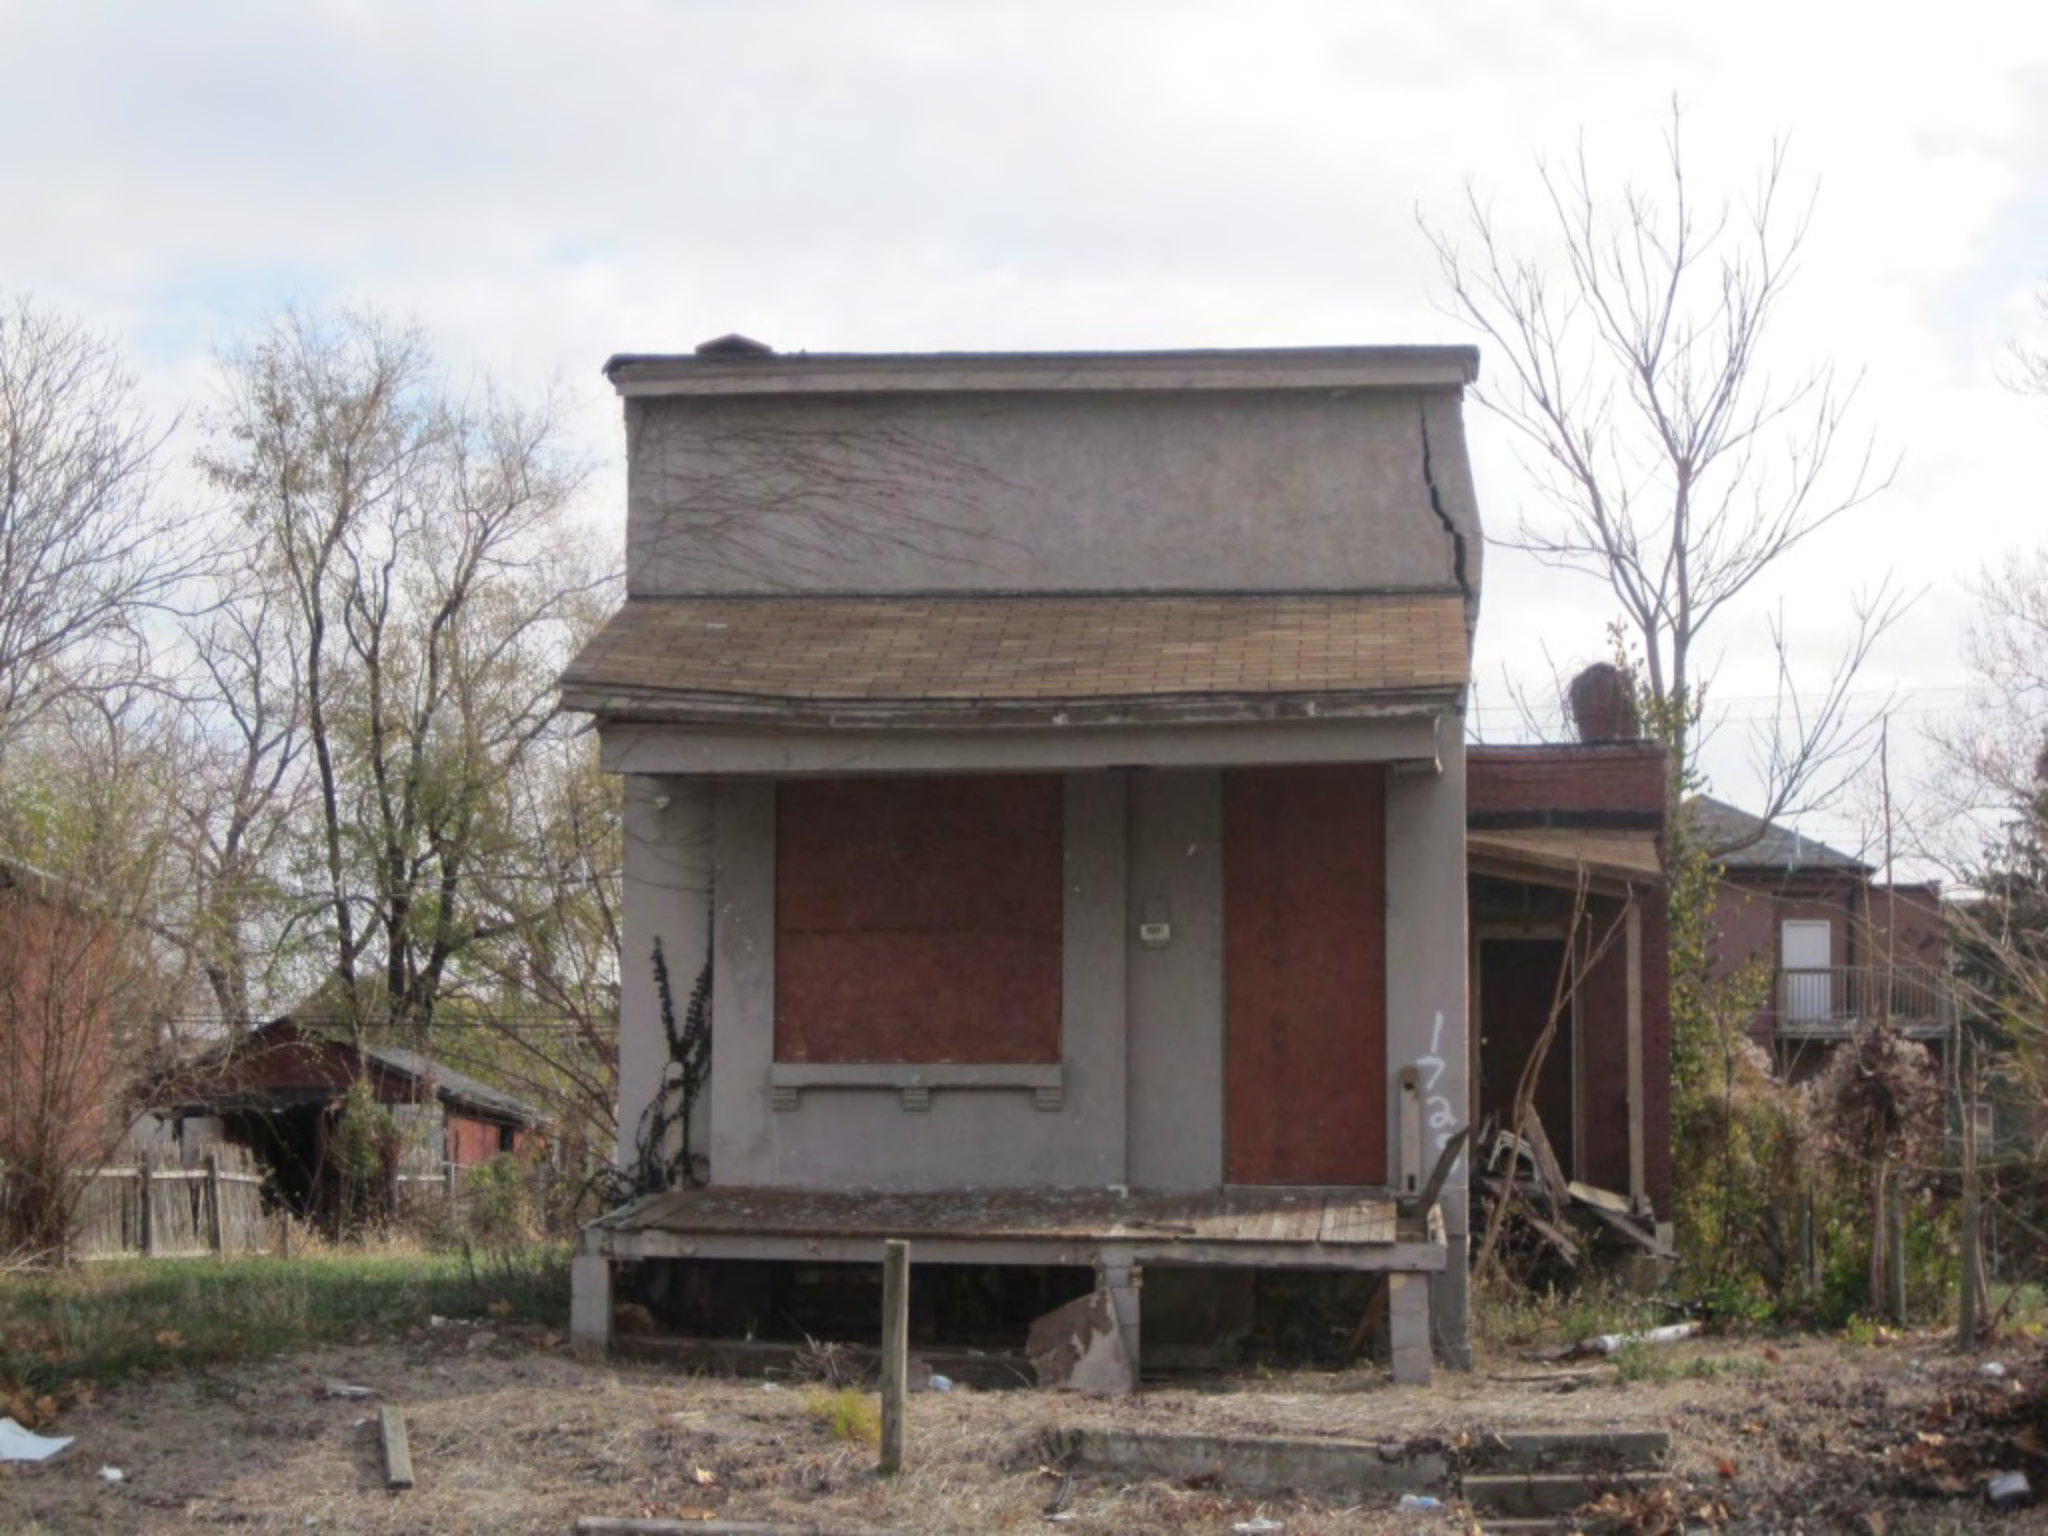
Ochre brick water table on red brick wall. Ochre brick is also used for courses at header level and alternating with red brick in the solid course headers over the window openings' segmental arches. Window openings have limestone sills. Wooden shed-roof porch deteriorated. Double entrance boarded. Basement and first floor window openings boarded. Second floor openings have paired one-over-one window at left and one-over-one window at right (glass missing). Gable end above has opening containing paired wooden one-over-one windows.

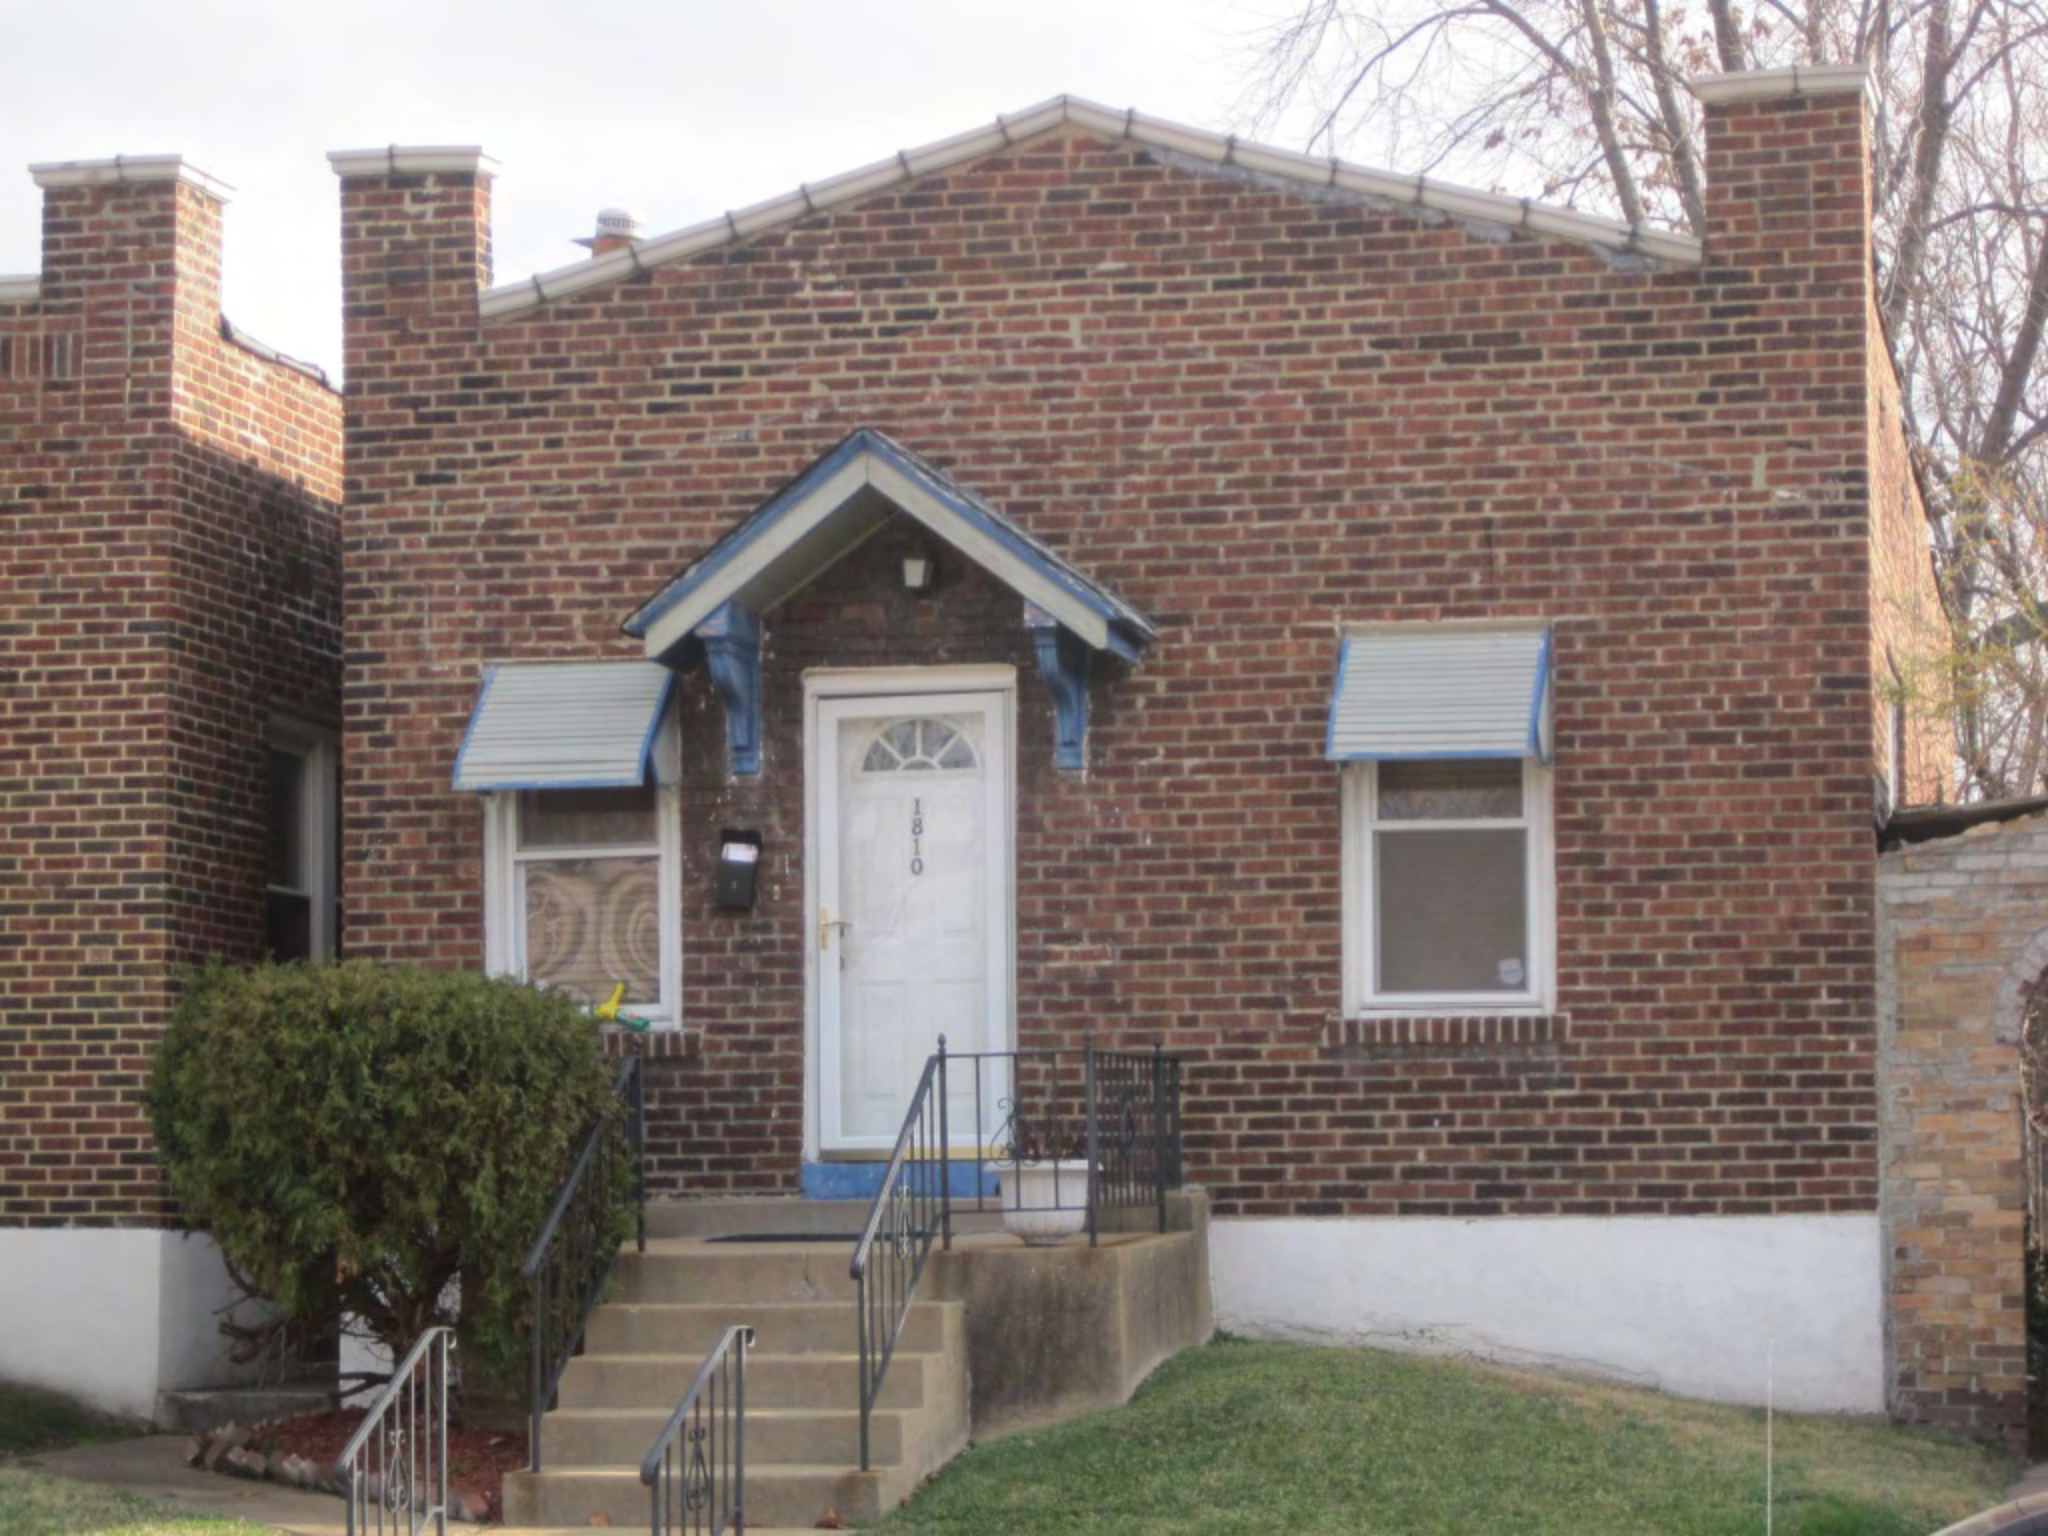
Buff brick. Buttress at left includes round-arch opening to gangway. Concrete steps to brick stoop. Entrance has replacement door and red brick label course. Window opening has red brick rowlock sill and soldier header as well as paired wooden one-over-one windows. Opening at top of gable end has red rowlock sill and soldier header with wooden louvered vent inside.

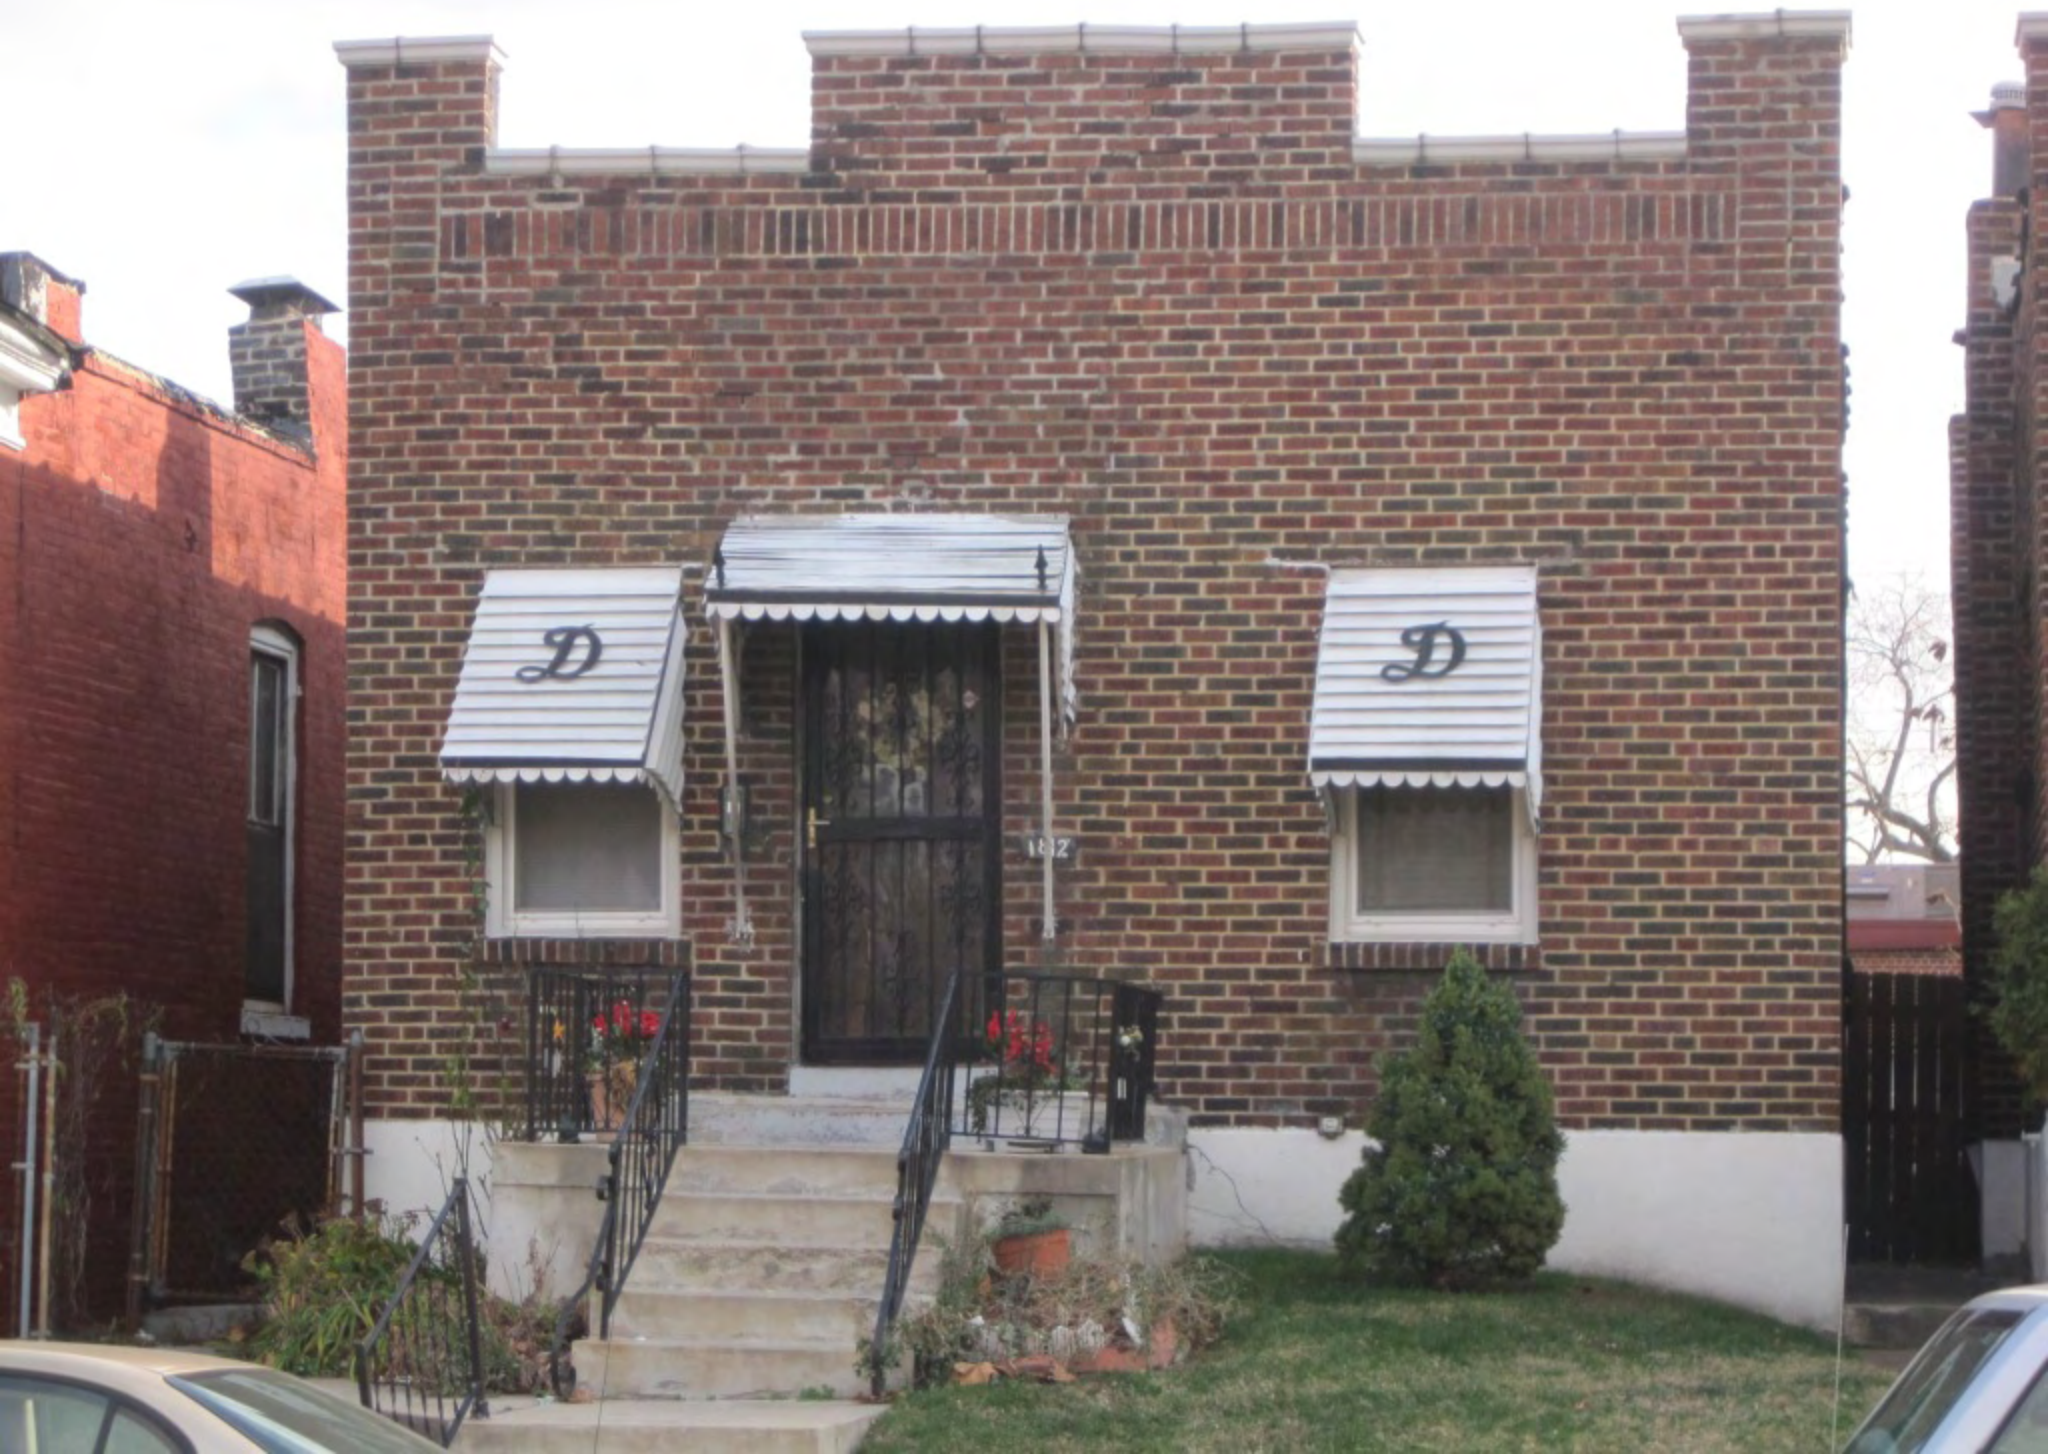
Concrete stoop with metal railings. Brown tapestry brick. Jack arch openings; window openings have rowlock sills. Entrance contains replacement door and has bracketed open wooden gabled hood overhead. Two windows are one-over-one wooden windows behind storm windows. Parapet has center rise and tall end blocks; white glazed terra cotta coping.

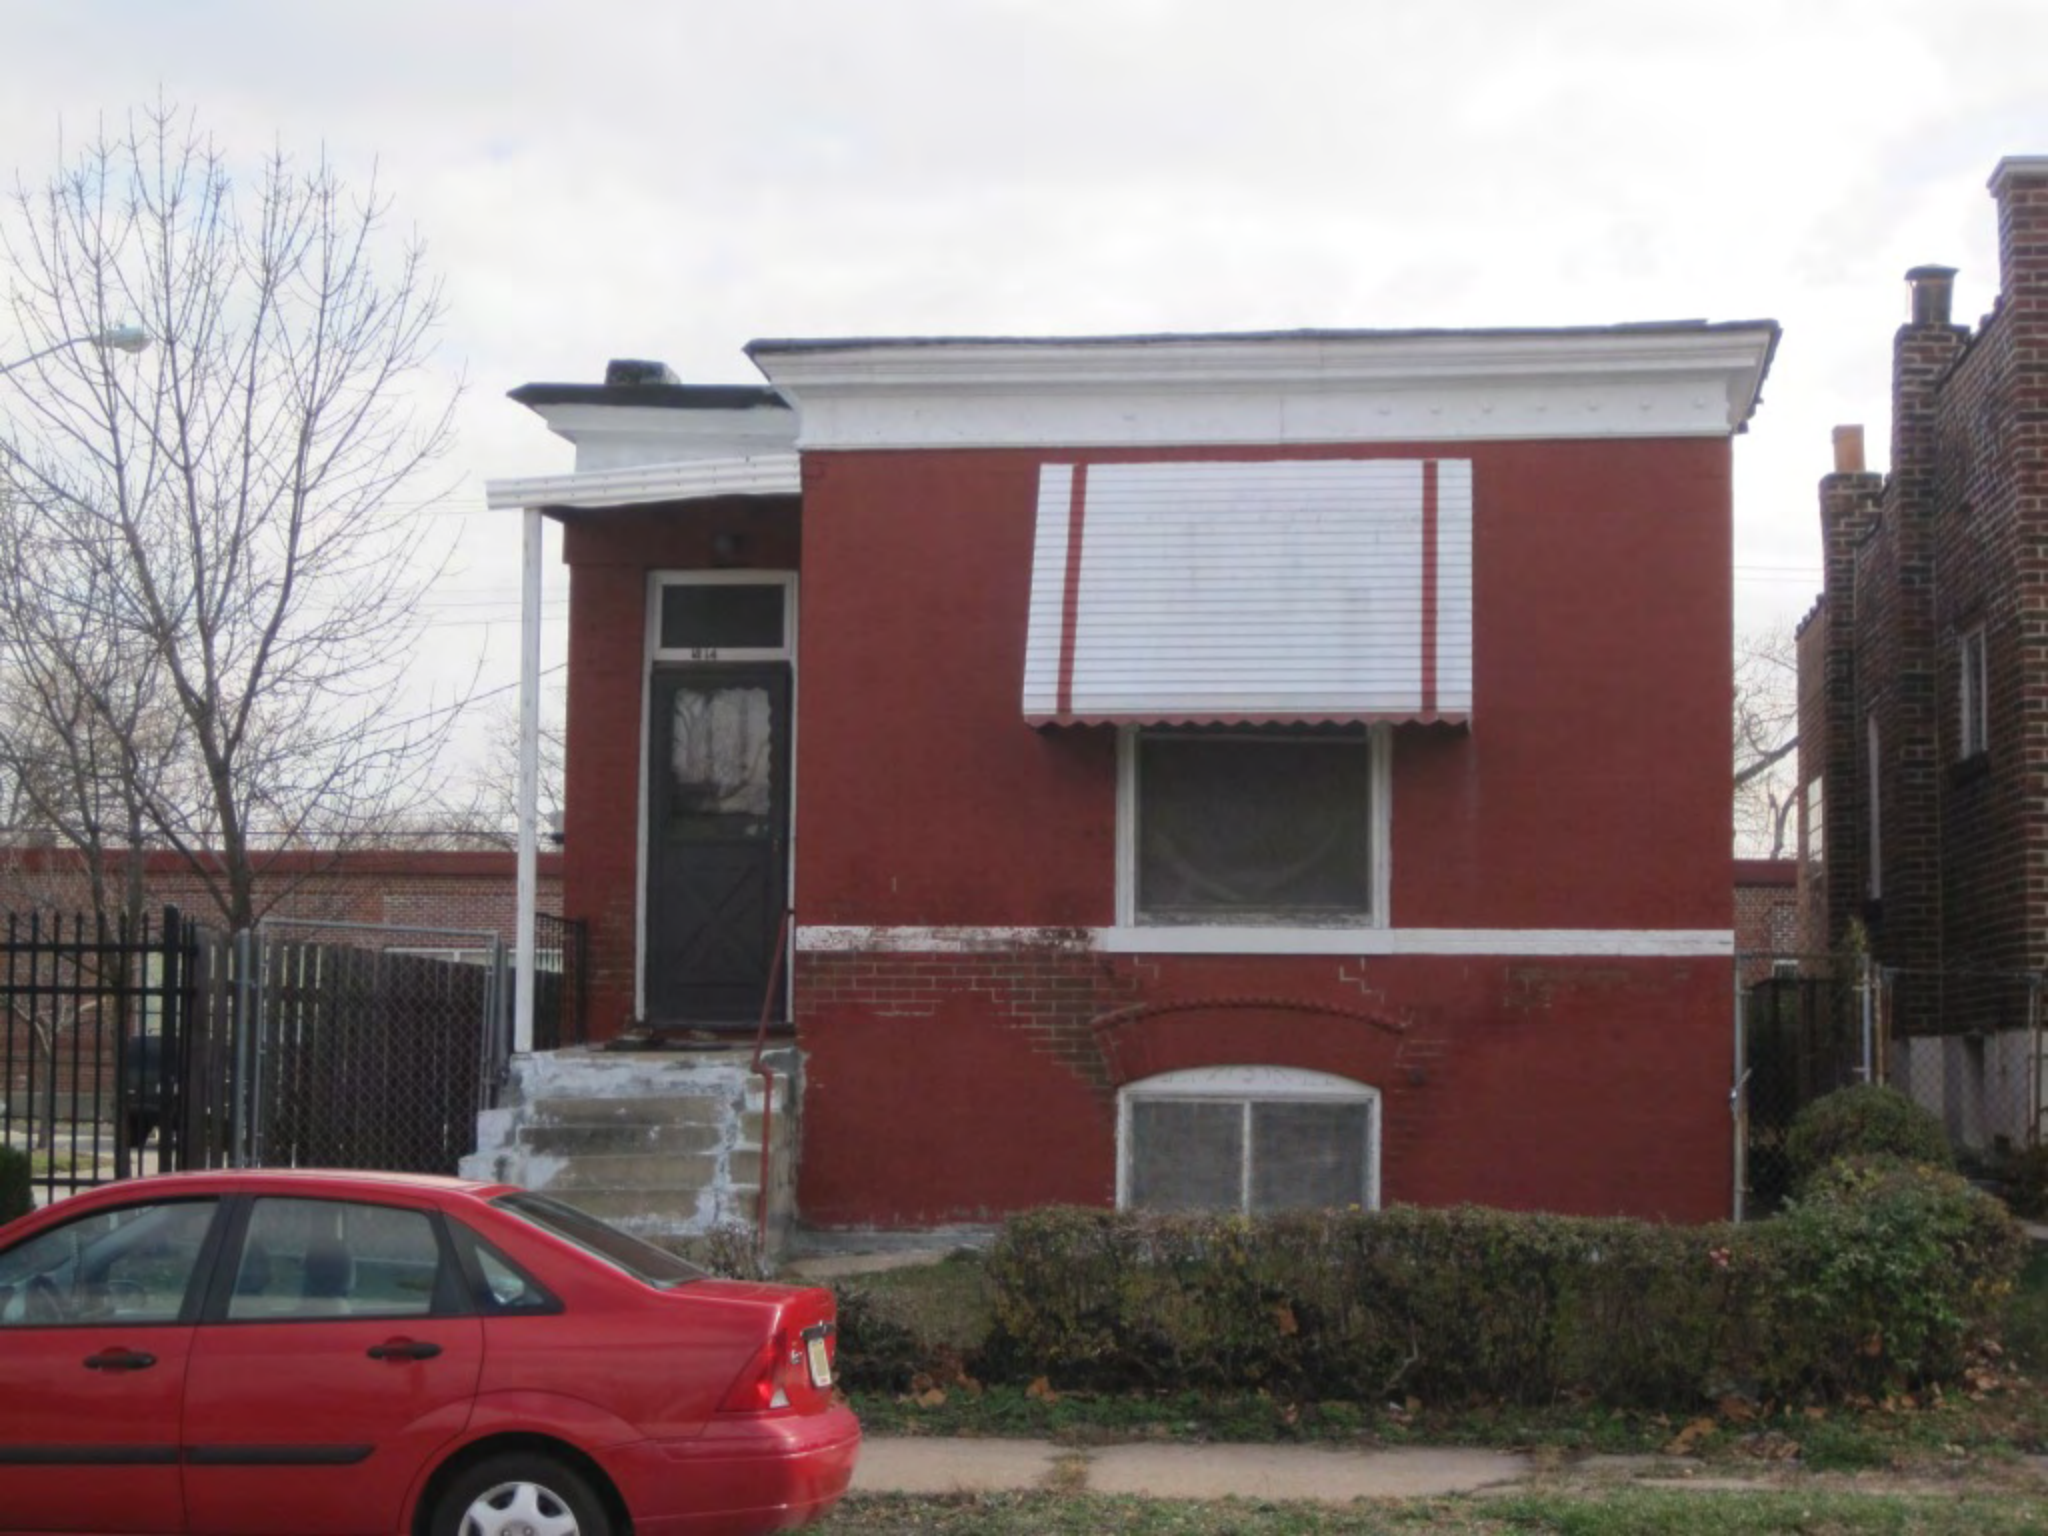
Concrete stoop with metal rails and parged painted foundation. Red-brown tapestry brick. Jack arch-openings; window openings have rowlock sills. Metal awnings over entrances. Windows are one-over-one wooden windows behind storm windows. Door in entrance is replacement behind security storm door. Soldier course across parapet, which has center step and tall end blocks as well as white glazed terra cotta coping.

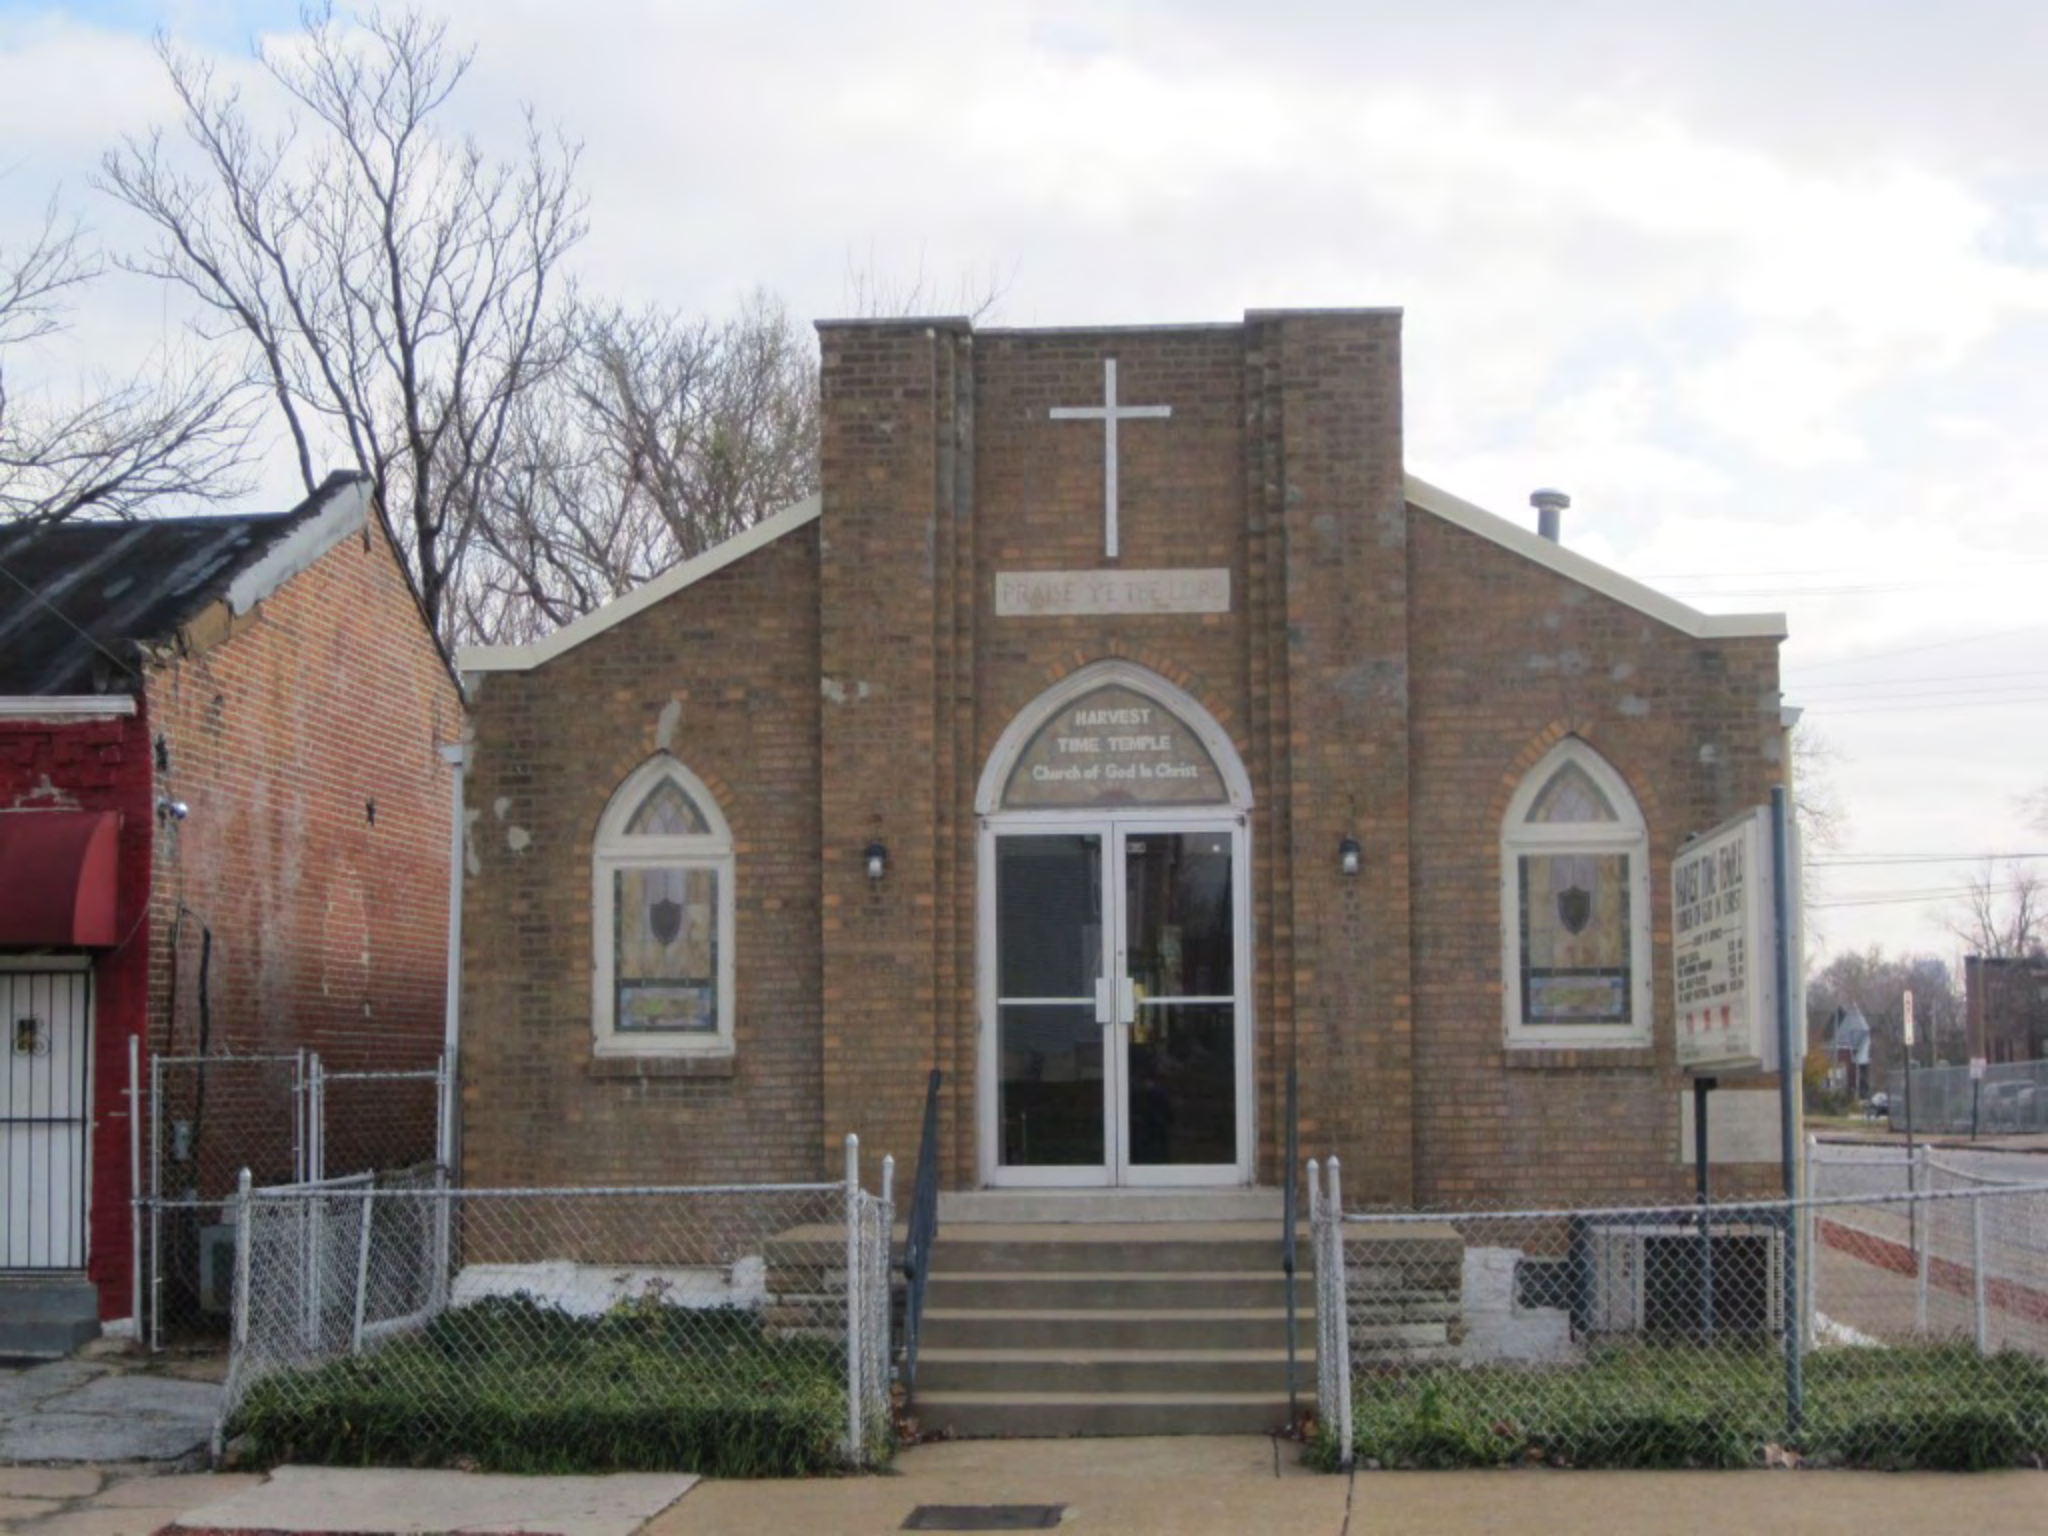
Painted brick. Painted stone sill course. Basement opening has vertical header and tracing course on segmental arch; wooden casement and metal window inside. Concrete steps and stop at left with metal rail and wooden column supporting flat roof. Recessed entrance bay; entrance has wooden door and transom window in casement. Window opening on right bay is obscured by awning and has a segmental arch with traced soldier course header and a wooden one-over-one window inside. Cornice retains beaded fascia and crown molding but may be missing other elements.

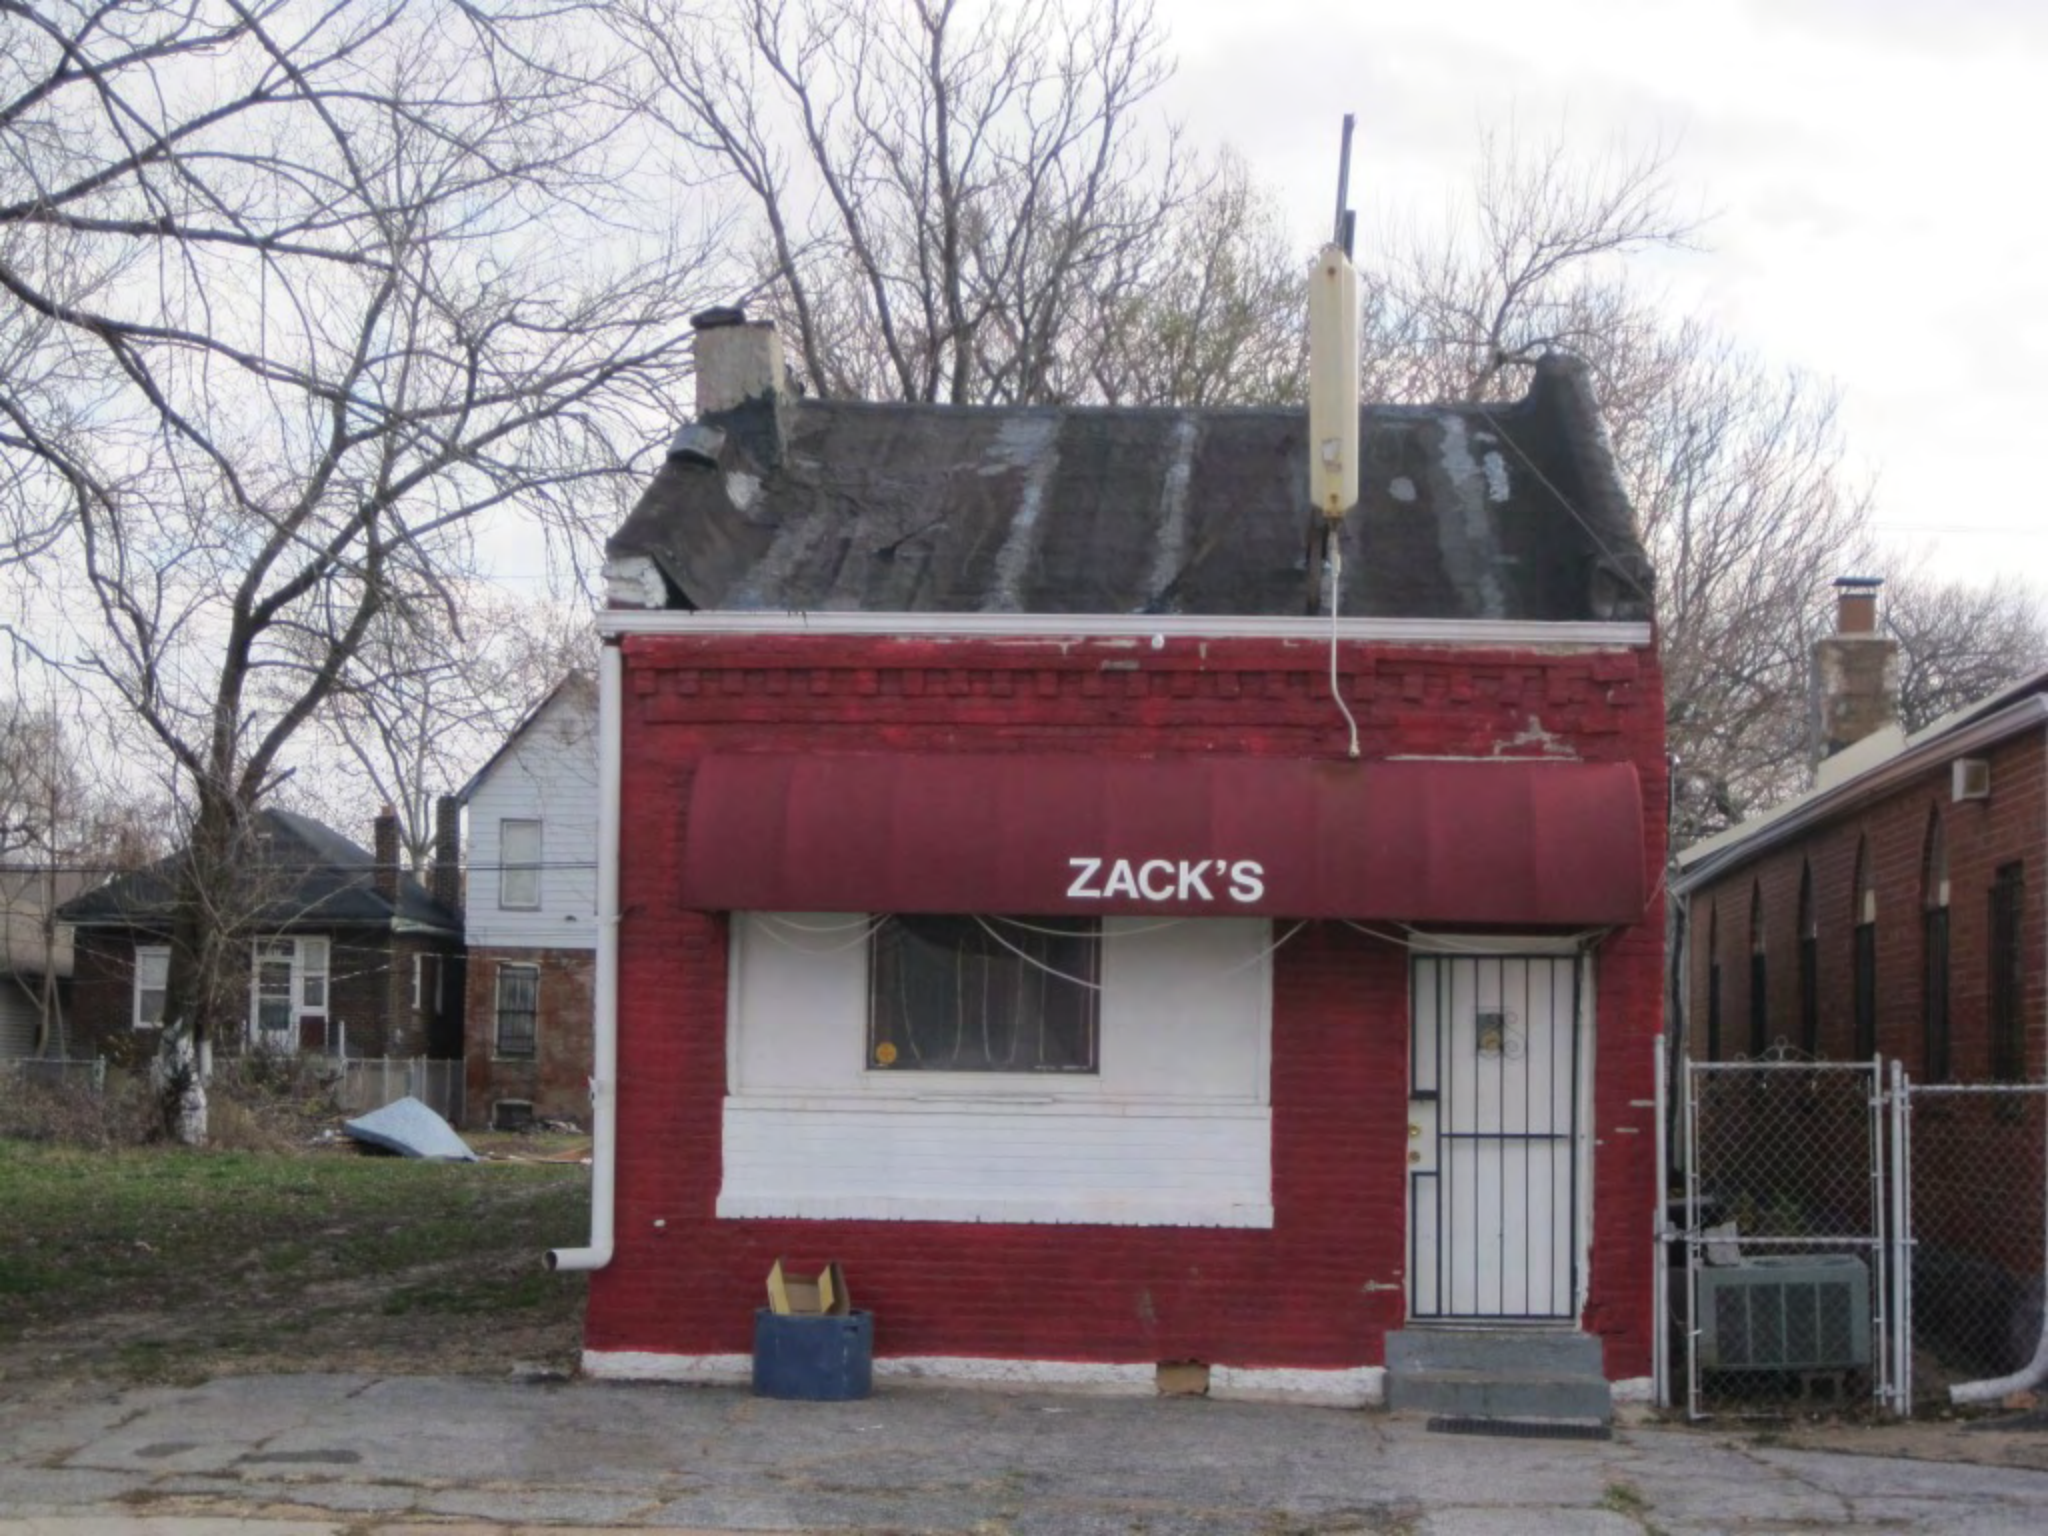
Buff brick church with painted stone foundation. Front elevation has two tall piers setpped out from center that rise to form a flat-top parapet. Entrance has lancet arch with gauged rowlock header; stained glass transom over metal double doors. Window openings on each side of entrance bay have rowlock sills and lancet arches with gauged rowlock headers; stained glass windows and transoms in wooden frames.

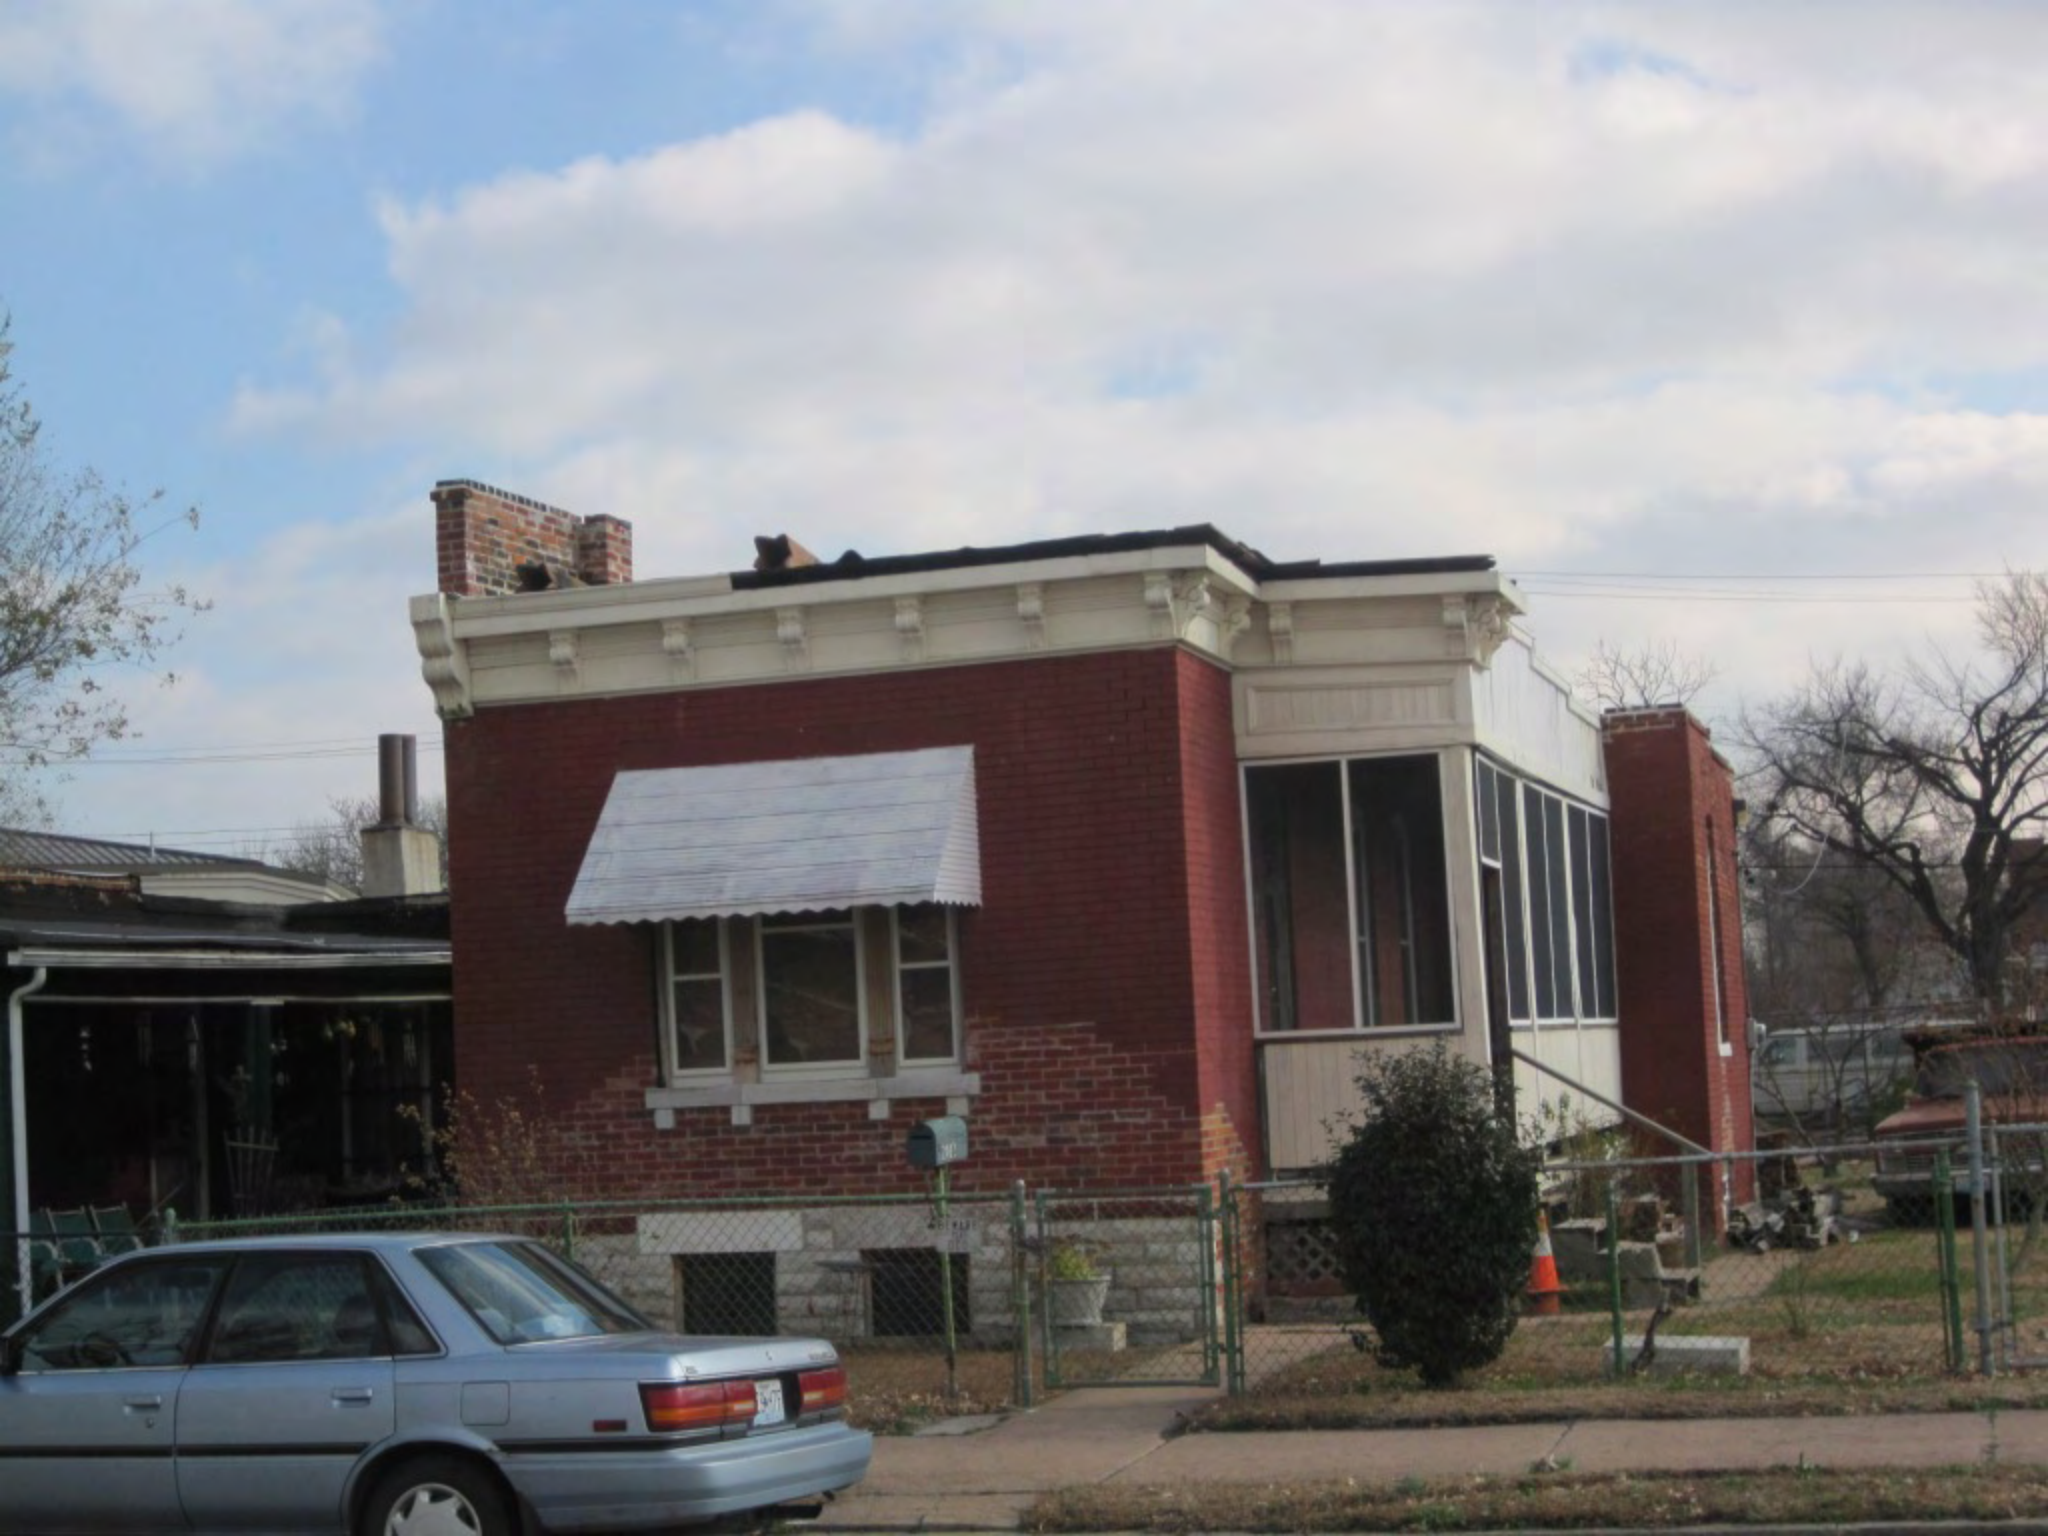
Painted front elevation with dentillated brick cornice. Blade sign projecting from roof slope. Full-width awning over large window opening at left and entrance at right (with concrete steps). Replacement door. Window opening covered with wood around small fixed-pane window. It appears likely that this was originally a two-room side gabled house with a later rear addition, converted to business use sometime before 1951.
