Architectural/Historic Inventory Form

1. Survey No. SEC 15-036 290		2. Survey Name: Villie	
3. County: St. Louis [Independent City]		4. Address: 4452 KENNERLY AV	
5. City/State: St. Louis, MO		6. UTM: / /	
7. Township/Range/Section: T: R: S:		Not Applicable	
8. Historic Name (if known):		9. Present Name (if known):	
10. Ownership: Domestic		11. Present Use: Domestic	
12. Historic Use (if known): Sub-use: Single Dwelling		13. Present Use: Sub-use:

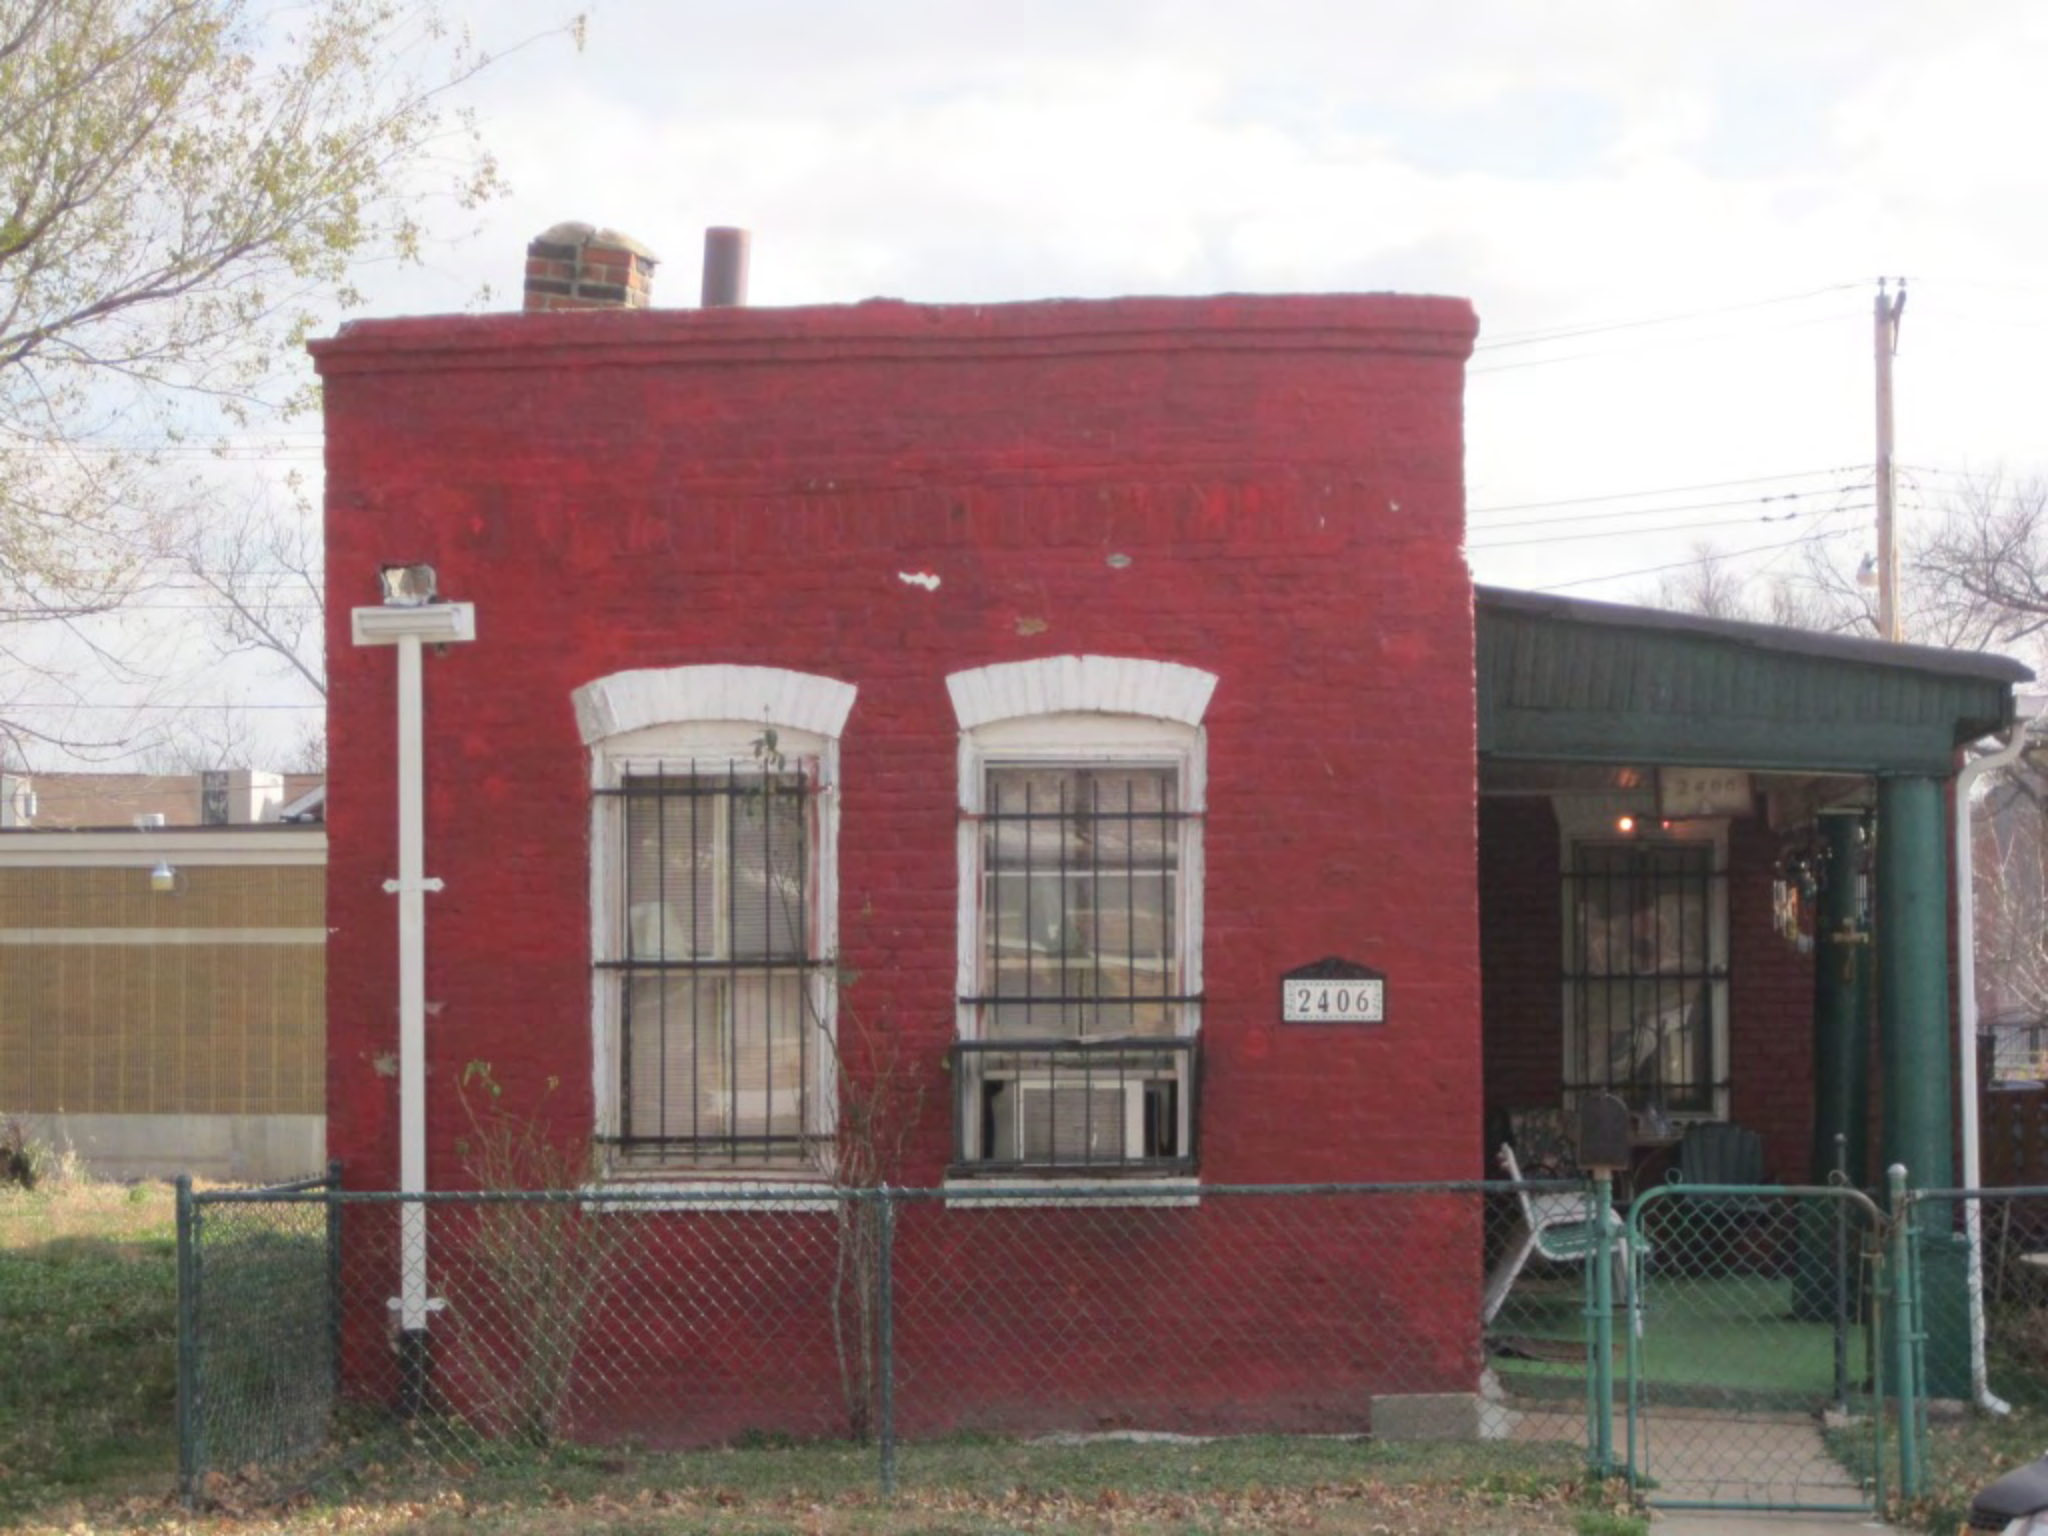
Rusticated limestone foundation and red brick body. Bracketed wooden cornice continues to face of enclosed side porch. Entrance on south elevation. Front elevation has two basement window openings with stone lintels under first floor opening with stone sills and consoles and segmental arch (obscured by awning). Opening has triple window consisting of wooden one-over-one sash divided by decorated wooden mullions.

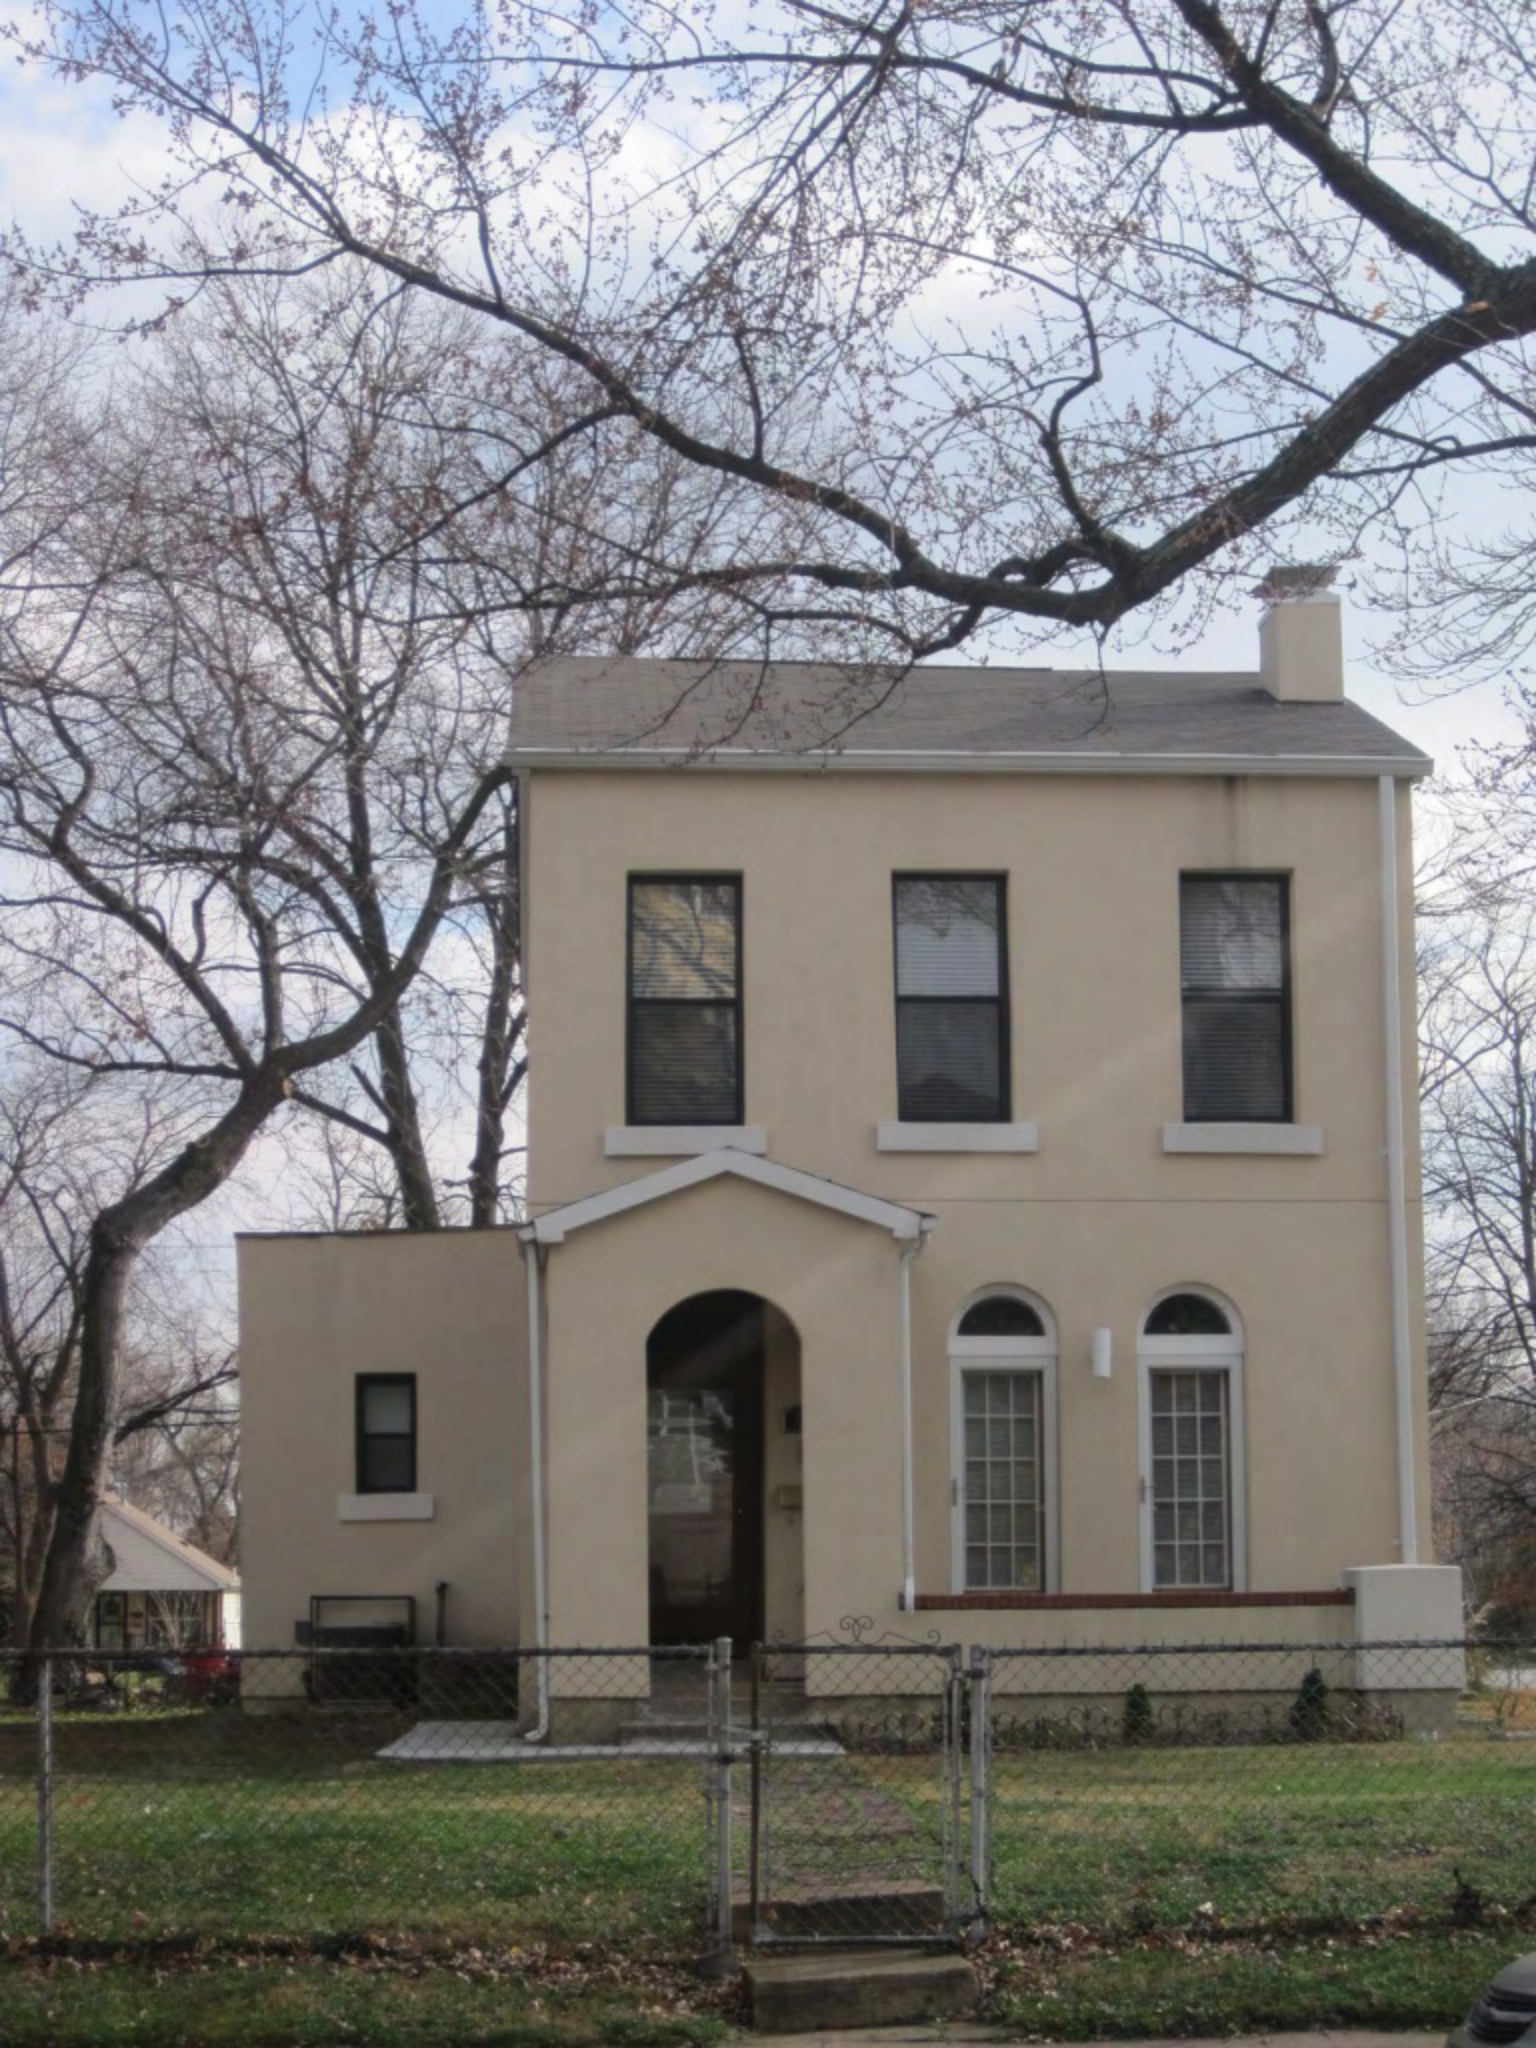
The front gabled facade is clad in simulated stone masonry. Entrance at left with replacement and security doors. Window opening at right with metal bars and one-over-one replacement window.

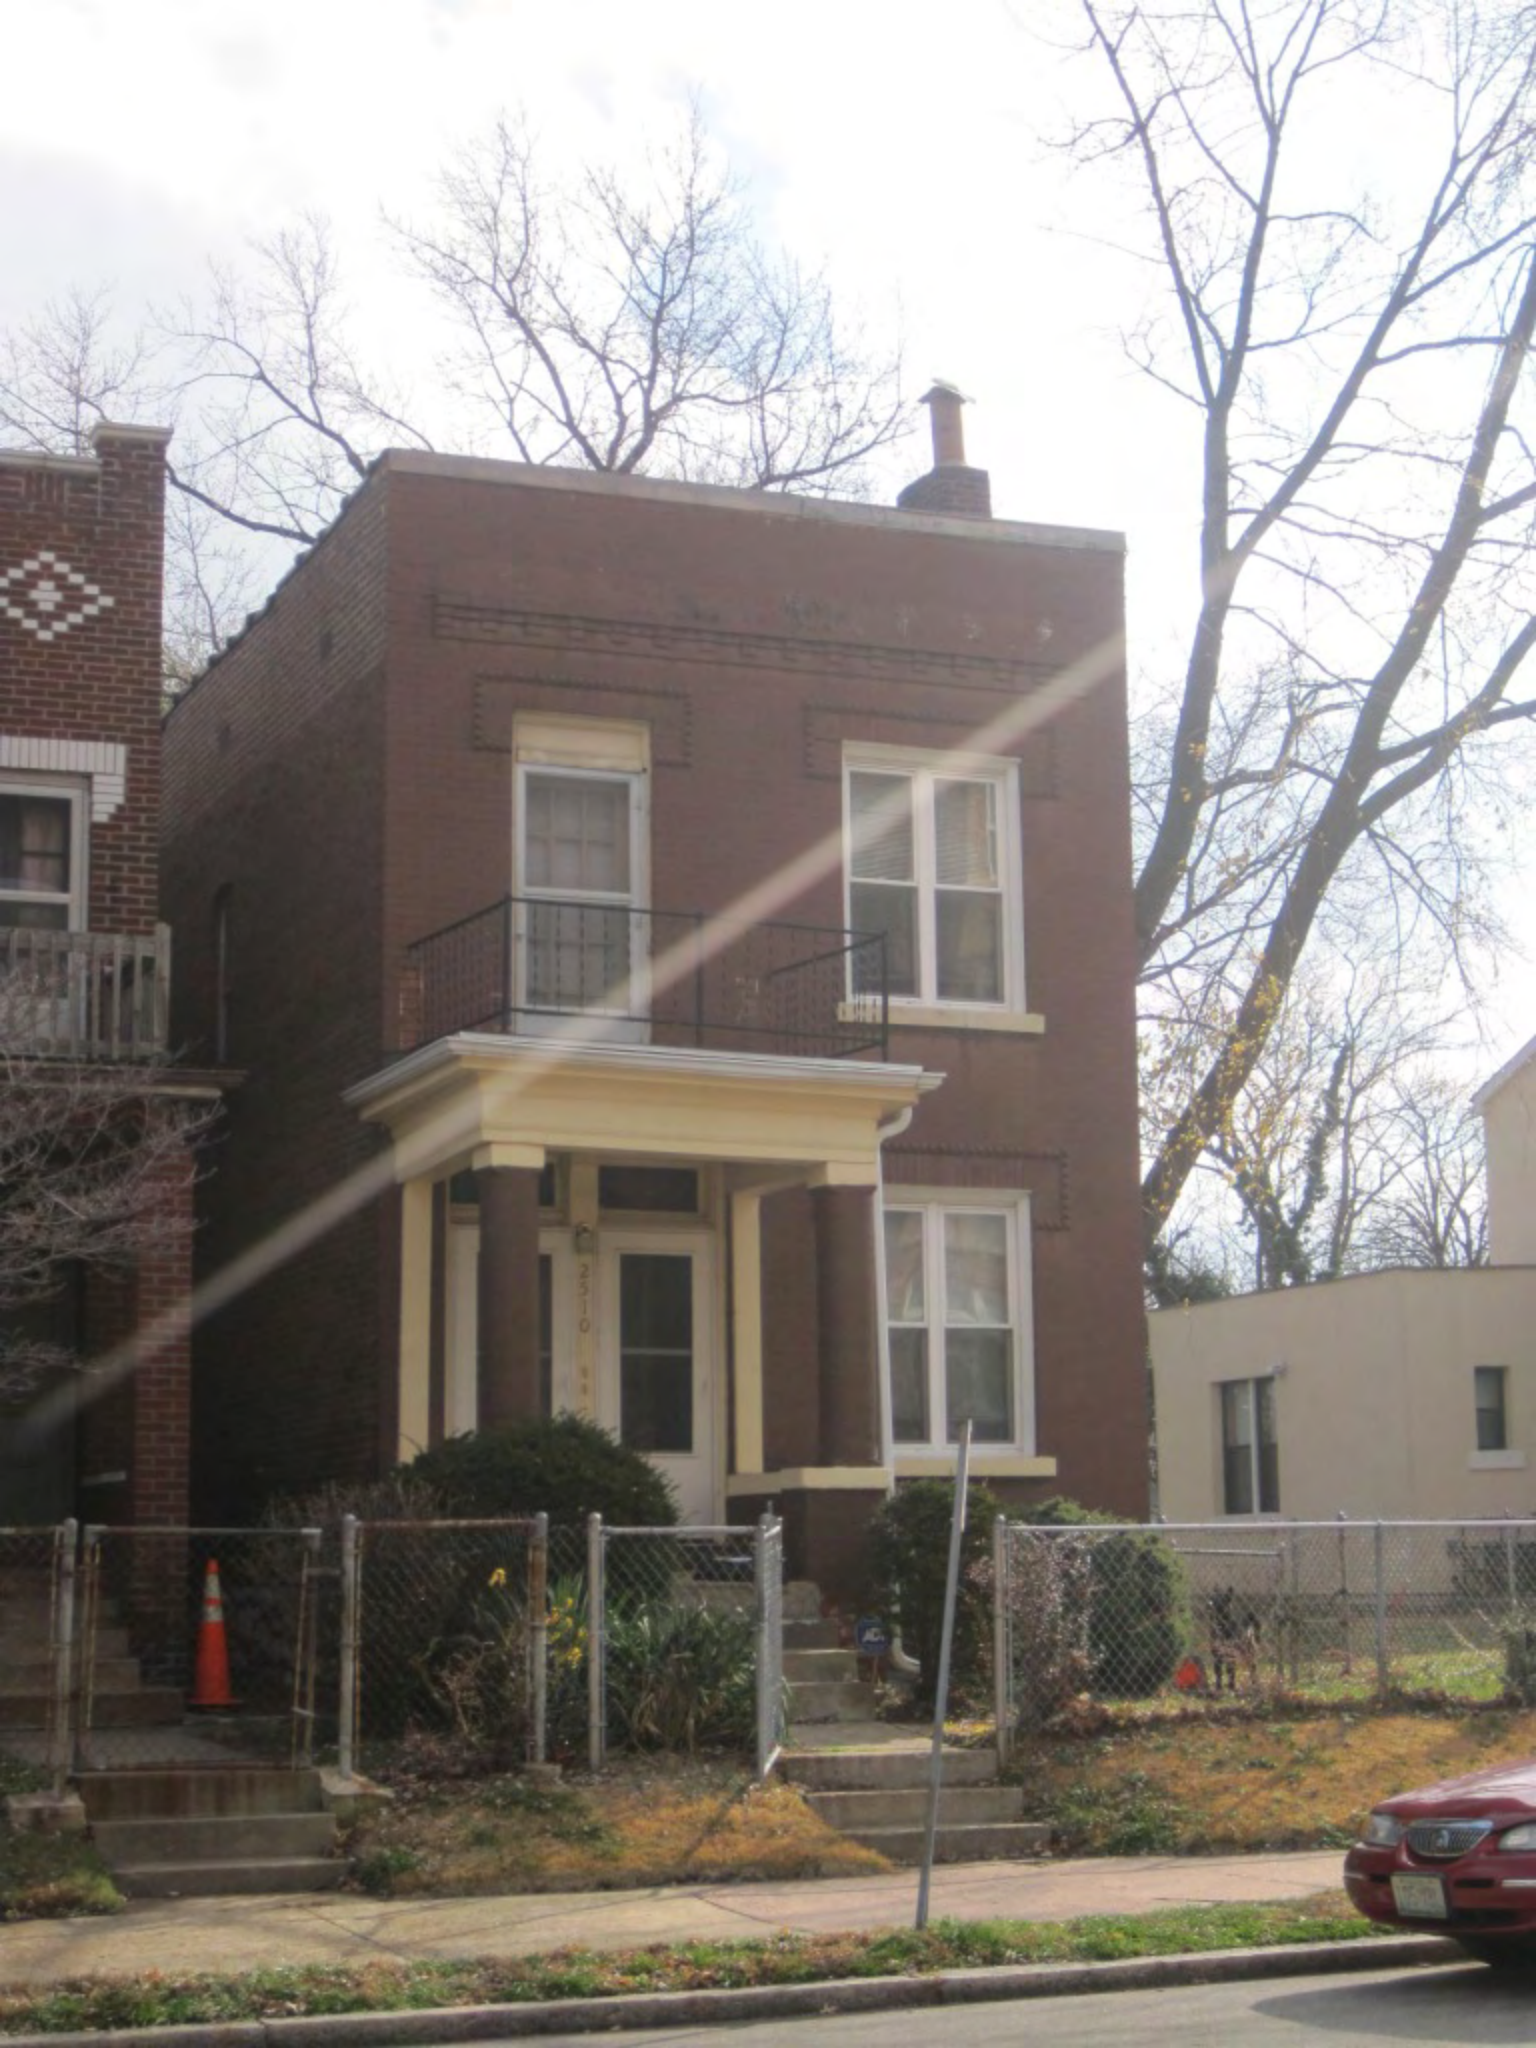
Clad in contemporary stucco. Porch rises to support gabled roof at entrance; round arch opening. Porch wall continues across front elevation. Entrance has replacement door. First floor window openings have round arches and tall hinged multi-light windows. Second floor openings have flat arches, pronounced sills and one-over-one replacement windows. There is a one-story shed-roofed addition on the north side.

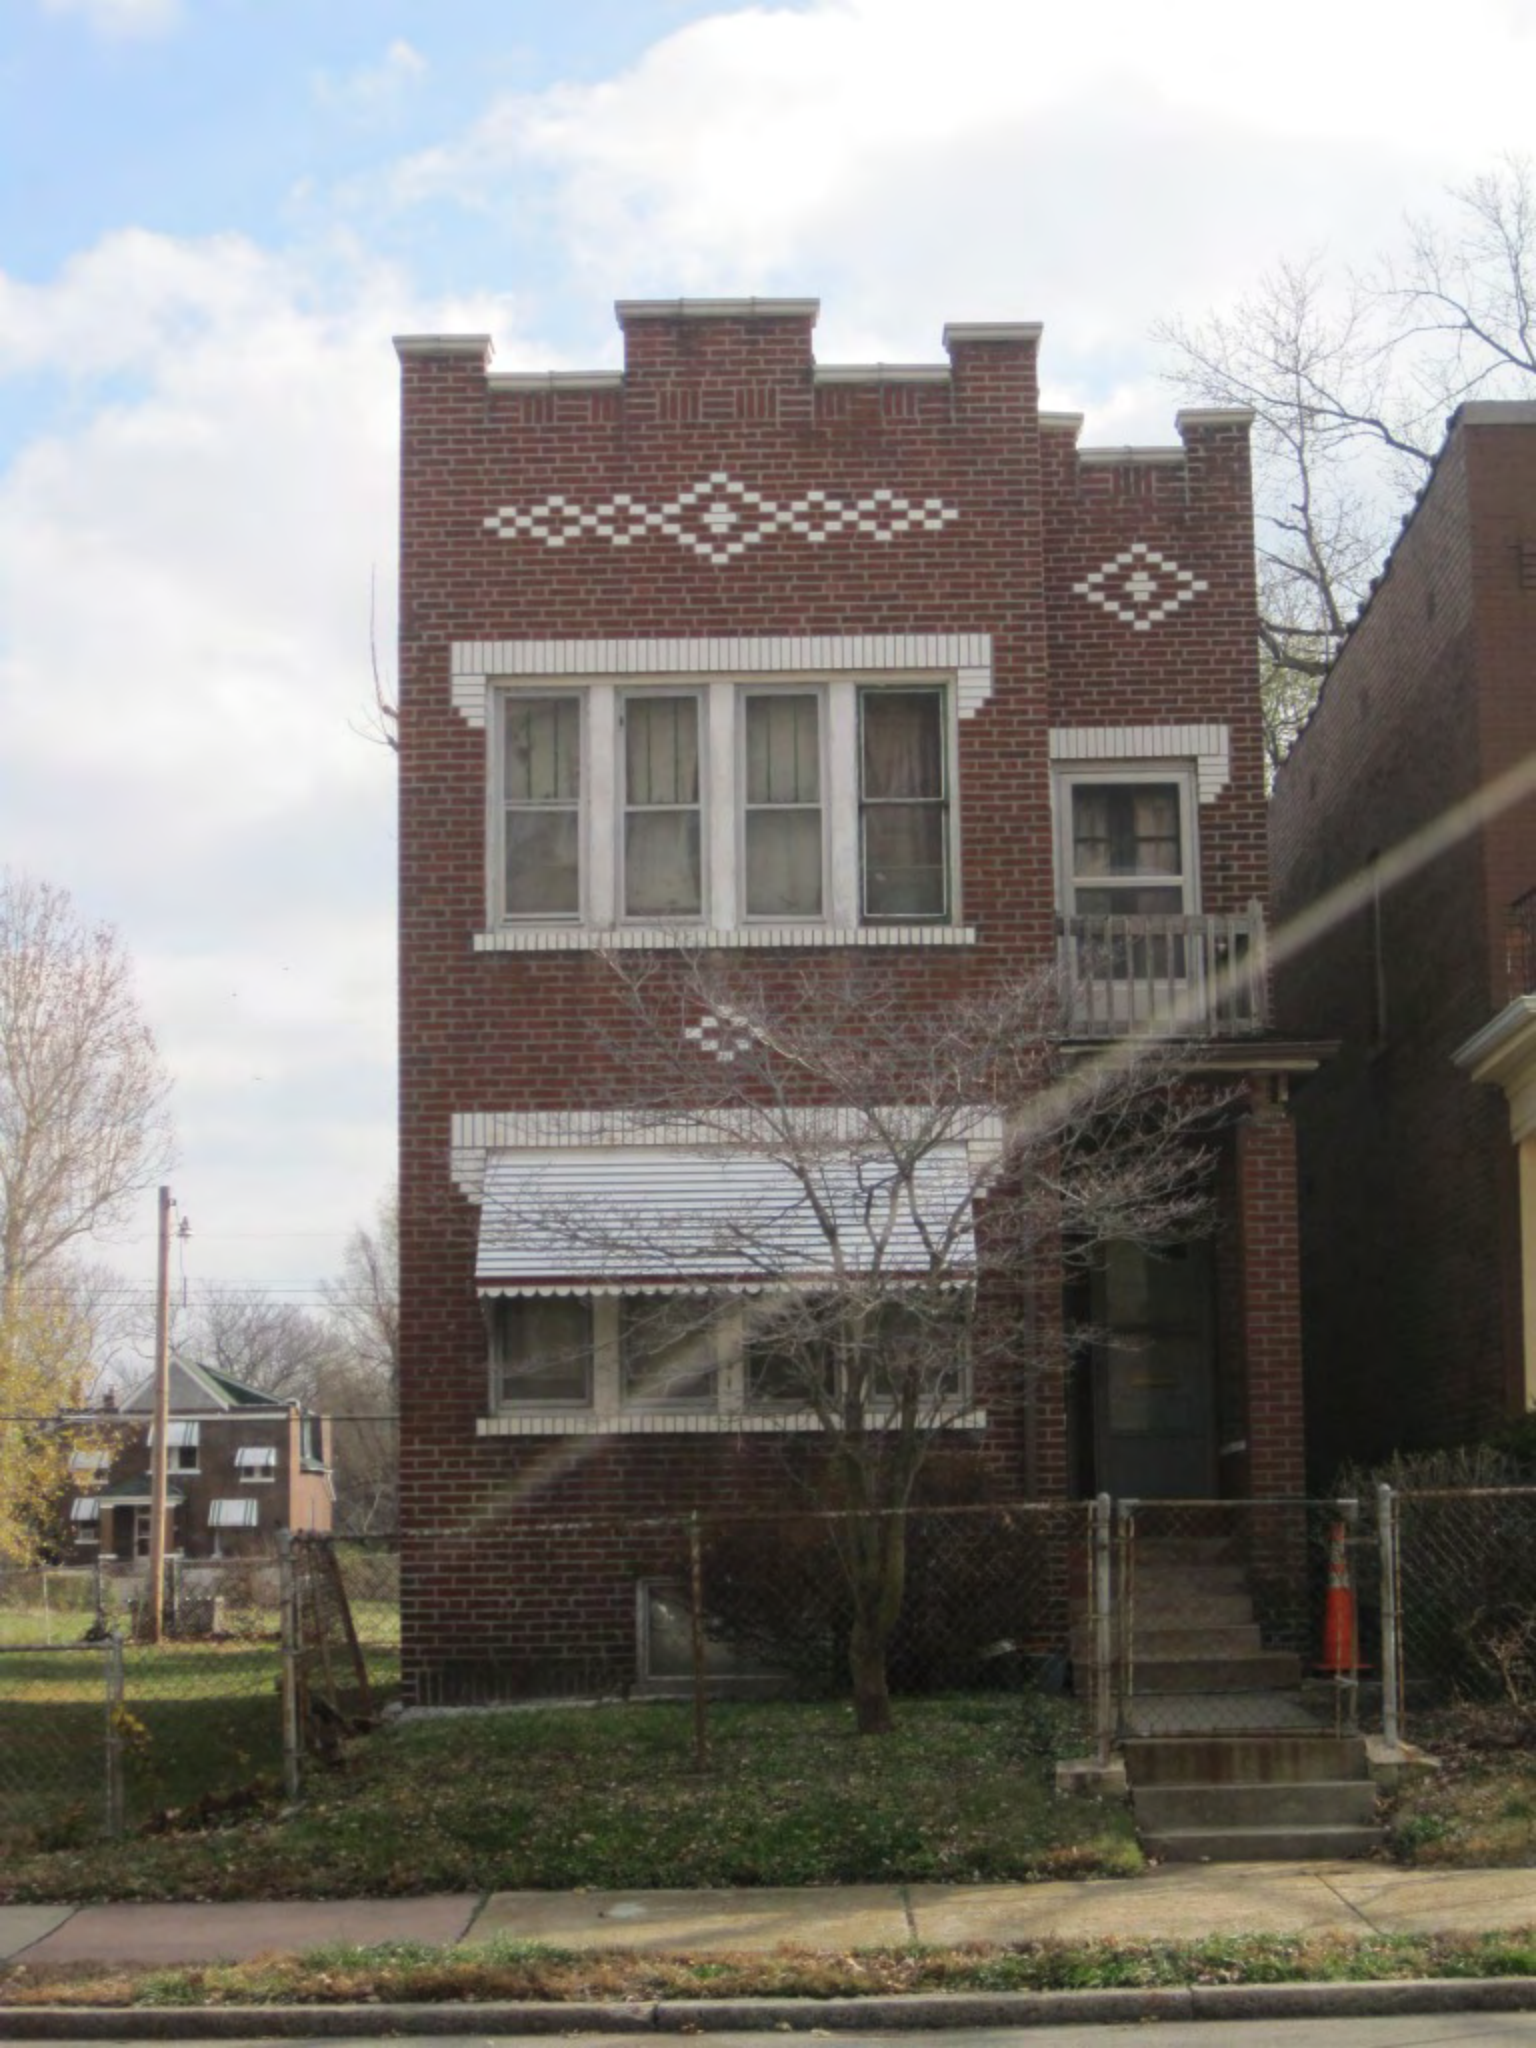
Painted brick on front elevation. Stone steps to porch with brick piers supporting wooden entablature and balcony above with iron railing. Double entrance retains casement and transom windows but has replacement doors. Opening at balcony contains wooden multi-light door. Replacement windows in window openings. Openings have jack arches and soldier course label courses with ornamental brick tracing courses. Corbelling above second floor.

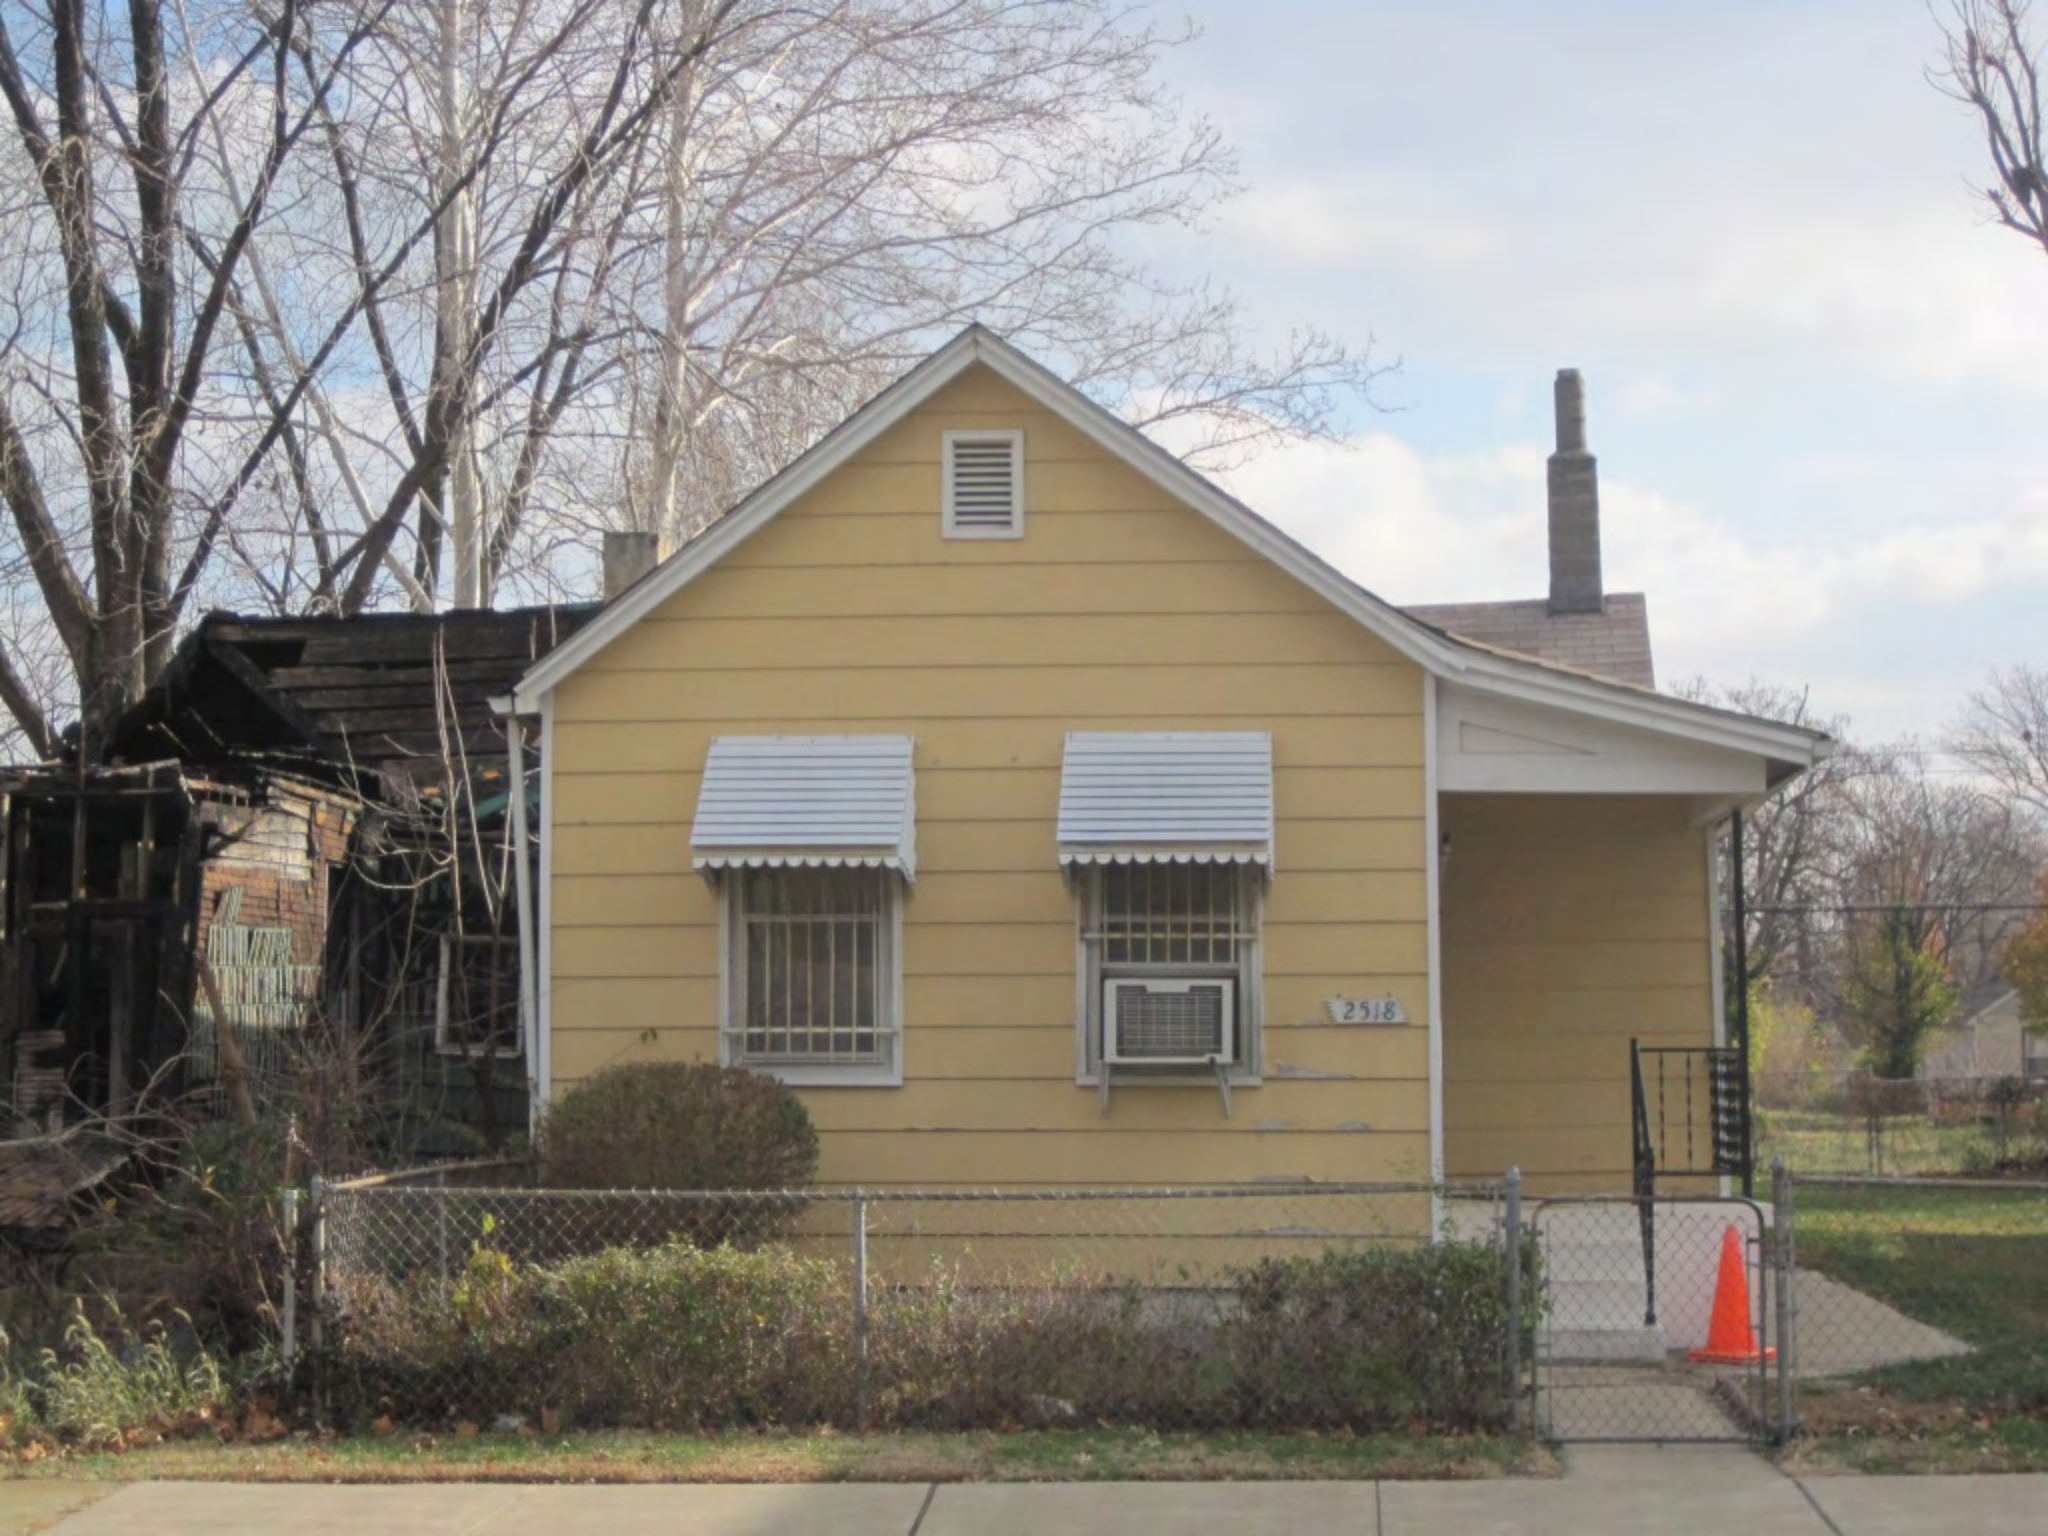
Red brick. Entrance bay is recessed. Parapet is shaped with white terra cotta coping and a basketweave pattern in the brick below. Bakery brick forms the rowlock sills and label courses around the window openings, which have jack arches. Bay at left has openings with groups of four three-over-one wooden windows. Basement window in jack-arch opening below. Entrance bay has replacement door at first floor and set of wooden French doors to balcony. Porch has brick pier to support balcony, which has wooden railing. Concrete steps.

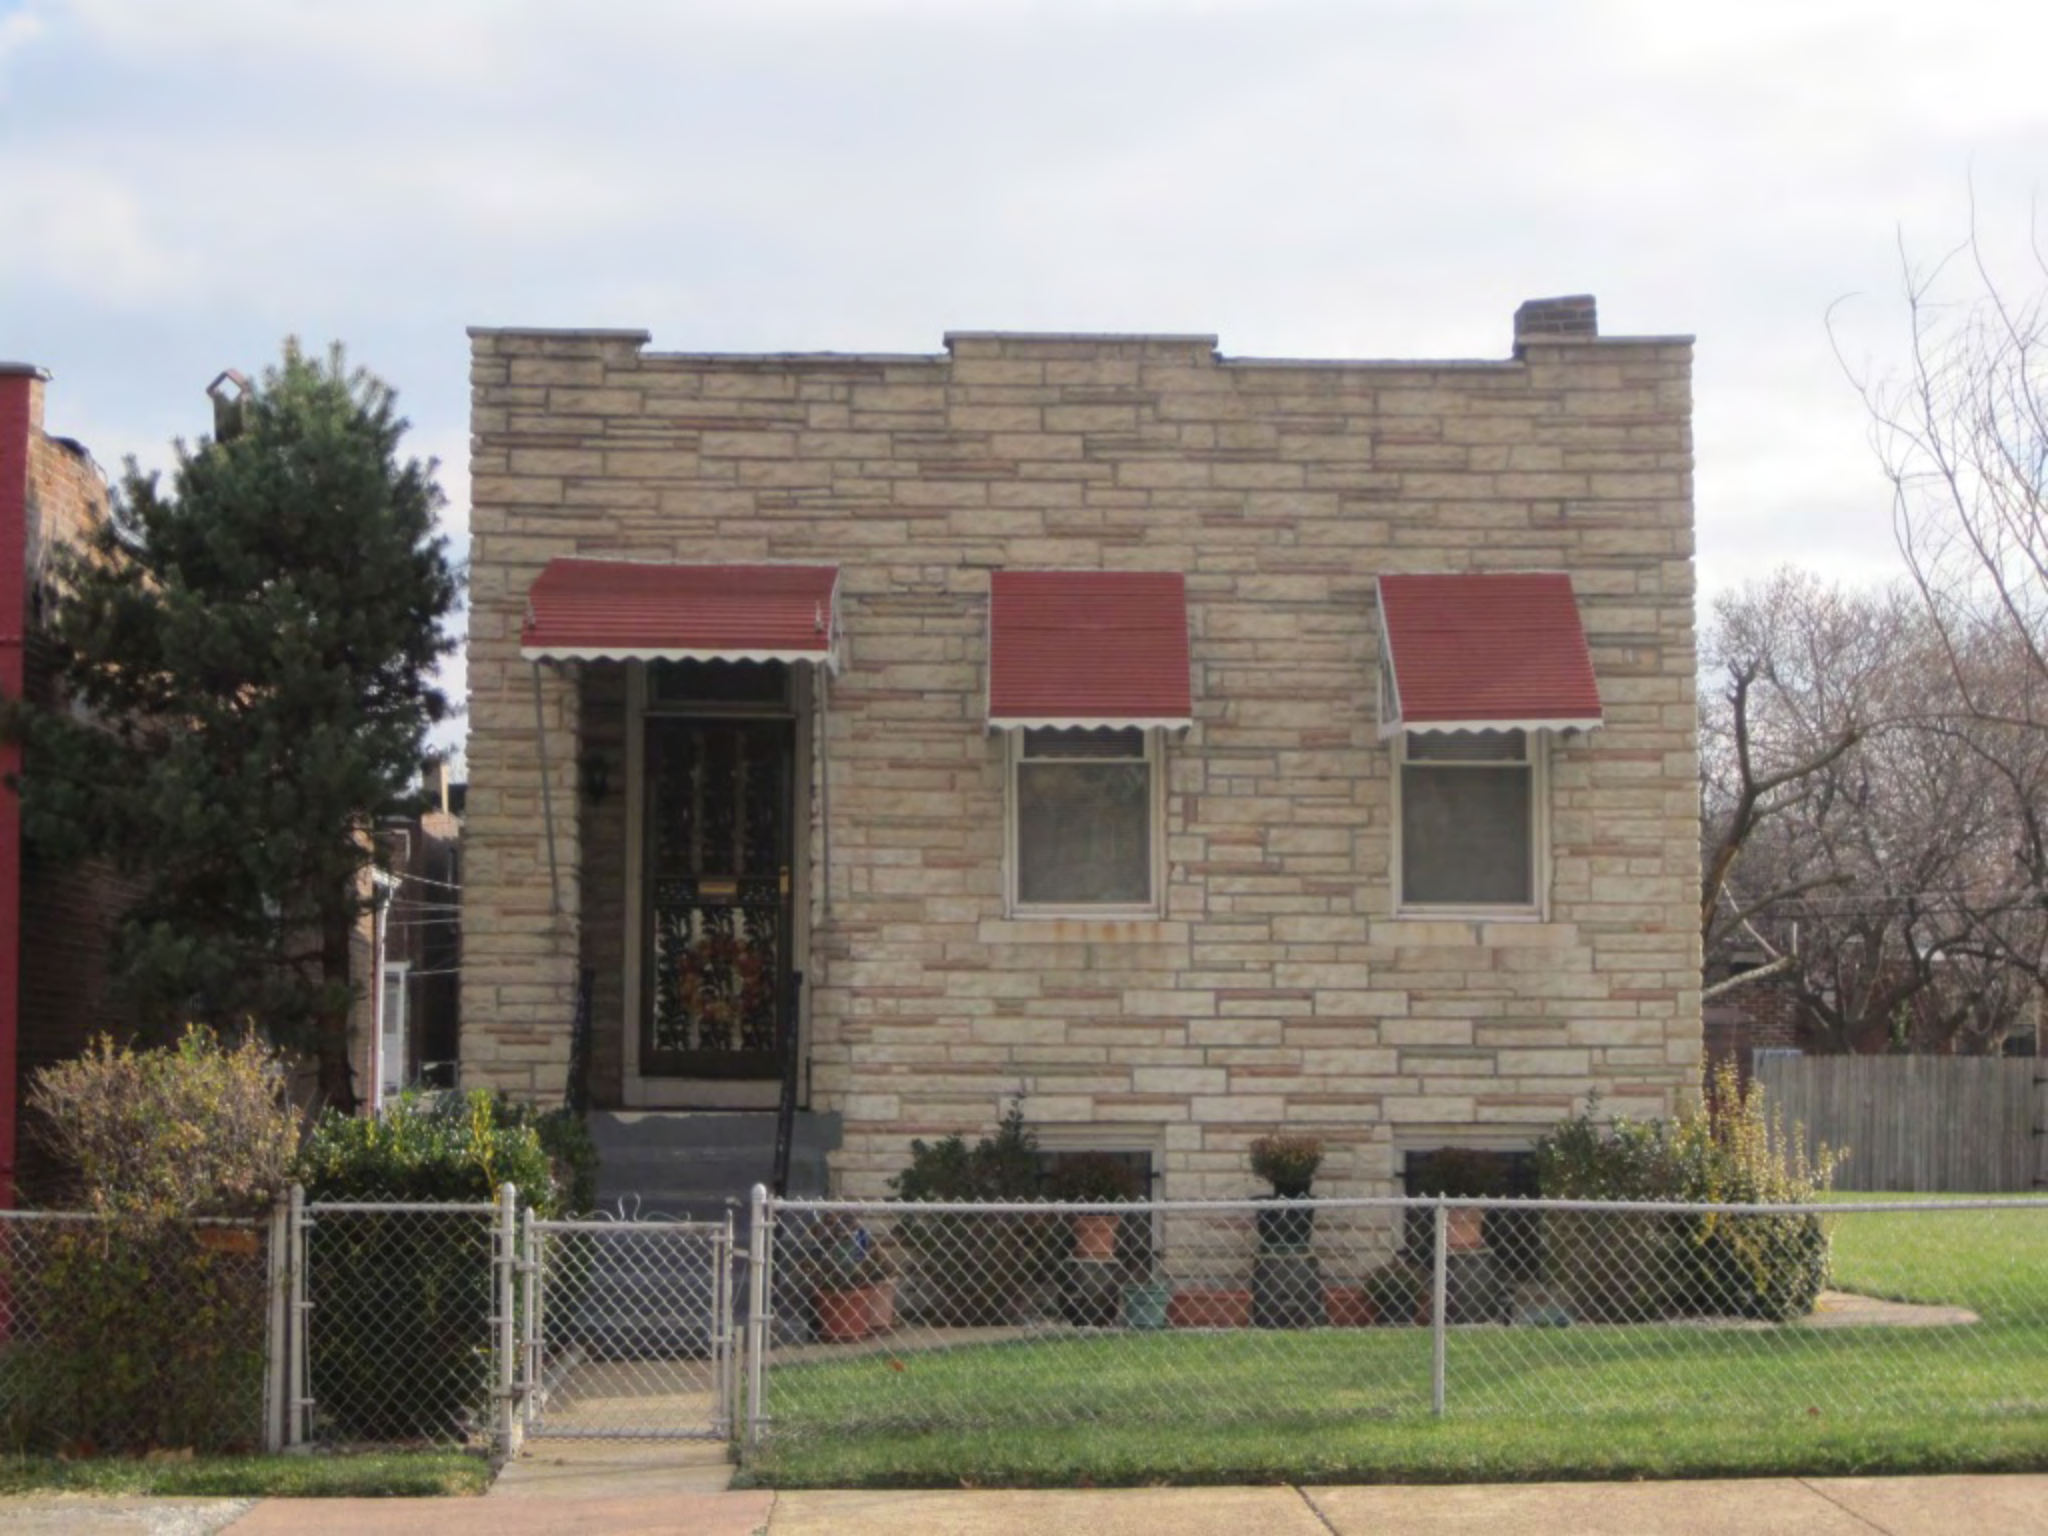
Brown brick with ochre brick rowlock sills and cap on porch knee wall. Side entrance to gabled front porch, with brick knee wall and piers. Gable end sided with vinyl siding. Openings have jack arches and soldier course headers. Window opening at left has metal bars and large single-pane sash. Entrance has metal replacement door with vinyl siding above. Window opening at right (on face of shed-roofed section) boarded. Window opening above porch clad in vinyl siding. Sanborn map apparently indicates this is actually a frame house.

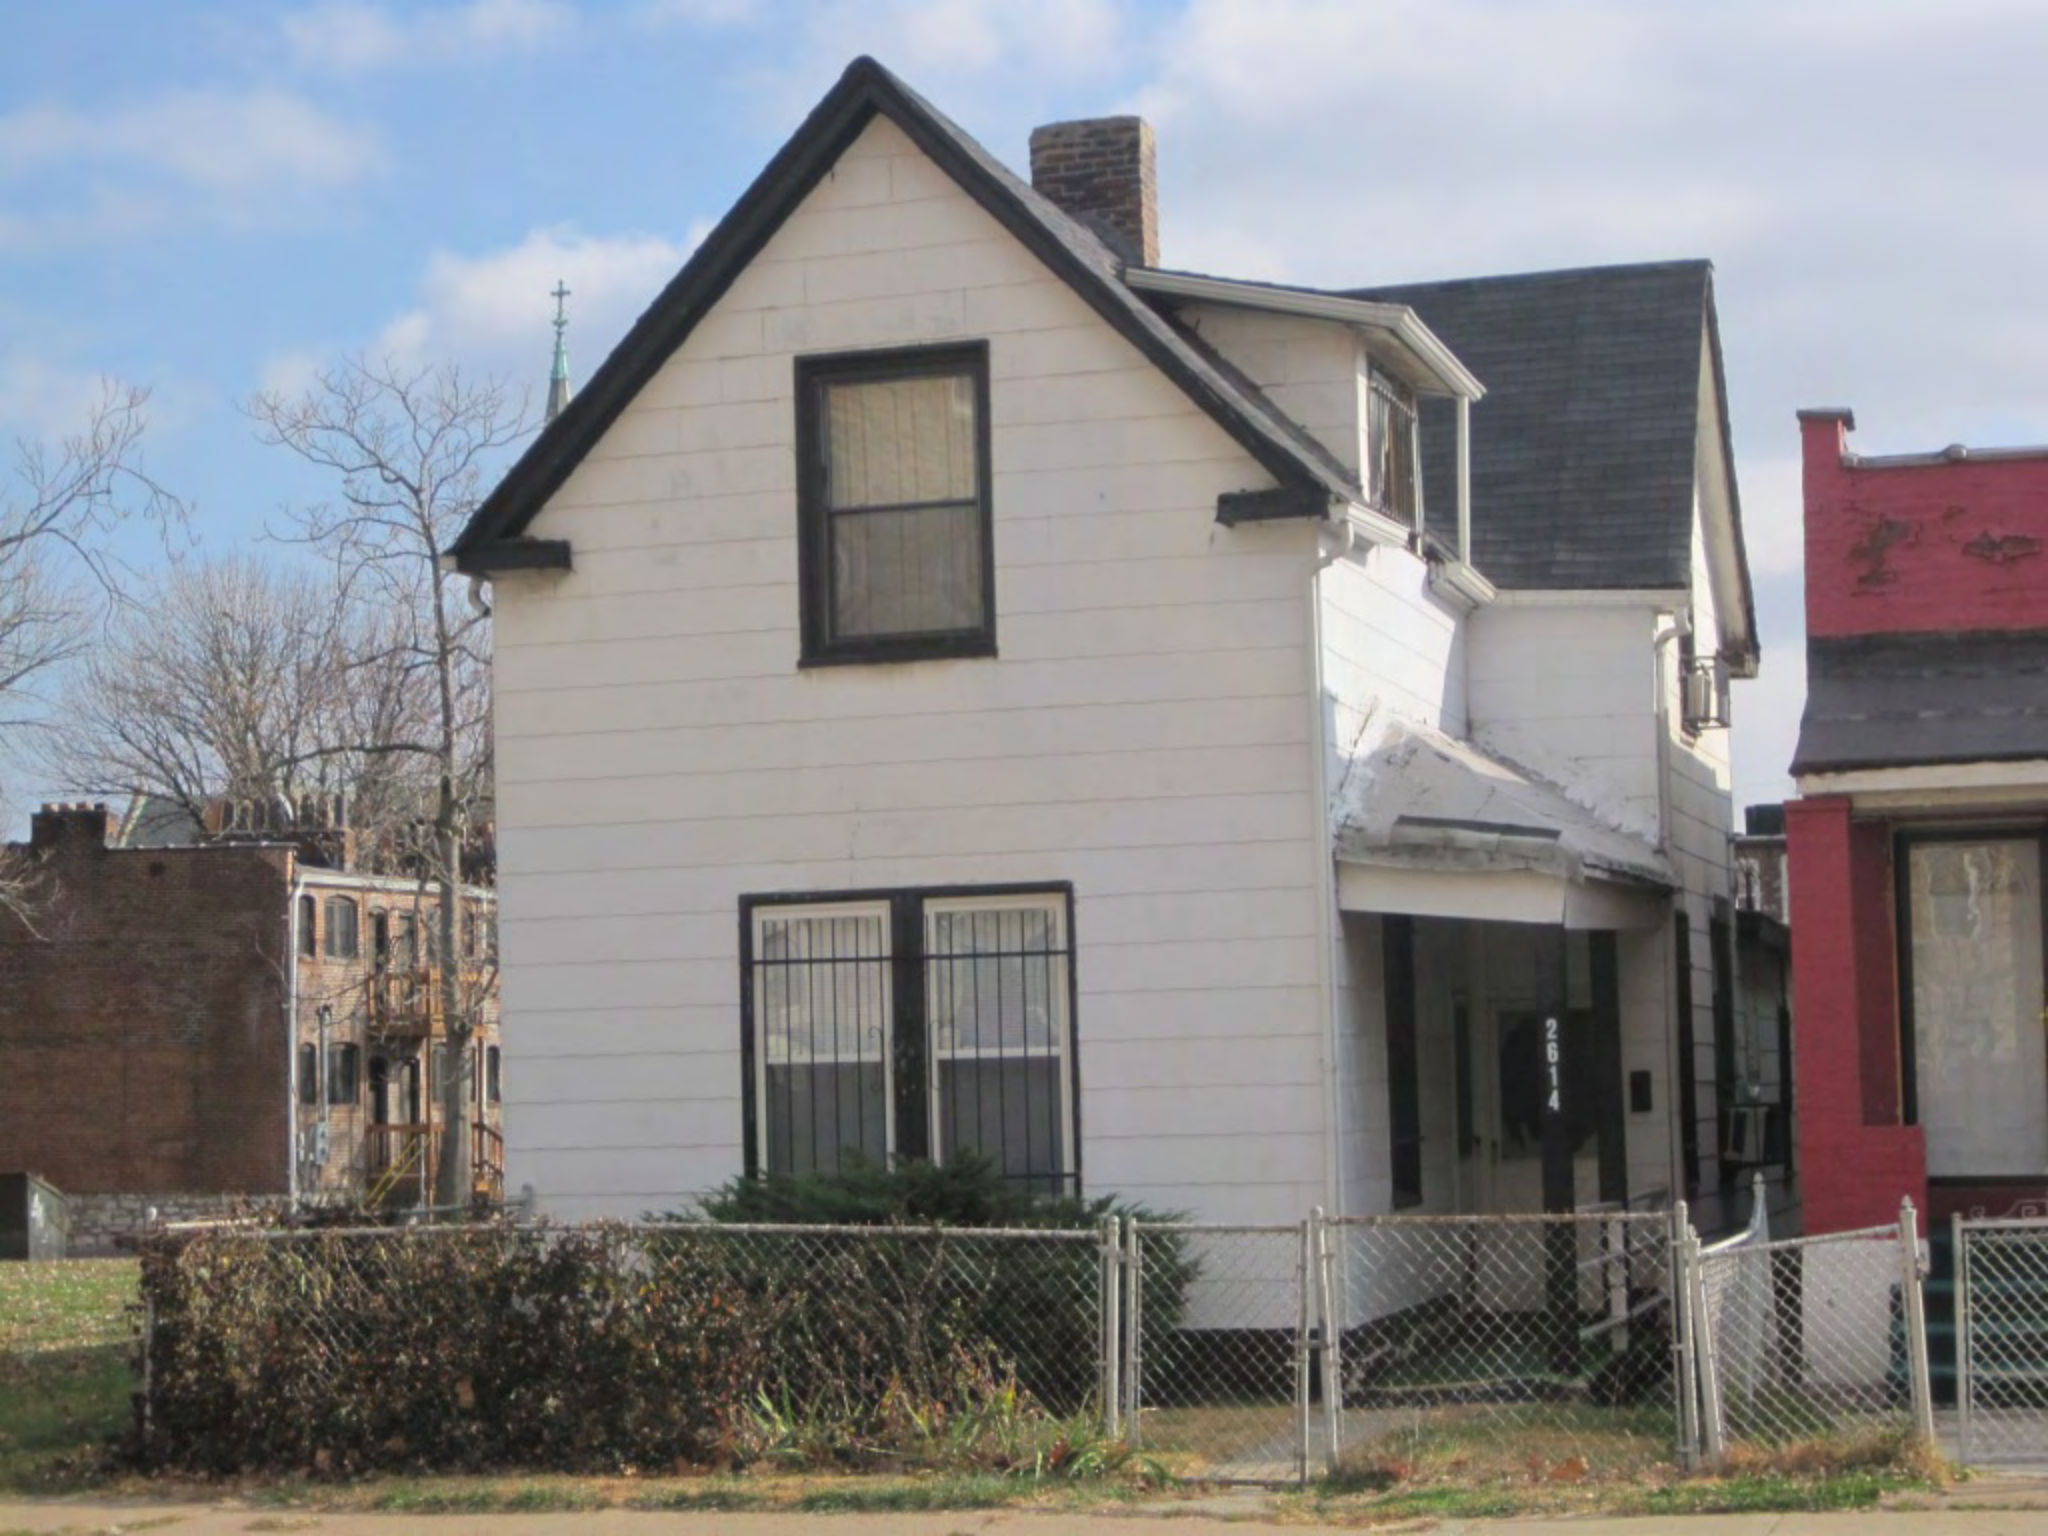
Painted front elevation. Shaped parapet with clay tile coping has center step and end blocks. Concrete steps on porch at left which has brick piers and shed roof. Entrance has replacement door. Ornamental brick courses run above basement and first floor levels. Basement has double window in jack-arch opening. First floor opening has segmental arch (obscured by metal awning) and stone sill. Wide wooden mullion divided replacement one-over-one windows.
