National Register of Historic Places Registration Form

Historic name Savings Trust Company of St. Louis
Other names/site number Easton-Taylor Trust Company
Name of related Multiple Property Listing N/A

Street & number 4915 Delmar Blvd

Barnett, Haynes & Barnett (architects)

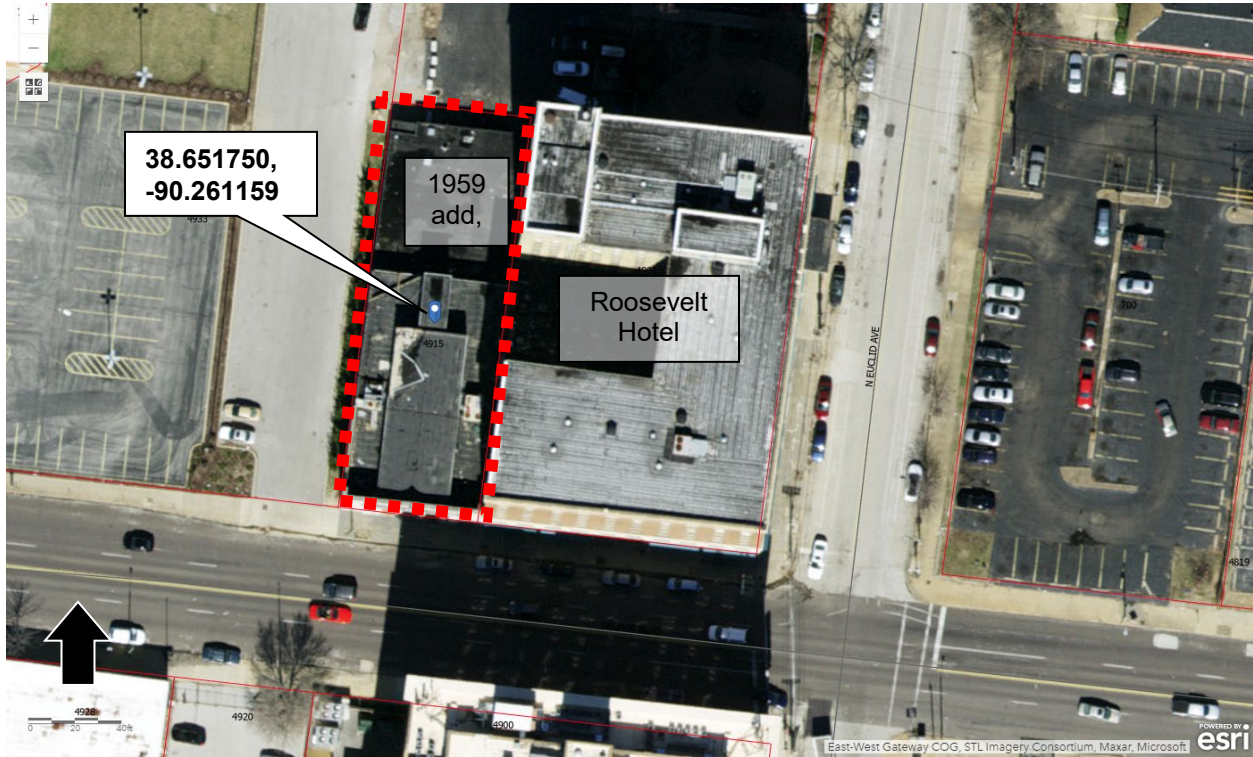
Figure 4. Site map, showing the boundaries of the Savings Trust Company Building within the heavy dashed heavy box. Base image from City of St. Louis GIS.

The east elevation is completely covered by the building to the east (*Figure 4; Photos 1, 6*).

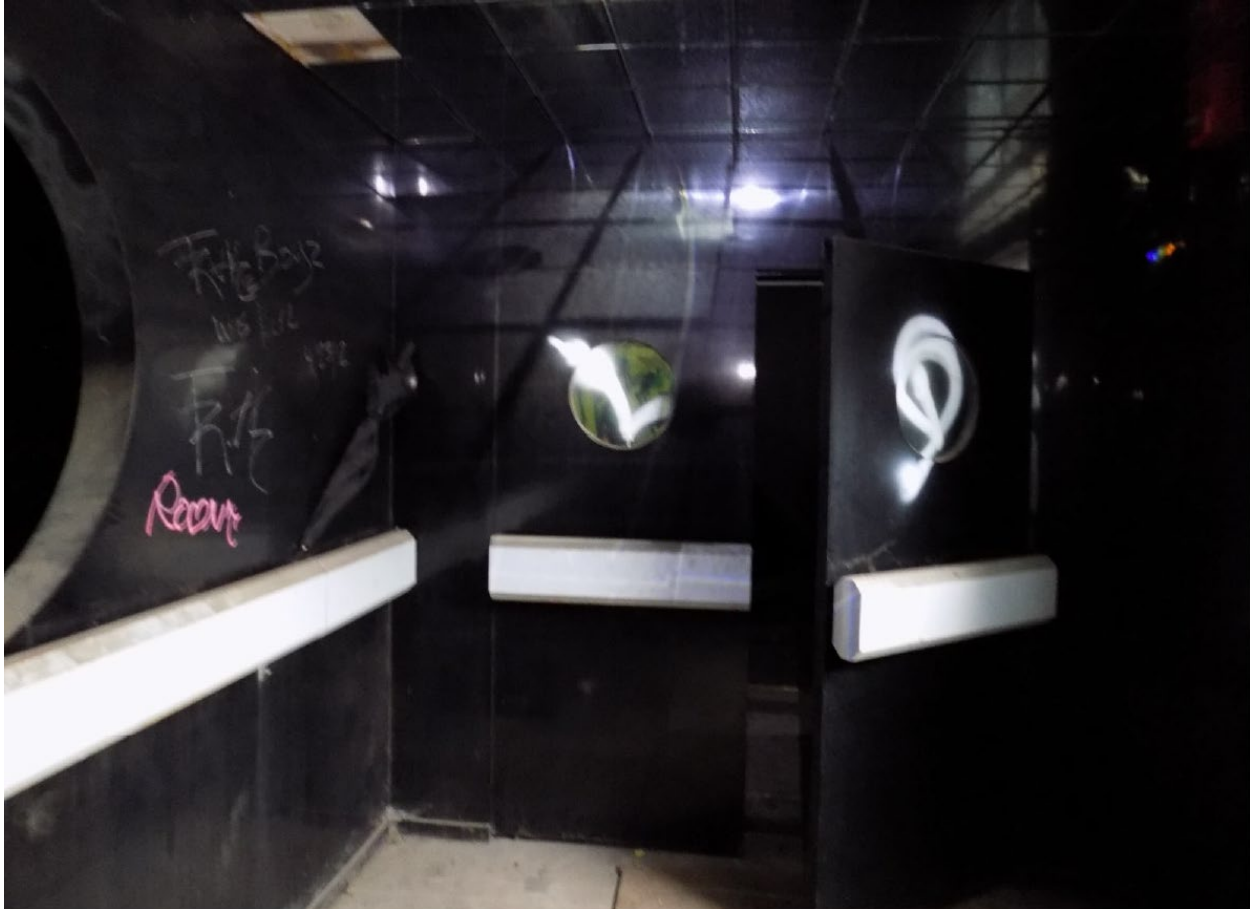
Figure 11. Entry vestibule, looking east, showing all non-historic materials except the historic marble floor.
Source: Matt Bevins, 2020.

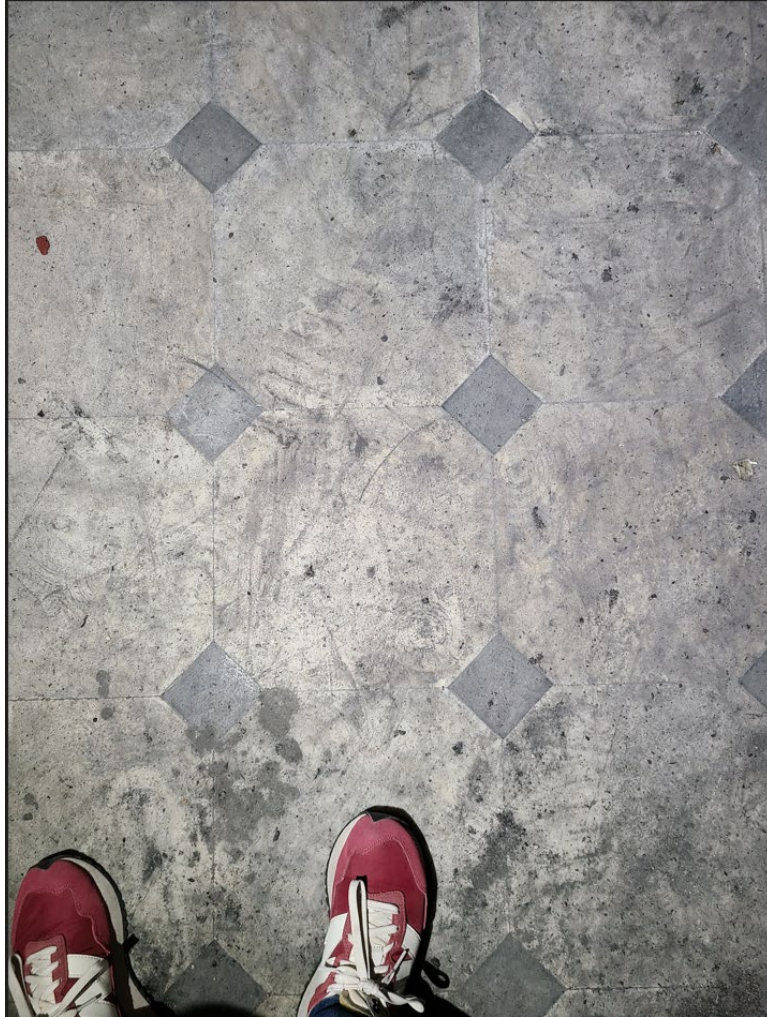
Figure 13. Detail of the Italian marble flooring in the bank lobby. Source: Loughlin, 2023.

above the historic bank vault. The historic volume of the building remains intact. Historic decorative plasterwork, although damaged by water infiltration, remains throughout the space, as does the historic Italian marble flooring. Some of the leaded glass windows in the clerestory have fallen; those that remain are in good shape, and historic metal railings remain at the second story.

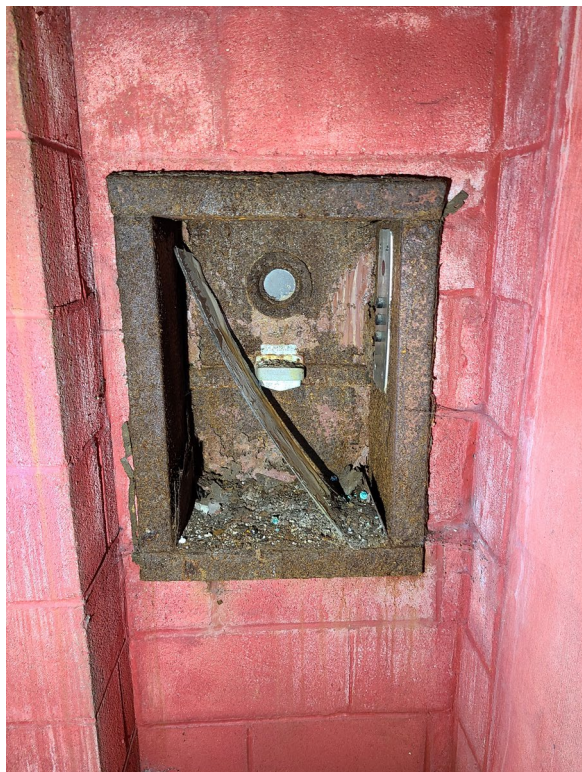
Figure 14. Door to the dumbwaiter in the basement, looking south. Source: Loughlin, June 2023.

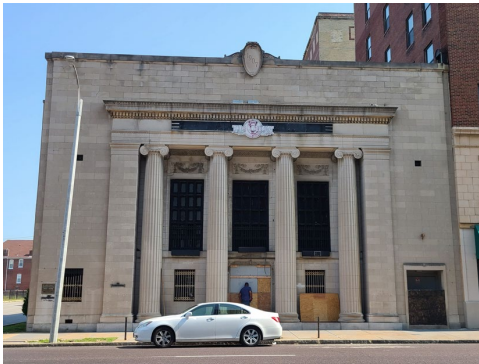
1. Savings Trust Company of St. Louis (1922)
4915 Delmar Blvd.
Central West End

Figure 20. Examples of comparable Classical Revival bank buildings within the city of St. Louis. Identifications by Bob Bettis, City of St. Louis Historic Preservation Office; photos by Loughlin, June 2023. Numbers correspond to map in Figure 19.

St. Louis neighborhoods outside of downtown saw the establishment of savings banks around the turn of the twentieth century. These locations allowed for the savings banks to serve specific populations within targeted neighborhoods. The Savings Trust Company of St. Louis served the Central West End neighborhood. At least five other Classical Revival-styled bank buildings remain scattered throughout the city within smaller neighborhood commercial districts (*Figures 19 & 20*). Including the nominated building, all six of these banks date to between 1916 and 1929 and represent at least the second iteration of the financial institution that constructed them. Physical similarities of the six buildings include a reliance on the Classical Revival as a design motif, the use of Indiana limestone cladding, and their presence within a small commercial district associated with a specific neighborhood in St. Louis. Only three can be classified as a Temple Front commercial form: the Lafayette-South Side Bank, the Jefferson-Gravois Bank, and the nominated Savings Trust Company of St. Louis. The nominated building is the only one of the six that historically occupied a mid-block lot.
