# OFF SYSTEM BRIDGE INSPECTION REPORT

COUNTY City of St. Louis BRIDGE NO. 600.02 ROUTE Educational Bridge of Washington Dr.

REVISIONS			PLAN & PROFILE	
NO.	DESCRIPTION	DATE		
			Prepared by:	<b>CITY OF ST. LOUIS, MISSOURI</b> DEPARTMENT OF THE PRESIDENT BOARD OF PUBLIC SERVICE  <b>REHABILITATION</b> <b>FRANKLIN BRIDGE</b> <b>FOREST PARK</b>
			Drawn by:	
			Checked by:	
SEAL

REVISIONS			PLAN & PROFILE	
NO.	DESCRIPTION	DATE		
			Designed by	CITY OF ST. LOUIS, MISSOURI
			Drawn by	DEPARTMENT OF THE PRESIDENT
			Checked by	BOARD OF PUBLIC SERVICE
				REHABILITATION
				OLD STABLE BRIDGE
				FOREST PARK
			FILE	1 OF 3

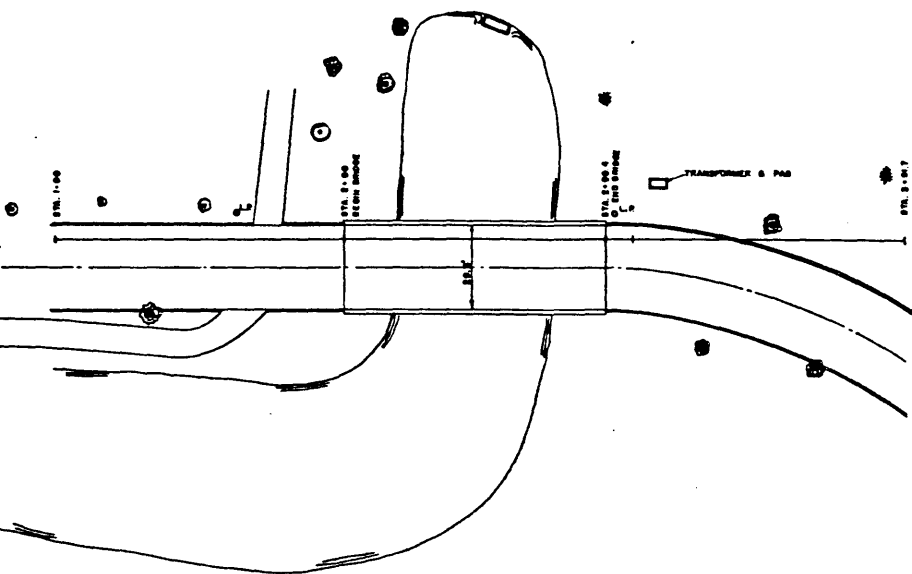
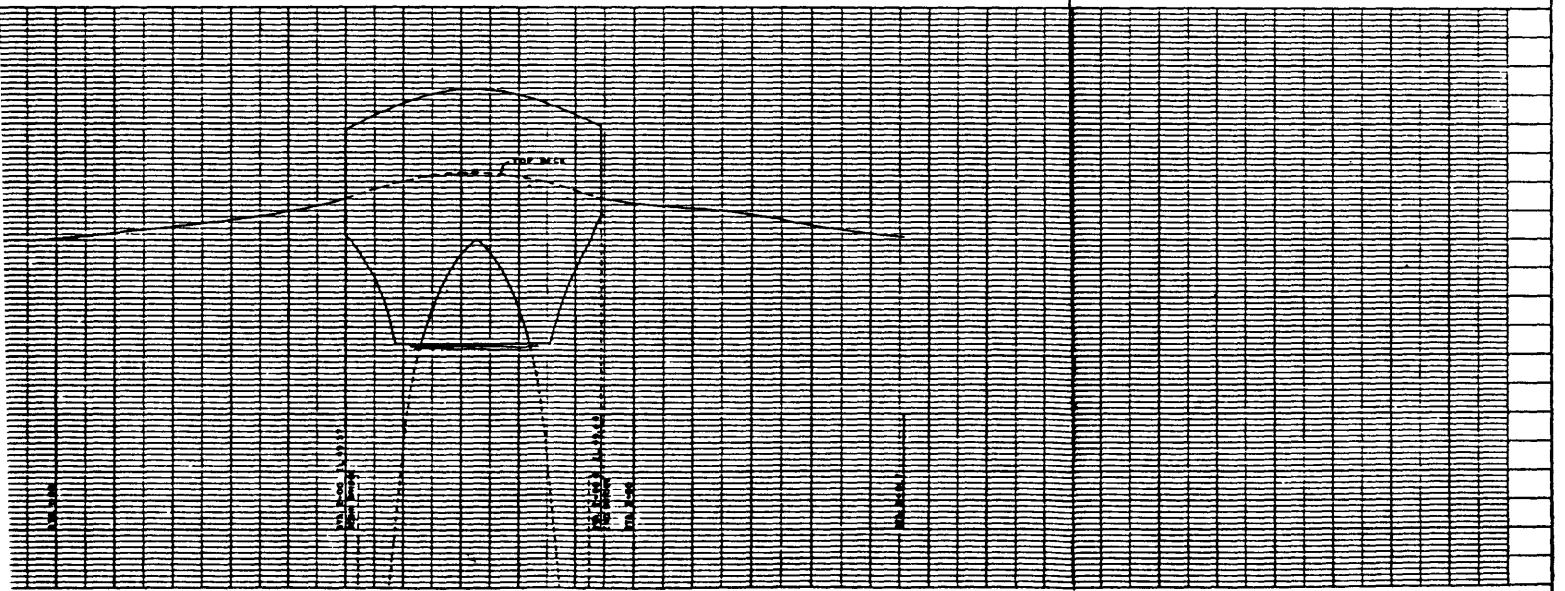
PLATE 1 PLAN - PROFILE & P & R DRAWINGS  
 FRANKLIN BRIDGE, ST. LOUIS, MO. 1954

Surveys were conducted to determine the bridge location, roadway profile and alignment, and the topographic features of the area. A preliminary drawing has been prepared and is presented herein.

BEGIN STA. EL. 49.26 N.E. CORNER OF TRANSFORMER PAD  
 20' S.E. OF THE S.E. CORNER OF BRIDGE

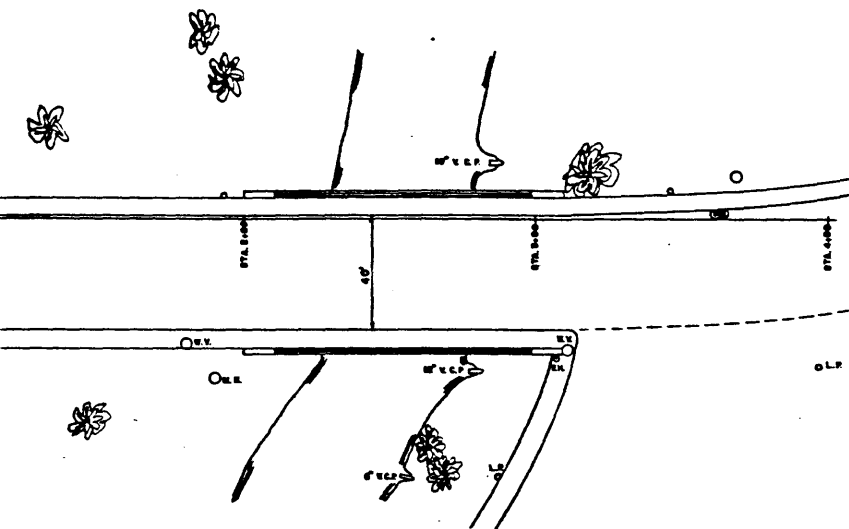
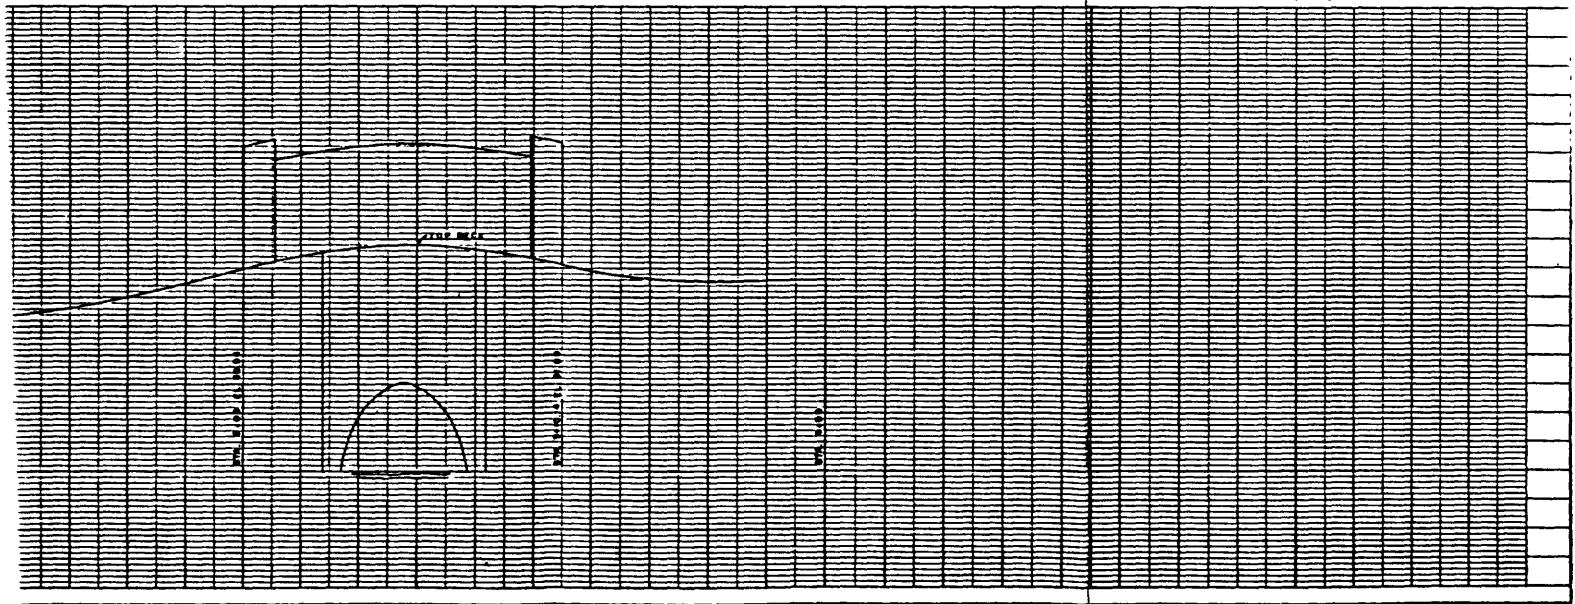
Surveys were conducted to determine the bridge location, roadway profile and alignment, and the topographic features of the area. A preliminary drawing has been prepared and is presented herein.

TBM 58 "0" IN OPEN ON FIRE HYDRANT  
SOUTH EAST CORNER OF BRIDGE

PLATE 1. PLAN-PROFILE OF OLD STABLE BRIDGE
