National Register of Historic Places
Registration Form

historic name Central Police Station

other name/site number The National Military Heritage Museum

street & town 701 Messanie N/A not for publication

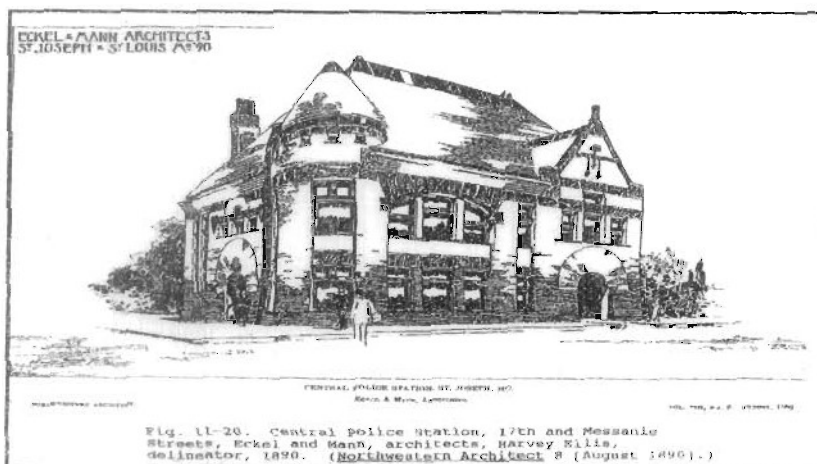
Figure 7: Conceptual Drawing for the Central Police Station, in St. Joseph, MO. The drawing differs from what was actually built. Found in: Toni Prawl. "E.J. Eckel (1845-1934): The Education of a Beaux-Arts Architect and His Practice in Missouri," (PhD. diss., University of Missouri-Columbia, 1994), 500.
