UNITED STATES DEPARTMENT OF THE INTERIOR
NATIONAL PARK SERVICENATIONAL REGISTER OF HISTORIC PLACES
INVENTORY -- NOMINATION FORM

CITY BANK BUILDING

STREET & NUMBER 1801 Grand Avenue

THE OLD CITY BANK BUILDING

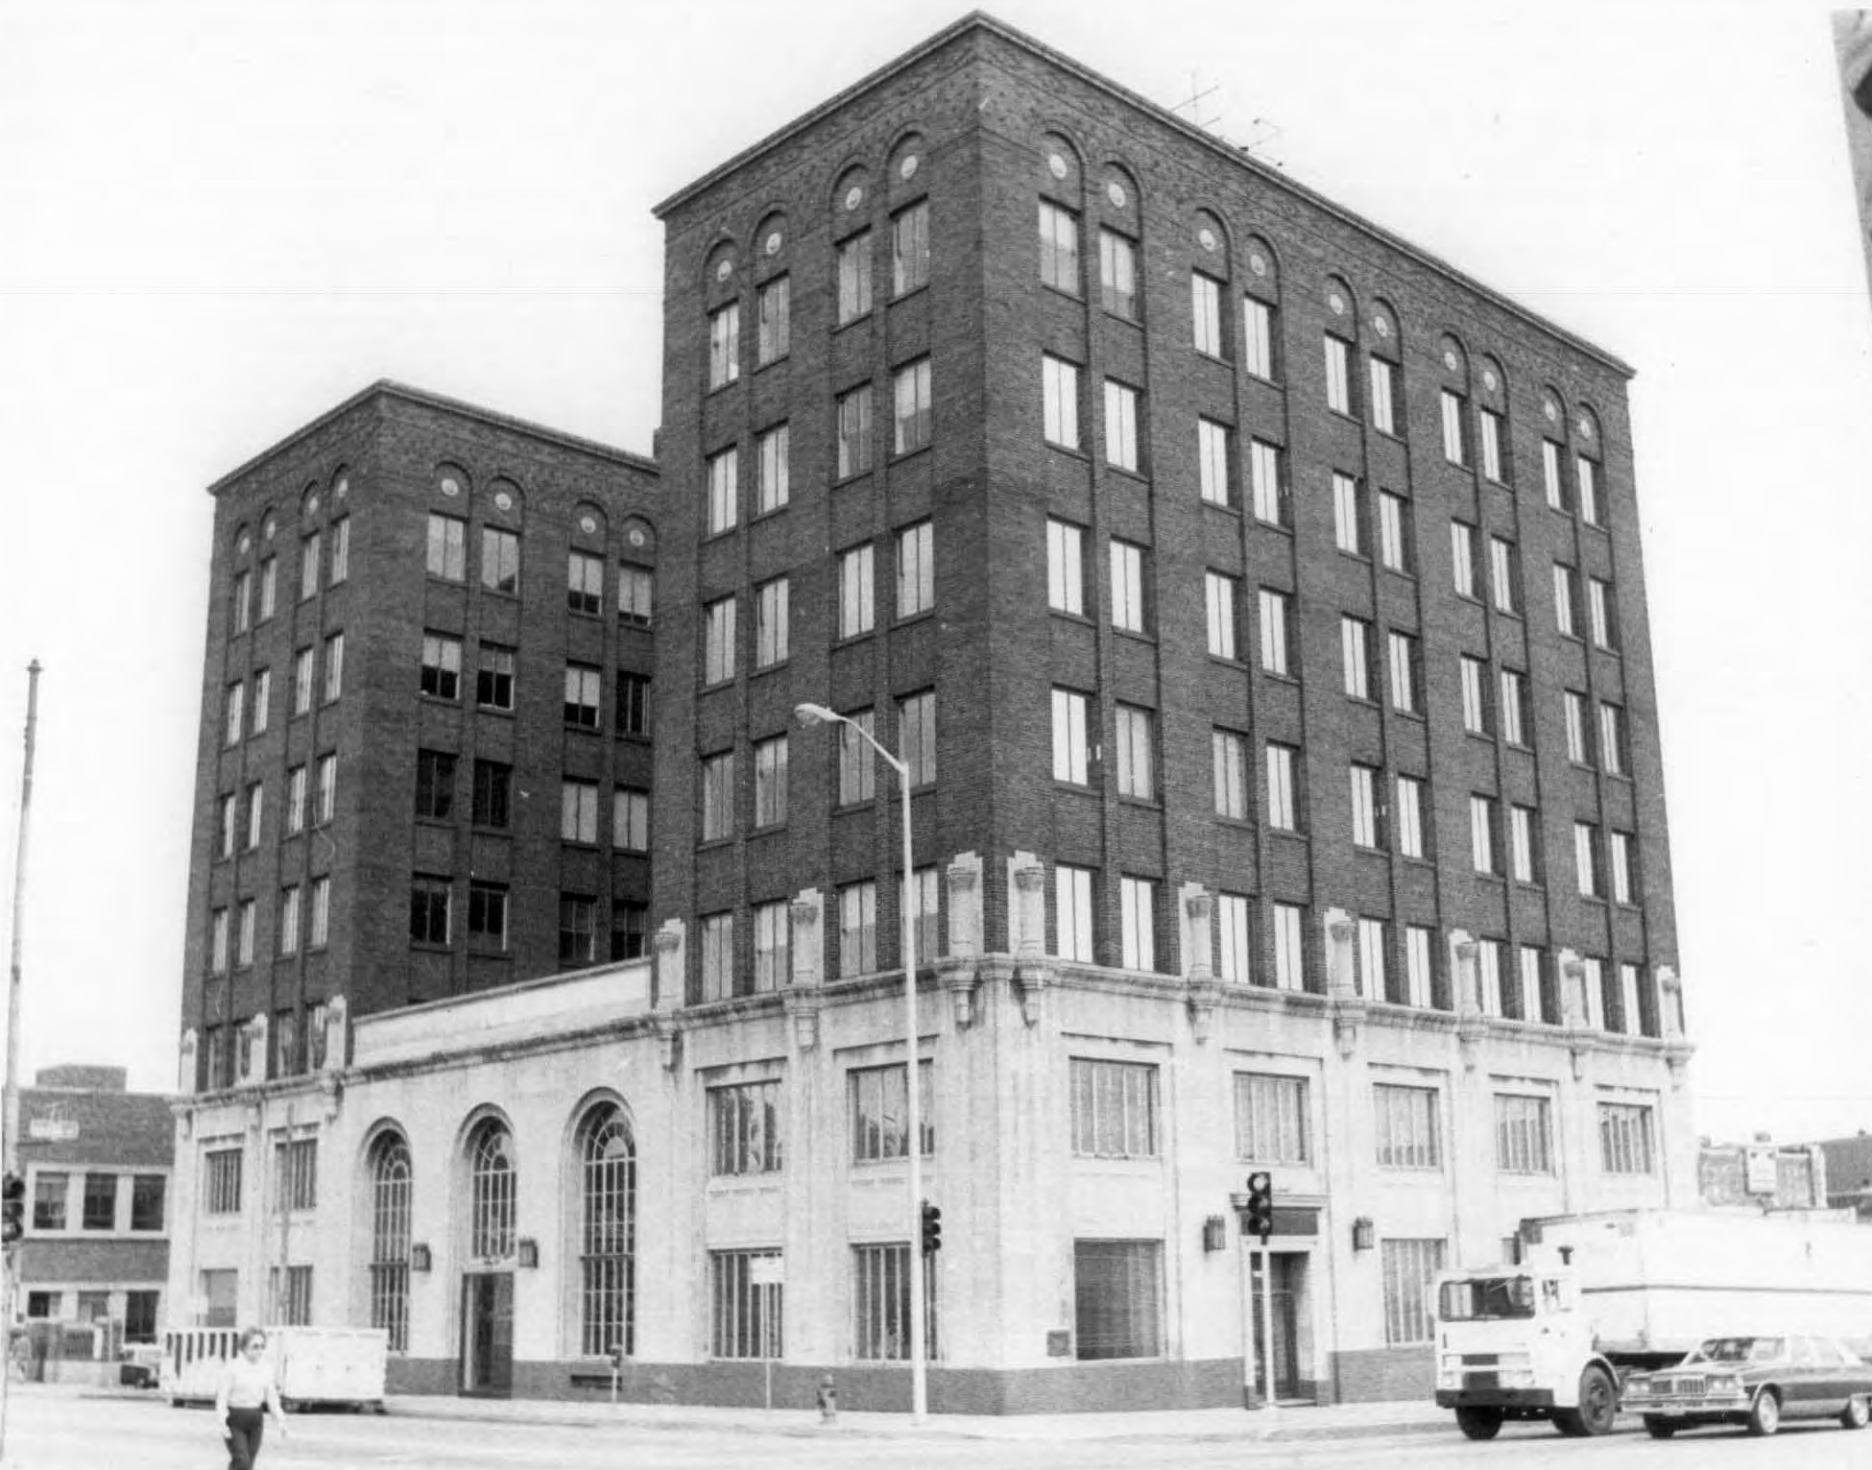
- 1 of 12. View NW corner of Grand Avenue and Eighteenth Street, N and W facades.
- 2 of 12. View of NW corner of Grand Avenue and Eighteenth Street, N and W facades. Copy of large format print dated 1926 and in the possession of J. Nelson Happy.

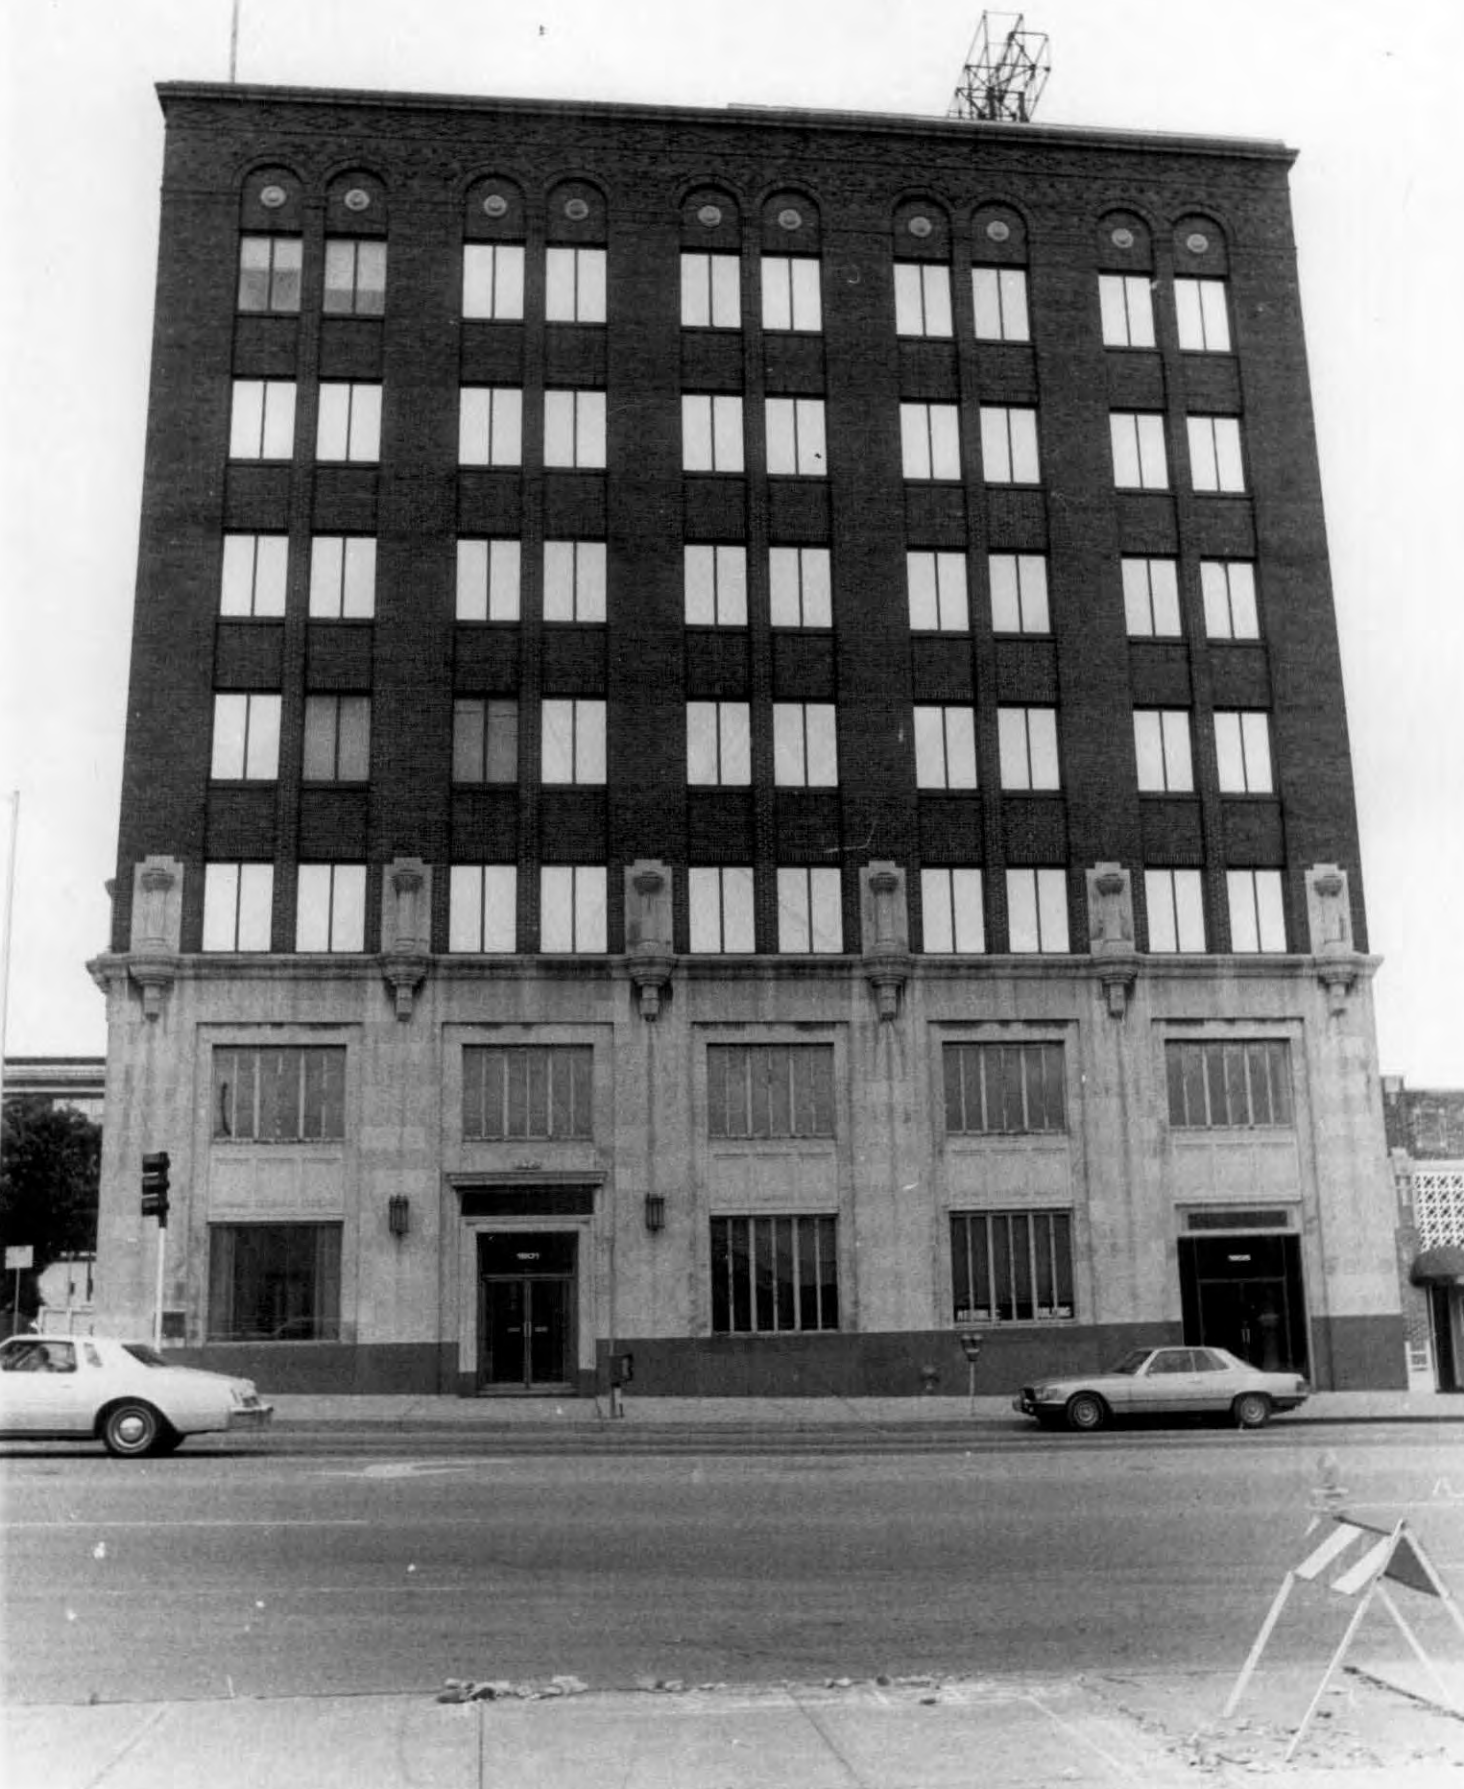
- 3 of 12. W façade.
- 4 of 12. View of S façade.
- 5 of 12. E façade.
- 6 of 12. N primary façade.
- 7 of 12. Details of W façade, first floor. Grand Avenue. Note torcheres.

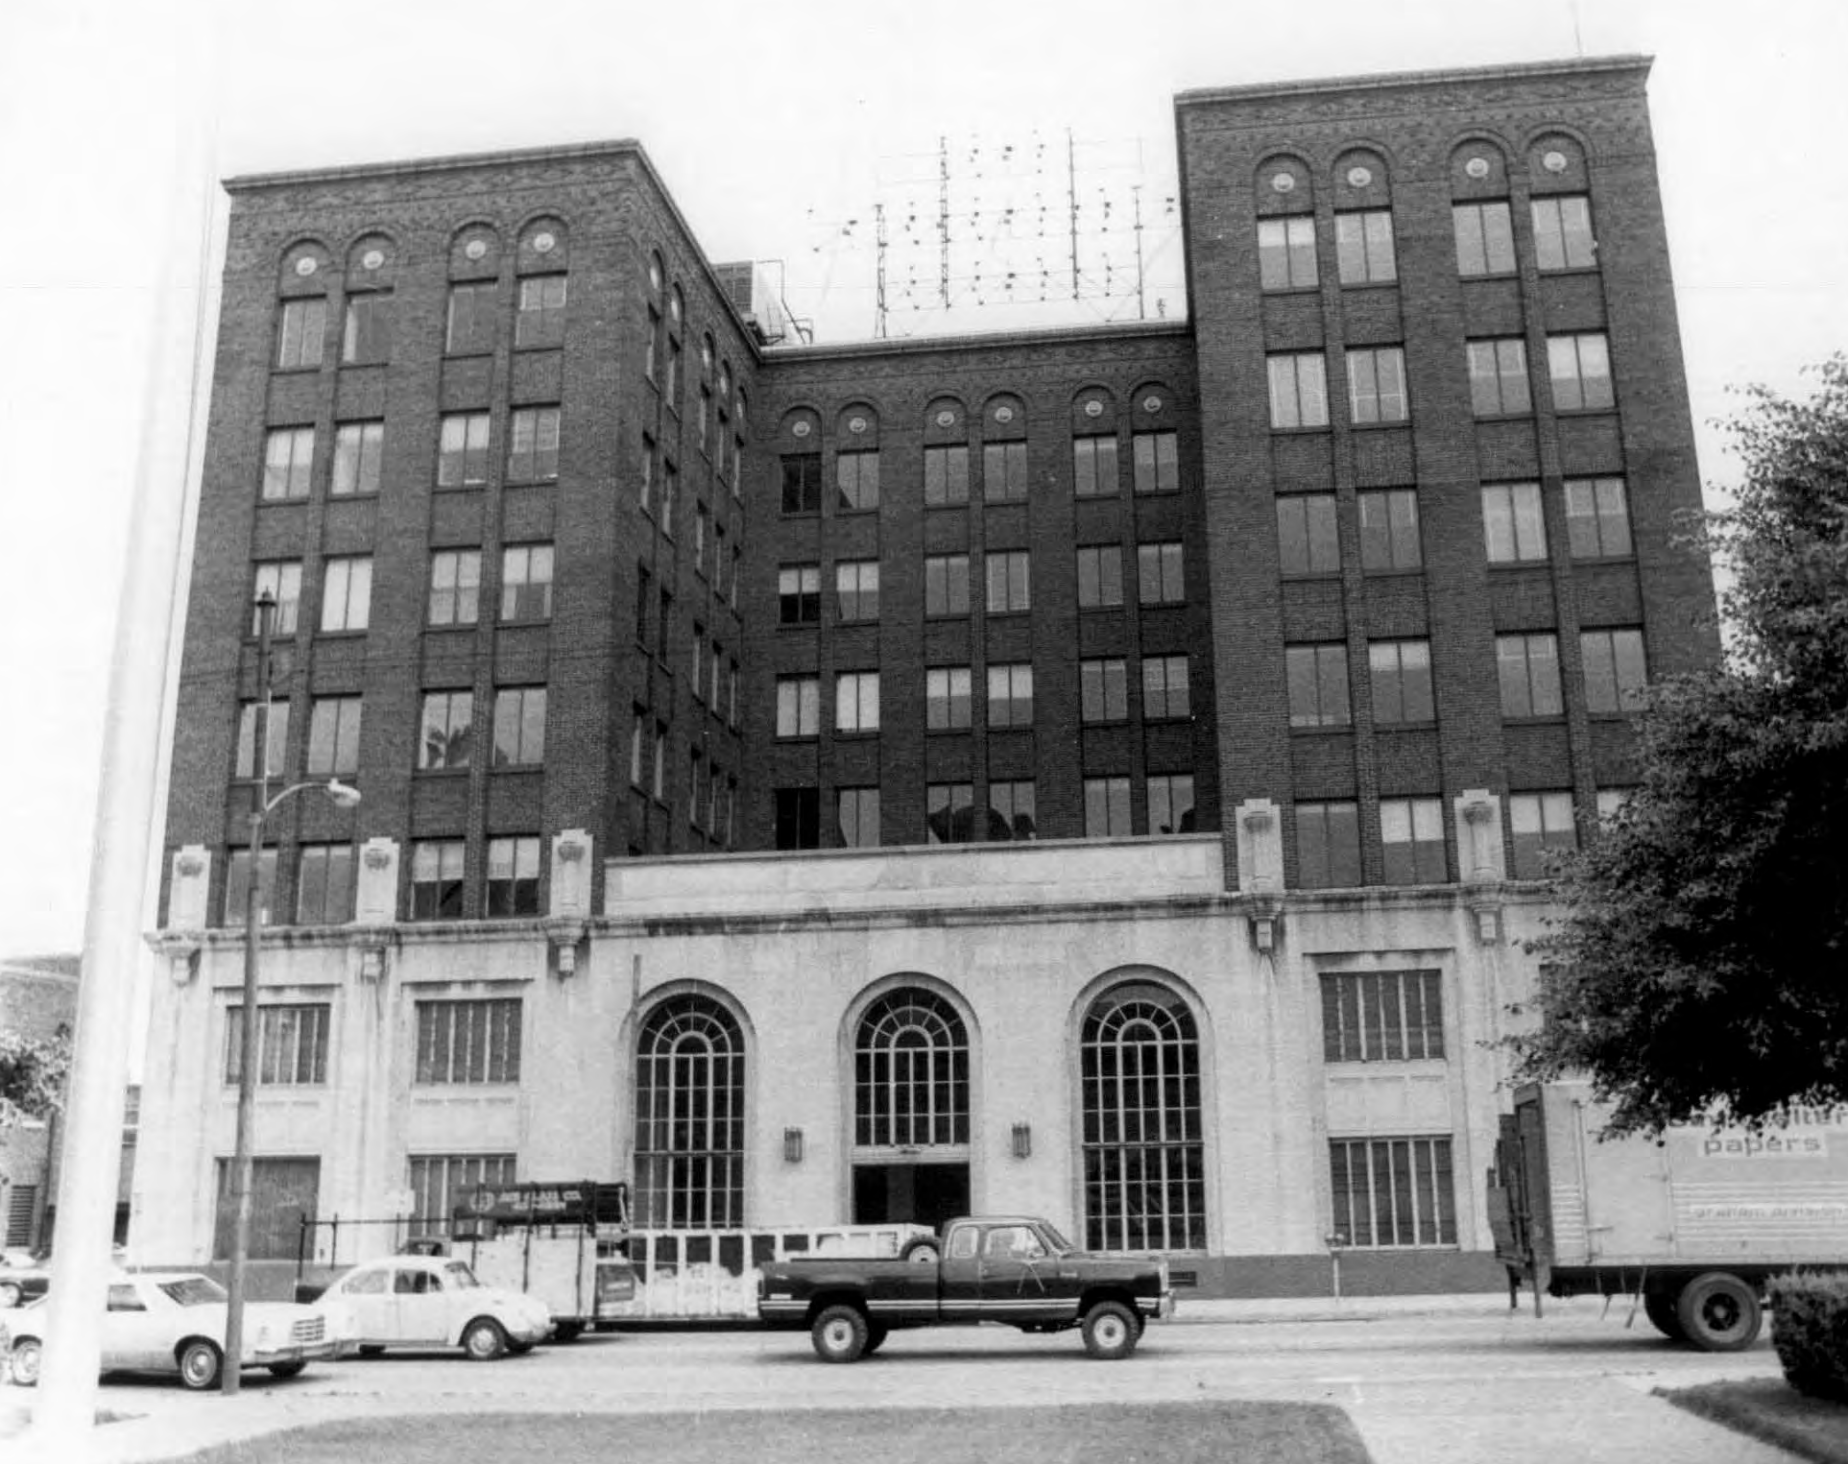
The north primary facade presents a central bay, two stories, of stone, flanked on each side by seven-story wings.

This central bay features three compound round-arched windows, extending up past the second floor, with radiating stone voussoirs. The window lights are of Neoclassic style. This central bay is flanked on each side by two inset and framed panels. Each panel consists of a large rectangular window (originally tripartite) at the top and at the bottom of the panel separated by a molded and tri-paneled apron.

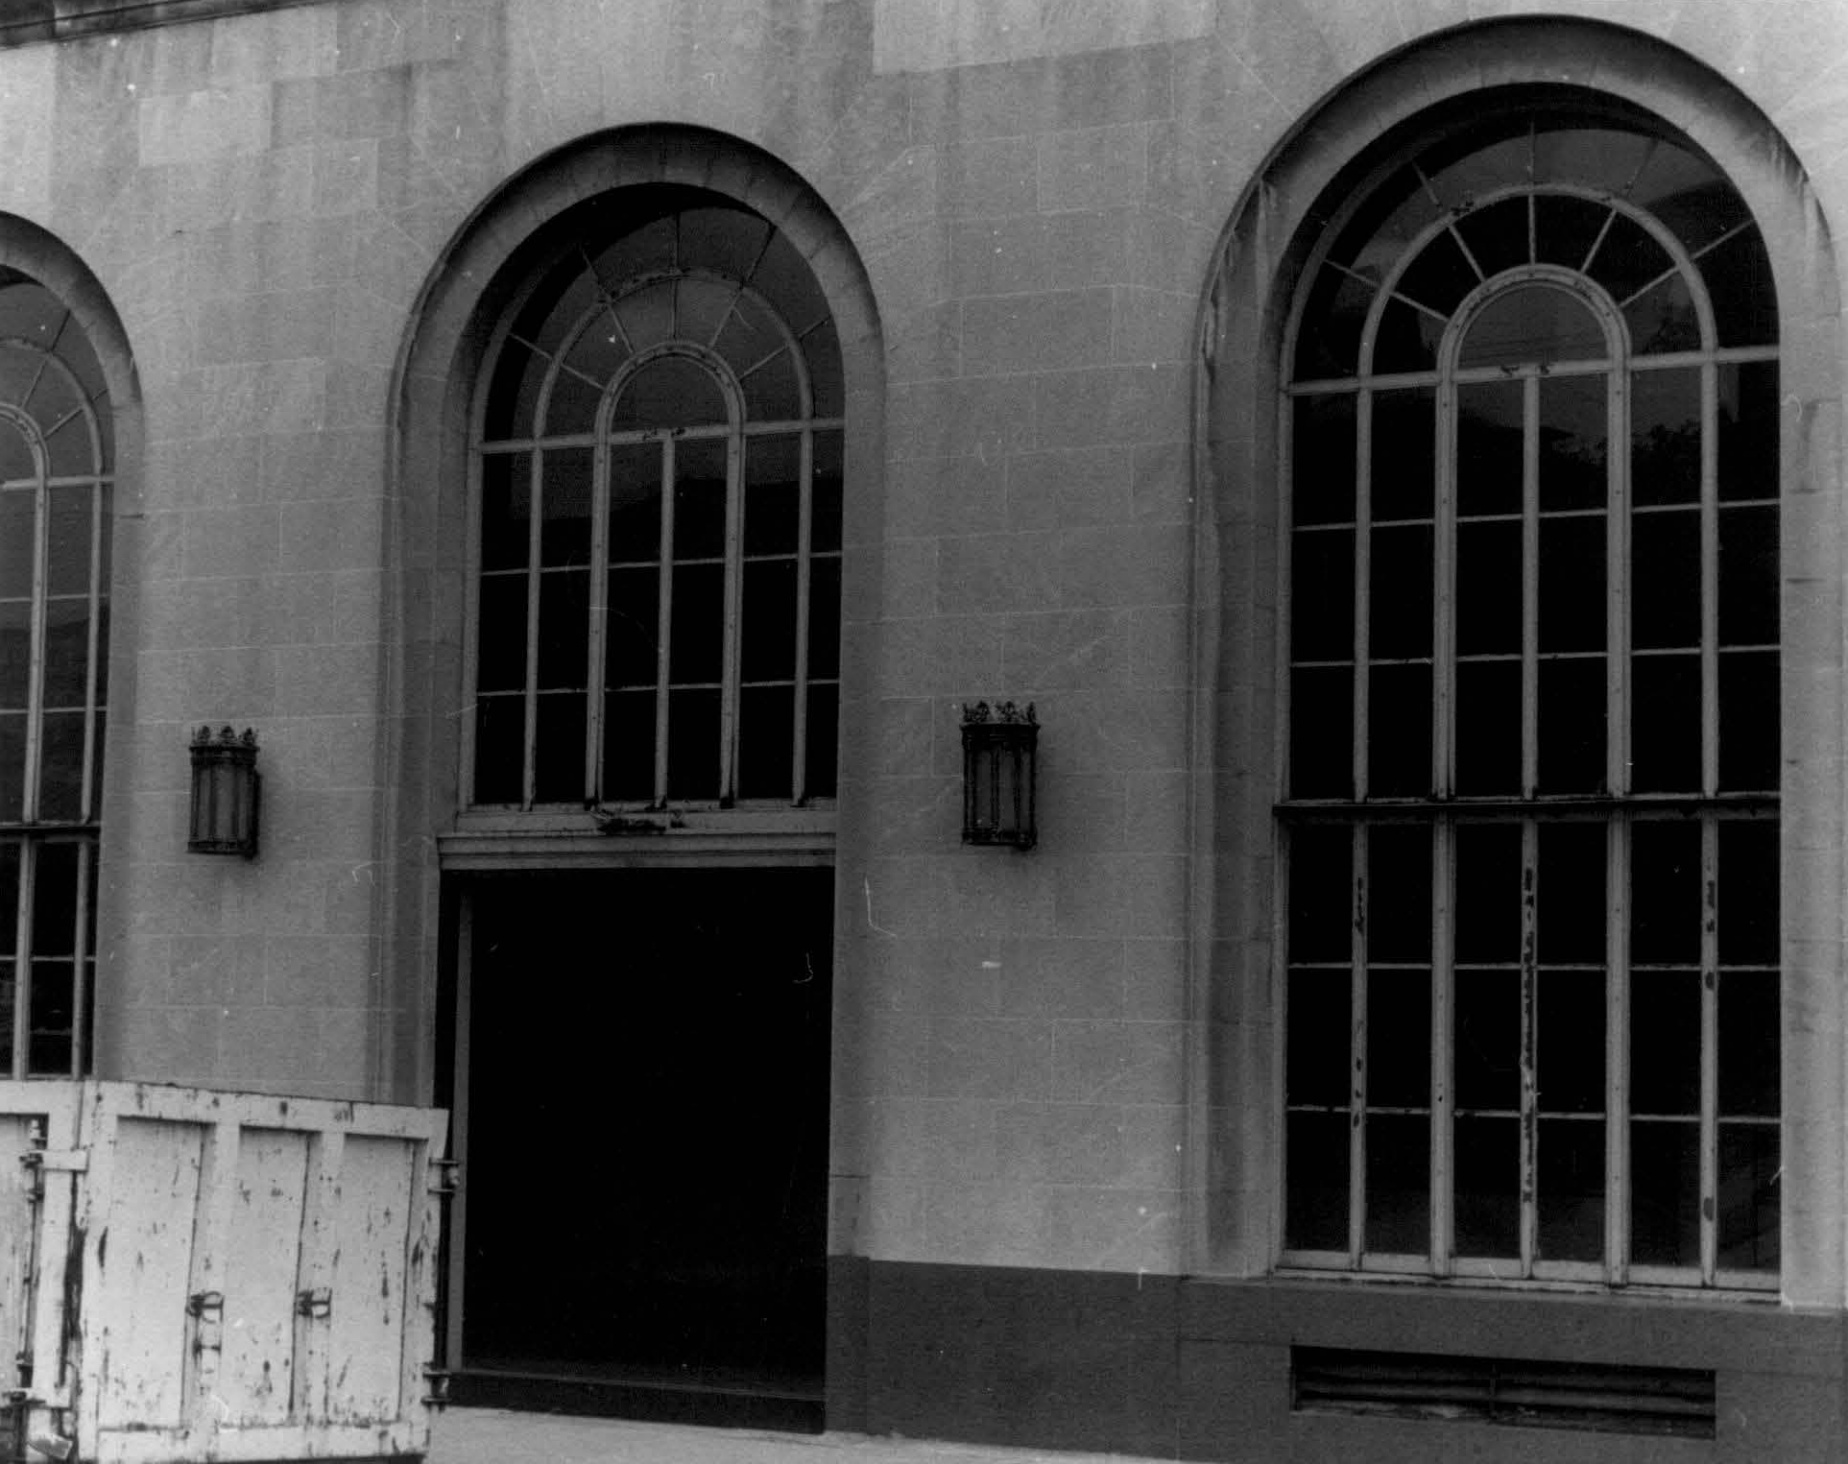
The 18th Street entry located below the central round-arched window, has been replaced with glass. The opening is flanked on each side by large copper pointed lanterns. A molded belt course above the ashlar facade is surmounted by a rectangular stone frieze above the three round-arched windows that originally had the words "City Bank" carved in stone. An important art deco feature is the placement of stone torches rising from the molded belt course up the center of the piers separating the vertical banding of the windows. The west facade features five bays of the rectangular inset framed panels on the first and second floors coupled with the double vertically banded window treatment. A stone architrave trim distinguishes the Grand Avenue entrance and the flanking lanterns present on the north facade are repeated. The overhanging cornice is decorated through its center with bead and reel molding.

1. "City Bank" removed from frieze over 18th Street entrance. Assumed 1956.³
2. 18th Street entry removed and glassed in. Date unknown.

- 8 of 12. Detail of N façade, first floor. Original Eighteenth Street entry has been removed.
- 9 of 12. Lobby looking S. Original marble teller cage bases are to the left. Mezzanine was open and has been enclosed.

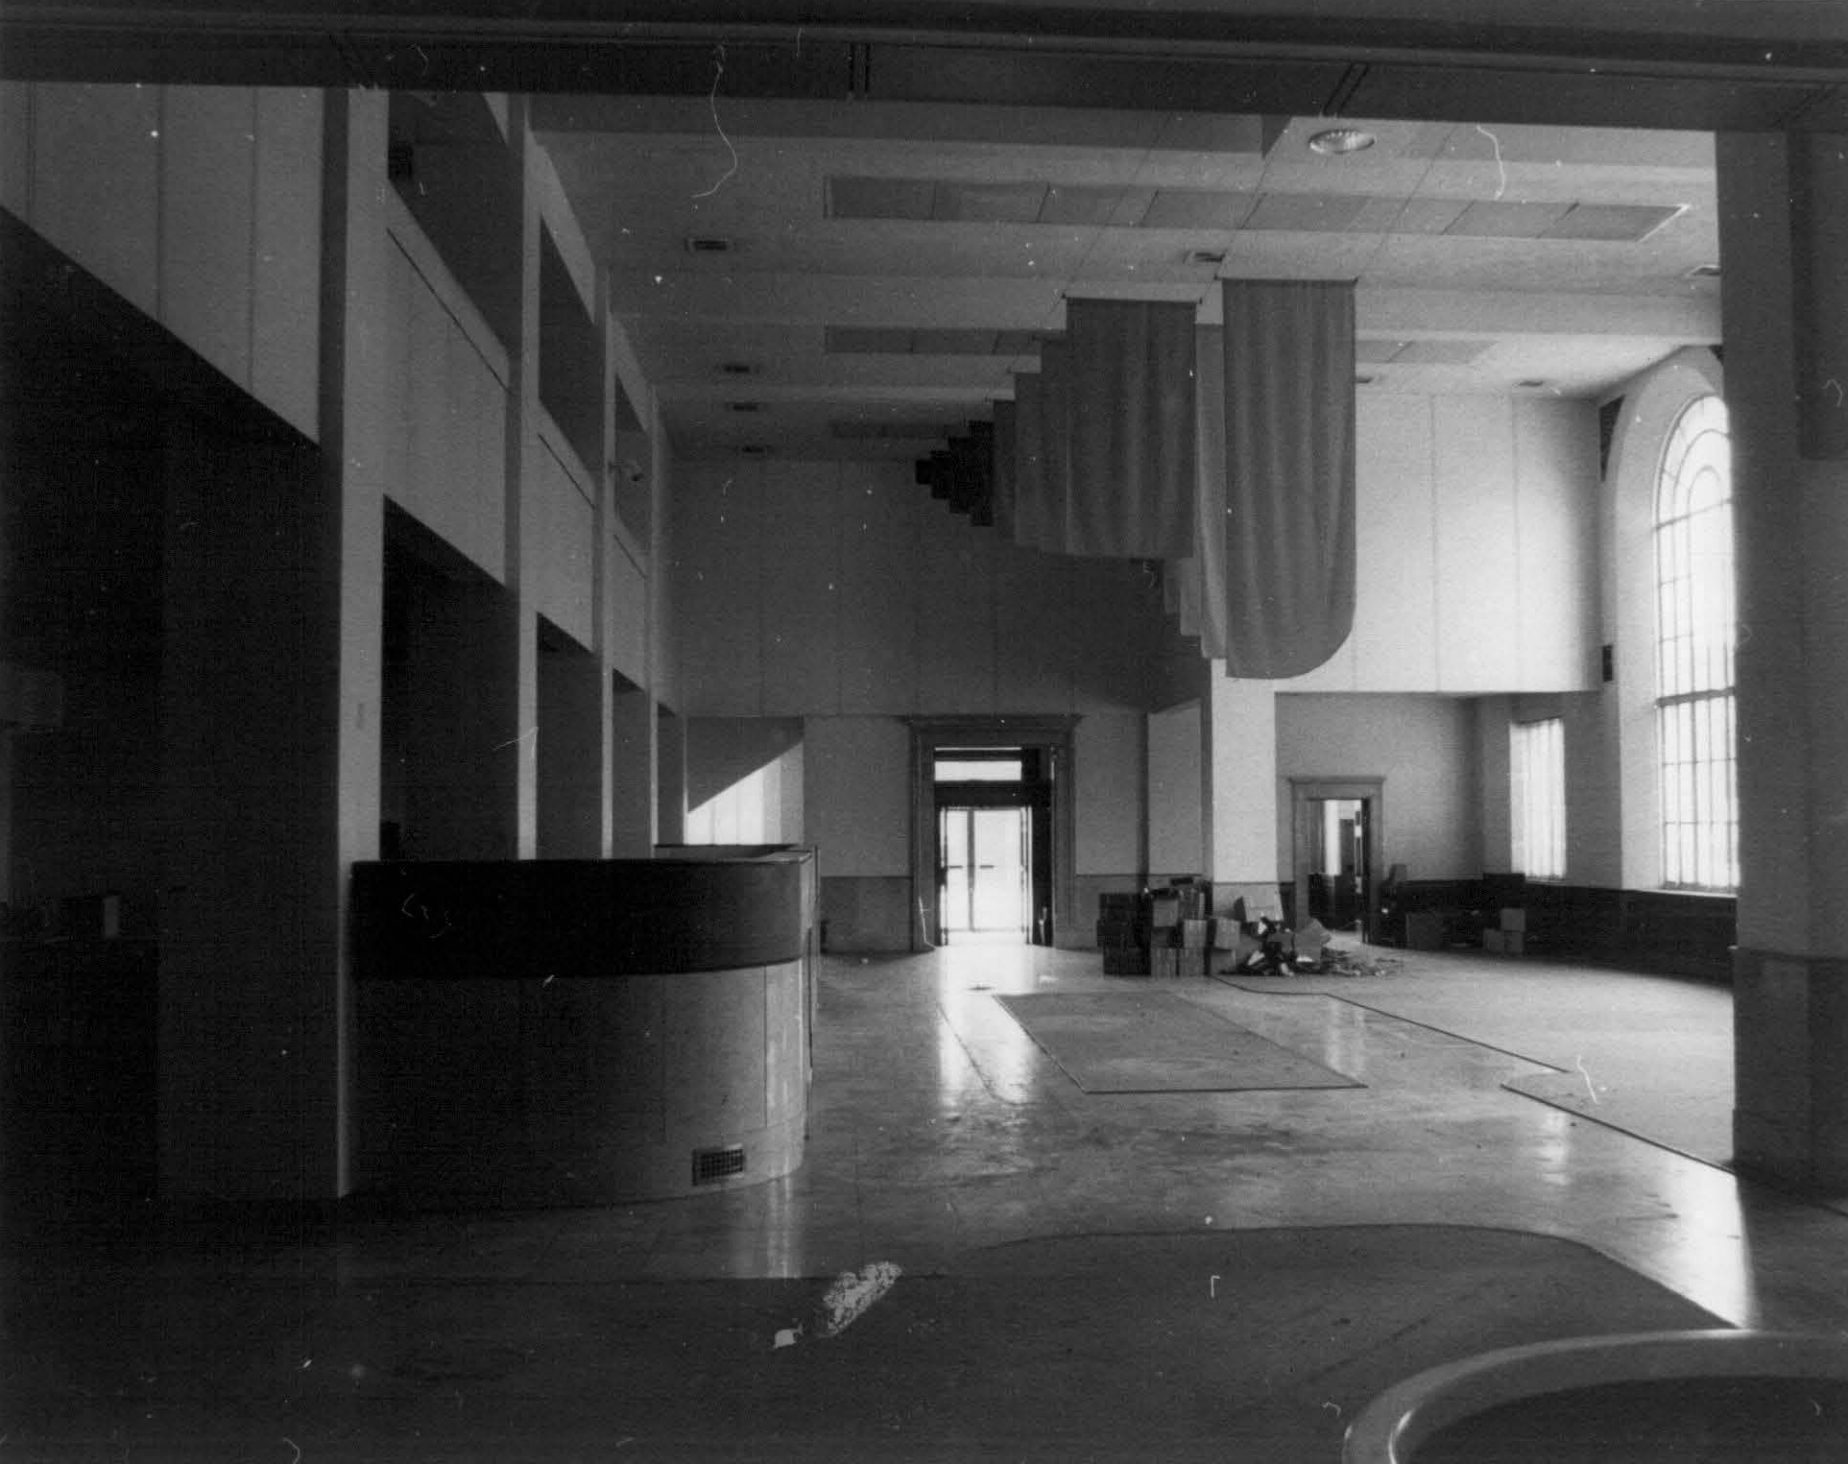
2. Ornate grillwork removed from the marble bases of the teller cages. 1956.⁴ (and all following).
3. Mezzanine area walled in and iron railing removed. 1956.

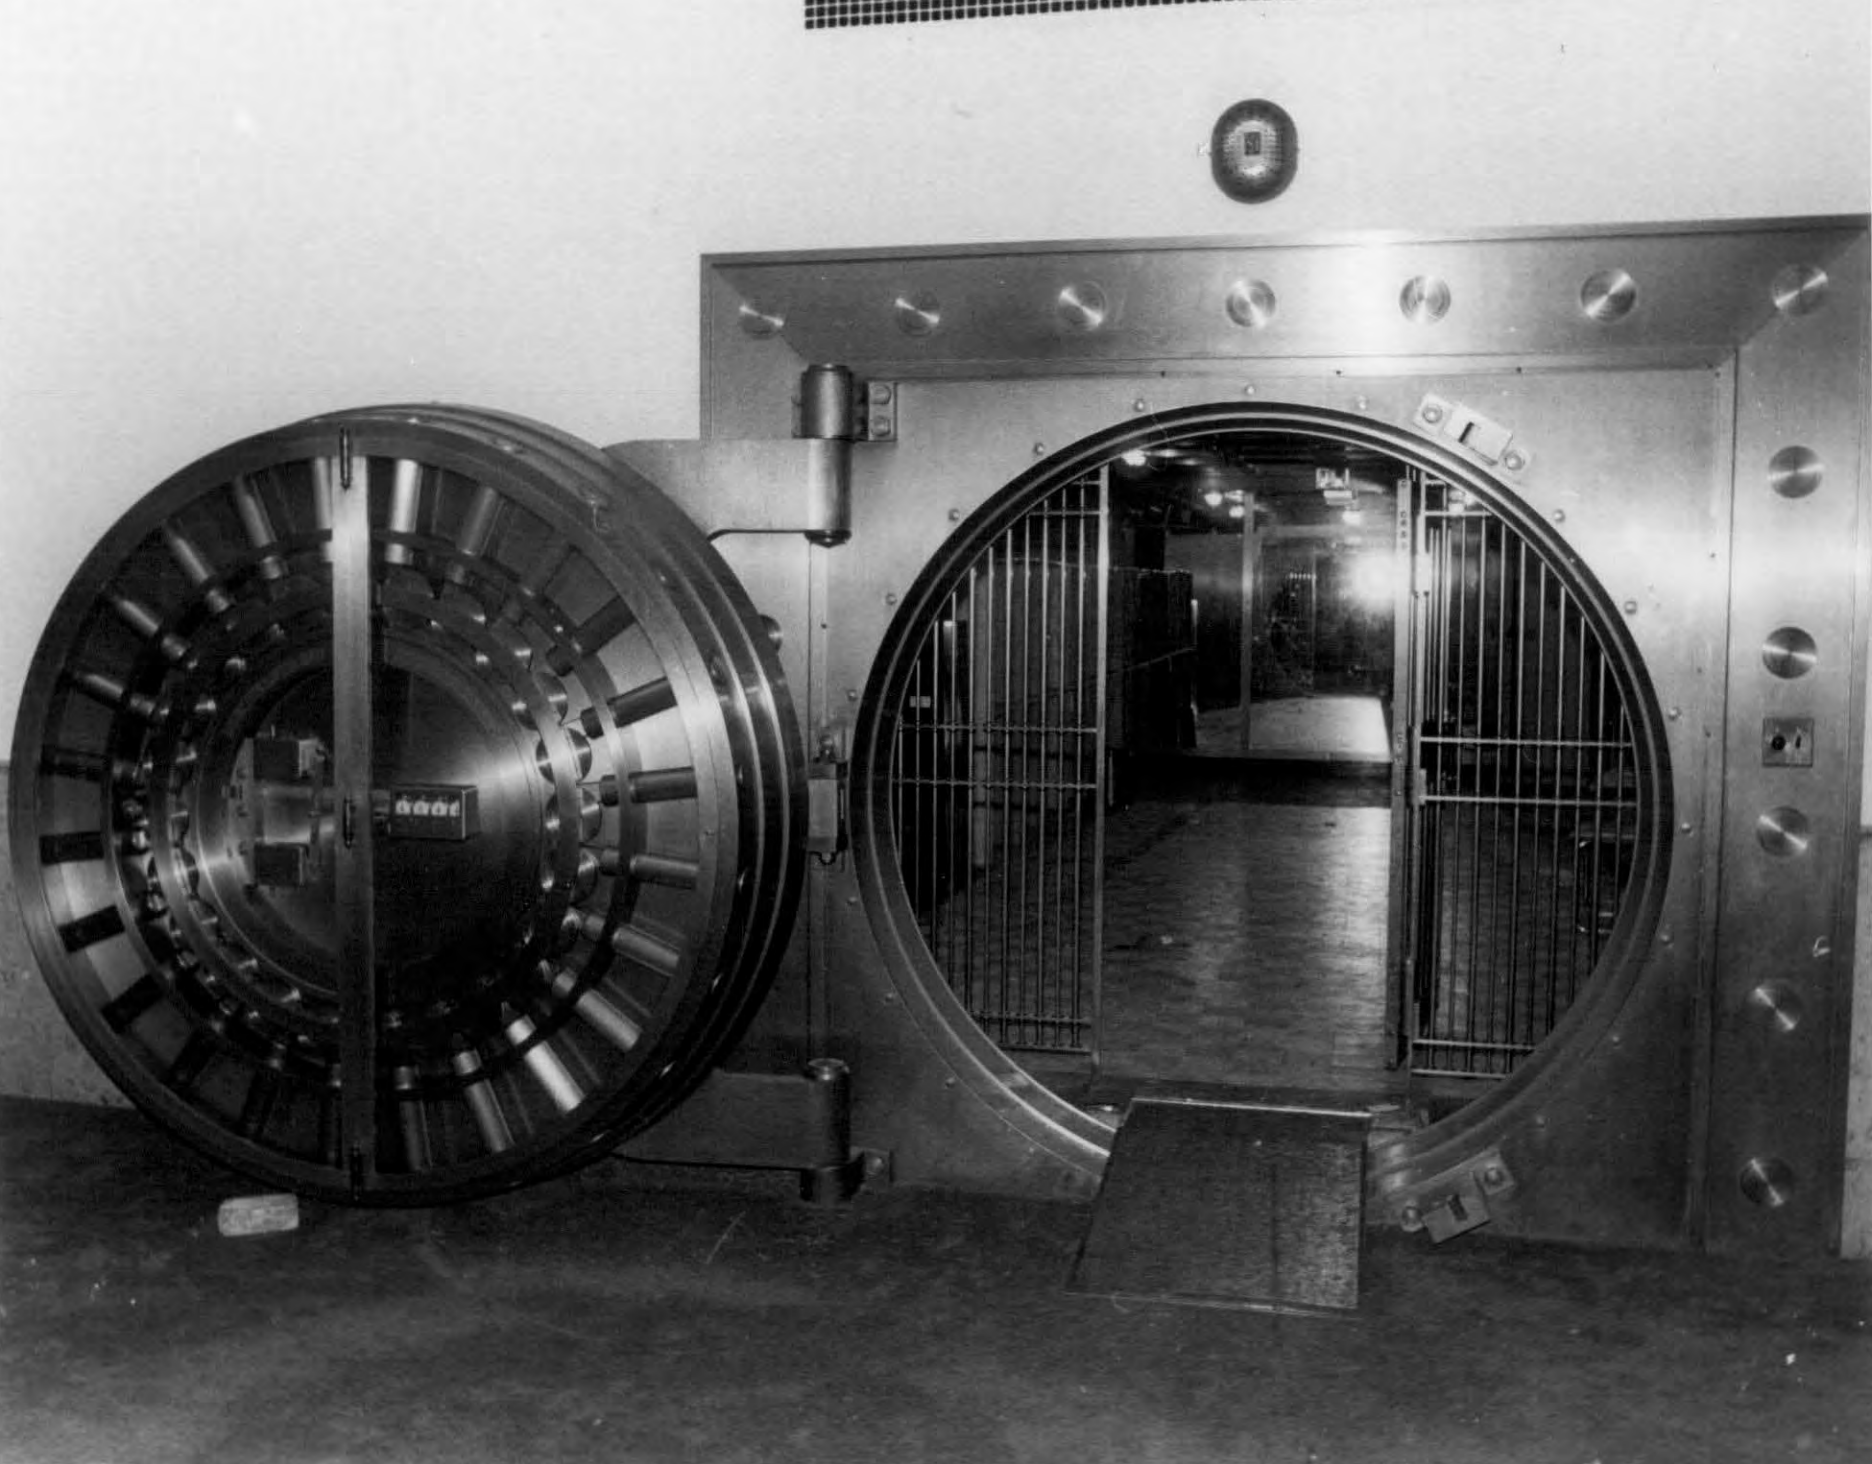
A major banking technological innovation was introduced to Kansas City in this bank: the massive steelcrete bank vault. There were a total of nine vaults in the facility altogether including the steelcrete vault that contained 4,000 individual safety deposit boxes: a money vault, a book vault, stationary vault, storage vault for old records, two trunk vaults, and two abstract vaults. "These

- 10 of 12. Main steel vault in basement.
- 11 of 12. Walnut wainscoting and enframements in original banking consultation rooms.
- 12 of 12. Proposed remodeling by architect D. Stevens of Howard, Needles, Tammen, and Bergendoff; circa 1956, commissioned by Grand Avenue Bank.

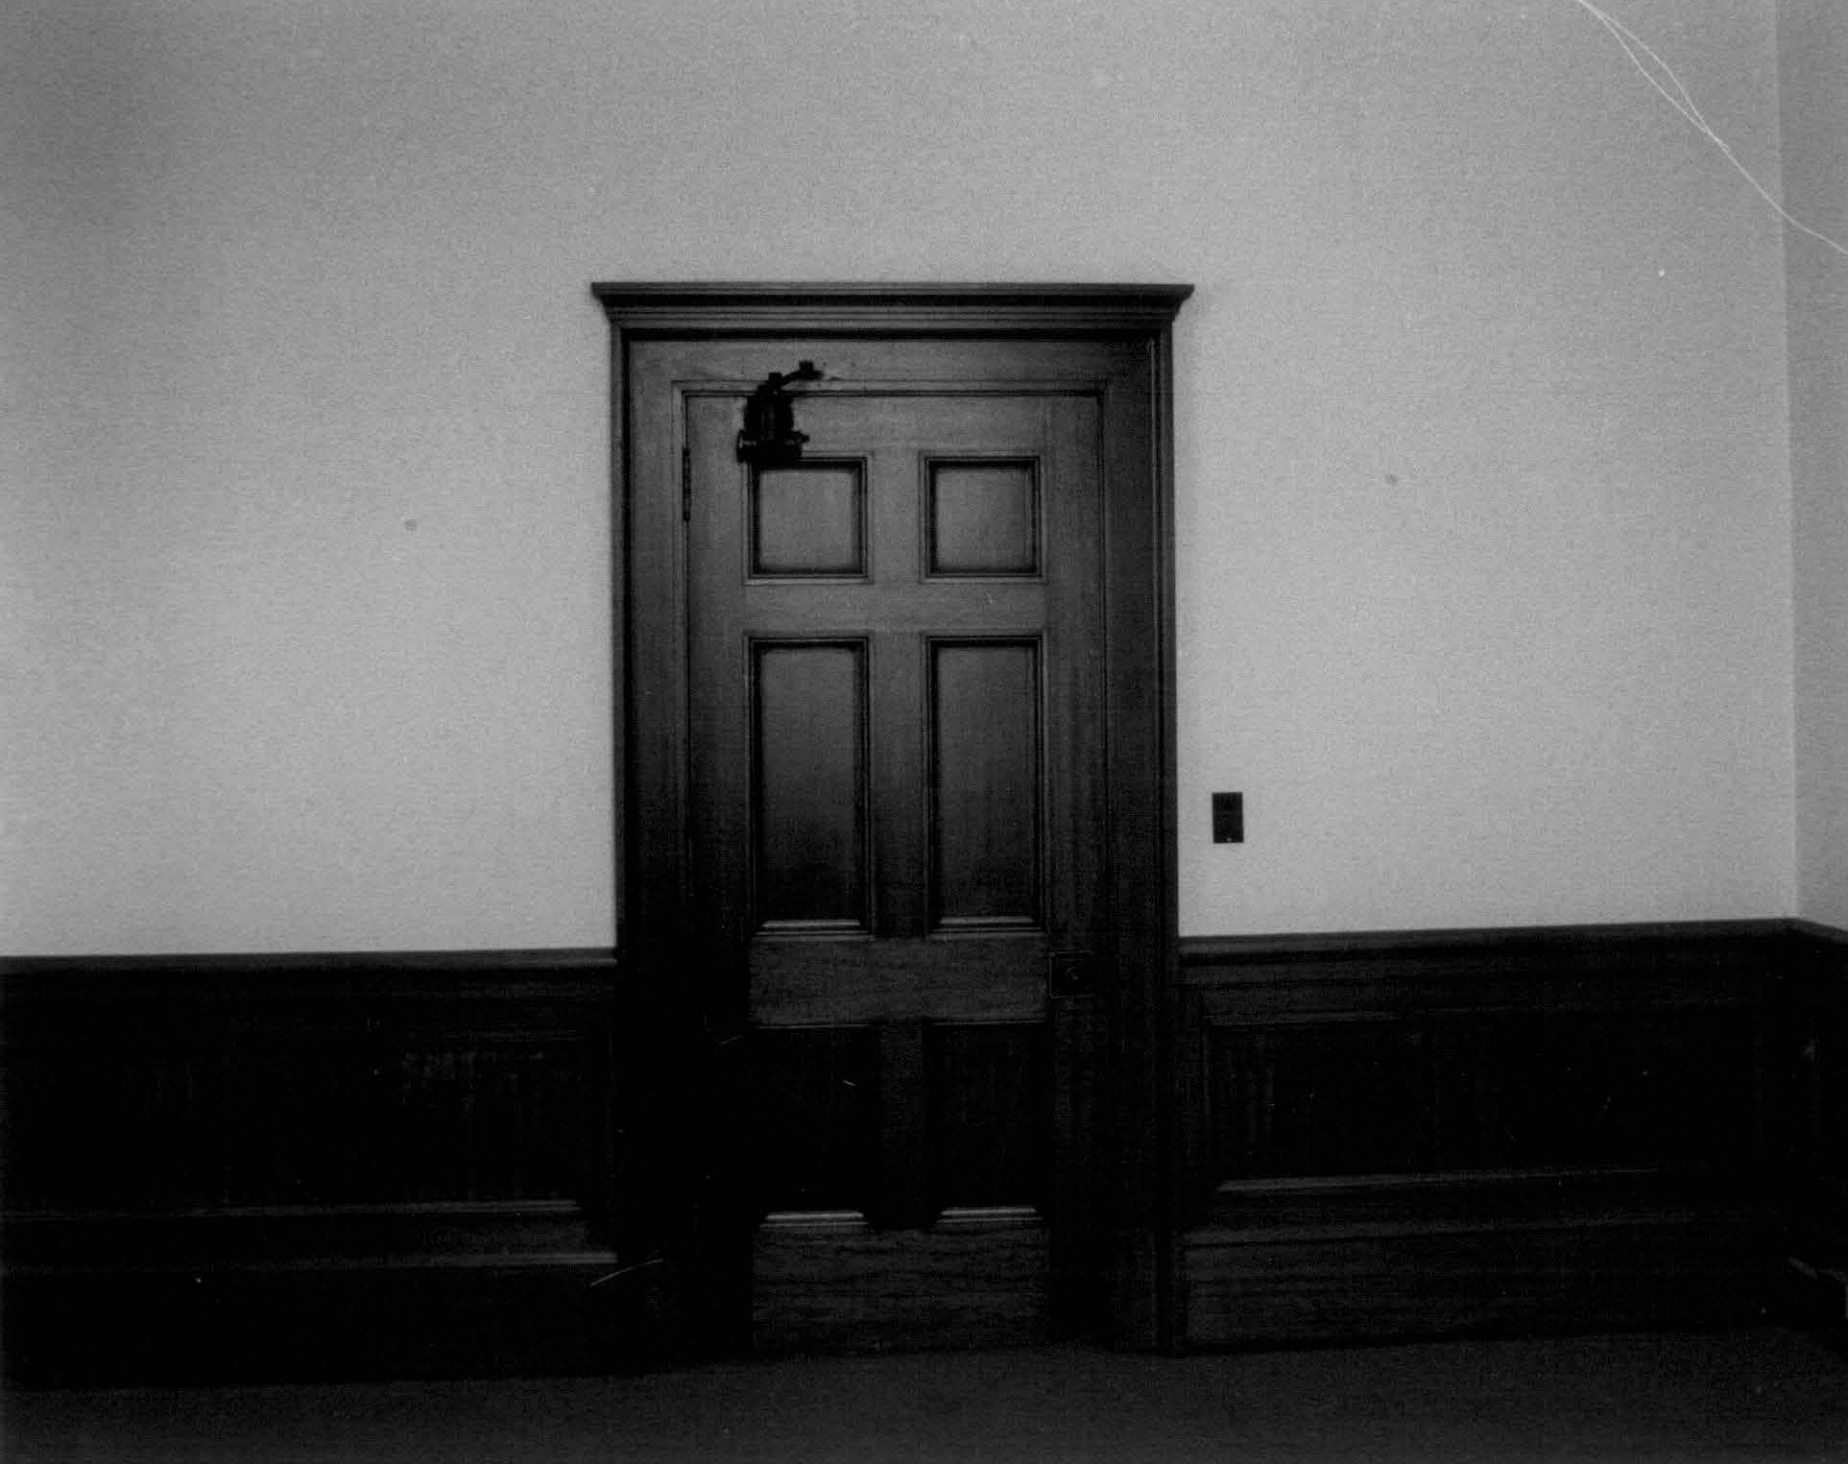
A basement level, also 84' x 115' 6", was entirely finished and used for various banking services. Several of the rooms are finished in walnut wainscoting and trim. These were originally consultation rooms, a director's room, a lobby and adjacent barber shop, ticket rooms, and other public spaces. The major massive vault is located on this floor. It is of steelcrete and opens into a large area used for a variety of vault services. An ornate iron grill spans the vault lobby entrance. The basement elevator floor is of terrazzo with a marble base.
