Habitat for Humanity Flora Survey
2009

JA-AS-045
Kansas City, Jackson County

ARCHITECTURAL/HISTORIC INVENTORY FORM

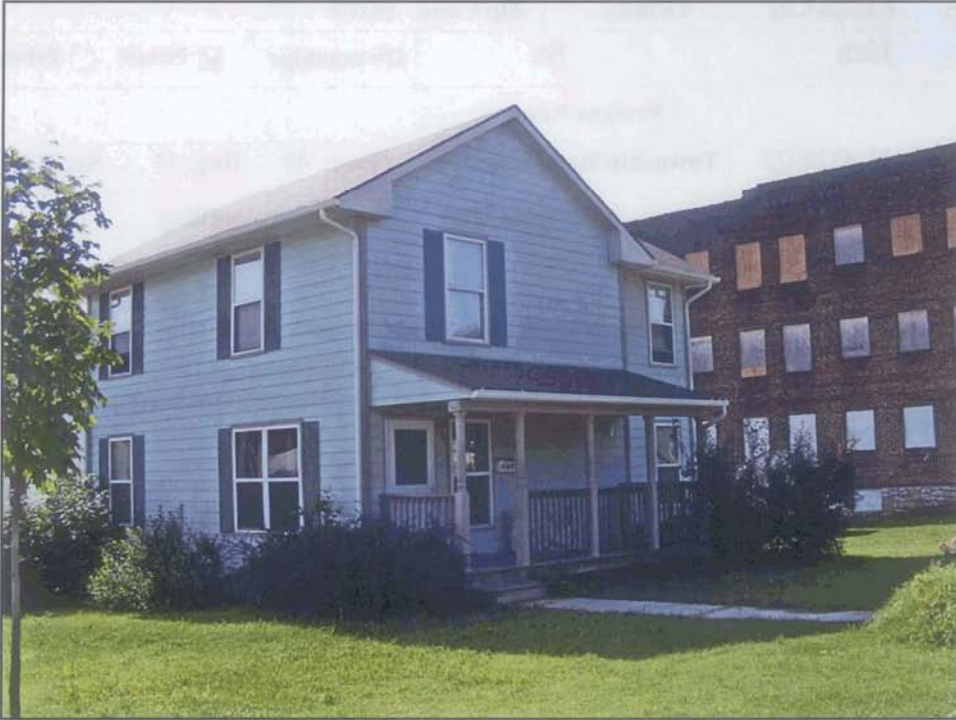
Property Category:	Building	Chimney Placement:	unknown	Outbuildings (list, describe on continuation sheet:)
Arch. Style and/or Vernacular Type:	upright and wing	Structural:	frame	
Plan shape:	L-shaped	Exterior Cladding:	pressed lapboard	
No. of Stories:	2	Foundation Material:	concrete	Changes <input type="checkbox"/> Additions Date(s): <input type="checkbox"/> Alteration Date(s): <input type="checkbox"/> Moved Date(s): <input type="checkbox"/> Other Date(s): Endangered By:
No. of Bays (1st story):	3	Basement Type:	unknown	
Roof Type:	gable	Front Porch Type:	full width, shed roof	
Roof Material:	composition shingle	Acreage (rural):		
		Visible from Public Rd	<input checked="" type="checkbox"/>

Eligibility: not eligible: less than 50 years old

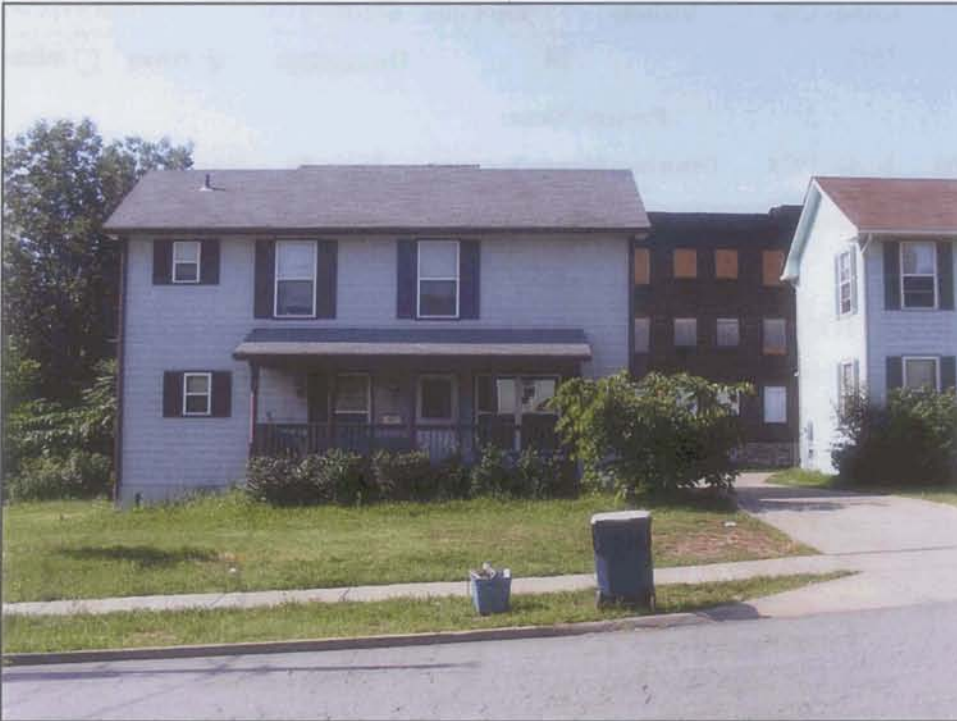
Property Category:	Building	Chimney Placement:	unknown	Outbuildings (list, describe on continuation sheet:)
Arch. Style and/or Vernacular Type:		Structural:	frame	
Plan shape:	rectangular	Exterior Cladding:	pressed lapboard	
No. of Stories:	2	Foundation Material:	concrete	Changes <input type="checkbox"/> Additions Date(s): <input type="checkbox"/> Alteration Date(s): <input type="checkbox"/> Moved Date(s): <input type="checkbox"/> Other Date(s): Endangered By:
No. of Bays (1st story):	3	Basement Type:	unknown	
Roof Type:	gable	Front Porch Type:	partial width, shed roof	
Roof Material:	composition shingle	Acreage (rural):		
		Visible from Public Rd	<input checked="" type="checkbox"/>

Eligibility: not eligible: less than 50 years old

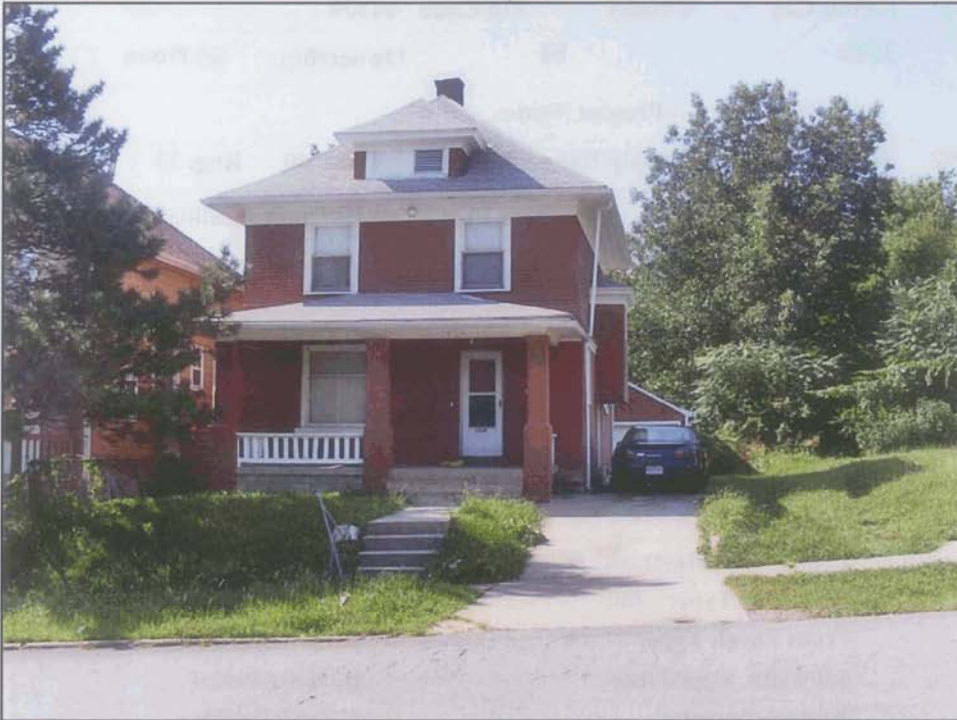
Property Category: Building	Chimney Placement:	Outbuildings (list, describe on continuation sheet:)
Arch. Style and/or Vernacular Type:	center on ridgeline	
American Foursquare	Structural: frame	
Plan shape: rectangular	Exterior Cladding:	
No. of Stories: 2 1/2	brick	Changes <input type="checkbox"/> Additions Date(s): <input type="checkbox"/> Alteration Date(s): <input type="checkbox"/> Moved Date(s): <input type="checkbox"/> Other Date(s): Endangered By:
No. of Bays (1st story): 2	Foundation Material: limestone	
Roof Type:	Basement Type: full	
hipped	Front Porch Type:	
Roof Material:	full width, hipped roof	
composition shingle	Acreage (rural):	
	Visible from Public Rd <input checked="" type="checkbox"/>

This is a common American Foursquare that would not be individually eligible for listing on the National Register.

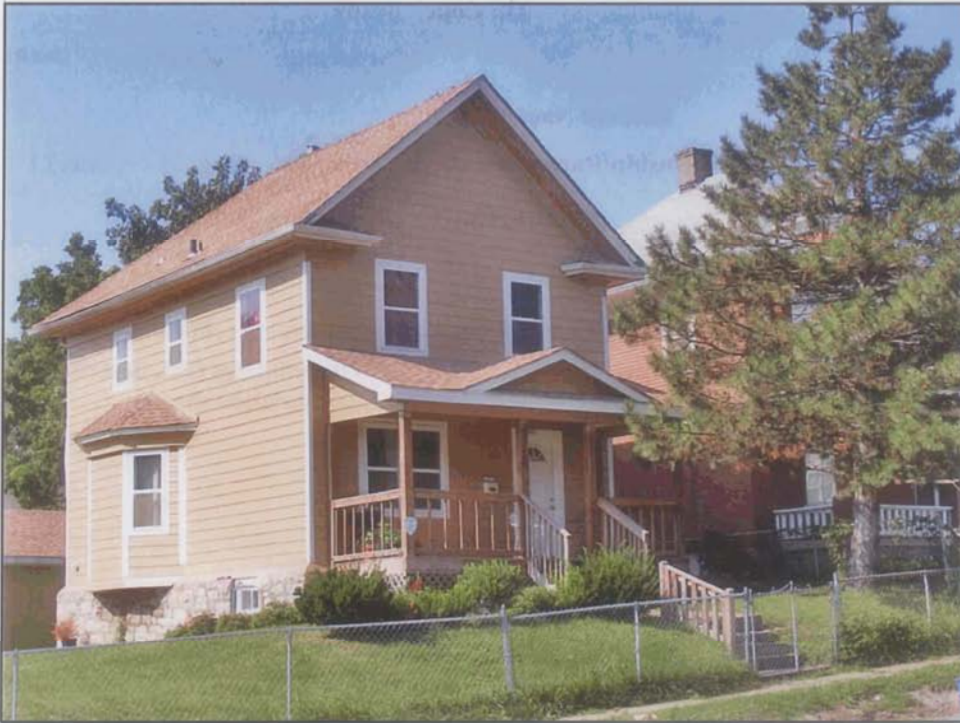
A chain link fence surrounds the property

This American Foursquare has had numerous alterations, including replacement of the original siding, new vinyl windows, new doors, and new porch columns and railings.

This house has had all the siding, windows and doors replaced, there it would not be eligible due to lack of integrity.

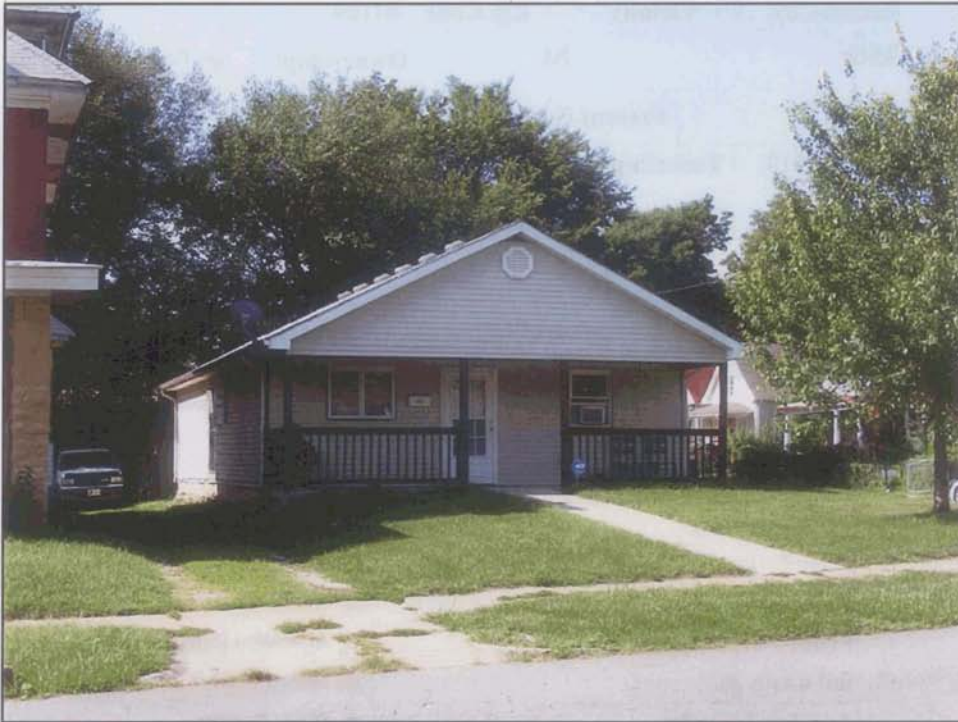
Property Category: Building	Chimney Placement:	Outbuildings (list, describe on continuation sheet:)
Arch. Style and/or Vernacular Type: ranch	unknown	
Plan shape: rectangular	Structural: frame	
No. of Stories: 1	Exterior Cladding: vinyl lap siding	
No. of Bays (1st story): 3	Foundation Material: concrete	Changes <input type="checkbox"/> Additions Date(s): <input type="checkbox"/> Alteration Date(s): <input type="checkbox"/> Moved Date(s): <input type="checkbox"/> Other Date(s): Endangered By:
Roof Type: gable	Basement Type: unknown	
Roof Material: composition shingle	Front Porch Type: full width gable roof	
	Acreage (rural):	
	Visible from Public Rd <input checked="" type="checkbox"/>

Eligibility: not eligible: less than 50 years old

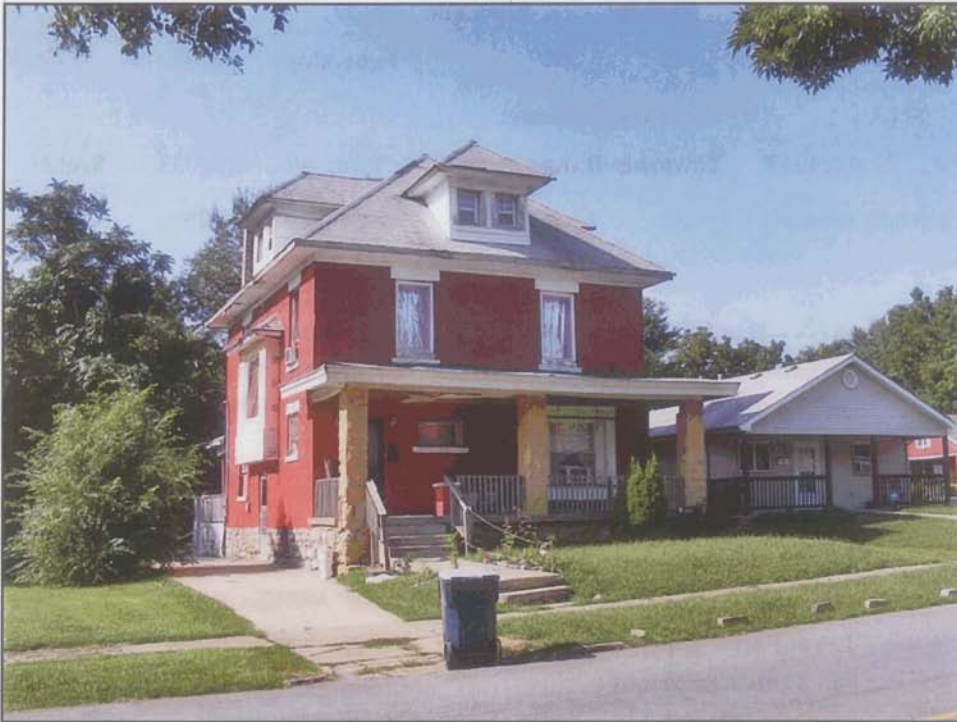
This American foursquare has four hipped dormers with 4/1 double hung windows. There is a bay window on the East façade. The original limestone porch columns have been painted yellow and there is a wood non-original porch balustrade. Many of the windows have been replaced. There is a half-light front door.

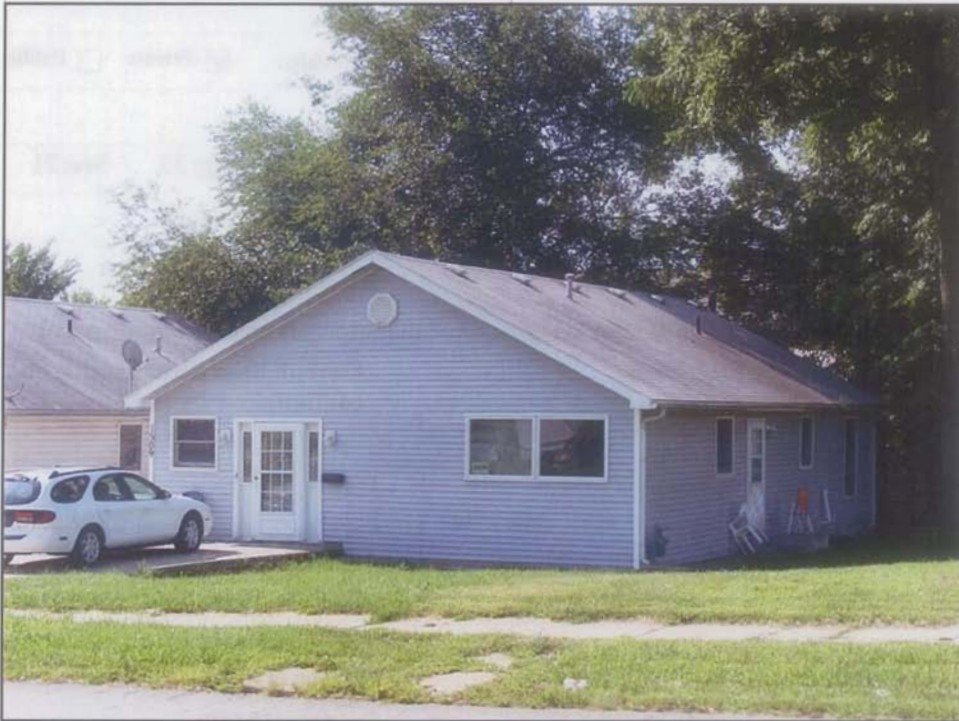
Property Category: Building	Chimney Placement:	Outbuildings (list, describe on continuation sheet):
Arch. Style and/or Vernacular Type: ranch	unknown	
Plan shape: rectangular	Structural: frame	
No. of Stories: 1	Exterior Cladding:	Changes <input type="checkbox"/> Additions Date(s): <input type="checkbox"/> Alteration Date(s): <input type="checkbox"/> Moved Date(s): <input type="checkbox"/> Other Date(s): Endangered By:
No. of Bays (1st story): 2	vinyl lap siding	
Roof Type:	Foundation Material: concrete	
gable	Basement Type: unknown	
Roof Material:	Front Porch Type:	
composition shingle	n/a	
	Acreage (rural):	
	Visible from Public Rd <input checked="" type="checkbox"/>

Eligibility: not eligible: less than 50 years old

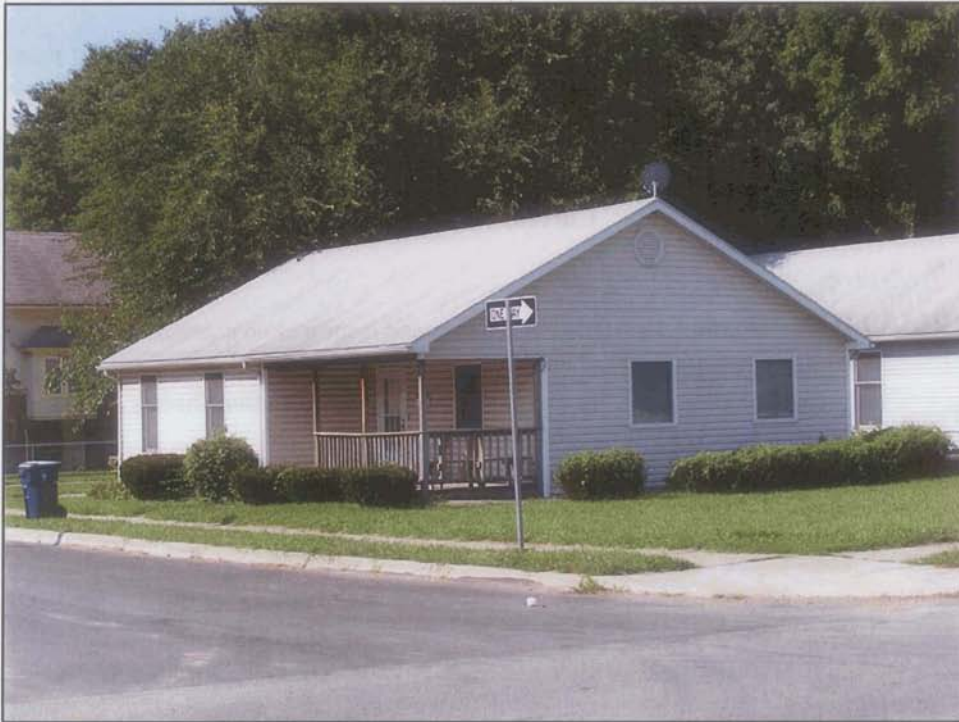
Property Category: Building	Chimney Placement: unknown	Outbuildings (list, describe on continuation sheet:)
Arch. Style and/or Vernacular Type: ranch	Structural: frame	
Plan shape: rectangular	Exterior Cladding: vinyl lap siding	
No. of Stories: 1	Foundation Material: concrete	
No. of Bays (1st story): 3	Basement Type: unknown	Changes <input type="checkbox"/> Additions Date(s): <input type="checkbox"/> Alteration Date(s): <input type="checkbox"/> Moved Date(s): <input type="checkbox"/> Other Date(s): Endangered By:
Roof Type: gable	Front Porch Type: inset	
Roof Material: composition shingle	Acreage (rural):	
	Visible from Public Rd <input checked="" type="checkbox"/>

Eligibility: not eligible: less than 50 years old

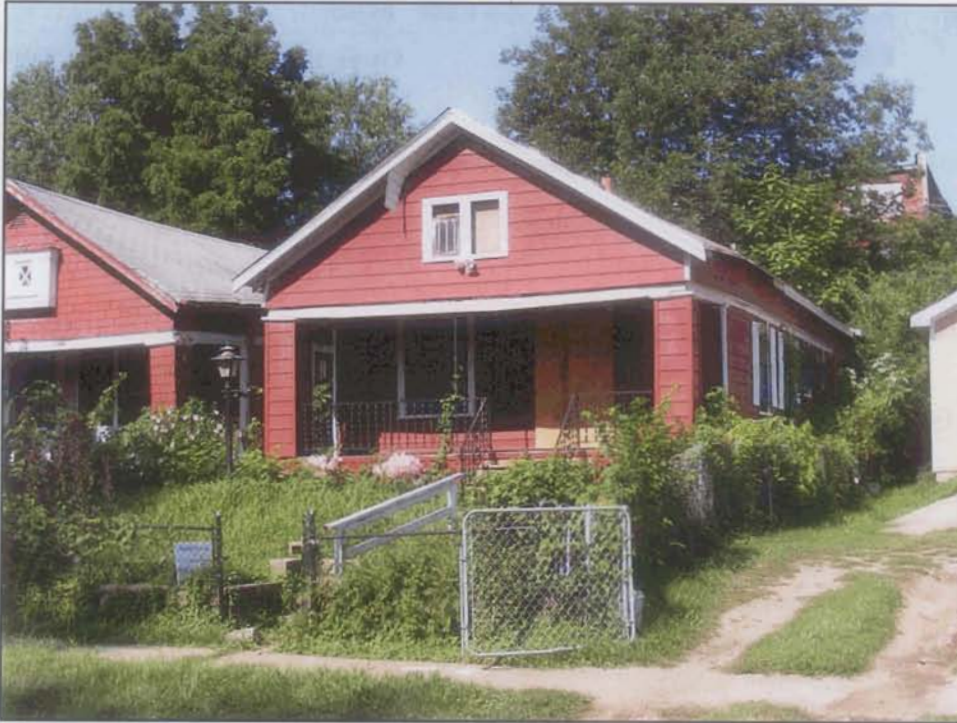
This bungalow has most of the windows boarded. The front porch is supported by vinyl wrapped posts and is surrounded by a metal balcony. The house is currently in poor physical condition.

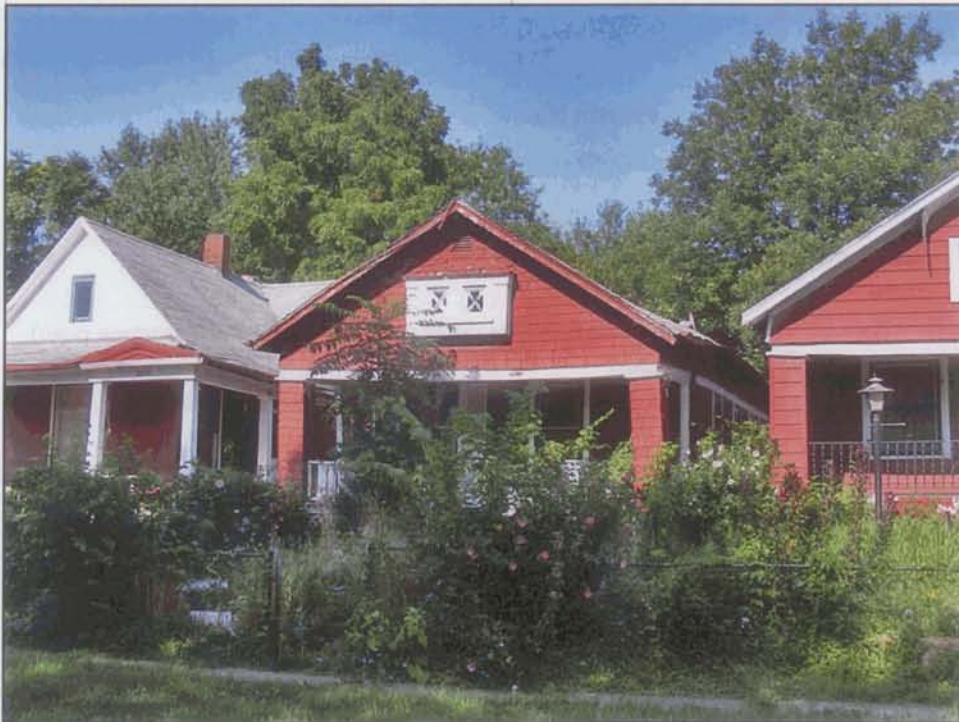
This bungalow has most of the windows boarded. The front porch is supported by vinyl wrapped posts and is surrounded by a metal balcony. The house is currently in poor physical condition.

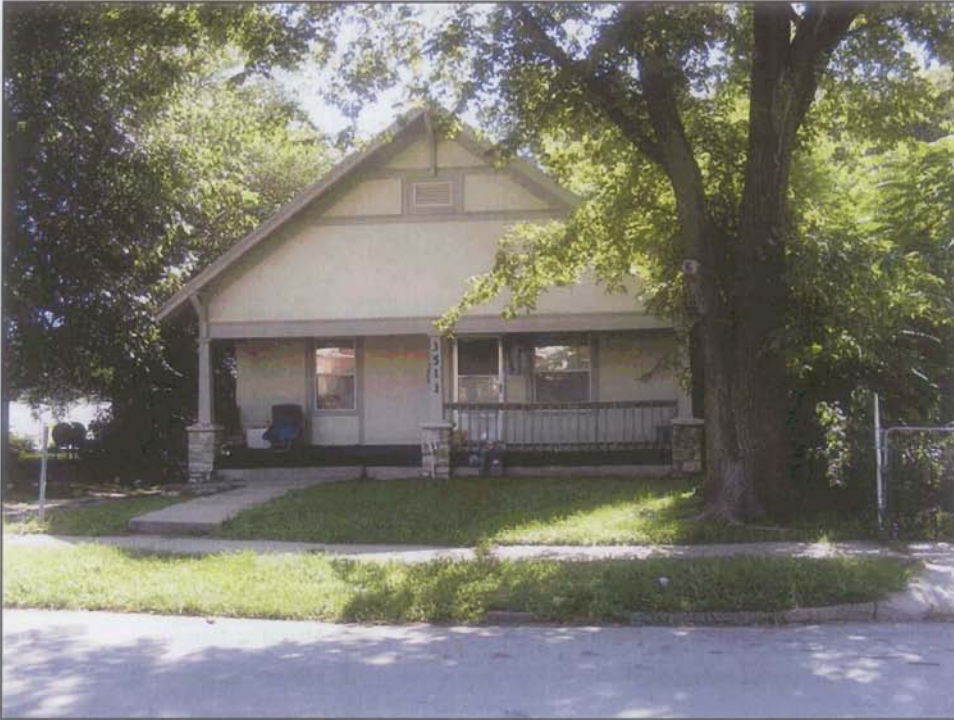
This craftsman bungalow has decorative half-timbering in the gable end and decorative brackets. The porch has wood posts atop limestone bases. The porch has a non-original wood balustrade.

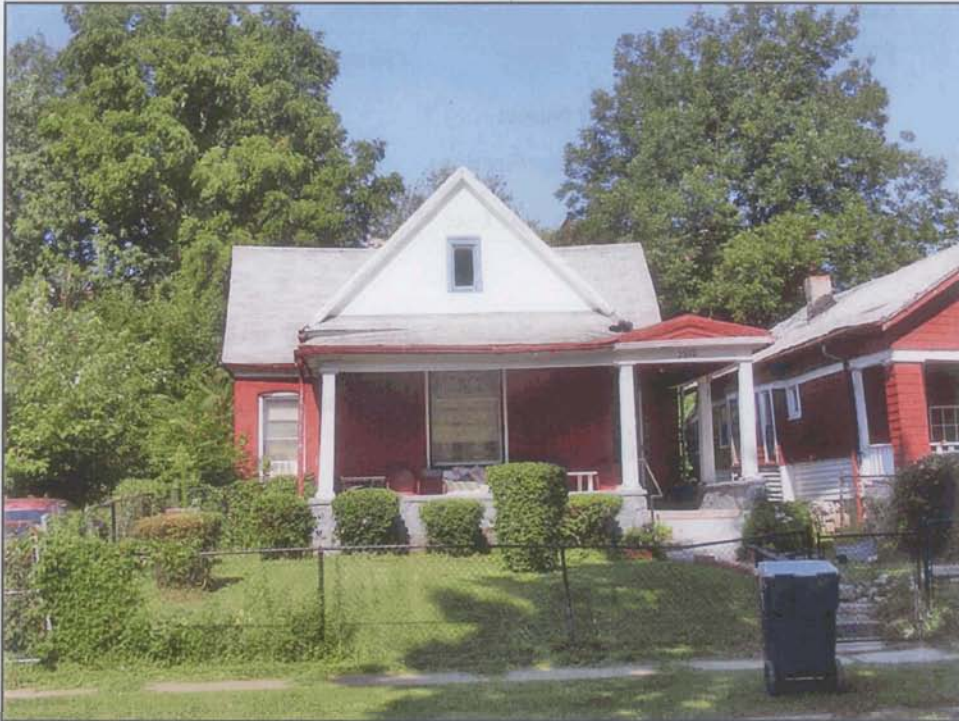
This folk Victorian has 1/1 double hung windows. The wrap around porch has wood posts atop limestone bases and is surrounded by a low limestone wall.

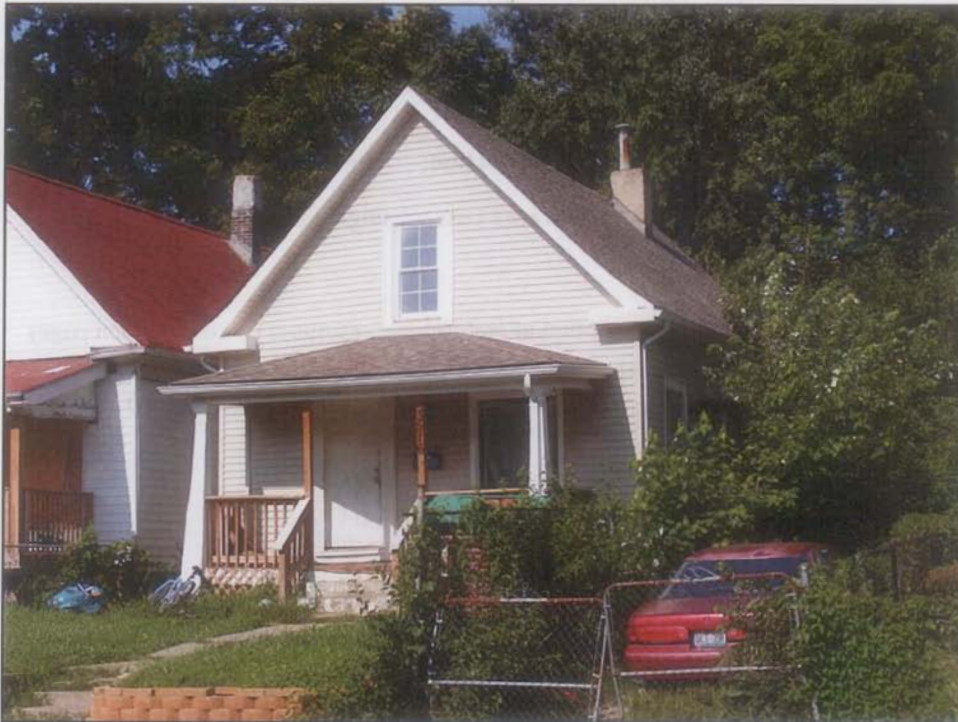
This vernacular cottage has vinyl lap siding, vinyl 4/4 windows, and a metal front door. The front porch has a non-original balustrade

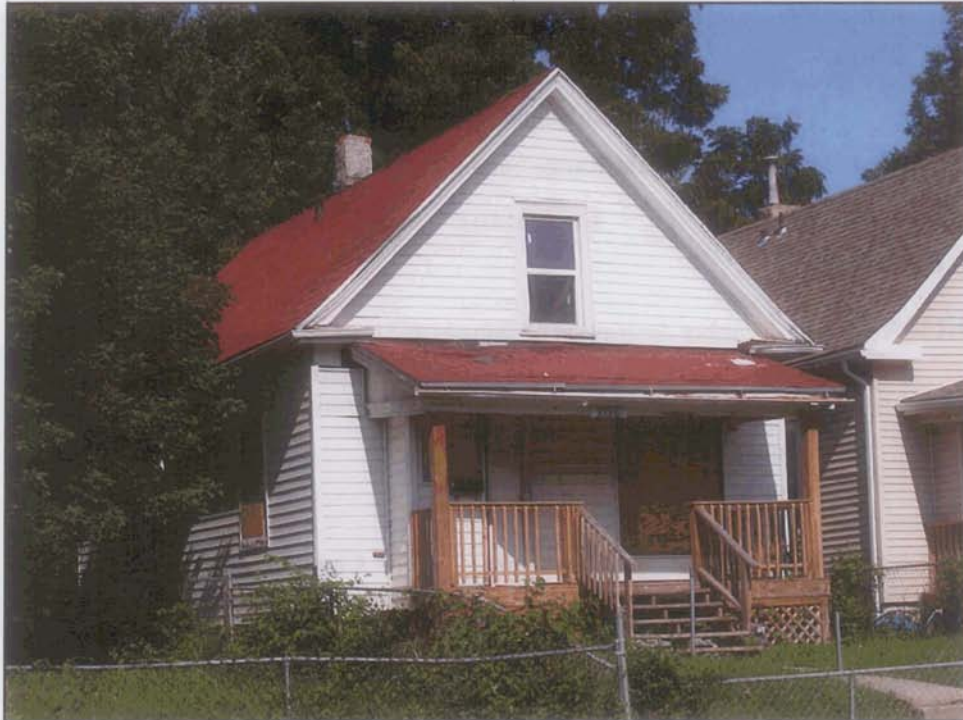
This vernacular cottage has vinyl lap siding, vinyl 1/1 windows, and a metal front door. The front porch has a non-original balustrade

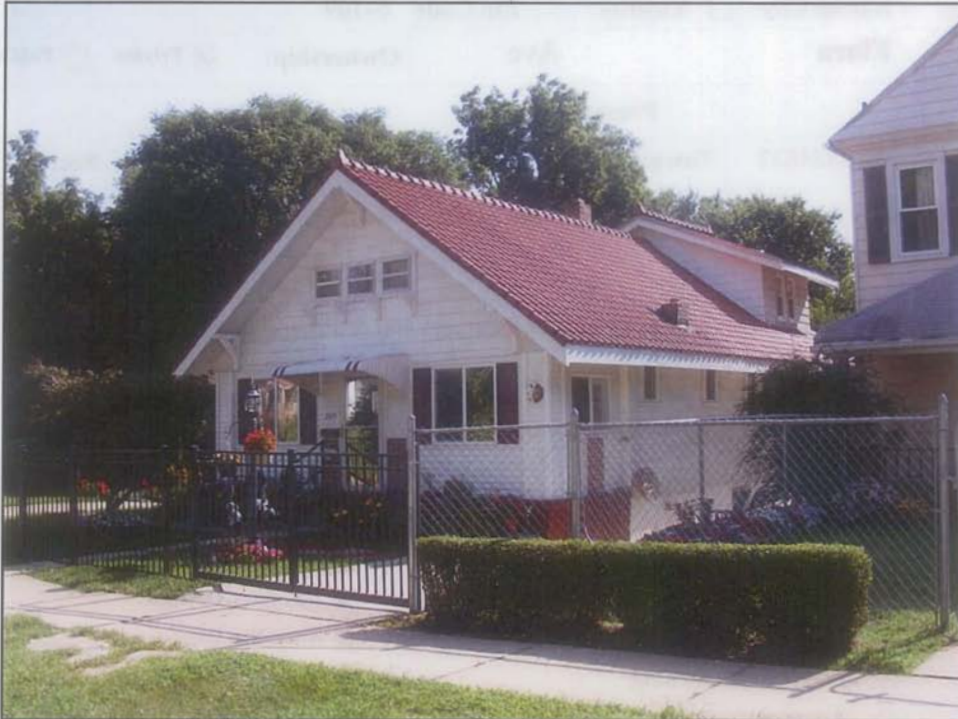
This craftsman bungalow has a gable roof and decorative brackets. The house has vinyl slider windows and metal siding.

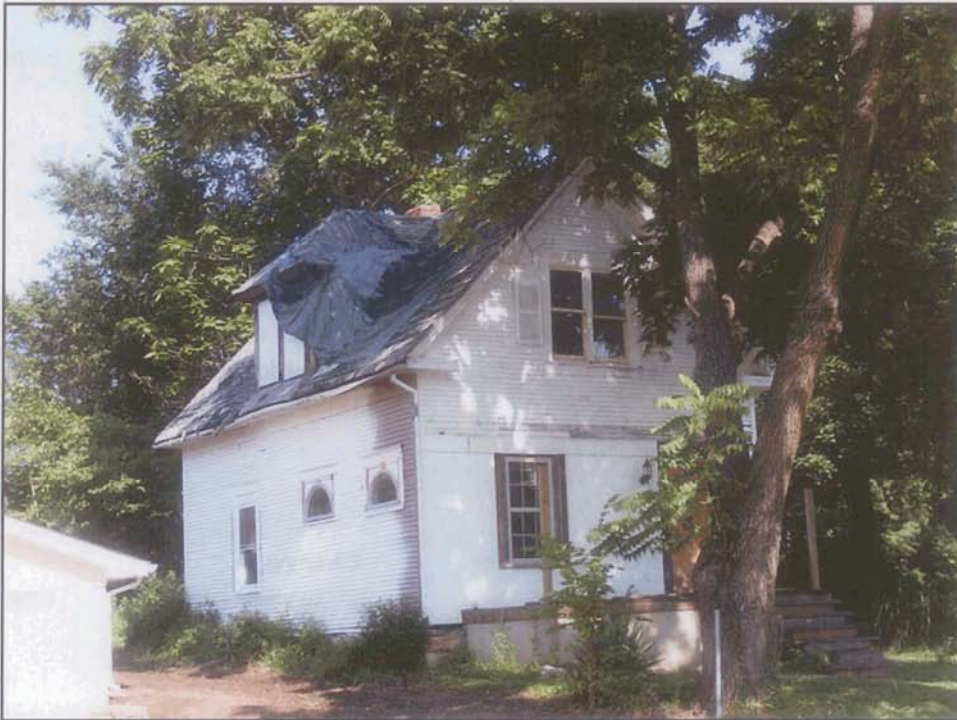
This vernacular cottage has wood lap siding, 1/1 wood windows and awning windows with decorative arched glazing. The front porch is missing, but has a concrete foundation and wood posts.

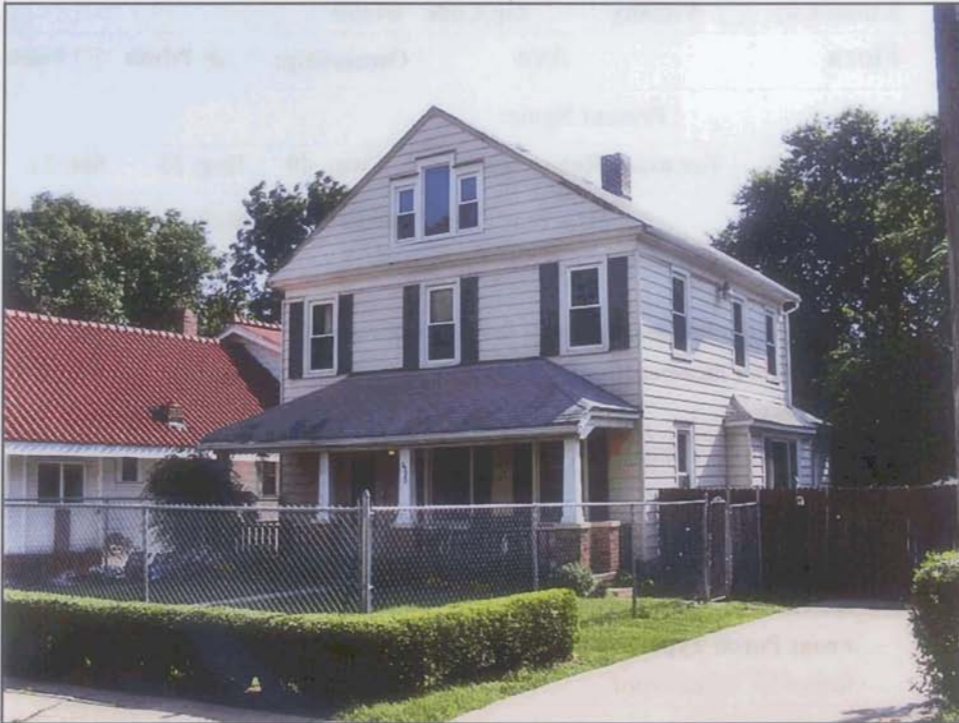
A chain link fence surrounds the front yard.

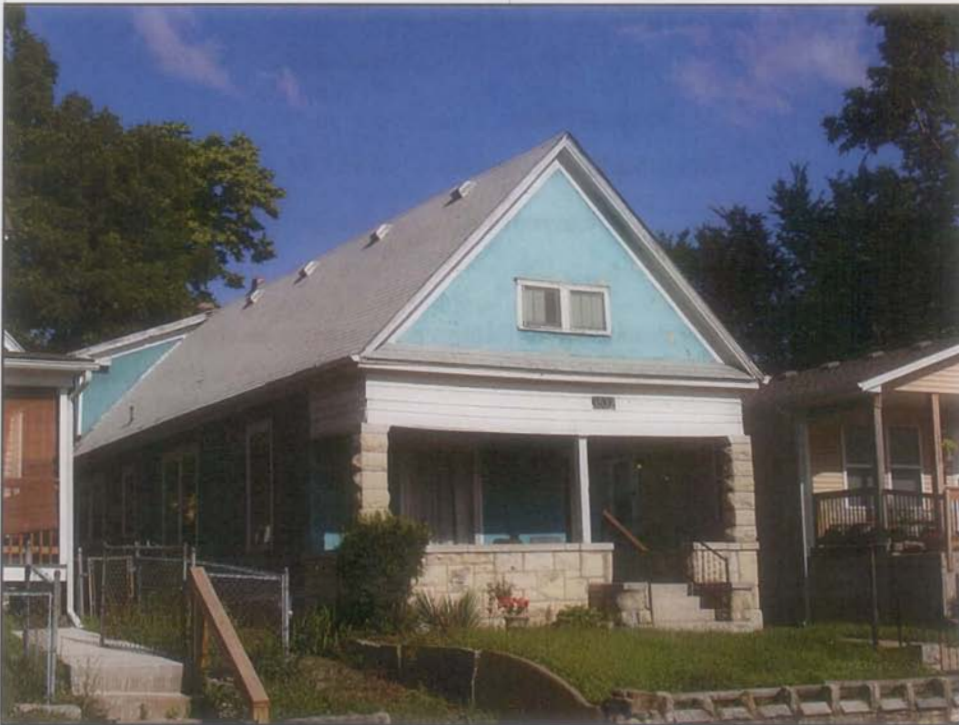
This craftsman bungalow is a common style that would not be individually eligible, and due to demolitions and alterations on the block, there is little potential for a district.

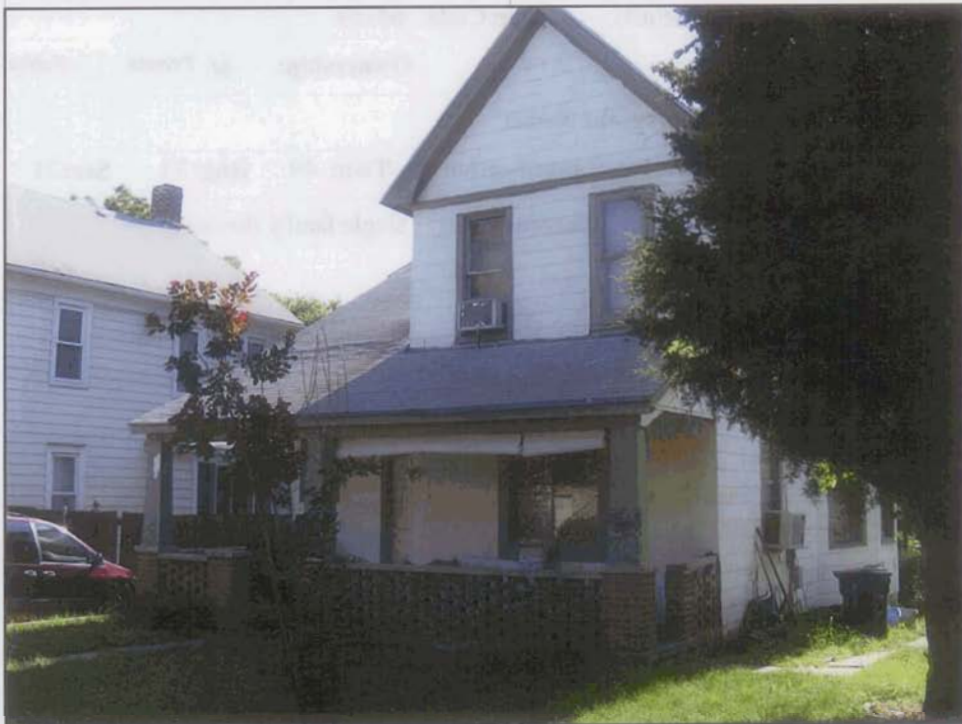
This vernacular victorian has had the original front porch, with turned posts and decorative barge boards, removed sometime after 1940 and a new porch with tapered posts and a low brick wall installed.

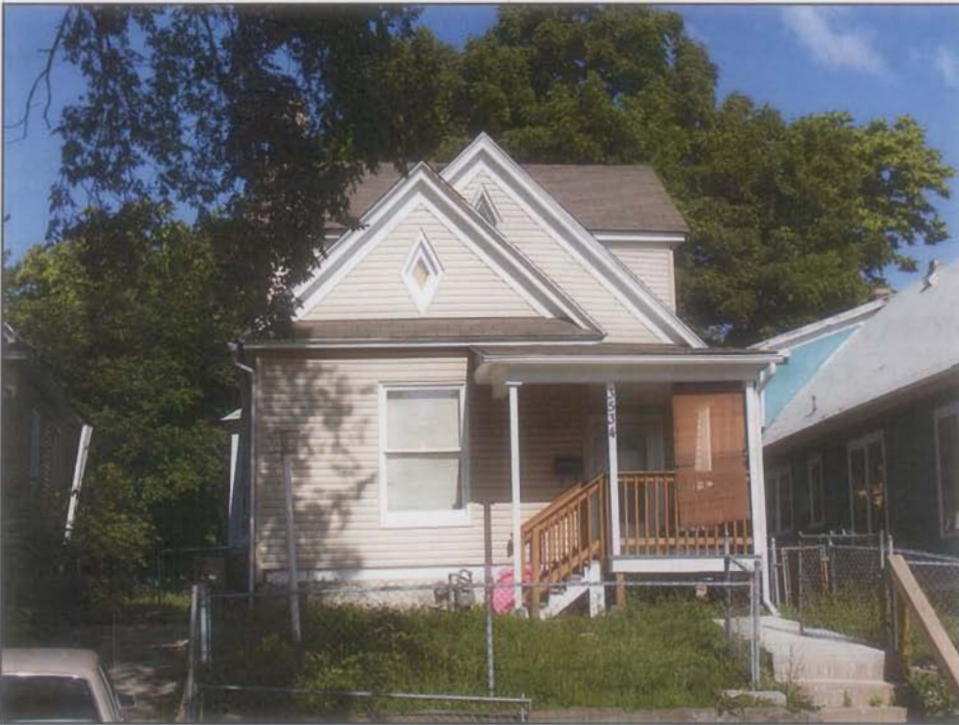
The front porch posts, railing and floor are not original. There is a second story addition in the middle of the building with a gable roof. The windows and doors have been replaced with vinyl window units.

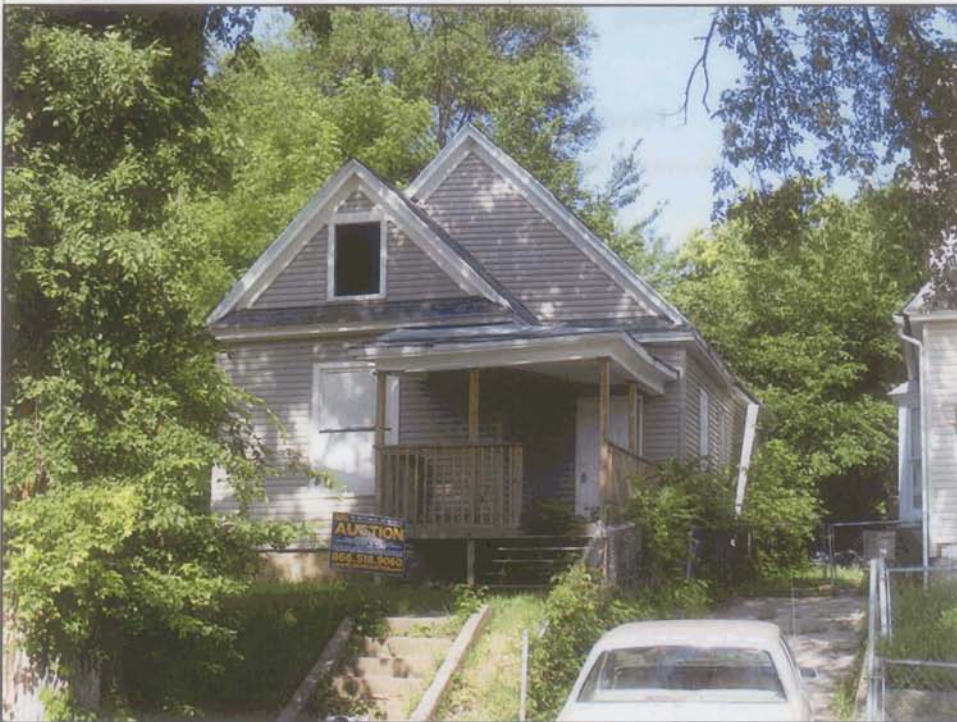
This house had a fire in 2009. The house has numerous alterations including vinyl lap siding, a new front door, and new wood posts and balustrade on the front porch. It is currently boarded up and missing many windows.

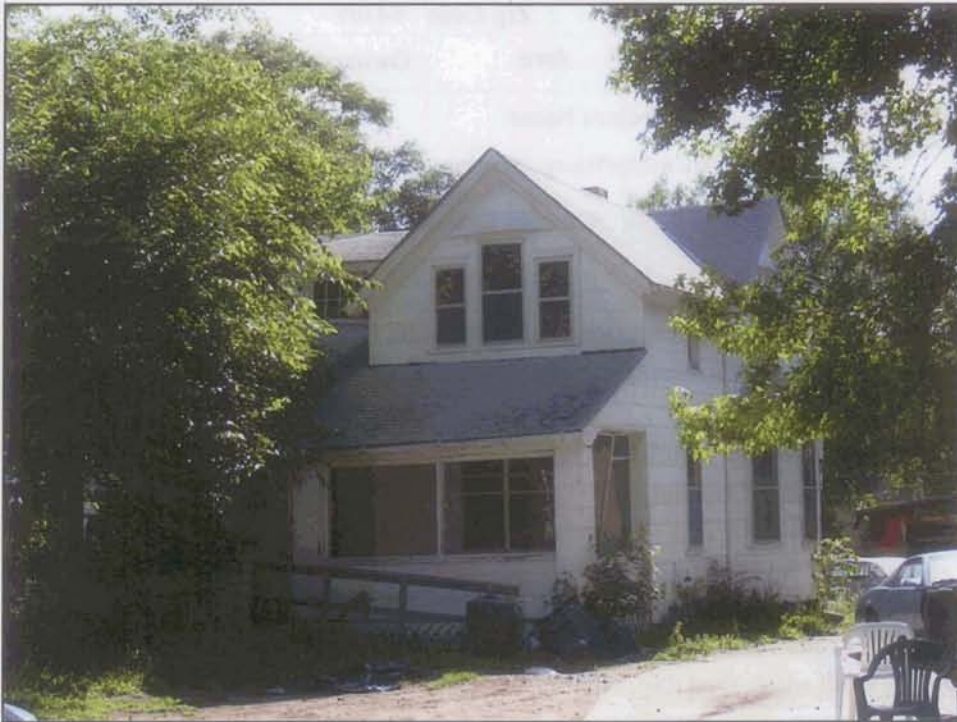
This vernacular cottage has 1/1 double hung windows, a bay on the south façade and a ADA ramp along the front (west) façade.

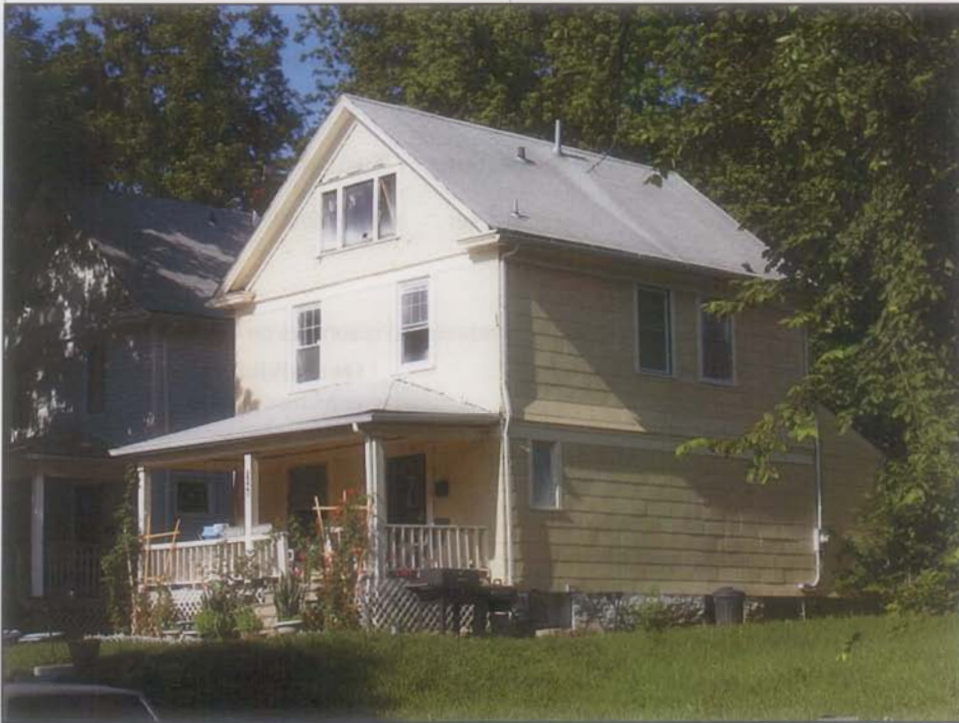
6/1 double hung windows on the front (east) façade. The other façade have 1/1 double hung windows. There is a small shed addition on the east façade.

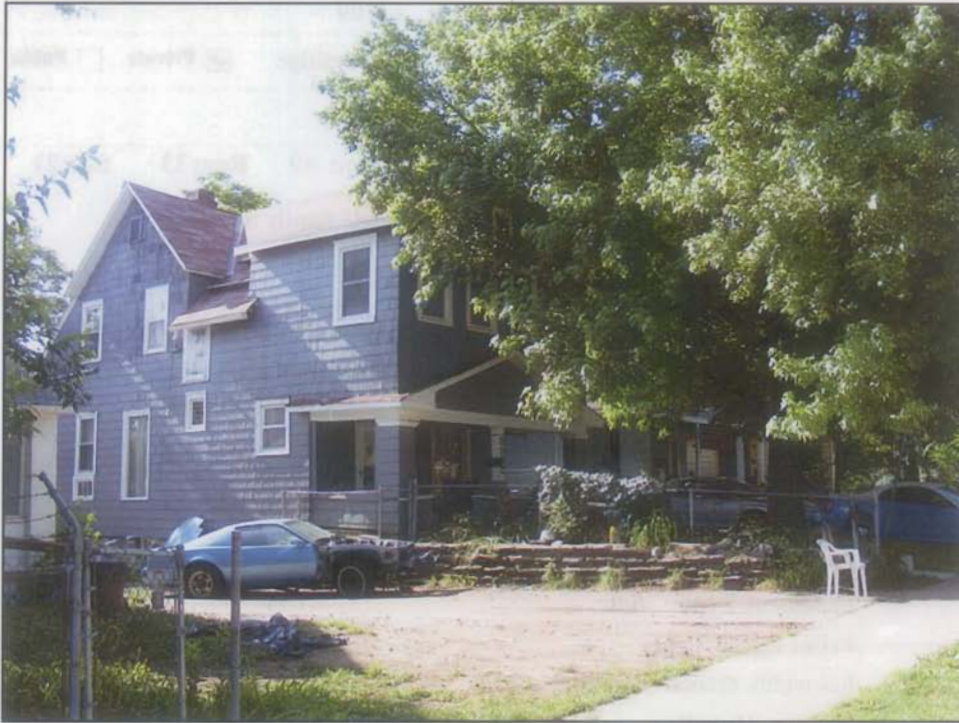
This two story have has 1/1 double hung vinyl windows. There is a large second story addition above the front porch.

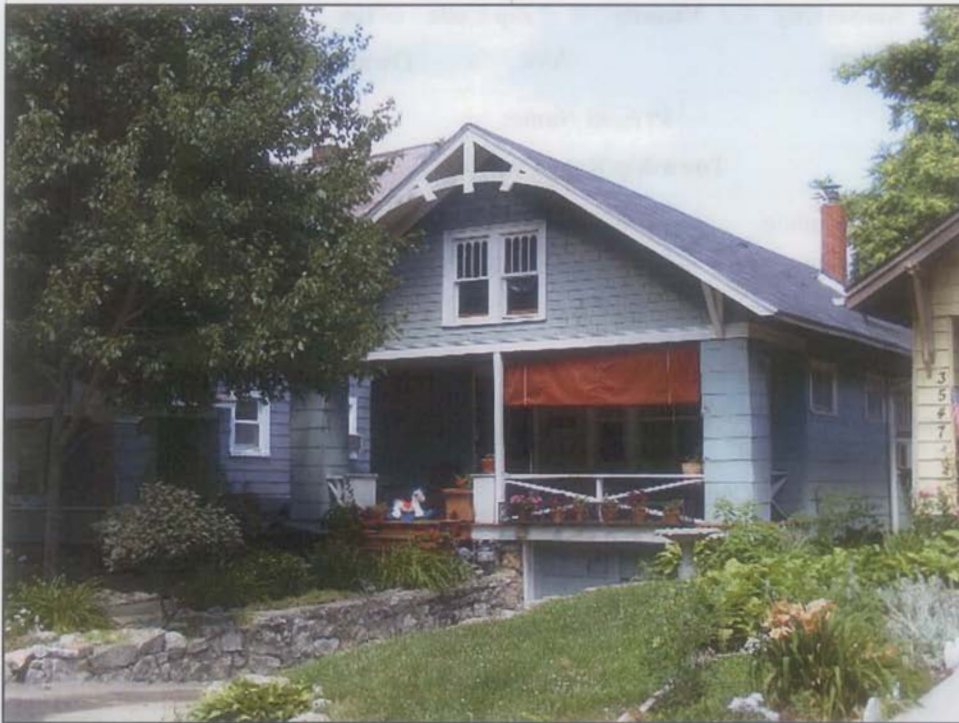
This craftsman bungalow has 4/1 double hung windows in the end gable. There is a basement garage with and entrance from the front (east) façade.

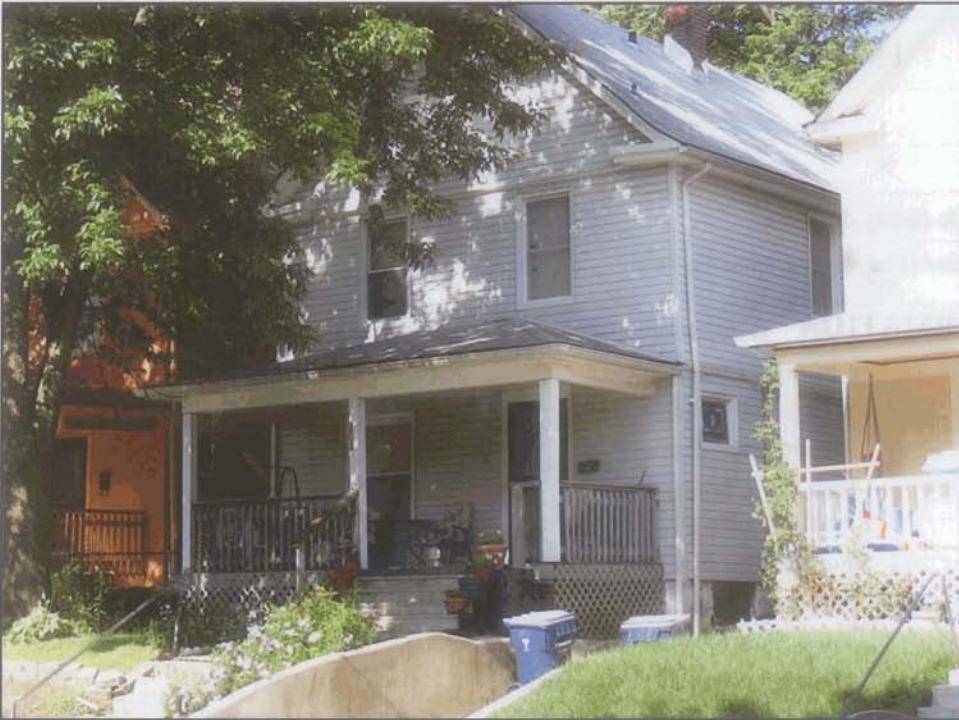
1/1 double hung vinyl windows, non original wood balustrade, fixed stained glass window on north façade first floor

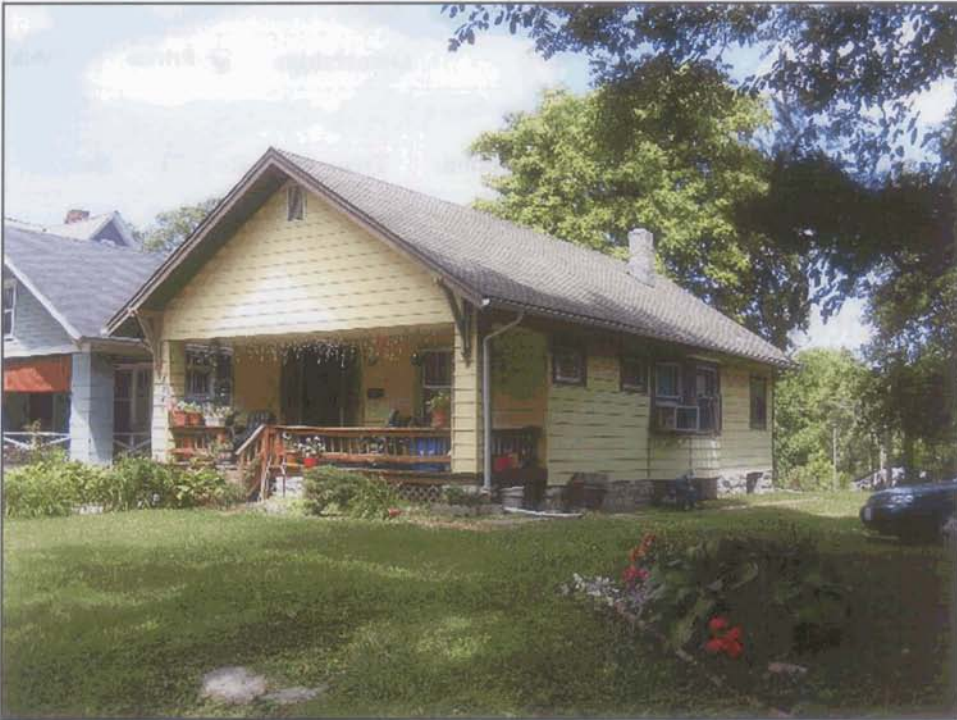
wood balustrade on the front porch is not original; there are 4/1 double hung windows on the front (west) façade. There are fixed six light windows on the south façade.

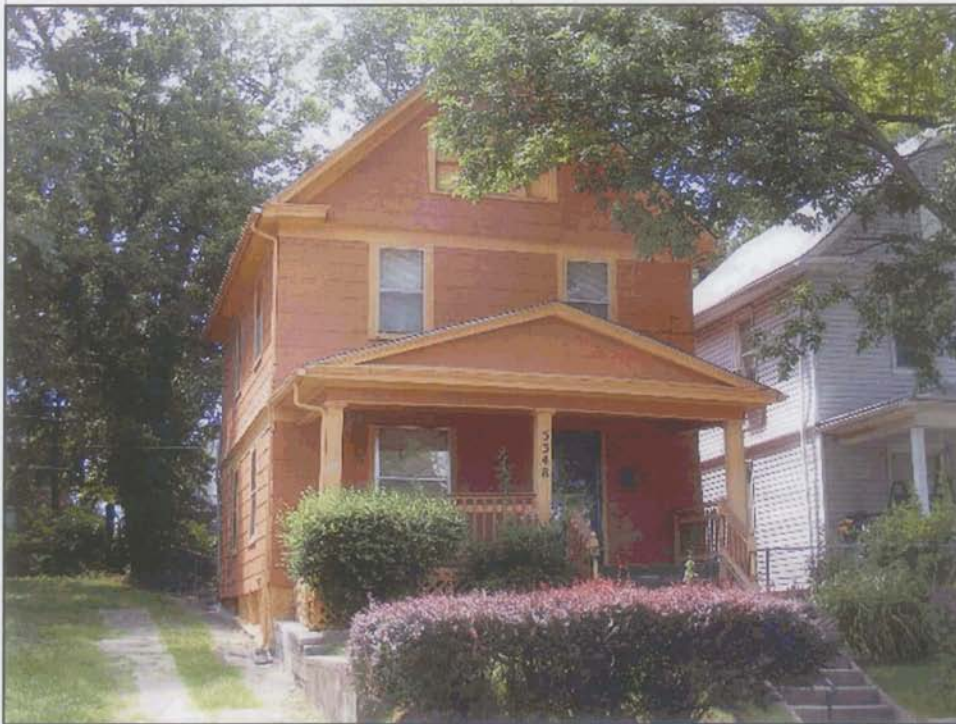
The house has 1/1 double hung windows, the porch balustrade is not original

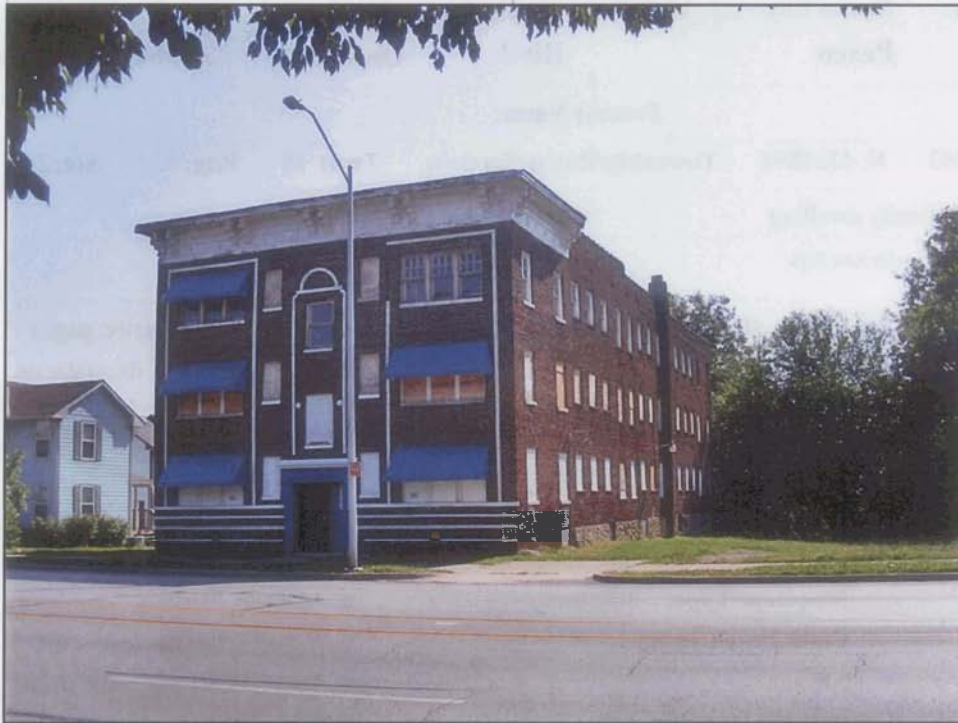
This vernacular brick apartment has a cornice on the front (west) elevation with paired brackets and dentils. The majority of the windows are boarded by the remaining are 6/1. There is a decorative limestone detail enframing the window bays on the front façade.

This is a common apartment building with many windows missing and would not be eligible for listing on the National Register.
