Habitat for Humanity Flora Survey
2009

JA-AS-045
Kansas City, Jackson County

ARCHITECTURAL/HISTORIC INVENTORY FORM

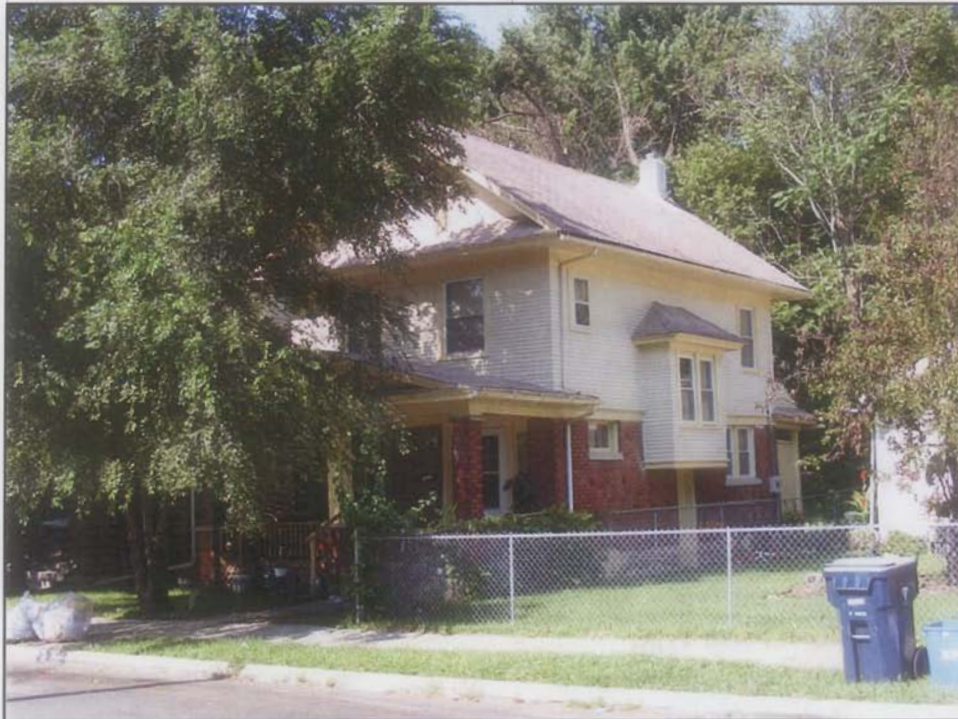
This American Foursquare has 1/1 windows, some vinyl and some wood. The front porch has brick posts surrounded by a wood balustrade. The porch roof is a pented gable. There is a bay window on the north façade and a one story wood porch on the rear.

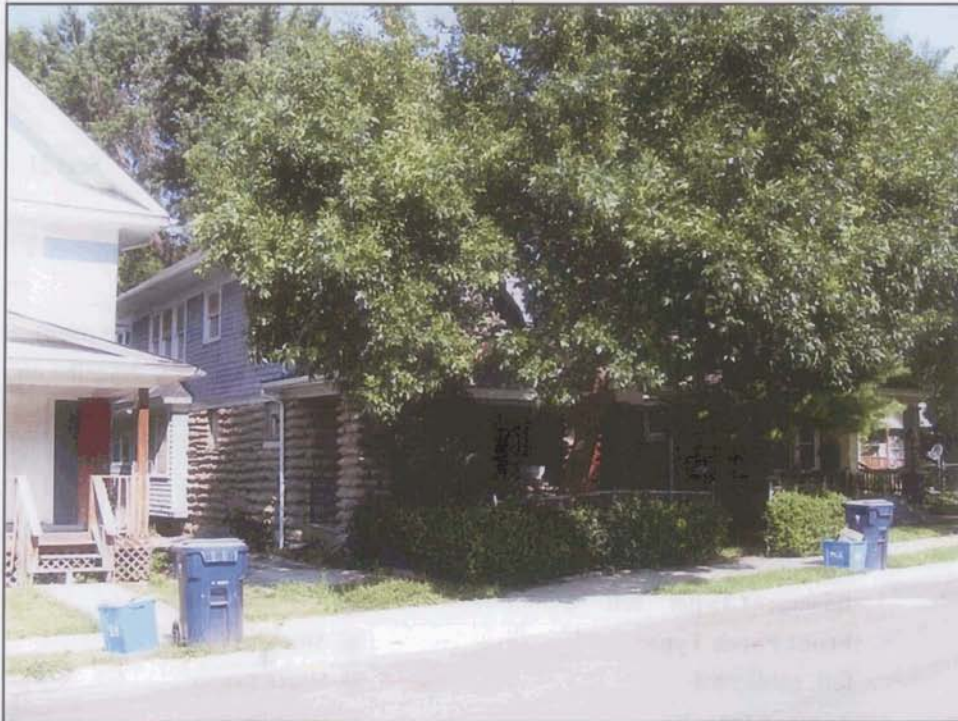
This American Foursquare has 1/1 windows, some vinyl and some wood. The front porch has limestone posts surrounded by a metal balustrade. The porch roof is a gable. There is a bay window on the south façade.

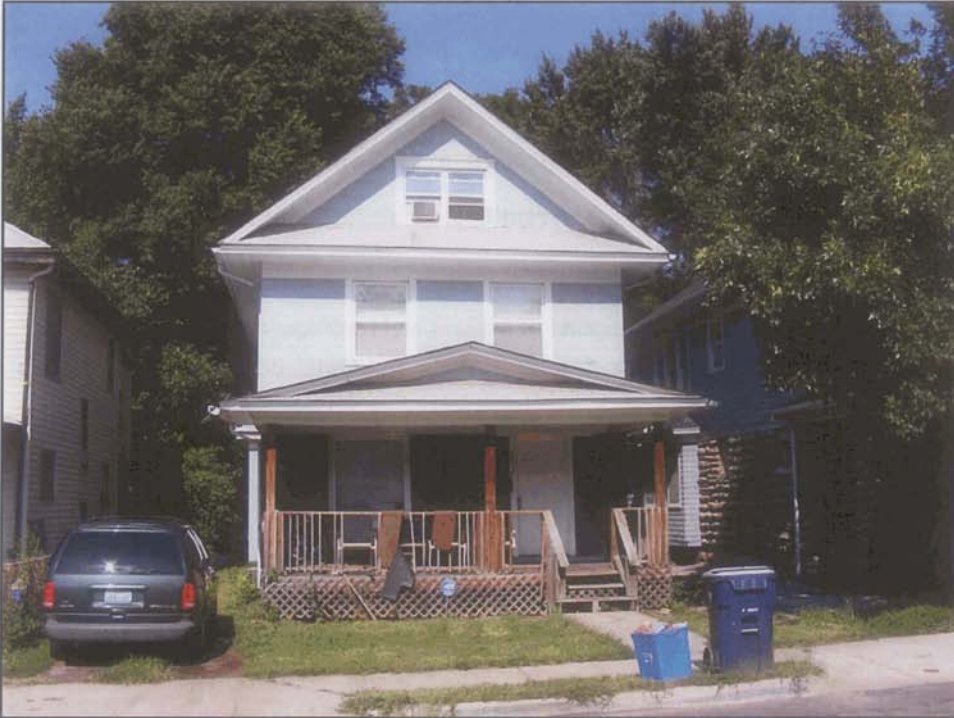
This American Foursquare has 1/1 windows, some vinyl and some wood. The front porch has wood posts surrounded by a wood balustrade. The porch roof is a pented gable.

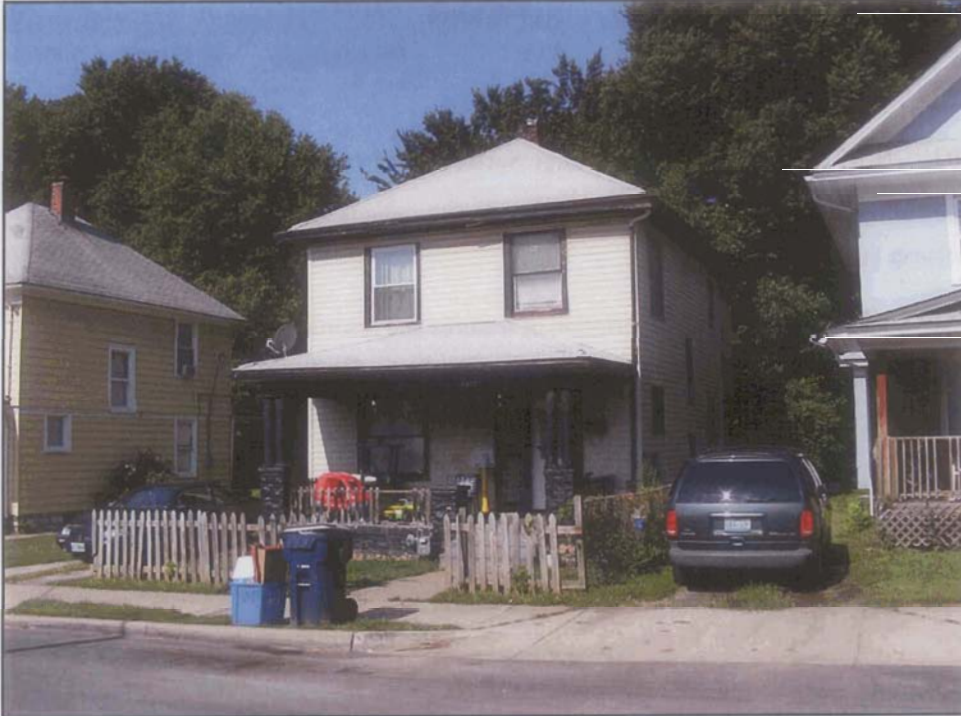
This American Foursquare has 1/1 wood double hung windows. The front porch has paired wood posts on brick bases surrounded by a wood balustrade.

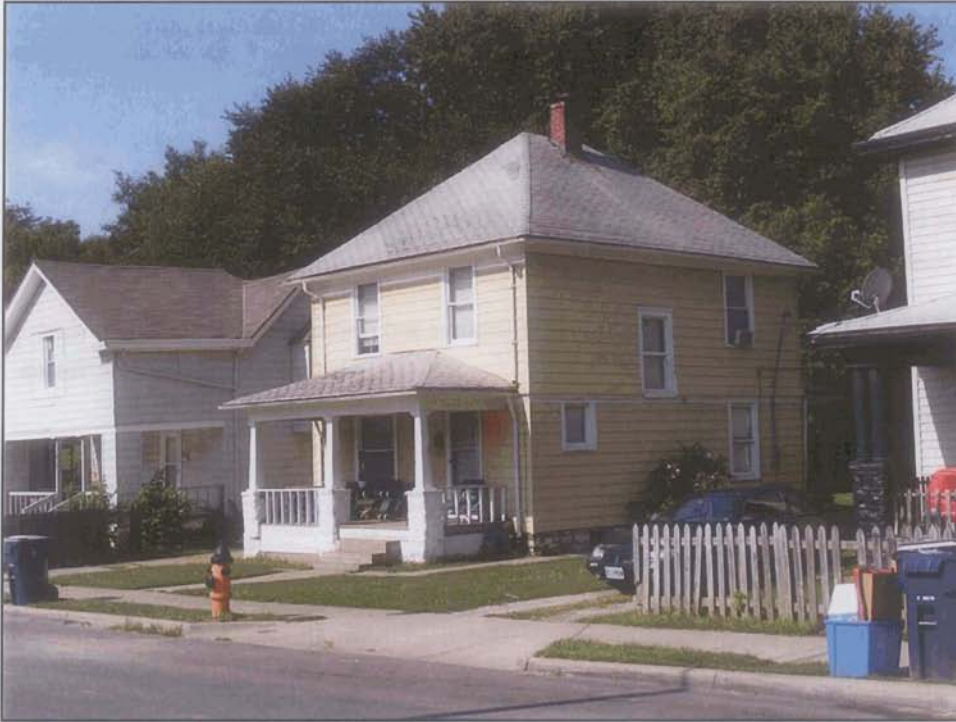
This American Foursquare has 1/1 wood double hung windows. The front porch has wood posts on limestone bases surrounded by a wood balustrade.
