**HISTORIC INVENTORY**

Presbyterian Church Tower Park  
100 E. Adams

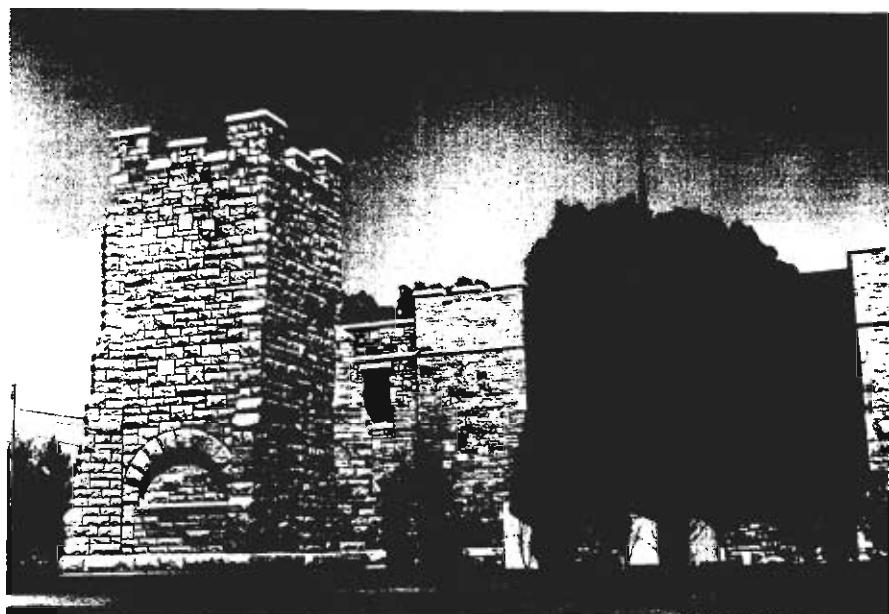
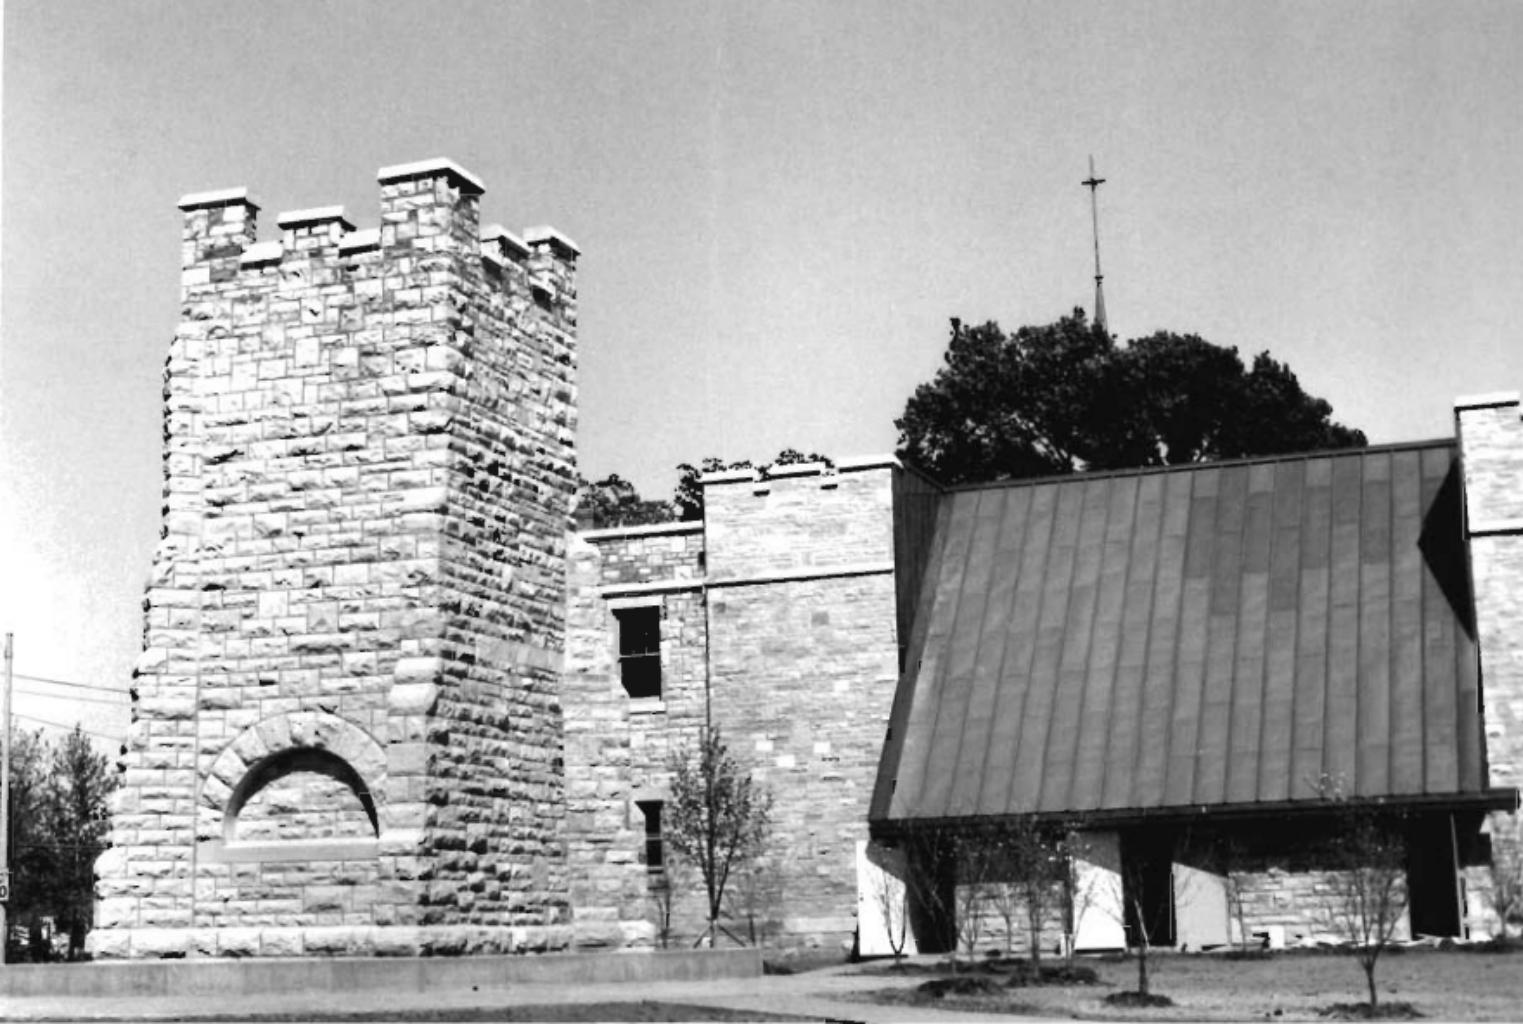
42. Further Description of Important Features This is a square limestone tower with buttresses at each corner. It was originally the entrance and the bellfry of the building built in 1889, and had a tall, wooden, steeple roof. The older part of the church was not being used and was torn down in 1980 and the tower was closed in on the east and south sides to become a free-standing monument. It had arched openings that are filled in with squared rock on the south and east sides and there is				
43 History and Significance The First Presbyterian Church of Kirkwood was established in 1854. It was the second protestant church in Kirkwood (the first was the Olive Chapel of the African Methodist Episcopal Church in 1853). Two ministers, E.T. Baird and Joseph Fenton, and an elder, Jonas Geyer, helped to found the church of seven members. The church met in the home of Henry Singleton on the southeast corner of Dickson and Adams and later in a log school

circle and is filled in with ivy and flood lights.

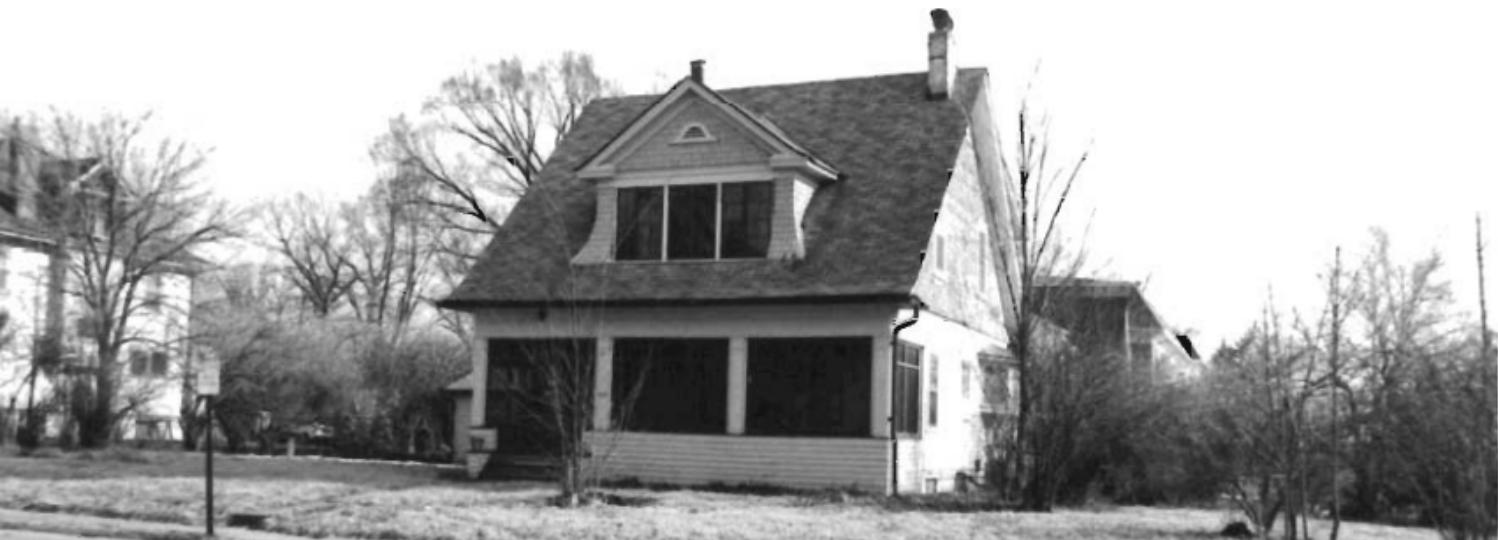
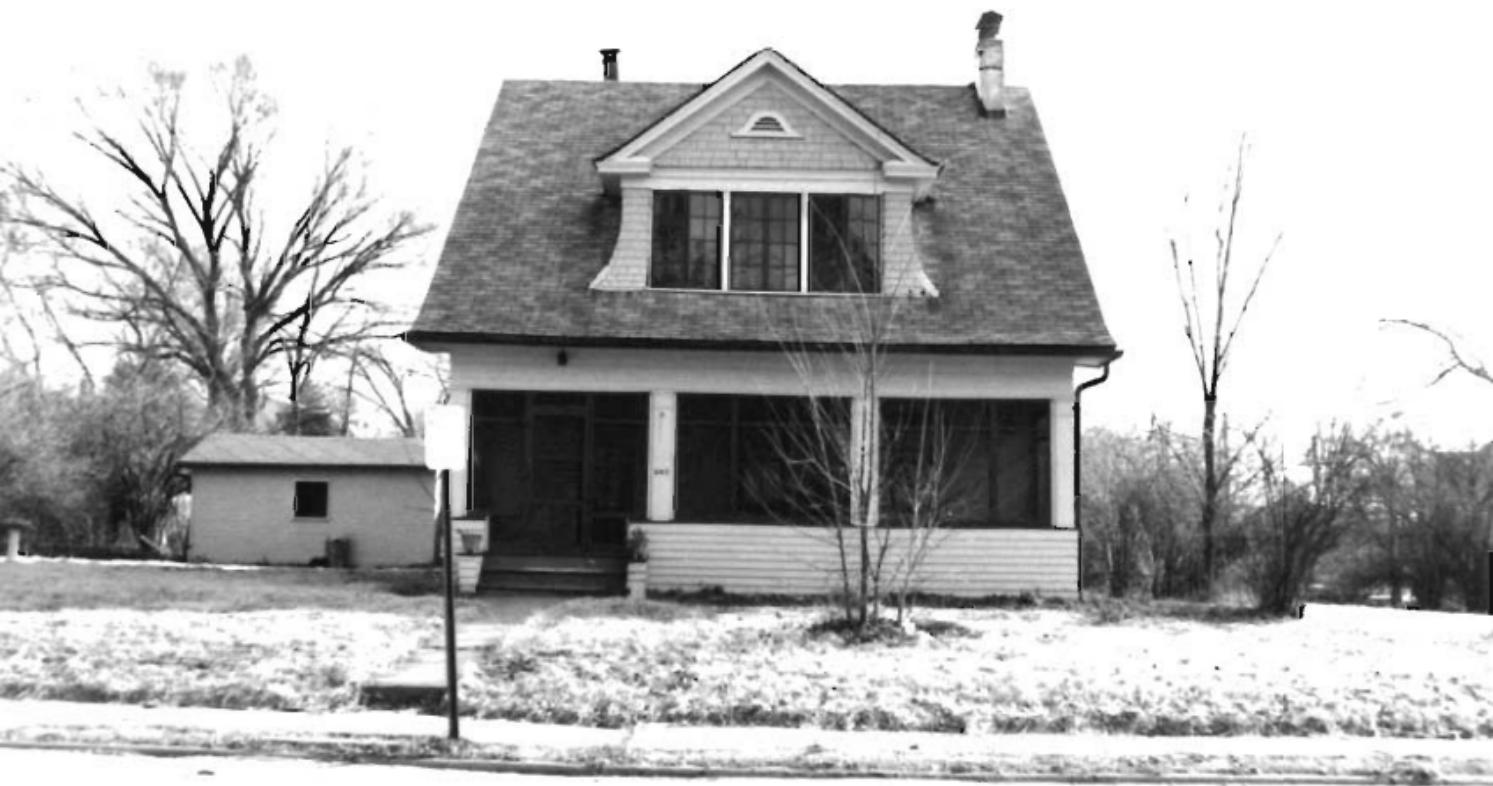
The prominent features of this building include: its sweeping bellcast gable which includes a screened-in facade porch within its confines; its overhanging eaves; its facade dormer which is gabled with returns; its wide shed dormer on its rear elevation; its oriel on its west elevation; and its stain-glass windows. The facade dormer has flared walls, an eyebrow ventilation opening within its gable and a triple wood window unit. These are two-leaf casement windows each containing eight lights. The unit has wood mullions, and is topped by a plain wood frieze that spans the dormer beneath the gable. The facade porch has sets of triple wood screens separated by stylized wood posts. The porch floor and stairs are wood. The entry is off-center toward the east and contains a single-leaf wood door with multi-lights. It is topped by a transom. The first level facade windows are wood with wood sash, double-hung, flat-topped, three over one, with wood sills, surrounds and entablatures. The roofline features a plain projecting boxed cornice. There is a one story frame addition at the rear of this building with a hipped roof.

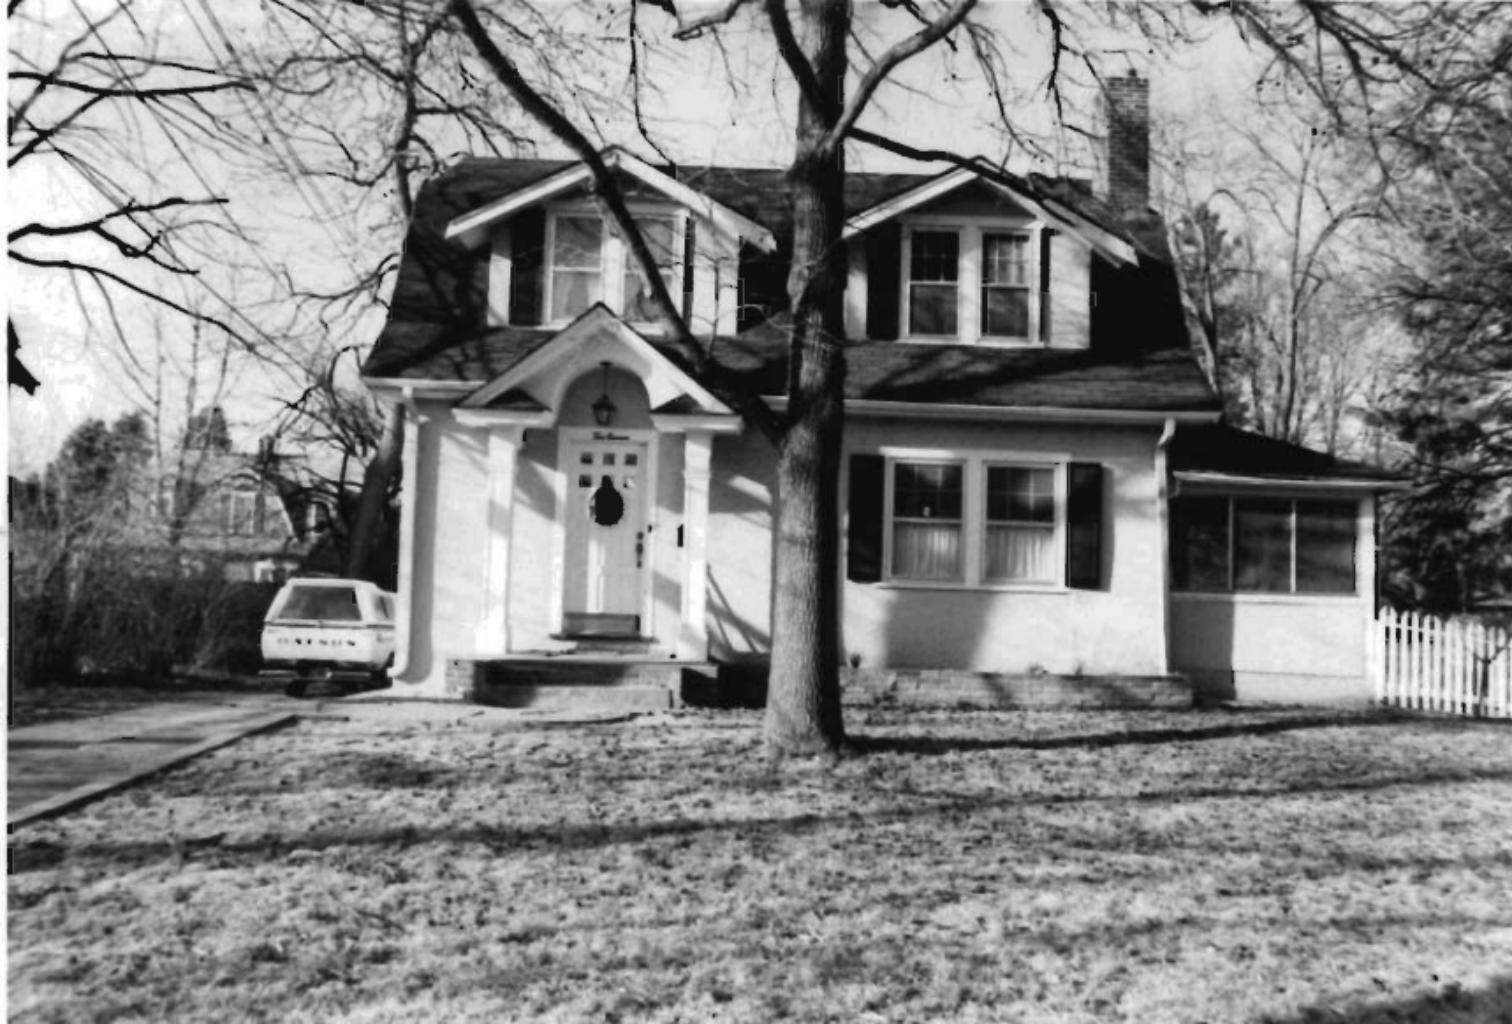
21. Original Use, if apparent single family residence	33. No. of Bays Front 3 Side 2	
	22. Present Use single family residence	34. Wall Treatment STUCCO	
9 Coordinates UTM Lat Long	23 Ownership Public II Private IX	35. Plan Shape irregular	
10 Site I I Building IX	24. Owner's Name & Address, if known	36. Changes (Explain in #42) Addition Altered Moved	
On National Register? Yes II No I I	12. Is It Eligible? Yes II No I I	37. Condition Interior Exterior good	
13 Part of Estab Hist Dist? Yes II No IX	14. District Potential? Yes IX No I I	38. Preservation Underway? Yes No X	
15 Name of Established District	25. Open to Public? Yes II No IX	39. Endangered? Yes II By What? No X	
42 Further Description of Important Features See attachment.	26. Local Contact Person or Organization	40. Visible from Public Road? Yes X No

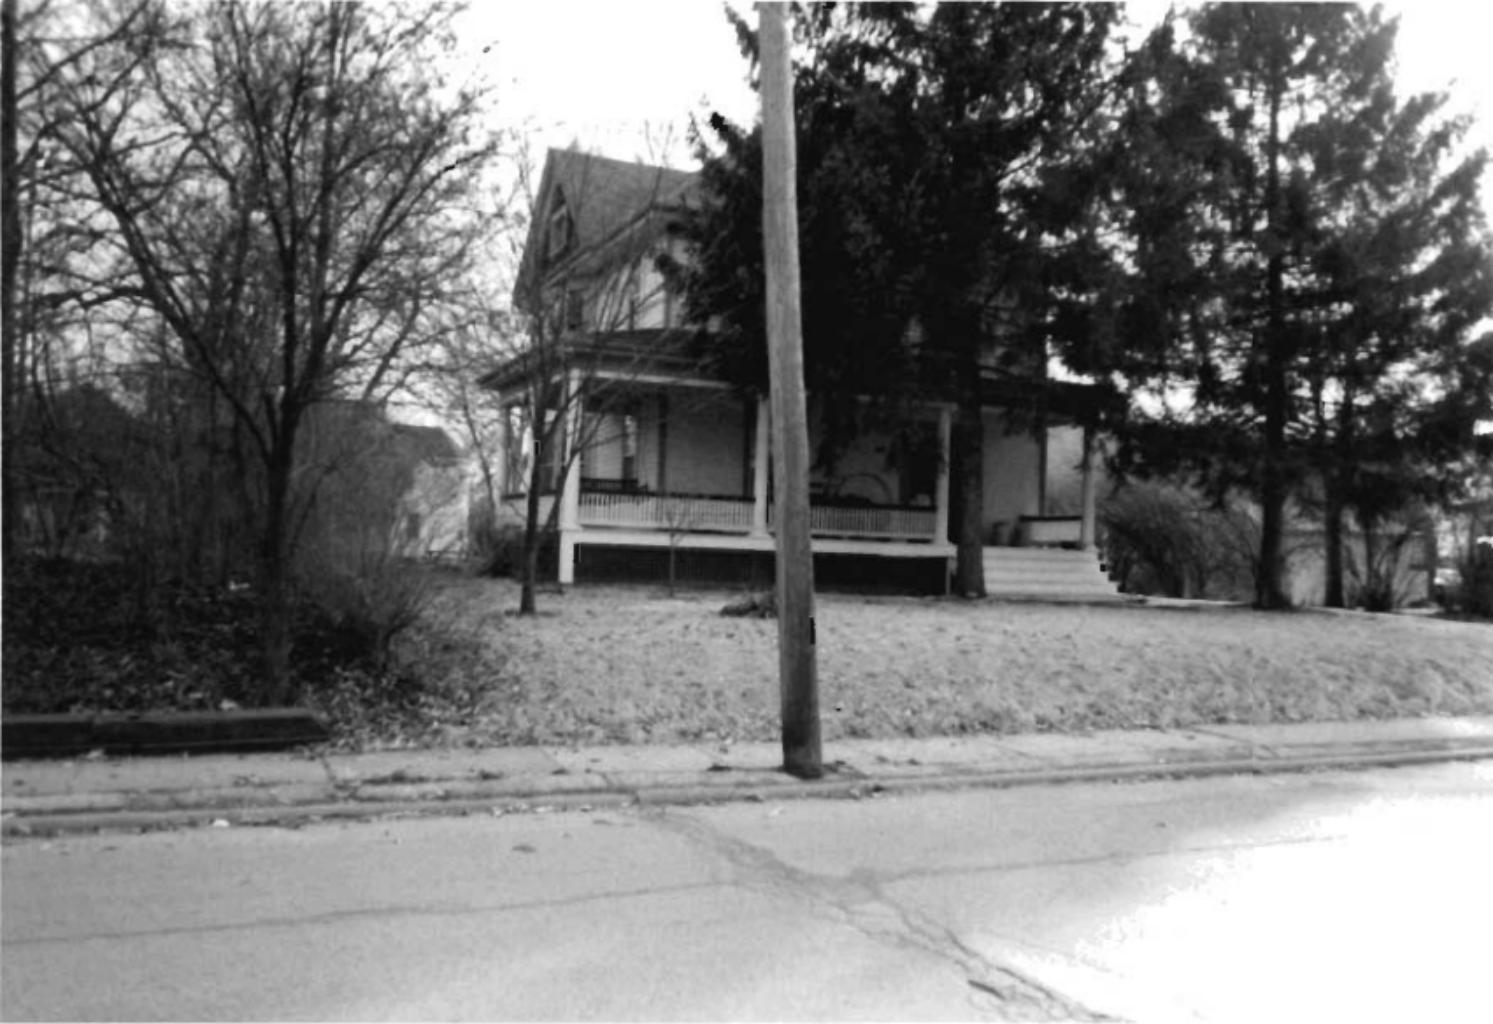
The prominent features of this building include: its two story box-like shape which is topped by a medium hipped roof; its window bay on the east elevation; its 1 1/2 story bracketed oriel on the west elevation; its triangular dormer on the east elevation; its pedimented dormers on the facade and west elevations; its stain-glass windows; and its open-frame wrap-around facade veranda. The veranda has a low hipped roof supported by wood doric columns. It has a plain wood balustrade and wood floor and stairs. The entry is off-center toward the west and contains a single-leaf wood door with a large pane of glass. It is covered by a wood screen door, and it is within wood framework that also contains one stain-glass side light (toward the west). A wood entablature spans the top of this framework. The facade windows are wood with wood sash, double-hung, one over one, flat-topped, with wood lugsills and surrounds. The first level facade window is topped by a wood entablature, and the second level facade windows are topped by a plain wood frieze which is beneath the roofline cornice. A decorative diamond-shaped panel is in place between the second level facade windows. The facade dormer windows are multi-paned wood casement windows, flat-topped, with wood molding and sills. This is a triple window set with wood mullions. The roofline features a plain projecting boxed cornice with a plain wood frieze beneath.

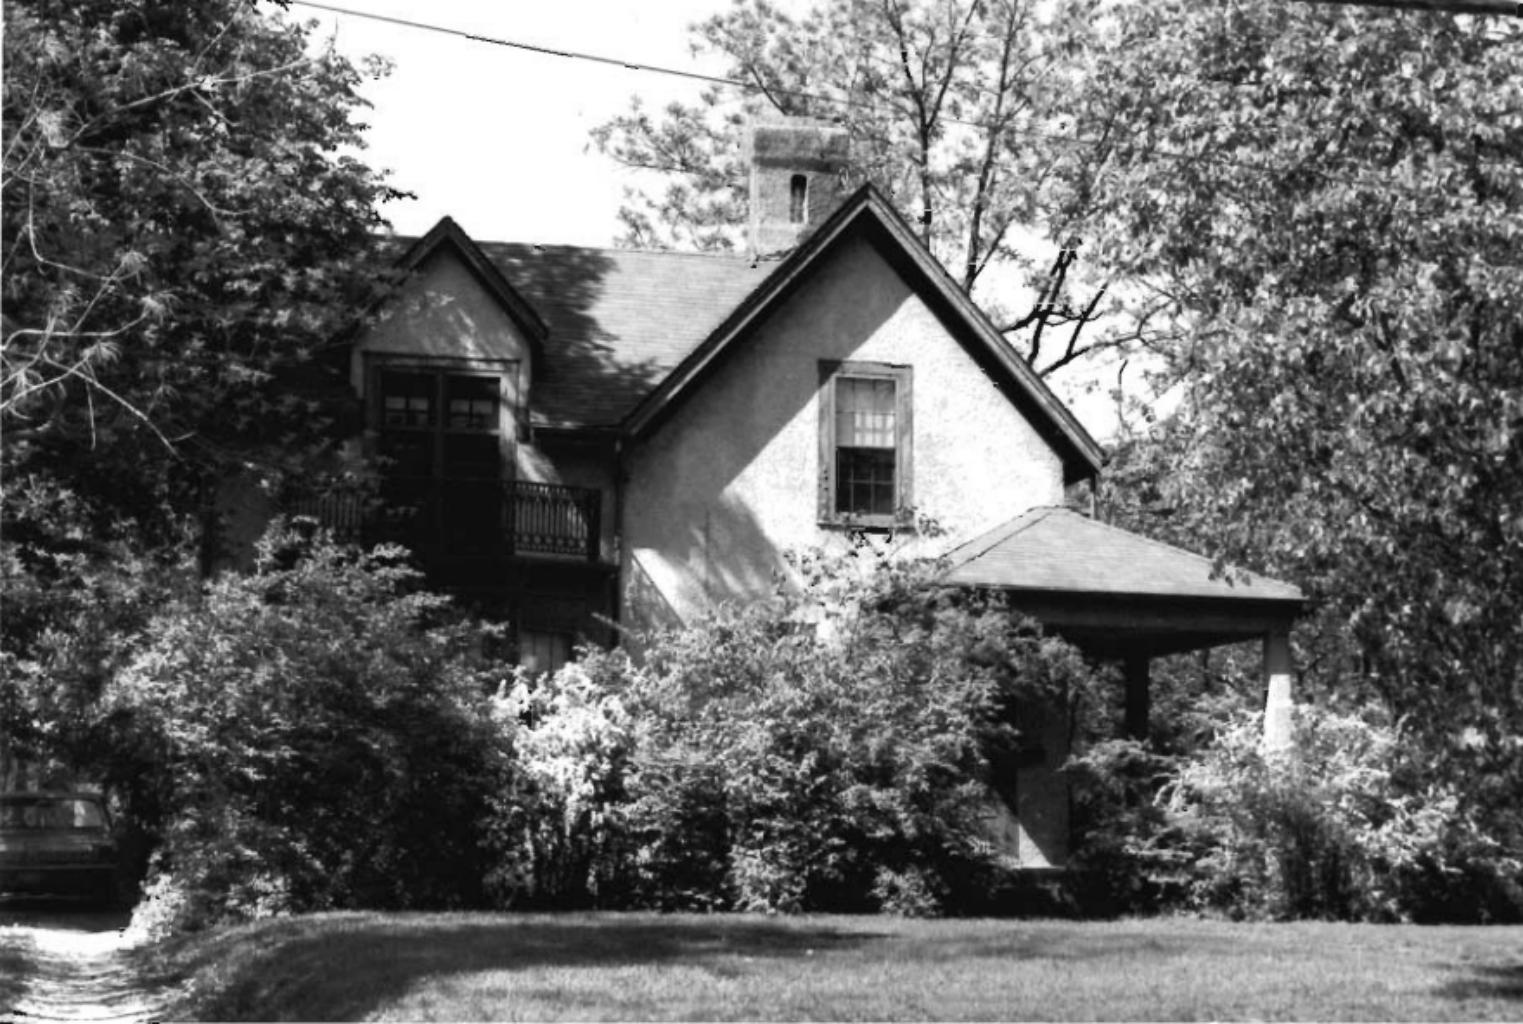
on the west-side of the front of the house, and the front door is on the east side of the front of the house. A small, square, one-story front porch with a hip roof shelters the front door and goes around the east side of the house for a short distance. The porch roof is supported by three plain, square, stucco posts. There is a wrought iron railing over the bay window and another forms a balcony in front of a second story window on the east side. There is a two-story sun room addition with a shed roof filling in the angle on the west side of the back. The east side of the back has the gable facing out and has a small, one-story room with a shed roof added on.

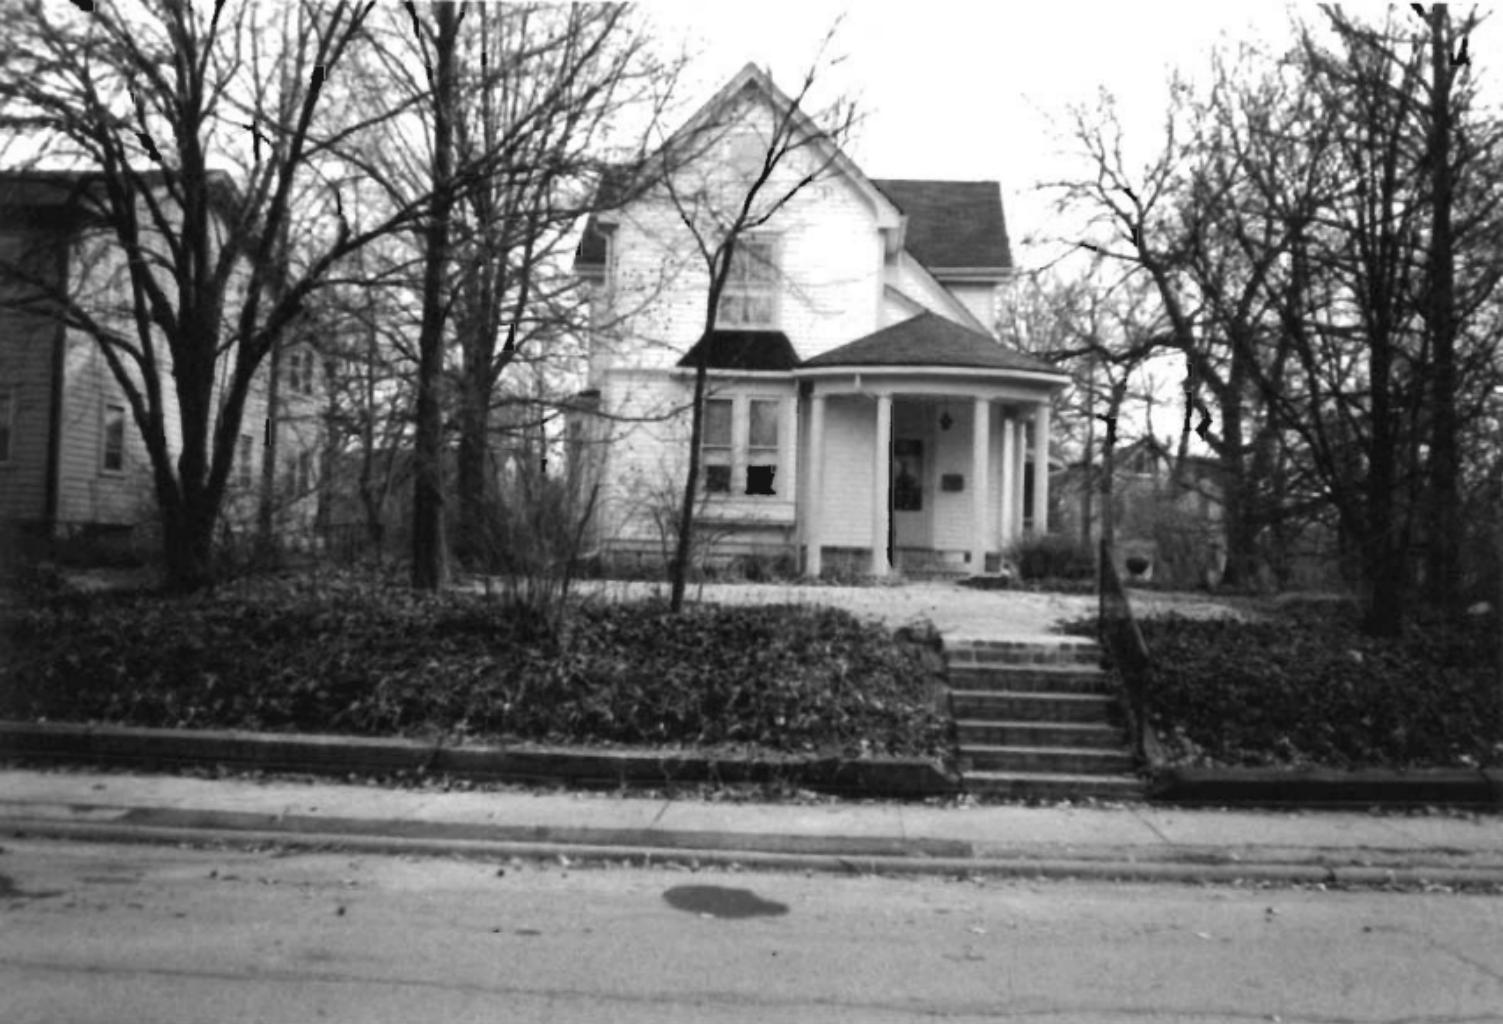
24. Owner's Name & Address, if known	36. Changes Addition X (Explain in #42) Altered Moved	
	25. Open to Public? Yes <input checked="" type="checkbox"/> No X	37. Condition Interior Exterior good

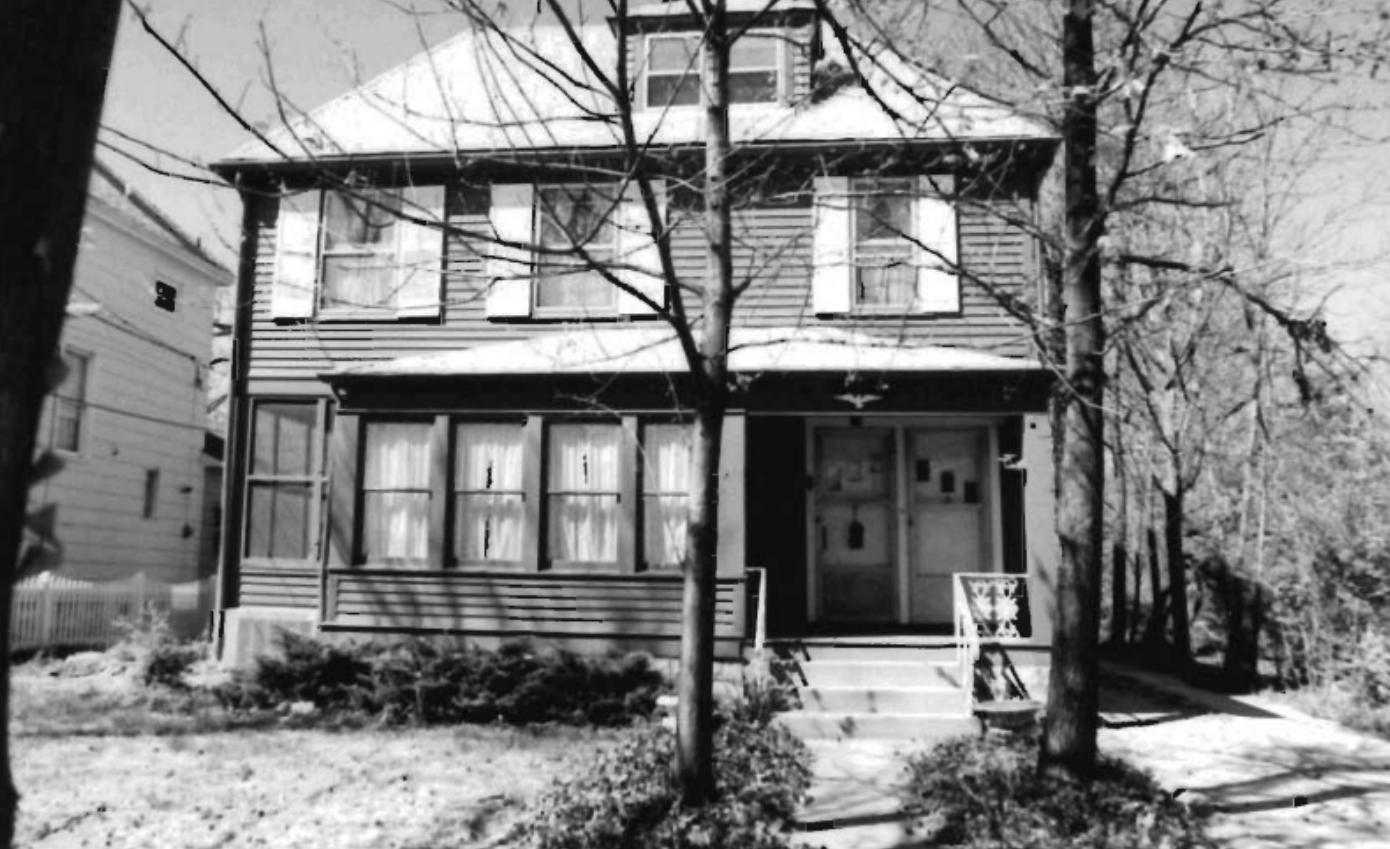
1 NO. 2094 LOCAL #	4 PRESENT NAME(S)	
2 COUNTY ST. LOUIS	5 OTHER NAME(S) LINDA STOCKMAN	
3 LOCATION OF NEGATIVES		
6 SPECIFIC LOCATION 241 N. ADAMS	10 THEMATIC CATEGORY	23 NO OF STORIES 02.5
7 CITY OR TOWN KIRKWOOD MO	17 DATE(S) OR PERIOD CA 1905	29 BASEMENT (Y/N) Y FULL (Y/N) Y
8 SITE PLAN WITH NORTH ARROW SEE MAP	18 STYLE OR DESIGN ECLECTIC AMERICAN FOUR SQUARE	30 FOUNDATION MATERIAL STONE
	19 ARCHITECT OR ENGINEER	31 WALL CONSTRUCTION FRAME
	20 CONTRACTOR OR BUILDER	32 ROOF TYPE & MATERIAL HIP WITH GABLET ASPHALT SHINGLES
	21 ORIGINAL USE, IF APPARENT	33 NO. OF BAYS FRONT 3 SIDE 5
	22 PRESENT USE	34 WALL TREATMENT WOOD HORIZONTAL LAP SIDING
		35 PLAN SHAPE IRREGULAR
9 COORDINATES LOT LANG	23 OWNERSHIP PUBLIC PRIVATE X	36 CHANGES IN ADDITION X (EXPLAIN IN #42) ALTERED MOVED
	24 OWNER'S NAME & ADDRESS (IF KNOWN) SYLVIA Ressel	37 CONDITION INTERIOR EXTERIOR GOOD
	25 OPEN TO PUBLIC (YES/NO) N	38 PRESERVATION UNDERWAY? (Y/N) N

10 SITE STRUCTURE BUILDING X OBJECT	26 LOCAL CONTACT PERSON OR ORGANIZATION	39 ENDANGERED (YES/NO) N BY WHAT?
11 ON NAT'L REG? (YES/NO) N	12 IS IT ELIGIBLE? (YES/NO) (YES/NC) Y	40 VISIBLE FROM PUBLIC ROAD? (YES/NO) Y
13 PART OF HIST DIST (YES/NO) N	14 DIST POTENT (YES/NC) Y	41 DISTANCE FROM AND FRONTAGE ON ROAD
15 NAME OF ESTABLISHED DISTRICT	27 OTHER SURVEYS IN WHICH INCLUDED	PHOTO
42 FURTHER DESCRIPTION OF IMPORTANT FEATURES SEE CONTINUATION SHEET		46 PREPARED BY LINDA STOCKMAN
43 HISTORY AND SIGNIFICANCE SEE CONTINUATION SHEET		47 ORGANIZATION KIRKWOOD LANDM COMM.
44 DESCRIPTION OF ENVIRONMENT AND OUTBUILDINGS SEE CONTINUATION SHEET		48 DATE 06/86
45 SOURCES OF INFORMATION SEE CONTINUATION SHEET		49 REVISION DATE(S)

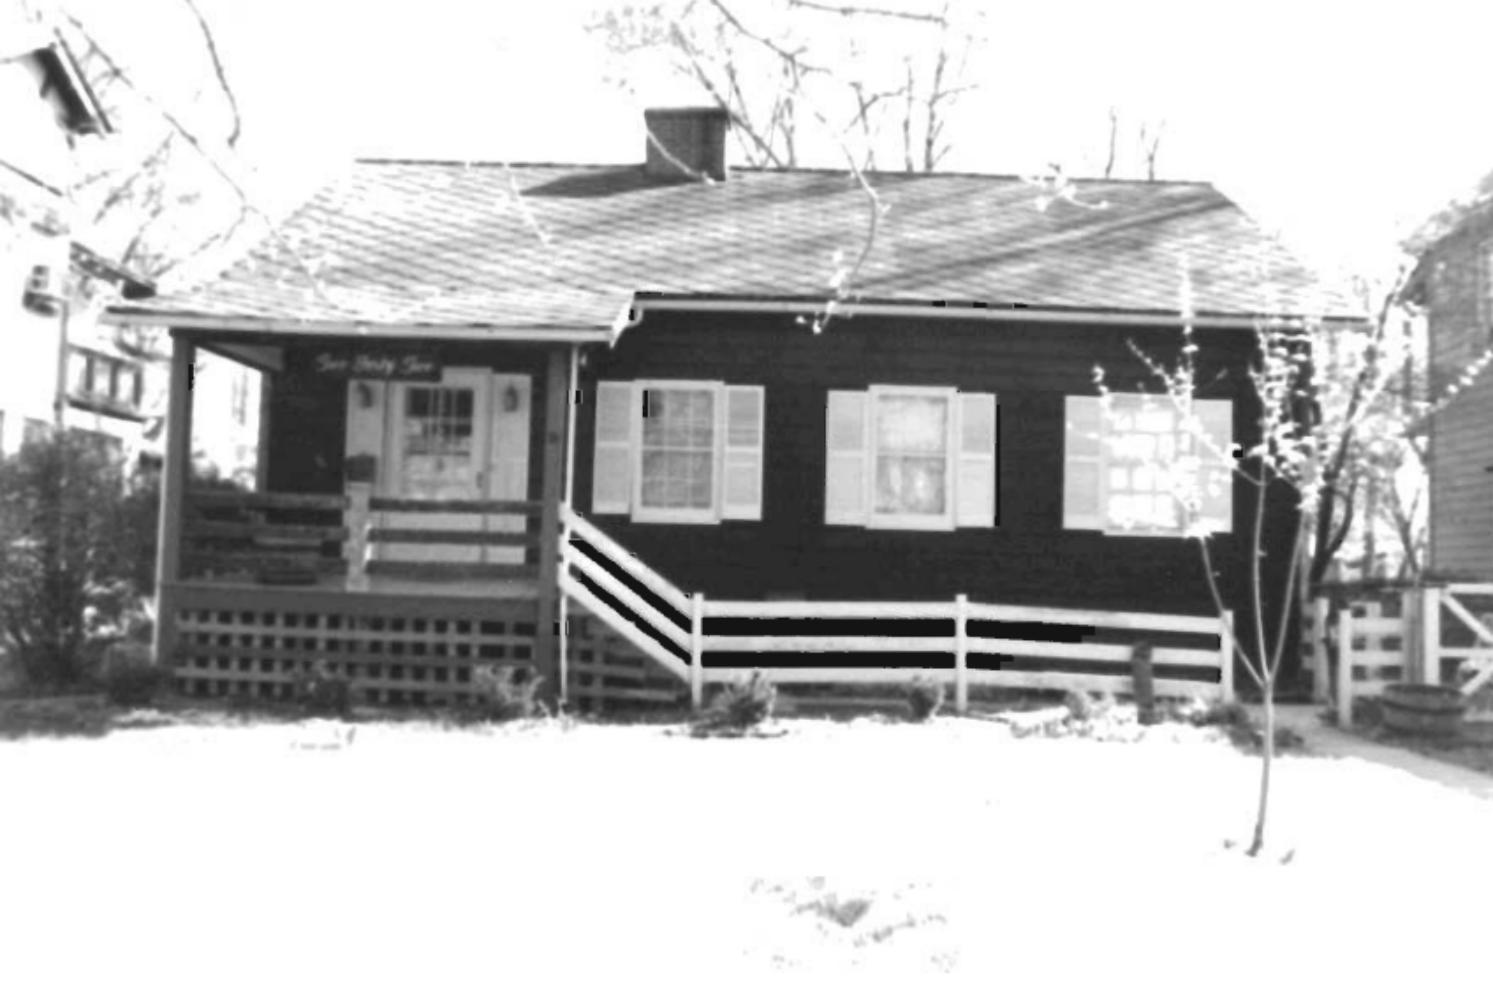
1 NO 2136 LOCAL #	4 PRESENT NAME(S)	
2 COUNTY		
3 LOCATION OF NEGATIVES ST. LOUIS LINDA STOCKMAN	5 OTHER NAME(S)	
6 SPECIFIC LOCATION 242 N. ADAMS	16 THEMATIC CATEGORY	26 NO OF STORIES 01.5
7 CITY OR TOWN KIRKWOOD, MO	17 DATE(S) OR PERIOD CA 1907	29 BASEMENT (Y/N) Y FULL (Y/N) Y
8 SITE PLAN WITH NORTH ARROW SEE MAP	18 STYLE OR DESIGN VERNACULAR	30 FOUNDATION MATERIAL CONCRETE
	19 ARCHITECT OR ENGINEER	31 WALL CONSTRUCTION FRAME
	20 CONTRACTOR OR BUILDER	32 ROOF TYPE & MATERIAL SIDE GABLE COMPOSITION SHINGLES
	21 ORIGINAL USE, IF APPARENT SINGLE FAMILY RESIDENCE	33 NO. OF BAYS FRONT 4 SIDE 2
	22 PRESENT USE SINGLE FAMILY RESIDENCE	34 WALL TREATMENT WOOD HORIZONTAL LAP SIDING
9 COORDINATES LOT LANG		35 PLAN SHAPE IRREGULAR
10 SITE STRUCTURE BUILDING X OBJECT	23 OWNERSHIP PUBLIC PRIVATE X	36 CHANGES ADDITION (EXPLAIN IN #42) ALTERED X MOVED
11 ON NAT'L REG? (YES/NO) N	12 IS IT ELIGIBLE? (YES/NO)	37 CONDITION INTERIOR EXTERIOR GOOD

13 PART OF HIST DIST (YES/NO) N	14 DIST POTENT (YES/NO) Y	38 PRESERVATION UNDERWAY? (Y/N) N
15 NAME OF ESTABLISHED DISTRICT	25 OPEN TO PUBLIC (YES/NO) N	39 ENDANGERED (YES/NO) N BY WHAT?
42 FURTHER DESCRIPTION OF IMPORTANT FEATURES SEE CONTINUATION SHEET	26 LOCAL CONTACT PERSON OR ORGANIZATION	40 VISIBLE FROM PUBLIC ROAD? (YES/NO) Y
43 HISTORY AND SIGNIFICANCE SEE CONTINUATION SHEET	27 OTHER SURVEYS IN WHICH INCLUDED	41 DISTANCE FROM AND FRONTAGE ON ROAD
44 DESCRIPTION OF ENVIRONMENT AND OUTBUILDINGS SEE CONTINUATION SHEET		42 ATTACHED PHOTOS
45 SOURCES OF INFORMATION SEE CONTINUATION SHEET		46 PREPARED BY LINDA STOCKMAN
		47 ORGANIZATION KIRKWOOD LANDM COMM.
		48 DATE 06/86 49 REVISION DATE(S)

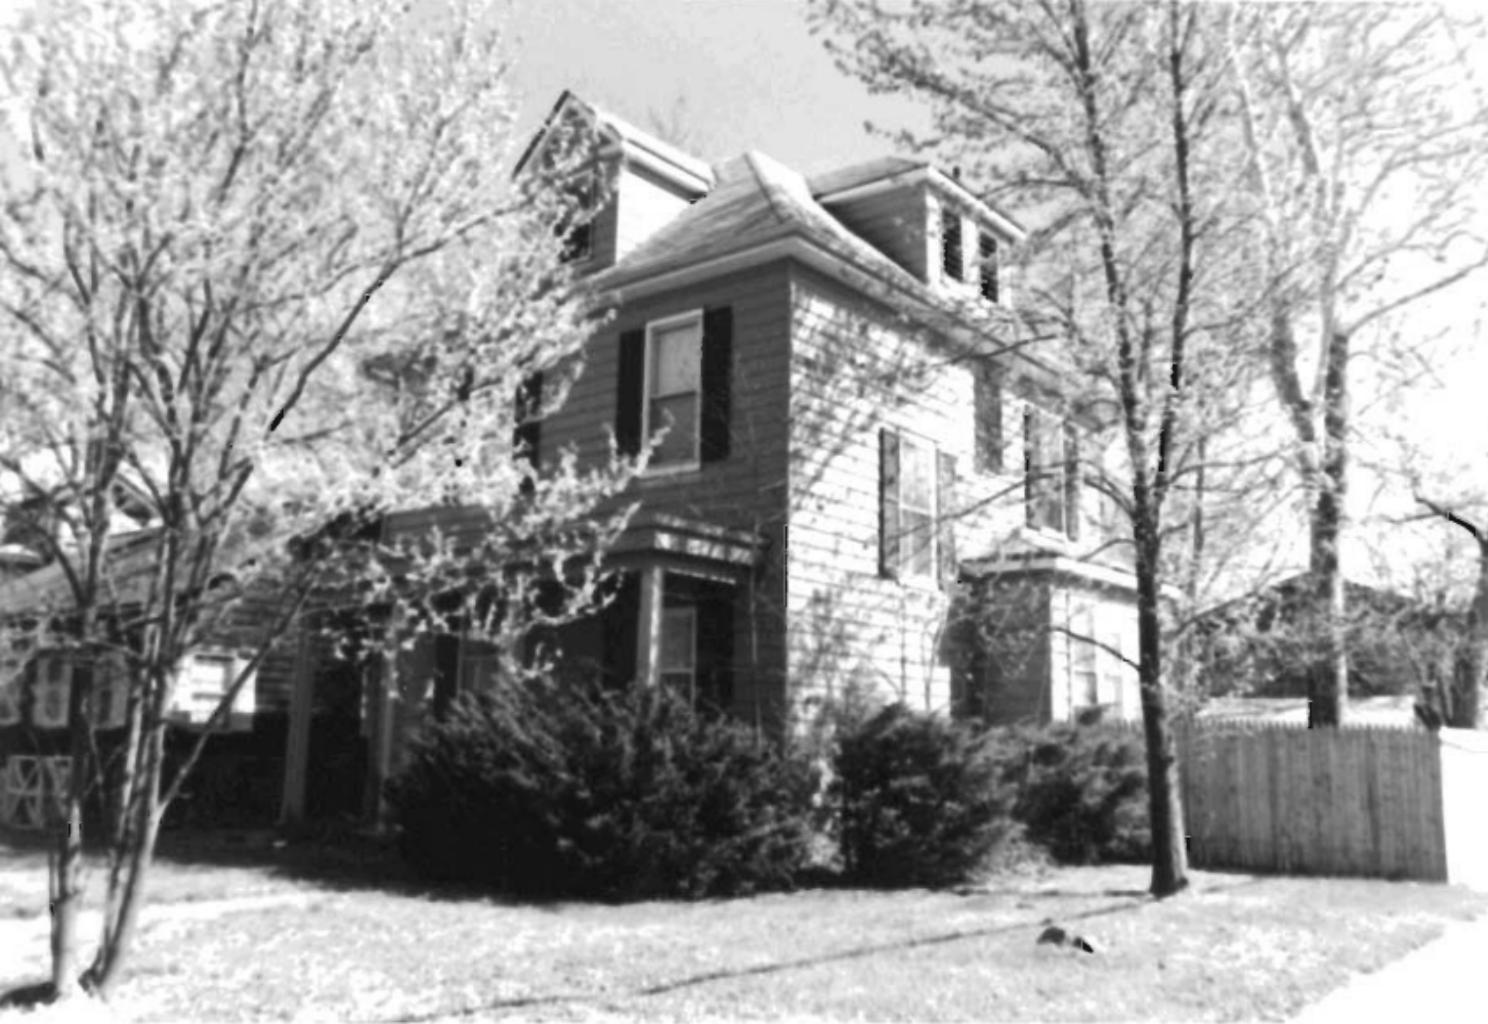
1 NC 6133 LOCAL #	4 PRESENT NAME(S)		
2 COUNTY ST. LOUIS	5 OTHER NAME(S) LINDA STOCKMAN		
6 SPECIFIC LOCATION 244 W. ADAMS	10 THEMATIC CATEGORY	26 NO OF STORIES 02.6	
7 CITY CR TOWN KIRKWOOD, MO	17 DATE(S) OR PERIOD CA 1905	29 BASEMENT (Y/N) Y FULL (Y/N) Y	
8 SITE PLAN WITH NORTH APROW SEE MAP	18 STYLE OR DESIGN AMERICAN FOUR SQUARE	30 FOUNDATION MATERIAL STONE	
	19 ARCHITECT OR ENGINEER	31 WALL CONSTRUCTION FRAME	
	20 CONTRACTOR OR BUILDER	32 ROOF TYPE & MATERIAL HIP ASPHALT SHINGLES	
	21 ORIGINAL USE, IF APPARENT SINGLE FAMILY RESIDENCE	33 NO. OF BAYS FRONT 2 SIDE 4	
	22 PRESENT USE SINGLE FAMILY RESIDENCE	34 WALL TREATMENT ALUMINUM SIDING	
		35 PLAN SHAPE SQUARE	
9 COORDINATES LOT LANG	23 OWNERSHIP PUBLIC PRIVATE X	36 CHANGES ADDITION (EXPLAIN ALTERED X IN #42) MOVED X	
10 SITE STRUCTURE BUILDING X OBJECT	24 OWNER'S NAME & ADDRESS (IF KNOWN)	37 CONDITION INTERIOR EXTERIOR GPPD	
11 ON NAT'L REG? (YES/NO) N	25 OPEN TO PUBLIC (YES/NO) N	38 PRESERVATION UNDERWAY? (Y/N) N

12 IS IT ELIGIBLE? (YES/NO)	26 LOCAL CONTACT PERSON OR ORGANIZATION	39 ENDANGERED (YES/NO) N BY WHAT?	
13 PART OF HIST DIST (YES/NO) N	14 DIST POTENT (YES/NO) Y	40 VISIBLE FROM PUBLIC ROAD? (YES/NO) Y	
15 NAME OF ESTABLISHED DISTRICT	27 OTHER SURVEYS IN WHICH INCLUDED	41 DISTANCE FROM AND FRONTAGE ON ROAD	
42 FURTHER DESCRIPTION OF IMPORTANT FEATURES SEE CONTINUATION SHEET		42 PHOTO	
43 HISTORY AND SIGNIFICANCE SEE CONTINUATION SHEET		46 PREPARED BY LINDA STOCKMAN	
44 DESCRIPTION OF ENVIRONMENT AND OUTBUILDINGS SEE CONTINUATION SHEET		47 ORGANIZATION KIRKWOOD LANDM COMM.	
45 SOURCES OF INFORMATION SEE CONTINUATION SHEET		48 DATE 06/86	49 REVISION DATE(S)

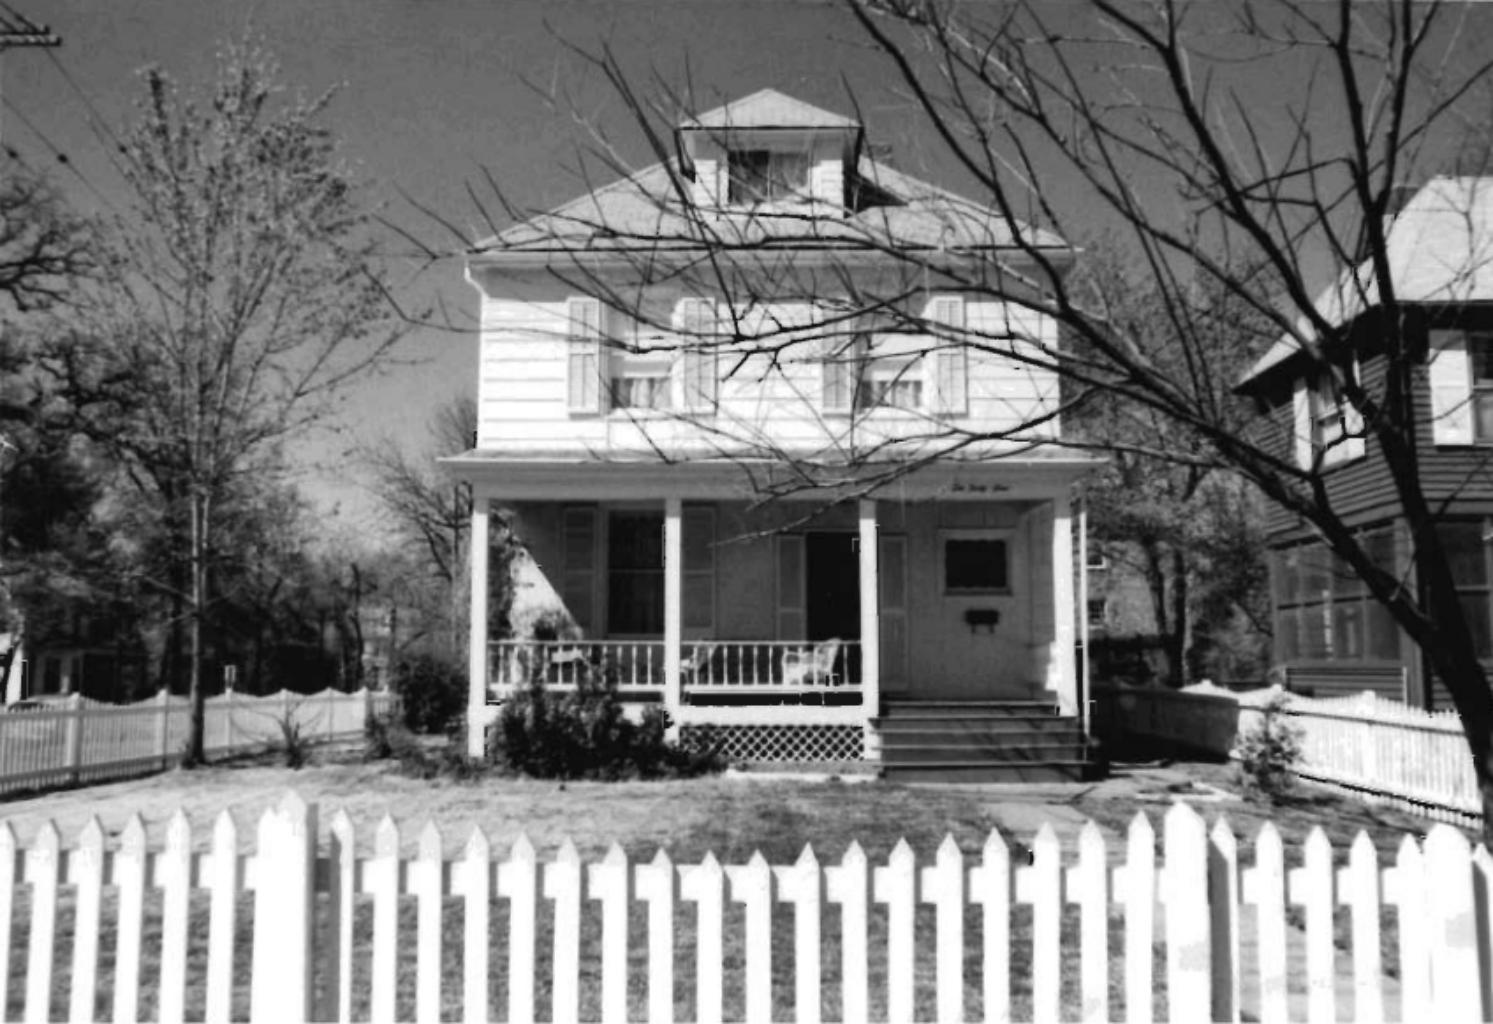
1 NO. 2095 LOCAL F 2 COUNTY ST. LOUIS	4 PRESENT NAME(S) 5 OTHER NAME(S)	
3. LOCATION OF NEGATIVES LINDA STOCKMAN		
6 SPECIFIC LOCATION 245 W. ADAMS	15 THEMATIC CATEGORY 17 DATE(S) OR PERIOD ca 1905	26 NO OF STORIES 2 2.5 29 BASEMENT (Y/N) Y FULL (Y/N) Y
7 CITY OR TOWN KIRKWOOD MO	18 STYLE OR DESIGN ECLECTIC AMERICAN FOUR SQUARE	30 FOUNDATION MATERIAL STONE/CONCRETE
8 SITE PLAN WITH NORTH ARROW SEE MAP	19 ARCHITECT OR ENGINEER 20 CONTRACTOR OR BUILDER	31 WALL CONSTRUCTION FRAME 32 ROOF TYPE & MATERIAL HIP WITH SECONDARY GABLE ASPHALT SHINGLES
	21 ORIGINAL USE, IF APPARENT SINGLE FAMILY RESIDENCE 22 PRESENT USE SINGLE FAMILY RESIDENCE	33 NO. OF BAYS FRONT 2 SIDE 3 34 WALL TREATMENT WIDE MASONITE LAP SIDING
	23 OWNERSHIP PUBLIC PRIVATE X	35 PLAN SHAPE IRREGULAR
9 COORDINATES LOT LANG	24 OWNER'S NAME & ADDRESS (IF KNOWN)	36 CHANGES IN ADDITION X (EXPLAIN ALTERED IN #42) MOVED
	25 OPEN TO PUBLIC (YES/NO) N	37 CONDITION INTERIOR EXTERIOR GOOD

10 SITE STRUCTURE BUILDING X OBJECT	26 LOCAL CONTACT PERSON OR ORGANIZATION 27 OTHER SURVEYS IN WHICH INCLUDED	38 PRESERVATION UNDERWAY? (Y/N) N
11 ON NAT'L REG? (YES/NO) N 12 IS IT ELIGIBLE? (YES/NO)		39 ENDANGERED (YES/NO) N BY WHAT?
13 PART OF HIST DIST (YES/NO) N 14 DIST POTENT (YES/NO) Y		40 VISIBLE FROM PUBLIC ROAD? (YES/NO) Y
15 NAME OF ESTABLISHED DISTRICT		41 DISTANCE FROM AND FRONTAGE ON ROAD
42 FURTHER DESCRIPTION OF IMPORTANT FEATURES SEE CONTINUATION SHEET		PHOTO
43 HISTORY AND SIGNIFICANCE SEE CONTINUATION SHEET		46 PREPARED BY LINDA STOCKMAN
44 DESCRIPTION OF ENVIRONMENT AND OUTBUILDINGS SEE CONTINUATION SHEET		47 ORGANIZATION KIRKWOOD LANDM. COMM.
45 SOURCES OF INFORMATION SEE CONTINUATION SHEET		48 DATE 06/86 49 REVISION DATE(S)

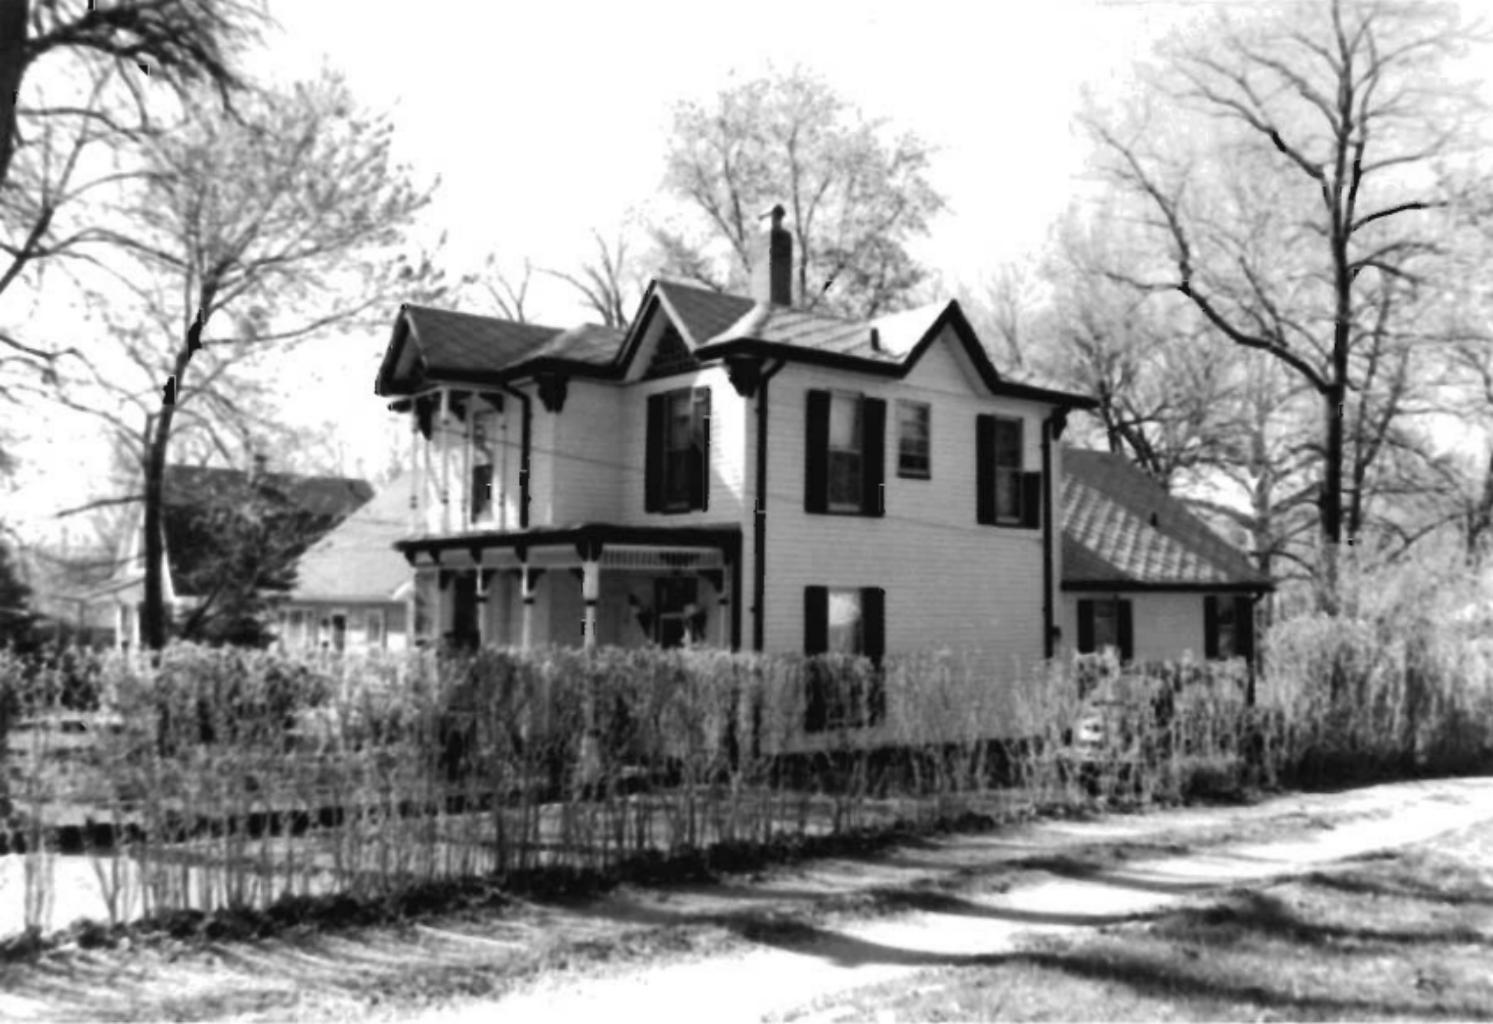
1 NO 2067 LOCAL #	4 PRESENT NAME(S)	
2 COUNTY ST. LOUIS	5 OTHER NAME(S) LINDA STOCKMAN	
3 LOCATION OF NEGATIVES		
6 SPECIFIC LOCATION 315 W. ADAMS	16 THEMATIC CATEGORY	28 NO OF STORIES 02.0
7 CITY OR TOWN KIRKWOOD, MO	17 DATE(S) OR PERIOD CA 1905	29 BASEMENT (Y/N) ? FULL (Y/N)
8 SITE PLAN WITH NORTH ARROW  SEE MAP	18 STYLE OR DESIGN VICTORIAN QUEEN ANNE	30 FOUNDATION MATERIAL STONE
	19 ARCHITECT OR ENGINEER	31 WALL CONSTRUCTION FRAME
	20 CONTRACTOR OR BUILDER	32 ROOF TYPE & MATERIAL INTERSECTING HIP WITH SEC. GABLES COMPOSITION SHINGLES
	21 ORIGINAL USE, IF APPARENT SINGLE FAMILY RESIDENCE	33 NO. OF BAYS FRONT 2 SIDE 5
	22 PRESENT USE SINGLE FAMILY RESIDENCE	34 WALL TREATMENT VINYL SIDING
		35 PLAN SHAPE IRREGULAR
	23 OWNERSHIP PUBLIC PRIVATE X	36 CHANGES ADDITION X (EXPLAIN ALTERED IN #42) MOVED
	24 OWNER'S NAME & ADDRESS (IF KNOWN)	37 CONDITION INTERIOR EXTERIOR GOOD
9 COORDINATES LOT LANG	25 OPEN TO PUBLIC (YES/NO) N	38 PRESERVATION UNDERWAY? (Y/N) N

10 SITE STRUCTURE BUILDING X OBJECT	26 LOCAL CONTACT PERSON OR ORGANIZATION	39 ENDANGERED (YES/NO) N BY WHAT?
11 ON NAT'L REG? (YES/NO) N	12 IS IT ELIGIBLE? (YES/NO)	40 VISIBLE FROM PUBLIC ROAD? (YES/NO) Y
13 PART OF HIST DIST (YES/NO) N	14 DIST POTENT (YES/NO) Y	41 DISTANCE FROM AND FRONTAGE ON ROAD
15 NAME OF ESTABLISHED DISTRICT		PHOTO
42 FURTHER DESCRIPTION OF IMPORTANT FEATURES SEE CONTINUATION SHEET		46 PREPARED BY LINDA STOCKMAN
43 HISTORY AND SIGNIFICANCE SEE CONTINUATION SHEET		47 ORGANIZATION KIRKWOOD LANDM. COMM.
44 DESCRIPTION OF ENVIRONMENT AND OUTBUILDINGS SEE CONTINUATION SHEET		48 DATE 06/86
45 SOURCES OF INFORMATION SEE CONTINUATION SHEET		49 REVISION DATE(S)
