**HISTORIC INVENTORY**

Presbyterian Church Tower Park  
100 E. Adams

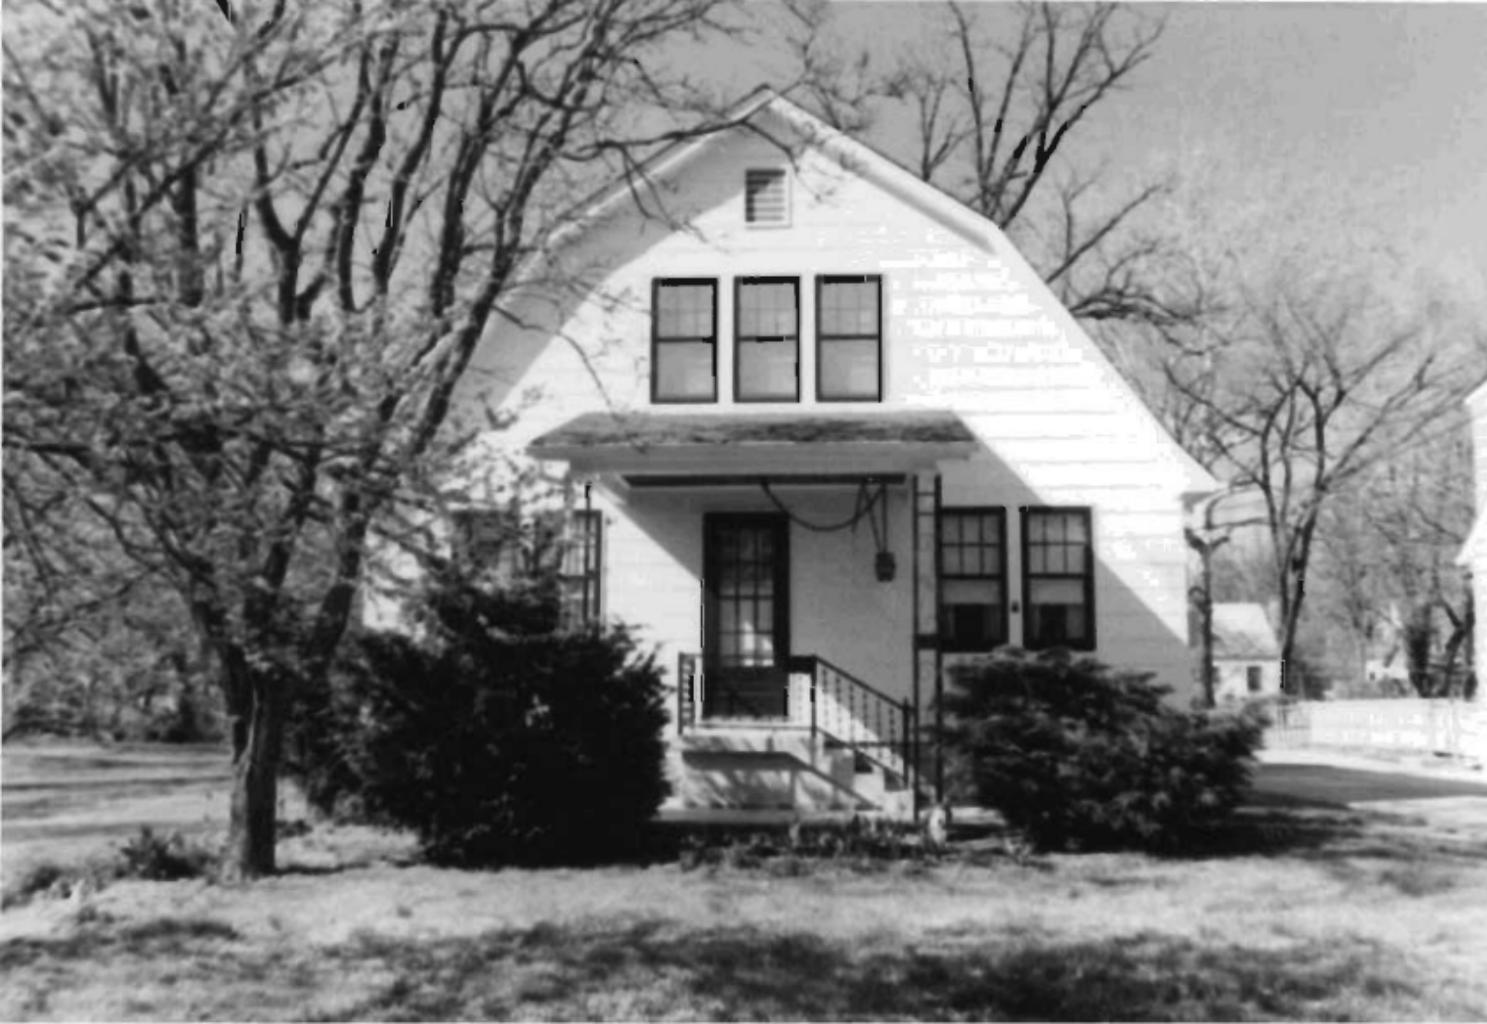
1 NO 2088 LOCAL # 2 COUNTY ST. LOUIS	4 PRESENT NAME(S) LINDA STOCKMAN	
3 LOCATION OF NEGATIVES LINDA STOCKMAN	5 OTHER NAME(S)	
6 SPECIFIC LOCATION 324 W. ADAMS	16 THEMATIC CATEGORY	28 NO OF STORIES 01.5
7 CITY OR TOWN KIRKWOOD, MO	17 DATE(S) OR PERIOD CA 1915	29 BASEMENT (Y/N) Y FULL (Y/N) Y
8 SITE PLAN WITH NORTH ARROW  SEE MAP	18 STYLE OR DESIGN ECLECTIC DUTCH COLONIAL REVIV	30 FOUNDATION MATERIAL CUT STONE
	19 ARCHITECT OR ENGINEER	31 WALL CONSTRUCTION FRAME
	20 CONTRACTOR OR BUILDER	32 ROOF TYPE & MATERIAL FRONT GAMBREL ASPHALT SHINGLES
	21 ORIGINAL USE, IF APPARENT SINGLE FAMILY RESIDENCE	33 NO. OF BAYS FRONT 3 SIDE 3
	22 PRESENT USE SINGLE FAMILY RESIDENCE	34 WALL TREATMENT COMPOSITION SHINGLES
		35 PLAN SHAPE IRREGULAR
	23 OWNERSHIP PUBLIC PRIVATE X	36 CHANGES ADDITION X (EXPLAIN ALTERED IN #42) MOVED
9 COORDINATES LOT LANG	24 OWNER'S NAME & ADDRESS (IF KNOWN)	37 CONDITION INTERIOR EXTERIOR GOOD

10 SITE STRUCTURE BUILDING X OBJECT	25 OPEN TO PUBLIC (YES/NO) N	38 PRESERVATION UNDERWAY? (Y/N) N
11 ON NAT'L REG? (YES/NO) N	12 IS IT ELIGIBLE? (YES/NO)	39 ENDANGERED (YES/NO) N BY WHAT?
13 PART OF HIST DIST (YES/NO) N	14 DIST POTENT (YES/NO) Y	40 VISIBLE FROM PUBLIC ROAD? (YES/NO) Y
15 NAME OF ESTABLISHED DISTRICT	26 LOCAL CONTACT PERSON OR ORGANIZATION	41 DISTANCE FROM AND FRONTAGE ON ROAD
42 FURTHER DESCRIPTION OF IMPORTANT FEATURES SEE CONTINUATION SHEET	27 OTHER SURVEYS IN WHICH INCLUDED	PHOTO
43 HISTORY AND SIGNIFICANCE SEE CONTINUATION SHEET		46 PREPARED BY LINDA STOCKMAN
44 DESCRIPTION OF ENVIRONMENT AND OUTBUILDINGS SEE CONTINUATION SHEET		47 ORGANIZATION KIRKWOOD LANDM COMM.
45 SOURCES OF INFORMATION SEE CONTINUATION SHEET		48 DATE 06/86 49 REVISION DATE(S)

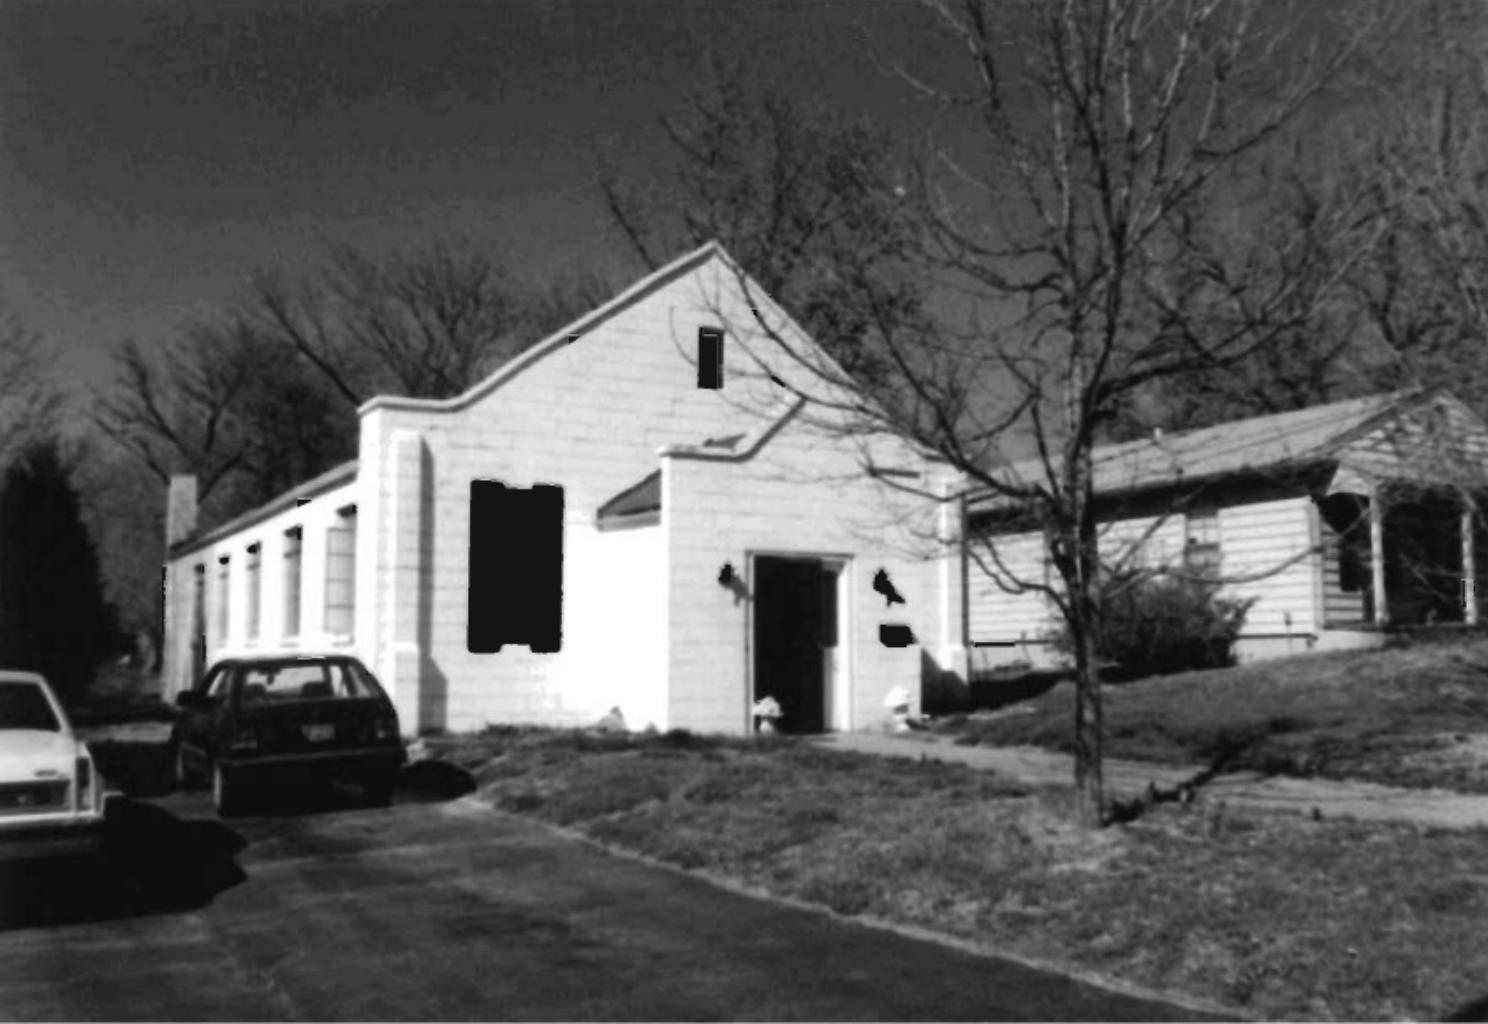
1 NO 2089 LOCAL # 2 COUNTY	4 PRESENT NAME(S)	
ST. LOUIS 3. LOCATION OF NEGATIVES LINDA STOCKMAN	5 OTHER NAME(S)	
6 SPECIFIC LOCATION 335 W. ADAMS	16 THEMATIC CATEGORY	23 NO OF STORIES 01.0
7 CITY OR TOWN KIRKWOOD, MO	17 DATE(S) OR PERIOD CA 1915	29 BASEMENT (Y/N) FULL (Y/N)
8 SITE PLAN WITH NORTH ARROW  SEE MAP	18 STYLE OR DESIGN VERNACULAR	30 FOUNDATION MATERIAL CONCRETE BLOCK
	19 ARCHITECT OR ENGINEER	31 WALL CONSTRUCTION MASONRY
	20 CONTRACTOR OR BUILDER	32 ROOF TYPE & MATERIAL GABLE WITH PARAPET ASPHALT SHINGLES
	21 ORIGINAL USE, IF APPARENT CHURCH	33 NO. OF BAYS FRONT 3 SIDE 5
	22 PRESENT USE SINGLE FAMILY RESIDENCE	34 WALL TREATMENT CONCRETE BLOCK
		35 PLAN SHAPE RECTANGLE
	23 OWNERSHIP PUBLIC PRIVATE X	36 CHANGES ADDITION (EXPLAIN ALTERED IN #42) MOVED
9 COORDINATES LOT LANG	24 OWNER'S NAME & ADDRESS (IF KNOWN)	37 CONDITION INTERIOR EXTERIOR GOOD
10 SITE STRUCTURE BUILDING X OBJECT	25 OPEN TO PUBLIC (YES/NO) N	38 PRESERVATION UNDERWAY? (Y/N) N

11 ON NAT'L REG? (YES/NO) N	12 IS IT ELIGIBLE? (YES/NO)	39 ENDANGERED (YES/NO) N BY WHAT?
13 PART OF HIST DIST (YES/NO) N	14 DIST POTENT (YES/NO) Y	40 VISIBLE FROM PUBLIC ROAD? (YES/NO) Y
15 NAME OF ESTABLISHED DISTRICT	26 LOCAL CONTACT PERSON OR ORGANIZATION	41 DISTANCE FROM AND FRONTAGE ON ROAD
42 FURTHER DESCRIPTION OF IMPORTANT FEATURES SEE CONTINUATION SHEET		PHOTO
43 HISTORY AND SIGNIFICANCE SEE CONTINUATION SHEET		46 PREPARED BY LINDA STOCKMAN
44 DESCRIPTION OF ENVIRONMENT AND OUTBUILDINGS SEE CONTINUATION SHEET		47 ORGANIZATION KIRKWOOD LANDM COMM.
45 SOURCES OF INFORMATION SEE CONTINUATION SHEET	48 DATE 06/86	49 REVISION DATE(S)

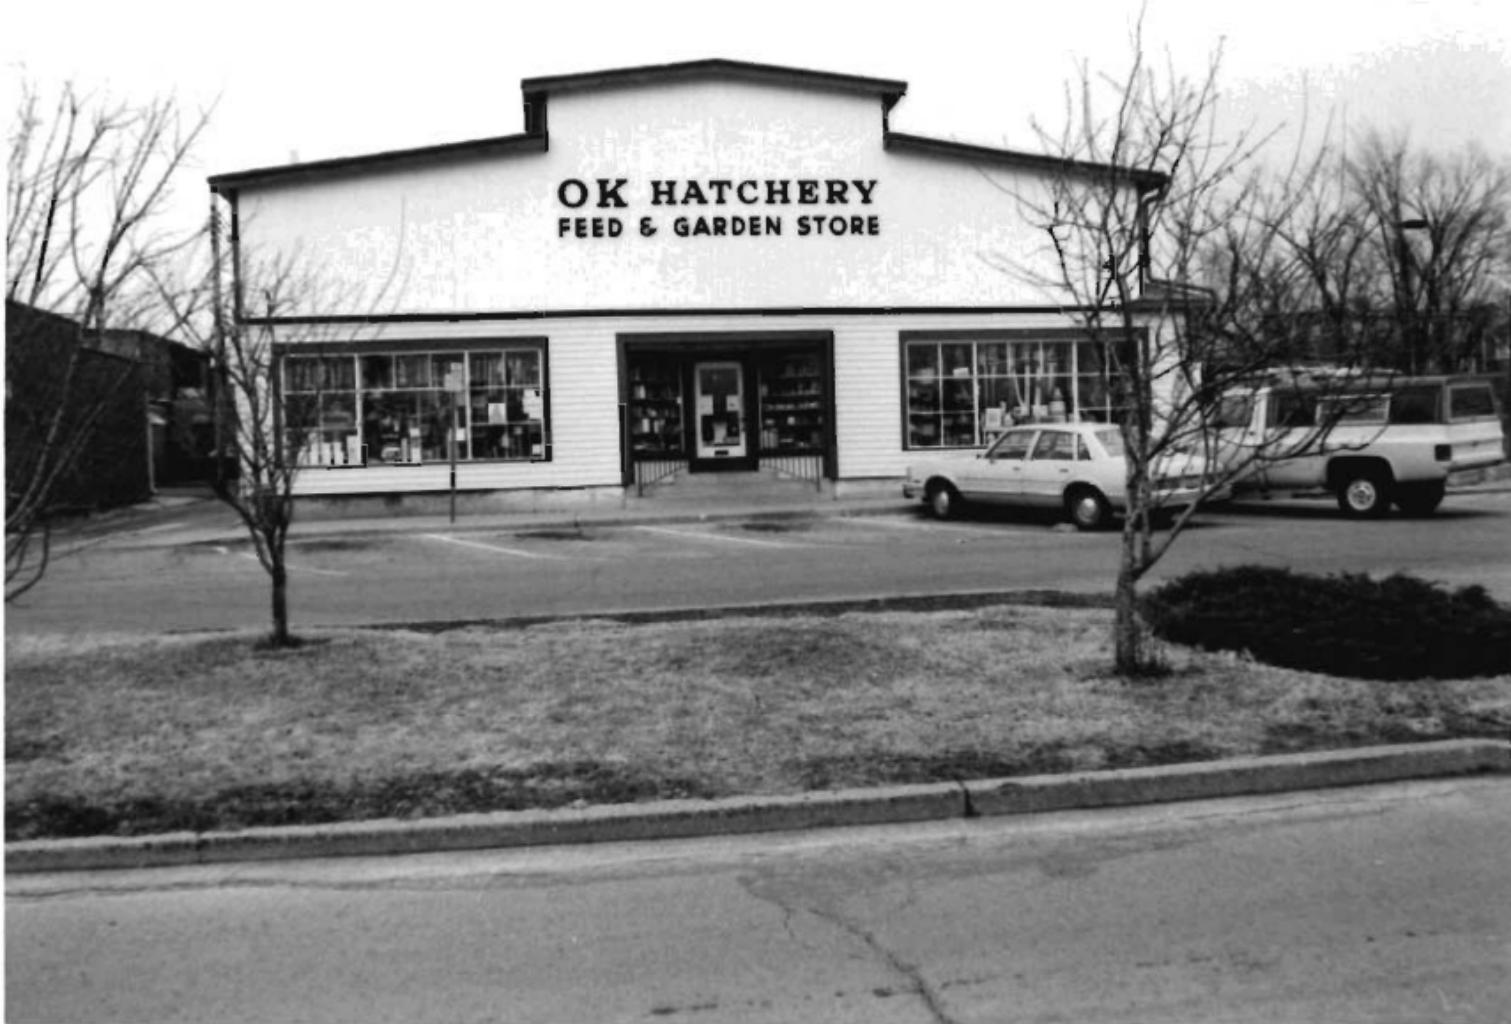
**OK HATCHERY  
FEED & GARDEN STORE**

1 NO 2039 LOCAL # 2 COUNTY	4 PRESENT NAME(S) OK HATCHERY, FEED, & GARDEN STORE	
3. LOCATION OF NEGATIVES ST. LOUIS LINDA STOCKMAN	5 OTHER NAME(S) HOLEKAMP LUMBERYARD	
6 SPECIFIC LOCATION 109 E. ARGONNE/MAIN	16 THEMATIC CATEGORY	28 NO OF STORIES 02.5
7 CITY OR TOWN KIRKWOOD, MO	17 DATE(S) OR PERIOD CA 1920	29 BASEMENT (Y/N) N FULL (Y/N)
8 SITE PLAN WITH NORTH ARROW  SEE MAP	18 STYLE OR DESIGN VERNACULAR	30 FOUNDATION MATERIAL CONCRETE
	19 ARCHITECT OR ENGINEER	31 WALL CONSTRUCTION FRAME
	20 CONTRACTOR OR BUILDER	32 ROOF TYPE & MATERIAL MODIFIED MONITOR ASPHALT SHINGLES
	21 ORIGINAL USE, IF APPARENT COMMERCIAL	33 NO. OF BAYS FRONT 3 SIDE 0
	22 PRESENT USE COMMERCIAL	34 WALL TREATMENT SIDING VINYL AND WOOD
		35 PLAN SHAPE RECTANGULAR
	23 OWNERSHIP PUBLIC PRIVATE X	36 CHANGES ADDITION X (EXPLAIN ALTERED X IN #42) MOVED
9 COORDINATES LOT LANG	24 OWNER'S NAME & ADDRESS (IF KNOWN)	37 CONDITION INTERIOR EXTERIOR GOOD

10 SITE STRUCTURE BUILDING X OBJECT	25 OPEN TO PUBLIC (YES/NO) Y	38 PRESERVATION UNDERWAY? (Y/N) N
11 ON NAT'L REG? (YES/NO) N	12 IS IT ELIGIBLE? (YES/NO)	39 ENDANGERED (YES/NO) N BY WHAT?
13 PART OF HIST DIST (YES/NO) N	14 DIST POTENT (YES/NO)	40 VISIBLE FROM PUBLIC ROAD? (YES/NO) Y
15 NAME OF ESTABLISHED DISTRICT	26 LOCAL CONTACT PERSON OR ORGANIZATION	41 DISTANCE FROM AND FRONTOAGE ON ROAD ADJOINS SIDEWALK
42 FURTHER DESCRIPTION OF IMPORTANT FEATURES SEE CONTINUATION SHEET		PHOTO
43 HISTORY AND SIGNIFICANCE SEE CONTINUATION SHEET		46 PREPARED BY LINDA STOCKMAN
44 DESCRIPTION OF ENVIRONMENT AND OUTBUILDINGS SEE CONTINUATION SHEET		47 ORGANIZATION KIRKWOOD LANDM COMM.
45 SOURCES OF INFORMATION SEE CONTINUATION SHEET		48 DATE 06/86   49 REVISION DATE(S)

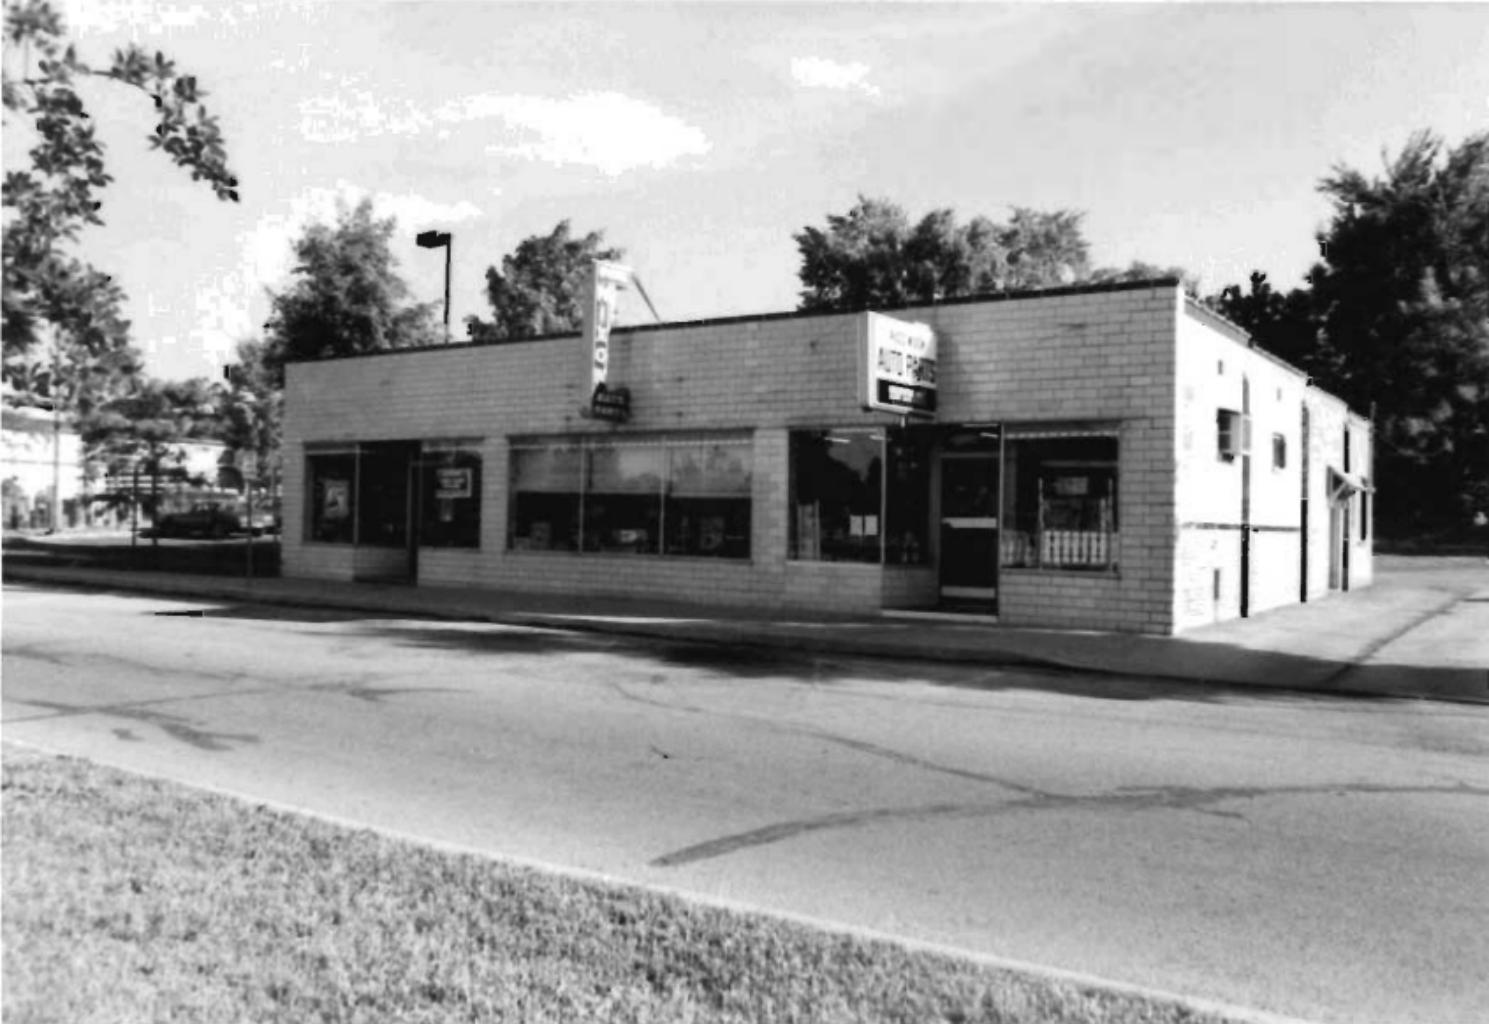
1 NO 2038 LOCAL # 2 COUNTY ST. LOUIS	4 PRESENT NAME(S) RUSS NIXON AUTO PARTS	
3. LOCATION OF NEGATIVES LINDA STOCKMAN	5 OTHER NAME(S) KIRKWOOD AUTO SUPPLY	
6 SPECIFIC LOCATION 125, 127 E. ARGONNE/MAIN	10 THEMATIC CATEGORY	28 NO OF STORIES 01.0
7 CITY OR TOWN KIRKWOOD, MO	17 DATE(S) OR PERIOD CA 1945	29 BASEMENT (Y/N) ? FULL (Y/N) ?
8 SITE PLAN WITH NORTH ARROW  SEE MAP	18 STYLE OR DESIGN VERNACULAR	30 FOUNDATION MATERIAL CONCRETE
	19 ARCHITECT OR ENGINEER	31 WALL CONSTRUCTION MASONRY
	20 CONTRACTOR OR BUILDER	32 ROOF TYPE & MATERIAL FLAT COMPOSITION
	21 ORIGINAL USE, IF APPARENT COMMERCIAL	33 NO. OF BAYS FRONT 3 SIDE 4
	22 PRESENT USE COMMERCIAL	34 WALL TREATMENT BRICK
		35 PLAN SHAPE RECTANGULAR
	23 OWNERSHIP PUBLIC PRIVATE X	36 CHANGES ADDITION (EXPLAIN ALTERED IN #42) MOVED
9 COORDINATES LOT LANG	24 OWNER'S NAME & ADDRESS (IF KNOWN)	37 CONDITION INTERIOR EXTERIOR GOOD
	25 OPEN TO PUBLIC (YES/NO) Y	38 PRESERVATION UNDERWAY? (Y/N) N

10 SITE STRUCTURE BUILDING X OBJECT	26 LOCAL CONTACT PERSON OR ORGANIZATION	39 ENDANGERED (YES/NO) N BY WHAT?
11 ON NAT'L REG? (YES/NO) N	12 IS IT ELIGIBLE? (YES/NO)	40 VISIBLE FROM PUBLIC ROAD? (YES/NO) Y
13 PART OF HIST DIST (YES/NO) N	14 DIST POTENT (YES/NO)	41 DISTANCE FROM AND FRONTAGE ON ROAD ADJOINS SIDEWALK
15 NAME OF ESTABLISHED DISTRICT	27 OTHER SURVEYS IN WHICH INCLUDED	PHOTO
42 FURTHER DESCRIPTION OF IMPORTANT FEATURES SEE CONTINUATION SHEET		46 PREPARED BY LINDA STOCKMAN
43 HISTORY AND SIGNIFICANCE SEE CONTINUATION SHEET		47 ORGANIZATION KIRKWOOD LANDM COMM.
44 DESCRIPTION OF ENVIRONMENT AND OUTBUILDINGS SEE CONTINUATION SHEET		48 DATE 06/86
45 SOURCES OF INFORMATION SEE CONTINUATION SHEET		49 REVISION DATE(S)

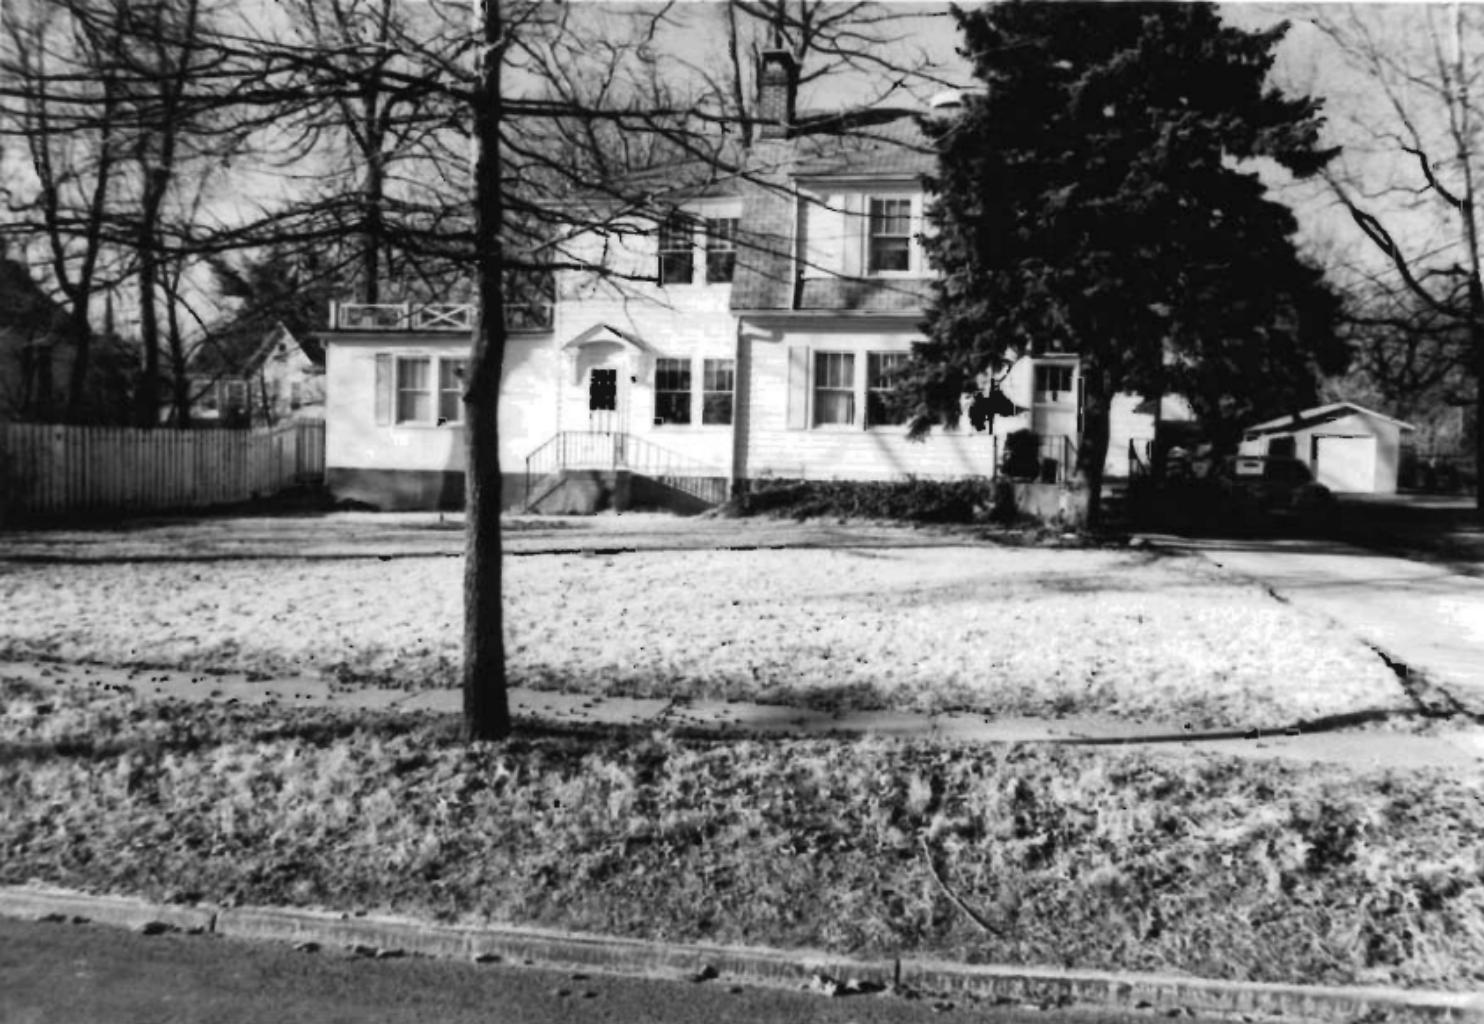
1 NO 2055 LOCAL #	4 PRESENT NAME(S)	
2 COUNTY ST. LOUIS	5 OTHER NAME(S) LINDA STOCKMAN	
3 LOCATION OF NEGATIVES		
6 SPECIFIC LOCATION 215 E. ARGONNE/MAIN	16 THEMATIC CATEGORY	28 NO OF STORIES 02.5
7 CITY OR TOWN KIRKWOOD, MO	17 DATE(S) OR PERIOD CA 1925	29 BASEMENT (Y/N) Y FULL (Y/N) Y
8 SITE PLAN WITH NORTH ARROW  SEE MAP	18 STYLE OR DESIGN ECLECTIC DUTCH COLONIAL REVIV	30 FOUNDATION MATERIAL CONCRETE BLOCK
	19 ARCHITECT OR ENGINEER	31 WALL CONSTRUCTION FRAME
	20 CONTRACTOR OR BUILDER	32 ROOF TYPE & MATERIAL GAMBREL ASPHALT SHINGLES
	21 ORIGINAL USE, IF APPARENT SINGLE FAMILY RESIDENCE	33 NO. OF BAYS FRONT 5 SIDE 0
	22 PRESENT USE SINGLE FAMILY RESIDENCE	34 WALL TREATMENT HORIZONTAL WOOD LAP SIDING
		35 PLAN SHAPE IRREGULAR
	23 OWNERSHIP PUBLIC PRIVATE X	36 CHANGES ADDITION X (EXPLAIN ALTERED X IN #42) MOVED
	24 OWNER'S NAME & ADDRESS (IF KNOWN)	37 CONDITION INTERIOR EXTERIOR GOOD
9 COORDINATES LOT LANG	25 OPEN TO PUBLIC (YES/NO) N	38 PRESERVATION UNDERWAY? (Y/N) N

10 SITE BUILDING X STRUCTURE OBJECT	26 LOCAL CONTACT PERSON OR ORGANIZATION	39 ENDANGERED (YES/NO) N BY WHAT?
11 ON NAT'L REG? (YES/NO) N	12 IS IT ELIGIBLE? (YES/NO)	
13 PART OF HIST DIST (YES/NO) N	14 DIST POTENT (YES/NO)	
15 NAME OF ESTABLISHED DISTRICT	27 OTHER SURVEYS IN WHICH INCLUDED	
42 FURTHER DESCRIPTION OF IMPORTANT FEATURES SEE CONTINUATION SHEET		40 VISIBLE FROM PUBLIC ROAD? (YES/NO) Y
43 HISTORY AND SIGNIFICANCE SEE CONTINUATION SHEET		41 DISTANCE FROM AND FRONTAGE ON ROAD
44 DESCRIPTION OF ENVIRONMENT AND OUTBUILDINGS SEE CONTINUATION SHEET		42 PHOTO
45 SOURCES OF INFORMATION SEE CONTINUATION SHEET		46 PREPARED BY LINDA STOCKMAN
		47 ORGANIZATION KIRKWOOD LANDM COMM.
		48 DATE 06/86 49 REVISION DATE(S)

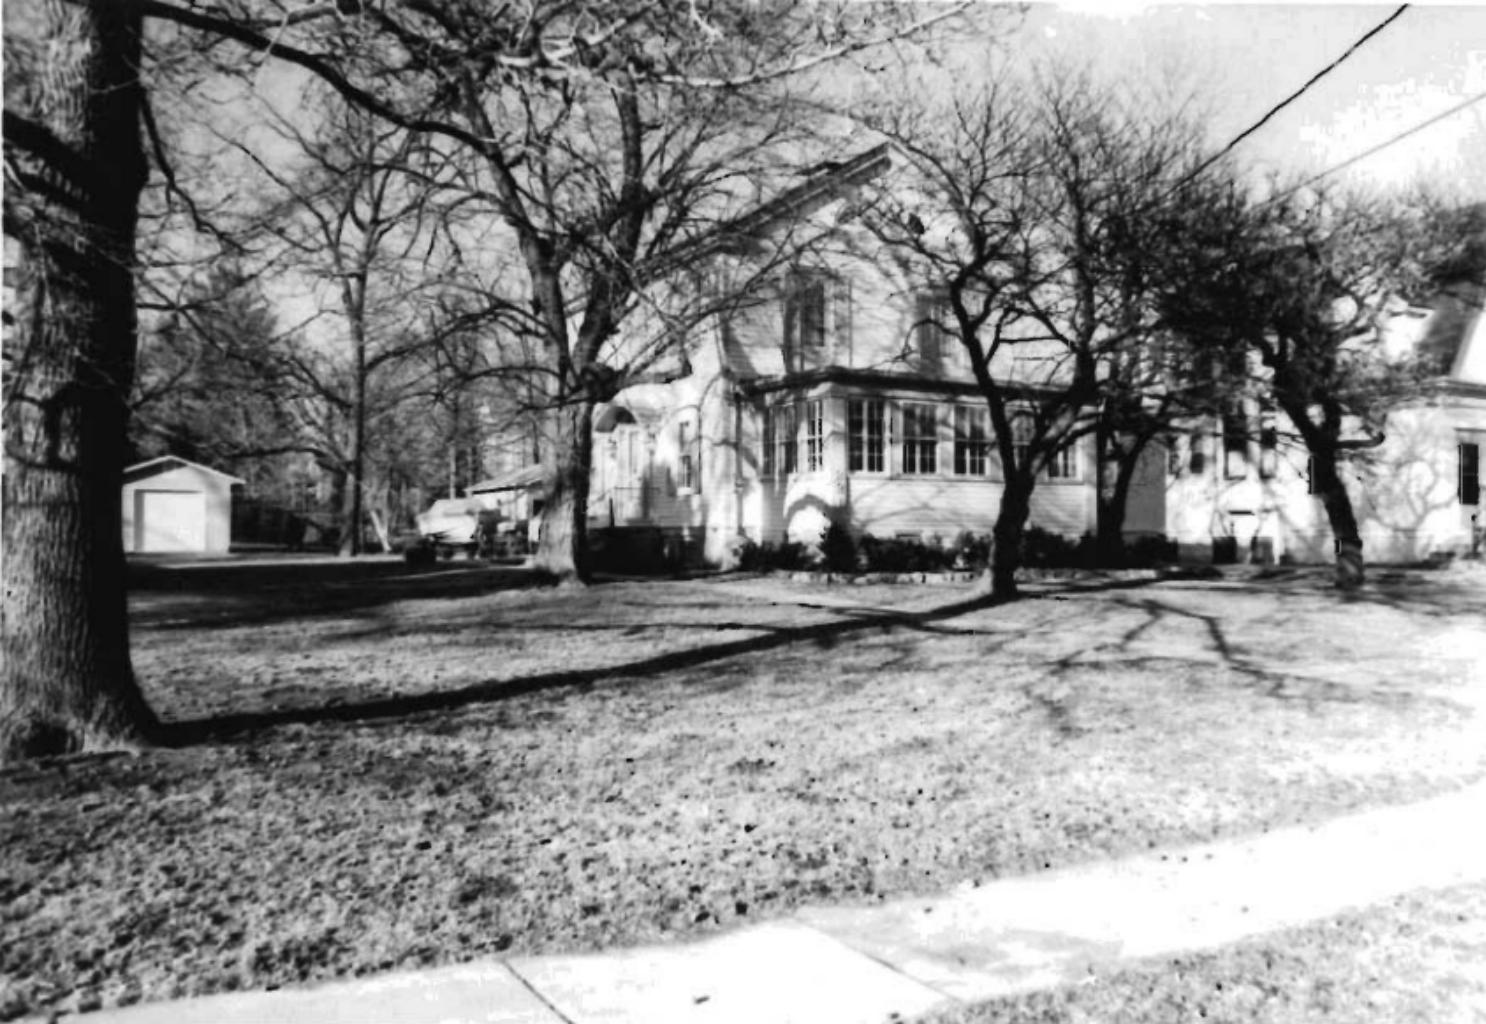
1 NO 2054 LOCAL #	4 PRESENT NAME(S)	
2 COUNTY ST LOUIS	5 OTHER NAME(S)	
3 LOCATION OF NEGATIVES LINDA STOCKMAN		
6 SPECIFIC LOCATION 221 E. ARGONNE/MAIN	16 THEMATIC CATEGORY	28 NO OF STORIES 02.5
7 CITY OR TOWN KIRKWOOD, MO	17 DATE(S) OR PERIOD CA 1915	29 BASEMENT (Y/N) Y FULL (Y/N) Y
8 SITE PLAN WITH NORTH ARROW  SEE MAP	18 STYLE OR DESIGN ECLECTIC COLONIAL REVIVAL	30 FOUNDATION MATERIAL CONCRETE BLOCK
	19 ARCHITECT OR ENGINEER	31 WALL CONSTRUCTION FRAME
	20 CONTRACTOR OR BUILDER	32 ROOF TYPE & MATERIAL MEDIUM GABLE ASPHALT SHINGLES
	21 ORIGINAL USE, IF APPARENT SINGLE FAMILY RESIDENCE	33 NO. OF BAYS FRONT 2 SIDE 3
	22 PRESENT USE SINGLE FAMILY RESIDENCE	34 WALL TREATMENT HORIZONTAL WOOD LAP SIDING
		35 PLAN SHAPE IRREGULAR
	23 OWNERSHIP PUBLIC PRIVATE X	36 CHANGES ADDITION X (EXPLAIN ALTERED X IN #42) MOVED
	24 OWNER'S NAME & ADDRESS (IF KNOWN)	37 CONDITION INTERIOR EXTERIOR GOOD
9 COORDINATES LOT LANG	25 OPEN TO PUBLIC (YES/NO) N	38 PRESERVATION UNDERWAY? (Y/N) N

10 SITE STRUCTURE BUILDING X OBJECT	26 LOCAL CONTACT PERSON OR ORGANIZATION	39 ENDANGERED (YES/NO) N BY WHAT?
11 ON NAT'L REG? (YES/NO) N	12 IS IT ELIGIBLE? (YES/NO)	40 VISIBLE FROM PUBLIC ROAD ? (YES/NO) Y
13 PART OF HIST DIST (YES/NO) N	14 DIST POTENT (YES/NO)	41 DISTANCE FROM AND FRONTAGE ON ROAD
15 NAME OF ESTABLISHED DISTRICT		
42 FURTHER DESCRIPTION OF IMPORTANT FEATURES SEE CONTINUATION SHEET		PHOTO
43 HISTORY AND SIGNIFICANCE SEE CONTINUATION SHEET		46 PREPARED BY LINDA STOCKMAN
44 DESCRIPTION OF ENVIRONMENT AND OUTBUILDINGS SEE CONTINUATION SHEET		47 ORGANIZATION KIRKWOOD LANDM COMM.
45 SOURCES OF INFORMATION SEE CONTINUATION SHEET		48 DATE 06/86   49 REVISION DATE(S)

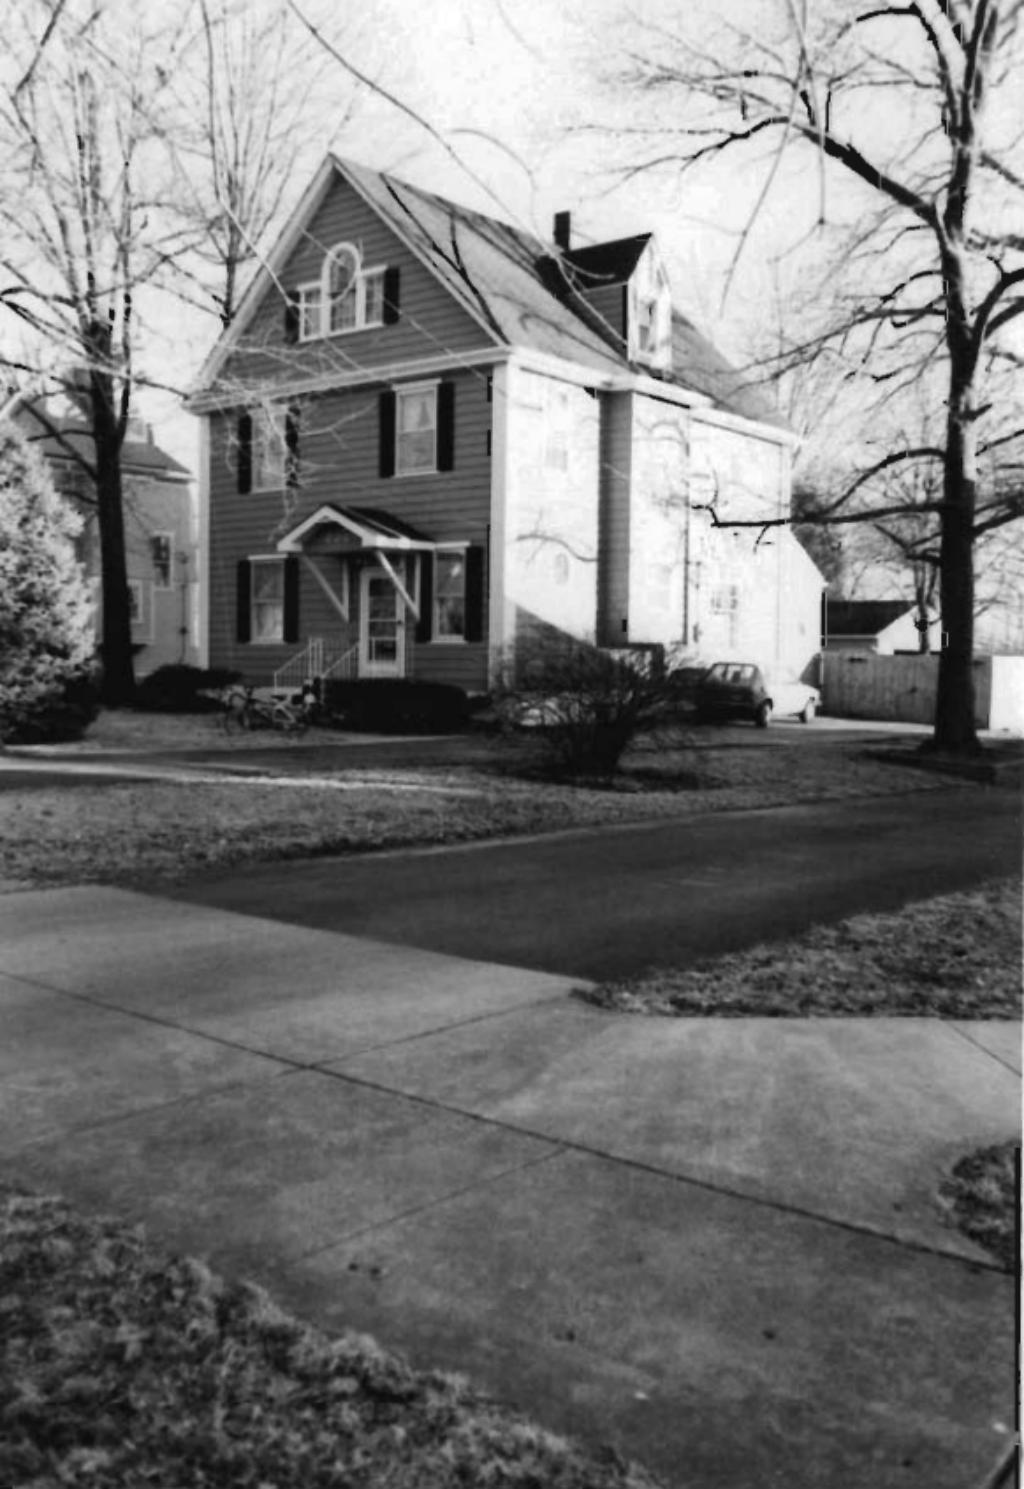
1 NO 2066 LOCAL #	4 PRESENT NAME(S) ST. LOUIS	
2 COUNTY		
3 LOCATION OF NEGATIVES	5 OTHER NAME(S) LINDA STOCKMAN	
6 SPECIFIC LOCATION 222 E. ARGONNE/MAIN	16 THEMATIC CATEGORY	28 NO OF STORIES 02.5
7 CITY OR TOWN KIRKWOOD, MO	17 DATE(S) OR PERIOD CA 1895	29 BASEMENT (Y/N) Y FULL (Y/N) Y
8 SITE PLAN WITH NORTH ARROW  SEE MAP	18 STYLE OR DESIGN ECLECTIC COLONIAL REVIVAL	30 FOUNDATION MATERIAL STONE
	19 ARCHITECT OR ENGINEER	31 WALL CONSTRUCTION FRAME
	20 CONTRACTOR OR BUILDER	32 ROOF TYPE & MATERIAL GABLE ASPHALT SHINGLES
	21 ORIGINAL USE, IF APPARENT SINGLE FAMILY RESIDENCE	33 NO. OF BAYS FRONT 3 SIDE 5
	22 PRESENT USE SINGLE FAMILY RESIDENCE	34 WALL TREATMENT ALUMINUM LAP SIDING & FACIAL
		35 PLAN SHAPE GOOD
	23 OWNERSHIP PUBLIC PRIVATE X	36 CHANGES ADDITION X (EXPLAIN ALTERED X IN #42) MOVED
9 COORDINATES LOT LANG	24 OWNER'S NAME & ADDRESS (IF KNOWN)	37 CONDITION INTERIOR EXTERIOR GOOD
10 SITE STRUCTURE BUILDING X OBJECT	25 OPEN TO PUBLIC (YES/NO) N	38 PRESERVATION UNDERWAY? (Y/N) N

11 ON NAT'L REG? (YES/NO) N	12 IS IT ELIGIBLE? (YES/NO)	39 ENDANGERED (YES/NO) N BY WHAT?
13 PART OF HIST DIST (YES/NO) N	14 DIST POTENT (YES/NO)	40 VISIBLE FROM PUBLIC ROAD? (YES/NO) Y
15 NAME OF ESTABLISHED DISTRICT	26 LOCAL CONTACT PERSON OR ORGANIZATION	41 DISTANCE FROM AND FRONTAGE ON ROAD
42 FURTHER DESCRIPTION OF IMPORTANT FEATURES SEE CONTINUATION SHEET		PHOTO
43 HISTORY AND SIGNIFICANCE SEE CONTINUATION SHEET		46 PREPARED BY LINDA STOCKMAN
44 DESCRIPTION OF ENVIRONMENT AND OUTBUILDINGS SEE CONTINUATION SHEET		47 ORGANIZATION KIRKWOOD LANDM COMM.
45 SOURCES OF INFORMATION SEE CONTINUATION SHEET		48 DATE 06/86 49 REVISION DATE(S)

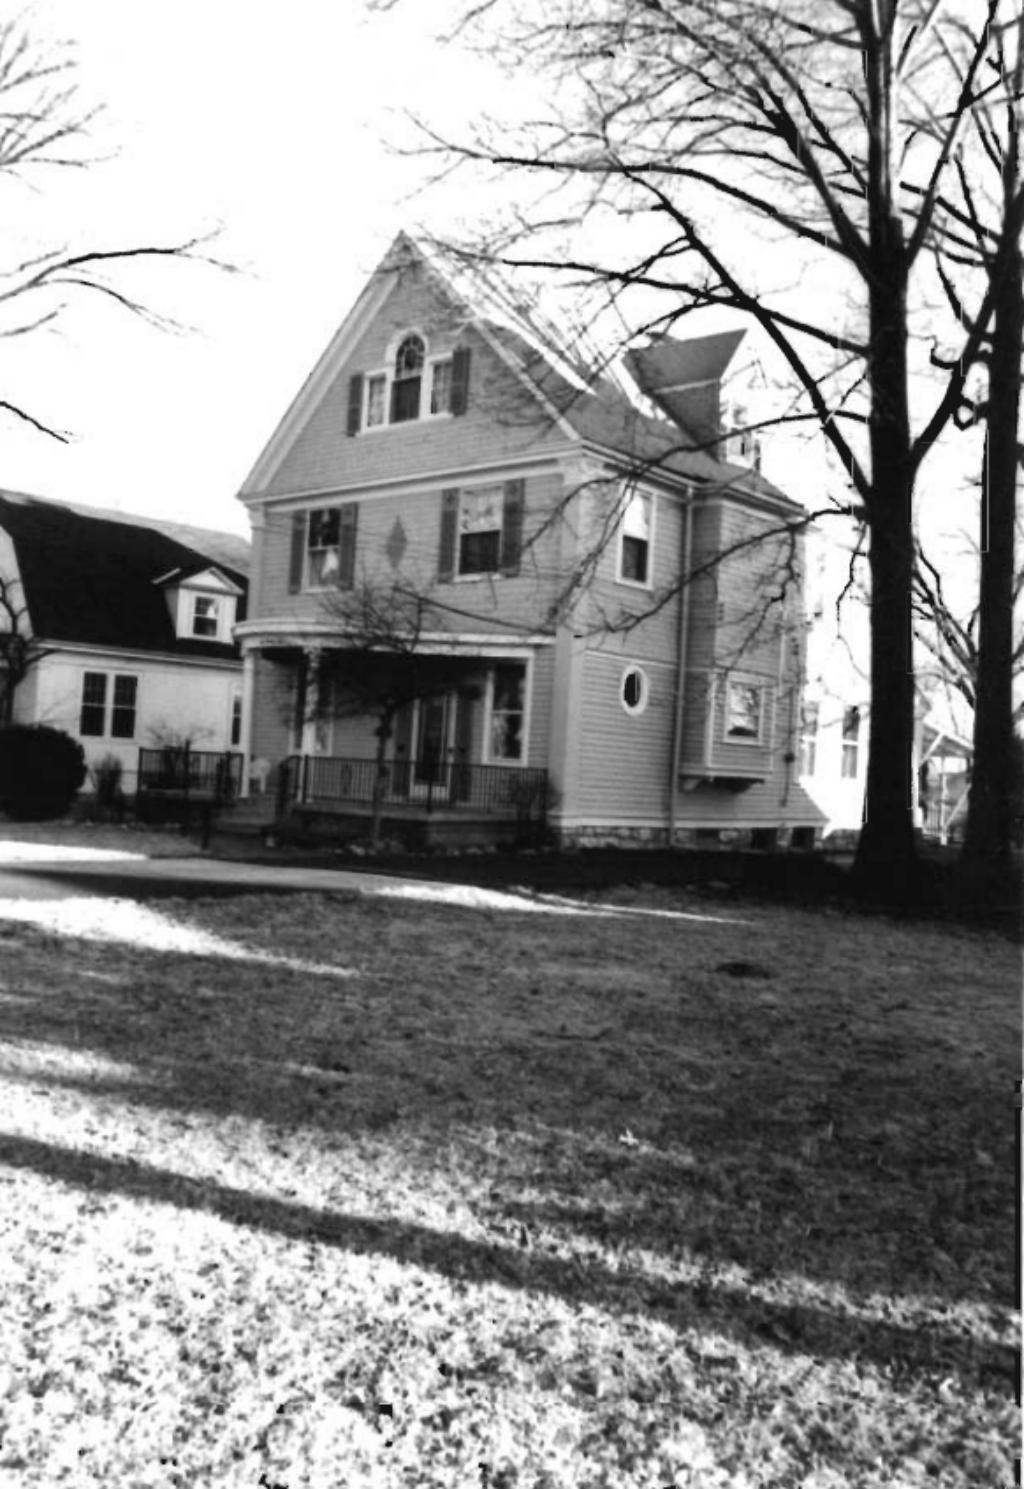
1 NO 2007 LOCAL #	4 PRESENT NAME(S)	
2 COUNTY ST. LOUIS	5 OTHER NAME(S) LINDA STOCKMAN	
6 SPECIFIC LOCATION 226 E. ARGONNE/MAIN	16 THEMATIC CATEGORY	28 NO OF STORIES 02.5
7 CITY OR TOWN KIRKWOOD, MO	17 DATE(S) OR PERIOD CA 1396	29 BASEMENT (Y/N) Y FULL (Y/N) Y
8 SITE PLAN WITH NORTH ARROW  SEE MAP	18 STYLE OR DESIGN ECLECTIC HOMESTEAD	30 FOUNDATION MATERIAL STONE
	19 ARCHITECT OR ENGINEER	31 WALL CONSTRUCTION FRAME
	20 CONTRACTOR OR BUILDER	32 ROOF TYPE & MATERIAL GABLE ASPHALT SHINGLES
	21 ORIGINAL USE, IF APPARENT SINGLE FAMILY RESIDENCE	33 NO. OF BAYS FRONT 3 SIDE 6
	22 PRESENT USE SINGLE FAMILY RESIDENCE	34 WALL TREATMENT WOOD SHAKES & WOOD HORIZONTAL LAP SIDING
		35 PLAN SHAPE RECTANGULAR
	23 OWNERSHIP PUBLIC PRIVATE X	36 CHANGES ADDITION X (EXPLAIN ALTERED IN #42) MOVED
9 COORDINATES LOT LANG	24 OWNER'S NAME & ADDRESS (IF KNOWN)	37 CONDITION INTERIOR EXTERIOR GOOD
10 SITE BUILDING X STRUCTURE OBJECT	25 OPEN TO PUBLIC (YES/NO) N	38 PRESERVATION UNDERWAY? (Y/N) N

11 ON NAT'L REG? (YES/NO) N	12 IS IT ELIGIBLE? (YES/NO)	39 ENDANGERED (YES/NO) N BY WHAT?
13 PART OF HIST DIST (YES/NO) N	14 DIST POTENT (YES/NO)	40 VISIBLE FROM PUBLIC ROAD? (YES/NO) Y
15 NAME OF ESTABLISHED DISTRICT	26 LOCAL CONTACT PERSON OR ORGANIZATION	41 DISTANCE FROM AND FRONTAGE ON ROAD
42 FURTHER DESCRIPTION OF IMPORTANT FEATURES SEE CONTINUATION SHEET		PHOTO
43 HISTORY AND SIGNIFICANCE SEE CONTINUATION SHEET		46 PREPARED BY LINDA STOCKMAN
44 DESCRIPTION OF ENVIRONMENT AND OUTBUILDINGS SEE CONTINUATION SHEET		47 ORGANIZATION KIRKWOOD LANDM COMM.
45 SOURCES OF INFORMATION SEE CONTINUATION SHEET		48 DATE 06/86 49 REVISION DATE(S)

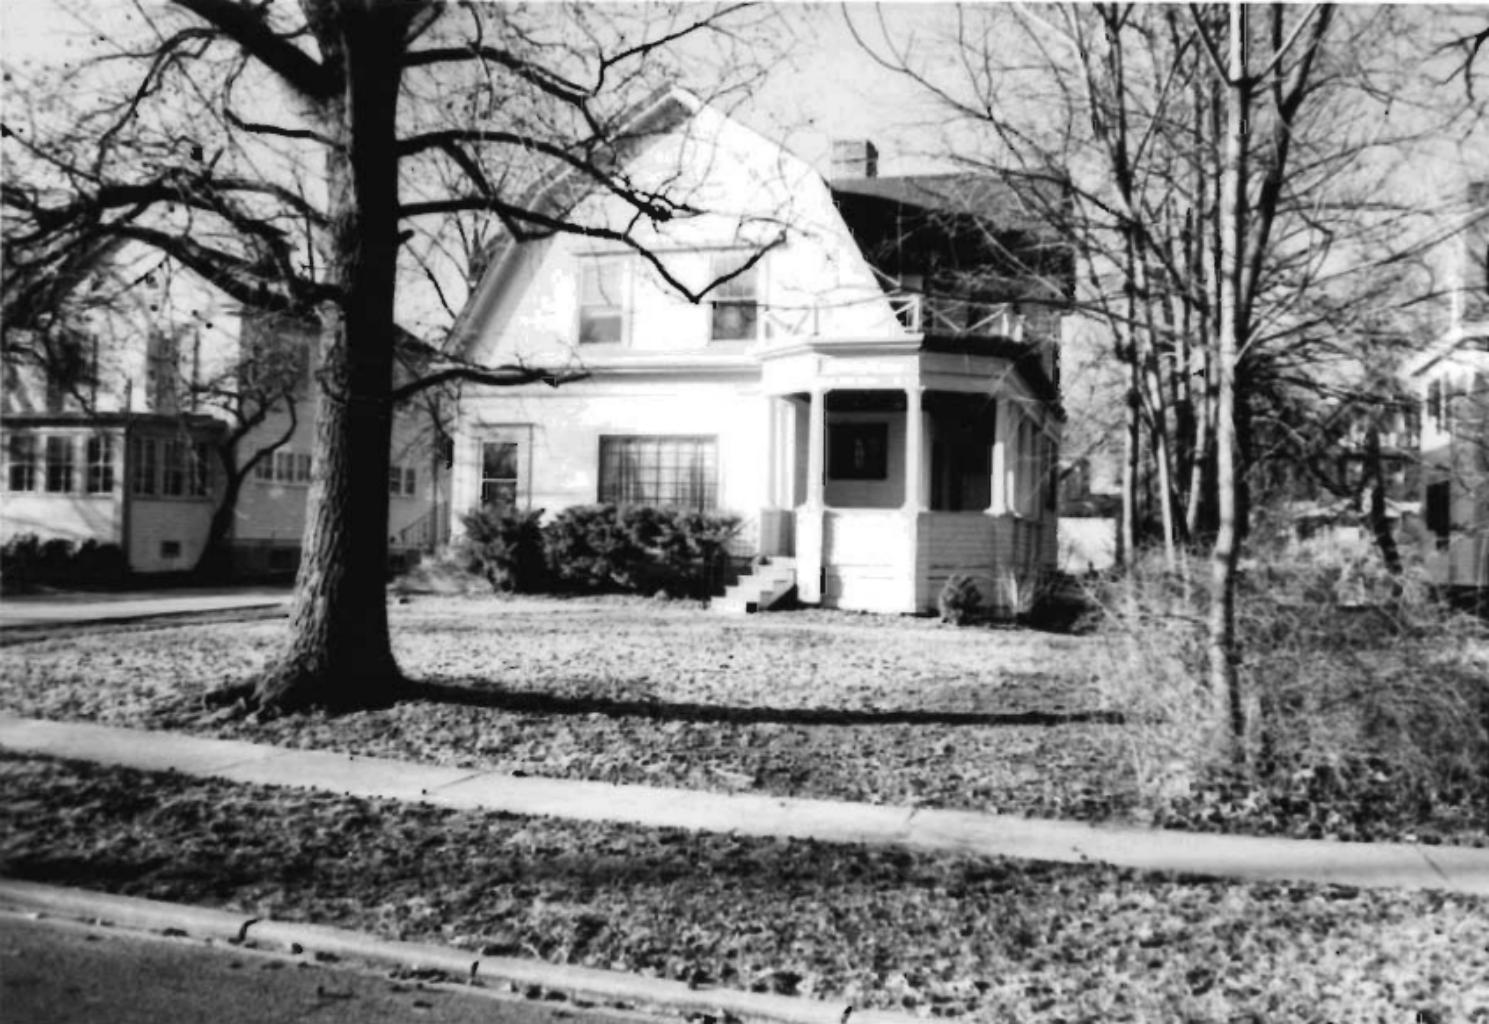
1 NO 2053 LOCAL #	4 PRESENT NAME(S)	
2 COUNTY ST. LOUIS	5 OTHER NAME(S) LINDA STOCKMAN	
3 LOCATION OF NEGATIVES		
6 SPECIFIC LOCATION 229 E. ARGONNE/MAIN	16 THEMATIC CATEGORY	28 NO OF STORIES 02.5
7 CITY OR TOWN KIRKWOOD, MO	17 DATE(S) OR PERIOD CA 1905	29 BASEMENT (Y/N) Y FULL (Y/N) Y
8 SITE PLAN WITH NORTH ARROW  SEE MAP	18 STYLE OR DESIGN ECLECTIC DUTCH COLONIAL REVIV	30 FOUNDATION MATERIAL STONE/DRESSED
	19 ARCHITECT OR ENGINEER	31 WALL CONSTRUCTION FRAME
	20 CONTRACTOR OR BUILDER	32 ROOF TYPE & MATERIAL GAMBREL ASPHALT SHINGLES
	21 ORIGINAL USE, IF APPARENT SINGLE FAMILY RESIDENCE	33 NO. OF BAYS FRONT 4 SIDE 3
	22 PRESENT USE SINGLE FAMILY RESIDENCE	34 WALL TREATMENT WOOD HORIZONTAL LAP SIDING
		35 PLAN SHAPE IRREGULAR
	23 OWNERSHIP PUBLIC PRIVATE X	36 CHANGES ADDITION X (EXPLAIN ALTERED X IN #42) MOVED
9 COORDINATES LOT LANG	24 OWNER'S NAME & ADDRESS (IF KNOWN)	37 CONDITION INTERIOR EXTERIOR GOOD

10 SITE STRUCTURE BUILDING X OBJECT	25 OPEN TO PUBLIC (YES/NO) N	38 PRESERVATION UNDERWAY? (Y/N) N
11 ON NAT'L REG? (YES/NO) N	12 IS IT ELIGIBLE? (YES/NO)	39 ENDANGERED (YES/NO) N BY WHAT?
13 PART OF HIST DIST (YES/NO) N	14 DIST POTENT (YES/NO)	40 VISIBLE FROM PUBLIC ROAD ? (YES/NO) Y
15 NAME OF ESTABLISHED DISTRICT		41 DISTANCE FROM AND FRONTAGE ON ROAD
42 FURTHER DESCRIPTION OF IMPORTANT FEATURES SEE CONTINUATION SHEET		PHOTO
43 HISTORY AND SIGNIFICANCE SEE CONTINUATION SHEET		46 PREPARED BY LINDA STOCKMAN
44 DESCRIPTION OF ENVIRONMENT AND OUTBUILDINGS SEE CONTINUATION SHEET		47 ORGANIZATION KIRKWOOD LANDM COMM.
45 SOURCES OF INFORMATION SEE CONTINUATION SHEET		48 DATE 06/86   49 REVISION DATE(S)

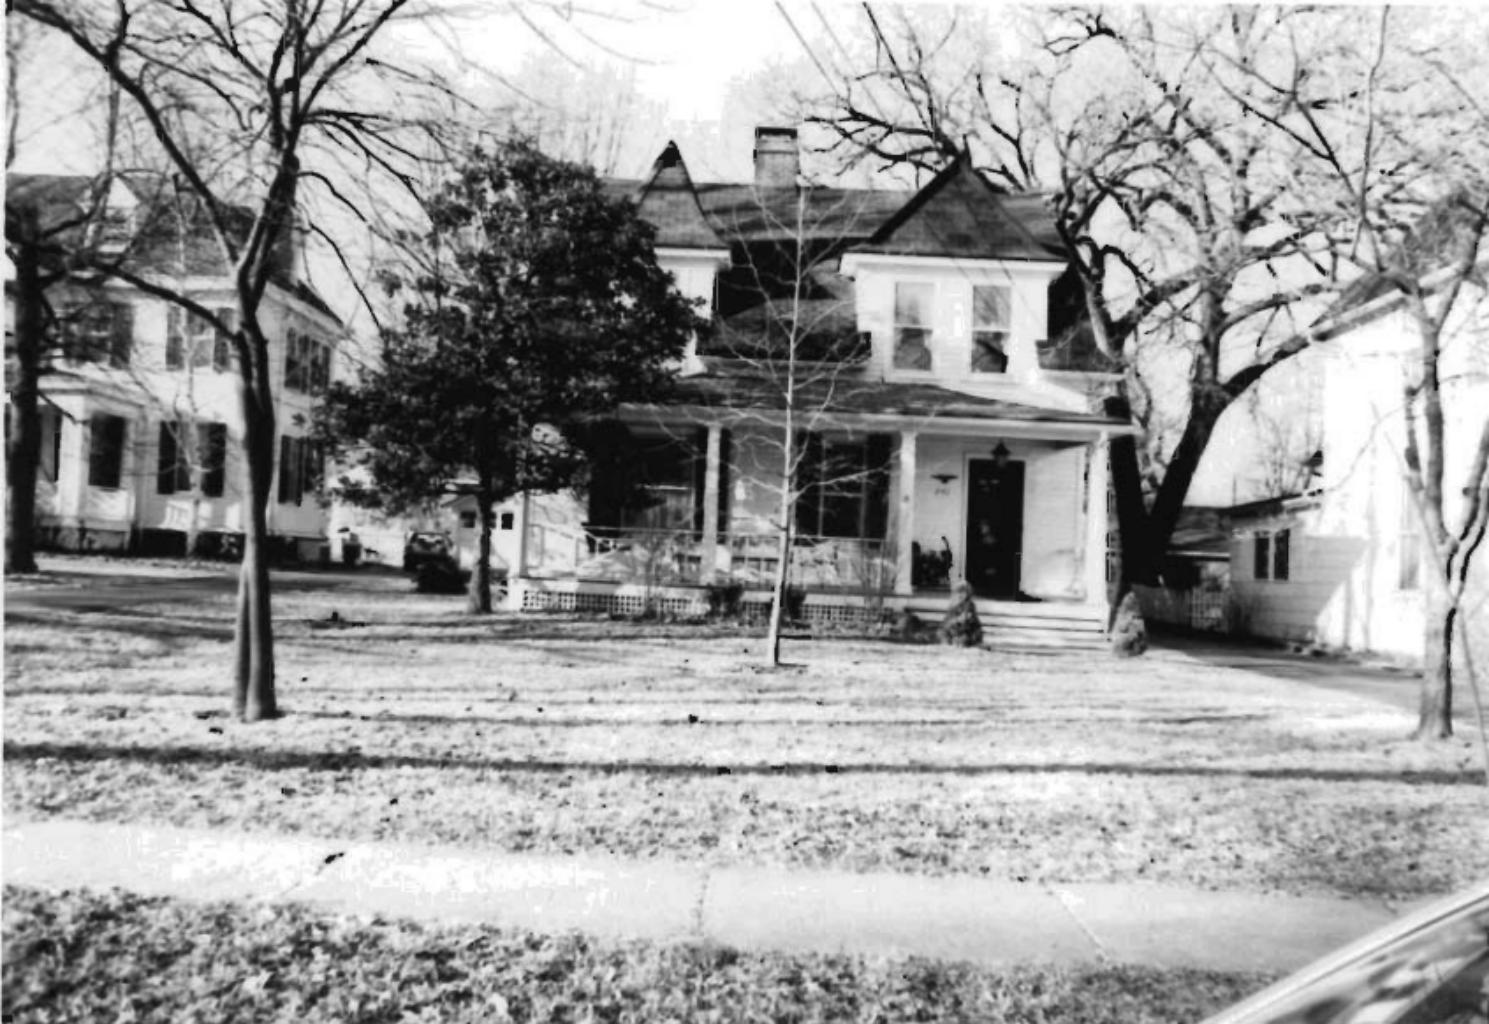
241 E. Argonne

The prominent features of this building are its side gambrel, its dormers with articulated ridgelines and its veranda. On the facade an open-frame wood veranda features a wood balustrade of geometric design and a low hipped roof. The entry is offset to the east, and a new wooden door is in place. The first level facade windows are wood with wood sash, double-hung, two over two, flat-topped, with wood sills and wood shutters. The dormer windows are wood with wood sash, double-hung, one over one, flat-topped, with plain wood surrounds. The roofline features a plain boxed cornice. There is central chimney.

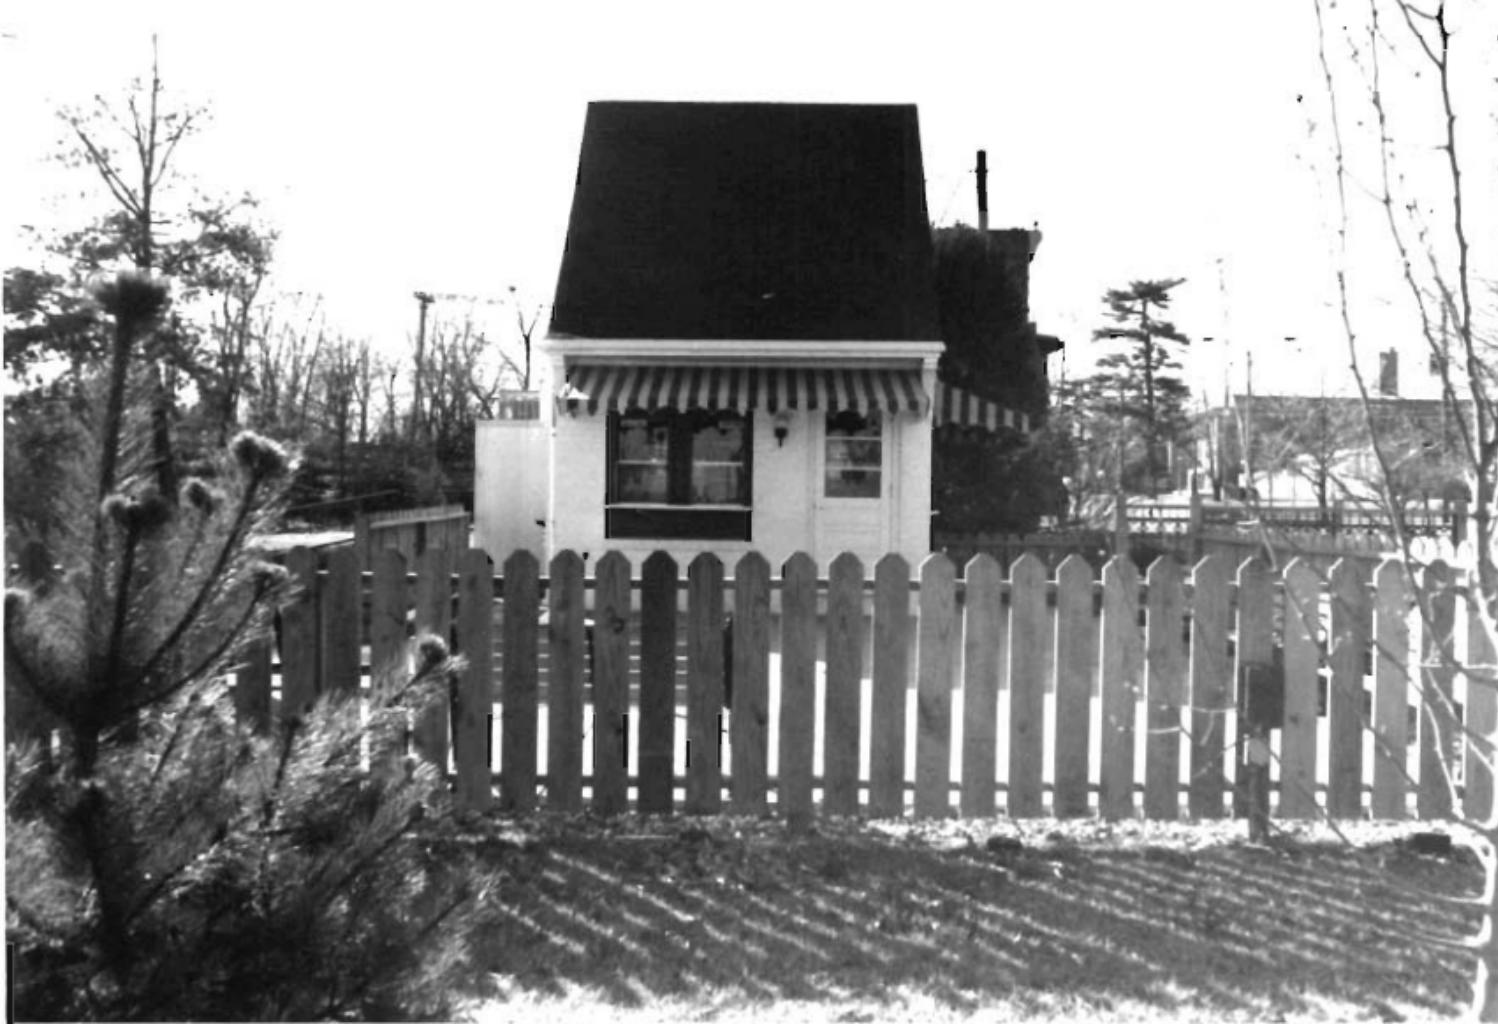
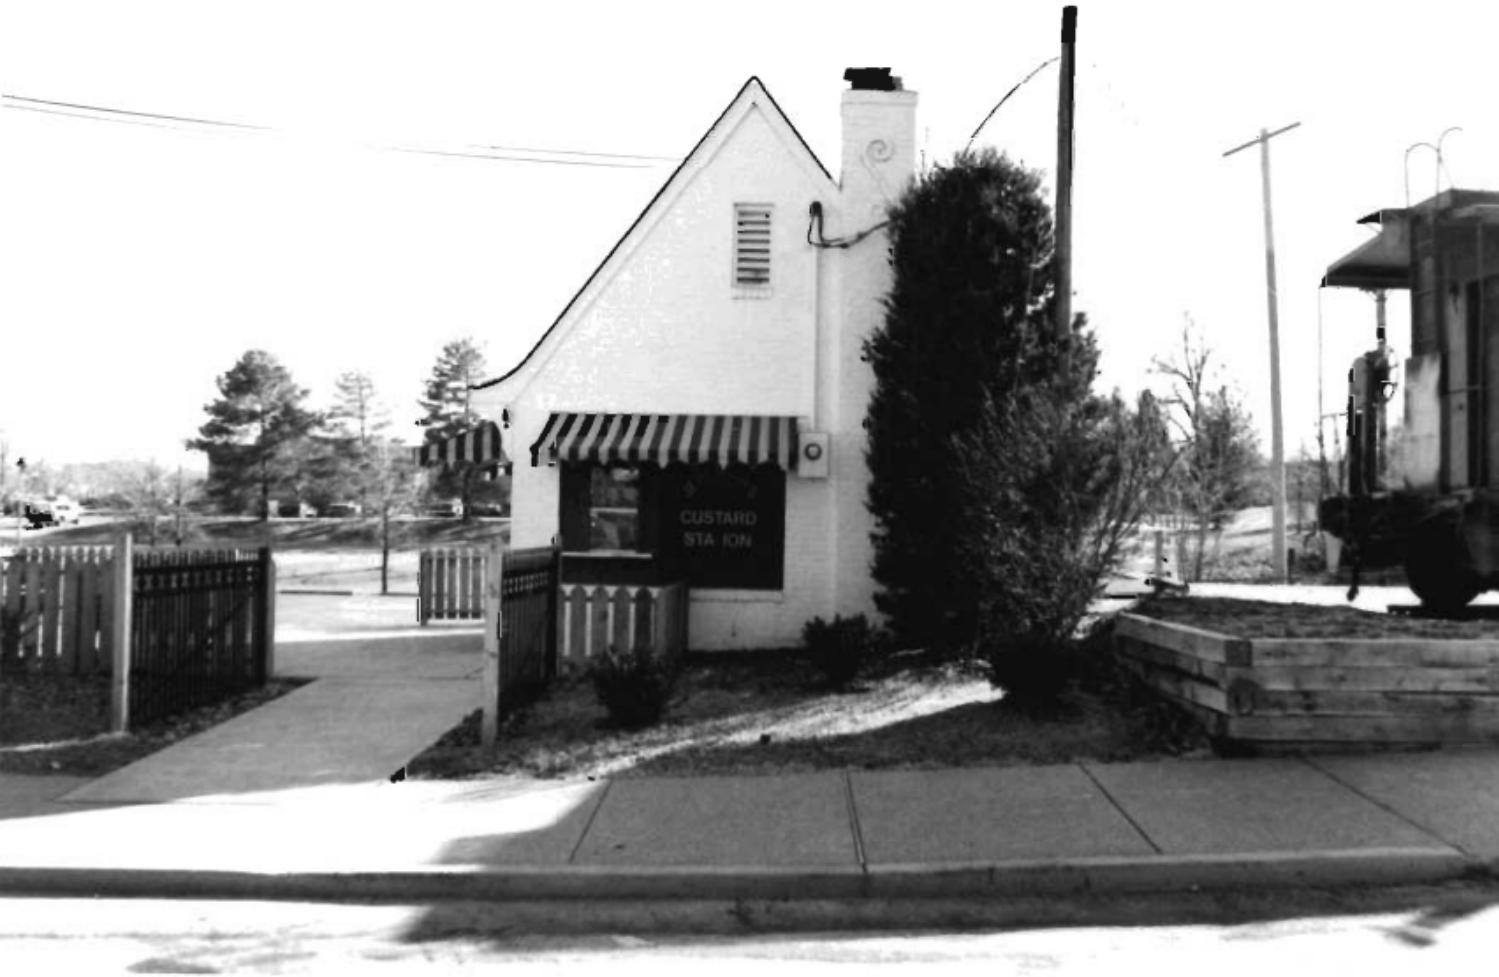
This building is dominated by its steeply pitched gable. It features an exterior chimney on its street elevation. Rather than being oriented toward the street, it is facing east. A slight sweeping cornice overhang on the east elevation serves as a small protective covering for the entry and a window. The entry contains a single-leaf wood door. To its south is a wide window opening with a brick soldier-course sill which is now filled with two order windows with stainless steel counters. Both the door and the order windows are covered by a canvas awning. The north elevation also contains a wide window opening with a brick soldier-course sill which is now filled with one order window with a stainless steel counter. It also contains a wood panel with the words "Jecemiah's Custard Station." There is a canvas awning in place above this window opening. There is a rectangular louvered ventilation opening in the gable. The gable roofline does not project.
