**HISTORIC INVENTORY**

Presbyterian Church Tower Park  
100 E. Adams

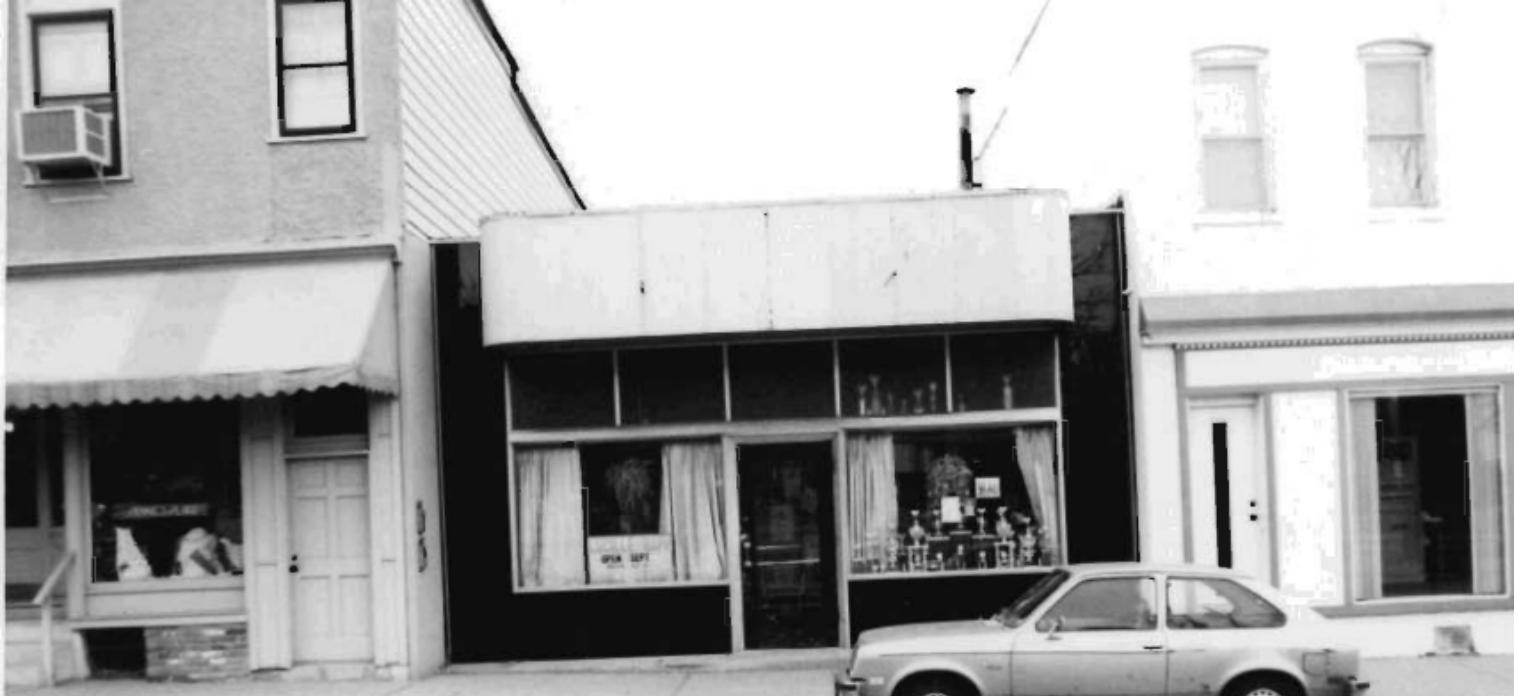
153 W. Argonne/Main

The facade of this building features a central wood single-leaf door containing a large single pane of glass flanked by large plate-glass storefront windows. A five light transom spans the storefront; containing semi-transparent panels. Metal siding covers a curved projection - probably once a marquis. Vitrolite panels are in place below the windows and at the corners of the facade.

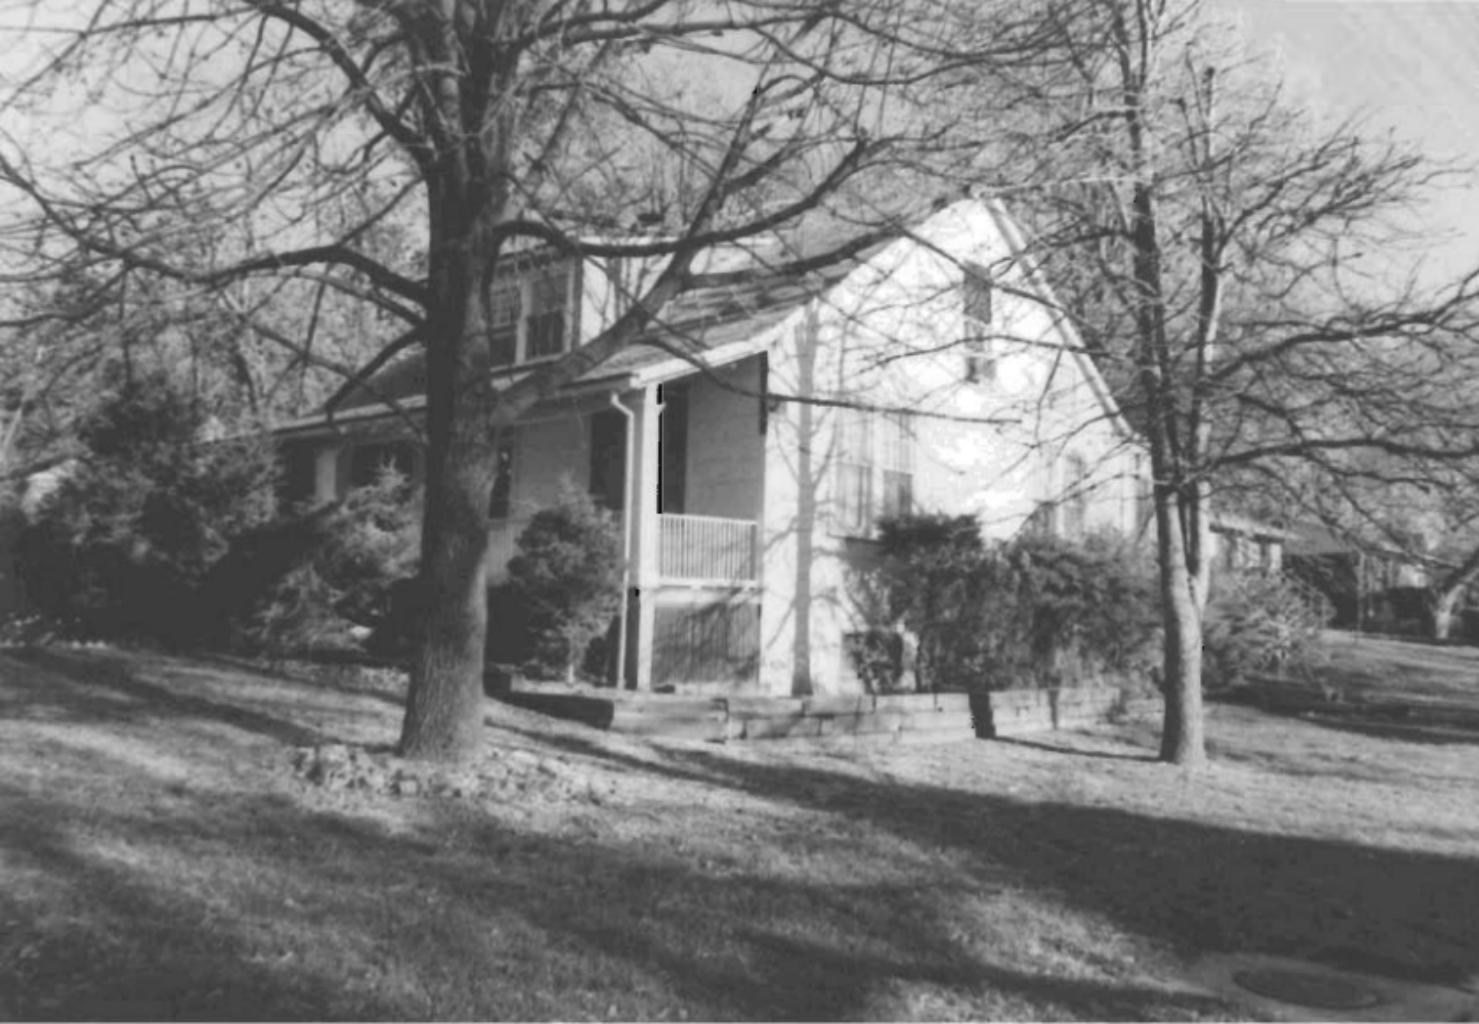
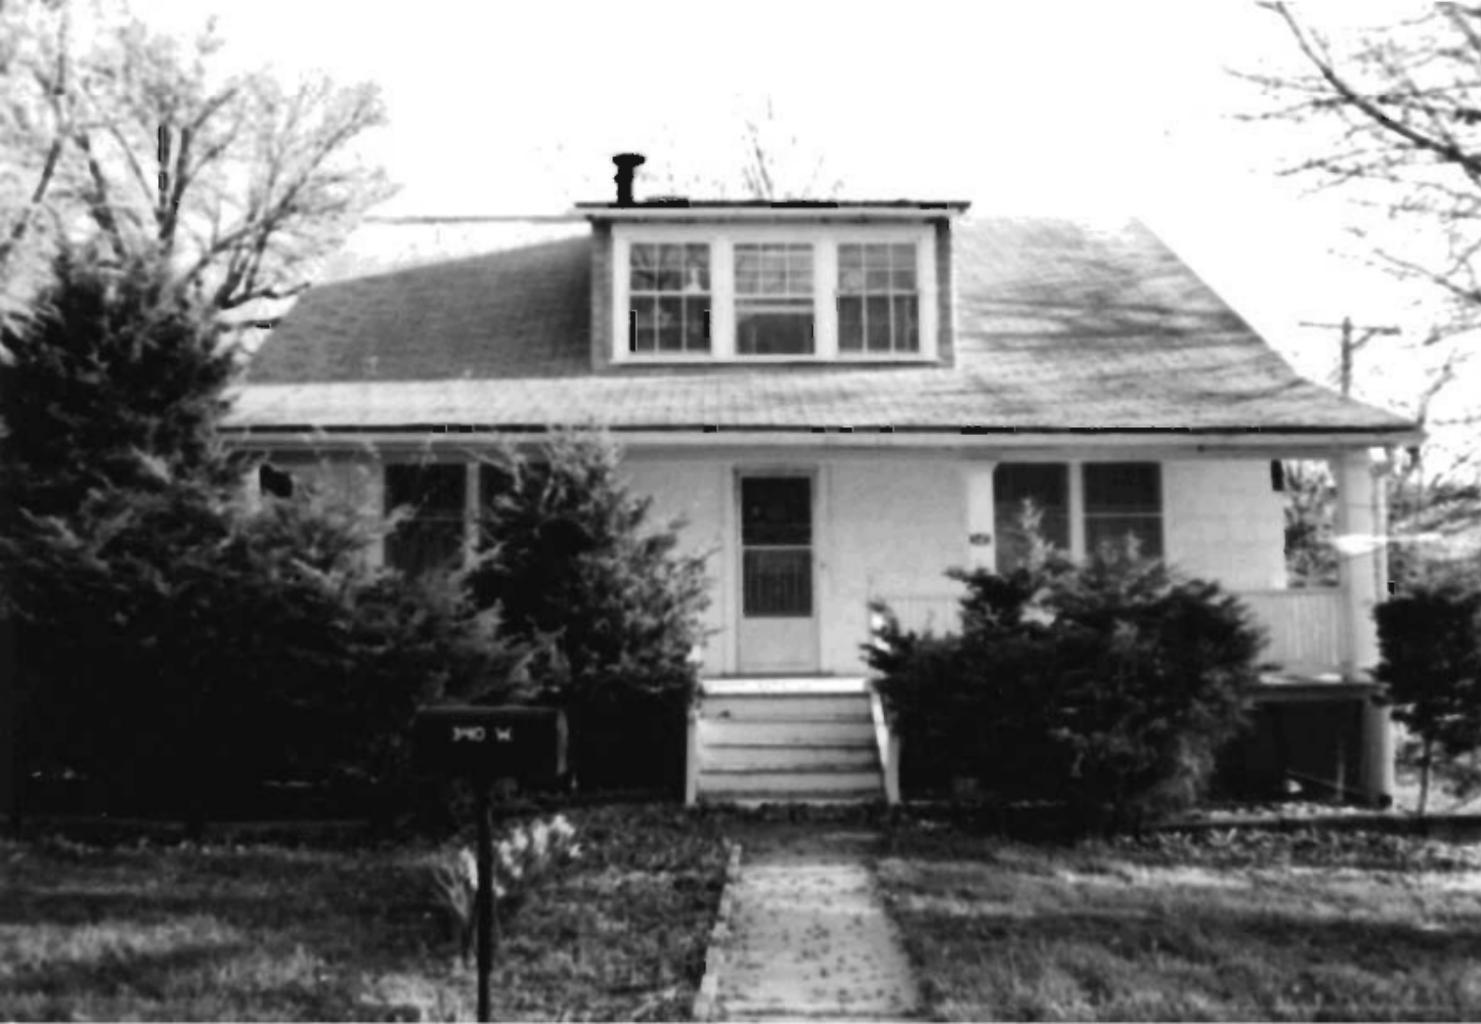
340 W. Jefferson

The prominent features of this building are: its low side bellcast gables; its projecting eaves with plain boxed cornice; its shed dormer with exposed rafters; and its veranda which spans the entire facade. A central facade entry contains a wood single-leaf door with a tracery window in the top half of the door. The door is now covered by an aluminum storm door. The facade first floor double windows are wood with wood sash, double-hung, eight over one, flat-topped, with plain wood lintels and wood sills. The dormer windows are triple with wood mullions, wood with wood sash, double-hung, six over six, flat-topped, with wood surrounds and lintels and wood sill. The facade veranda's roof is a continuation of the building's roof. It rests on wood posts and has a wood floor and stairs.

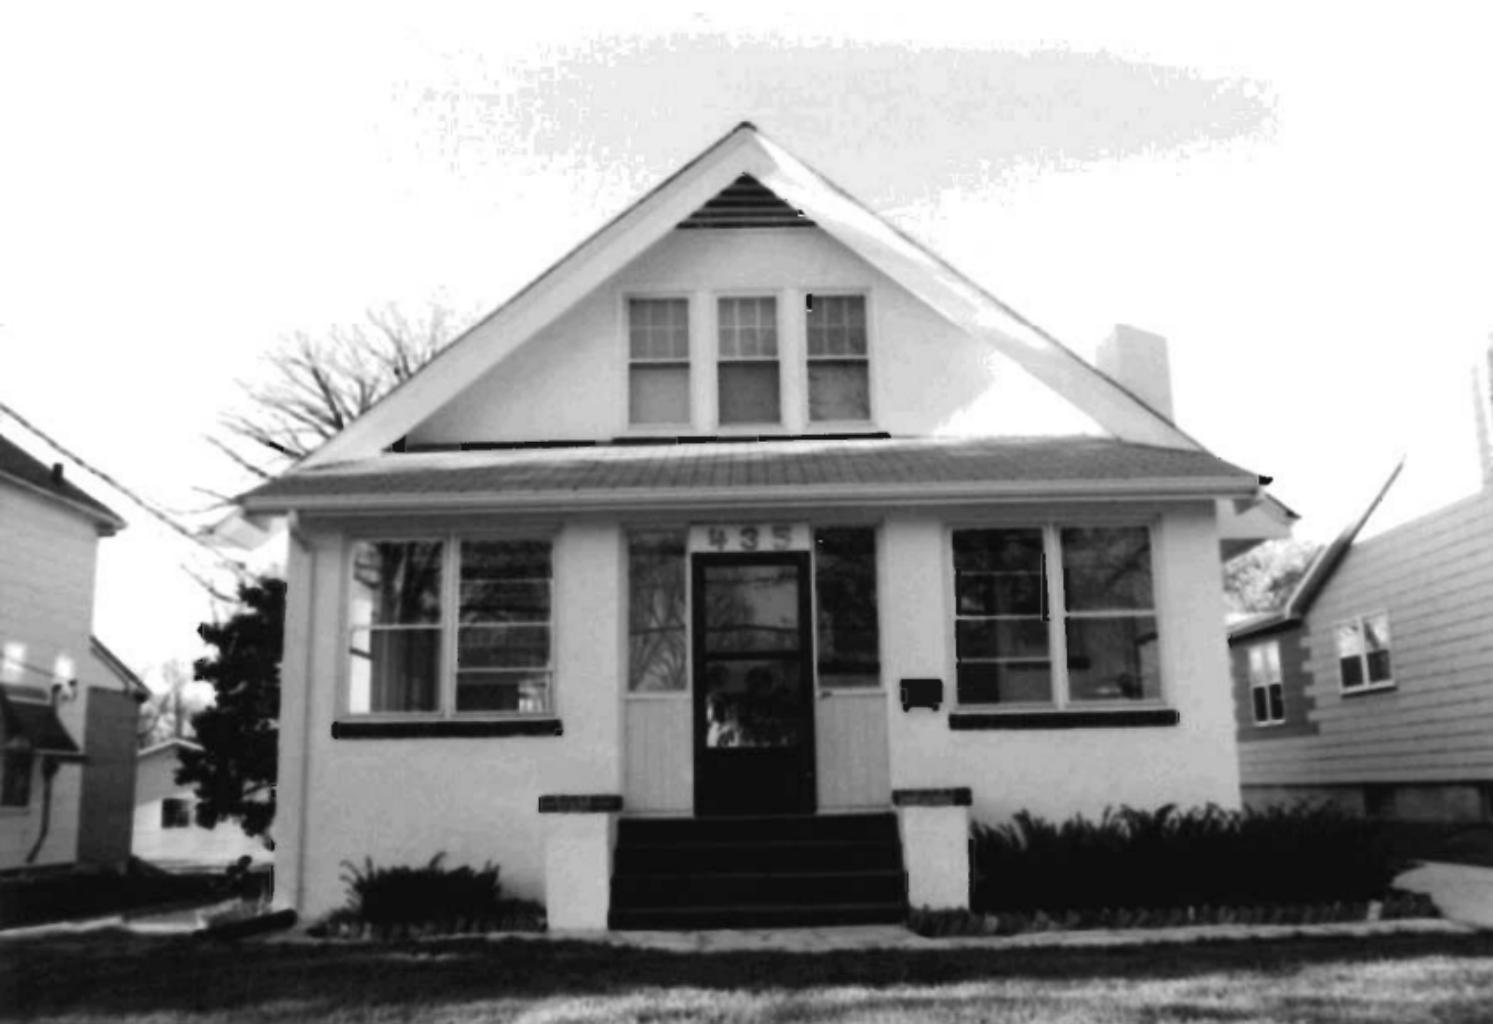
1 NC 2142 LOCAL #	4 PRESENT NAME(S)	
2 COUNTY ST. LOUIS	5 OTHER NAME(S) LINDA STOCKMAN	
6 SPECIFIC LOCATION 435 W. ARGONNE/MAIN	10 THEMATIC CATEGORY	28 NO OF STORIES 01.5
7 CITY OR TOWN KIRKWOOD, MO	17 DATE(S) OR PERIOD CA 1920	29 BASEMENT (Y/N) Y FULL (Y/N) Y
8 SITE PLAN WITH NORTH ARROW  SEE MAP	13 STYLE OR DESIGN ECLECTIC BUNGALOW	30 FOUNDATION MATERIAL CONCRETE
	19 ARCHITECT OR ENGINEER	31 WALL CONSTRUCTION FRAME
	20 CONTRACTOR OR BUILDER	32 ROOF TYPE & MATERIAL GABLE ASPHALT SHINGLES
	21 ORIGINAL USE, IF APPARENT SINGLE FAMILY RESIDENCE	33 NO. OF BAYS FRONT 3 SIDE 4
	22 PRESENT USE SINGLE FAMILY RESIDENCE	34 WALL TREATMENT STUCCO
9 COORDINATES LOT LANG		35 PLAN SHAPE IRREGULAR
10 SITE STRUCTURE BUILDING X OBJECT	23 OWNERSHIP PUBLIC PRIVATE X	36 CHANGES IN ADDITION X (EXPLAIN ALTERED IN #42) MOVED
11 ON NAT'L REG? (YES/NO) N	12 IS IT ELIGIBLE? (YES/NO)	37 CONDITION INTERIOR EXTERIOR GOOD
13 PART OF HIST DIST (YES/NO) N	14 DIST POTENT (YES/NO) Y	38 PRESERVATION UNDERWAY? (Y/N) N

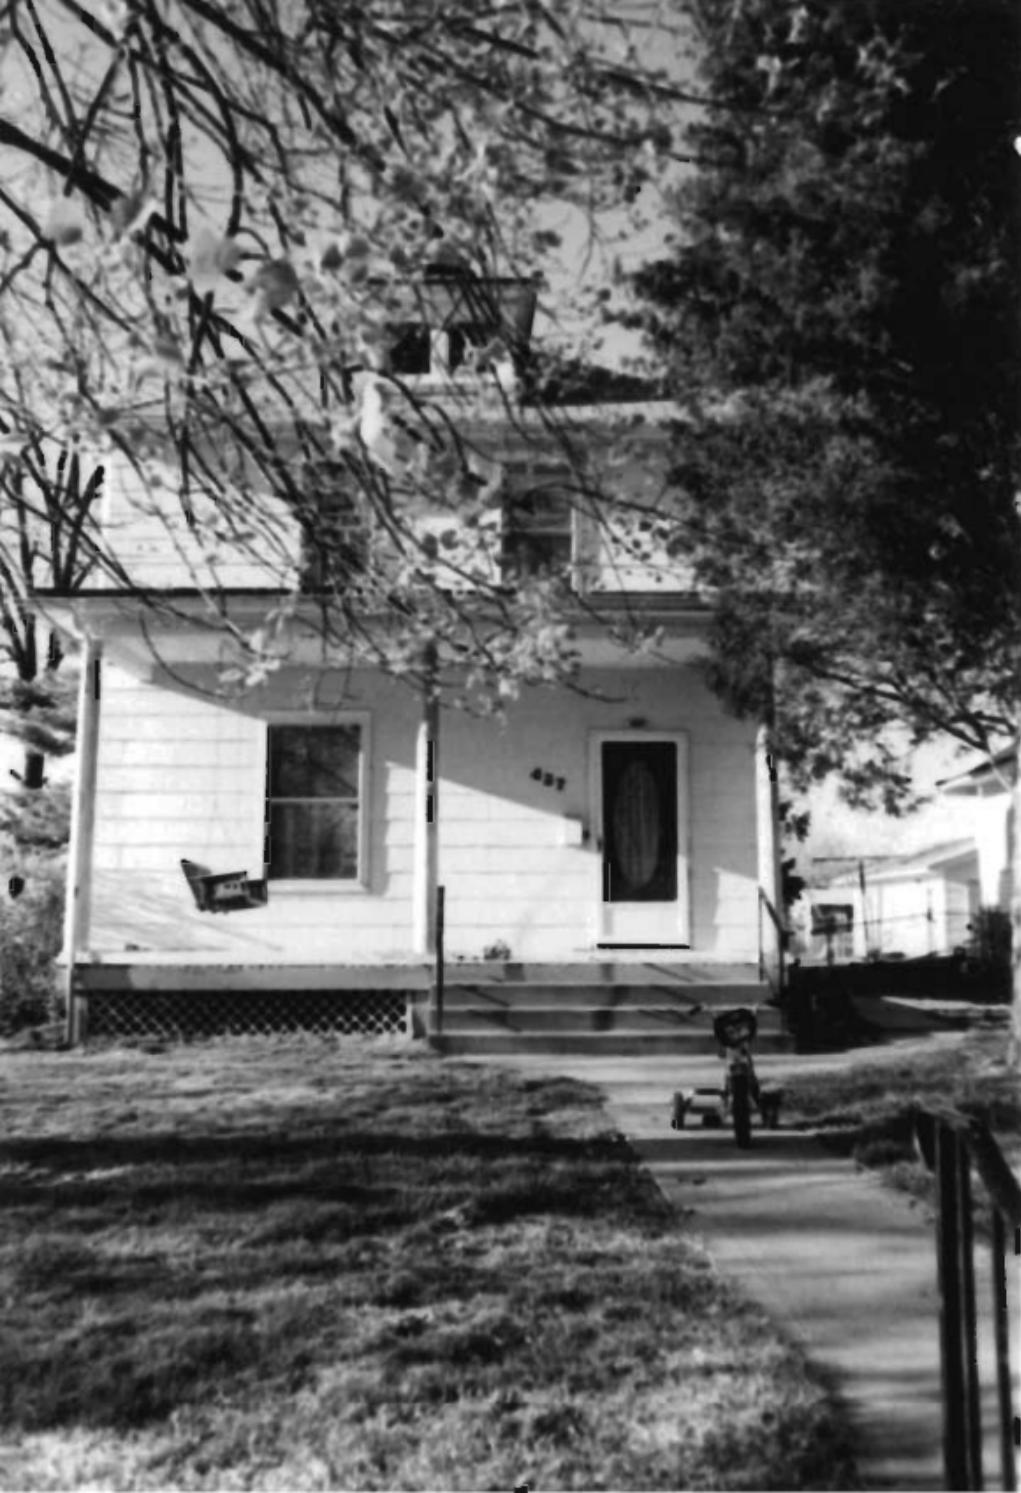
1 NO 2130 LOCAL 4 2 COUNTY 3 LOCATION OF NEGATIVES ST. LOUIS LINDA STOCKMAN	4 PRESENT NAME(S)  5 OTHER NAME(S)	
6 SPECIFIC LOCATION 437 W. ARGONNE/MAIN	16 THEMATIC CATEGORY  17 DATE(S) OR PERIOD CA 1905	28 NO OF STORIES 2.5 29 BASEMENT (Y/N) Y FULL (Y/N) Y
7 CITY OR TOWN KIRKWOOD, MO	18 STYLE OR DESIGN ECLECTIC AMERICAN FOLK SQUARE	30 FOUNDATION MATERIAL STONE/CONCRETE BLOCK
8 SITE PLAN WITH NORTH ARROW  SEE MAP	19 ARCHITECT OR ENGINEER  20 CONTRACTOR OR BUILDER	31 WALL CONSTRUCTION FRAME  32 ROOF TYPE & MATERIAL MEDIUM HIP ASPHALT SHINGLES
	21 ORIGINAL USE, IF APPARENT SINGLE FAMILY RESIDENCE	33 NO. OF BAYS FRONT 2 SIDE 3
	22 PRESENT USE SINGLE FAMILY RESIDENCE	34 WALL TREATMENT ASBESTOS SHINGLES
9 COORDINATES LOT LANG	23 OWNERSHIP PUBLIC PRIVATE X	35 PLAN SHAPE IRREGULAR
10 SITE STRUCTURE BUILDING X OBJECT	24 OWNER'S NAME & ADDRESS (IF KNOWN)	36 CHANGES ADDITION X (EXPLAIN ALTERED IN #42) MOVED

11 ON NAT'L REG? N (YES/NO)	25 OPEN TO PUBLIC (YES/NO) N	37 CONDITION INTERIOR EXTERIOR GOOD
12 IS IT ELIGIBLE? (YES/NO) Y	26 LOCAL CONTACT PERSON OR ORGANIZATION	38 PRESERVATION UNDERWAY? (Y/N) N
13 PART OF HIST DIST N (YES/NO)	27 OTHER SURVEYS IN WHICH INCLUDED	39 ENDANGERED (YES/NO) N BY WHAT?
15 NAME OF ESTABLISHED DISTRICT		40 VISIBLE FROM PUBLIC ROAD ? (YES/NO) Y
42 FURTHER DESCRIPTION OF IMPORTANT FEATURES SEE CONTINUATION SHEET		41 DISTANCE FROM AND FRONTAGE ON ROAD  PHOTO
43 HISTORY AND SIGNIFICANCE SEE CONTINUATION SHEET		42 PREPARED BY LINDA STOCKMAN
44 DESCRIPTION OF ENVIRONMENT AND OUTBUILDINGS. SEE CONTINUATION SHEET		47 ORGANIZATION KIRKWOOD LANDMARK COMM.
45 SOURCES OF INFORMATION SEE CONTINUATION SHEET		48 DATE 06/96 49 REVISION DATE(S)

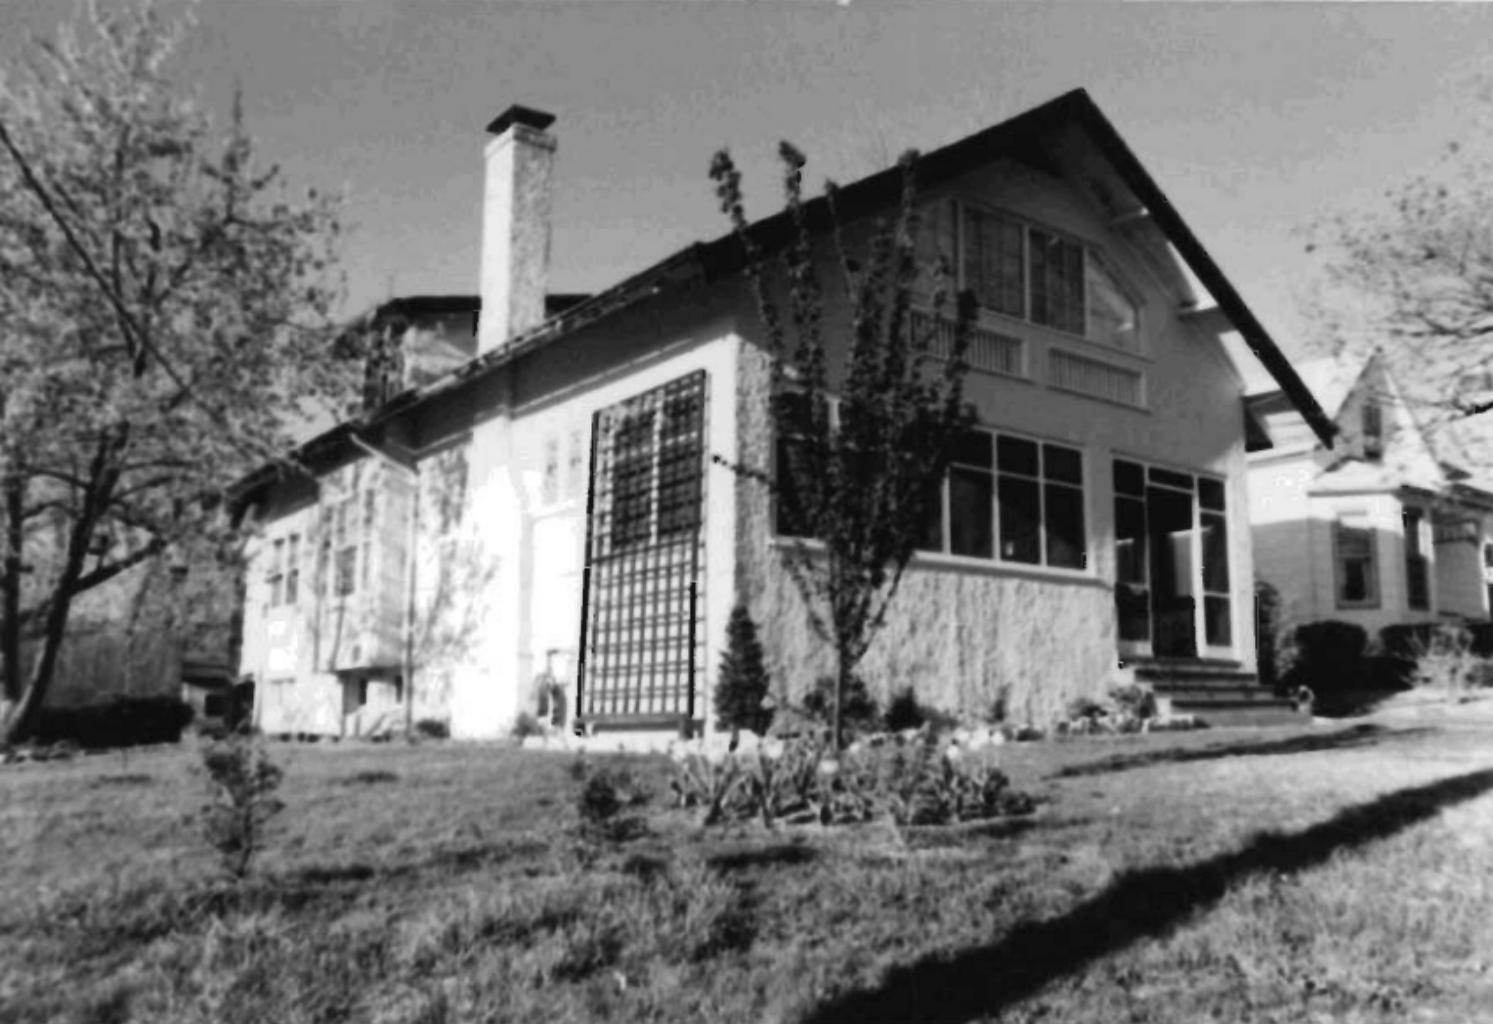
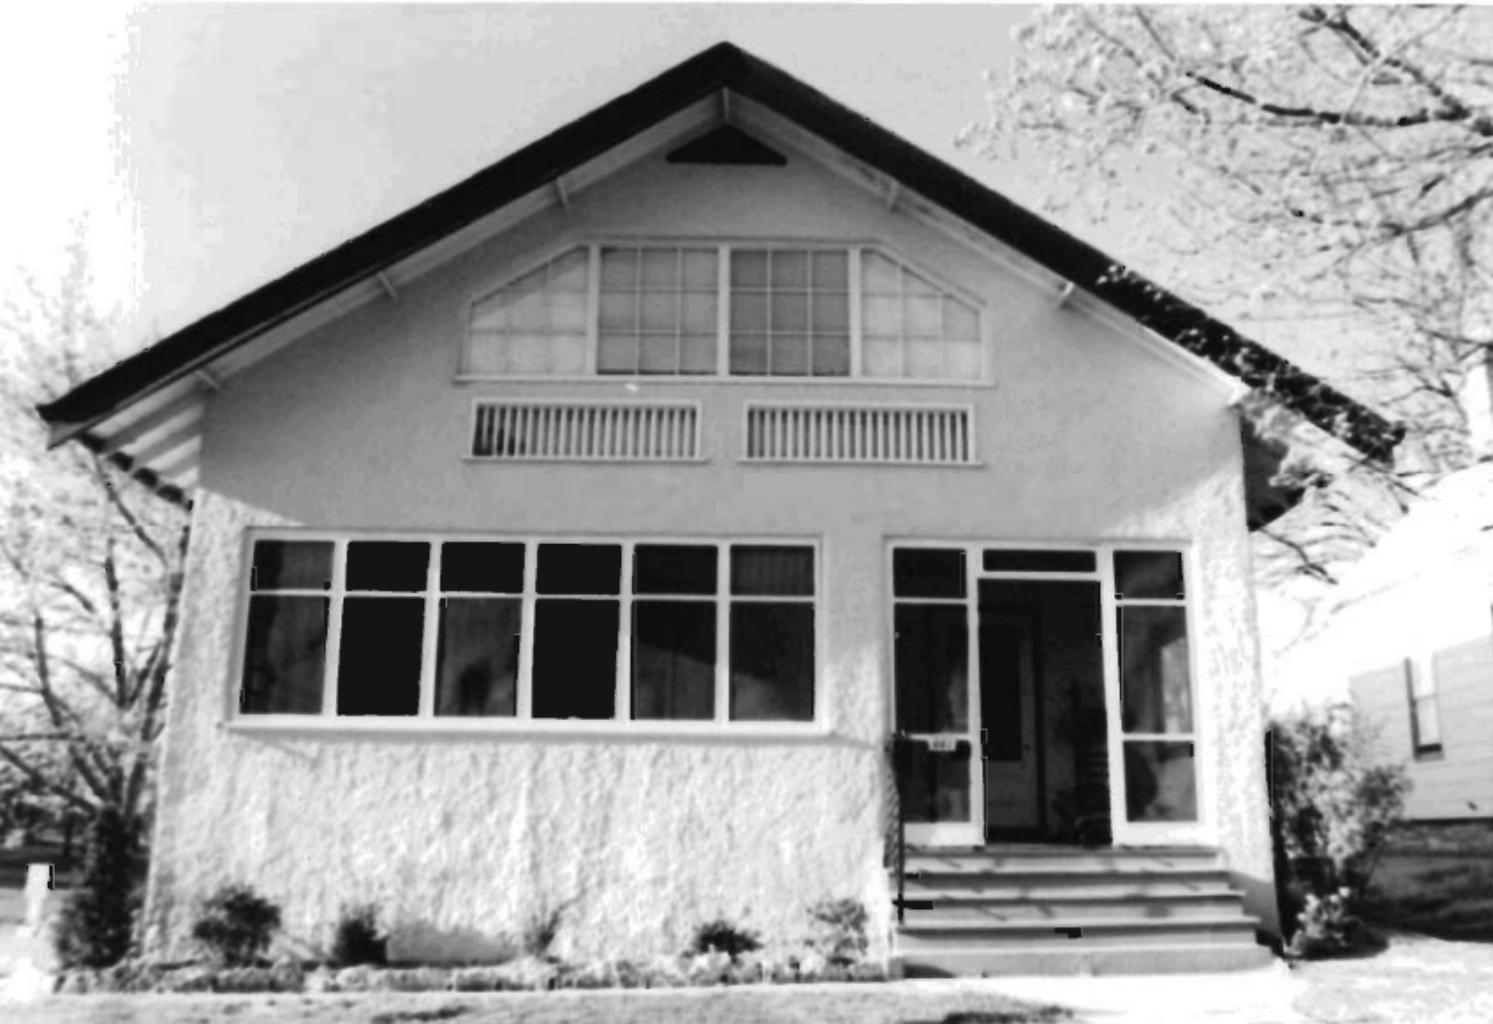
The prominent features of this house include: its greatly overhanging eaves with exposed rafters; its bands of windows; its screened-in facade porch; and its stain-glass and oriel window on the west elevation. The facade porch contains wood-frame screens. The facade entry is off-center toward the west and contains a single-leaf wood door with multi-lights. The double window to the west of the entry is wood with wood sash, double-hung, eight over one, flat-topped, with wood sill, surrounds and mullion. The attic level of the facade features two eyebrow windows, each containing four lights and covered with wood slats. Above these is a band of four windows. The center two have flat tops, and they are flanked by similar windows whose tops have been angled to conform with the pitch of the roof. These windows are wood with wood mullions, surrounds and sill. They contain multi-lights.

1 NO. 2102 LOCAL #	4 PRESENT NAME(S)	
2 COUNTY ST. LOUIS	5 OTHER NAME(S) LINDA STOCKMAN	
3 LOCATION OF NEGATIVES		
6 SPECIFIC LOCATION 441 W. ARGONNE/MAIN	16 THEMATIC CATEGORY	23 NO OF STORIES 31.5
7 CITY OR TOWN KIRKWOOD, MO	17 DATE(S) OR PERIOD CA 1920	29 BASEMENT (Y/N) Y FULL (Y/N) Y
8 SITE PLAN WITH NORTH ARROW SEE MAP	18 STYLE OR DESIGN ECLECTIC BUNGALOW	30 FOUNDATION MATERIAL CONCRETE
	19 ARCHITECT OR ENGINEER	31 WALL CONSTRUCTION FRAME
	20 CONTRACTOR OR BUILDER	32 ROOF TYPE & MATERIAL GABLE ASPHALT SHINGLES
	21 ORIGINAL USE, IF APPARENT SINGLE FAMILY RESIDENCE	33 NO. OF BAYS FRONT 2 SIDE 5
	22 PRESENT USE SINGLE FAMILY RESIDENCE	34 WALL TREATMENT STUCCO
		35 PLAN SHAPE IRREGULAR
	23 OWNERSHIP PUBLIC PRIVATE X	36 CHANGES / ADDITION (EXPLAIN ALTERED IN #42) MOVED
9 COORDINATES LOT LANG	24 OWNER'S NAME & ADDRESS (IF KNOWN)	37 CONDITION INTERIOR EXTERIOR GOOD
10 SITE STRUCTURE BUILDING X OBJECT	25 OPEN TO PUBLIC (YES/NO) N	38 PRESERVATION UNDERWAY? (Y/N) N

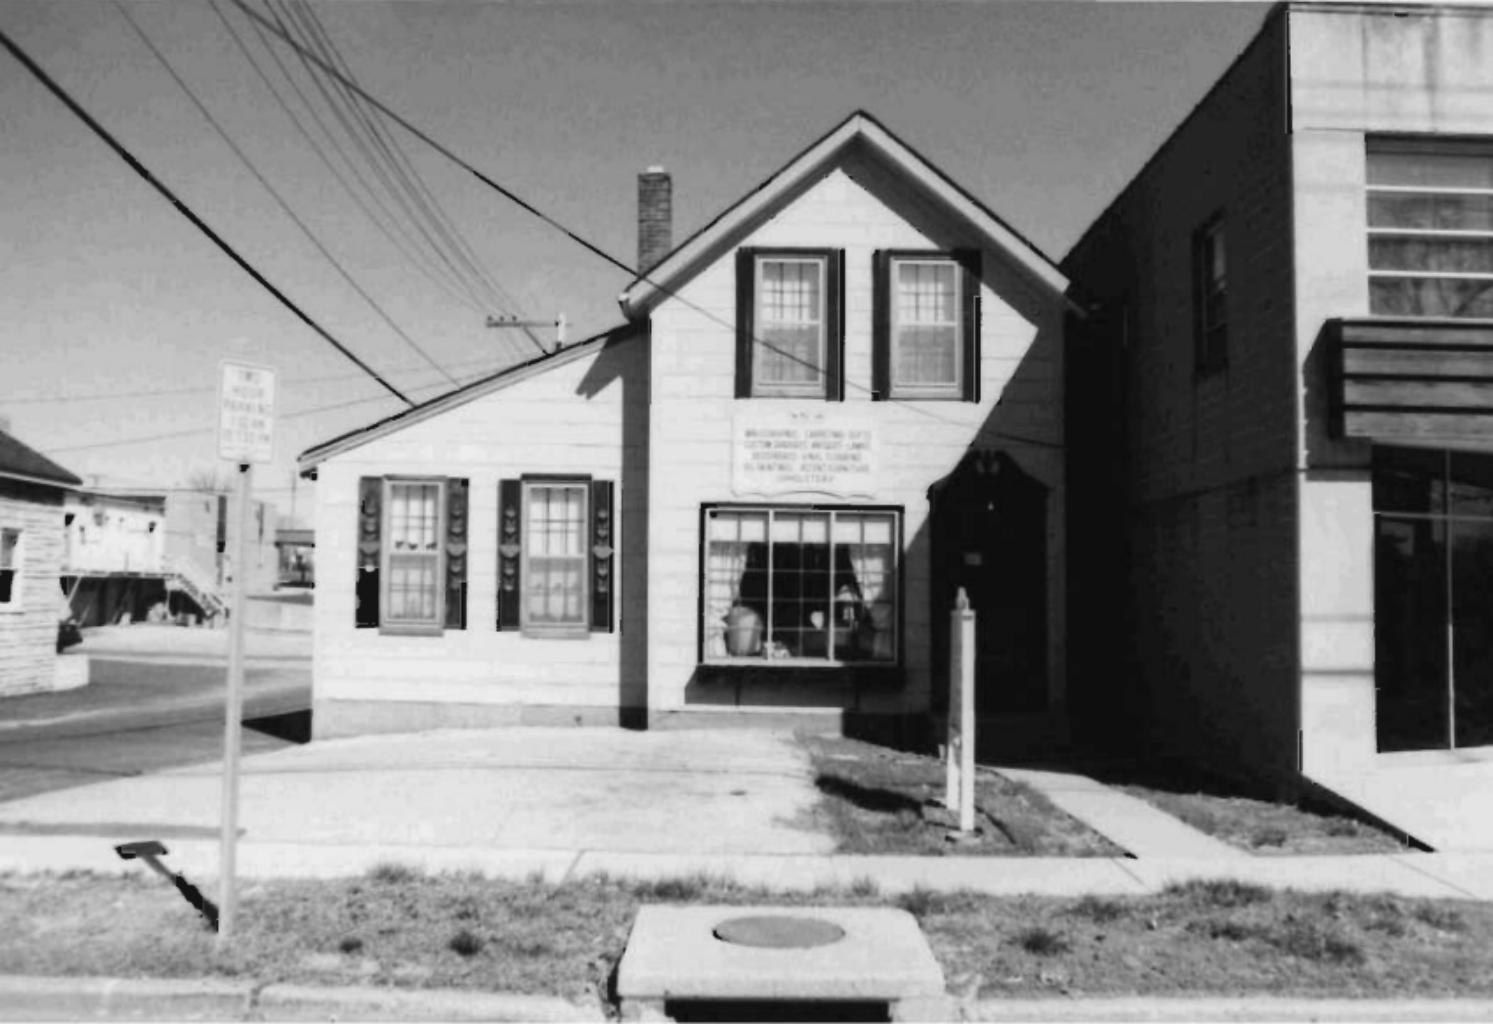
This building is of the I-house-plus-shed-addition plan. It is dominated by its front-facing gable which is somewhat unusual in a suburban setting. It also features multi-paned windows and a Colonial facade entry. The facade entry is off-center toward the south. It features a flush door and framework. The door is a single-leaf wood panel door with two small lights at the top. It is covered by an aluminum storm door. Its surrounds are fluted pilasters, and it is topped by a simple wood entablature with a flat broken pediment. A concrete stoop and stair access this entry. The large window to the north of the entry is a stationary wood window. It is flat-topped, with plain wood molding, a wood planter box and thirty lights. Three fixed aluminum storm windows cover this window. The remainder of the facade windows are wood with wood sash, double-hung, flat-topped, six over six, with plain wood molding and wood slipsills. They are flanked by decorative wood shutters and covered by aluminum storm sash. The roofline of the gable features a projecting plain boxed cornice. The facade roofline of the shed addition does not project, but the roofline does project slightly on the north elevation of the shed addition.

1 NO 2129 LOCAL #	4 PRESENT NAME(S)	
2 COUNTY ST. LOUIS	5 OTHER NAME(S) LINDA STOCKMAN	
6 SPECIFIC LOCATION 212 W. CLAY	10 THEMATIC CATEGORY	28 NO OF STORIES 01.5
7 CITY OR TOWN KIRKWOOD, MO	17 DATE(S) OR PERIOD CA 1890	29 BASEMENT (Y/N) Y FULL (Y/N) Y
8 SITE PLAN WITH NORTH ARROW SEE MAP	18 STYLE OR DESIGN NATIONAL FOLK	30 FOUNDATION MATERIAL CONCRETE/STONE
	19 ARCHITECT OR ENGINEER	31 WALL CONSTRUCTION FRAME
	20 CONTRACTOR OR BUILDER	32 ROOF TYPE & MATERIAL GABLE AND SHED ASPHALT SHINGLES
	21 ORIGINAL USE, IF APPARENT RESIDENCE/COMMERCIAL	33 NO. OF BAYS FRONT 4 SIDE 1
	22 PRESENT USE COMMERCIAL	34 WALL TREATMENT COMPOSITION SHINGLES
		35 PLAN SHAPE IRREGULAR
9 COORDINATES LOT LANG	23 OWNERSHIP PUBLIC PRIVATE X	36 CHANGES IN ADDITION X (EXPLAIN ALTERED IN #42) MOVED
	24 OWNER'S NAME & ADDRESS (IF KNOWN)	37 CONDITION INTERIOR EXTERIOR GOOD
	25 OPEN TO PUBLIC (YES/NO) N	38 PRESERVATION UNDERWAY? (Y/N) N

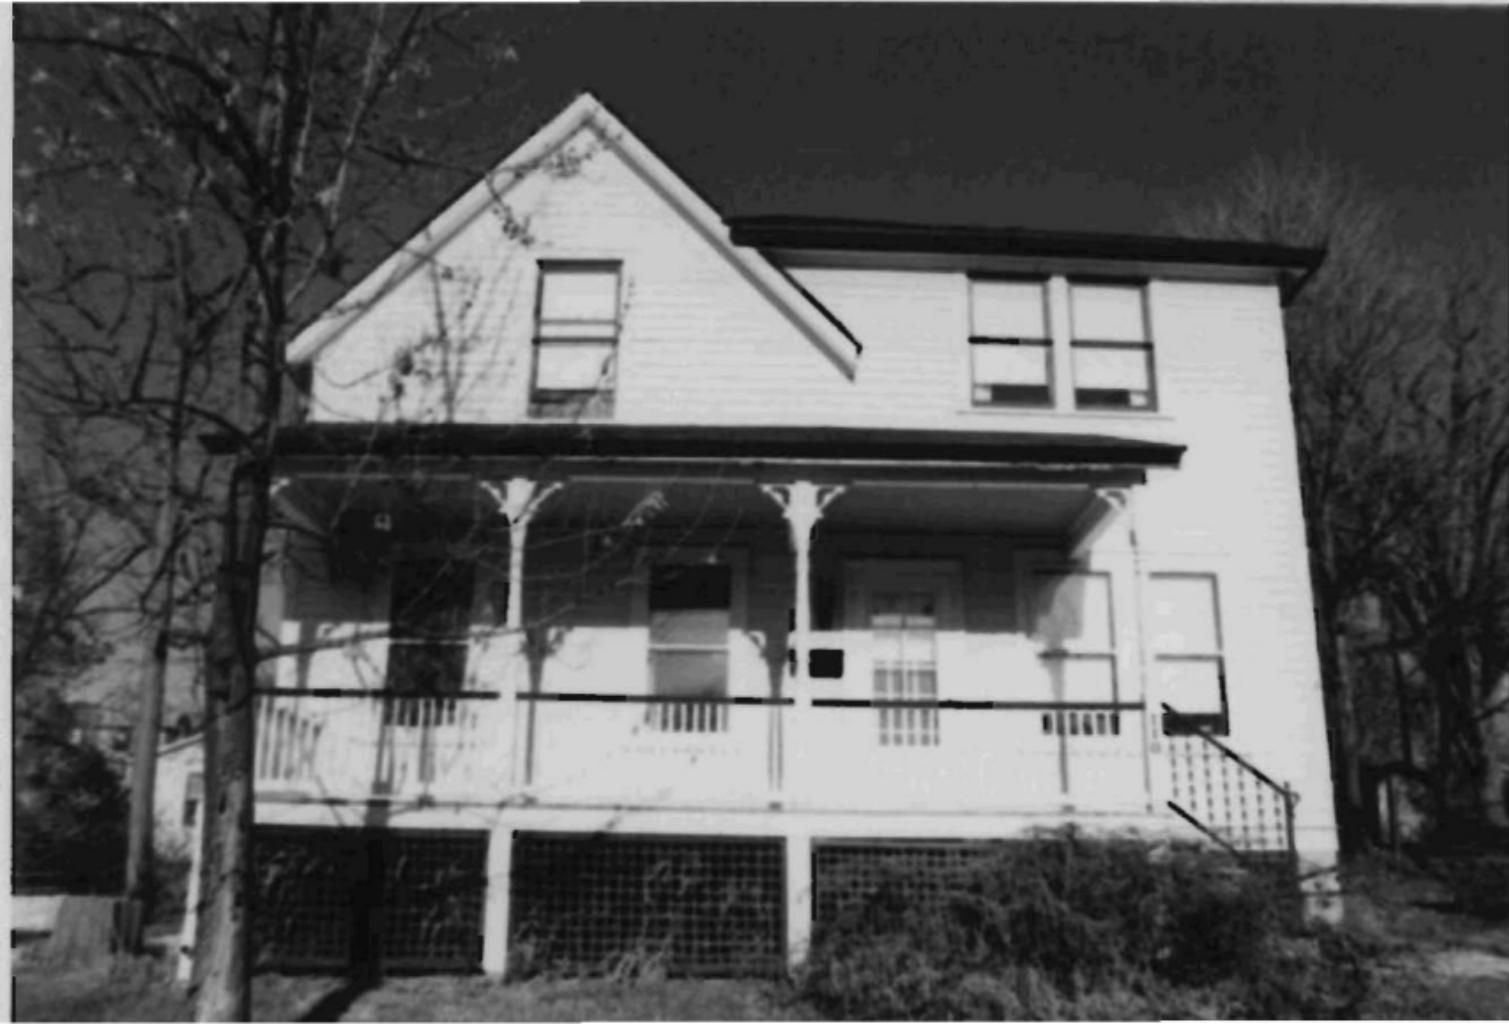
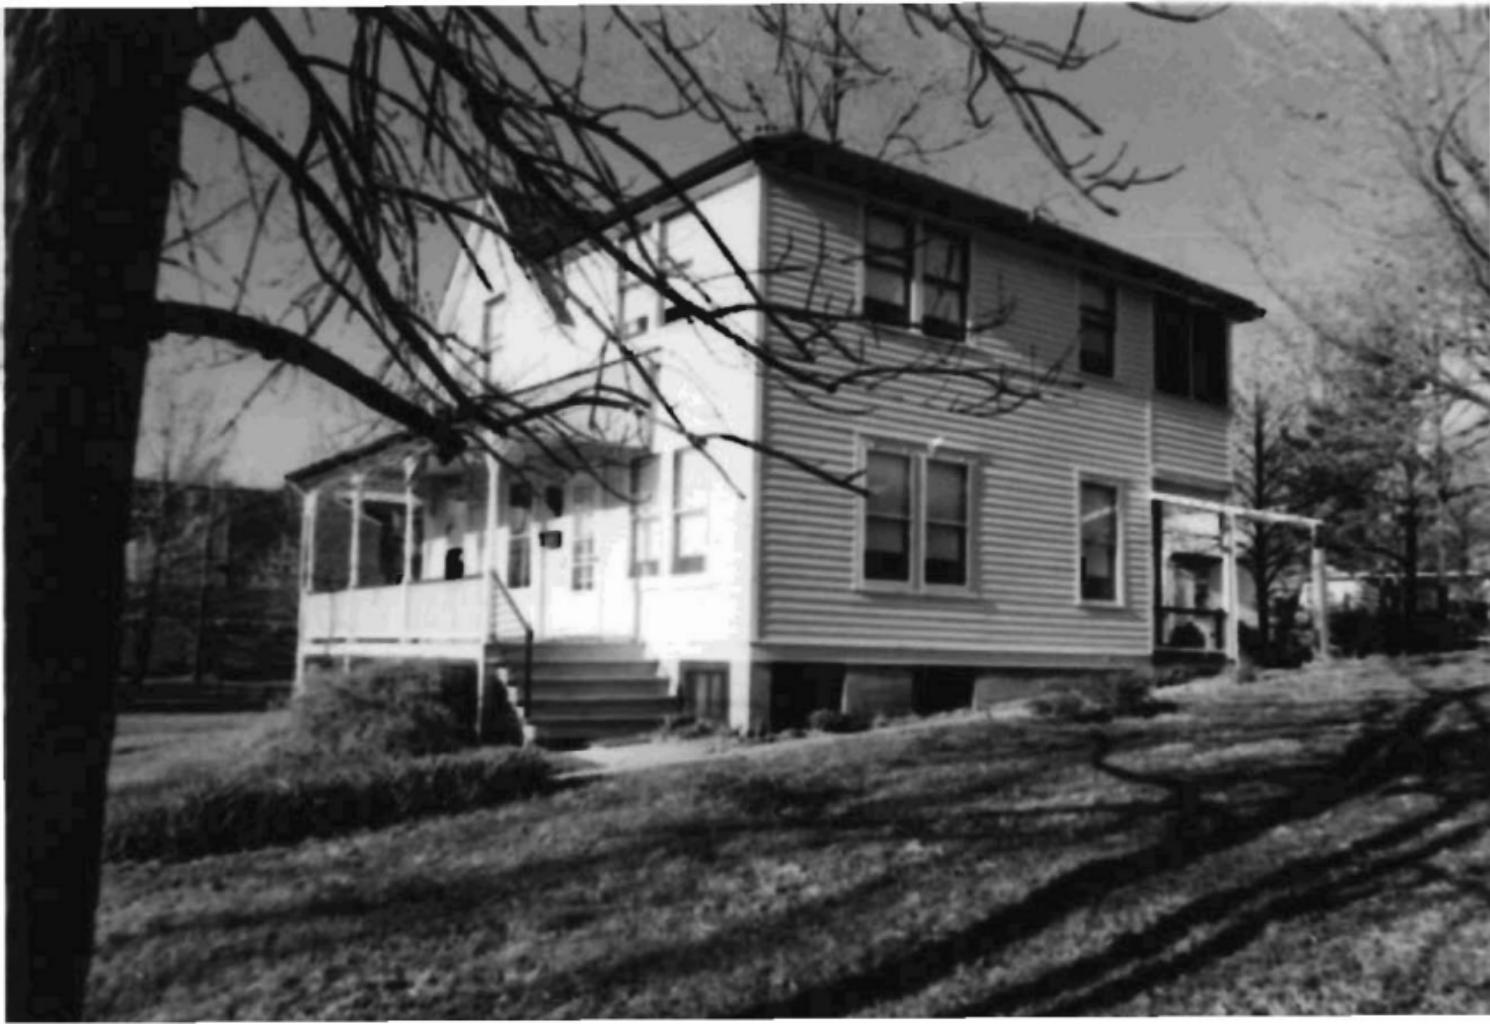
This house has been greatly expanded because of a two story addition toward the south. The original structure's foundation material is stone, while the addition's foundation material is concrete. The prominent features of this building include its interesting roofline with intersecting gable and truncated hip and its open-frame facade veranda. The facade veranda has a shed roof which rests on turned wood posts, eastlake details, a wood balustrade, floor and stairs and a wrought iron stair railing. The facade entrance is slightly off-center toward the south and contains a single-leaf wood door with multi-lights and decorative wood surrounds and lintel. The door is covered by a wood screen door. The facade windows are wood with wood sash, double-hung, flat-topped, one over one, with wood surrounds, lugsills and lintels. The roofline features a projecting plain boxed cornice.

1 NO 2153 LOCAL #	4 PRESENT NAME(S)	
2 COUNTY ST. LOUIS	5 OTHER NAME(S)	
3. LOCATION OF NEGATIVES LINDA STOCKMAN		
6 SPECIFIC LOCATION 110 N. GEYER/JACKSON	16 THEMATIC CATEGORY	28 NO OF STORIES 31.5
7 CITY OR TOWN KIRKWOOD, MO	17 DATE(S) OR PERIOD CA 1890	29 BASEMENT (Y/N) Y FULL (Y/N) Y
8 SITE PLAN WITH NORTH ARROW SEE MAP	18 STYLE OR DESIGN NATIONAL FOLK	30 FOUNDATION MATERIAL STONE/CONCRETE
	19 ARCHITECT OR ENGINEER	31 WALL CONSTRUCTION FRAME
	20 CONTRACTOR OR BUILDER	32 ROOF TYPE & MATERIAL TRUNCATED HIP AND HIGH GABLE ASPHALT SHINGLES
	21 ORIGINAL USE, IF APPARENT SINGLE FAMILY RESIDENCE	33 NO. OF BAYS FRONT 4 SIDE 3
	22 PRESENT USE SINGLE FAMILY RESIDENCE	34 WALL TREATMENT WOOD HORIZONTAL LAP SIDING
	23 OWNERSHIP PUBLIC PRIVATE X	35 PLAN SHAPE REGULAR
	24 OWNER'S NAME & ADDRESS (IF KNOWN)	36 CHANGES ADDITION X (EXPLAIN ALTERED X IN #42) MOVED
9 COORDINATES LOT LANG		37 CONDITION INTERIOR EXTERIOR GOOD

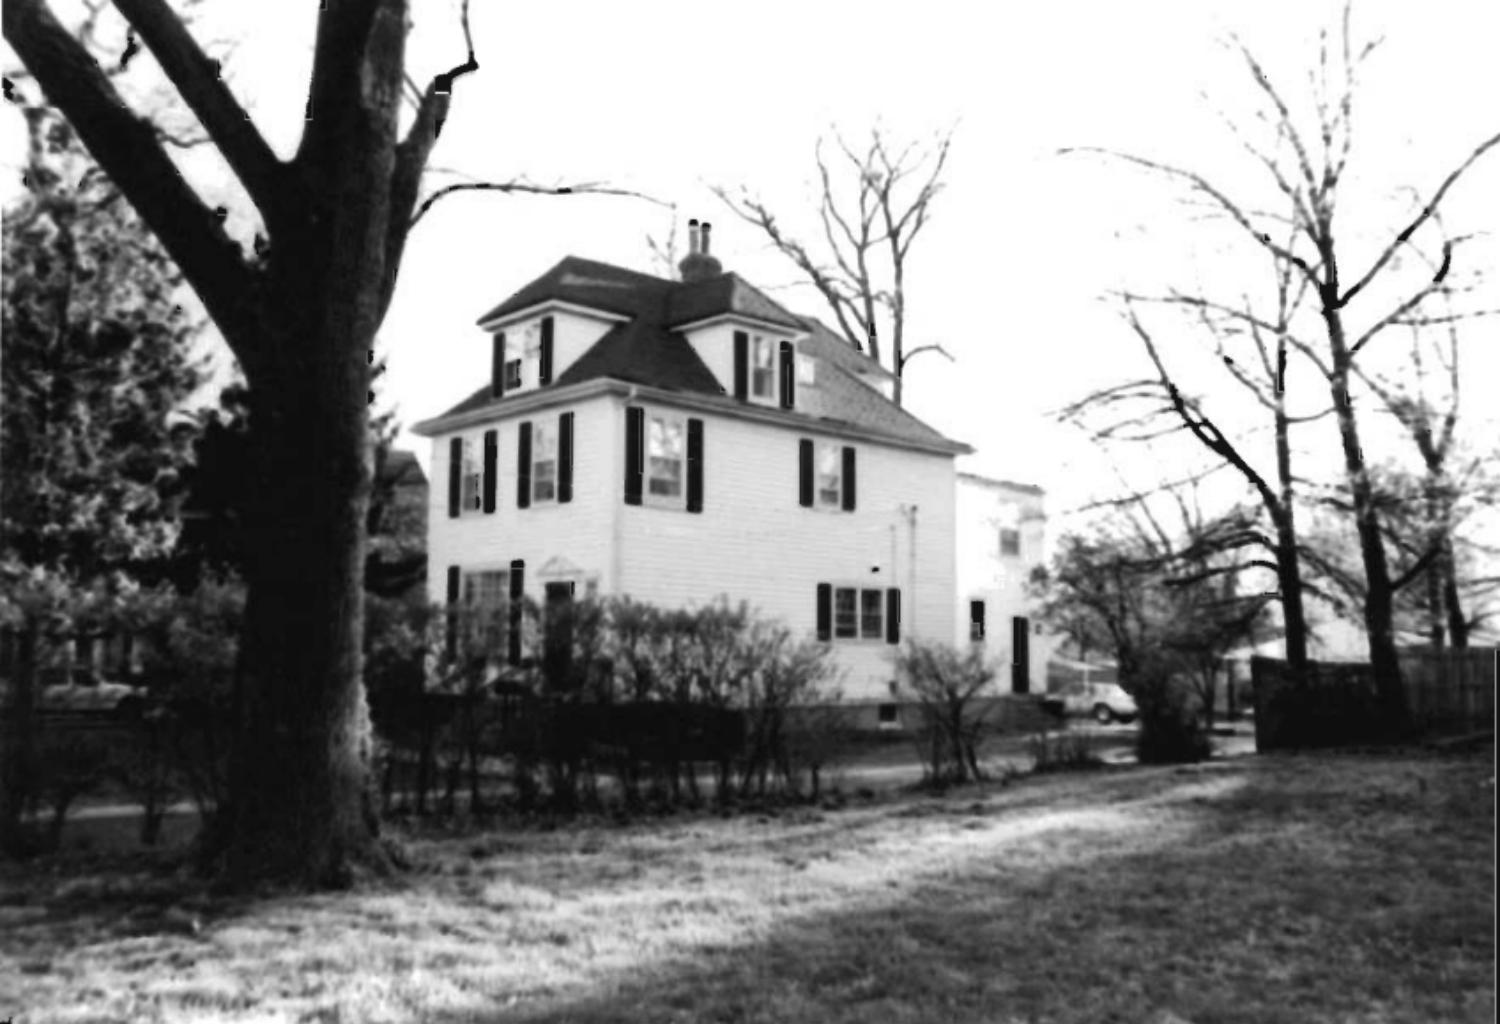
The prominent features of this building include: its bellcast hipped roof; its hipped dormers; its projecting plain boxed cornice; and its projecting screened-in side porch. The facade entrance is off-center toward the north. It contains a wood single-leaf panel door which has fluted wood surrounds, topped by a broken pediment. To the north of the entrance is a small fixed wood window which is flat-topped with plain wood surrounds, sill and lintel. The large fixed window to the south of the entrance is wood, flat-topped, with wood surrounds, lintel and sill. It contains 30 lights. The remainder of the facade windows are wood with wood sash, double-hung, one over one, flat-topped, with wood surrounds, lintels and sills. All facade windows with the exception of the porch window have wood shutters. A brick stoop and stairs access the facade entrance featuring wrought iron railings and balustrade. There is a two story frame addition at the rear of this building.
