**HISTORIC INVENTORY**

Presbyterian Church Tower Park  
100 E. Adams

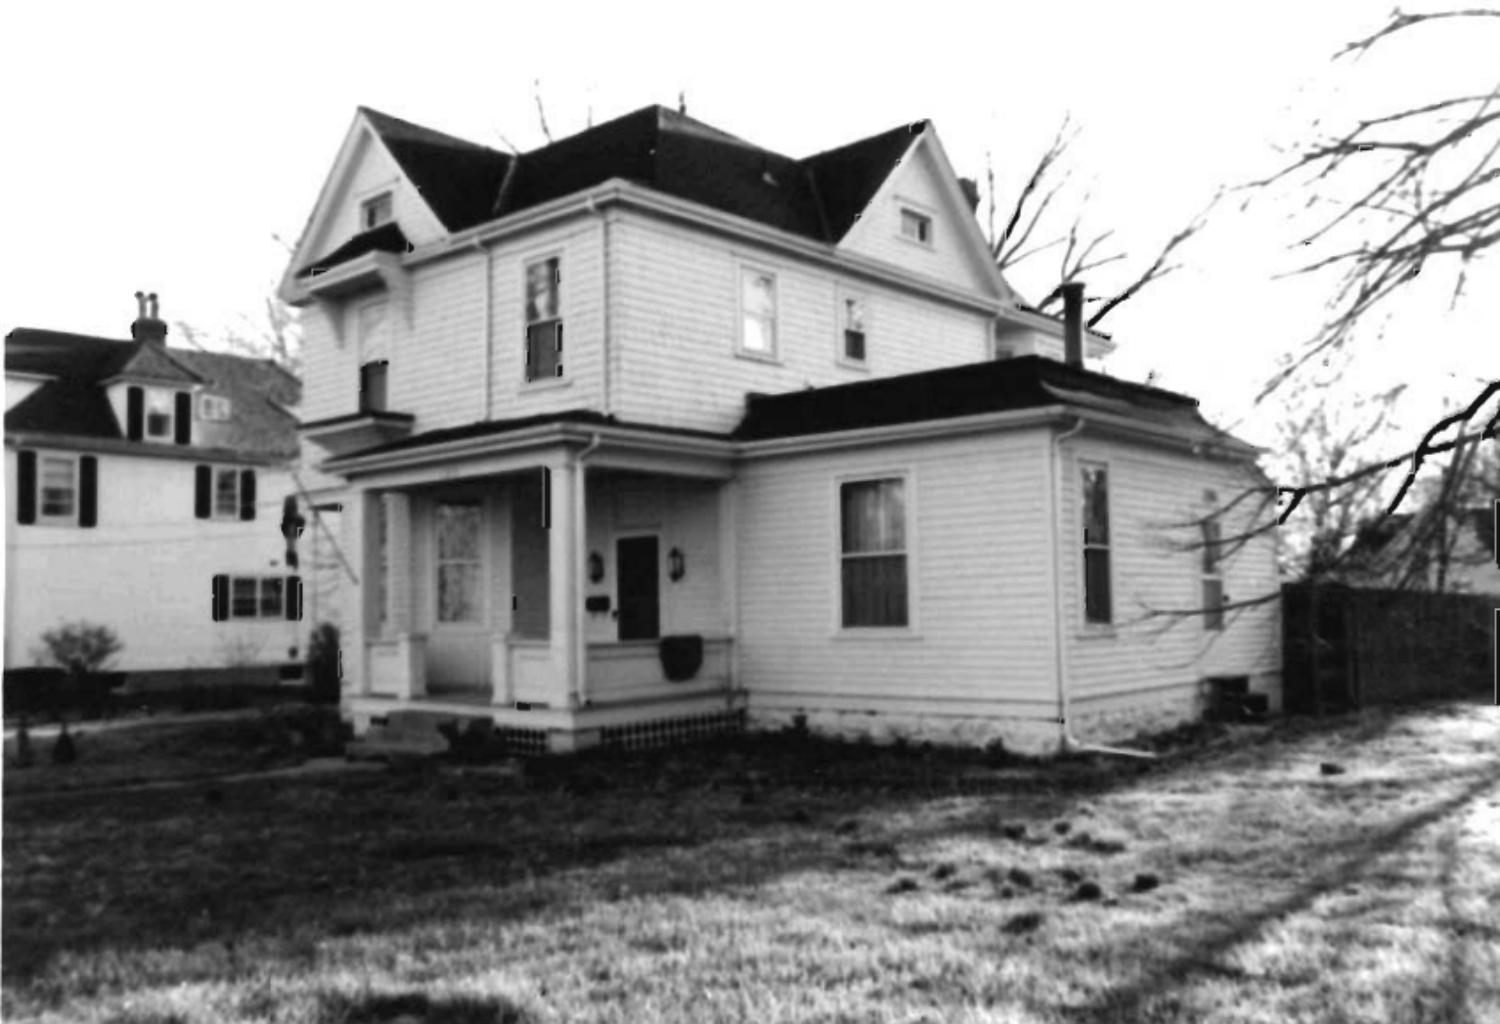
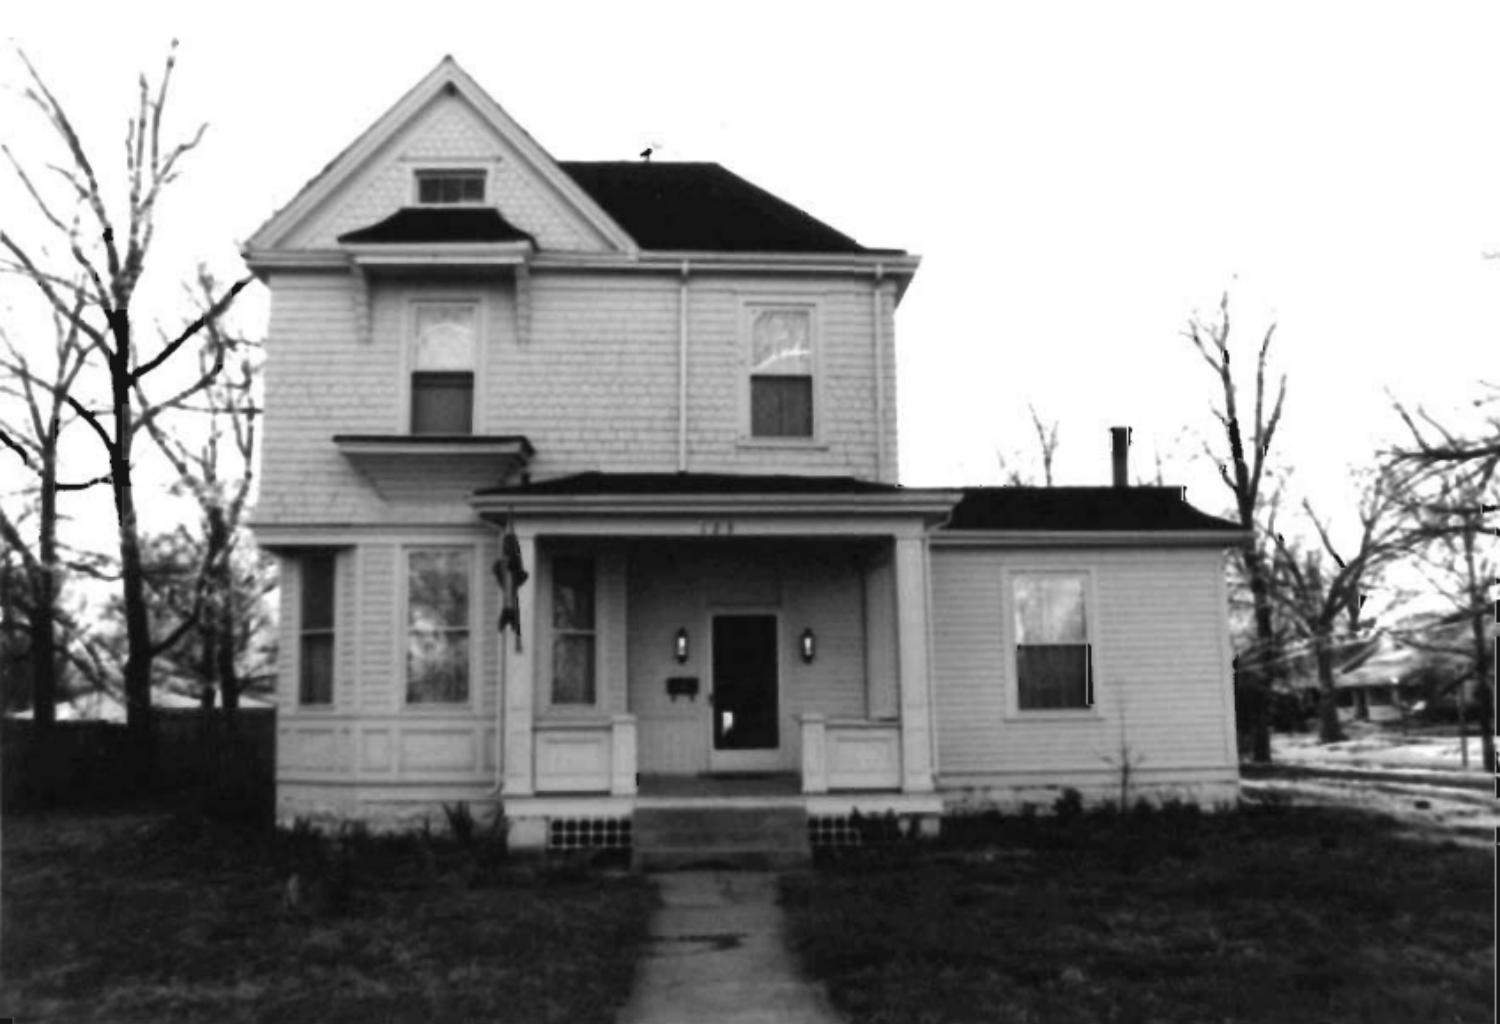
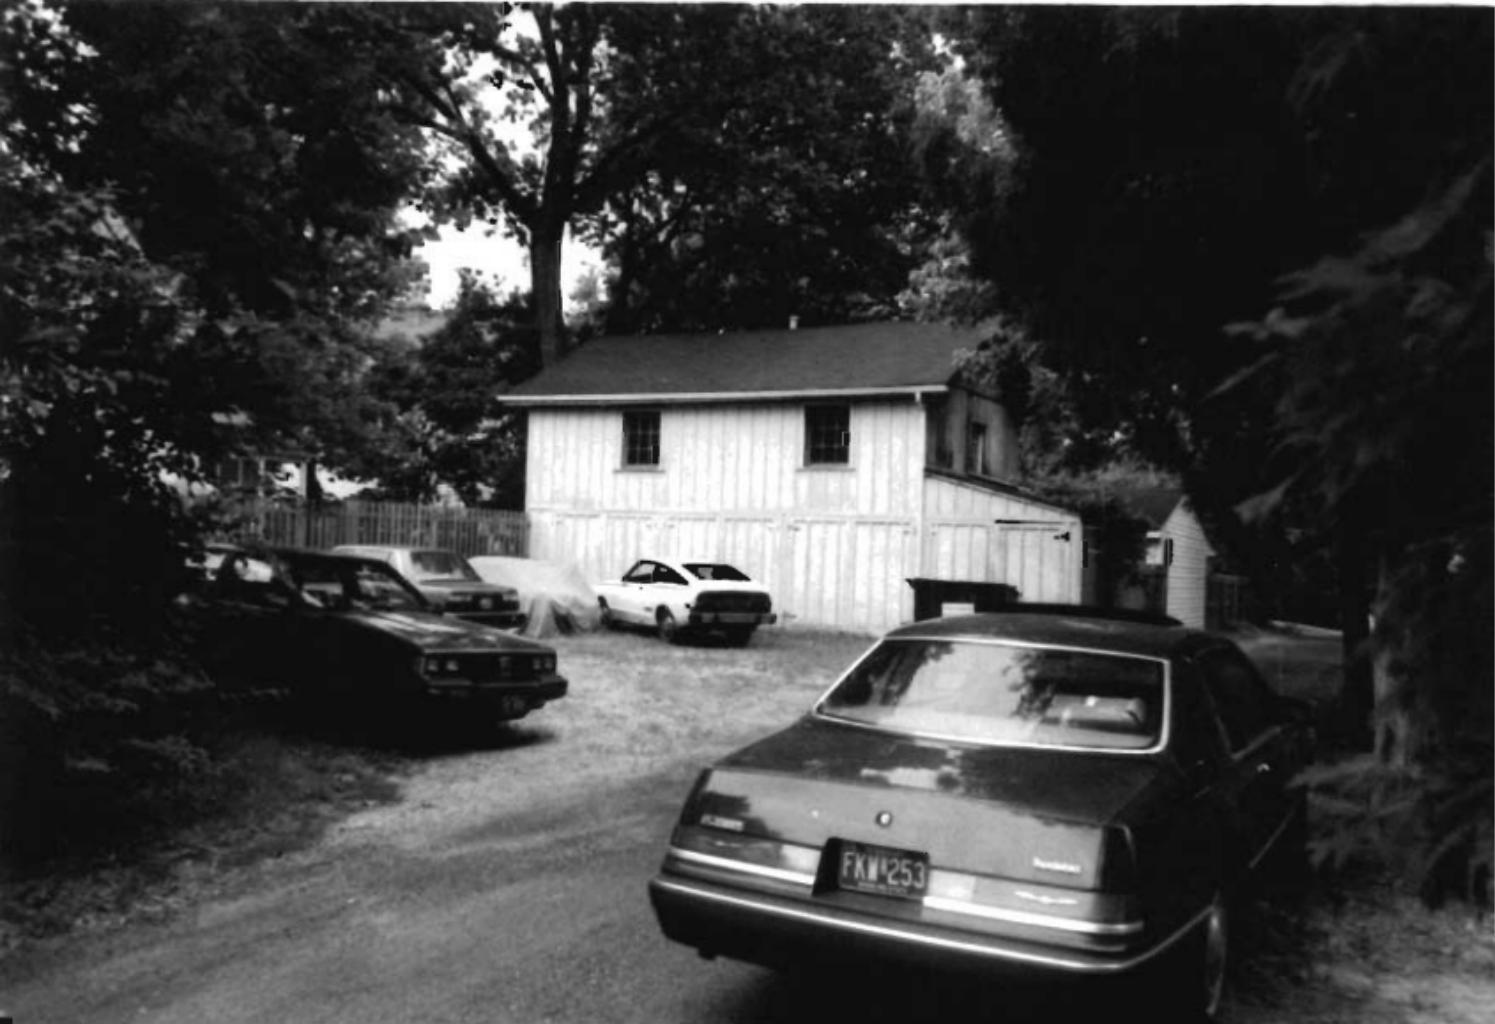
This is a very large dwelling featuring irregular massing, triangular dormers, a truncated hipped roof, bay windows, a hooded facade balcony, projecting bays, an open-frame facade porch and traditional varied siding material. The recessed facade entry is now centered due to the addition of a one story frame room addition toward the north. This addition has a stone foundation and a bellcast roof with a flat top. The facade entry contains a single-leaf raised panel wood door with a Queen Anne window in its upper 1/3. It is topped by a transom which contains a decorative wood panel. The door has a wood surround and simple wood entablature. The facade porch has a hipped roof which rests on wood posts. It has a wood floor with concrete stairs and a wood closed balustrade. Vertical tongue and groove siding which is the same height as the porch balustrade flanks the entry. To the south of the porch on the first level the facade features a three-sided bay window which is under a projecting second story. It has a window on each of its three sides. The windows are wood with wood sash, double-hung, one over one, flat-topped. The window angled toward the porch is topped by a simple wood entablature like that of the door. Raised wood panels are beneath the bay windows. A continuous wood band on this bay serves as the sill for these windows. The window in the room addition is wood with wood sash, double-hung, flat-topped, with a wood sill. The second level windows are wood with wood sash, double-hung, with wood surrounds and lugsills, topped by simple wood entablatures. They have a typical Queen Anne light configuration; i.e. the top sash contains a band of ribbon windows above a large pane of glass, and the bottom sash contains one pane of glass. The facade dormer window is wood, with wood surrounds and a simple entablature. It contains three lights. The primary covering for the first level is wood horizontal lap siding. The second level features wood shingles with a three-course band of three-edged imbricated wood shingles. The facade dormer contains imbricated fish scale wood shingles. All the facade windows are covered with aluminum storm sash. The entry is covered with an aluminum storm door.

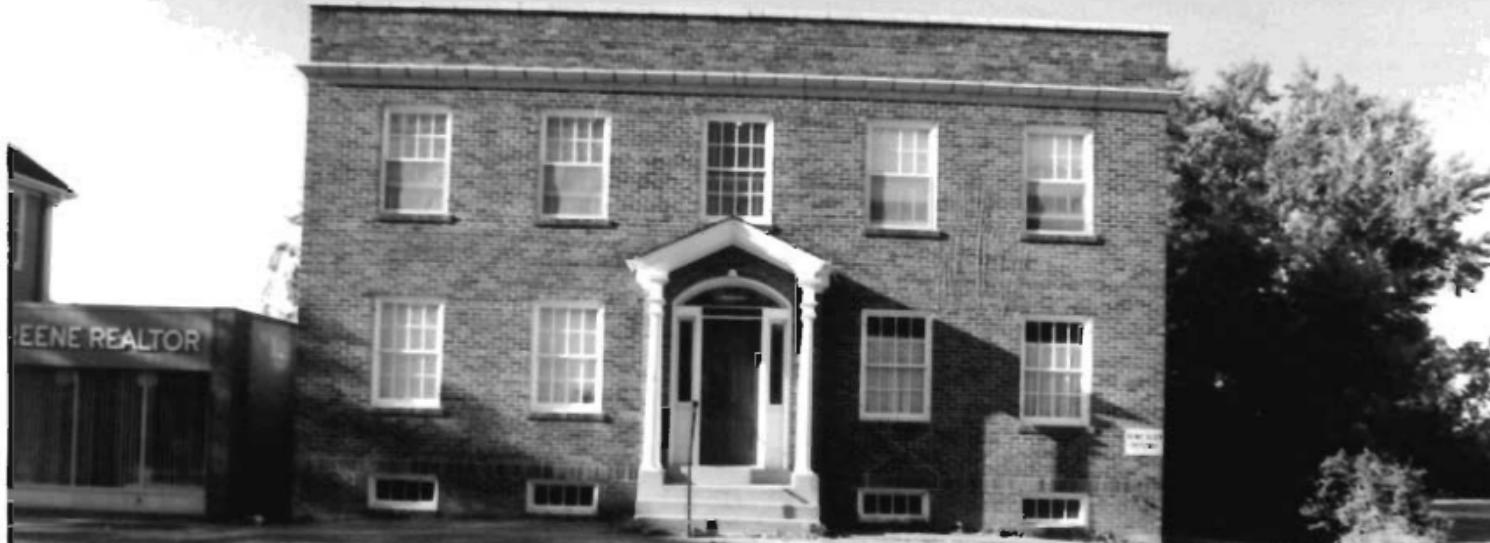
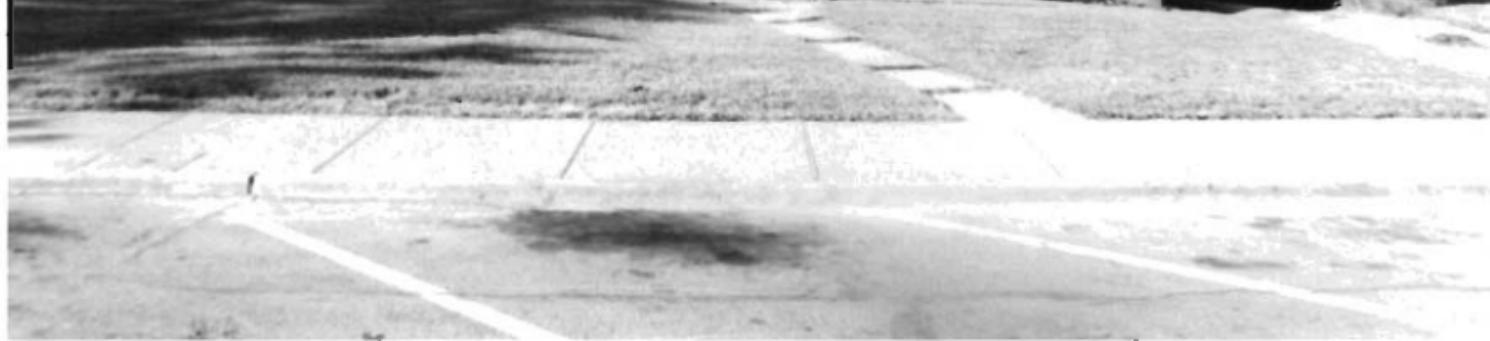
126 E. Jefferson

The prominent features of this building are its symmetry and porticoed facade entrance. The facade entry is central and contains a single-leaf wood door with sidelights and a fan-light transom. Its portico features wood columns of the tuscan order topped by a gable with a plain boxed cornice with return. The first and second level facade windows are wood with wood sash, double-hung, eight over eight, with flat brick lintels and brick soldier-course sills. The facade basement level windows are wood with four lights. A stringcourse of brick soldier-coursing separates the basement level from the first floor. A white glazed terra cotta stringcourse and cornice molding separate the second floor from the parapet which is unadorned except for coping tiles at the roofline.

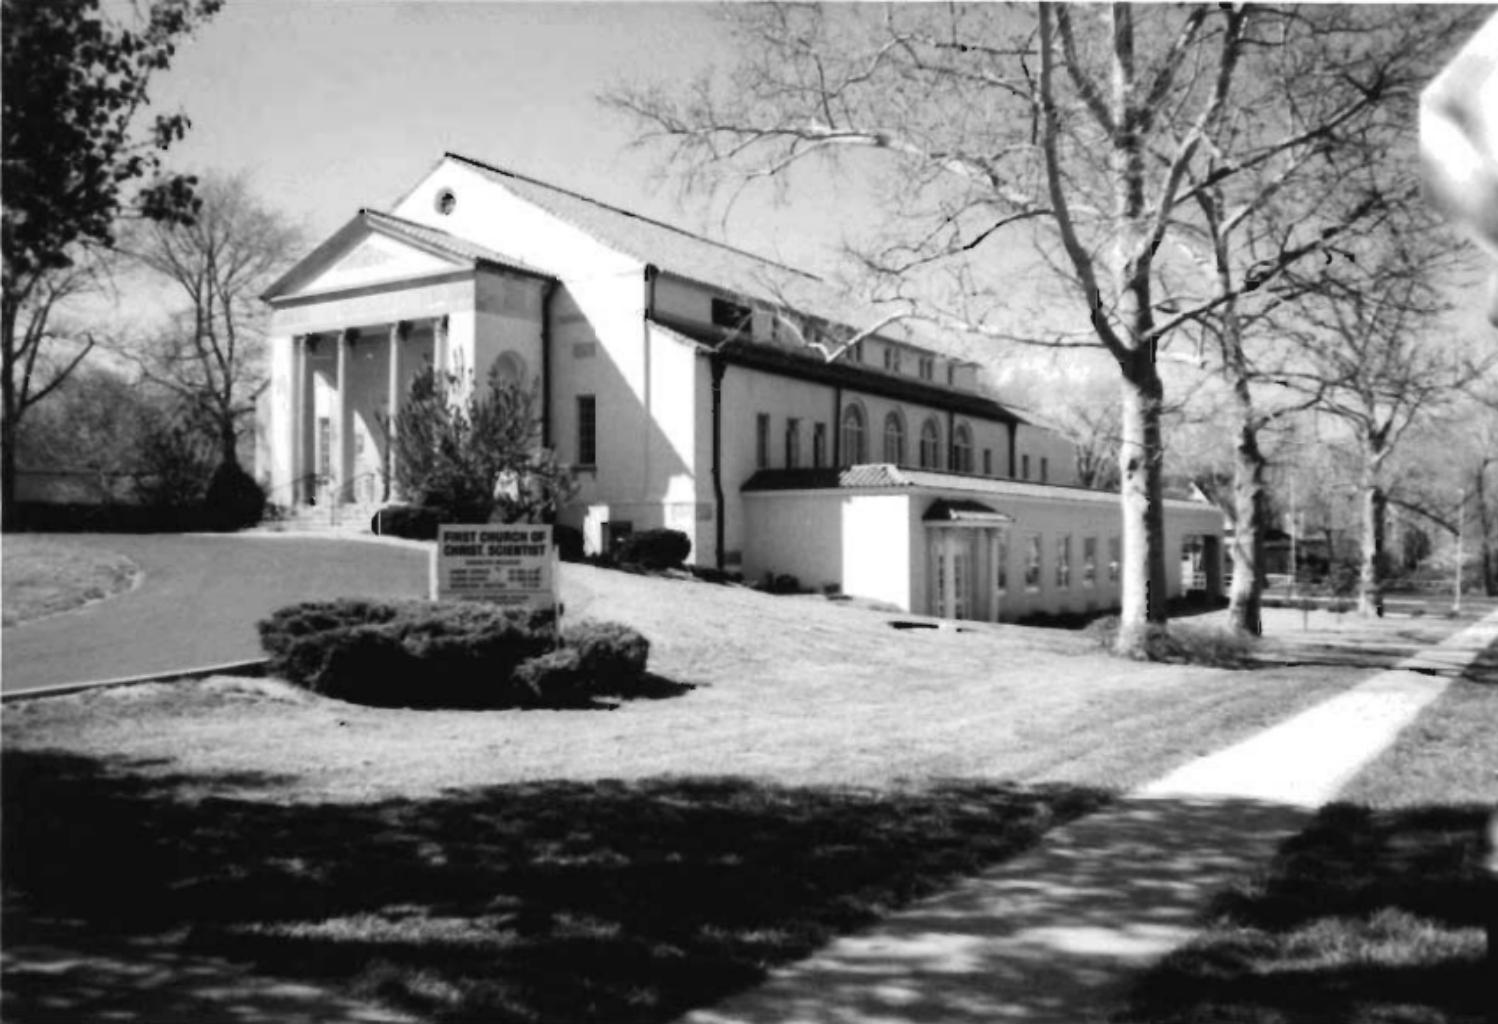
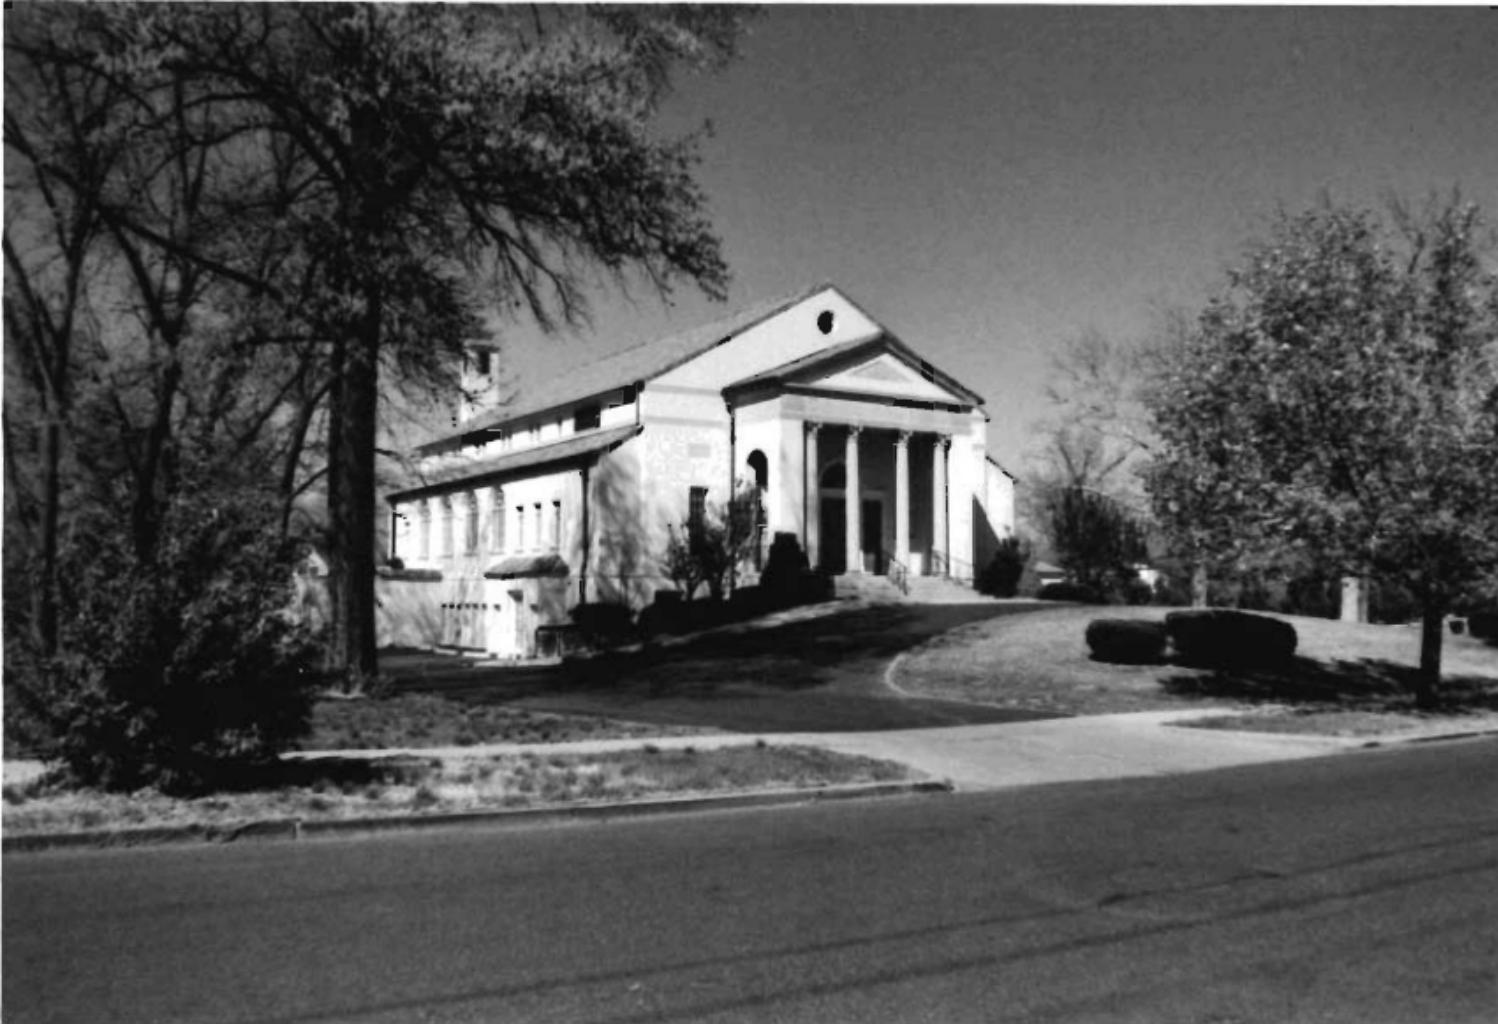
FIRST CHURCH OF  
CHRIST, SCIENTIST

Quite a few members of the First Church of Christ, Scientist in St. Louis lived in St. Louis County. In 1906, twenty county residents decided to organize a First Church of Christ, Scientist in Kirkwood. The first service was held on October 7, 1906 in rented Choral Hall on Bodley Avenue. As membership increased, property was purchased at the northwest corner of Clay and Washington Avenues. The purchase transpired on October 10, 1907, but ground was not broken until July 22, 1909 with cornerstone ceremonies being held on October 11, 1909. Apparently, the construction of the church was planned to take place in stages, according to membership and affordability. By August 14, 1916 all outstanding indebtedness against the first stage of the building had been paid. World War I building restrictions delayed construction on the next stage. After complete revision of plans the building was completed in 1924. The first service was held in the new auditorium on Sunday, December 15, 1924. Total cost of the church, its furnishings and the ground was approximately \$90,000. The church was free of all indebtedness when dedication services were held on December 30, 1928.

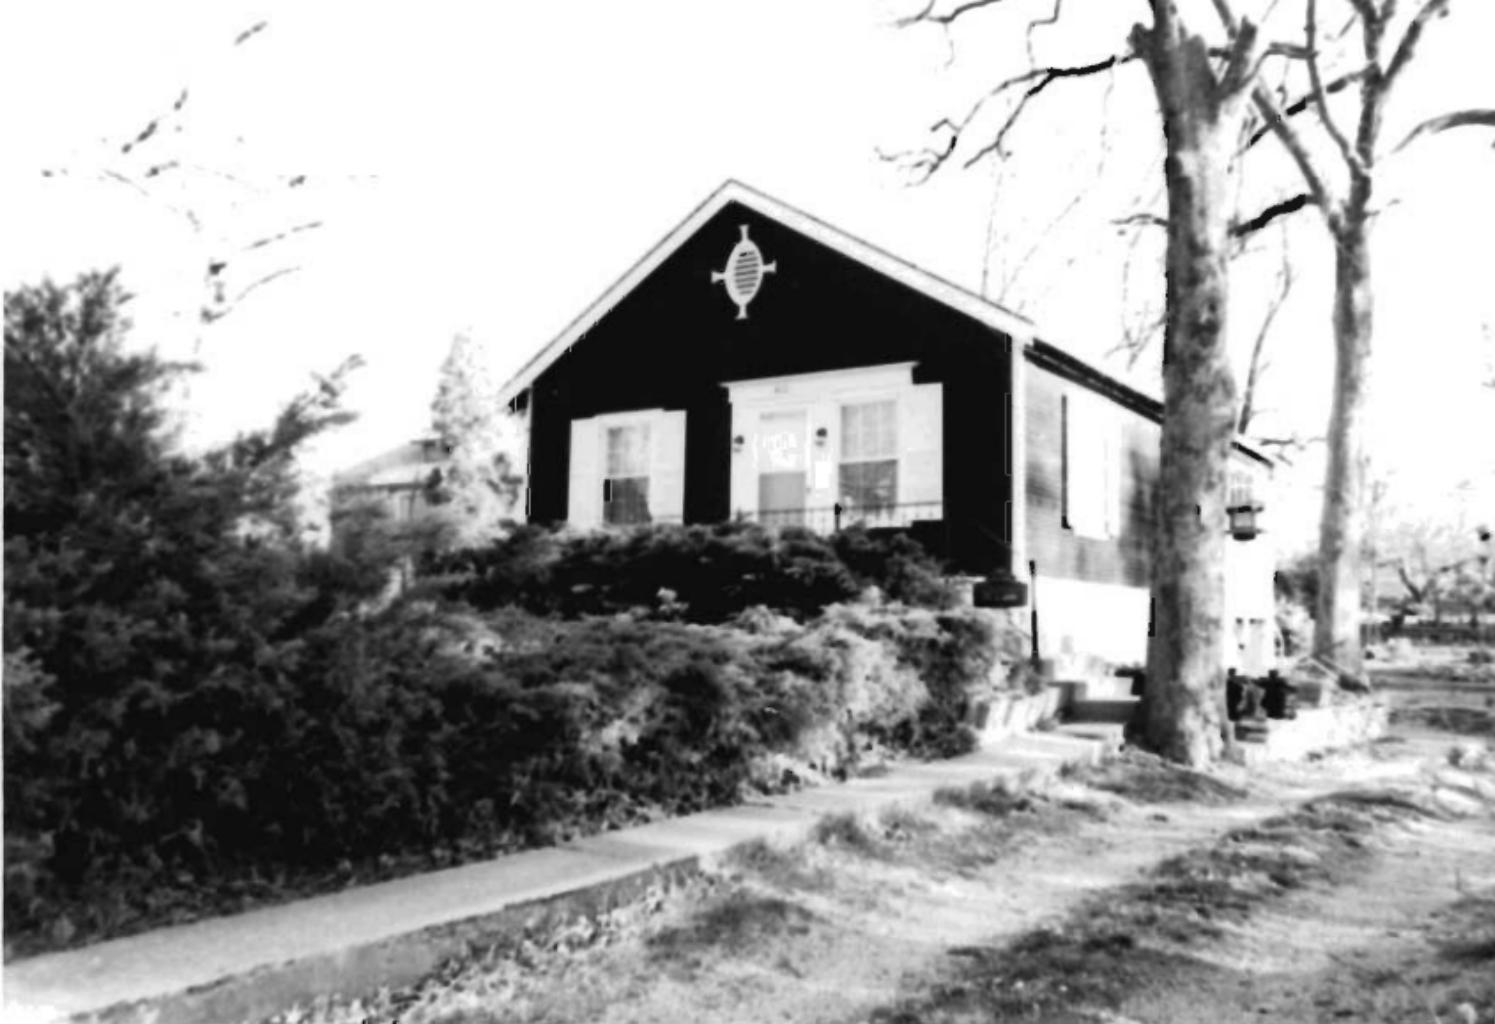
410 W. Jefferson

This is a small house. Its prominent feature is its colonial detailing. It has an off-center entry toward the west which contains a single leaf wood door. The door is covered by an aluminum storm door. Directly to the west of the door and contained within the same framework is a window with a wood shutter on its west side. A plain wood entablature spans the top of the door and window, and the door has molded surrounds. The facade windows are wood with wood sash, double-hung, six over six, flat-topped, with wood lugsills. The facade window to the east of the entry is flanked by wood shutters. A cameo-shaped ventilation opening exists in the attic of the facade, and it contains wood louvers. The roofline features exposed rafters and a plain bargeboard in its gable. There is a concrete block addition at the rear of this building which contains a basement level garage with a room above.

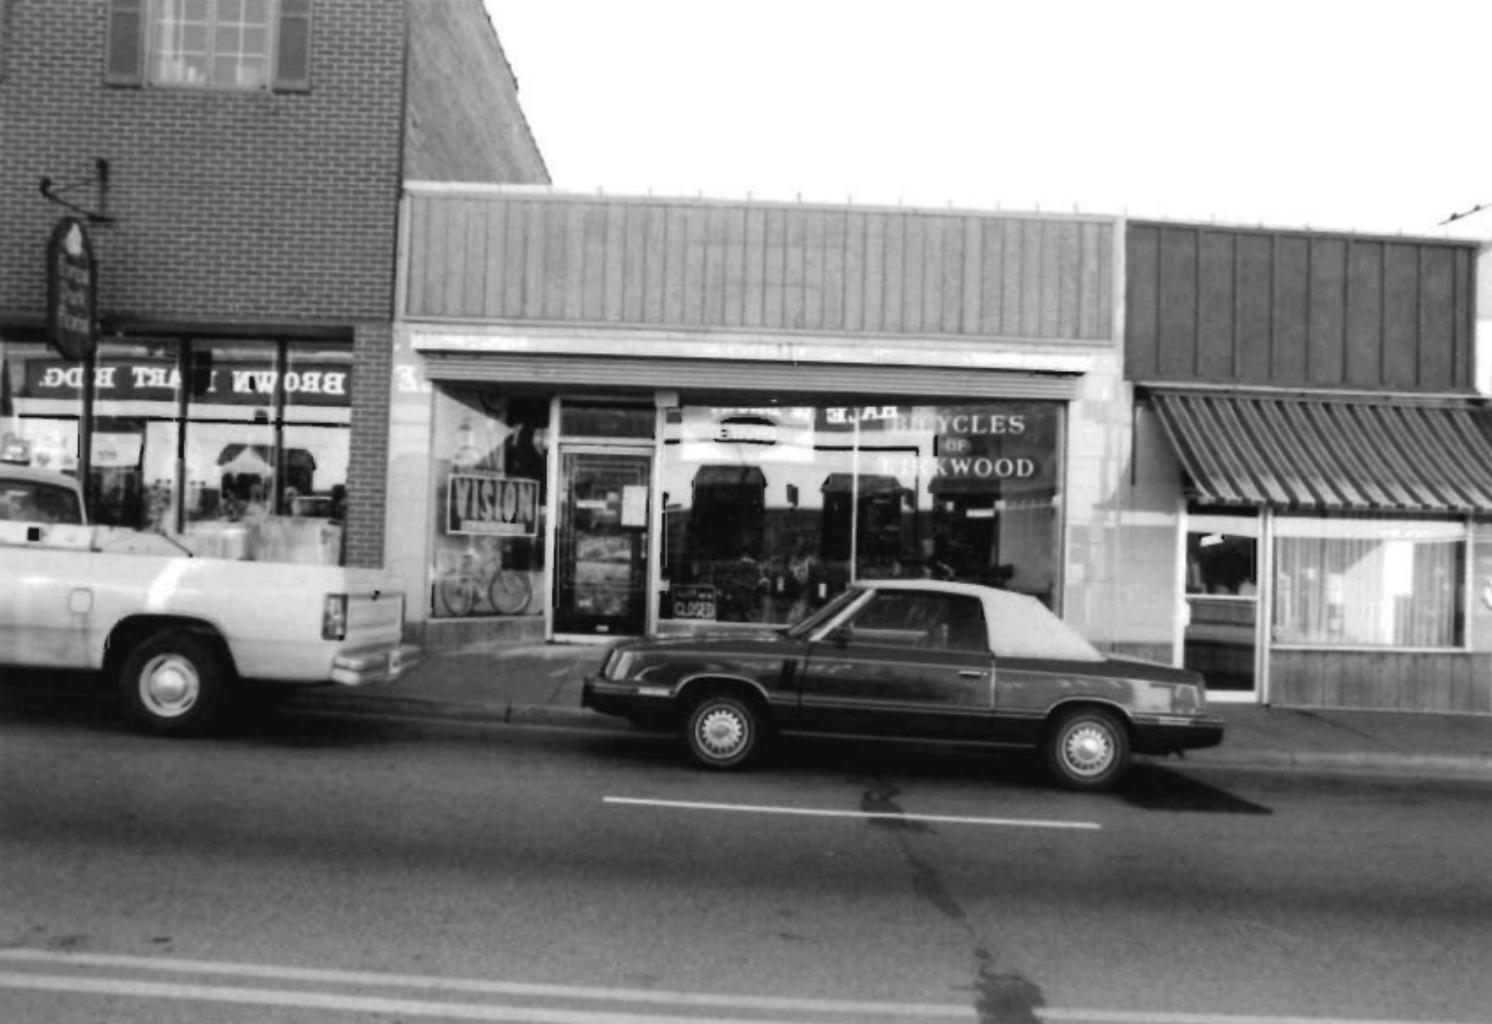
CYCLES  
OF  
BROOKWOOD

1 NO 2045 LOCAL #	4 PRESENT NAME(S) BICYCLES OF KIRKWOOD	
2 COUNTY ST. LOUIS	5 OTHER NAME(S)	
3. LOCATION OF NEGATIVES LINDA STOCKMAN		
6 SPECIFIC LOCATION 112 N. KIRKWOOD/WEBSTER	16 THEMATIC CATEGORY	28 NO OF STORIES 01.0
7 CITY OR TOWN KIRKWOOD, MO	17 DATE(S) OR PERIOD CA 1948	29 BASEMENT (Y/N) Y FULL (Y/N) Y
8 SITE PLAN WITH NORTH ARROW SEE MAP	18 STYLE OR DESIGN VERNACULAR	30 FOUNDATION MATERIAL CONCRETE
	19 ARCHITECT OR ENGINEER	31 WALL CONSTRUCTION MASONRY
	20 CONTRACTOR OR BUILDER	32 ROOF TYPE & MATERIAL FLAT REAR GABLE ASPHALT SHINGLES
	21 ORIGINAL USE, IF APPARENT COMMERCIAL	33 NO. OF BAYS FRONT 3 SIDE 0
	22 PRESENT USE COMMERCIAL	34 WALL TREATMENT BRICK/FACADE GLASS & FRAME
		35 PLAN SHAPE
	23 OWNERSHIP PUBLIC PRIVATE X	36 CHANGES ADDITION (EXPLAIN ALTERED X IN #42) MOVED X
9 COORDINATES LOT LANG	24 OWNER'S NAME & ADDRESS (IF KNOWN)	37 CONDITION INTERIOR EXTERIOR GOOD
10 SITE STRUCTURE BUILDING X OBJECT	25 OPEN TO PUBLIC (YES/NO) Y	38 PRESERVATION UNDERWAY? (Y/N) N

11 ON NAT'L REG? (YES/NO) N	12 IS IT ELIGIBLE? (YES/NO)	39 ENDANGERED (YES/NO) N BY WHAT?
13 PART OF HIST DIST (YES/NO) N	14 DIST POTENT (YES/NO)	40 VISIBLE FROM PUBLIC ROAD ? (YES/NO) Y
15 NAME OF ESTABLISHED DISTRICT		41 DISTANCE FROM AND FRONTAGE ON ROAD ADJOINS SIDEWALK
42 FURTHER DESCRIPTION OF IMPORTANT FEATURES SEE CONTINUATION SHEET		PHOTO
43 HISTORY AND SIGNIFICANCE SEE CONTINUATION SHEET		46 PREPARED BY LINDA STOCKMAN
44 DESCRIPTION OF ENVIRONMENT AND OUTBUILDINGS SEE CONTINUATION SHEET		47 ORGANIZATION KIRKWOOD LANDM COMM.
45 SOURCES OF INFORMATION SEE CONTINUATION SHEET		48 DATE 06/86   49 REVISION DATE(S)

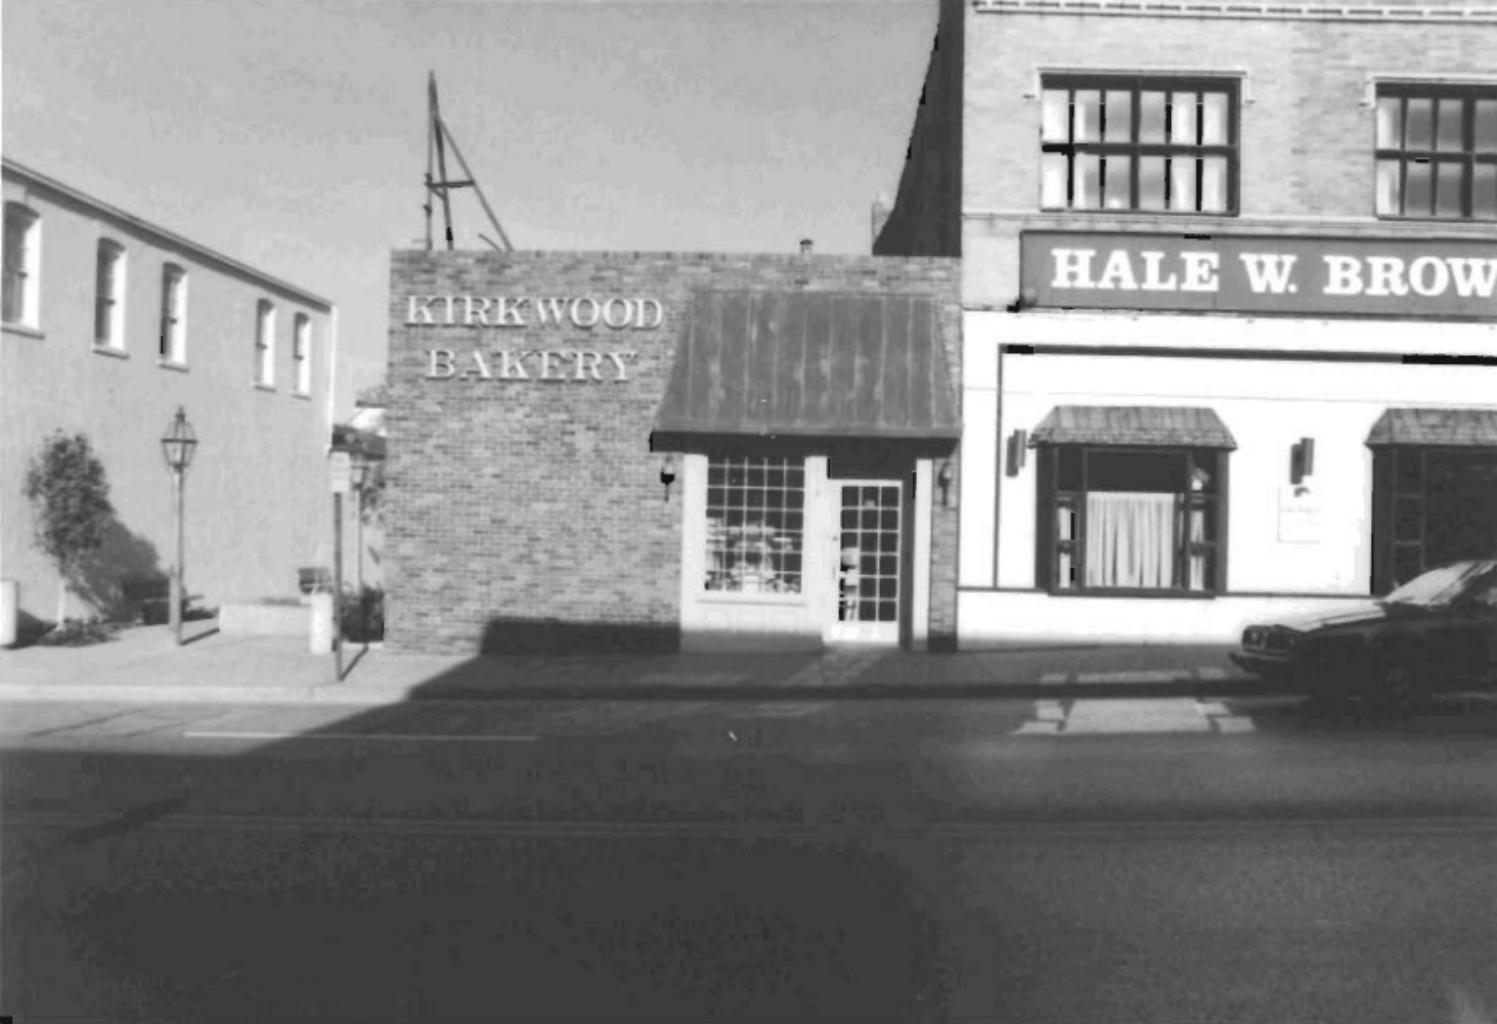
1 NO 2023 LOCAL #	4 PRESENT NAME(S) KIRKWOOD BAKERY	
2 COUNTY ST. LOUIS	5 OTHER NAME(S)	
3. LOCATION OF NEGATIVES LINDA STOCKMAN		
6 SPECIFIC LOCATION 113 N. KIRKWOOD/WEBSTER	16 THEMATIC CATEGORY	28 NO OF STORIES 01.0
	17 DATE(S) OR PERIOD CA 1890	29 BASEMENT (Y/N) Y FULL (Y/N) Y
7 CITY OR TOWN KIRKWOOD, MO	18 STYLE OR DESIGN VERNACULAR	30 FOUNDATION MATERIAL STONE
8 SITE PLAN WITH NORTH ARROW SEE MAP	19 ARCHITECT OR ENGINEER	31 WALL CONSTRUCTION MASONRY
	20 CONTRACTOR OR BUILDER	32 ROOF TYPE & MATERIAL FLAT COMPOSITION
	21 ORIGINAL USE, IF APPARENT COMMERCIAL	33 NO. OF BAYS FRONT 2 SIDE 7
	22 PRESENT USE COMMERCIAL	34 WALL TREATMENT BRICK
		35 PLAN SHAPE RECTANGULAR
	23 OWNERSHIP PUBLIC PRIVATE X	36 CHANGES ADDITION X (EXPLAIN ALTERED X IN #42) MOVED X
	24 OWNER'S NAME & ADDRESS (IF KNOWN)	
9 COORDINATES LOT LANG		37 CONDITION INTERIOR GOOD EXTERIOR GOOD
10 SITE STRUCTURE BUILDING X OBJECT	25 OPEN TO PUBLIC (YES/NO) Y	38 PRESERVATION UNDERWAY? (Y/N) N

11 ON NAT'L REG? (YES/NO) N	12 IS IT ELIGIBLE? (YES/NO)	26 LOCAL CONTACT PERSON OR ORGANIZATION
13 PART OF HIST DIST (YES/NO) N	14 DIST POTENT (YES/NO)	27 OTHER SURVEYS IN WHICH INCLUDED
15 NAME OF ESTABLISHED DISTRICT		39 ENDANGERED (YES/NO) N BY WHAT?
42 FURTHER DESCRIPTION OF IMPORTANT FEATURES SEE CONTINUATION SHEET		40 VISIBLE FROM PUBLIC ROAD ? (YES/NO) Y
43 HISTORY AND SIGNIFICANCE SEE CONTINUATION SHEET		41 DISTANCE FROM AND FRONTAGE ON ROAD
44 DESCRIPTION OF ENVIRONMENT AND OUTBUILDINGS SEE CONTINUATION SHEET		PHOTO
45 SOURCES OF INFORMATION SEE CONTINUATION SHEET		46 PREPARED BY LINDA STOCKMAN
		47 ORGANIZATION KIRKWOOD LANDM COMM.
		48 DATE 06/86   49 REVISION DATE(S)

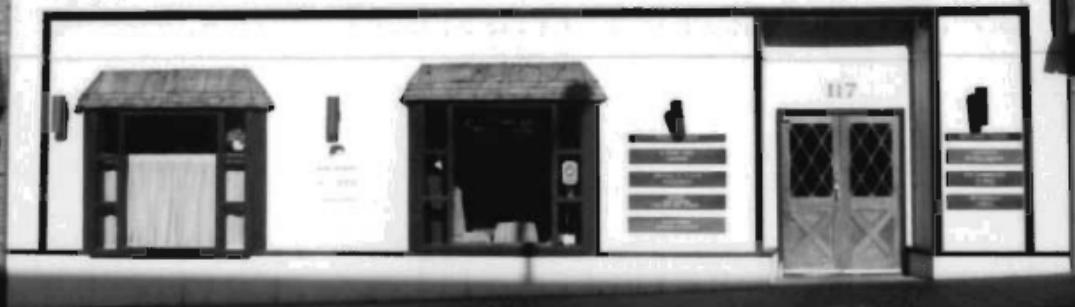
# **HALE W. BROWN MART BLDG.**

1 NO 2022 LOCAL #	4 PRESENT NAME(S)	
2 COUNTY ST. LOUIS	5 OTHER NAME(S) LINDA STOCKMAN	
3 LOCATION OF NEGATIVES		
6 SPECIFIC LOCATION 117 N. KIRKWOOD/WEBSTER SEE 27A	16 THEMATIC CATEGORY	28 NO OF STORIES 02.0
7 CITY OR TOWN KIRKWOOD, MO	17 DATE(S) OR PERIOD CA 1900 1935	29 BASEMENT (Y/N) FULL (Y/N)
8 SITE PLAN WITH NORTH ARROW SEE MAP	18 STYLE OR DESIGN VERNACULAR 19 ARCHITECT OR ENGINEER	30 FOUNDATION MATERIAL NOT VISIBLE 31 WALL CONSTRUCTION MASONRY
	20 CONTRACTOR OR BUILDER	32 ROOF TYPE & MATERIAL FLAT COMPOSITION
	21 ORIGINAL USE, IF APPARENT COMMERCIAL	33 NO. OF BAYS FRONT 3 SIDE 0
	22 PRESENT USE COMMERCIAL	34 WALL TREATMENT ORANGE BRICK AND VERTICAL WOOD SIDING
		35 PLAN SHAPE IRREGULAR
9 COORDINATES LOT LANG	23 OWNERSHIP PUBLIC PRIVATE X	36 CHANGES ADDITION X (EXPLAIN ALTERED X IN #42) MOVED
10 SITE STRUCTURE BUILDING X OBJECT	24 OWNER'S NAME & ADDRESS (IF KNOWN)	37 CONDITION INTERIOR GOOD EXTERIOR GOOD

11 ON NAT'L REG? (YES/NO) N	25 OPEN TO PUBLIC (YES/NO) Y	38 PRESERVATION UNDERWAY? (Y/N) N
12 IS IT ELIGIBLE? (YES/NO)	26 LOCAL CONTACT PERSON OR ORGANIZATION	39 ENDANGERED (YES/NO) N BY WHAT?
13 PART OF HIST DIST (YES/NO) N	27 OTHER SURVEYS IN WHICH INCLUDED 112 W. JEFFERSON	40 VISIBLE FROM PUBLIC ROAD? (YES/NO) Y
15 NAME OF ESTABLISHED DISTRICT		41 DISTANCE FROM AND FRONTAGE ON ROAD
42 FURTHER DESCRIPTION OF IMPORTANT FEATURES SEE CONTINUATION SHEET	PHOTO	
43 HISTORY AND SIGNIFICANCE SEE CONTINUATION SHEET	46 PREPARED BY LINDA STOCKMAN	
44 DESCRIPTION OF ENVIRONMENT AND OUTBUILDINGS SEE CONTINUATION SHEET	47 ORGANIZATION KIRKWOOD LANDM COMM.	
45 SOURCES OF INFORMATION SEE CONTINUATION SHEET	48 DATE 06/86	49 REVISION DATE(S)

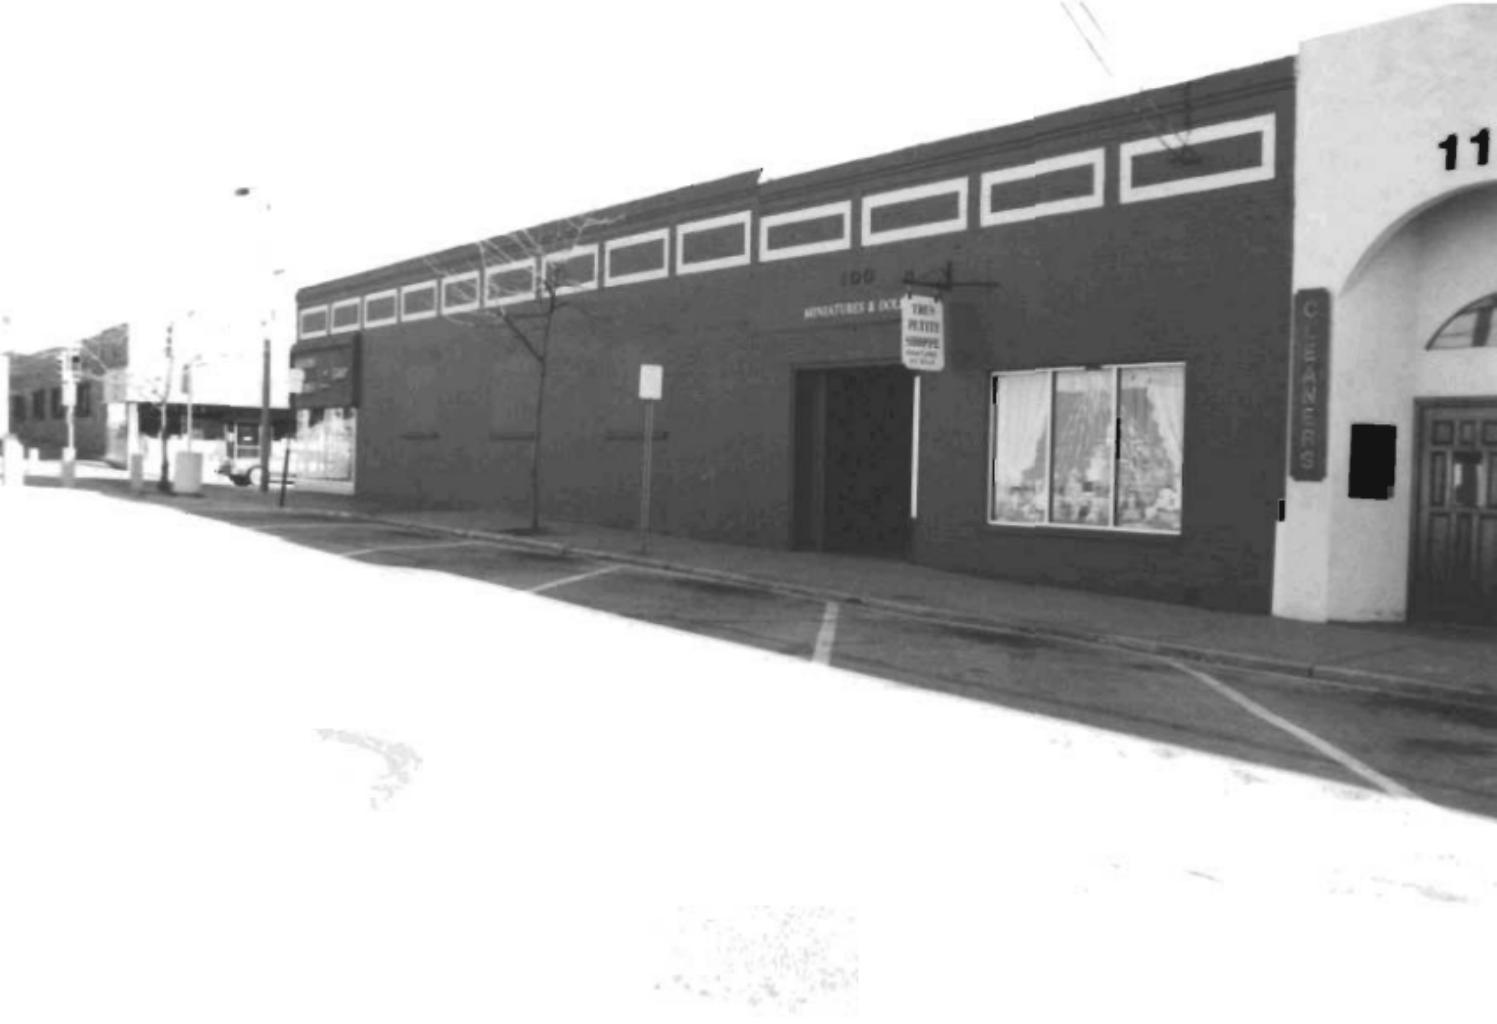
RIBBONS N RHYMES  
TM & © 2000 SHOP

1 NO 2021 LOCAL #	4 PRESENT NAME(S) 119 - ART MART (SEE #5)	
2 COUNTY O	5 OTHER NAME(S) #121 RIBBONS 'N RHYMES HALLMARK #100 W. JEFFERSON - PETITE SHOP	
3 LOCATION OF NEGATIVES LINDA STOCKMAN		
6 SPECIFIC LOCATION 119, 121 N. KIRKWOOD/WEBSTER SEE27	16 THEMATIC CATEGORY	28 NO OF STORIES 01.0
	17 DATE(S) OR PERIOD CA 1920	29 BASEMENT (Y/N) FULL (Y/N)
7 CITY OR TOWN KIRKWOOD, MO	18 STYLE OR DESIGN VERNACULAR	30 FOUNDATION MATERIAL NOT VISIBLE
8 SITE PLAN WITH NORTH ARROW SEE MAP	19 ARCHITECT OR ENGINEER	31 WALL CONSTRUCTION MASONRY
	20 CONTRACTOR OR BUILDER	32 ROOF TYPE & MATERIAL FLAT COMPOSITION
	21 ORIGINAL USE, IF APPARENT COMMERCIAL	33 NO. OF BAYS FRONT 9 SIDE 6
	22 PRESENT USE COMMERCIAL	34 WALL TREATMENT PAINTED BRICK AND WOOD PANELS
		35 PLAN SHAPE RECTANGULAR
	23 OWNERSHIP PUBLIC PRIVATE X	36 CHANGES ADDITION (EXPLAIN ALTERED X IN #42) MOVED
	24 OWNER'S NAME & ADDRESS (IF KNOWN)	37 CONDITION INTERIOR EXTERIOR GOOD

9 COORDINATES LOT LANG	25 OPEN TO PUBLIC (YES/NO) Y	38 PRESERVATION UNDERWAY? (Y/N) N
10 SITE STRUCTURE BUILDING X OBJECT	26 LOCAL CONTACT PERSON OR ORGANIZATION	39 ENDANGERED (YES/NO) N BY WHAT?
11 ON NAT'L REG? (YES/NO) N	12 IS IT ELIGIBLE? (YES/NO)	40 VISIBLE FROM PUBLIC ROAD? (YES/NO) Y
13 PART OF HIST DIST (YES/NO) N	14 DIST POTENT (YES/NO)	41 DISTANCE FROM AND FRONTAGE ON ROAD
15 NAME OF ESTABLISHED DISTRICT	27 OTHER SURVEYS IN WHICH INCLUDED 100 W. JEFFERSON	PHOTO
42 FURTHER DESCRIPTION OF IMPORTANT FEATURES SEE CONTINUATION SHEET		46 PREPARED BY LINDA STOCKMAN
43 HISTORY AND SIGNIFICANCE SEE CONTINUATION SHEET		47 ORGANIZATION KIRKWOOD LANDM COMM.
44 DESCRIPTION OF ENVIRONMENT AND OUTBUILDINGS SEE CONTINUATION SHEET		48 DATE 06/86
45 SOURCES OF INFORMATION SEE CONTINUATION SHEET		49 REVISION DATE(S)

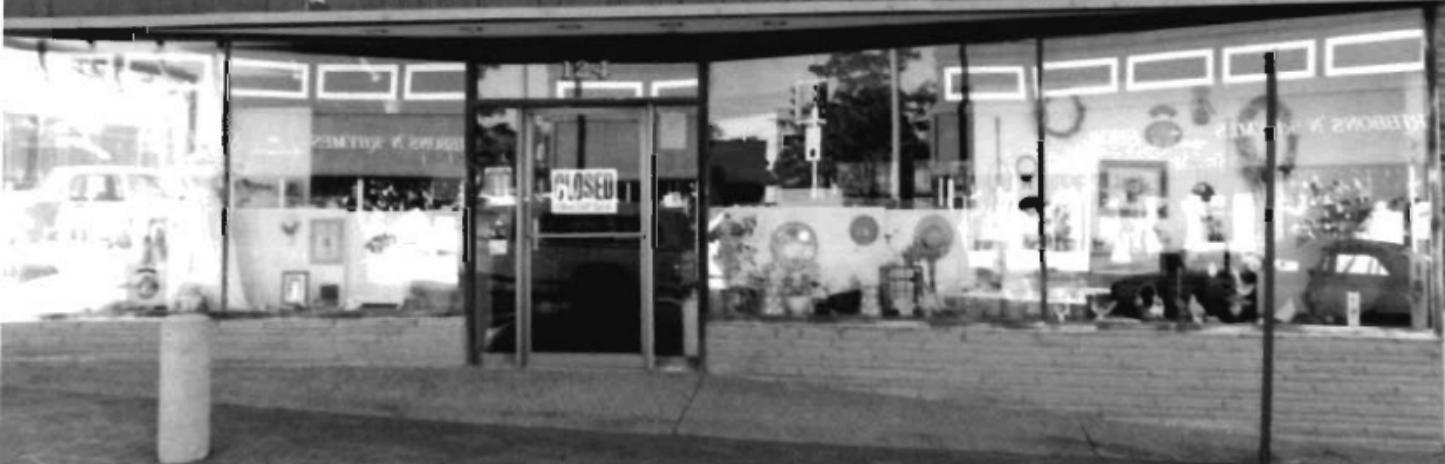
1 NO 2047 LOCAL #	4 PRESENT NAME(S) THE IDEA SHOP	
2 COUNTY ST. LOUIS	5 OTHER NAME(S)	
3 LOCATION OF NEGATIVES LINDA STOCKMAN		
6 SPECIFIC LOCATION 124 N. KIRKWOOD/WEBSTER	16 THEMATIC CATEGORY	28 NO OF STORIES 01.0
7 CITY OR TOWN KIRKWOOD, MO	17 DATE(S) OR PERIOD CA 1925	29 BASEMENT (Y/N) Y FULL (Y/N) Y
8 SITE PLAN WITH NORTH ARROW  SEE MAP	18 STYLE OR DESIGN ECLECTIC CRAFTSMAN	30 FOUNDATION MATERIAL CONCRETE
	19 ARCHITECT OR ENGINEER FRANK L. THOMPSON	31 WALL CONSTRUCTION MASONRY
	20 CONTRACTOR OR BUILDER	32 ROOF TYPE & MATERIAL FLAT COMPOSITION
	21 ORIGINAL USE, IF APPARENT COMMERCIAL	33 NO. OF BAYS FRONT 3 SIDE 5
	22 PRESENT USE COMMERCIAL	34 WALL TREATMENT TEXTURED BRICK
	23 OWNERSHIP PUBLIC PRIVATE X	35 PLAN SHAPE RECTANGULAR
	24 OWNER'S NAME & ADDRESS (IF KNOWN)	36 CHANGES ADDITION (EXPLAIN ALTERED IN #42) MOVED X
9 COORDINATES LOT LANG	25 OPEN TO PUBLIC (YES/NO) Y	37 CONDITION INTERIOR EXTERIOR GOOD

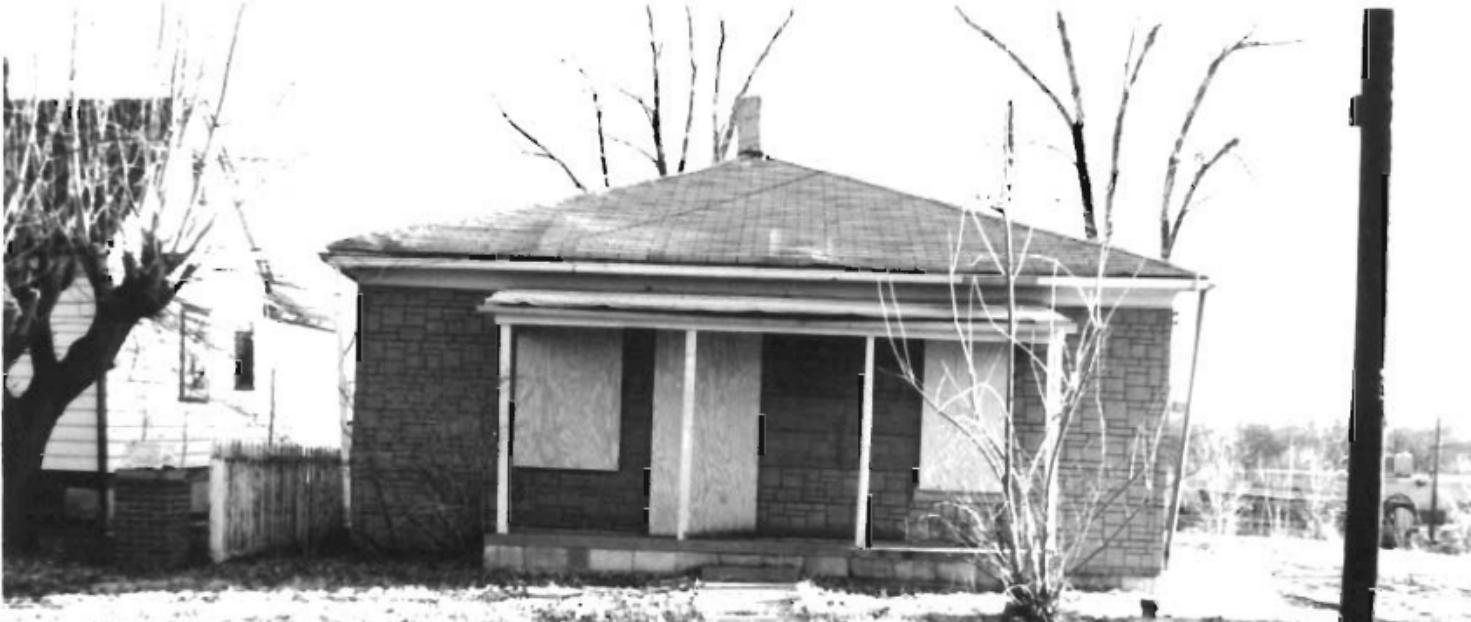
1 NO 2073 LOCAL #	4 PRESENT NAME(S) JEREMIAH'S CUSTARD STATION	
2 COUNTY ST. LOUIS	5 OTHER NAME(S)	
3. LOCATION OF NEGATIVES LINDA STOCKMAN		
6 SPECIFIC LOCATION 228 E. MADISON	16 THEMATIC CATEGORY	23 NO OF STORIES 01.0
7 CITY OR TOWN KIRKWOOD, MO	17 DATE(S) OR PERIOD CA 1915	29 BASEMENT (Y/N) Y FULL (Y/N) Y
8 SITE PLAN WITH NORTH ARROW  SEE MAP	18 STYLE OR DESIGN NATIONAL FOLK  19 ARCHITECT OR ENGINEER	30 FOUNDATION MATERIAL CONCRETE BLOCK  31 WALL CONSTRUCTION FRAME
	20 CONTRACTOR OR BUILDER	32 ROOF TYPE & MATERIAL PYRAMIDIAL HIP
	21 ORIGINAL USE, IF APPARENT SINGLE FAMILY RESIDENCE	33 NO. OF BAYS FRONT 3 SIDE 2
	22 PRESENT USE SINGLE FAMILY RESIDENCE	34 WALL TREATMENT ASPHALT SIDING
		35 PLAN SHAPE SQUARE
	23 OWNERSHIP PUBLIC PRIVATE X	36 CHANGES ADDITION (EXPLAIN ALTERED IN #42) MOVED
9 COORDINATES LOT LANG	24 OWNER'S NAME & ADDRESS (IF KNOWN)	37 CONDITION INTERIOR EXTERIOR POOR
10 SITE STRUCTURE BUILDING X OBJECT	25 OPEN TO PUBLIC (YES/NO) N	38 PRESERVATION UNDERWAY? (Y/N) N

11 ON NAT'L REG? (YES/NO) N	12 IS IT ELIGIBLE? (YES/NO)	39 ENDANGERED (YES/NO) N BY WHAT?
13 PART OF HIST DIST (YES/NO) N	14 DIST POTENT (YES/NO)	40 VISIBLE FROM PUBLIC ROAD? (YES/NO) Y
15 NAME OF ESTABLISHED DISTRICT	26 LOCAL CONTACT PERSON OR ORGANIZATION	41 DISTANCE FROM AND FRONTRAGE ON ROAD
42 FURTHER DESCRIPTION OF IMPORTANT FEATURES SEE CONTINUATION SHEET		PHOTO
43 HISTORY AND SIGNIFICANCE SEE CONTINUATION SHEET		46 PREPARED BY LINDA STOCKMAN
44 DESCRIPTION OF ENVIRONMENT AND OUTBUILDINGS SEE CONTINUATION SHEET		47 ORGANIZATION KIRKWOOD LANDM COMM.
45 SOURCES OF INFORMATION SEE CONTINUATION SHEET		48 DATE 06/86 49 REVISION DATE(S)

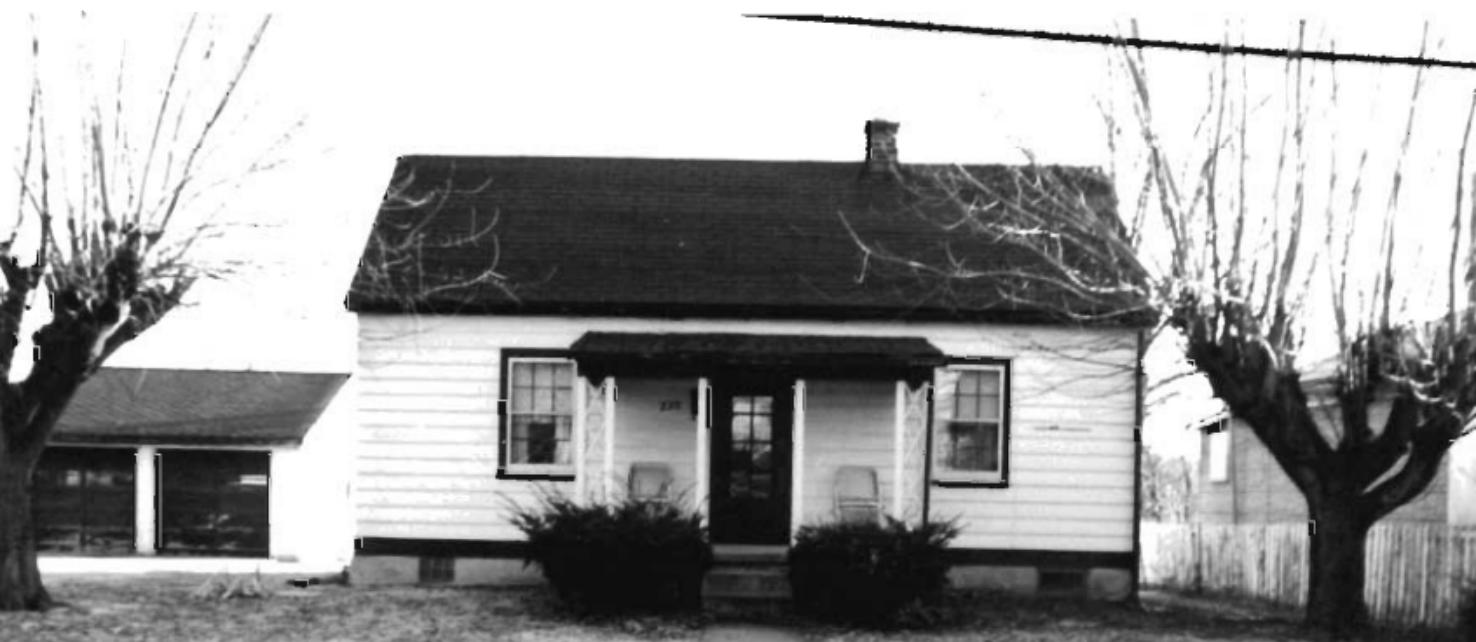
1 NO 2074 LOCAL #	4 PRESENT NAME(S)	
2 COUNTY ST. LOUIS	5 OTHER NAME(S)	
3 LOCATION OF NEGATIVES LINDA STOCKMAN		
6 SPECIFIC LOCATION 230 E. MADISON	16 THEMATIC CATEGORY	28 NO OF STORIES 01.5
7 CITY OR TOWN KIRKWOOD, MO	17 DATE(S) OR PERIOD CA 1905	29 BASEMENT (Y/N) Y FULL (Y/N) Y
8 SITE PLAN WITH NORTH ARROW  SEE MAP	18 STYLE OR DESIGN VERNACULAR  19 ARCHITECT OR ENGINEER	30 FOUNDATION MATERIAL CONCRETE  31 WALL CONSTRUCTION FRAME
	20 CONTRACTOR OR BUILDER	32 ROOF TYPE & MATERIAL SIDE GABLE ASPHALT SHINGLES
	21 ORIGINAL USE, IF APPARENT SINGLE FAMILY RESIDENCE	33 NO. OF BAYS FRONT 3 SIDE 1
	22 PRESENT USE SINGLE FAMILY RESIDENCE	34 WALL TREATMENT WOOD HORIZONTAL LAP SIDING
		35 PLAN SHAPE RECTANGULAR
	23 OWNERSHIP PUBLIC PRIVATE X	36 CHANGES ADDITION (EXPLAIN ALTERED IN #42) MOVED
9 COORDINATES LOT LANG	24 OWNER'S NAME & ADDRESS (IF KNOWN)	37 CONDITION INTERIOR EXTERIOR GOOD
10 SITE STRUCTURE BUILDING X OBJECT	25 OPEN TO PUBLIC (YES/NO) N	38 PRESERVATION UNDERWAY? (Y/N) N

11 ON NAT'L REG? (YES/NO) N	12 IS IT ELIGIBLE? (YES/NO)	39 ENDANGERED (YES/NO) N BY WHAT?
13 PART OF HIST DIST (YES/NO) N	14 DIST POTENT (YES/NO)	40 VISIBLE FROM PUBLIC ROAD? (YES/NO) Y
15 NAME OF ESTABLISHED DISTRICT	26 LOCAL CONTACT PERSON OR ORGANIZATION	41 DISTANCE FROM AND FRONTRAGE ON ROAD
42 FURTHER DESCRIPTION OF IMPORTANT FEATURES SEE CONTINUATION SHEET		PHOTO
43 HISTORY AND SIGNIFICANCE SEE CONTINUATION SHEET		46 PREPARED BY LINDA STOCKMAN
44 DESCRIPTION OF ENVIRONMENT AND OUTBUILDINGS SEE CONTINUATION SHEET		47 ORGANIZATION KIRKWOOD LANDM COMM.
45 SOURCES OF INFORMATION SEE CONTINUATION SHEET		48 DATE 06/86 49 REVISION DATE(S)
