**HISTORIC INVENTORY**

Presbyterian Church Tower Park  
100 E. Adams

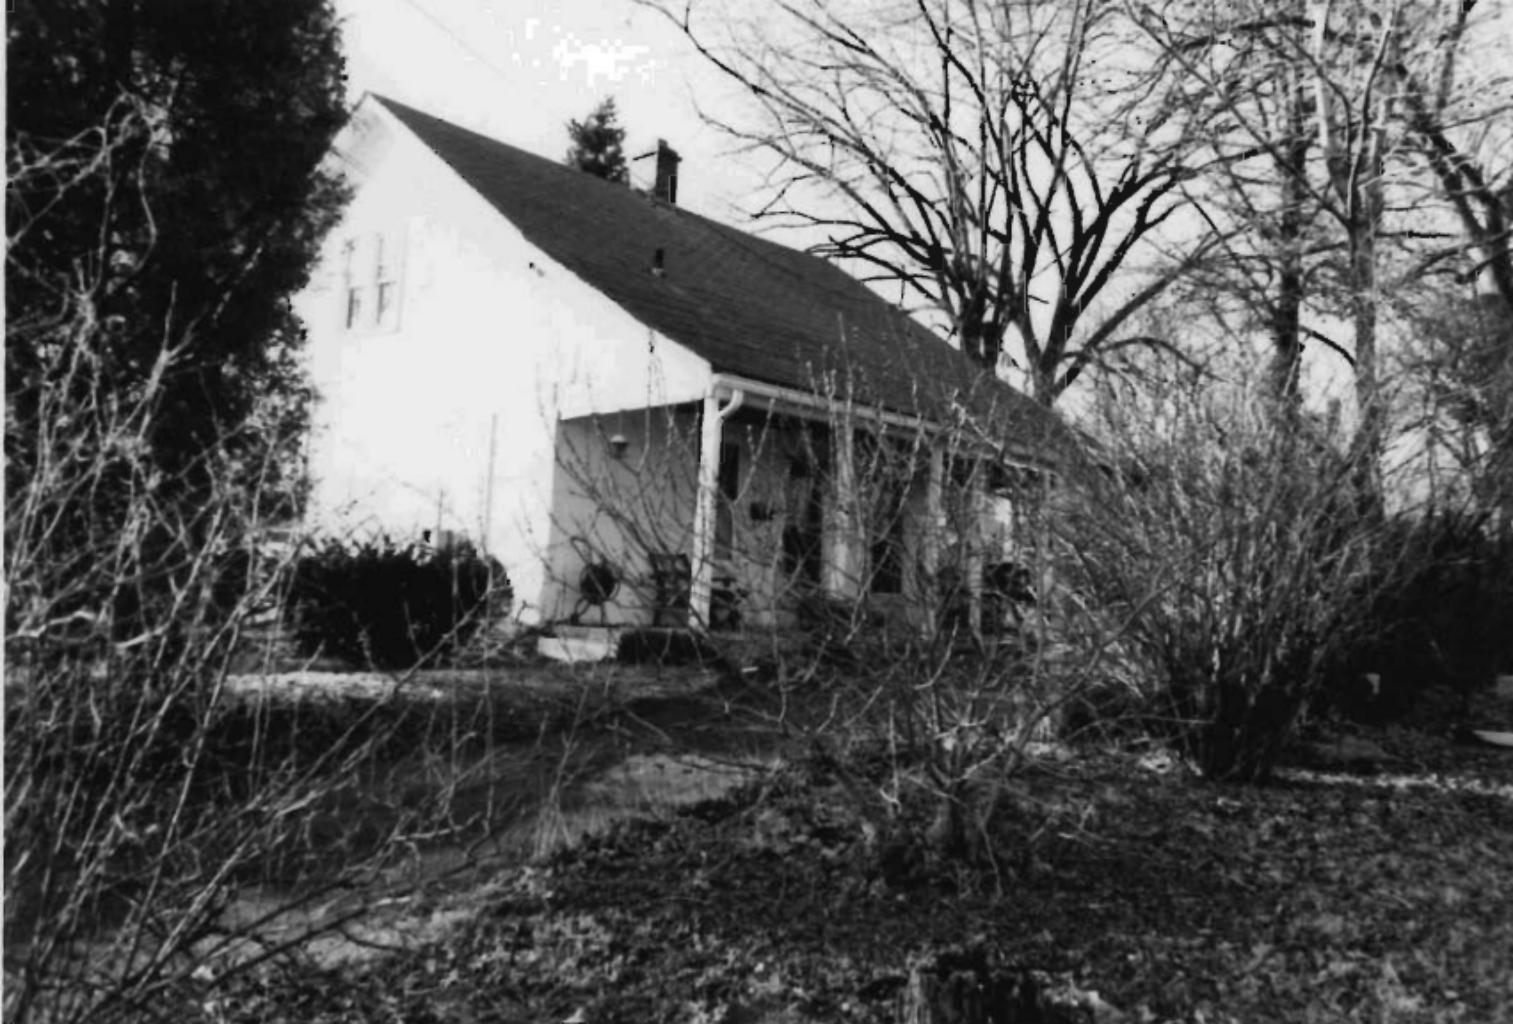
1 NO 2065 LOCAL # 2 COUNTY 3. LOCATION OF NEGATIVES ST. LOUIS LINDA STOCKMAN	4 PRESENT NAME(S)  5 OTHER NAME(S)	
6 SPECIFIC LOCATION 235 E. MADISON	16 THEMATIC CATEGORY  17 DATE(S) OR PERIOD CA 1925	28 NO OF STORIES 01.5  29 BASEMENT (Y/N) Y FULL (Y/N) Y
7 CITY OR TOWN KIRKWOOD, MO	18 STYLE OR DESIGN VERNACULAR	30 FOUNDATION MATERIAL CONCRETE
8 SITE PLAN WITH NORTH ARROW  SEE MAP	19 ARCHITECT OR ENGINEER  20 CONTRACTOR OR BUILDER	31 WALL CONSTRUCTION FRAME  32 ROOF TYPE & MATERIAL SALT BOX GABLE ASPHALT SHINGLES
	21 ORIGINAL USE, IF APPARENT SINGLE FAMILY RESIDENCE  22 PRESENT USE SINGLE FAMILY RESIDENCE	33 NO OF BAYS FRONT 4 SIDE 2  34 WALL TREATMENT ASBESTOS SHINGLES
		35 PLAN SHAPE RECTANGULAR
	23 OWNERSHIP PUBLIC PRIVATE X	36 CHANGES ADDITION (EXPLAIN ALTERED IN #42) MOVED
9 COORDINATES LOT LANG	24 OWNER'S NAME & ADDRESS (IF KNOWN)	37 CONDITION INTERIOR EXTERIOR GOOD
10 SITE STRUCTURE BUILDING X OBJECT	25 OPEN TO PUBLIC (YES/NO) N	38 PRESERVATION UNDERWAY? (Y/N) N

11 ON NAT'L REG? (YES/NO) N	12 IS IT ELIGIBLE? (YES/NO)	39 ENDANGERED (YES/NO) N BY WHAT?
13 PART OF HIST DIST (YES/NO) N	14 DIST PTENT (YES/NO)	40 VISIBLE FROM PUBLIC ROAD? (YES/NO) Y
15 NAME OF ESTABLISHED DISTRICT	26 LOCAL CONTACT PERSON OR ORGANIZATION  27 OTHER SURVEYS IN WHICH INCLUDED	41 DISTANCE FROM AND FRONTAGE ON ROAD  PHOTO
42 FURTHER DESCRIPTION OF IMPORTANT FEATURES SEE CONTINUATION SHEET		46 PREPARED BY LINDA STOCKMAN
43 HISTORY AND SIGNIFICANCE SEE CONTINUATION SHEET		47 ORGANIZATION KIRKWOOD LANDM COMM.
44 DESCRIPTION OF ENVIRONMENT AND OUTBUILDINGS SEE CONTINUATION SHEET		48 DATE 06/86
45 SOURCES OF INFORMATION SEE CONTINUATION SHEET		49 REVISION DATE(S)

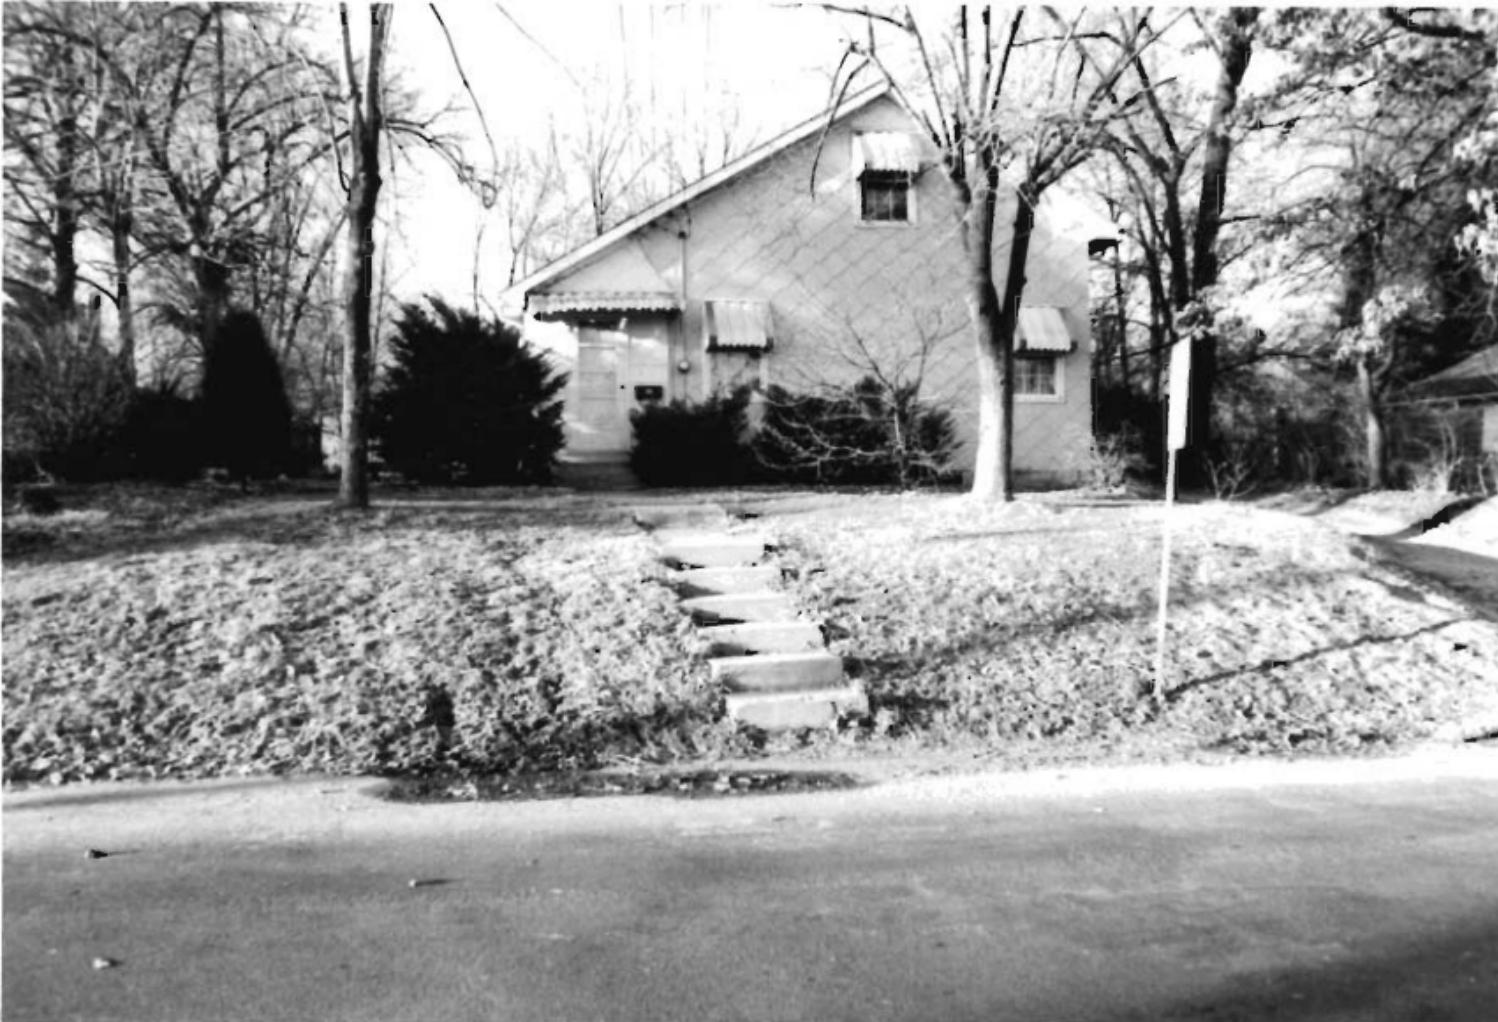
1 NO 2064 LOCAL #	4 PRESENT NAME(S)	
2 COUNTY ST. LOUIS	5 OTHER NAME(S) LINDA STOCKMAN	
3. LOCATION OF NEGATIVES		
6 SPECIFIC LOCATION 237 E. MADISON	16 THEMATIC CATEGORY	28 NO OF STORIES 01.5
7 CITY OR TOWN KIRKWOOD, MO	17 DATE(S) OR PERIOD CA 1925	29 BASEMENT (Y/N) Y FULL (Y/N) Y
8 SITE PLAN WITH NORTH ARROW  SEE MAP	18 STYLE OR DESIGN VERNACULAR	30 FOUNDATION MATERIAL CONCRETE BLOCK
	19 ARCHITECT OR ENGINEER	31 WALL CONSTRUCTION FRAME
	20 CONTRACTOR OR BUILDER	32 ROOF TYPE & MATERIAL SALT BOX GABLE ASPHALT SHINGLES
	21 ORIGINAL USE, IF APPARENT SINGLE FAMILY RESIDENCE	33 NO. OF BAYS FRONT 4 SIDE 2
	22 PRESENT USE SINGLE FAMILY RESIDENCE	34 WALL TREATMENT ASBESTOS FISHSCALE SHINGLES & WOOD LAP SIDING
		35 PLAN SHAPE RECTANGULAR
	23 OWNERSHIP PUBLIC PRIVATE X	36 CHANGES ADDITION X (EXPLAIN ALTERED X IN #42) MOVED
	24 OWNER'S NAME & ADDRESS (IF KNOWN)	37 CONDITION INTERIOR EXTERIOR FAIR
9 COORDINATES LOT LANG	25 OPEN TO PUBLIC (YES/NO) N	38 PRESERVATION UNDERWAY? (Y/N) N

10 SITE STRUCTURE BUILDING X OBJECT	26 LOCAL CONTACT PERSON OR ORGANIZATION	39 ENDANGERED (YES/NO) N BY WHAT?
11 ON NAT'L REG? (YES/NO) N	12 IS IT ELIGIBLE? (YES/NO)	40 VISIBLE FROM PUBLIC ROAD? (YES/NO) Y
13 PART OF HIST DIST (YES/NO) N	14 DIST POTENT (YES/NO)	41 DISTANCE FROM AND FRONTOGE ON ROAD
15 NAME OF ESTABLISHED DISTRICT		
42 FURTHER DESCRIPTION OF IMPORTANT FEATURES SEE CONTINUATION SHEET		PHOTO
43 HISTORY AND SIGNIFICANCE SEE CONTINUATION SHEET		46 PREPARED BY LINDA STOCKMAN
44 DESCRIPTION OF ENVIRONMENT AND OUTBUILDINGS SEE CONTINUATION SHEET		47 ORGANIZATION KIRKWOOD LANDM COMM.
45 SOURCES OF INFORMATION SEE CONTINUATION SHEET		48 DATE 06/86 49 REVISION DATE(S)

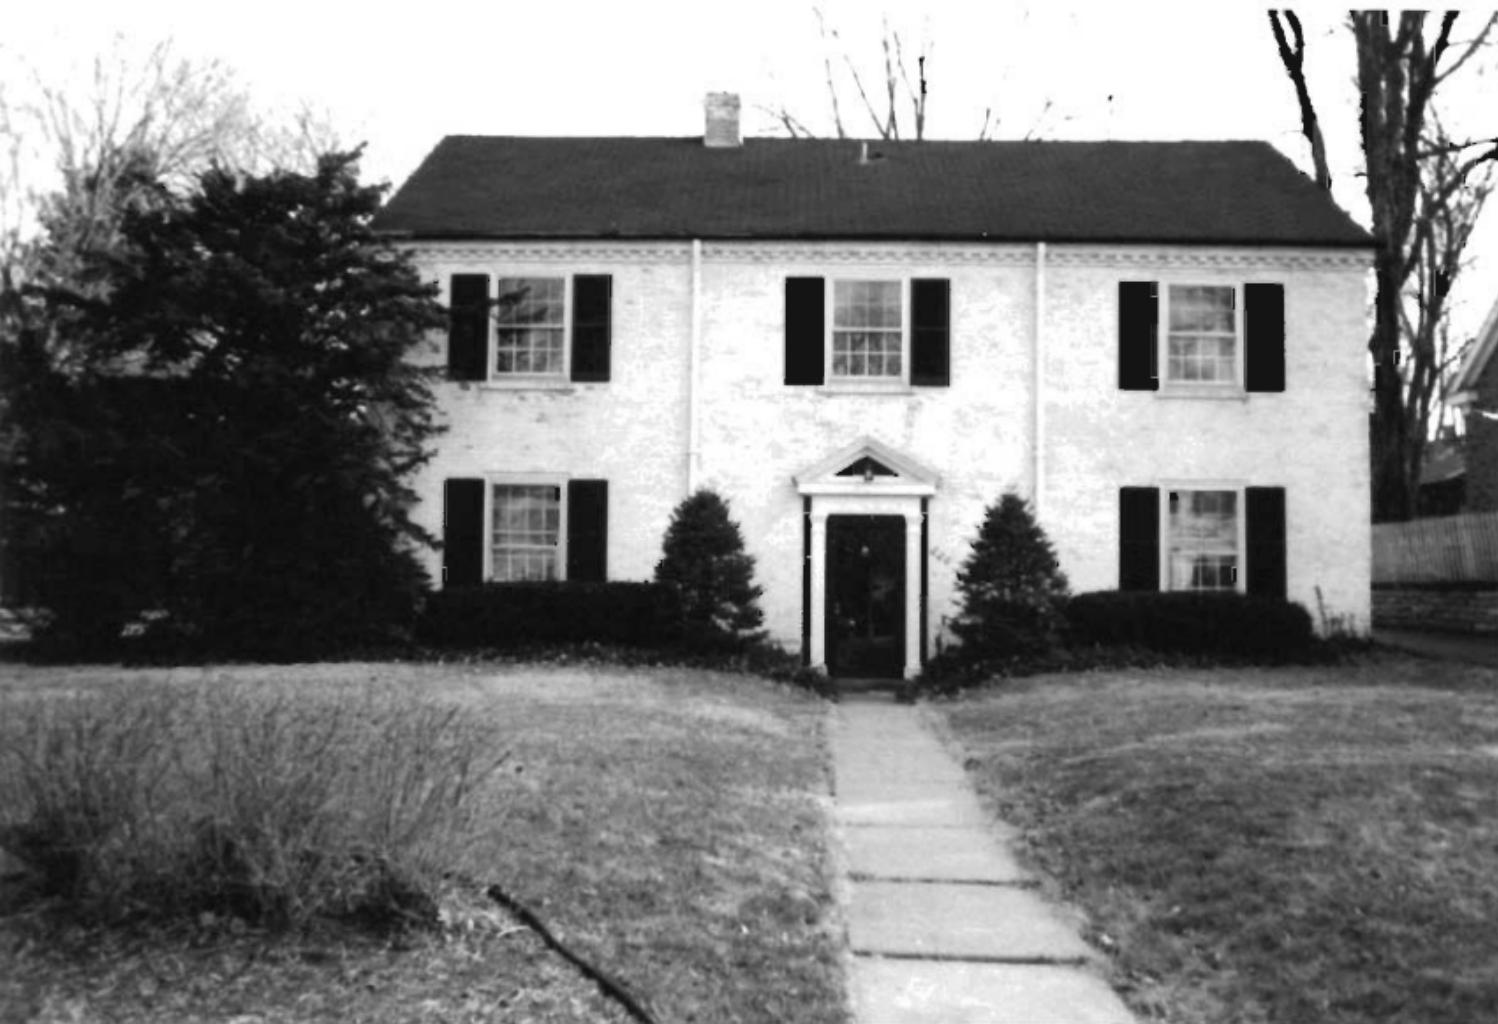
1 NO 2081 LOCAL #	4 PRESENT NAME(S)	
2 COUNTY ST. LOUIS		
3. LOCATION OF NEGATIVES LINDA STOCKMAN	5 OTHER NAME(S)	
6 SPECIFIC LOCATION 220 ORRICK LANE	16 THEMATIC CATEGORY	28 NO OF STORIES 02.5
7 CITY OR TOWN KIRKWOOD, MO	17 DATE(S) OR PERIOD CA 1925	29 BASEMENT (Y/N) Y FULL (Y/N) Y
8 SITE PLAN WITH NORTH ARROW  SEE MAP	18 STYLE OR DESIGN ECLECTIC COLONIAL REVIVAL	30 FOUNDATION MATERIAL CONCRETE SLAB
	19 ARCHITECT OR ENGINEER	31 WALL CONSTRUCTION MASONRY
	20 CONTRACTOR OR BUILDER	32 ROOF TYPE & MATERIAL SIDE GABLE ASPHALT SHINGLES
	21 ORIGINAL USE, IF APPARENT SINGLE FAMILY RESIDENCE	33 NO. OF BAYS FRONT 4 SIDE 2
	22 PRESENT USE SINGLE FAMILY RESIDENCE	34 WALL TREATMENT PAINTED BRICK & WOOD HORIZONTAL LAP SIDING
	23 OWNERSHIP PUBLIC PRIVATE X	35 PLAN SHAPE IRREGULAR
	24 OWNER'S NAME & ADDRESS (IF KNOWN)	36 CHANGES ADDITION X (EXPLAIN ALTERED IN #42) MOVED
9 COORDINATES LOT LANG		37 CONDITION INTERIOR EXTERIOR GOOD

10 SITE STRUCTURE BUILDING X OBJECT	25 OPEN TO PUBLIC (YES/NO) N	38 PRESERVATION UNDERWAY? (Y/N) N
11 ON NAT'L REG? (YES/NO) N	12 IS IT ELIGIBLE? (YES/NO)	26 LOCAL CONTACT PERSON OR ORGANIZATION
13 PART OF HIST DIST (YES/NO) N	14 DIST POTENT (YES/NO) Y	27 OTHER SURVEYS IN WHICH INCLUDED
15 NAME OF ESTABLISHED DISTRICT		39 ENDANGERED (YES/NO) N BY WHAT?
42 FURTHER DESCRIPTION OF IMPORTANT FEATURES SEE CONTINUATION SHEET		40 VISIBLE FROM PUBLIC ROAD ? (YES/NO) Y
43 HISTORY AND SIGNIFICANCE SEE CONTINUATION SHEET		41 DISTANCE FROM AND FRONTAGE ON ROAD
44 DESCRIPTION OF ENVIRONMENT AND OUTBUILDINGS SEE CONTINUATION SHEET		PHOTO
45 SOURCES OF INFORMATION SEE CONTINUATION SHEET	46 PREPARED BY LINDA STOCKMAN	
	47 ORGANIZATION KIRKWOOD LANDM COMM.	
	48 DATE 06/86	49 REVISION DATE(S)

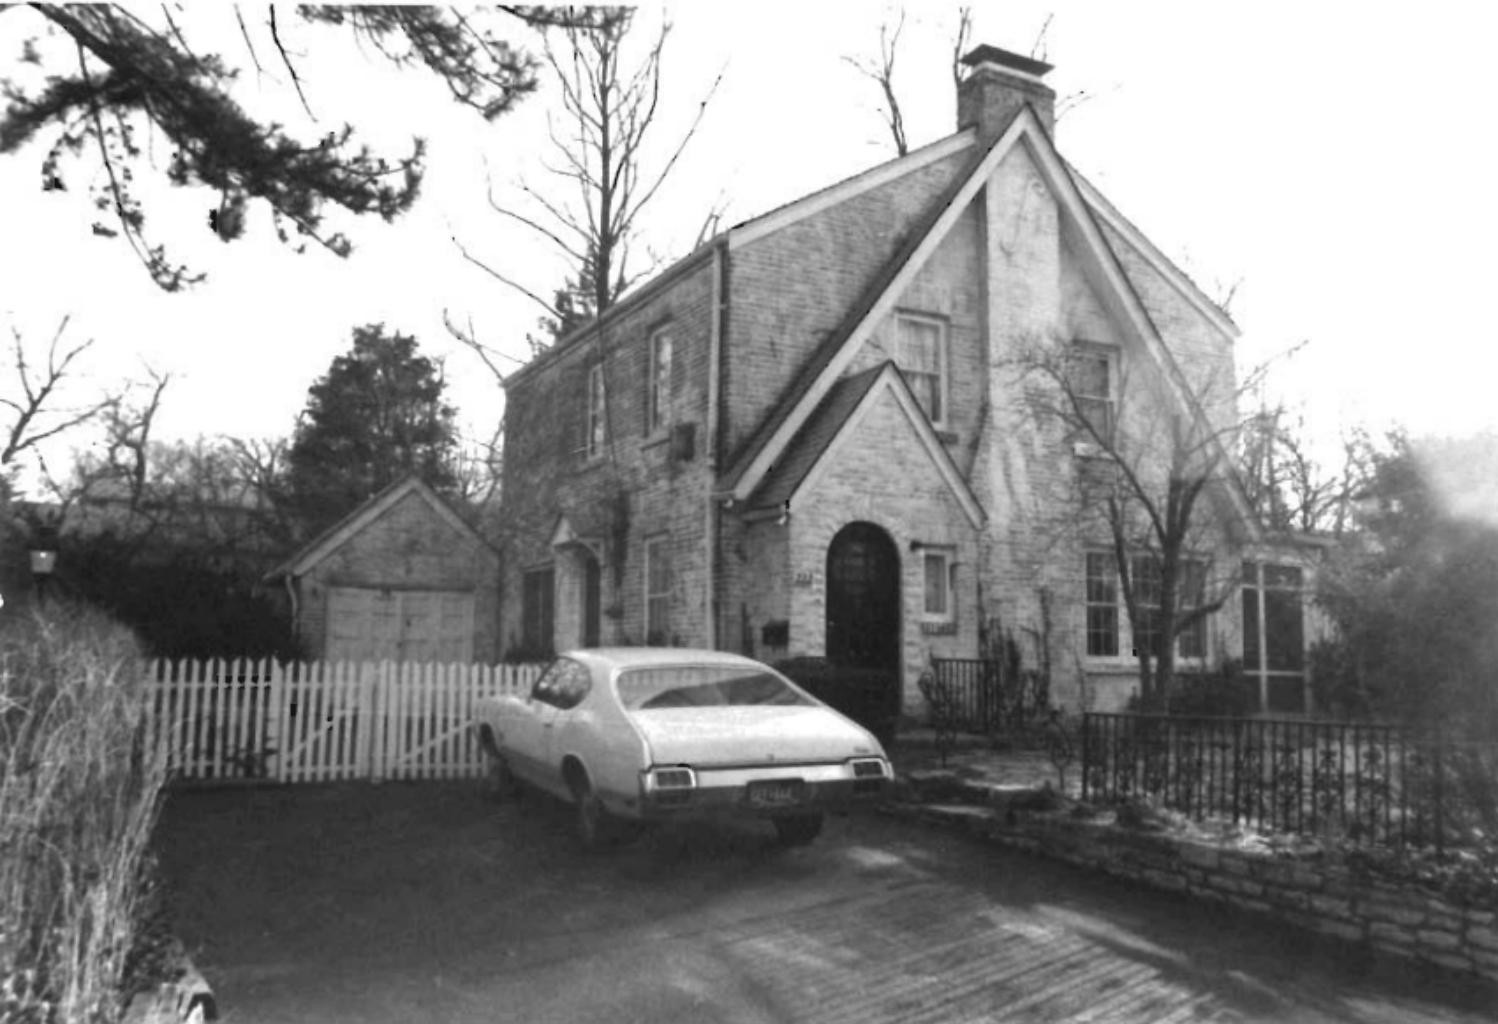
1 NO 2082 LOCAL #	4 PRESENT NAME(S)	
2 COUNTY ST. LOUIS	5 OTHER NAME(S) LINDA STOCKMAN	
6 SPECIFIC LOCATION 222 ORRICK LANE	16 THEMATIC CATEGORY	28 NO OF STORIES 02.0
	17 DATE(S) OR PERIOD CA 1925	29 BASEMENT (Y/N) Y FULL (Y/N) Y
7 CITY OR TOWN KIRKWOOD, MO	18 STYLE OR DESIGN ECLECTIC CRAFTSMAN	30 FOUNDATION MATERIAL CONCRETE
8 SITE PLAN WITH NORTH ARROW SEE MAP	19 ARCHITECT OR ENGINEER	31 WALL CONSTRUCTION MASONRY
	20 CONTRACTOR OR BUILDER	32 ROOF TYPE & MATERIAL GABLE ASPHALT SHINGLES
	21 ORIGINAL USE, IF APPARENT SINGLE FAMILY RESIDENCE	33 NO. OF BAYS FRONT 3 SIDE 3
	22 PRESENT USE SINGLE FAMILY RESIDENCE	34 WALL TREATMENT PAINTED BRICK
		35 PLAN SHAPE IRREGULAR
	23 OWNERSHIP PUBLIC PRIVATE X	36 CHANGES ADDITION (EXPLAIN ALTERED IN #42) MOVED
	24 OWNER'S NAME & ADDRESS (IF KNOWN)	37 CONDITION INTERIOR EXTERIOR GOOD
9 COORDINATES LOT LANG	25 OPEN TO PUBLIC (YES/NO) N	38 PRESERVATION UNDERWAY? (Y/N) N

10 SITE STRUCTURE BUILDING X OBJECT	26 LOCAL CONTACT PERSON OR ORGANIZATION	39 ENDANGERED (YES/NO) N BY WHAT?
11 ON NAT'L REG? (YES/NO) N	12 IS IT ELIGIBLE? (YES/NO) Y	40 VISIBLE FROM PUBLIC ROAD ? (YES/NO) Y
13 PART OF HIST DIST (YES/NO) N	14 DIST POTENT (YES/NO) Y	41 DISTANCE FROM AND FRONTAGE ON ROAD
15 NAME OF ESTABLISHED DISTRICT		
42 FURTHER DESCRIPTION OF IMPORTANT FEATURES SEE CONTINUATION SHEET		PHOTO
43 HISTORY AND SIGNIFICANCE SEE CONTINUATION SHEET		46 PREPARED BY LINDA STOCKMAN
44 DESCRIPTION OF ENVIRONMENT AND OUTBUILDINGS SEE CONTINUATION SHEET		47 ORGANIZATION KIRKWOOD LANDM COMM.
45 SOURCES OF INFORMATION SEE CONTINUATION SHEET	48 DATE 06/86	49 REVISION DATE(S)

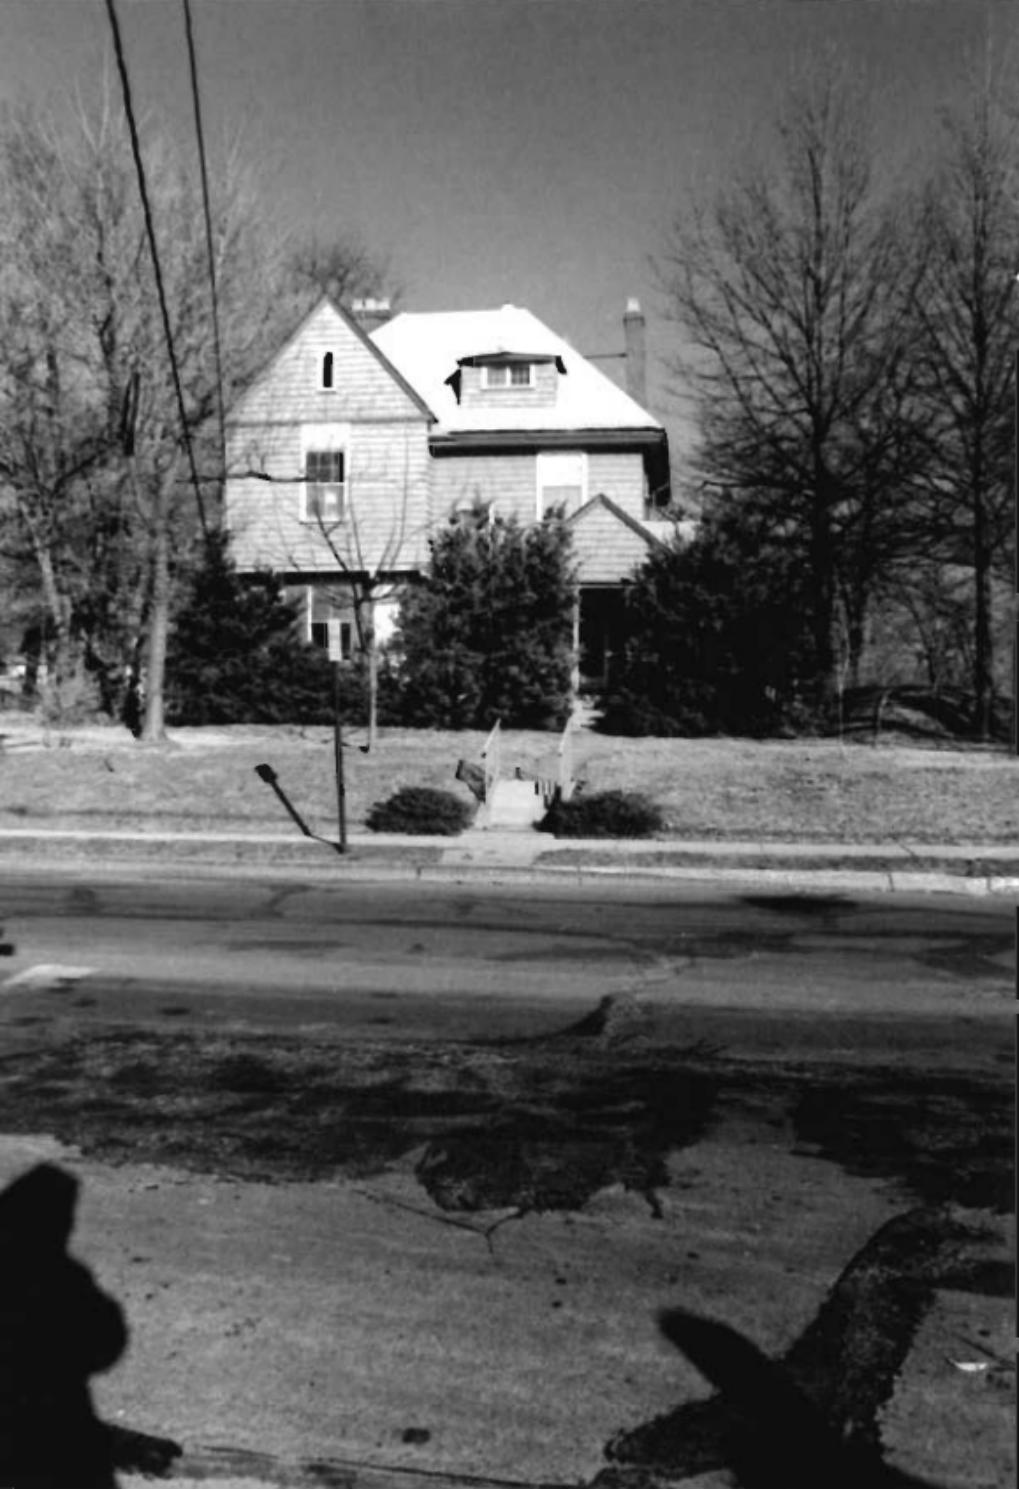
1 NO 2056 LOCAL #	4 PRESENT NAME(S)	
2 COUNTY ST. LOUIS	5 OTHER NAME(S) LINDA STOCKMAN	
3 LOCATION OF NEGATIVES		
6 SPECIFIC LOCATION 102 N. TAYLOR	16 THEMATIC CATEGORY	28 NO OF STORIES 02.5
7 CITY OR TOWN KIRKWOOD, MO	17 DATE(S) OR PERIOD CA 1880	29 BASEMENT (Y/N) Y FULL (Y/N) Y
8 SITE PLAN WITH NORTH ARROW  SEE MAP	18 STYLE OR DESIGN VICTORIAN QUEEN ANNE	30 FOUNDATION MATERIAL STONE/DRESSED
	19 ARCHITECT OR ENGINEER	31 WALL CONSTRUCTION FRAME
	20 CONTRACTOR OR BUILDER	32 ROOF TYPE & MATERIAL HIGH HIP WITH GABLE ASPHALT SHINGLES
	21 ORIGINAL USE, IF APPARENT SINGLE FAMILY RESIDENCE	33 NO. OF BAYS FRONT 3 SIDE 2
	22 PRESENT USE SINGLE FAMILY RESIDENCE	34 WALL TREATMENT WOOD SHAKES AND WOOD HORIZONTAL LAP SIDING
		35 PLAN SHAPE SQUARE
	23 OWNERSHIP PUBLIC PRIVATE X	36 CHANGES ADDITION X (EXPLAIN ALTERED X IN #42) MOVED
	24 OWNER'S NAME & ADDRESS (IF KNOWN)	37 CONDITION INTERIOR EXTERIOR GOOD
9 COORDINATES LOT LANG	25 OPEN TO PUBLIC (YES/NO) N	38 PRESERVATION UNDERWAY? (Y/N) N

10 SITE STRUCTURE BUILDING X OBJECT	26 LOCAL CONTACT PERSON OR ORGANIZATION	39 ENDANGERED (YES/NO) N BY WHAT?
11 ON NAT'L REG? (YES/NO) N	12 IS IT ELIGIBLE? (YES/NO)	40 VISIBLE FROM PUBLIC ROAD ? (YES/NO) Y
13 PART OF HIST DIST (YES/NO) N	14 DIST POTENT (YES/NO)	41 DISTANCE FROM AND FRONTAGE ON ROAD
15 NAME OF ESTABLISHED DISTRICT		
42 FURTHER DESCRIPTION OF IMPORTANT FEATURES SEE CONTINUATION SHEET		PHOTO
43 HISTORY AND SIGNIFICANCE SEE CONTINUATION SHEET		46 PREPARED BY LINDA STOCKMAN
44 DESCRIPTION OF ENVIRONMENT AND OUTBUILDINGS SEE CONTINUATION SHEET		47 ORGANIZATION KIRKWOOD LANDM COMM.
45 SOURCES OF INFORMATION SEE CONTINUATION SHEET		48 DATE 06/86   49 REVISION DATE(S)

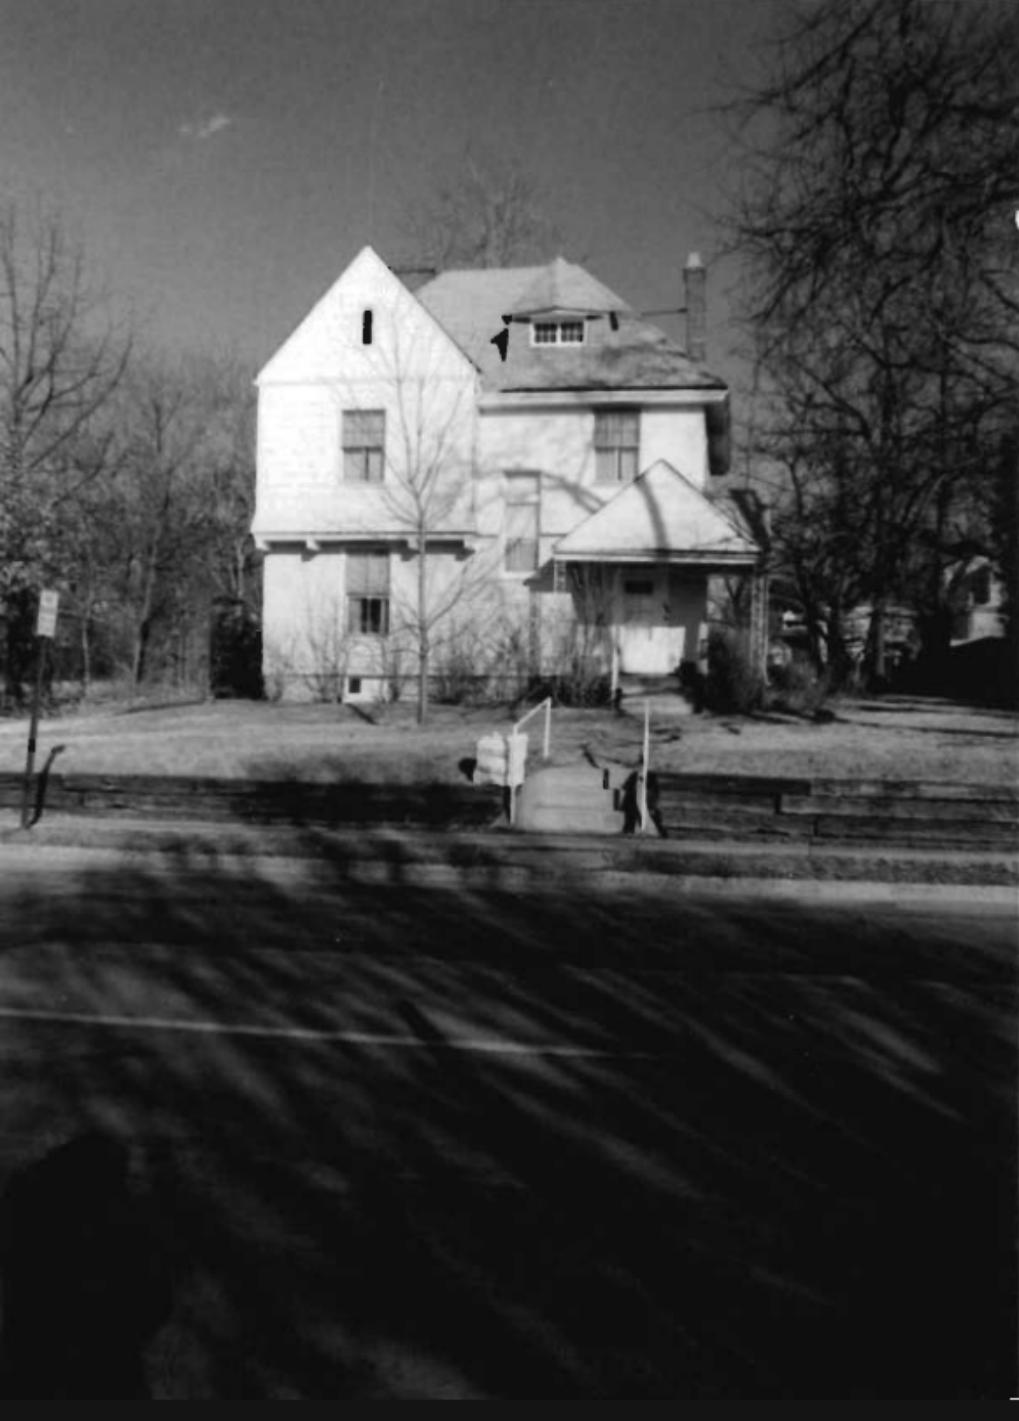
This is a large home. Its prominent features include: a complex roofline with its hipped roof, its gable atop a bracketed projecting second and attic story bay, and its bayed gabled dormer; its deeply projecting boxed cornice; its facade porch; and its varied siding materials. The facade entrance is recessed and off-center and contains a single-leaf wood door with a single light. The open-frame projecting porch has a gabled roof. Wooden posts have been replaced by wrought iron posts. The first level facade windows are wood with wood sash, double-hung, two over two, with flat wood lintels and wood sills. The facade stair/hall window is fixed, one over one, and is topped by a transom. The second level facade windows are wood with wood sash, double-hung, six over two, flat-topped, with wood lintels and sills. The small wood facade gable window features a round arch. It is one over one with arched wood molding and sill. The facade dormer contains a double casement window which is wood with wood mullion, three over three, flat-topped, with wood sill. The first level has wood horizontal lap-siding, and the second level is covered by metal shingles. There is a one story frame addition at the rear.

1 NO 2057 LOCAL #	4 PRESENT NAME(S)	
2 COUNTY ST. LOUIS	5 OTHER NAME(S)	
3. LOCATION OF NEGATIVES LINDA STOCKMAN		
6 SPECIFIC LOCATION 108 N. TAYLOR	16 THEMATIC CATEGORY	28 NO OF STORIES 02.5
7 CITY OR TOWN KIRKWOOD, MO	17 DATE(S) OR PERIOD CA 1830	29 BASEMENT (Y/N) Y FULL (Y/N) Y
	18 STYLE OR DESIGN VICTORIAN QUEEN ANNE	30 FOUNDATION MATERIAL STONE
8 SITE PLAN WITH NORTH ARROW  SEE MAP	19 ARCHITECT OR ENGINEER  20 CONTRACTOR OR BUILDER	31 WALL CONSTRUCTION FRAME  32 ROOF TYPE & MATERIAL HIGH HIP WITH GABLE ASPHALT SHINGLES
	21 ORIGINAL USE, IF APPARENT SINGLE FAMILY RESIDENCE  22 PRESENT USE SINGLE FAMILY RESIDENCE	33 NO. OF BAYS FRONT 3 SIDE 2  34 WALL TREATMENT ALUMINUM SHINGLES AND WOOD HORIZONTAL LAP SIDING
		35 PLAN SHAPE SQUARE
	23 OWNERSHIP PUBLIC PRIVATE X	36 CHANGES ADDITION X (EXPLAIN ALTERED X IN #42) MOVED
	24 OWNER'S NAME & ADDRESS (IF KNOWN)	37 CONDITION INTERIOR EXTERIOR GOOD
9 COORDINATES LOT LANG	25 OPEN TO PUBLIC (YES/NO) N	38 PRESERVATION UNDERWAY? (Y/N) N

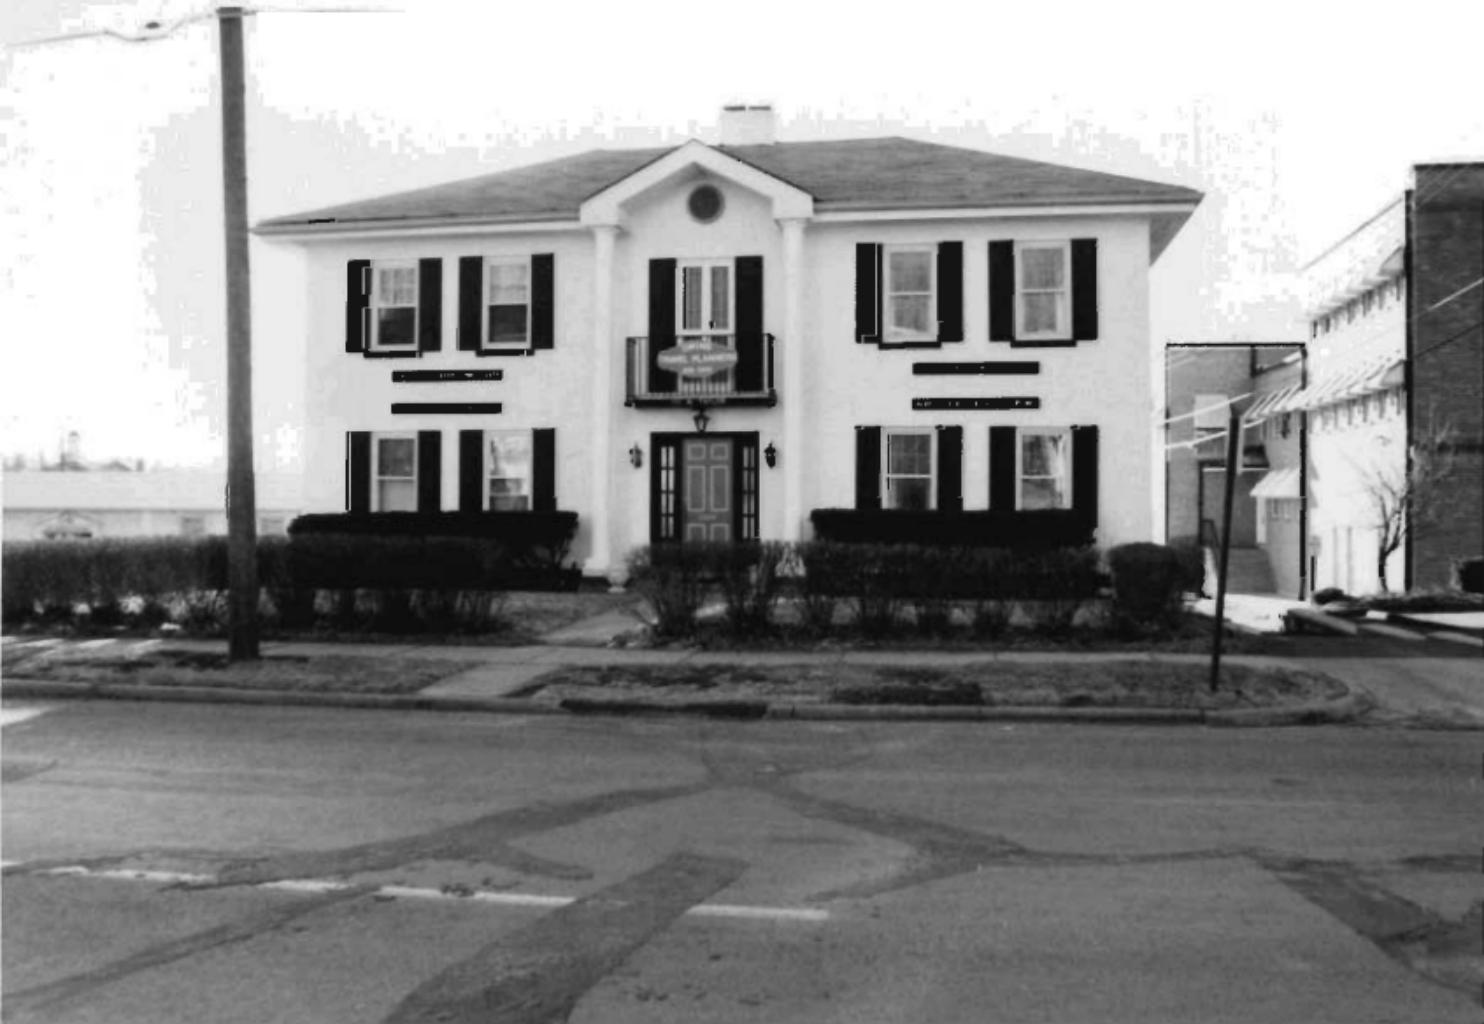
1 NO 2037 LOCAL #	4 PRESENT NAME(S)		
2 COUNTY ST. LOUIS	5 OTHER NAME(S) LINDA STOCKMAN		
3 LOCATION OF NEGATIVES			
6 SPECIFIC LOCATION 111 N. TAYLOR	16 THEMATIC CATEGORY	28 NO OF STORIES 02.5	
7 CITY OR TOWN KIRKWOOD, MO	17 DATE(S) OR PERIOD CA 1910	29 BASEMENT (Y/N) Y FULL (Y/N) Y	
8 SITE PLAN WITH NORTH ARROW  SEE MAP	18 STYLE OR DESIGN ECLECTIC COLONIAL REVIVAL	30 FOUNDATION MATERIAL CONCRETE BLOCK	
	19 ARCHITECT OR ENGINEER	31 WALL CONSTRUCTION MASONRY	
	20 CONTRACTOR OR BUILDER	32 ROOF TYPE & MATERIAL LOW HIP ASPHALT SHINGLES	
	21 ORIGINAL USE, IF APPARENT APARTMENTS	33 NO. OF BAYS FRONT 5 SIDE 6	
	22 PRESENT USE COMMERCIAL	34 WALL TREATMENT BRICK PAINTED WHITE	
		35 PLAN SHAPE U	
	23 OWNERSHIP PUBLIC PRIVATE X	36 CHANGES ADDITION (EXPLAIN ALTERED IN #42) MOVED	
9 COORDINATES LOT LANG	24 OWNER'S NAME & ADDRESS (IF KNOWN)	37 CONDITION INTERIOR EXTERIOR GOOD	
10 SITE BUILDING X STRUCTURE OBJECT	25 OPEN TO PUBLIC (YES/NO) Y	38 PRESERVATION UNDERWAY? (Y/N) N

11 ON NAT'L REG? (YES/NO) N	12 IS IT ELIGIBLE? (YES/NO)	39 ENDANGERED (YES/NO) N BY WHAT?	
13 PART OF HIST DIST (YES/NO) N	14 DIST POTENT (YES/NO)	40 VISIBLE FROM PUBLIC ROAD? (YES/NO) Y	
15 NAME OF ESTABLISHED DISTRICT	26 LOCAL CONTACT PERSON OR ORGANIZATION	41 DISTANCE FROM AND FRONTAGE ON ROAD	
42 FURTHER DESCRIPTION OF IMPORTANT FEATURES SEE CONTINUATION SHEET		PHOTO	
43 HISTORY AND SIGNIFICANCE SEE CONTINUATION SHEET		46 PREPARED BY LINDA STOCKMAN	
44 DESCRIPTION OF ENVIRONMENT AND OUTBUILDINGS SEE CONTINUATION SHEET		47 ORGANIZATION KIRKWOOD LANDM COMM.	
45 SOURCES OF INFORMATION SEE CONTINUATION SHEET		48 DATE 06/86	49 REVISION DATE(S)

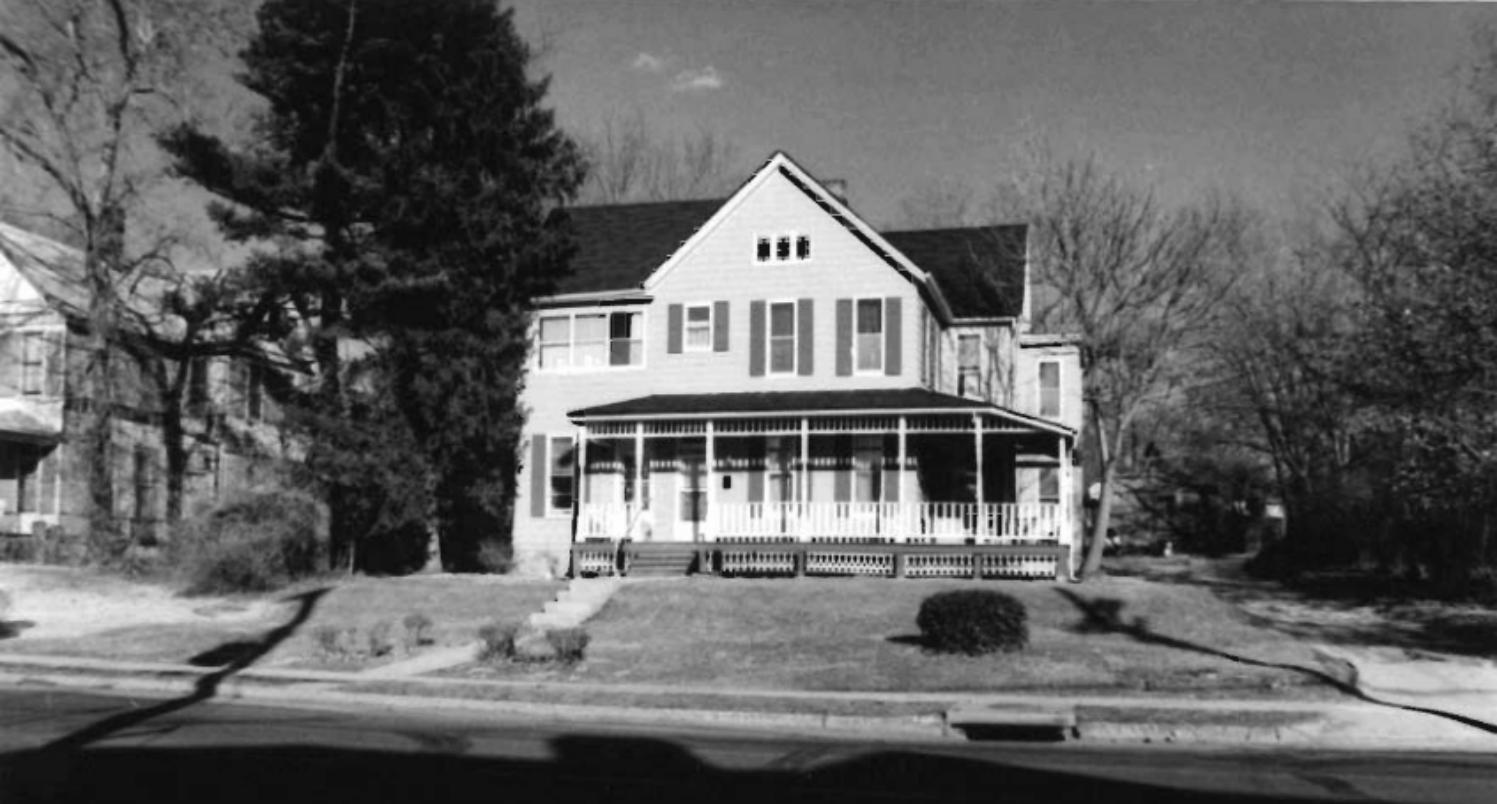
The first story facade features an open-frame, wrap-around veranda, with turned wooden posts and spindle work; plain lower balustrades replace the original. There are 3 single-leaf facade doors, one is recessed (SW corner). Each door is wood, contains 15 lights, and is topped by a transom. There is a two story addition on the NW corner (with concrete foundation). The facade of this addition contains a triple window with wood mullions at the second level and squatter proportions than the remainder of the facade windows. All first and second story windows are wood, double-hung, one over one, flat-topped with wood slipsills. Wood shutters exist on the first and second story windows. The facade also features a decorative triple window in the gable above the second story windows; of wood, with wood mullions, multi-paned, casement. All facade windows are covered by aluminum storm sash. There are also aluminum storm doors. The roofline features a plain boxed cornice. There is a two story frame addition with a concrete foundation at the SE corner of the rear of the building; as well as a one story frame addition with a concrete foundation at the NE corner of the rear of the building.

1 NO 2058 LOCAL # 2 COUNTY 3. LOCATION OF NEGATIVES ST. LOUIS LINDA STOCKMAN	4 PRESENT NAME(S)  5 OTHER NAME(S)	
6 SPECIFIC LOCATION 116 N. TAYLOR	16 THEMATIC CATEGORY  17 DATE(S) OR PERIOD CA 1880  18 STYLE OR DESIGN VICTORIAN QUEEN ANNE  19 ARCHITECT OR ENGINEER	28 NO OF STORIES 02.5  29 BASEMENT (Y/N) Y FULL (Y/N) Y  30 FOUNDATION MATERIAL STONE/CONCRETE  31 WALL CONSTRUCTION FRAME
7 CITY OR TOWN KIRKWOOD, MO	20 CONTRACTOR OR BUILDER	32 ROOF TYPE & MATERIAL HIGH CROS GABLE ASPHALT SHINGLES
8 SITE PLAN WITH NORTH ARROW  SEE MAP	21 ORIGINAL USE, IF APPARENT SINGLE FAMILY RESIDENCE  22 PRESENT USE SINGLE FAMILY RESIDENCE	33 NO. OF BAYS FRONT 6 SIDE 5  34 WALL TREATMENT WOOD HORIZONTAL LAP SIDING
		35 PLAN SHAPE IRREGULAR
	23 OWNERSHIP PUBLIC PRIVATE X	36 CHANGES ADDITION X (EXPLAIN ALTERED X IN #42) MOVED
9 COORDINATES LOT LANG	24 OWNER'S NAME & ADDRESS (IF KNOWN)	37 CONDITION INTERIOR EXTERIOR GOOD

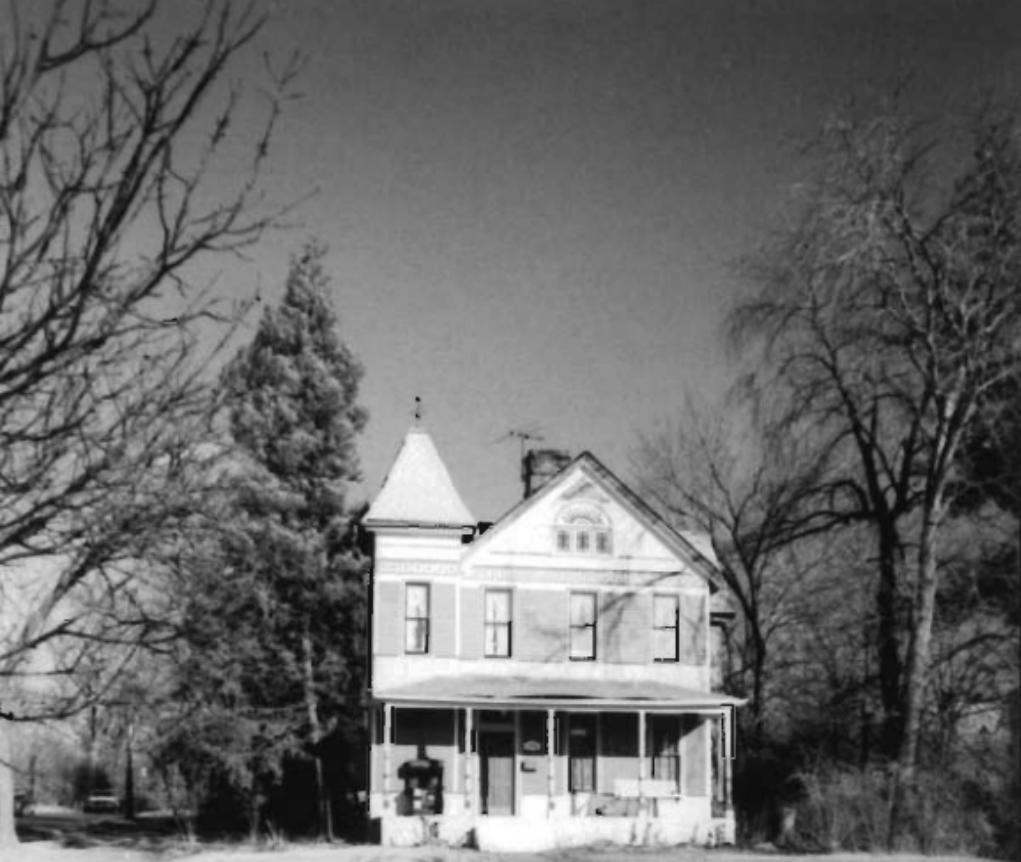
21. Original Use, if apparent single family residence	34. Wall Treatment wood shingles & wood horizontal lap siding
	22. Present Use single family residence	35. Plan Shape irregular
9 Coordinates UTM Lat Long	23. Ownership Public <input type="checkbox"/> Private <input checked="" type="checkbox"/>	36. Changes (Explain in #42) Addition <input type="checkbox"/> Altered <input checked="" type="checkbox"/> Moved <input type="checkbox"/>
10 Site I Building <input checked="" type="checkbox"/> Structure II Object III	24. Owner's Name & Address, if known	37. Condition Interior _____ Exterior good
On National Register? Yes <input type="checkbox"/> No <input checked="" type="checkbox"/>	25. Open to Public? Yes <input type="checkbox"/> No <input checked="" type="checkbox"/>	38. Preservation Underway? Yes <input type="checkbox"/> No <input checked="" type="checkbox"/>
11 Part of Estab Hist Dist? Yes <input type="checkbox"/> No <input checked="" type="checkbox"/>	12. Is It Eligible? Yes <input type="checkbox"/> No <input checked="" type="checkbox"/>	39. Endangered? By What? Yes <input type="checkbox"/> No <input checked="" type="checkbox"/>

1 NO 2059 LOCAL #	4 PRESENT NAME(S)	
2 COUNTY ST. LOUIS	5 OTHER NAME(S) LINDA STOCKMAN	
3. LOCATION OF NEGATIVES		
6 SPECIFIC LOCATION 124 N. TAYLOR	16 THEMATIC CATEGORY	28 NO OF STORIES 02.5
7 CITY OR TOWN KIRKWOOD, MO	17 DATE(S) OR PERIOD CA 1880	29 BASEMENT (Y/N) Y FULL (Y/N) Y
8 SITE PLAN WITH NORTH ARROW SEE MAP	18 STYLE OR DESIGN VICTORIAN QUEEN ANNE	30 FOUNDATION MATERIAL STONE
	19 ARCHITECT OR ENGINEER	31 WALL CONSTRUCTION FRAME
	20 CONTRACTOR OR BUILDER	32 ROOF TYPE & MATERIAL HIGH CROSS GABLE WITH TURRET ASPHALT SHINGLES
	21 ORIGINAL USE, IF APPARENT SINGLE FAMILY RESIDENCE	33 NO. OF BAYS FRONT 5 SIDE 6
	22 PRESENT USE SINGLE FAMILY RESIDENCE	34 WALL TREATMENT WOOD SHINGLES AND WOOD HORIZONTAL LAP SIDING
	23 OWNERSHIP PUBLIC PRIVATE X	35 PLAN SHAPE IRREGULAR
	24 OWNER'S NAME & ADDRESS (IF KNOWN)	36 CHANGES ADDITION (EXPLAIN ALTERED X IN #42) MOVED
9 COORDINATES LOT LANG	25 OPEN TO PUBLIC (YES/NO) N	37 CONDITION INTERIOR EXTERIOR GOOD

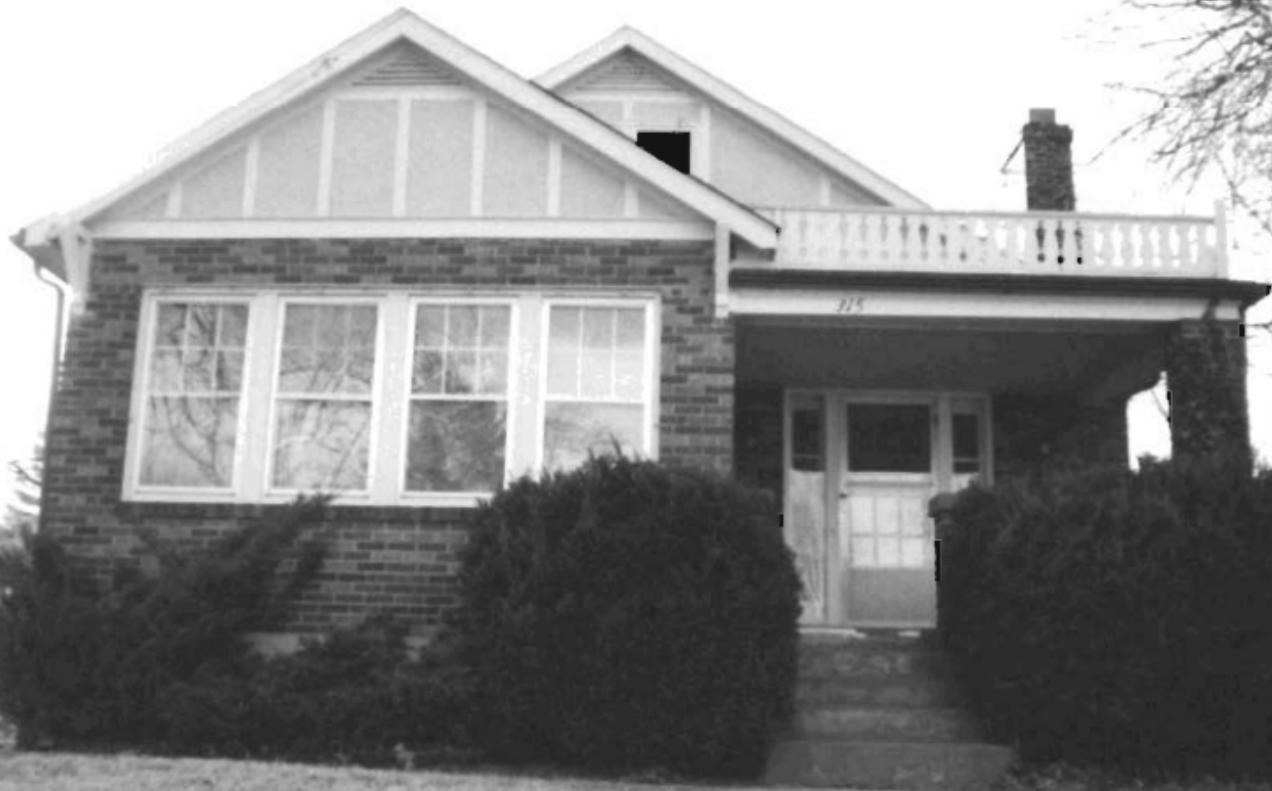
315

The prominent features of this building include: its double facade gables with their applied stucco and half-timber finish and wood corner elbow brackets; its facade entry porch; and its one story projecting facade bay which contains a sunroom. The roofline features a slightly projecting plain boxed cornice. The main facade entry is recessed and off-center toward the north. There is also an entry on the north wall of the sunroom. Both entries contain single-leaf wood doors and are flanked by sidelights. The main door contains multi-lights, and the sunroom door contains three small lights at the top. The facade porch has a concrete floor and stairs and a brick post. It is topped by a wood jig-saw balustrade. The sunroom facade windows are in a band of four. They are wood with wood sash, double-hung, flat-topped, six over one lights, with brick soldier-course sills and wood molding and mullions. The facade gables contain triangular louvered ventilation openings at their peaks.

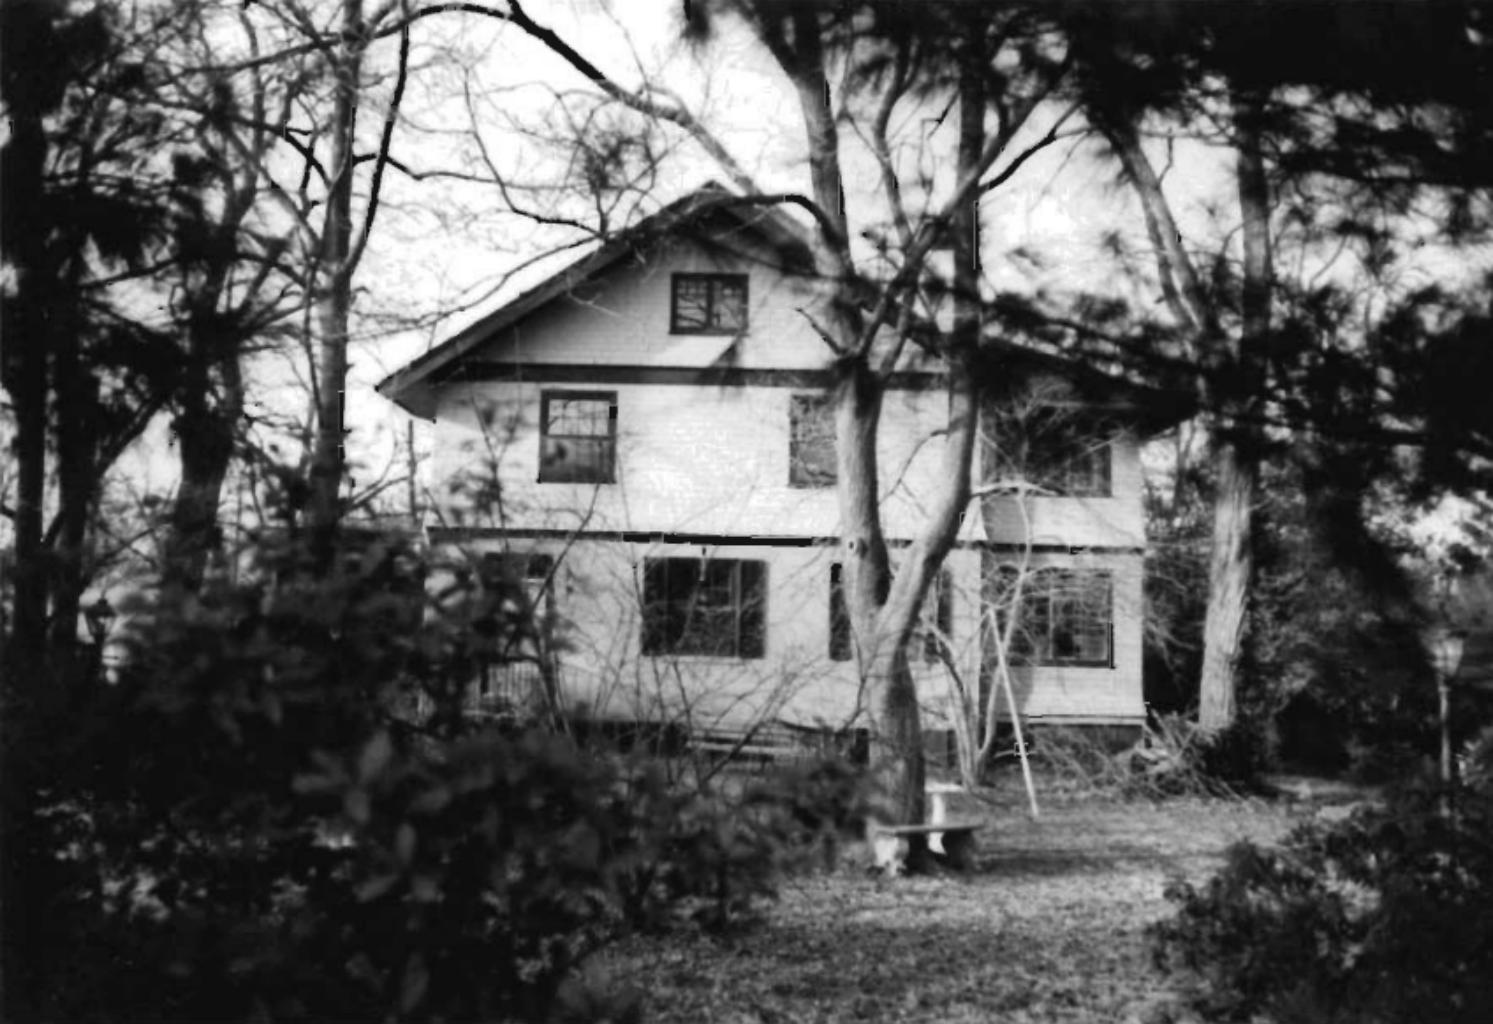
1 NO 2075 LOCAL #	4 PRESENT NAME(S)	
2 COUNTY ST. LOUIS	5 OTHER NAME(S) LINDA STOCKMAN	
6 SPECIFIC LOCATION 235 E. WASHINGTON	16 THEMATIC CATEGORY	28 NO OF STORIES 02.5
7 CITY OR TOWN KIRKWOOD, MO	17 DATE(S) OR PERIOD CA 1915	29 BASEMENT (Y/N) Y FULL (Y/N) Y
8 SITE PLAN WITH NORTH ARROW  SEE MAP	18 STYLE OR DESIGN ECLECTIC PRAIRIE	30 FOUNDATION MATERIAL CONCRETE
	19 ARCHITECT OR ENGINEER	31 WALL CONSTRUCTION FR & MS
	20 CONTRACTOR OR BUILDER	32 ROOF TYPE & MATERIAL FRONT GABLE WITH INTERSECTING HIP ASPHALT SHINGLES
	21 ORIGINAL USE, IF APPARENT SINGLE FAMILY RESIDENCE	33 NO. OF BAYS FRONT 5 SIDE 5
	22 PRESENT USE SINGLE FAMILY RESIDENCE	34 WALL TREATMENT PAINTED BRICK AND WOOD SHAKES
		35 PLAN SHAPE IRREGULAR
	23 OWNERSHIP PUBLIC PRIVATE X	36 CHANGES ADDITION (EXPLAIN ALTERED IN #42) MOVED
	24 OWNER'S NAME & ADDRESS (IF KNOWN)	37 CONDITION INTERIOR EXTERIOR GOOD
9 COORDINATES LOT LANG	25 OPEN TO PUBLIC (YES/NO) N	38 PRESERVATION UNDERWAY? (Y/N) N

10 SITE STRUCTURE BUILDING X OBJECT	26 LOCAL CONTACT PERSON OR ORGANIZATION	39 ENDANGERED (YES/NO) N BY WHAT?
11 ON NAT'L REG? (YES/NO) N	12 IS IT ELIGIBLE? (YES/NO)	40 VISIBLE FROM PUBLIC ROAD? (YES/NO) Y
13 PART OF HIST DIST (YES/NO) N	14 DIST POTENT (YES/NO) Y	41 DISTANCE FROM AND FRONTAGE ON ROAD
15 NAME OF ESTABLISHED DISTRICT		
42 FURTHER DESCRIPTION OF IMPORTANT FEATURES SEE CONTINUATION SHEET		PHOTO
43 HISTORY AND SIGNIFICANCE SEE CONTINUATION SHEET		46 PREPARED BY LINDA STOCKMAN
44 DESCRIPTION OF ENVIRONMENT AND OUTBUILDINGS SEE CONTINUATION SHEET		47 ORGANIZATION KIRKWOOD LANDM COMM.
45 SOURCES OF INFORMATION SEE CONTINUATION SHEET		48 DATE 06/86   49 REVISION DATE(S)

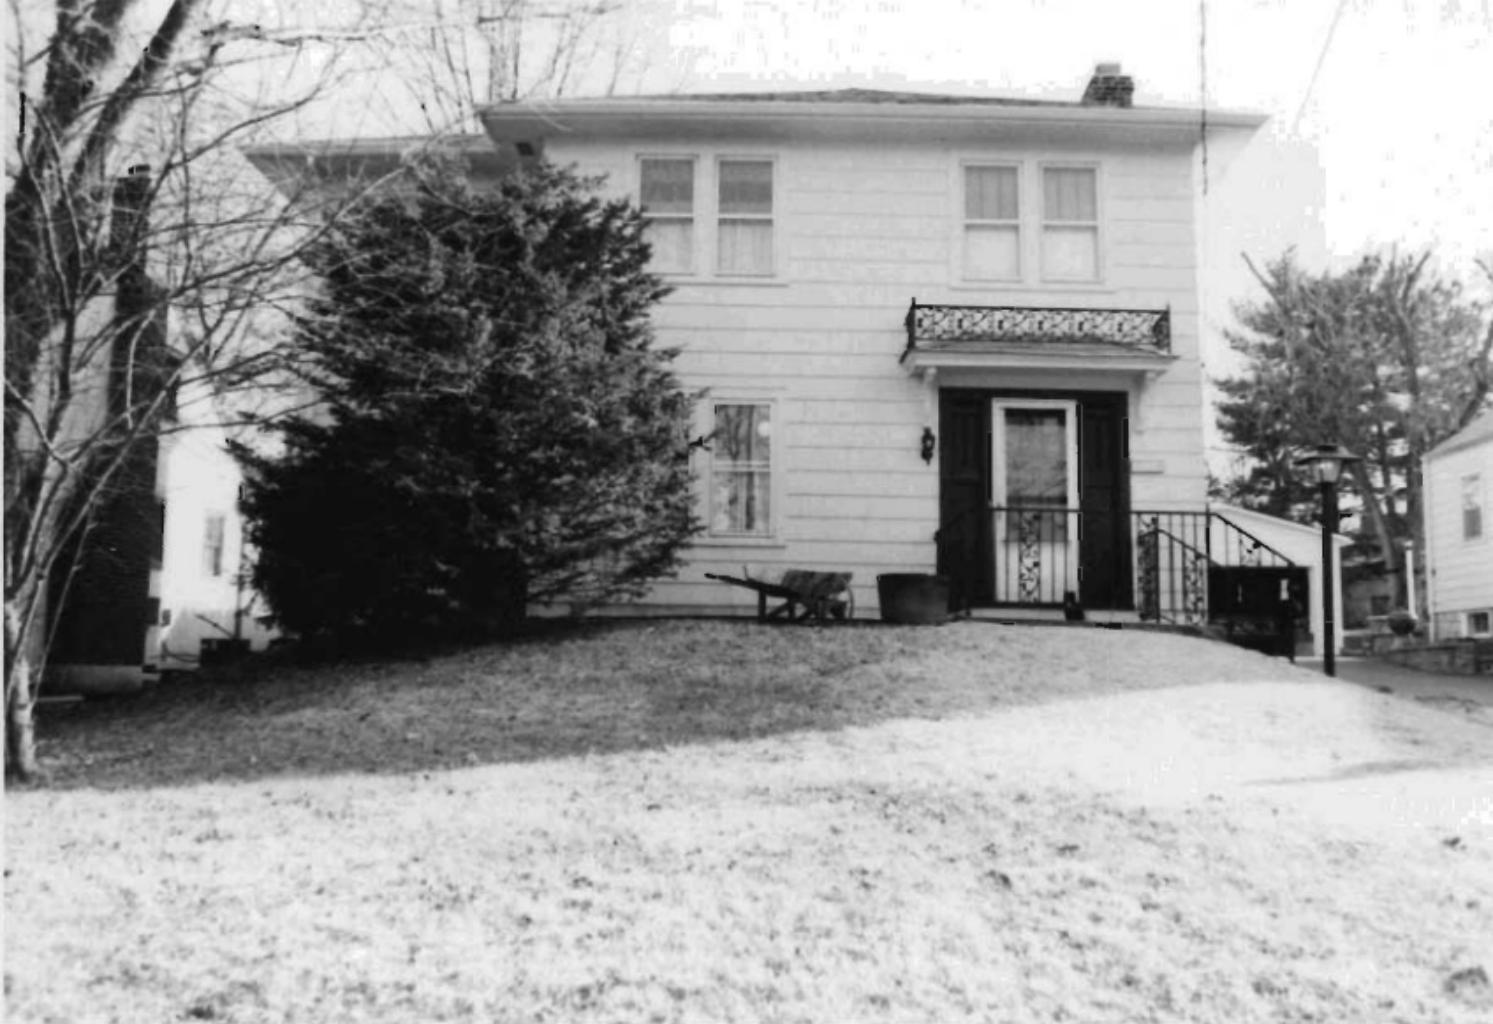
1 NC 2114 LOCAL #	4 PRESENT NAME(S)	
2 COUNTY ST. LOUIS	5 OTHER NAME(S) LINDA STOCKMAN	
3 LOCATION OF NEGATIVES		
6 SPECIFIC LOCATION 238 E. WASHINGTON	10 THEMATIC CATEGORY	28 NO OF STORIES 02.0
7 CITY OR TOWN KIRKWOOD, MO	17 DATE(S) OR PERIOD CA 1925	29 BASEMENT (Y/N) Y FULL (Y/N) Y
8 SITE PLAN WITH NORTH ARROW SEE MAP	18 STYLE OR DESIGN ECLECTIC PRAIRIE	30 FOUNDATION MATERIAL CONCRETE
	19 ARCHITECT OR ENGINEER	31 WALL CONSTRUCTION FRAME
	20 CONTRACTOR OR BUILDER	32 ROOF TYPE & MATERIAL PYRAMIDAL HIP ASPHALT SHINGLES
	21 ORIGINAL USE, IF APPARENT SINGLE FAMILY RESIDENCE	33 NO. OF BAYS FRONT 3 SIDE 2
	22 PRESENT USE SINGLE FAMILY RESIDENCE	34 WALL TREATMENT WOOD SHAKES
9 COORDINATES LOT LANG		35 PLAN SHAPE IRREGULAR
	23 OWNERSHIP PUBLIC PRIVATE X	36 CHANGES / ADDITION (EXPLAIN IN #42) ALTERED X MOVED
	24 OWNER'S NAME & ADDRESS (IF KNOWN)	37 CONDITION INTERIOR EXTERIOR GOOD
10 SITE STRUCTURE BUILDING X PROJECT	25 OPEN TO PUBLIC (YES/NO) N	38 PRESERVATION UNDERWAY? (Y/N) N

11 ON NAT'L REG? (YES/NO) N	12 IS IT ELIGIBLE? (YES/NO) (YES/NO)	39 ENDANGERED (YES/NO) N BY WHAT?
13 PART OF HIST DIST (YES/NO) N	14 DIST POTENT (YES/NO) Y	40 VISIBLE FROM PUBLIC ROAD? (YES/NO) Y
15 NAME OF ESTABLISHED DISTRICT	26 LOCAL CONTACT PERSON OR ORGANIZATION	41 DISTANCE FROM AND FRONTAGE ON ROAD
42 FURTHER DESCRIPTION OF IMPORTANT FEATURES SEE CONTINUATION SHEET	27 OTHER SURVEYS IN WHICH INCLUDED	PHOTO
43 HISTORY AND SIGNIFICANCE SEE CONTINUATION SHEET		45 PREPARED BY LINDA STOCKMAN
44 DESCRIPTION OF ENVIRONMENT AND OUTBUILDINGS SEE CONTINUATION SHEET		47 ORGANIZATION KIRKWOOD LANDM. COMM.
45 SOURCES OF INFORMATION SEE CONTINUATION SHEET		48 DATE 06/86 49 REVISION DATE(S)
