**HISTORIC INVENTORY**

Presbyterian Church Tower Park  
100 E. Adams

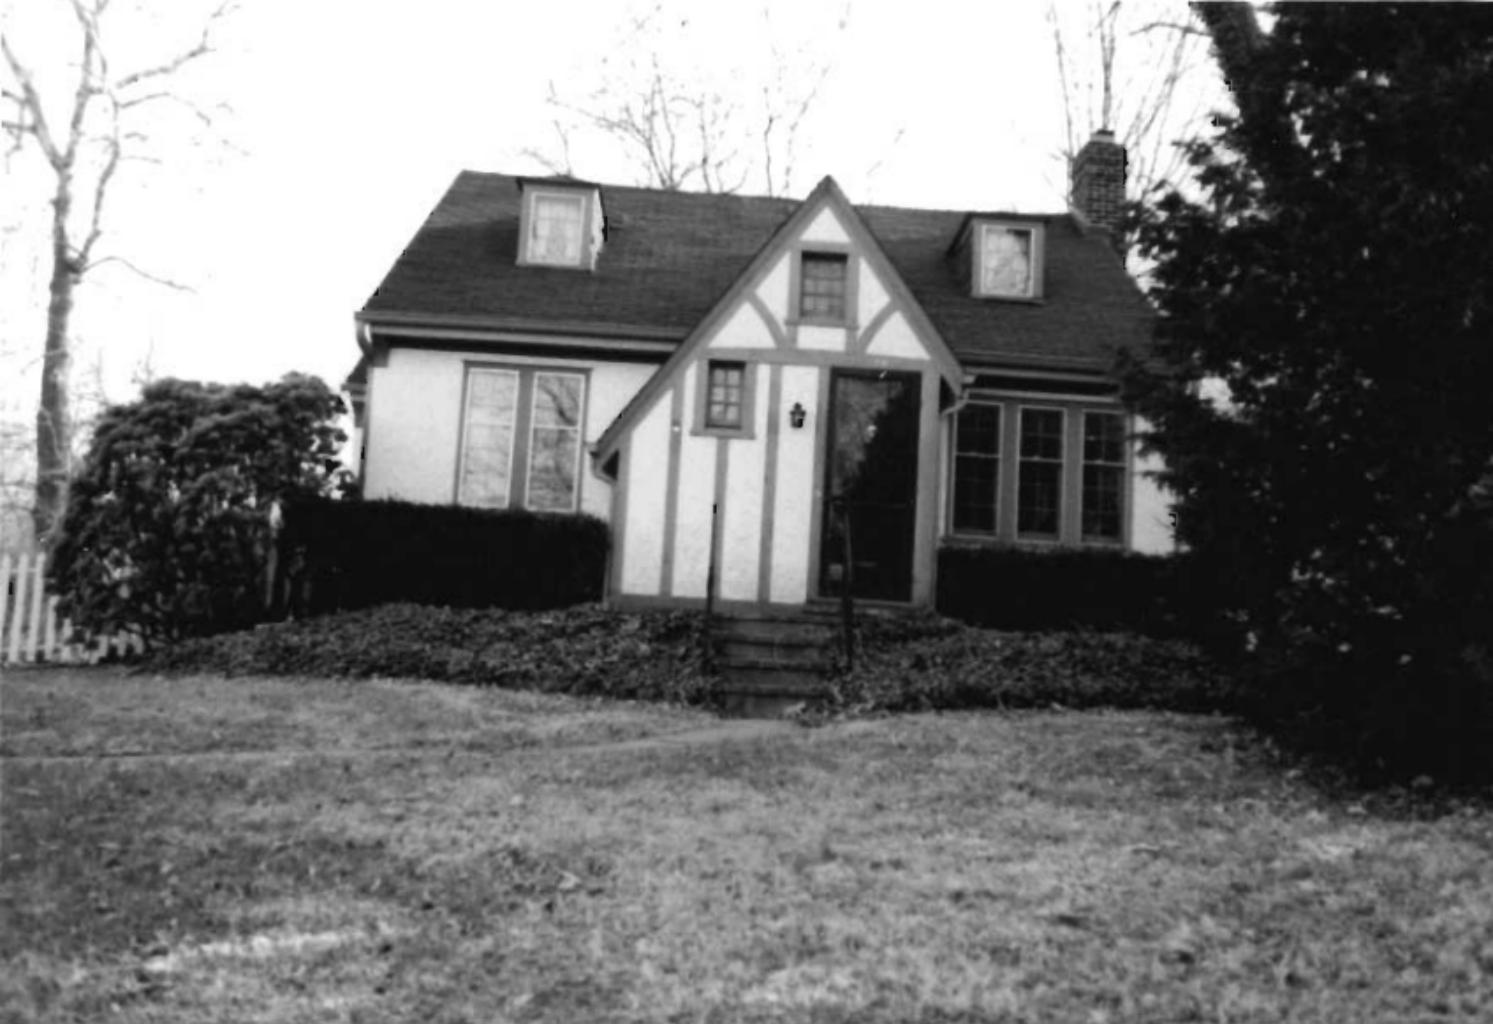
1 NO 2115 LOCAL #	4 PRESENT NAME(S)	
2 COUNTY ST. LOUIS	5 OTHER NAME(S)	
3 LOCATION OF NEGATIVES LINDA STOCKMAN		
6 SPECIFIC LOCATION 240 E. WASHINGTON	1c THEMATIC CATEGORY  17 DATE(S) OR PERIOD ca 1913	25 NO OF STORIES 31.5  29 BASEMENT (Y/N) Y FULL (Y/N) Y
7 CITY OR TOWN KIRKWOOD, MO	18 STYLE OR DESIGN ECLECTIC CRAFTSMAN	30 FOUNDATION MATERIAL CONCRETE
8 SITE PLAN WITH NORTH ARROW SEE MAP	19 ARCHITECT OR ENGINEER  20 CONTRACTOR OR BUILDER	31 WALL CONSTRUCTION FRAME  32 ROOF TYPE & MATERIAL SIDE GABLE ASPHALT SHINGLES
	21 ORIGINAL USE, IF APPARENT SINGLE FAMILY RESIDENCE	33 NO. OF BAYS FRONT 3 SIDE 3
	22 PRESENT USE SINGLE FAMILY RESIDENCE	34 WALL TREATMENT STUCCO AND HALF-TIMBER
		35 PLAY SHAPE IRREGULAR
9 COORDINATES LOT LANG	23 OWNERSHIP PUBLIC PRIVATE X	36 CHANGES IN ADDITION (EXPLAIN) IN #42) ALTERED MOVED
	24 OWNER'S NAME & ADDRESS (IF KNOWN)	37 CONDITION INTERIOR EXTERIOR GOOD
	25 OPEN TO PUBLIC (YES/NO) N	38 PRESERVATION UNDERWAY? (Y/N) N

10 SITE STRUCTURE BUILDING X OBJECT	26 LOCAL CONTACT PERSON OR ORGANIZATION	39 ENDANGERED (YES/NO) N BY WHAT?
11 ON NAT'L REG? (YES/NO) N	12 IS IT ELIGIBLE? (YES/NO)	40 VISIBLE FROM PUBLIC ROAD? (YES/NO) Y
13 PART OF HIST DIST (YES/NO) N	14 DIST POTENT (YES/NO) Y	41 DISTANCE FROM AND FRONTAGE ON ROAD
15 NAME OF ESTABLISHED DISTRICT	27 OTHER SURVEYS IN WHICH INCLUDED	42 FURTHER DESCRIPTION OF IMPORTANT FEATURES SEE CONTINUATION SHEET
43 HISTORY AND SIGNIFICANCE SEE CONTINUATION SHEET		43 PREPARED BY LINDA STOCKMAN
44 DESCRIPTION OF ENVIRONMENT AND OUTBUILDINGS SEE CONTINUATION SHEET		45 ORGANIZATION KIRKWOOD LANDM COMM.
45 SOURCES OF INFORMATION SEE CONTINUATION SHEET		46 DATE 06/36 49 REVISION DATE(S)

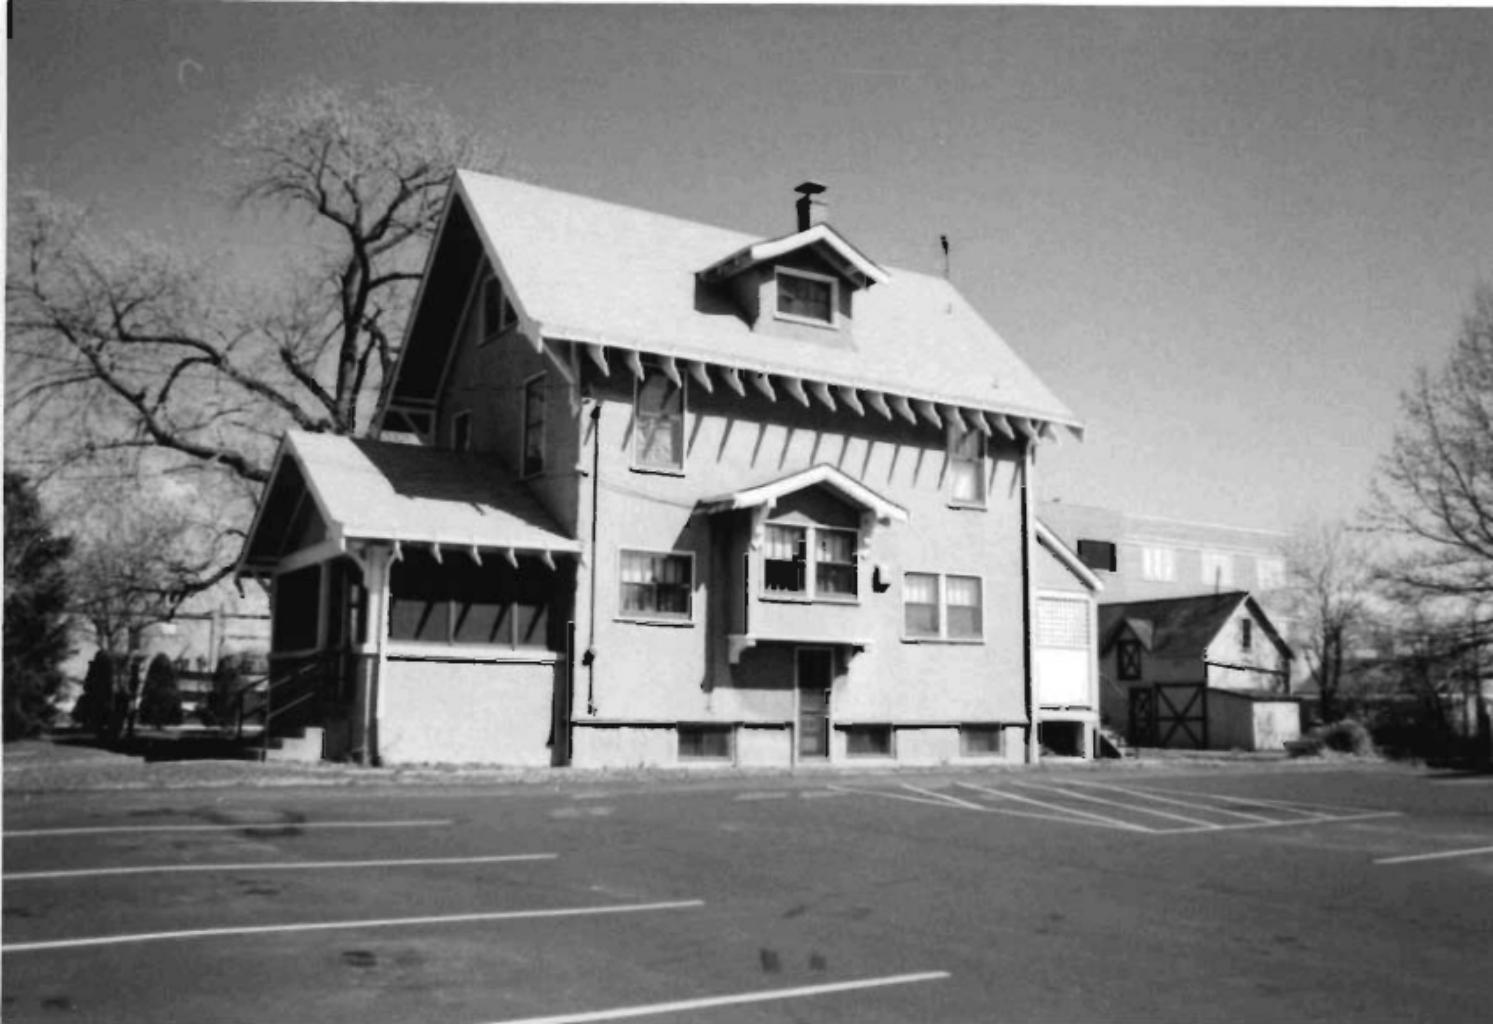
1 NO. 2047 LOCAL #	4 PRESENT NAME(S)	
2 COUNTY ST. LOUIS	5 OTHER NAME(S) LINDA STOCKMAN	
3 LOCATION OF NEGATIVES		
6 SPECIFIC LOCATION 132 W. WASHINGTON	10 THEMATIC CATEGORY	28 NO OF STORIES 02.5
7 CITY OR TOWN KIRKWOOD, MO	17 DATE(S) OR PERIOD CA 1915	29 BASEMENT (Y/N) Y FULL (Y/N) Y
3 SITE PLAN WITH NORTH ARROW SEE MAP	18 STYLE OF DESIGN ECLECTIC CRAFTSMAN	30 FOUNDATION MATERIAL CONCRETE
	19 ARCHITECT OR ENGINEER	31 WALL CONSTRUCTION FRAME
	20 CONTRACTOR OR BUILDER	32 ROOF TYPE & MATERIAL HIGH GABLE ASPHALT SHINGLES
	21 ORIGINAL USE, IF APPARENT SINGLE FAMILY RESIDENCE	33 NO. OF BAYS FRONT 2 SIDE 3
	22 PRESENT USE SINGLE FAMILY RESIDENCE	34 WALL TREATMENT STUCCO
		35 PLAN SHAPE IRREGULAR
9 COORDINATES LOT LANG	23 OWNERSHIP PUBLIC PRIVATE X	36 CHANGES ADDITION (EXPLAIN ALTERED IN #42) MOVED
	24 OWNER'S NAME & ADDRESS (IF KNOWN)	37 CONDITION INTERIOR EXTERIOR GOOD
10 SITE STRUCTURE BUILDING X OBJECT	25 OPEN TO PUBLIC (YES/NO) N	38 PRESERVATION UNDERWAY? (Y/N) N

11 ON NAT'L REG? (YES/NO) N	12 IS IT ELIGIBLE? (YES/NO)	39 ENDANGERED (YES/NO) N BY WHAT?
13 PART OF HIST DIST (YES/NO) N	14 DIST POTENT (YES/NO) Y	40 VISIBLE FROM PUBLIC ROAD? (YES/NO) Y
15 NAME OF ESTABLISHED DISTRICT	26 LOCAL CONTACT PERSON OR ORGANIZATION	41 DISTANCE FROM AND FRONTAGE ON ROAD
42 FURTHER DESCRIPTION OF IMPORTANT FEATURES SEE CONTINUATION SHEET	27 OTHER SURVEYS IN WHICH INCLUDED	42 PHOTO
43 HISTORY AND SIGNIFICANCE SEE CONTINUATION SHEET		45 PREPARED BY LINDA STOCKMAN
44 DESCRIPTION OF ENVIRONMENT AND OUTBUILDINGS SEE CONTINUATION SHEET		47 ORGANIZATION KIRKWOOD LANDM. COMM.
45 SOURCES OF INFORMATION SEE CONTINUATION SHEET		48 DATE 06/80   49 REVISION DATE(S)

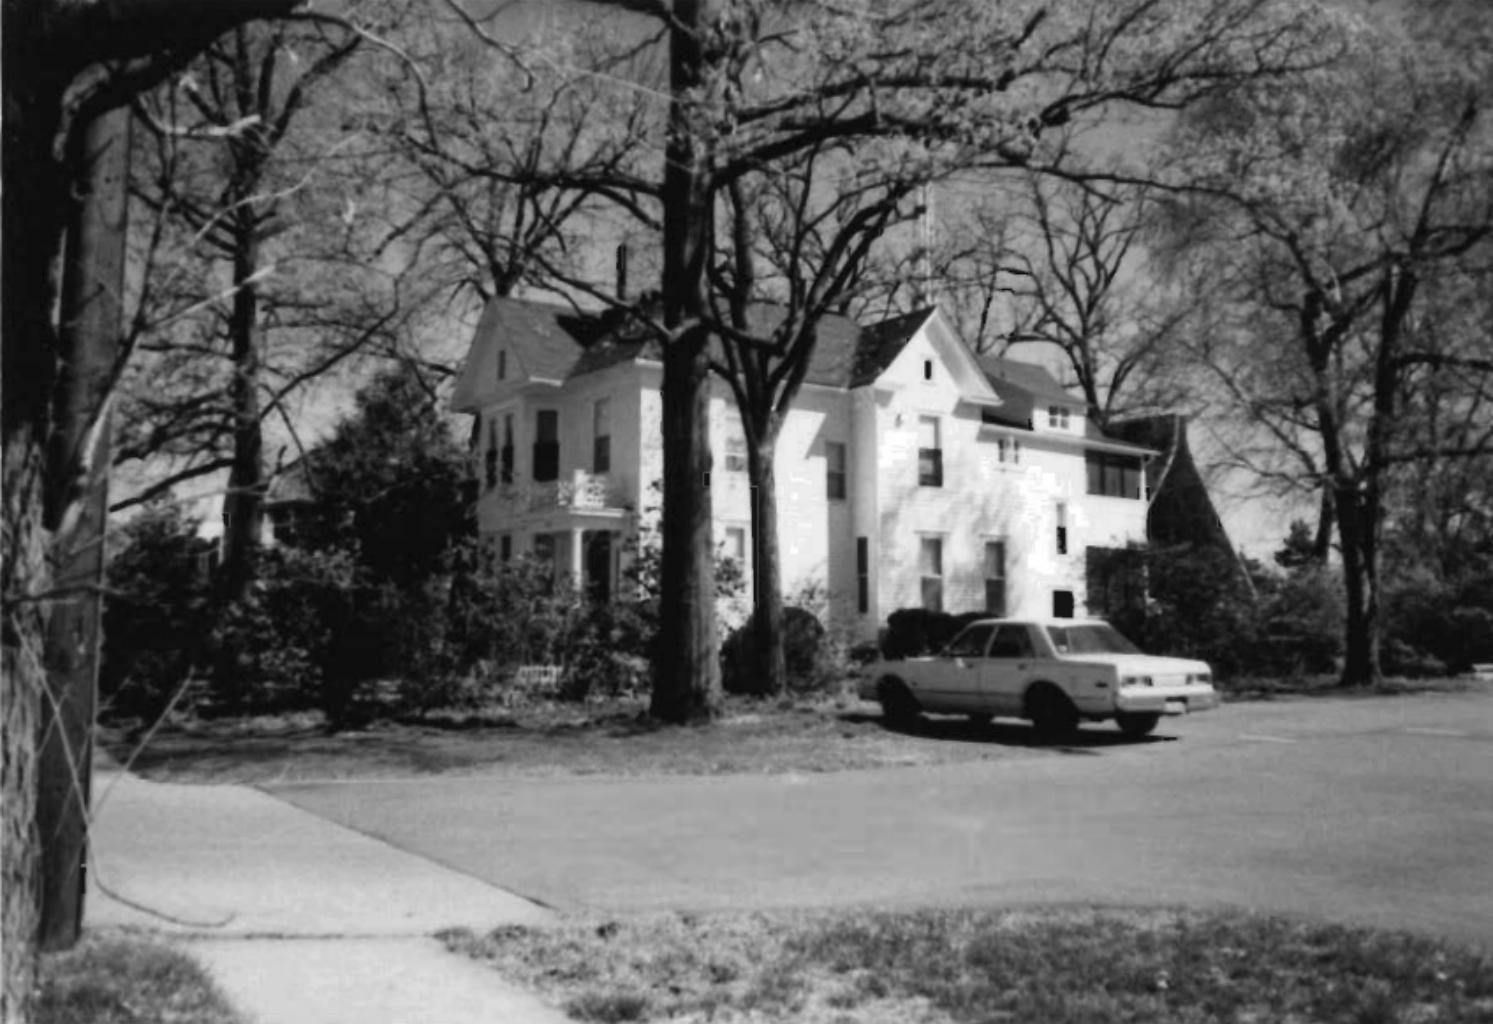
1 NO 2095 LOCAL #	4 PRESENT NAME(S)
2 COUNTY ST. LOUIS	5 OTHER NAME(S) LINDA STOCKMAN
6 SPECIFIC LOCATION 220 W. WASHINGTON	10 THEMATIC CATEGORY
7 CITY OR TOWN KIRKWOOD MO	17 DATE(S) OR PERIOD CA 1860
8 SITE PLAN WITH NORTH ARROW SEE MAP	18 STYLE OR DESIGN VICTORIAN QUEEN ANNE
	19 ARCHITECT OR ENGINEER
	20 CONTRACTOR OR BUILDER
	21 ORIGINAL USE, IF APPARENT SINGLE FAMILY RESIDENCE
	22 PRESENT USE SINGLE FAMILY RESIDENCE
9 COORDINATES LOT LANG	23 OWNERSHIP PUBLIC PRIVATE X
10 SITE STRUCTURE BUILDING X OBJECT	24 OWNER'S NAME & ADDRESS (IF KNOWN)
11 ON NAT'L REG? (YES/NO) N	12 IS IT ELIGIBLE? (YES/NO)
13 PART OF HIST DIST (YES/NO) N	14 DIST POTENT (YES/NO) Y
15 NAME OF ESTABLISHED DISTRICT	25 OPEN TO PUBLIC (YES/NO) N
42 FURTHER DESCRIPTION OF IMPORTANT FEATURES SEE CONTINUATION SHEET	26 LOCAL CONTACT PERSON OR ORGANIZATION
43 HISTORY AND SIGNIFICANCE SEE CONTINUATION SHEET	27 OTHER SURVEYS IN WHICH INCLUDED

44 DESCRIPTION OF ENVIRONMENT AND OUTBUILDINGS SEE CONTINUATION SHEET	30 FOUNDATION MATERIAL STONE
45 SOURCES OF INFORMATION SEE CONTINUATION SHEET	31 WALL CONSTRUCTION FRAME
	32 ROOF TYPE & MATERIAL TRUNCATED HIP WITH INTERSECTING GABLE ASPHALT SHINGLES
	33 NO. OF BAYS FRONT 2 SIDE 6
	34 WALL TREATMENT WOOD HORIZONTAL LAP SIDING
	35 PLAN SHAPE IRREGULAR
	36 CHANGES ADDITION (EXPLAIN ALTERED IN #42) MOVED
	37 CONDITION INTERIOR EXTERIOR GOOD
	38 PRESERVATION UNDERWAY? (Y/N) N
	39 ENDANGERED (YES/NO) N BY WHAT?
	40 VISIBLE FROM PUBLIC ROAD? (YES/NO) Y
	41 DISTANCE FROM AND FRONTEAGE ON ROAD
	PHOTO
	46 PREPARED BY LINDA STOCKMAN
	47 ORGANIZATION KIRKWOOD LANDM. COMM.
	48 DATE 06/30
	49 REVISION DATE(S)

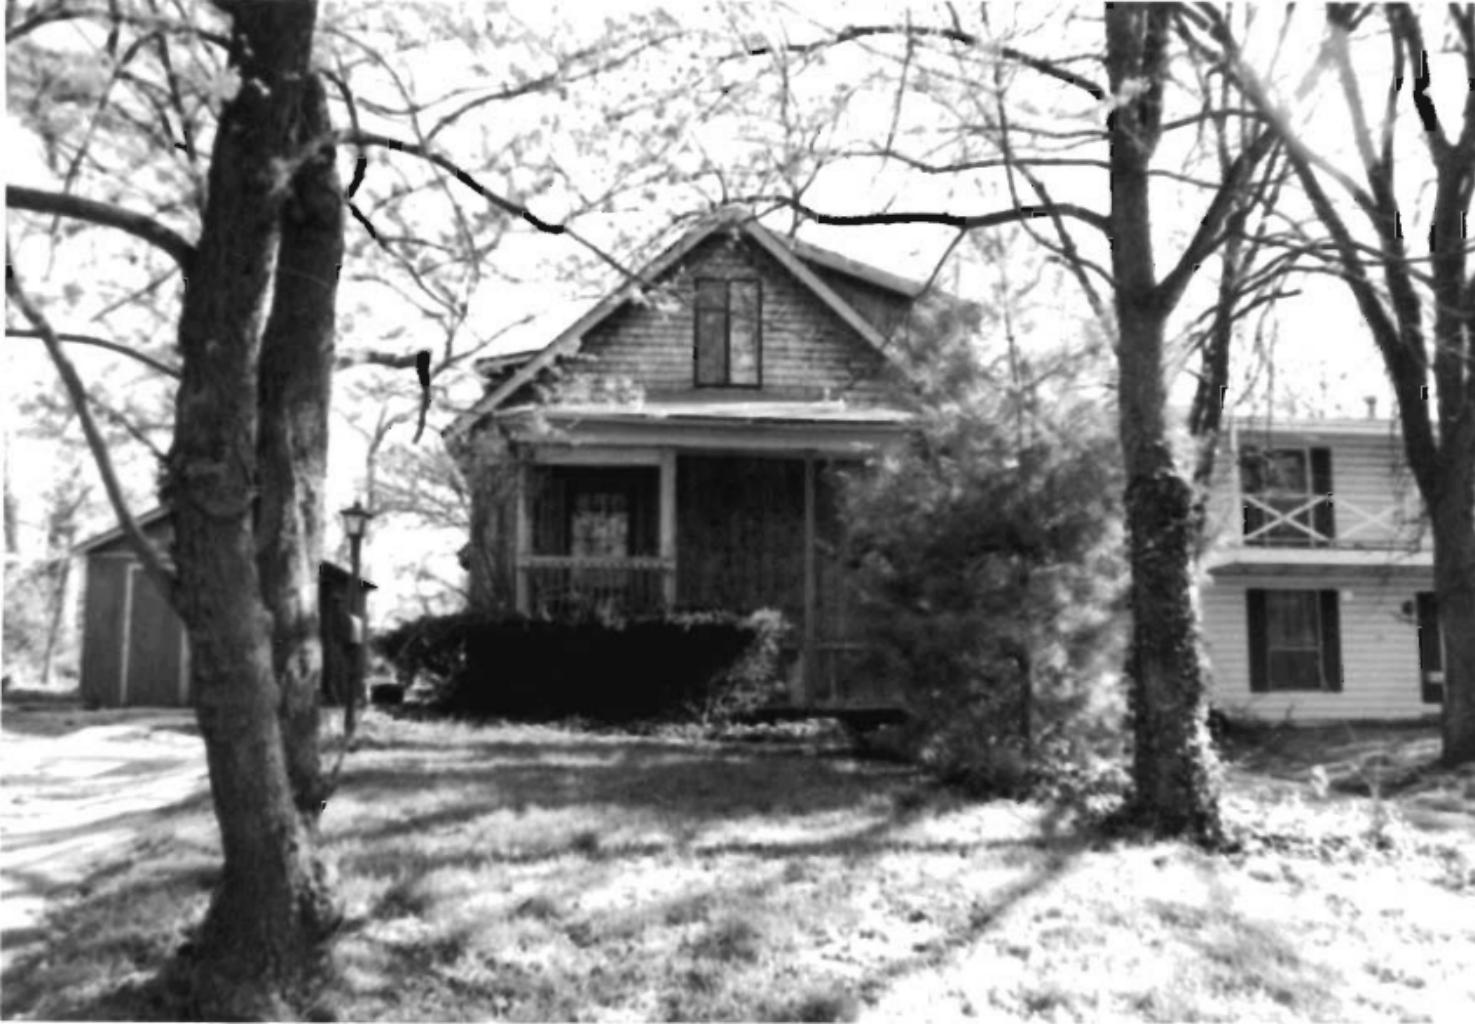
1 NO 202 LOCAL #	4 PRESENT NAME(S)	
2 COUNTY ST. LOUIS	5 OTHER NAME(S) LINDA STOCKMAN	
3 LOCATION OF NEGATIVES		
6 SPECIFIC LOCATION 322 W. WASHINGTON	1c THEMATIC CATEGORY	23 NO OF STORIES 01.5
	17 DATE(S) OR PERIOD CA 1920 1980	29 BASEMENT (Y/N) Y FULL (Y/N) Y
7 CITY OR TOWN KIRKWOOD, MO	18 STYLE OR DESIGN ECLECTIC CRAFTSMAN	30 FOUNDATION MATERIAL CONCRETE BLOCK
8 SITE PLAN WITH NORTH APROX. SEE MAP	19 ARCHITECT OR ENGINEER	31 WALL CONSTRUCTION FRAME
	20 CONTRACTOR OR BUILDER	32 ROOF TYPE & MATERIAL FRONT GABLE ASPHALT SHINGLES
	21 ORIGINAL USE, IF APPARENT SINGLE FAMILY RESIDENCE	33 NO. OF BAYS FRONT 2 SIDE 3
	22 PRESENT USE SINGLE FAMILY RESIDENCE	34 WALL TREATMENT NATURAL WOOD SHAKES, VERTICAL BOARDS AND WOOD LAP SIDING
	23 OWNERSHIP PUBLIC PRIVATE X	35 PLAN SHAPE RECTANGULAR
	24 OWNER'S NAME & ADDRESS (IF KNOWN)	36 CHANGES ADDITION (EXPLAIN) ALTERED X IN #42 MOVED
9 COORDINATES LOT LANG		37 CONDITION INTERIOR EXTERIOR ALTERED EXTENSIVELY

10 SITE STRUCTURE BUILDING X OBJECT	25 OPEN TO PUBLIC (YES/NO) N	38 PRESERVATION UNDERWAY? (Y/N) N
11 ON NAT'L REG? (YES/NO) N	12 IS IT ELIGIBLE? (YES/NO)	39 ENDANGERED (YES/NO) N BY WHAT?
13 PART OF HIST. DIST (YES/NO) N	14 DIST POTENT (YES/NO) Y	40 VISIBLE FROM PUBLIC ROAD? (YES/NO) Y
15 NAME OF ESTABLISHED DISTRICT	26 LOCAL CONTACT PERSON OR ORGANIZATION	41 DISTANCE FROM AND FRONTAGE ON ROAD
42 FURTHER DESCRIPTION OF IMPORTANT FEATURES SEE CONTINUATION SHEET	27 OTHER SURVEYS IN WHICH INCLUDED	42 PHOTO
43 HISTORY AND SIGNIFICANCE SEE CONTINUATION SHEET		46 PREPARED BY LINDA STOCKMAN
44 DESCRIPTION OF ENVIRONMENT AND OUTBUILDINGS SEE CONTINUATION SHEET		47 ORGANIZATION KIRKWOOD LANDM. COMM.
45 SOURCES OF INFORMATION SEE CONTINUATION SHEET		48 DATE 06/85 49 REVISION DATE(S)

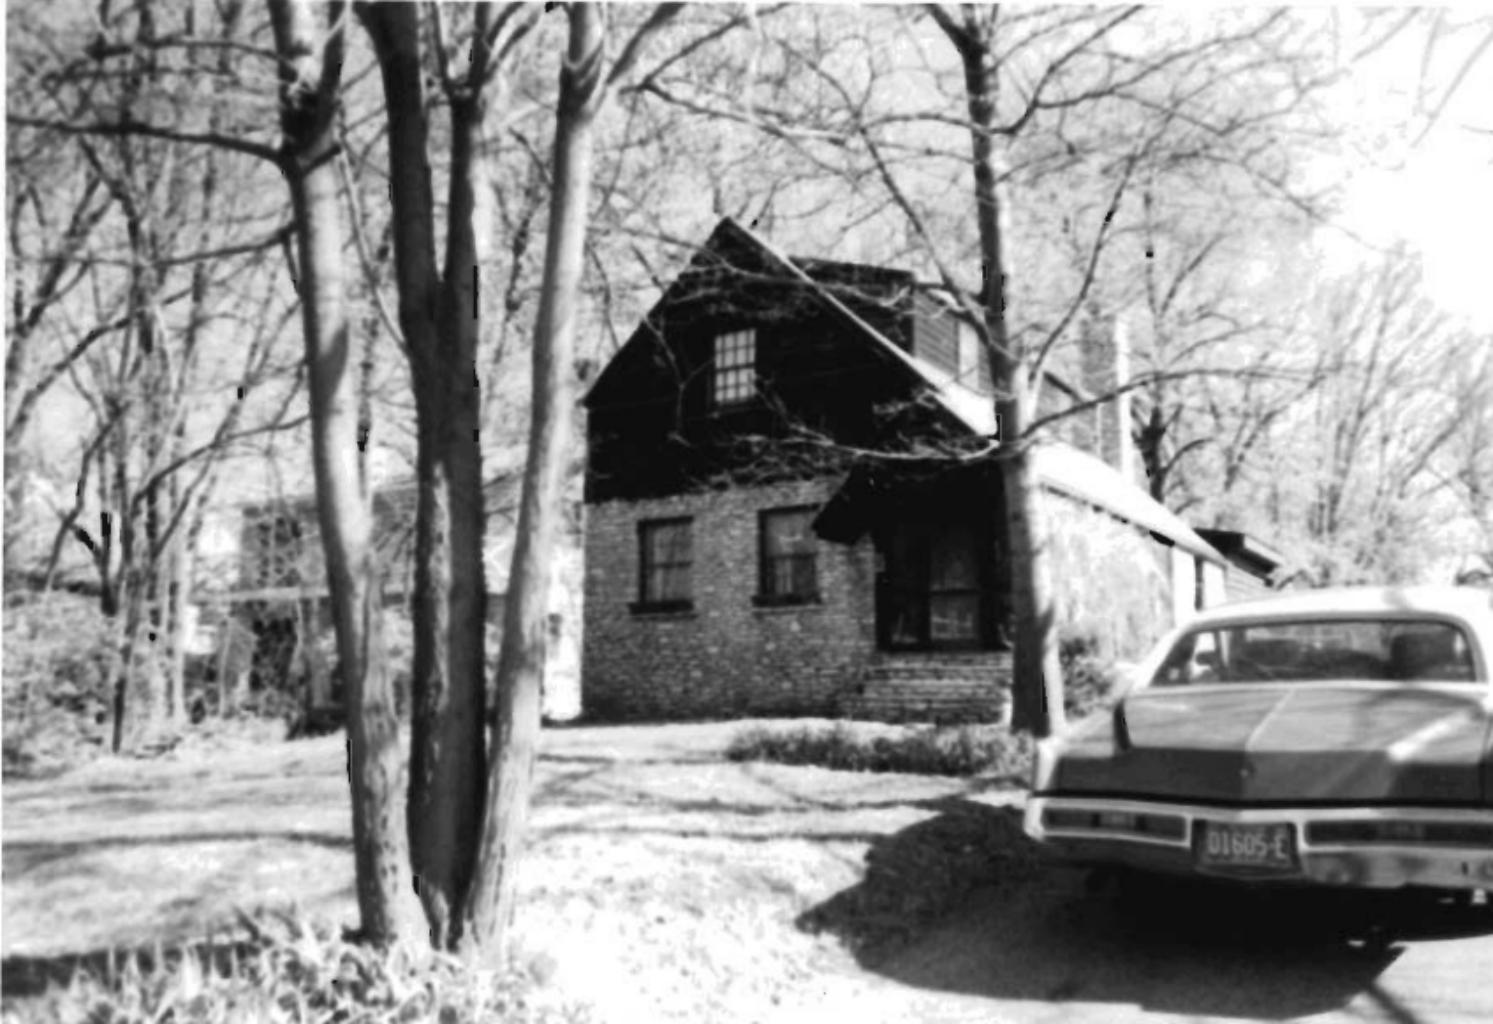
This rustic residence was at one time a small stone church. It has an eastern orientation rather than toward the street. The first floor is constructed of shale, while the attic level is covered with wood lap siding and board and batten. The prominent features of this building include: its facade gable with an extended east leg; a long shed dormer on the east elevation; a massive stone chimney at the rear of the original building; and the screened-in porch which has been included under the extension of the gable. The facade entry to the screened-in porch is covered by a gabled hood with an extended west leg. This entry is accessed by shale stone stairs. The main entry is recessed on the east wall and contains a single-leaf wood door with multi-lights which is covered by an aluminum storm door. The facade windows are wood with wood sash, double-hung, flat-topped, eight over eight. On the second level they have wood surrounds, lintel and lugsill. The windows on the first level have projecting shale sills, and there is no visible molding. Wood plant boxes set on these sills. There is a one story log addition at the rear with a low gabled roof.

1 NO 2091 LOCAL - 2 COUNTY - 3 LOCATION OF NEGATIVES	4 PRESENT NAME(S) ST. LOUIS LINDA STOCKMAN	5 OTHER NAME(S)
6 SPECIFIC LOCATION 300 W. WASHINGTON	16 THEMATIC CATEGORY  17 DATE(S) OR PERIOD CA 1860	26 NO OF STORIES 31.5 29 BASEMENT (Y/N) Y FULL (Y/N) Y
7 CITY CR TOWN KIRKWOOD, MO	18 STYLE OR DESIGN VERNACULAR	30 FOUNDATION MATERIAL STONE
8 SITE PLAN WITH NORTH ARROW SEE MAP	19 ARCHITECT OR ENGINEER  20 CONTRACTOR OR BUILDER	31 WALL CONSTRUCTION FRAME  32 ROOF TYPE & MATERIAL FRONT GABLE ASPHALT SHINGLES
	21 ORIGINAL USE, IF APPARENT RELIGIOUS/CHURCH	33 NO. OF BAYS FRONT 3 SIDE 4
	22 PRESENT USE SINGLE FAMILY RESIDENCE	34 WALL TREATMENT WOOD HORIZONTAL LAP SIDING BOARD AND BATTEN LOG RUBBLESTONE
9 COORDINATES LON LAT	23 OWNERSHIP PUBLIC PRIVATE X	35 PLAN SHAPE RECTANGULAR
	24 OWNER'S NAME & ADDRESS (IF KNOWN)	36 CHANGES (EXPLAIN IN #42) ADDITION X ALTERED X MOVED X
10 SITE STRUCTURE BUILDING X OBJECT	25 OPEN TO PUBLIC (YES/NO) Y	37 CONDITION INTERIOR EXTERIOR GOOD

11 ON NAT'L REG? (YES/NO) N	12 IS IT ELIGIBLE? (YES/NO)	38 PRESERVATION UNDERWAY? (Y/N) N
13 PART OF HIST. DIST (YES/NO) N	14 DIST POTENT (YES/NO) Y	39 ENDANGERED (YES/NO) N BY WHAT?
15 NAME OF ESTABLISHED DISTRICT	26 LOCAL CONTACT PERSON OR ORGANIZATION  27 OTHER SURVEYS IN WHICH INCLUDED	40 VISIBLE FROM PUBLIC ROAD? (YES/NO) Y
42 FURTHER DESCRIPTION OF IMPORTANT FEATURES SEE CONTINUATION SHEET		41 DISTANCE FROM AND FRONTAGE ON ROAD  PHOTO
43 HISTORY AND SIGNIFICANCE SEE CONTINUATION SHEET		45 PREPARED BY LINDA STOCKMAN
44 DESCRIPTION OF ENVIRONMENT AND OUTBUILDINGS SEE CONTINUATION SHEET		46 ORGANIZATION KIRKWOOD LANDM. COMM.
45 SOURCES OF INFORMATION SEE CONTINUATION SHEET		47 DATE 06/86 48 REVISION DATE(S)
