National Register of Historic Places Registration Form

historic name Lee's Summit Christian Church Building

street & number 401 Douglas Street

SUMMARY DESCRIPTION STATEMENT

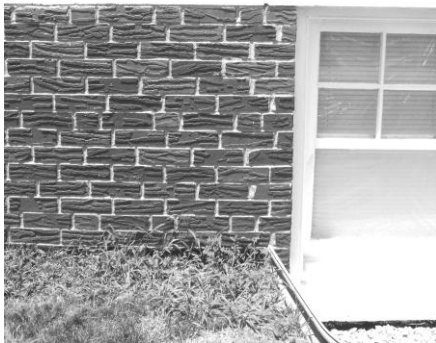
Figure 6: Lee's Summit Christian Church, Window well, "oak bark" brick, and cast stone water table string course on Southwest Elevation, 20 July 2010, digital photograph, A. Loughlin.

A steel frame rises from the foundation walls and forms the building structure.³ The walls have a veneer of rust-colored, textured "oak bark" brick [Figure No. 6] installed in a running bond pattern. A cast stone water table string course separates the lower and main levels of the building and runs the entire perimeter of the building. In the coursing directly above the water table on the Fourth and Douglas Street primary corner is the cornerstone, which is now covered by a yew.⁴ The north portion of the stone reads, "Est. 1870."⁵[Figure No. 7] The simple building cornice has little overhang.

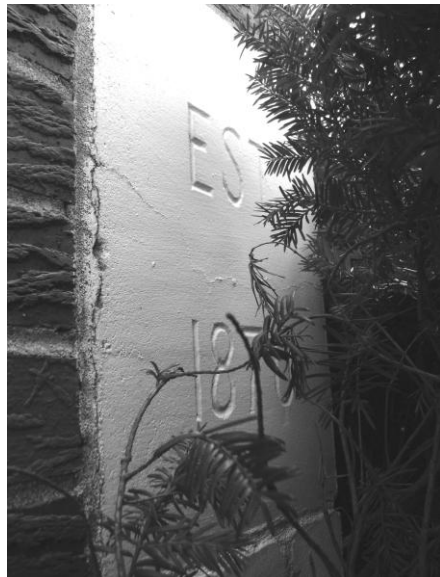
Figure 7: Cornerstone of Lee's Summit Christian Church, 23 July 2010, digital photograph, A. Loughlin.

⁴ Julia Canterbury interview by Amanda K. Loughlin, 23 April 2010, interview notes. Sally Schwenk Associates, Inc. Kansas City, Missouri. Congregation historian, Julia Canterbury, noted that a time-capsule of items from 1949 are sealed in this cornerstone. It was not removed when the congregation relocated.

⁵ This was the year the congregation was founded in Lee's Summit. Unable to access the southwest side of the stone because of the yew shrub, it may be possible that the date of 1949 appears on this side since the cornerstone laying service was held 8 May 1949.

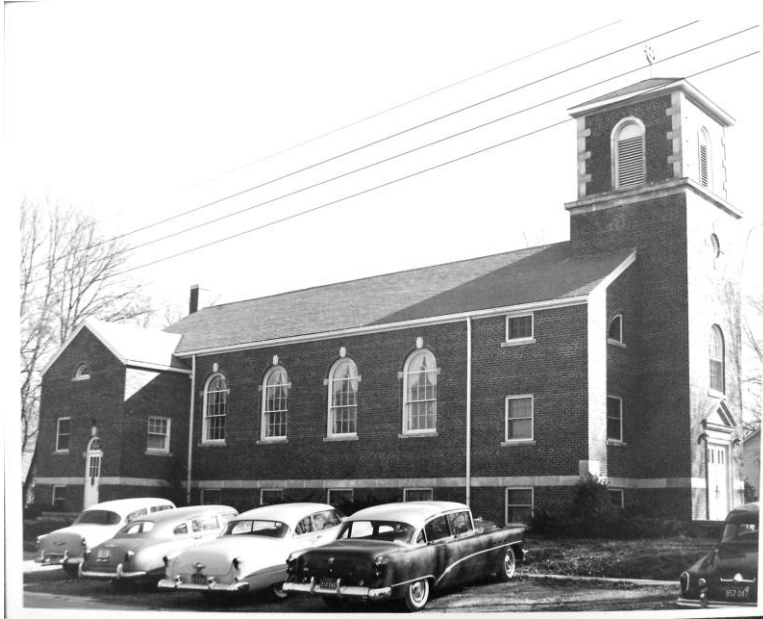
Figure 8: Lee's Summit Christian Church, Northeast Elevations, c. 1950, Anonymous, Lee's Summit Christian Church Archives.

The door on the projecting gable ell of the northeast wall of the transept (Photograph No. 3) is a replacement door. According to the circa 1950 photograph, the original door had six lights. Above the door is an original half-circle, Adam style fan transom with three, evenly spaced muntins. The circa 1950 photograph also clearly shows that on the Fourth Street elevation, the two doors now found at grade beneath the arched windows were originally windows.⁷ The site at this location reflects a later excavation exposing the foundation and the current solid doors replaced the two end windows. With these exceptions, the remaining windows in the building appear on exterior and interior inspection to be the original wood units dating to the building's construction.

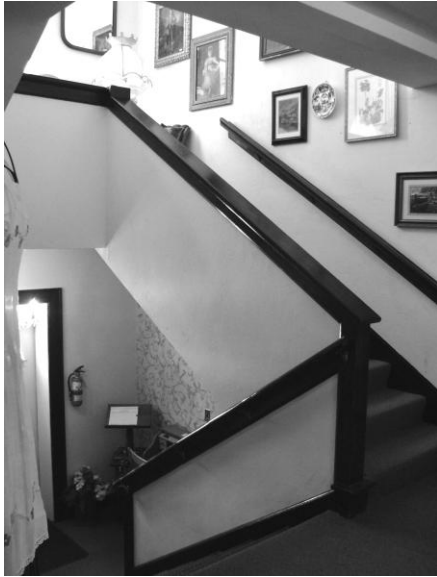
Figure 10. Lee's Summit Christian Church, Entrance Vestibule and Staircase Looking at Main Stair Leading Down to Entrance and Up to Sanctuary Space on Second Level, 20 July 2010. Digital Photograph, A. Loughlin.

The main entrance leads directly into a vestibule stair landing the width of the bell tower. [Figures No. 5 and 10] To the landing's northeast is a narrow flight of stairs leading to the lowest level; to the southwest is a wide set of eight steps leading up into the narthex⁹ on the main level of the church. A second flight of stairs leads up from this landing to a balcony level above the narthex overlooking the sanctuary.

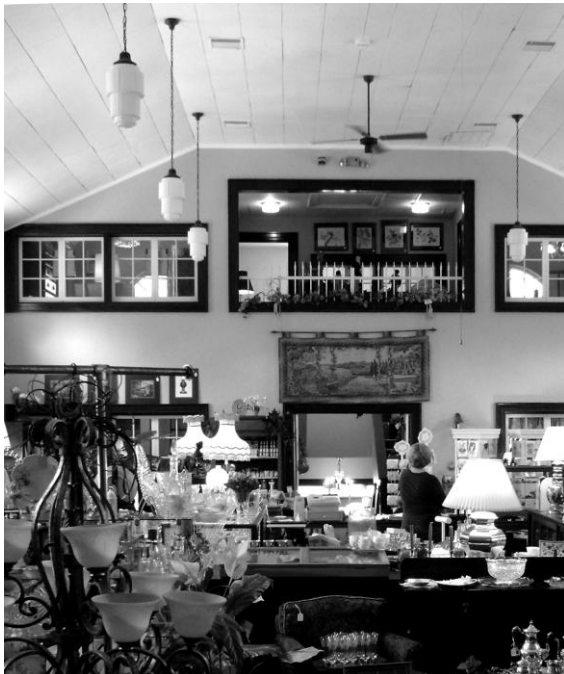
Figure: 11: Lee's Summit Christian Church Sanctuary Looking West from Altar, 20 July 2010, Digital Photograph, A. Loughlin.

One enters the sanctuary auditorium through the narthex's central pair of doors. On either side of the narthex are doors leading into smaller rooms, one originally used as a chapel and the other as a Sunday school room and for over-flow seating. Glass multipane windows in these spaces, which can be opened, face into the sanctuary.¹⁰ Directly above these rooms are two other identically sized rooms, also with glass paned windows. A large, rectangular framed opening looking into the sanctuary makes up most of the wall of the second level landing. [Figure No. 11]

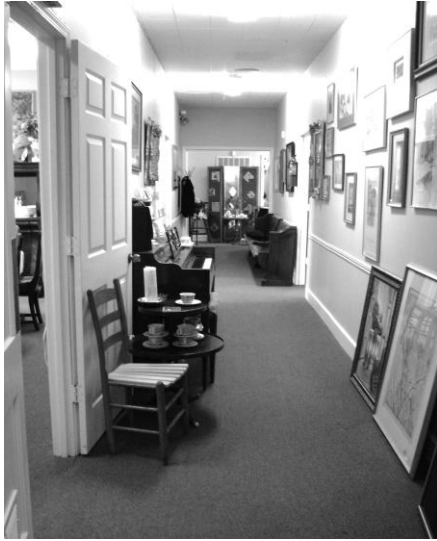
Figure 12: Lee's Summit Christian Church, Lower Level Looking West Down Central Corridor, 20 July 2010. Digital Photograph, A. Loughlin.
