National Register of Historic Places
Registration Form

historic name Lee's Summit Downtown Historic District (Amended)

Lee's Summit Downtown Historic District (Amended)
Jackson County, Missouri

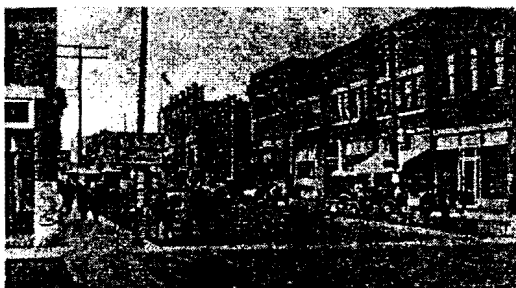
**Turn-of-the-Century Streetscape,
3rd and Douglas Streets Looking Northwest**
*(Lee's Summit, Missouri Downtown History &
Architectural Walking Tour)*

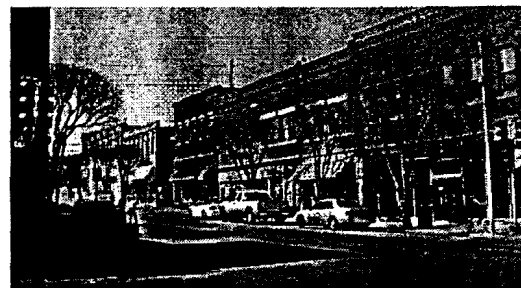
**Current Streetscape,
3rd and Douglas Streets Looking Northwest**
*(Lee's Summit, Missouri Downtown History &
Architectural Walking Tour)*

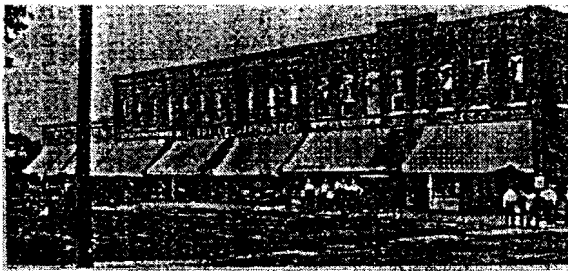
**East Side of Main Street Between 2nd and 3rd Streets,
c. 1890**

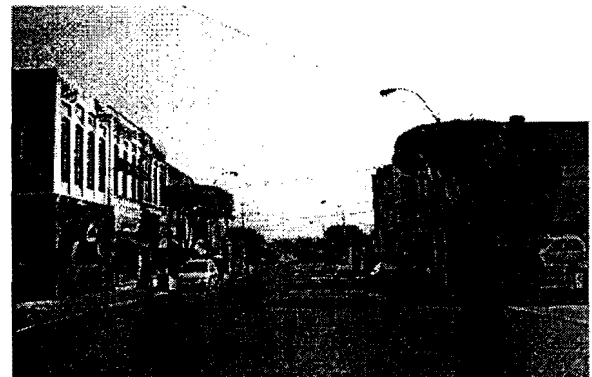
SW 3rd Street from Market to Main Streets, 2003
*Lee's Summit, Missouri Downtown History &
Architecture Walking Tour*
