National Register of Historic Places
Registration Form

historic name Lee's Summit Downtown Historic District

**Lee's Summit Downtown Historic District
Jackson County, Missouri**

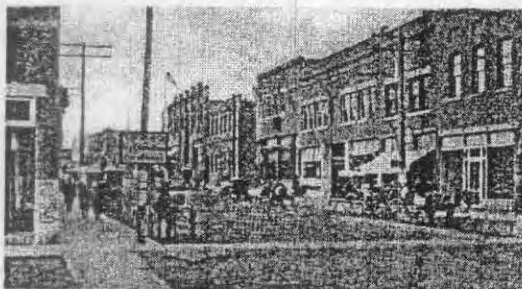
**Turn-of-the-Century Streetscape,
3rd and Douglas Streets Looking Northwest**
*(Lee's Summit, Missouri Downtown History &
Architectural Walking Tour)*

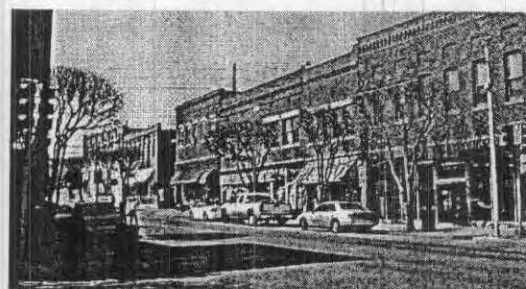
**Current Streetscape,
3rd and Douglas Streets Looking Northwest**
*(Lee's Summit, Missouri Downtown History &
Architectural Walking Tour)*

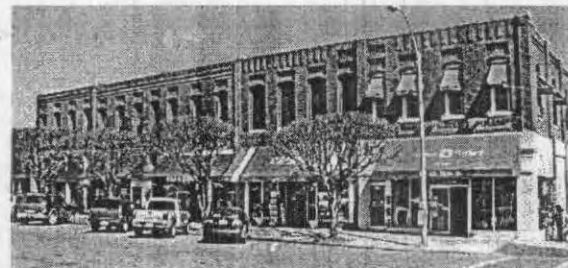
East Side of Main Street Between 2nd and 3rd Streets,
2003

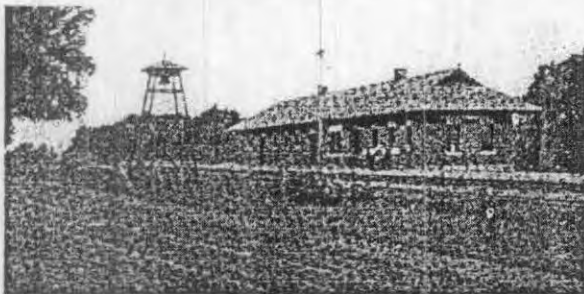
Railroad Depot, c. 1907
*Lee's Summit, Missouri Downtown History &
Architecture Walking Tour*

220 SE Main Street. 1905. Erected to replace a pre-existing depot, this facility served as the Missouri Pacific Railroad freight and passenger depot.

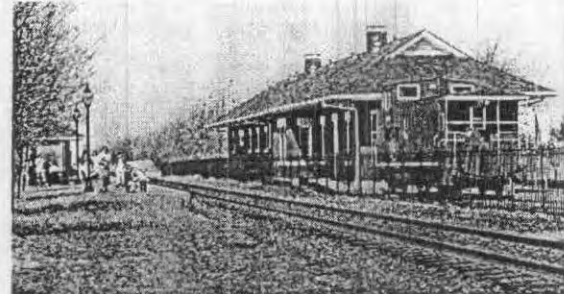
Railroad Depot and Caboose, 2003
*Lee's Summit, Missouri Downtown History &
Architecture Walking Tour*

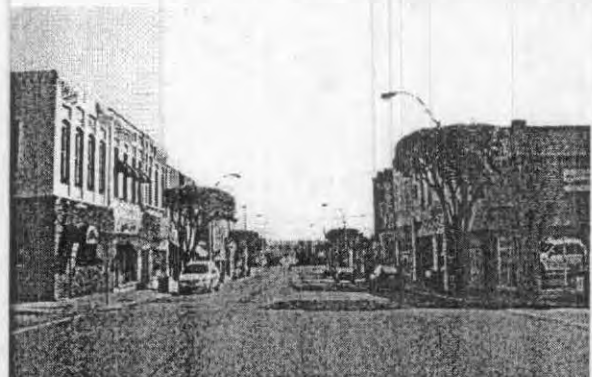
SW 3rd Street from Market to Main Streets, 2003
*Lee's Summit, Missouri Downtown History &
Architecture Walking Tour*
