National Register of Historic Places
Registration Form

historic name Parade Park Maintenance Building

Parade Park Maintenance Building
Jackson County, Missouri

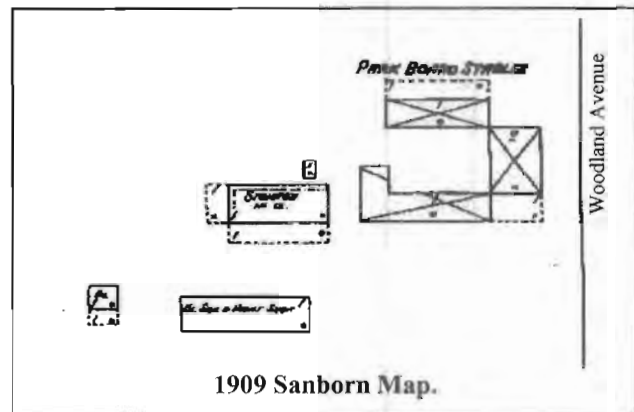
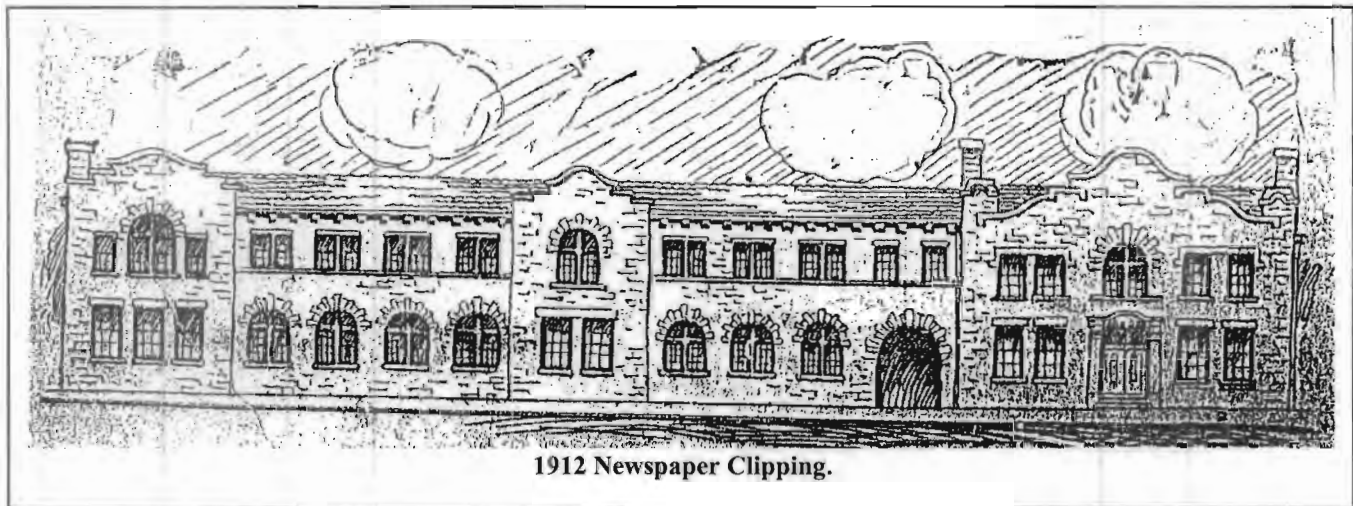
A few years later the Parks Department erected a more permanent maintenance facility on the site. A February 1912 newspaper article announced the construction of a \$20,000 two-story building on the south side of Parade Park. It would measure 130 feet on the south side and 50 feet on the east side, along Woodland Avenue. The first floor facing Woodland Avenue would house offices for department heads, while the remainder of the building would become paint and repair shops and storage. The building would have a steel structure and native limestone walls. The limestone would be quarried at Spring Valley Park, just to the southeast near 27th Street and Euclid Avenue. Architect Arthur L. Sparks prepared the plans.¹⁴ The image published in the paper is readily identifiable as the nominated building.

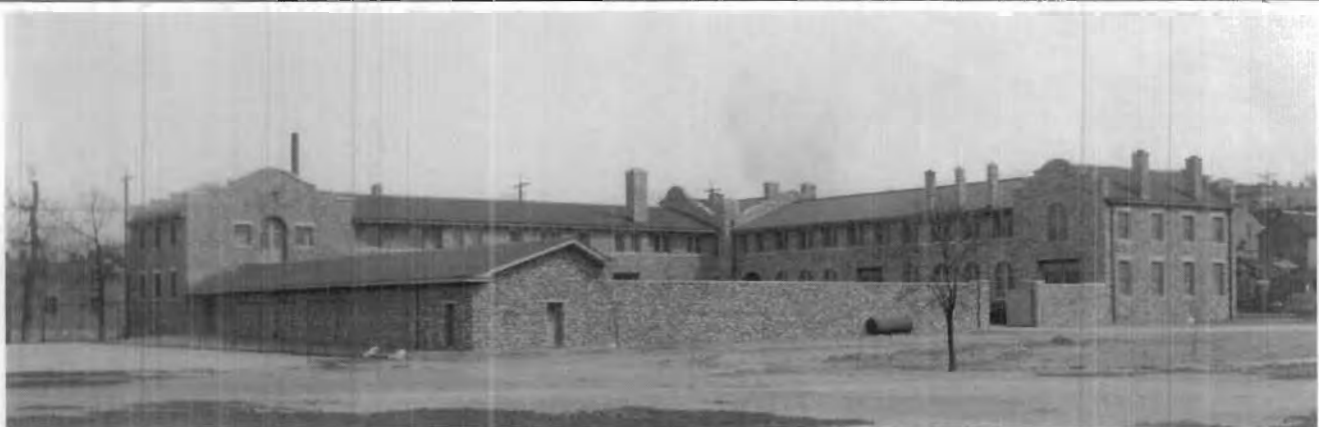
Rear view of Parade Park Maintenance Facility showing enclosed courtyard, 1918.
Source: Kansas City Parks & Recreation Department Archives (P-P3-055).

While the historic plans depict a simple courtyard wall, a 1918 photograph shows an open one-story garage with a shallow shed roof. A second photo from the 1940s shows the courtyard side of the equipment and vehicle storage area.

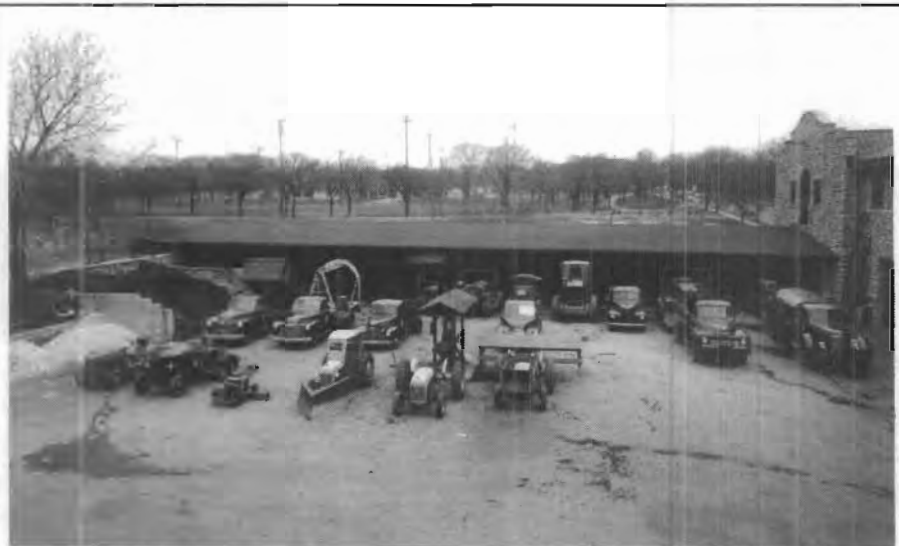
Equipment storage on north side of courtyard, c. 1940s.
Source: Kansas City Parks & Recreation Department Archives (P-P3-022).

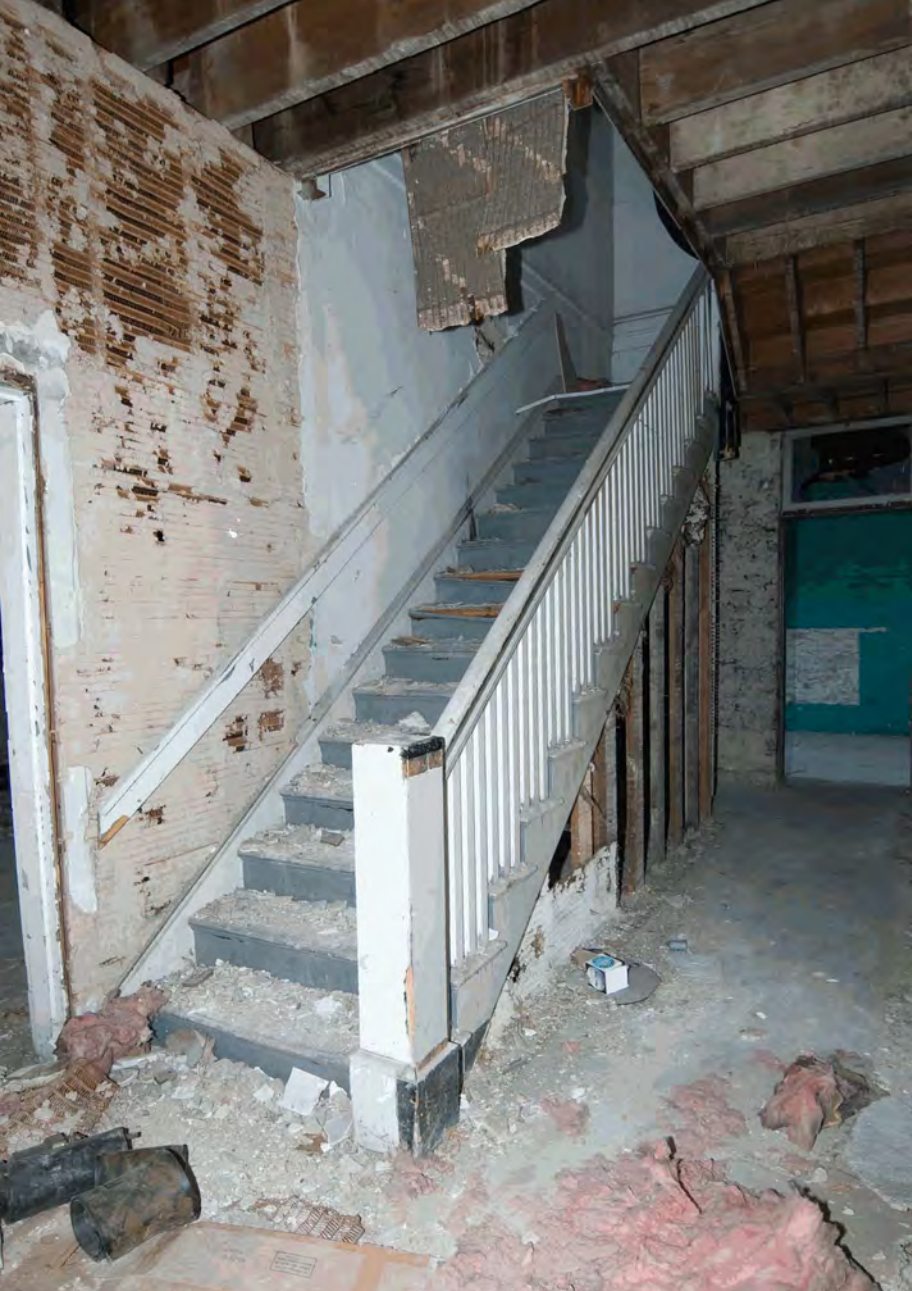
The first story of the corner block housed administrative operations and offices. In this location, a central, double-loaded corridor extends north from the main entrance in the south wall. The lath-covered wood structure that historically defined the corridor remains, although the plaster finish is substantially missing. The only staircase in the building anchors the north end of the corridor. The historic wood staircase rises from the first floor to the second floor. It has a wood railing composed of square balusters and a curved handrail (*Photo 14*).
