ST. JOSEPH, MISSOURI

SURVEY BLOCK #1

FALL, 1978

NWMSU Historical Survey
Thomas Carneal, Director

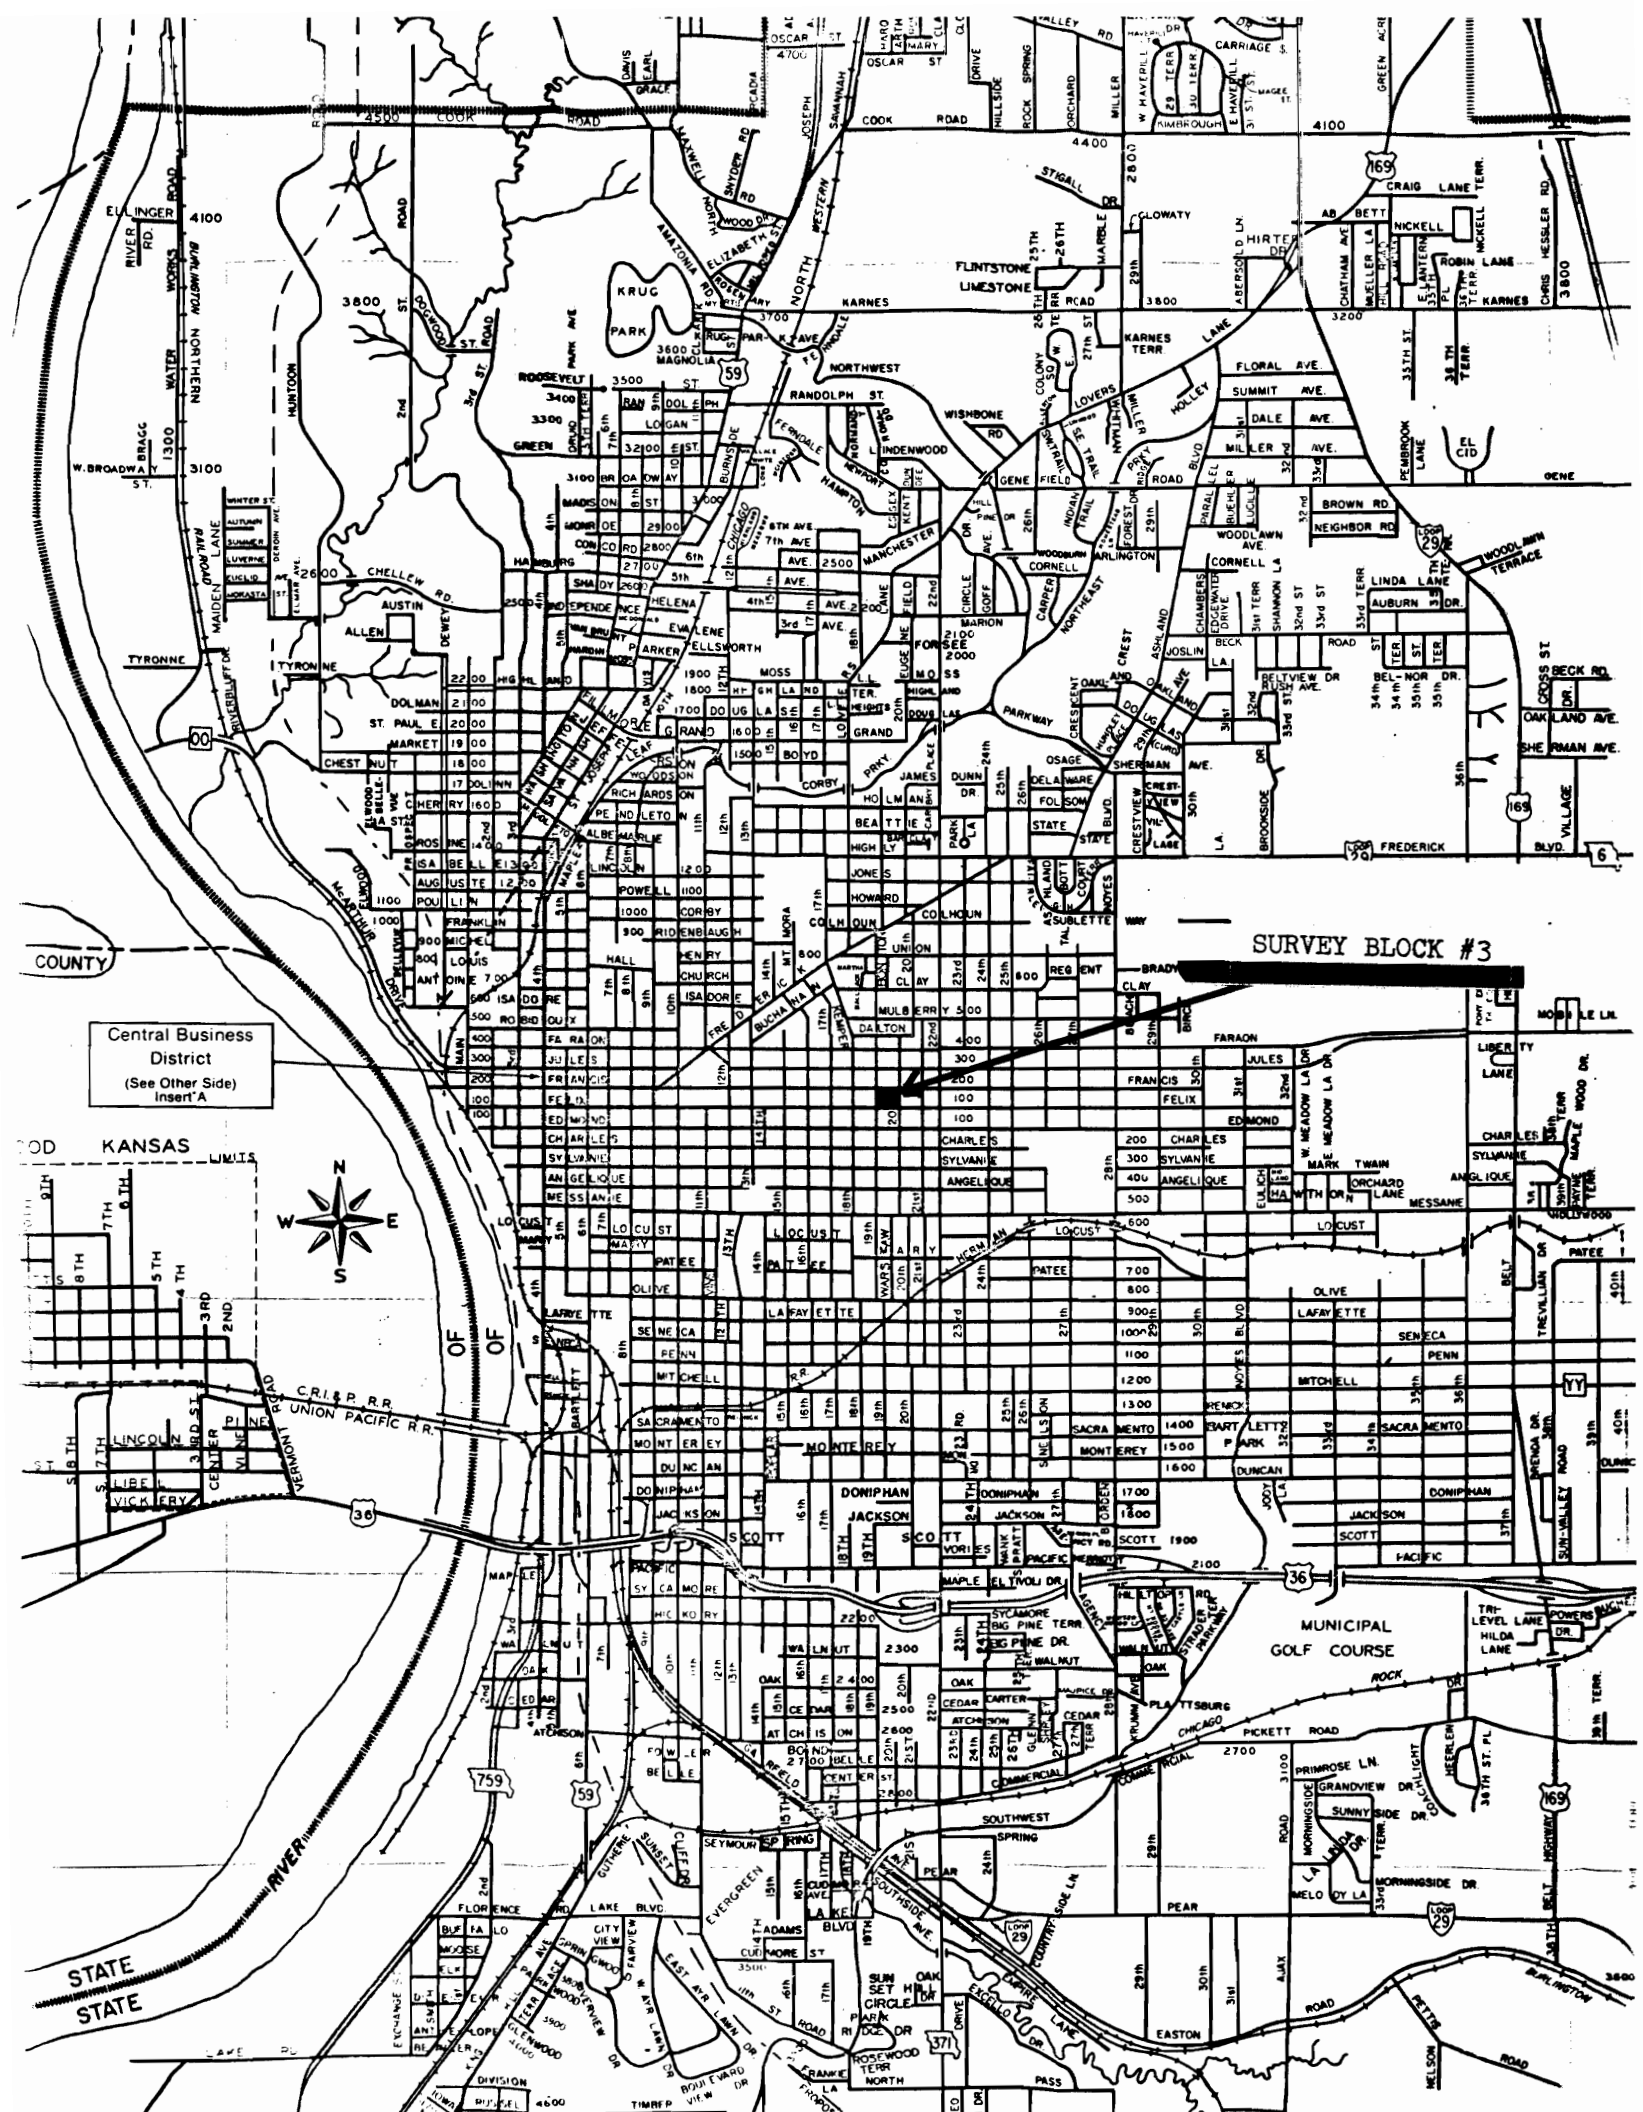
SURVEY BLOCK #3

This area represents a series of homes constructed at different time periods over the past 130 years. A search of the County Histories and other material suggest that part of the homes could be grouped into a historic district. The homes for possible inclusion are located at: 105 N. 19th, and 119 N. 19th or Community Development numbers A-04-20 and A-04-36. These homes should be attached to the homes in the block immediately to the West as the William T. Harris Historic District. The home at 102 N. 20th has no relationship to the district and stands by itself as a ranch style in an older neighborhood.

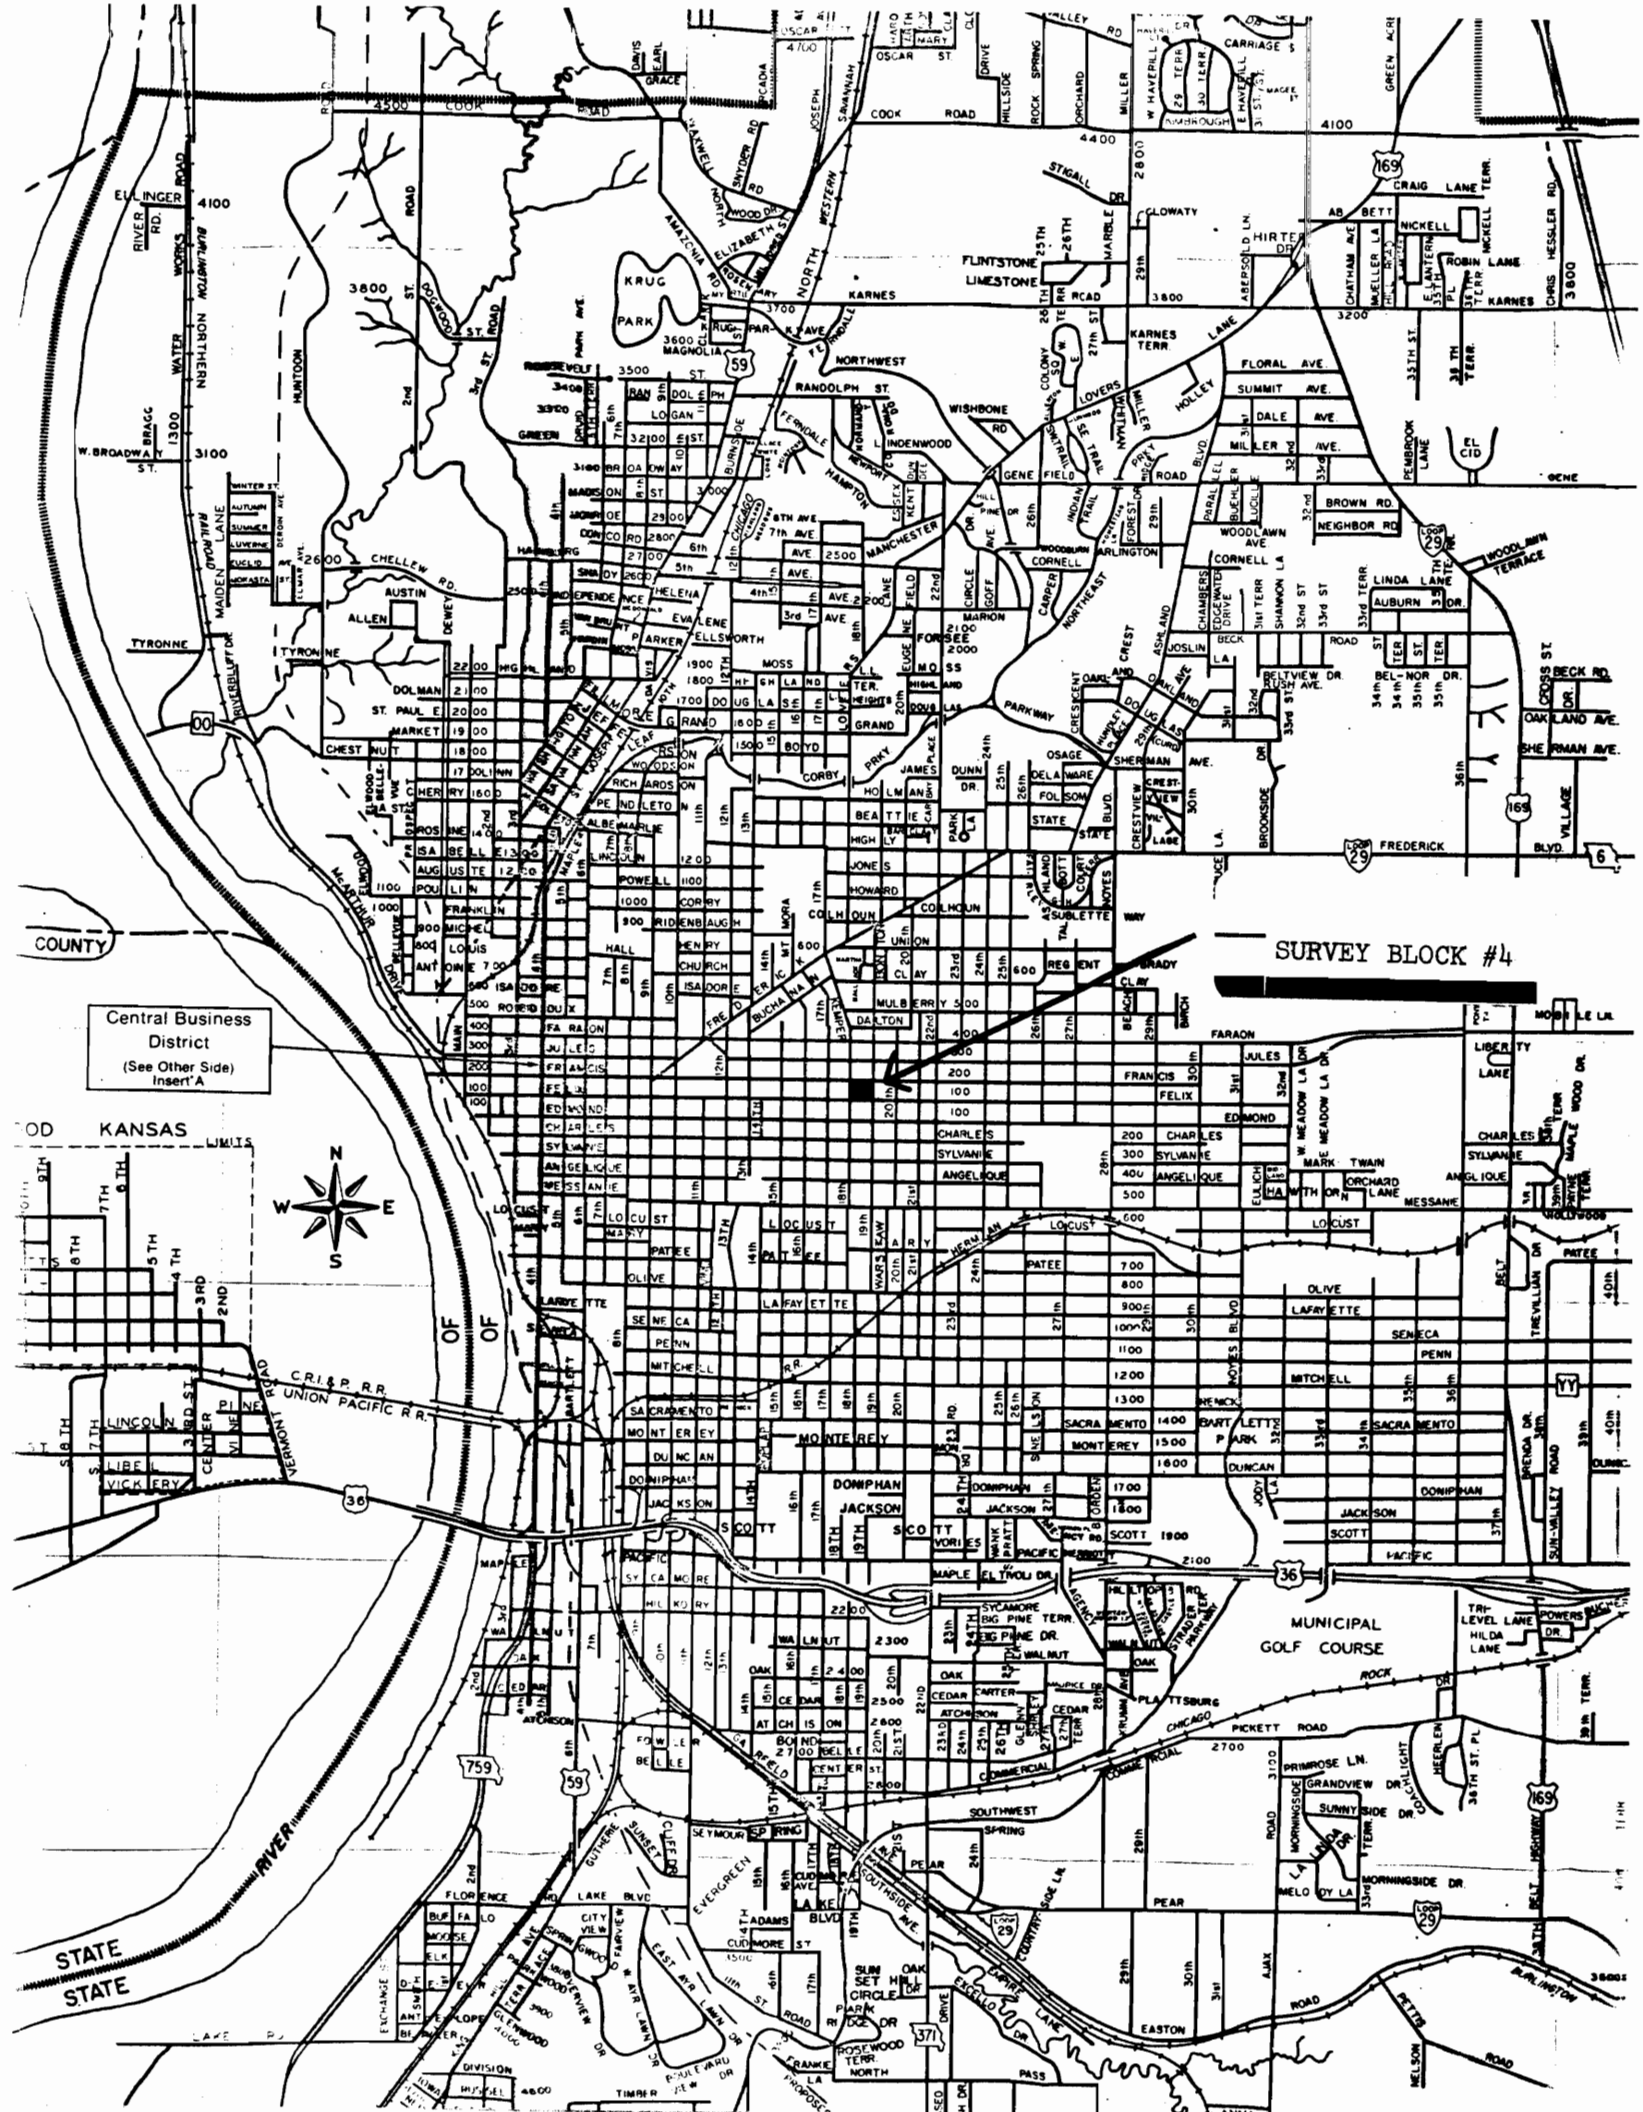
SURVEY BLOCK #4

This area represents a series of homes constructed at different time periods over the past 130 years. A search of the County Histories and other material suggest that entire block could be grouped into a historic district with only one intrusion being the fire station at 18th and Felix (A-01-19). These homes should be attached to the homes in the block immediately to the North as the William T. Harris Historic District.

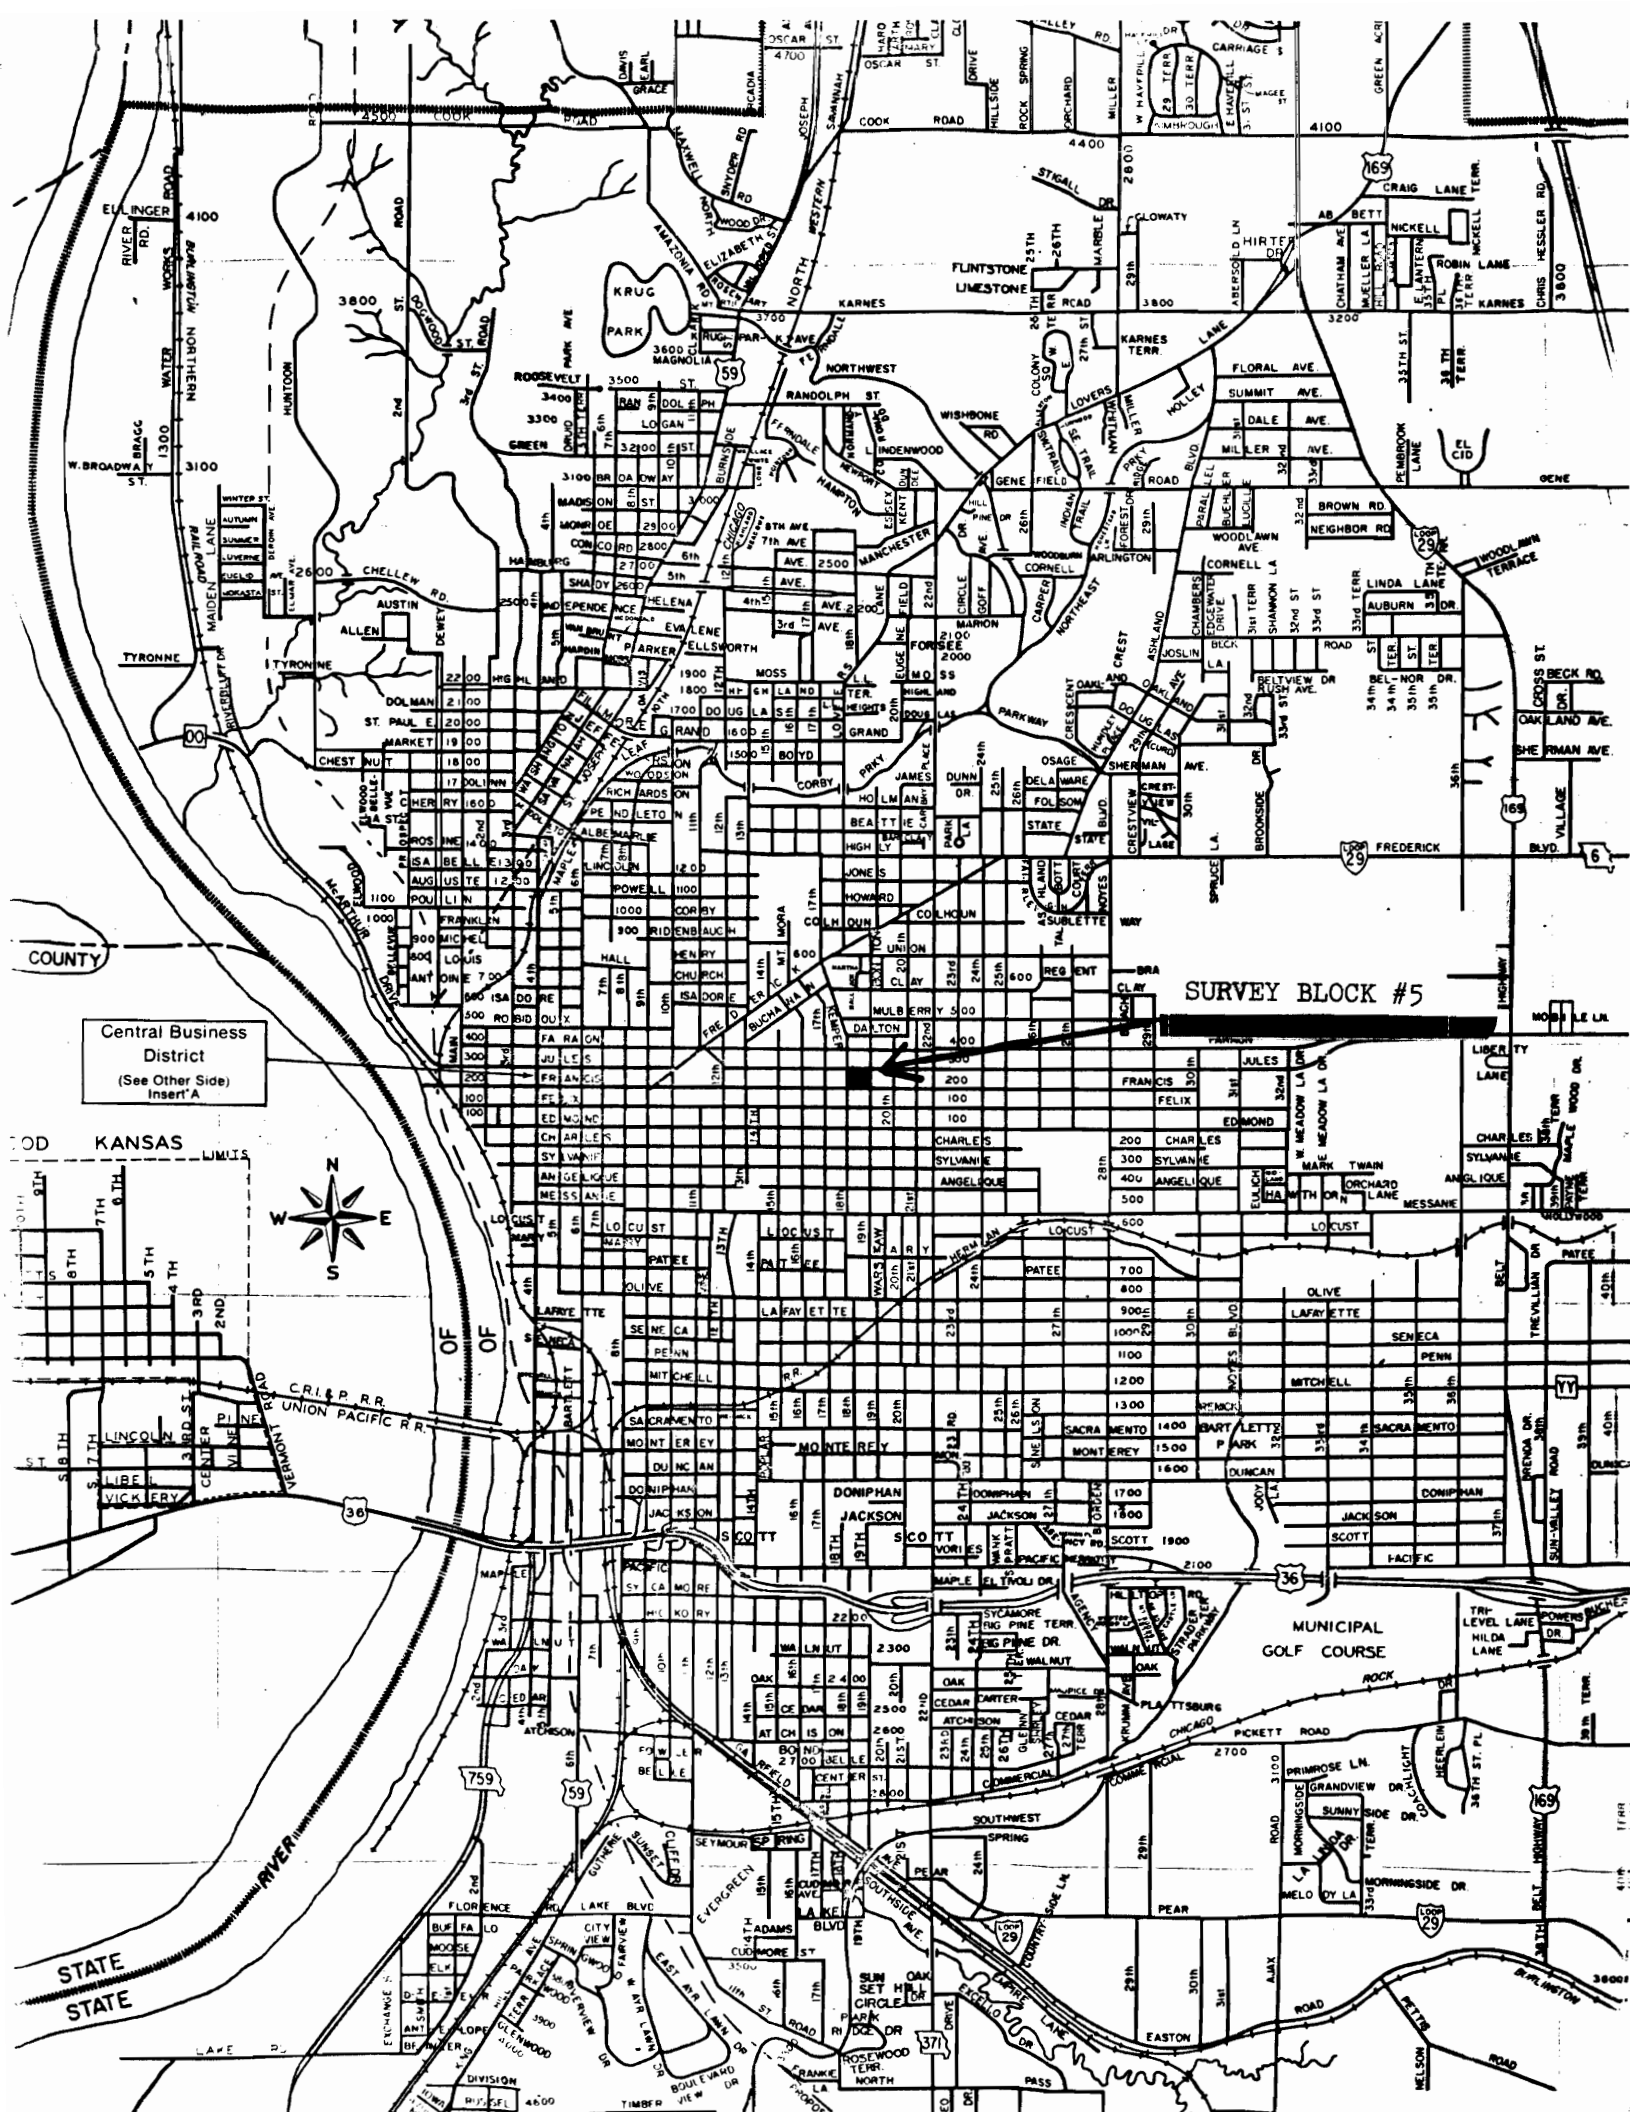
Survey Block #5

This area represents a series of homes constructed at different time periods over the past 100 years. A search of the County Histories and other material indicates the homes at 209 N. 18th (B-01-04); 221 N. 18th (C-01-03); 206 N. 19th (B-01-01); 208 N. 19th (B-01-02); and 1815 Francis (B-01-03) have historic significance and should be connected with the William T. Harris Historic District which is located in the block directly south of both of these structures. The other homes in this block survey represent a variety of styles, but they can be duplicated in several other block surveys. There is not enough symmetry in this block to include it in the William T. Harris Historic District.

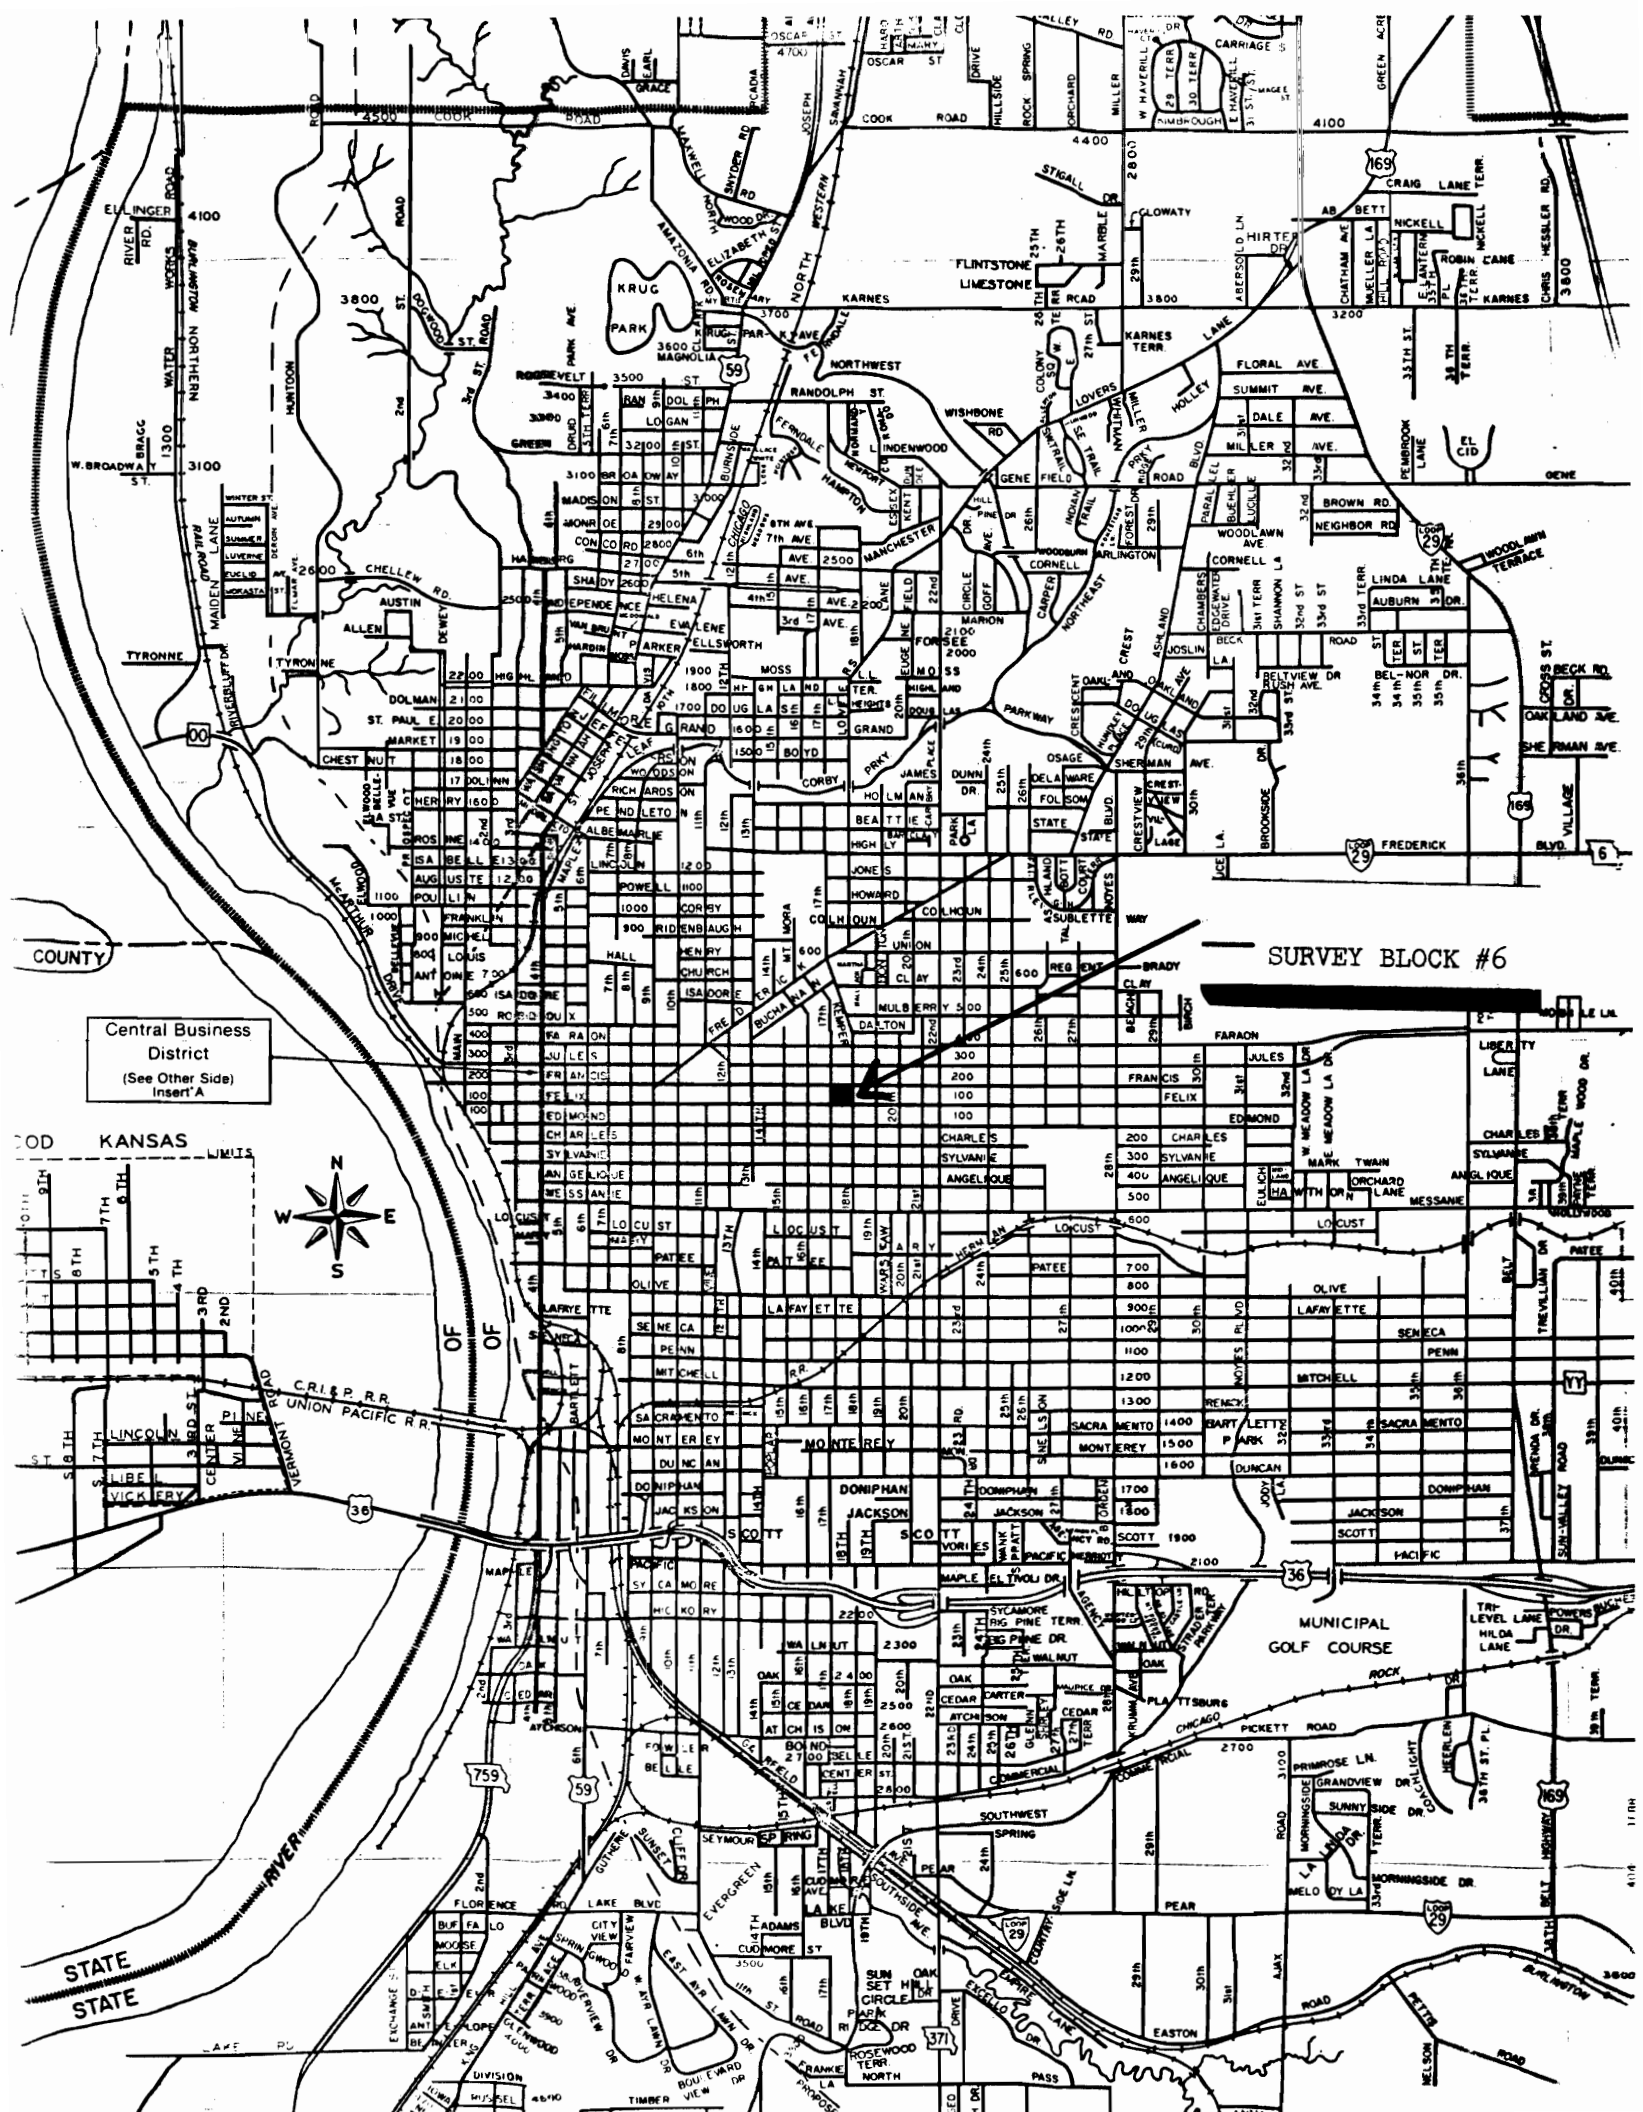
SURVEY BLOCK #6

This area represents a series of homes constructed at different time periods over the past 100 years. A search of the County Histories and other material indicates that only the homes at 1716 Francis (C-01-14 or C-47-27) and 1715 Felix (C-01-21) have any significance and should be connected with the William T. Harris Historic District which is located in the block directly East of both of these structures. The other homes in this block survey represent a variety of styles but they can be duplicated in several other block surveys. There is not enough symmetry in this block to include it in the William T. Harris Historic District.

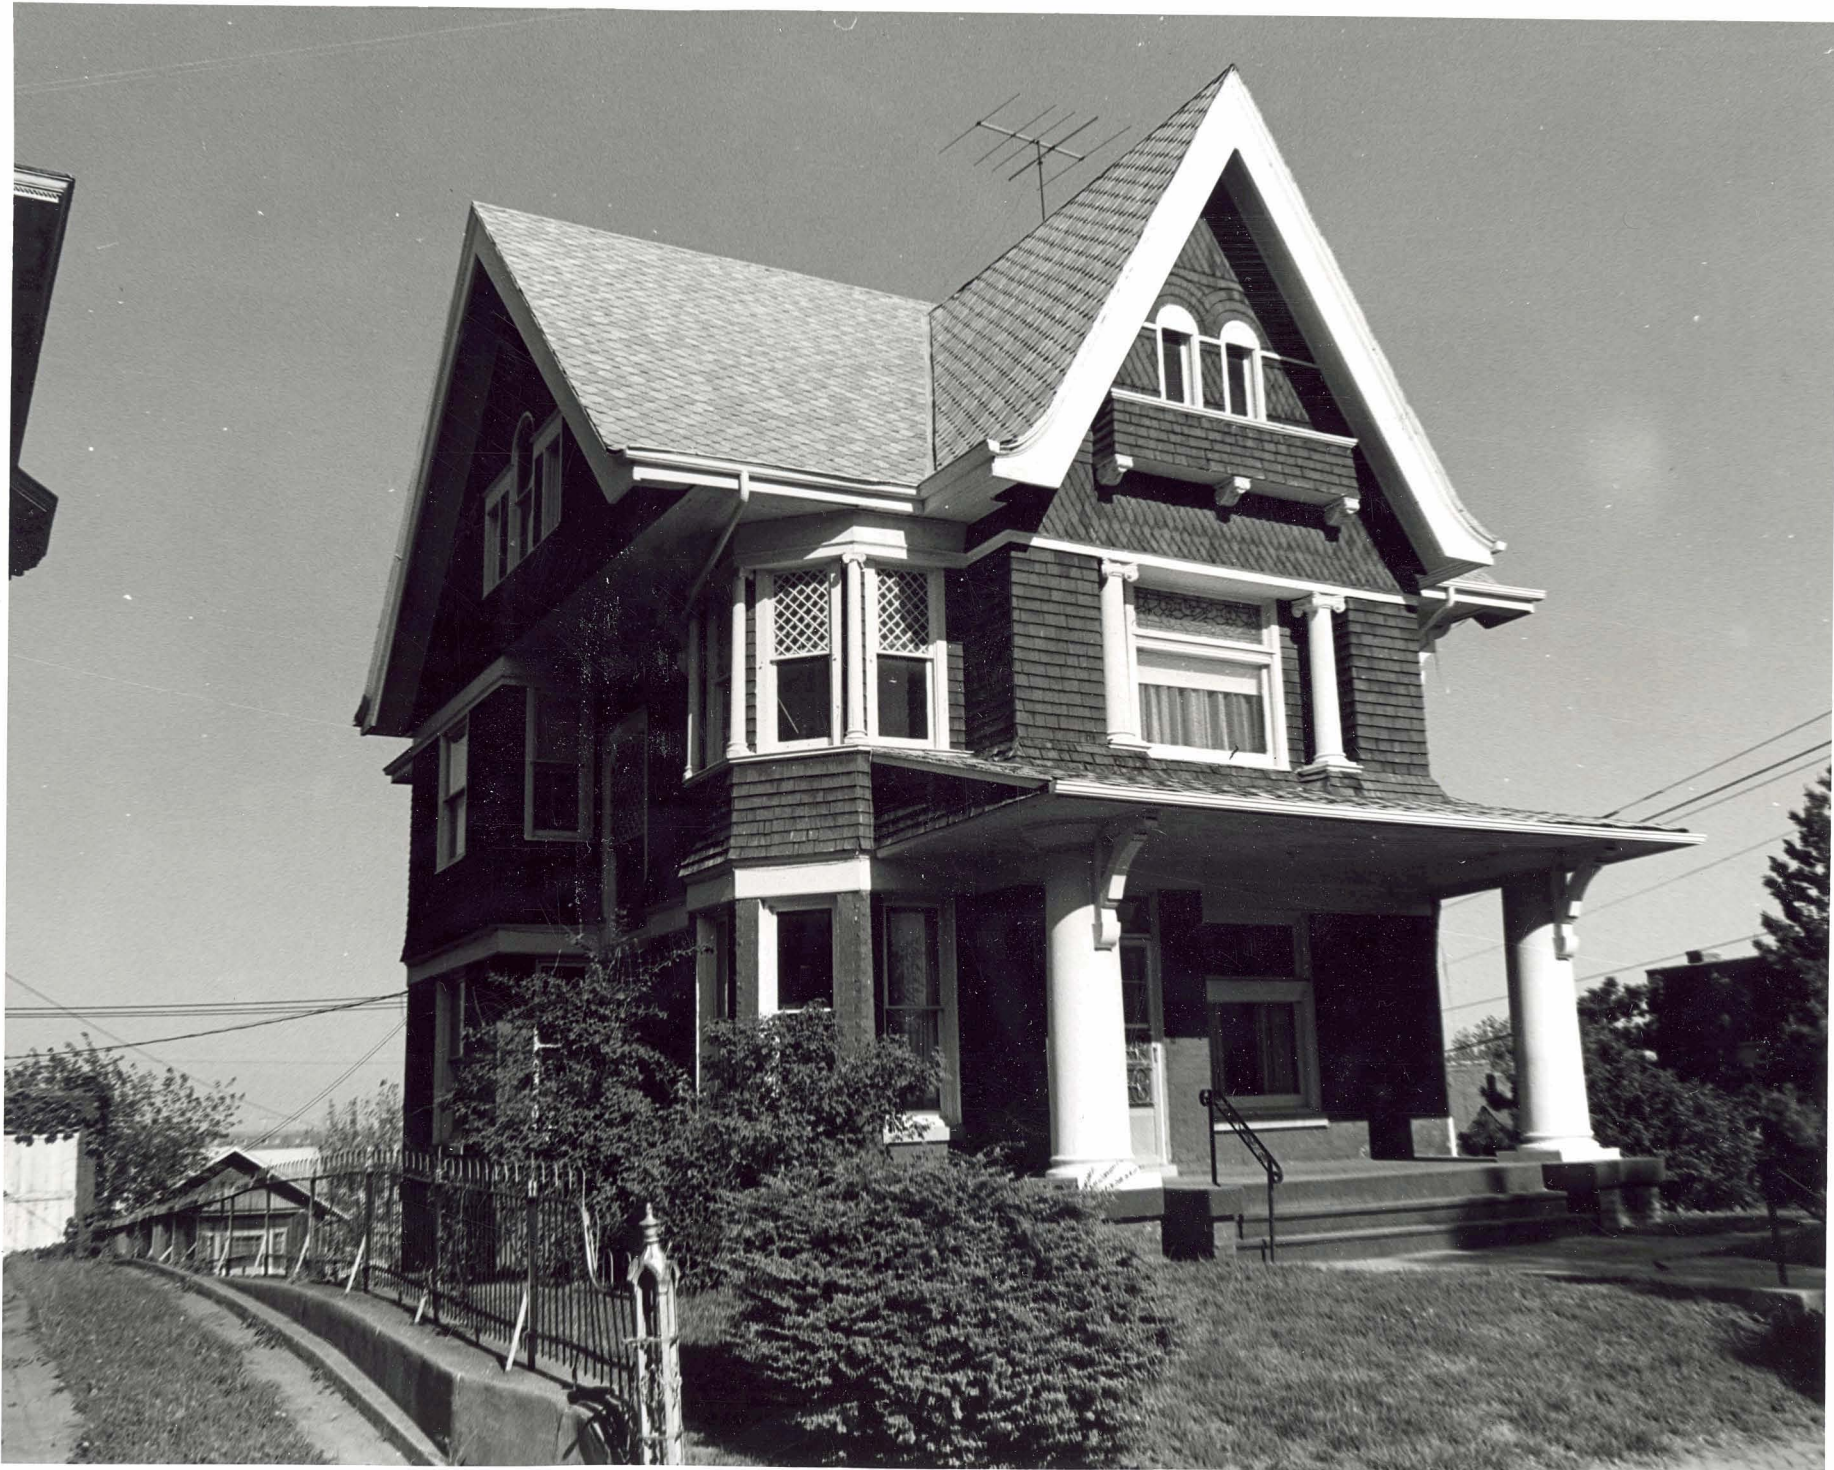
HISTORIC INVENTORY

The porch is supported by a pair of extremely large Tuscan columns. They give the appearance of being much too heavy for the house style. One would speculate they are an alteration. At the second floor windows there are Ionic columns.

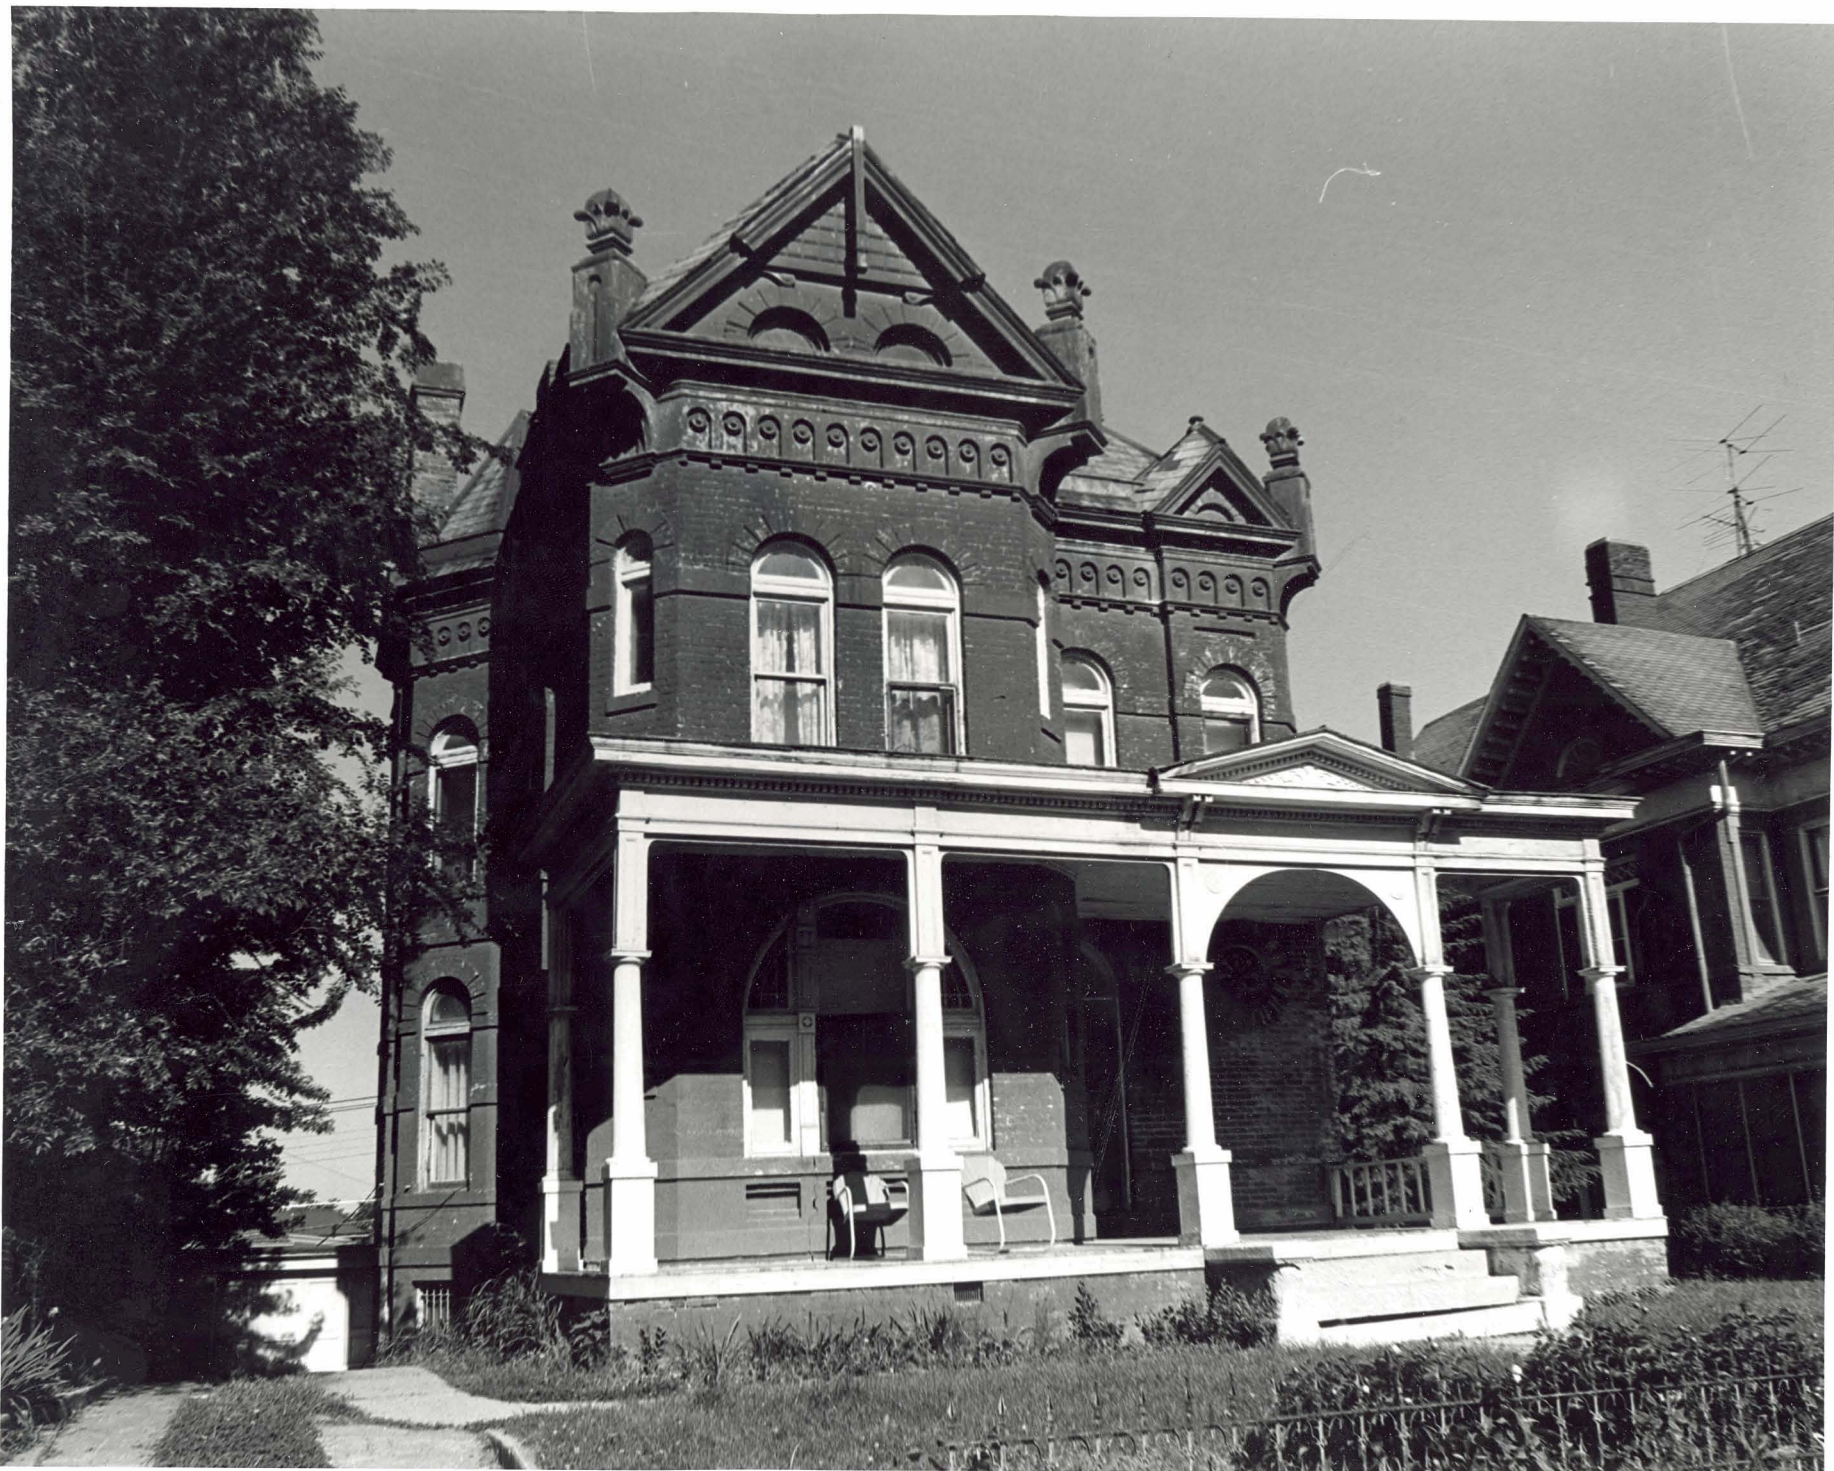
HISTORIC INVENTORY

The porch is an obvious addition from 1902. A pediment accentuates the entrance. There are dentils at the roof line and the columns are set on square bases with a doric column in the middle. This \$550 addition might have had balustrades in 1902, but only a section on the north shows this evidence today.

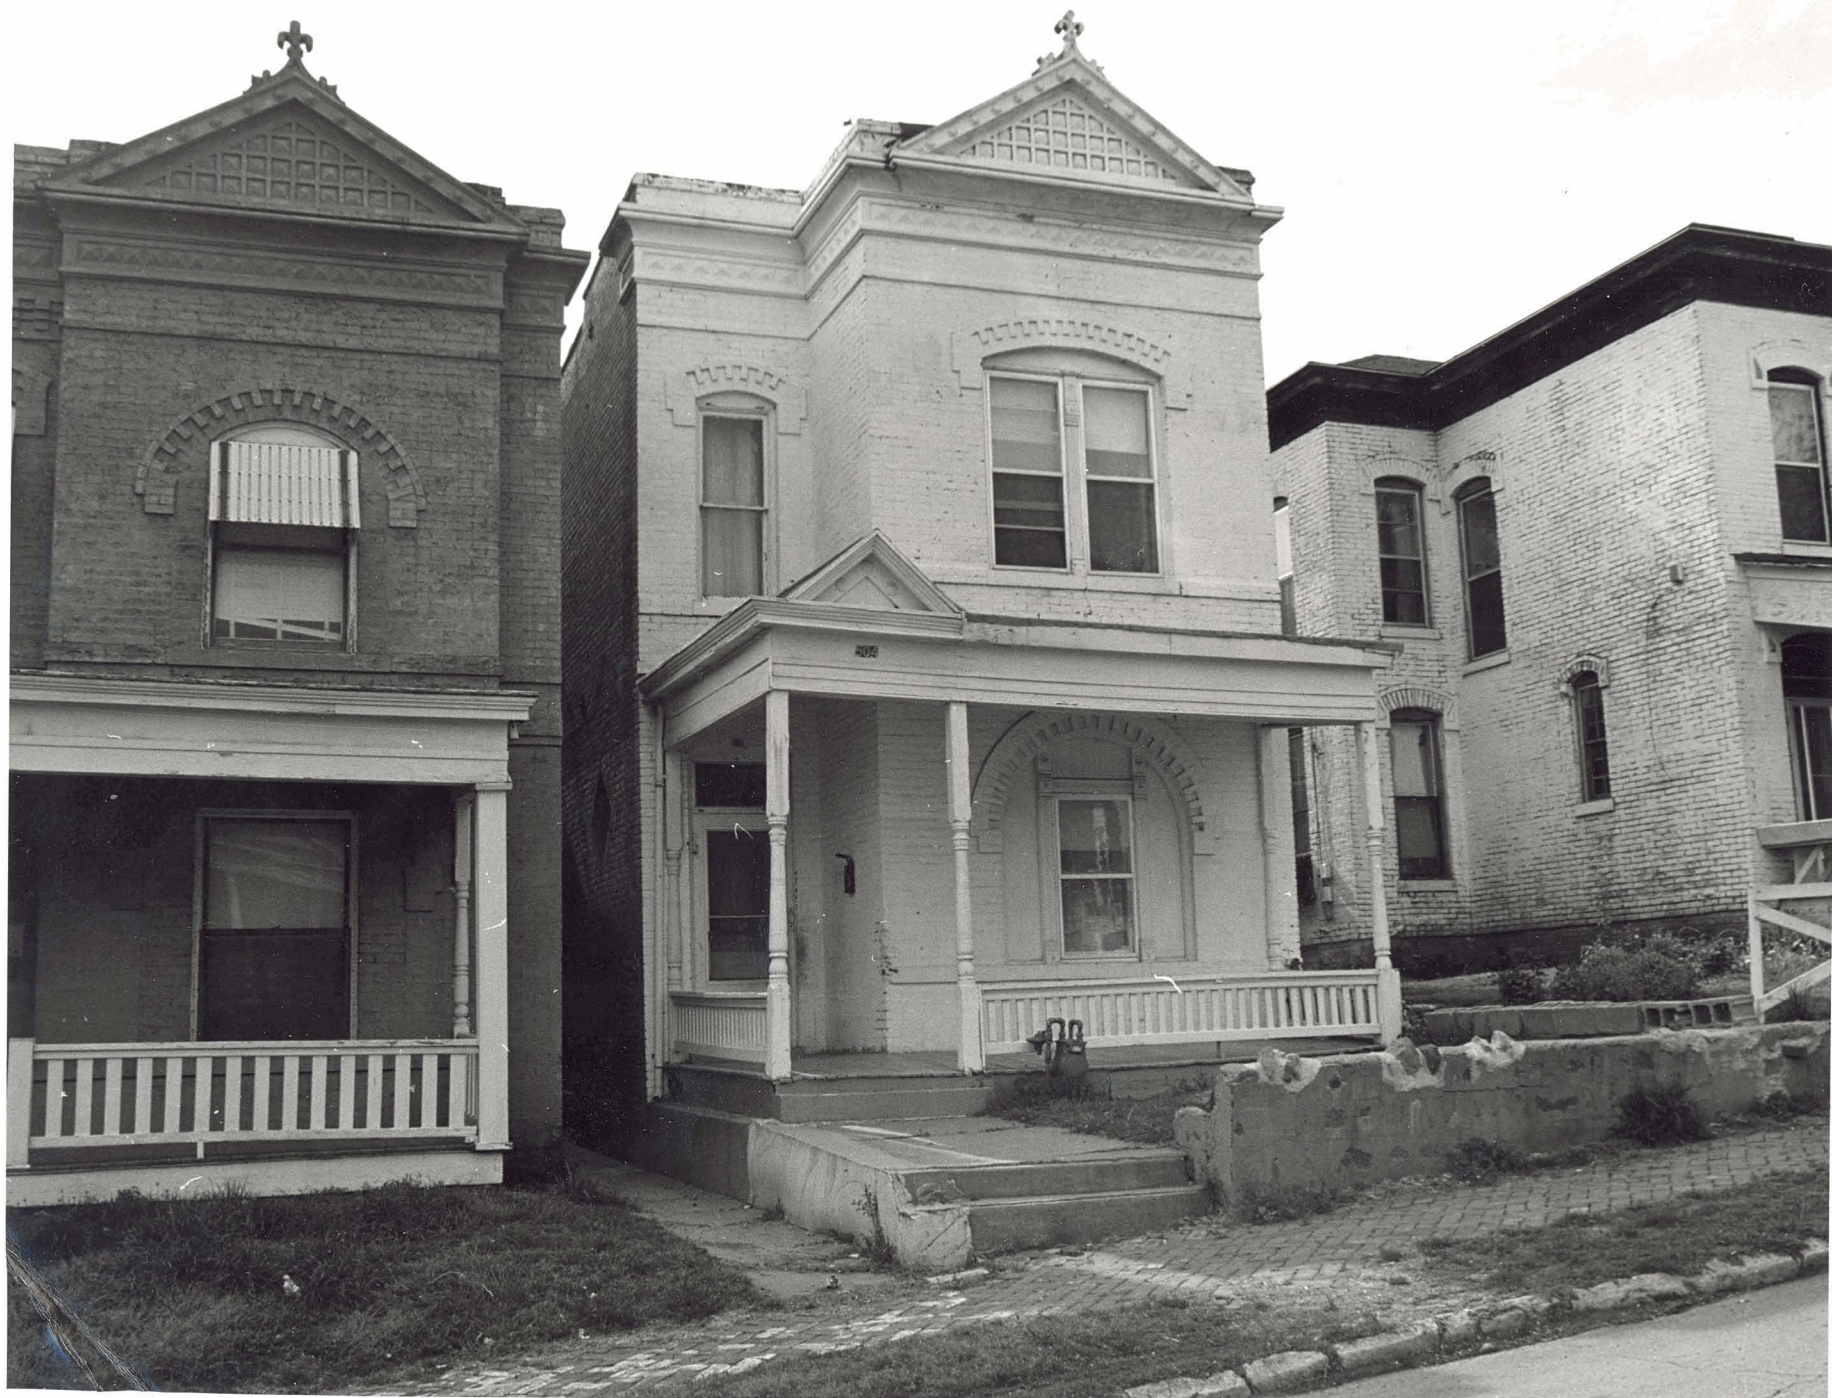
HISTORIC INVENTORY

There are string course bands at the water table level, the base of the windows at the first and second floor levels, and at the attic level. There is a pressed tin cornice at the roof level. The chimneys appear to be original.

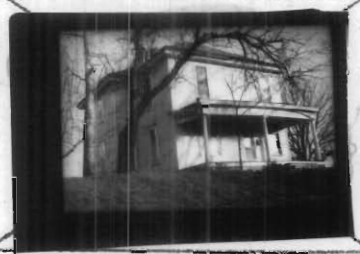
16. Further Description of Important Features There is a lead glass window above the door. A bay window is on the side of the house. The porch is supported on columns with a ionic capital.

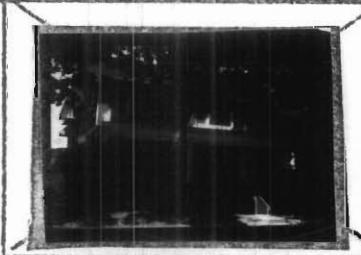
43. History and Significance 2 The home was built by E.W. Duke, son-in-law of Judge S.P. Huston. Perhaps its only significance is that it is one of a number of duplexes being built in the city at that period of time and is one of four in this neighborhood. The house sits above street level with stone wall to front (E) and side (S).

44. Description of Environment and Outbuildings This is one of the properties in the neighborhood which is more severely affected by the deterioration of property to the South. While some property is well maintained, a number of pieces are rental property which have been (see appendix)		46. Prepared by T. Carneal		17. Other Name(s) E. W. Duke Residence
