ST. JOSEPH, MISSOURI

SURVEY BLOCK #1

FALL, 1978

NWMSU Historical Survey
Thomas Carneal, Director

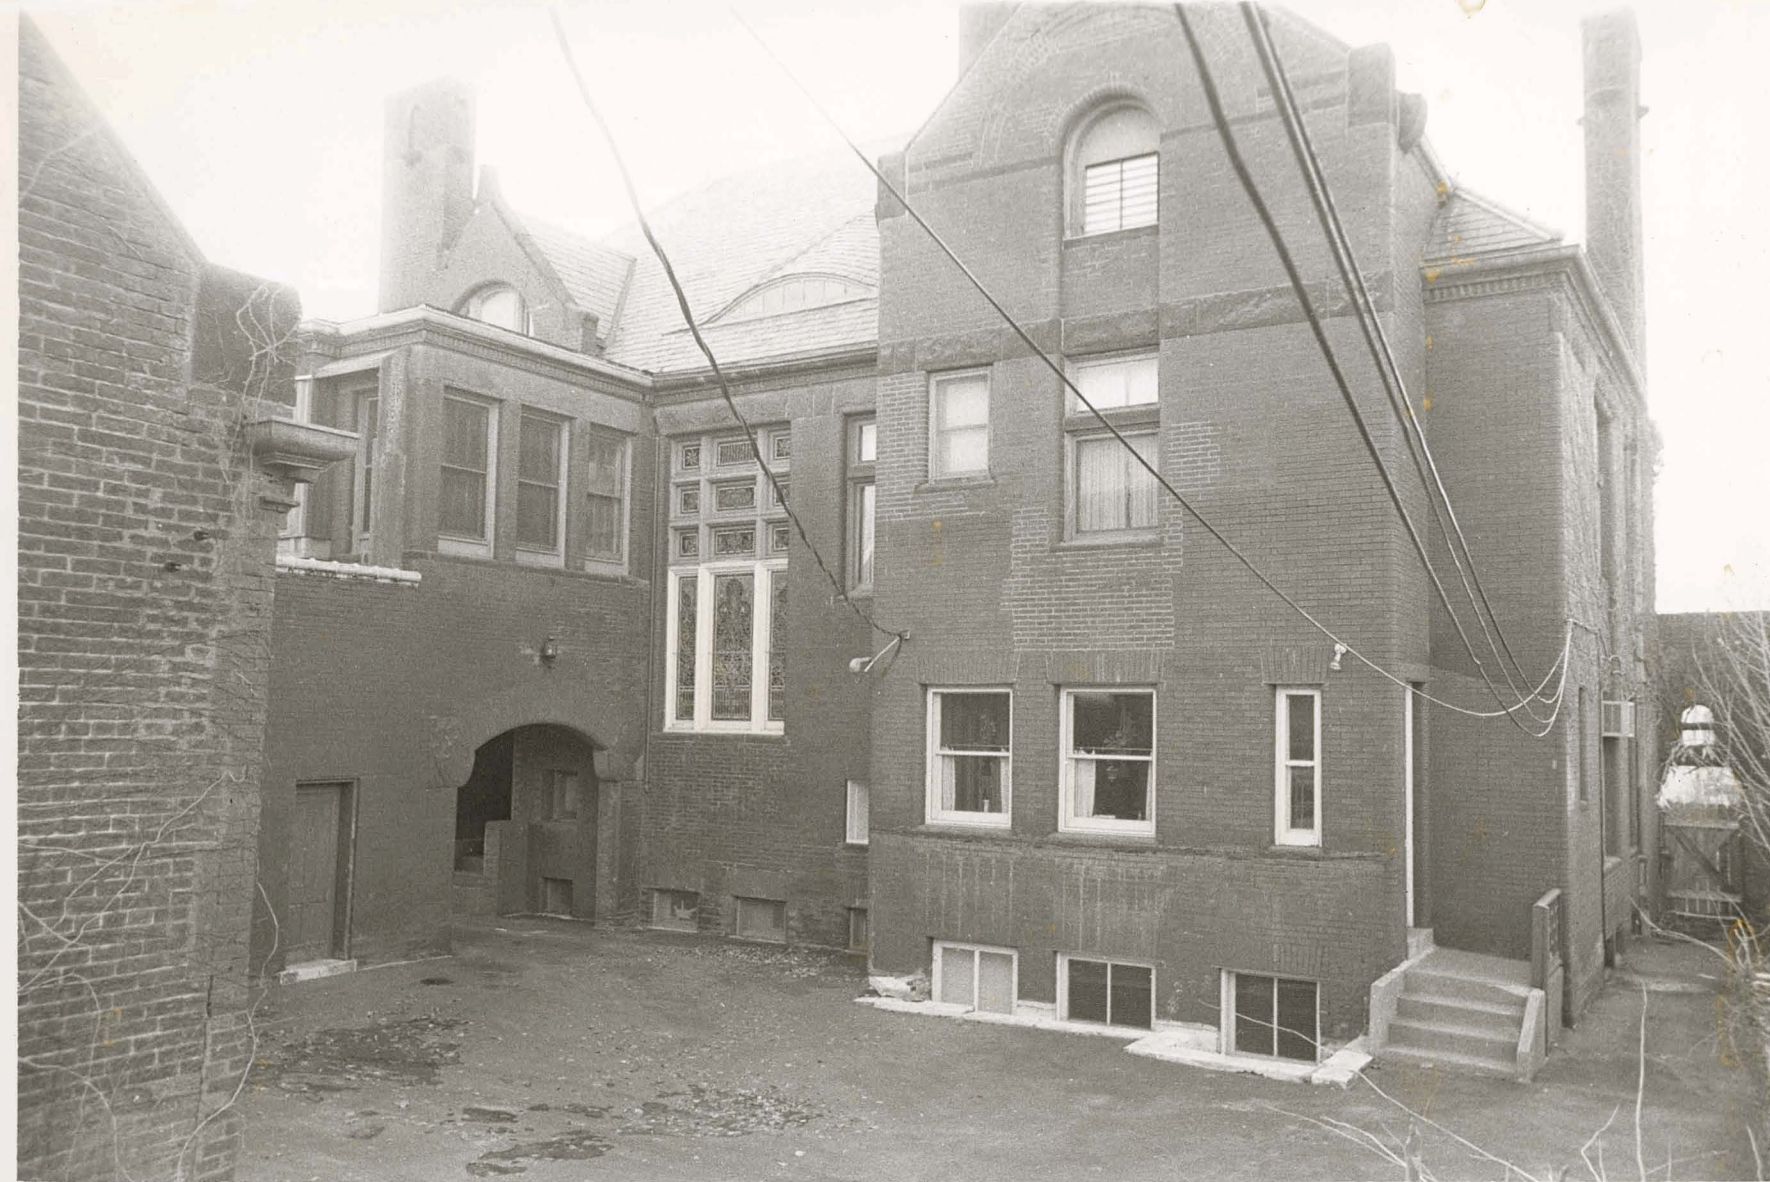
and the back of the house. Sitting above street level, the front yard has much heavy evergreen shrubbery. Side yard to South is large with drive from street to porte-cochere. Front facade is heavily covered with climbing vines which obstruct the view of architectural detail during summer months. There are no intrusions.

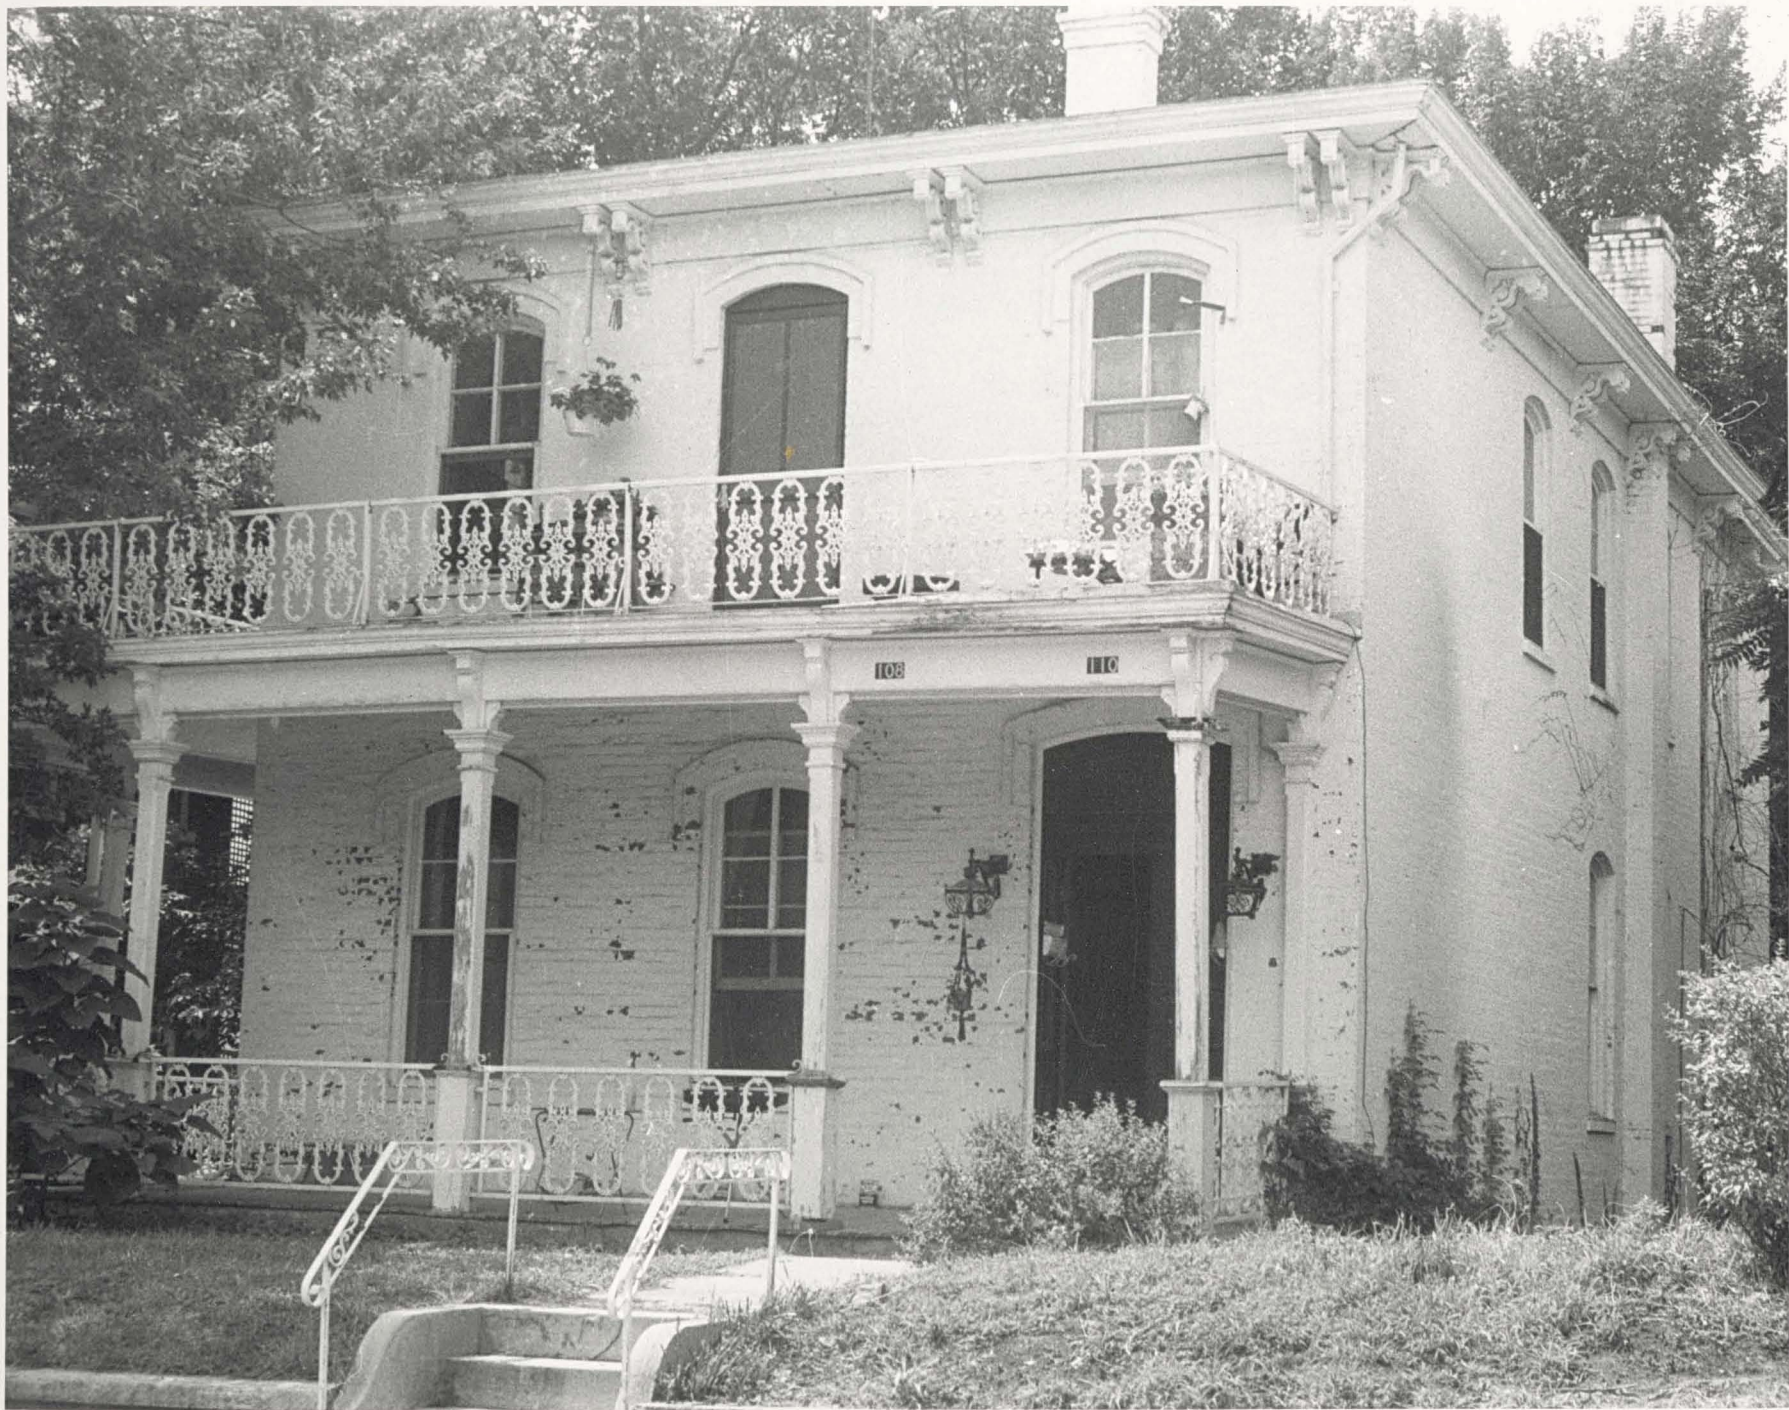
The house sets above the street level with a two course stone wall capped with stone. There is a slab of wrought iron banister at the steps. The house faces properties at 109 and 119 N. 19th. There is a two car brick garage at the rear (W) on alley level which is an intrusion. Also, at the rear is a red brick retaining wall and steps.

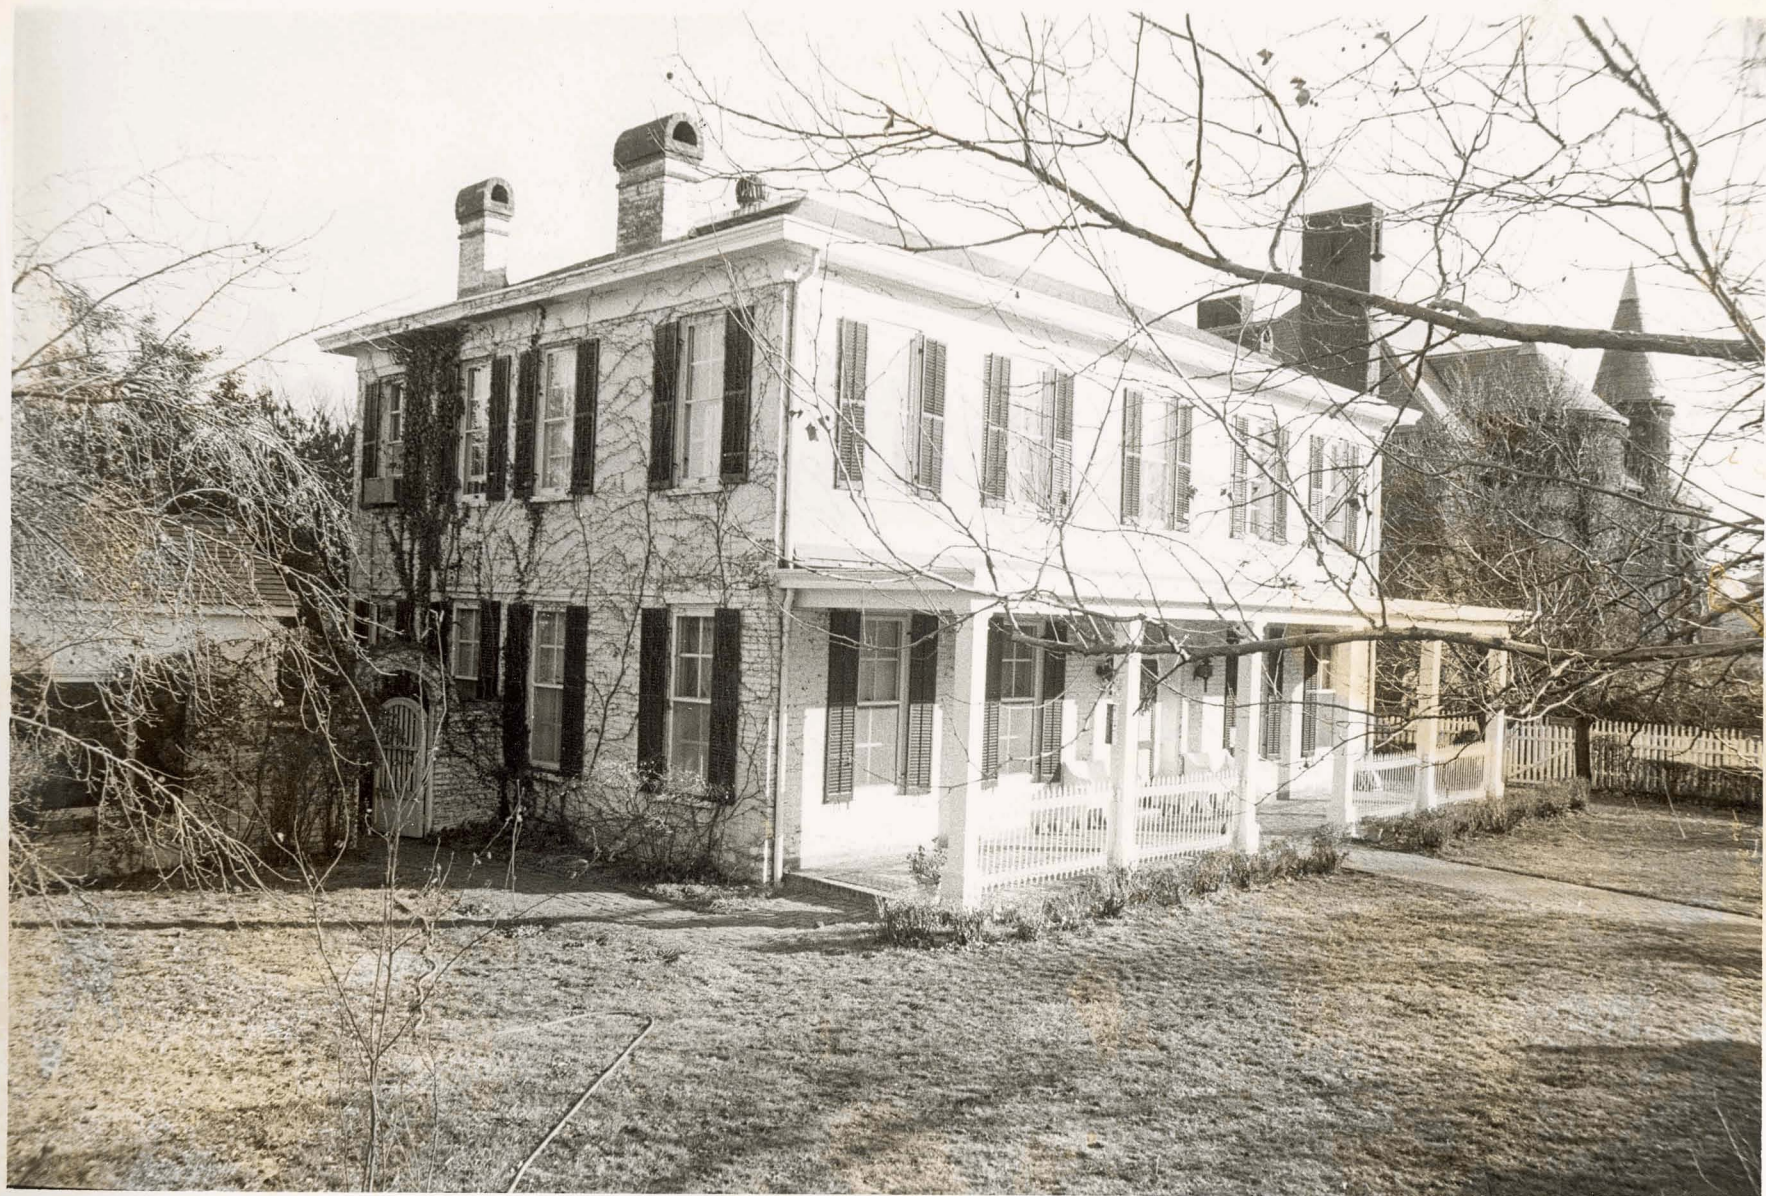
graciousness. A large two car garage, dating from 1923, sits at the rear of the lot (S/E corner). A brick drive leads from the street alongside the house to the brick and concrete block garage, painted white. Herringbone brick sidewalks surround the house on the North and West sides and lead through the brick fence, upstairs and toward the main entrance. A brick fence with white wooden picket fence on top extends across the front of the property to the North and East sides. The brick fence continues as a ten foot private wall. Arched entrance ways in the center of each of these walls are not bricked in. A stone slab tops this wall and there is a water table approximately four feet from ground level. To the North of the main block of the house and connected to it by an arched brick gateway is a small summer house, (1940's). The West wall is brick painted white with two rectangular windows with black wooden shutters. The remaining three sides are screened. The Landscaping was done in 1923 by Hare and Hare, Landscape Architects, and remains intact. Garage and summer house are of secondary significance. There are no intrusions.

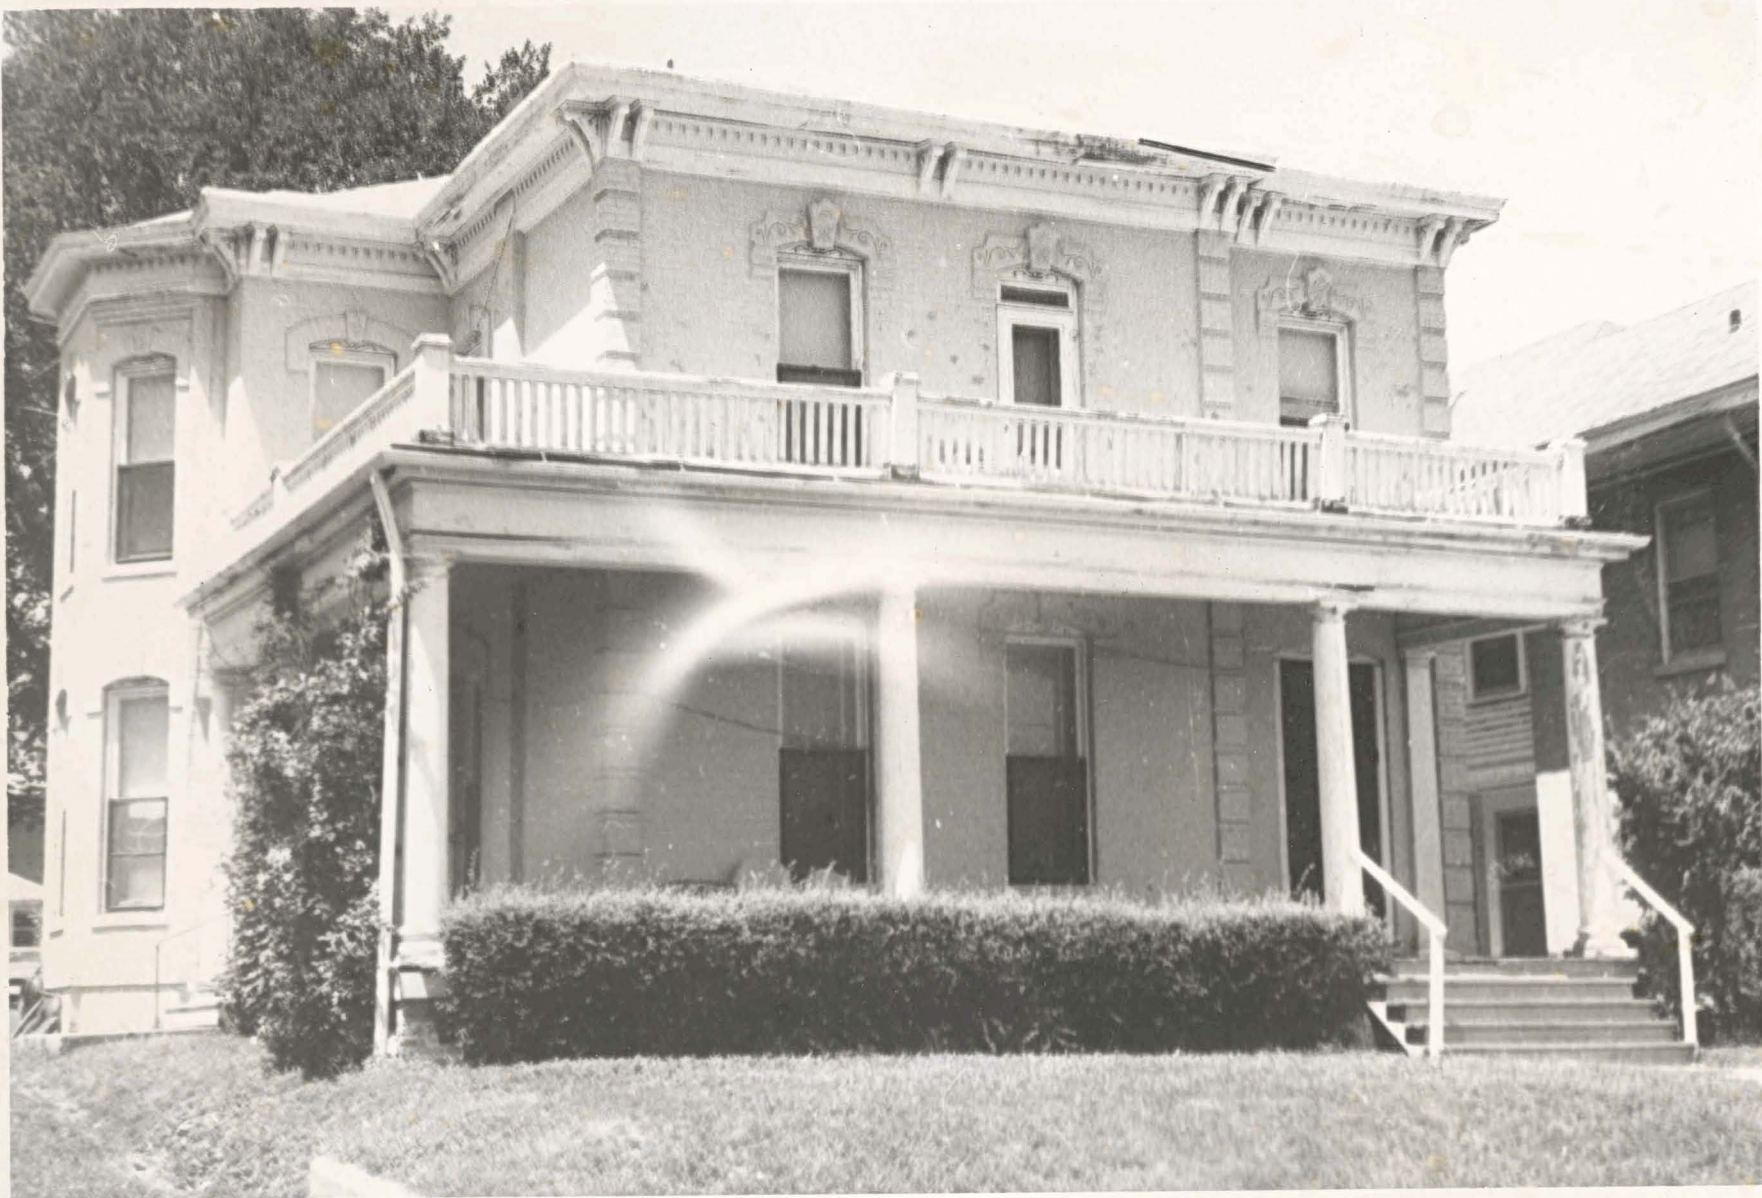
Burnham Apartments
206 N. 19th

At some point in time between the ownership of Buckingham and Mrs. Bode Long, the house was converted into efficiency apartments. The front porch was built between 1897 and 1911, as illustrated by the Sanborn Insurance Maps of those years.

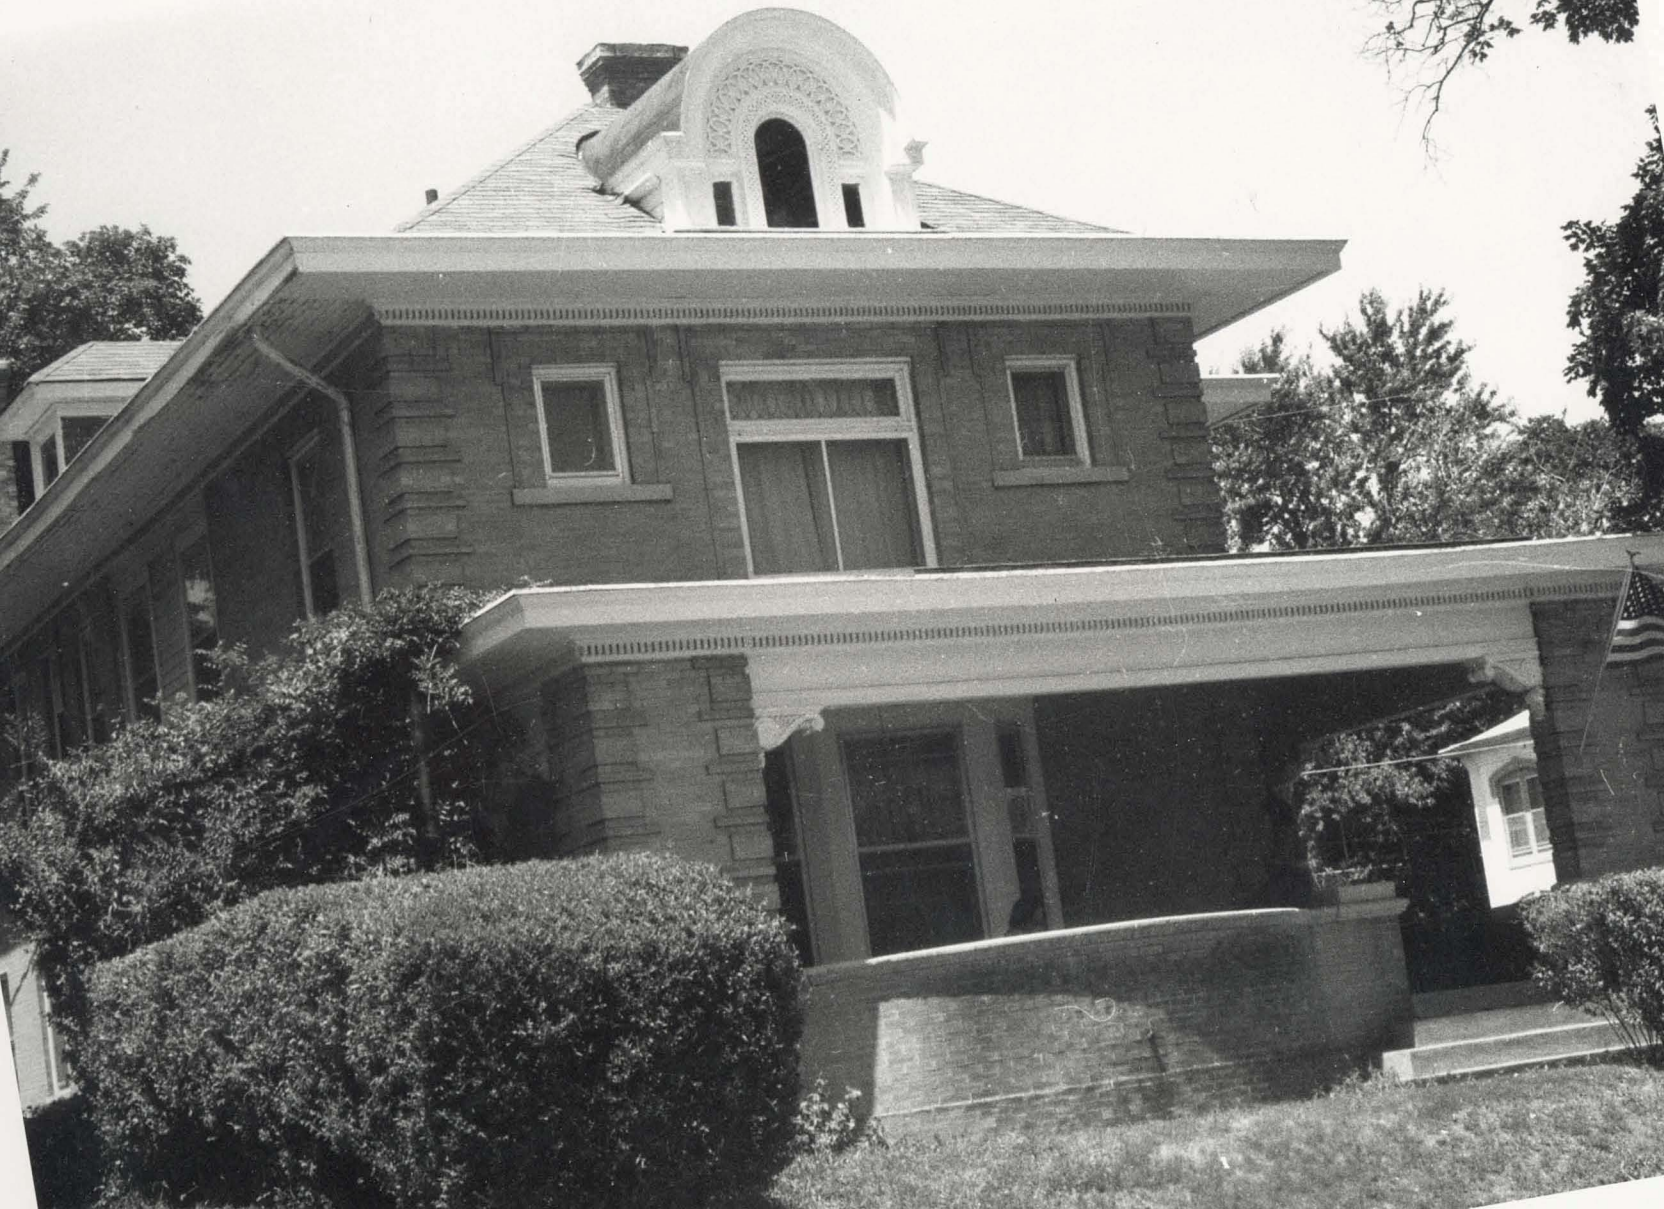
16. Further Description of Important Features Wide eaves and a deep porch emphasizes the horizontal in the manner of the prairie style, but the Palladin dormer, brick quoins and scroll brackets at the porch are eclectic details. Precise brick with crisp detail shown in the quoins and the projected window surrounds, give this house a distinctive appearance. There is leaded glass used in many of the upper portions of the sash windows.		37. Condition Interior Excellent Exterior Excellent

There is leaded glass used in many of the upper portions of the sash windows.

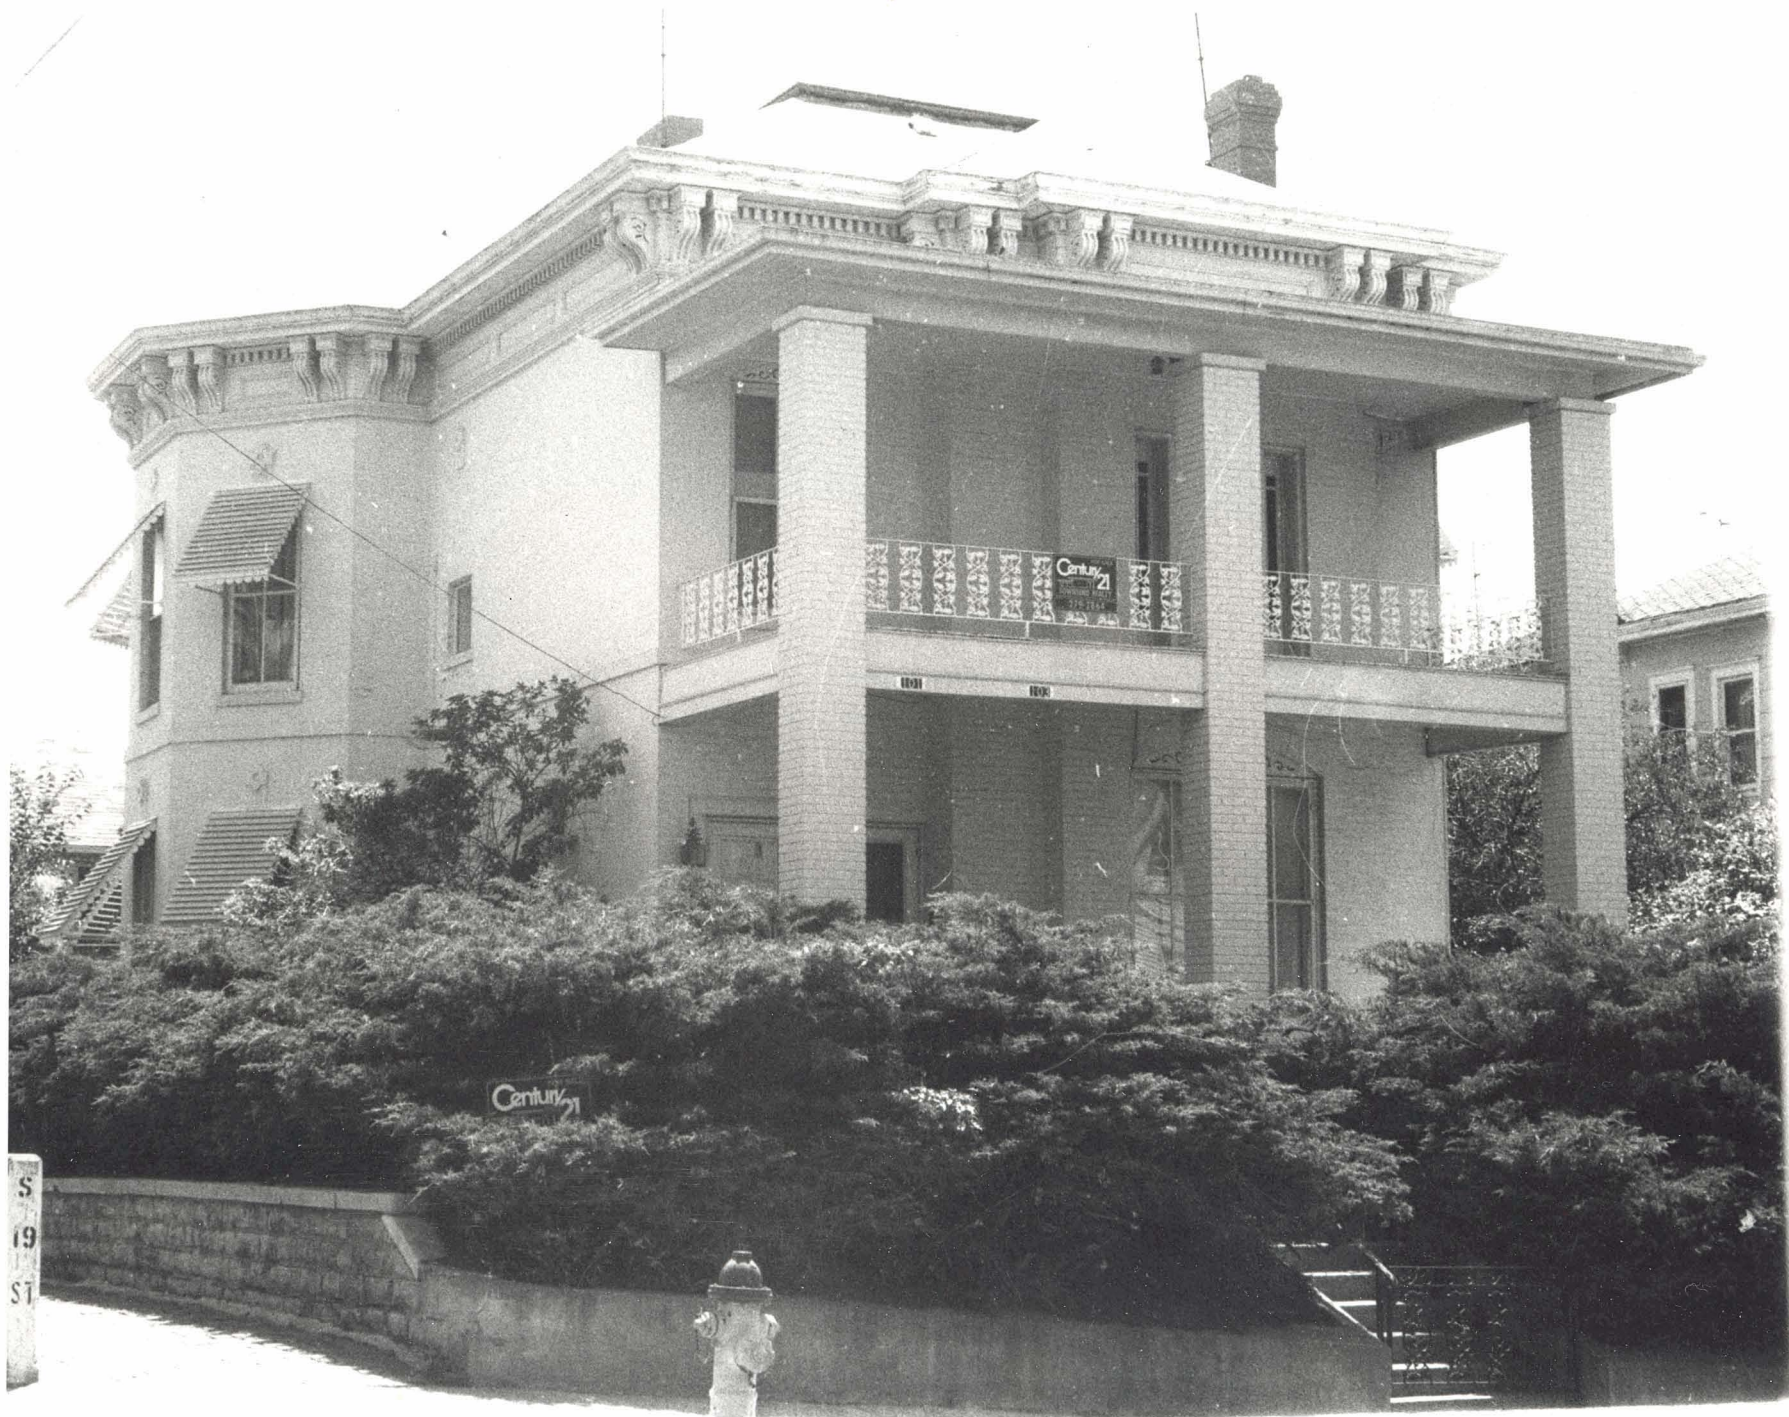
43. History and Significance 2 A large family home from the late 19th Century period, but converted to a duplex between 1907 and 1925. Dr. Charles R. Woodson was first listed at this address in the 1887 City Directory. The two story front porch was added in 1907.		44. Description of Environment and Outbuildings There is a carriage house at the rear of the property. A rusticated stone wall about feet high sits at the north property line, and a poured concrete wall with steps is at the west property line. There are no other intrusions on the property.

window. The two story porch appears to be an addition. The pillars are square brick and mortar with a very plain wood cornice. There is a wrought iron railing at the second floor level between the pillars.

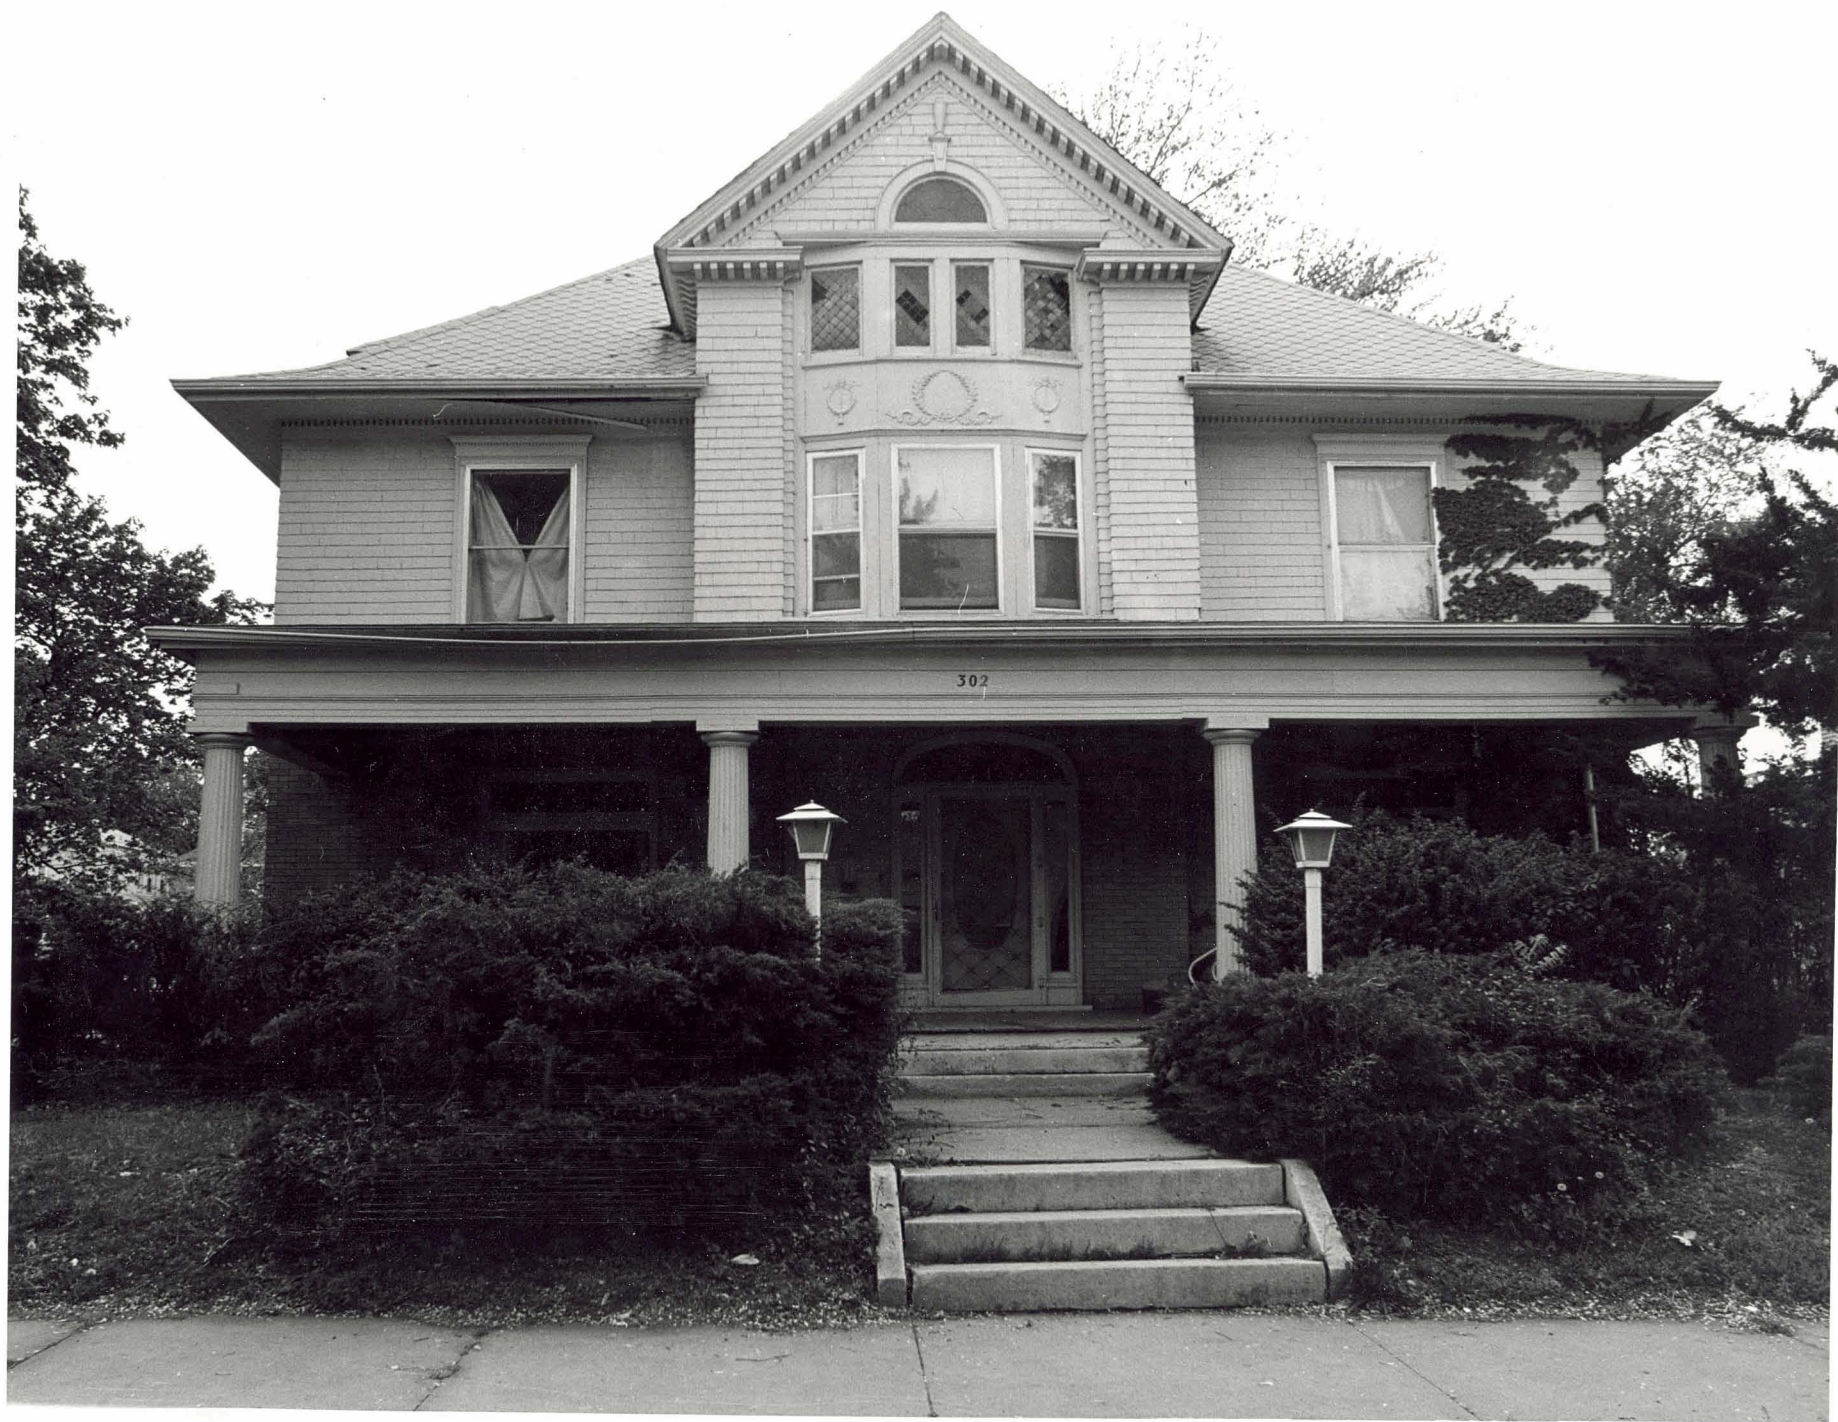
HISTORIC INVENTORY

The windows are double-hung. The porch is rather plain and the roof is supported on fluted Tuscan columns.

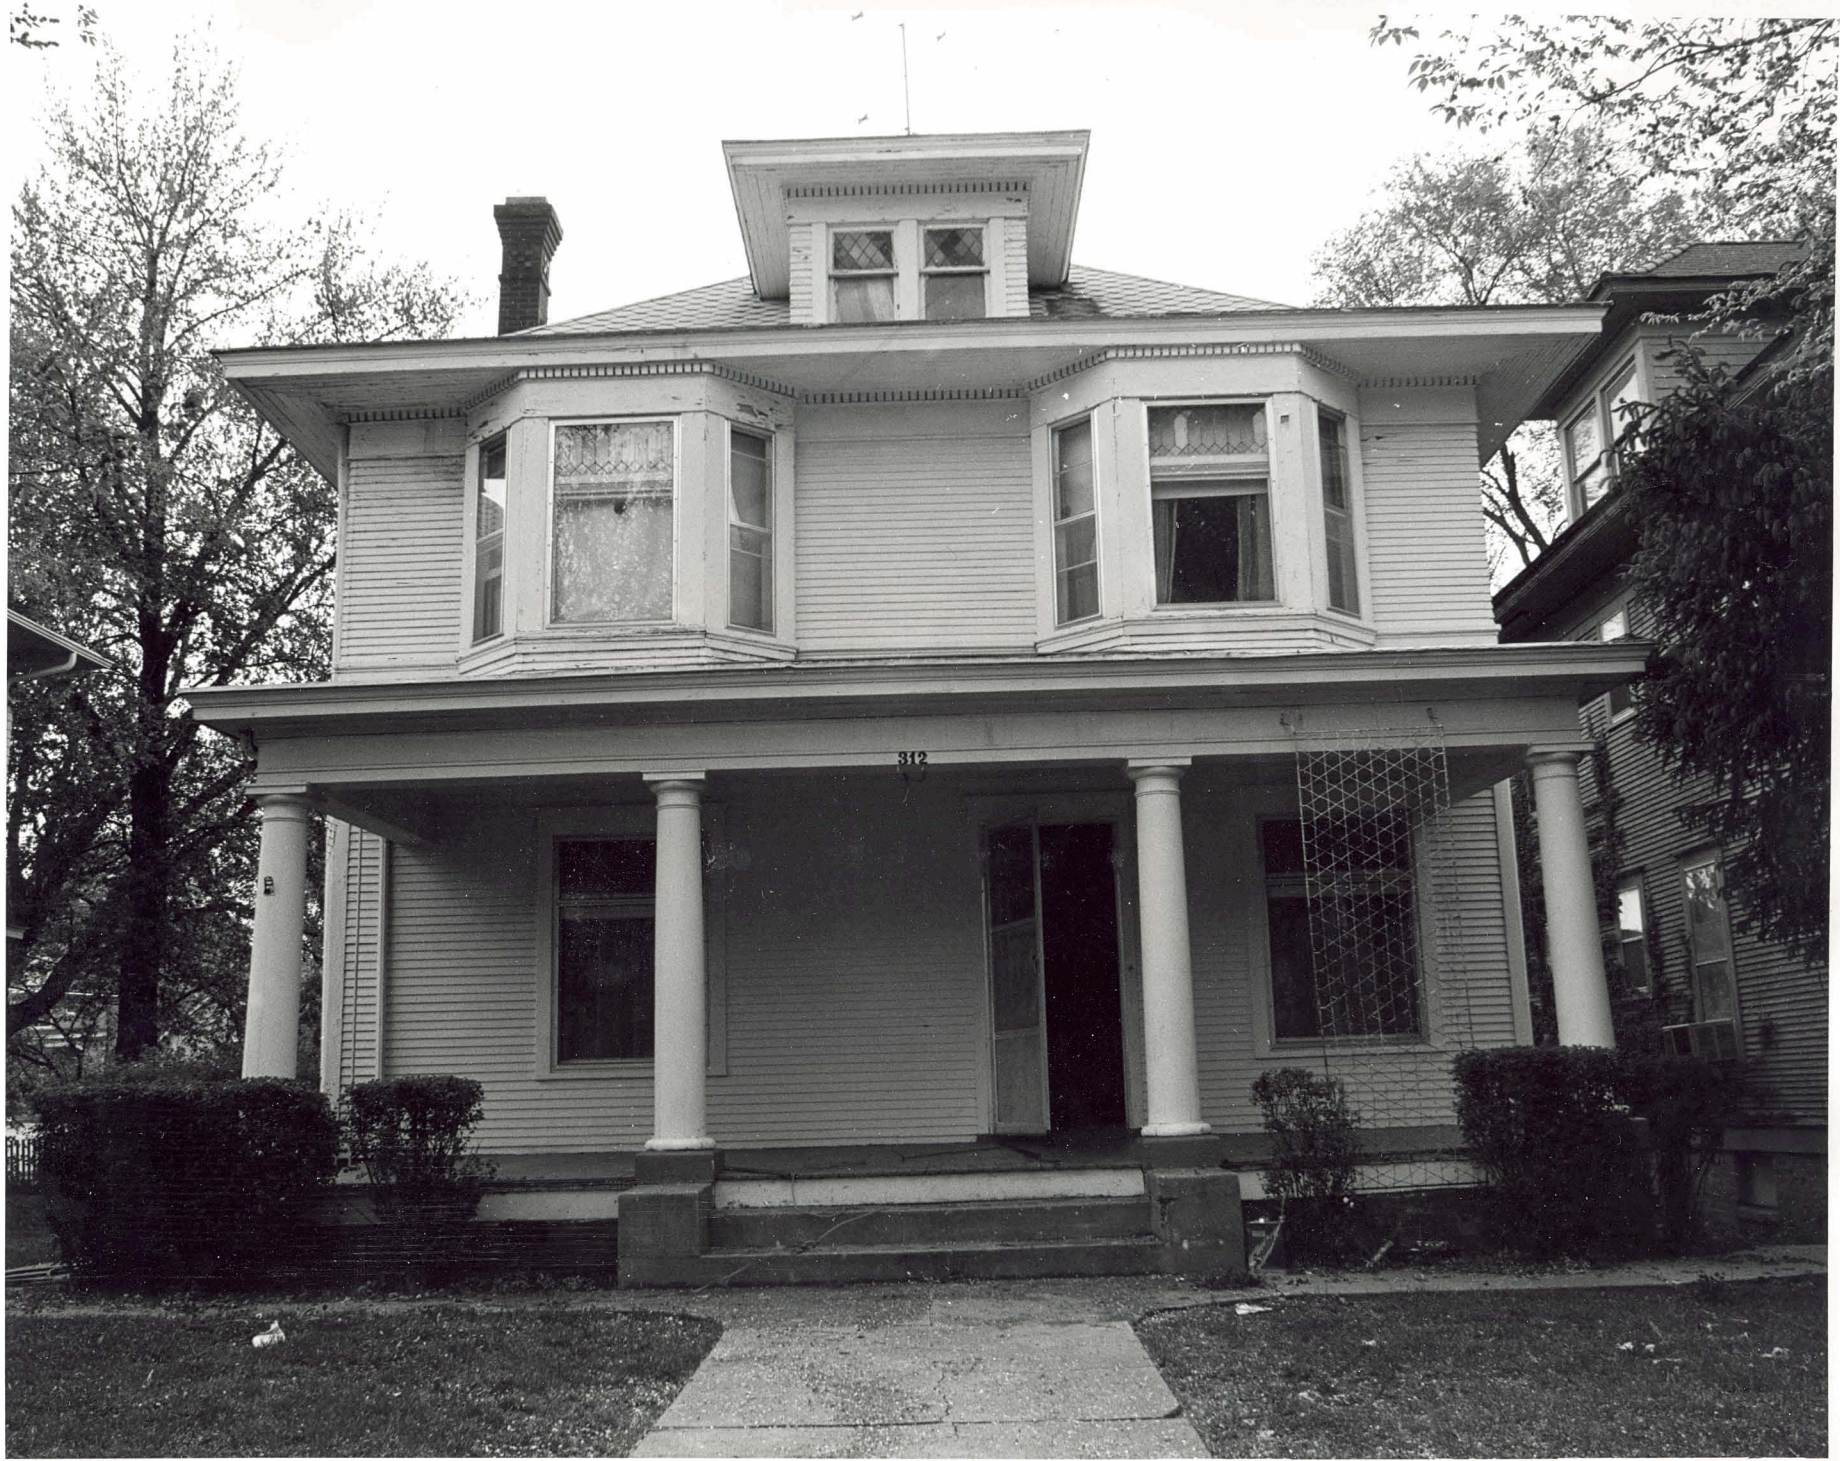
HISTORIC INVENTORY

There are boxed eaves with dentils at this level. The hipped roof dormer on the east side of the hipped roof has dentils at the eave level. The upper sash of the windows are also leaded glass.

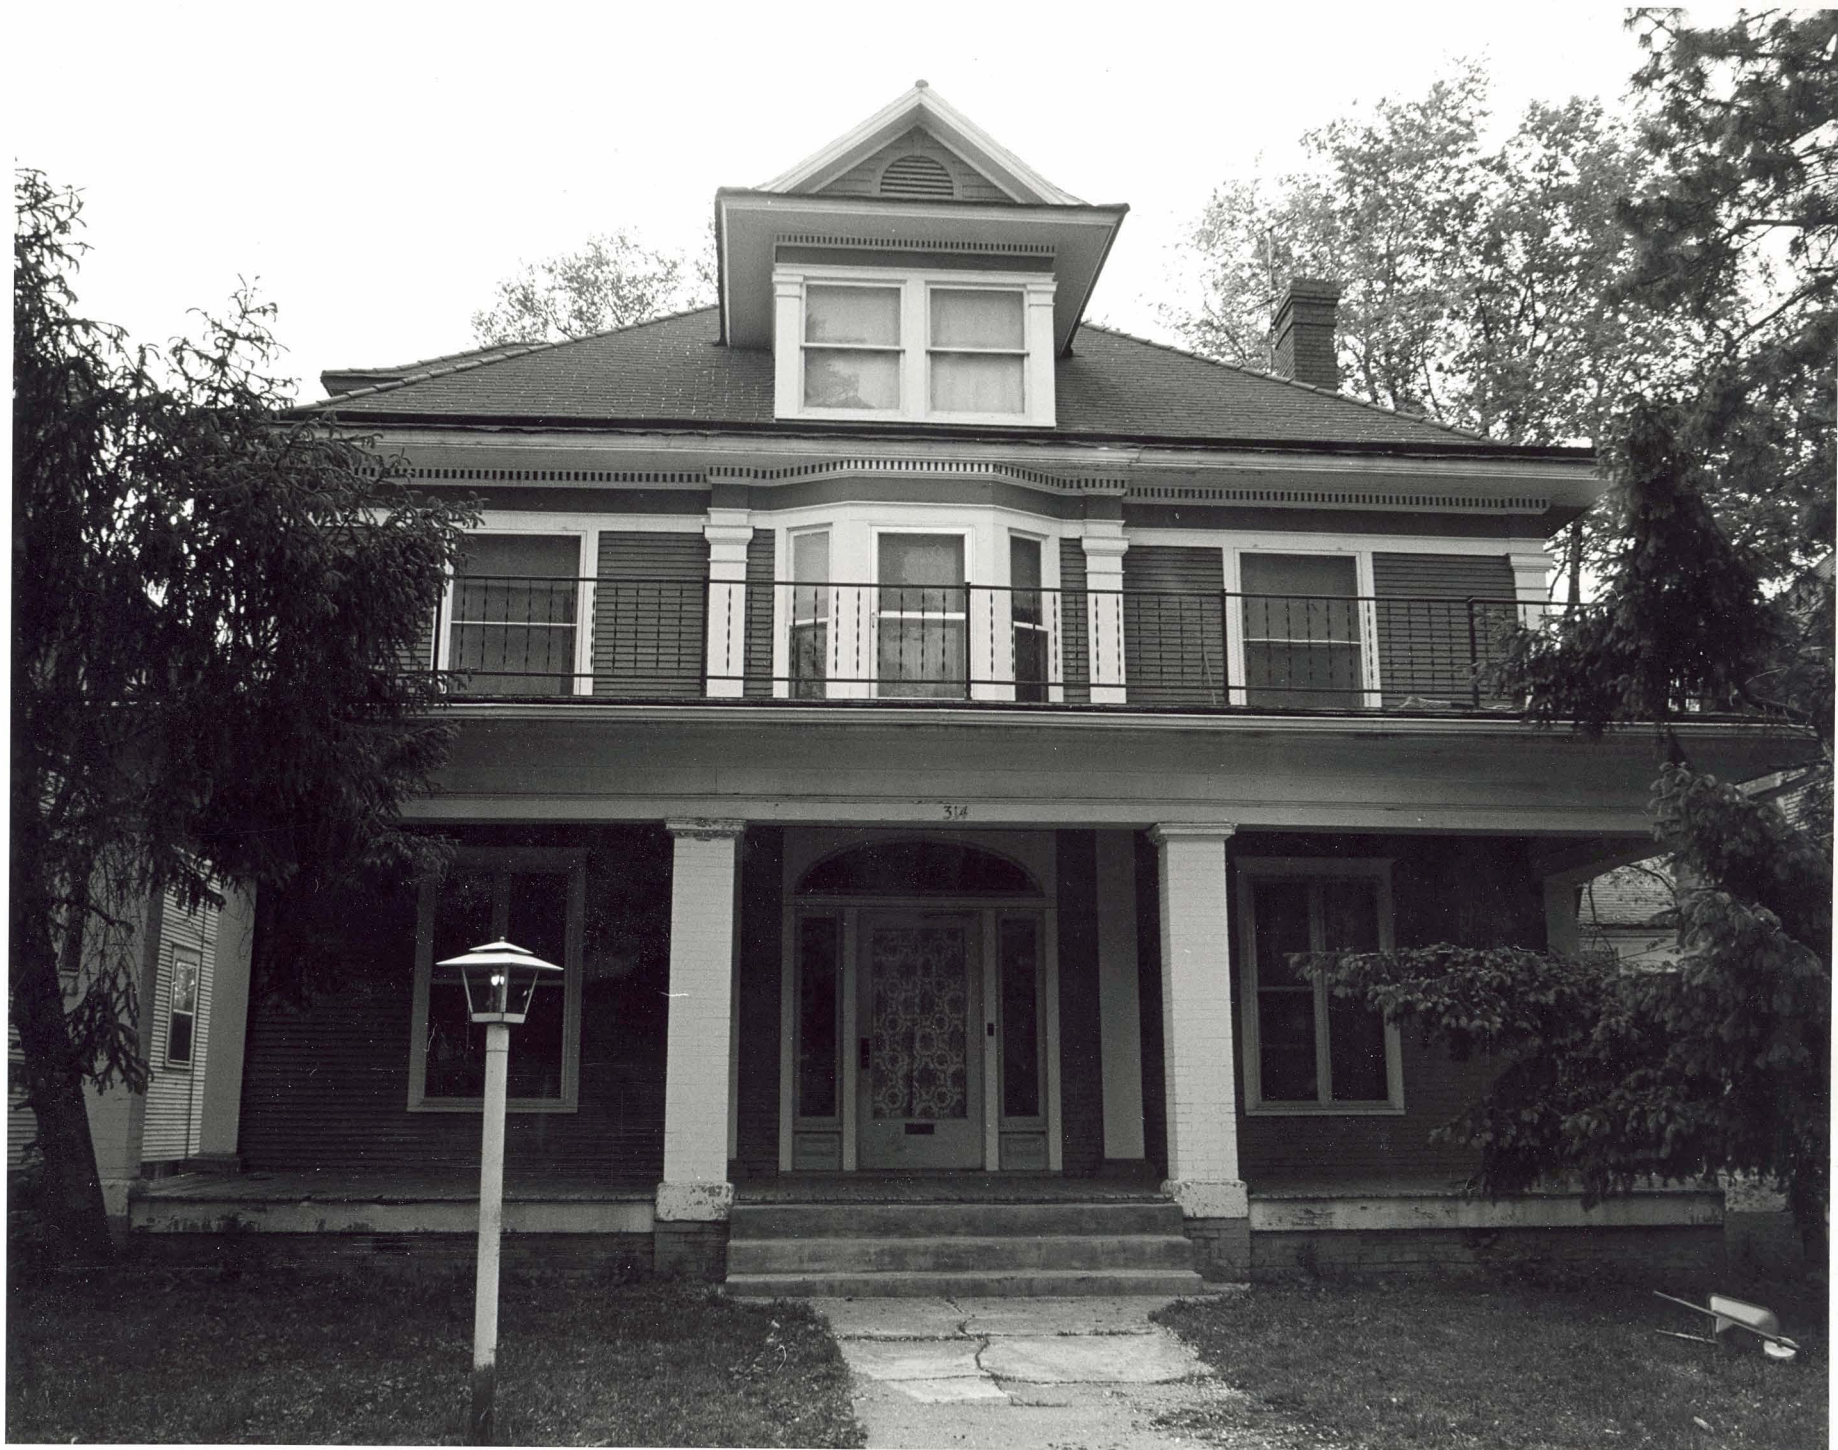
HISTORIC INVENTORY

There is a hipped roof dormer on the east side of the hipped roof. There are double-hung windows in the dormer. The windows are symmetrical on the front and side.
