ST. JOSEPH, MISSOURI

SURVEY BLOCK #1

FALL, 1978

NWMSU Historical Survey
Thomas Carneal, Director

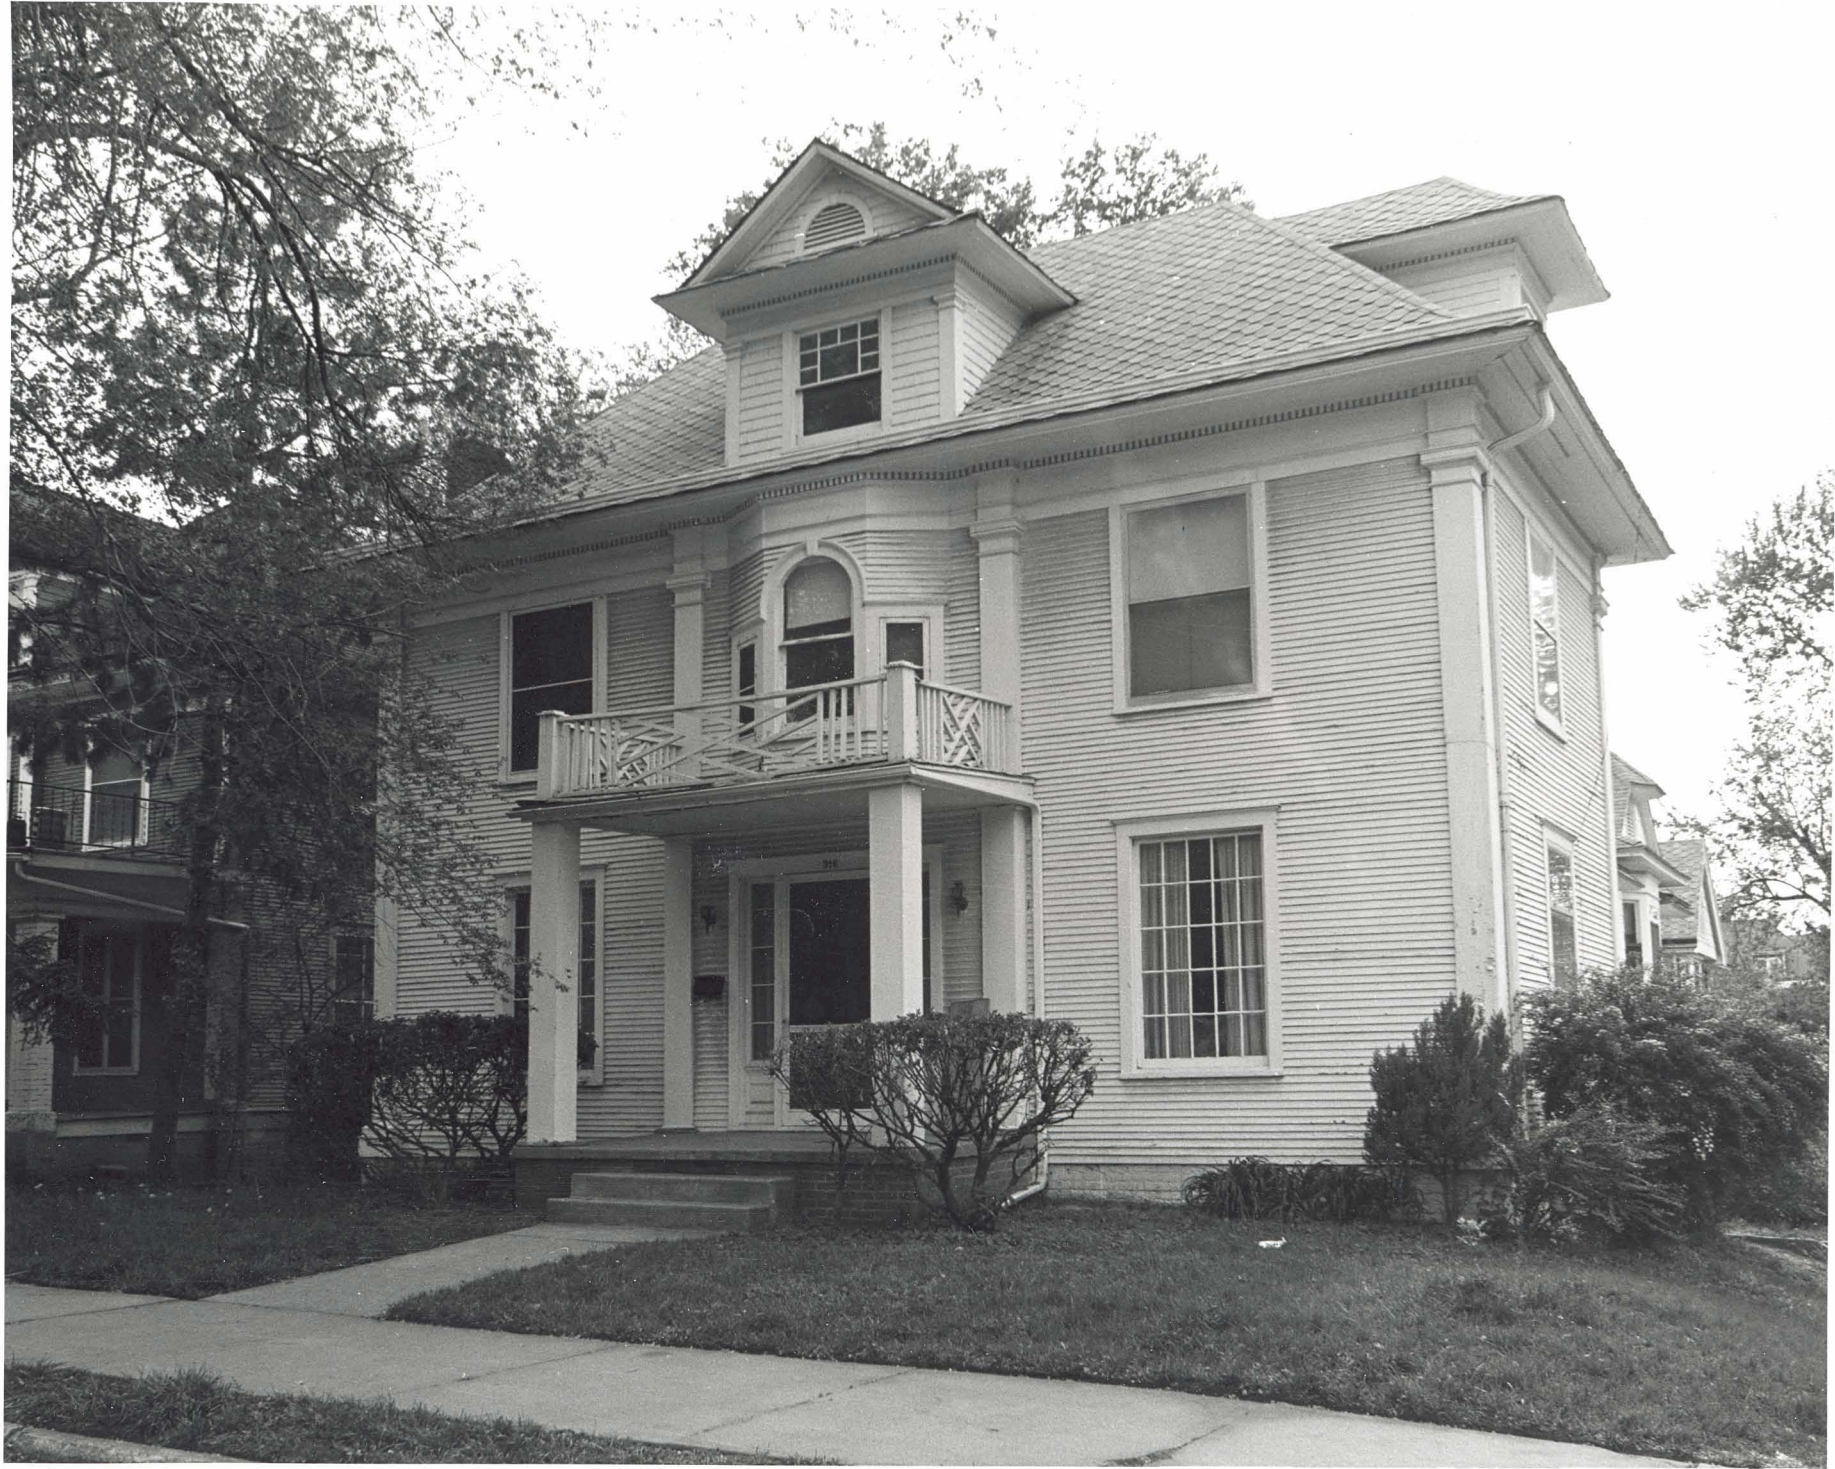
HISTORIC INVENTORY

There are hipped roof dormers on the east and north side of the hipped roof. The double hung windows have a design in the upper panels. Other than these variations the windows are fairly symmetrical in front and side.

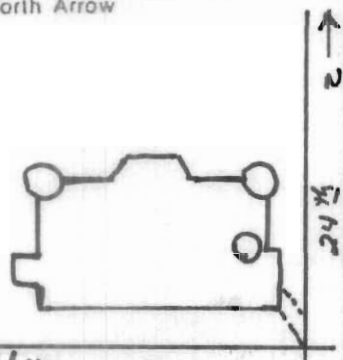
1. No. F04-34		4. Present Name(s) Robert Ferguson Home	
2. County Buchanan		5. Other Name(s)	
3. Location of Negatives Community Development			
6. Specific Location Lots 17 & 18 Blk 14 602 N. 24th corner of 24 & Clay Eastern extension		16. Thematic Category Architecture

17. Date(s) or Period	
7. City or Town If Rural, Township & Vicinity St. Joseph		18. Style or Design Queen Anne	
		19. Architect or Engineer	
8. Site Plan with North Arrow

18. Style or Design Queen Anne	30. Foundation Material Stretcher Brick	
		19. Architect or Engineer	31. Wall Construction frame

25. Open to Public? Yes <input type="checkbox"/> No <input checked="" type="checkbox"/>	37. Condition Interior excellent Exterior excellent	
9. Coordinates Lat. UTM Long.		26. Local Contact Person or Organization Jack Habig	38. Preservation Underway? Yes <input type="checkbox"/> No <input checked="" type="checkbox"/>	Other Name(s)

43. History and Significance There is a rusticated ashlar stone wall on the East side of the property.		46. Prepared by T. Carneal		
44. Description of Environment and Outbuildings		47. Organization NWMSU Hist. Survey

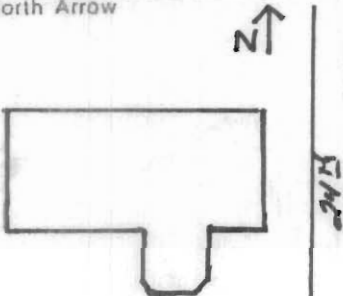
1. No. F04-31		4. Present Name(s) Martha Jansen	
2. County Buchanan		5. Other Name(s)	
3. Location of Negatives Community Development			
6. Specific Location Lots 10 & 11 Blk 14 618 N. 24th Eastern Extention		16. Thematic Category Architecture

17. Date(s) or Period	
7. City or Town If Rural, Township & Vicinity St. Joseph		18. Style or Design Queen Anne	
		19. Architect or Engineer	
8. Site Plan with North Arrow

15. Name of Established District		30. Foundation Material brick	
42. Further Description of Important Features The most distinguishing features of this home is the bay windows on the South and the patterned shingles.		31. Wall Construction frame

36. Changes (Explain in #42) Addition <input type="checkbox"/> Altered <input type="checkbox"/> Moved <input type="checkbox"/>	
45. Sources of Information On site visitation, tax records-City of St. Joesph.		37. Condition Interior good Exterior excellent

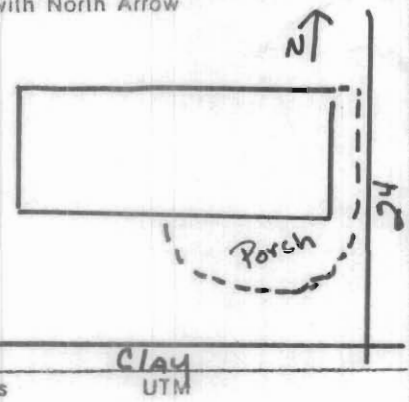
1. No. F04-30		4. Present Name(s) David Chase	
2. County Buchanan		5. Other Name(s)	
3. Location of Negatives Community Development		Morton Home	
6. Specific Location Lots 8 & 9 Blk 14 620 N. 24th Eastern Extension		16. Thematic Category Architecture

17. Date(s) or Period 1900	
7. City or Town If Rural, Township & Vicinity St. Joseph		18. Style or Design Vernacular	
8. Site Plan with North Arrow

30. Foundation Material Cement Blocks		31. Wall Construction frame	
32. Roof Type & Material Cross gable/asbestos		33. No. of Bays Front 3 Side	
34. Wall Treatment weatherboard		35. Plan Shape rectangular

36. Changes (Explain in #42) Addition I I Altered I I Moved I I		37. Condition Interior good Exterior excellent	
38. Preservation Underway? Yes I I No <input checked="" type="checkbox"/>		39. Endangered? By What? Yes I I No <input checked="" type="checkbox"/>

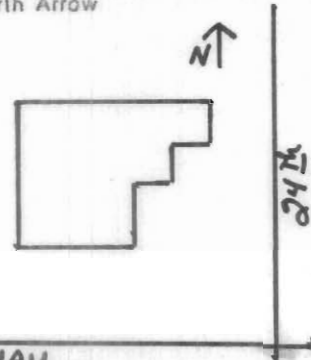
1. No. F04-28		4. Present Name(s) Robert Keiber	
2. County Buchanan		5. Other Name(s)	
3. Location of Negatives Community Development			
6. Specific Location Lots 4&5 Blk 14 628 N 24 Eastern Extension		16. Thematic Category Architecture

18. Style or Design Cottage Style

30. Foundation Material Brick	
		31. Wall Construction Frame	
		32. Roof Type & Material High gable/asbestos	
		33. No. of Bays shingles Front 3 Side 3

37. Condition Interior Exterior Good	
		38. Preservation Underway? Yes <input checked="" type="checkbox"/> No <input type="checkbox"/>	
		39. Endangered? By What? Yes <input type="checkbox"/> No <input checked="" type="checkbox"/>

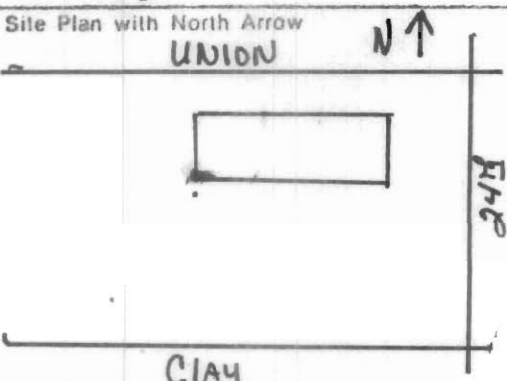
6. Specific Location Lots 2-3 Blk 14 632 N. 24th Eastern Extension		16. Thematic Category <u>Architecture</u>		3. Present Name(s) Susan Towsied	
7. City or Town If Rural, Township & Vicinity St. Joseph		17. Date(s) or Period

</div>		18. Style or Design <u>Queen Anne</u>		4. Present Name(s) Susan Towsied	
		19. Architect or Engineer

30. Foundation Material <u>Concrete</u>		31. Wall Construction <u>Frame</u>			
32. Roof Type & Material <u>high gable/asbestos</u>		33. No. of Bays <u>shingles</u> Front <u>3</u> Side <u>5</u>

34. Wall Treatment <u>weatherboard</u>		35. Plan Shape <u>rectangular</u>			
36. Changes (Explain in #42) Addition <input type="checkbox"/> Altered <input type="checkbox"/> Moved <input type="checkbox"/>		37. Condition Interior <u>good</u> Exterior <u>good</u>

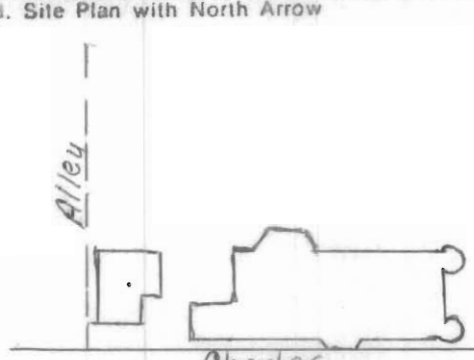
6. Specific Location Lots 8 to 10 block 6 1123-1125 Charles Wilson Addition		16. Thematic Category Architecture		4. Present Name(s) Dorothy Creverling

7. City or Town If Rural, Township & Vicinity St Joseph		17. Date(s) or Period 1880's			
8. Site Plan with North Arrow		18. Style or Design Queen Anne

14. District Potent'l? Yes <input checked="" type="checkbox"/> No <input type="checkbox"/>					
15. Name of Established District					
42. Further Description of Important Features This is an elaborate home with a carriage house being used for antiques. There are several round turrents with curved windows. There is extensive use of terra cotta decorative pieces in the lintels. Stained glass is used throughout the house.

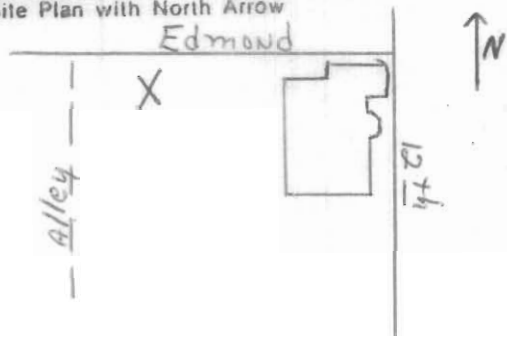
1. No. E03-06		4. Present Name(s) Davis Bros. Realty	
2. County Buchanan		5. Other Name(s)	
3. Location of Negatives Community Development			
6. Specific Location 25F W50F S50F E $\frac{1}{2}$ B1 S501 E $\frac{1}{2}$ B1 1120 Edmond Corner of 12th & Edmond		16. Thematic Category Architecture

7. City or Town If Rural, Township & Vicinity St. Joseph		17. Date(s) or Period 1880-1900	
8. Site Plan with North Arrow

30. Foundation Material Brick	
		31. Wall Construction Stretchers Brick	
		32. Roof Type & Material High Hip-Asbestos	
		33. No. of Bays Shingles Front 4 Side 2

37. Condition Interior Exterior -Good-	
		38. Preservation Underway? Yes <input type="checkbox"/> No <input checked="" type="checkbox"/>	
		39. Endangered? By What? Neglect Yes <input checked="" type="checkbox"/> No <input type="checkbox"/>

42. Further Description of Important Features There is a wall dormer on the North side of the house. There is a plain box cornice around the entire roof. The majority of the windows are triple hung. The front window has a stained glass transom, much of the wood has a diamond pattern stamped into it for decoration. The first floor porch curves around the East and North sides of the house. There is a great deal of wood trim in this area.

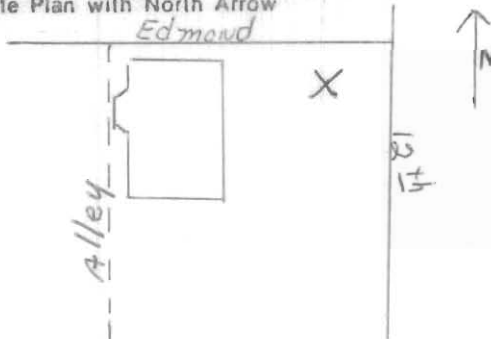
6. Specific Location N 7 of E 1/2 BLK 1 N 25F w 50 F S50 1114-1116 Edmond 2 houses W of 12th & Edmond on N side		16. Thematic Category Architecture		3. Present Name(s) James Clark

18. Style or Design Venacular		4. Present Name(s) James Clark

30. Foundation Material Brick			
		31. Wall Construction Brick & Frame			
		32. Roof Type & Material Truncated Hip Asbestos			
		33. No. of Bays Front 3 Side 4

37. Condition Interior Exterior Good			
		38. Preservation Underway? Yes <input type="checkbox"/> No <input checked="" type="checkbox"/>			
		39. Endangered? By What? Neglect Yes <input checked="" type="checkbox"/> No <input type="checkbox"/>

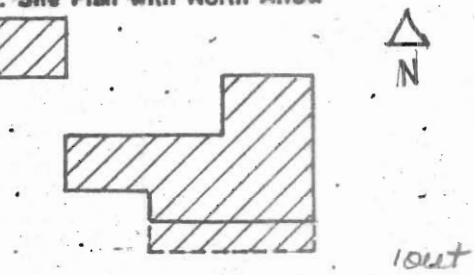
3. Location of Negatives <u>Carneal's Office</u>		6. Specific Location <u>2015 Faraon</u>		2. County Buchanan
7. City or Town If Rural, Township & Vicinity <u>St. Joseph, MO</u>		16. Thematic Category <u>Architecture</u>

17. Date(s) or Period <u>ca. 1891</u>		3. Present Name(s) Jones House
		18. Style or Design <u>Richardson Romanesque 47</u>

16. Further Description of Important Features <p>This house was built in 1891 at a cost of \$3,500, it has a facade that is symmetrical in style. The alterations which cost \$5,000 in 1907 probably include the front porch, portico on the west and the sun room on the west. There is leaded and stained glass used in the transom of the windows at the first and second floor levels. The front windows on the south side of the structure are slightly bowed. At the attic level there is a palladian window (see appendix)</p>		26. Local Contact Person or Organization <u>Nancy Sandehn</u>

20. Prepared by <u>T. Carneal</u>		30. Foundation Material <u>Brick & Mortar 30</u>		
21. Organization <u>NWMSU Hist. Survey</u>		31. Wall Construction <u>Brick & Mortar LB</u>		10. Other Name(s) Eugene Westheimer House

24. Distance from and Frontage on Road <u>50' D</u>		34. Wall Treatment <u>Running Bond 30</u>		
25. Condition Interior <u>Excellent</u> Exterior <u>Excellent</u>		35. Plan Shape <u>Rectangle</u>		12. Other Name(s) Eugene Westheimer House

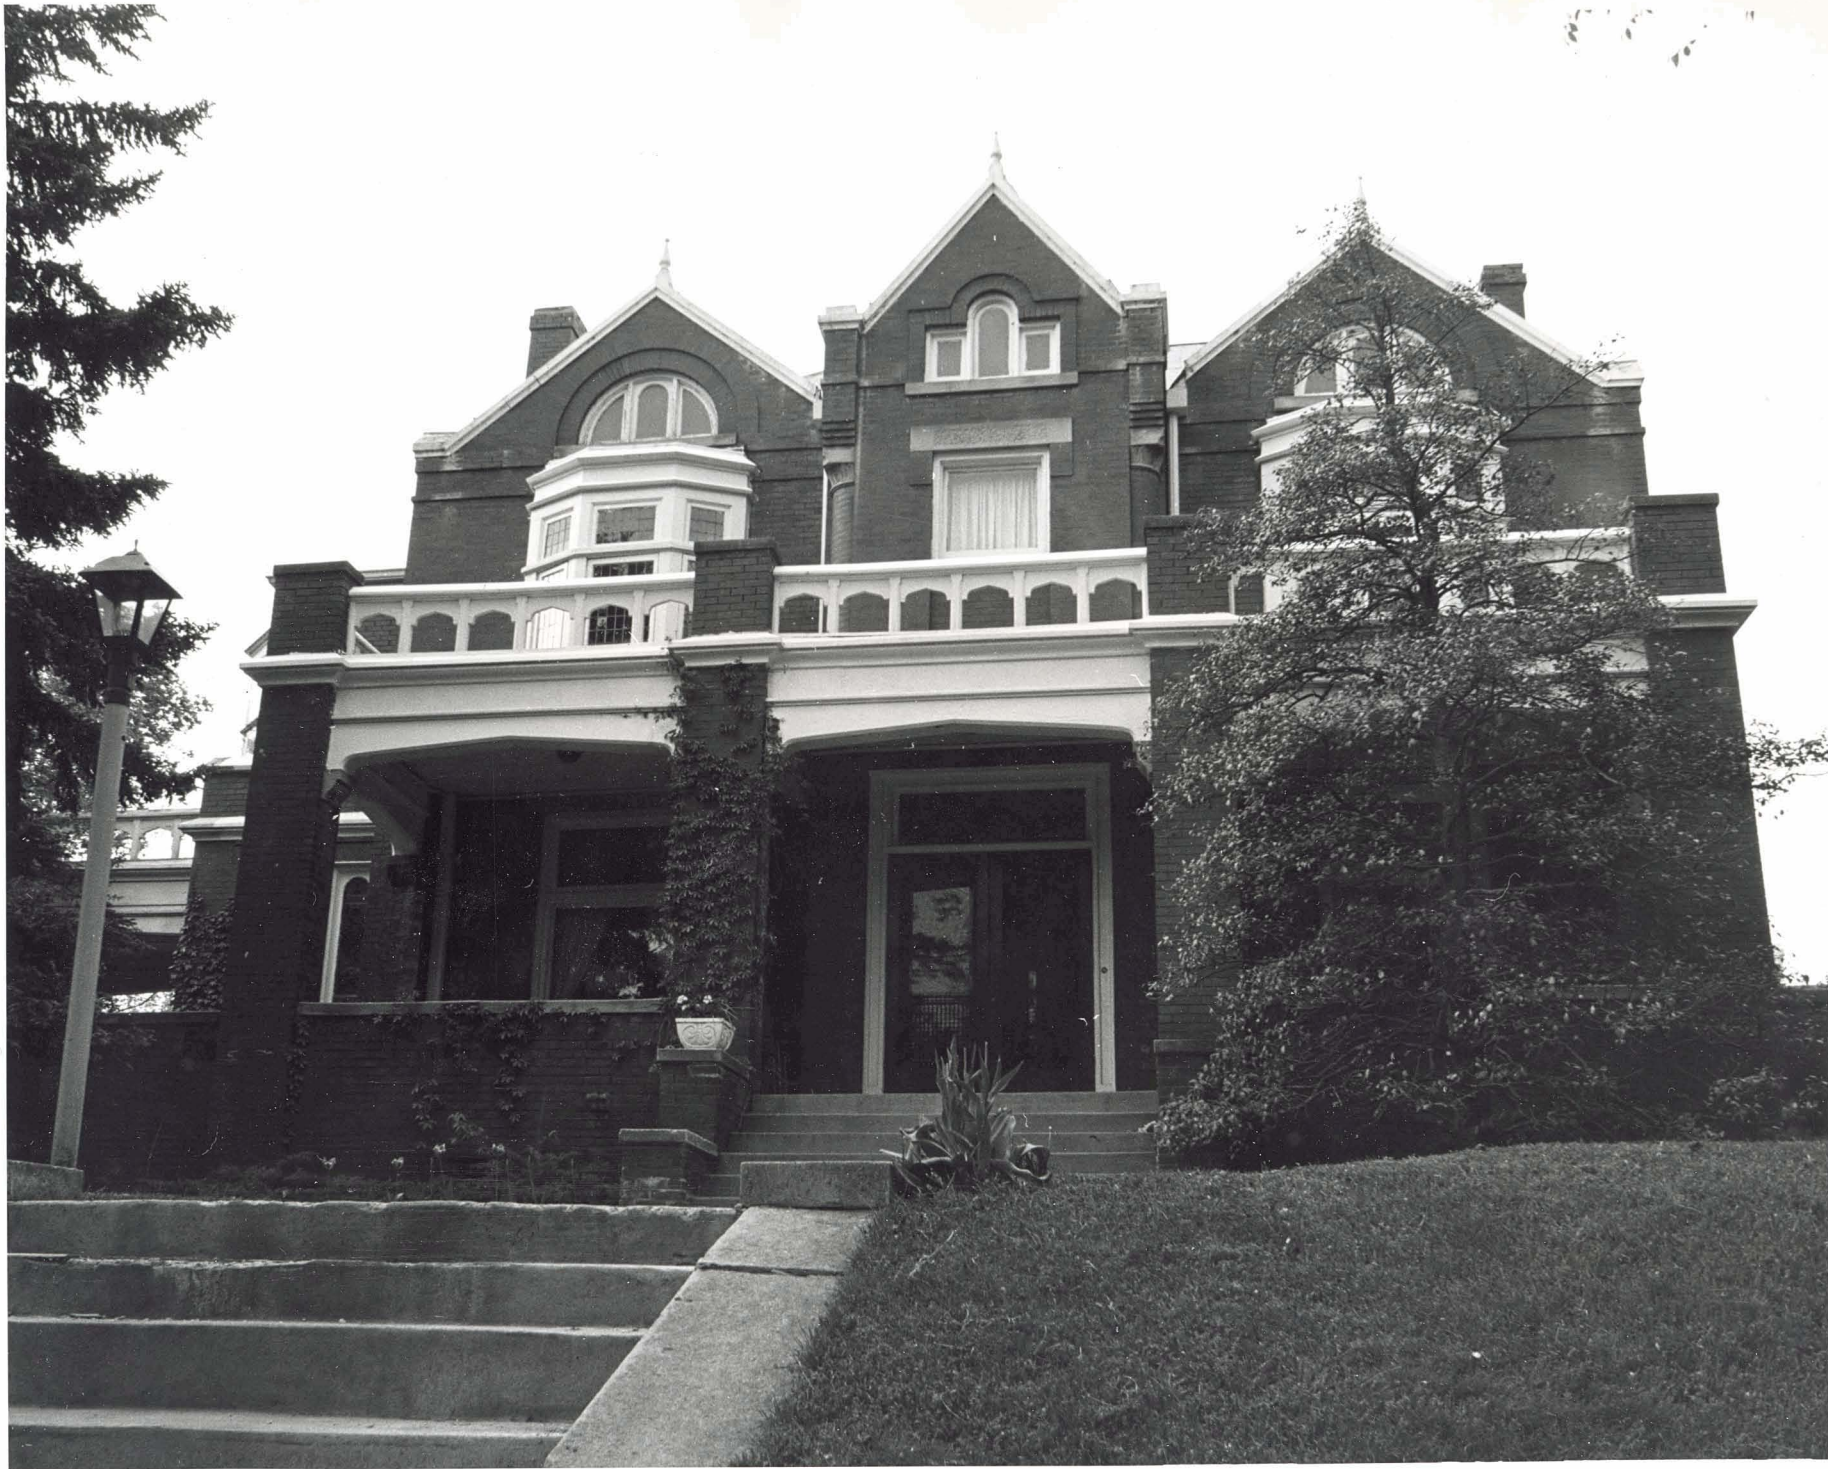
HISTORIC INVENTORY

in the middle of the house and a rounded arch window on the east and west. The side porch on the east is obviously of the original structure and has carpenter trim at the roof line. There is a basket weave pattern in the bricks at various levels of the house. The gable dormers are very large with the windows mentioned above.

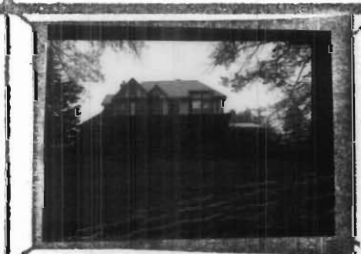
Rix-Zollinger House
2021 Faraon

6. Specific Location 2021 Faraon		16. Thematic Category Architecture		28. No. of Stories 2	
7. City or Town If Rural, Township & Vicinity St. Joseph, MO		17. Date(s) or Period 1926		29. Basement? Yes <input checked="" type="checkbox"/> No <input type="checkbox"/>

18. Style or Design English Country 53		30. Foundation Material Brick & mortar	
9. Coordinates UTM Lat. E 50' Lt 4 & 5 Long. Blk 3, Harris Add.		19. Architect or Engineer Eugene Meier		31. Wall Construction Brick & Mortar/Frame

10. Site is Building M		20. Contractor or Builder Unknown 20 30		32. Roof Type & Material Truncated hip/slate	
11. On National Register? Yes <input type="checkbox"/> No <input checked="" type="checkbox"/>		21. Original Use, if apparent Residence DIA		33. No. of Bays Front 5 Side 4

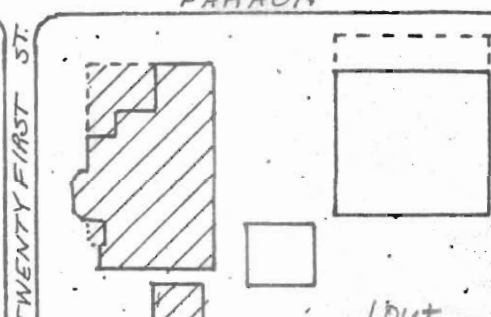
6. Specific Location 2102 Faraon		16. Thematic Category Architecture		
7. City or Town If Rural, Township & Vicinity St. Joseph, MO		17. Date(s) or Period 1896		4. Present Name(s) Bethel House

8. Site Plan with North Arrow FARAON		18. Style or Design Queen Anne 45

29. Basement? Yes X No //		
		30. Foundation Material Brick & mortar		
		31. Wall Construction Frame WK		
		32. Roof Type & Material CB 69 TW Gable/asbestos shingle

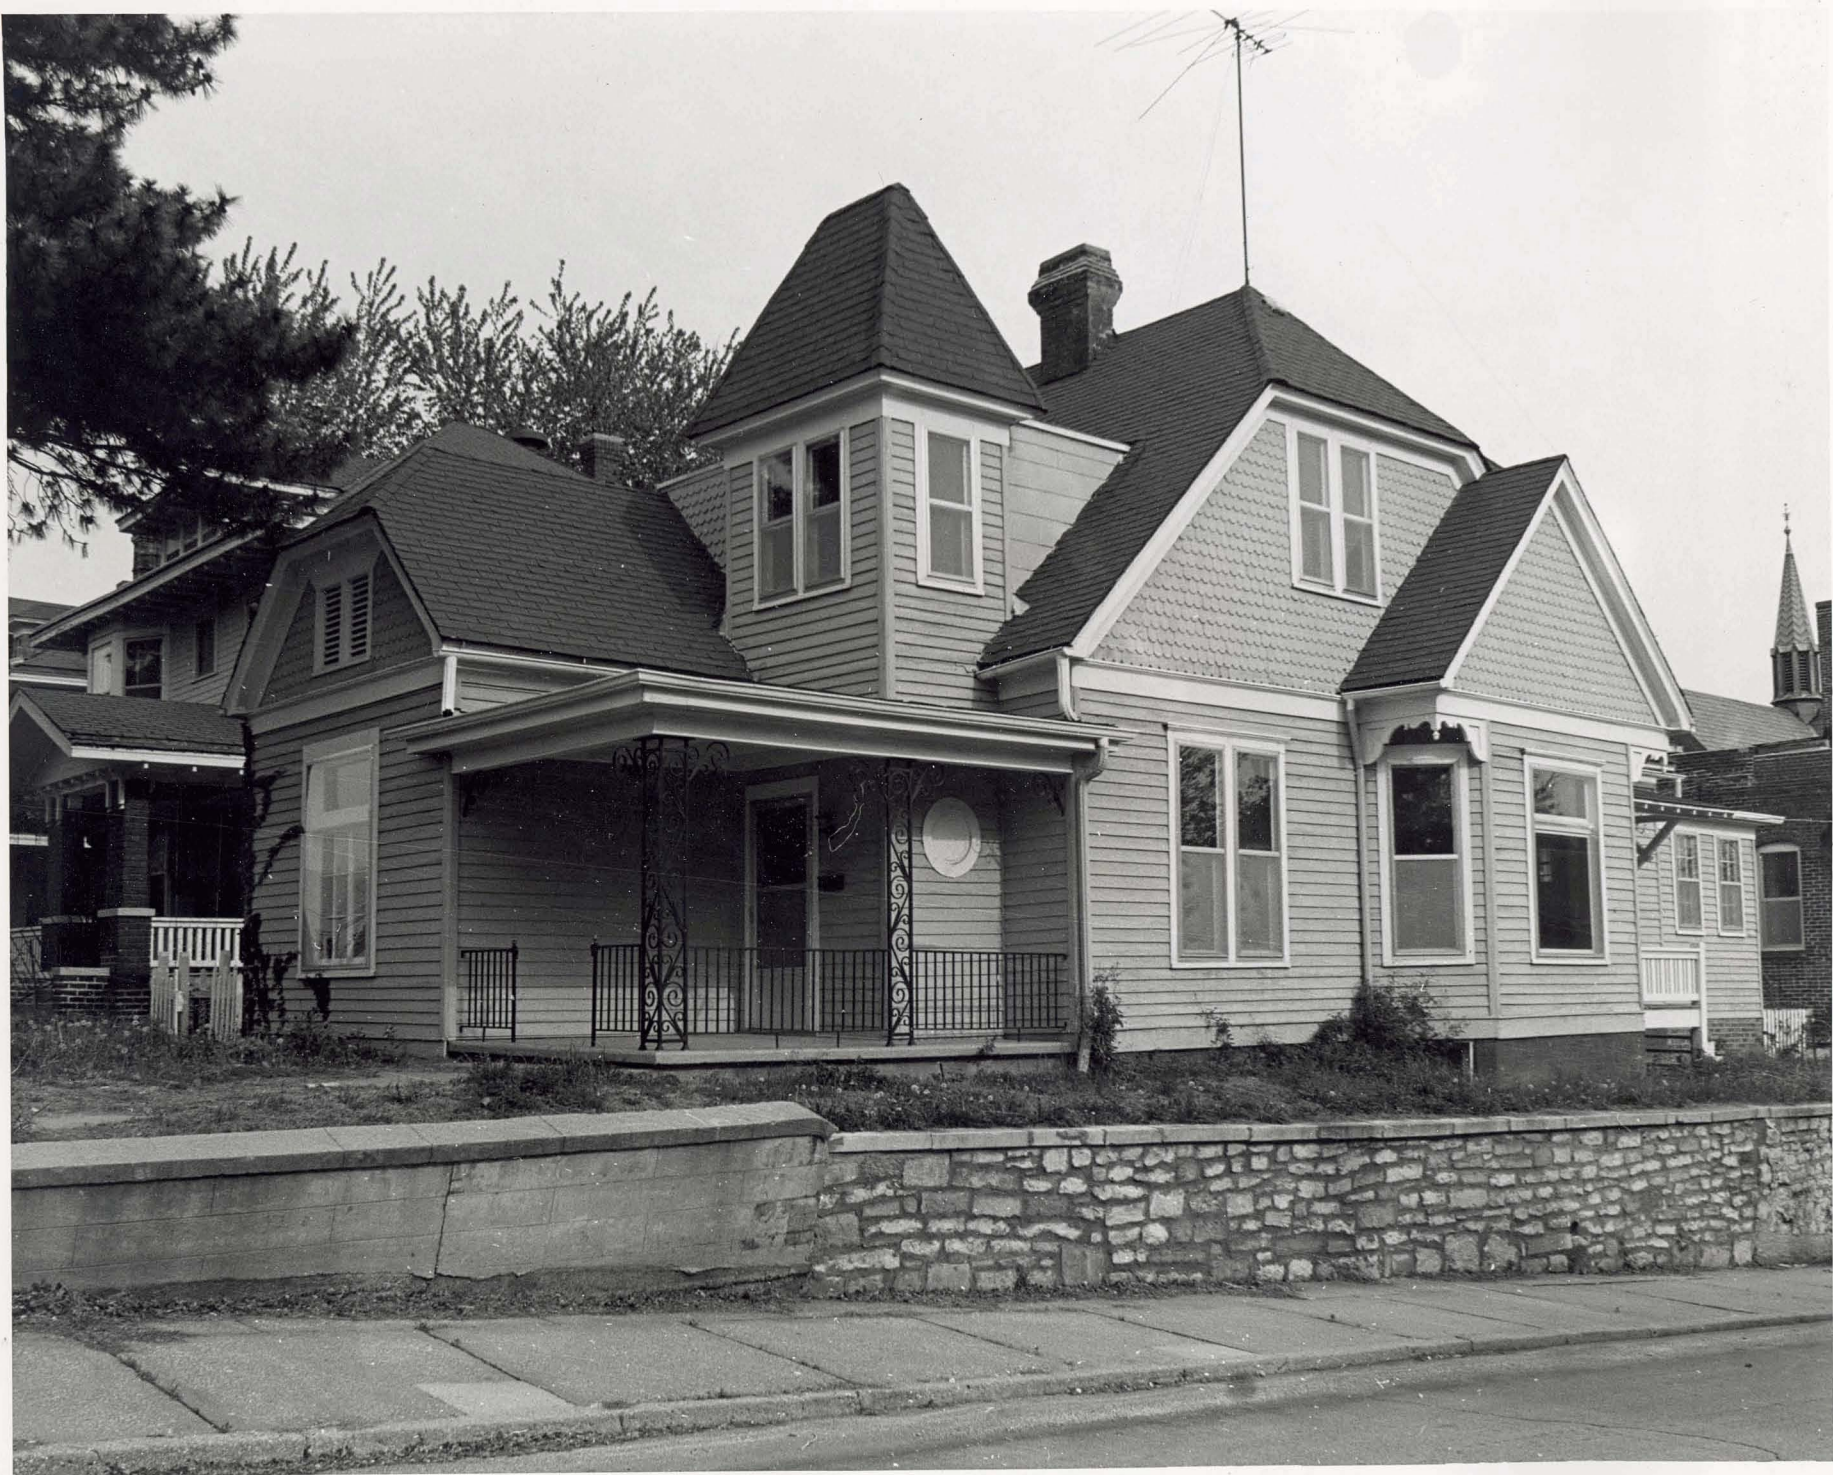
HISTORIC INVENTORY

There is a garage on the south side of the house and a cement and coursed stone wall on the west property line. This wall became eight feet high on the south west corner of the property and the street makes a decline in this area.

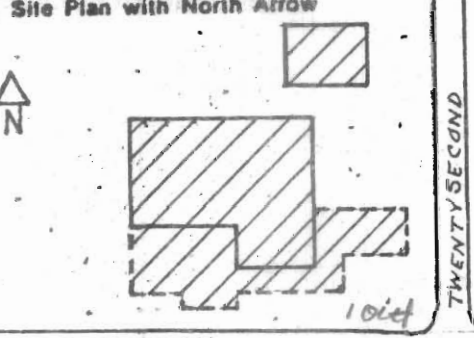
1. No. 52		4. Present Name(s) Porter House		1. No. 52
2. County Buchanan		5. Other Name(s) C.B. Sanders Residence		
3. Location of Negatives Carneal's Office		6. Specific Location 2117 Faraon		2. County Buchanan

7. City or Town If Rural, Township & Vicinity St. Joseph, MO		16. Thematic Category Architecture		
8. Site Plan with North Arrow		17. Date(s) or Period 1888		3. Present Name(s) Porter House

18. Style or Design Richardson Romanesque 40

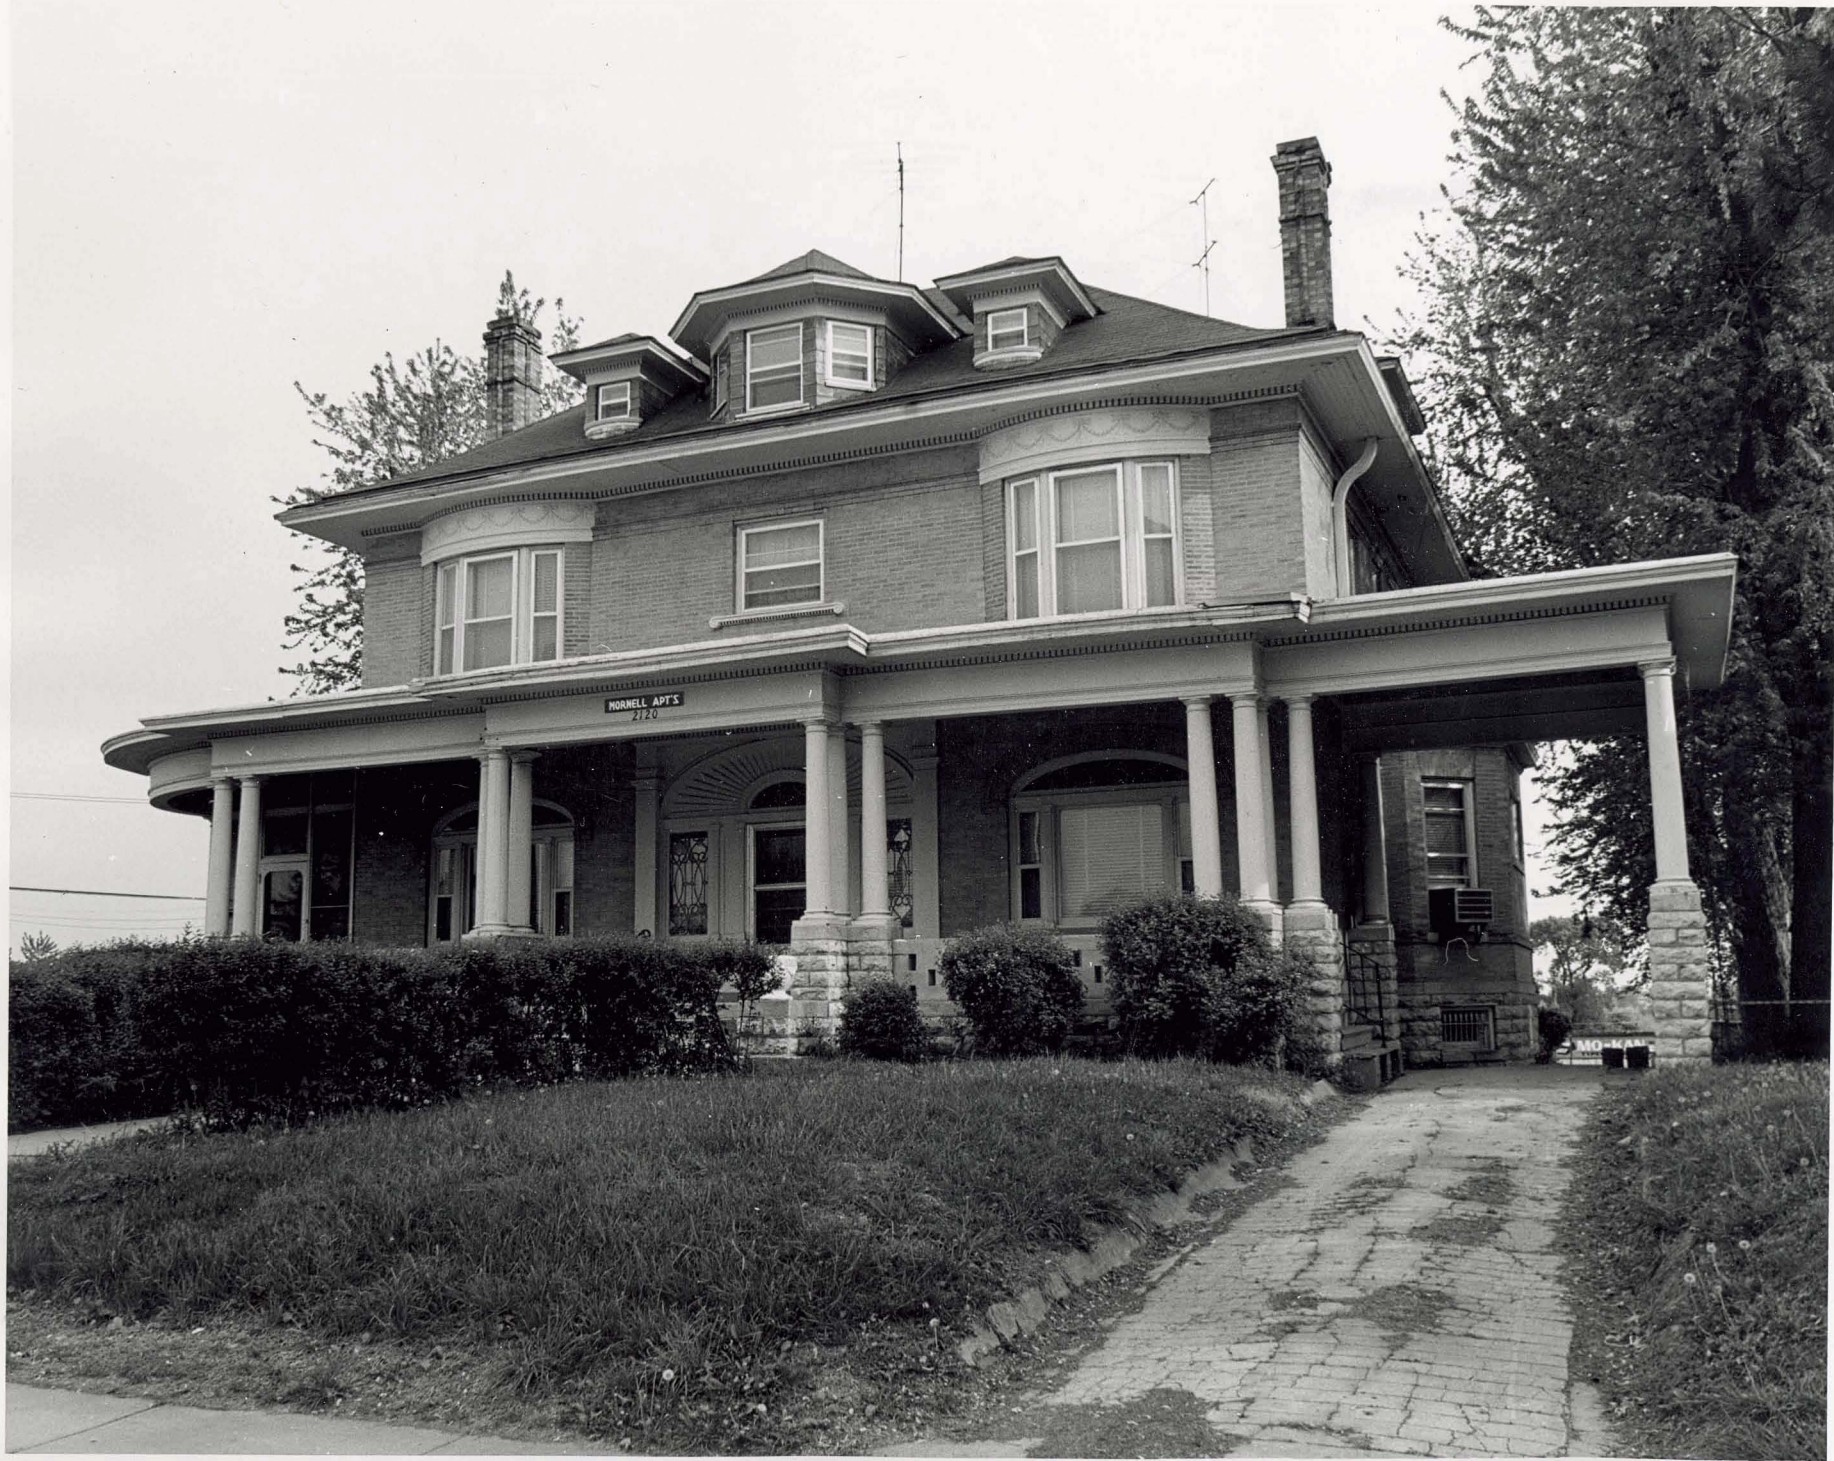
The porch encircles the house on the north and east sides. There is a porte-cochere attached on the west side of the porch. The eave is accentuated with dentils at the boxed cornice. The Tuscan columns set on limestone bases.

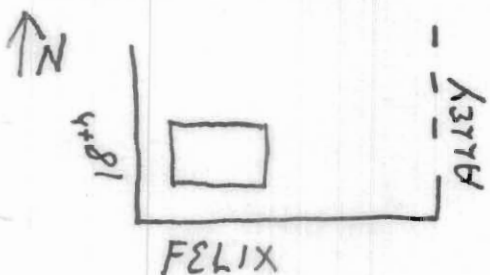
30. Foundation Material Brick	
		31. Wall Construction Brick	
		32. Roof Type & Material Flat/built-up	
		33. No. of Bays Front na Side 4	
		34. Wall Treatment Running bond

35. Plan Shape	
		36. Changes (Explain in #42) Addition <input type="checkbox"/> Altered <input type="checkbox"/> Moved <input type="checkbox"/>	
		37. Condition Interior Poor Exterior Poor

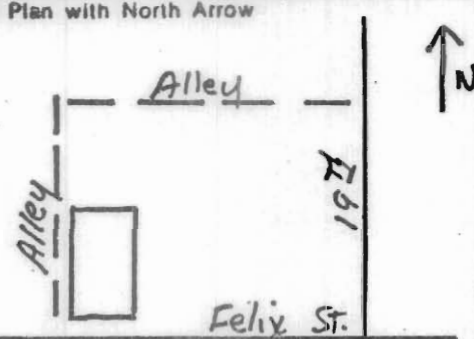
9. Other Name(s)	
44. Description of Environment and Outbuildings This house is adjacent to and to the rear of the Farr duplex and faces the same problem of deterioration of property to the south and in addition is adjacent to the semi-abandoned city fire station. Once again it is representative of the (see appendix)

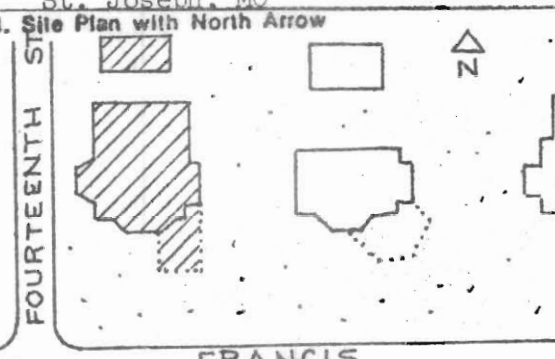
19. Architect or Engineer Unknown		31. Wall Construction Brick & Mortar	
		20. Contractor or Builder Hamilton		32. Roof Type & Material Asbestos shingle Low Truncated Hip

21. Original Use, if apparent Residence		33. No. of Bays Front 5 Side irreg	
		22. Present Use Residence		34. Wall Treatment running bond brick	
		23. Ownership Public <input type="checkbox"/> Private <input checked="" type="checkbox"/>		35. Plan Shape asymmetrical

9. Coordinates UTM Lat. W 1/2 of the W 1/2 of Blk 9 Long. Carter's Add.		25. Open to Public? Yes <input type="checkbox"/> No <input checked="" type="checkbox"/>		37. Condition Interior good Exterior good

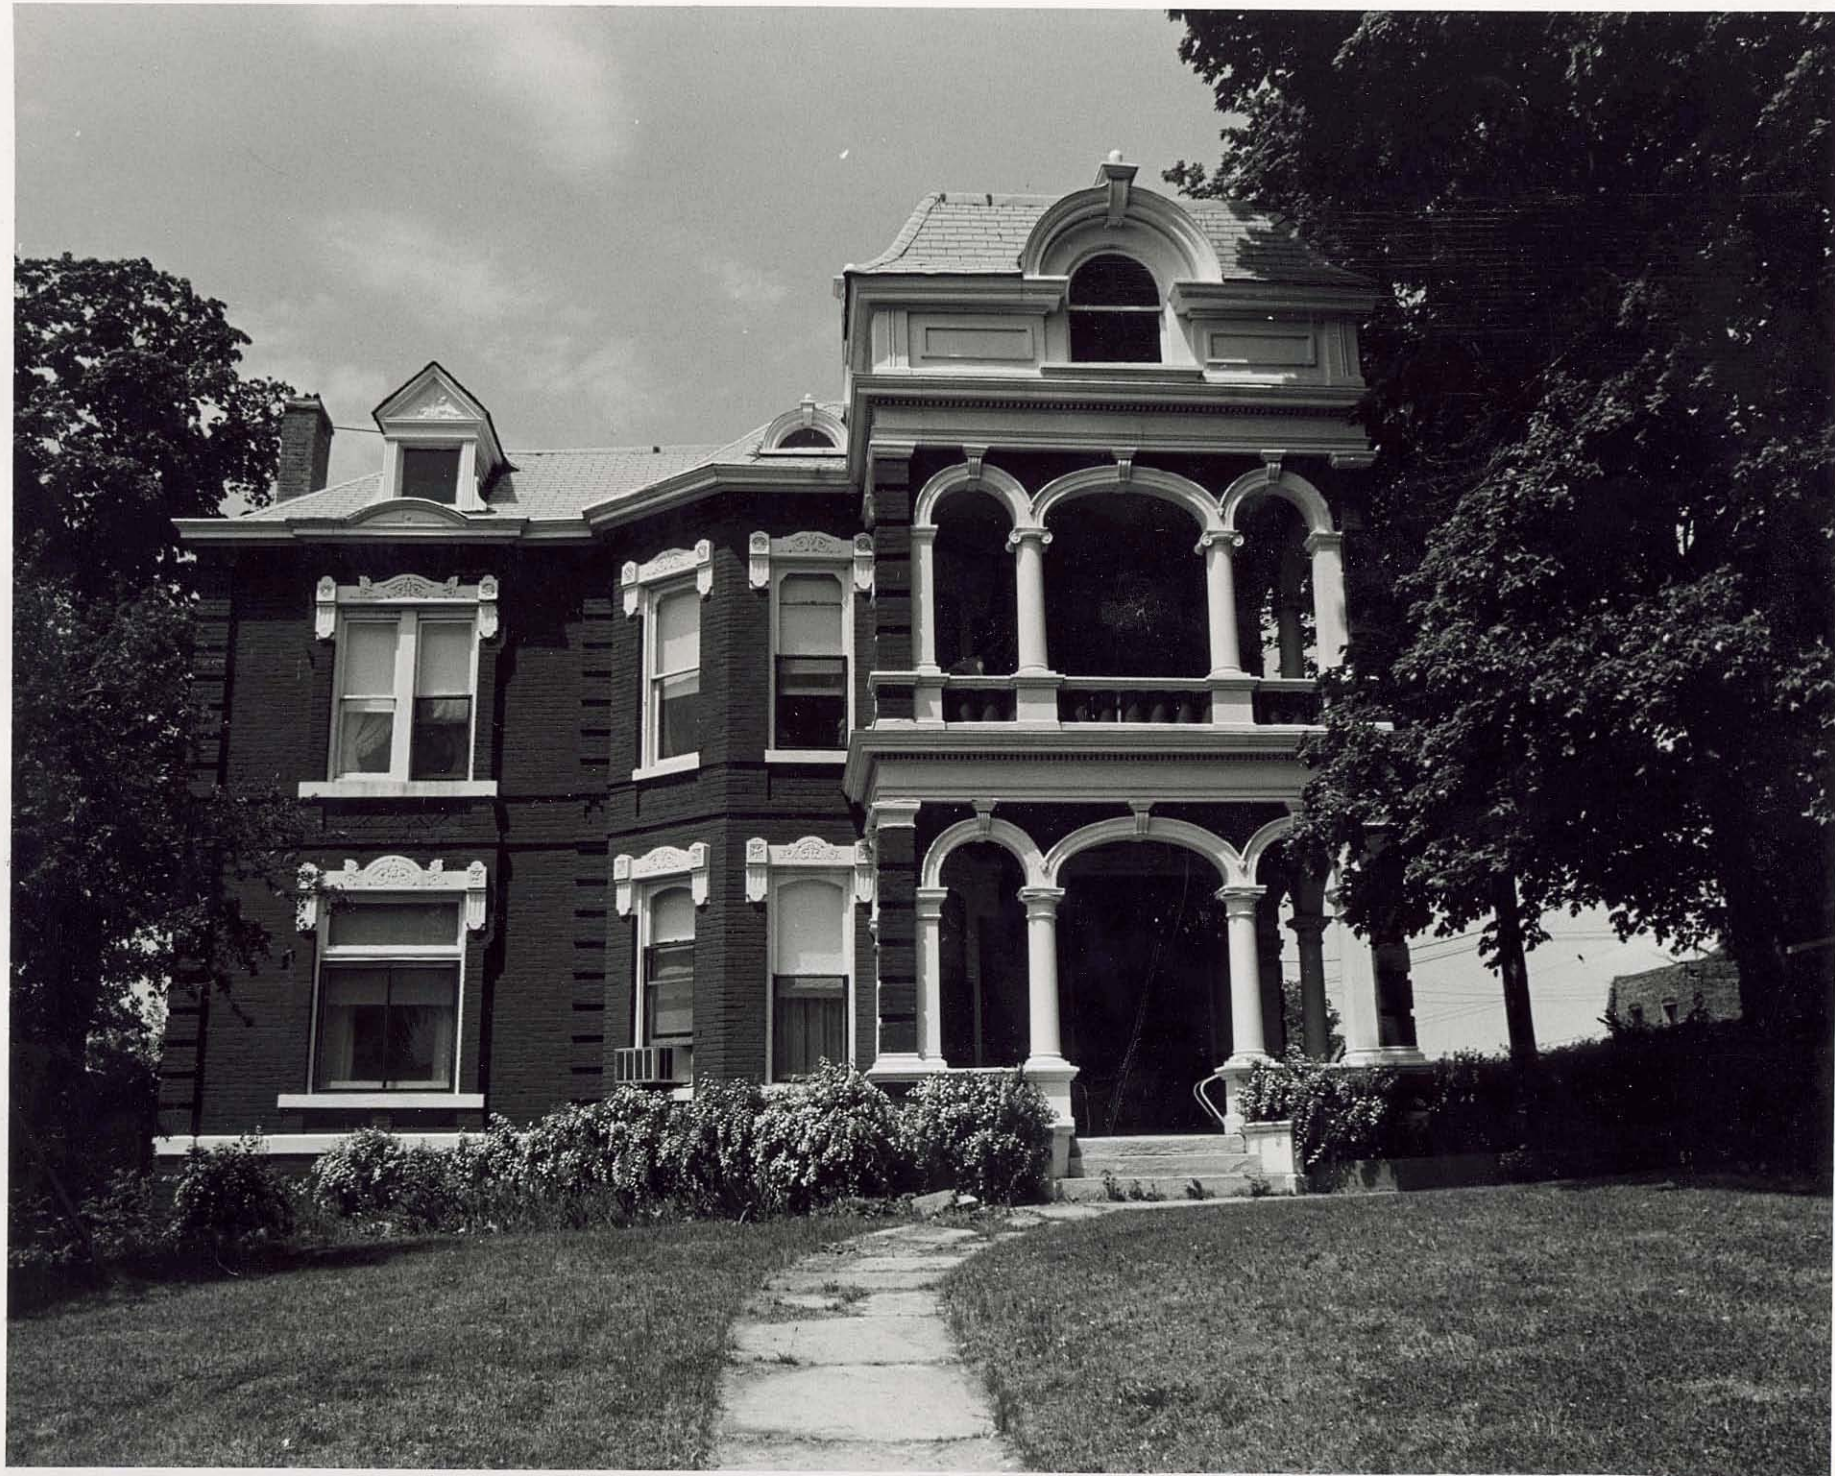
HISTORIC INVENTORY

There is a gable dormer with a pediment, an eyebrow dormer and Victorian round dormer in the porch roof. The porch was added in 1906 at a cost of \$500. The porch corners are brick quoins and the semi-circular arches have a decorative bracket in the center of the arch. The balustrades are circular bricks with mortar. The columns are tapered Tuscan which set on stone bases.

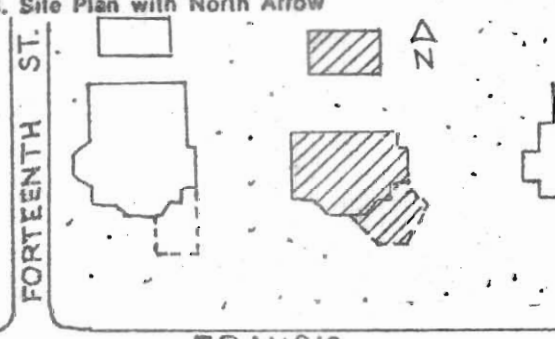
43. History and Significance This house was built by the Hamilton family, an early entrepreneur in the city.				
44. Description of Environment and Outbuildings This house was identical to the structure at 1311 Francis at the time of its construction. There is a rusticated ashlar wall on the south side of the property. This is five feet in height and is topped by an iron fence.

west side of the protruding bay window which projects from the southeast corner of the house. This dormer appears to be an alteration. The porch was added in 1905 by owner Isabelle Bates. The deep fascia of the porch is supported on Tuscan columns. There is an additional brick building at the rear of the property, probably a carriage house converted to a garage and storage shed.

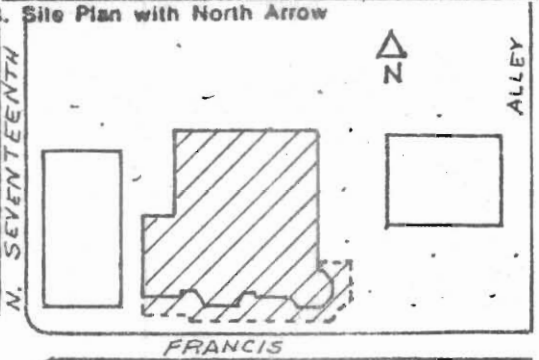
28. No. of Stories 2		29. Basement? Yes <input checked="" type="checkbox"/> No <input type="checkbox"/>		
30. Foundation Material Brick & Mortar 30		31. Wall Construction Brick & Mortar LB

32. Roof Type & Material HP 64 Hip/asbestos shingle		33. No. of Bays Irreg. Side		
34. Wall Treatment Running Bond 30		35. Plan Shape Asymmetrical		
36. Changes (Explain in #42) Addition <input type="checkbox"/> Altered <input checked="" type="checkbox"/> Moved <input type="checkbox"/>		37. Condition Interior Good Exterior Good

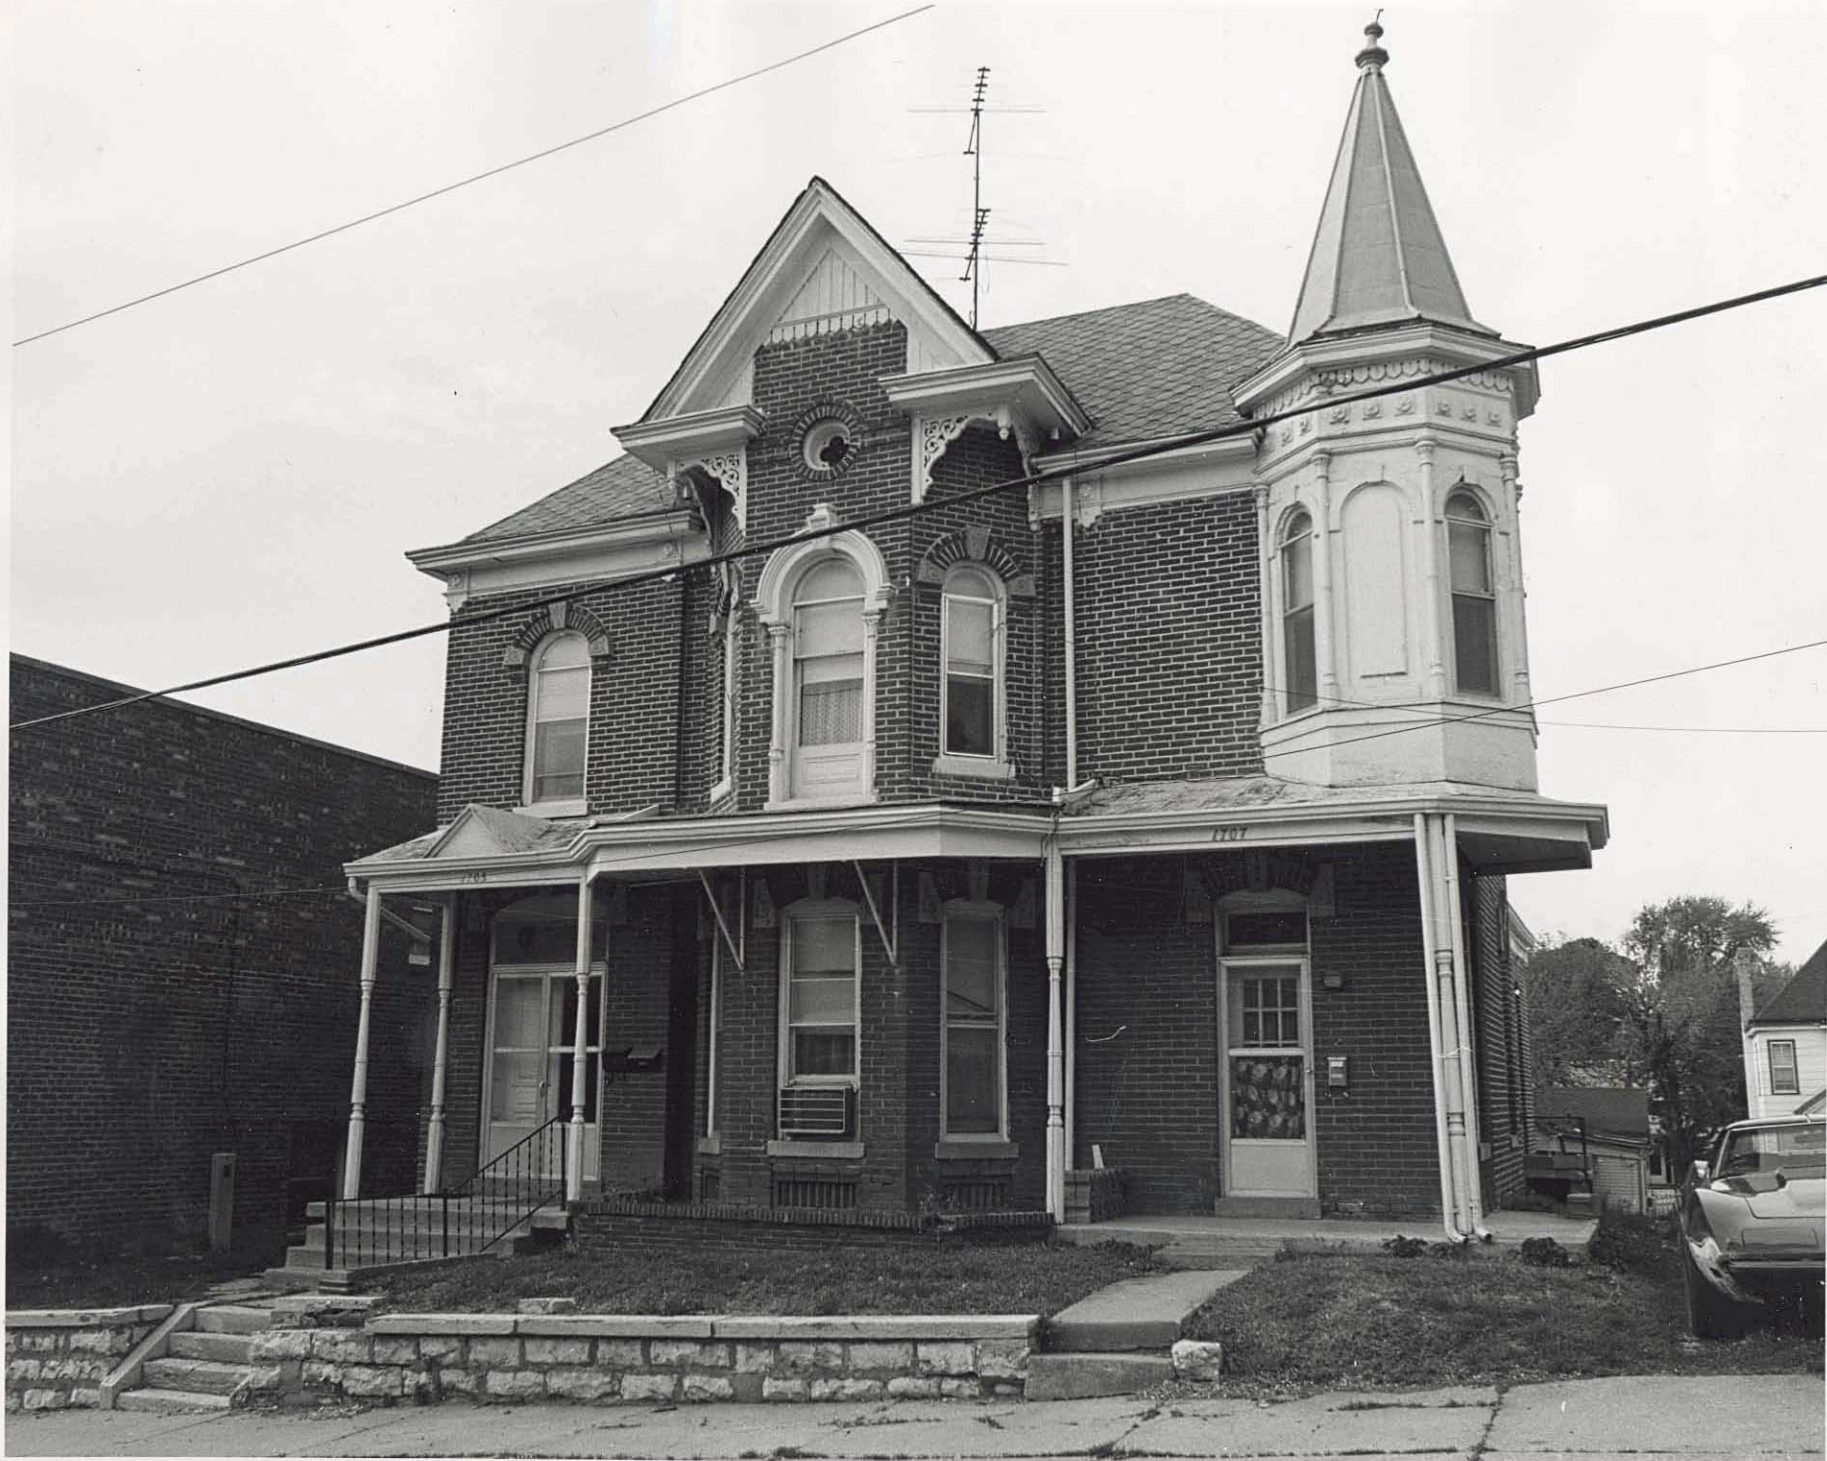
HISTORIC INVENTORY

The windows in the bay, in the tower and on the west wall on the front facade are topped with brick and stone straight sided arches with decorative keystones. The center window in the bay has Tuscan columns at either side which appear to hold the hood mold. There is a round window opening at the third level of the bay which has a cross shaped window recessed in the opening.
