ST. JOSEPH, MISSOURI

SURVEY BLOCK #1

FALL, 1978

NWMSU Historical Survey
Thomas Carneal, Director

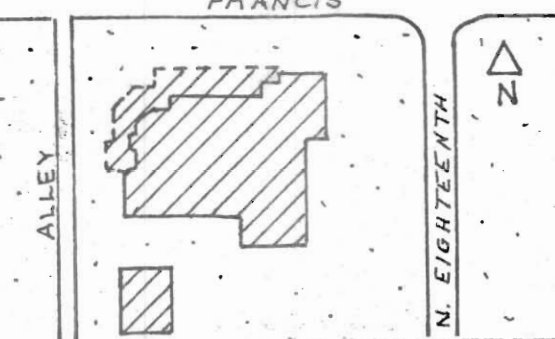
43. History and Significance This house would be a key in preserving the wide variety of architectural styles found in the Harris tract. This landmark calibre house was built for Henry E. Barnard, an attorney.		30. Foundation Material Brick 30

37. Condition Interior Excellent Exterior Excellent	
		38. Preservation Underway? Yes <input checked="" type="checkbox"/> No <input type="checkbox"/>

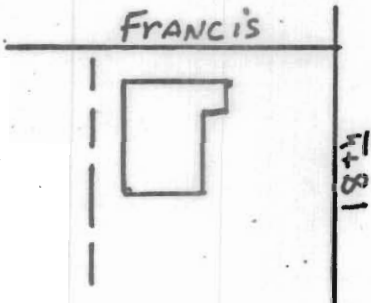
42. Further Description of Important Features An assymetric plan and elevations with tower, make this house prominent in the neighborhood. The deep cornice is supported visually by paired brackets. The ornate paired porch columns have brackets. The segmentally arched wall openings with carved straight sided stone hoodmolds have prominent keystones. A second color is used to accent the decorative millwork.		28. No. of Stories 2 29. Basement? Yes <input checked="" type="checkbox"/> No <input type="checkbox"/> 30. Foundation Material Brick 31. Wall Construction Brick 32. Roof Type & Material Cross gable/ slate 33. No. of Bays Front 4 Side 6 34. Wall Treatment Running bond 35. Plan Shape rectangular 36. Changes (Explain in #42) Addition <input type="checkbox"/> Altered <input type="checkbox"/> Moved <input type="checkbox"/> 37. Condition Interior Excellent Exterior Excellent 38. Preservation Underway? Yes <input checked="" type="checkbox"/> No <input type="checkbox"/> 39. Endangered? By What? Yes <input type="checkbox"/> No <input checked="" type="checkbox"/> 40. Visible from Public Road? Yes <input checked="" type="checkbox"/> No <input type="checkbox"/> 41. Distance from and Frontage on Road 120' corner city lot

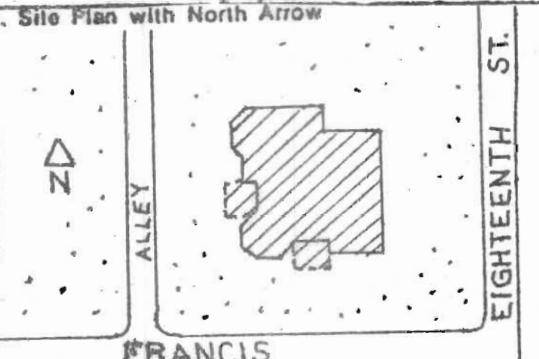
11. On National Register? Yes <input type="checkbox"/> No <input checked="" type="checkbox"/>		27. Other Surveys in Which Included		
12. Is it Eligible? Yes <input checked="" type="checkbox"/> No <input type="checkbox"/>		30. Foundation Material Brick & Mortar		31. Wall Construction Brick & Mortar LB

36. Condition Interior good Exterior good		37. Preservation Underway? Yes <input checked="" type="checkbox"/> No <input type="checkbox"/>
		37. Endangered? By What? Yes <input type="checkbox"/> No <input checked="" type="checkbox"/>

The double dormer in the attic is embellished with brackets at wide eaves. There is a balcony like treatment of the dormer. A belcast hip roof is above the wide eaves. There is a two story bay on the West with rusticated brick at the corners at every other course. There is a four course water table at the base of the first floor. On the second story there are four decorative belt courses of brick raised from the wall surface. There is also a raised belt course of brick immediately below the entablature on the second story which runs around the whole of the building. Raised brick also surrounds the bulls' eye window.

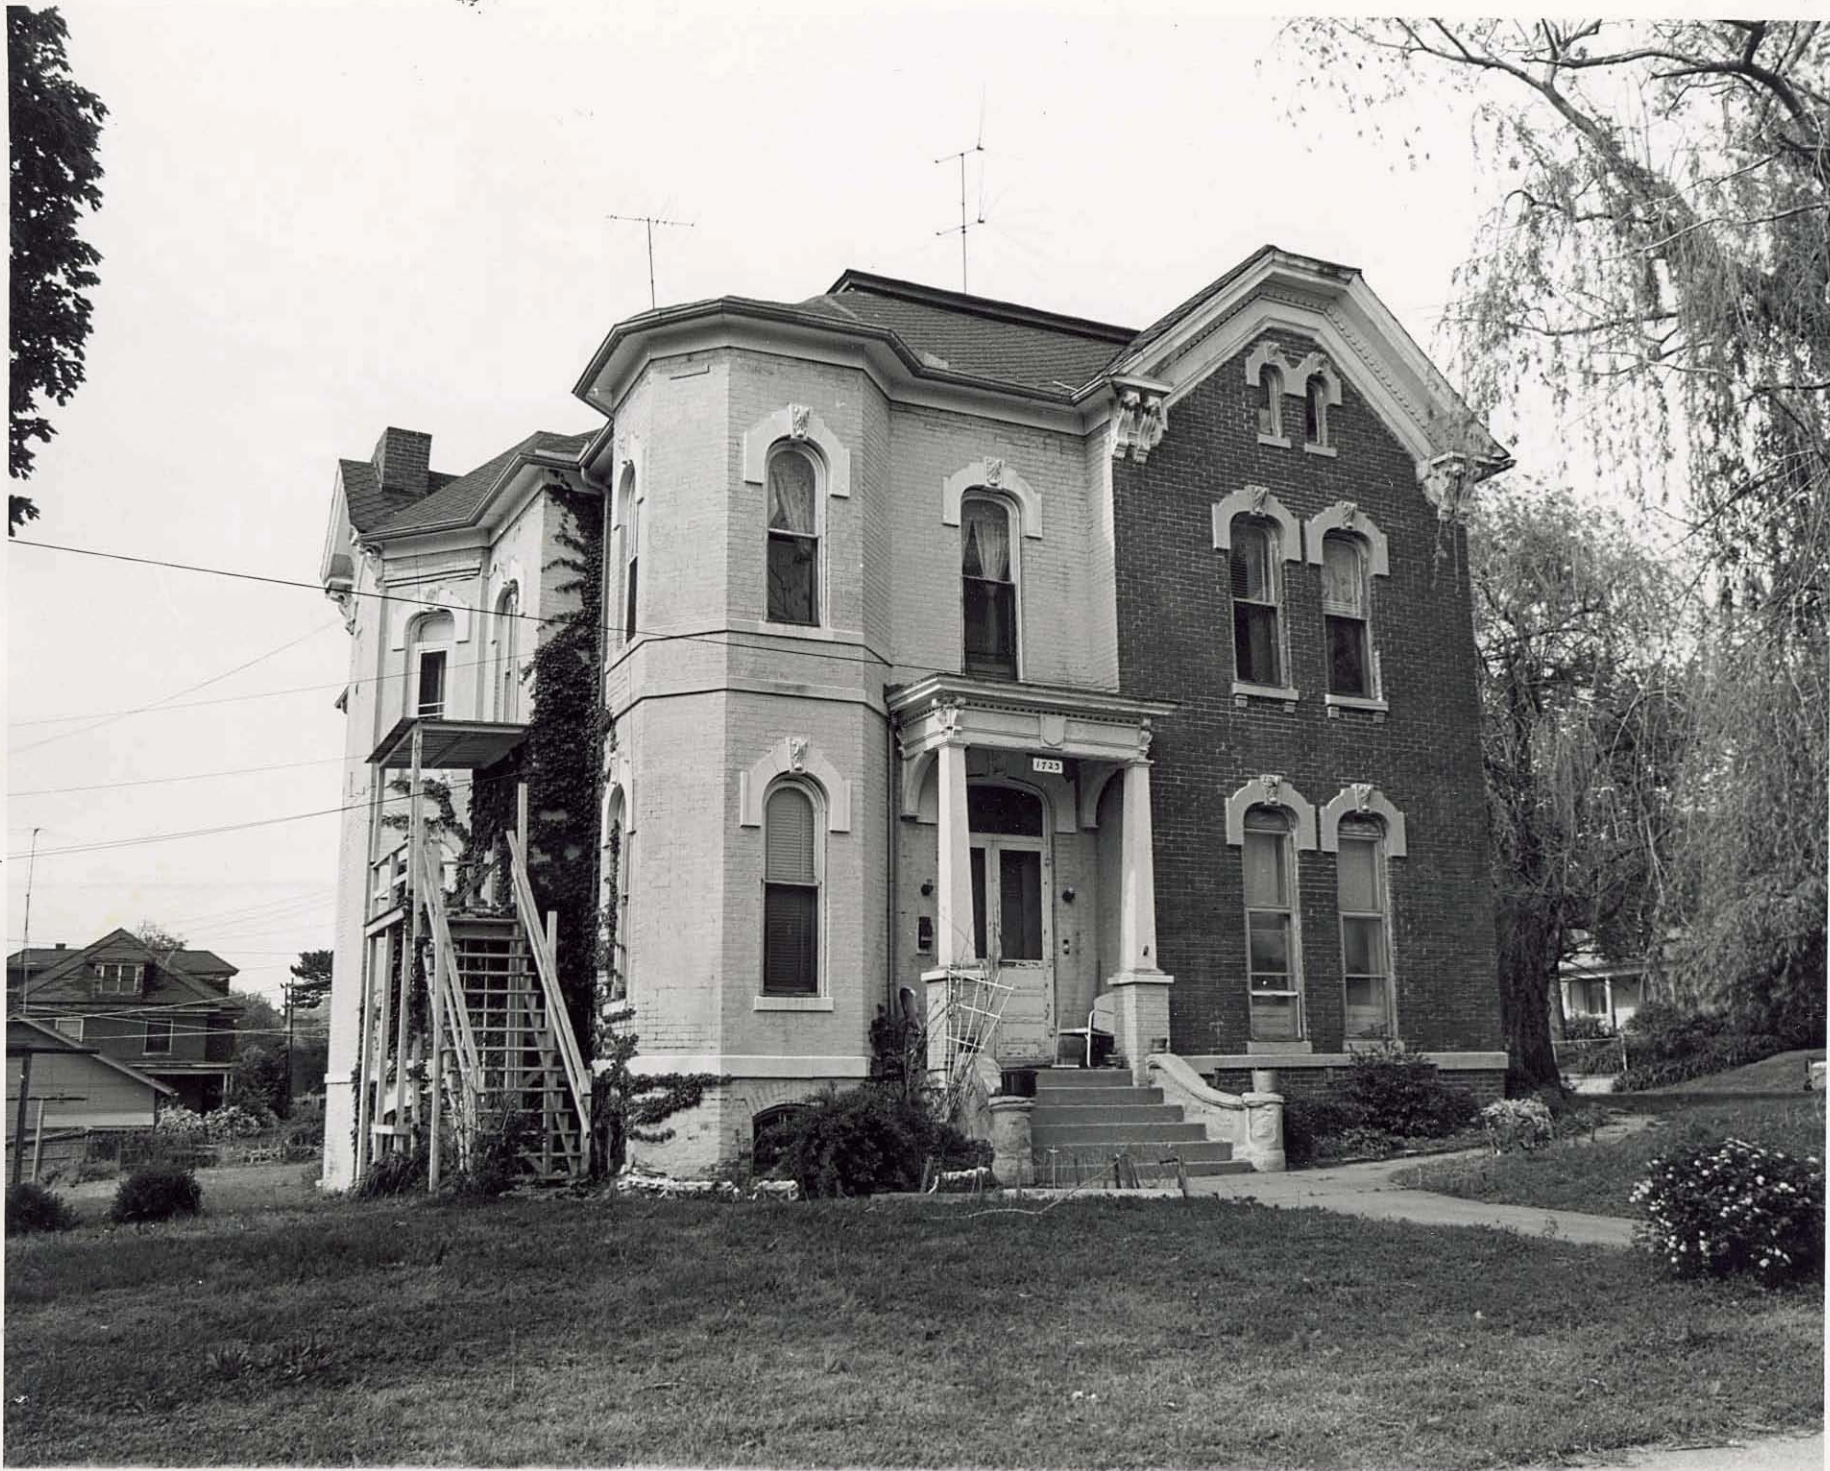
HISTORIC INVENTORY

The home has been remodeled into apartments. There is an addition of an outside stairway on the west side of the house.

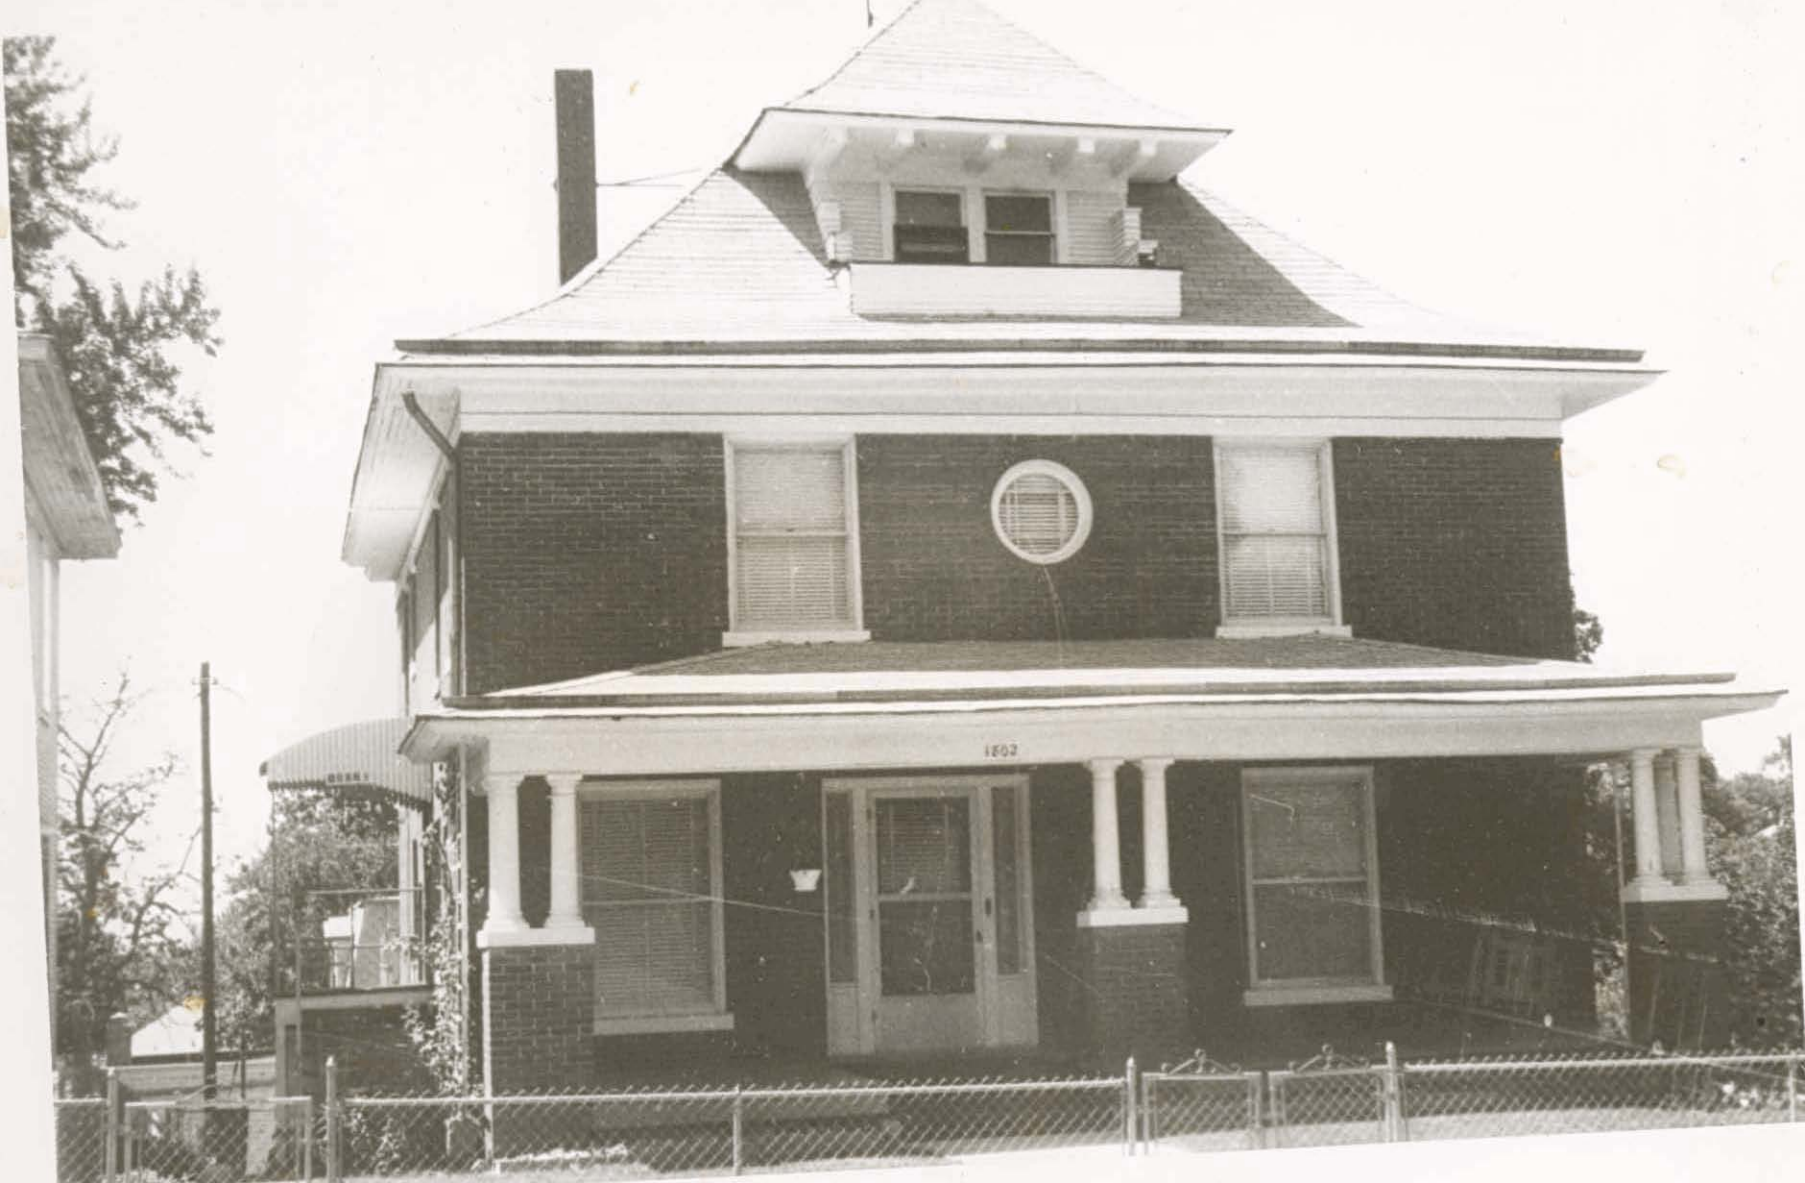
HISTORIC INVENTORY

There is a concrete attached garage at the Southwest corner of the house. The roof of the garage forms a back porch floor surface for the first story.

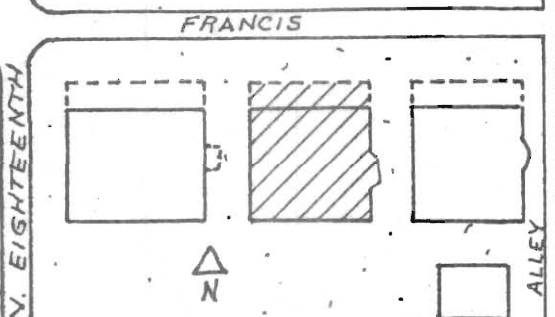
29. Basement? Yes <input checked="" type="checkbox"/> No <input type="checkbox"/>		
		30. Foundation Material Brick 30		
		31. Wall Construction Frame wu		8. Other Name(s)

36. Changes (Explain in #42) Addition <input type="checkbox"/> Altered <input checked="" type="checkbox"/> Moved <input type="checkbox"/>		
		37. Condition Interior Good Exterior Good		10. Other Name(s)

Box style, with an attic story double dormer, a second story double bay window at slight angles and the first story large rectangular windows with lead glass upper panes. A prominent wide front porch characteristic of this style and common to the neighborhood, has a wide entablature, originally supported by columns on a brick base. The columns have been replaced by wrought iron. Classical detailing includes the use of wide entablatures with dentils used throughout the house.

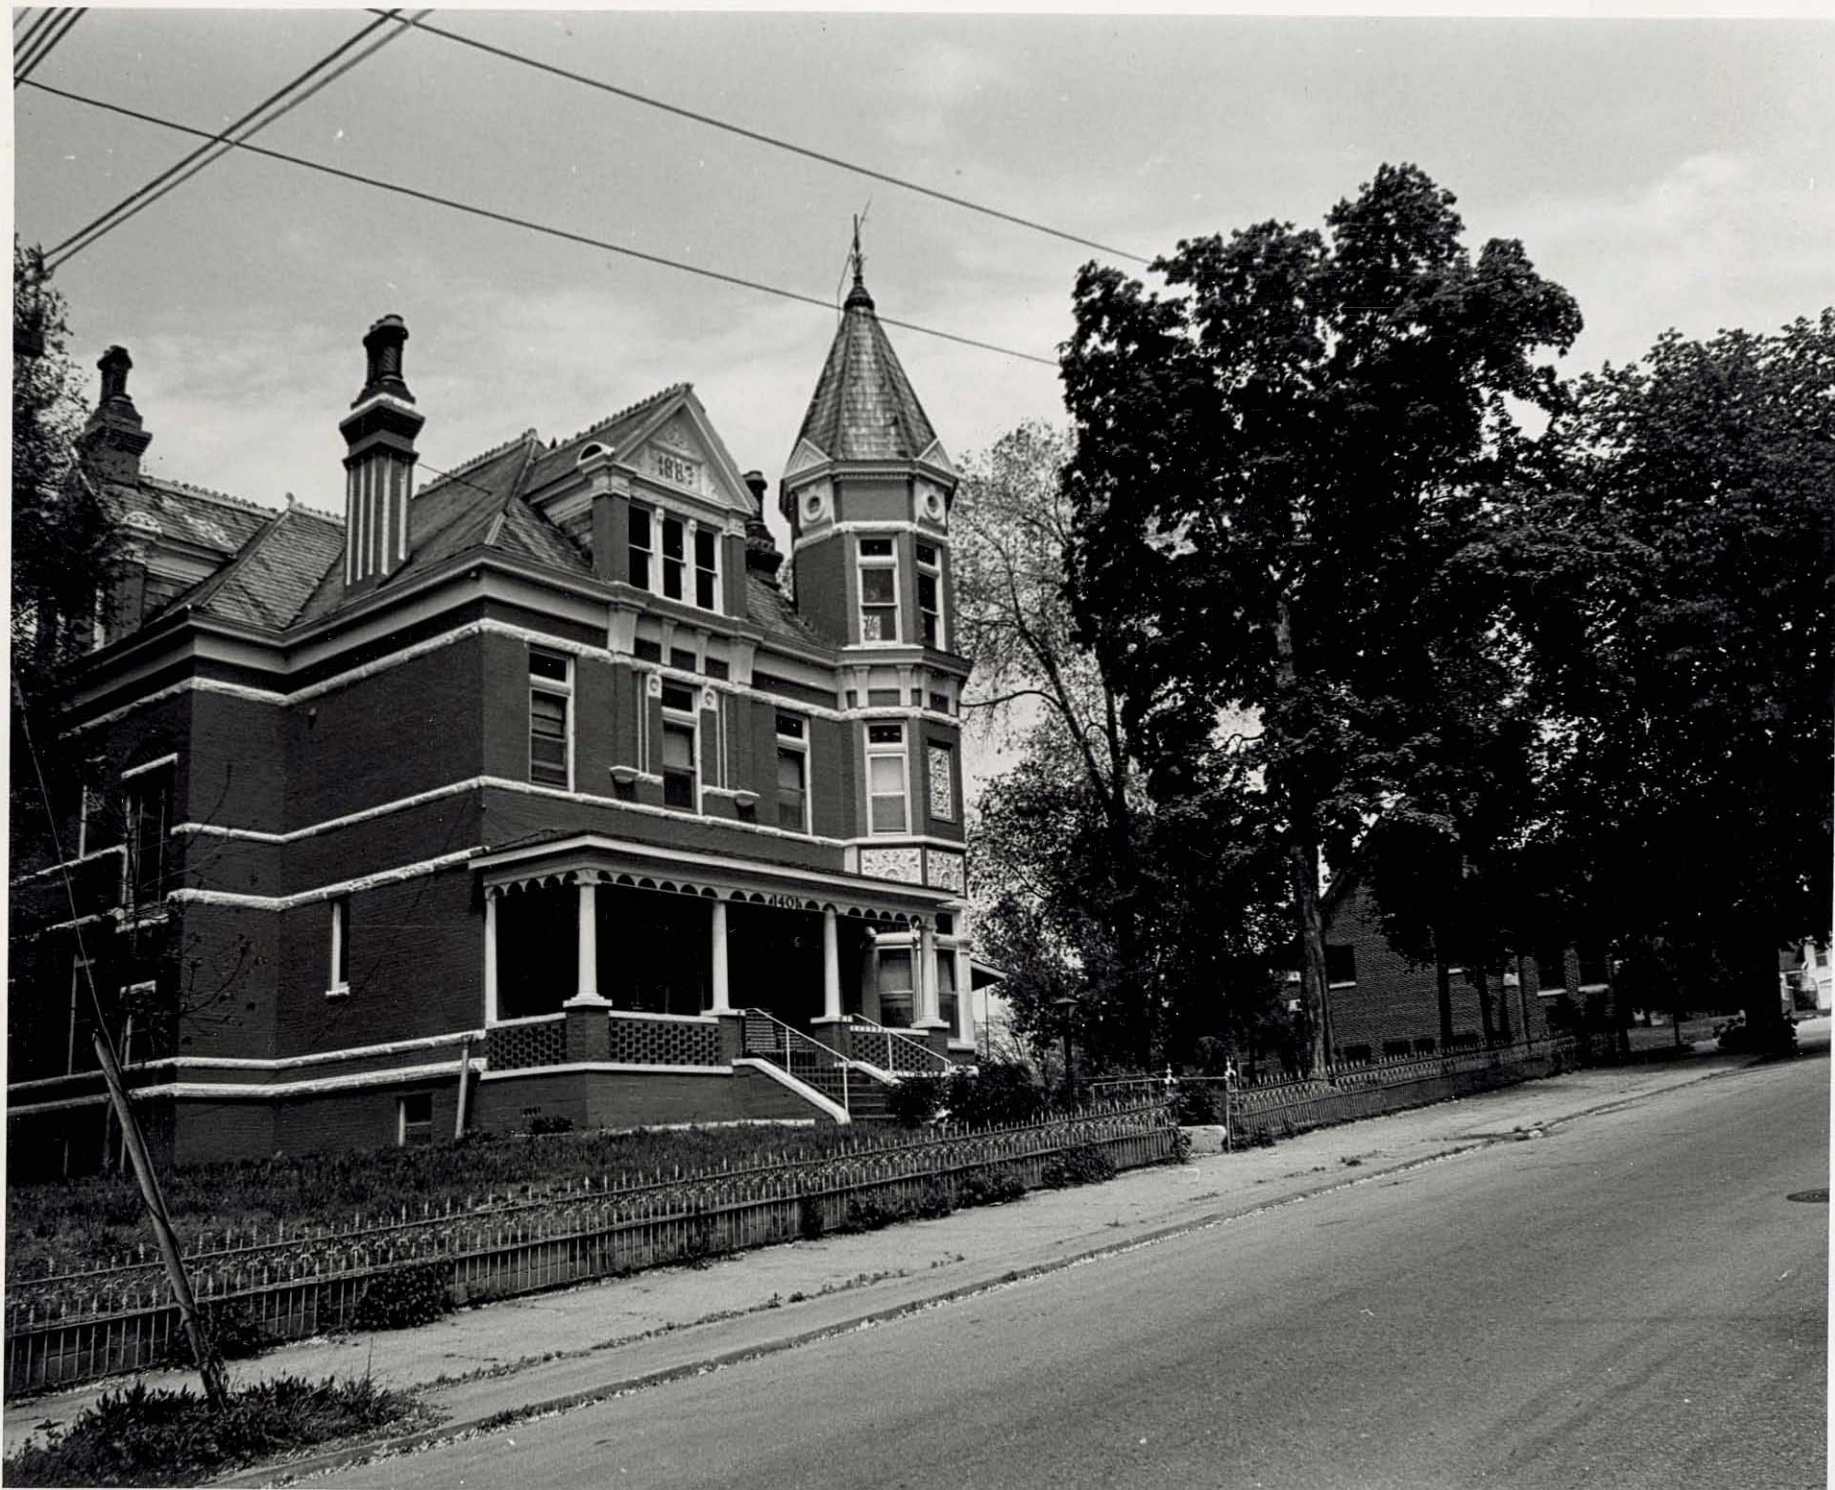
HISTORIC INVENTORY

The windows are double-hung with stained glass transoms over them. There is a large stained glass window in the stairway on the west side of the house.

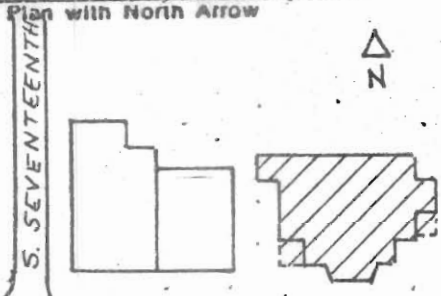
18. Style or Design Vernacular	30. Foundation Material Brick	
	19. Architect or Engineer Unknown	31. Wall Construction Brick & Mortar

20. Contractor or Builder Fred Heckel	32. Roof Type & Material Flat hip/asbestos shingle	
	21. Original Use, if apparent Duplex	33. No. of Bays Irregular Front Side

44. Description of Environment and Outbuildings There is a large yard on the east side of this house with a wood picket and wire fence enclosing the area. There are no other intrusions on the property.

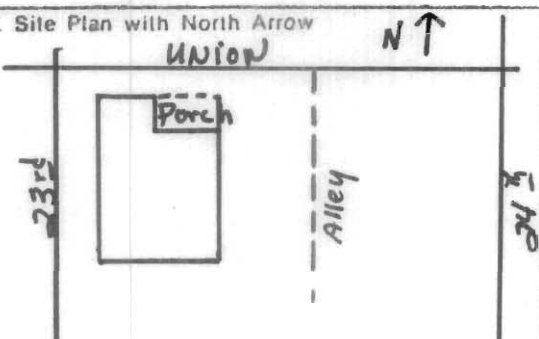
8. Site Plan with North Arrow

6. Specific Location Lots 33-36 Blk 14 2302 Union Eastern Extension		16. Thematic Category Architecture		3. Present Name(s) Mildred Hopkins	
7. City or Town If Rural, Township & Vicinity St. Joseph		17. Date(s) or Period

37. Condition Interior good Exterior good			
		38. Preservation Underway? Yes <input type="checkbox"/> No <input checked="" type="checkbox"/>			
		39. Endangered? By What? Yes <input type="checkbox"/> No <input checked="" type="checkbox"/>

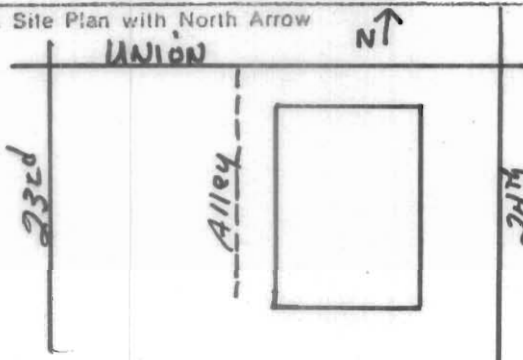
17. Date(s) or Period	
7. City or Town If Rural, Township & Vicinity St. Joseph		18. Style or Design Queen Anne	
8. Site Plan with North Arrow

1. No. F04-35		4. Present Name(s) Bruce D. Clouse	
2. County Buchanan		5. Other Name(s)	
3. Location of Negatives Community Development			
6. Specific Location Lots 33-36 Blk 14 2312 & 2310 Union Eastern Extension		16. Thematic Category Architecture

36. Changes (Explain in #42) Addition <input type="checkbox"/> Altered <input type="checkbox"/> Moved <input type="checkbox"/>	
		37. Condition Interior fair Exterior poor

42. Further Description of Important Features This apartment house has stained glass transom's over the windows on the first floor. The North side of the property is lined with a rusticated stone wall.
