UNITED STATES DEPARTMENT OF THE INTERIOR  
NATIONAL PARK SERVICENATIONAL REGISTER OF HISTORIC PLACES  
INVENTORY -- NOMINATION FORM

Westminster Congregational Church

3600 Walnut Street

Westminster Congregational Church, 3600 Walnut Street, is located on the southwest corner of Thirty-sixth and Walnut streets in Kansas City's Westport District. The church has a frontage of approximately 109 feet on East Thirty-sixth Street and 91 feet on Walnut Street. The structure consists of the church proper, and an addition housing administrative offices, Sunday School rooms and a room for social activities. The church is asymmetrical in plan, with its main entrance on the north facade. The Sunday School addition is rectangular in plan.

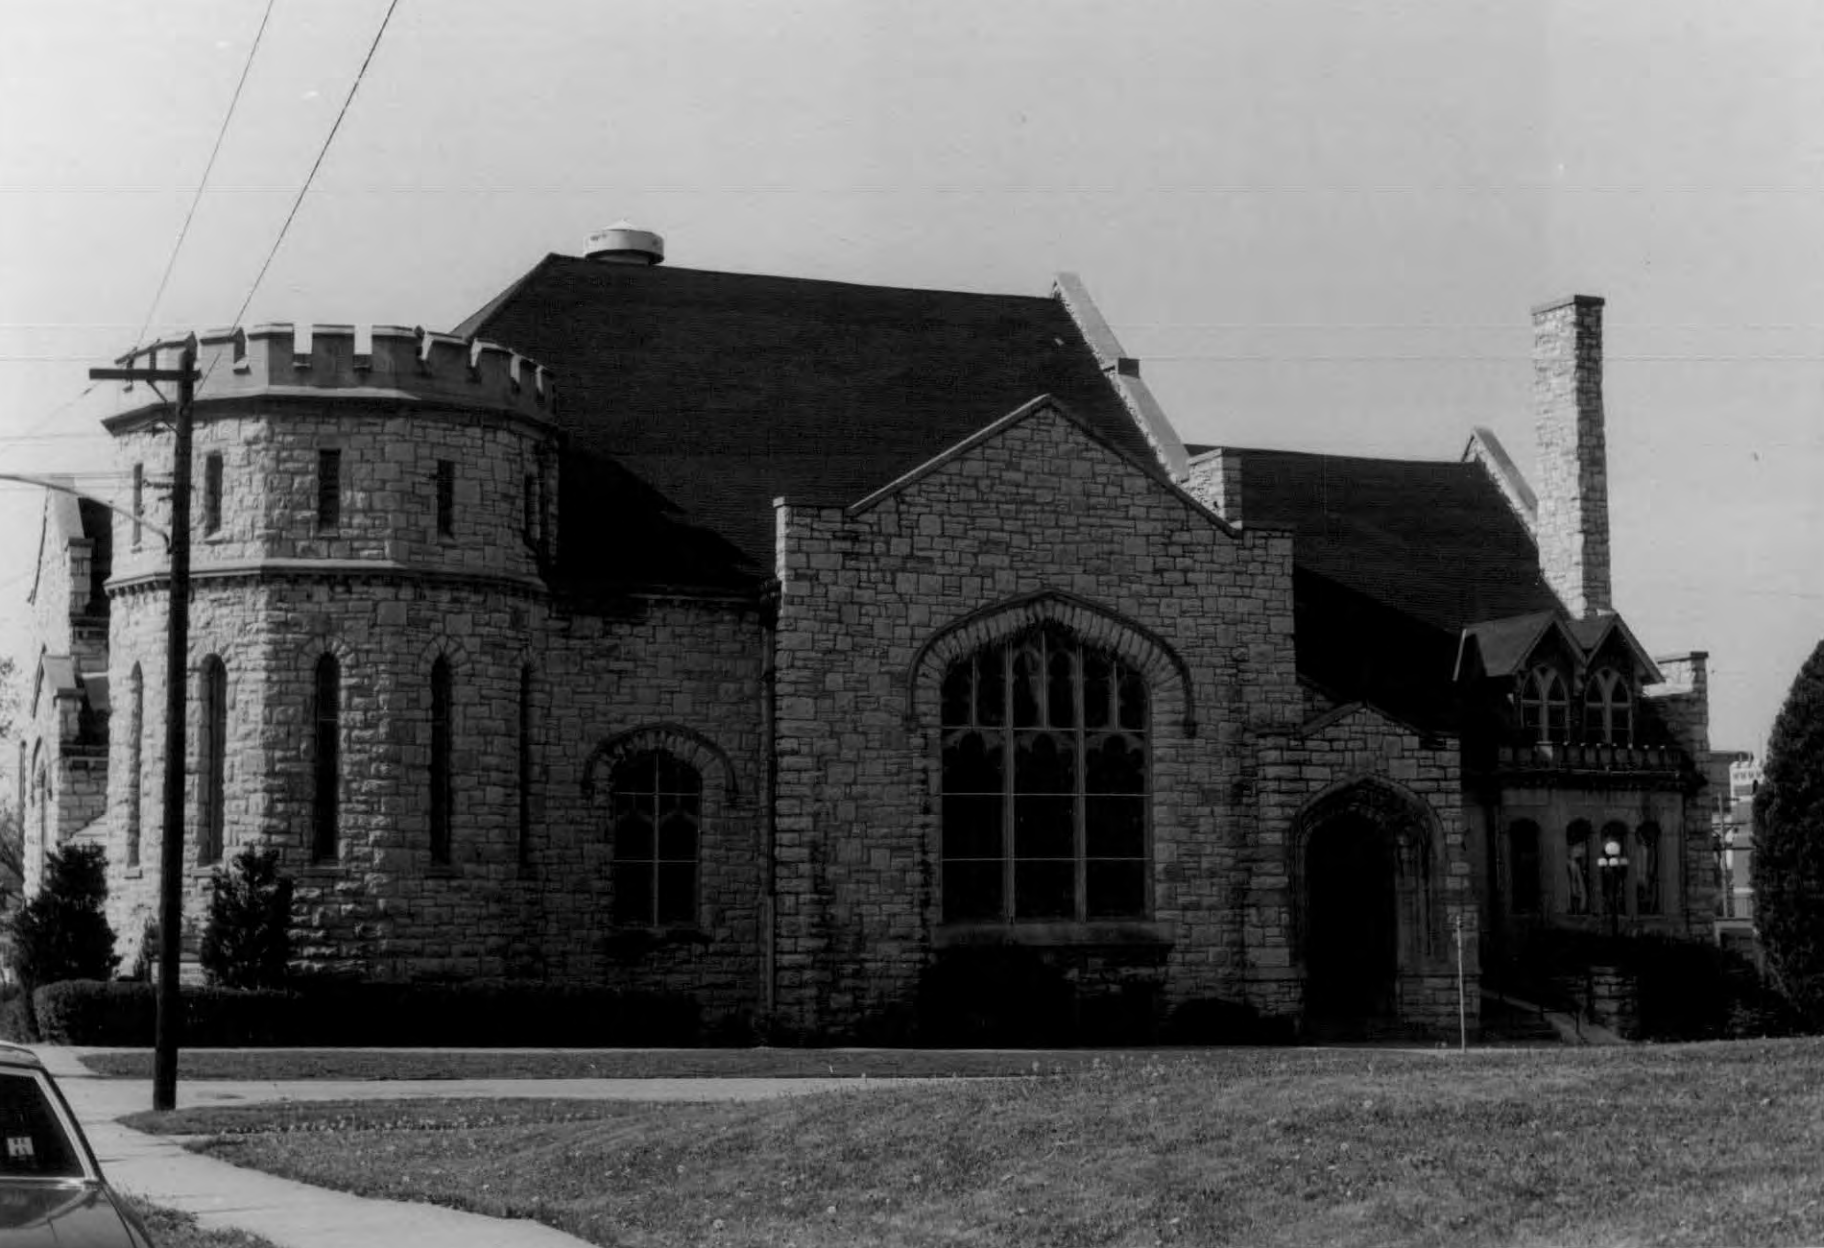
- 1 of 13. Exterior of N façade of church. View looking S.
- 2 of 13. Exterior – E façade of church. View looking NW.
- 3 of 13. Exterior – Tower located on the NE corner of the church. View looking SW.

The north facade, facing Thirty-sixth Street is the main facade. Located on the extreme east end of this facade is a two story, polygonal stone tower with a stone battlement. The tower contains slender louvered windows in rectangular frames on the second story and slender windows in rounded arches on the first story. Directly to the west of the tower is a stained glass window with stone tracery in a Gothic arch. Above the window is a stone hood mold. Next to the window and located in the middle of the facade is a large projection featuring a large stained glass window with stone tracery within a Gothic frame. A stone hood mold is also located above the window. The roof line of the projection is pointed with stone coping. The main entrance, located to the west of the projection is recessed within a modified cloister composed of paired columns with early English capitals. A secondary entrance is located to the west of the main entrance. A castellated semi-hexagonal stone bay is located on the west end of the north facade. The bay contains a painted three dimensional stained glass window. Directly above the bay is a pair of dormers with a pair of Gothic windows.

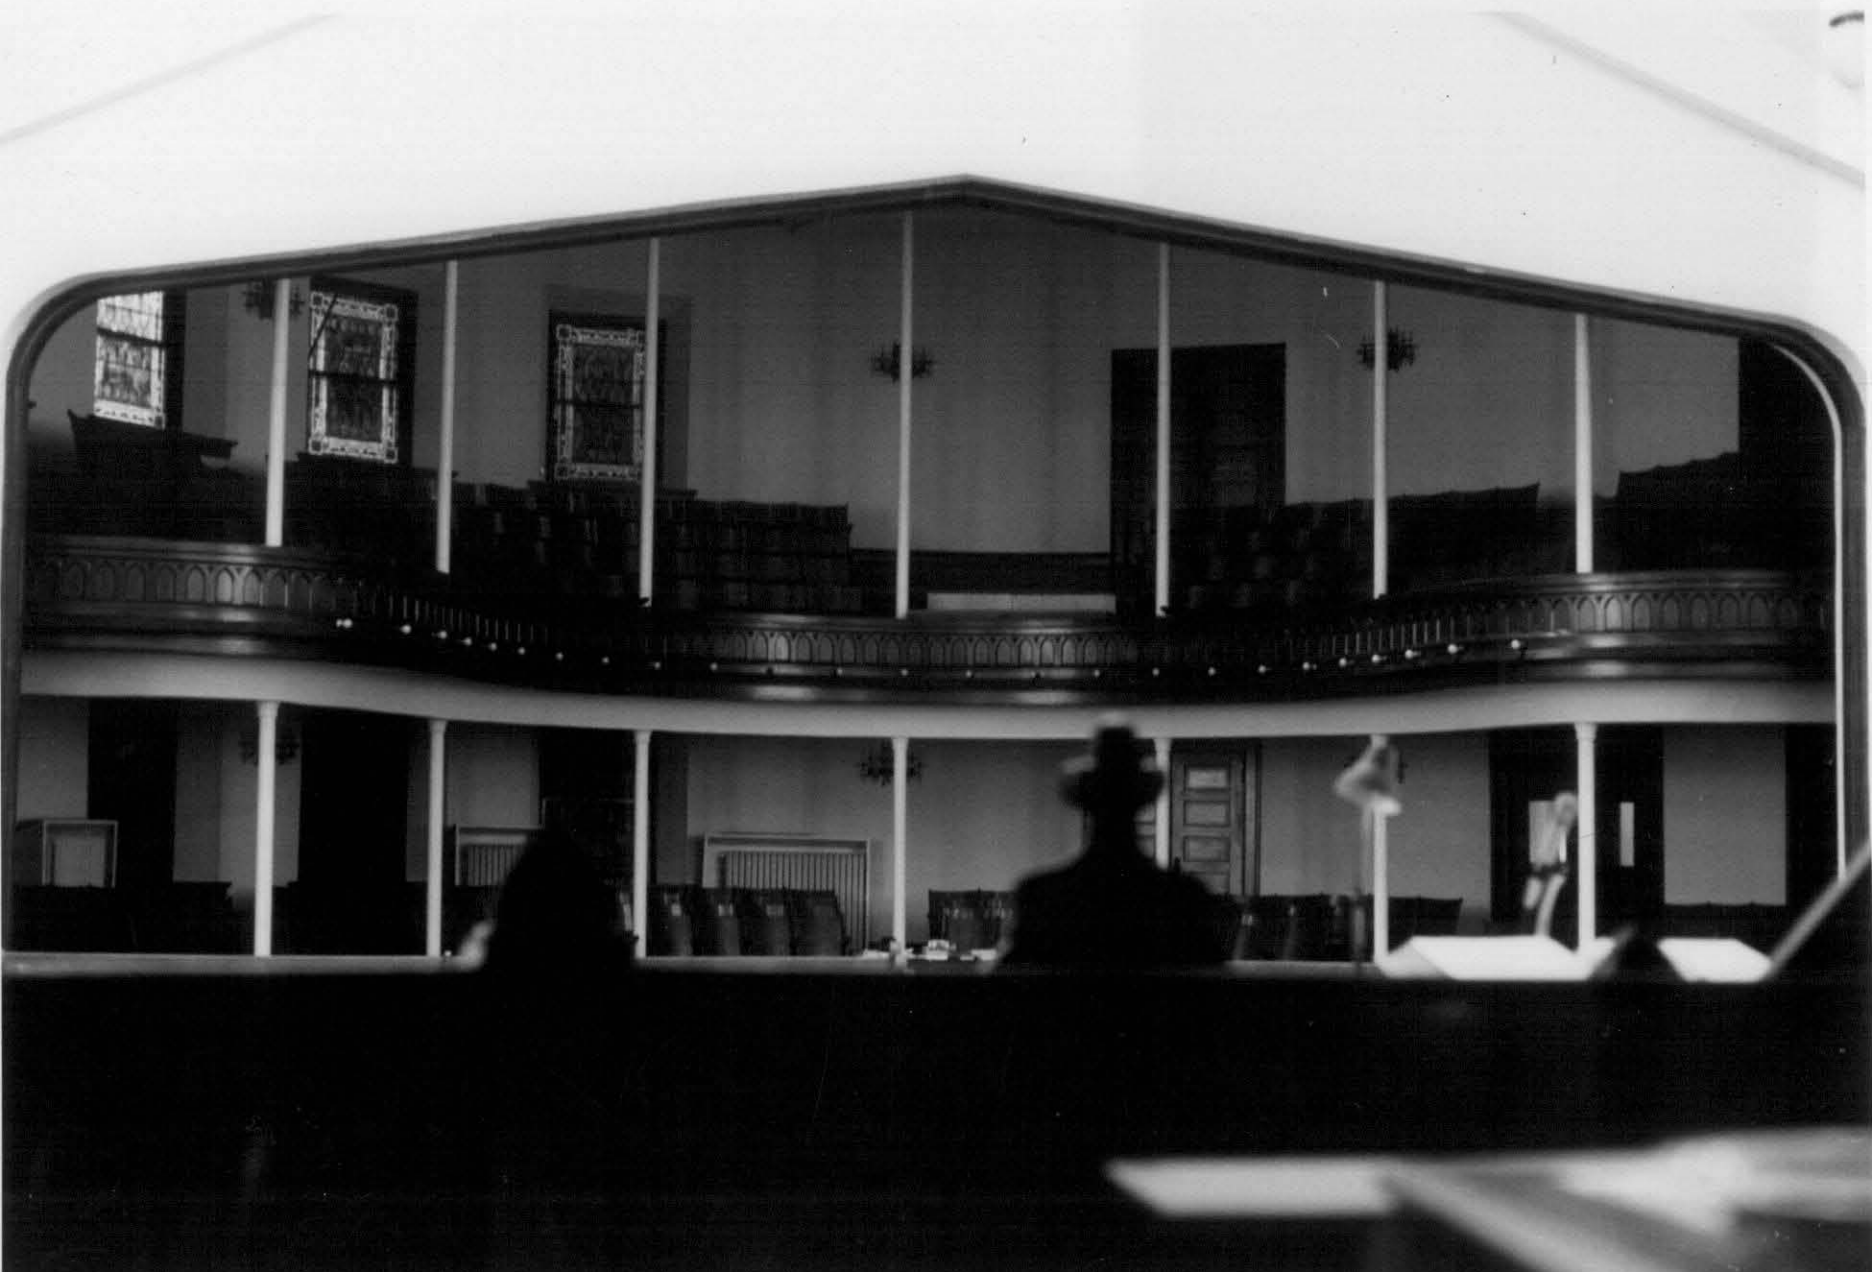
- 7 of 13. Interior – Horseshoe gallery and first floor located to the rear of the main sanctuary. View looking S.
- 8 of 13. Interior – Main sanctuary of the church, showing alter platform and organ pipes. View looking NW.

Behind the main sanctuary, located in the southwest corner of the church is a horseshoe shaped area with ground floor and gallery, that can be closed off from the main sanctuary by a partition that drops from the ceiling.<sup>4</sup> This horseshoe area has a small stained glass interior dome in the ceiling. The back wall of the horseshoe area in both the gallery and ground floor area contain one-over-one double hung sash stained glass windows in rectangular frames that open into the Sunday School area. A Gothic wooden arcaded balustrade runs along the gallery level.

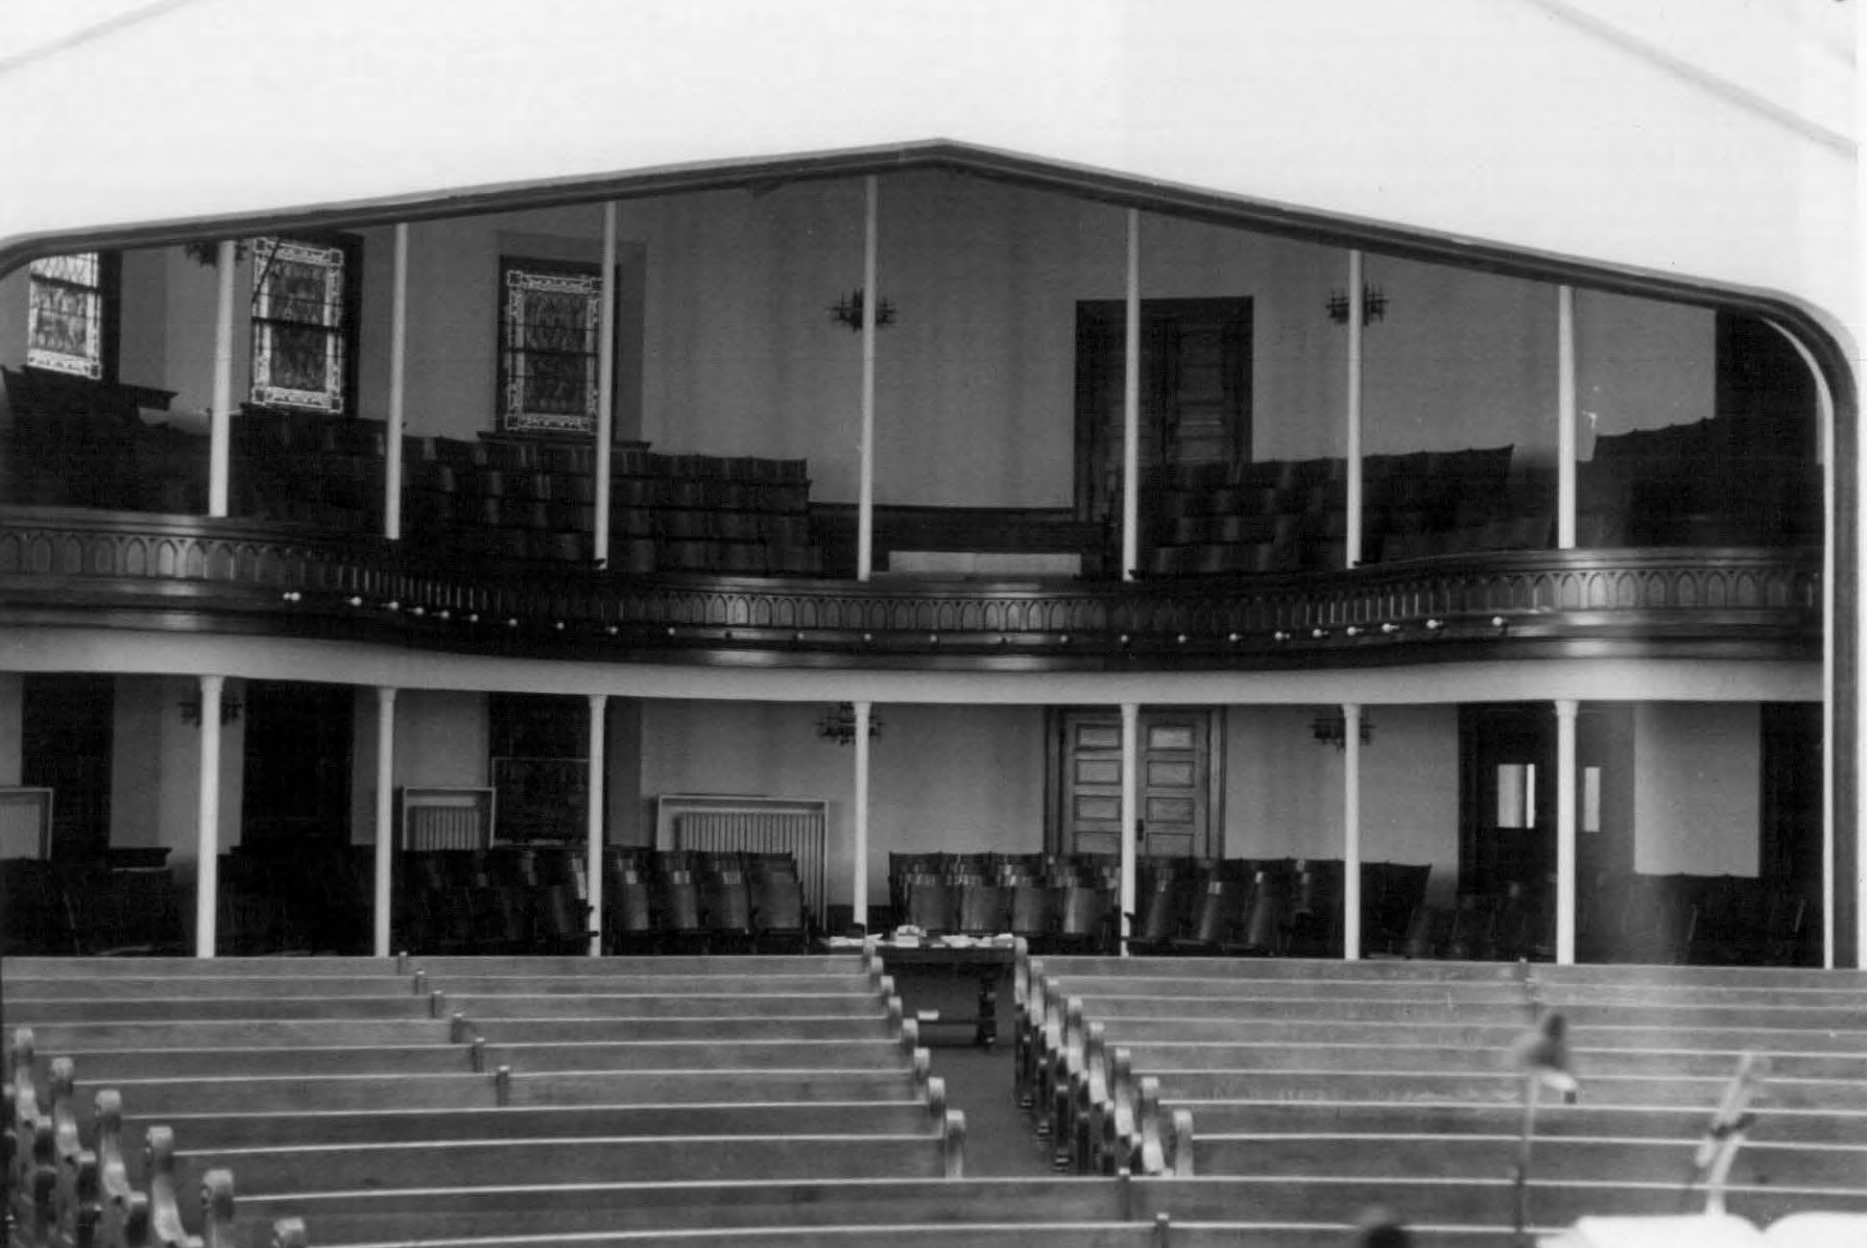
- 9 of 13. Interior – Horseshoe gallery and balcony located in rear of main sanctuary. View looking S.
- 10 of 13. Interior – 1912 Addition showing detail of first and second floor of Sunday School rooms. View looking NE.

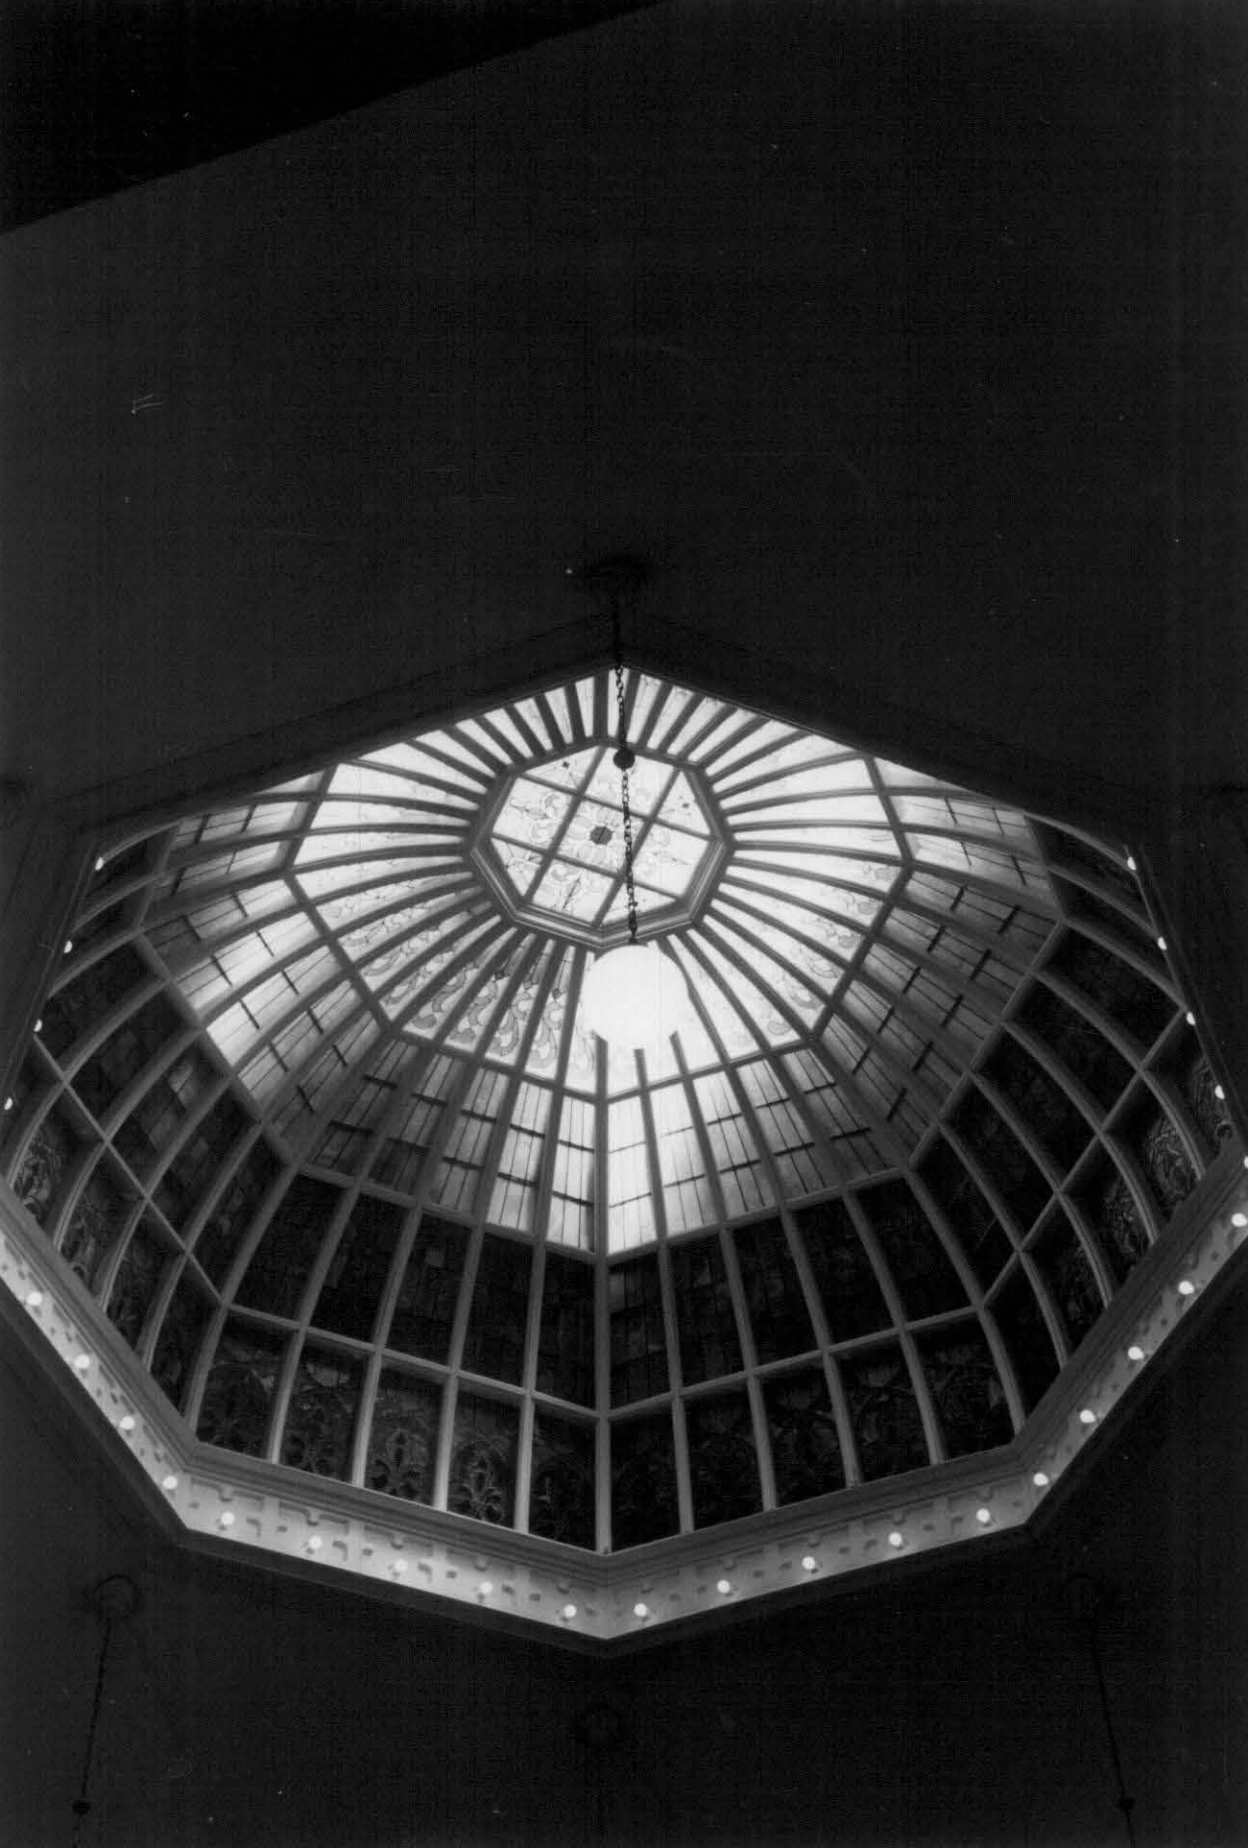
- 11 of 13. Interior – Stained glass dome located in main sanctuary.
- 12 of 13. Interior – 1912 Addition, first floor and balcony showing accordion door partitions for Sunday School. View looking SE.

The ceiling of the church is polygonal in shape and is supported by ribs rising from four Corinthian pilasters. An interior stained glass dome is located in the middle of the ceiling. The walls of the church were smooth plaster originally, but have been texturized.
