National Register of Historic Places Registration Form

other names/site number Downtown Columbia Historic District (Boundary Increase)

Downtown Columbia Historic District (Boundary Increase)
Historic Resources of Downtown Columbia, MO
Boone County, Missouri

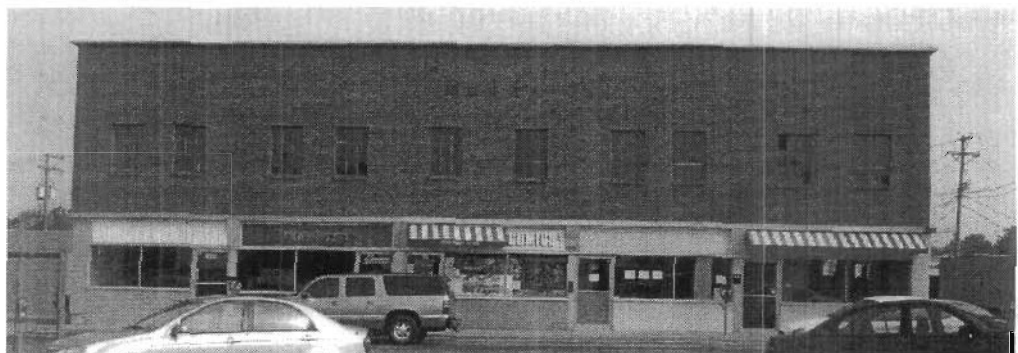
Figure Three.
Berry Building
façade.

The south wall, which faces Walnut Street, is tall and flat, with a row of small storefronts at the first floor and widely spaced windows along the second. The storefronts have brushed aluminum framing that may have been added in the 1940s or early 50s. The roof of the building slopes down from south to north, and the south wall extends almost a half story above the tops of the second floor windows. The name "BERRY" is spelled out in block letters that are

in the center of the upper south wall, and the words "Berry Who. Gro. Co." are featured in a painted sign on the section of the west wall that overlooks the former spur line. The west wall and the westernmost bays of the side walls have all been painted brown; the other walls are all of oversized unpainted red bricks.

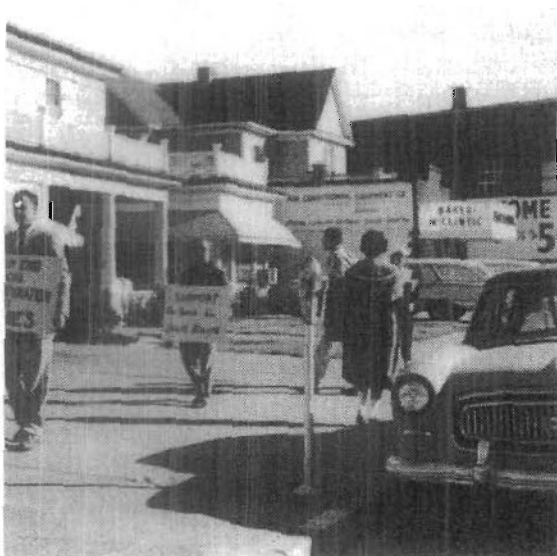
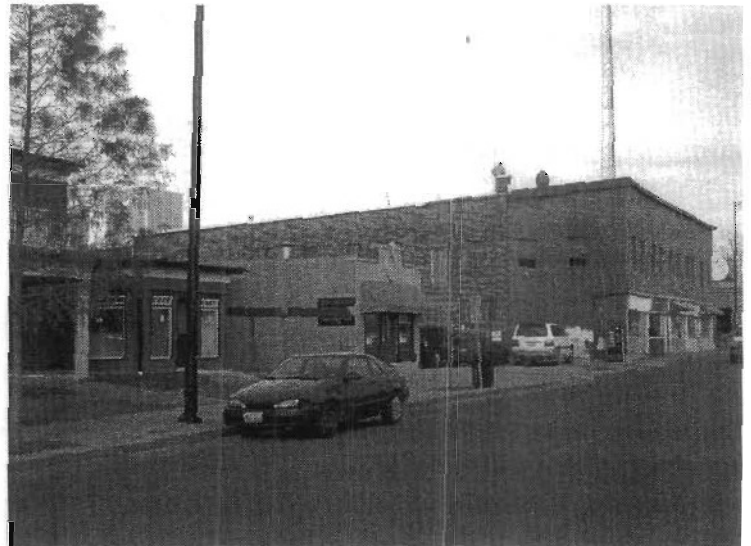
Figure Five. Left: Walnut Street ca. 1960. Right: The same block in 2007.

The simple buildings of the boundary increase are significant for their early association with wholesale commerce in downtown Columbia. The streetscape on West Walnut Street today looks much as it did in the middle years of the 20th century, and the historic buildings in the area reflect their long years of commercial service.
