National Register of Historic Places Registration Form

historic name Virginia Building

street & number 111 South Ninth Street [N/A] not for publication

Virginia Building
Boone County, Missouri

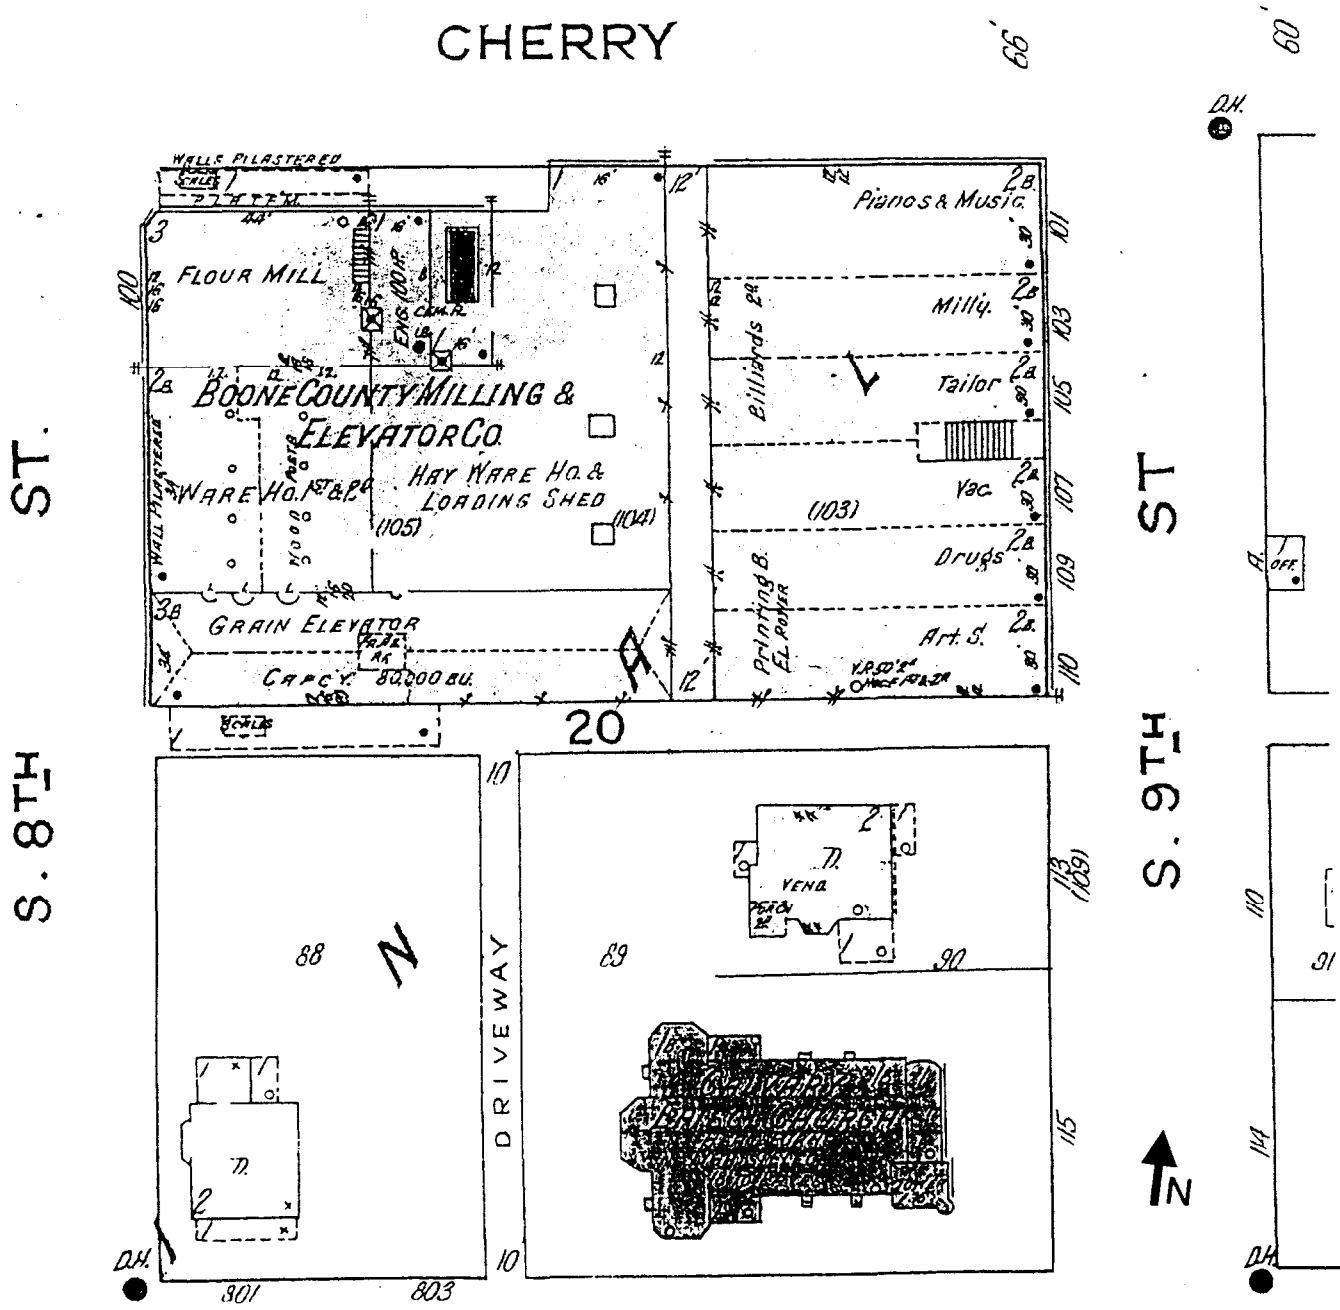
Figure One. 1914 Sanborn Map of the Virginia Building.

The Virginia Building occupies a prominent corner lot, with busy streets along both the east-facing facade and the north side wall. (See Figure One.) The back, or west wall, faces other buildings across a narrow pedestrian alley, and the south wall adjoins a wider alley which is open to vehicular traffic. The lot slopes down to the west, away from Ninth Street, and part of the basement level is above ground along the rear and side elevations.

The first floor plan of the building today is very much like it was when it was mapped by the Sanborn Fire Insurance Map Company in 1914, with rectangular retail spaces lighted by the storefront and transom units, and the main building entrance just off-center on the facade. (See Figure One, Sanborn Map of the building from 1914, and Figure Three, Current First Floor Plan.) There are fewer shops today than there were originally, but the general configuration is the same, and the storefront openings are identical. The shops all have, or will have, open retail space near the front, and service areas along the back wall. Almost all of the interior partitions are new, as the original walls were torn out during the 1960s remodeling.

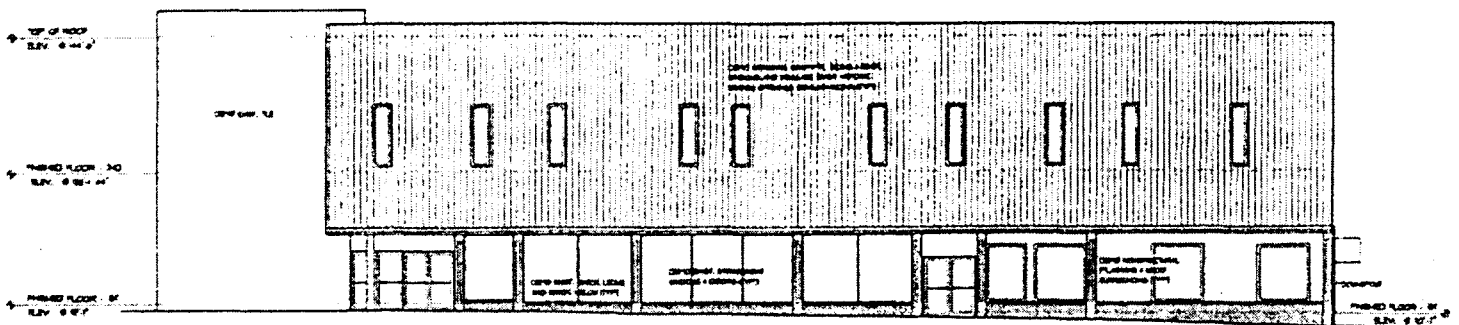
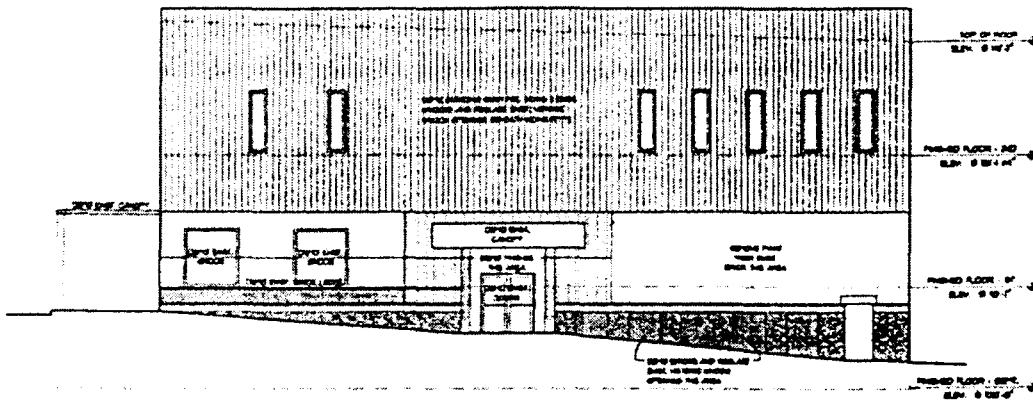
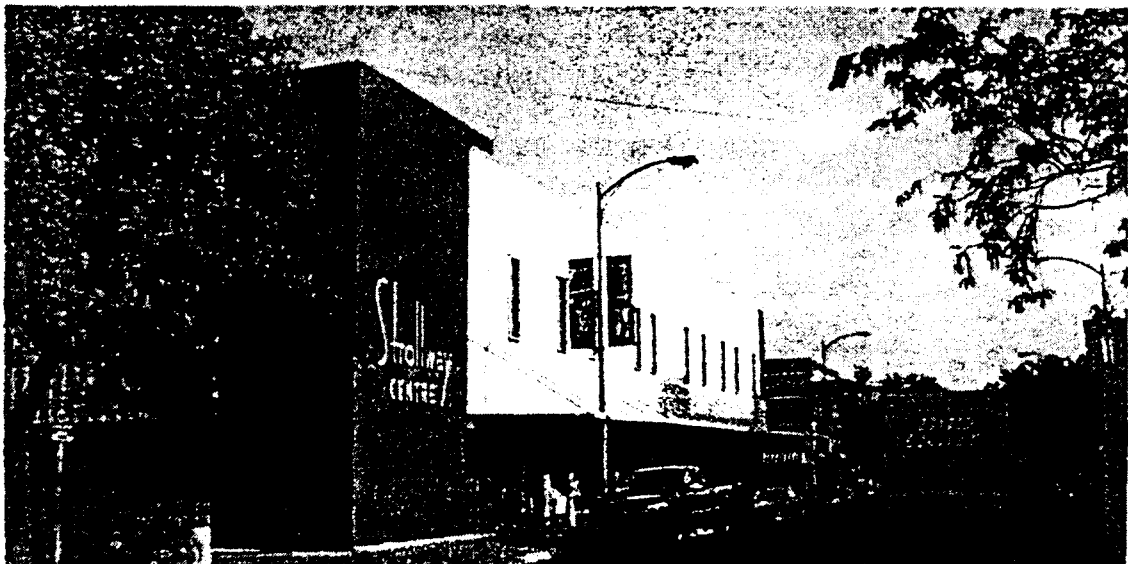
Figure Two. Appearance Before the Recent Rehabilitation. (Drawings by Simon and Associates, Inc., Architecture, Columbia, MO.)

EXISTING EAST ELEVATION
SCALE 1/4\"/>

EXISTING NORTH ELEVATION
SCALE 1/4\"/>

The building was built in 1911, and extensively remodeled in 1965. Notable changes in the 1960s included replacing the second floor windows with massive concrete-framed units, and wrapping most of the second story with vertical metal siding. (See Figure Two, appearance before rehabilitation.) Also, the main entrance was moved to one side, and the interior layout was greatly altered. The ground floor plan was changed from storefront shops to a "mini-mall" layout, with squared shop spaces and a central hallway running parallel to the facade. Ceilings were dropped throughout the building, and new partitions were installed in both the basement and the second floor as well.

Although the remodeling had an extreme affect upon the appearance of the building, much original fabric was left in place. The basic form and patterns of fenestration were intact beneath the sheathing, as was most of the original face brick, the cast iron piers between the storefronts, and much of the original terra cotta ornamentation. Inside, the ornamental ceilings of the ground floor shop spaces remained in place beneath modern suspended ceiling panels. A recent rehabilitation project, done to the Secretary of the Interior's Standards for Rehabilitation and guided by historic photos, reversed most of those later changes, and the building today looks much as it did when it was new. (Compare photos 1 and 2.)

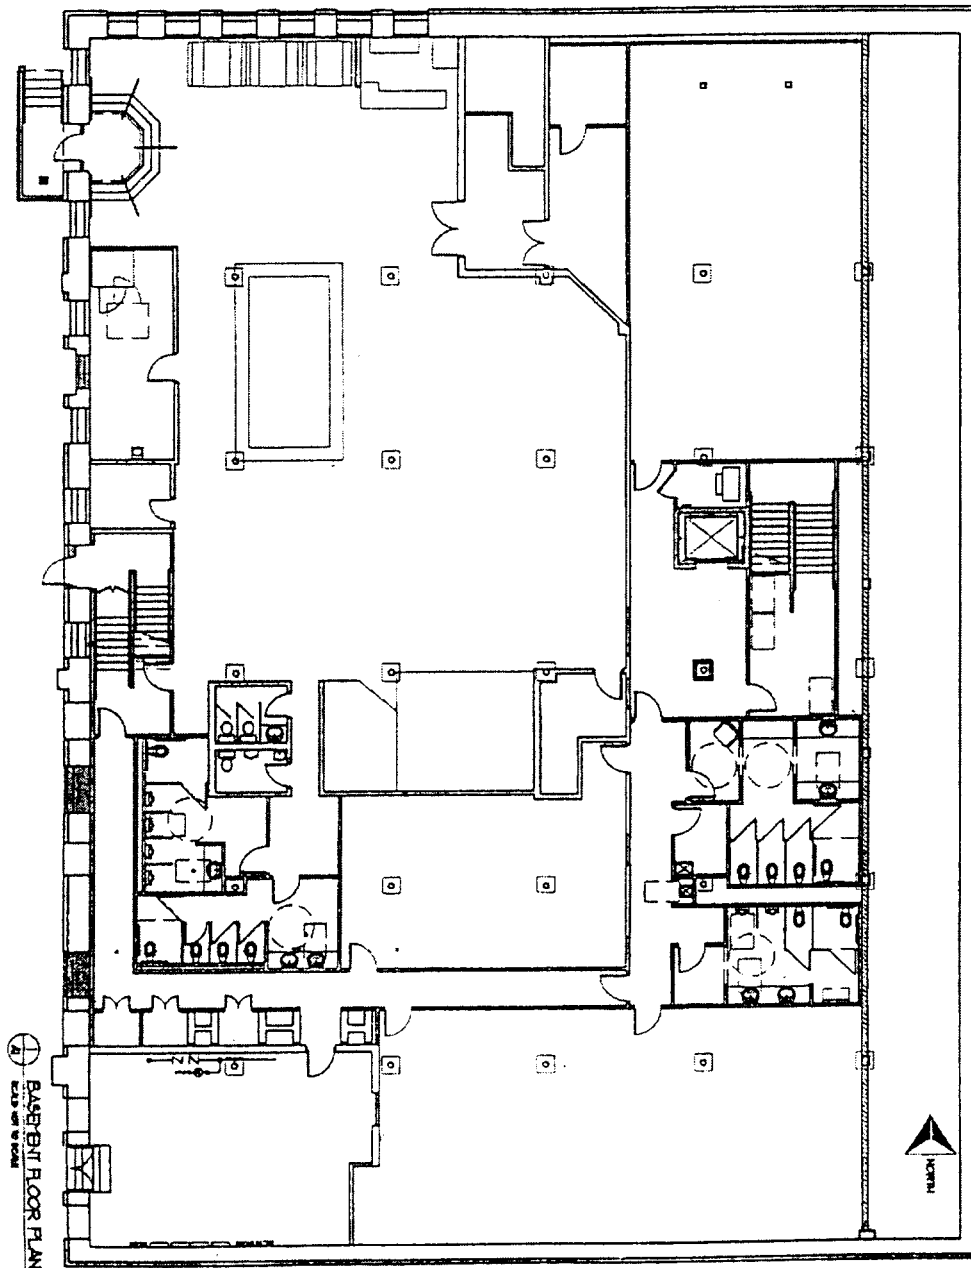
Figure Five. Basement Plan. Drawn by Simon Associates, Inc. Architecture, Columbia, MO.

The basement is also only partially finished. There are some original elements in place there, including several of the heavy support columns, and a small amount of embossed metal ceiling sheathing. (See photo 11.) The basement ceiling covering, which is in the southernmost room, is much more heavy-duty than the panels found on the first floor, and consists of large sheets rather than individual panels with separate borders and cornices. The original boiler/mechanical room is still in place in the southwest corner of the basement; it has rock-faced stone walls and a concrete floor. Other basement rooms include newly finished storage rooms, and a nightclub space which has been in the northwest part of the basement for decades.
